Geo-engineering Reconnaissance of the 2010 Maule, Chile Earthquake

Report of the NSF Sponsored GEER Association Team

GEER Association Report No. GEER-022

Version 1: April 15, 2010

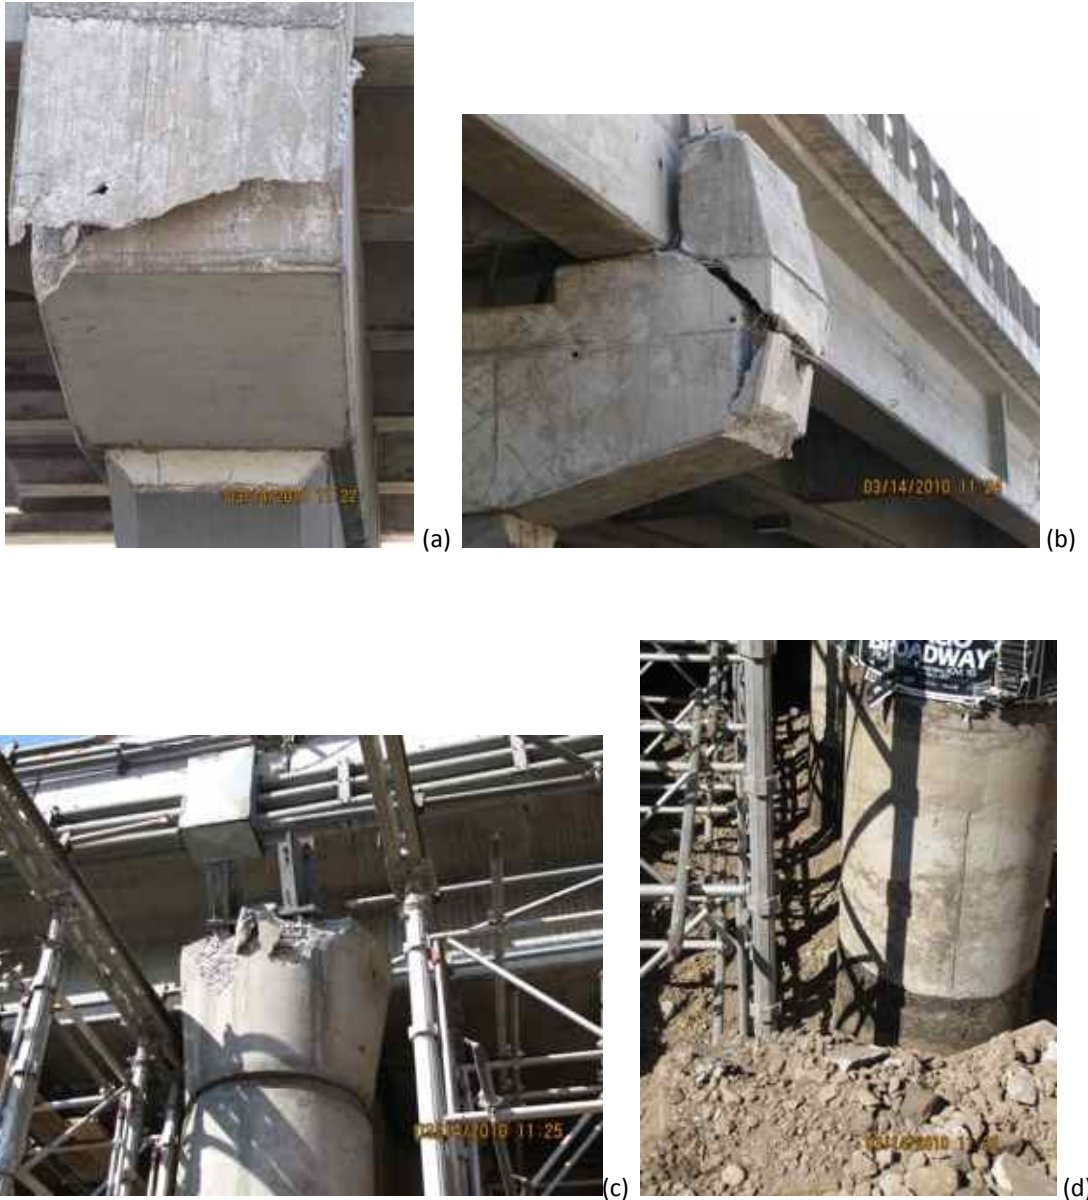
Figure 5.5. Paso San Martin (S33.3660° W70.6891°, 1122 hrs on 03/14/2010). Shear key failure and longitudinal, transverse deck displacement.

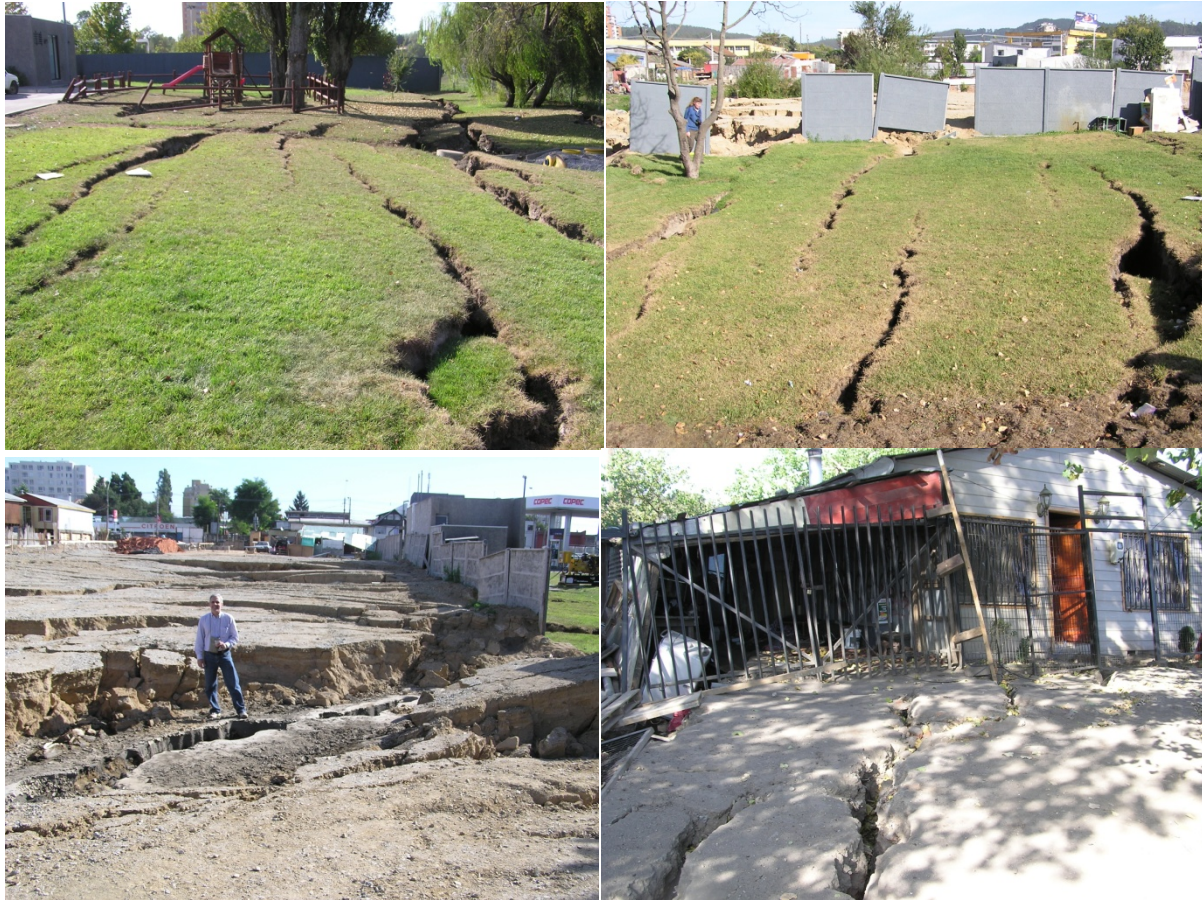
Figure 6.8. Effects of the lateral spread at the southwest edge of Laguna Las Tres Pascualas (S36.8153°, W73.0458°; 1700 hrs on 3/14/2010).

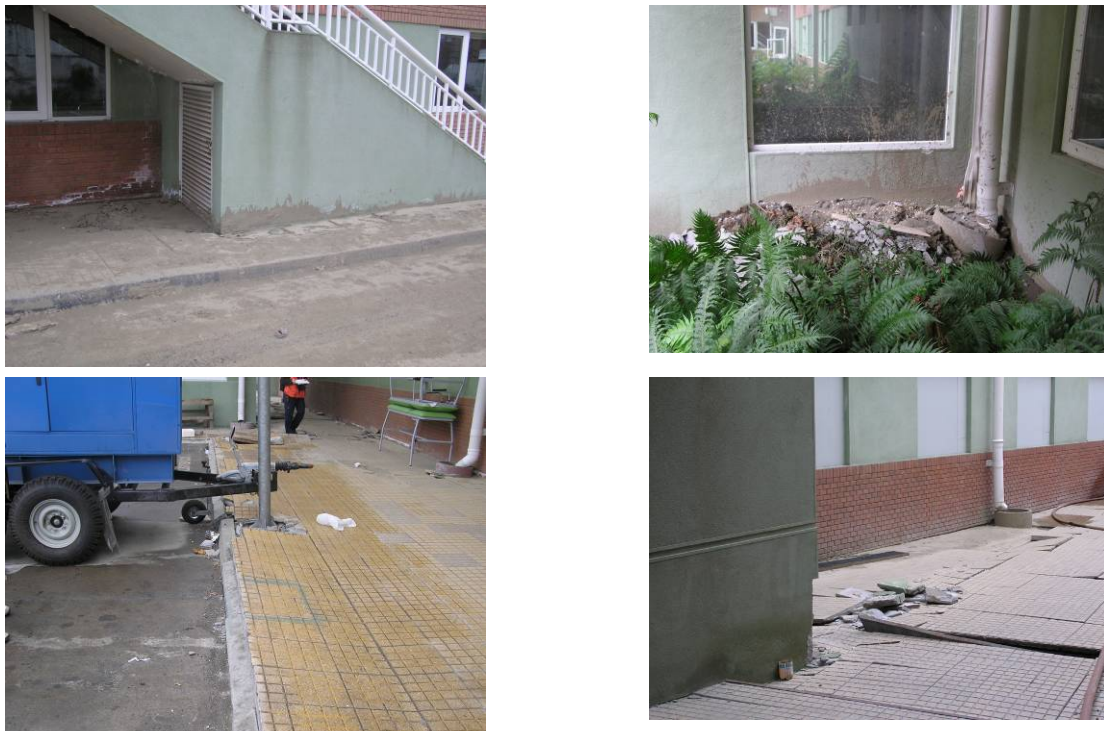
Figure 7.7. Sediment ejecta observed around hospital wings; (a) ejecta observed along exterior staircase of Wing 1D (S37.47358°, W73.34890°), (b) ejecta observed along exterior of Wing 1C (S37.47342°, W73.34829°), (c) ejecta observed along south side of Wing 1D(S37.47375°, W73.34851°), and ejecta observed along east side of Wing 2G (S37.47343°, W73.34788°).

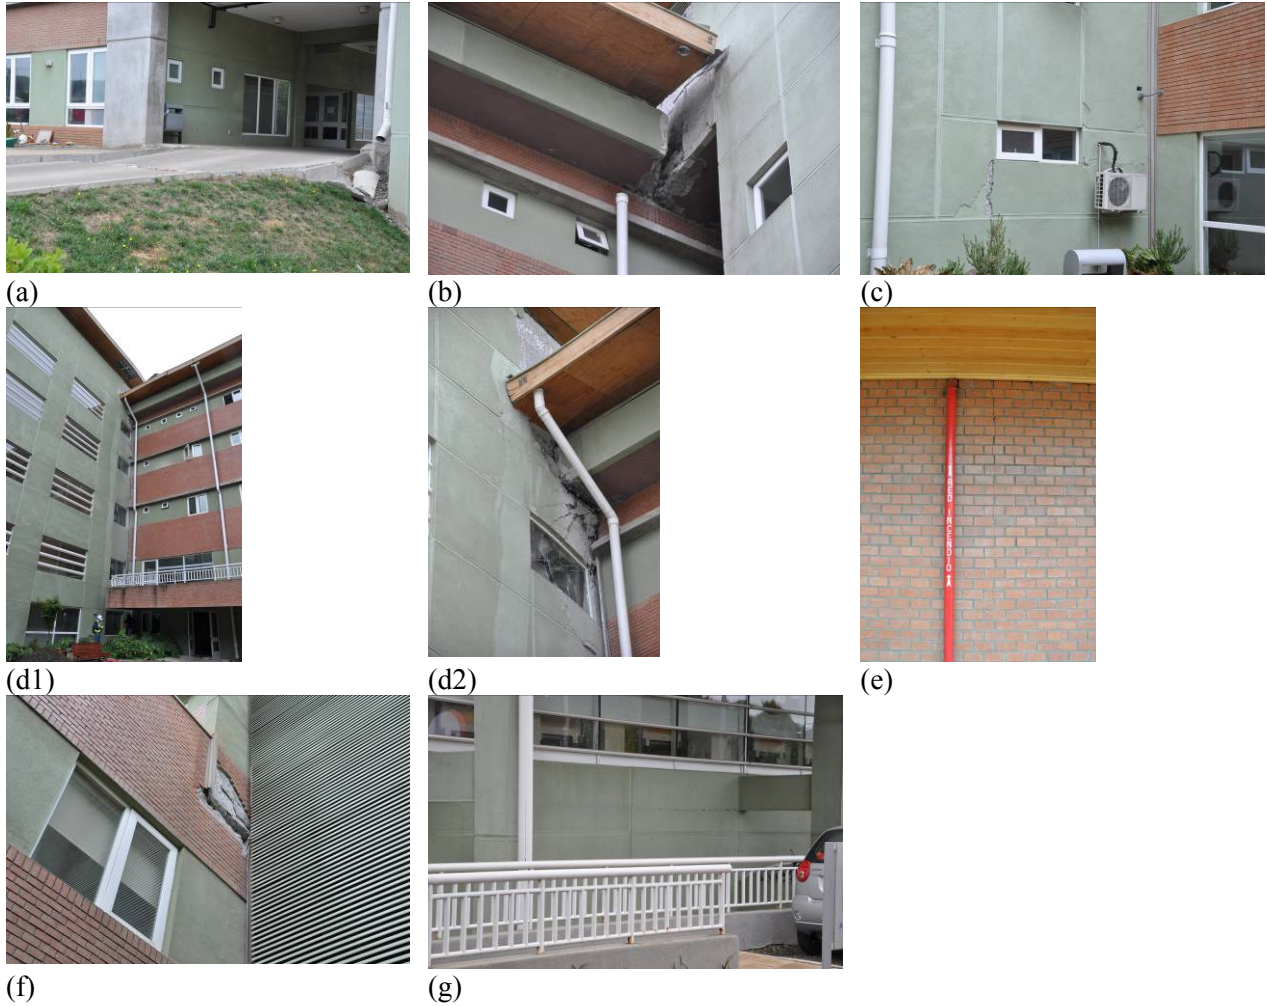
Figure 7.12 Most pronounced structural damage observations. (a) approach ramp to entrance bay at wing 1A (S37.473084°,W73.348712°), (b) pounding damage and resulting permanent gap developed between wings 1A-1C due to the easterly rocking of wing 1C (note the gap was measured by hospital staff as 37 cm after the main event on February 27, 2010) (S37.473376°, W73.348452°), (c) damage to shear wall of wing 1C due to contact with wing 1D (S37.473537°, W73.348488°), (d1) elevation view of the interface between wing 1B-1C and (d2) local view at the roof line of wing 1B observing the pounding between these two wings (S37.473406°,W73.348304°), (e) vertical cracks in masonry in-fill of wing 2H (S37.473713°, W73.347839°), (f) fallen masonry façade and spalling of structural wall of wing 1F due to impact with wing 1B (S37.473494°, W73.347948°), and (g) cracking damage at in-fill and structural shear wall interface at front of wing 2I-2J (S37.473528°, W73.347363°). Images taken at 1430, 1715, 1415, 1725, 1725, 1350, 1625, and 1645 hrs, respectively, on 3/16/2010.

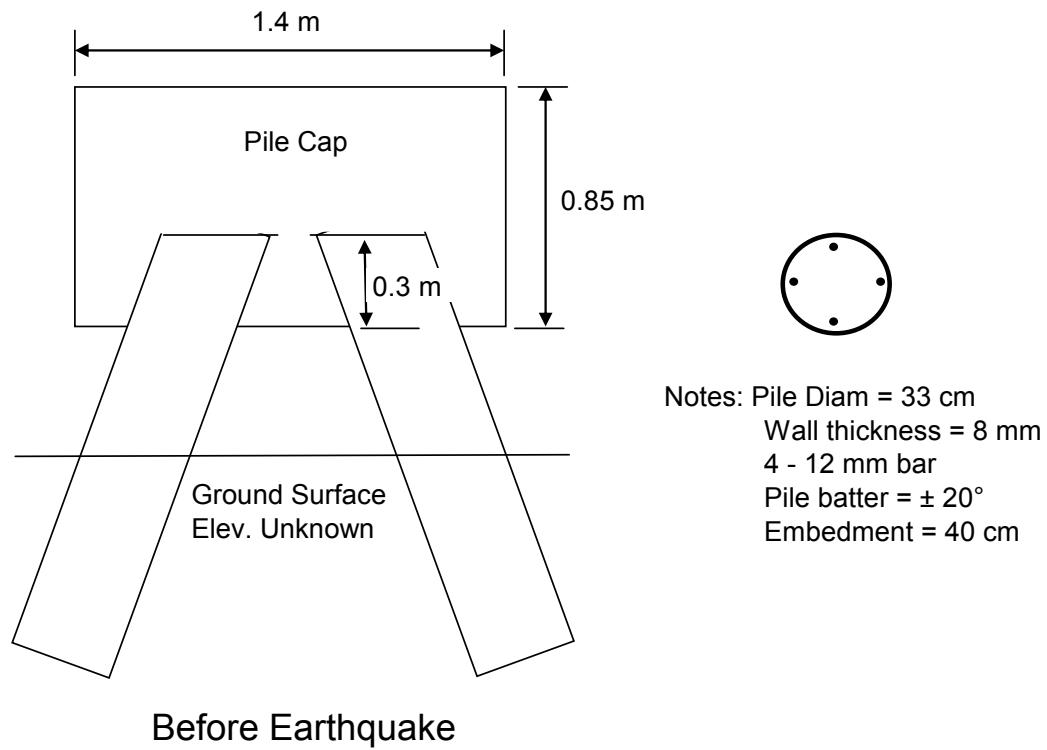
Figure 8.14. Measurements of pile cap with battered piles supporting pier at small fishermen's Port of Coronel before and after lateral spreading. (Rollins, Mylonakis, and Assimaki).

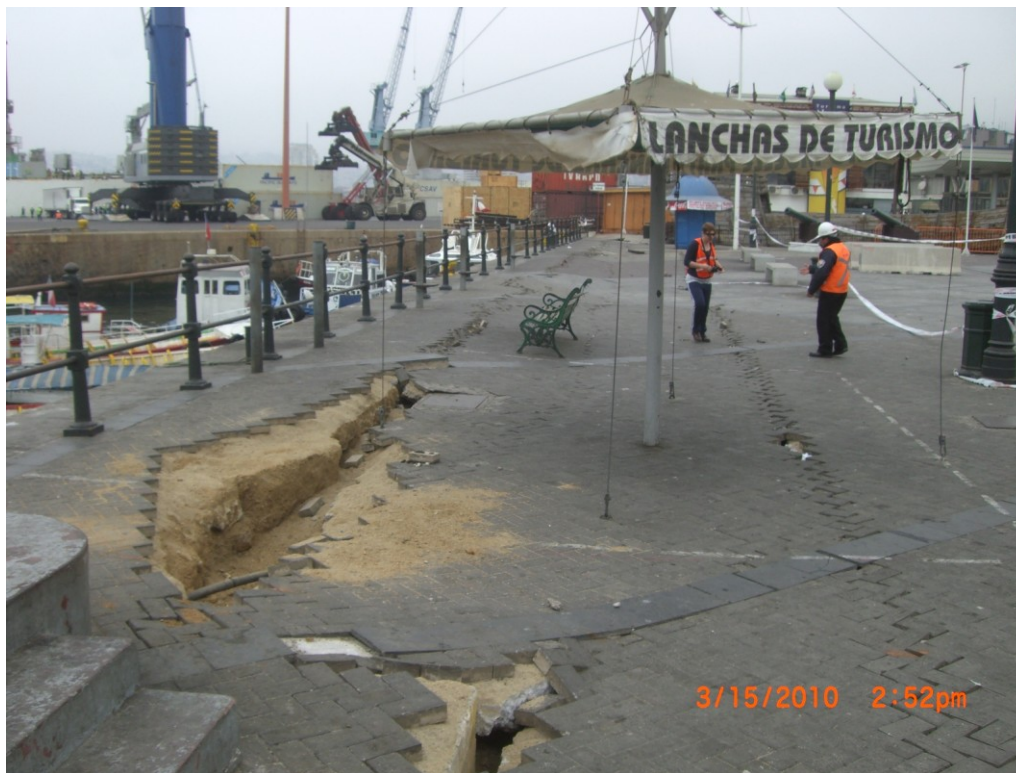
Figure 8.16. Photograph of lateral movement and vertical displacement of ground behind public dock at port of Valparaíso (S33.0375°, W71.6274°; 1452 hrs, 03/15/2010).

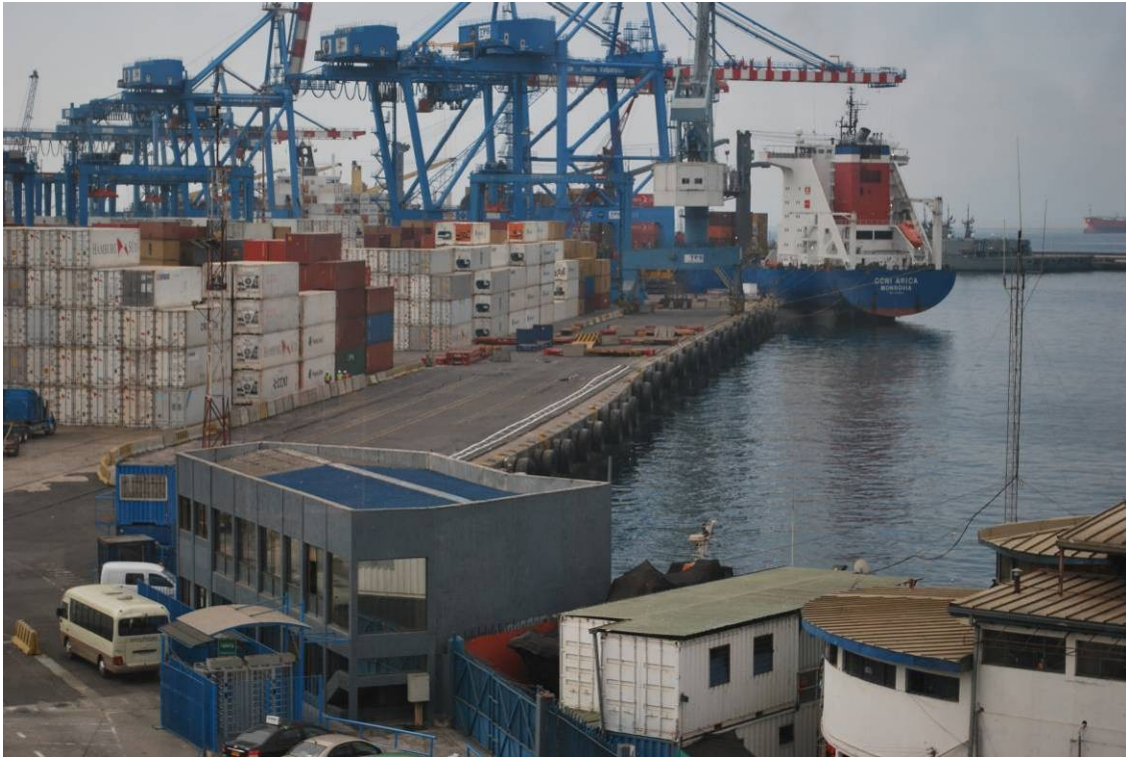
Figure 8.18. Outward movement of quay wall and asphalt pavement cracks at commercial dock of Valparaíso port (S33.036°, W71.628°; 1640 hrs, 03/15/2010).

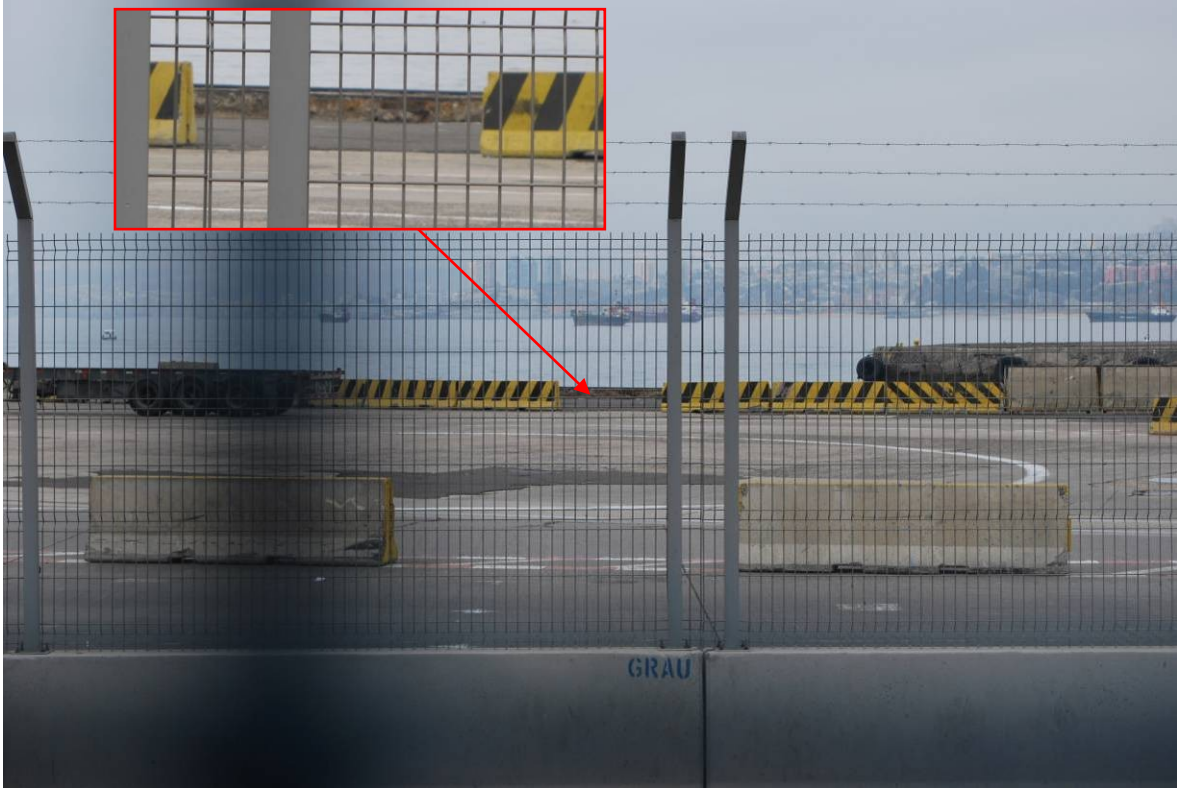
Figure 8.19. Settlement in backfill behind the quay wall at commercial dock of Valparaíso port (S33.034°, W71.627°; 1620 hrs, 03/15/2010).

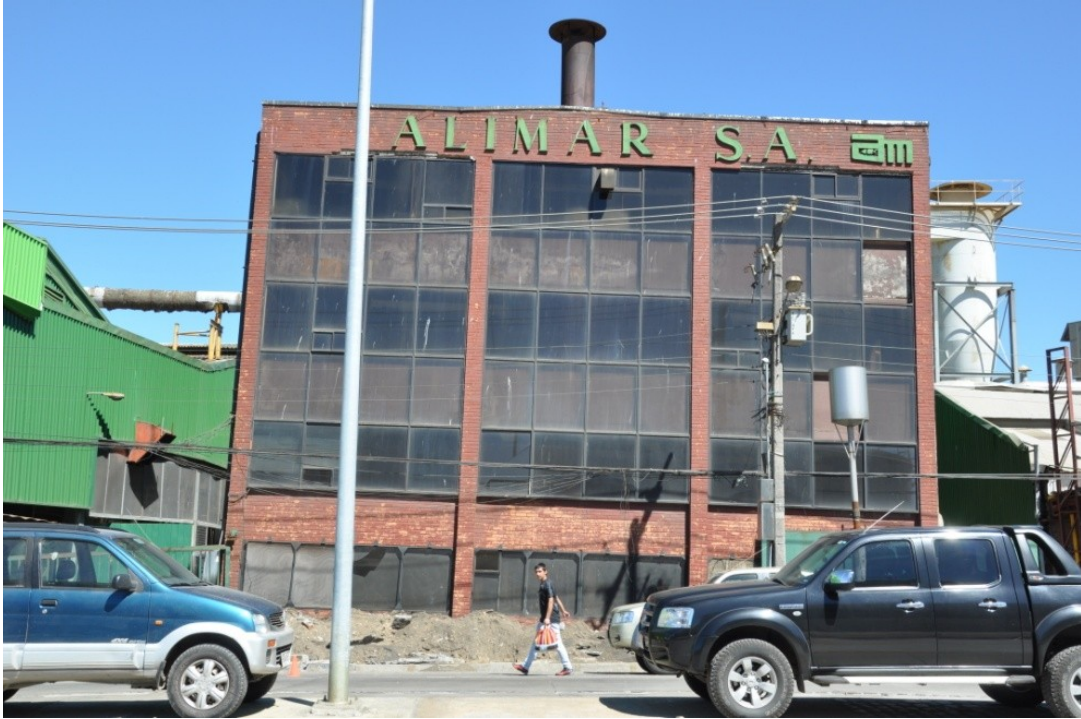
Figure 8.24. Damage to fish packaging facility (S36.7260°, W73.1288°; 1345 hrs, 03/15/2010).

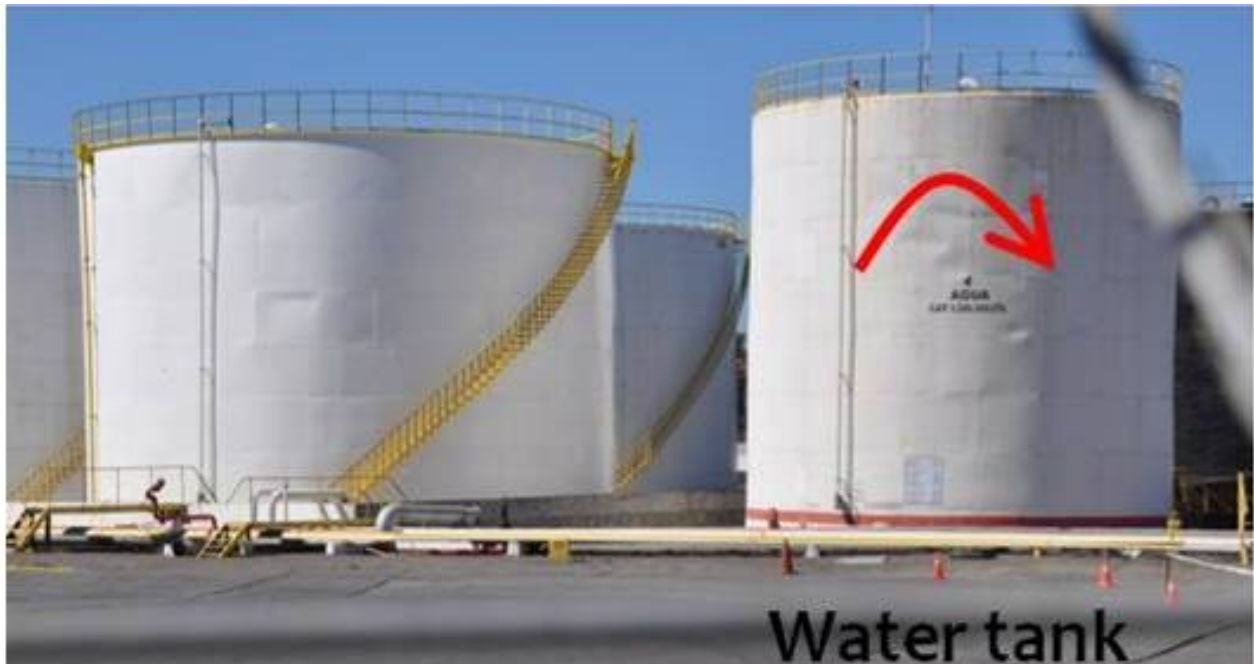
Figure 8.30. Tilted water tank at Petrobas gas facility (S36.7270°, W73.1272°; 1250 hrs, 03/15/2010).

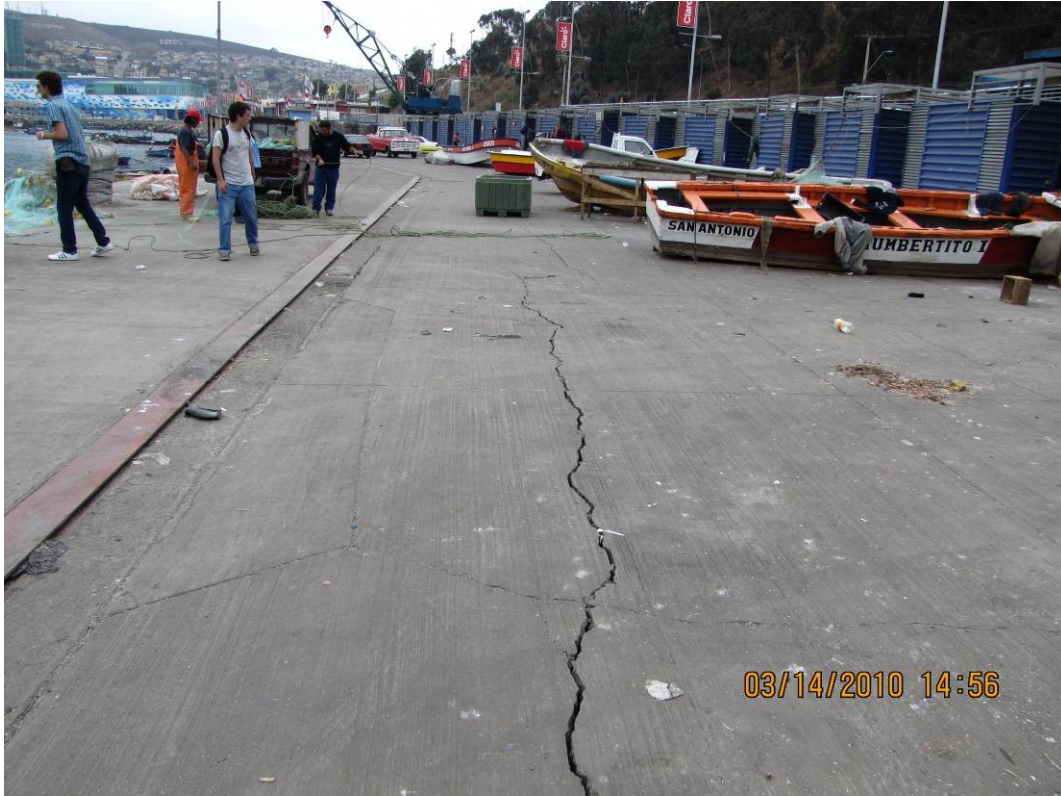
Figure 8.31. Cracks on asphalt pavement behind quay wall in San Antonio Port (S33.5870°, W71.6132°; 1456 hrs, 03/14/2010).

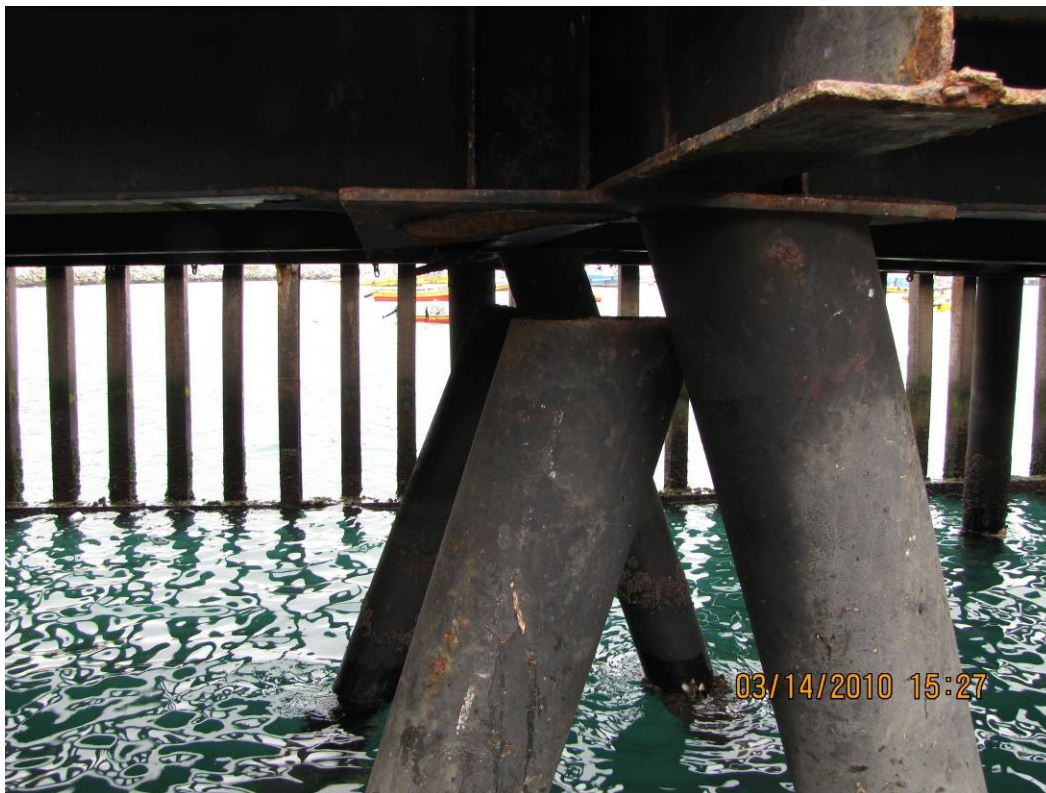
Figure 8.36. Failure of head connection between wharf and raked piles in San Antonio Port (S33.5817°, W71.6154°; 1527 hrs, 03/14/2010).

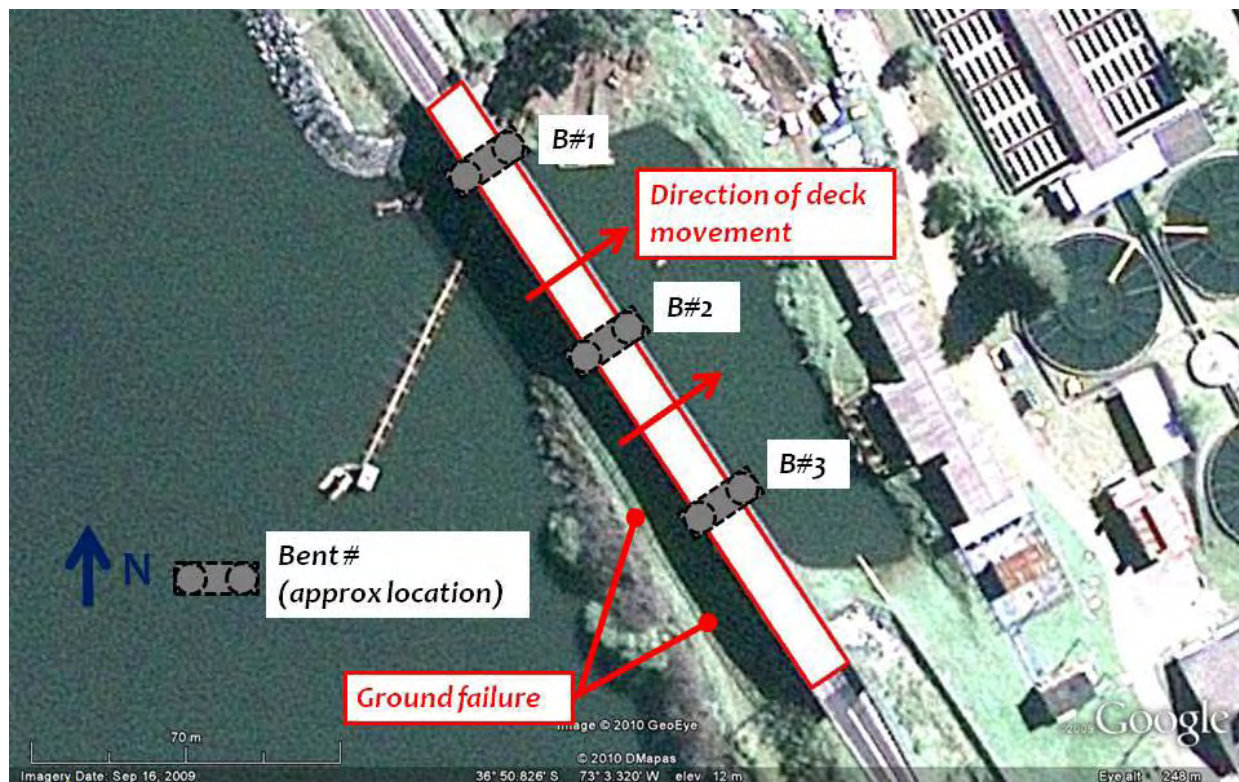
Figure 9.16. Plan view of the La Mochita bridge in south Concepción describing observed damage (S36.846841° W73.055496°).

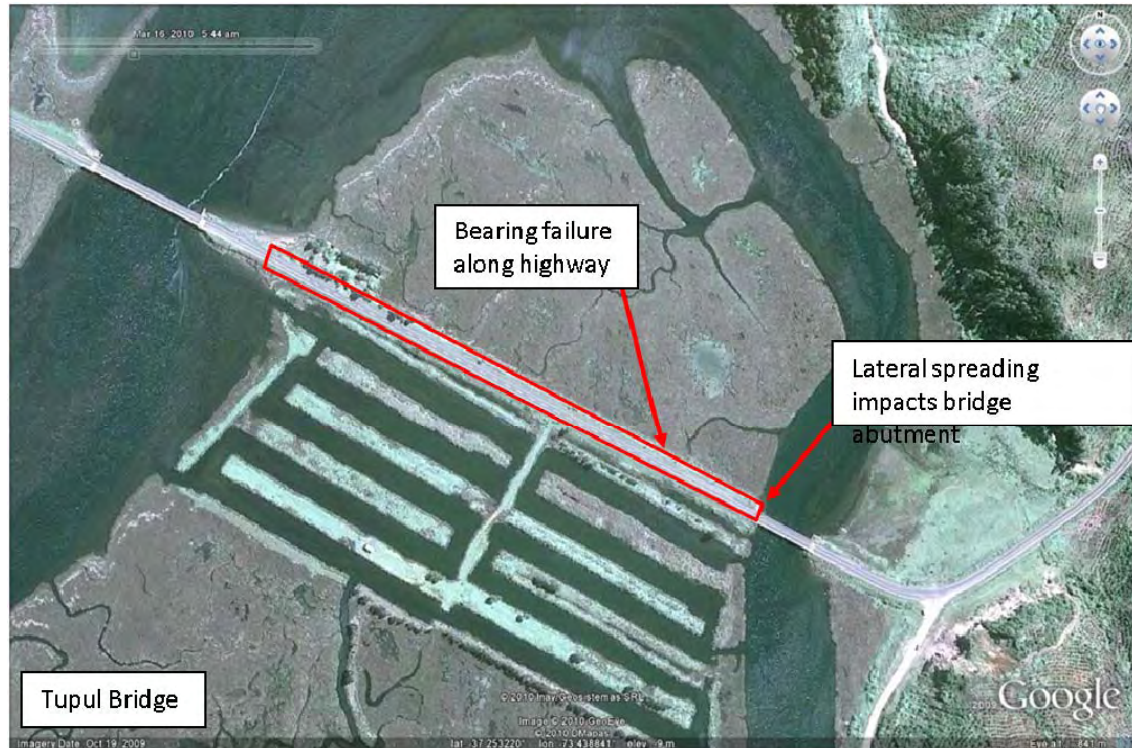
Figure 9.44. Damage to roadway and bridge due to ground failure near town of Tupul, Chile (S37.254345°, W73.437021°).

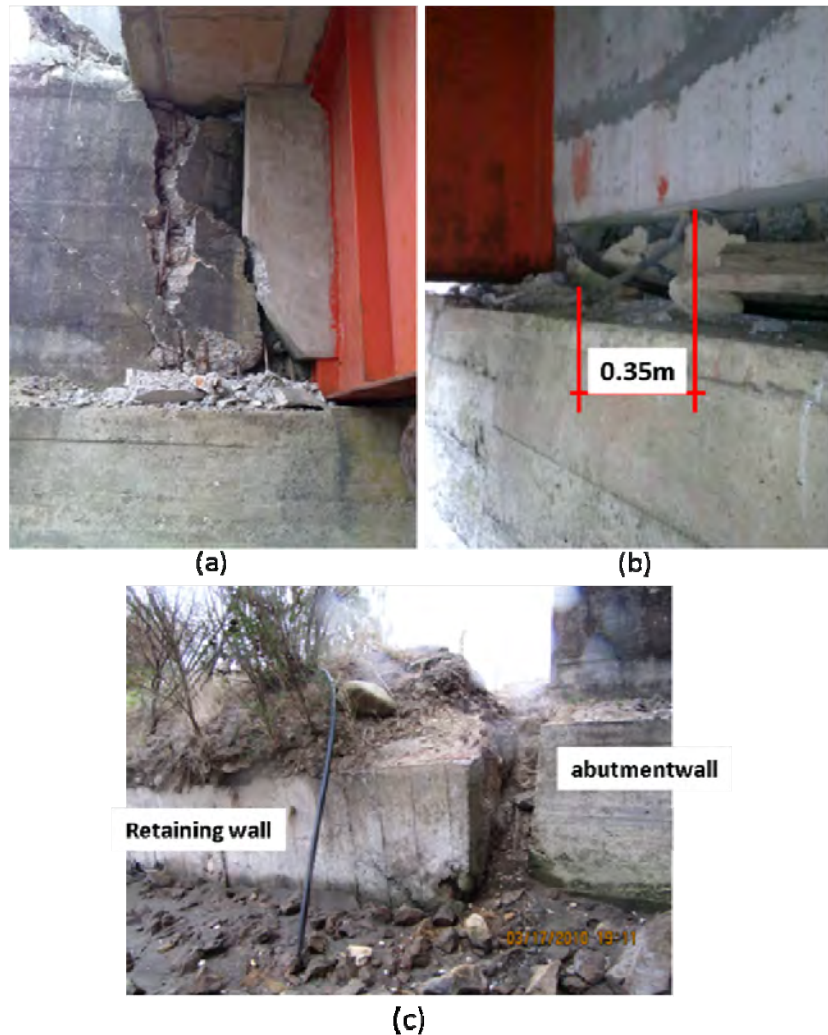
Figure 9.45. Damage to bridge abutment due to lateral spreading of soil around bridge abutment. (a) abutment wall movement relative to beams, (b) deformation of vertical restraining bar due to abutment movement relative to beams, (c) movement of retaining wall relative to abutment. (S37.254345°, W73.437021°; 1911 hrs on 3/17/2010)

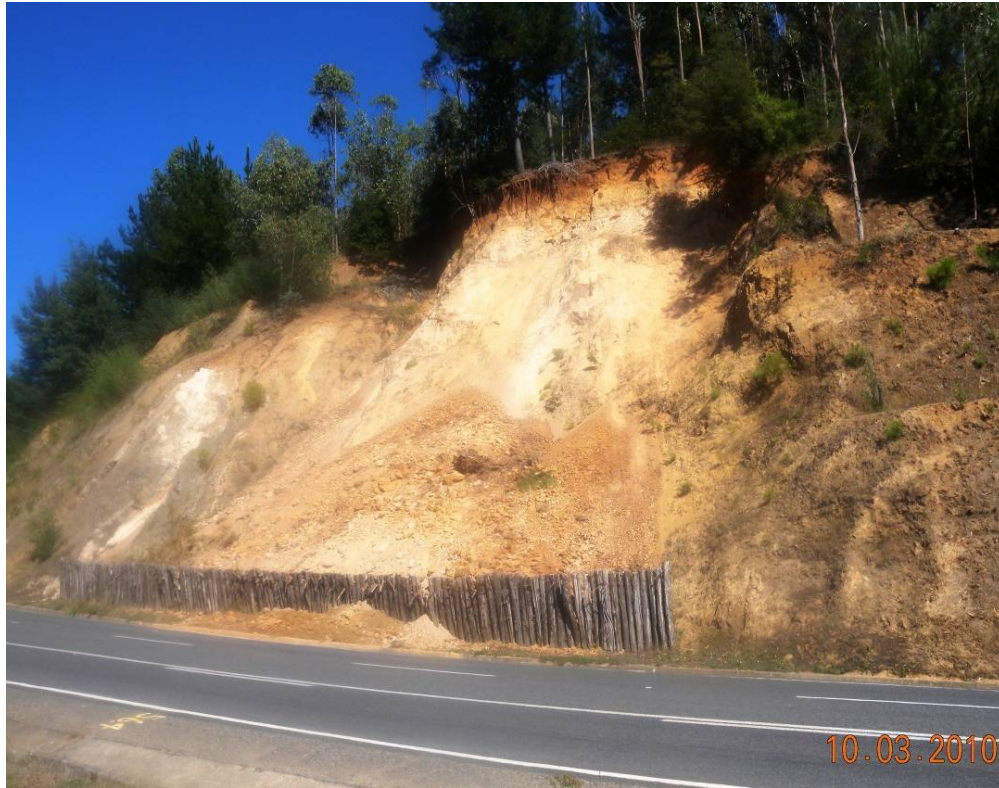
Figure 10.5. Shallow failure in a road cut in highly weathered bedrock (37.256493°S, 72.96018°W, looking SW).

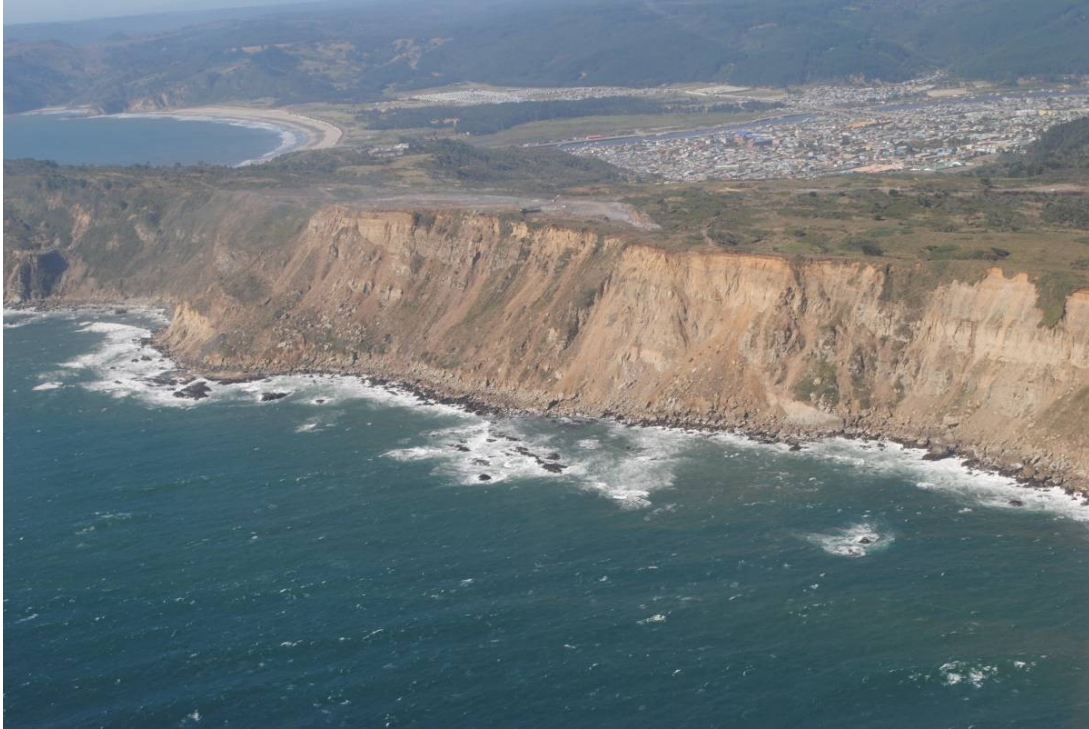
Figure 10.8. Shallow slides along bluffs southwest of Lebu (37.6°S , 73.674°W).

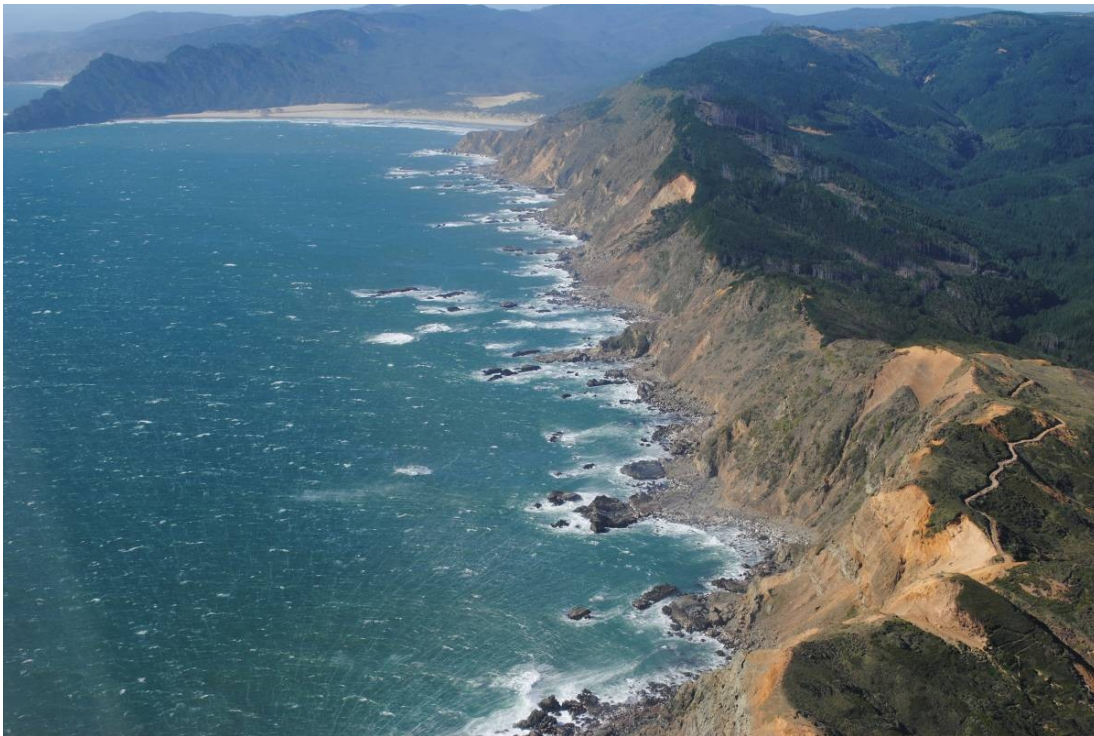
Figure 10.9. Bluffs north of Pta Carneros, southwest of Arauco, showing frequent but not pervasive sliding and raveling (37.326°S , 73.2674°W).

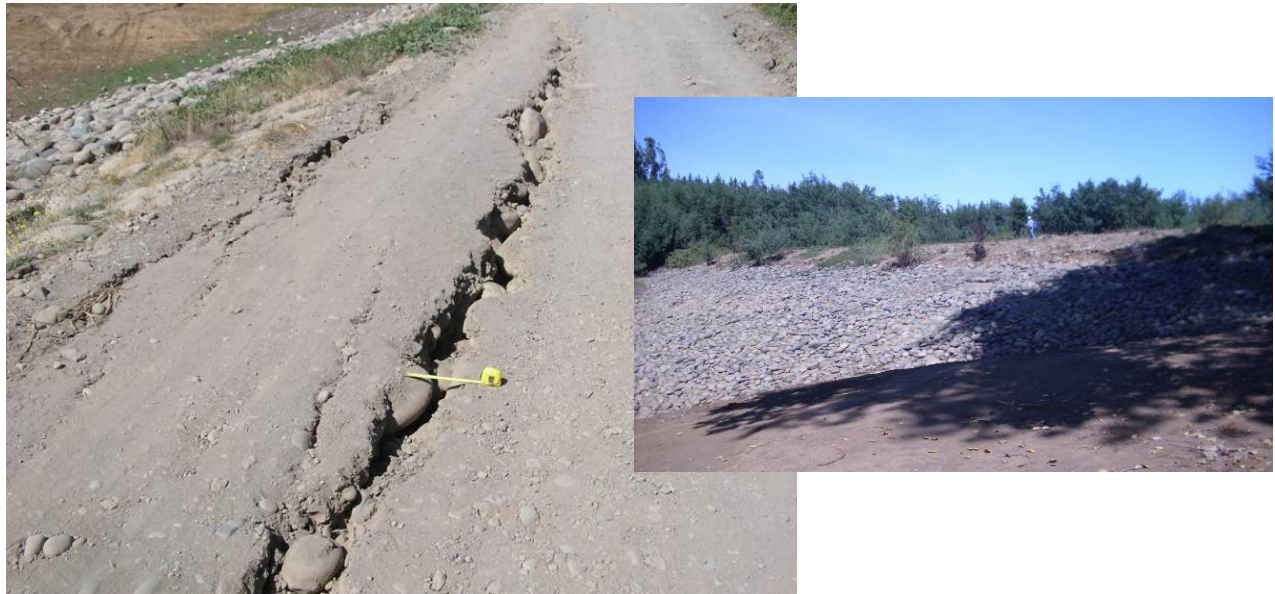
Figure 11.5. March 10, 2010. Cracking of Crest of Small Dam South of Main Coihueuco Dam (S36.645411°, W71.800212°).

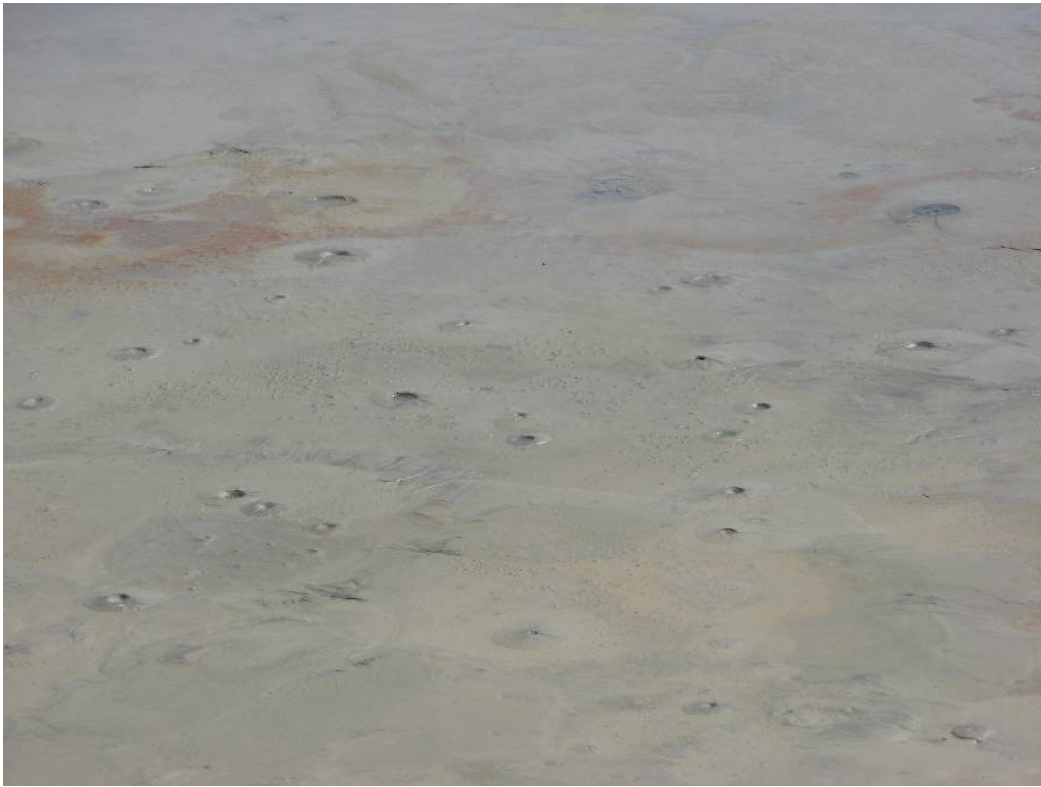
Figure 11.11. March 9, 2010 Sand Boils in Tailings about 10 m Upstream of Ovejeria Tailings Dam (S33.052016°, W70.798687°)

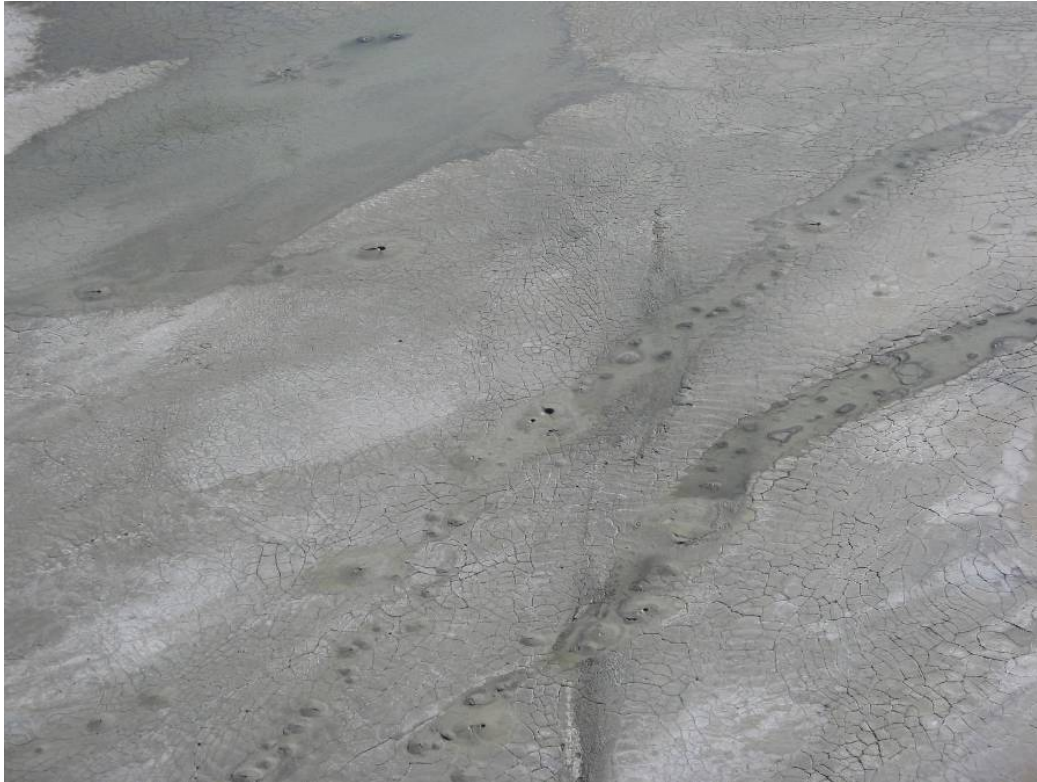
Figure 11.17. March 10, 2010 Sand Boils in Tailings Upstream of Caren Dam
(S34.111476°, W71.141992°)

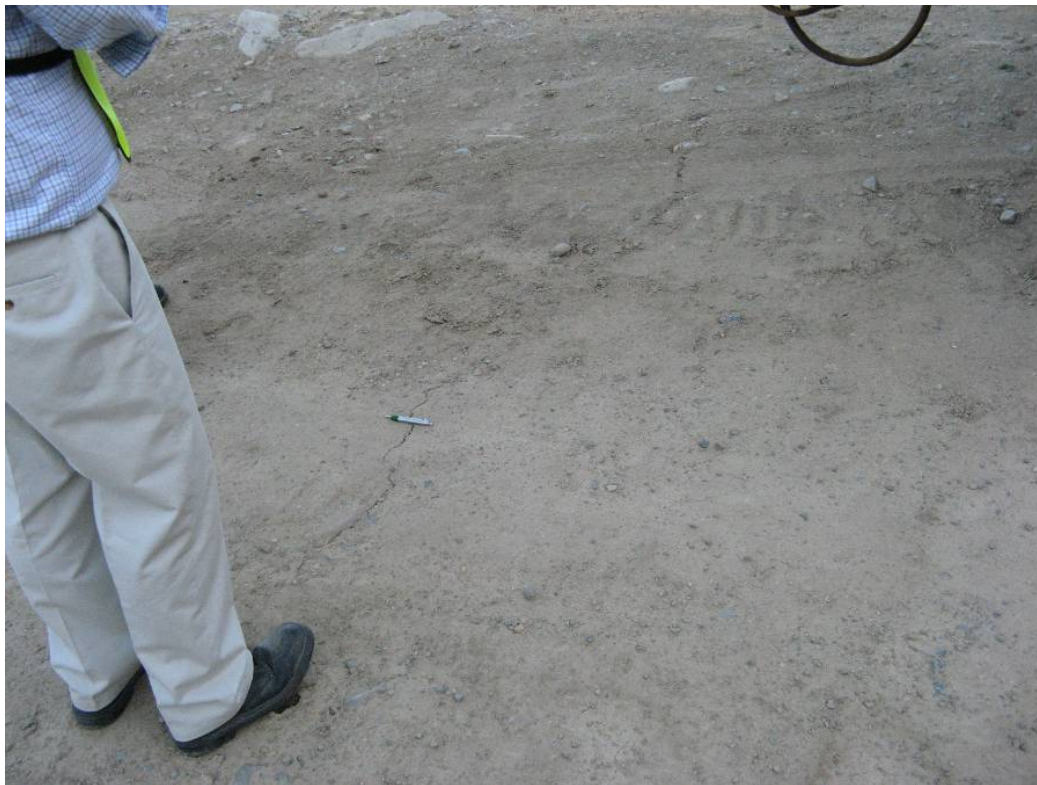
Figure 11.19. March 10, 2010 Millimeter Width Transverse Crack Near the Left Abutment of Caren Tailings Dam (S34.096050°, W71.180748°)

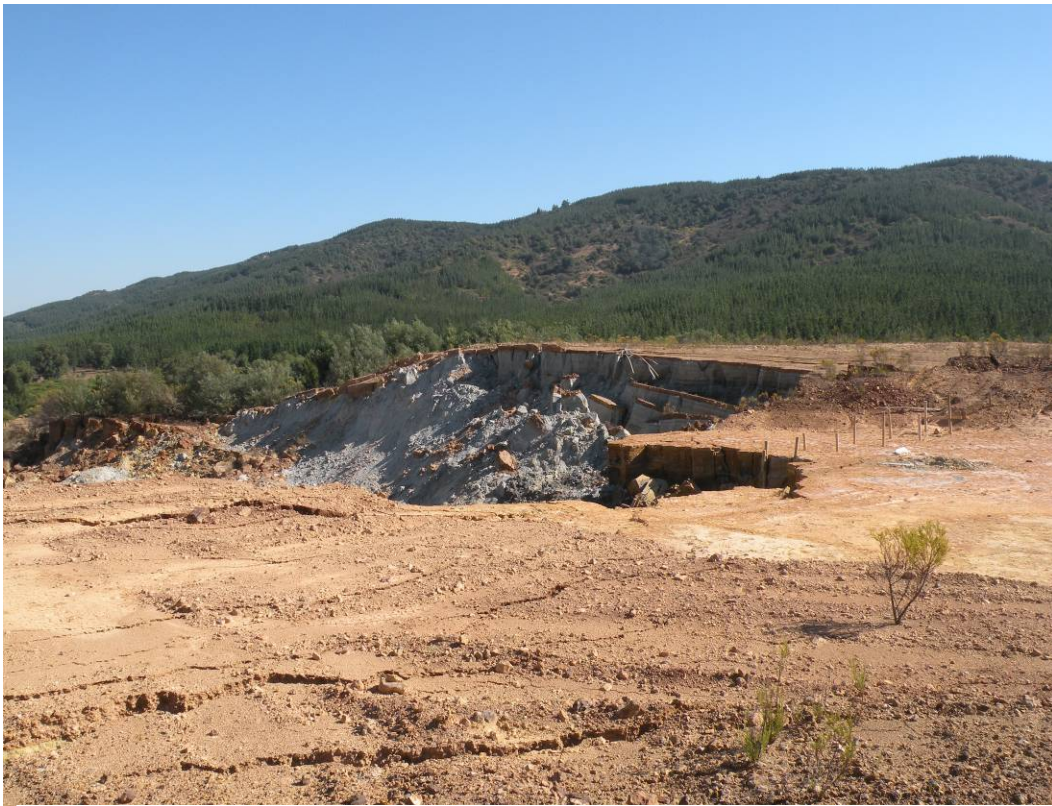
Figure 11.23. March 11, 2010. Upper Scarp of Failed Tailings Impoundment Looking Southwest (35.184679° S, 71.759410° W)

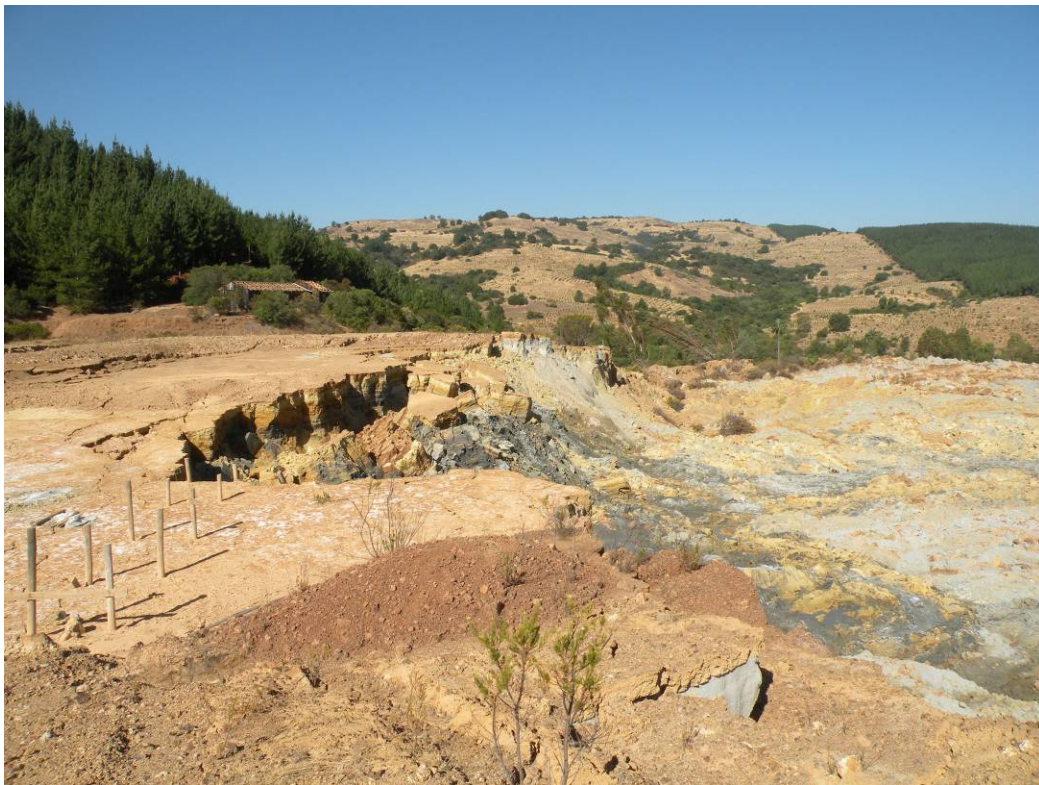
Figure 11.24. Upper Scarp of Failed Tailings Impoundment Looking Northeast (35.184679° S, 71.759410° W)

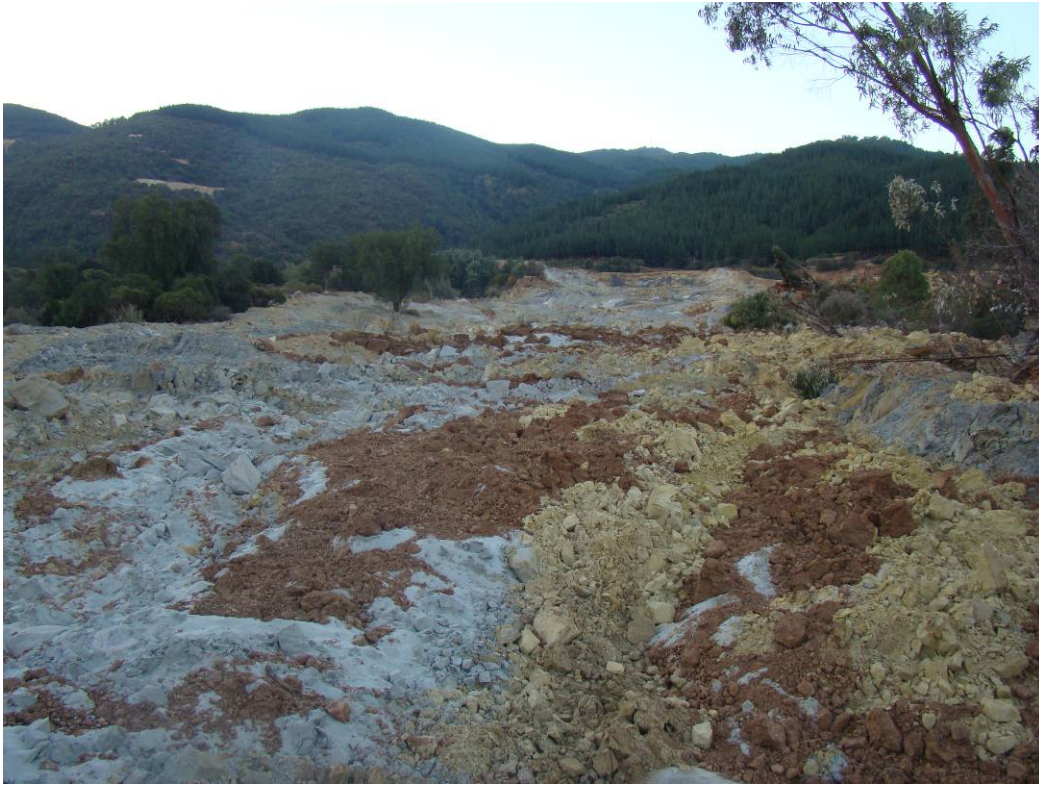
Figure 11.25. March 11, 2010. View Along Flowpath of Tailings
(35.18468° S, 71.759410° W)
