Geo-engineering Reconnaissance of the 2010 Maule, Chile Earthquake

Report of the NSF Sponsored GEER Association Team

GEER Association Report No. GEER-022

Version 1: April 15, 2010

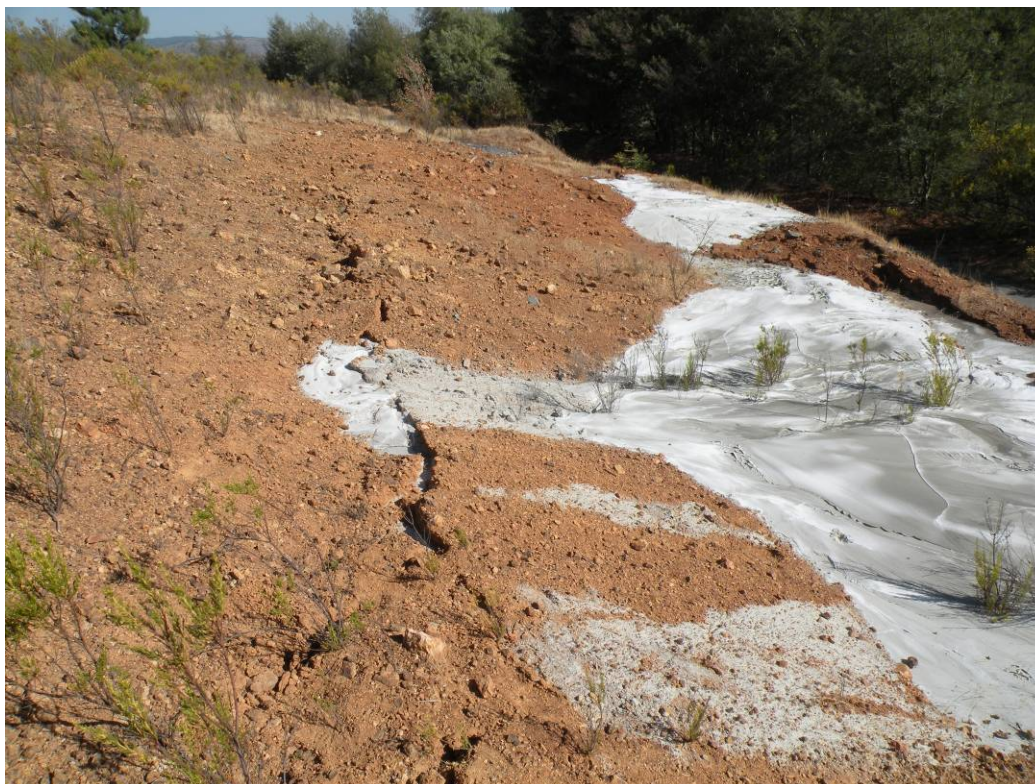
Figure 11.34. March 11, 2010. Ejecta of Tailings from Cracks Indicating Liquefaction of Tailings ($S35.183986^{\circ}$, $W71.761844^{\circ}$)

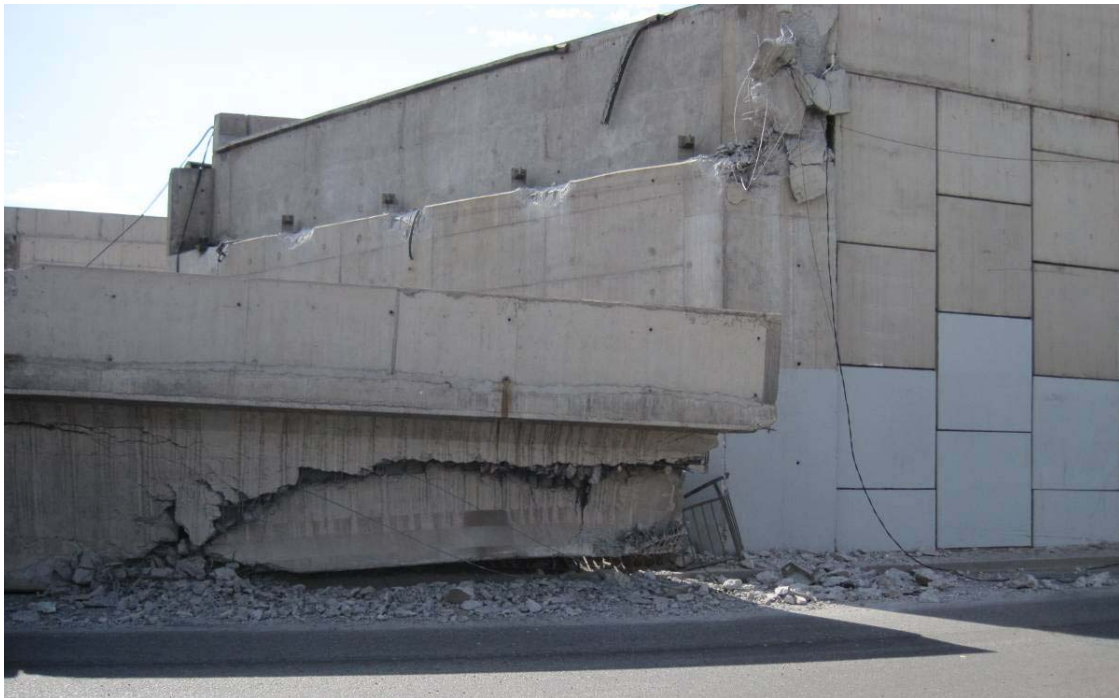
Figure 12.1. Intersection of Americo Vespucio Norte and Independencia. Abutment of a collapsed bridge.
(33°21'57.83"S, 70°41'17.71"W)

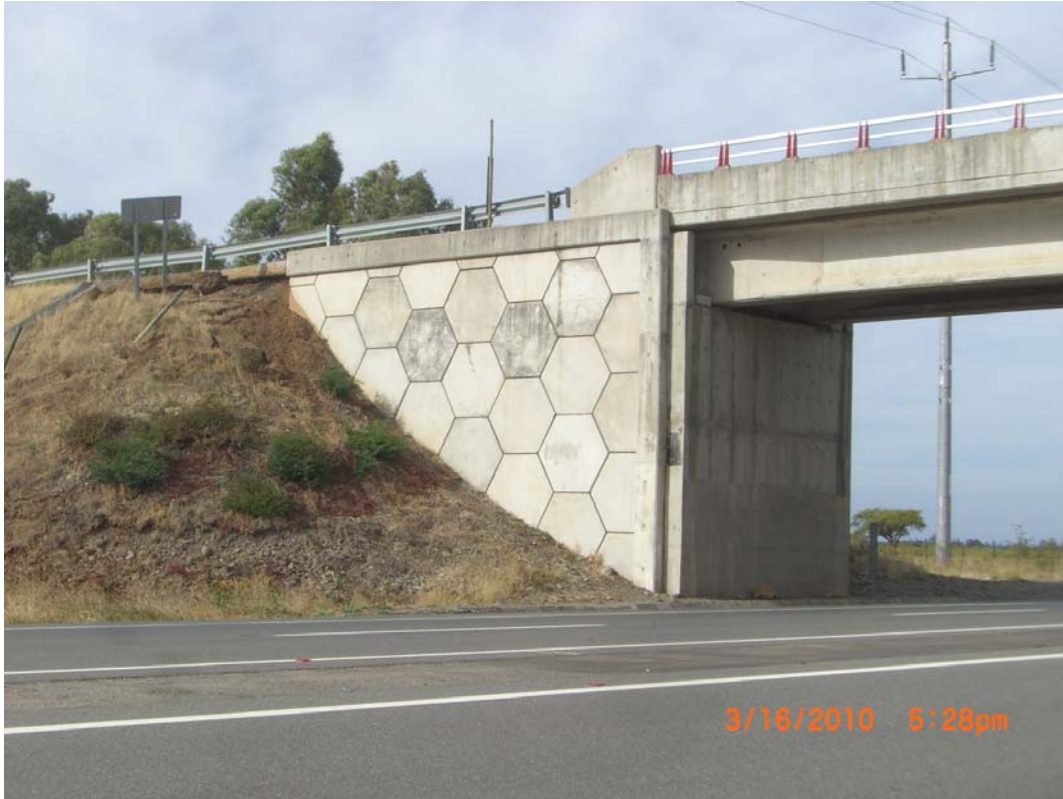
Figure 12.4 Undamaged MSE wingwall on overpass structure over highway 152 west of Chillan despite sliding of adjacent fill slope (S36.6588, W72.2776).

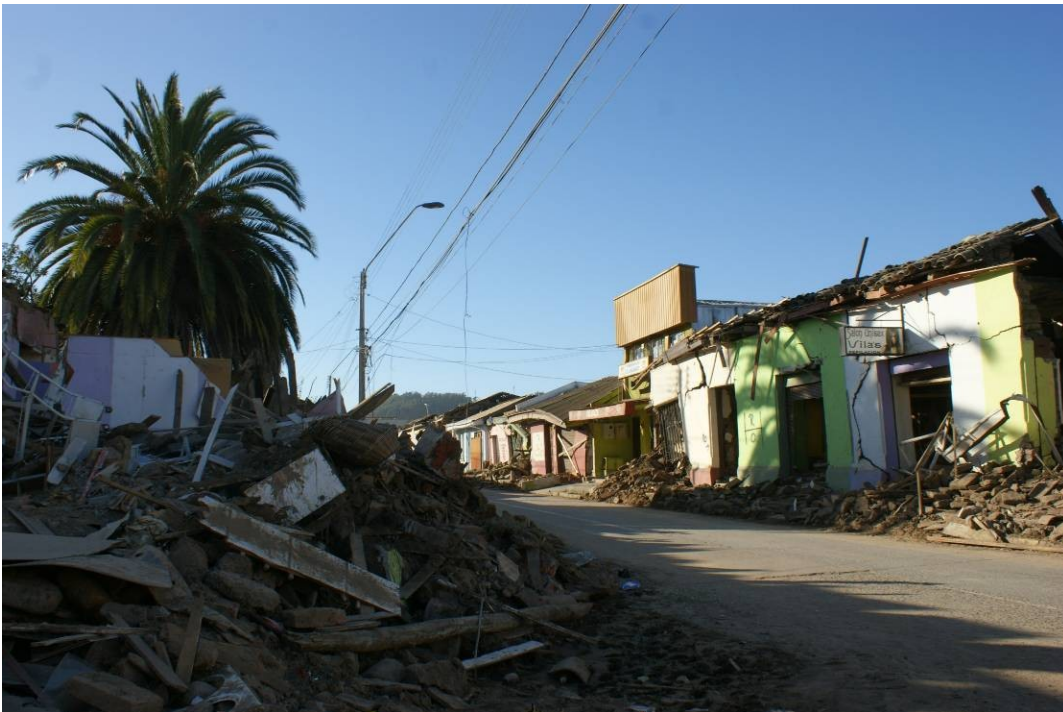
Figure 14.3. Constitucion, March 14, 2010. Tsunami damage merges with shaking related damage in the older section of the city center with its many adobe and unreinforced masonry buildings.

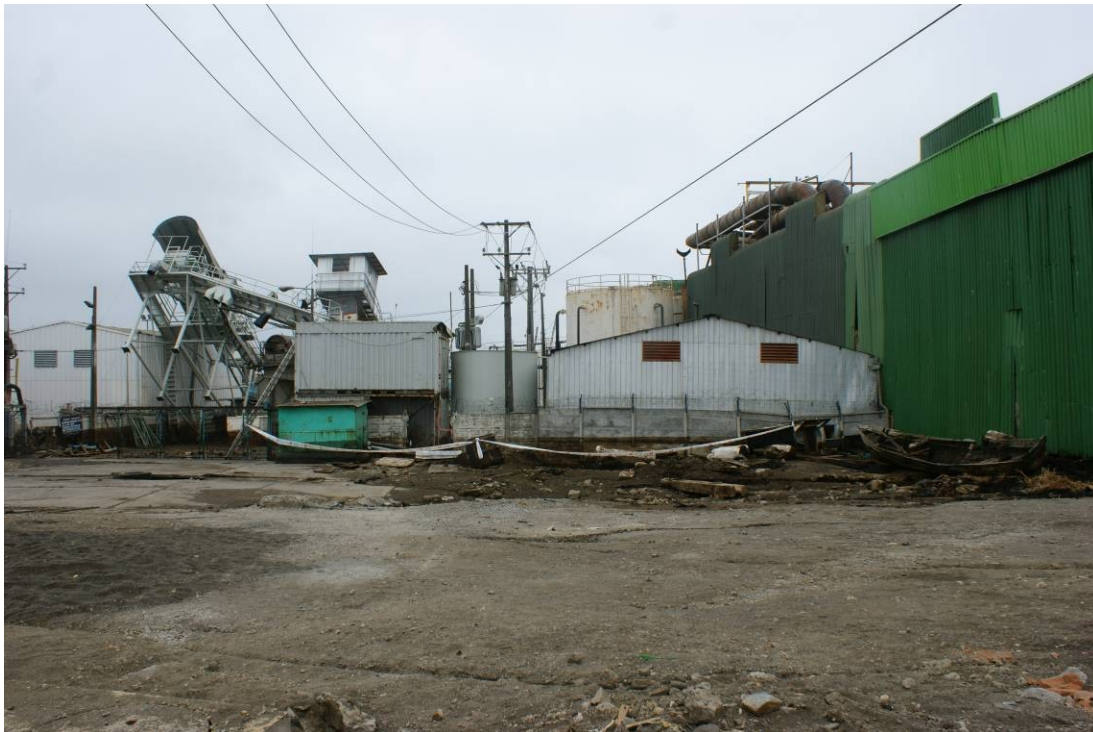
Figure 14.16. Port San Vicente, Talcahuano, March 16. The damaged Concesion Maritima fish processing plant.

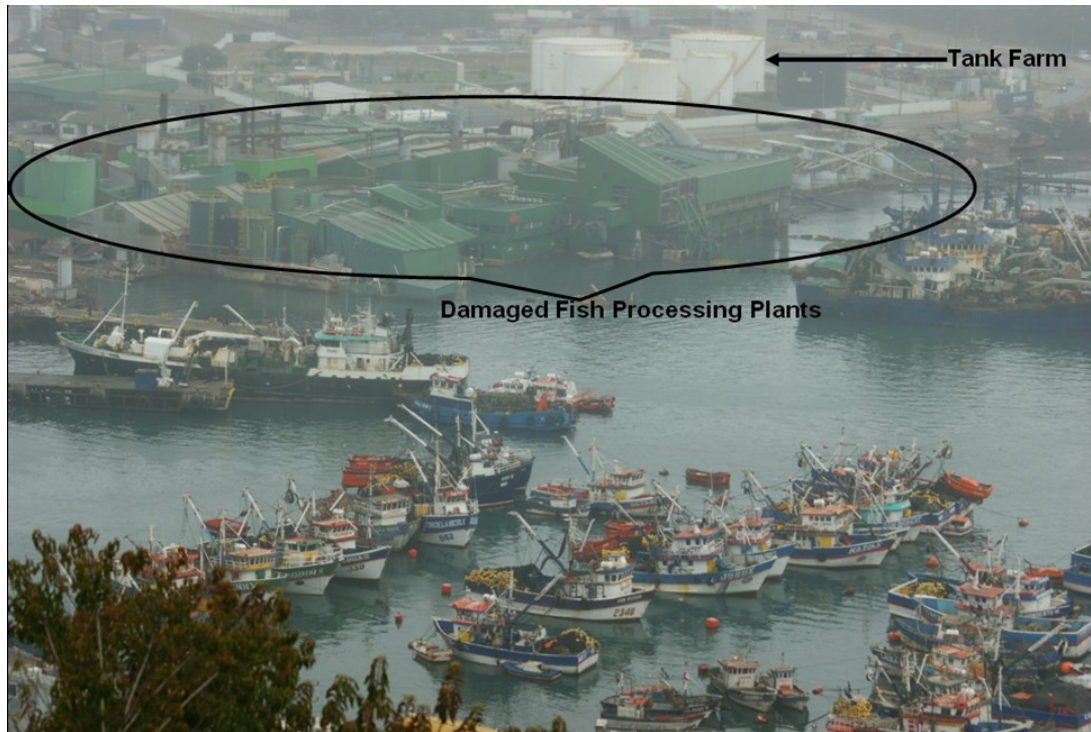
Figure 14.17. Port San Vicente, Talcahuano, March 16. View of two damaged fish processing plants and nearby tank farm.
