Case Study: Oso, Washington, Landslide of March 22, 2014—Material Properties and Failure Mechanism

Timothy D. Stark, F.ASCE¹; Ahmed K. Baghdady, S.M.ASCE²; Oldrich Hungr, M.ASCE³; and Jordan Aaron, S.M.ASCE⁴

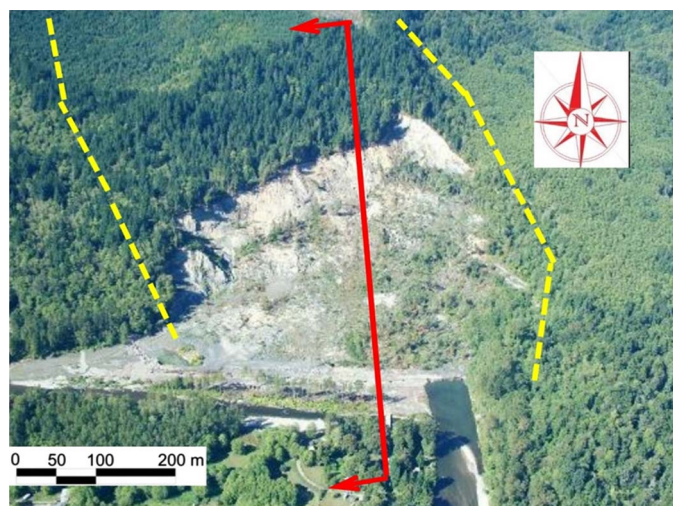
Fig. 1. Aerial view of 2006 landslide, location of cross section in Fig. 2 (solid line), and outline of sides of 2014 landslide (dashed lines) (image courtesy of Rupert G. Tart)

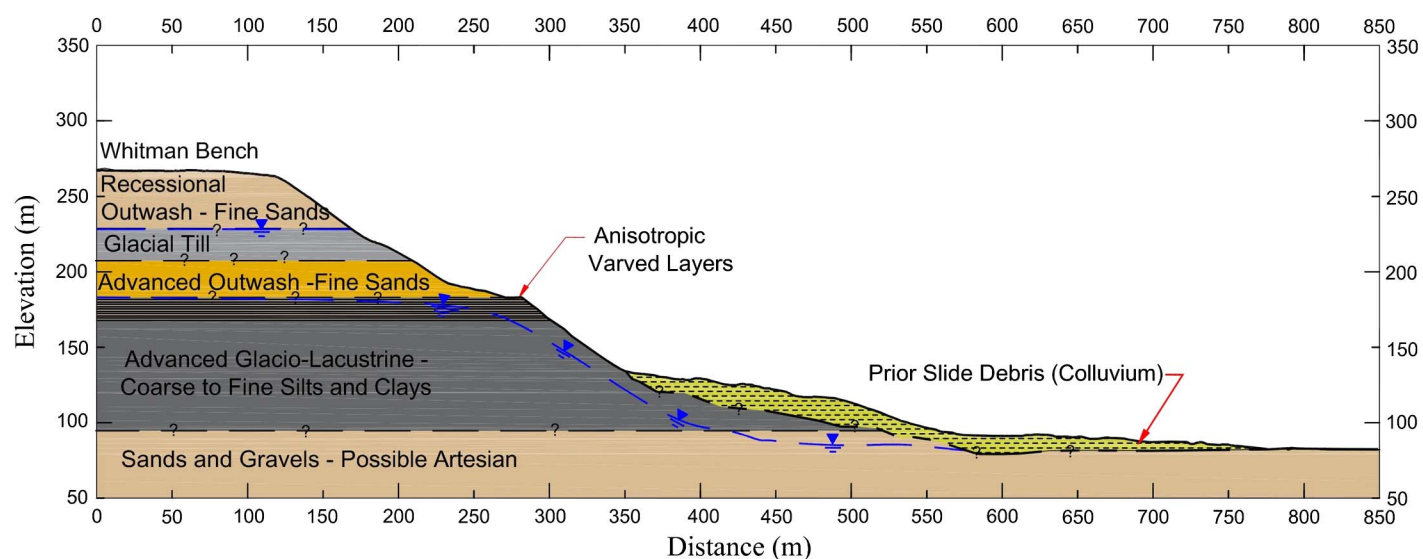
Fig. 2. Slope cross section at location in Fig. 1 prior to 2014 landslide with phreatic surfaces inferred from inverse stability analyses except where observed in borings from the Whitman Bench

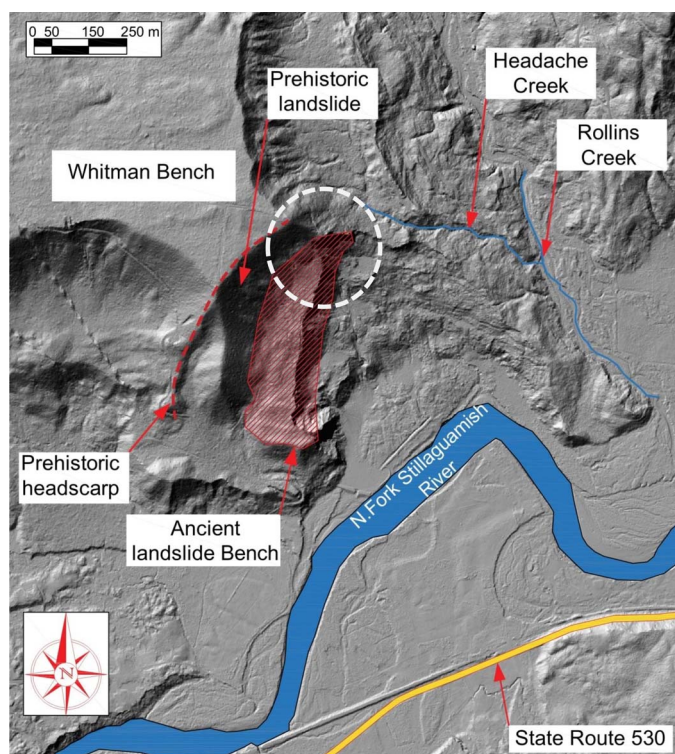
Fig. 4. 2013 LiDAR-derived topography showing the Oso, Washington, landslide in context with the Ancient Landslide Bench (base courtesy of Puget Sound Lidar Consortium)

The occurrence of a large prehistoric landslide at the location of the 2014 landslide is important because it created the Ancient Landslide Bench shown in Fig. 4 that supported and protected the Whitman Bench from landslides in the lower portion of the slope primarily caused by river toe erosion and precipitation. Based on the geometry of neighboring high-elevation landslides also shown in Fig. 4, it is anticipated that the ancient landslide at this location occurred through the weak varved lacustrine layers in the upper portion of the advanced glaciolacustrine deposit and evacuated some of the overlying Whitman Bench. After this landslide,

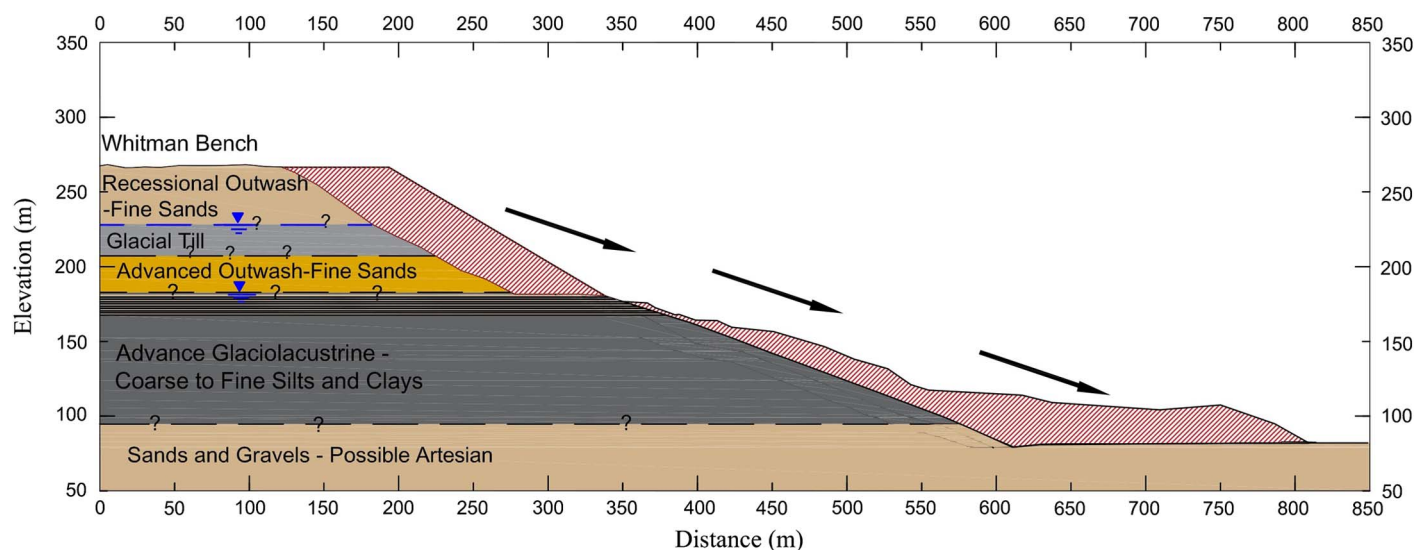
a bench or ledge was created that supported the overlying Whitman Bench slope (Fig. 5) and protected the Whitman Bench from oversteepening by landslides in the lower portion of the slope primarily caused by river toe erosion until after 2006.

Fig. 5. Hypothesis of prehistoric landslide showing depletion zone, slide mass in valley, and landslide bench near the top of the upper glaciolacustrine deposit based on LiDAR image in Fig. 4 at cross section location shown in Fig. 1

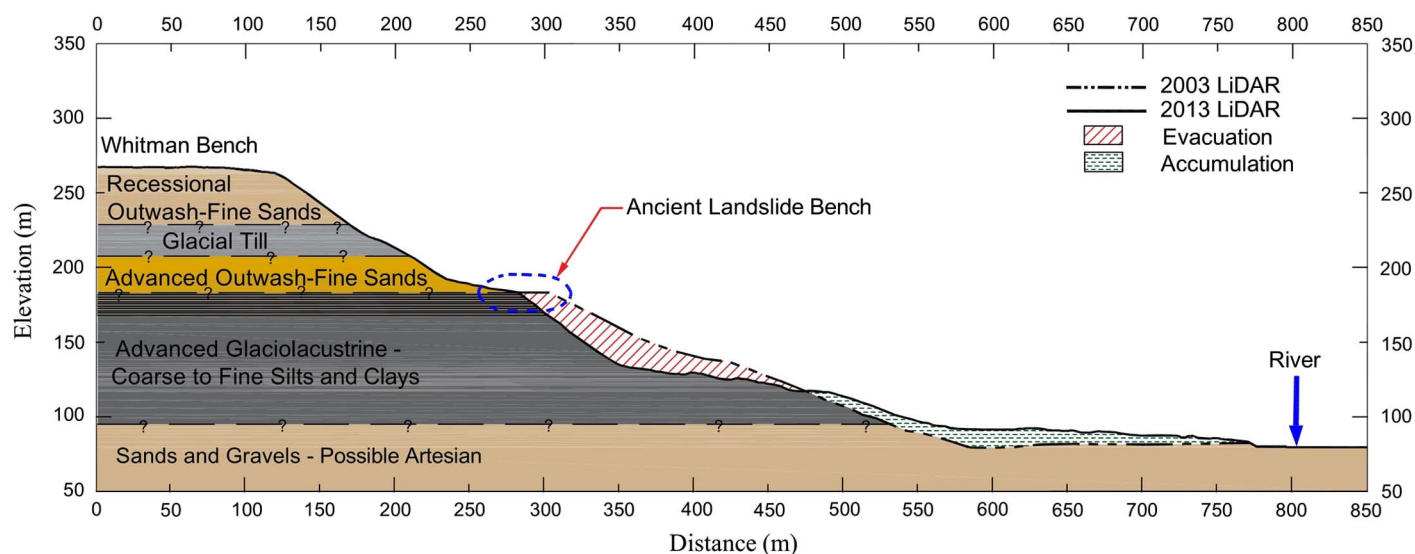
Fig. 6 presents the slope cross section shown in Fig. 1 and the difference in slope topography from the 2003 and 2013 LiDAR images. Using the difference in topography from 2003 and 2013,

Fig. 6. Differences in surface topography between 2003 and 2013 and locations of the depletion and accumulation zones for the 2006 landslide at the cross-section location shown in Fig. 1

the depletion and accumulation zones for the 2006 landslide were determined and are shown in Fig. 6. These zones show that the source of the 2006 landslide mass is the advanced glaciolacustrine deposit and the resulting colluvium moved the river to the southern extent of the accumulation zone. This is important for concluding that the Stillaguamish River erosion did not contribute to the 2014 landslide because the river was pushed significantly south (horizontal distance of approximately 800 m in Fig. 6) of the Ancient Landslide Bench (horizontal distance of approximately 300 m in Fig. 6) after the 2006 landslide. More importantly, the colluvium from the 2006 landslide added to the existing colluvium that had accumulated along the slope toe.

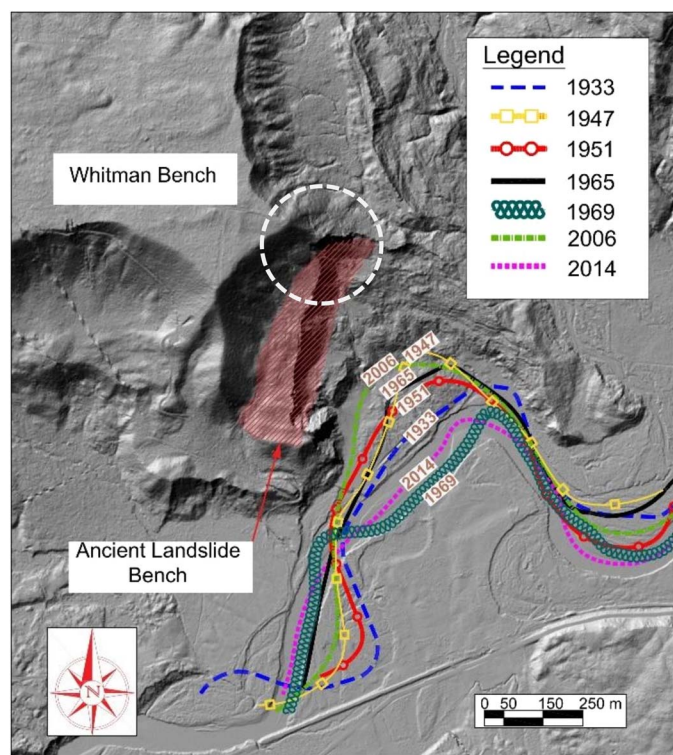
Fig. 7 also shows the changes in the Stillaguamish River channel with time and shows that the river channel was pushed south after

Fig. 7. Changes in Stillaguamish River channel between 1933 and 2014 due to prior landslides in the lower portion of the slope shown on 2013 LiDAR-derived topography (base courtesy of Puget Sound Lidar Consortium)

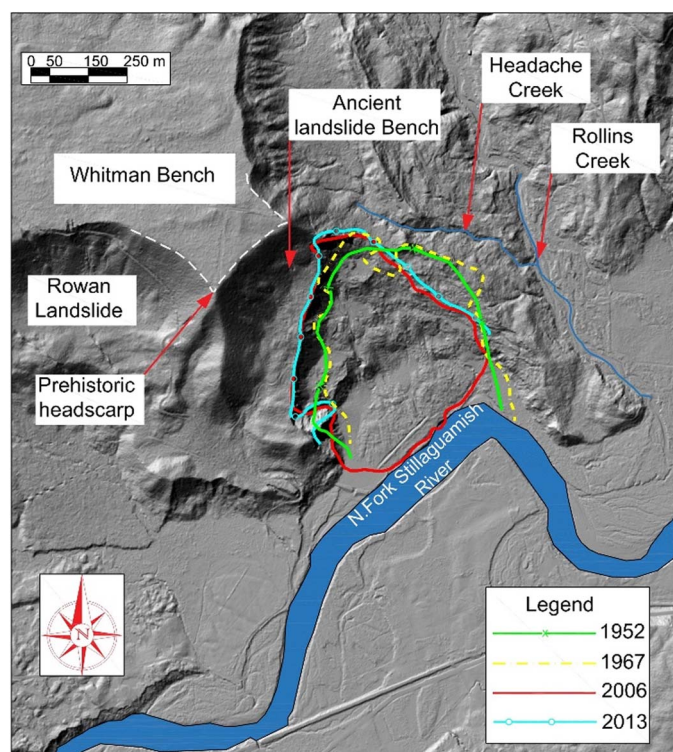
Fig. 8. Location of historic landslide scarps from 1952 to 2013 shown on 2013 LiDAR-derived topography (base courtesy of Puget Sound Lidar Consortium)

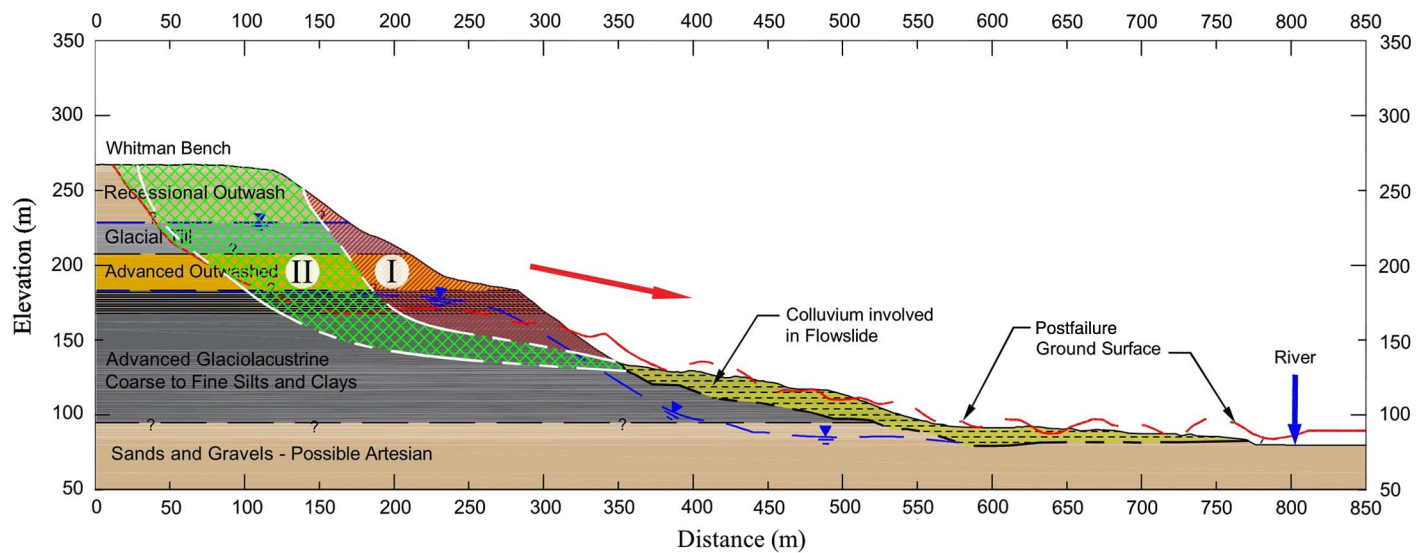
Based on inverse 2D limit equilibrium stability analyses using the software packages *SLIDE* and *SLOPE/W* and the soil properties in Table 2, Fig. 9 shows the probable failure surface for the initial instability that triggered the first phase (Phase I) of the 2014 two-phase failure mechanism. This instability initiated in the eastern portion of the Ancient Landslide Bench slope (Fig. 7) where the

**Fig. 9.** Two-phase failure mechanism prior to 2014 landslide with the Phase 1 failure surface based on field observations and inverse slope stability analyses at cross section location shown in Fig. 1

bench had been oversteepened by prior sliding in the lower portion of the slope. The failure surface in Fig. 9 is based on field observations and inverse stability analyses that yielded a factor of safety of approximately unity for a variety of compound failure surfaces and piezometric levels estimated from the inverse analysis of the 2006 landslide.

In summary, Fig. 9 summarizes the two large slope movements involved in the two-phase failure mechanism, which was initially described in a 1 June 2015 *Seattle Times* newspaper article (Doughton 2015). The Phase I slide mass moved first with significant speed and momentum, as described by an eyewitness (described subsequently), and impacted the colluvium that had accumulated on the lower part of the slope. The Phase I slide mass impacted, pushed, and overrode the water-filled colluvium in front of it and caused the colluvial flow slide that moved rapidly across the river and the valley, entombed the unexpected neighborhood, SR530 highway, and beyond. The steep valley slope then remained unsupported and some 2 min later the Phase II slide mass slid down the cleared slope but did not move far because the materials were primarily unsaturated, dense, and frictional so it stopped at the back edge of the Phase I slide mass.

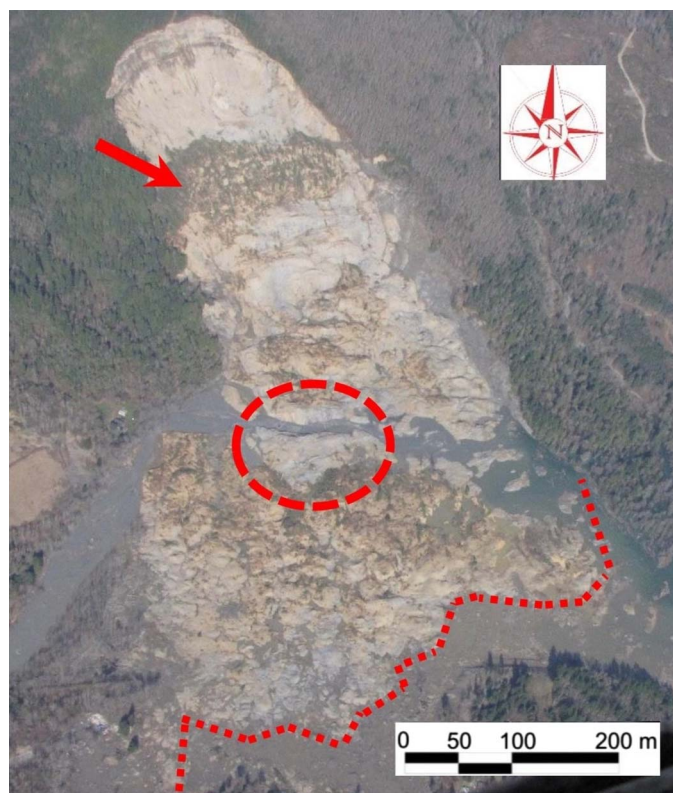
Fig. 10. Aerial view of extent of sand (dashed line) pushing and overriding fluidized colluvium from the slope toe, a new landslide bench (arrow), and the Phase II slide mass overriding back end of Phase I slide mass (dashed circle) (image courtesy of Rupert G. Tart)

Fig. 10 shows that the Phase II slide mass stretched or spread out as it moved down the slope but did not become highly mobile like the colluvial flowslide. The runout of the Phase II slide mass was limited because it was mainly frictional and its leading edge collided with the back edge of the Phase I slide mass. On the western end, the Phase II slide mass actually overrode the northern edge of the Phase I slide mass because some advanced glaciolacustrine clay from the Phase II slide mass was found overlying the outwash sands of the Phase I slide mass (dashed circle in Fig. 10).

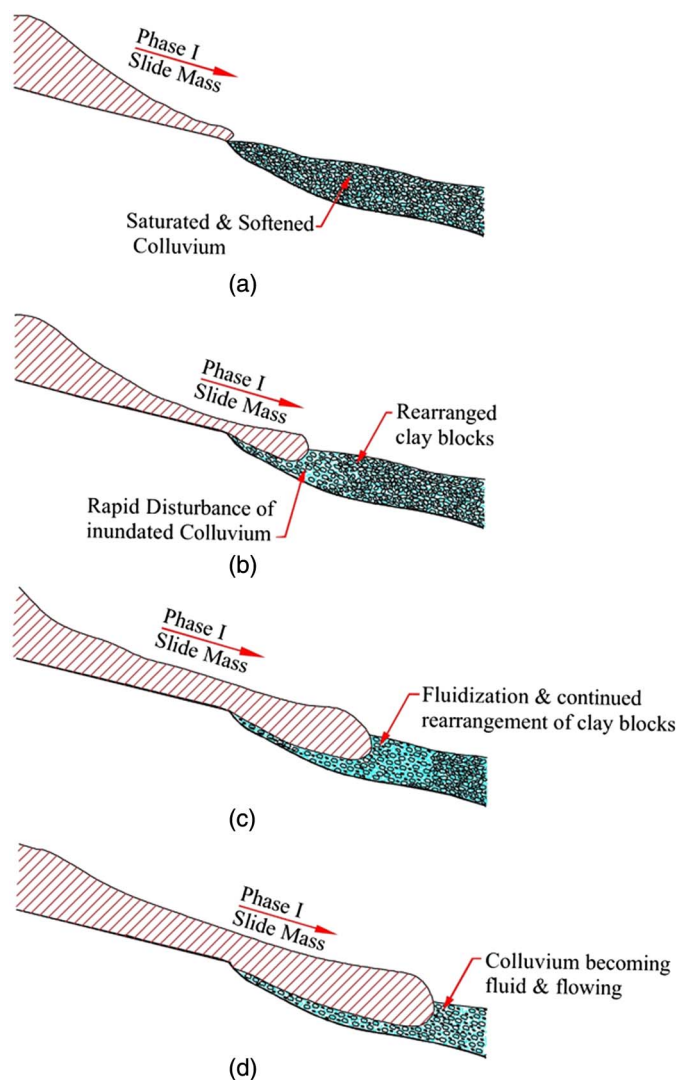
Fig. 11 illustrates the mechanism of undrained strength loss in the disturbed colluvium by rapid loading and the resulting flowslide on Sassa (1985, 2000) and Hutchinson and Bhandari (1971). Sassa (1985) hypothesizes that shallow landslides from steep slopes may surcharge downslope loose granular soil so rapidly as to cause “impact liquefaction” (Fig. 11), a process he later duplicated in an undrained ring shear apparatus (Sassa 2000).

Fig. 11. Schematic of Phase I slide mass rapidly moving downslope and initiating the colluvial flow slide: (a) rapid upslope slide; (b) pushing of colluvium and initiation of undrained strength loss; (c) initiation of colluvial flow slide; (d) enlargement of colluvial flow slide

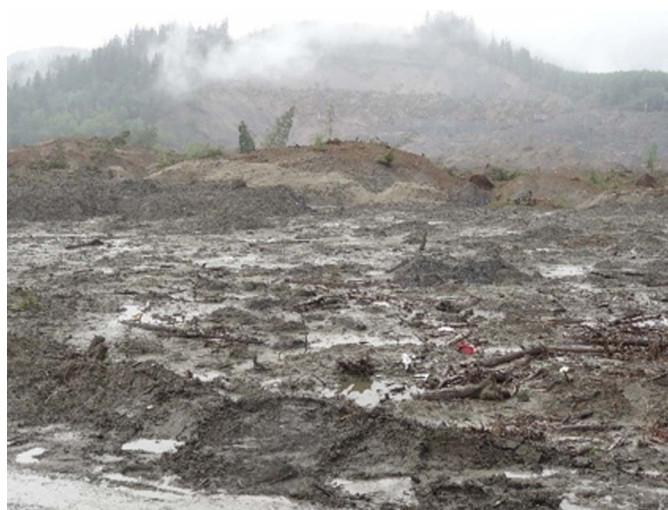
Fig. 12 is a view from SR530 showing the fluid nature of the colluvium, piles of rafted outwash sand from the Whitman Bench in the background, and some still upright trees that were carried on top of the rafted sand blocks from north of the river. This is evidence that the fluid colluvium moved farther than the outwash sands from the Whitman Bench (Phase 1), which was riding or rafting along on some of the liquefied colluvium. Fig. 12 also shows the fluid nature of the colluvium shortly after the flowslide and the more intact or frictional outwash sands and glacial till from the Whitman Bench in the background. In particular, the colluvial

Fig. 12. View of colluvial flow slide from SR530 with some trees still standing on top of a rafted sand block from the Phase I slide mass in the middle distance

deposit shows little structure in front of the Phase I slide mass, whereas Fig. 12 shows significant deposits of sand, some of which still had trees in a vertical to near-vertical position even after moving down the slope and part way across the valley. The rheology of the disturbed colluvium (fluidlike) is clearly different from the rheology of the Phase I initial slide mass, which involved unsaturated materials, e.g., outwash sands and glacial till, and remained frictional instead of exhibiting fluid or liquefied behavior.

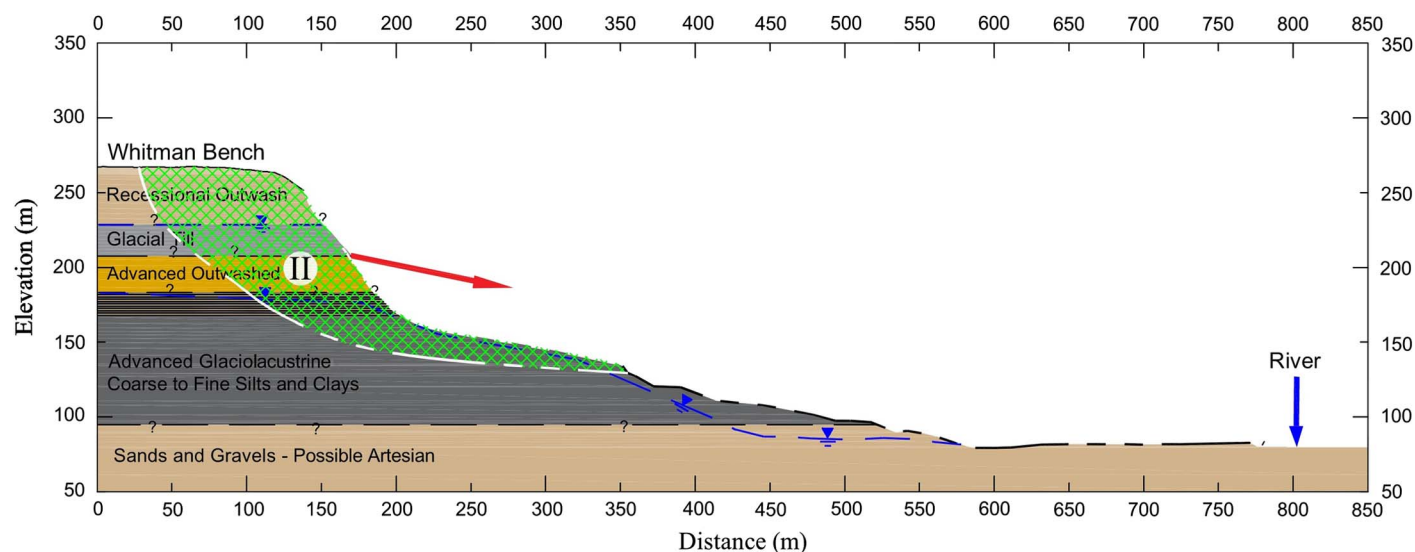
Fig. 13. Phase II failure surface–based field observations and inverse slope stability analyses at cross section location shown in Fig. 1

The mobility of the colluvium and Phase I initial slide mass caused unbuttressing of the upper slope, which initiated a retrogression into the intact material of the Whitman Bench. Based on inverse limit equilibrium stability analyses, Fig. 13 shows the probable compound failure surface for the Phase II slide mass that primarily involved the upper portion of the slope. The Phase II slide mass involves mostly unsaturated and intact outwash sands, glacial till, and the upper portion of the advanced glaciolacustrine clay deposit. The unsaturated portions of outwash and till deposits exhibited frictional behavior, which resulted in the formation of large landslide blocks instead of a flowslide as observed in the colluvium. As a result, the Phase II slide mass was much less mobile and is not responsible for any of the property damage or loss of life in the valley. The top of this slide mass forms the new landslide bench (Fig. 10) that will protect the overlying Whitman Bench for many years to come because the river cannot directly erode this bench or the upper plateau due to the lower portion of the Phase II slide mass covering the lower portion of the slope.

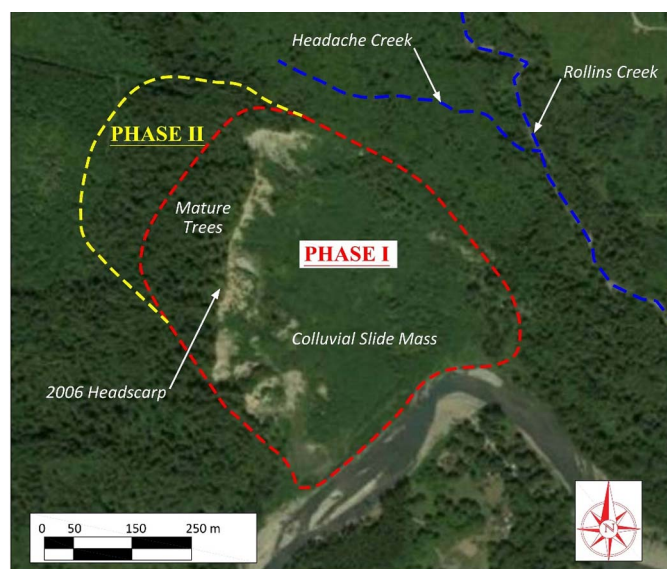
Fig. 14. Aerial view of slope in July 2013 and outline of the 2014 Phases I and II slide masses (© 2014 Google)
