COMPARING LIQUEFACTION PHENOMENA OBSERVED DURING THE 2010 MAULE, CHILE EARTHQUAKE AND 2011 GREAT EAST JAPAN EARTHQUAKE

Ramón VERDUGO¹

¹ Principal, CMGI Ltda. Santiago, Chile
rverdugo@cmgi.cl

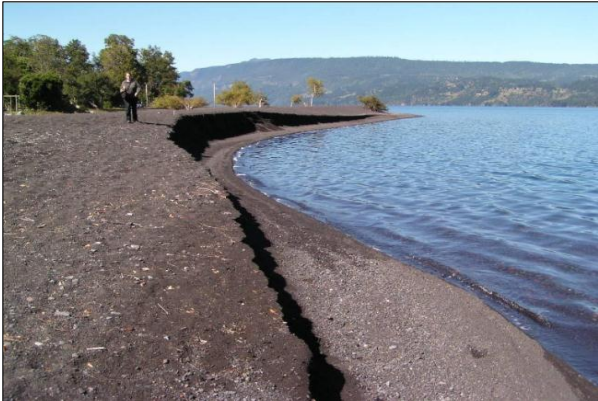
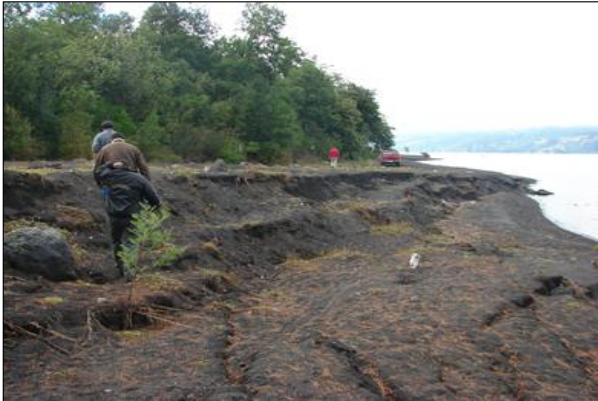
It is remarkable the fact that liquefied sites were observed in areas where the intensity was less than V. For example, the lateral spreading that involved banks of Lake Calafquén in the south (Fig. 10). The description of witnesses at Pucura sector (kilometer 10 of route Coñaripe - Lican Ray) states: "We had a family of gypsies who were camping on the site when the shaking started, they shouted calling us, a once we got over there the water come out of the earth as a hose stream "(website of the Panguipulli City Hall). This necessarily implies that the intensity of the quake, which correlates directly with structural damages, is not completely associated with the occurrence of liquefaction. Although this confirms the well-known dependence of the liquefaction strength on both level of cyclic stresses and number of cycles, it also shows the actual impact of the earthquake duration on the liquefaction strength.

Fig. 10.- Lateral Spreading observed in an area of low intensity: Pocura and Calafquen (source: Sernageomin and Municipalidad of Panguipulli)

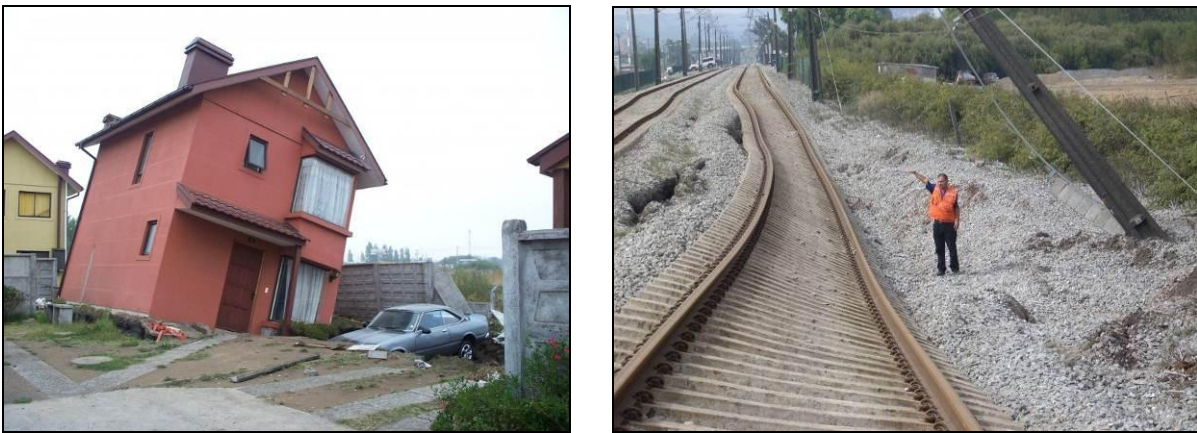
One example is the case of Brisas del Sol Condominium, located in Talcahuano, where 5 houses located in front of a wetland (similar to a swamp) suffered lateral displacement up to 2 meters. One of the houses is shown in Fig. 11. Another case occurred near the City of Concepcion, where the railway collapsed in several places due to liquefaction and subsequent settlements, as shown Fig. 11.

Fig. 11.- Liquefaction of flat areas. Condominium Brisas del Sol and railway near Concepción (EFE)

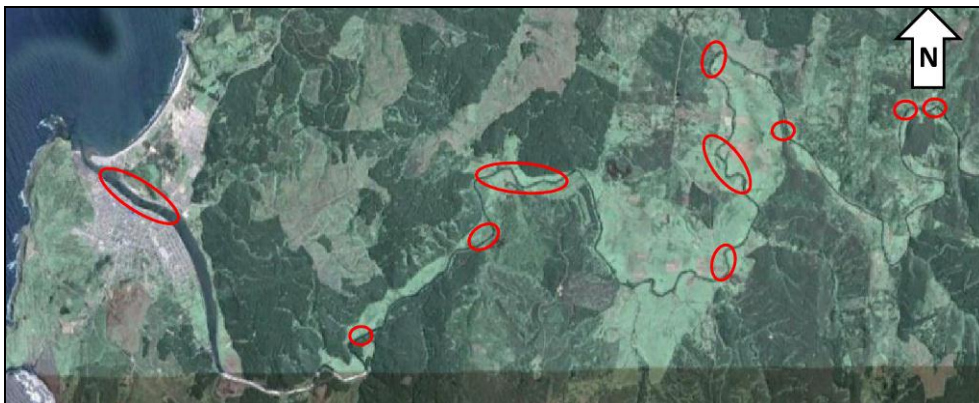
Lateral spreading is probably the most recurrent phenomenon observed after earthquakes on sloping ground, adjacent to river banks or lakes. Numerous cases of lateral spreading occurred along the rivers Nilahue, Mataquito, Itata, BioBio, Carampangue and Lebu. In some cases the cracks involved several kilometers along the river banks. Also, lakes were affected by lateral spreading: Laguna Aculeo, Rapel, Vichuquén, Calafquén, Panguipulli, and the main lagoons in Concepción. The sites where the phenomenon of lateral spreading occurred along the Lebu River are identified in Fig. 12.

Fig. 12.- Lateral spreading observed along the Lebu River. Maule 2010 Chile Earthquake

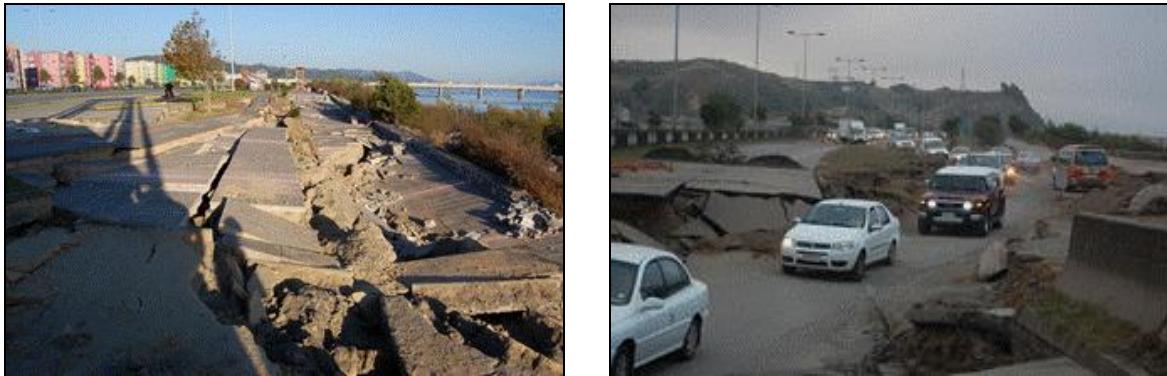
From Fig. 13, it is possible to quantify the potential effect of lateral displacements and settlements. In this case, different sites along the northern bank of Bio Bio River collapsed deforming toward the river.

Fig. 13.- Cracks and settlements on right side of BioBio River caused by lateral spreading

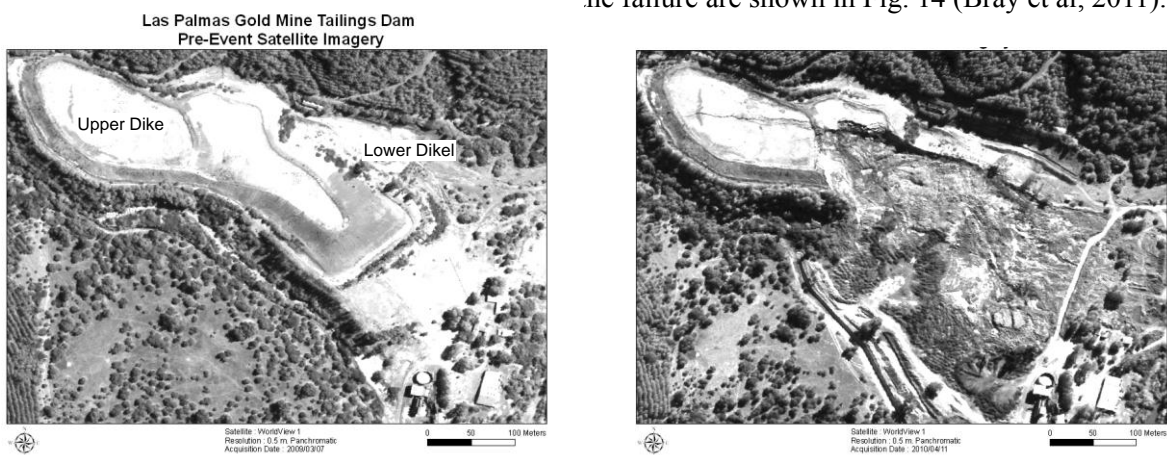
After the 2010 Chile earthquake five tailings dams constructed by the upstream method were reported with different levels of seismic failure: Chancón, Bellavista Dike No. 1, Veta del Agua Dike No. 5, Alhué and Las Palmas (Ramirez, 2010). Bellavista Dike No.1 collapsed, and a significant volume of tailings flowed into the Dike No. 2, which worked as a buffer, stopping the tailings flow. Dike No. 5 of Veta del Agua experienced a limited seismic failure; the toe of the dike moved down for a distance of 100 m, reaching El Sauce creek. Las Palmas experienced a catastrophic failure triggered by the 2010 Chile earthquake. The geometries before and after the failure are shown in Fig. 14 (Bray et al, 2011).

Fig. 14.- Pre-earthquake and post-earthquake satellite images of Las Palmas tailings dam

The tailings liquefied, flowing for a distance of about 0.5 km, killing four people who lived in a house that was buried under 4 m of tailings. The tailings dam consisted of two dikes (a lower one and an upper one), constructed in stages using the upstream construction method. This dam was operating until 1997, when the mining activity finished. From field observations it has been deduced that the bottom of this tailings dam was saturated, triggering a flow failure.

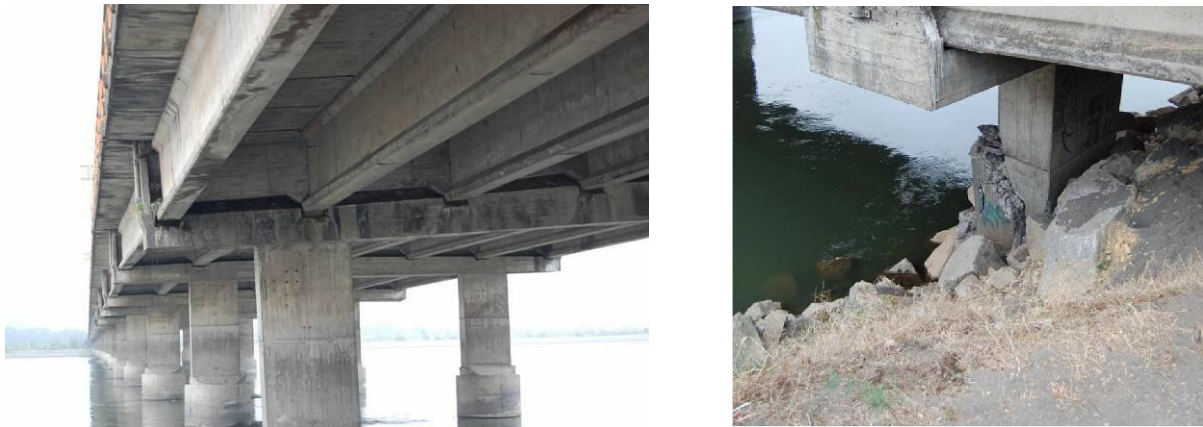
The bridge Juan Pablo II, located at the BioBio River, was the most seriously affected by the phenomenon of liquefaction. After the quake significant differential settlement showed up along the deck and the first pier (Concepcion abutment) collapsed due to the loads generated by lateral spreading (Fig. 17).

Fig. 17.- Settlement caused by liquefaction, and failure due to lateral spreading. Juan Pablo II Bridge affected by 2010 Chile Earthquake

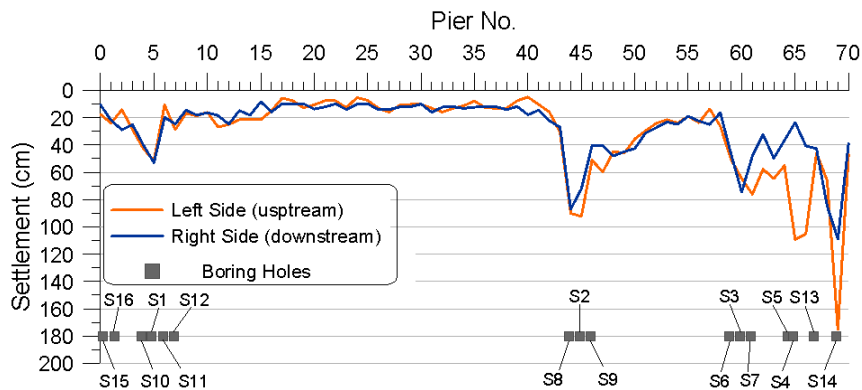
The topographic information obtained along both lines of the bridge allowed the assessment of the vertical deformation developed along the bridge. The result is presented in Fig. 18; around 15 piers developed settlements higher than 50 cm. In general, supports of the left longitudinal axis (upstream)

developed greater settlements than those observed in the right longitudinal axis. Larger settlements are concentrated at the Concepción abutment bank. The largest settlement is approximately 1.8 m, followed by settlements of 1.1 m and 0.9 m.

Fig. 18- Post-seismic settlements, Juan Pablo II Bridge

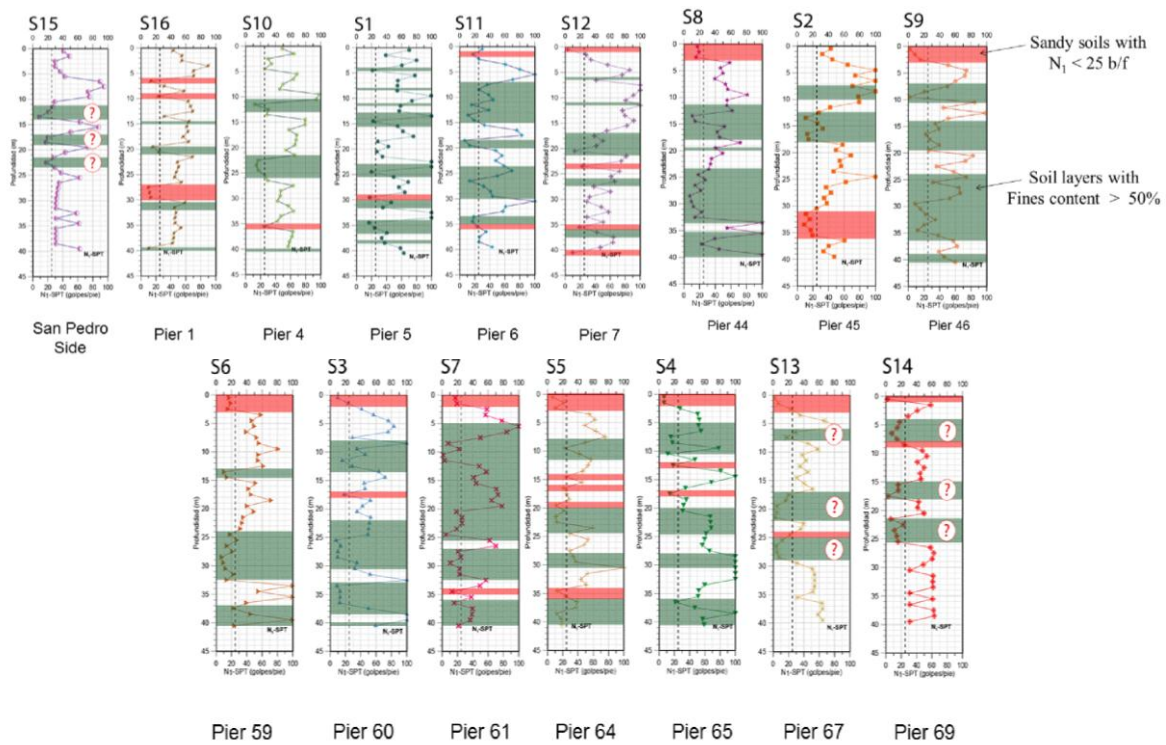
Because of the large differential settlements suffered by the piers, Juan Pablo Bridge was closed, and a series of 16 boreholes with N-SPT measurements was carried out by the Ministry of Public Works. Additionally, a limited number of classification tests were performed. The results are shown in Fig. 19, in terms of the normalized N_1 -SPT (normalized to 1 kg/cm²) and the fines content.

The most interesting aspect of this case is associated with the fact that only vertical permanent displacements were developed. The absence of lateral displacements necessarily implies that there are layers of non-liquefiable soils that were able to develop sufficient lateral stiffness to stabilize the structure. The N_1 -SPT confirms the existence of a highly stratified ground deposit, consisting of loose to dense sands and soft sandy silts. It is estimated that values of standard penetration tests (N_1)₆₀, exceeding 30 blows/foot are associated with layers of dense soil that should be responsible for the existence of enough lateral stiffness to prevent horizontal displacement.

It is important to indicate that, due to geological and tectonic issues, in Chile it is possible the occurrence of highly stratified soil deposits, where may coexist loose and dense sandy soils, with soft silts. As a consequence of this, the strength and deformability may be significantly different in both vertical and horizontal direction. This is the case of the ground that supports Juan Pablo II Bridge.

Fig. 19.- N_1 -SPT, results obtained in Juan Pablo II Bridge

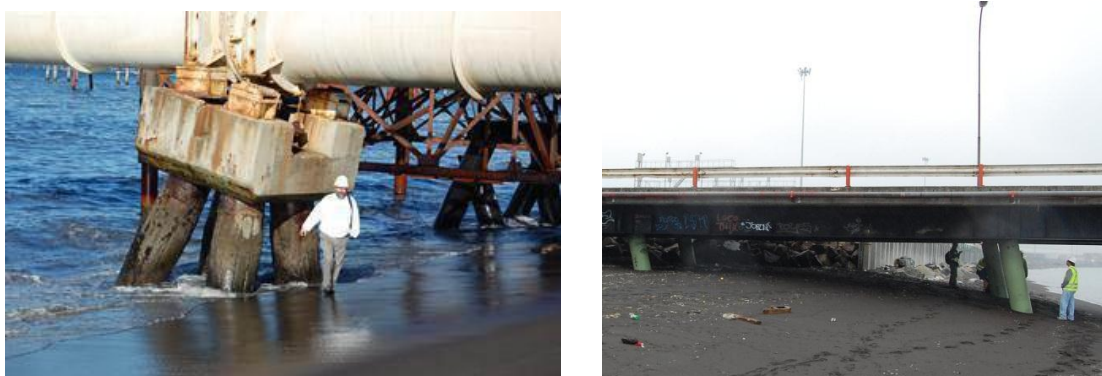
Ports and quays were also affected by liquefaction of the coastline and the seabed. The most severe cases of failure occurred between Talcahuano and Lota, specifically in the La Poza (Talcahuano), Lo Rojas (Coronel), Lota Bajo (Lota) and the Port of Coronel areas. In addition, some industrial facilities located in Coronel also suffered the effects of liquefaction. Part of the damages observed in these coastal structures is shown in Fig. 20.

The liquefaction of the line shore soil, in addition to the inclination of the ground toward the sea, generated a lateral flow which dragged the piles. However, the end part of the docks was supported by non-liquefiable soils that prevented any horizontal displacement. Thus the piles kept the head in place, fixed by the supra-structure, but their bottoms moved toward the sea following the direction of the flow of the liquefied soil.

Fig. 20.- Damages observed in private infrastructure and Port of Coronel
