Seismic Performance of Earth Structures during the February 2010 Maule, Chile, Earthquake: Dams, Levees, Tailings Dams, and Retaining Walls

Ramon Verdugo,^{a)} Nicholas Sitar,^{b)} M.EERI, J. David Frost,^{c)} M.EERI, Jonathan D. Bray,^{d)} M.EERI, Gabriel Candia,^{e)} M.EERI, Terry Eldridge,^{f)} Youssef Hashash,^{g)} M.EERI, Scott M. Olson,^{h)} M.EERI, and Alfredo Urzuaⁱ⁾

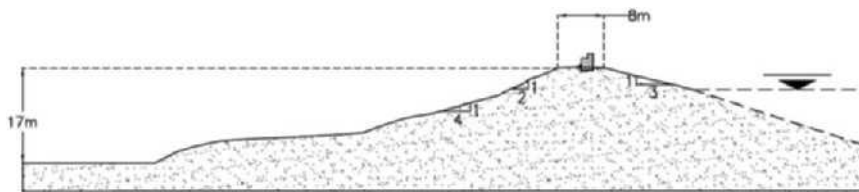
- Tutuvén Dam was the closest dam to the fault plane generated by the earthquake, with similar distances of about 40 km to both the conventional epicenter and to the fault trace as illustrated in Figure 3. According to the limited available information, this dam was built in 1951 as a homogeneous dam. It was repaired in 1979 due to serious damage caused by a flood. Its crest length is close to 1,000 m, and its maximum height is 17 m. It is interesting to observe that the cross section shown in Figure 4 indicates a systematic reduction of the downstream slope, which likely ensured its seismic stability.

Figure 4. Cross section of Tutuven Dam with no damage.

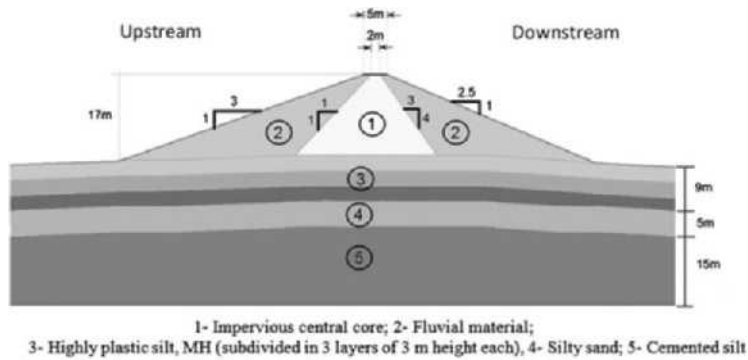
A pseudostatic slope stability analysis was performed considering both horizontal (K_h) and vertical (K_v) seismic coefficients, with $K_v = 0.5K_h$. The limit equilibrium slope stability analysis using Janbu’s method applied to non-circular surfaces was performed using commercial software. The results show that failure ($FOS \leq 1$) occurs for seismic coefficient:

$K_h \geq 0.22$ and $K_v \geq 0.11$. These values are consistent with the level of shaking experienced at this site and match well with values adopted in engineering practice for evaluating the impact of large earthquakes (i.e., maximum credible earthquakes) on earth structures. The authors are sensitive to the importance of the actual acceleration levels that occurred on the dam and the resulting magnitude of displacements of the soil mass involved in the failure. In this context, the condition of $FOS = 1$ is necessarily associated with the lower boundary of the inertial forces that the dam suffered. Considering the stratigraphy of the dam site, consisting of several layers, including soft MH soils, the use of horizontal time acceleration histories recorded for different soil deposits does not represent the dam site

Figure 14. Geotechnical profile used in the stability analysis. Coihueco Dam.

conditions well, and so the classical Newmark sliding block calculation is not presented. Accordingly, the available data only permit the conclusion that the horizontal and vertical seismic coefficients were greater than 0.22 and 0.11, respectively.

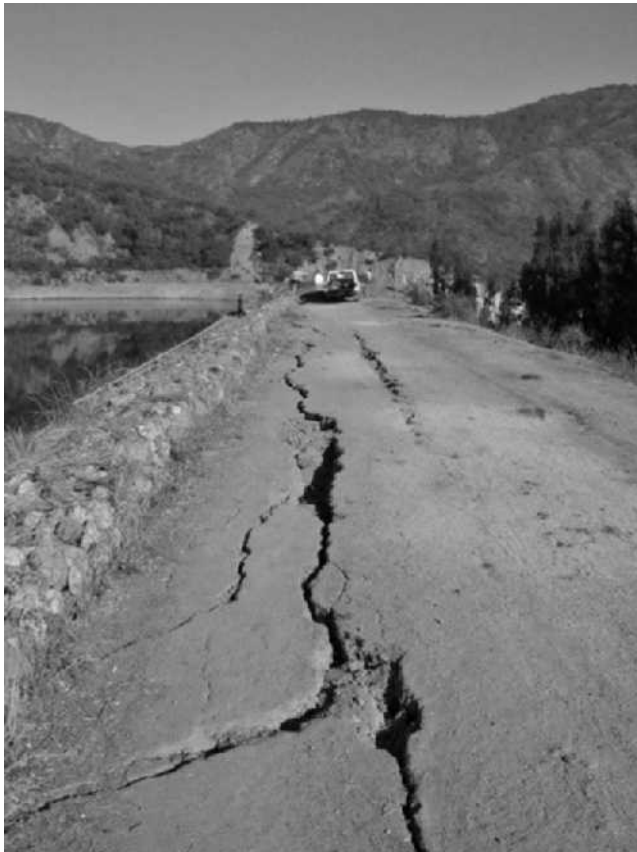
the crest of these failures was 36 m and 21 m, respectively. Additionally, a series of longitudinal cracks along the crest with a maximum lateral openings of 10 cm were observed (Figure 16). Lliu-Lliu Dam was constructed around 1920 and has a crest length of about 500 m and a maximum height of 18 m. The upstream and downstream slopes had similar inclinations of about 1.5:1.0 ($H:V$), and a crest width of 8 m. The available information indicated that both shells consisted of gravelly material with an important fines content of clayey soils. The core would have been constructed with a mixture of fines soils and bentonite. All the aftershocks, including one of Magnitude 6.9 (11 March 2010), with an epicenter located approximately 160 km south of the dam, did not induce any additional movements of the upstream slope.

Figure 16. Open cracks observed along the crest of Lliu-Lliu Dam.
