Failures of sand tailings dams in a highly seismic country

Gabriel Villavicencio, Raúl Espinace, Juan Palma, Andy Fourie, and Pamela Valenzuela

Key words: sand tailings dams, earthquakes, liquefaction, slope instability.

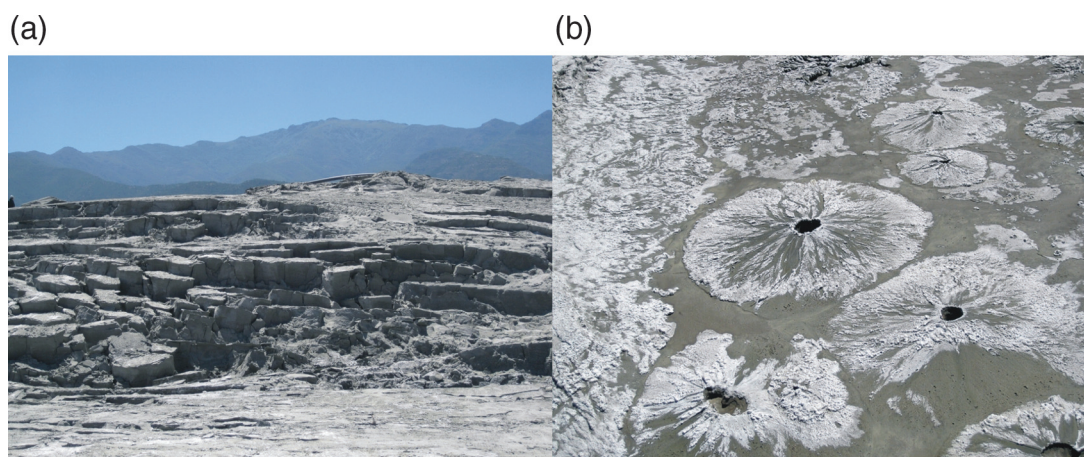
Fig. 1. Effects of the earthquake of 27 February 2010, Maule Region, Chile: (a) stepped terraces in an retaining dyke resulting from seismically induced liquefaction; (b) sand craters in tailings basin.

terraces that remained even after the earthquake (Fig. 1a). The evidence of liquefaction in the tailings basin was shown by the eruption of volcanoes caused by the increased pore pressures (Fig. 1b). Once the excess pore pressures dissipated, the structures stabilized, with a new geometry that provided less resistance (residual, post-liquefaction) than the original retaining dyke.

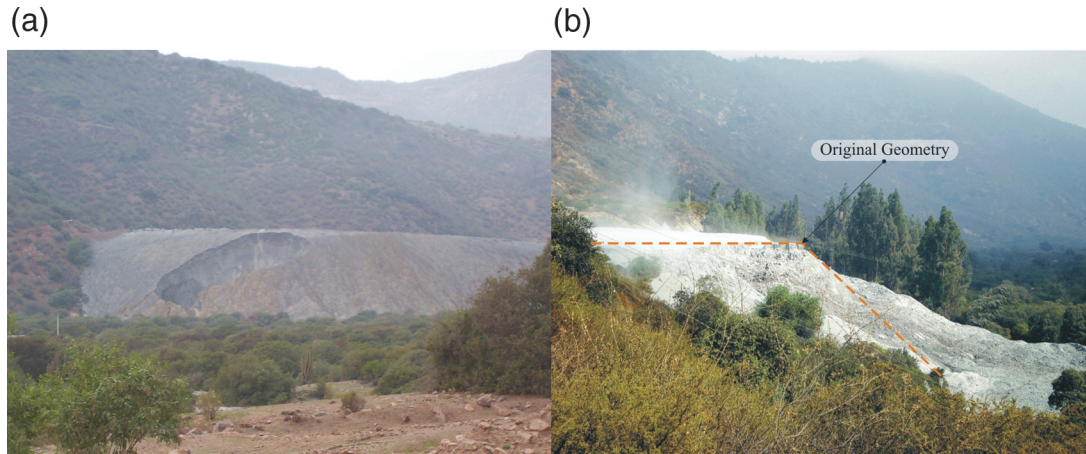
Observations have allowed identification of various failure surfaces having either a semicircular-type shape or wedge morphology (see Figs. 2a and 2b, respectively). According to studies carried out by Troncoso (1997), the failure mechanisms in tailings sand dams constructed using upstream and centerline methods usually develop sliding-wedge type failure surfaces.

Fig. 2. Slope instability: (a) circular-type failure surface; (b) landslide of slopes generated at the moment of a seismic event.

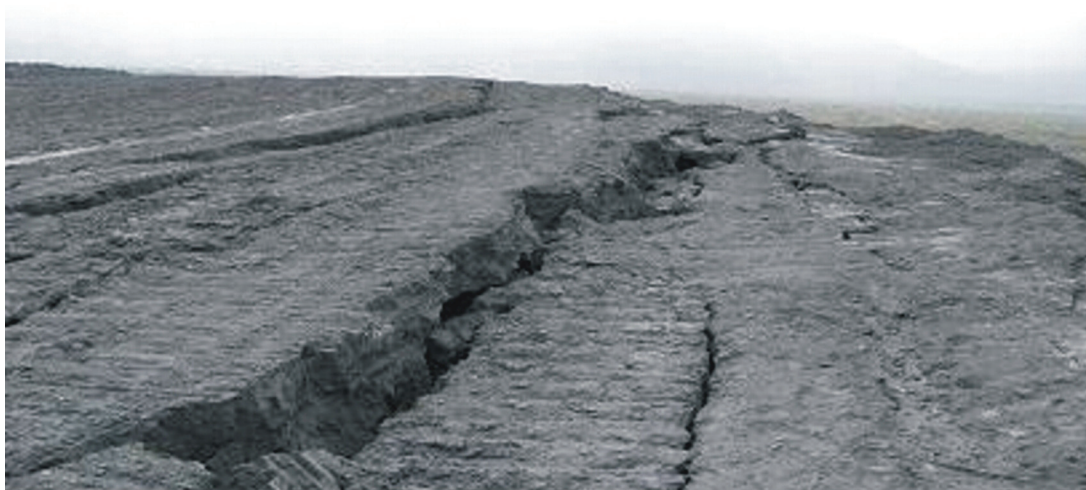
Propagation of seismic waves generates tensile stresses that may exceed the material resistance. This occurs particularly in the retaining dyke crest, where the acceleration amplification is higher and the confining stresses are minimal. Resulting fissures are longitudinal and propagate downwards from the surface, usually being about 1.0 to 2.0 cm wide. This type of discontinuity does not usually represent a risk of partial or total emptying of the basin (Fig. 3).

Fig. 3. Longitudinal fissures generated by tensile stresses in retaining dyke.

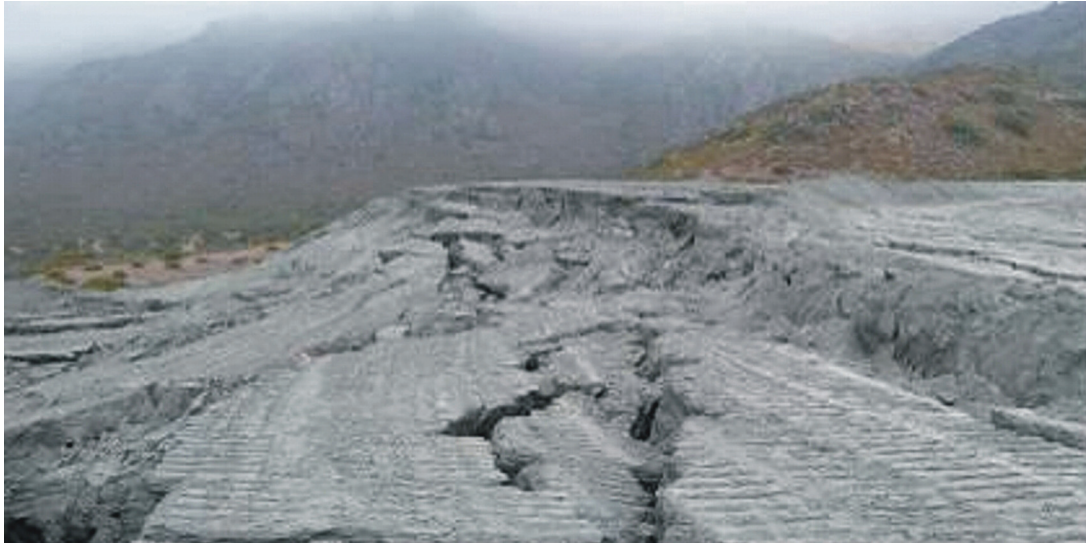
Fig. 4. Deformations caused by seismic shear stresses in retaining dyke resulting from the earthquake of 27 February 2010, Maule Region, Chile.

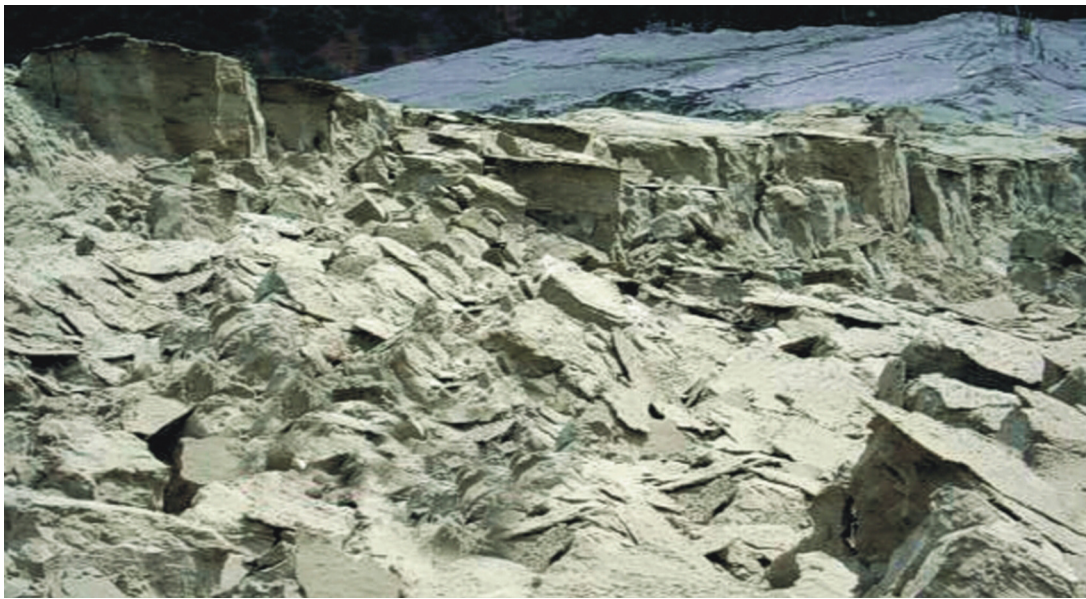
Even more dangerous is the development of fissures due to settlement caused by the presence of slime pockets inside the retaining dyke. Such pockets result from poor construction control, which is almost inevitable in the centerline construction method, but less frequent in downstream dams. These fissures generally have a parabolic shape in plan, open towards the basin. In extreme cases, these may induce a flow and release of the retained tailings (Fig. 5).

Fig. 5. Upstream slope deformations of retaining dyke caused by settling of underlying slimes.

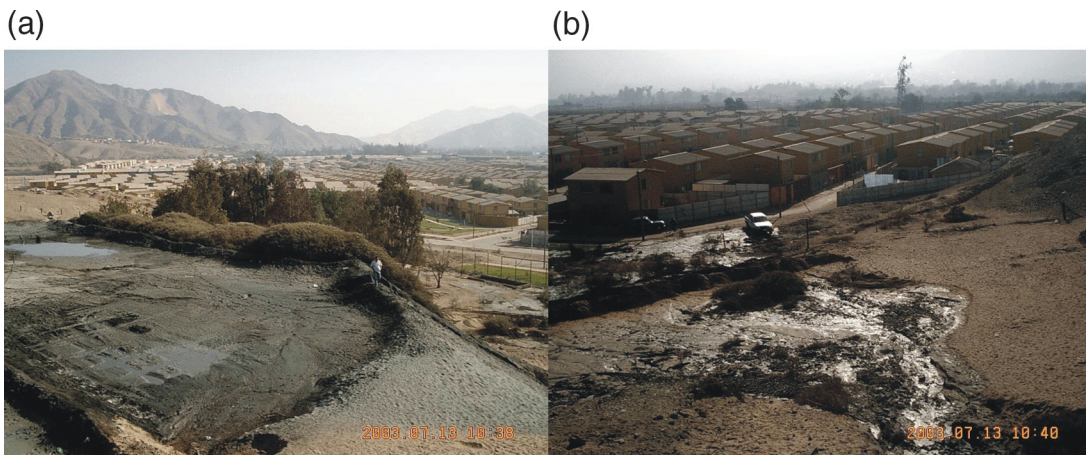
An excessive level of retained fine tailings in the decant pond, resulting from an extreme rainfall event or poorly controlled operation of a tailings sand dam, may result in reduced freeboard. Failure of a dam may be caused by an overflow of the ponded waters, as the level rises progressively. Ultimately, a slide surface can be produced, which may lead to progressive collapse of the dam (Figs. 6a and 6b show such overtopping, which could possibly

Fig. 6. Overtopping incident: (a) retaining dyke and basin of the sand tailings dam; (b) flow failure in downstream direction.

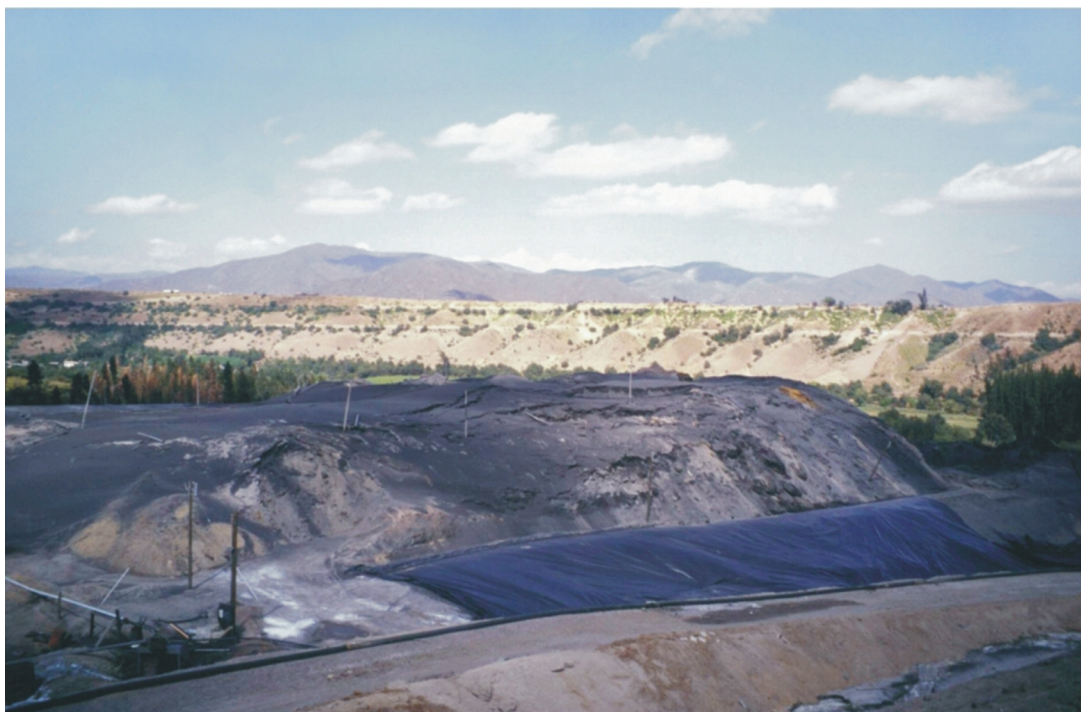
Fig. 7. Antiguo sand tailings dam at La Cocinera Plant, where slides and deformations were caused by the earthquake of 14 October 1997.

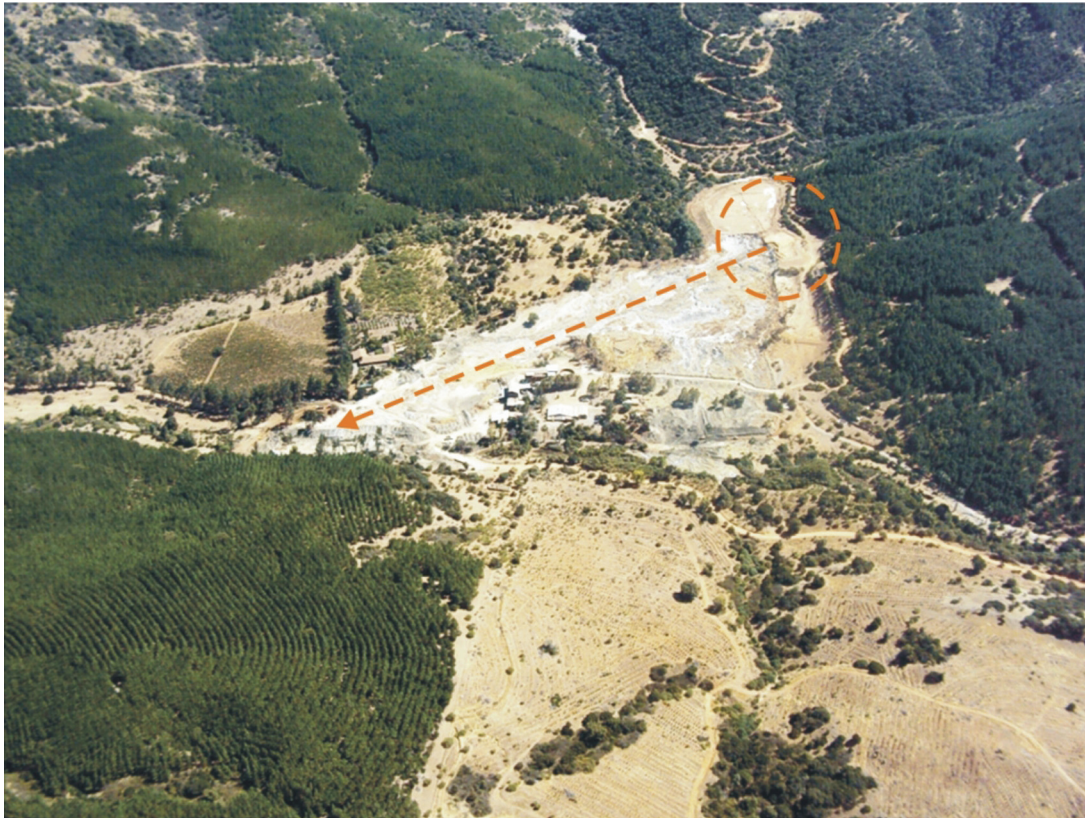
Ramirez 2010; Verdugo 2011). Figure 8 shows the general condition of the tailings dam after the collapse, with flow clearly evident. The distance of travel of the tailings was approximately 500 m. The collapse caused the death of four people inhabiting a nearby home, and generated an obstruction of the Los Ladrones and Las Palmas streams.

Fig. 8. Las Palmas sand tailings dam after the collapse generated by the 27 February 2010 earthquake.

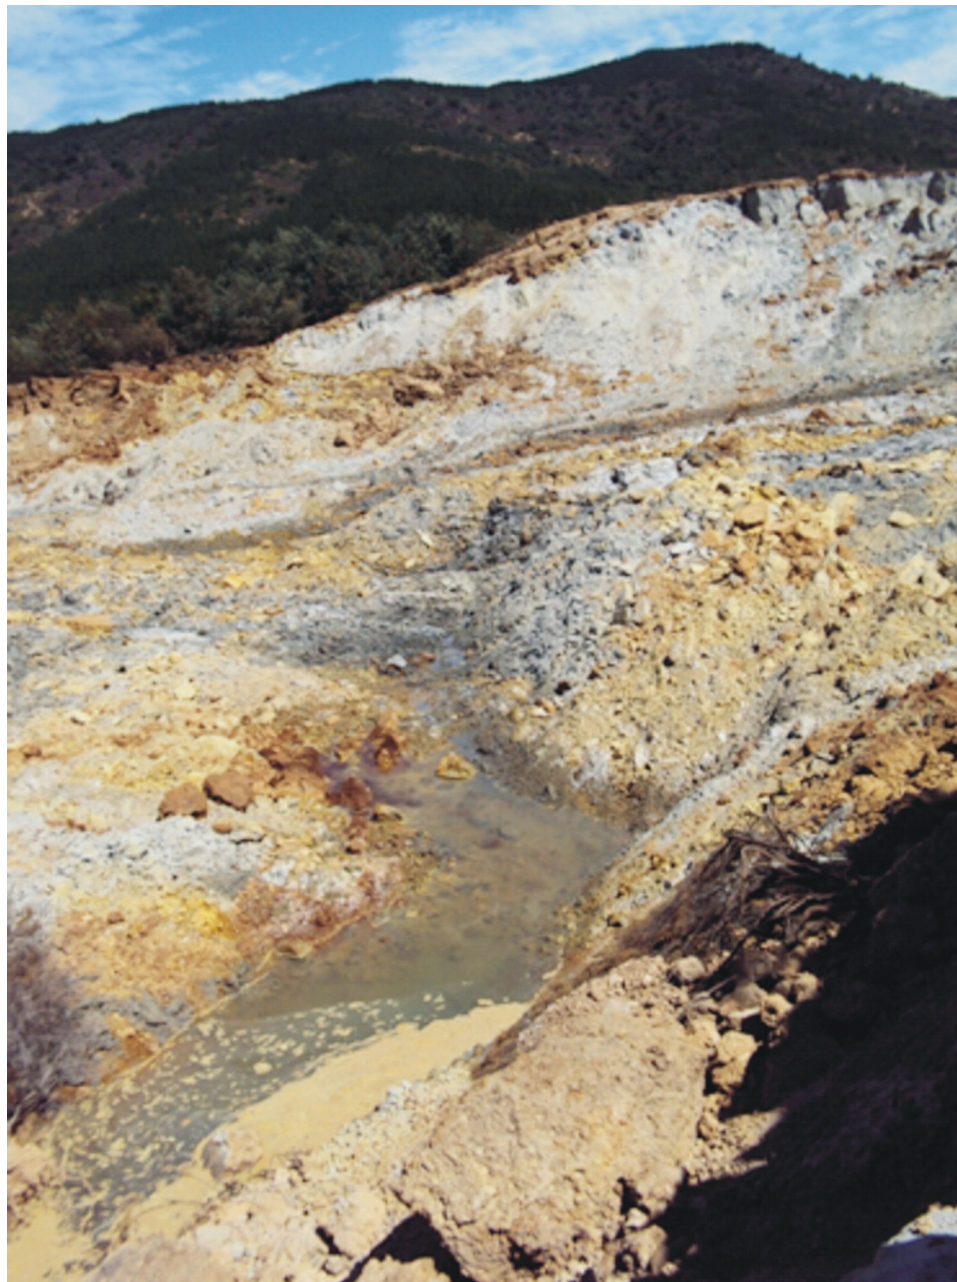
Fig. 9. Groundwater flow through the retaining dyke that collapsed at Las Palmas Dam.

Under this critical scenario, trenches were excavated in the retaining dyke to generate rapid drainage, dissipate the pore-water pressures, and lower the phreatic surface, thus minimizing further liquefaction potential. The 27 February 2010 earthquake generated a maximum effective acceleration (a_{max}) of 0.34g, causing the liquefaction of the sand tailings dam (Fig. 11). It is believed that the measures adopted prior to the earthquake prevented a catastrophic flow failure from occurring.

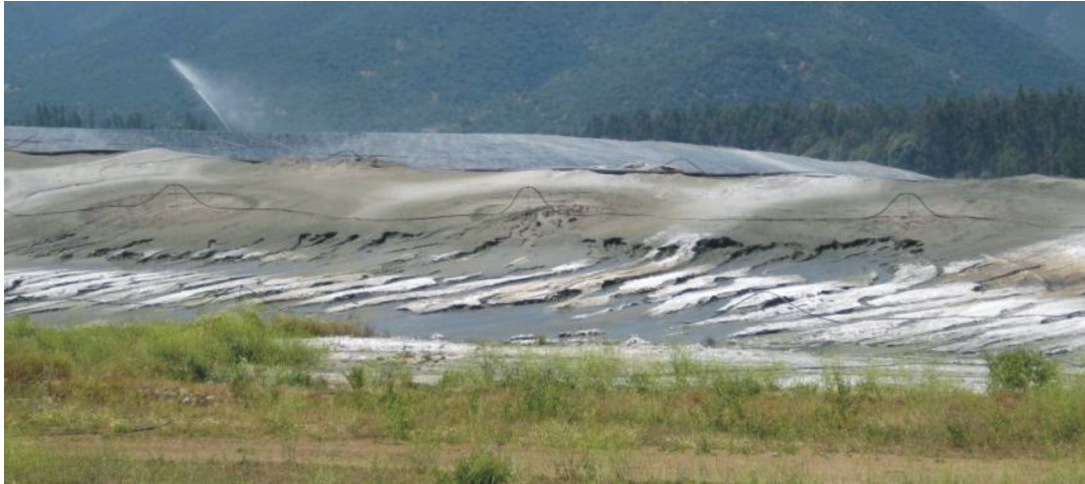
Fig. 10. Retaining dyke saturation caused by elevated water table and irrigation (sand tailings dam Adosado).

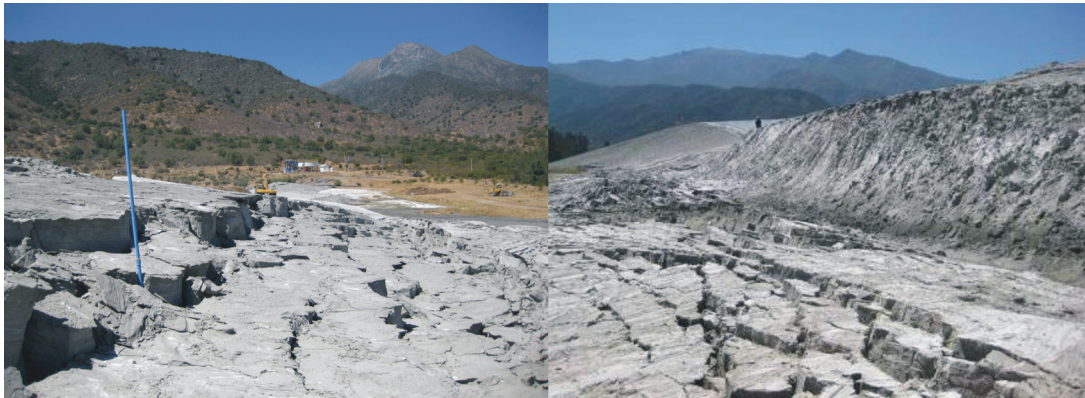
Fig. 11. Final situation after liquefaction of sand tailings dam, resulting from the earthquake of 27 February 2010, Maule Region, Chile.
