Case History

Geotechnical damage caused by the 2010 Maule, Chile earthquake

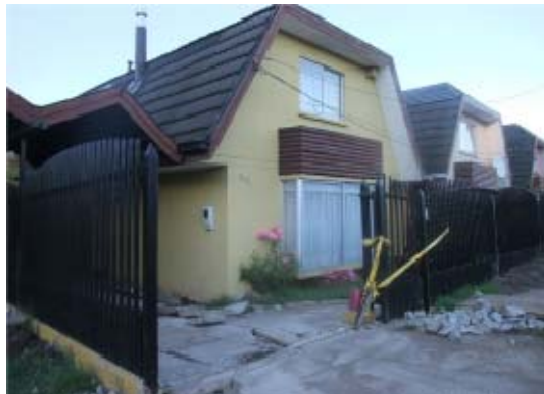
Many houses settled in three housing lots in Concepción as shown in Photo 2. The maximum settlement was about 17 cm. Because the original topography here was swamp as well, the backfilled sand in the swamp liquefied and caused house to subside. Furthermore, underground tanks uplifted in cities of Concepción, Chillan, and Arauco. Photo 3 shows uplifted sewage tanks. It seems that backfilled sand liquefied and caused this uplift.

Photo 2 17-cm Subsidence of houses in Bayona, San Pedro de la Paz

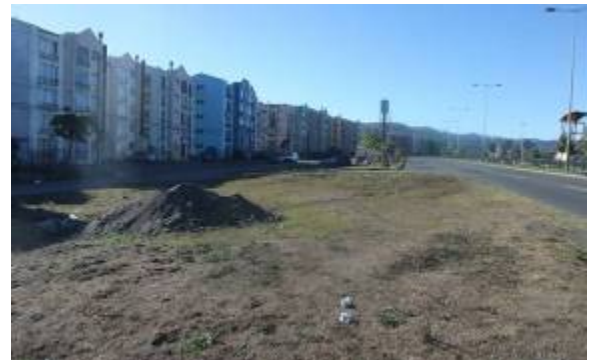
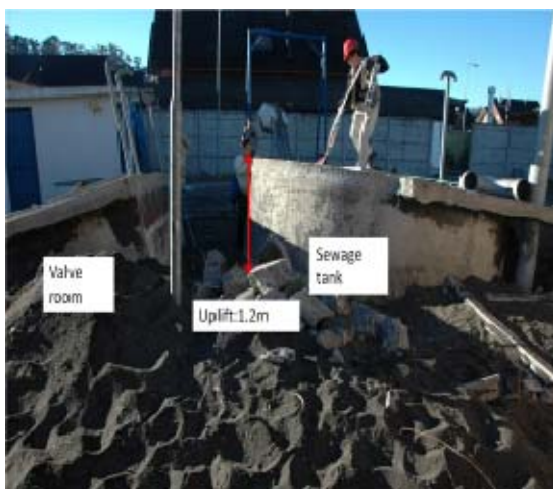
Photo 3 Uplift of buried sewage tank in San Pedro de la Valle

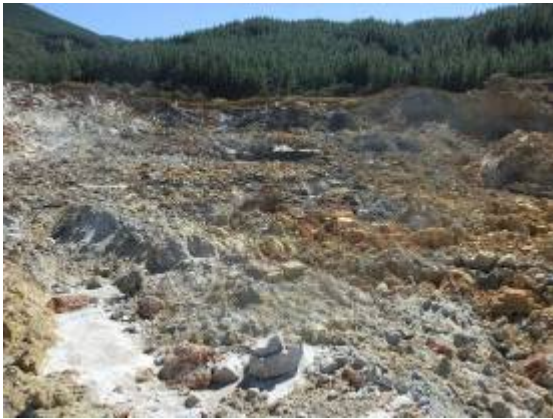
Photo 7 Tailing deposit after liquefaction

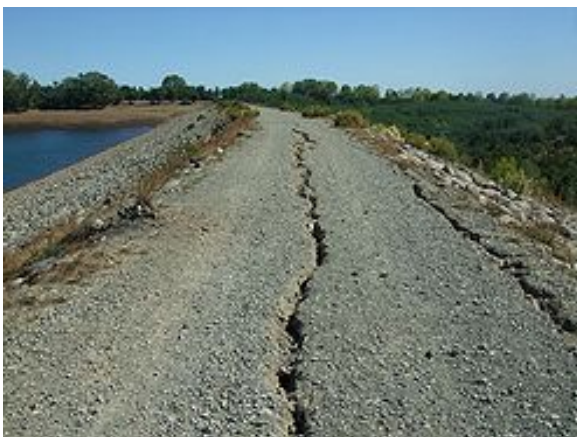
Coihueco Dam is situated at around 130 km to the east of Concepción. It is an earth dam and measures 975 m in length, 31 m in the maximum height, 19 degrees in the upstream slope, and 21 degrees in the downstream slope. The reservoir area is 2.26 million m². Photo 9 indicates two longitudinal cracks along the crest of the dam; one in the centre and the other at the downstream (right side) shoulder. The width of the crest is 5.2 m. The depth of the crack reached at maximum 1.9 m. Photo 10 demonstrates the downward slip movement of the slope on the reservoir side. This movement resulted in at maximum 3.3 m subsidence near the shoulder.

Photo 9 Longitudinal cracks at the crest of Coihueco Dam

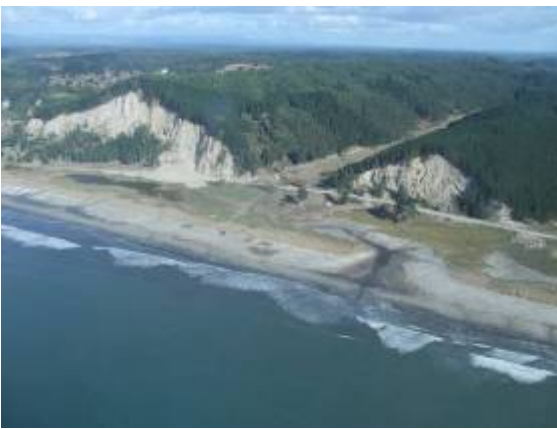
It was fortunate that the size of failures in natural slopes was small. This is because the Andes Mountains where there are many unstable slopes were far from the earthquake-affected area. The Coastal Mountains conversely do not have many steep slopes except cliffs at the coast. Therefore, the present report on natural terrain addresses only the coastal region. There are many steep cliffs along the coast from Arauco to Lebu through Cape Lavapie and they are subject to shallow failures. Photo 11 and Photo 12 indicate surface failures near Arauco and Cape Lavapie, respectively. Height of the cliff shown in Photo 11 is about 100 m.

Photo 11 Slope failure at Las Peñas near Arauco

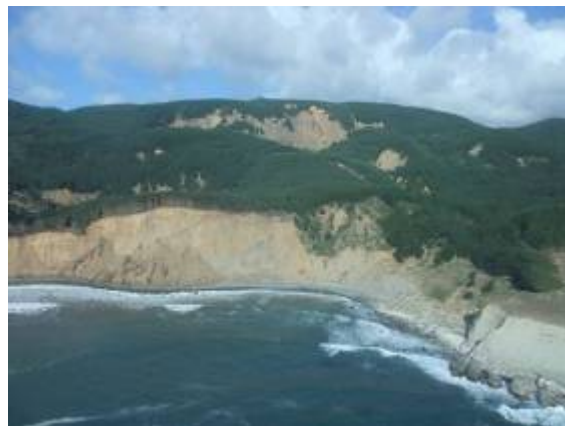
Photo 12 Slope failure at Lavapié

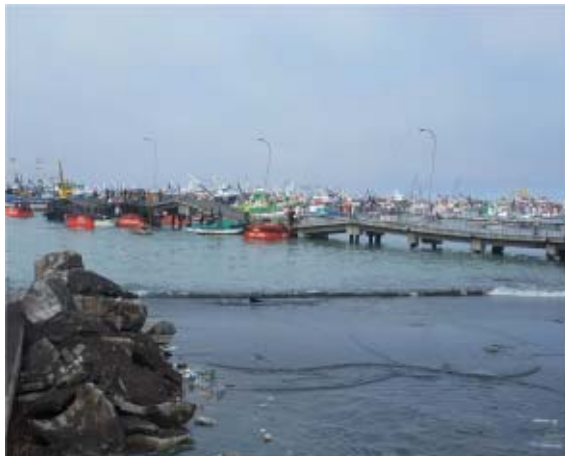
Coronel Harbor is located at about 450km to the south of Valparaiso. A distortion occurred in a fishermen's pier there (Photo 18). The damaged structure connects the land and the main part of the harbor and is supported by a pile foundation. Because substantial translation and tension cracks were found on the land side of the pier (Photo 19), it is inferred that the structure was subjected to compression from the land side, and, because of the very rigid foundation of the main part of the offshore pier, the connecting part developed significant compressional deformation and buckling. This soil-structure interaction deserves further study. Note that two larger commercial piers next to this place received only minor effect from the earthquake and were able to start operation one day after the earthquake.

Photo 18 Damaged pier in Coronel

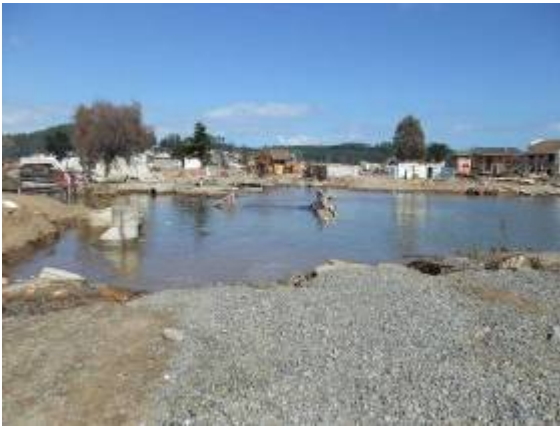
Photo 23 Tsunami-induced erosion in Dichato

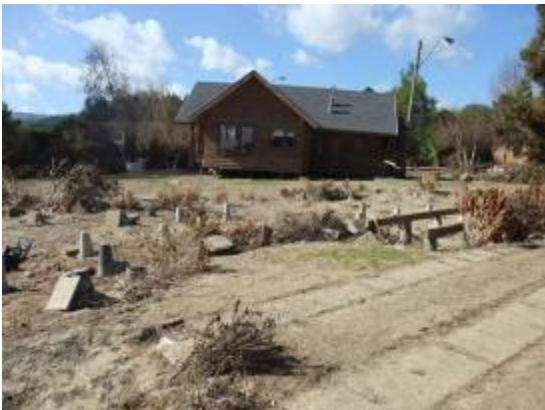
Photo 25 House that floated when tsunami came
