## Learning from Earthquakes

# The $M_w$ 8.8 Chile Earthquake of February 27, 2010

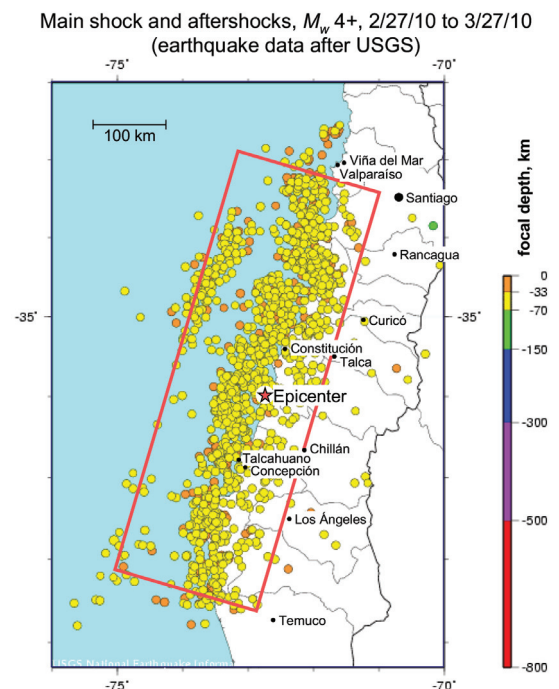
Note: The superimposed rectangle has dimensions 600 km by 200 km.

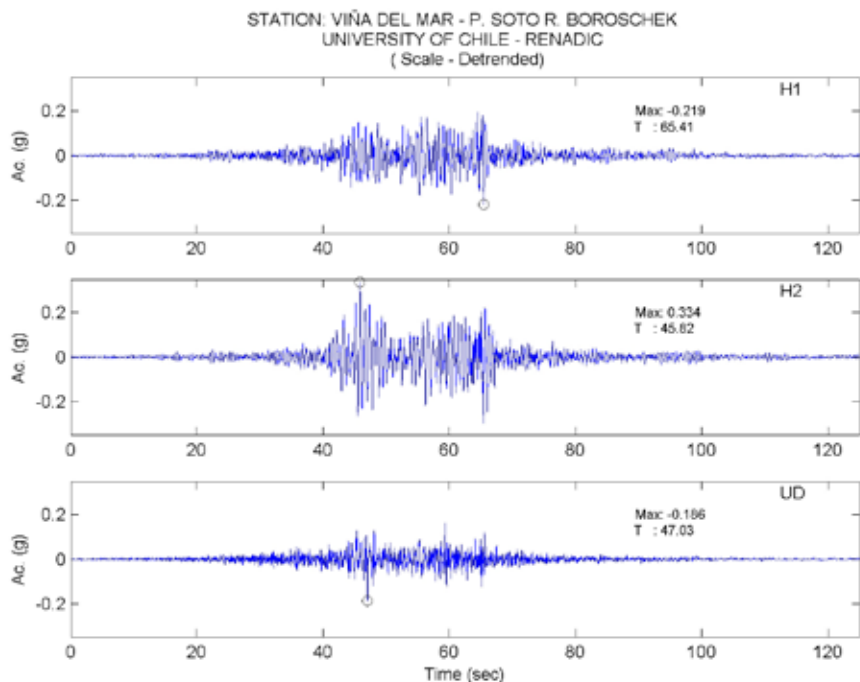
**Figure 4.** Viña del Mar downtown area earthquake records. This same station recorded the 1985 Central Chile Earthquake. NS and EW are nominal coordinates.

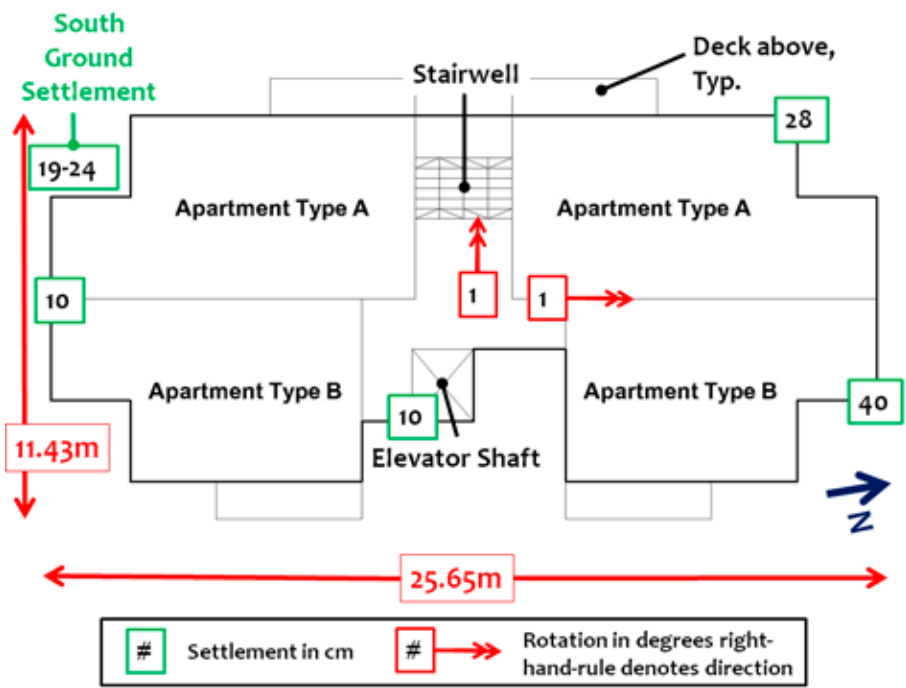
**Figure 5.** Schematic plan view of the Riesco building in Concepción (GEER, 2010).

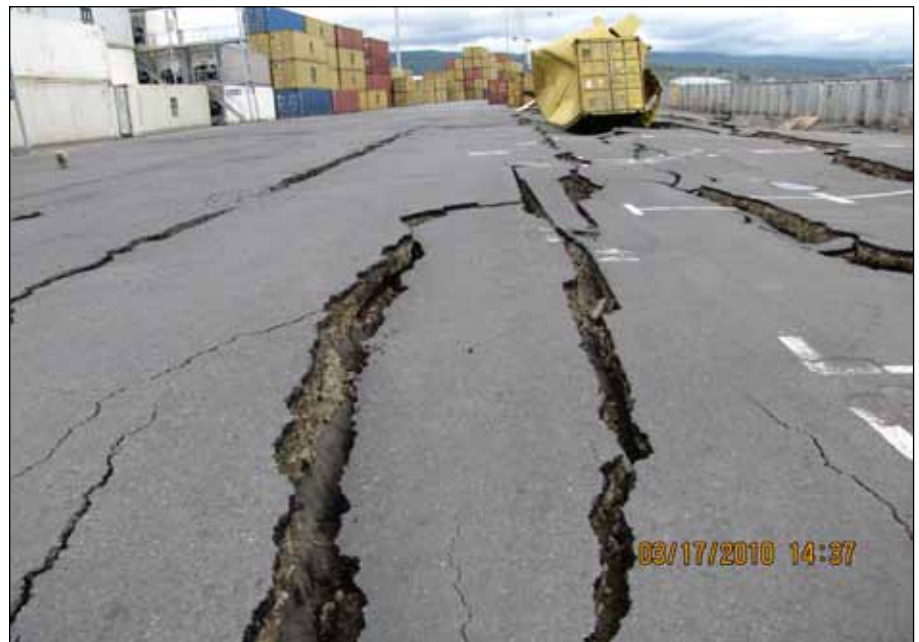
**Figure 6.** Liquefaction and lateral spreading-induced damage at the Port of Coronel (photo: GEER, 2010).

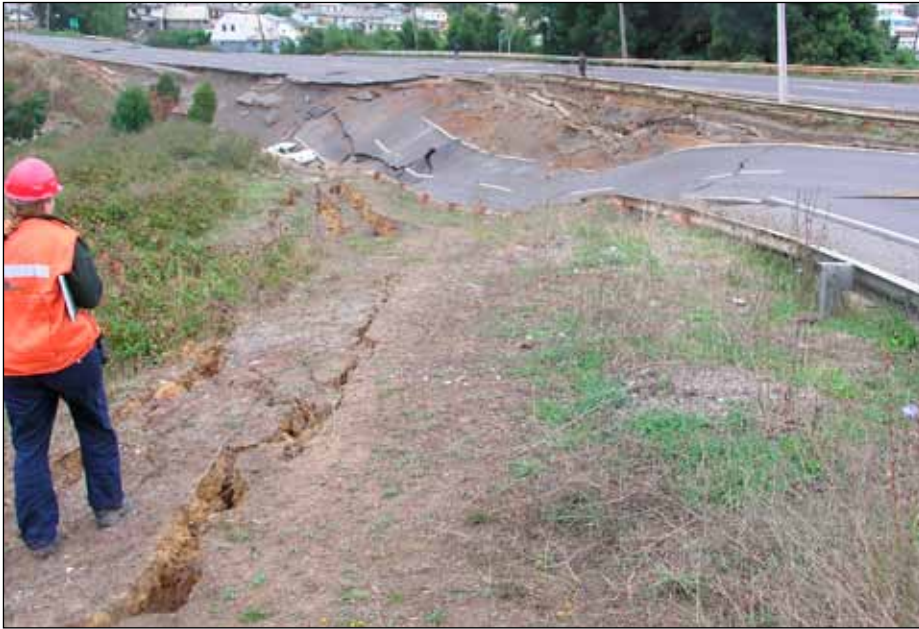
**Figure 7.** Slope failure on Route 160 in Lota (photo: GEER 2010).

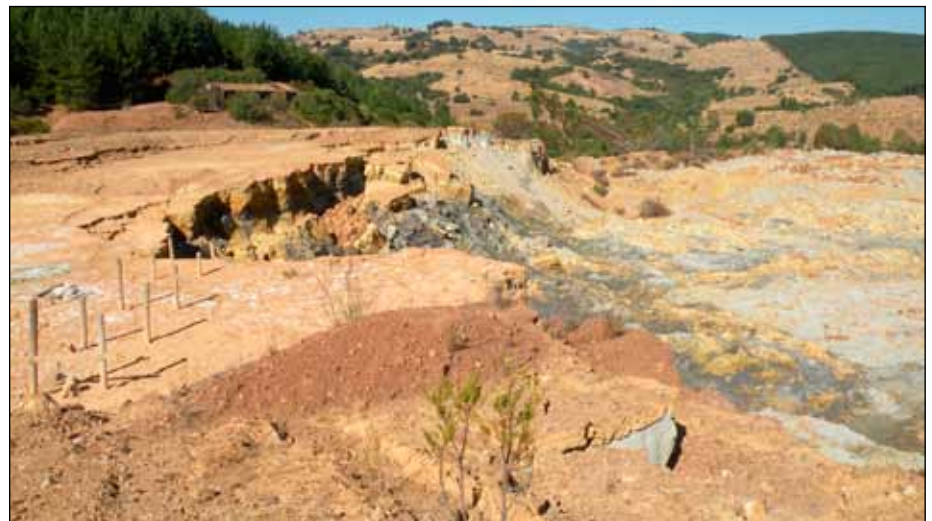
**Figure 8.** Upper scarp of Failed Tailings Impoundment (photo: GEER 2010).

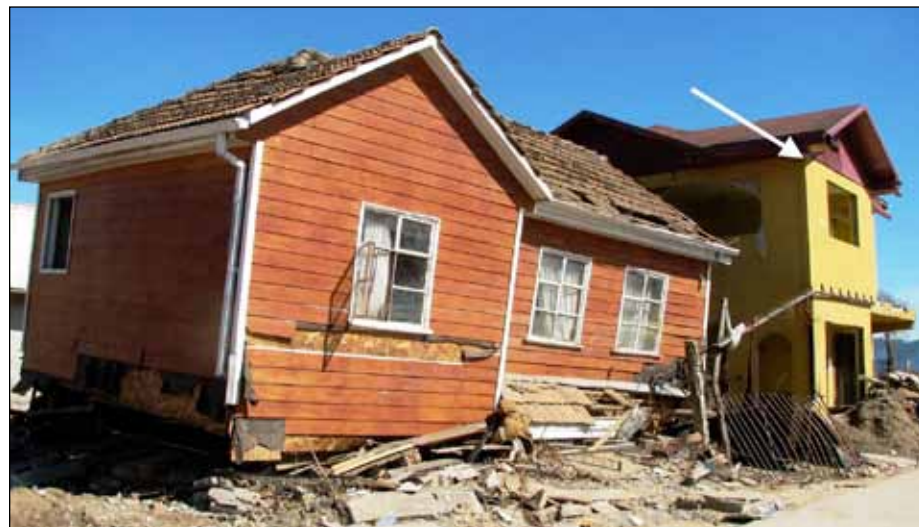
**Figure 9.** Wood building on left in Dichato was transported from across street and collided with the concrete frame building on the right. Arrow shows water height (photo: L. Dengler).

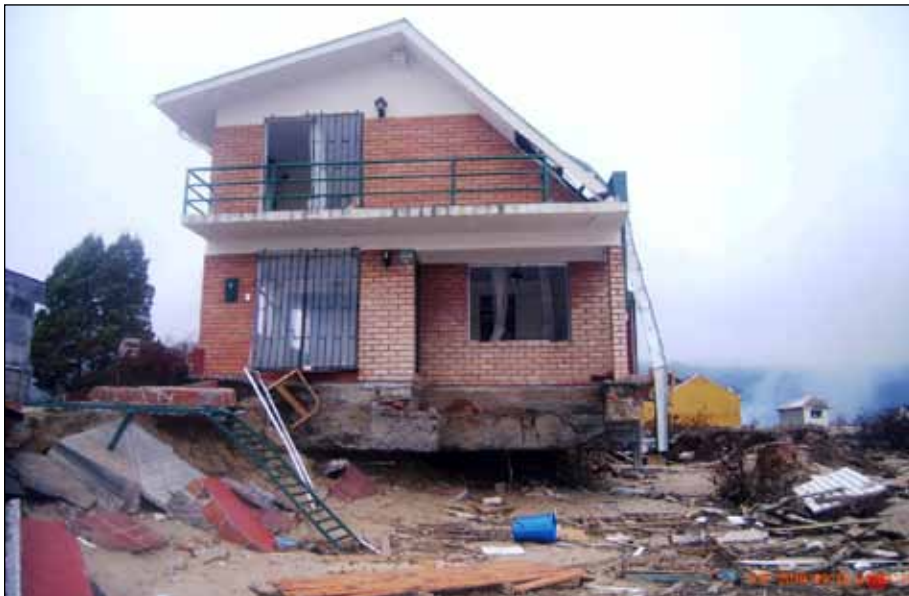
**Figure 11.** This concrete frame and confined masonry building in Dichato survived the hydrodynamic loads, but suffered substantial foundation scour (photo: G. Chock).

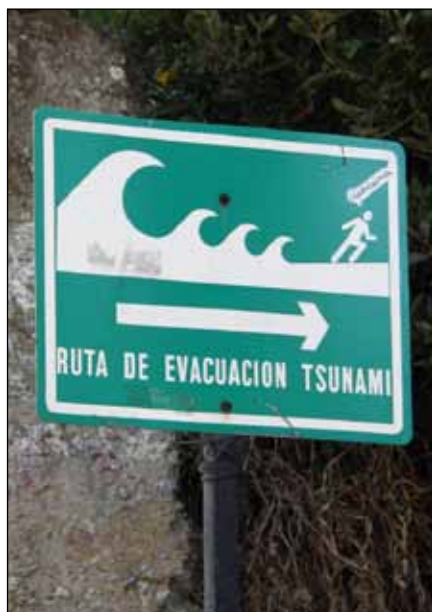
**Figure 12.** Tsunami evacuation sign, Curanipe (photo: N. Graehl).

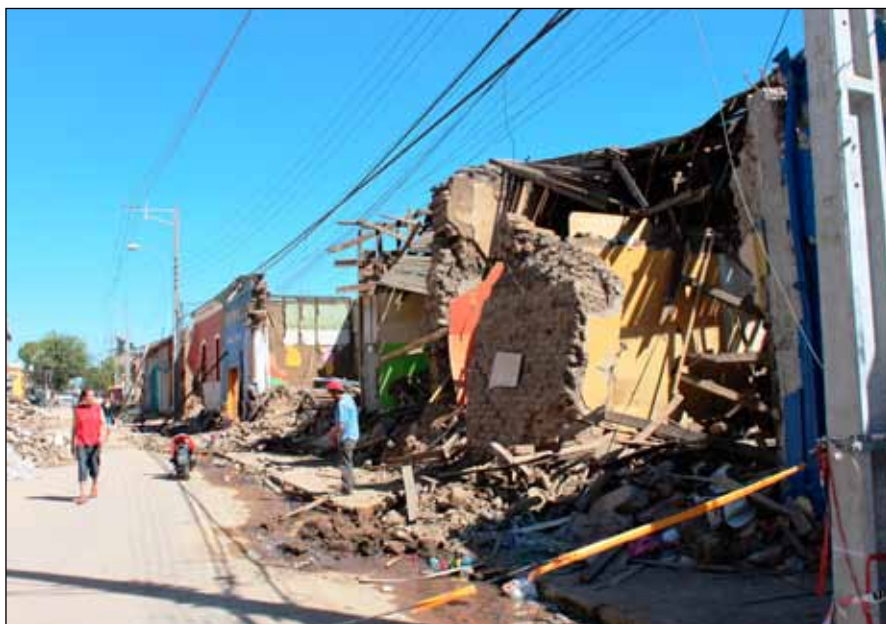
**Figure 13.** Street in Talca (photo: J. Moehle).

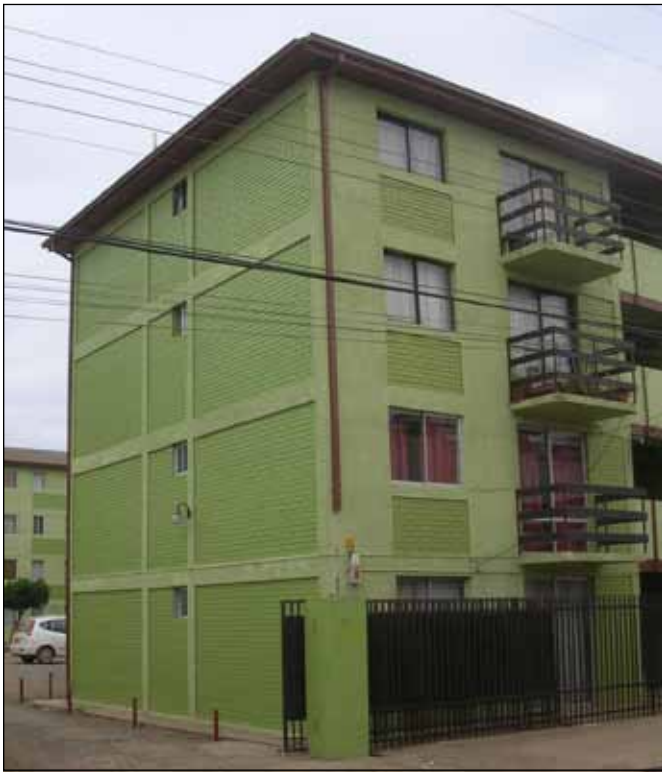
**Figure 14.** Engineered confined masonry apartment building, showing confining elements at boundaries of walls and openings (photo: M. Astroza).

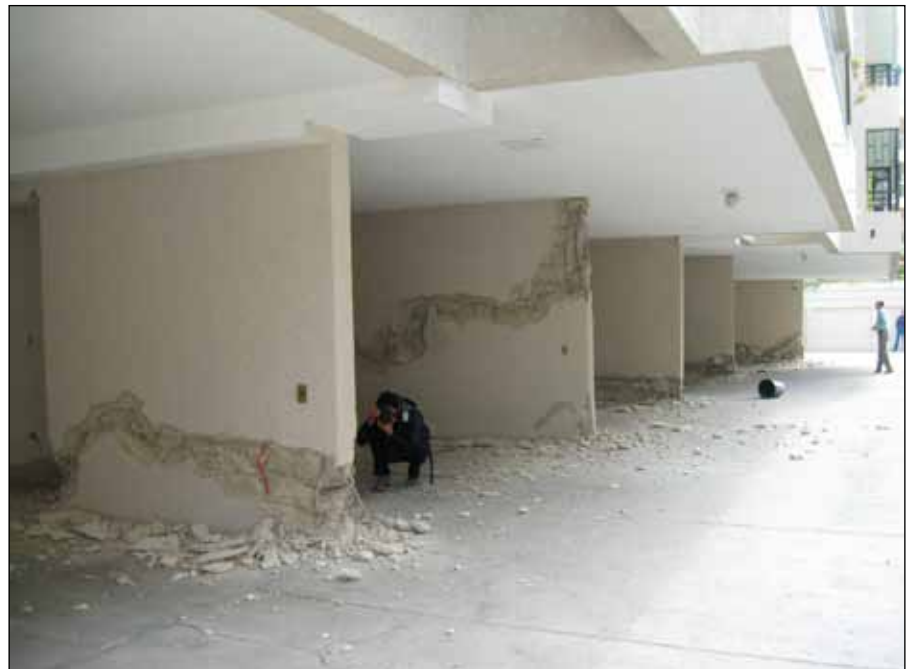
**Figure 15.** Wall damage, Viña del Mar (photo: P. Bonelli).

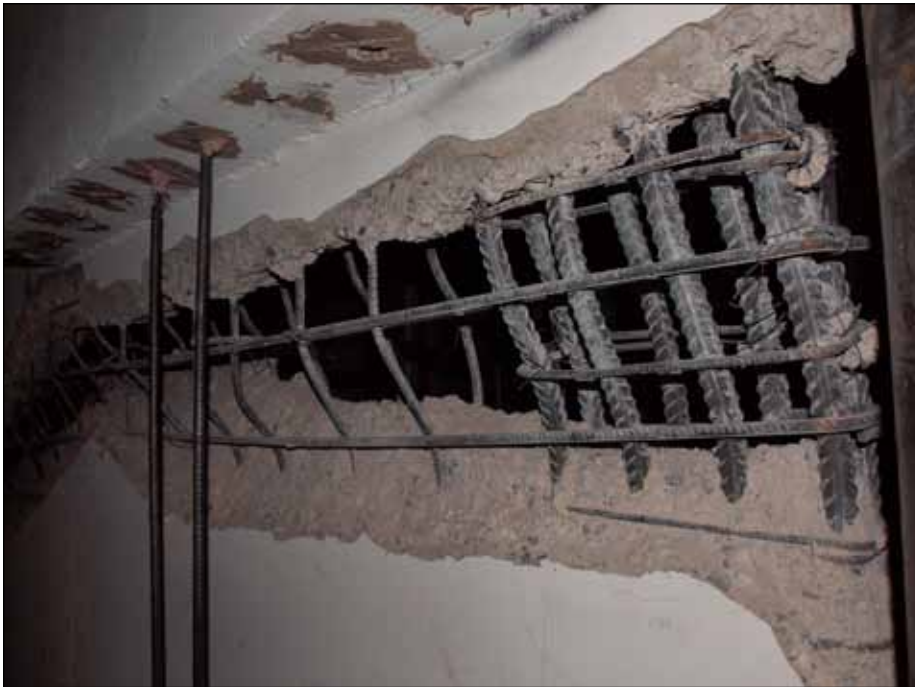
**Figure 16.** Wall damage, Santiago. Note the 90-degree bends on the transverse reinforcement (photo: J. Wallace).

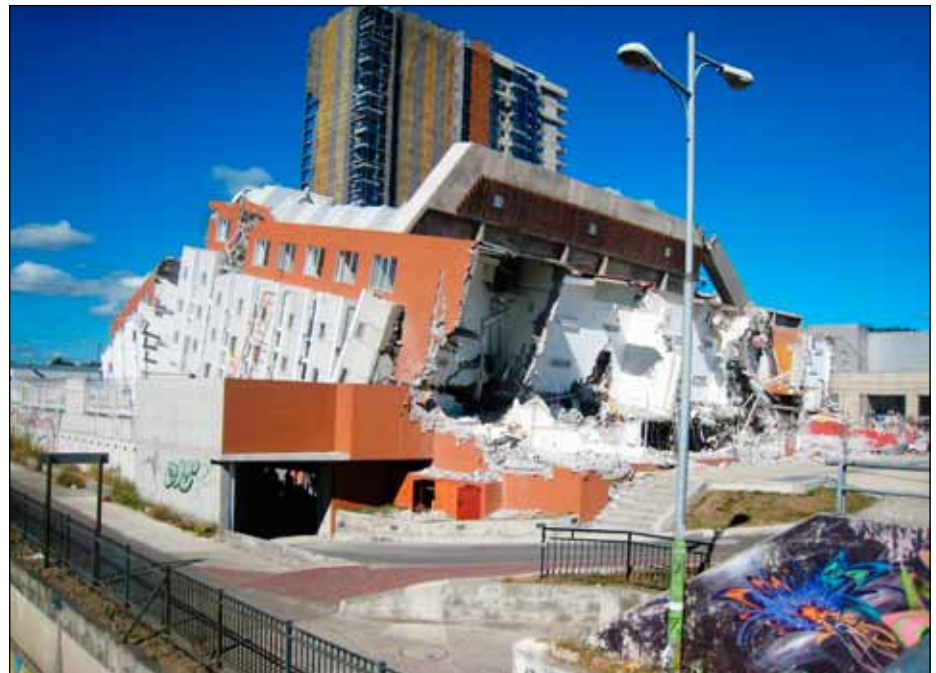
**Figure 17.** Collapsed Alto Río tower showing underside (photo: J. Maffei).

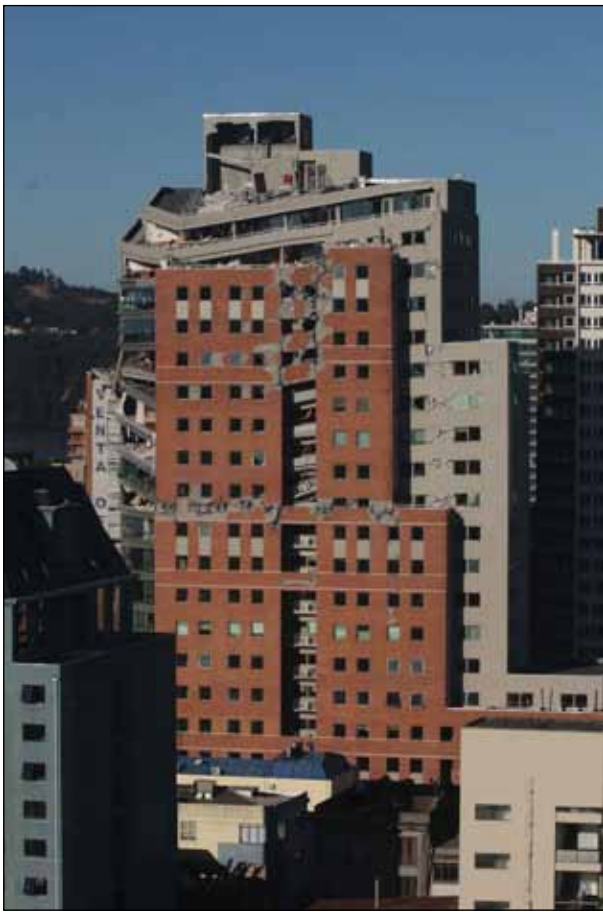
**Figure 18.** O'Higgins 241 office tower (photo: E. Miranda).

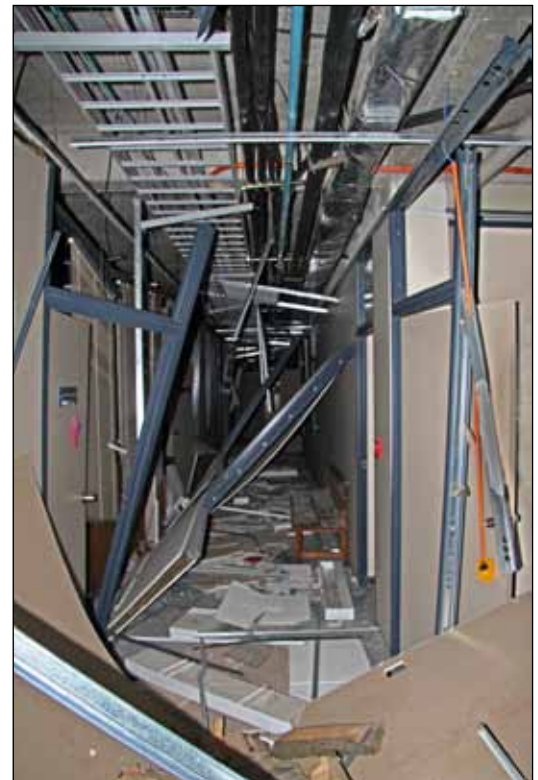
**Figure 19.** Nonstructural damage in the Talca Supreme Court building constructed in 2003 (photo: E. Miranda).

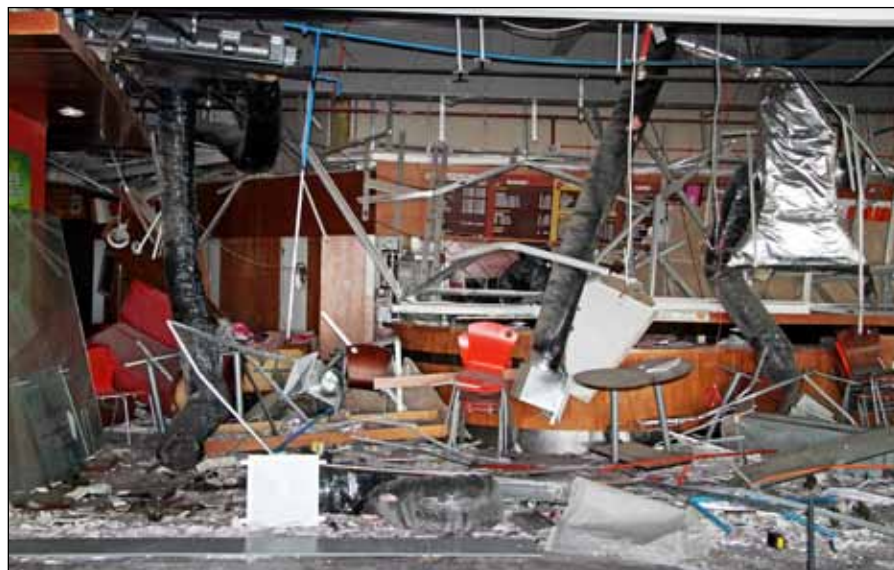
**Figure 20.** Nonstructural damage at the Santiago International Airport terminal (photo: E. Miranda).

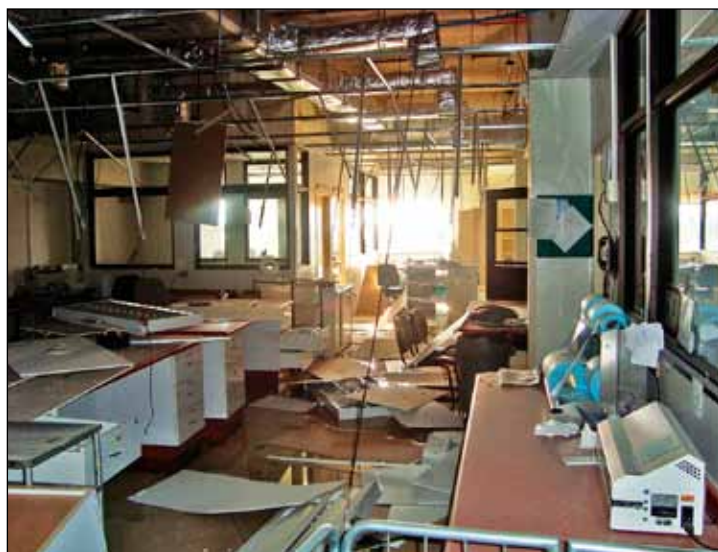
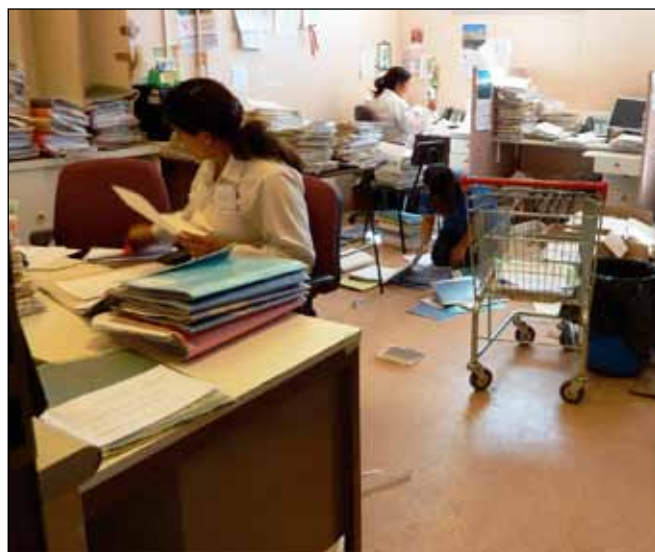
**Figure 21.** (a) Ceiling collapse and nonstructural damage in Chilean hospital (photo: W. Holmes), and (b) tedious reorganization of medical records three weeks after the earthquake (photo: J. Mitrani-Reiser).

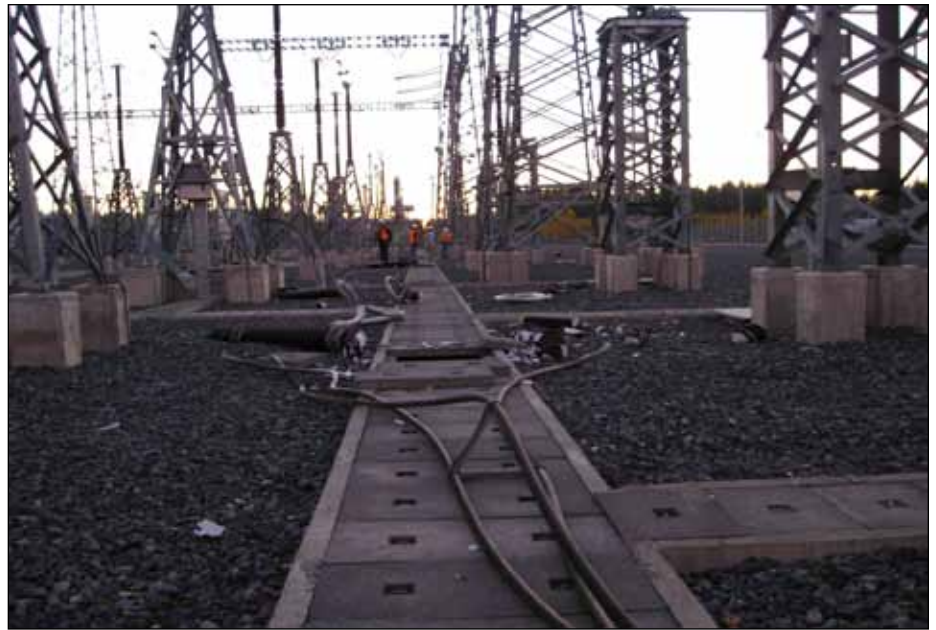
**Figure 22.** Damaged candlestick style live-tank circuit breakers (photo: TCLEE).

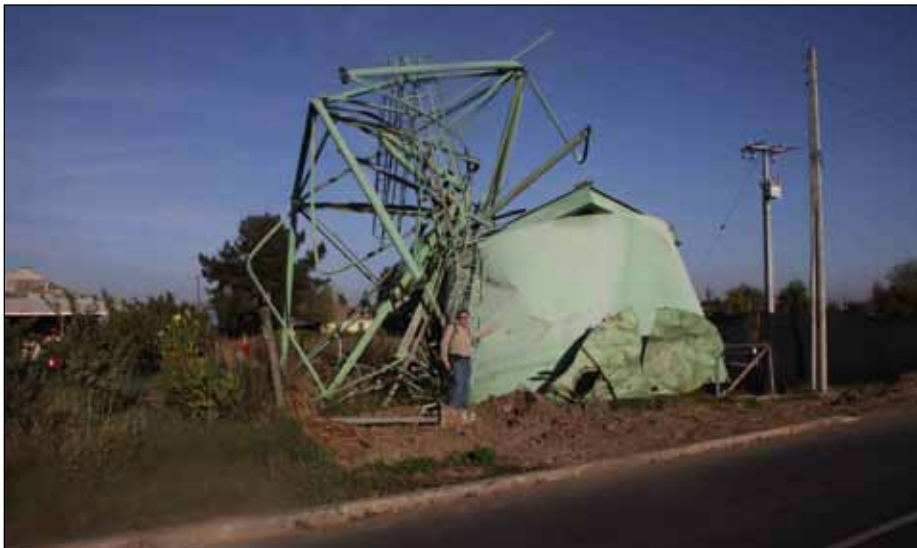
**Figure 23.** Typical collapsed elevated small steel tank (constructed in 1999) (photo: TCLEE).

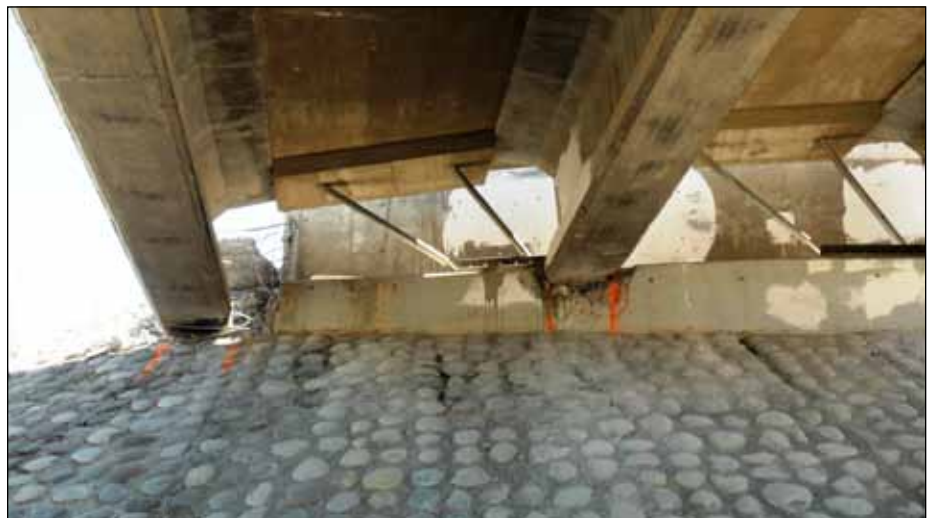
**Figure 24.** Lateral movement of the superstructure of Las Mercedes Bridge across Route 5 near Rancagua, due to absence of end diaphragms and transverse shear keys. Note extreme deformation of vertical seismic bars and damaged curtain walls (photo: Ministerio de Obras Públicas).

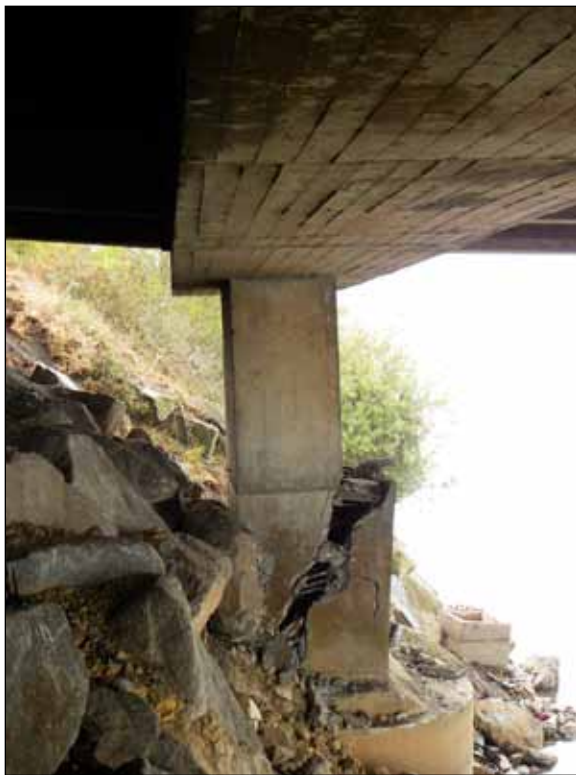
**Figure 26.** Shear failure in a column in northern approach to Juan Pablo II Bridge across Bio-Bio River, Concepción, due to lateral spreading and the propping action of the superstructure at the top of the column (photo: J. Arias).

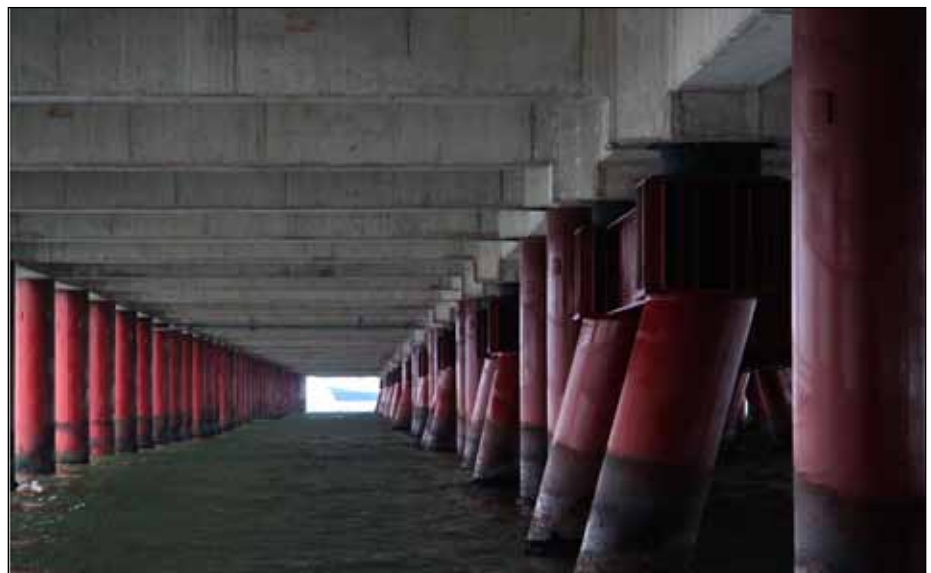
**Figure 27.** Base-isolated wharf at Coronel (photo: E. Miranda).

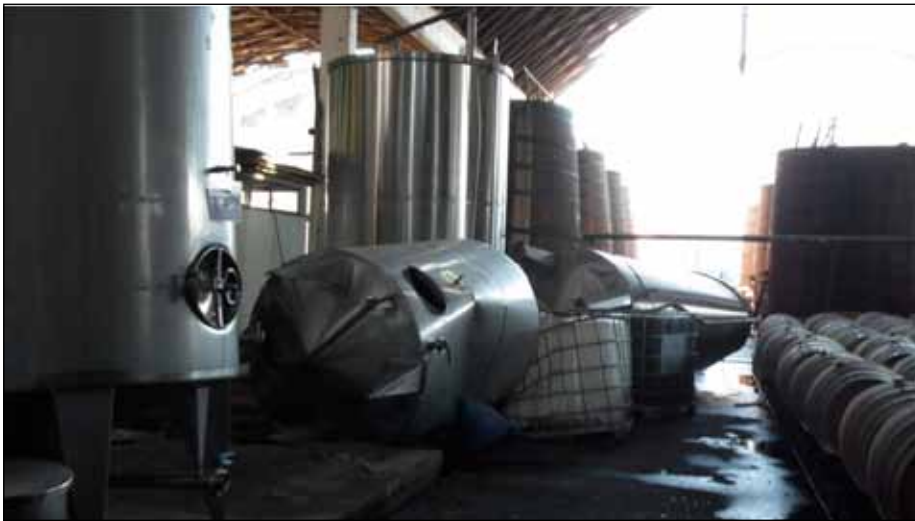
**Figure 28.** Typical damage to storage tanks in wineries (photo: R. Leon).

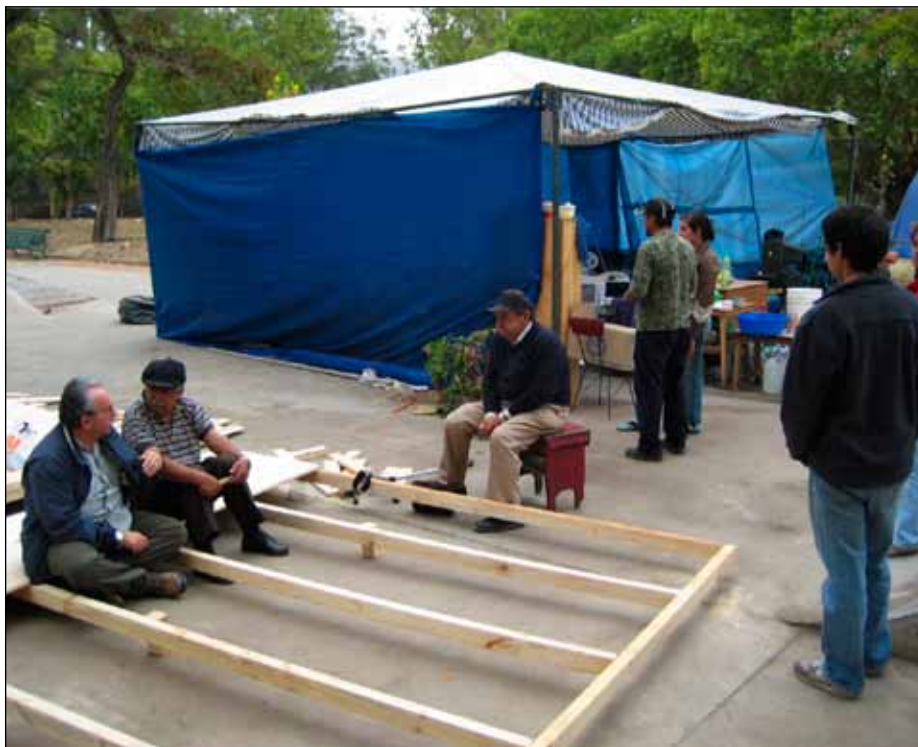
**Figure 29.** Families displaced to temporary tent camps in the center of Talca. Construction of simple wood frame shelter is under way (photo: G. Franco).
