Description and analysis of geotechnical aspects associated to the large 2010 Chile earthquake

Descripción y análisis de aspectos geotécnicos asociados al gran terremoto de Chile del 2010

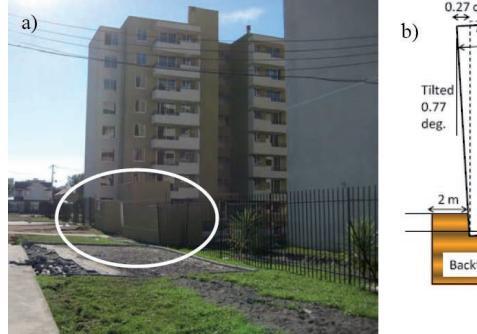
Los Presidentes (1)

Figure 4a shows one of the four three-year-old apartment buildings of eight floors where liquefaction of the subsoil caused structural damage. It is possible to observe the tilted fence and booth at the entrance and material expelled by ejection from below the lawn and concrete block of the car park space. Evidence of sand boils was found around two buildings, which verifies the occurrence of liquefaction. Figure 4b shows the inclination suffered by the building Riesco, which is estimated around 0.77-degree. GEER7 (2010) estimated a maximum settlement of 40 cm on one corner and 10 cm on the other extreme. The report released by GEER (2010) also gives information about the damage in structural elements of the building. According to the soil mechanic study of the project a depth of ground water table of 1 m is considered for summer and a sand backfill of 4 m deep in replacement of the original loose sandy and silty soil deposits belonging to a wetland was recommended. The ground level is 15 masl, which is very low and explains the wetland condition of the area. The ground formation is recent and involves mostly fine sand transported by the Bío Bío River in times when the river formed a delta flowing to the sea. The building foundation consists of shallow strip footings 1.2 m wide and 1 m deep. The soil replacement was not deep enough to countermeasure the highly likely occurrence of liquefaction. Analysis of SPT data, of the original project, indicates that below the soil replacement, i.e. from 4 m to 11 m, estimated relative densities were less than 60% and safety factors against liquefaction were less than 1 for the Riesco building. The building in front of Riesco building suffered slightly less structural damage.

Since there is no SPT data available for this building, it is believed that favourable variations in soil deposits may explain this situation. The other two buildings next to the Riesco building did not suffer considerable structural damage and people are again living there. In this case a borehole data was available whereby relative densities were found higher than 60% between 4 m and 11 m and the safety factor against liquefaction was found higher than 1, except between 5.5 m and 7.5 m. This assessment is in agreement with the liquefaction evaluation following the procedure by Seed and Idriss (1971) based on the interpretation of SPT test and soil mechanics data (see also Kramer 1996).

Figure 4: Building Los Presidentes a) granular material on the lawn and on a concrete block surface as a result of liquefaction and b) schematic cross section of the most tilted building

Possible thoughts about the foundation design of the buildings may include the use of deep foundations. The election of a piled foundation does not avoid per se the occurrence of liquefaction and therefore requires also a careful design. Probably the use of basements together with deeper soil improvement techniques may be a good option. Gravel columns, cement or slime injection can be considered as possible ground improvement techniques to choose from. In any situation it is compulsory to carry out a more detailed soil exploration and geotechnical laboratory and desk studies, which includes deeper soil deposits, beyond 11 m.

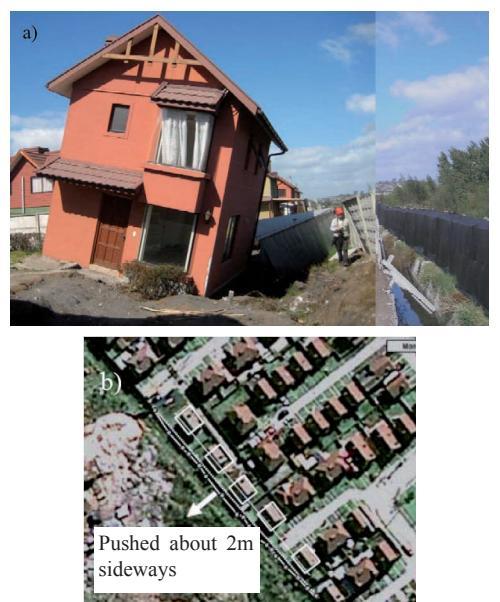
Brisa del Sol (2)

At Brisa del Sol a couple of less than one year old houses located along the border of a canal suffered serious lateral displacement and rotation. Figure 5a shows the enormous rotation of a house as a result of lateral movement of the foundation soil. Seismic forces caused the soil to displace around 2 m, as depicted in Figure 5b, which left houses without support, in other words soil foundation was removed. The ground is similar to that described for Los Presidentes buildings, i.e. loose and soft soil deposits as part of a wetland. On the other side of the canal the land is green due to shallow water table (Figure 5a). The ground improvement technique worked well for the majority of the housing development except for this border next to a canal. The 2 and 3 m of compacted sand used as a fill did not have more lateral restrain than a 2.5 m high narrow stone block wall which forms one of the canal side. In view of these evidences, it is not recommended to build a structure close to a border which does not have firm restrains to lateral movements. There are many types of retaining structures to hold an embankment such as concrete walls.

Figure 5: Houses at Brisa del Sol a) significantly tilted house and b) line of houses affected by ground lateral displacement

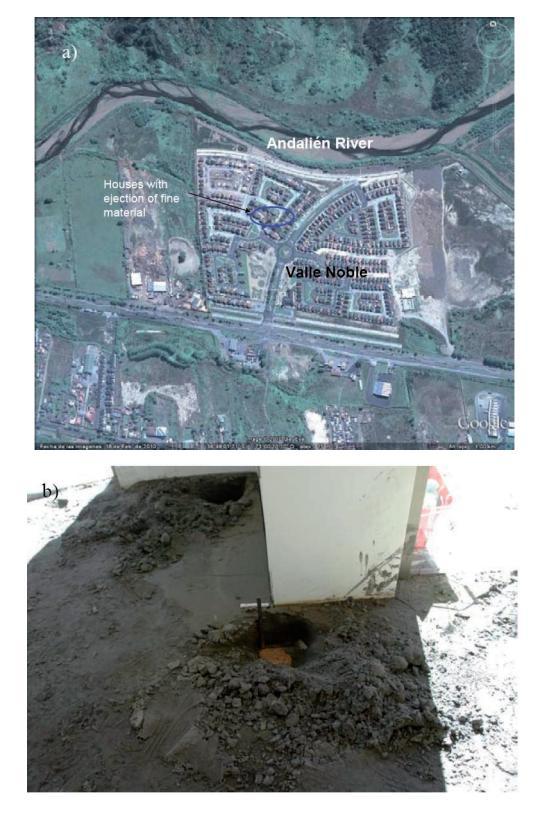
Valle Noble (3)

Valle Noble is a relatively new group of houses located on a flood area of the Andalién River. To avoid flood houses were built on top of approximately 3 m high fill soil, mostly sand although is also possible to find finer material. Only in a few houses strong ejection of fine material occurred in the garden and unfortunately in two houses ejection took place also inside the house. It is not know whether gaps between walls and floor slab already existed or elevated excess pore water pressure broke through. The river presence indicates that the water table is relatively superficial even during dry season. But the question is why this occurred only in a few houses. It is probable that the presence of a perched water table in this site together with the presence of a low permeability material, did not allow adequate dissipation of excess pore water pressure.

Figure 6: Valle Noble a) location and b) large amount of fine material ejected inside a house

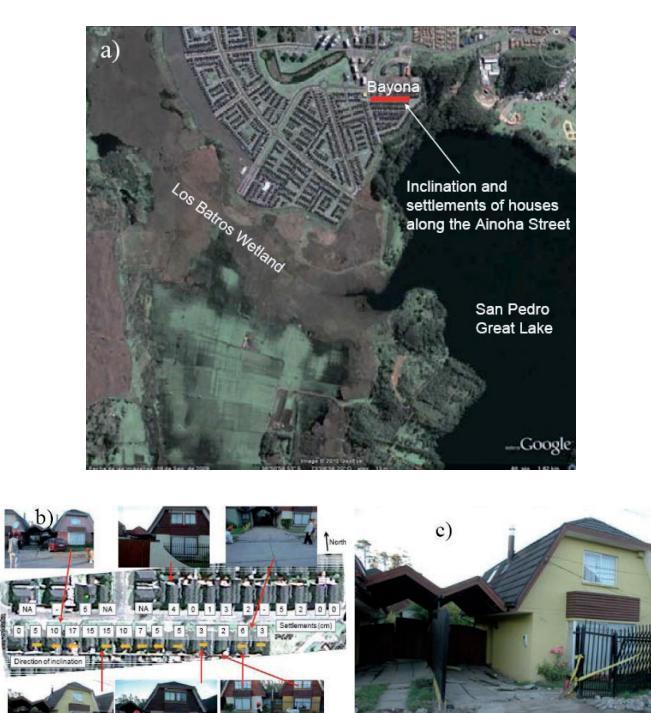
San Pedro de la Paz is a town on the other side of the Bío Bío River. Around hundred thousand people live over there as a consequence of continuous constructions of housing developments. In San Pedro de la Paz soil deposits are mostly composed of loose to medium sand transported in the past by the Bío Bío River. However, there are also residual soils as a result of weathering of metamorphic rocks as part of hills and there are also organic and soft soils in low land areas belonging to wetlands. Figure 7a shows that Bayona, group of houses built in the early 90s, is located in the transition between residual soils on the lap of a hill and the former location of the wetland Los Batros. For the house construction, shallower soft and organic soils were replaced by compacted sand. However, this superficial improvement technique was not enough to avoid the occurrence of liquefaction in Ainoha Street shown in Figure 7b, where settlements in cm and direction of house rotation are shown. Figure 7c shows the case of a house with a subsidence of 17 cm. It is worth mentioning that settlements were not uniform and more pronounced under the house strip footing foundations, which resulted in the bulging of the house floor slab,

breaking the slab and the covering of the floor. Pavement concrete blocks in the house entrances were also twisted and broken. Moreover, ejected fine soil was observed as a proof of liquefaction.

Figure 7: Bayona houses in San Pedro de la Paz: a) aerial view showing proximity to a lake and a wetland, b) measurements of settlements and c) house with a maximum subsidence of around 17 cm

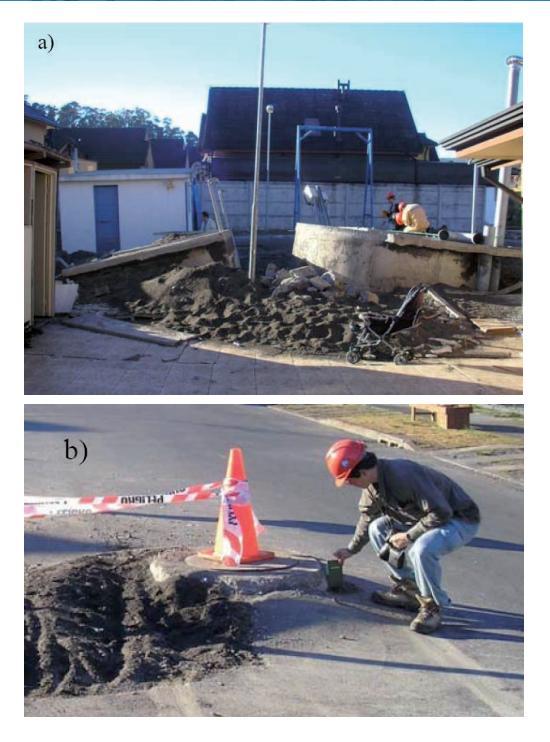
San Pedro del Valle (SPV) is a much more recent group of houses, around 2 years old, which shares practically the same characteristics of Bayona. Despite SPV is almost completely on Los Batros wetland, lesser houses suffered damage due to liquefaction or another soil phenomenon. However, the SPV sewage plant in Laguna Grande Avenue was found with important damage caused by what is called floating of buried structures. Sewage tanks were uplifted from their original positions in a very spectacular way as shown in Figure 8a. Two tanks of approximately 7 m deep rotated when uplifted around 1.2 m, breaking the steel pipe which connected them. Not well compacted sand used as a fill after excavating for the tank construction liquefied and caused the uplift of the buried tanks.

In addition, manhole uplifts up to 30 cm were observed in the middle and along of Laguna Grande Avenue. Figure 8b shows an example of an uplifted manhole. In general, this phenomenon is not taken into account in the design of sewage systems, hence further research in this topic is needed.

Figure 8: a) Uplift of buried sewage tanks in San Pedro del Valle and b) manhole uplifted

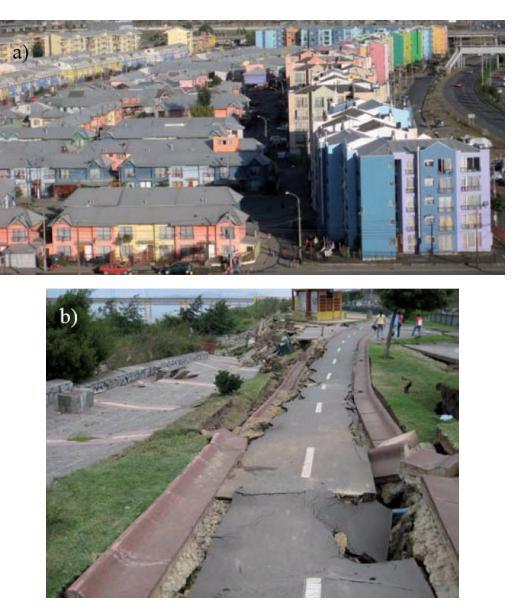
Ribera Norte Bío Bío (6)

It is important to highlight the well performance against the earthquake of a housing development project where dynamic compaction was used as a ground improvement technique. The project Ribera Norte Bío Bío was carried out in 1998 and 1999 with the purpose of reclaiming 10 hectares a flood swamp area close to the centre of Concepción and next to Bío Bío River North Bank. The project was initially studied by Poblete (1997), who proposed a grid with the sequence of impacts of a mass of 15 tons and 10 m of drop height. The project was subsequently performed by the consulting company Geotécnica Consultores, who based the soil improvement study on analyses of liquefaction potential of the replaced soil as well as the underlying soils (Verdugo, 1998). The sand replaced and used as a fill had 6 m thickness and the effect of densification is estimated to improve at least 10 m deep. To verify the dynamic compaction results a series of SPT tests were carried out before, during and after the dynamic compaction. The criterion was that that no liquefaction of the subsoil should occur even under strong earthquakes. It is worth pointing out that the promenade between the motorway and the Bío Bío River, where soil was not dynamically compacted, suffered considerable lateral spreading due to liquefaction, destroying pedestrian pavements, cycle paths, gardens, small shops, etc (see Figure 9b).

Figure 9: a) Housing developments in Concepción built on densified soil by dynamic compaction, no damage found and b) crossing the road, lateral spreading destroyed promenade

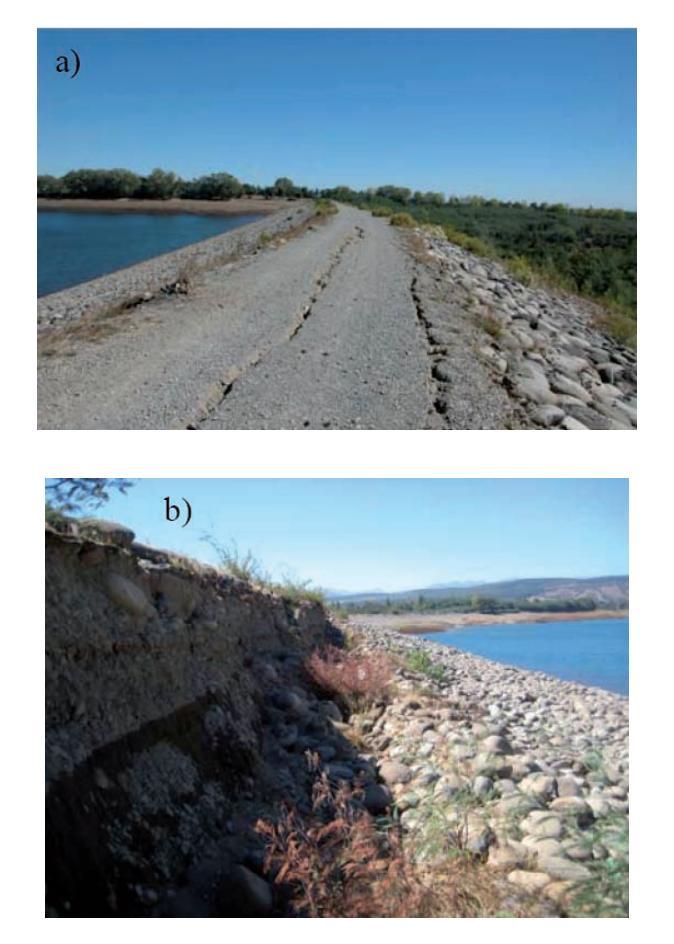
Coihueco dam is situated 130 km to the East of Concepción and 30 km to the East of Chillán, capital of the province of Nuble. The geology underlying the dam corresponds to what is called the Mountain formation, a mix of moraine, glacial and lacustrine sediments and due to the proximity of Cato River there are also fluvial terrace sediments. Coihueco is an earth dam made up of gravely soil with an impervious core protected on both shoulders with boulders. It has dimensions of 975 m in length, 31 m maximum height and shoulder slopes of 19 degrees upstream and 21 degrees downstream. The maximum reservoir area is 2.26 million m2. Since the earthquake occurred at the end of the dry season the reservoir water level was around 12 m lower than during winter. The dam suffered localised evidences of damage such as cracks and slides of dam material. Figure 10a shows two longitudinal cracks along the 5.2 m wide crest of the dam; one in the centre and the other one on the downstream shoulder side. The depth of the centre crack reached a maximum of 1.9 m, close to where the largest movement of the dam was found. This is shown in Figure 10b, where it can be observed the shoulder downward slip movement of the slope on the reservoir side, which extended for approximately 100 m. This movement resulted in a maximum subsidence of 3.3 m near the crest and an average horizontal displacement of 1.3m extending to the toe. In Figure 10b it can be also

observed the presence of gravel on top followed by a wet fine material corresponding to the impervious core. A possible hypothesis is that the failure mechanism involves the sliding of the downstream shoulder made up of dry gravel over the impervious wet core material, which acted as a lubricated sliding surface. The question is why this occurred only in this section of the dam and did not propagate further. It is believed that humidity was kept because of the proximity of the dam buttress, where it can be seen in Figure 10a predominance of vegetation.

Figure 10: Coihueco dam a) longitudinal cracks at the dam crest and b) downwards movement of the upstream slope

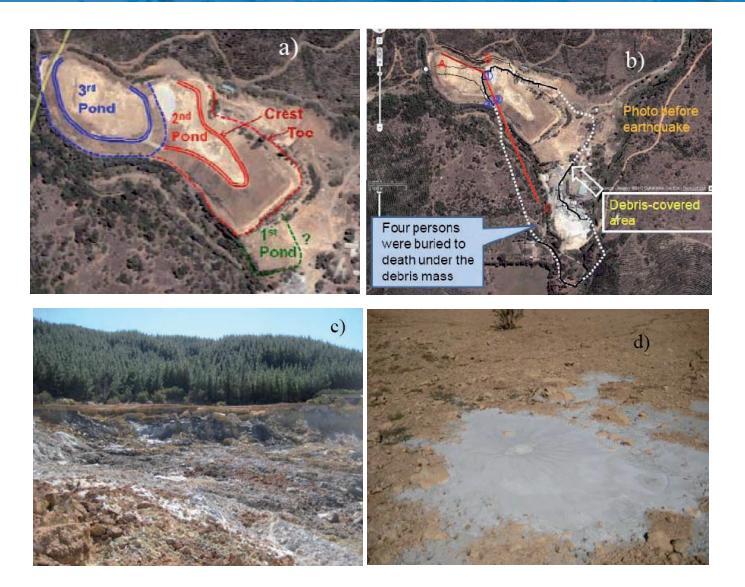
Liquefaction of mine tailings occurred at Las Palmas near Curicó, Veta del Agua, and La Florida. The authors were able to inspect the significant damage at Las Palmas. Las Palmas is located in the coastal mountain chain of central Chile. This tailing reservoir was used as a deposit of a gold mine wastes between the years 1981 and 1997. Figure 11a shows an aerial view of the abandoned Las Palmas tailing dam where it can be observed that it is not really clear whether there was or not a dam or a wall to retain the tailings. It seems that ponds were extended forward as a plateau without being impounded. Figure 11b shows in dashed lines the area covered by the debris after the tailing flow failure (Figure 11c). Water and liquefied tailings erupted from many cracks at the surface as shown in Figure 11d. On the debris hundreds of little volcanoes could be seen, indicating that once the material flowed and rested in a new lower position, liquefaction occurred probably due to excess pore water pressure still accumulated or due to aftershocks. The liquefied mine tailings flowed down about 400 m and hit a farmer's house, killing four people who were buried to death under the tailing mass (Figure 11b).

Figure 11: Las Palmas tailing dam: a) arrangement, b) geometry of the debris covered area, c) debris flow and d) isolated volcano on a pond

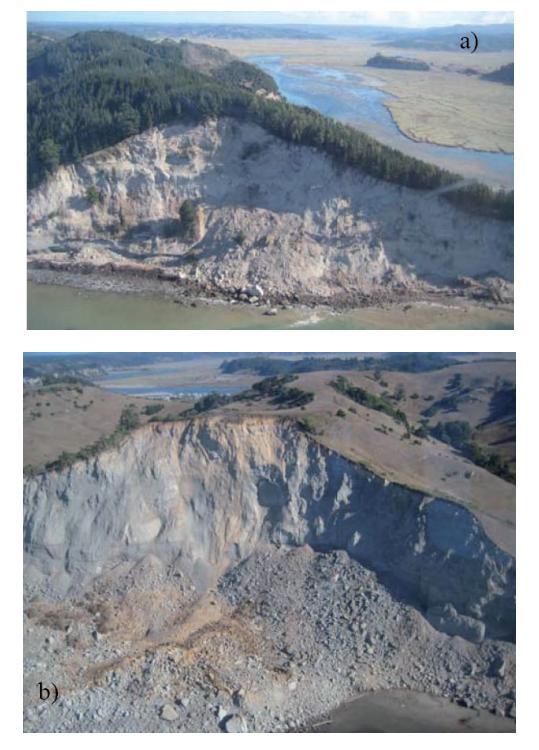
observations. For example, in Concepción (50 km north from Arauco city) horizontal displacements between 3 and 4 m and uplifts in Punta Lavapié of around 2 m have been estimated (Barrientos 2010). It is believed that landslides were triggered not only by the strong cyclic motion but also by the lateral (towards the trench) and vertical (uplift) displacements of the earth crust. Further research is needed to understand the effect of coupling of this complex shaken plus pushing and uplifting on seismic slope stability.

Figure 13: Landslides in coastal cliffs a) from the north and b) from the south of Tubul

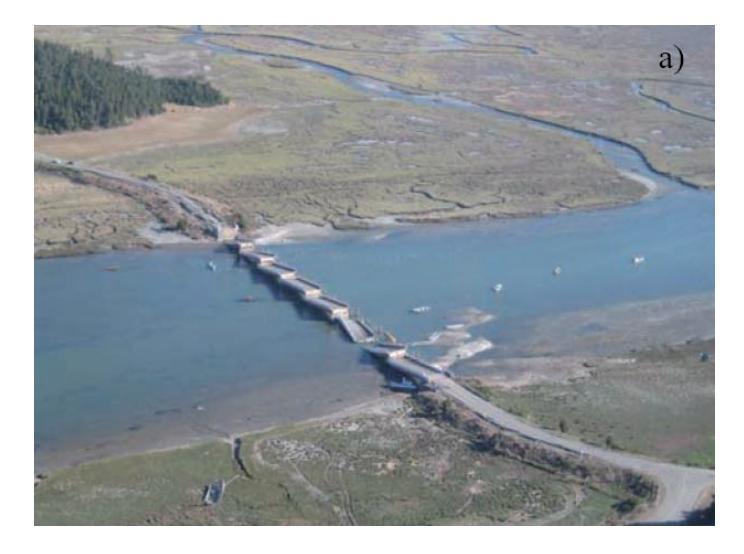
Figure 14 shows the complete collapse of Tubul Bridge. Tubul Bridge is the largest bridge of a series of three bridges located on the Raqui wetland. From the other two bridges of similar structural characteristics, Raqui I and Raqui II suffered complete failure of the embankment accesses, but only Raqui I did not have a deck collapse. These bridges had small and low reinforced concrete piers initially designed for a timber deck. Timber decks were later on replaced by high steel girders supporting reinforced concrete decks without making substantial changes to the piers. Since the bridges are founded on very soft and organic soils, it is believed that a significant seismic amplification took place during the earthquake inducing large displacements. The pier small area where the girders were resting was unable to cope with large and mainly horizontal displacements, although the collapse of the girders was probably eased by vertical displacements as well.

Figure 14: Tubul Bridge a) aerial view showing complete deck collapse and b) failure of bridge access

Possible solutions to avoid this type of collapse need to be carefully studied owing to the very poor quality of the foundation soil in conjunction with strong seismic events. Soil improvement techniques for the embankments have to be considered reaching a deep enough depth into the organic soil. There are methods such as gravel or sand compacted columns, chemical or cement injections can also be considered as well as solutions using geosynthethic materials. Piers should be enlarged to allow girders to move without falling from the pier.

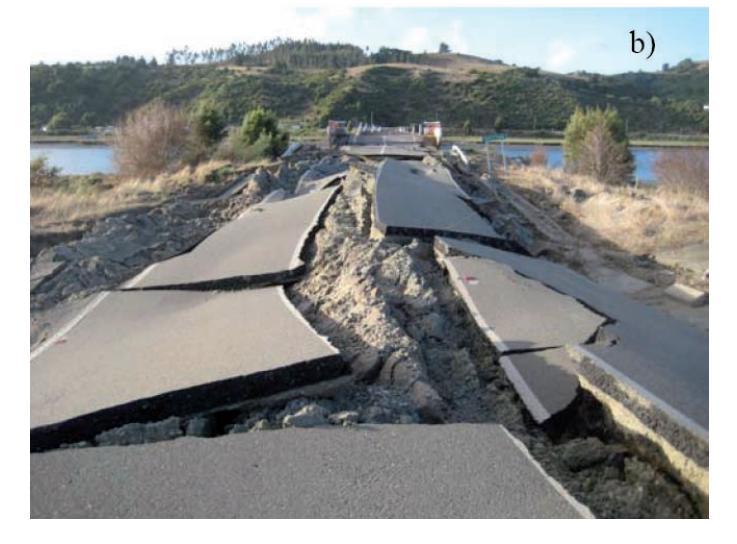
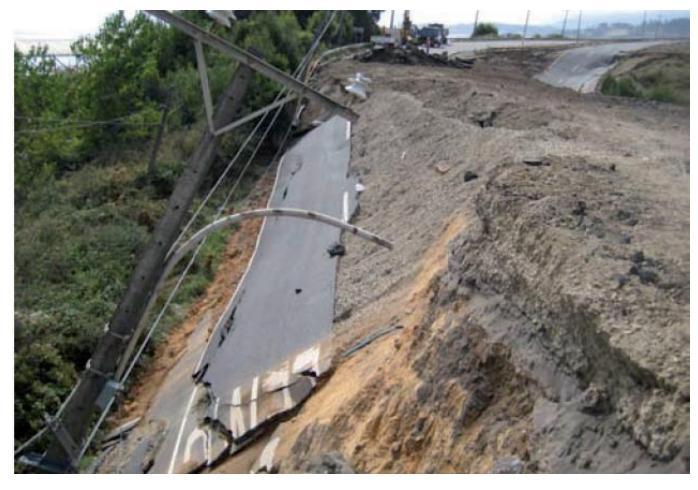
Figure 15 shows the collapse of the road embankment which is the access to the town of Lota. This 16 m high embankment had originally only one road with two carriageways. In the beginning of the 90s a second road with two carriageways was added next to the original one. Both road embankments were founded on a soft soil, saturated the whole year. For that reason the embankment slid over both side of the road destroying completely the asphalt road and everything around. Even assuming a good quality of compaction of the embankment fill, this did not avoid a highly likely amplification of the seismic waves. Since the soil where the embankments were founded corresponds to a saturated, soft and low permeability soil, non dissipated excess pore pressure generated during the earthquake reduced the undrained shear resistance of this soil. This resulted in the development of failure surfaces over where parts of the embankments slid. It is also believed that the contact surface between the old and newer embankment may have acted as a sliding surface too.

Figure 15: Road embankment collapse at the entrance of the town of Lota2
