# Geo-engineering Reconnaissance of the 2010 Maule, Chile Earthquake

Report of the NSF Sponsored GEER Association Team

# GEER Association Report No. GEER-022

Version 2: May 25, 2010

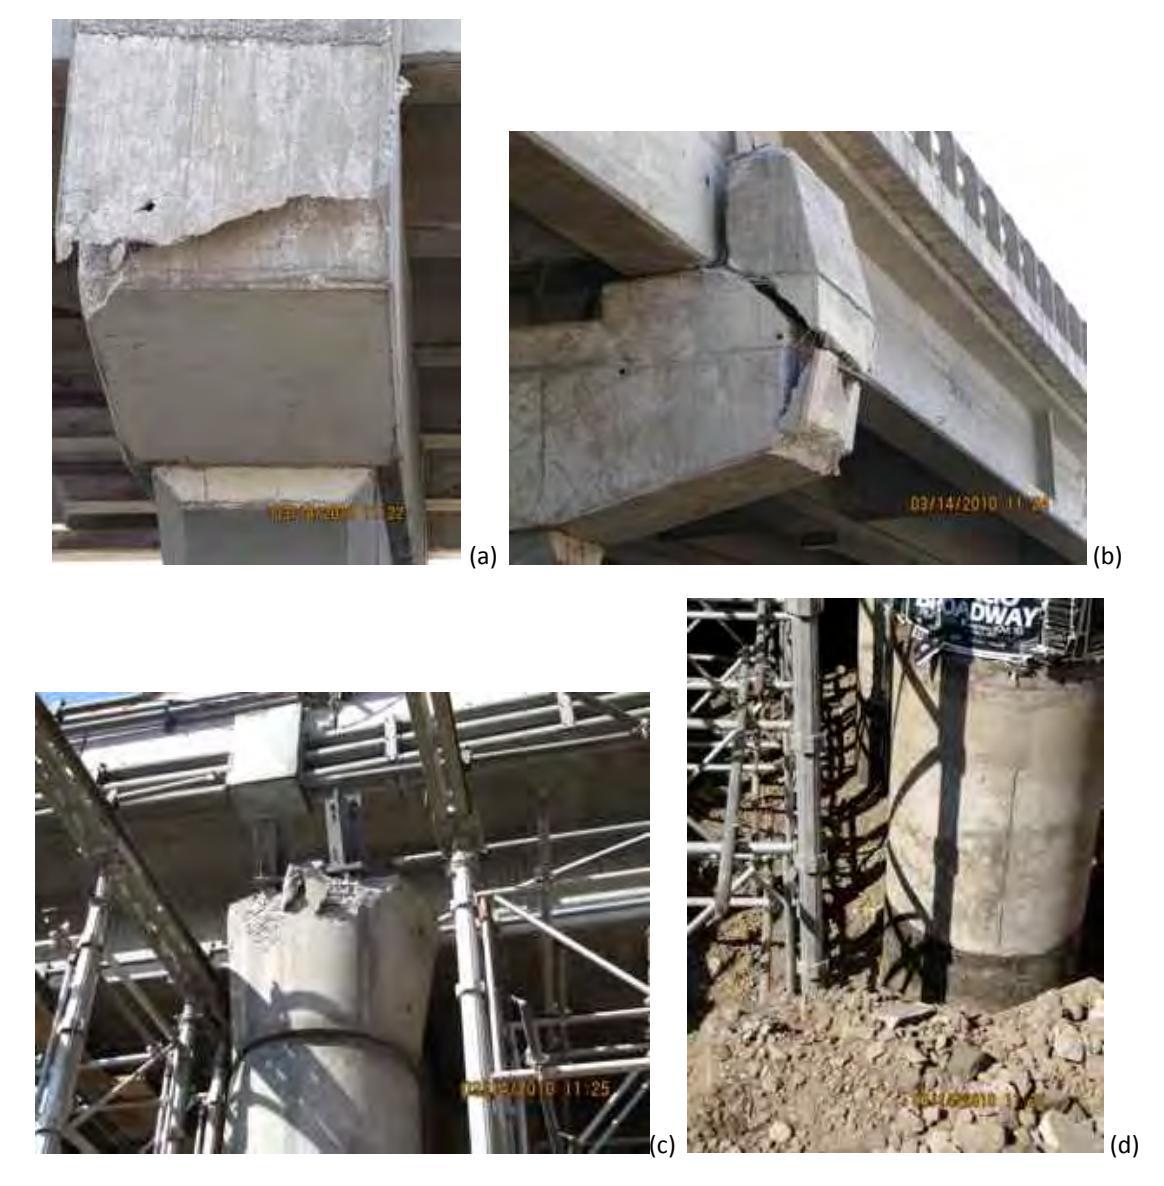
The bridge suffered repairable structural damage, characterized by shear key failure as shown in Figures 5.5a and 5.5b below. Longitudinal and transverse deck movement was also documented, leading to joint damage between the deck segments (Figure 5.5c). The two pile-diameter-deep excavation shown in Figure 5.5d, revealed no foundation failure. According to the local geology map, the soil profile at the site is clay and silty clay.

Figure 5.5. Paso San Martin (S33.3660° W70.6891°, 1122 hrs on 03/14/2010). Shear key failure and longitudinal, transverse deck displacement.

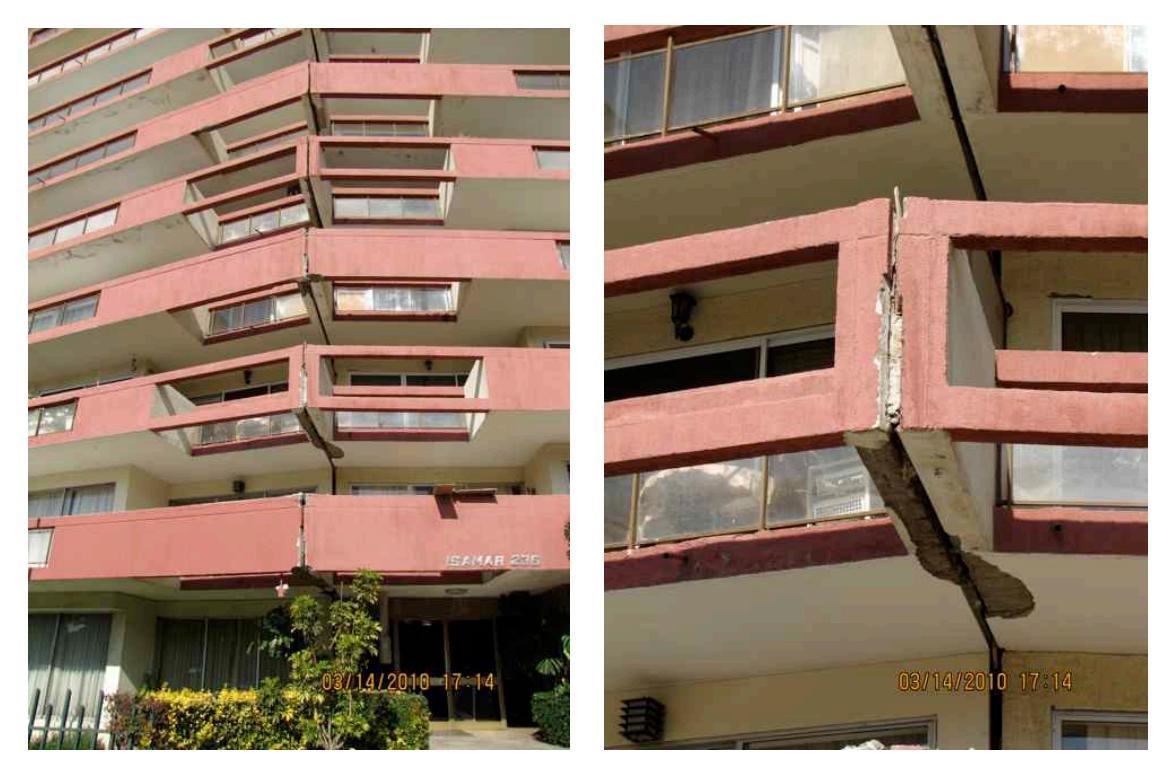
Figure 5.22 Site DA017 (S 33.018904° W 71.559206°, 1714 hrs on 03/14/2010) Damaged 9-story building.

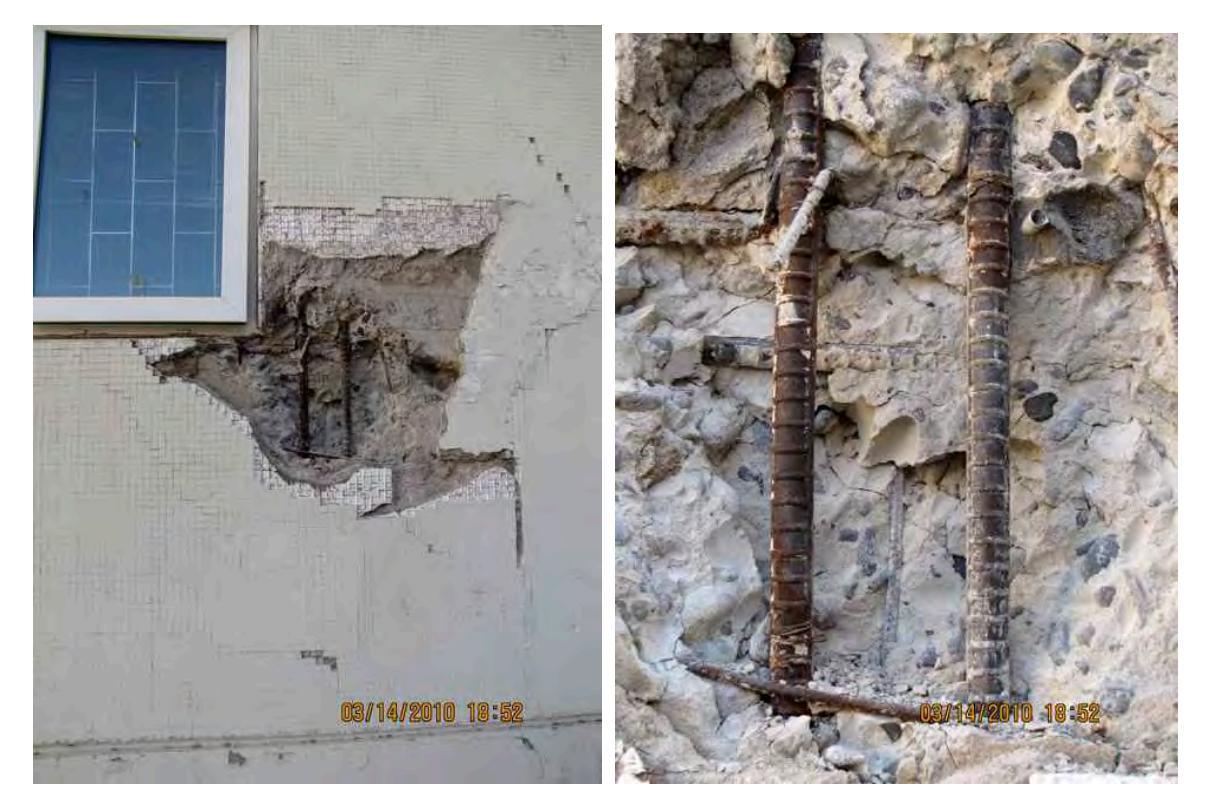
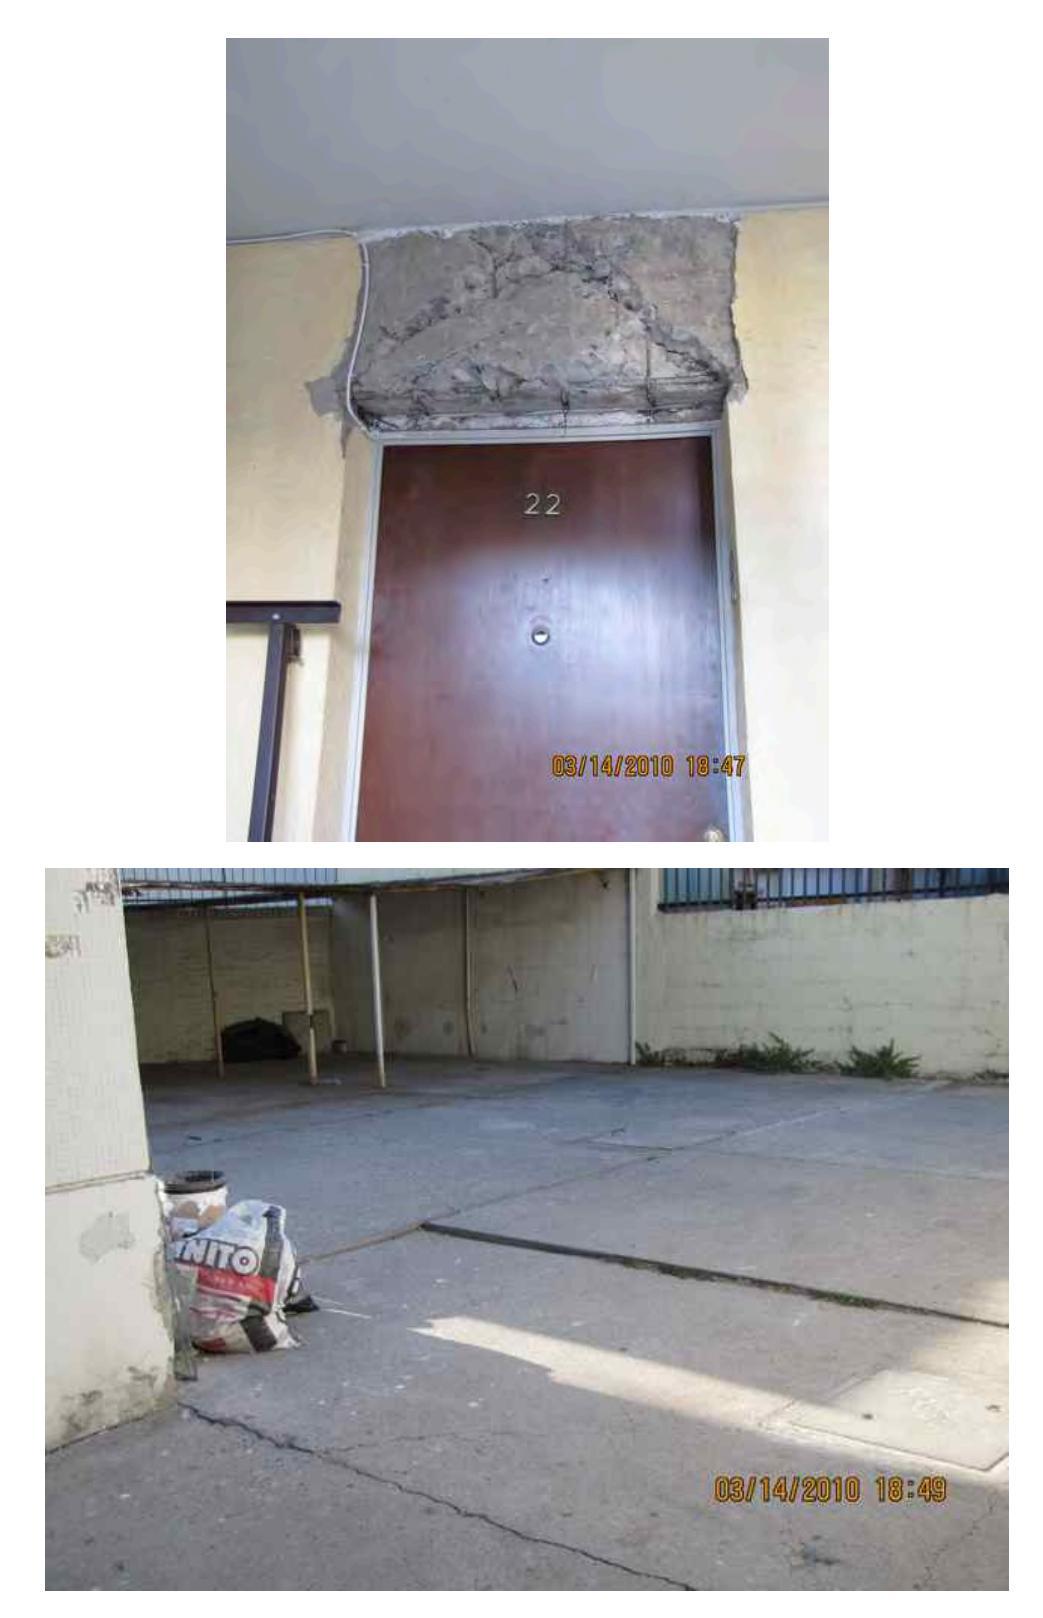
Figure 5.23. Site DA018 (S 33.017386° W 71.557107°, 18:48 hrs on 03/14/2010) Damaged 6-story building. Evidence of ground settlement.

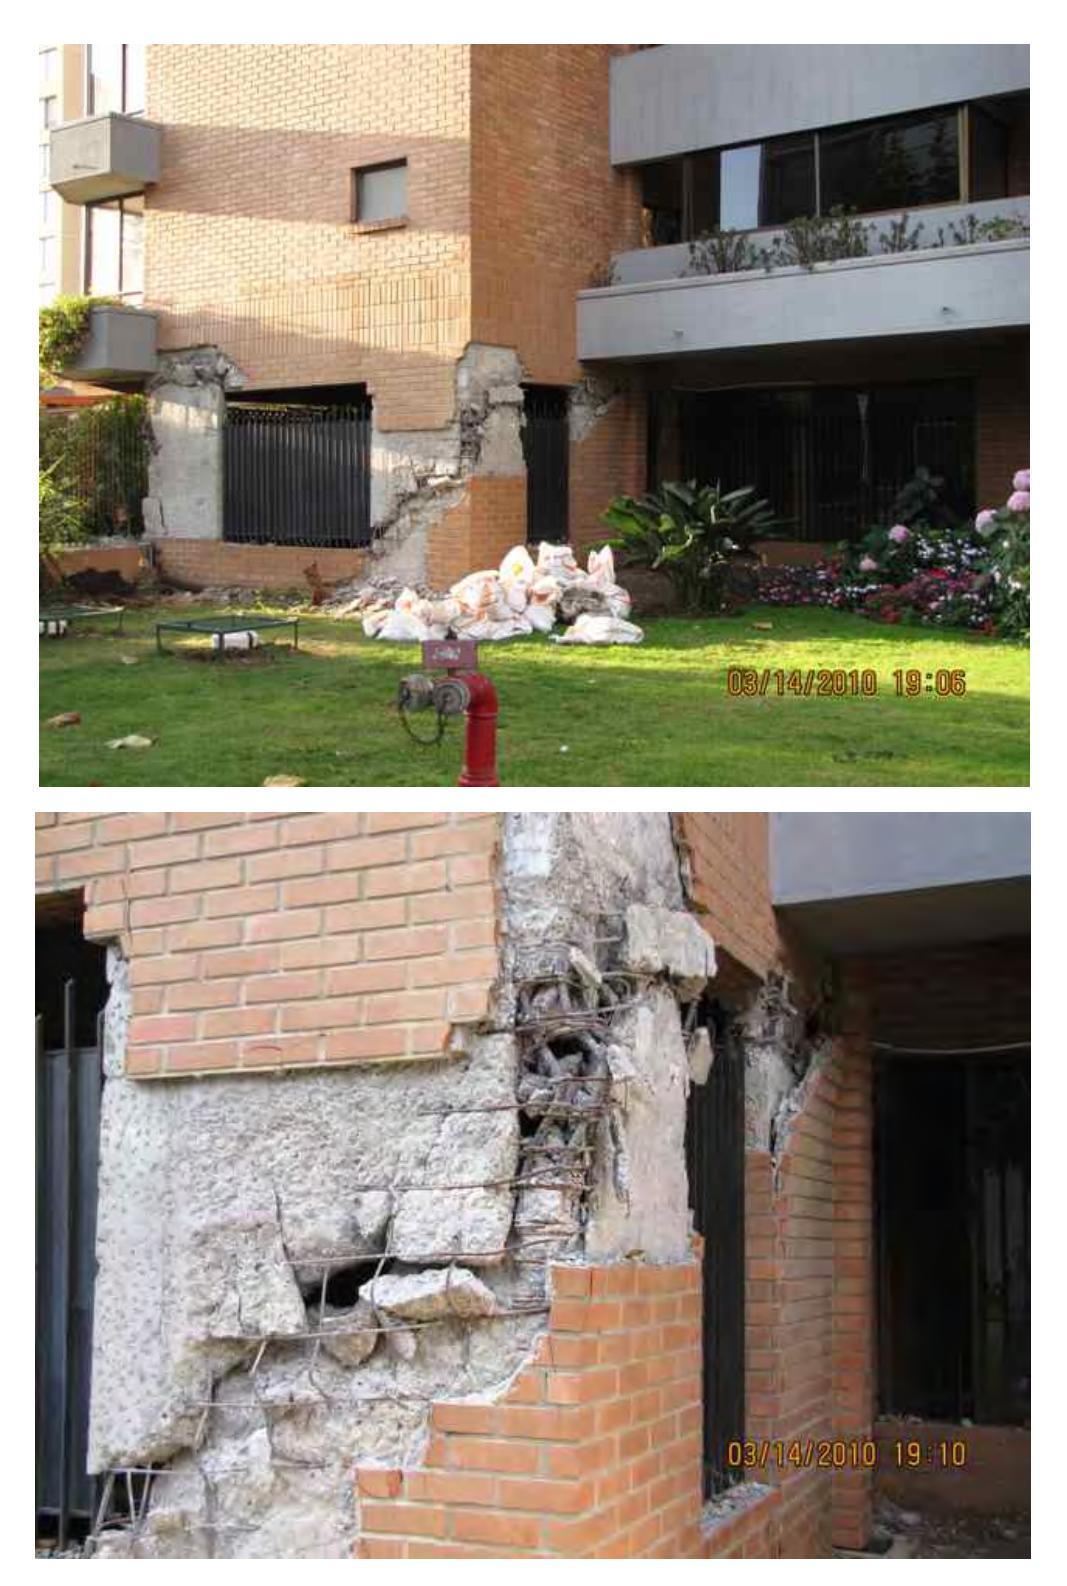
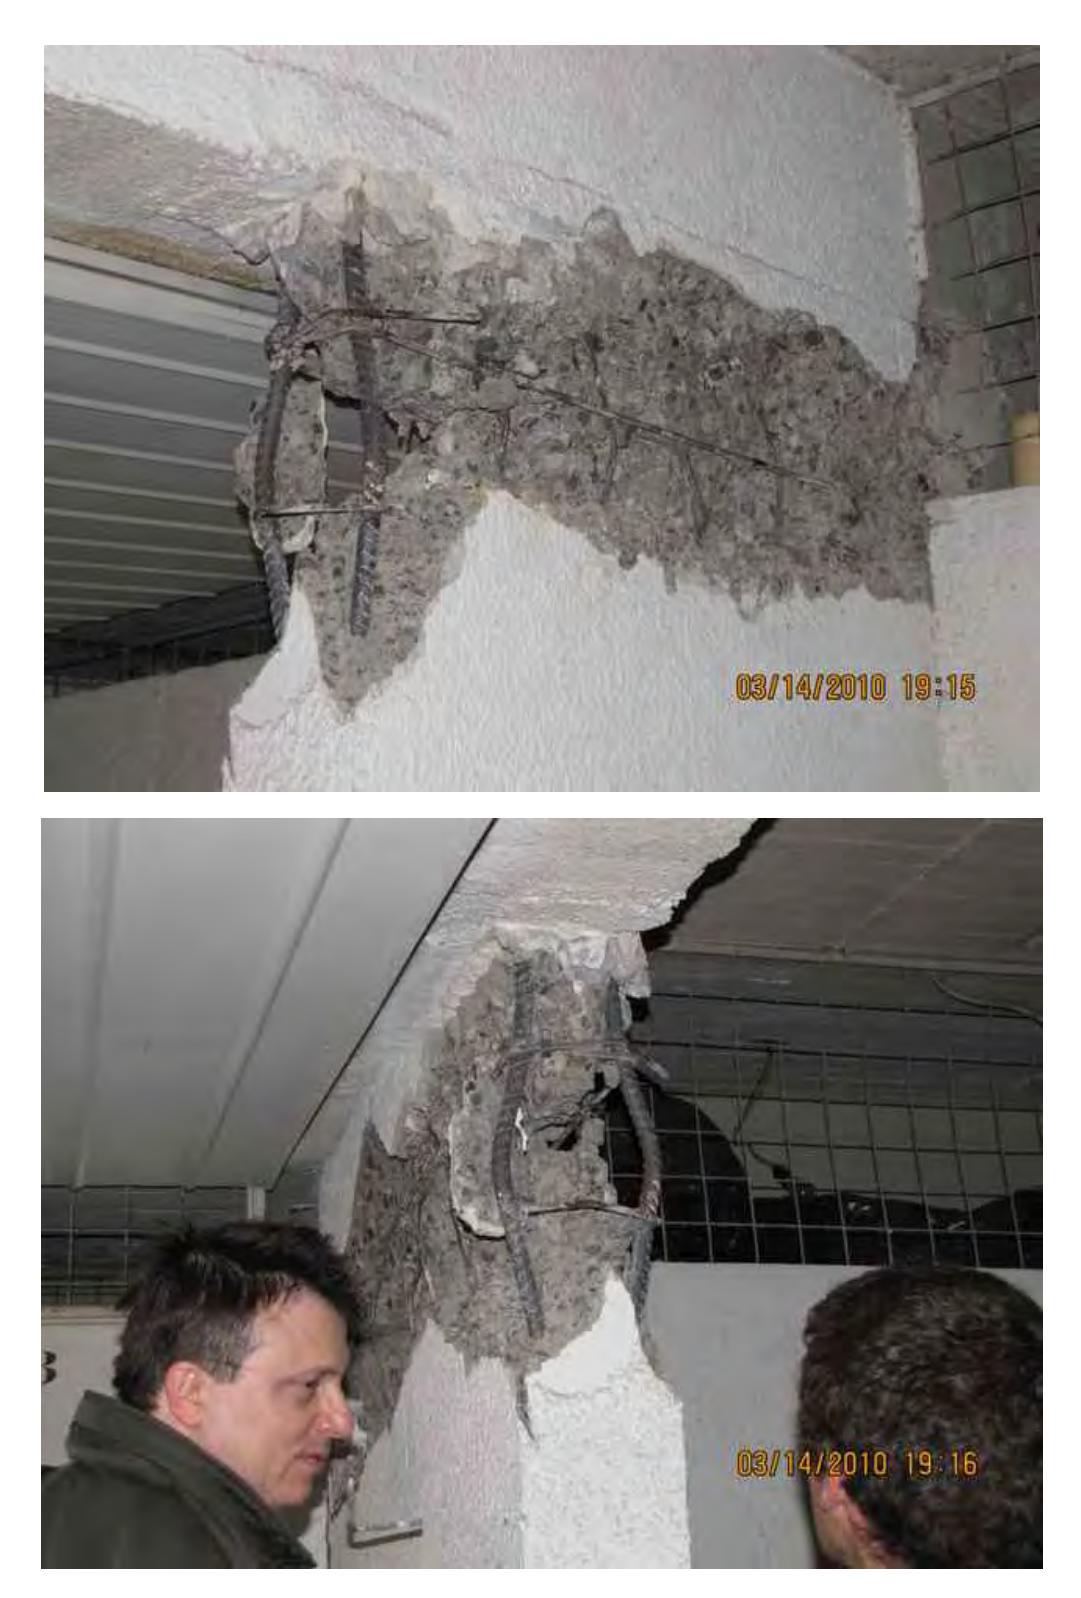
Figure 5.24. Site DA019 (S33.016045° W 71.551990°, 1916 hrs on 03/14/2010). Damaged 10-story building. Lack of confinement beam-column joints and low quality concrete.

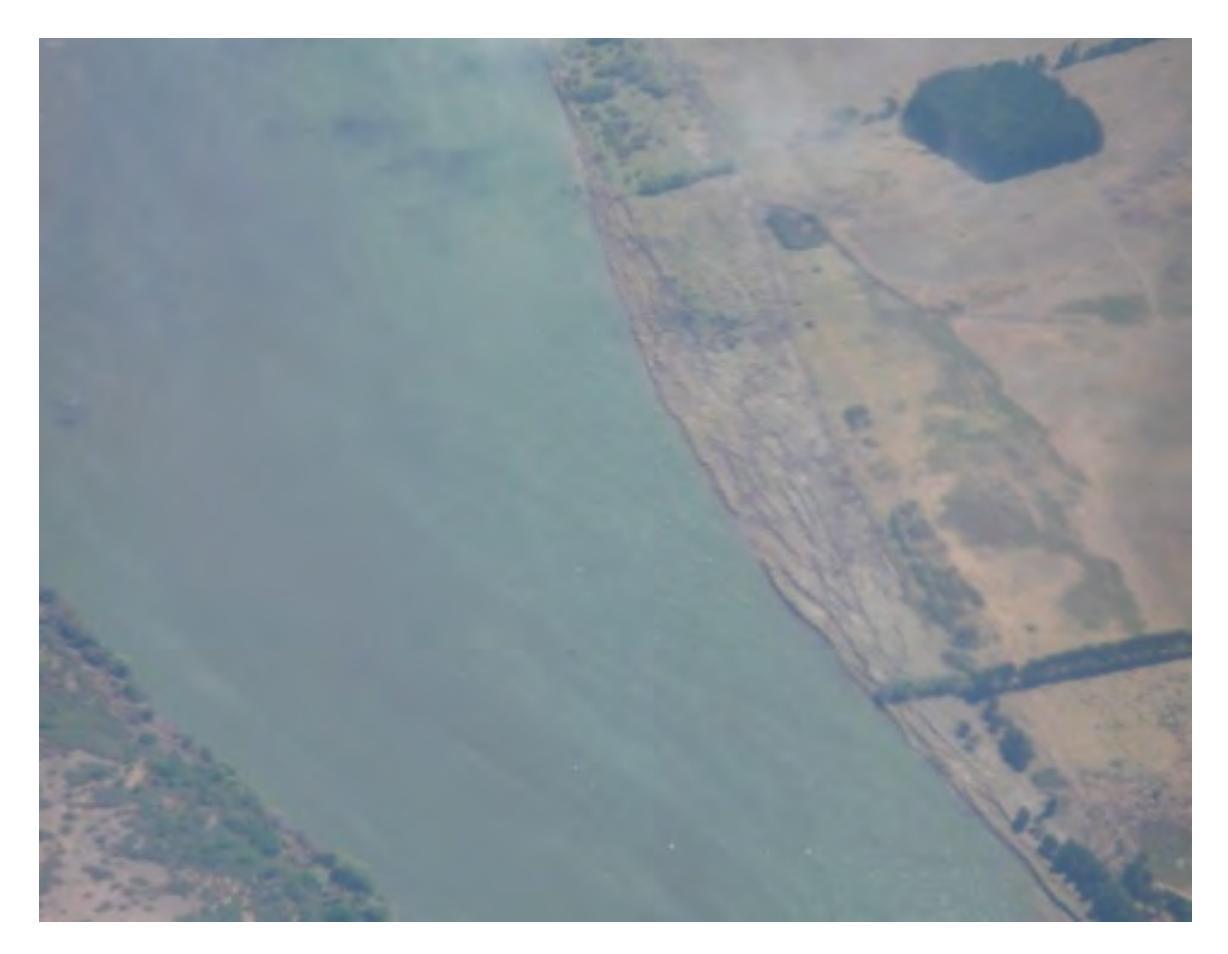
Figure 6.3. Lateral spreading feature observed along Rio Maipo towards the northern extents of damage (S33.9913° W71.5316°, 12:30, 3/6/2010).

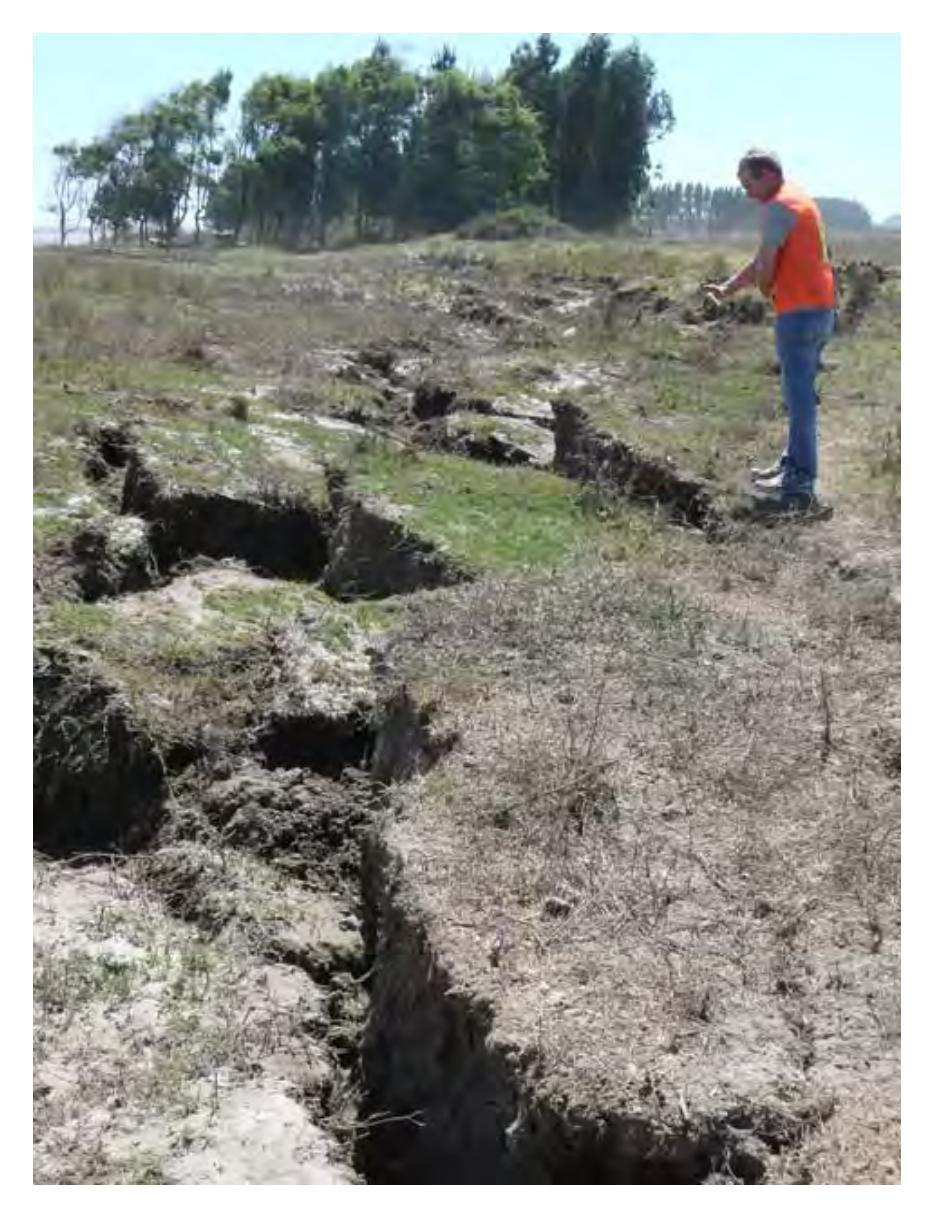
Figure 6.6. Lateral spreading blocks translated and rotated towards the river. This picture shows Keith Kelson standing on the north bank of the Mataquito River downstream of the coastal highway bridge (S3505078°, W72.16240°, 11:00, 3/8/2010).

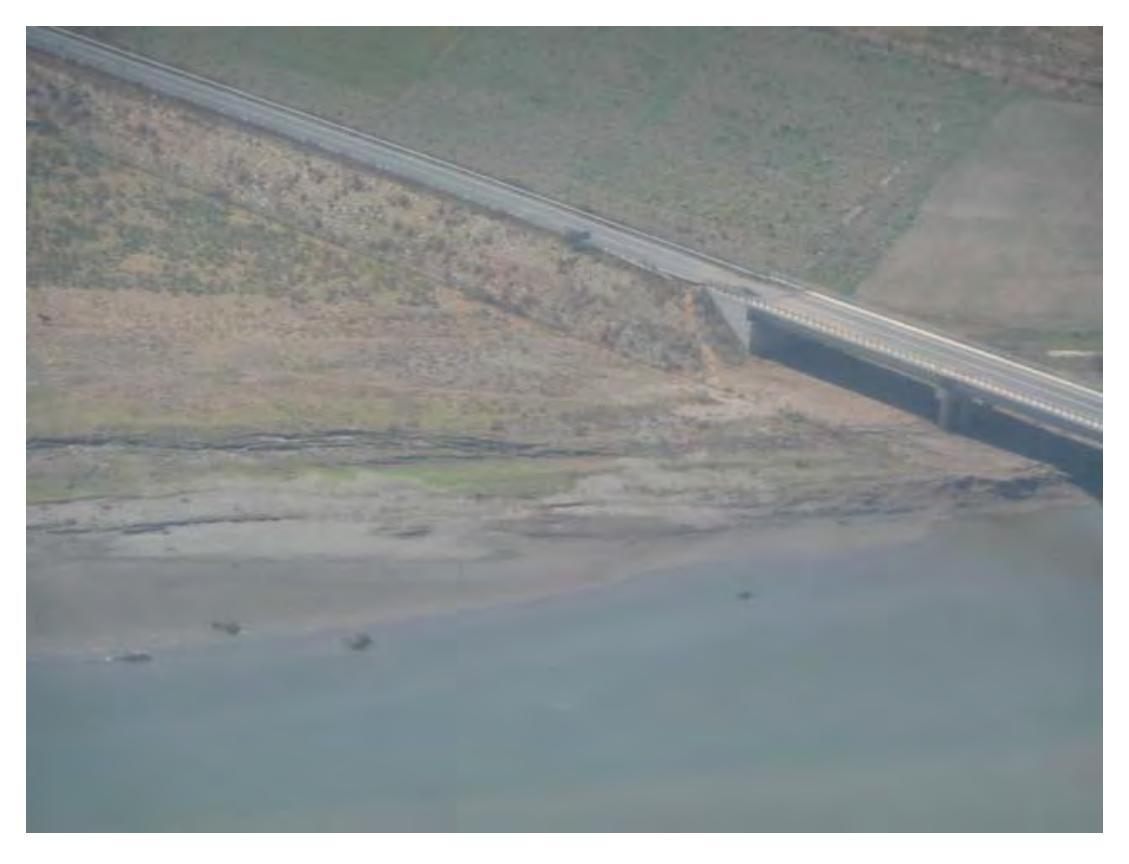
Figure 6.10. Lateral spreading on the north bank of the Mataquito Bridge along the coastal highway (S3505078 $^{\circ}$ , W72.16240 $^{\circ}$ , 11:00, 3/10/10).

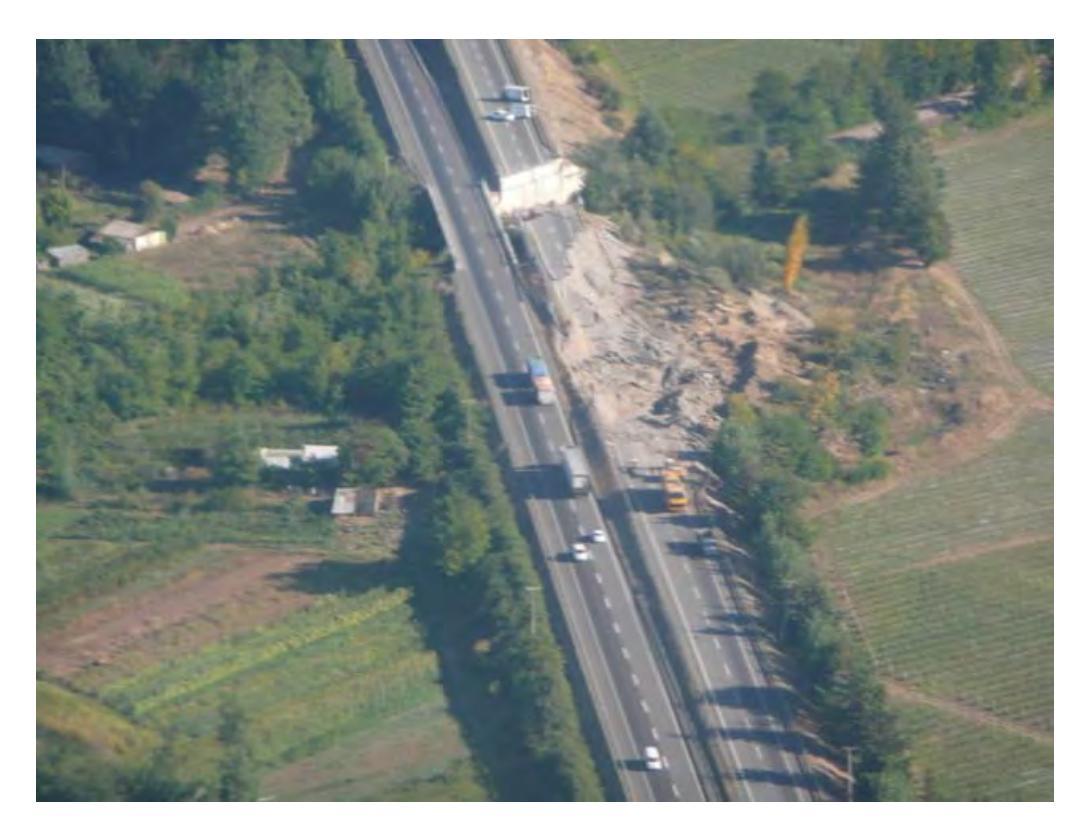
Figure 6.16. Typical road base failure along Pan American highway. Line of trees show where the water crossing intersects the highway. These type of road failures were observed at regular intervals corresponding to the minor water crossings. This picture is from near the town of Curico (~S34.7794°, ~W71.1599°, 17:30, 3/6/2010).

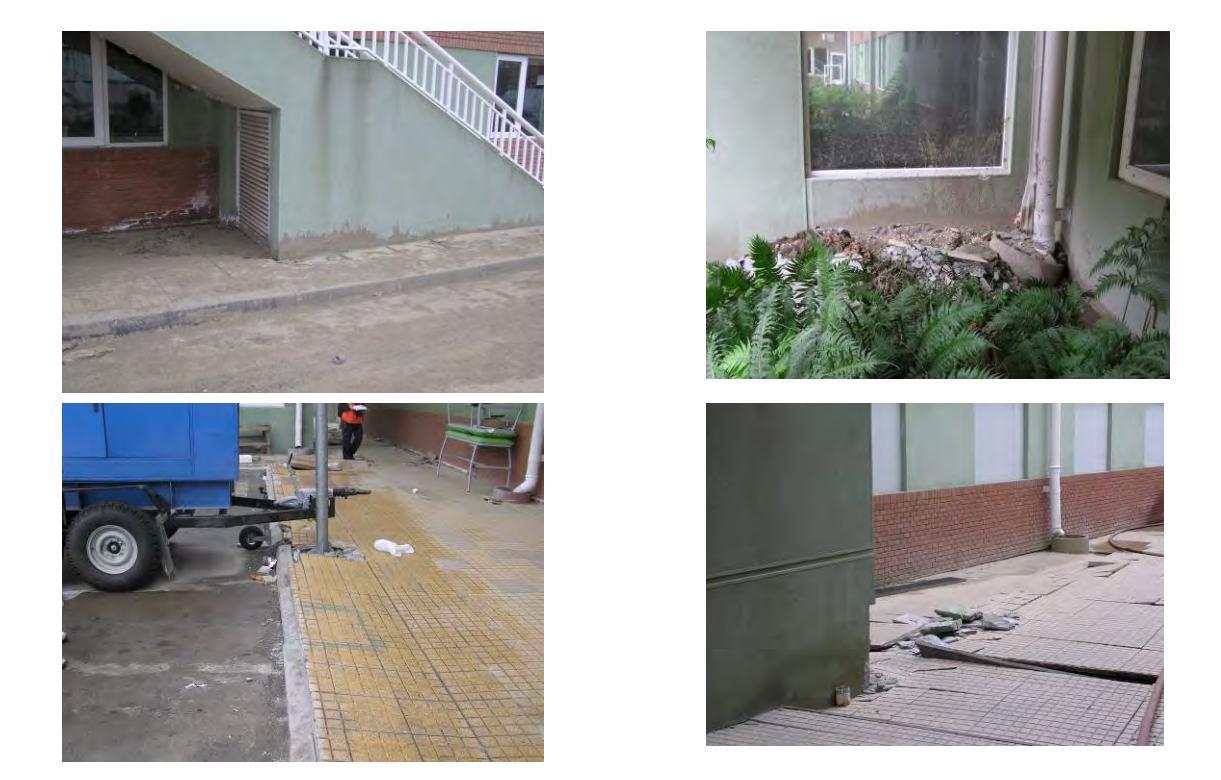
Figure 7.7. Sediment ejecta observed around hospital wings; (a) ejecta observed along exterior staircase of Wing 1D (S37.47358°, W73.34890°), (b) ejecta observed along exterior of Wing 1C (S37.47342°, W73.34829°), (c) ejecta observed along south side of Wing 1D(S37.47375°, W73.34851°), and ejecta observed along east side of Wing 2G (S37.47343°, W73.34738°).

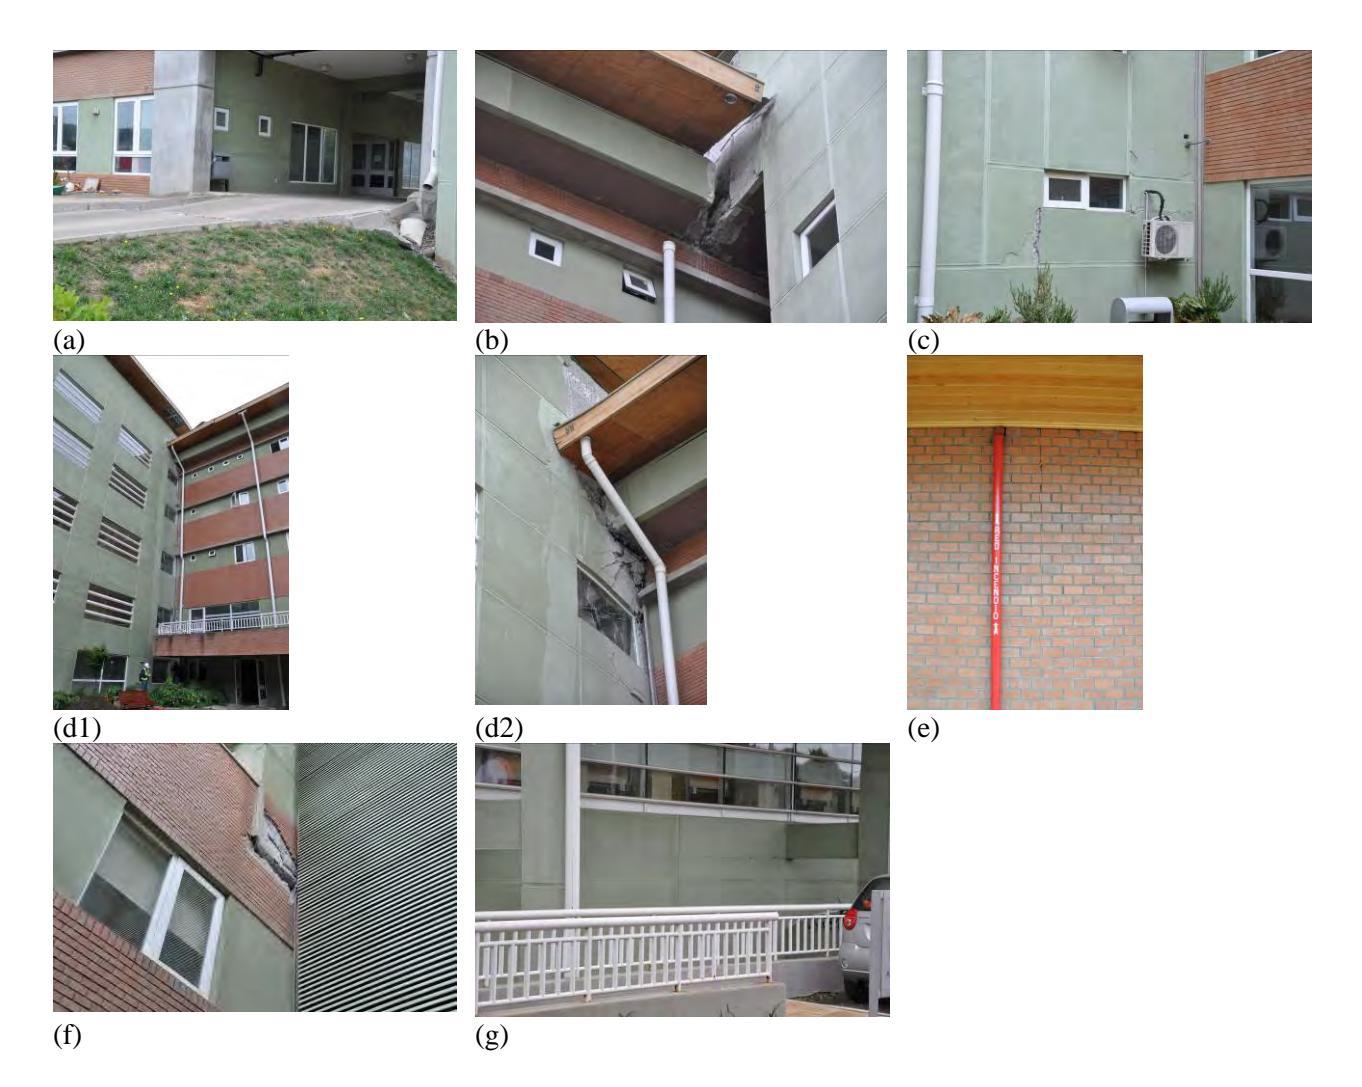
Figure 7.12 Most pronounced structural damage observations. (a) approach ramp to entrance bay at wing 1A (S37.473084°,W73.348712°), (b) pounding damage and resulting permanent gap developed between wings 1A-1C due to the easterly rocking of wing 1C (note the gap was measured by hospital staff as 37 cm after the main event on February 27, 2010) (S37.473376°, W73.348452°), (c) damage to shear wall of wing 1C due to contact with wing 1D (S37.473537°, W73.348488°), (d1) elevation view of the interface between wing 1B-1C and (d2) local view at the roof line of wing 1B observing the pounding between these two wings (S37.473406°,W73.348304°), (e) vertical cracks in masonry in-fill of wing 2H (S37.473713°, W73.347839°), (f) fallen masonry façade and spalling of structural wall of wing 1F due to impact with wing 1B (S37.473494°, W73.347948°), and (g) cracking damage at in-fill and structural shear wall interface at front of wing 2I-2J (S37.473528°, W73.347363°). Images taken at 1430, 1715, 1415, 1725, 1725, 1350, 1625, and 1645 hrs, respectively, on 3/16/2010.

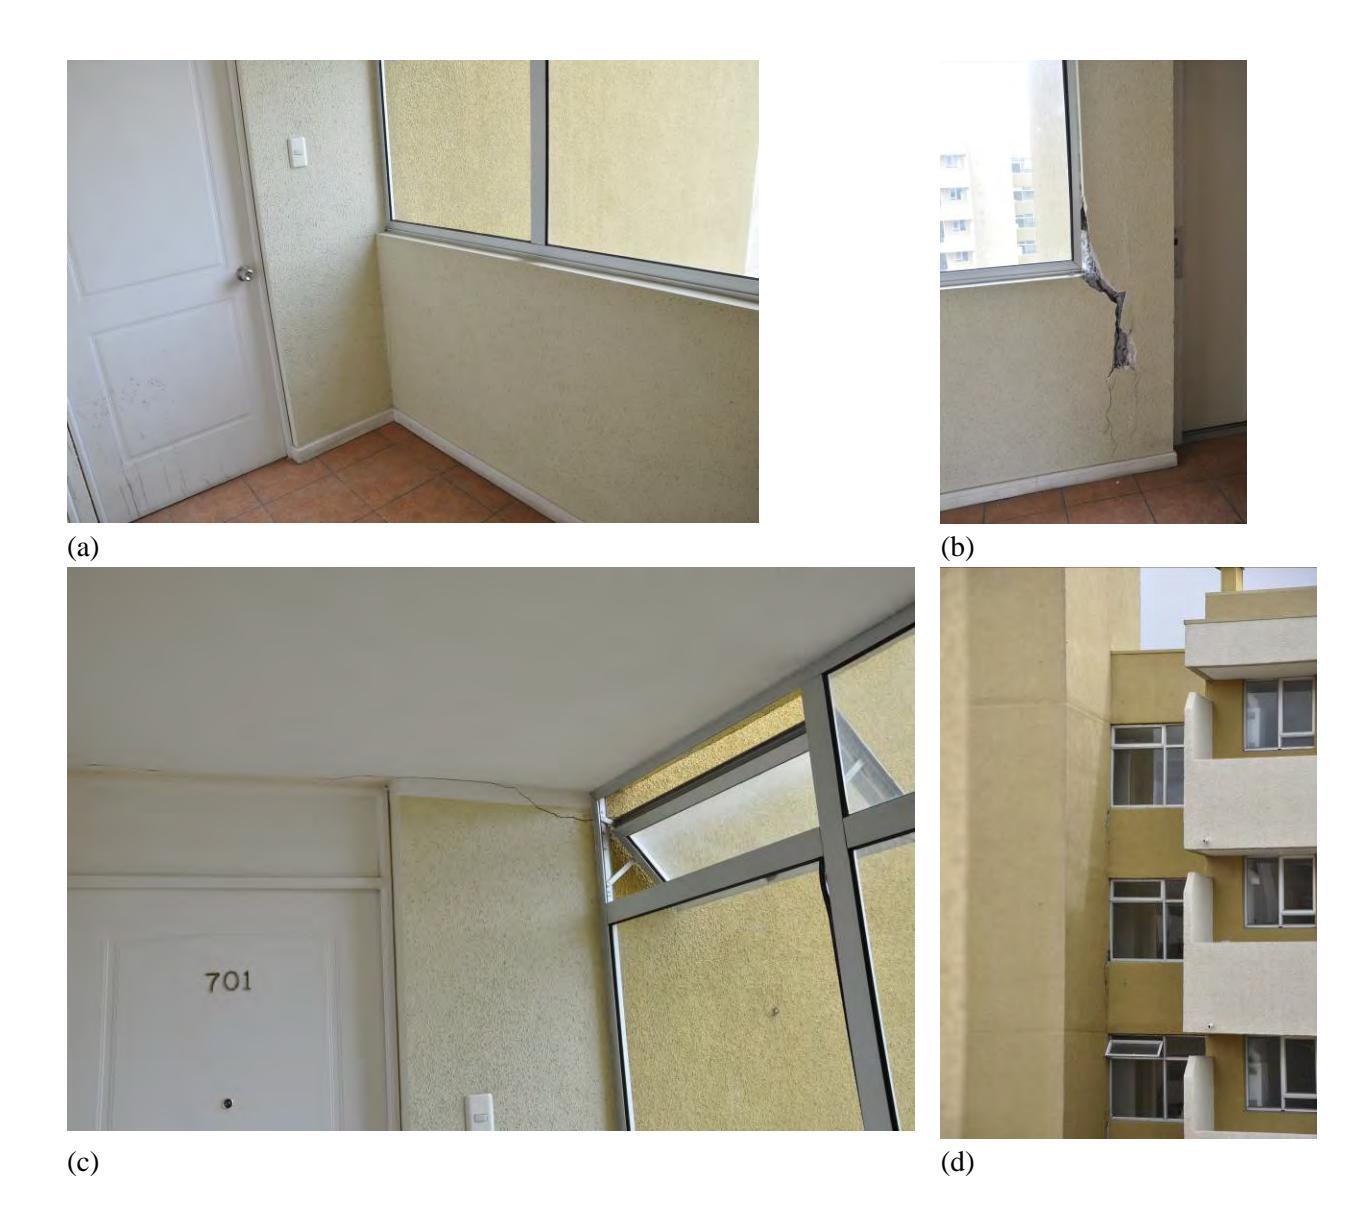
Figure 7.24 Observations at damage induced to the Riesco building due to liquefaction-induced movement of foundation. (a)-(c) at 7<sup>th</sup> floor of building; (a) left (north) end and (b) right (south end – at elevator shearwall interface), (c) ceiling-wall interface at end of coupling beam. Images taken at approximately S36.790867°, W73.081391°. (d) upper floor level coupling beam damage. Image taken at S36.791063°, W73.081043°. (images taken at 1430, 1430, 1430, and 1400 hrs, respectively on 3/17/2010).

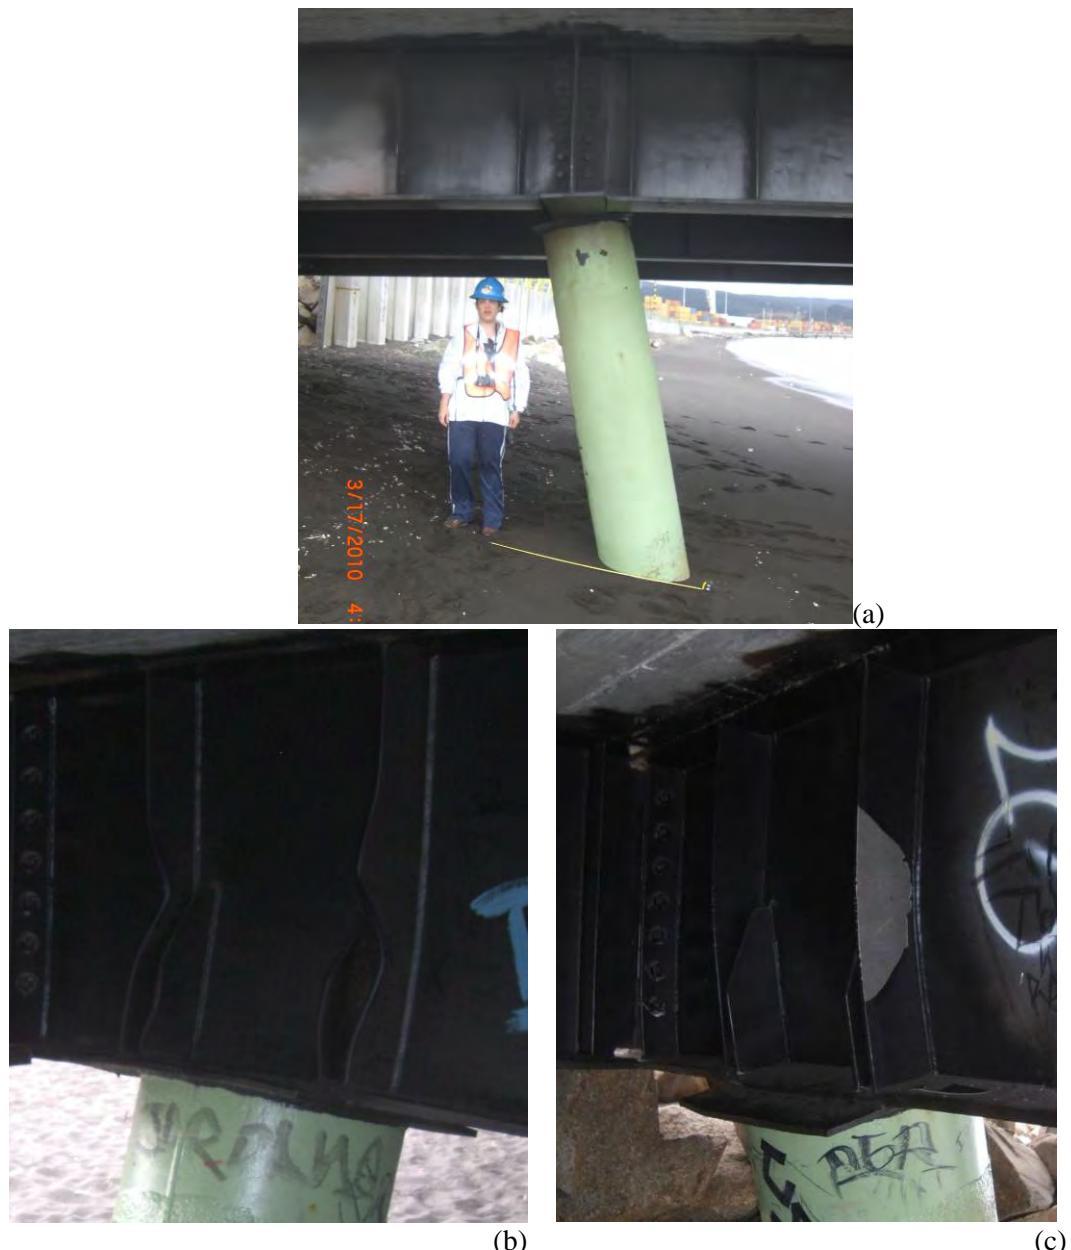
(b) (c) Figure 8.7. (a) Rotation of pile supported pier at Port of Coronel due to lateral spreading. The rotation of the pile led to (b) buckling and (c) yielding of stiffeners on connection beam (S37.0280°, W73.1508°; 1555 hrs, 03/17/2010).

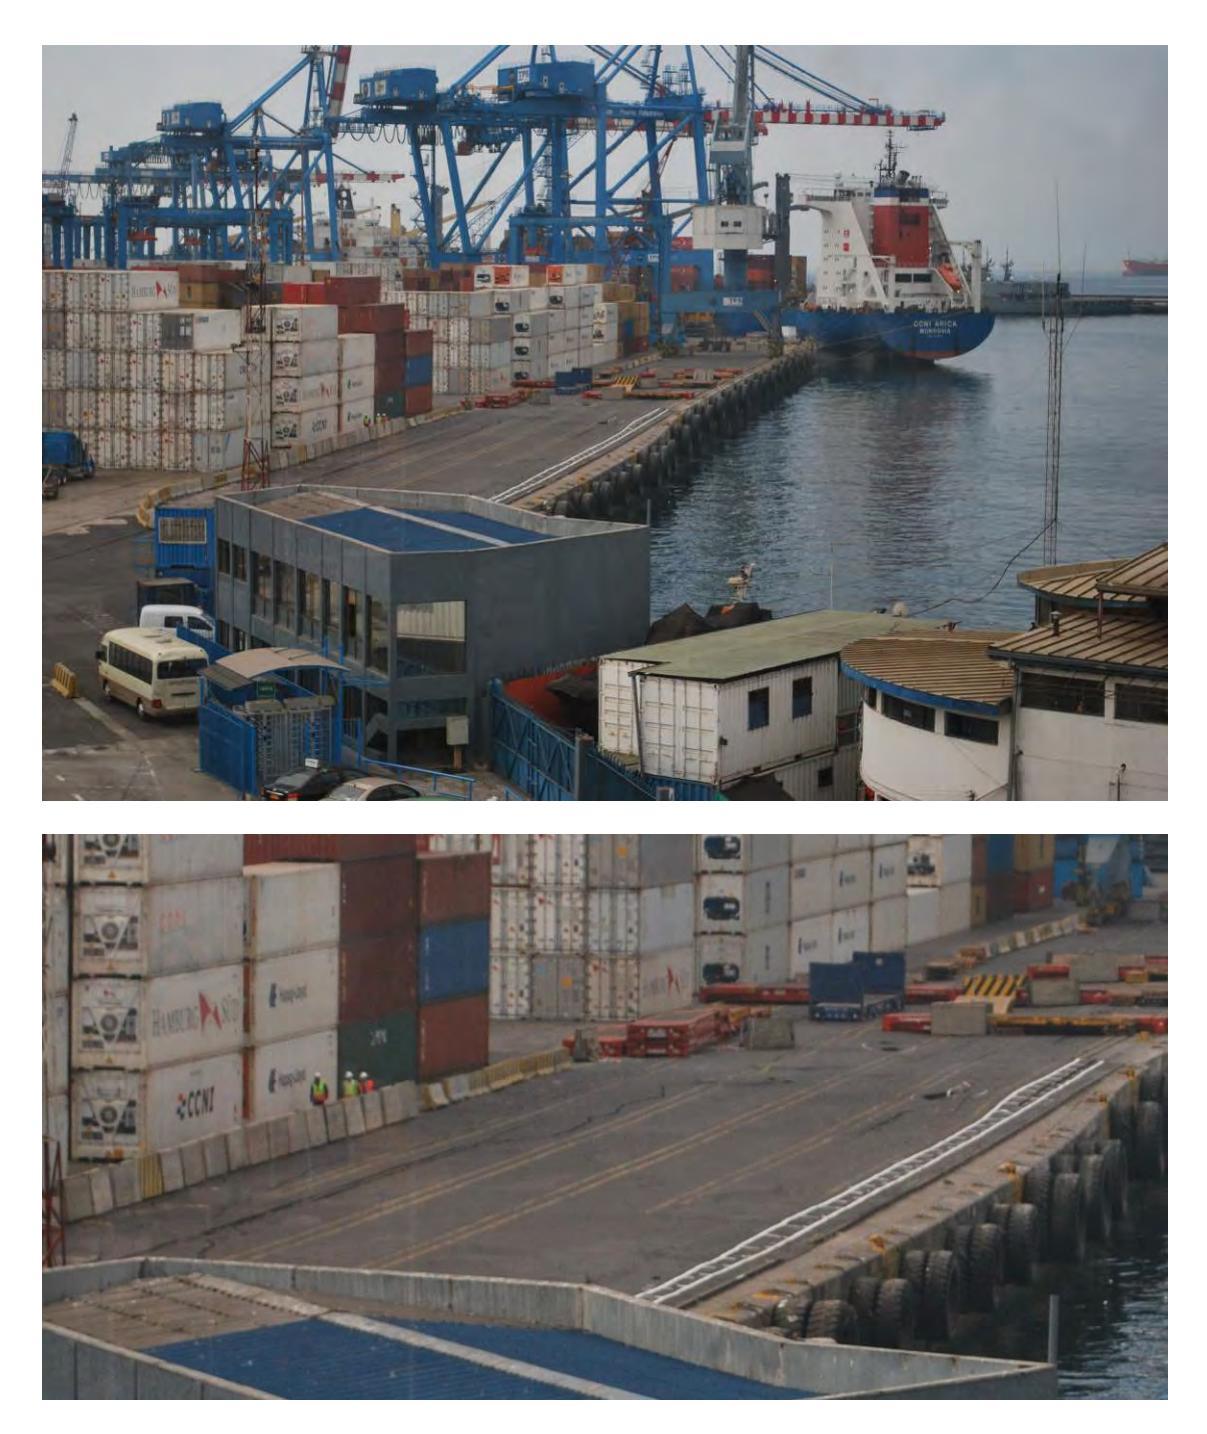
Figure 8.18. Outward movement of quay wall and asphalt pavement cracks at commercial dock of Valparaiso port (S33.036°, W71.628°; 1640 hrs, 03/15/2010).

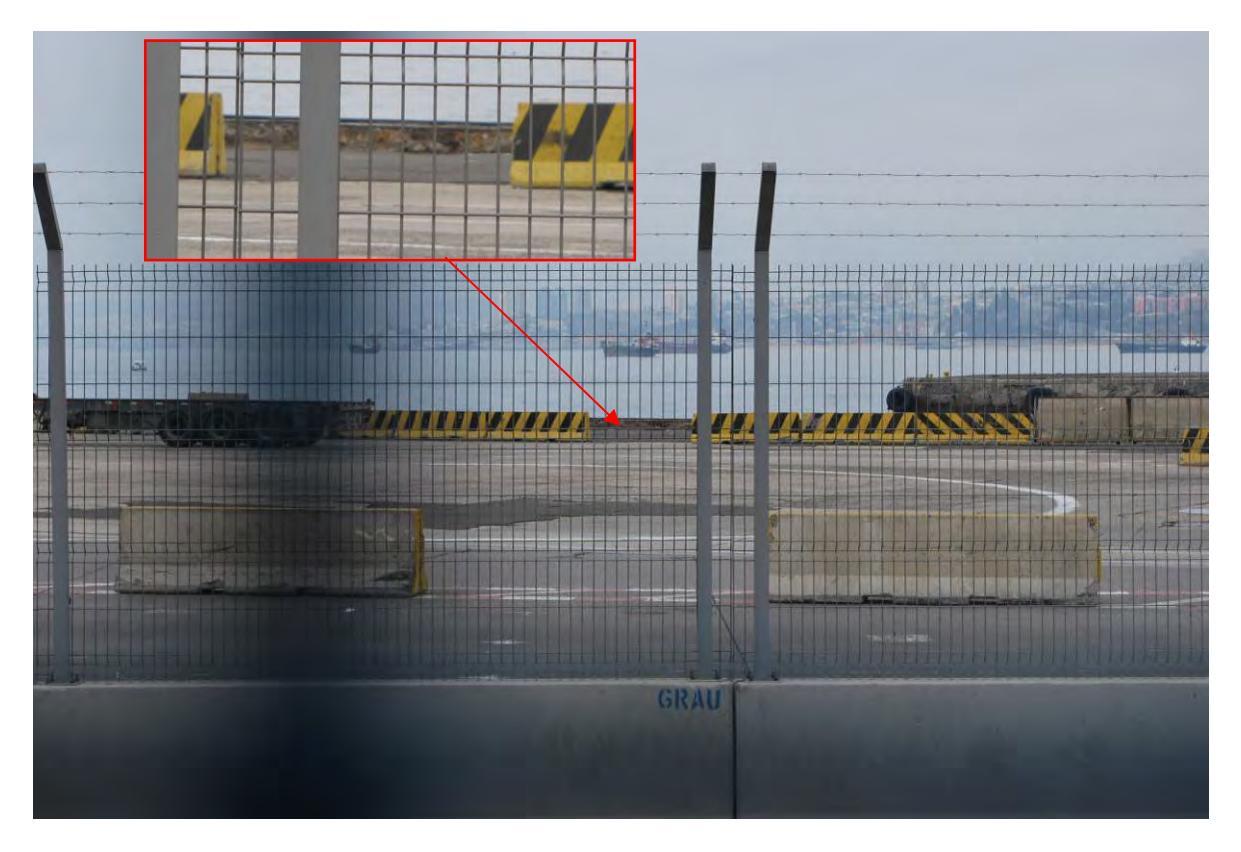
Figure 8.19. Settlement in backfill behind the quay wall at commercial dock of Valparaiso port (S33.034°, W71.627°; 1620 hrs, 03/15/2010).

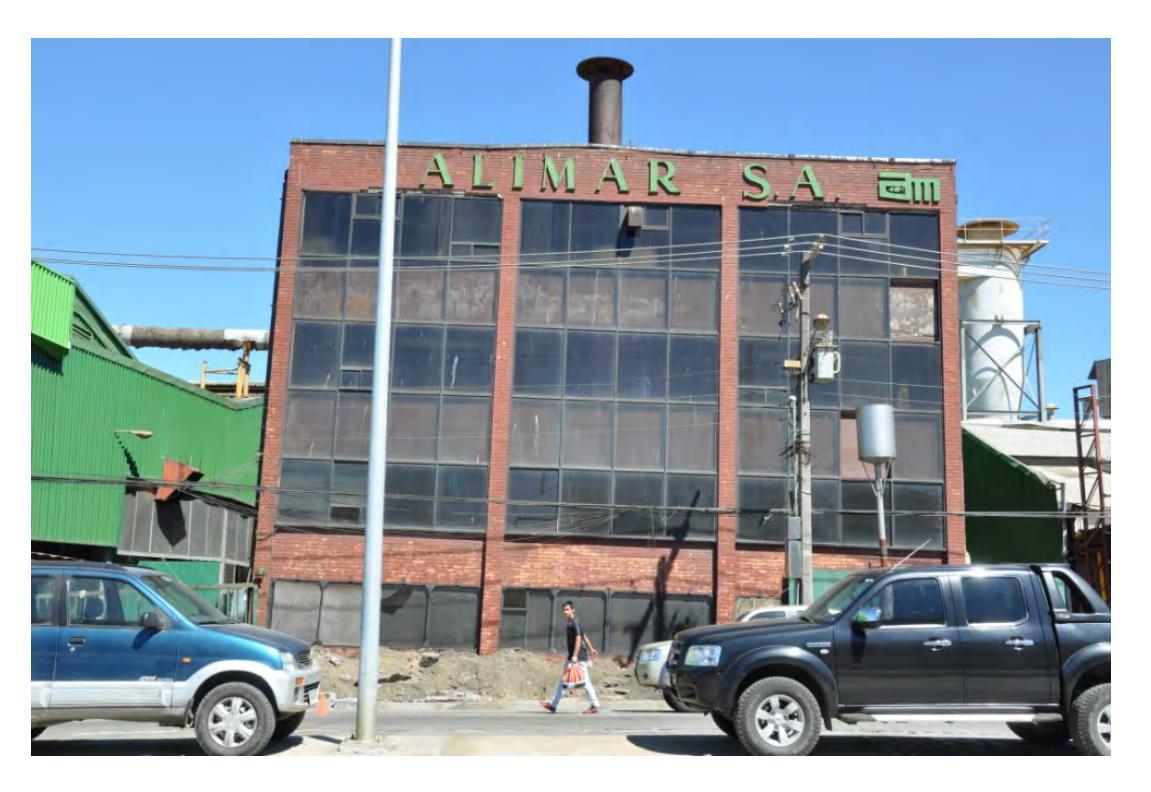
Figure 8.24. Damage to fish packaging facility (S36.7260°, W73.1288°; 1345 hrs, 03/15/2010).
