# Geo-engineering Reconnaissance of the 2010 Maule, Chile Earthquake

Report of the NSF Sponsored GEER Association Team

# GEER Association Report No. GEER-022

Version 2: May 25, 2010

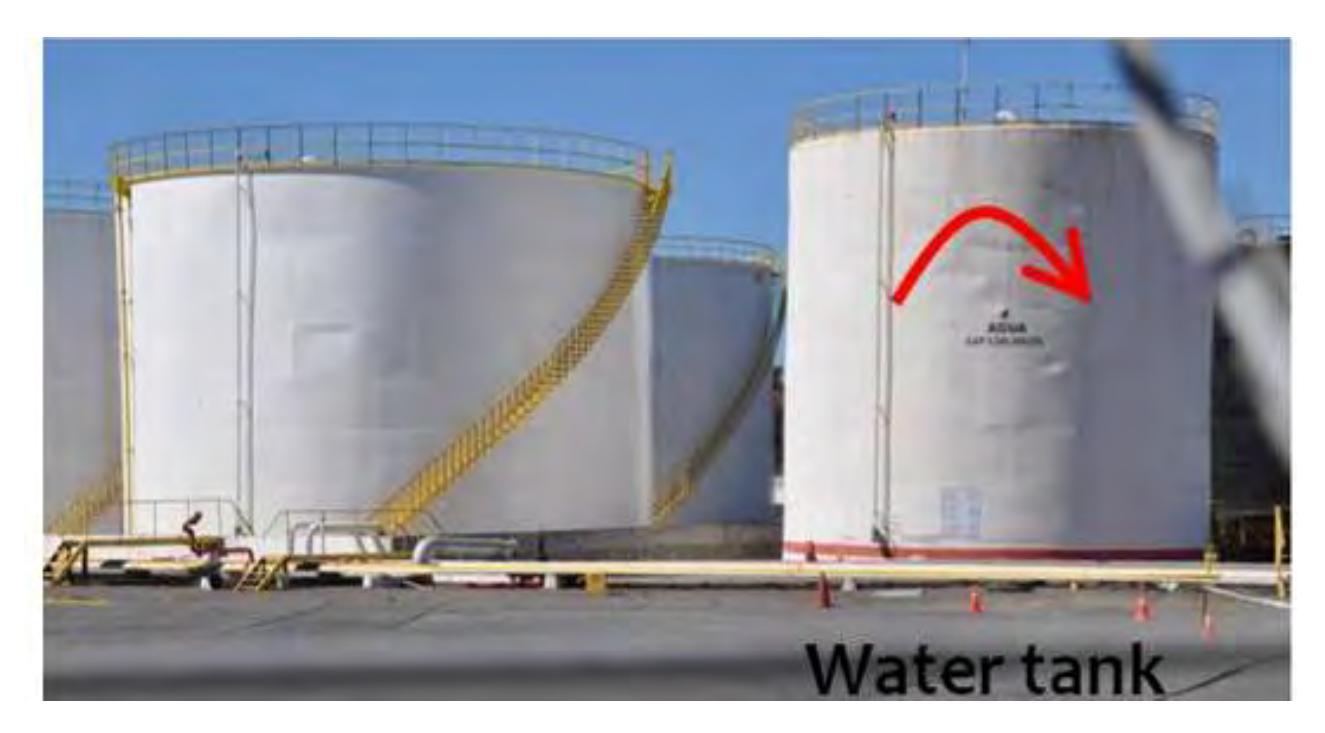
Figure 8.30. Tilted water tank at Petrobas gas facility (\$36.7270°, W73.1272°; 1250 hrs, 03/15/2010).

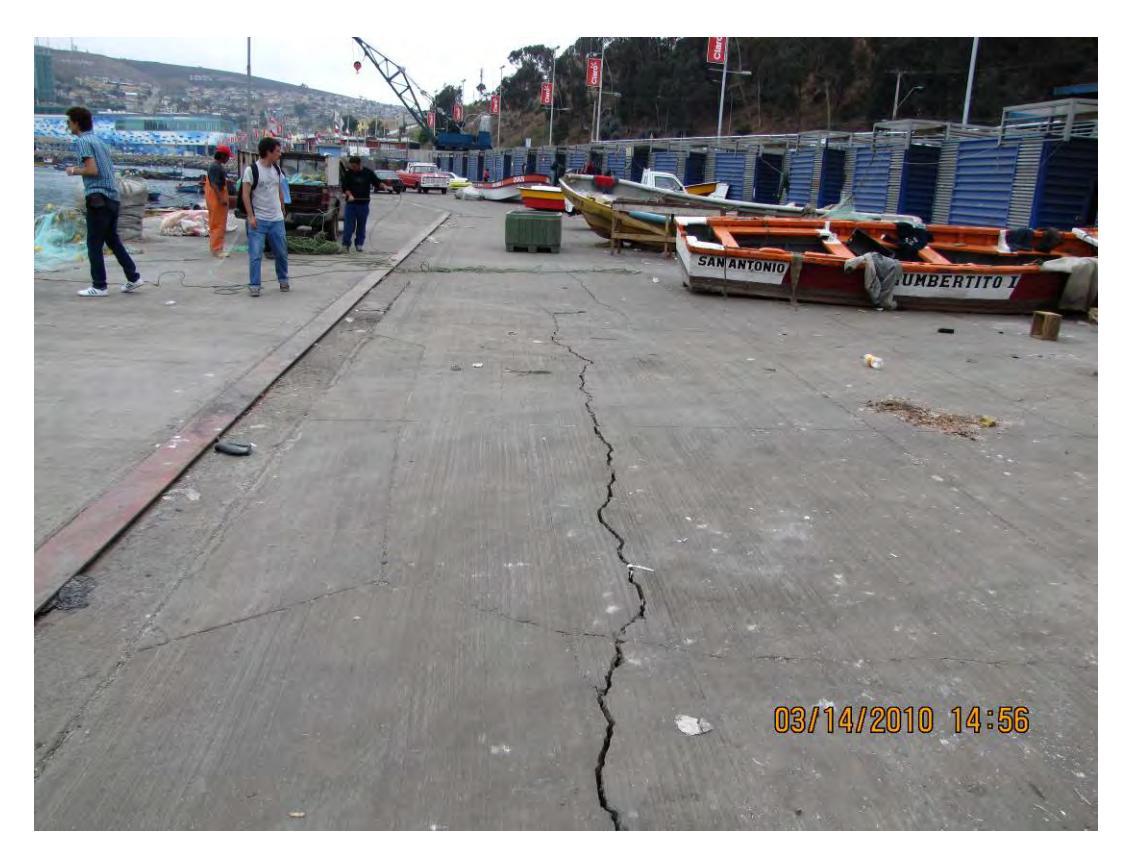
Figure 8.31. Cracks on asphalt pavement behind quay wall in San Antonio Port (S33.5870°, W71.6132°; 1456 hrs, 03/14/2010).

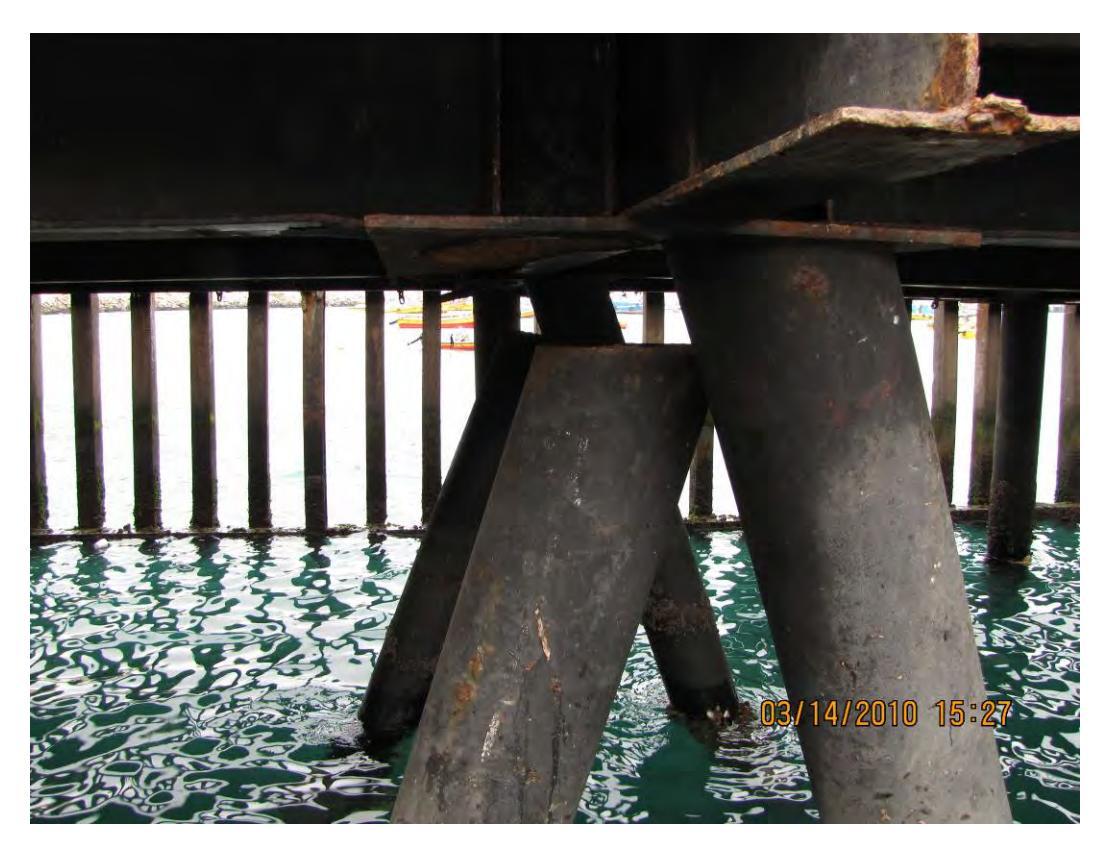
Figure 8.36. Failure of head connection between wharf and raked piles in San Antonio Port (S33.5817°, W71.6154°; 1527 hrs, 03/14/2010).

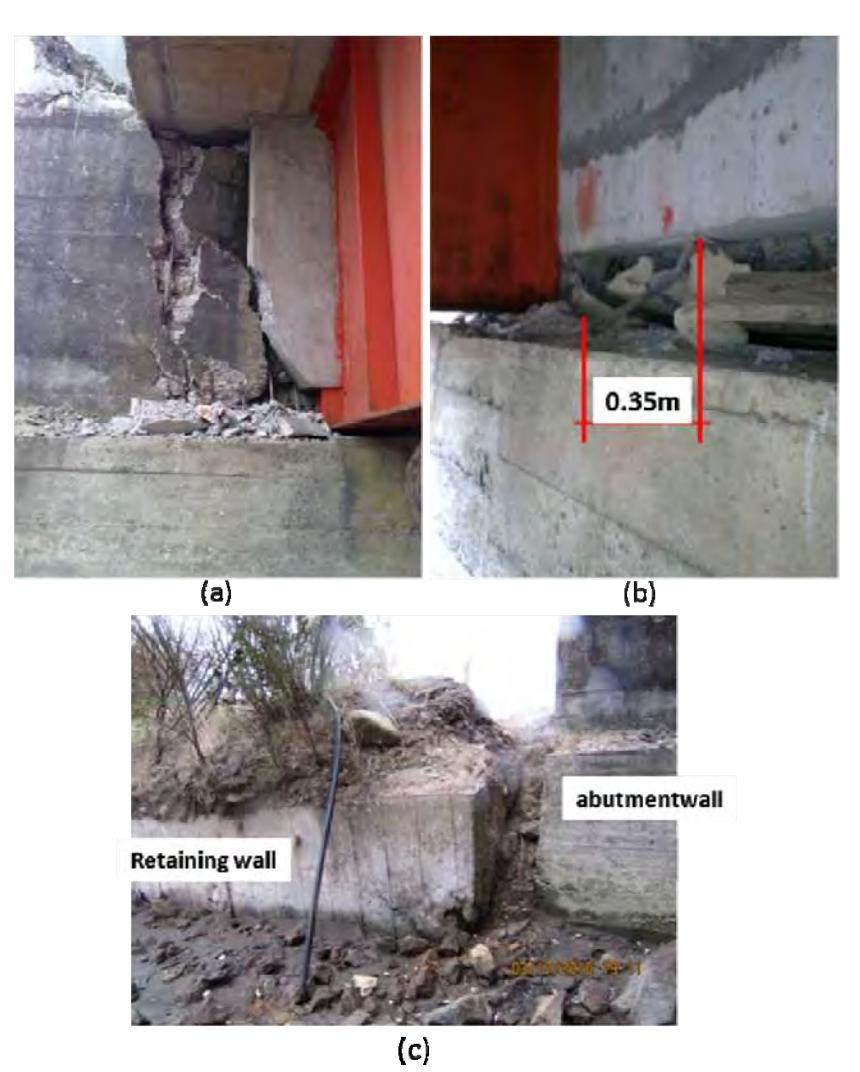
Figure 9.51. Damage to bridge abutment due to lateral spreading of soil around bridge abutment. (a) abutment wall movement relative to beams, (b) deformation of vertical restraining bar due to abutment movement relative to beams, (c) movement of retaining wall relative to abutment. (S37.254345°, W73.437021°; 1911 hrs on 3/17/2010)

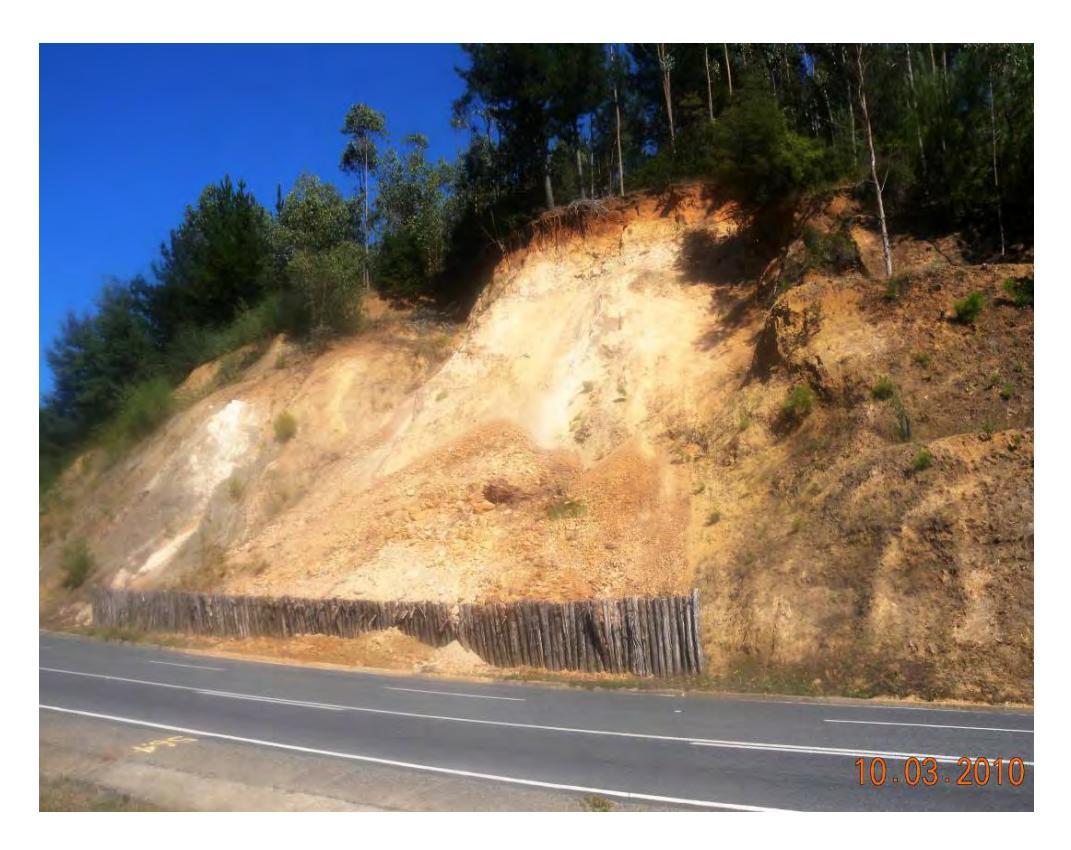
Figure 10.5. Shallow failure in a road cut in highly weathered bedrock (37.256493°S, 72.96018°W, looking SW).

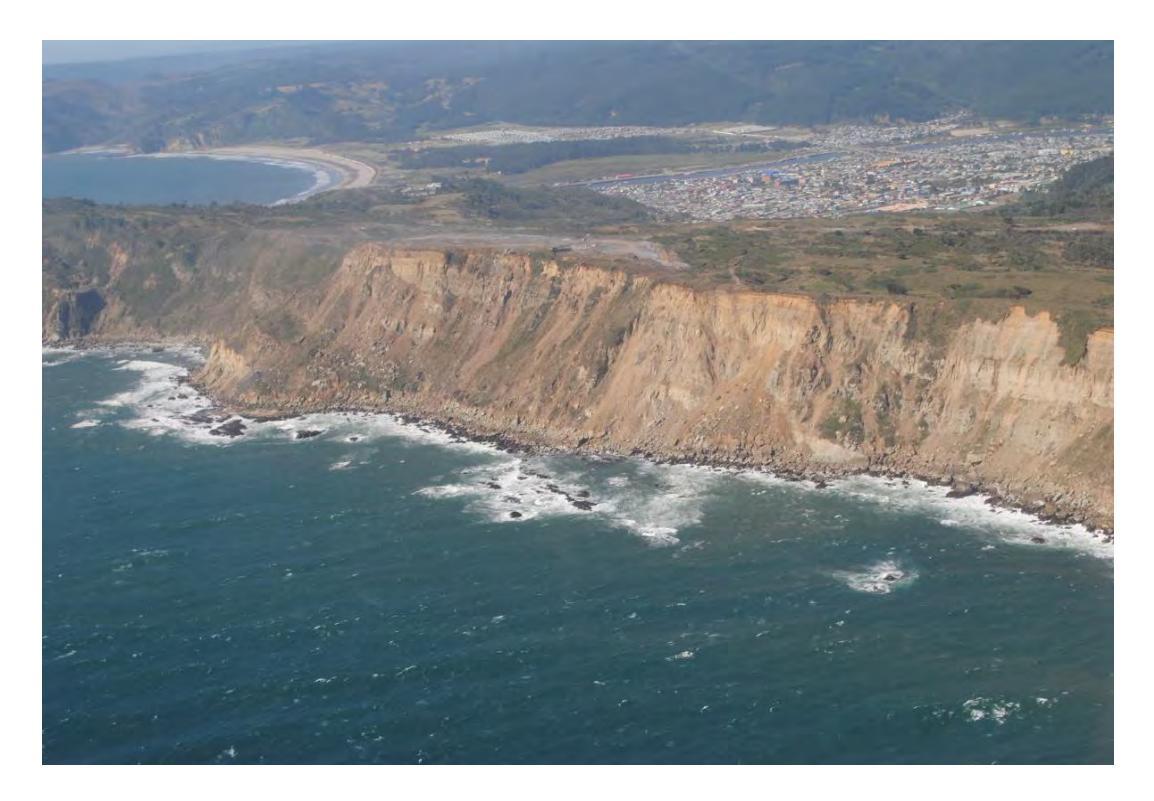
Figure 10.8. Shallow slides along bluffs southwest of Lebu (37.6°S, 73.674°W).

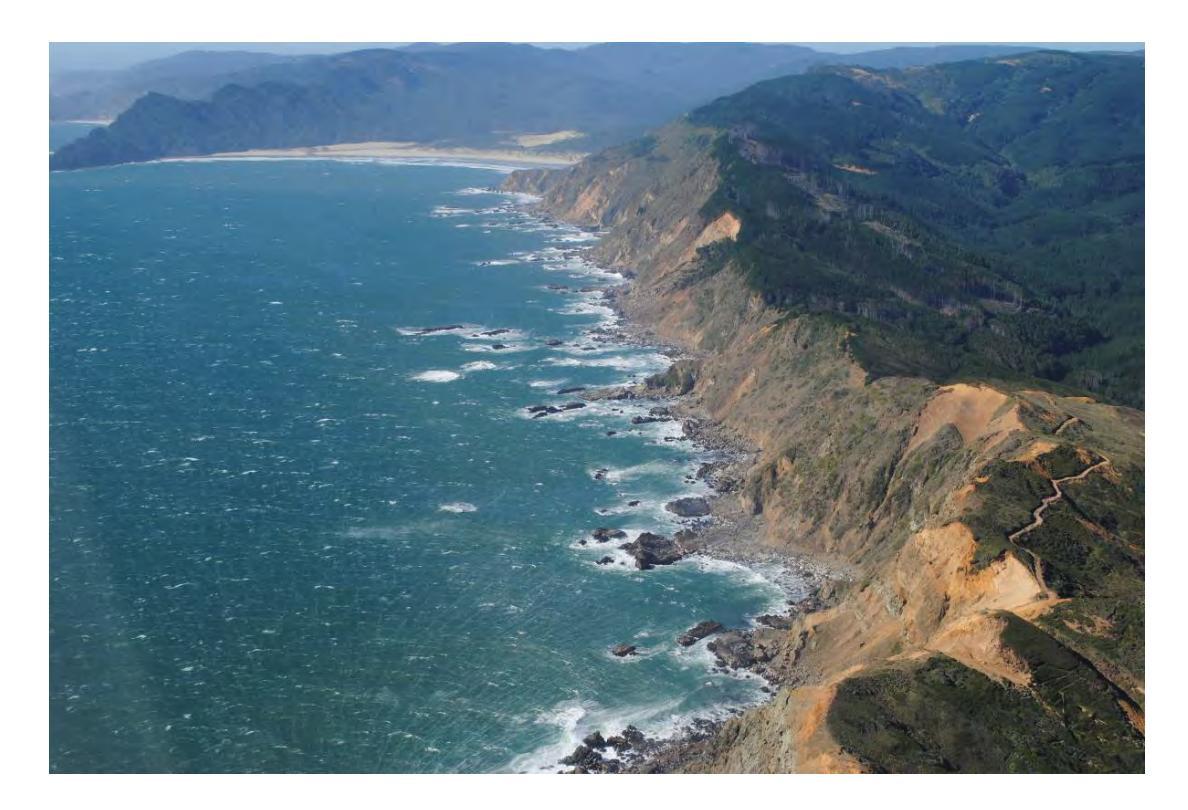
Figure 10.9. Bluffs north of Pta Carneros, southwest of Arauco, showing frequent but not pervasive sliding and raveling (37.326°S, 732674°W).

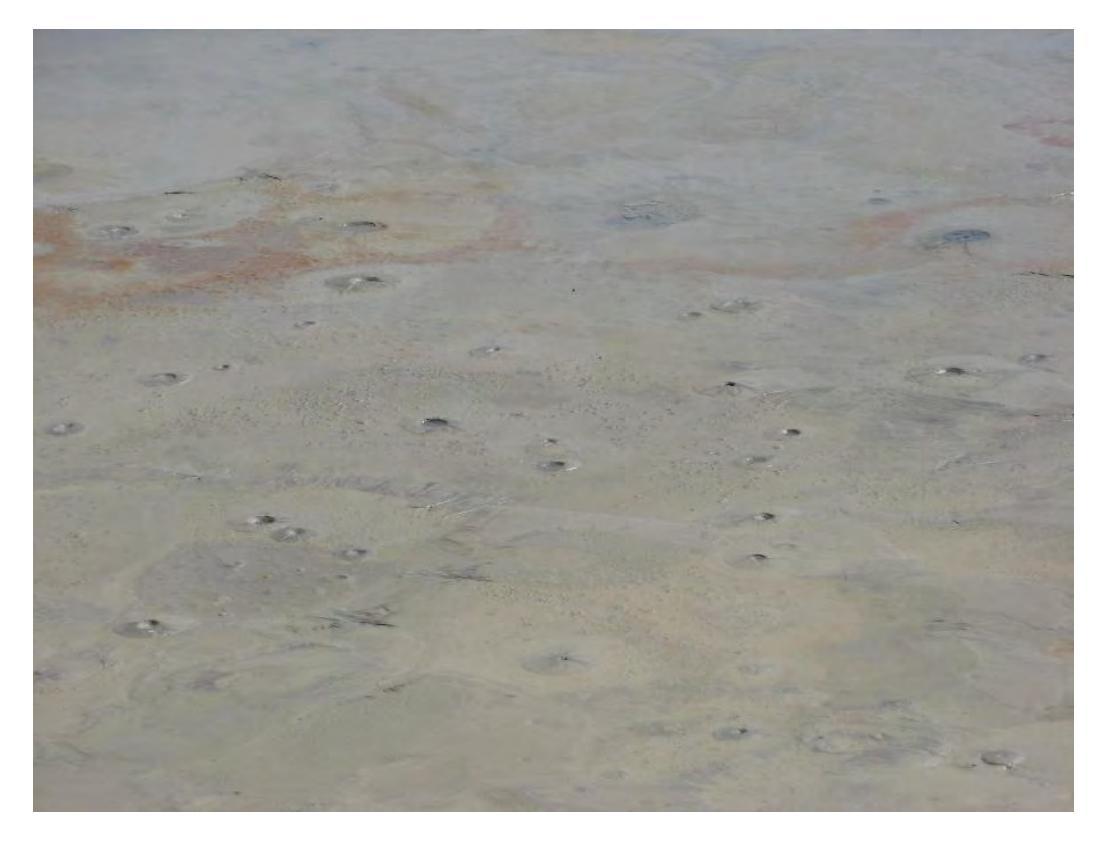
Figure 11.11. March 9, 2010 Sand Boils in Tailings about 10 m Upstream of Ovejeria Tailings Dam (S33.052016°, W70.798687°)

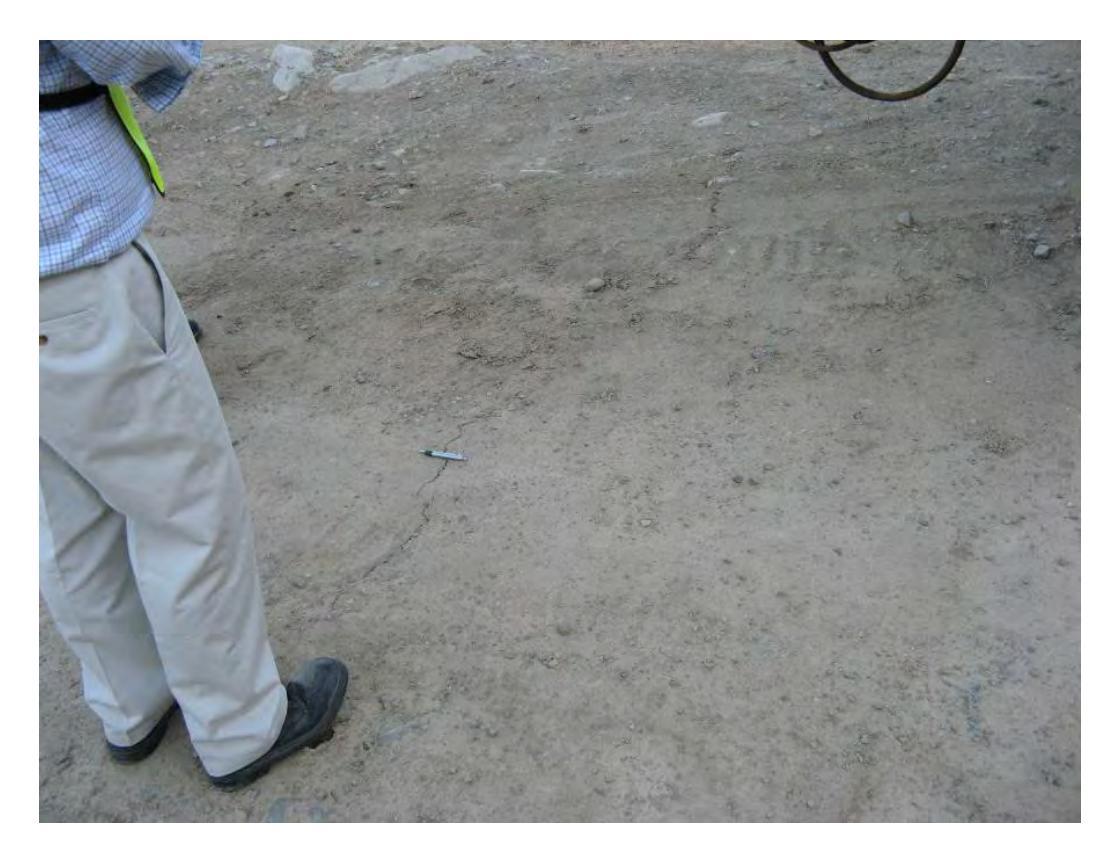
Figure 11.19. March 10, 2010 Millimeter Width Transverse Crack Near the Left Abutment of Caren Tailings Dam (S34.096050°, W71.180748°)

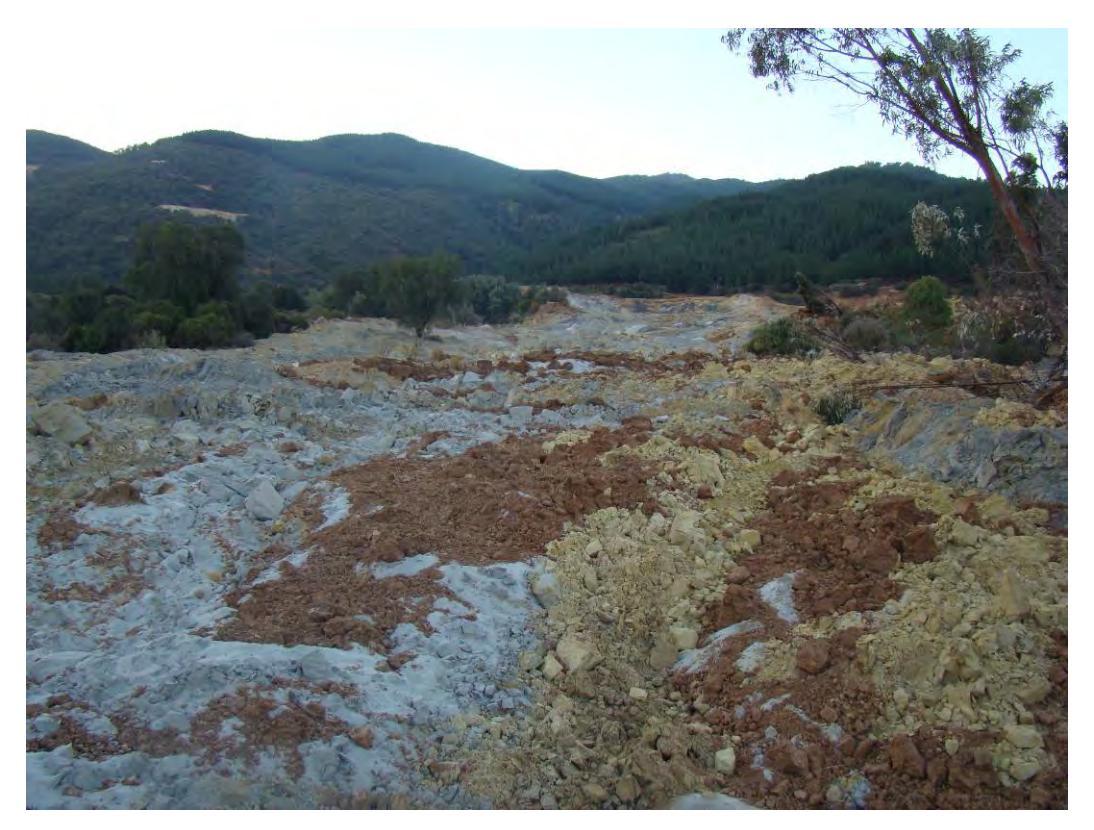
Figure 11.25. March 11, 2010. View Along Flowpath of Tailings (35.18468° S, 71.759410° W)

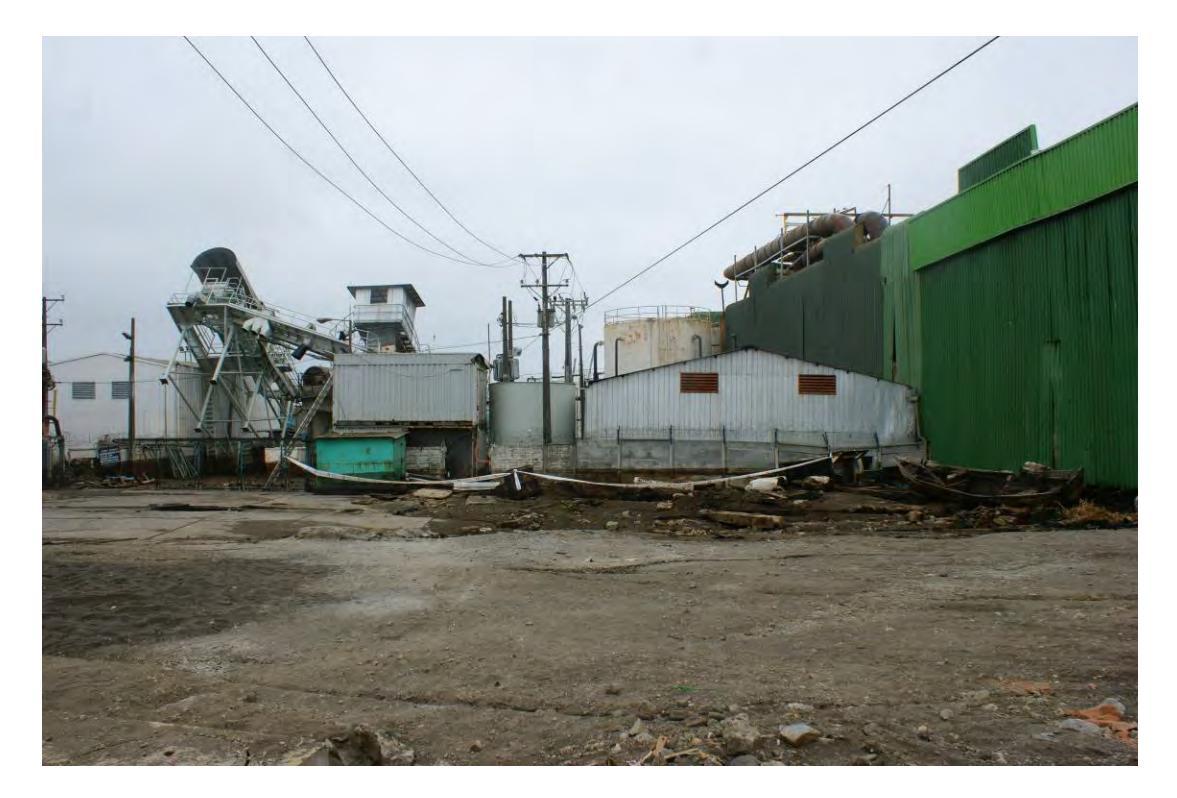
Figure 14.16. Port San Vicente, Talcahuano. The damaged Concession Maritima fish processing plant. (S36.725892°, W73.128678°; 11:50 hours on 3/16/2010)

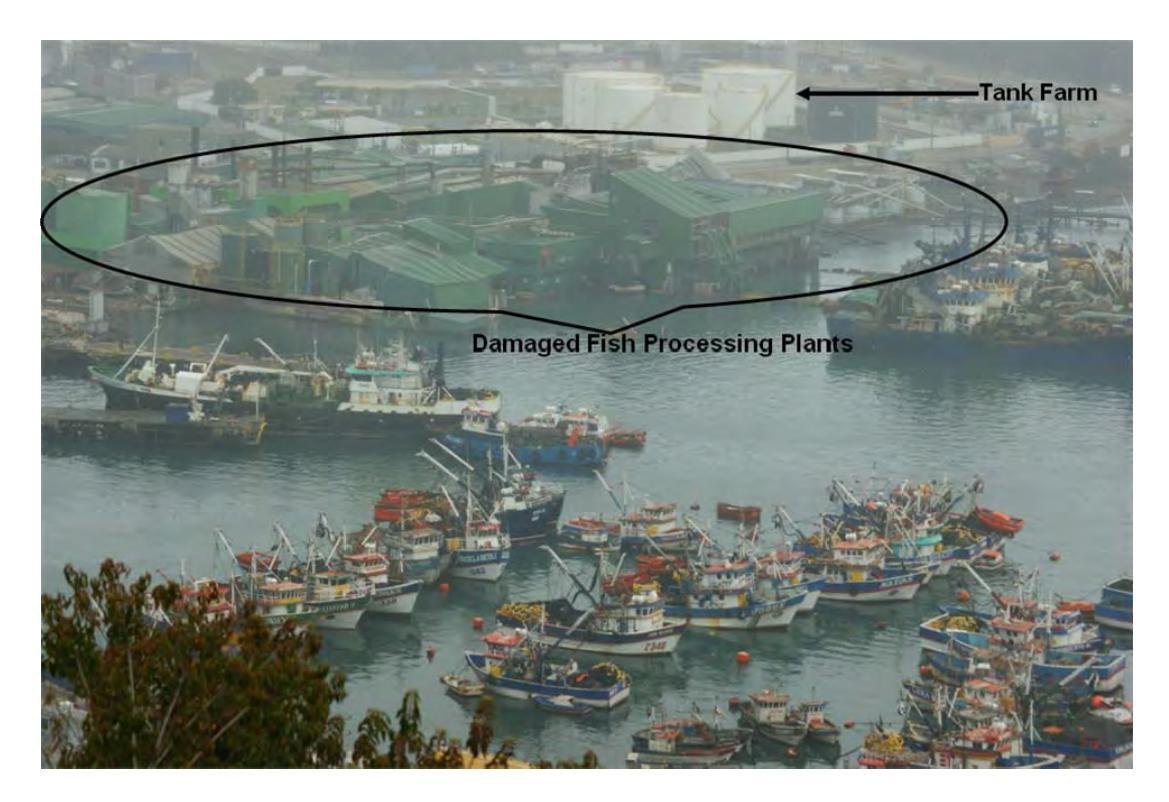
Figure 14.17. Port San Vicente, Talcahuano. View of two damaged fish processing plants and nearby tank farm. (\$36.724605°, W73.136475°; 12:18 hours on 3/16/2010)

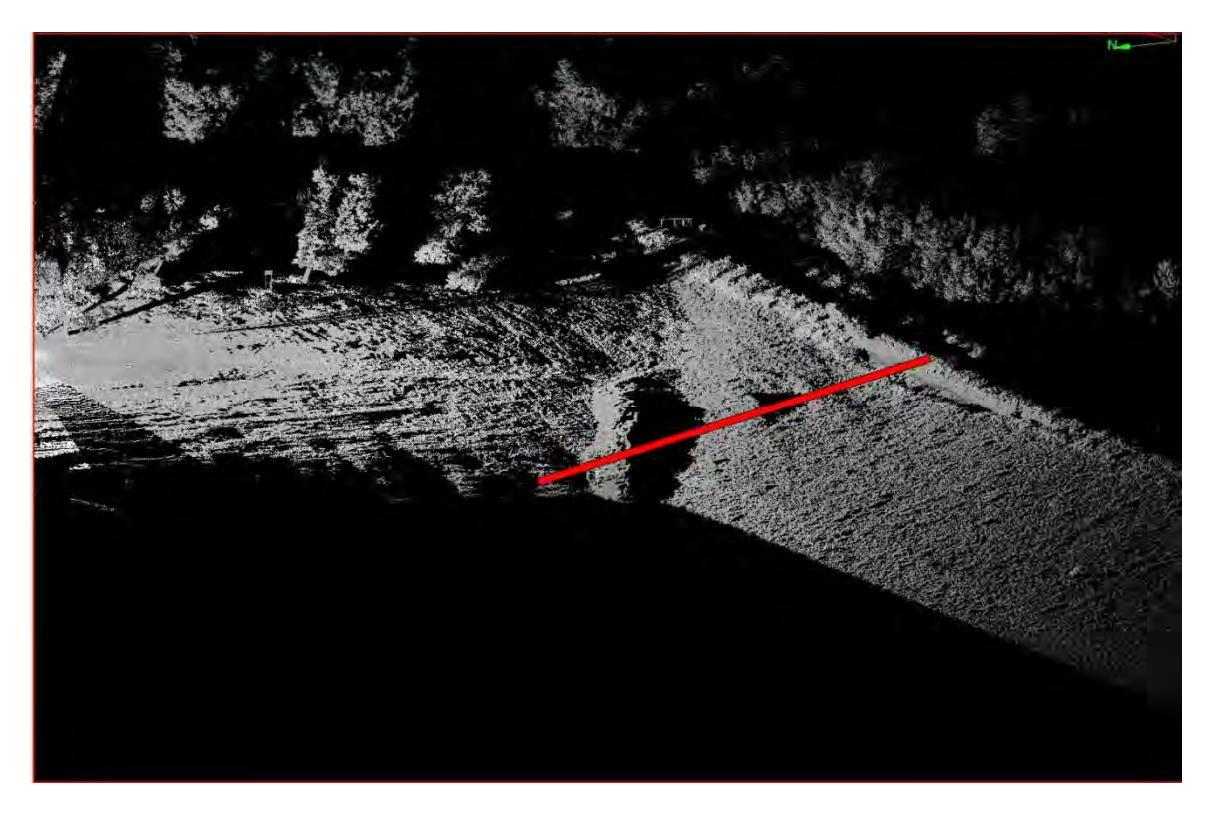
Figure 15.15. Oblique view of slump at the Coihueco Dam (36.63782°S, 71.79700°W; 27 March 2010; 13:00)

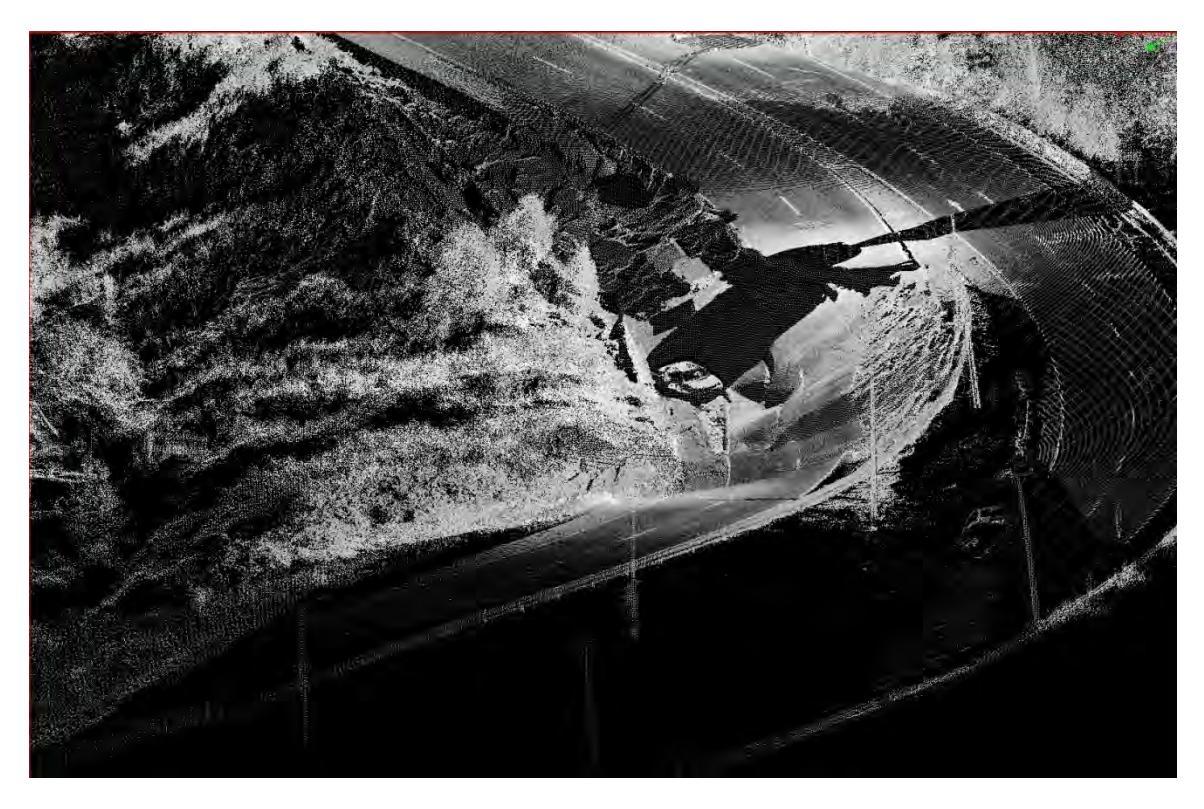
Figure 15.39. Oblique view of route 160 east side embankment failure at the fork in the highway (note vehicle in slide for scale).

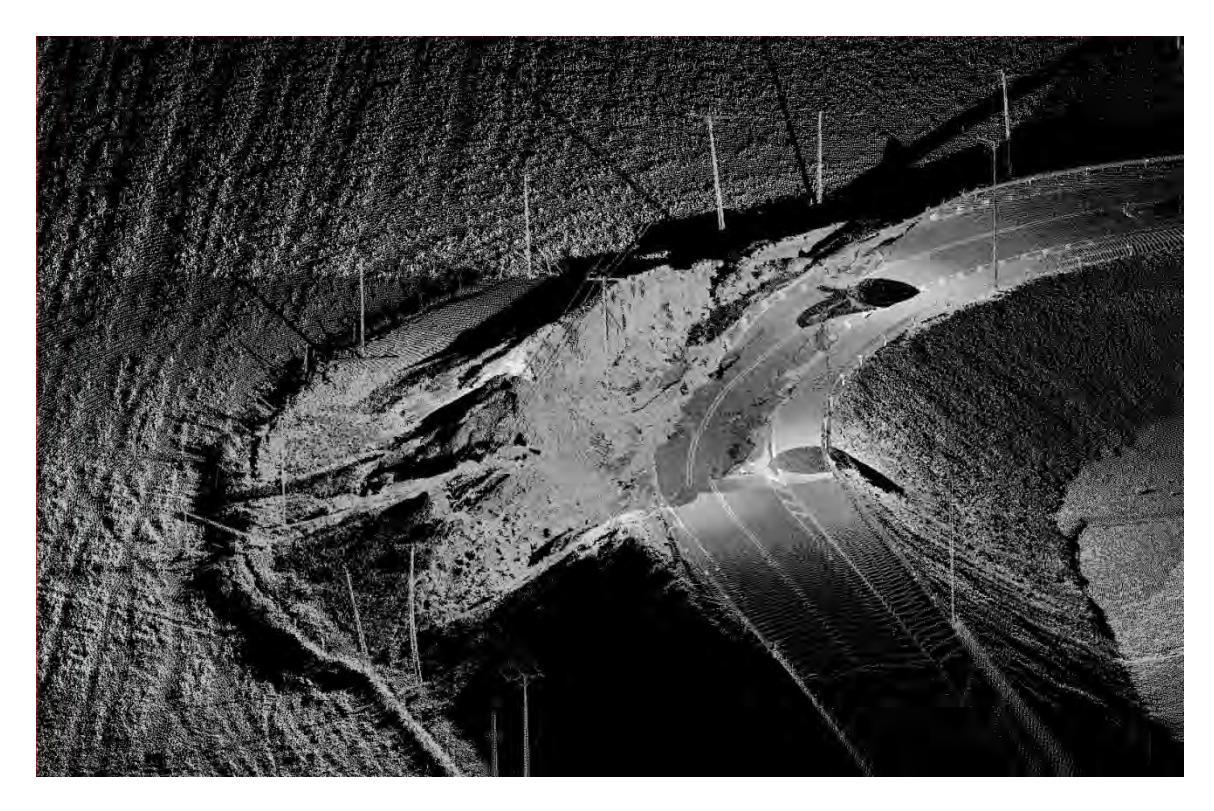
Figure 15.47. Oblique view of the Route 5 overpass embankment failure from the southeast side. The outside curve can be seen to have slid out laterally into the field.

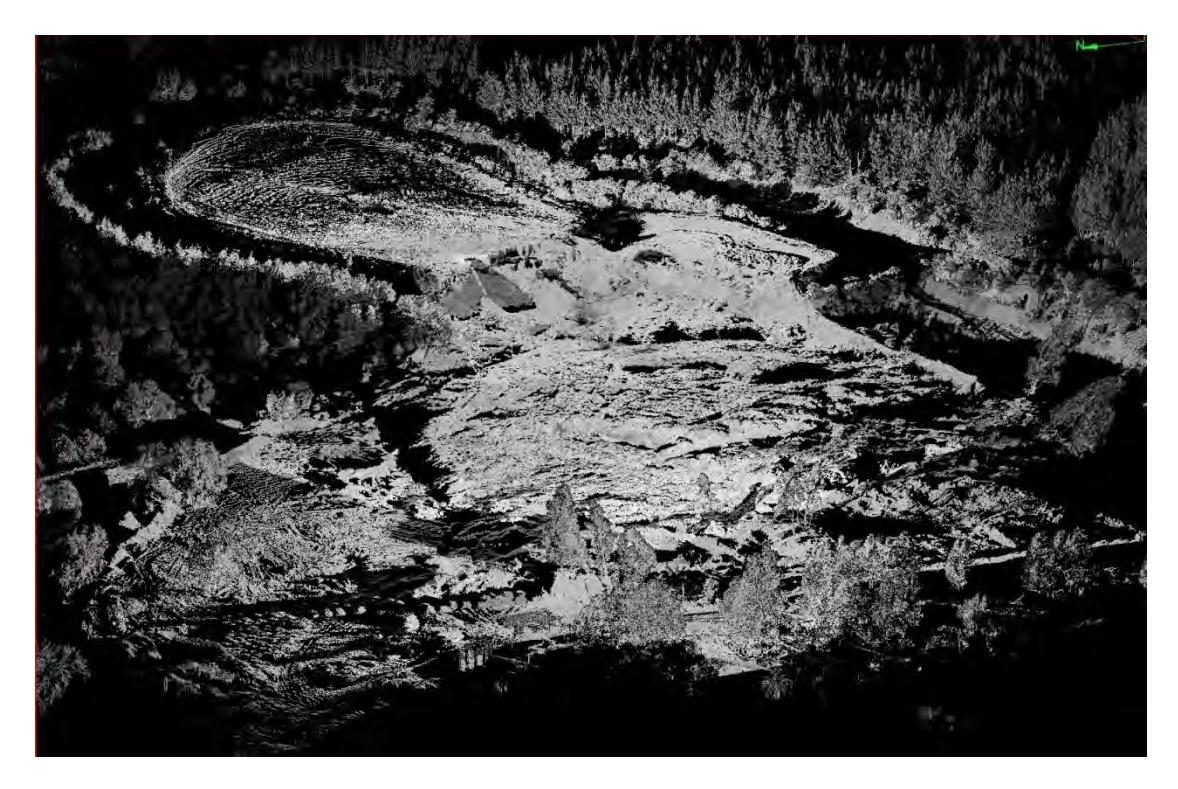
Figure 15.54 Oblique LIDAR view of the Las Palmas Tailings Pond Failure, Talca (35.184679° S, 71.759410° W). The tailings pond head scarp is in the upper-left. The te of the slide is in the line of trees at the bottom right.
