Geo-engineering Reconnaissance of the 2010 Maule, Chile Earthquake

Report of the NSF Sponsored GEER Association Team

GEER Association Report No. GEER-022

Version 1: April 15, 2010

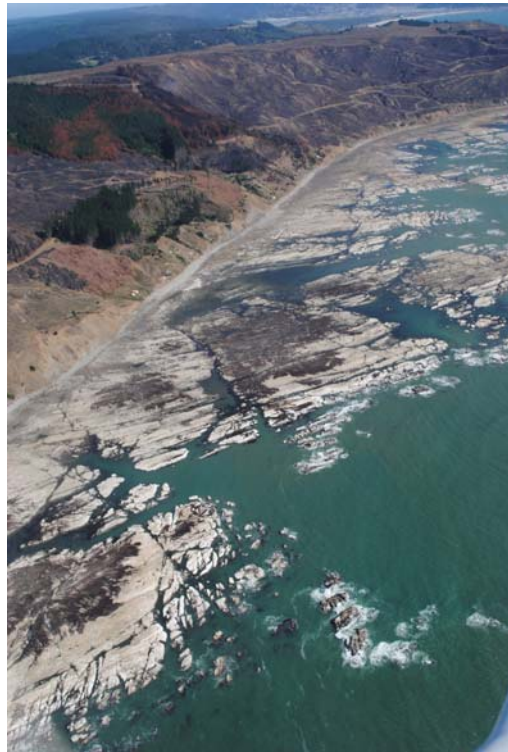
Aerial reconnaissance on March 9 included observation of the Arauco Peninsula and the town of Lebu on the southwestern side of the peninsula, and demonstrated the presence uplifted (formerly active) wave-cut platforms cut on bedrock (Figure 4.5). From the air, these platforms appear white, because of coverage by intertidal marine organisms, and brown because of coverage by kelp. It is notable that kelp debris on these platforms was preserved, rather than being removed by high-velocity tsunami waves. A lighthouse northwest of the Lebu Harbor inlet is on an island that was uplifted enough to nearly form a peninsula (Figure 4.6); the lighthouse appeared to be undamaged by subsequent tsunami waves.

Figure 4.5. Oblique aerial photograph looking south along the western coastline of the Arauco Peninsula, showing uplifted (formerly) modern wave-cut platform and exposed tidal zone. (S37.540303° W73.623628°; 1701 hrs on 03/09/2010).

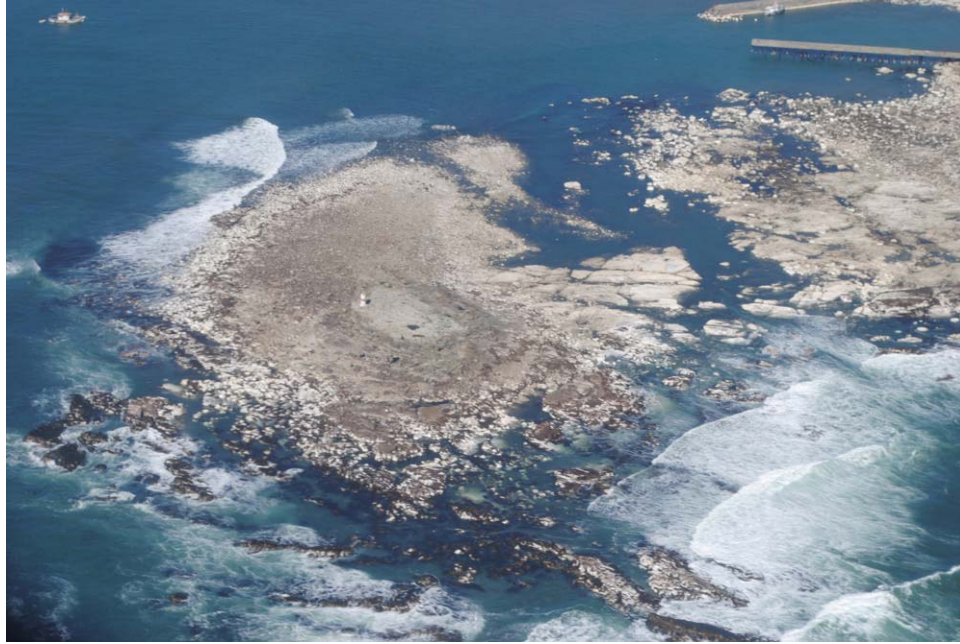
Figure 4.6. Uplifted island with lighthouse, north of Lebu Harbor inlet. Areas with whitish colors were uplifted during earthquake. (S37.591897° W73.668353°; 1714 hrs on 03/09/2010).

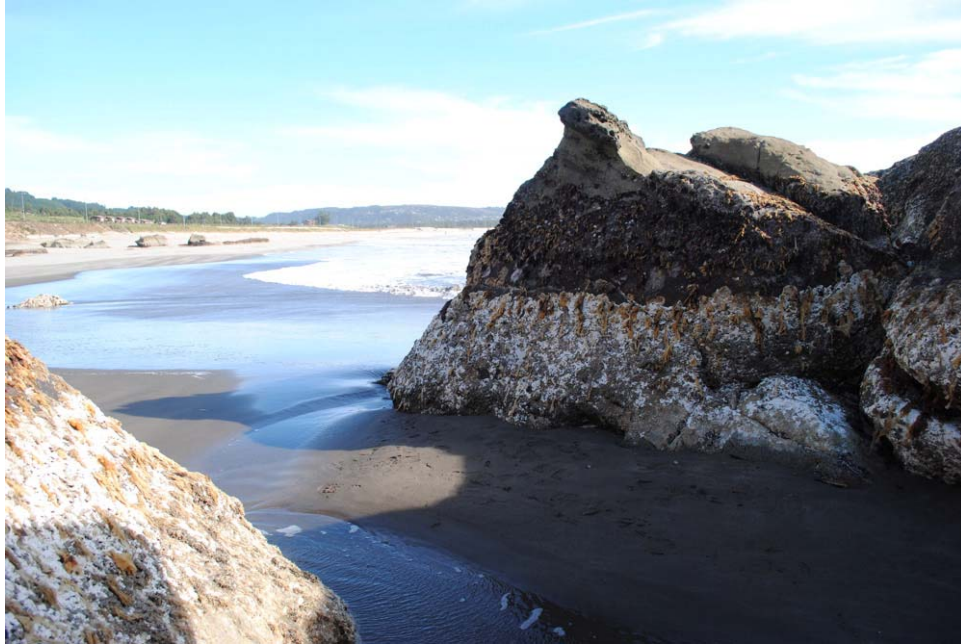
Ground reconnaissance of the coastline directly west and east of Lebu documents approximately 1.5 to 2.0 m of uplift of the coastline. Figures 4.7 and 4.8 show uplifted tidal organisms attached to sandstone bedrock. Local fishermen contacted at this site indicated that sea level went down (i.e., the coast was uplifted) approximately 1.8 m as a result of the February 27 earthquake. Evidence of coastal uplift is also present on the eastern side of the Lebu harbor inlet, where fishing boats are stranded above high tide and a wooden jetty now is above tidal level (Figure 4.9). The area east of the jetty is now emergent as a result of earthquake-related uplift (Figure 4.10). Local fishermen in this area noted that the “water level went down” about 1.5 to 2.0 m as a result of the earthquake, suggesting uplift of about 1.5 to 2.0 m. Measurement of the former high-tide level on the harbor wall indicates an uplift of about 1.8 m (Figure 4.10). North of the Lebu Harbor inlet, the former wave-cut platform is now emergent and about 2 m above high tide (Figure 4.11). Several observations indicate that seawater drained from this platform without high flow velocities expected during tsunami surge, including the presence of attached kelp draped on the wave-cut platform, scattered buoyant trash, and several species of mobile tidal organisms (e.g., crabs, starfish) preserved in a “life assemblage” unaffected by unusual seawater velocity. Almost all of the boats in the Lebu Harbor, including a large ferry, have been grounded as result of the uplift stranded; the absence of tsunami damage to wooden-frame residences at the same elevation as the harbor docks show that the tsunami wave did not inundate areas outside of the harbor channel. Although originally only slightly above sea level, structures with the town of Lebu were unaffected by tsunami flow, apparently because coastal uplift raised the above the inundation level. The measurements of uplift of about 1.5 to 2.0 m are consistent with (but lower than) measurements provided by Tassara et al. (2010), which range from about 1.0 m near Tirua to 3.5 m at Morhuilla, including uplift of 2.4 to 3.0 m at Punta Lavapié on the northwestern tip of the Arauco Peninsula.

Figure 4.7. Uplifted tidal organisms northeast of Lebu Harbor, looking west; distinct bands of white organic material and brown kelp are at comparable elevations (respectively) throughout this area. Top of kelp band about 2 m above tidal level when photo was taken (5:34 pm local time, 1.5 hr prior to daily high tide). (S37.580447° W73.642911°; 1734 hrs on 03/10/2010).

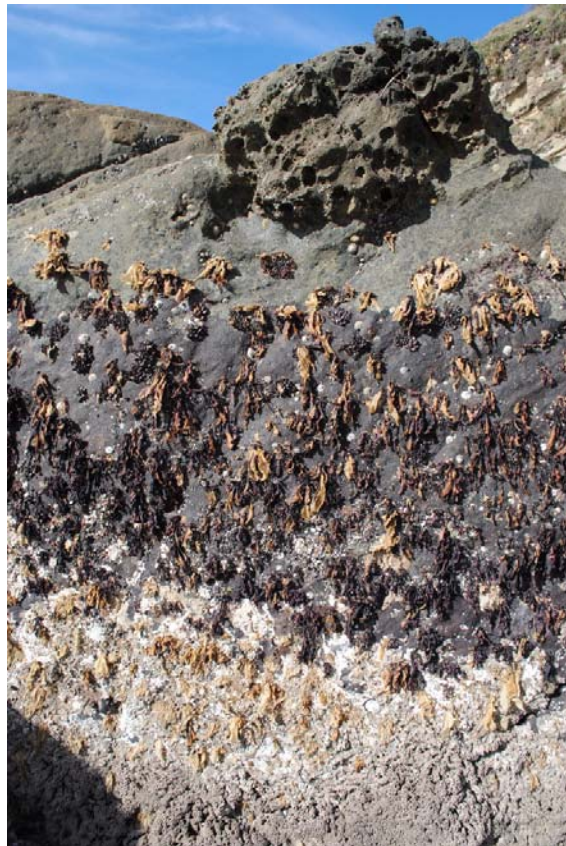
Figure 4.8. Close-up photograph of uplifted intertidal organisms, northeast of Lebu Harbor. (S37.580447° W73.642911°; 1743 hrs on 03/10/2010).

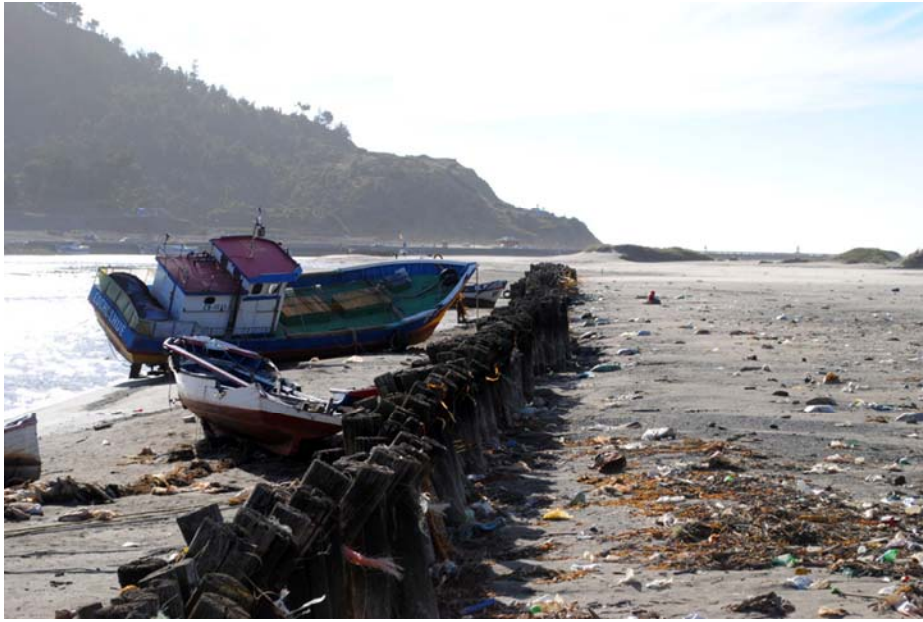
Figure 4.9. Eastern margin of Lebu Harbor, with stranded fishing boat and emergent wooden jetty; area to right was former tidal flat adjacent to harbor channel. Present high tide water level to left of boats. (S37.600789° W73.656317°; 1800 hrs on 03/10/2010).

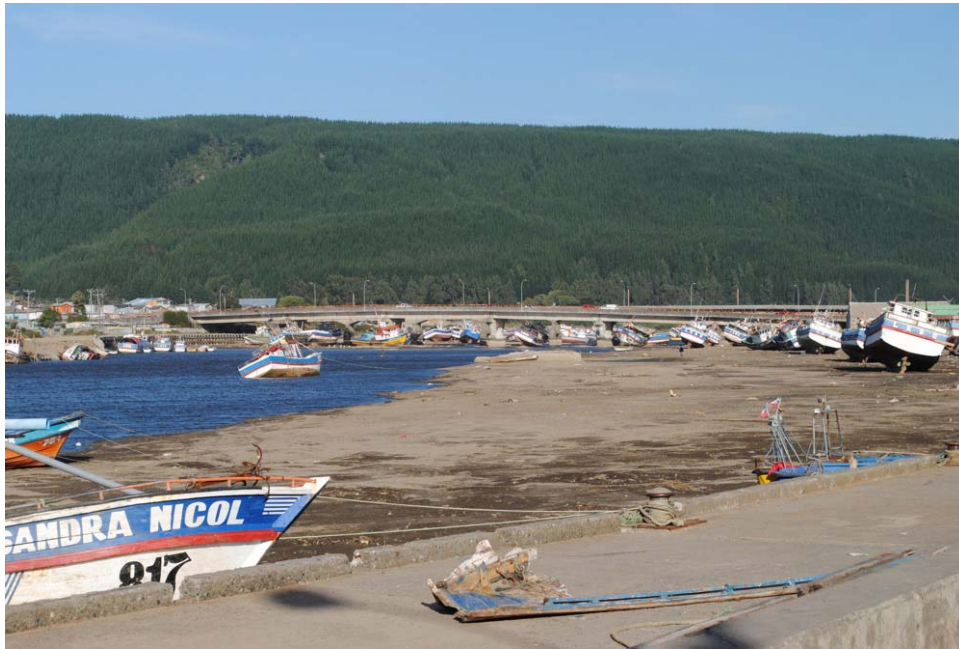
Figure 4.10. Fishing boats in Lebu harbor, stranded along uplifted western margin of harbor channel. Former high tide mark on harbor quay wall was indicated by local fishermen; measurement from high tide level on March 10 indicates uplift of $1.8 \text{ m} \pm 0.2 \text{ m}$ of the harbor quay wall. (S37.603694° W73.654372°; 1832 hrs on 03/10/2010).

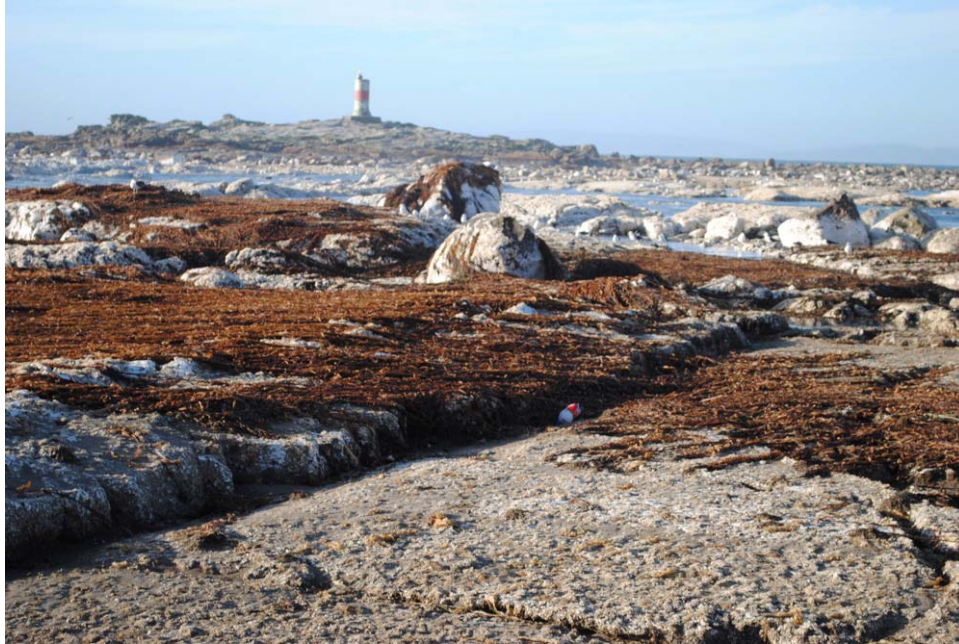
Figure 4.11. Wave-cut platform north of Lebu Harbor inlet, as also shown on Figure 4-6. Kelp draped on the platform, presence of “life assemblage” of mobile tidal organisms (e.g., crabs, starfish), and buoyant trash on the platform all suggest that seawater drained from the platform without high flow velocities expected during a tsunami surge. (S37.593958° W73.668225°; 1910 hrs on 03/10/2010).

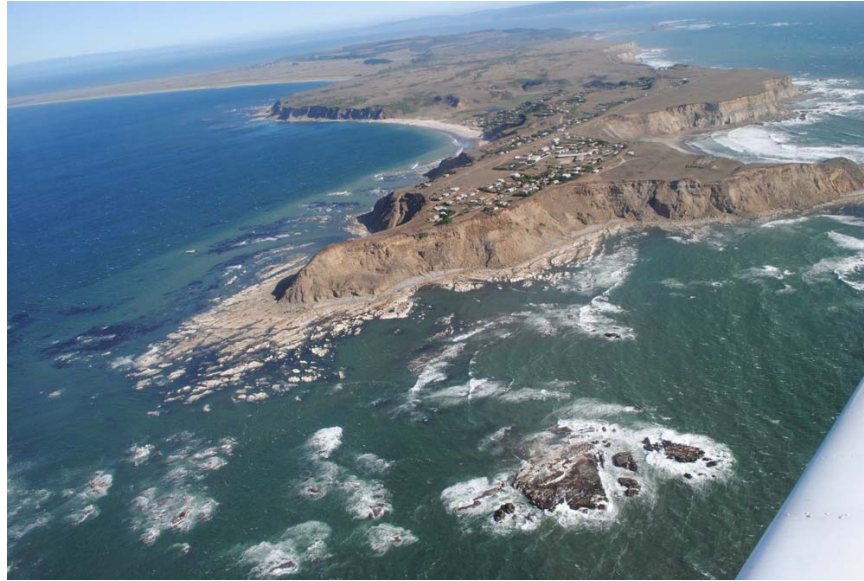
Figure 4.12. Northern end of Isla Santa Maria, looking south toward wave-cut platforms on uplifted coastline and islands. (S37.593958° W73.668225°; 1910 hrs on 03/9/2010).

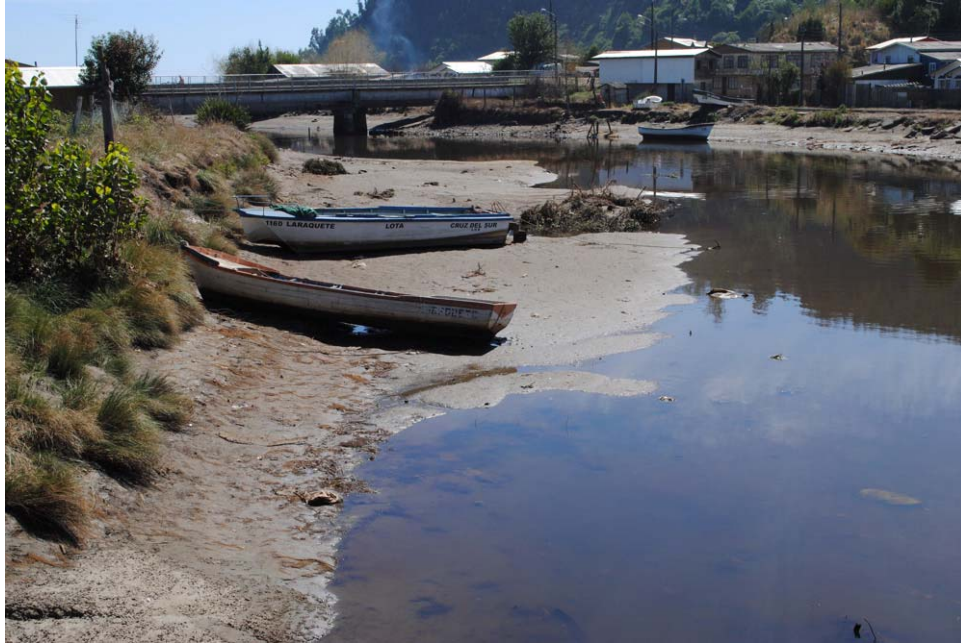
Figure 4.13. Ground view looking north in village of Laraquete, from the highway bridge toward the estuary outlet. Fishing boats stranded on left bank; tsunami high water mark approximately at the bank crest. Light, wooden-frame residences on both left and right banks were unaffected by tsunami waves, suggesting that wave(s) progressed upstream within the existing tidal channel only. Local witness indicated that the sea level has gone down about 0.5 m after the earthquake, and that the estuary bottom had not been exposed before (i.e., uplift of about 0.5 m).

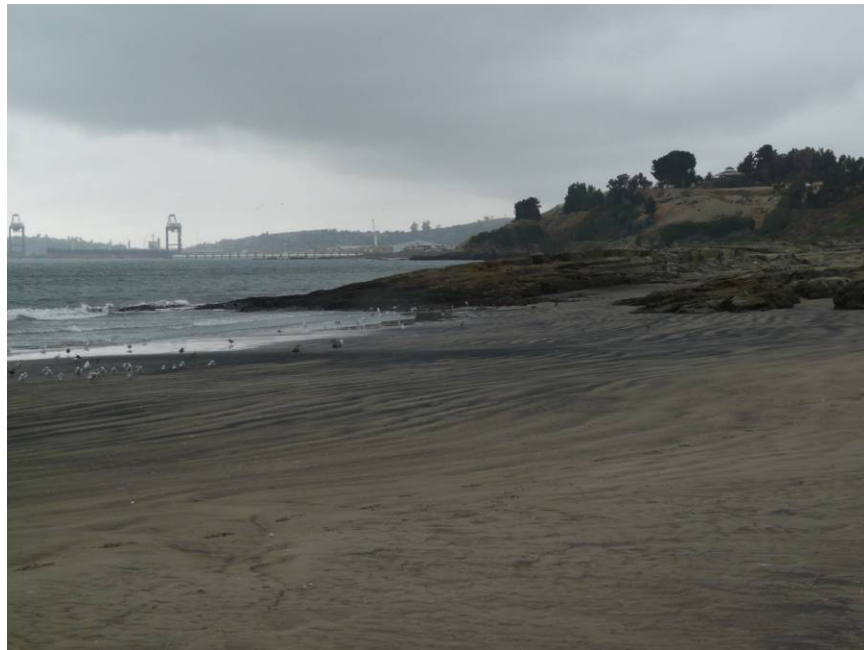
Figure 4.14. Raised mussel colonies inhabiting rocky intertidal habitats at Playa Blanca in Lota suggest the earthquake uplifted this area by about 0.9 m. A local witness attests to uplift at this site saying the shoreline has shifted westward by 15 to 25 m. (S37.058390° W73.142323°; 1701 hrs on 03/16/2010).

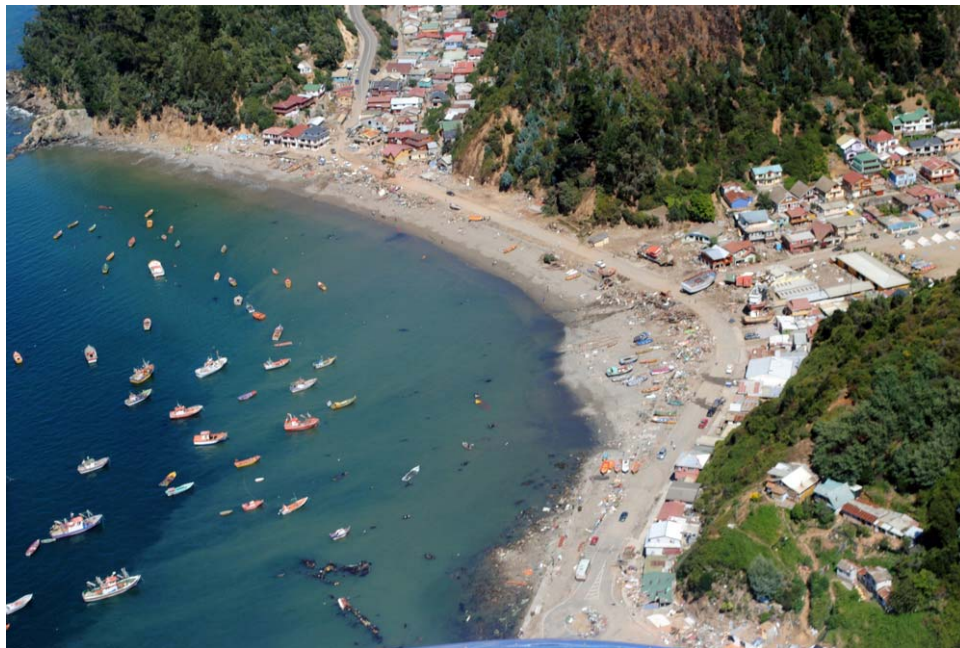
Figure 4.15. Aerial view of village on the eastern shoreline of Punta Tumbes, on western side of Bahía Talcahuano; substantial tsunami damage from runup into urbanized valleys.

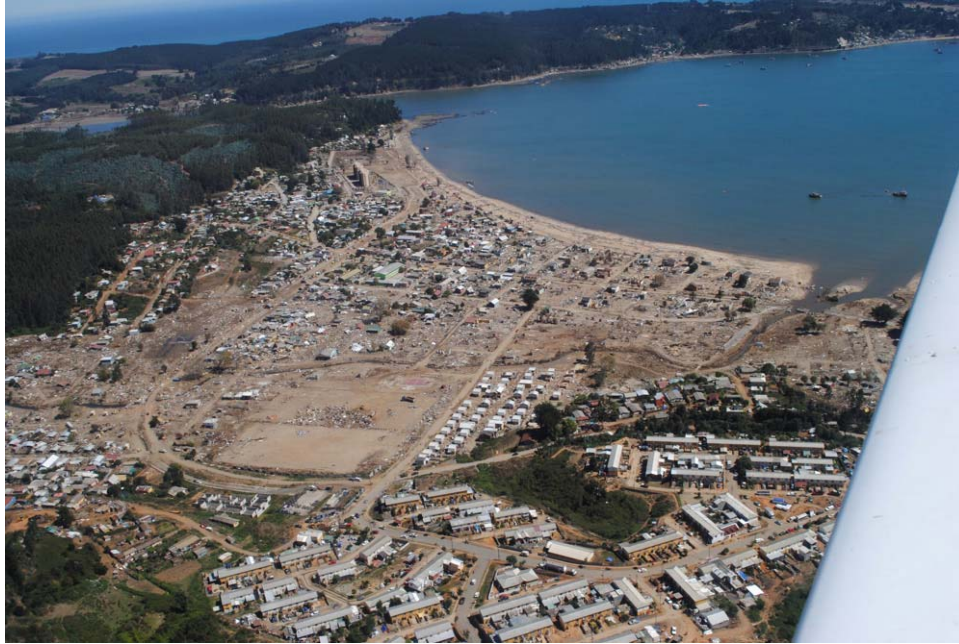
Figure 4.16. Aerial view looking west of town of Dichato, showing tsunami damage focused on north-facing shoreline in Bahía Talcahuano.

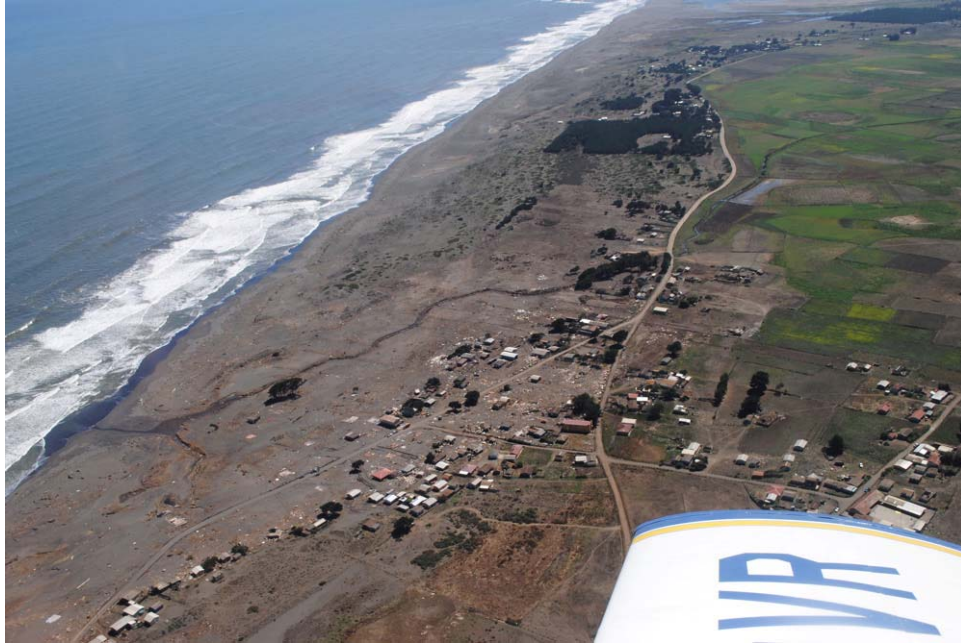
Figure 4.17. Aerial view looking north at village of Vegas de Itata, showing substantial tsunami damage. No evidence was observed of substantial uplift of this area.

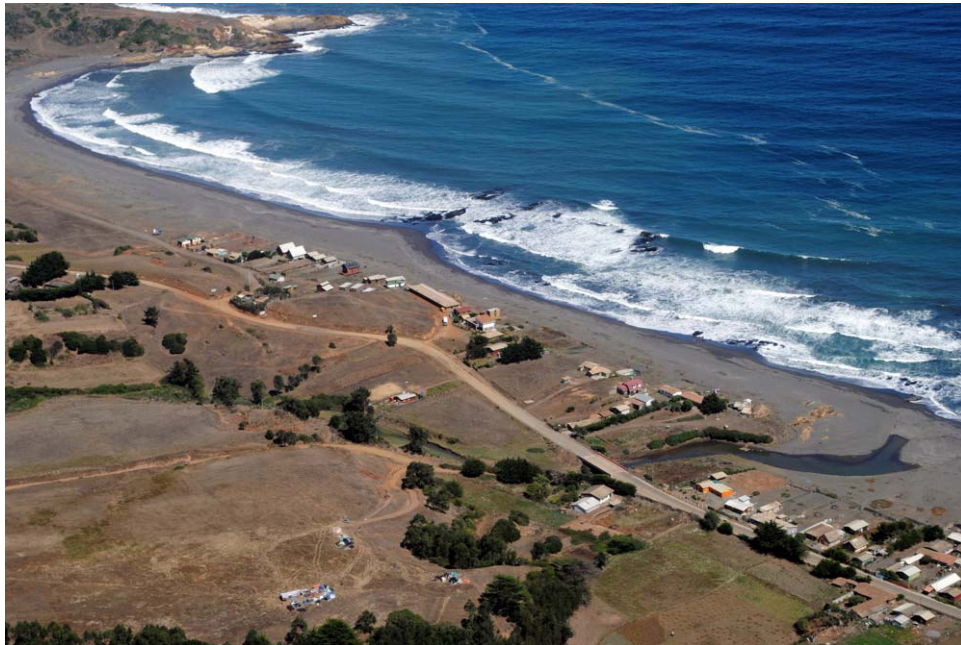
Figure 4.18. Aerial view looking southwest of shoreline at latitude of town of Cobquecura, near the Feb 27 epicenter. The tsunami extended up the tributary valley but apparently did not produce damage of residential structures close to the west-facing shore. Proximity to the epicenter and the orientation of the shoreline suggests that the comparatively greater damage in the Dichato and Talcahuano bays may be related to focusing of wave energy in confined bays.

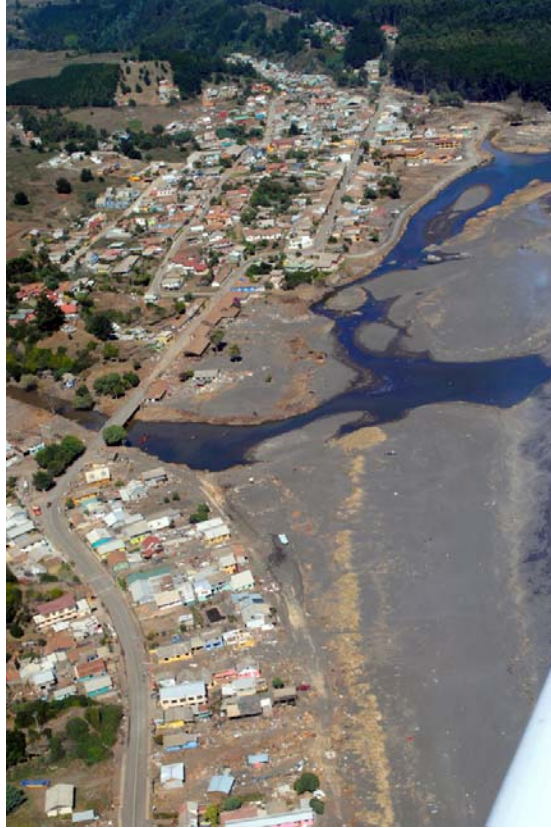
Figure 4-19. Aerial view looking south at village of Curanipe, including evidence of tsunami damage (i.e., large red truck within tidal estuary). Field observations of wave-cut platforms in this area indicate earthquake-related uplift of approximately 2 m.

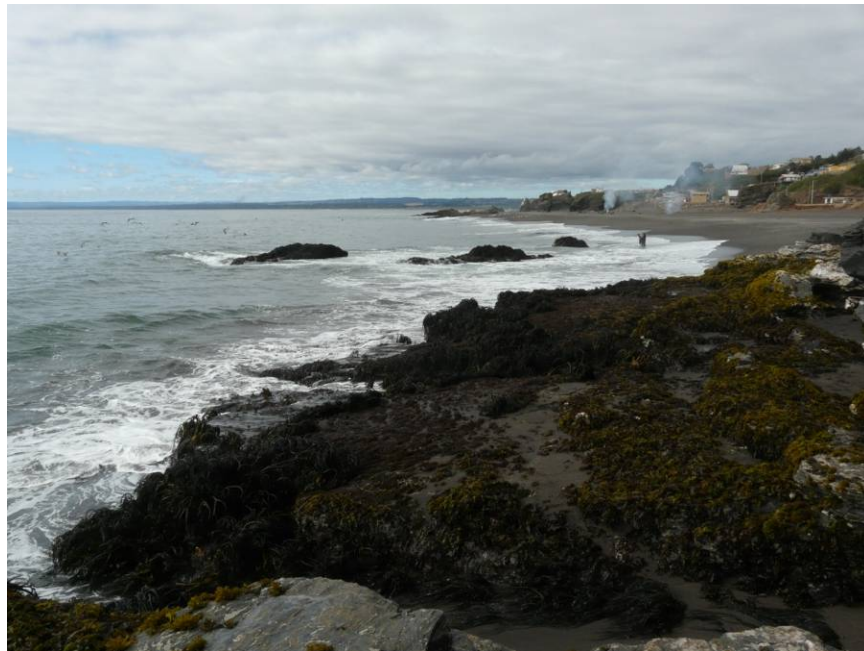
Figure 4-20. Intertidal mussels and algae exposed on rocky reefs along a small beach south of Pelluhue suggest as much as 2.0 m of coastal uplift. (S35.821915° W72.602106°, 1706 hrs on 03/17/2010).

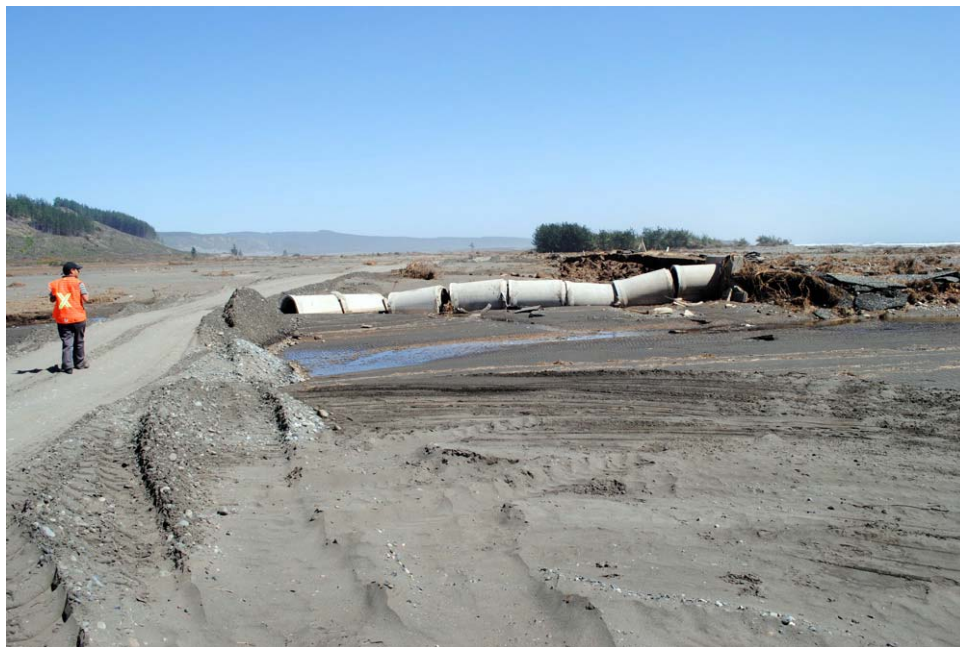
Figure 4.21. Ground photograph of area inundated and scoured by tsunami between Rio Mataquito and the town of Putú. Sections of concrete pipe were exposed and highway asphalt was eroded by tsunami flow, suggesting very high velocities; the extensive inundation in this area suggests possible land subsidence.

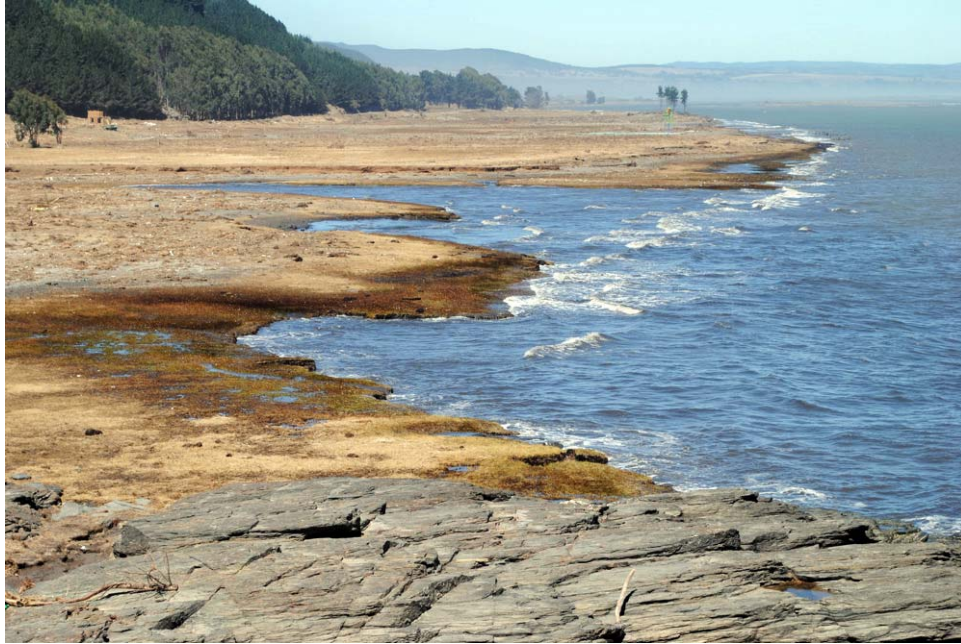
At the mouth of Rio Mataquito, erosion and/or subsidence has lowered and submerged the barrier bar, and the nearshore sand deposit is no longer visible. The barrier spit at the mouth of Rio Mataquito was breached by the tsunami and suffered extensive erosion. Field observations show that ocean waves now break over the remains of the barrier bar. Evidence of ocean flooding along the shoreline during higher tides, formerly the bank of the Rio Mataquito, suggests the area may have subsided during the earthquake. Near the village of Iloca, which was strongly affected by tsunami inundation, waves now regularly wash the lower part of pasture fields that were not inundated prior to the earthquake (Figure 4.22). These relationships suggest the occurrence of local coastal subsidence during the earthquake.

Figure 4.22. Ground photograph looking south from near Iloca, along the present coastline. Inundated grassy area in middle ground suggests substantial subsidence to as far north as the town of Iloca. The amount of subsidence at this location was not determined.

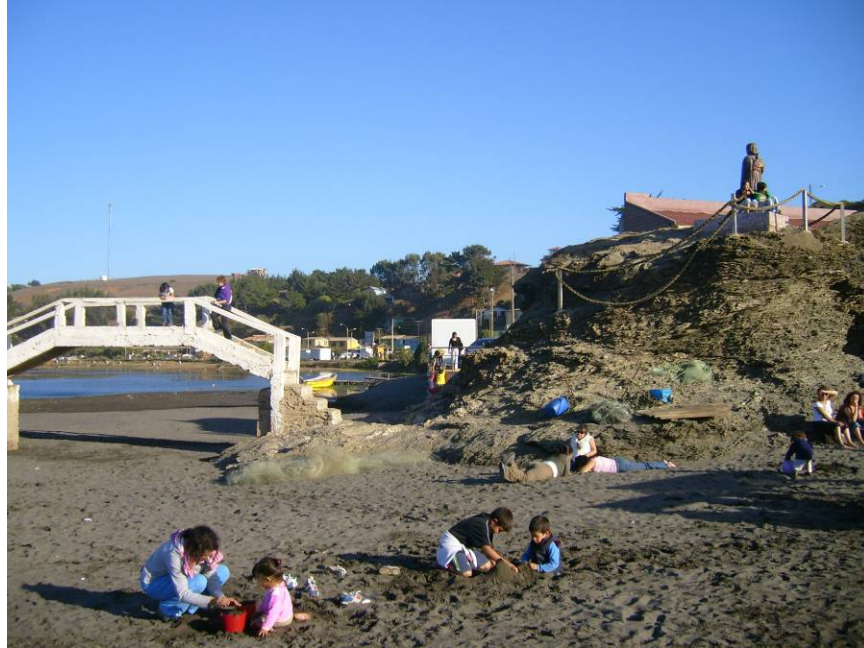
Evidence for coseismic subsidence at Bucalemu includes a dramatic eastward (landward) shift in the shoreline, extensive erosion of the beach, and a previously protected lagoon that is now inundated. Pre-earthquake images of Bucalemu show a 25-m-wide sandy beach that is now submerged (Figure 4.23). Field observation suggests that the present shoreline is located about 150 m east of the pre-earthquake shoreline. These changes may be related, in part, to tsunami scour or instead to tectonic subsidence. The field observations favor the interpretation that the beach at Bucalemu was lowered about 0.5 m during the earthquake.

Figure 4.23. Photograph from Panoramio website. View of Playa Bucalemu in 2007, showing the bridge and statue visible in post-earthquake photographs. Photo available at: <http://www.panoramio.com/photo/3369082>. Before the 2010 earthquake, the bridge at Bucalemu was located ~25 m east of the shoreline.

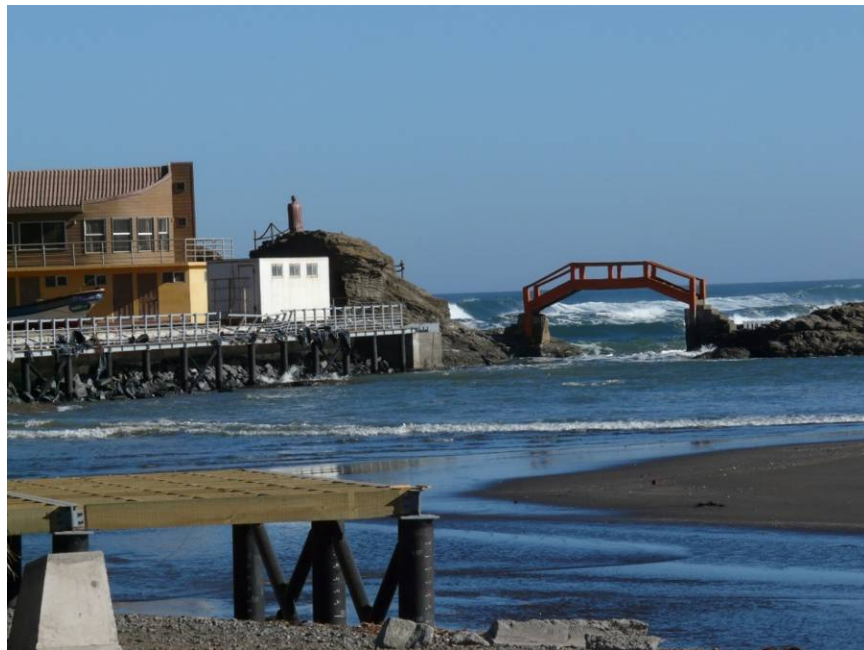
Figure 4.24. Erosion by tsunami waves and, possibly, an undetermined amount of coseismic subsidence has shifted the shoreline approximately 150 m eastward into an area formerly occupied by a shallow lagoon. S34.641883° W72.042919°, 1012 hrs on 03/15/2010).

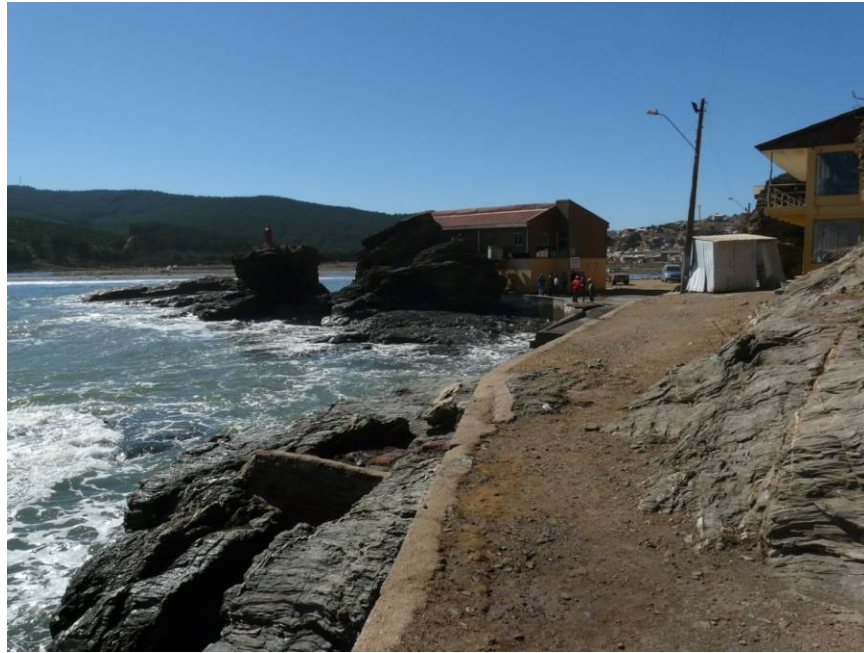
Figure 4.25. The shoreline at Bucalemu has shifted over 25 m east as a result of tsunami erosion and, possibly, coseismic subsidence. Pre-earthquake imagery shows a 25-m-wide sandy beach west of the boat ramp and sea wall that is now under attack by ocean waves. Where waves now crash on rocks in this photo taken two weeks after the earthquake, once was a wide sandy beach before tsunami flooding. (S34.639916° W72.044664°, 1142 hrs on 03/15/2010).

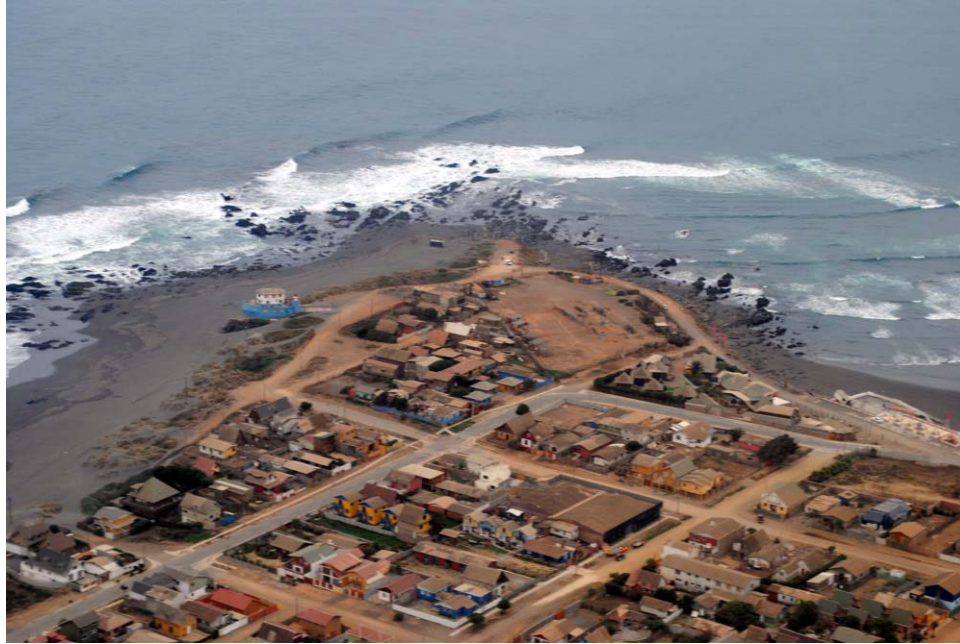
Figure 4.26. Aerial view looking northwest of shoreline in town of Pichilemu, showing bedrock underlying low-elevation marine terrace. The town of Pichilemu sustained local tsunami damage at elevations lower than this marine terrace or areas not protected by beach dunes.

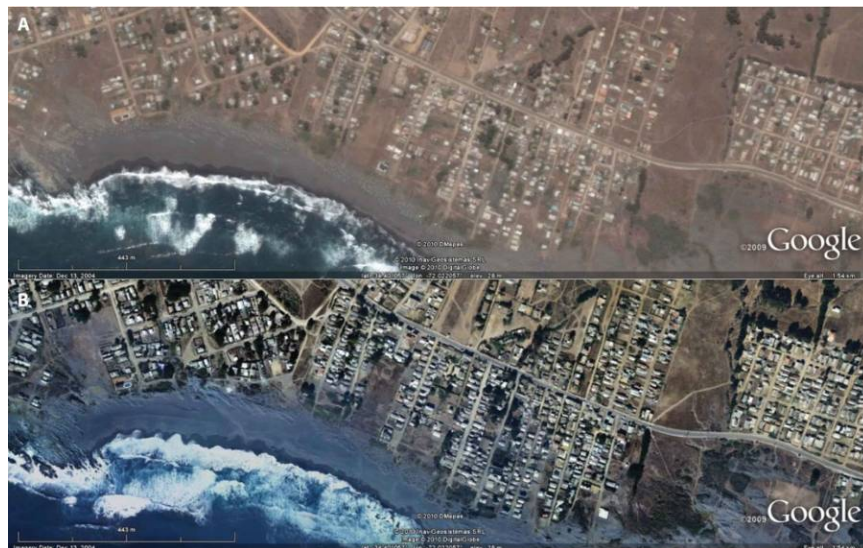
Figure 4.27. (A) Pre-earthquake satellite image of Pichilemu. (B) The same site after the February 27, 2010 earthquake shows no discernible evidence of changes in the shoreline that could be attributed to tectonic vertical land-level change.

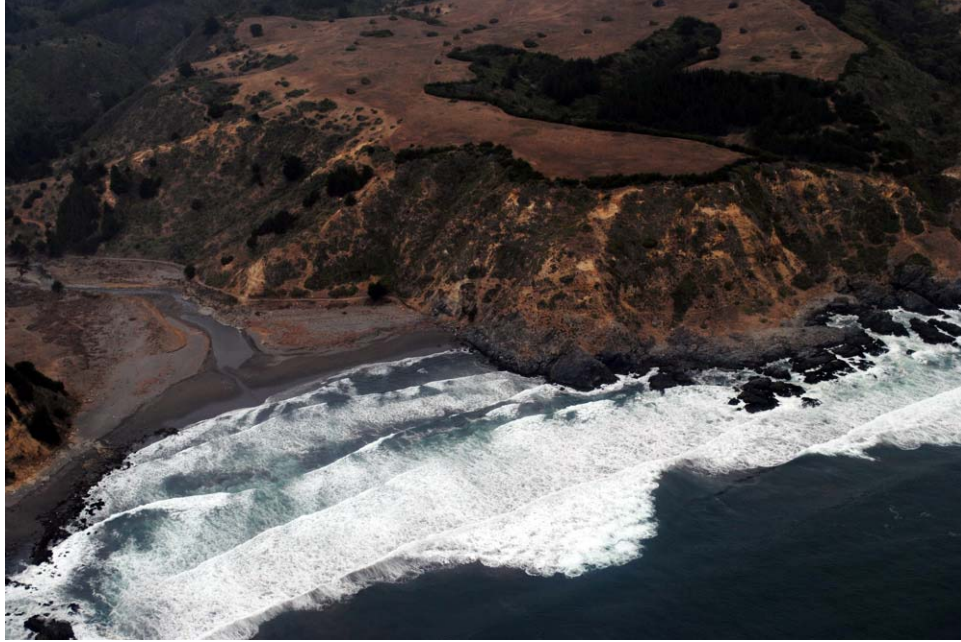
Figure 4.28. Aerial view looking southeast at shoreline on remote coastline between Pichilemu and Navidad, showing low-elevation marine terrace on far right, and thick marine deposits underlying high marine terrace in background. No evidence of earthquake-related uplift or subsidence was observed in this area.

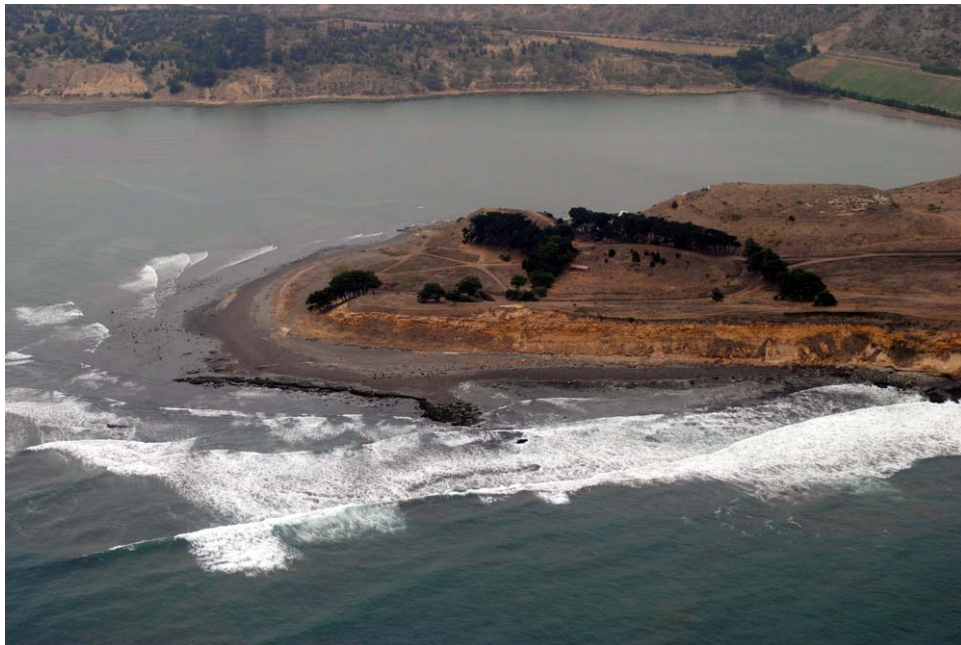
Figure 4.29. Aerial view looking east at shoreline at mouth of Rio Rapel near town of Navidad, showing low-elevation bedrock marine terrace in center, and thick marine deposits underlying high marine terrace. No evidence of earthquake-related uplift or subsidence was observed in this area.

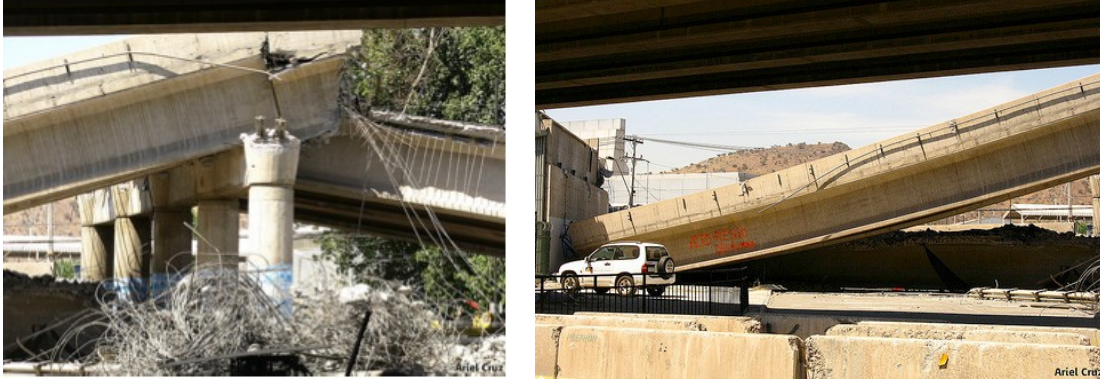
Site DA008a (S33.3759° W70.7476°) – Paso Superior Lo Echevers

The bridge suffered collapse of the east direction deck of the highway (see Figure 5.6). According to the local geology map, the soil profile at the site is clayey/silty sand.

Figure 5.6. Paso Superior Lo Echevers (S33.3759° W70.7476°). Collapse of the eastbound deck of the Americo Vespucio Norte ring road (Source: http://www.flickr.com/photos/consulta_recorridos/).

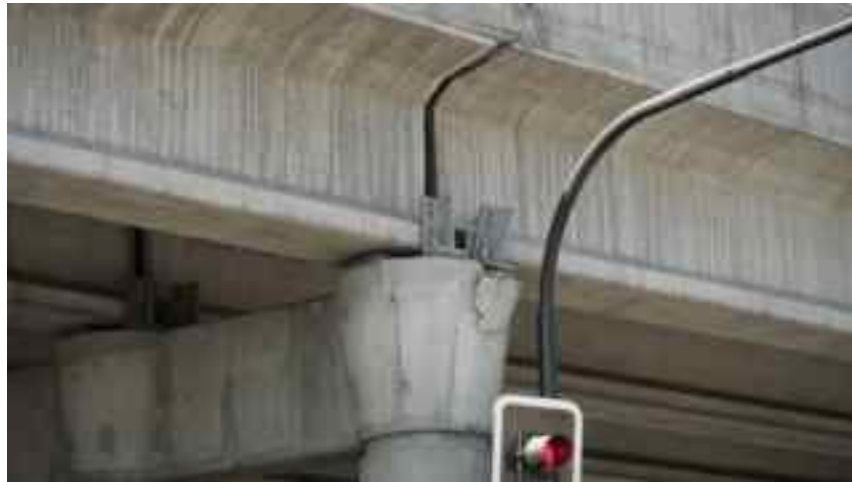
Site RL001 (S33.3865° W70.7601°) – Paso Lo Boza

The bridge suffered minor damage, primarily shear key failure and subsequent displacement of the deck in the transverse direction (see Figure 5.7). According to the local geology map, the soil profile at the site is sandy silt.

Figure 5.7. Paso Lo Boza (S33.3865° W70.7601°). Minor structural damage of shear keys (Source: Dr. Roberto Leon, personal communication).

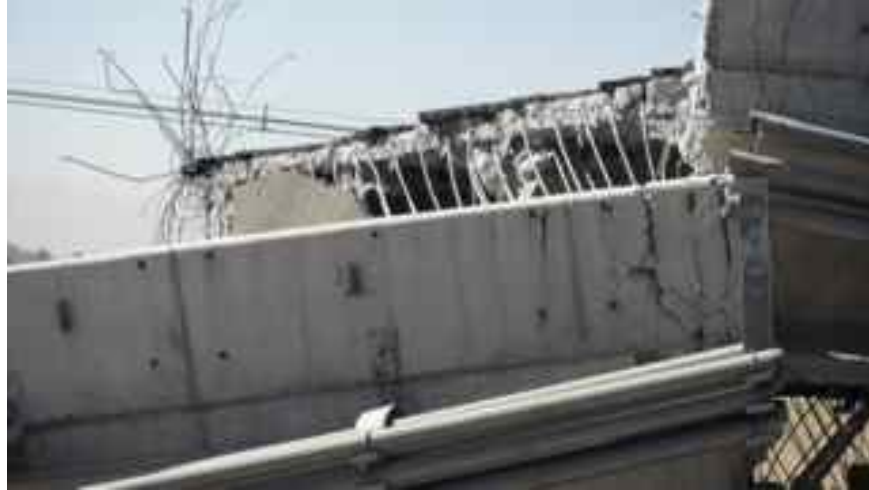
Site DA009 (S33.3945° W70.7700°)– Paso Miraflores

The bridge suffered collapse of the east direction deck of the highway (see Figure 5.8). According to the local geology map, the soil profile at the site is sandy silt.

Figure 5.8. Paso Miraflores (S33.3945° W70.7700°). Deck collapse detail (Source: Dr. Roberto Leon, personal communication).

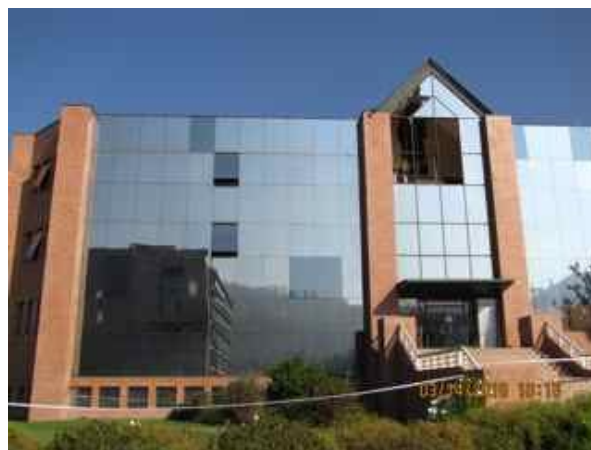
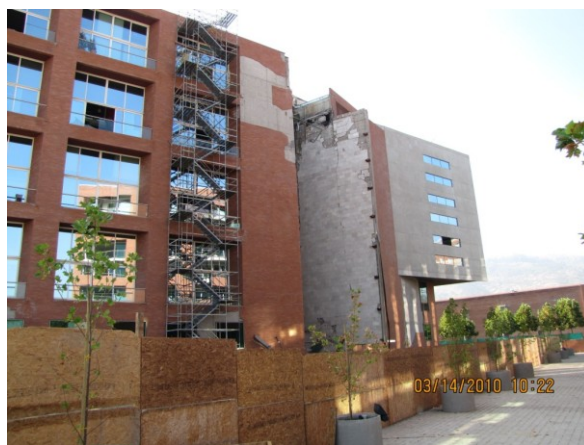
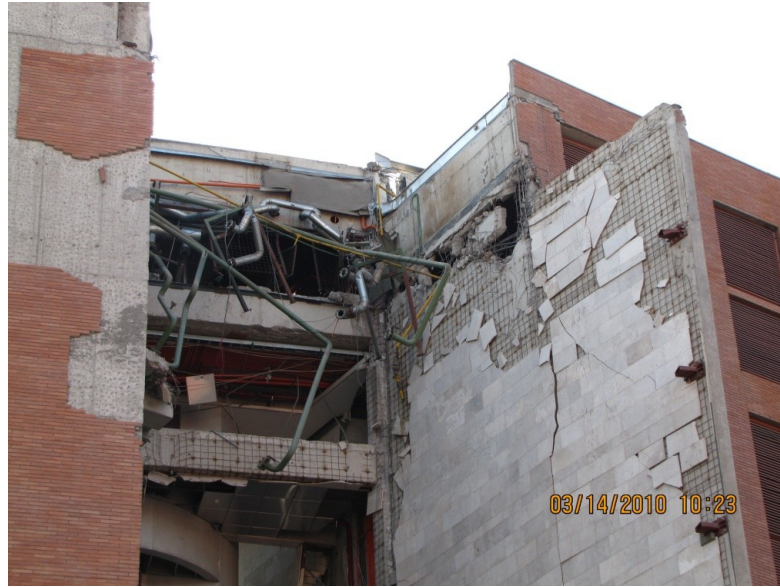
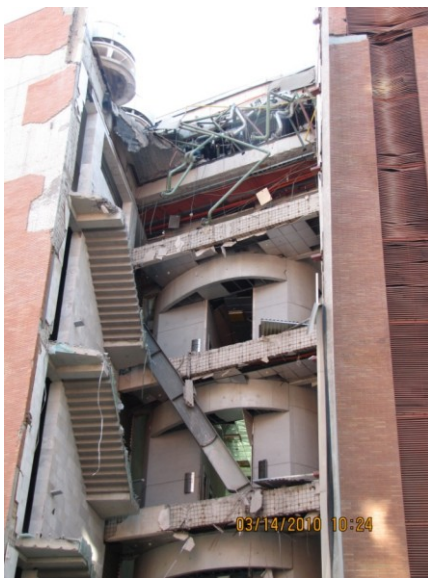
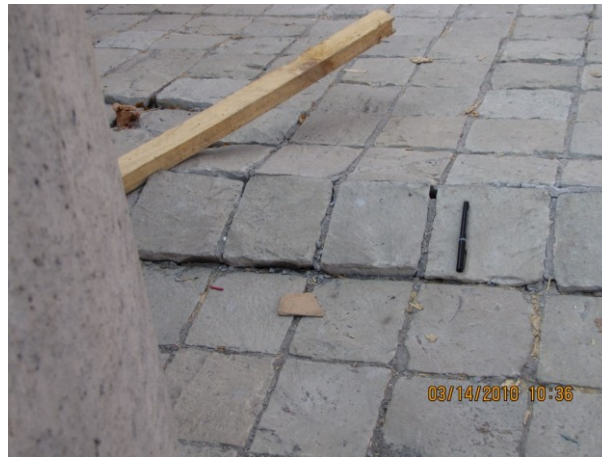
Figure 5.11. Site DA003 ($S33.387985^{\circ}$ $W70.618815^{\circ}$, 1015 hrs on 03/14/2010) 6-story commercial building. Damage of non-structural elements (glass windows, red brick façade) (Figures 11a,b) and emergency staircase (Figures 11c,d). Evidence of ground deformation (Figure 11e).

Overall, the business park was severely damaged, with 7 buildings that failed and were closed to the public. No total collapse was documented and no casualties were reported at the site, while the only evidence of soil deformation is shown in Figure 11e. The damaged structures ranged from a 5- to 12-stories, which to first approximation corresponds to 0.5-1.2 sec resonant periods (0.8-2 Hz).

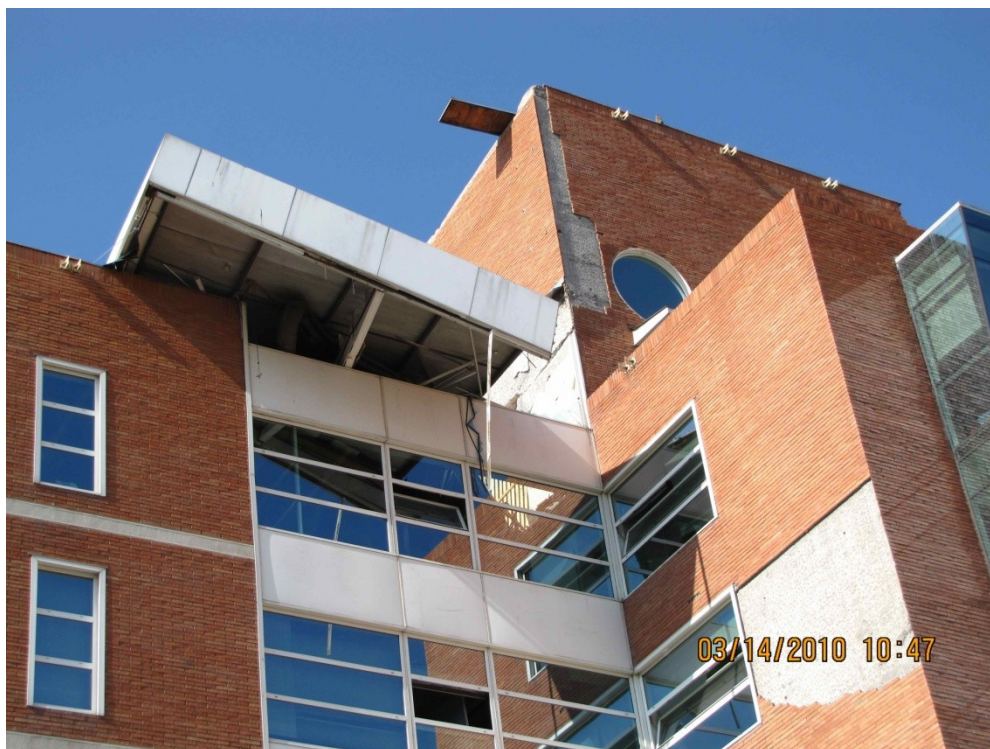
Figure 5.12. Site DA004 ($S33.387652^{\circ}$ $W70.617122^{\circ}$, 1047 hrs on 03/14/2010) Identical 7-story buildings connected; damage was observed in only one of the two.

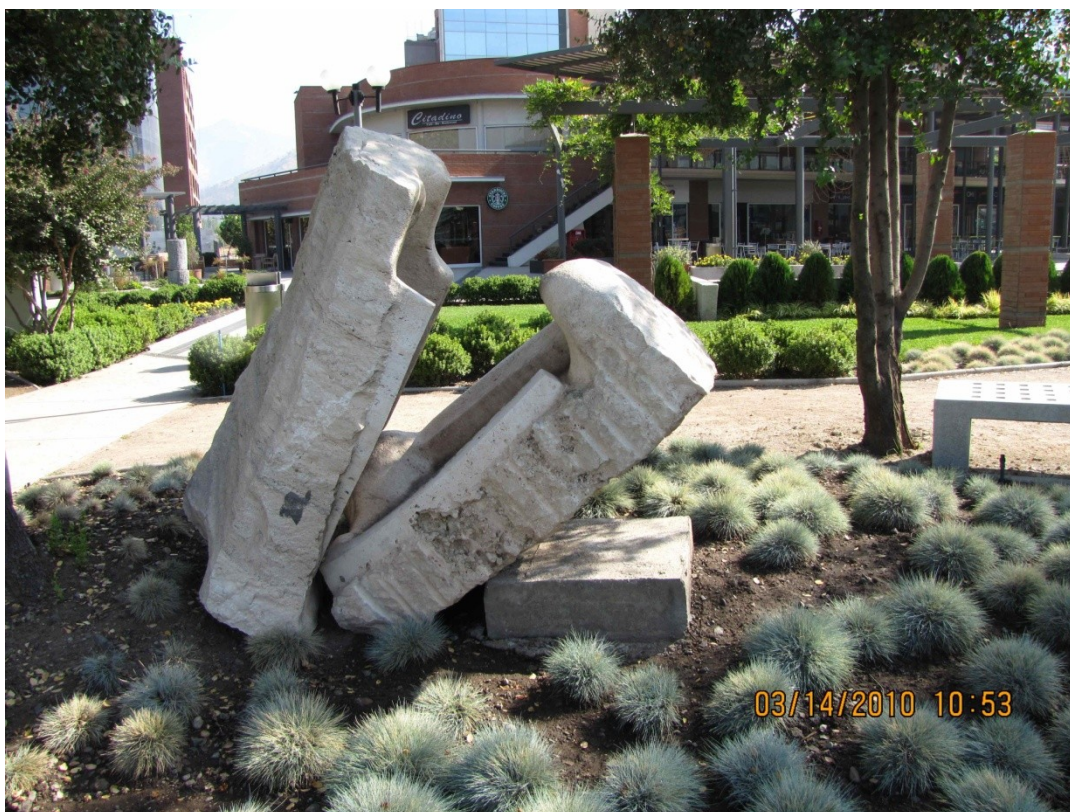
Figure 5.13. Site DA005 ($S33.387652^{\circ}$ $W70.617123^{\circ}$, 1053 hrs on 03/14/2010) Overtopped art.
