Geo-engineering Reconnaissance of the 2010 Maule, Chile Earthquake

Report of the NSF Sponsored GEER Association Team

GEER Association Report No. GEER-022

Version 1: April 15, 2010

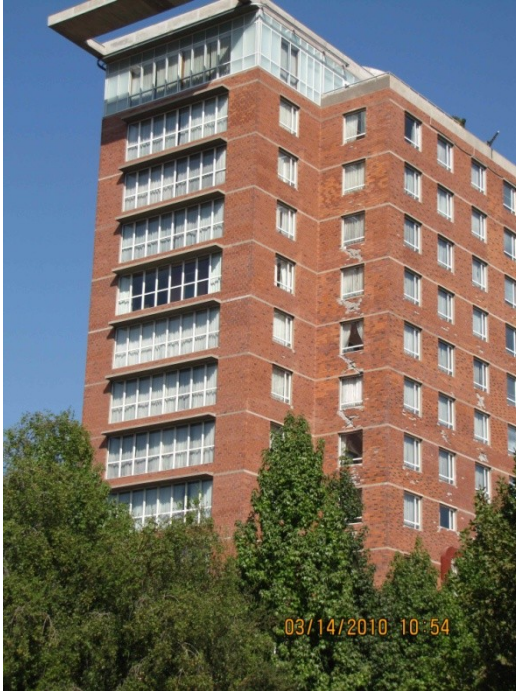
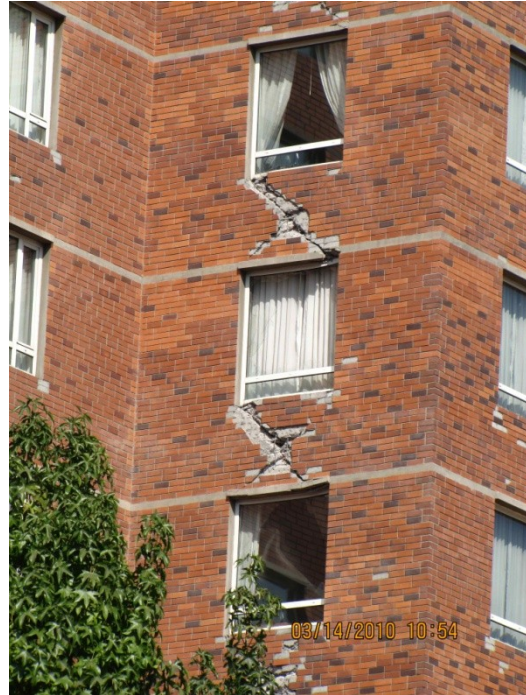
Figure 5.14. Site DA005 ($S33.387652^{\circ}$ $W70.617123^{\circ}$, 1054 hrs on 03/14/2010) 12-story building with severe structural damage.

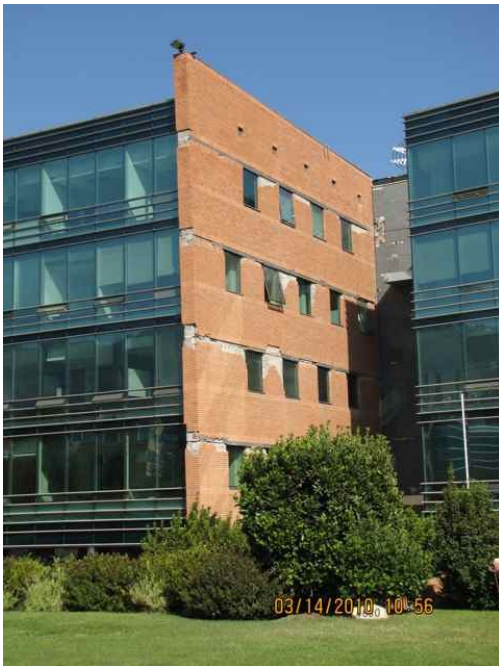
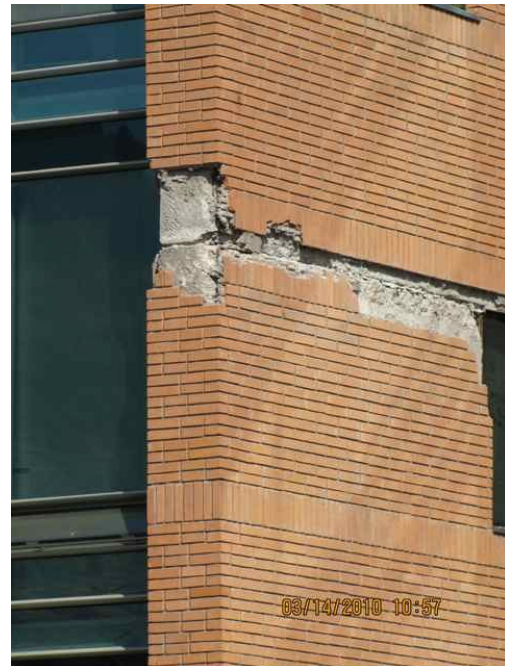
Figure 5.15. Site DA006 ($S33.389586^{\circ}$ $W70.618349^{\circ}$, 1056 hrs on 03/14/2010) 5-story building, structural damage.

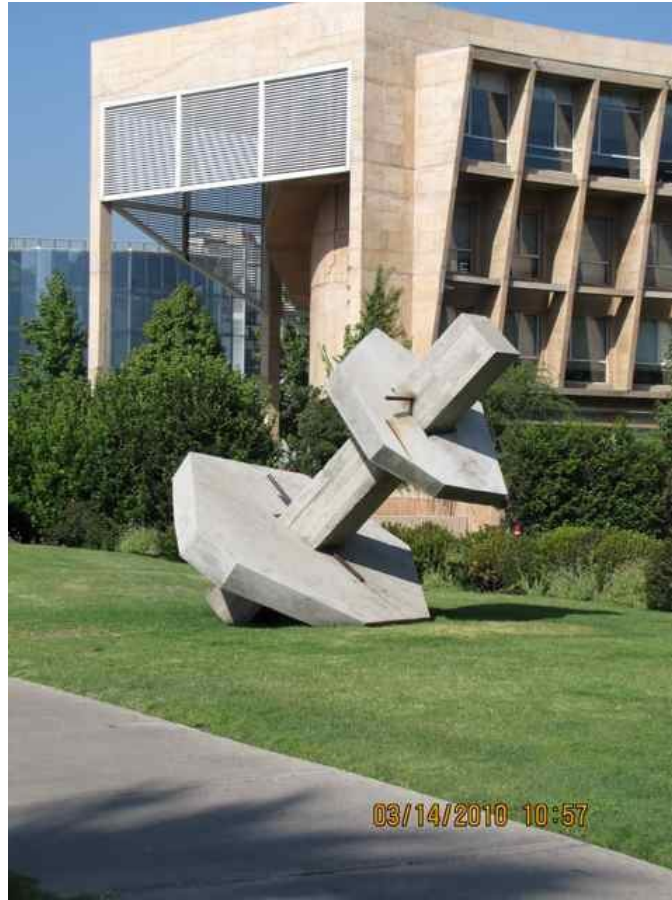
Figure 5.16. Site DA007 (S33.391163° W70.619502°, 1057 hrs on 03/14/2010) Minor external damage – non-structural. Overtopped art.

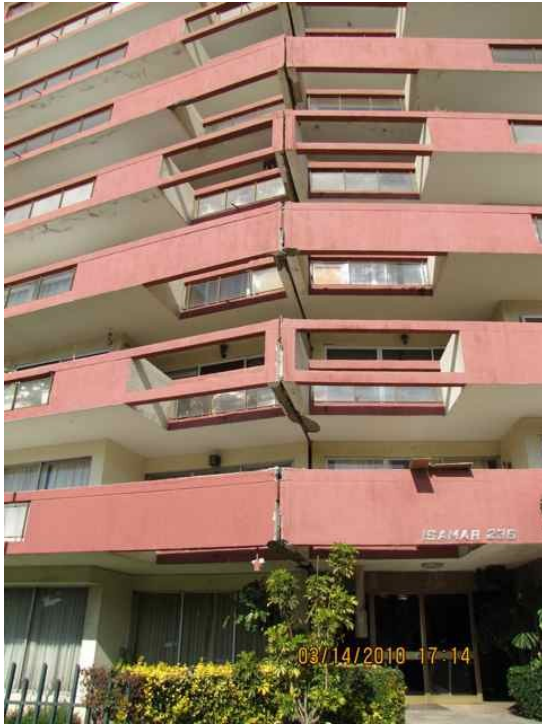
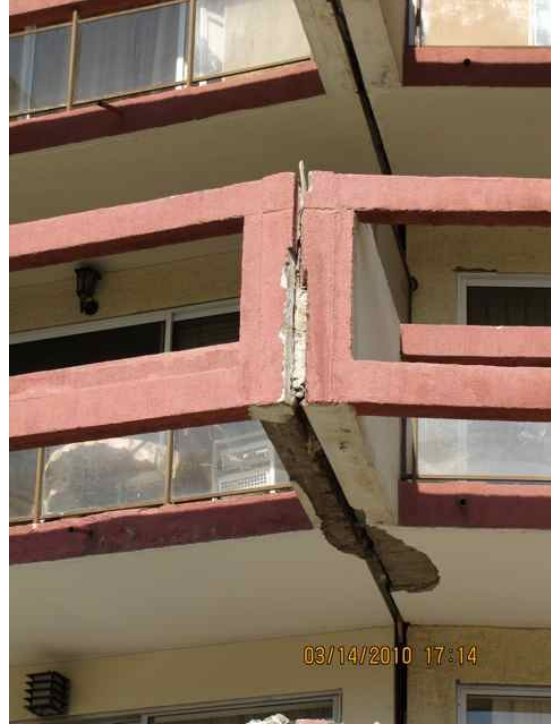
Figure 5.22 Site DA017 (S 33.018904° W 71.559206°, 1714 hrs on 03/14/2010) Damaged 9-story building.

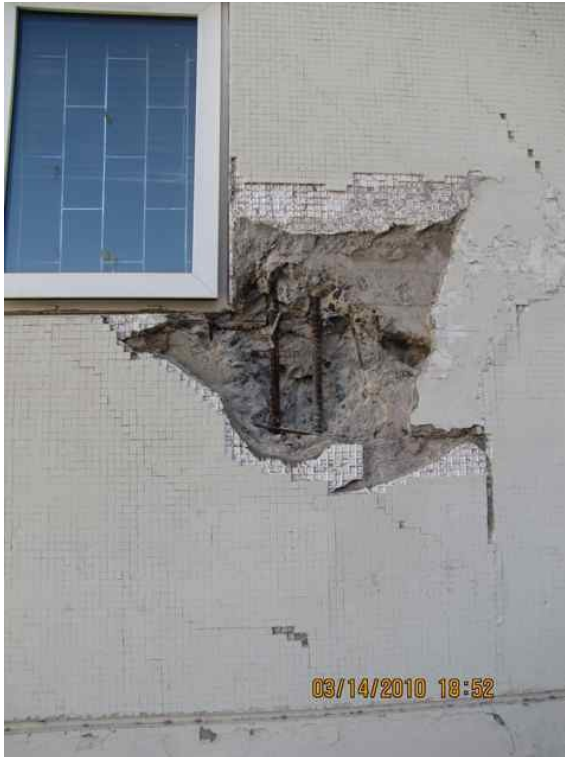
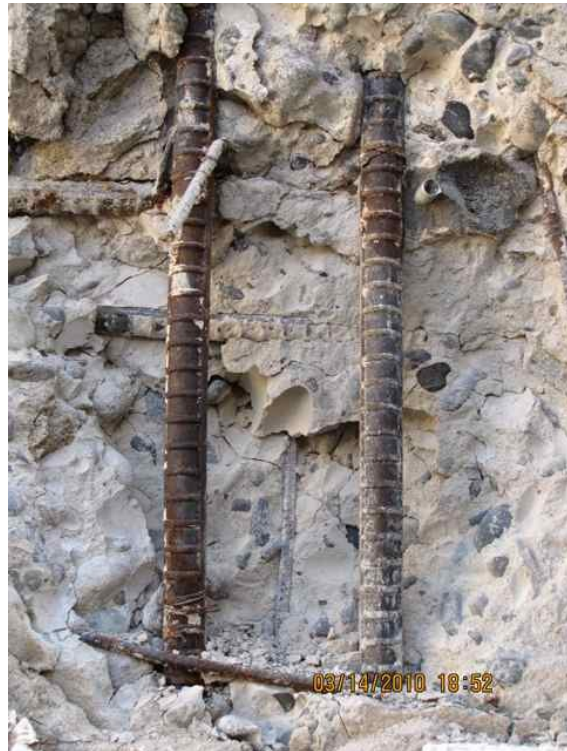
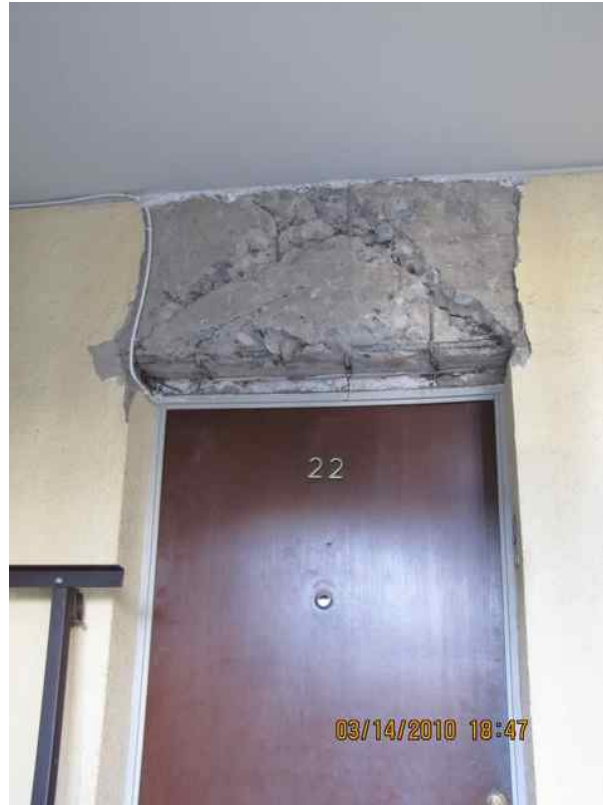
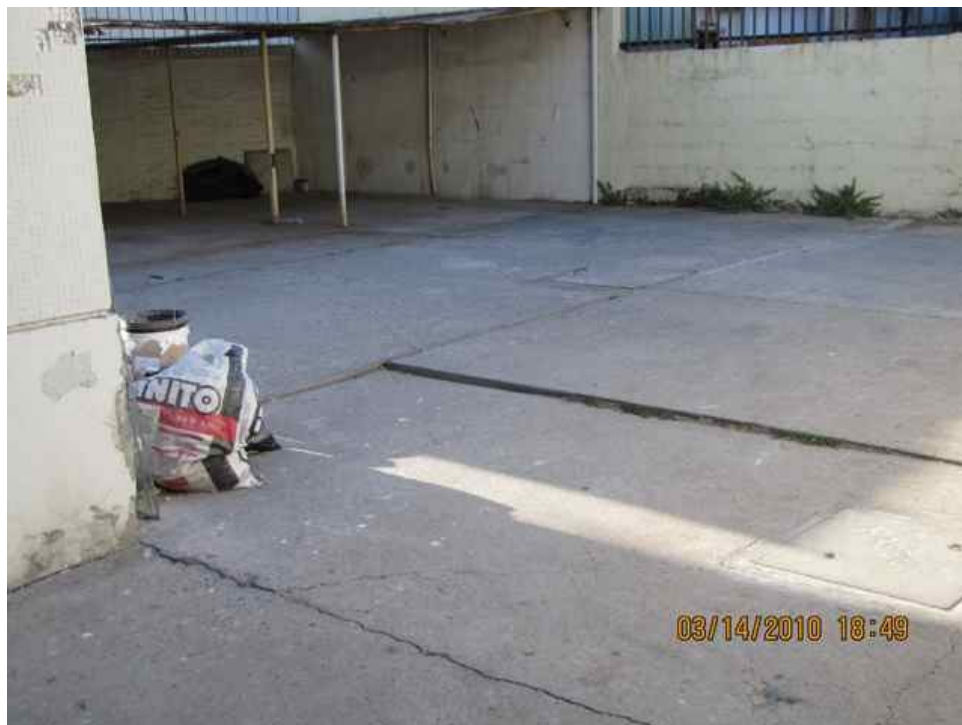
Figure 5.23. Site DA018 (S 33.017386° W 71.557107°, 18:48 hrs on 03/14/2010) Damaged 6-story building. Evidence of ground settlement.

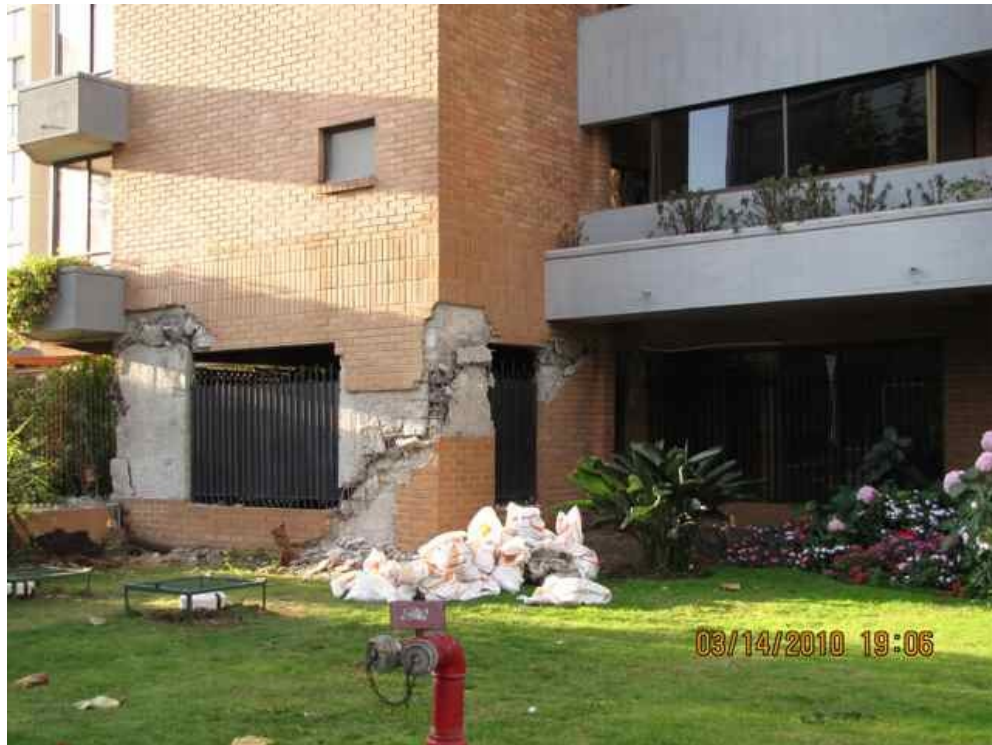
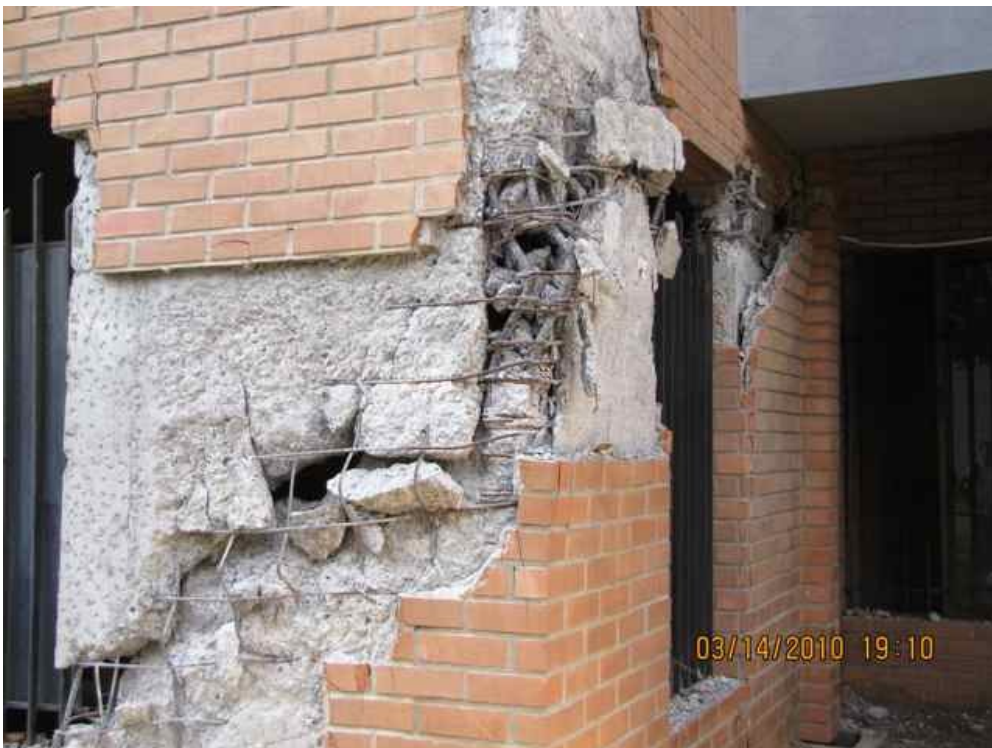
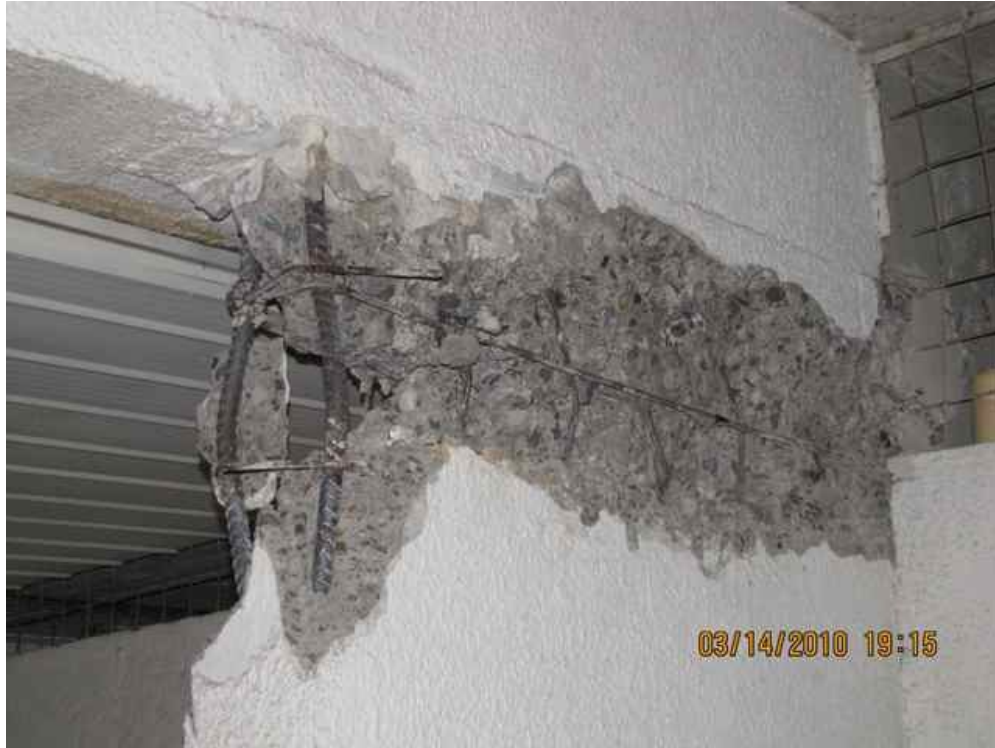
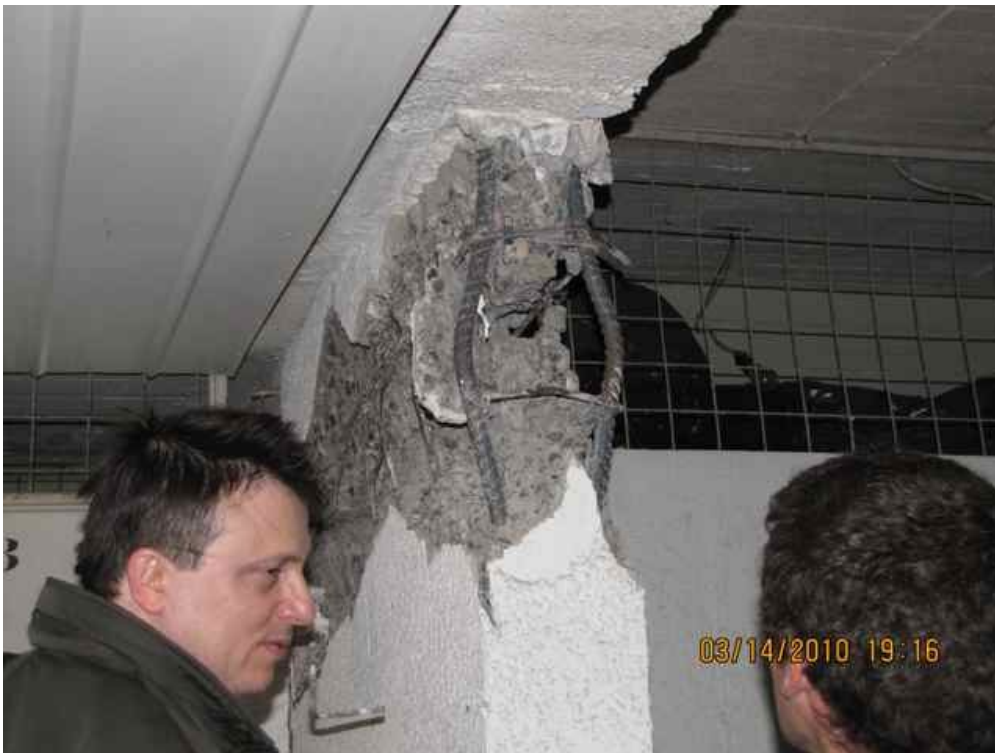
Figure 5.24. Site DA019 ($S33.016045^{\circ}$ W 71.551990° , 1916 hrs on 03/14/2010). Damaged 10-story building. Lack of confinement beam-column joints and low quality concrete.

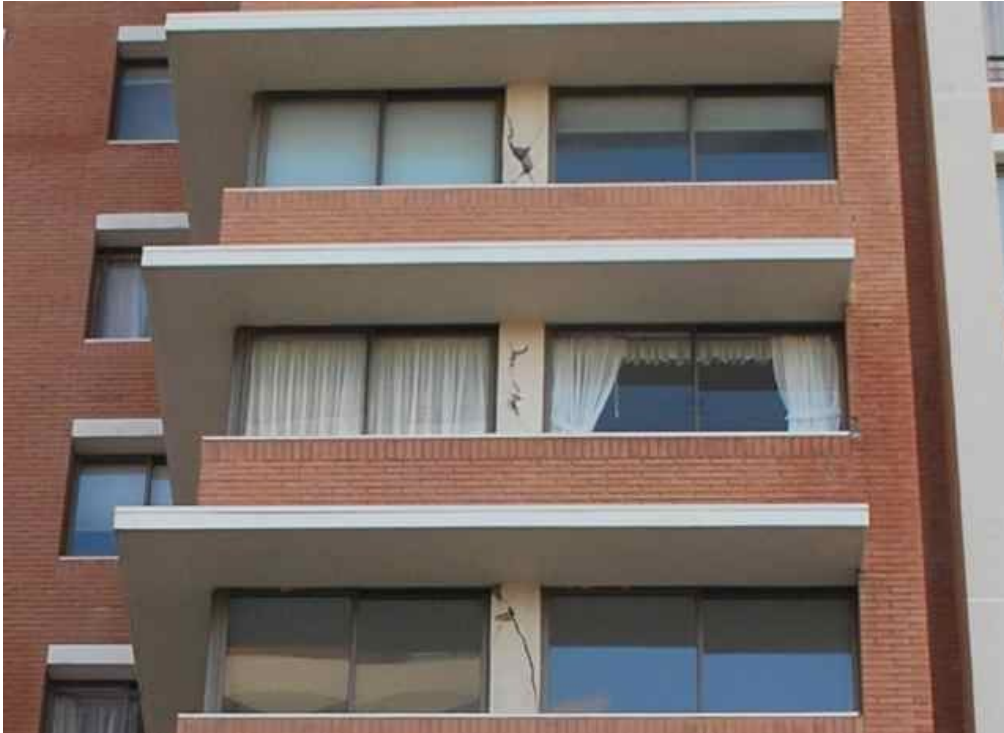
Figure 5.25. Site DA020 (S 33.018678° W 71.556288°, 1953 hrs on 03/14/2010). Diagonal cracks of columns in all the floors of 19-story building.

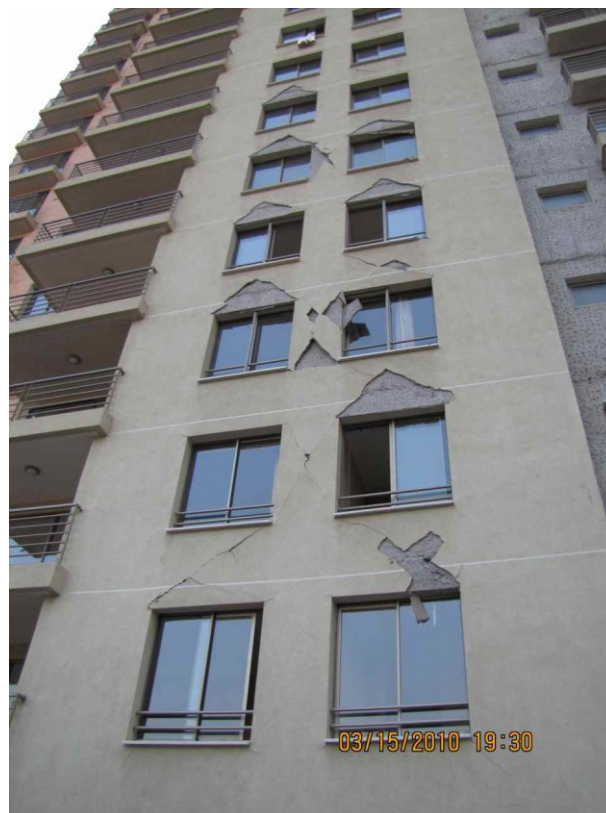
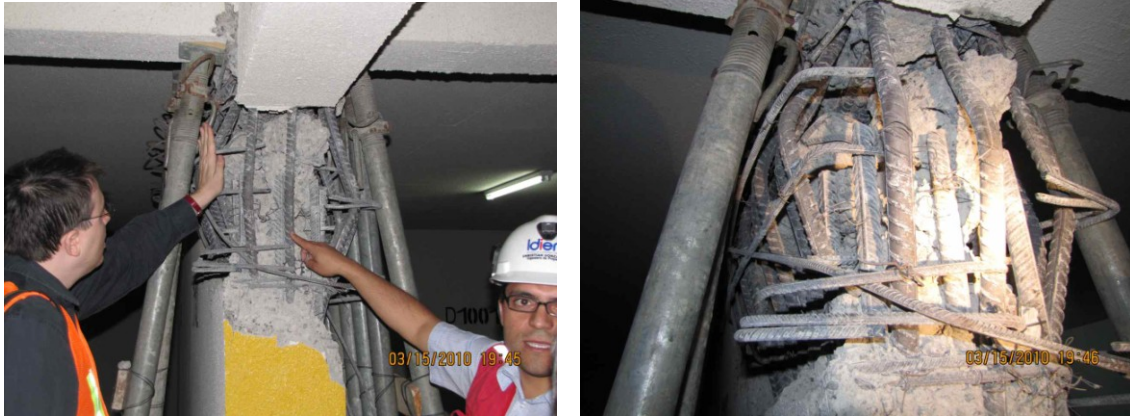
Figure 5.26. Site DA027 (S 33.020074° W 71.544055°, 1945 hrs on 03/15/2010). Heavily damaged 20-story building, lack of confinement at beam-column joints.

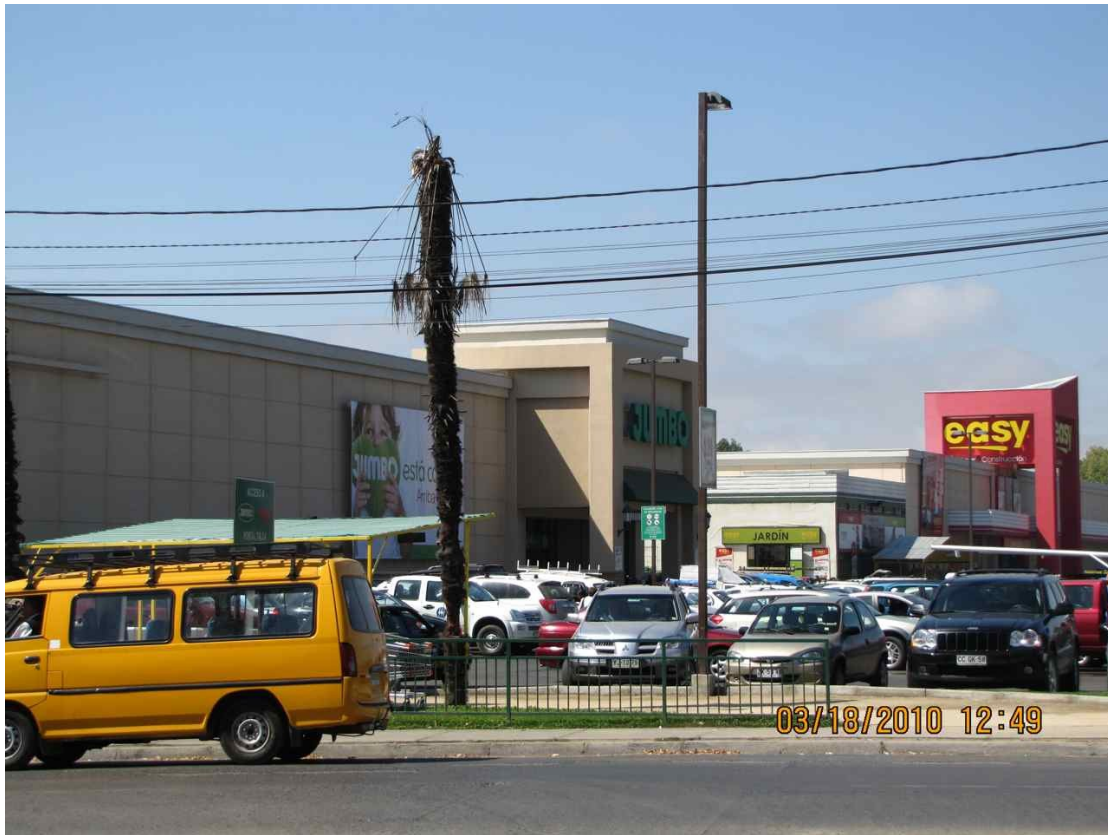
Figure 5.29. Modern (engineered) structures adjacent to the river that showed no or minor damage (S 35.437897° W 71.660151°, 1249 hrs on 03/18/2010).

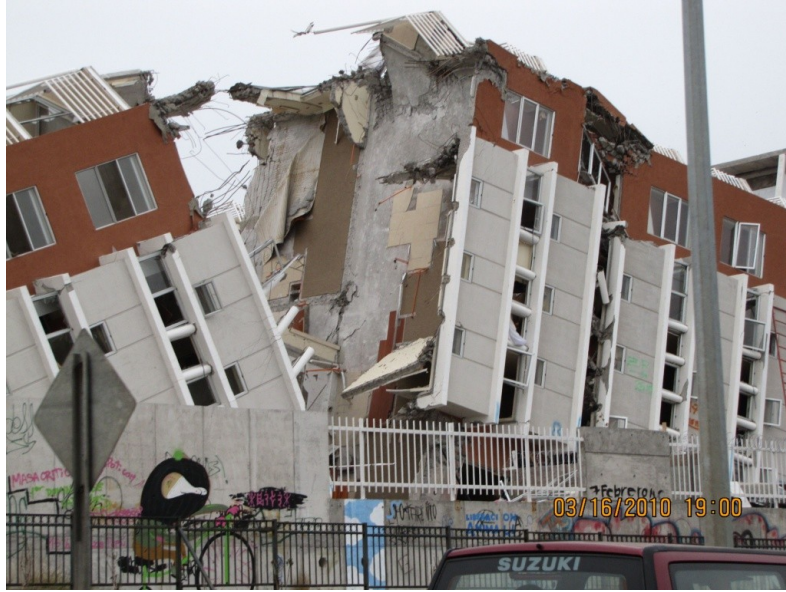
Two adjacent 20-story structures were inspected during reconnaissance close to the Llacolen bridge in downtown Concepción (see location in Figure 5.32), one fully collapsed during the 2010 event and the other suffered minor damage and is currently being repaired. The collapsed building was designed using Site Type II (Chilean design code) and the one that did not collapse using Site Type III, which implies different design spectra. While there is no evidence that the soil conditions are indeed different at the locations of the two structures (distance between approximately 20m), the difference in design spectra likely played an important role in the failure of the building. The locations of the two buildings are depicted in Figure 5.33 below.

Figure 5.34. Collapsed structure (S 36.828067° W73.061639°, 1900 hrs on 03/16/2010) designed using Soil Type II conditions.

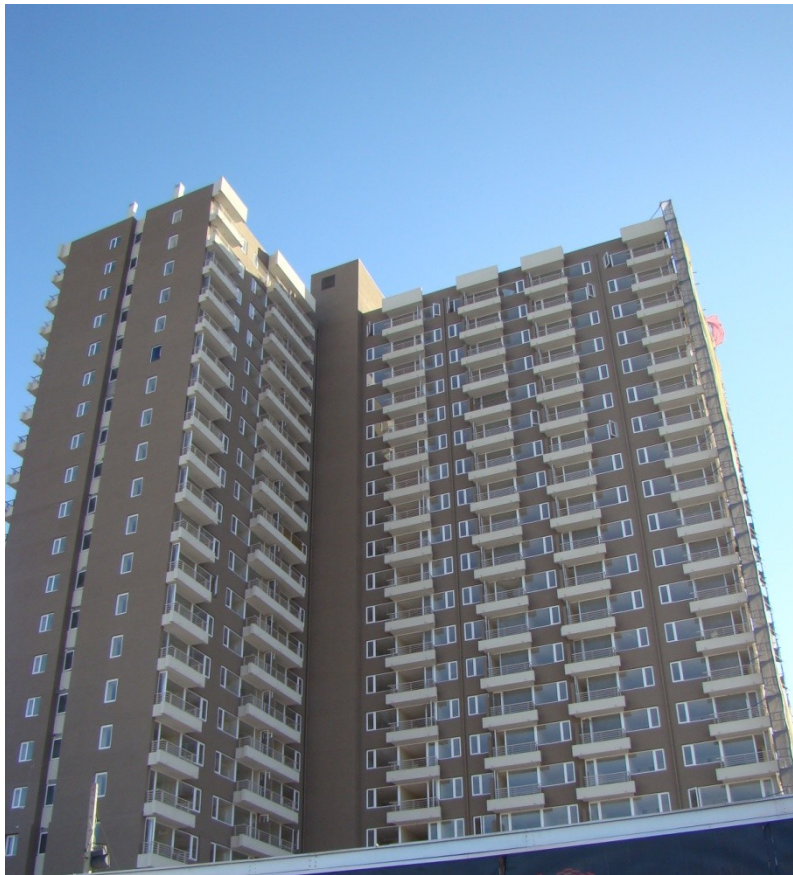
Figure 5.35. 20-story structure adjacent to collapsed (S 36.828083° W 73.060600°, 1910 hrs on 03/16/2010) designed using Soil Type III conditions, and suffering only minor damage.

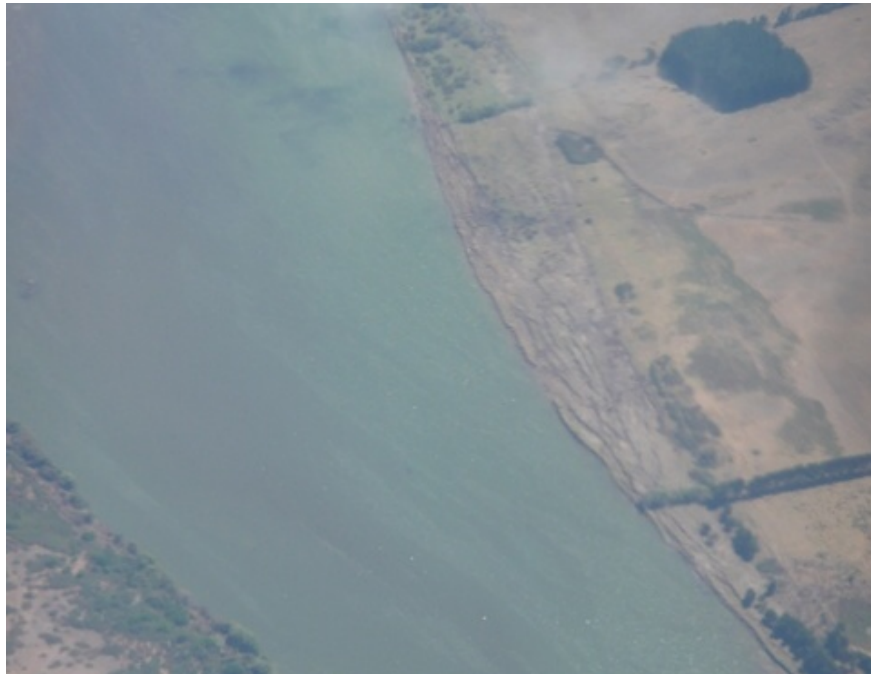
Figure 6.3. Lateral spreading feature observed along Rio Maipo towards the northern extents of damage

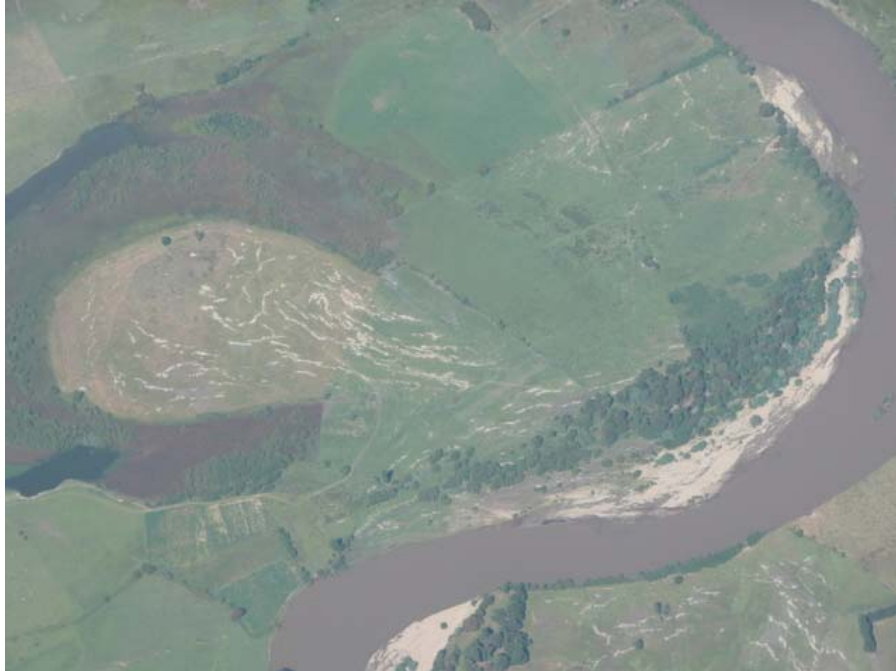
Figure 6.4. Liquefaction ejected and lateral spreading features observed along Carampangue River towards the southern extents of damage ($\sim S37.2780^\circ$, $\sim W73.2541^\circ$, 17:00, 3/6/2010).

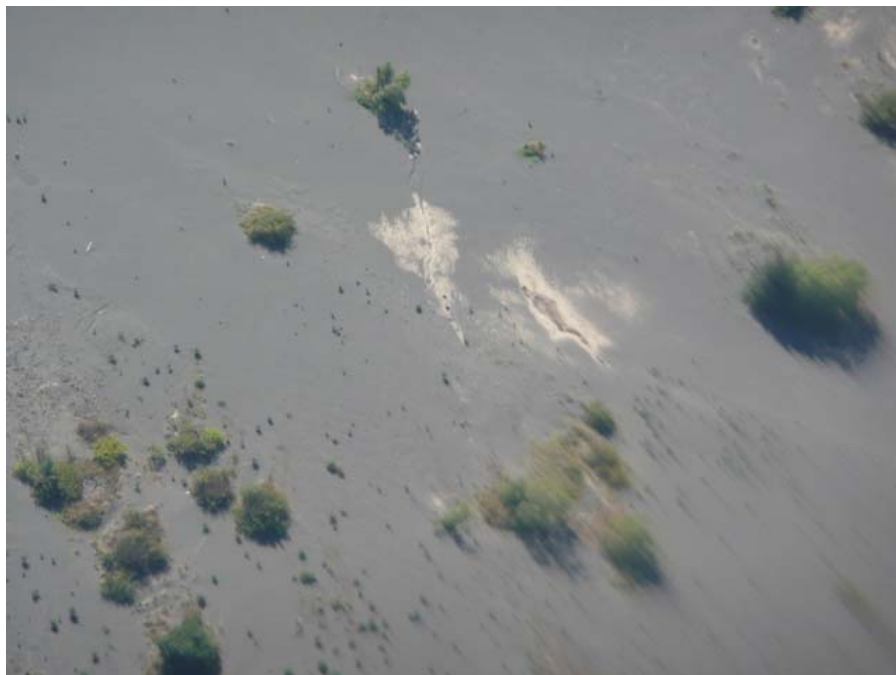
Figure 6.5. Lower elevation view of fissures and liquefaction ejecta. This was taken along the lower Rio Bio Bio near Concepcion ($\sim S36.8239^\circ$, $\sim W73.0944^\circ$, 15:00, 3/6/2010). The dark surface sediment is from the Rio Laja that intersects the Bio Bio approximately 20-30 km upstream from this point. The light ejected sediment is supplied by the main stem of the Rio Bio Bio upstream of the Rio Laja.

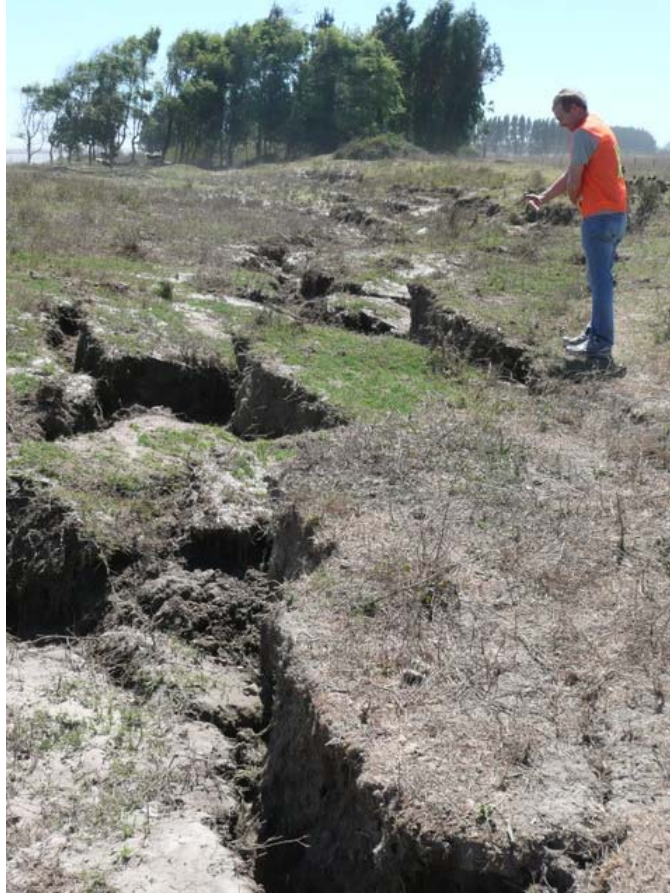
Figure 6.6. Lateral spreading blocks translated and rotated towards the river. This picture shows Keith Kelson standing on the north bank of the Mataquito River downstream of the coastal highway bridge (S3505078°, W72.16240°, 11:00, 3/8/2010).

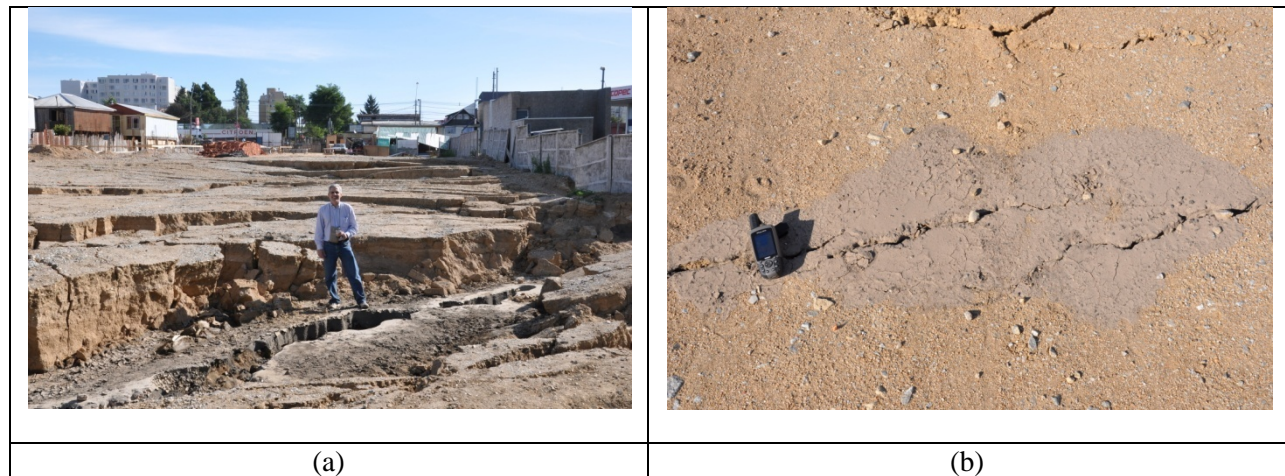
Figure 6.7. Images of lateral spread (a) and (b) liquefaction boils in undeveloped land area along west shore of Tres Pasquales lagoon in Concepcion (S36.8155°, W73.0460°)

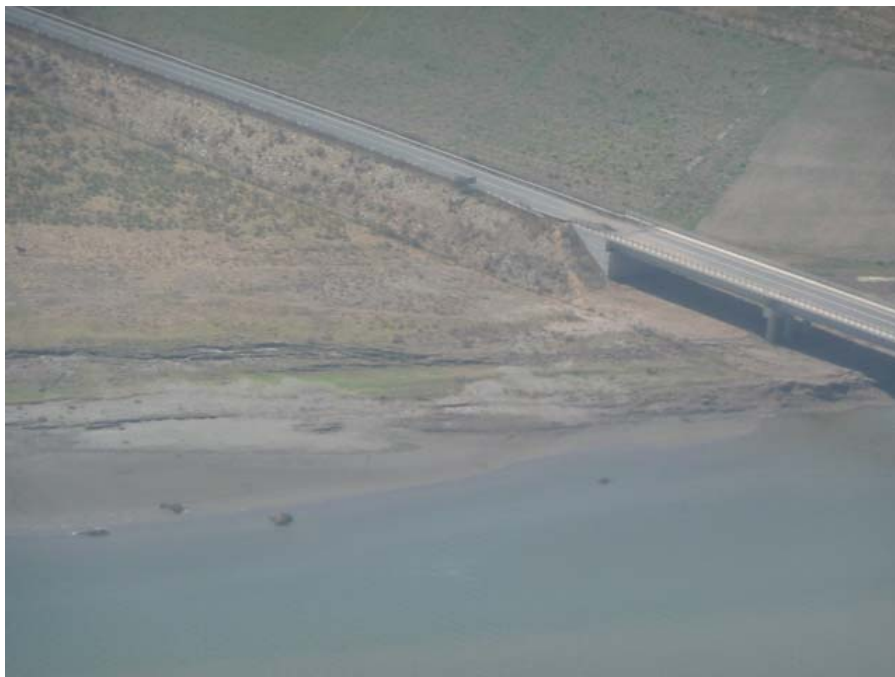
liquefaction under the approach fills that contributed to deformations. Mataquito Bridge (Figures 6.9-6.14) exhibited this type of performance and is used here for illustrative purposes. The north approach was founded on river sediments that liquefied and spread towards the river causing medium to large transverse and longitudinal deformations in the approach fill. The south approach however was founded on dune sands over possibly shallow bedrock and exhibited better seismic performance. Lateral spreading occurred around both north and south bridge bents but the deformations appear to have been “pinned” by the pile foundation. Liquefaction and lateral spreading associated with bridges were observed in many locations from the air and at the following locations on the ground; the Rio Itata River bridge, Juan Pablo II bridge, and LLacolen bridge, Concepcion bridge, Lota bridge, Tupul bridge, and others.

Figure 6.9. Lateral spreading on the north bank of the Mataquito Bridge along the coastal highway (S3505078°, W72.16240°, 11:00, 3/10/10).

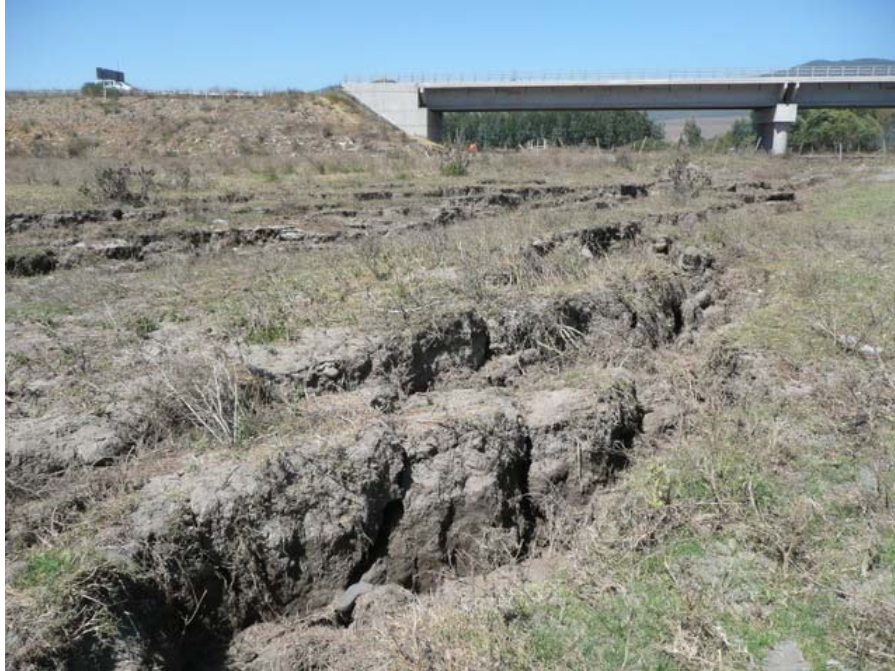
Figure 6.10. Ground based image of the previous photo (S3505078°, W72.16240°, 11:00, 3/8/2010).

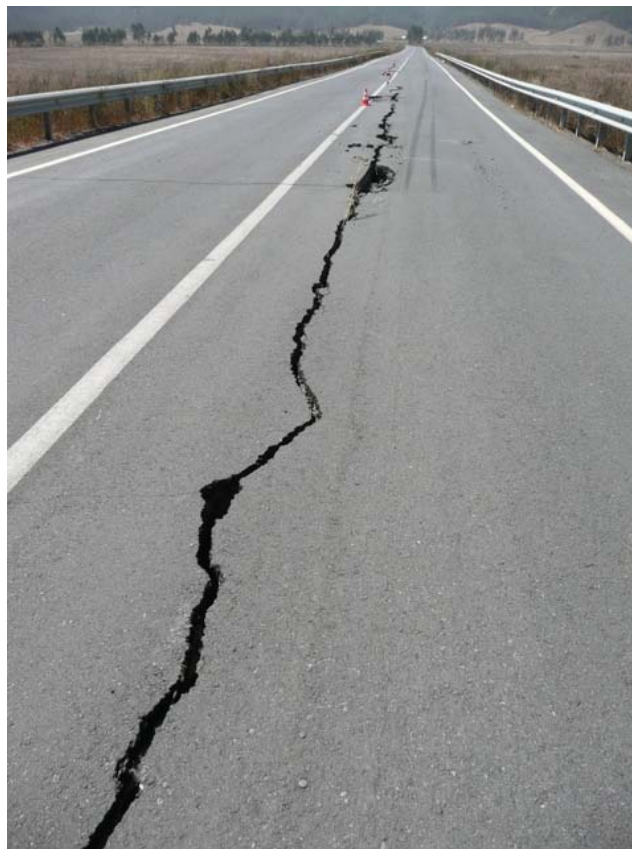
Figure 6.11. Impact of liquefaction and lateral spreading on the north approach fill of Mataquito Bridge (S3505078°, W72.16240°, 11:00, 3/8./2010).

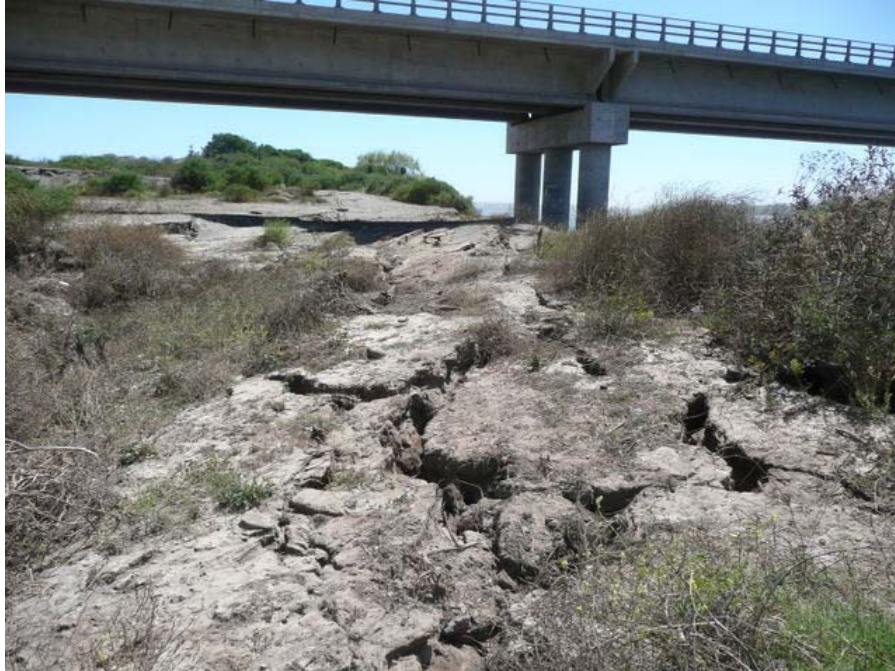
Figure 6.12. Lateral spreading at the south landing of the Mataquito bridge along the coastal highway (S3505078°, W72.16240°, 11:00, 3/8/2010).

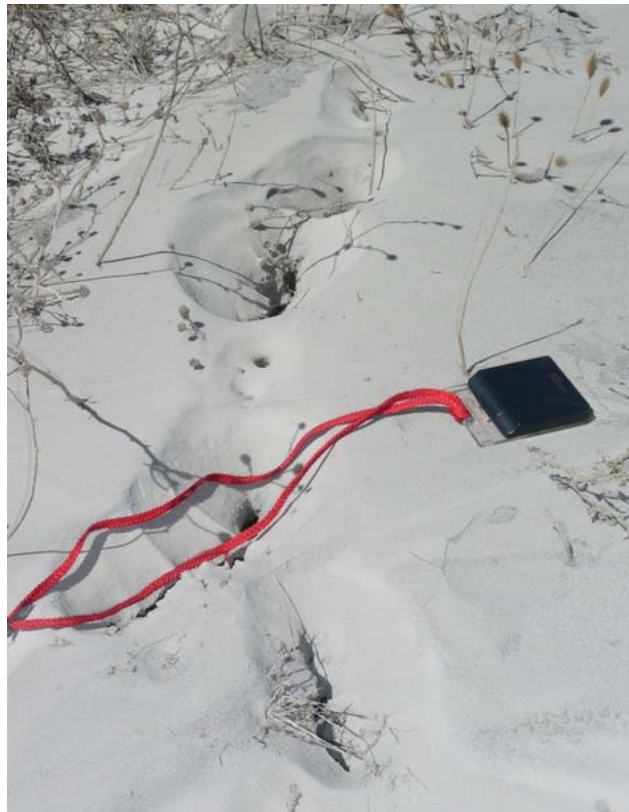
Figure 6.13. Typical liquefaction ejecta found at Mataquito bridge (S3505078°, W72.16240°, 11:00, 3/8/2010).
The ejecta consisted of medium to fine sand with some fines.

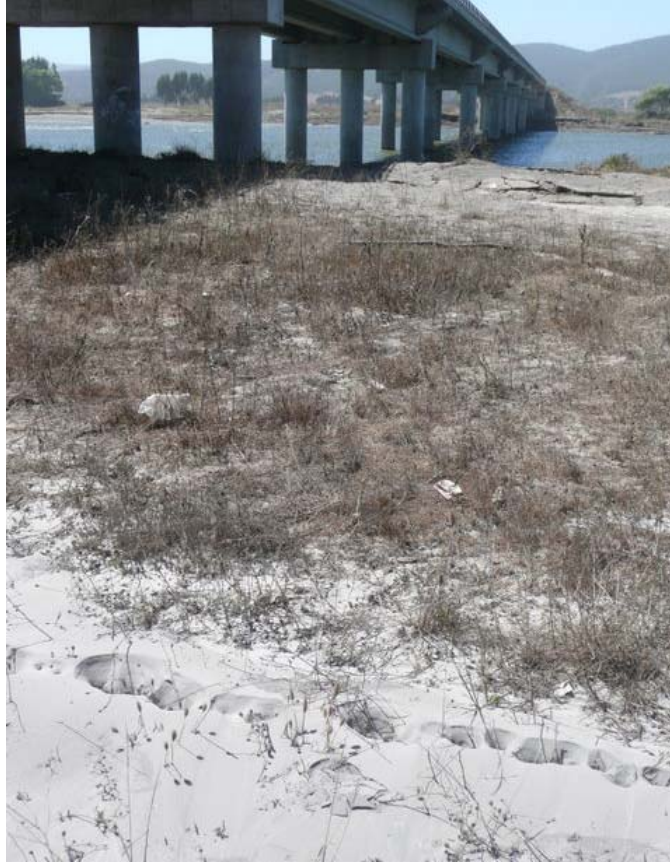
Figure 6.14. Ejecta in the foreground and lateral spreading cracks in the back ground along the south landing of the Mataquito bridge (S3505078°, W72.16240°, 11:00, 3/8/2010).

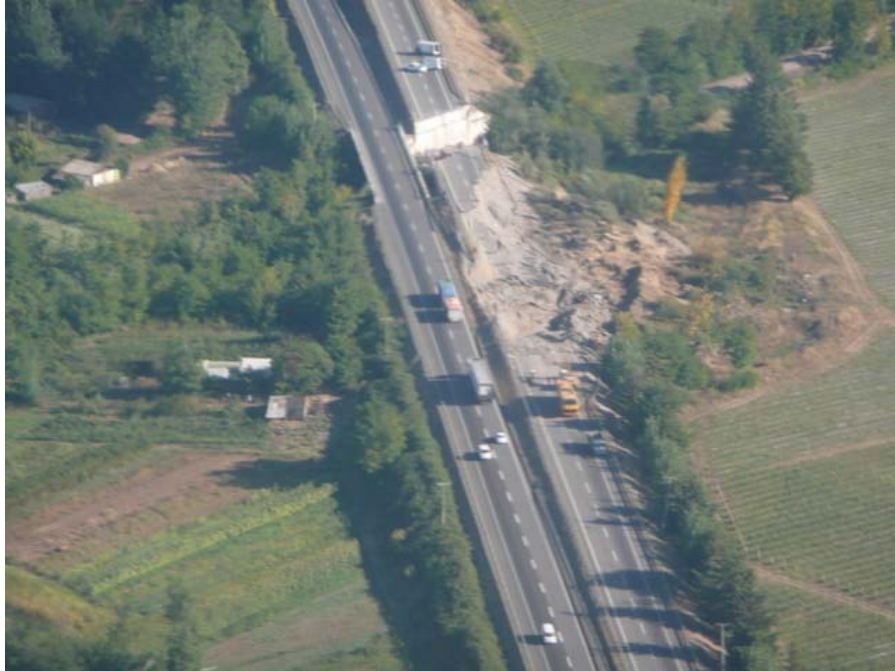
Figure 6.15. Typical road base failure along Pan American highway. Line of trees show where the water crossing intersects the highway. These type of road failures were observed at regular intervals corresponding to the minor water crossings. This picture is from near the town of Curico ($\sim S34.7794^\circ$, $\sim W71.1599^\circ$, 17:30, 3/6/2010).

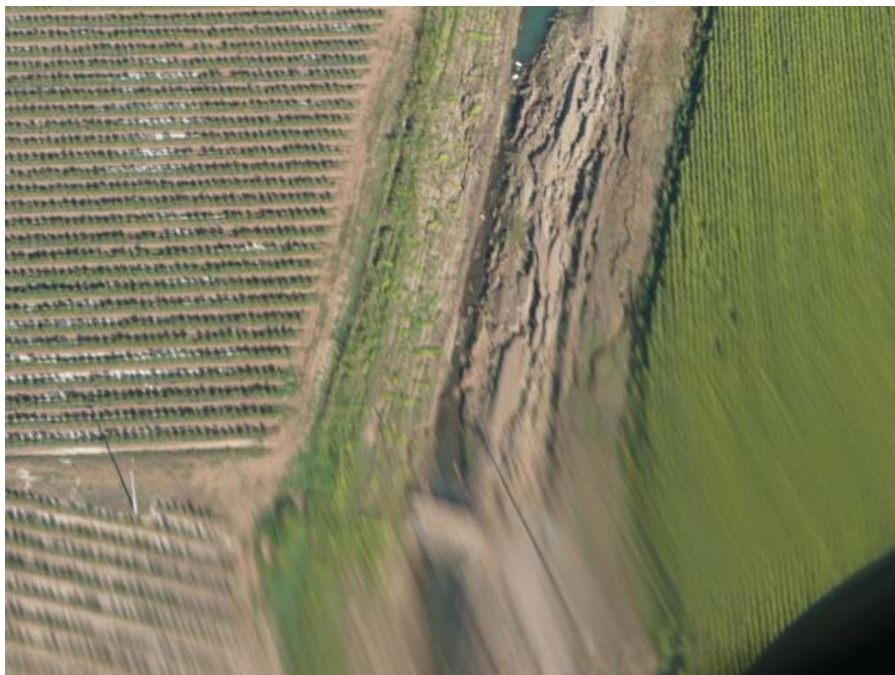
Figure 6.16. Lateral deformations in an agricultural ditch along the Pan American highway. Along the highway these non-engineered features performed very poorly in comparison with the engineered water crossings that fared much better ($\sim S34.7794^\circ$, $\sim W71.1599^\circ$, 17:30, 3/6/2010).

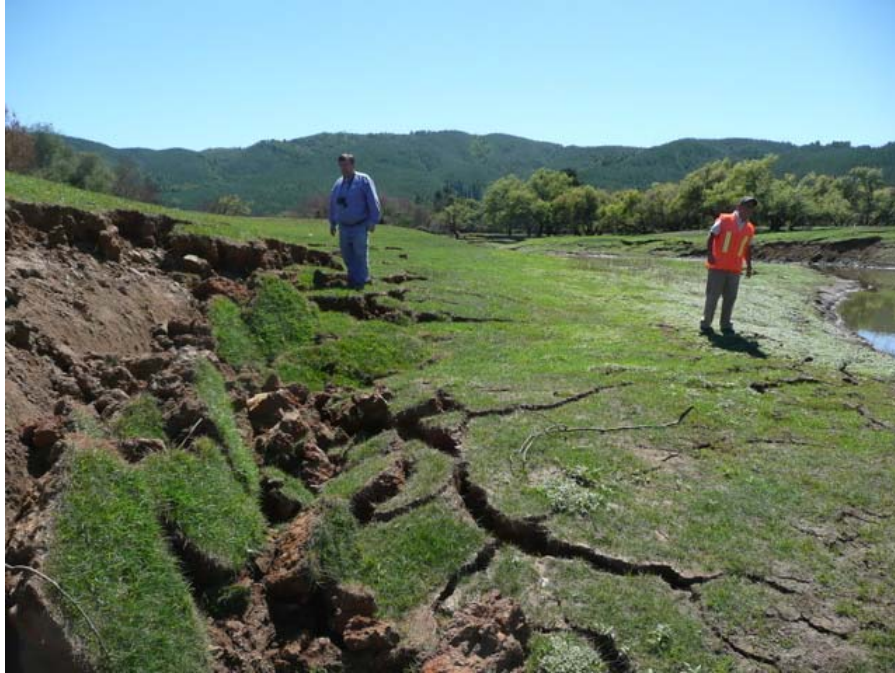
Similar lateral spreading was observed on the ground near Tutuven Dam (Figure 6.17). Deformations were seen along the banks of the stream near the upstream end of the reservoir that may have been due to liquefaction. The dam itself however was not subjected to poor foundation performance as it appears from the topography and geomorphology that the foundation soils are primarily competent hillslope soils not susceptible to strength loss.

Figure 6.17. Deformations at the upstream end of Tutuven reservoir that may have been due to liquefaction (S35.87581°, W72.39243°, 11:30, 3/9/2010). These deformations posed no engineering threat to the reservoir, and the earth dam (not pictured) built in the 1940's appears to be founded on competent material that did not experience detrimental strength loss.

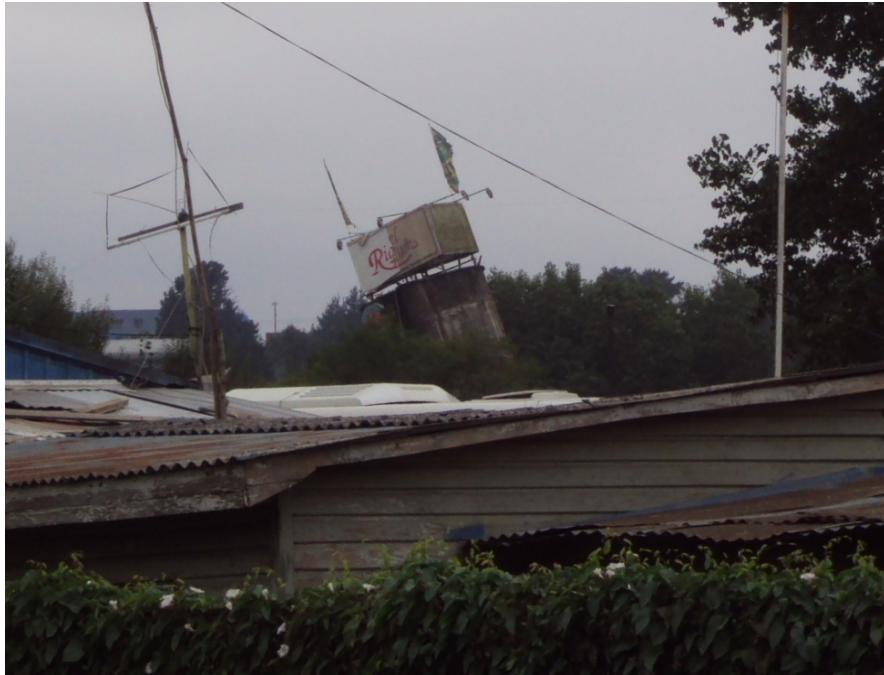
Figure 6.18. Leaning tank due to liquefaction of the foundation soil, near Arauco (S37.2458°, W73.3197°).

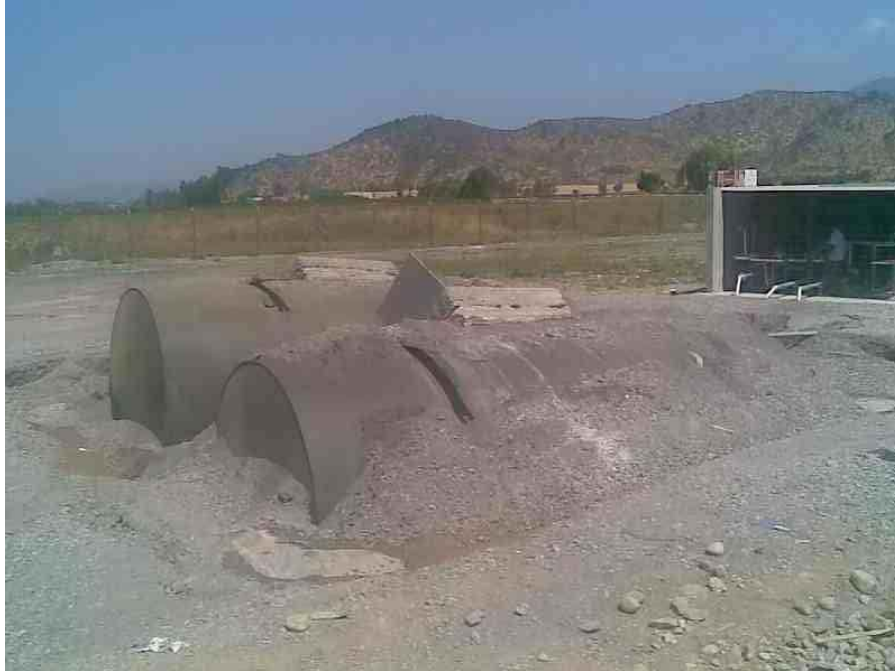
Figure 6.19. Tanks buoyed above the ground surface when the higher unit weight soil fluidized due to excess pore pressure generation. This occurred near San Fernando ($\sim S34.5898^\circ$, $\sim W70.9890^\circ$)
