Geo-engineering Reconnaissance of the 2010 Maule, Chile Earthquake

Report of the NSF Sponsored GEER Association Team

GEER Association Report No. GEER-022

Version 1: April 15, 2010

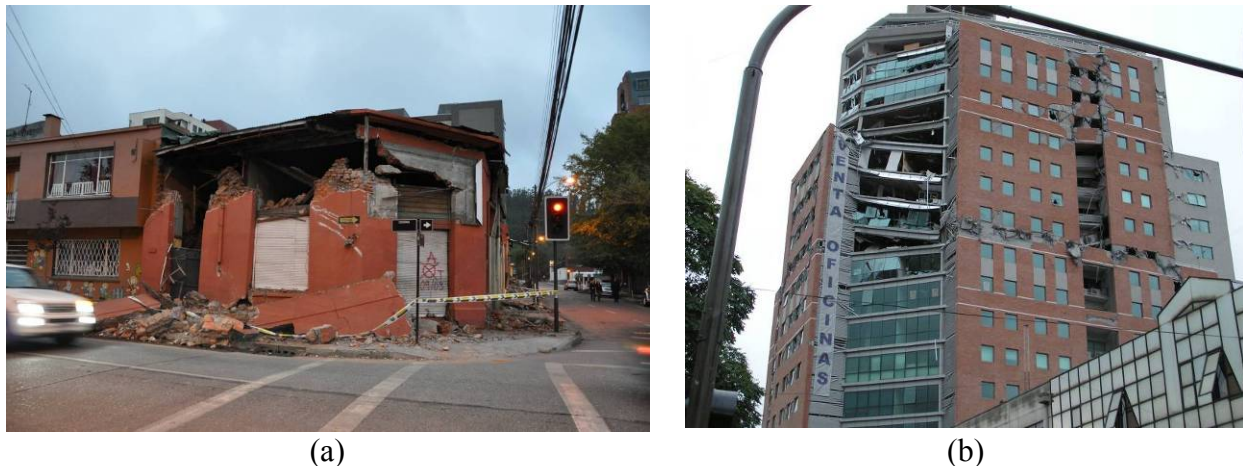
Figure 7.1. (a) Typical construction type and observed damage within the city of Talca ($S36.8323^\circ, W73.0554^\circ$; 1230 hrs on 3/18/2010) and (b) Significant structural damage, including partial collapse of a floor, of a modern high-rise building in downtown Concepción ($S36.8296^\circ W73.0550^\circ$; 2000 hrs on 03/17/2010).

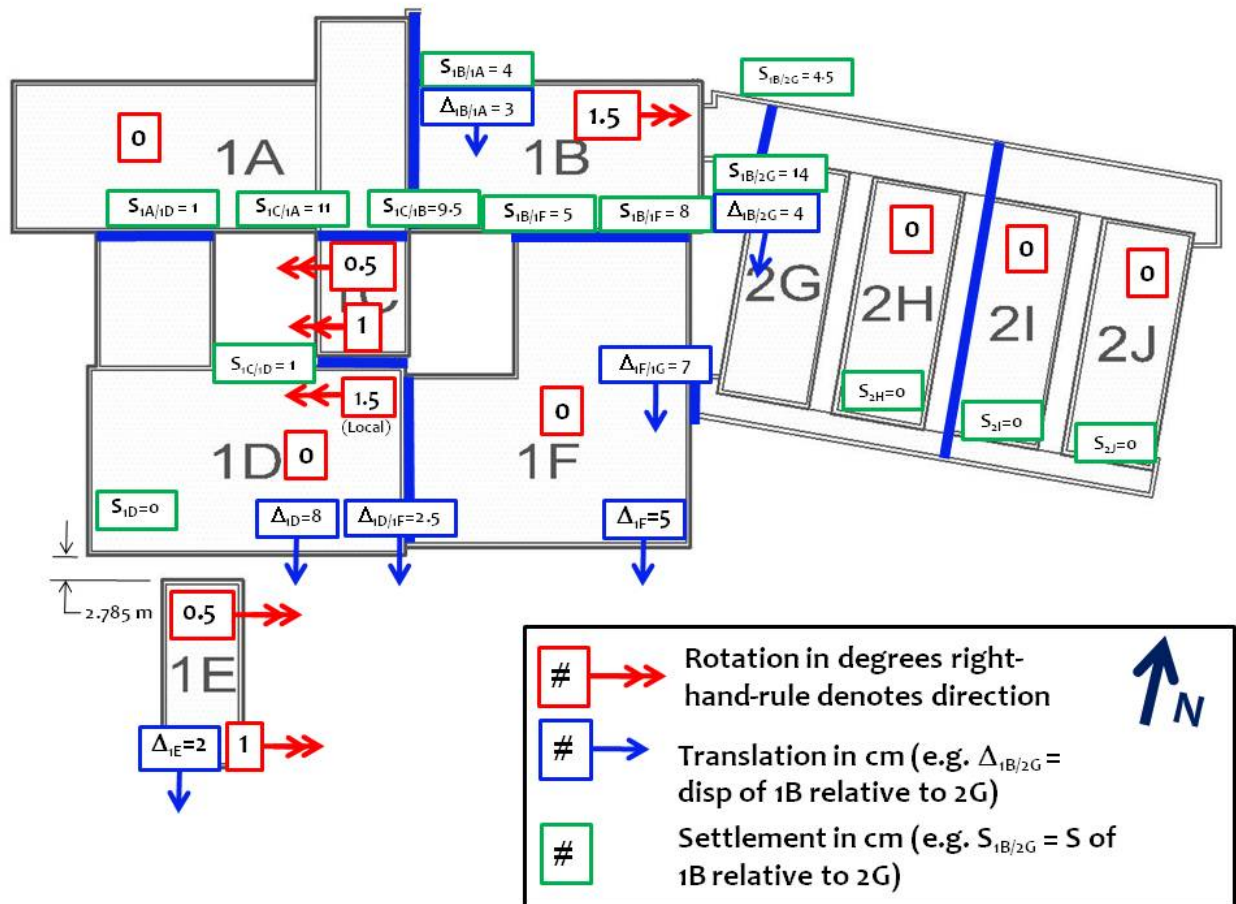
Measurements of relative building movement and tilt are provided on Figure 7.8. Wing 1C is the tallest wing and it contains the primary elevator shaft. It displaced downward the most relative to the other wings of the hospital. Wing 1C displaced downward around 11 cm relative to 1A. Wing 1C displaced downward about 9.5 cm relative to the southwest corner of Wing 1B, and Wing 1C displaced downward 1 cm relative to Wing 1D. The northeast side of Wing 1D was pulled down locally with respect to Wing 1C and a tilt of 1.5° downward toward Wing 1C was measured on the ground floor of Wing 1D in this area. As no tilt was measured in Wings 1A and 1D, the non-uniform downward displacement of Wing 1C indicated that it tilted somewhat back towards Wing 1A.

Figure 7.8. Measurements of relative building movement (Bray, Hutchinson, Arduino, and Maureira).

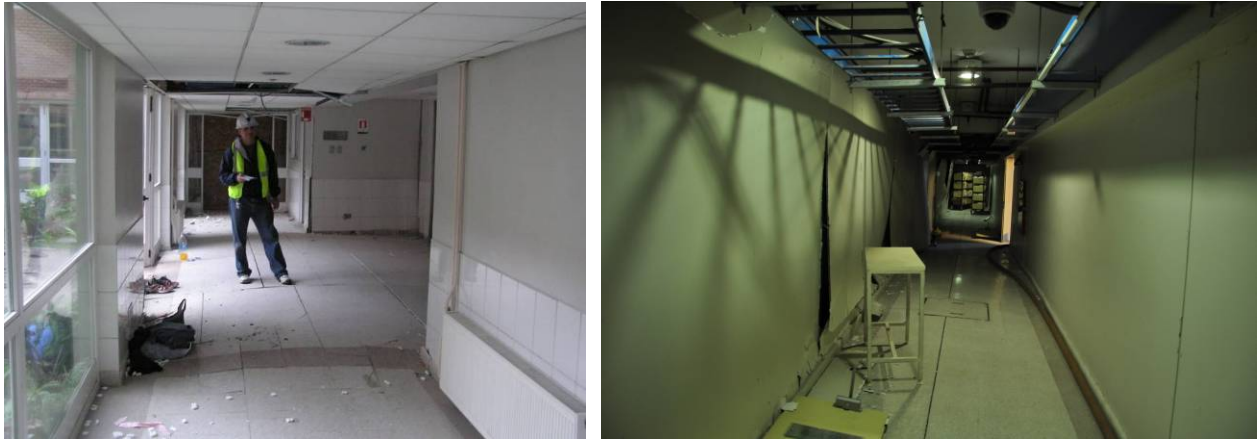
There was also evidence of internal distortion of these structures and their foundations. Bulging of the ground slab in front of the elevator shaft in Wing 1C is shown in Figure 7.9a. The slab raised up about 19 cm relative the undeformed slab in the foreground of the picture. There was also evidence of floor bulging up or distorting in other wings of the hospital, such as the extensive warping of the slab-on-grade in Wing 1B as shown in Figure 7.9b.

Figure 7.9. Distortion of the slab-on-grade: (a) floor bulging in front of elevator shaft in Wing 1C (S37.47345°, W73.34835°), and (b) floor distortion in eastern hallway of Wing 1B (S37.4733°, W73.3478°).

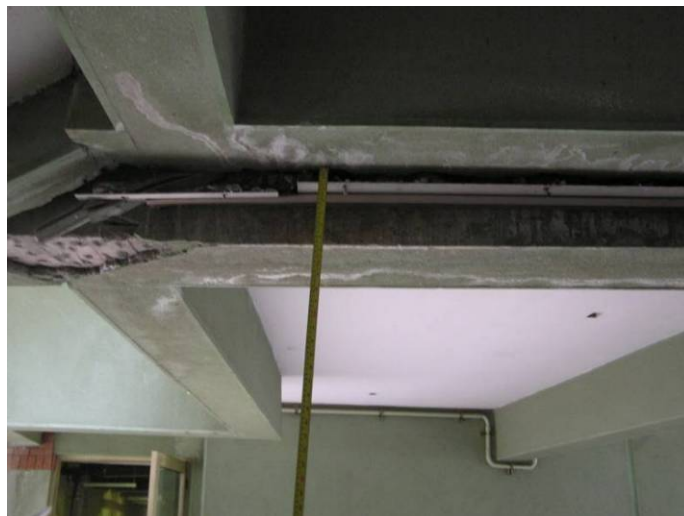
Relative movement between Wings 1B and 2G was apparent at the connection of these two wings as shown in Figure 7.10. At the northeast corner of the Wing 1B extension adjacent to the northwest corner of Wing 2G, Wing 1B displaced 4.5 cm downward and 4 cm southward relative to Wing 2G. The downward movement of Wing 1B relative to Wing 2G at the location of the photograph shown in Figure 7.10 was 14 cm. The measured relative offset between these two wings, however, was non-uniform, which suggested that Wing 1B tilted with respect to Wing 2G, which appeared not to tilt. The tilt of Wing 1B was reliably measured to be 1.5° with its top displacing to the south relative to its base. The southeast corner of Wing 1B displaced downward 8 cm relative to Wing 1F. The northwest corner of Wing 1B displaced downward 4 cm relative to Wing 1A. Wing 1B also displaced laterally to the south about 4 cm relative to Wing 2G.

Figure 7.10. Relative movement between Wing 1B (in the background) and Wing 2G (in the foreground) (S37.47335°, W73.34786°; 03/16/10).

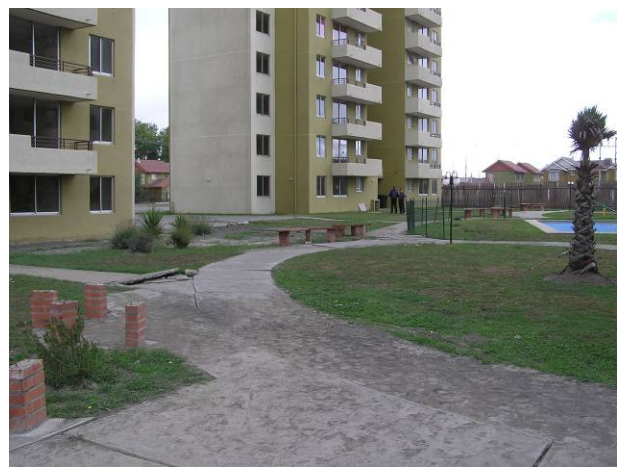
As shown in Figure 7.19, evidence of liquefaction of the gray sandy fill was present throughout the site. Sediment ejecta, ground cracking, ground settlement, and other evidence of liquefaction could be seen throughout the site. In the left photograph of Figure 7.19, sediment ejecta, ground settlement, ground cracks, and tilt of the guard room at the condominium entrance are seen. In the right photograph of Figure 7.19, similar evidence of liquefaction is seen inside the fenced area of the property.

Figure 7.19. Sediment ejecta, ground cracks, and other evidence of liquefaction of the sandy fill were found throughout the condominium site; however, street curbs around the property did not show evidence of liquefaction (S36.79107°, W73.08149°; 1300 hrs on 03/17/10).

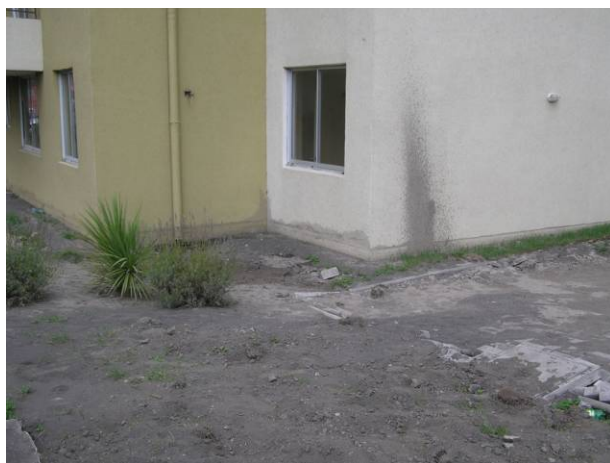
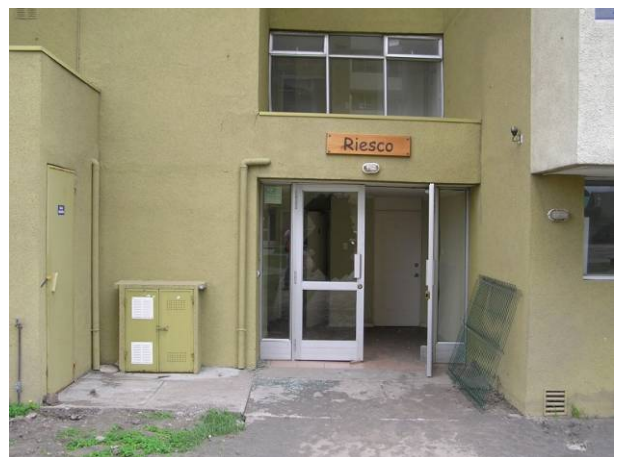
Clear evidence of sediment ejecta is seen in the left photograph of Figure 7.20. Large amounts of sand and water stains were observed in this area, which is at the northeast corner of the Riesco Building (i.e., the southwest existing building). The maximum vertical displacement of a building at this site was measured at this location. The base of the northeast corner of the northern extension of the Riesco Building displaced downward about 40 cm with respect of the ground adjacent to the Bulnes Building (i.e., the northwest existing building), which did not appear to undergo seismically induced permanent ground movement during the earthquake. The southern end of the Riesco Building, however, appeared to settle only 10 cm, and in this area, the ground surrounding the building actually settled an additional 9 to 14 cm more than the building's foundation. The top of the Riesco Building's northern end tilted 1° to the east and 1° to the north as a result of the differential ground movement across the building. The differential foundation movement produced tilting and warping of the interior on floor slab, which appeared to be on grade, and this produced damage of the living spaces as shown in Figure 7.21. A map depicting the measured foundation movement can be seen in Figure 7.22.

Figure 7.20. Riesco building that underwent most significant liquefaction-induced movement. Left photo shows evidence of large sediment ejecta at its northeast corner (S36.79077°, W73.08124°; 1330 hrs on 03/17/10). Right photo shows entrance to the building in the middle of its east facing side (S36.79089°, W73.08131°; 1310 hrs on 03/17/10).

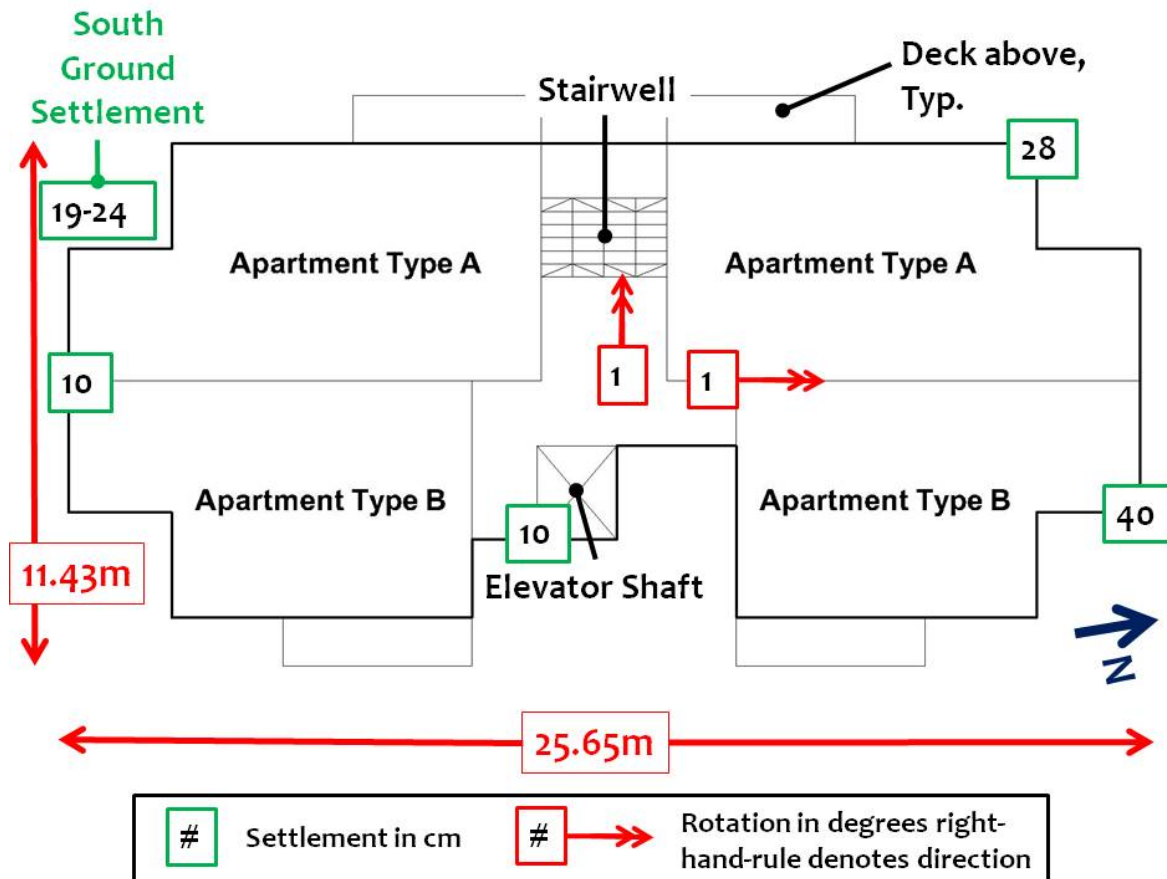
Figure 7.22. Schematic plan view of the Riesco building depicting measured movement of foundation. (note that rotation about the transverse axis of the building is believed to largely hinge about the shear wall-coupling beam interface as shown in Figure 7.23 (Bray, Hutchinson, Arduino, and Maureira).

In summary, the Riesco Building settled 40 cm at its northeast corner and only 10 cm at its south end. This led to a tilt of the top of the building toward the north and toward the east of 1 degree, respectively. The northern axis tilt appeared to hinge about the ends of the coupling beams to the structural shear walls along the longitudinal axis of the building. The differential ground settlement contributed to structural damage. In contrast the Bulnes Building did not appear to settle. The Errázuriz and Montt buildings appeared to settle at most 10 cm, and this settlement was fairly uniform around the perimeter of the buildings. The ground in the open space between buildings settled a non-uniform amount ranging from 0 cm in the area around the Bulnes Building, but more commonly 10 to 20 cm in the areas closer to the other three buildings (e.g., Figure 7.27). The street that surrounded the property did not appear to settle and there was no evidence of ground failure in adjacent properties which contained relatively light one- and two-story homes. However, there was evidence of ground failure which collapsed a sidewalk within the neighborhood of the condominiums adjacent to a culvert approximately 120 m north of the site, in addition to a ground failure at a roads edge exiting the neighborhood at 700 m north of the site was observed (Figure 7.28). Neither failure was related to that at the condominium site.

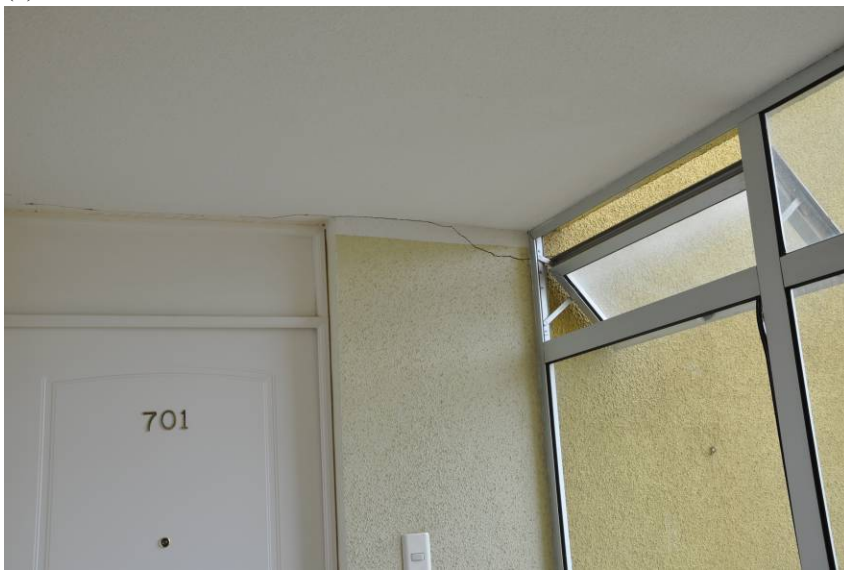
Structural damage to the Riesco building appeared to be largely a result of damage induced by differential settlement of its foundation. In particular, damage was precipitated by the significant liquefaction-induced settlement of the northern end of the building. As a result of the uneven foundation settlement and rotation about the transverse axis of the building of its northern half, excessive internal deformations were imposed on the coupling beams. All coupling beams up the height of the building were heavily loaded and observed shear failure at their interface with the full height shear wall at the elevator core (Figure 7.23 and 7.24). Shear walls in the transverse direction of the Riesco building appeared to be undamaged.

Figure 7.24 Observations at damage induced to the Riesco building due to liquefaction-induced movement of foundation. (a)-(c) at 7th floor of building; (a) left (north) end and (b) right (south end – at elevator shearwall interface), (c) ceiling-wall interface at end of coupling beam. Images taken at approximately S36.790867°, W73.081391°. (d) upper floor level coupling beam damage. Image taken at S36.791063°, W73.081043°. (images taken at 1430, 1430, 1430, and 1400 hrs, respectively on 3/17/2010).

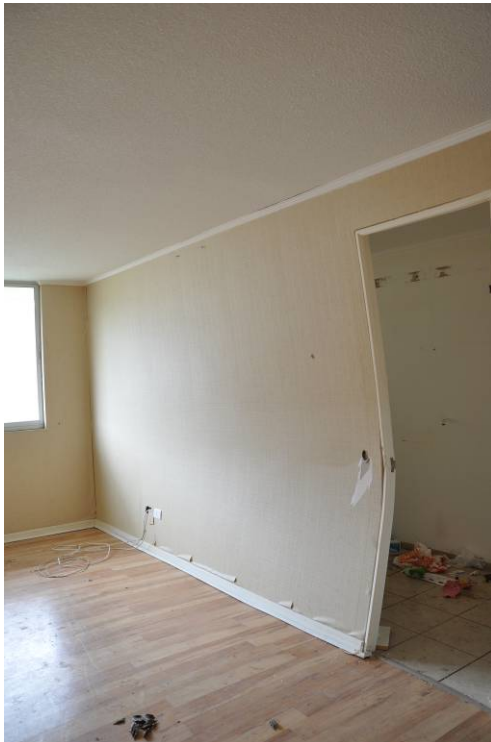
(a)

In contrast transverse shear walls in the other three buildings, which did not significantly rotate, suffered damage to the first floor structural shear walls in the form of large shear cracks (Figure 7.25). Nonstructural damage to these buildings included primarily cracked and fallen glass and partition wall damage buckling and cracking (e.g., see Figure 7.26).

Figure 7.26. Typical nonstructural damage to nonstructural components in the buildings. Interior partition wall due to bulging of the ground slab (ground floor Errázuriz building, S36.791063°, W73.081043°; 1415 and 1430 hrs, respectively, on 3/17/2010)

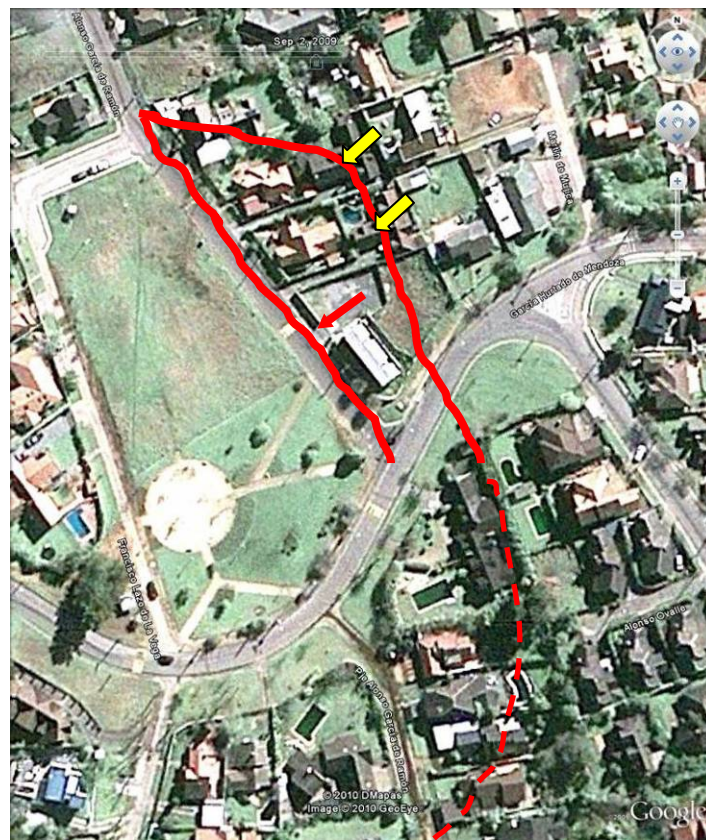
The slide appeared to be relatively shallow with its toe compressing ground directly along Alonso García de Ramón Road in a zone that was about 8 m wide, its head scarp causing a series of parallel extension cracks over a zone that was about 11 m wide, and its body between the toe and head scarp showing little evidence of internal ground distortion within it. Careful measurements across the head scarp extension zone at the location of the right photograph in Figure 7.32 showed that a zone that was 9.05 m wide initially (as evidenced by regular-sized pavement sections) extended about 1.7 m, so that it was now 10.73 m wide. At the toe of the slide, at the location of the person standing in the right photograph of Figure 7.30, the ground shortened about 1 m and pushed up about 1 m due to compression across a zone that was initially 8.5 m wide.

Figure 7.29. Affected area with approximate limits of the translational earth movement; the toe of the slide is along the eastern side of Alonso García de Ramón Road and the head scarp runs through the houses and the open field behind the rectangular apartment complex. (S36.791841°, W73.056996°). The yellow arrows denote the location of two severely damaged home which are shown in Figure 7.31.

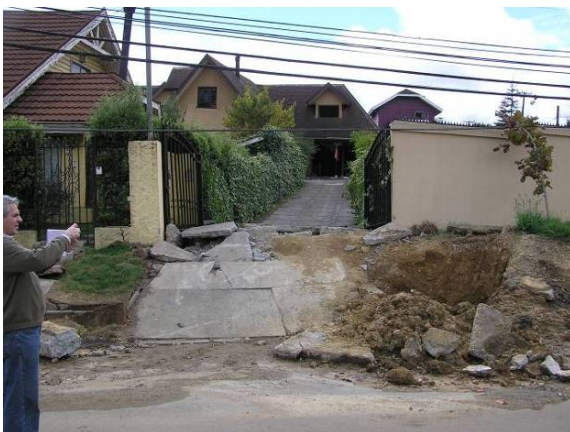
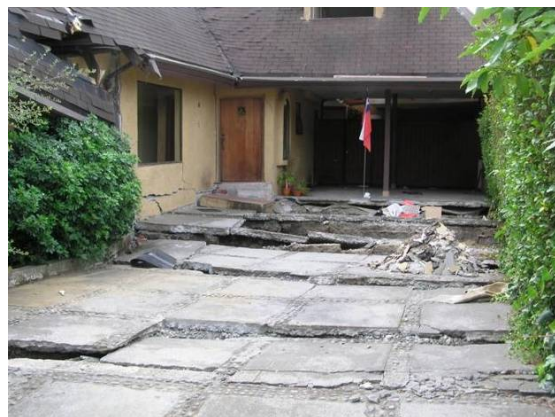
Figure 7.32. View of toe of translation slide in foreground of left photo (also note that the driveway behind the toe is not damaged(S 36.79134°, W 73.05762°; 1150 hrs on 03/17/10), and view of the head scarp of the translation slide at back of driveway in the right photo (S36.79126°, W73.05719°; 1130 hrs on 03/17/10).

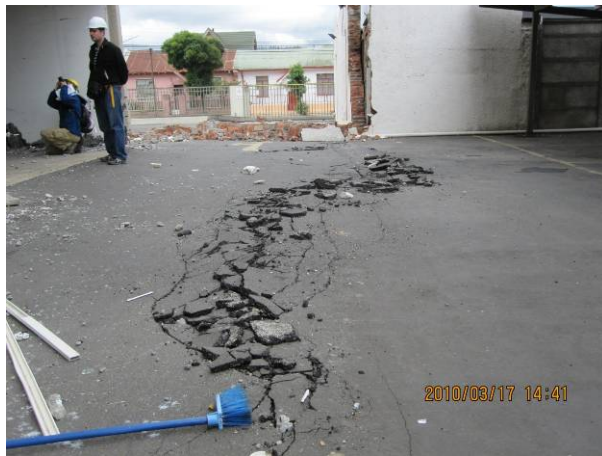
Although minor settlement was observed around both wings, pavement buckling was observed on the west, south, and east sides of the south wing (Figure 7.37), leading the EERI team to suspect that the south end foundation of the south wing underwent rocking during the shaking (Figures 7.37 and 7.38). The foundation below the north end (east-west running walls) of the south wing did not manifest pavement buckling. This may be due to restraint provided at the north end of the south wing foundation from the north wing. Minor pounding between the north and south wings was evident in the upper stories of the east side (Figure 7.39). It should be noted that the cracking pattern observed at the south end of the south wing was not pure shear as would be observed in well designed Chilean construction practice, but rather tension-type failure manifesting nearly horizontal crack patterns (Figure 7.37). For more information on the structural performance, refer to the EERI Reconnaissance Report.

Figure 7.37. Pavement buckling on the west side of the south wing (a) looking south and (b) looking north (note the utility settlement off to the left of the photograph and the diminishing intensity of damage to the structure, with greatest damage at south end – foreground of photograph) (S36.8205°, W73.0619°; 03/17/10).

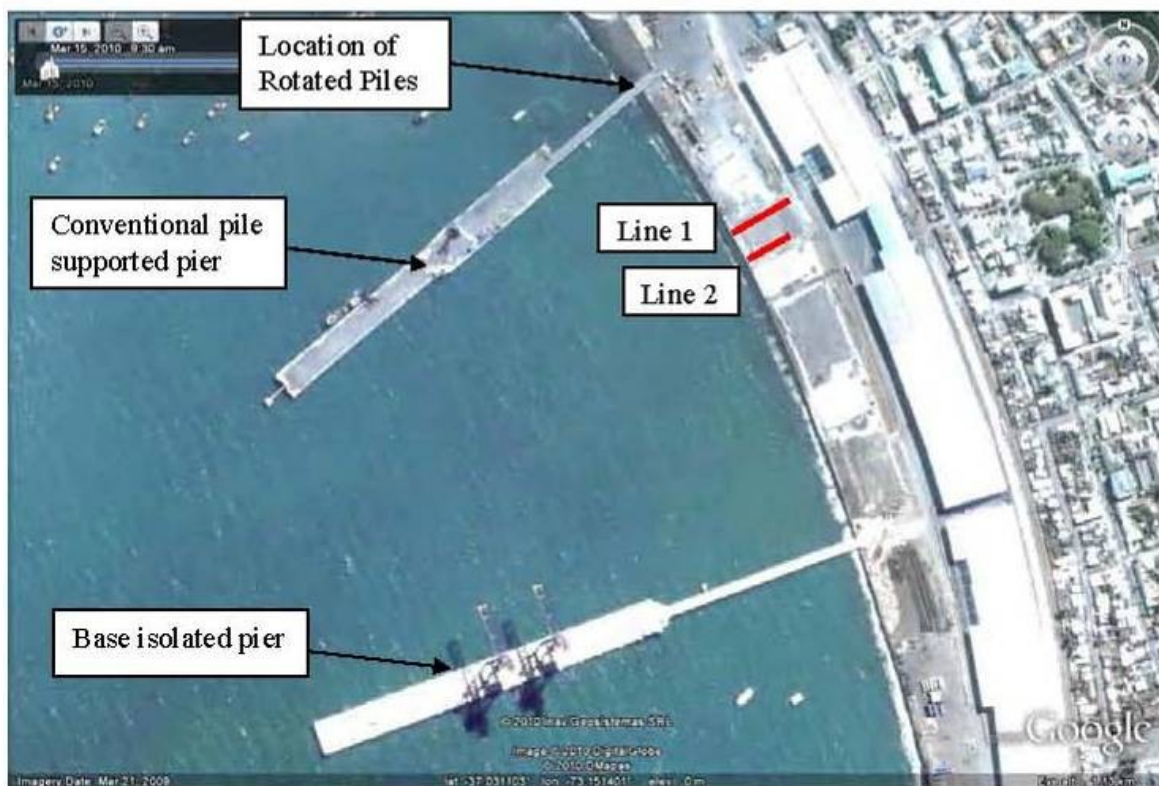
Figure 8.1. Location of lateral spread displacement measurements relative to sheet pile wall at Coronel Port. Photo from Google EarthTM (S37.0281°, W73.1507°).

Measurements were made of the cumulative horizontal displacement behind the sheet pile wall by summing the crack widths in the pavement along two lines. The locations of the survey lines are shown in Fig. 8.1 and plots of the displacement vs. distance for each line are provided in Fig. 8.4. Maximum movement at the wall was between approximately 1 and 1.20 m and relatively little movement occurred beyond a distance of 25 m behind the wall.

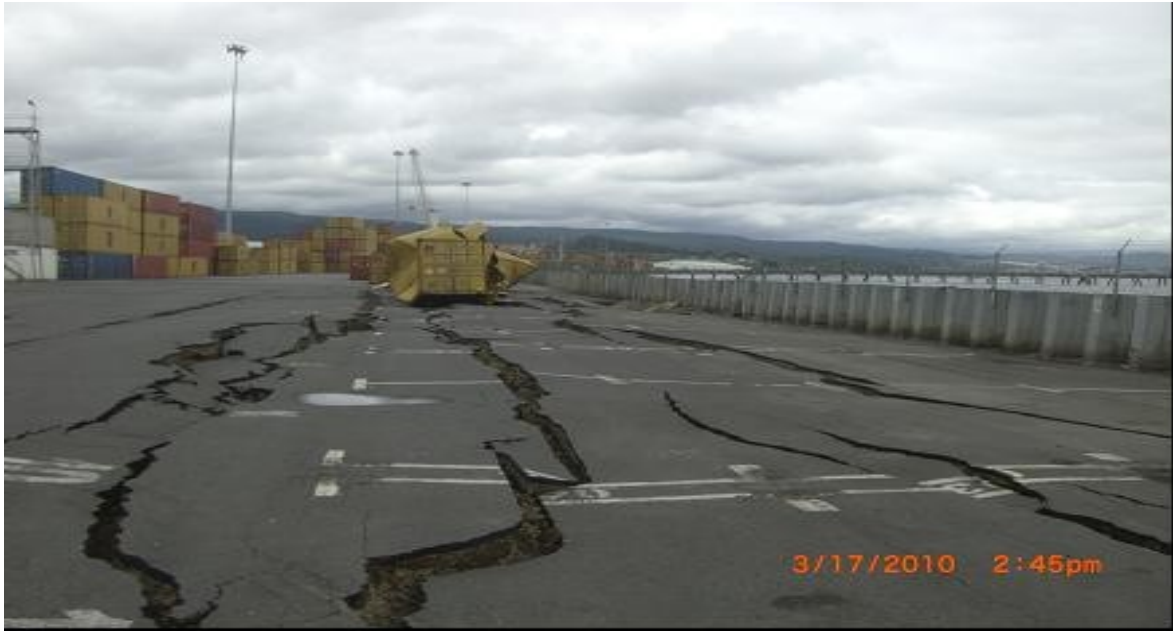
During the earthquake, about 10% of the cargo containers, which were typically stacked four high, fell over according to port personnel. In one case, the top two containers were ejected in front of the sheet pile wall, passing through the barbwire fence above the wall. The wrecked containers were subsequently recovered from the beach and brought back to the dock using a crane (Figs. 8.2, 8.3).

In addition, the port experienced significant lateral spreading as shown in Figs. 8.2, 8.3 which caused cracking to the pavement as shown in Figs. 8.2 & 8.3. Black sand ejecta obtained from cracks in the lateral spread was similar to that of the sand on the beach. The sand had a D_{50} size of 0.5 mm and a fines content of 2%. The sand classified as SP material based on the Unified Soil Classification System (USCS). Based on Google EarthTM, the slope of the beach at the port varies from 4 to 6 percent. Evidence of lateral spreading was greatest in the northern part of the port where the surface was paved with asphalt with a 0.2 m thick layer of compacted gravel fill. Movement was, naturally, less obvious in the southern part of the port where the surface was paved with bricks underlain by a 0.8 m thick layer of gravel.

Figure 8.2. Photograph of lateral spread displacements at the Port of Coronel (S37.028680°, W73.150054°; 1445 hrs, 03/17/2010).

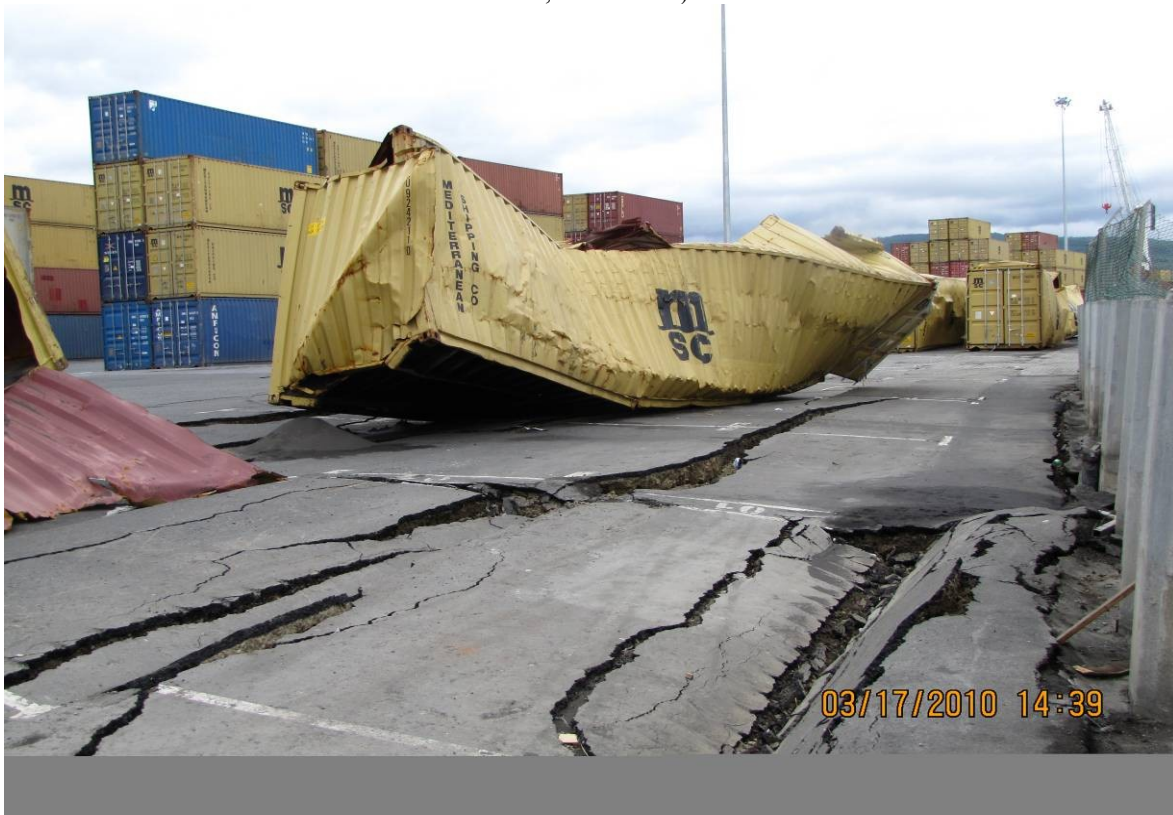
Figure 8.3. Photograph of lateral spread displacements at the Port of Coronel. The wrecked container was part of a stack and was ejected in front of the sheet pile wall, passing through the barbwire fence above the wall. It was subsequently recovered from the beach and brought back to the dock using a crane (S37.028680°, W73.150054°; 1440 hrs, 03/17/2010).

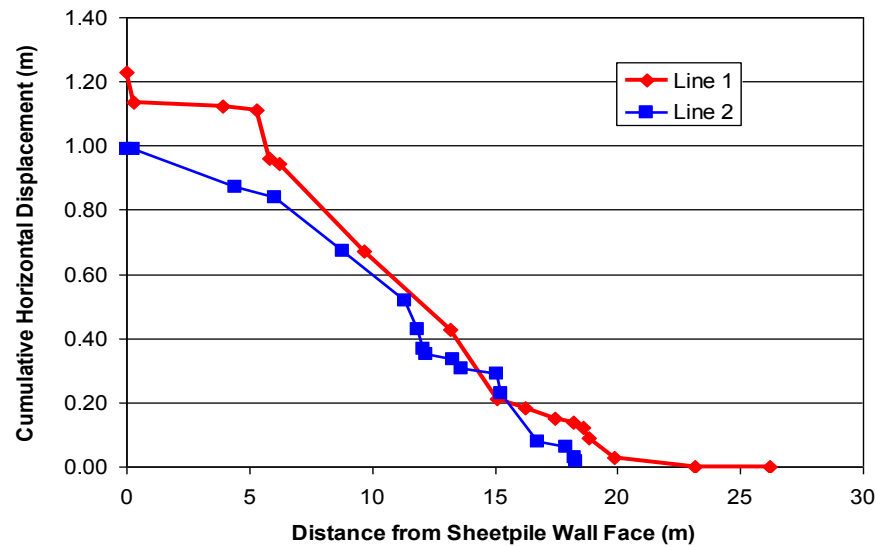
Figure 8.4. Cumulative horizontal displacement vs. distance from the sheet pile face resulting from lateral spreading at the port of Coronel, Chile. (Rollins, Mylonakis, and Assimaki).

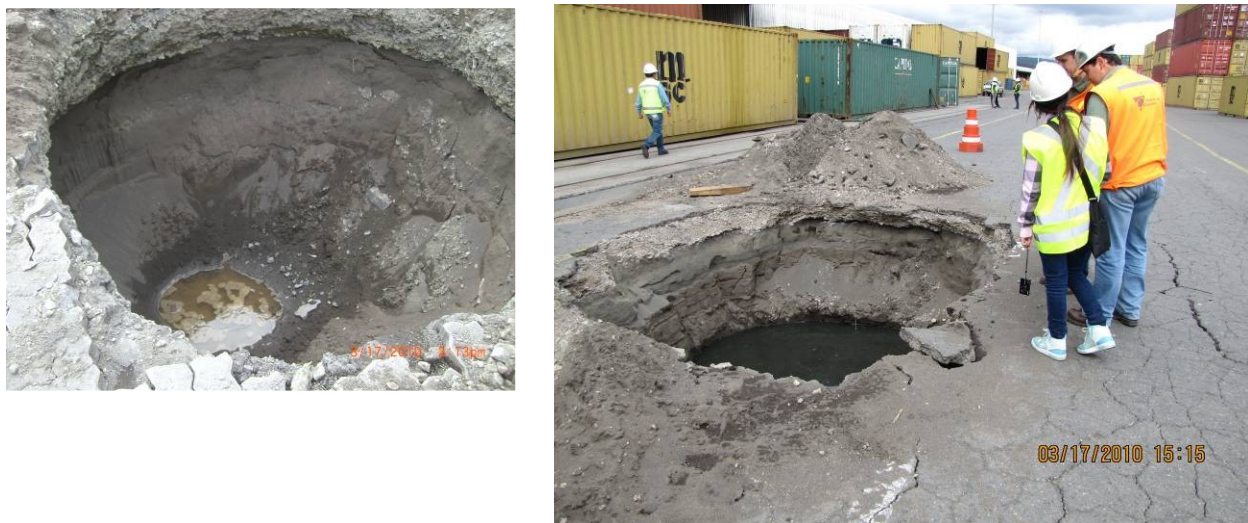
At least four large sinkholes developed at the port sometime after the earthquake. The sinkholes were typically about 3.5 m in diameter and extended to a depth of 2.2 to 2.4 m as shown in Fig. 8.5. These dimensions are approximate, as some of the sinkholes were excavated after the earthquake. At the bottom of one hole a crack or gap in an underground pipeline could be observed as shown in the right photo of Fig. 8.5. Sand could flow into this gap eventually producing a cave-in at the ground surface. A major pipeline runs parallel to shore in the North-South direction. Secondary pipelines run perpendicular to the sheetpile wall at a number of locations as highlighted in the photo in Fig. 8.6. These pipelines would be subjected to longitudinal strain due to lateral spreading which could cause distress to the pipes.

Figure 8.5. Development of sinkholes (2.2 m deep, 3.5 m diameter) as a result of crack (gap) in pipe (S37.0339°, W73.1467°; 1513 hrs, 03/17/2010).

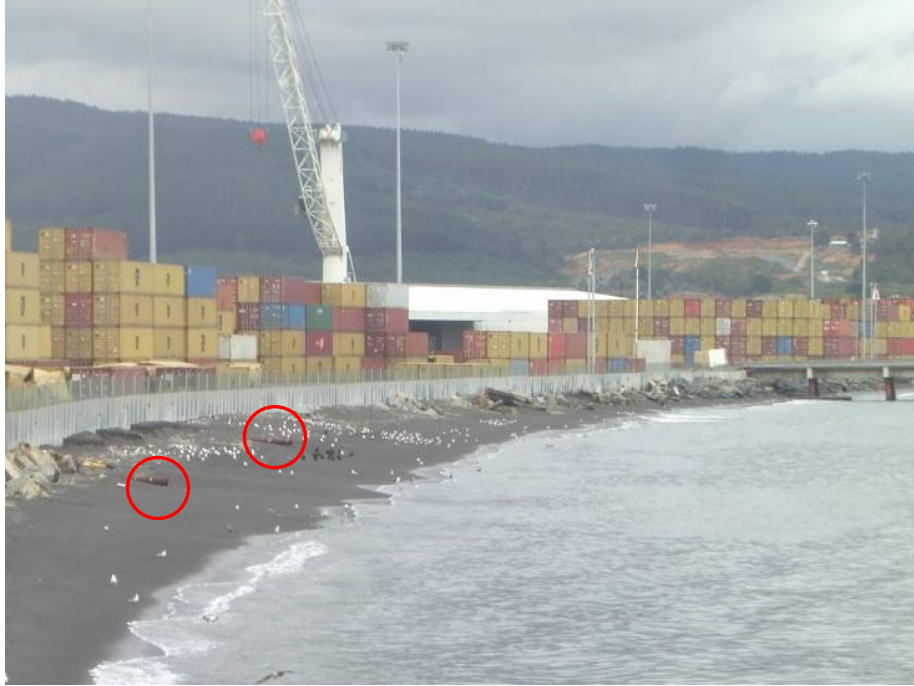
Figure 8.6. Pipelines running transverse to sheetpile wall which were subjected to longitudinal strain due to lateral spreading (S37.028680°, W73.150054°; 1520 hrs, 03/17/2010).

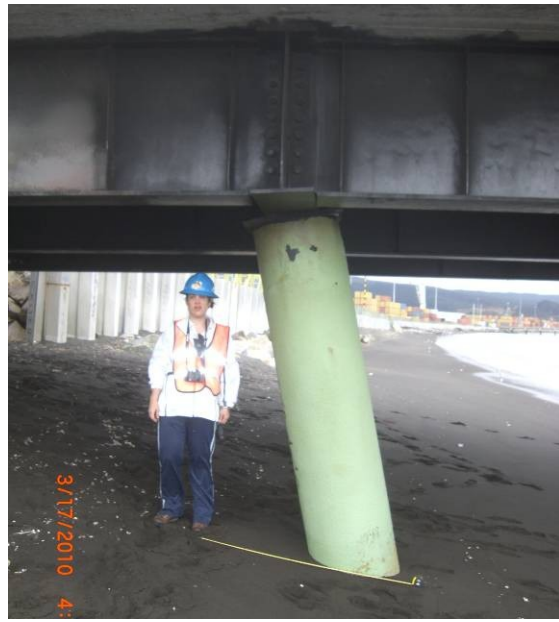
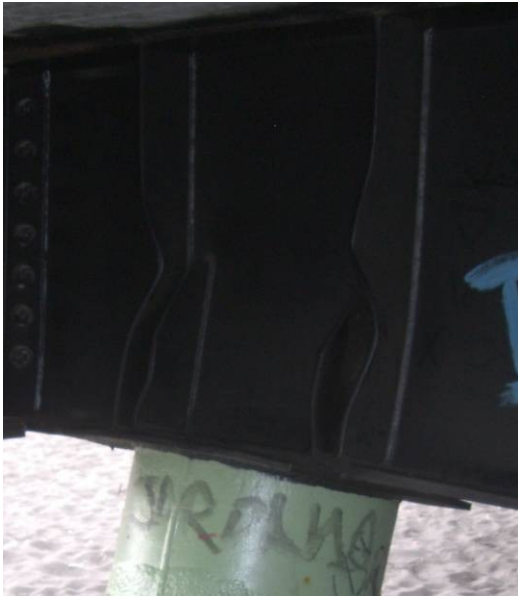
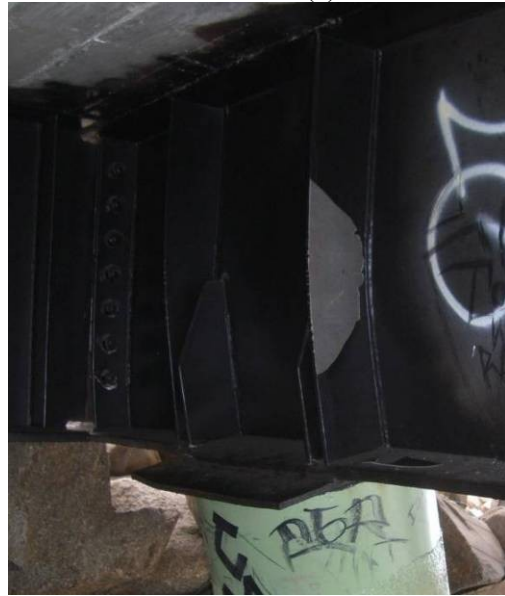
The measured lateral spreading of 1 to 1.2 m caused the 0.5 m diameter steel pipe piles supporting the northern pier to rotate 14° from vertical to accommodate the movement as shown in Fig. 8.7. There were, however, no obvious signs of distress in the surface of the pier. Drawings of the piles and their connection to the pier are provided in Fig. 8.8 based on measurements made in the field and information provided by engineers at the port. The piles were welded to plates which were in turn welded to steel beams on the pier as illustrated in Fig. 8.8. Pile rotation due to lateral spreading caused buckling of the stiffeners on the compression side and yielding of the stiffeners on the tension side of the beam as shown in photos in Fig. 8.7.

Figure 8.7. (a) Rotation of pile supported pier at Port of Coronel due to lateral spreading. The rotation of the pile led to (b) buckling and (c) yielding of stiffeners on connection beam (S37.0280°, W73.1508°; 1555 hrs, 03/17/2010).

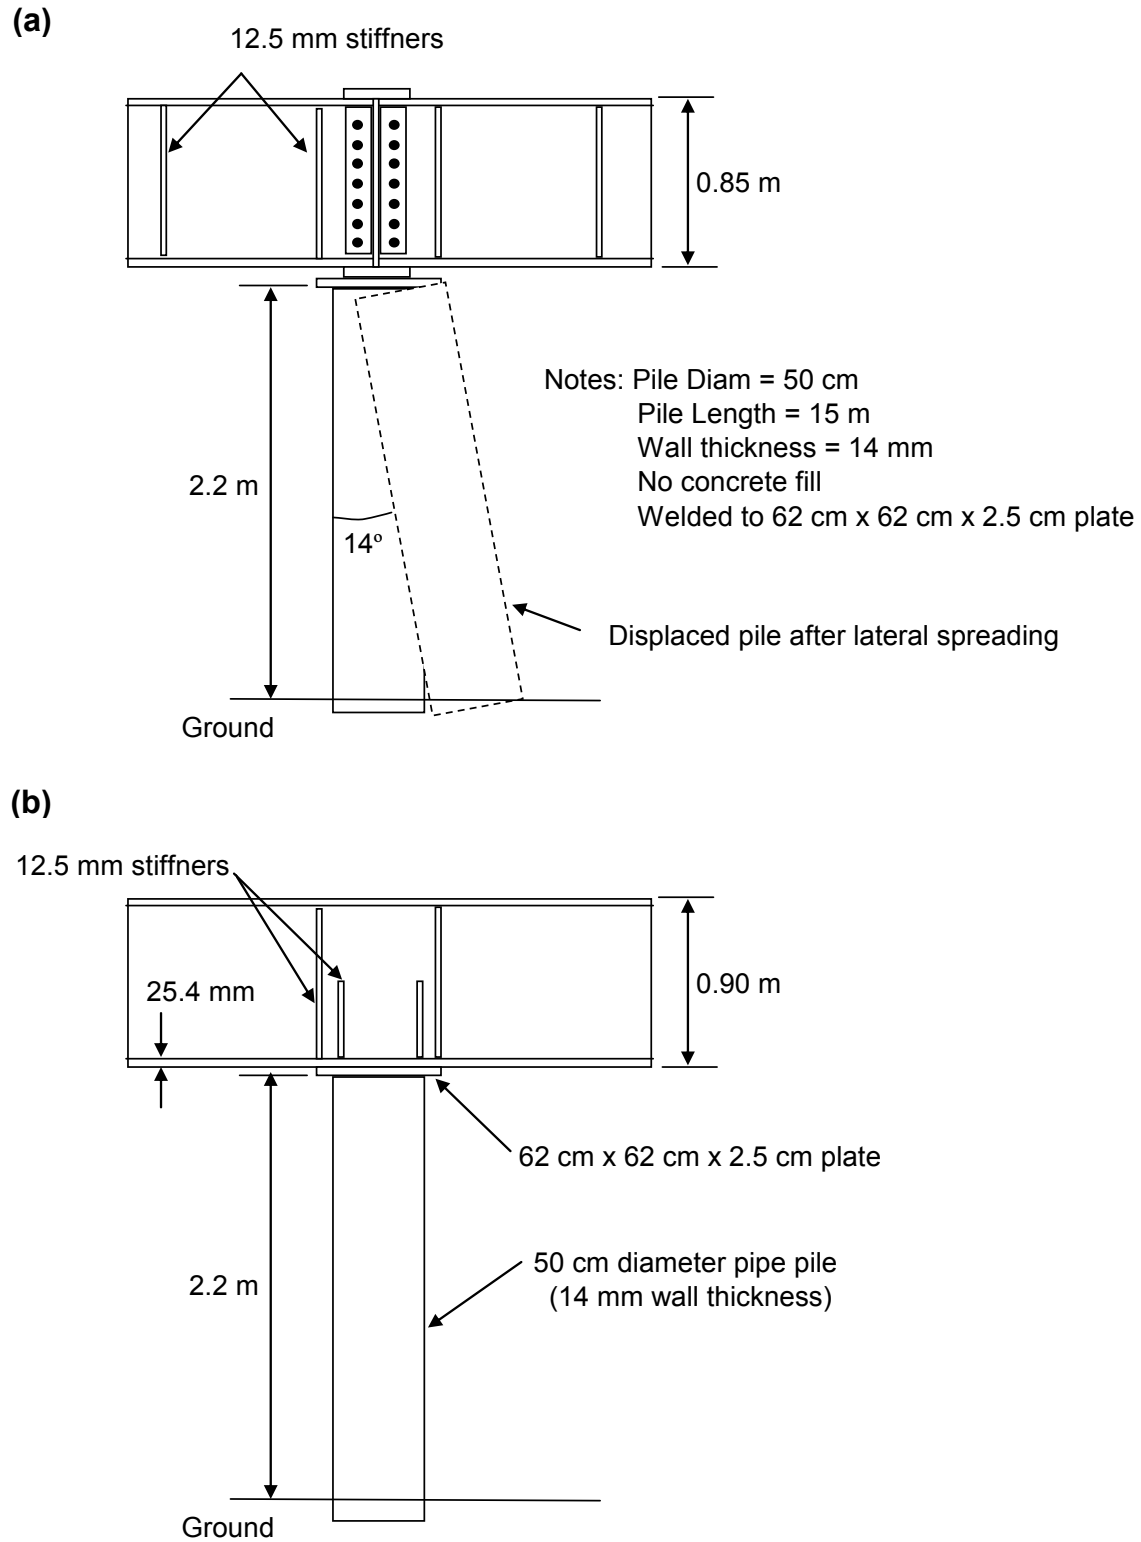
Figure 8.8. Drawing of pile cap with battered piles before and after lateral spreading (a) longitudinal section and (b) transverse section (S37.0280°, W73.1508°). (Rollins, Mylonakis, and Assimaki)

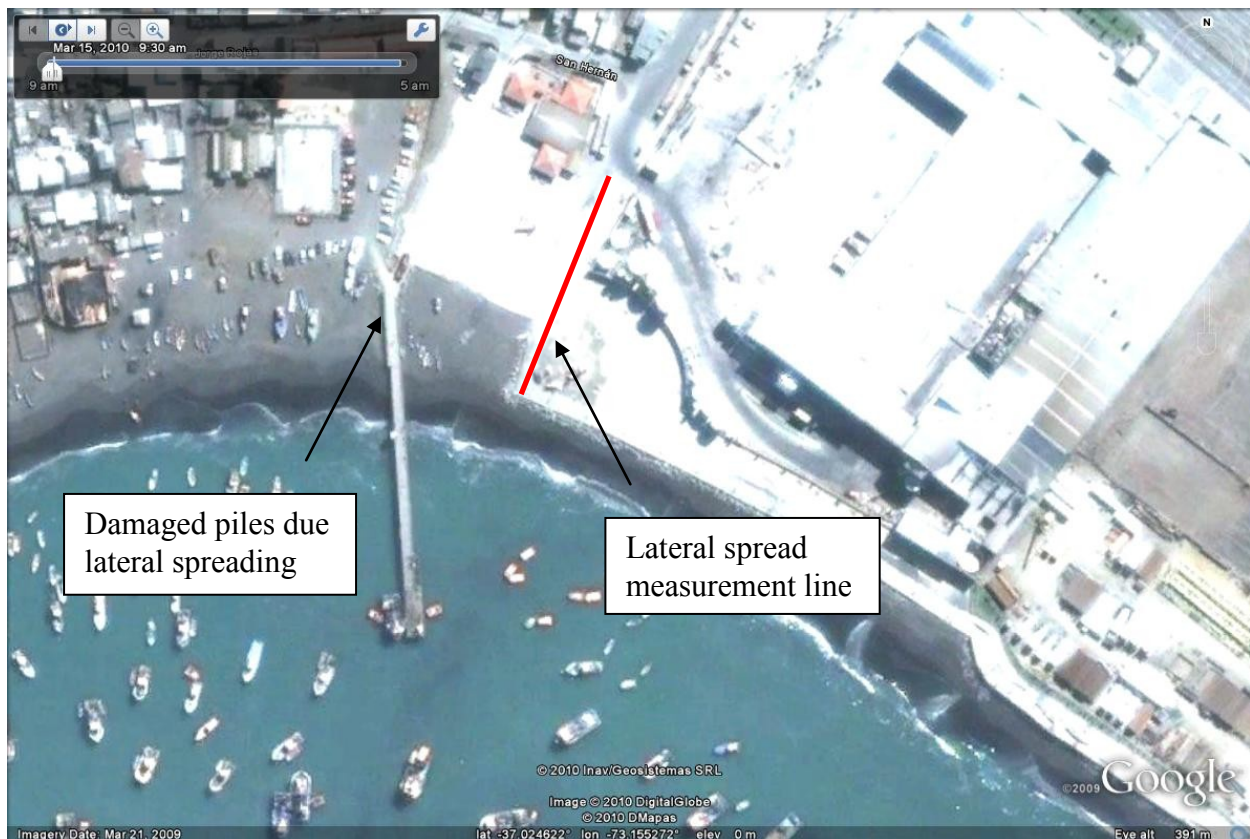
Figure 8.9. Location of lateral spread measurement line and damaged pile cap with battered piles supporting pier at fishermen port north of the main Port at Coronel ($S37.024622^\circ$, $W73.155272^\circ$).

In a small fishing port located about 600 m north of the main port (37.024° , 73.156°), liquefaction-induced lateral spreading also produced significant damage to paved areas and a small pier extending 80 m into the ocean. An aerial view of the pier and the line along which displacement measurements were made is provided Fig. 8.9. A photograph of the damage to the pavement and adjacent wall produced by lateral spreading is shown in Fig. 8.10. Horizontal ground displacements were measured relative to a concrete wall on the beach as shown in Fig. 8.9 by summing crack widths in the concrete pavement. Maximum displacements reached nearly 3 m and movement extended about 90 m behind the wall (Fig. 8.11). Ground slope above water level at this location ranged from 3.5 to 5%.

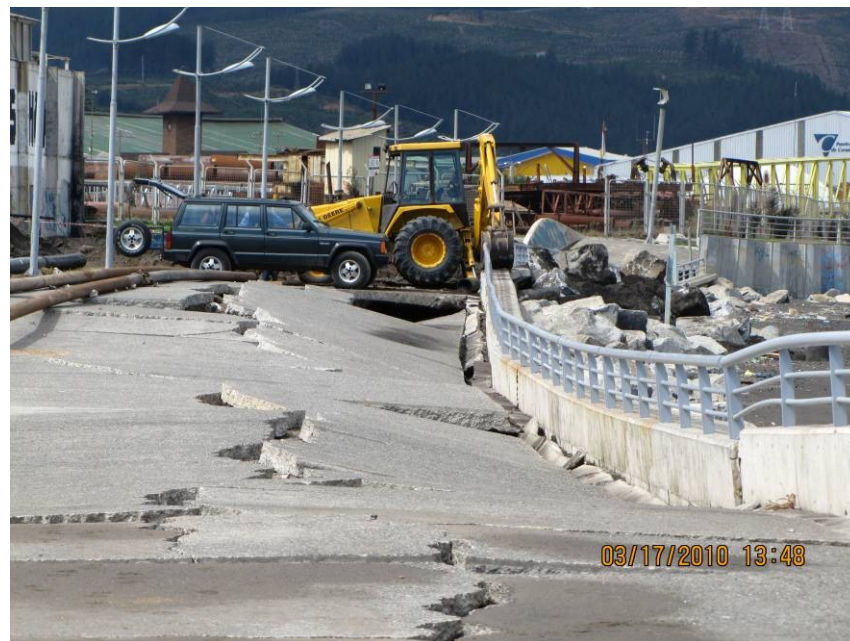
Figure 8.10. Photograph of lateral spreading which destroyed pavement and cracked walls at the fishermen's Port of Coronel ($S37.0247^\circ$, $W73.1550^\circ$; 1348 hrs, 03/17/2010).

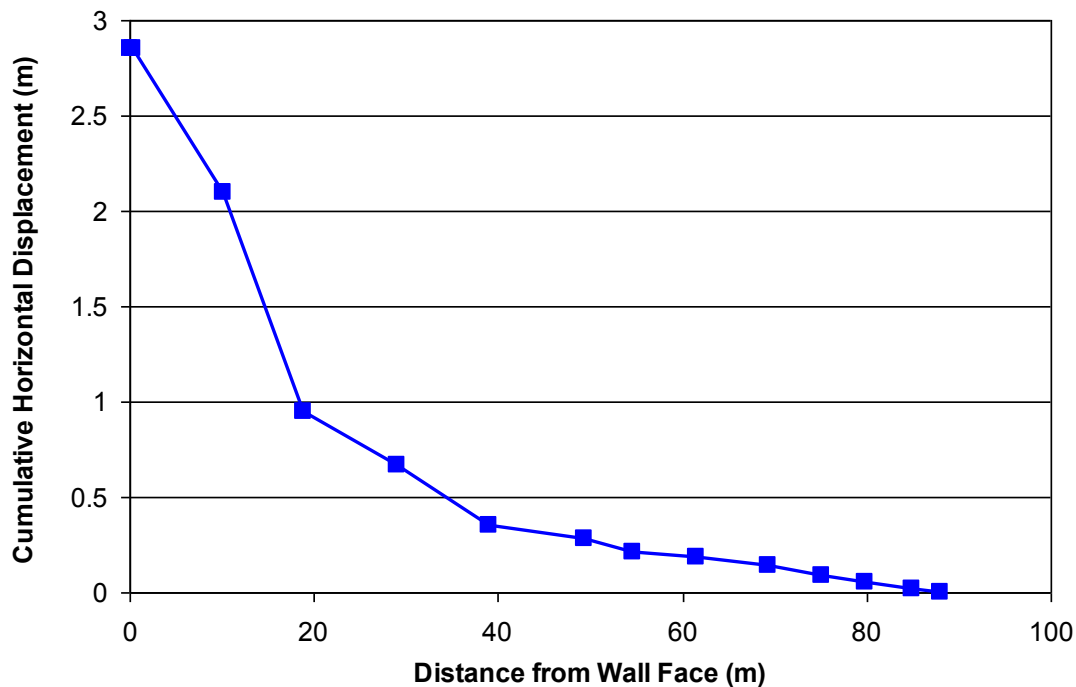
Figure 8.11. Cumulative horizontal displacement vs. distance from wall face due to lateral spreading at Pier on small fishermen's port at north end of Port of Coronel. (Rollins, Mylonakis, and Assimaki).

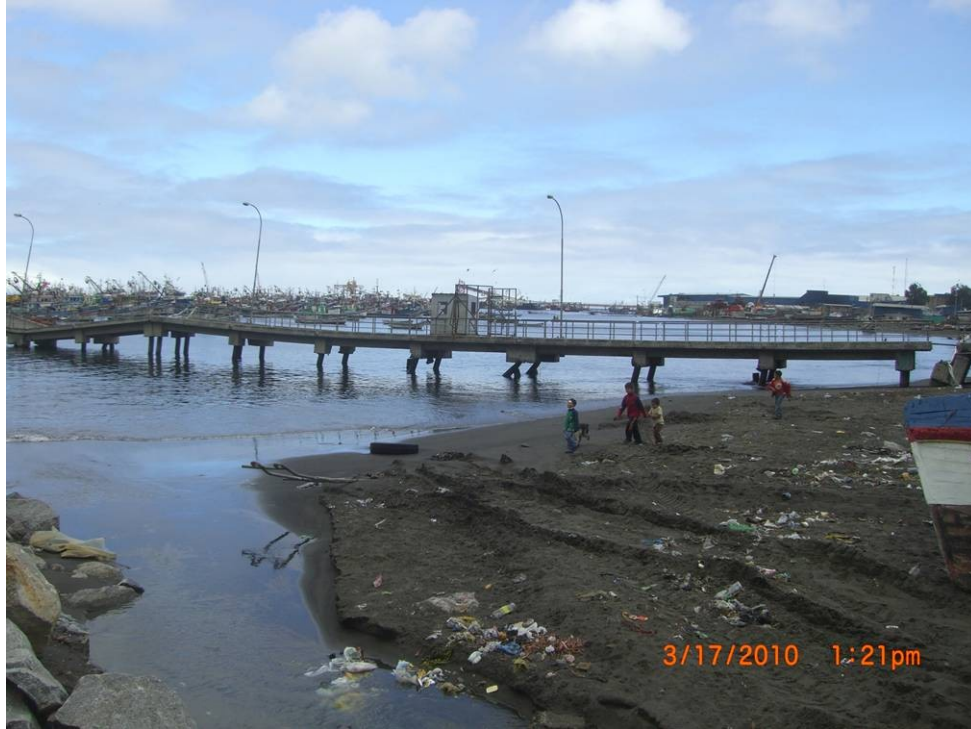
Damage to the pier, which was subjected to the 3 m measured previously, is shown in Fig. 8.12. The pier was pulled apart in the landward side with gaps of 0.5 and 1.1 m between two segments; however, at the seaward end, the pier appears to be in compression as no gaps were present and the pier appears to have moved upward relative to the rest of the pier. The pier was supported by a combination of battered piles and vertical piles. Battered piles were used on alternating supports along the pier. A photo of a pile cap supported by battered piles is provided in Fig. 8.13. Based on field measurements, the batter was approximately forward 20° for the seaward pile and backward 20° for the landward pile. A sketch of the pile cap before and after the earthquake is provided in Fig. 8.14. When subjected to the large lateral spread movements induced by earthquake, the leading row pile remained embedded in the cap, while the trailing row pile pulled out of the pile cap. Relative to the pile cap, the trailing row pile moved down 0.8 m and horizontally 0.3 m so that it was within 10 cm of impacting the leading row pile.

Figure 8.12. Damage to pile supported pier at small fishermen's Port of Coronel due to lateral spreading (S37.024319°, W73.156210°; 1321 hrs, 03/17/2010).
