Geo-engineering Reconnaissance of the 2010 Maule, Chile Earthquake

Report of the NSF Sponsored GEER Association Team

GEER Association Report No. GEER-022

Version 1: April 15, 2010

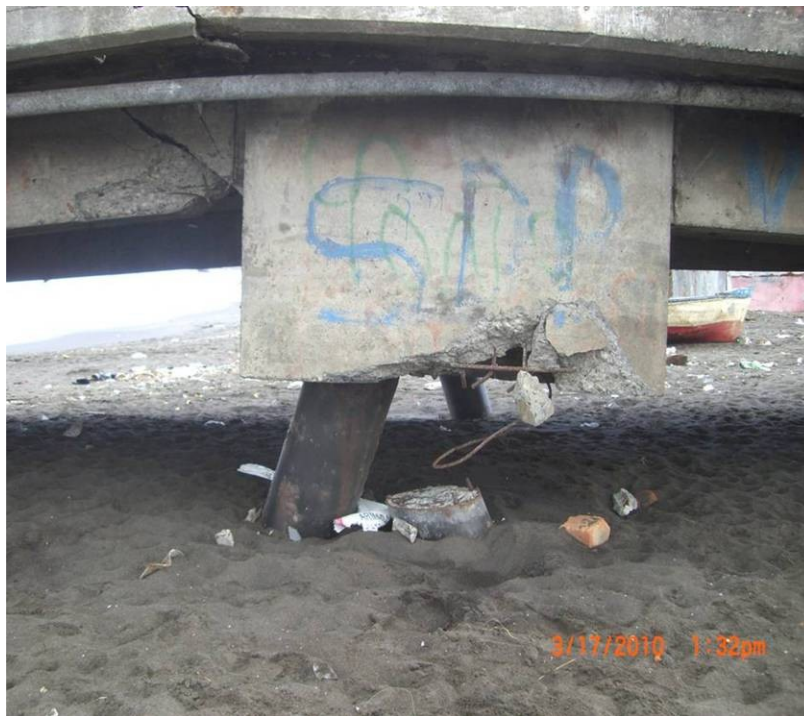
Figure 8.13. Photograph of pile cap with battered piles supporting pier at small fishermen's Port of Coronel showing pull out of trailing row piles (S37.024319°, W73.156210°; 1322 hrs, 03/17/2010).

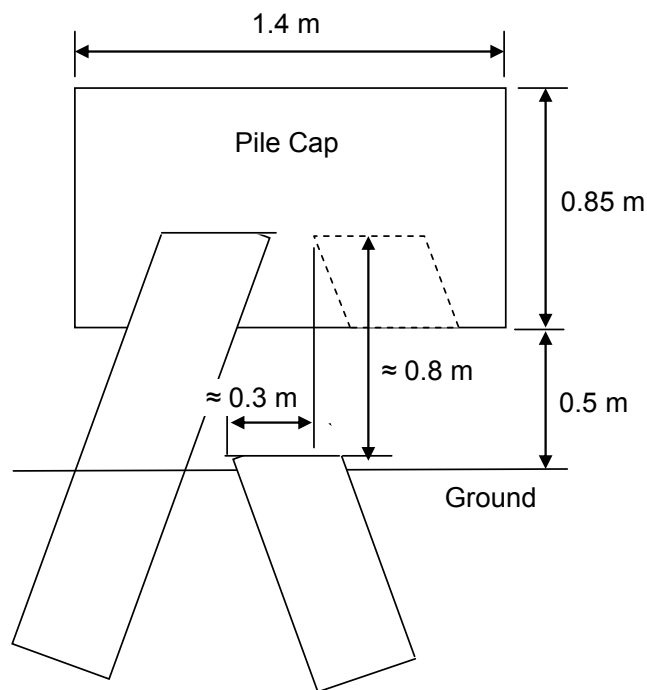
Figure 8.14. Measurements of pile cap with battered piles supporting pier at small fishermen's Port of Coronel before and after lateral spreading. (Rollins, Mylonakis, and Assimaki).

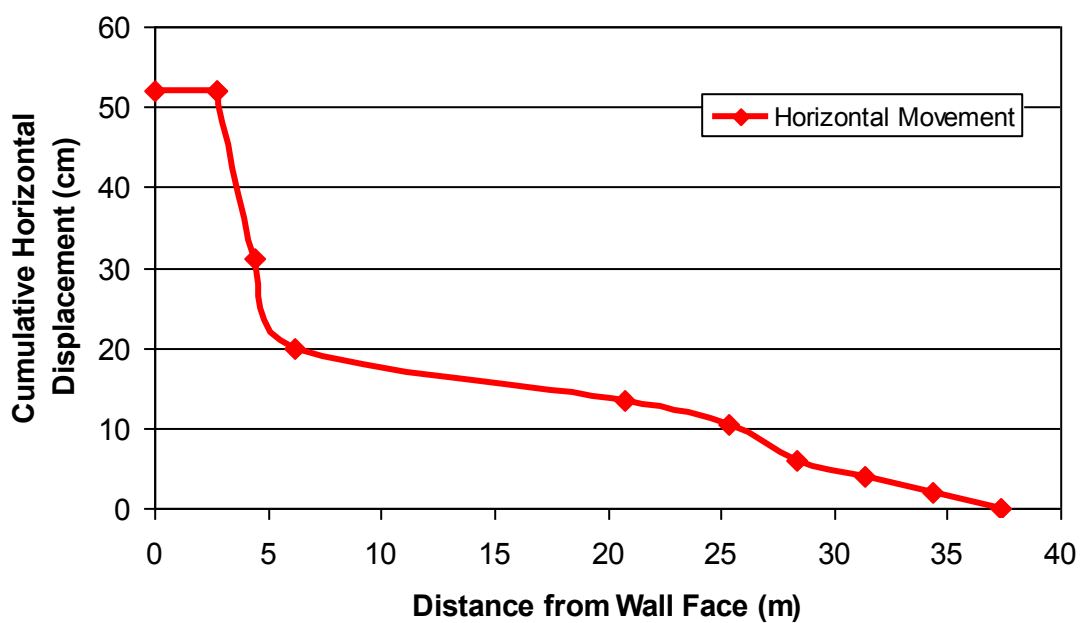
The public dock consists of a concrete-block gravity wall about 1m thick which extends about 5.5 m above water level. No sand boils were observed at the site, so it is not possible to determine if the movement was a result of liquefaction or simply lateral pressure on the wall. Outward movement of the wall led to settlement of about 20cm in a section behind the wall as shown in the figure. A plot of cumulative horizontal displacement vs. distance behind the wall is provided in Fig. 8.17.

Figure 8.17. Plot of cumulative horizontal displacement vs. distance from free-face. (Rollins, Assimaki and Mylonakis).

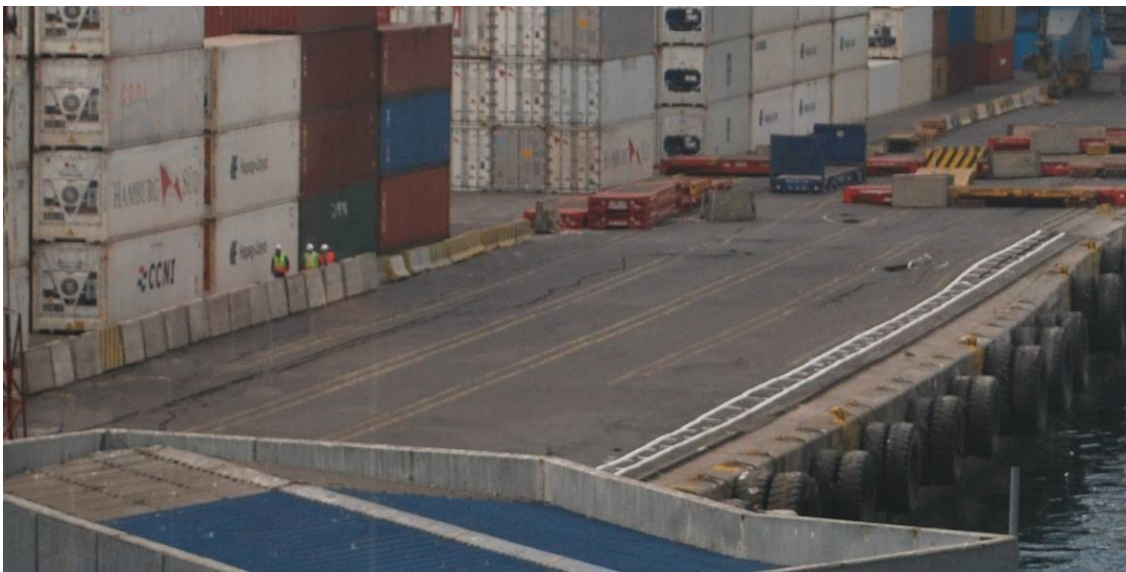
Figure 8.18. Outward movement of quay wall and asphalt pavement cracks at commercial dock of Valparaíso port (S33.036°, W71.628°; 1640 hrs, 03/15/2010).

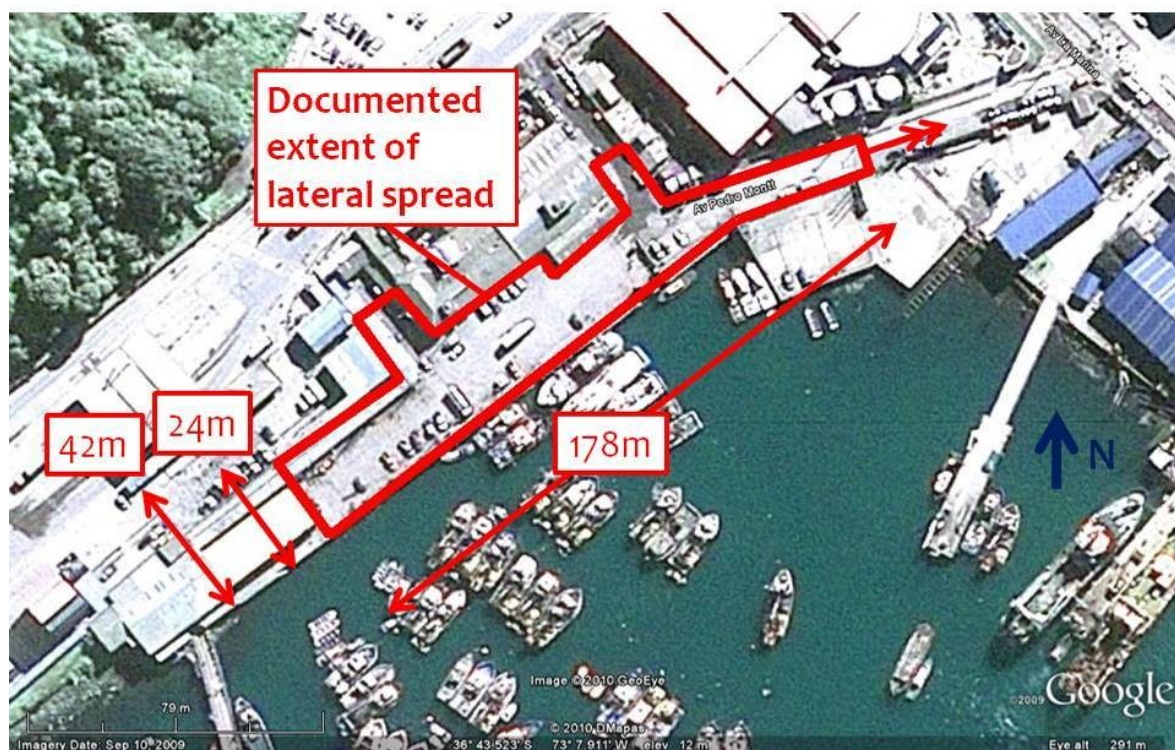
Figure 8.21. Lateral spread at fishing wharf area (S36.7252°, W73.1320°) denoted by red boundary. Note that spread likely continued to the East of the area documented.

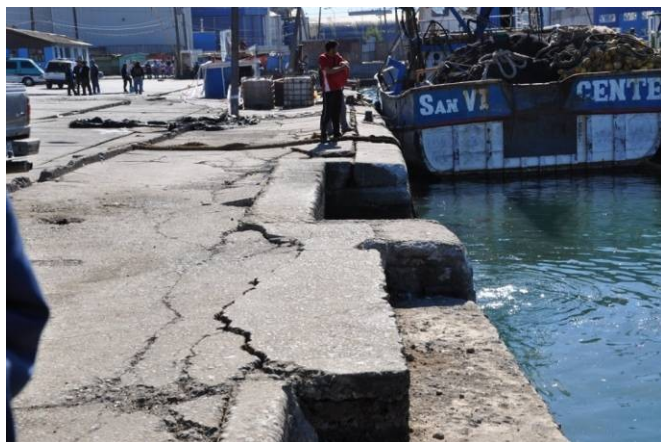
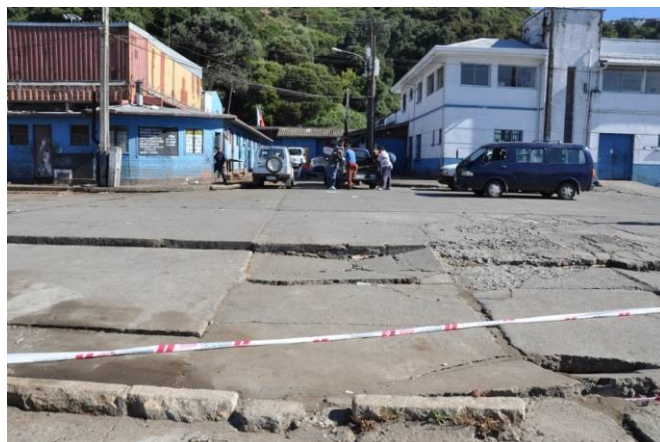
Figure 8.22. Photographs of lateral spread at fishing wharf (1110 hrs, 03/15/2010).

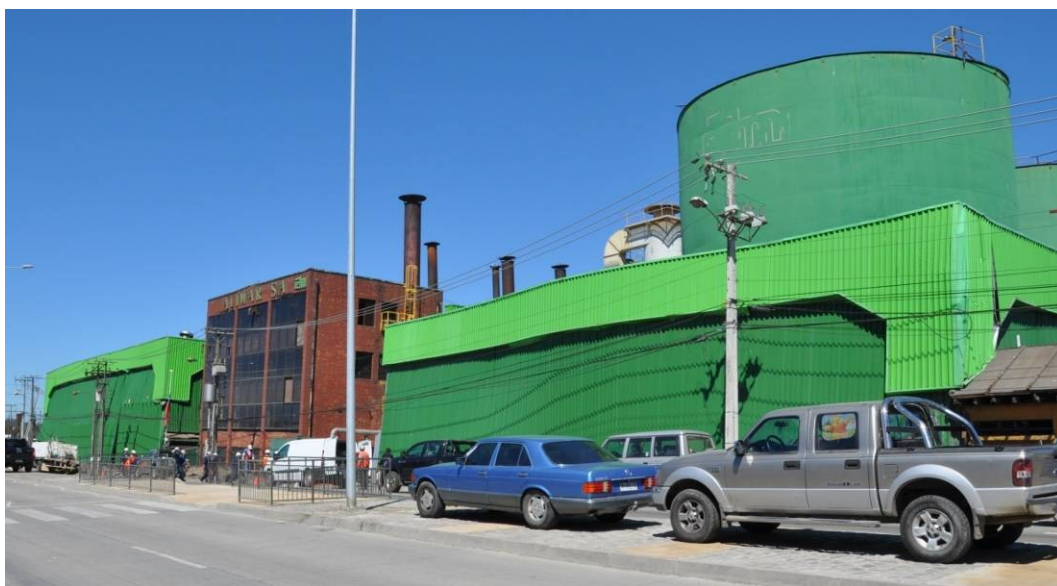
Figure 8.23. Damage to fish packaging facility (S36.7260°, W73.1288°; 1356 hrs, 03/15/2010).

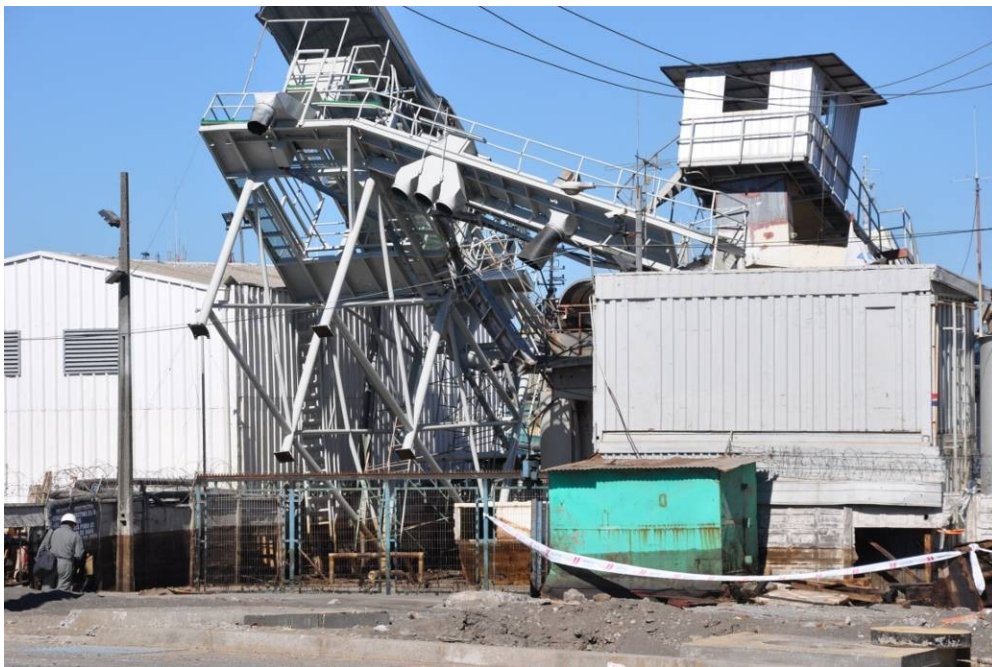
Figure 8.27. Damage to structures neighboring the fish packaging facility (S36.7267°, W73.1282°; 1200 hrs, 03/15/2010). Note the scum level at the base of the structure of approximately 1-2 m evidence of the water rise.

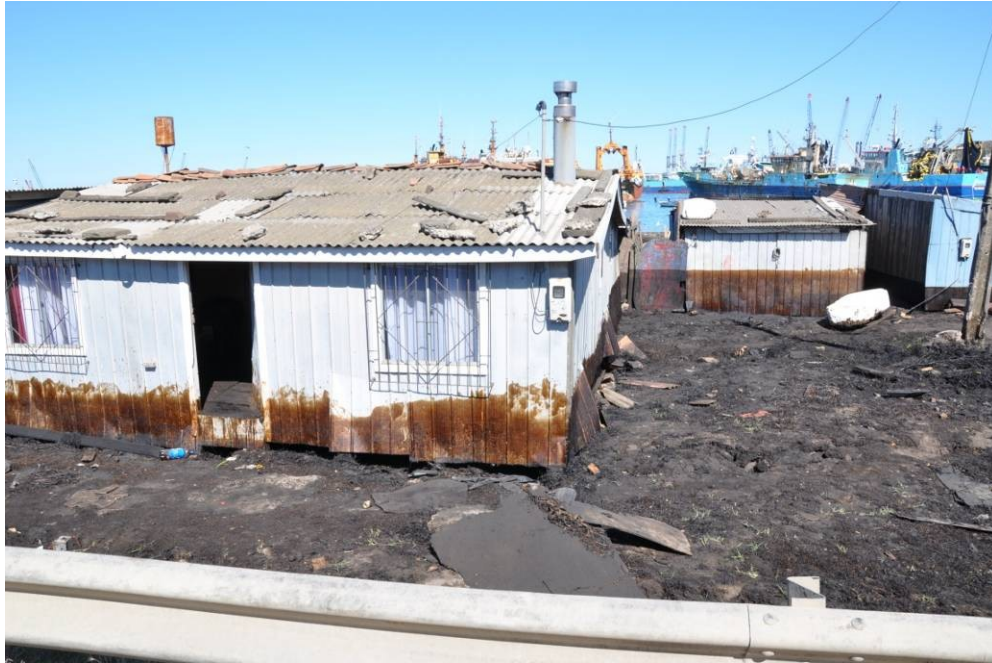
Figure 8.28. Evidence of water level rise at port area – neighboring fish packaging facility (S36.7267°, W73.1282°; 1200 hrs, 03/15/2010).

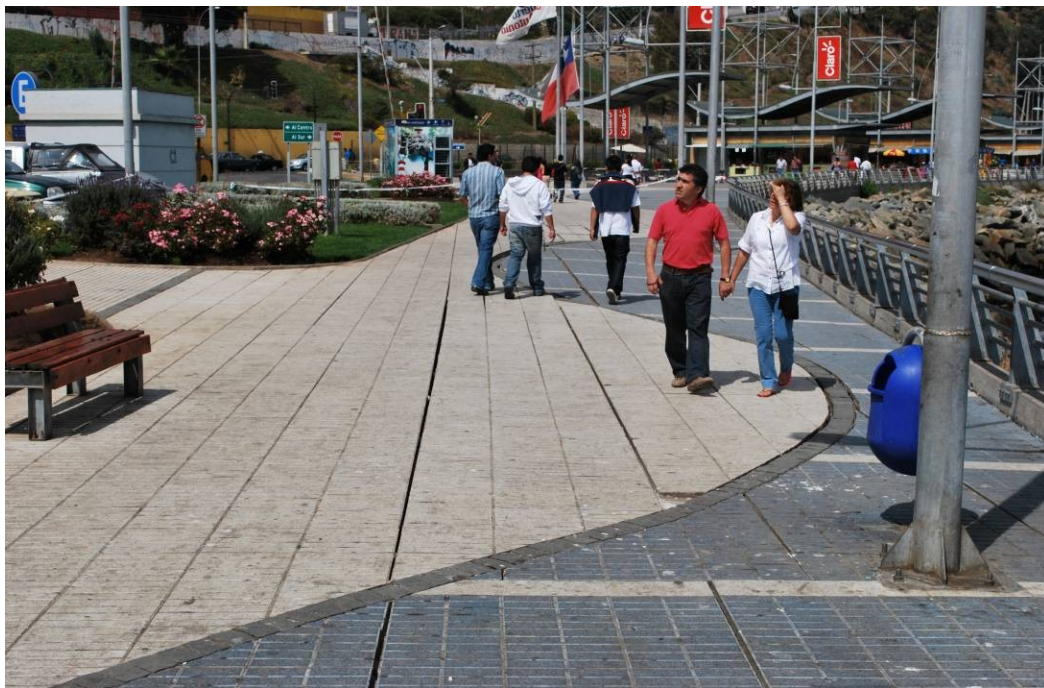
Surprisingly, despite the magnitude of the Feb 27, 2010 event, little damage was observed in the port. Indeed, with the exception on several minor cracks measuring no more than 5cm on the asphalt pavement behind the quay wall (Figs. 8.31, 8.32) and some rock falls (Fig 8.33), most of the port appears to be undamaged. No surface evidence of soil liquefaction was observed. The satisfactory performance is attributed to the reconstruction of 1992-1997.

Figure 8.32. Cracks on brick pavement behind quay wall in San Antonio Port (S33.5830°, W71.6138°; 1432 hrs, 03/14/2010).

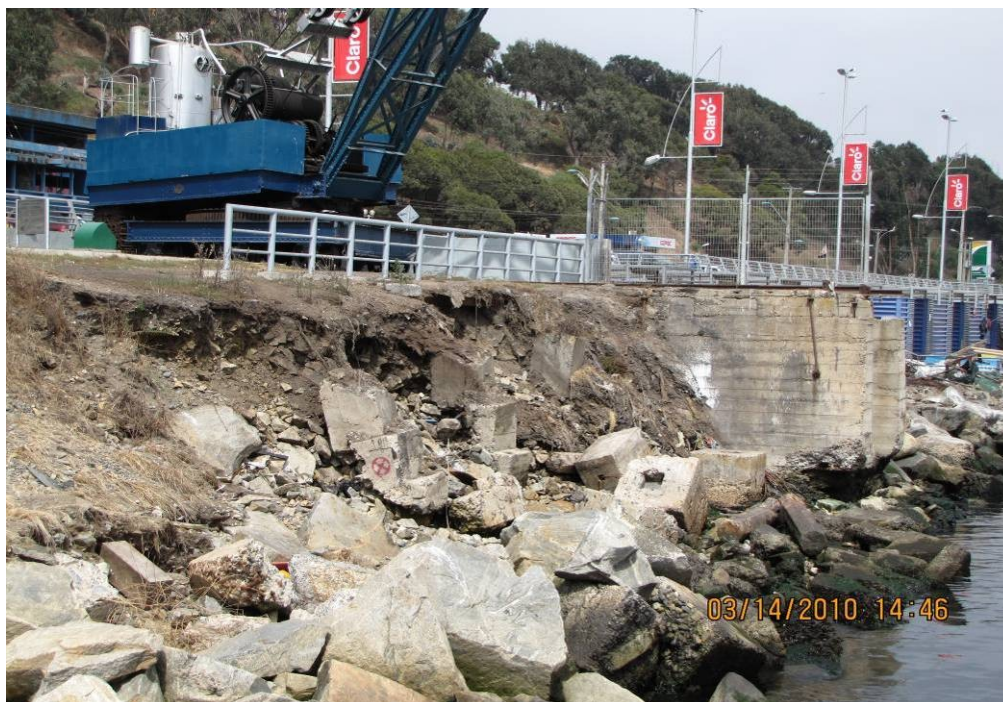
Figure 8.33. Rockfalls in San Antonio Port (S33.587°, W71.613°; 1446 hrs, 03/14/2010).

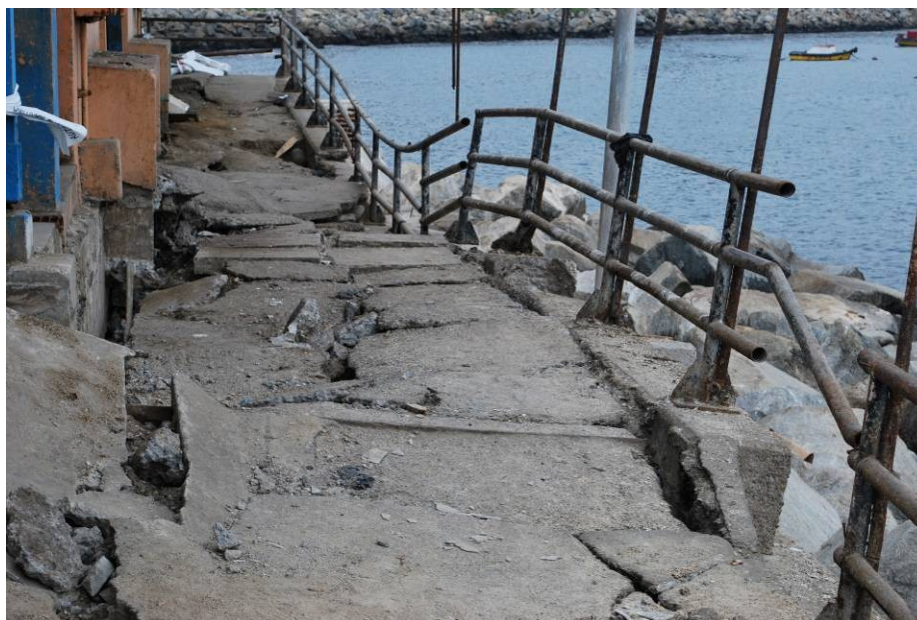
Notable exceptions are an old dock (apparently not part of the reconstruction) which suffered very severe damage (Fig. 8.34) and a wharf structure supported on combinations of vertical and raked steel piles. Displacements in excess of 1m were observed (Fig. 8.35) leading to failure of the connections at the pile heads (Fig. 8.36). The settlement of the piles – a consequence of liquefaction - is also evident the figure.

Figure 8.34. Severely damaged old dock in San Antonio Port (S33.5817°, W71.6154°; 1448 hrs, 03/14/2010).

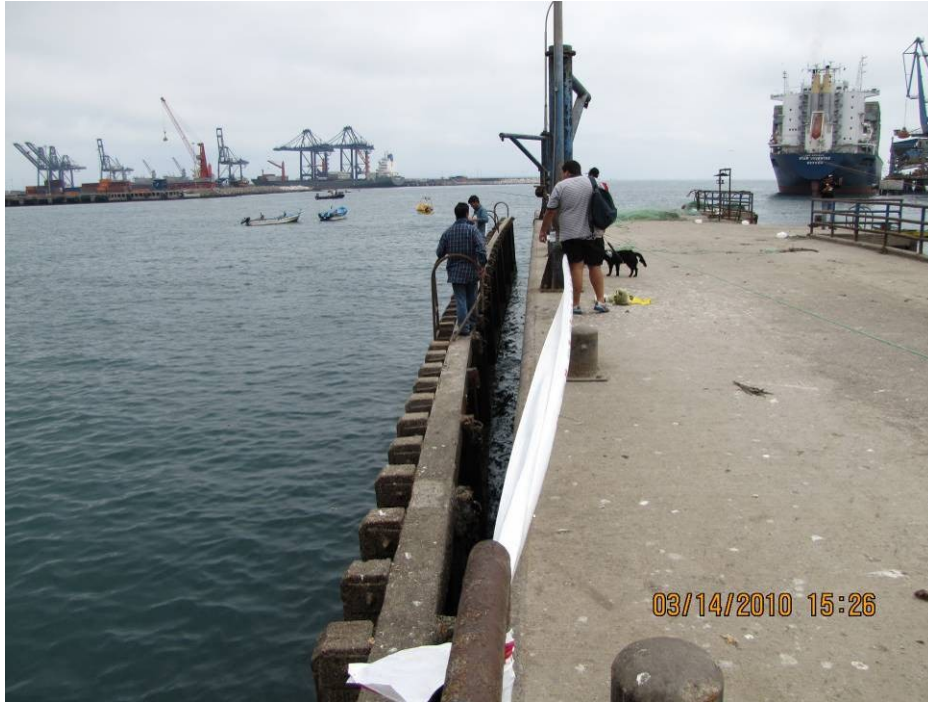
Figure 8.35. Separation from lateral pile screen of wharf structure in San Antonio Port (S33.5817°, W71.6154°; 1526 hrs, 03/14/2010).

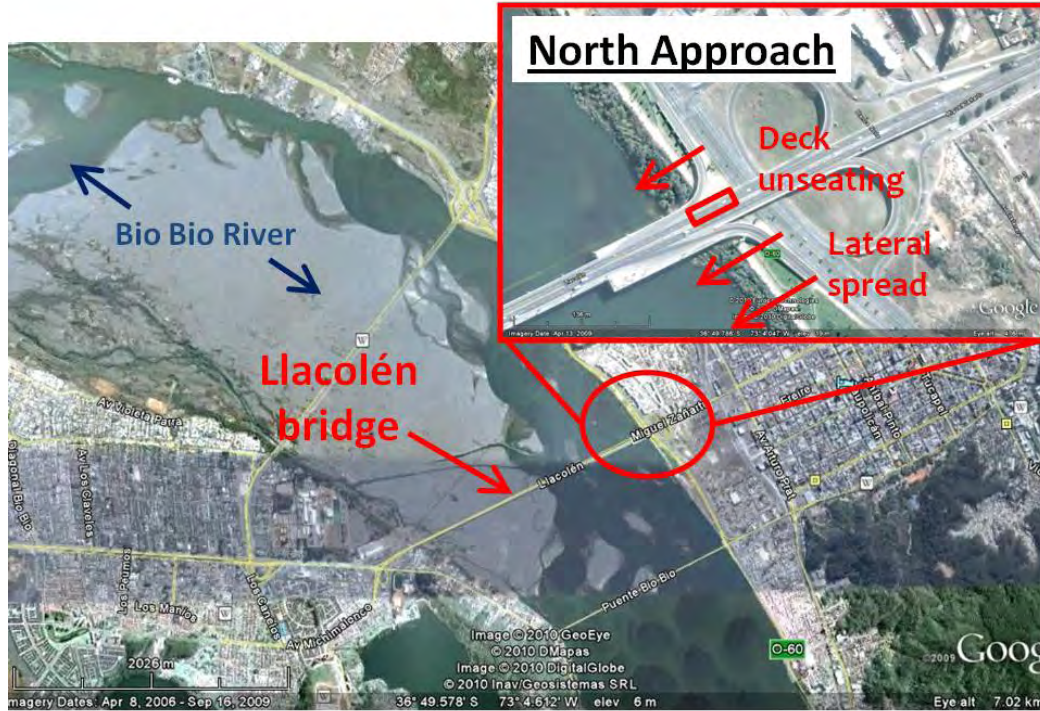
Lateral spreading ground was observed at the Llacolén Bridge in Concepción on the North approach shore (Figure 9.2). The Llacolén Bridge in Concepción was constructed in 2000 and spans 2,160 m across the Bio Bio river supporting four lanes of vehicular as well as pedestrian access to downtown Concepción (Figure 9.3). Ground damage at the north approach area was observed to extend inland into the southbound traffic lane of Calle Nueva road and south below the bridge's exit ramp continuing along a pedestrian walkway (Figure 9.4). Calle Nueva parallels the coastline and runs under the approach to the bridge. The lateral spreading ground resulted in unseating of the west and east bound traffic support deck (Figure 9.5). Flexural cracks on the river-side face of the 1.5 m diameter support columns were observed near the ground surface typically tightly spaced at approximately 0.10-0.20 m on center (Figure 9.6). The distribution of flexural cracking was more severe for those columns supporting the unseated deck, however, all columns at the north shoreline support observed flexural cracking at their construction joint (between 2-2.5m above ground surface). Ground settlement of 0.25-0.30 m was also noted to surround each of the exit ramp bents (Figure 9.7).

Figure 9.2. Plan view of the Bio Bio river region locating the damaged region of the Llaolén bridge in Concepción (S36.830108°, W73.067991°)

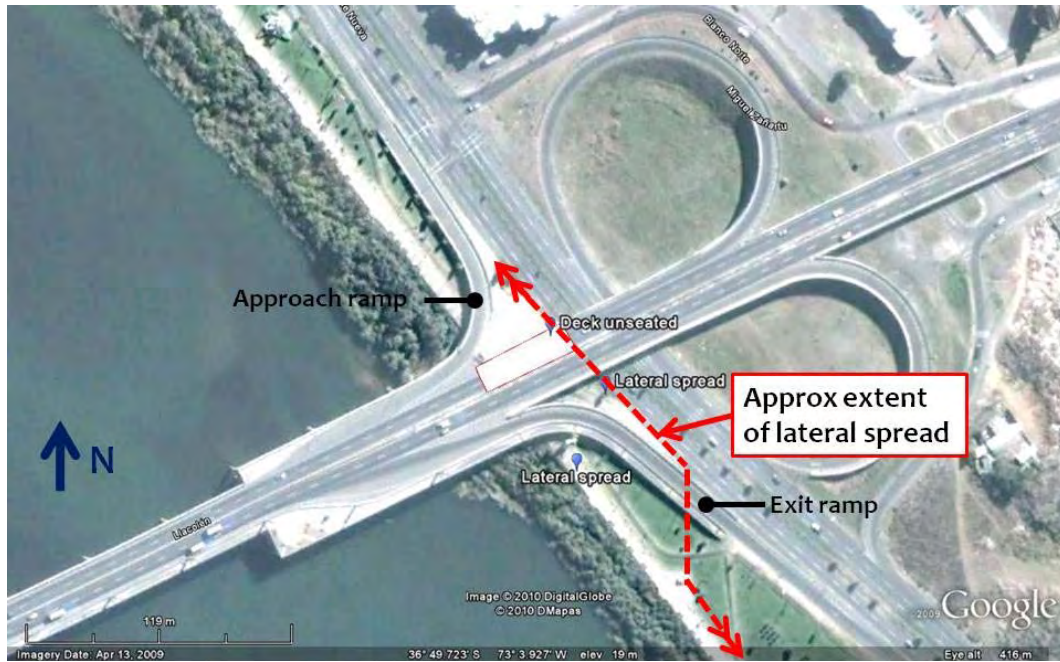
Figure 9.4. Plan view of the North approach to the damaged Llacolén bridge in Concepción ($S36.830108^\circ$, $W73.067991^\circ$).

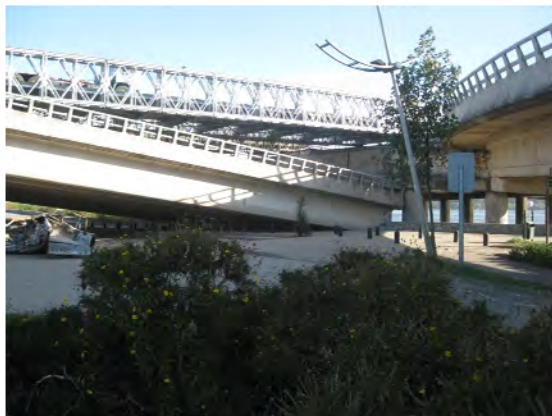
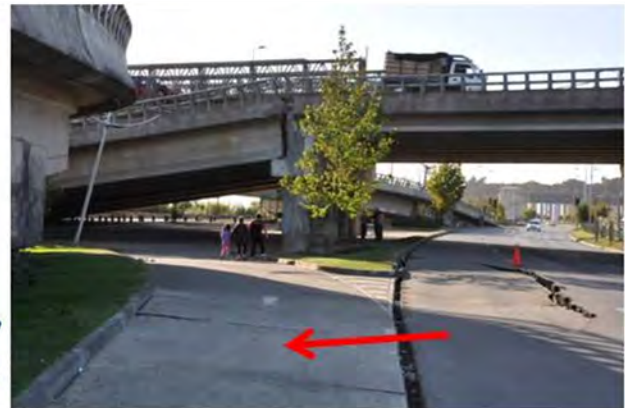
The observed damage at the north approach of the Llacolén Bridge (S36.830108°; W73.067991°) suffered deck unseating and lateral spreading.

Figure 9.5. Deck unseating at Llacolén bridge in Concepción. (note the temporary deck supporting approach traffic). View South ($S36.829707^\circ$, $W73.068220^\circ$, 1809 hrs on 3/14/2010) and (b) view north ($S36.830380^\circ$, $W73.067541^\circ$, 1911 hrs on 3/14/2010).

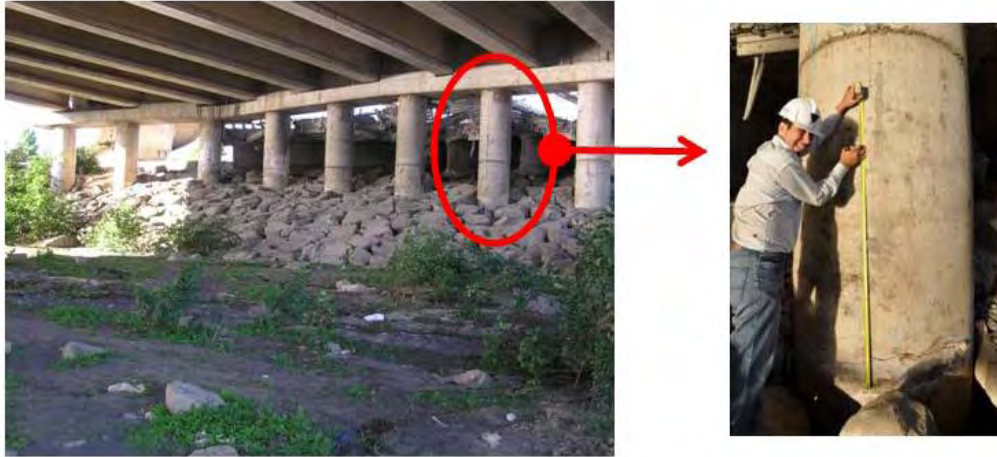
Figure 9.6. Substructure of the of the north approach to the damaged Llacolén bridge in Concepción showing the unseated deck in the foreground. Flexural cracking of the column supports was observed at ground level and extending to the construction joint (2-2.5m above ground) for all columns at this support (S36.830232°, W73.068379°, 1936 hrs. on 3/14/2010).

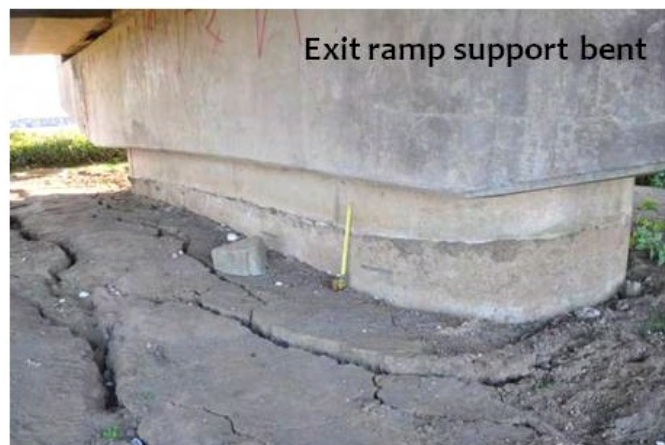
Figure 9.7. Ground settlement surrounding an exit ramp support bent at the Llacolén bridge in Concepción (S36.830380°, W73.067541°, 1901 hrs. on 3/14/2010).

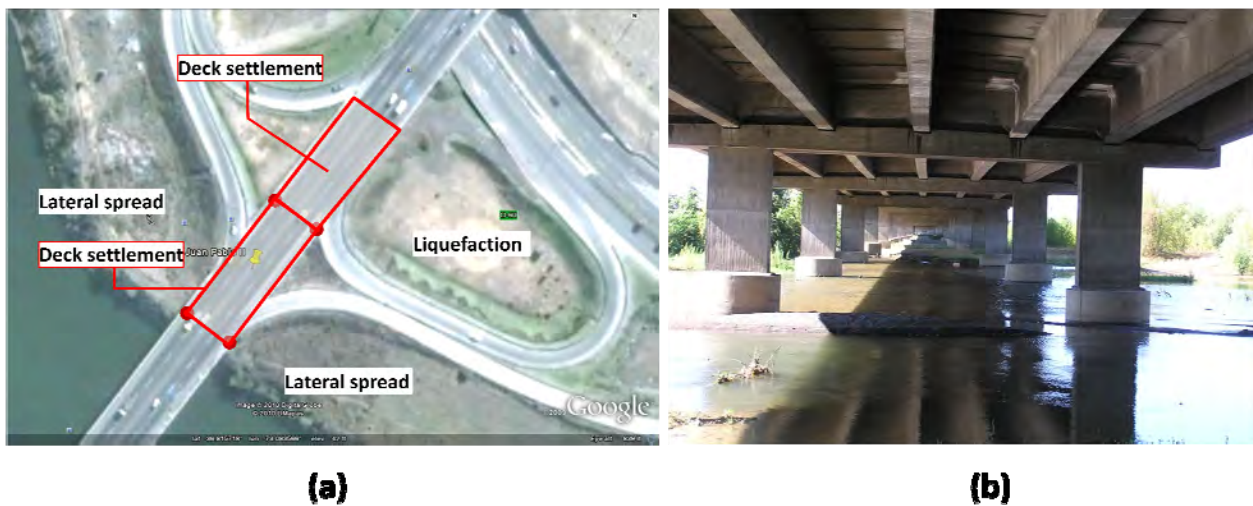
During the 2010 Chile earthquake, the bridge suffered severe damage and was closed to the public. Evidence of liquefaction and lateral spreading was observed in the north-east approach with significant effects on the bridge. A Google Earth view of the northeast approach with schematics of the observed ground failure and structural effects is shown in Figure 9.9b. As shown in Figure 9.10, liquefaction of the soil and lateral spreading in the embankment contributed to settlements and lateral displacement of the bridge deck. Visual inspection of the surrounding soils indicated the presence of fine loose sands. Several sand ejecta features were observed near the structure on the south and north sides of the embankment as shown in Figure 9.12. Several samples of the ejected soil were taken at this site, and grain size analysis and Atterberg limit testing are being performed. The results of this testing will be included in later versions of this report.

Figure 9.9. Juan Pablo II Bridge (a) Google Earth view of northeast Approach with schematics of observed damage (S36.815864° W73.083674°) (b) Typical bridge bent configuration (S36.828181° W73.095850°; 1636 hrs on 3/15/2010)

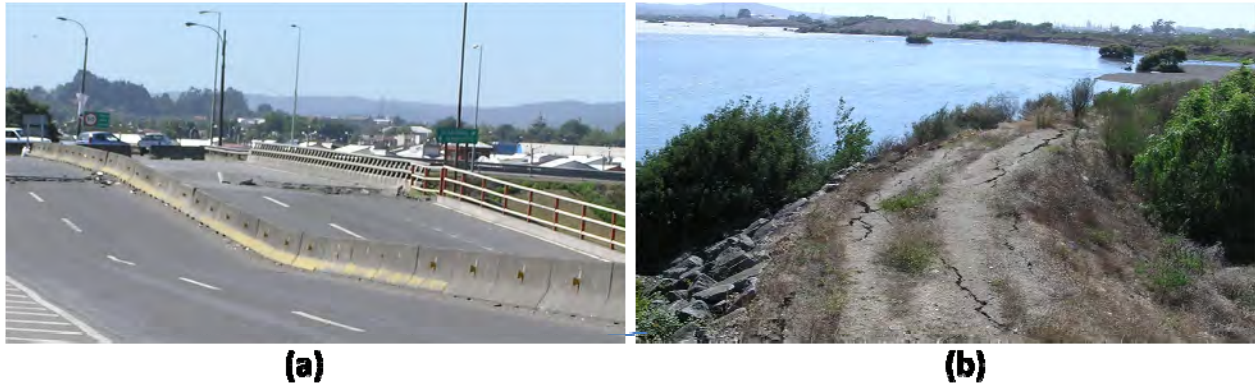
Figure 9.10. Juan Pablo II northeast approach: (a) Settlement of bridge deck near bridge approach (S36.815900° W73.084064°; 1455 hrs on 3/15/2010), (b) Lateral spreading on northeast bridge abutment.

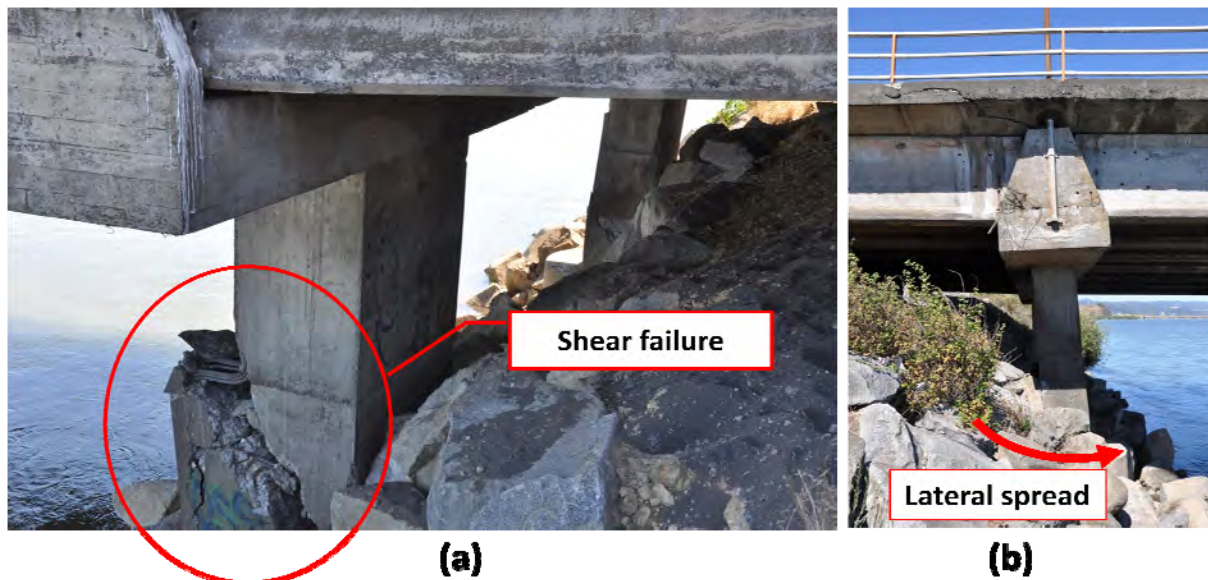
Column shear failure and significant displacements and rotation of the bridge bent were observed on the north-east approach. Figure 9.11(a) shows shear failure of the column facing the bent's south side. The north column, shown in Figure 9.11(b), shows evidence of tension cracks and rotation and also suffered shear failure. In contrast with the damage observed at the northeast approach to the bridge, the southwest approach suffered minor damage.

Figure 9.11. Juan Pablo II northeast approach: (a) Column shear failure (S36.816233° W73.084144°; 1528 hrs on 3/15/2010) (b) Rotation and lateral displacement of bridge bent (S36.816233° W73.084144°; 1530 hrs on 3/15/2010)

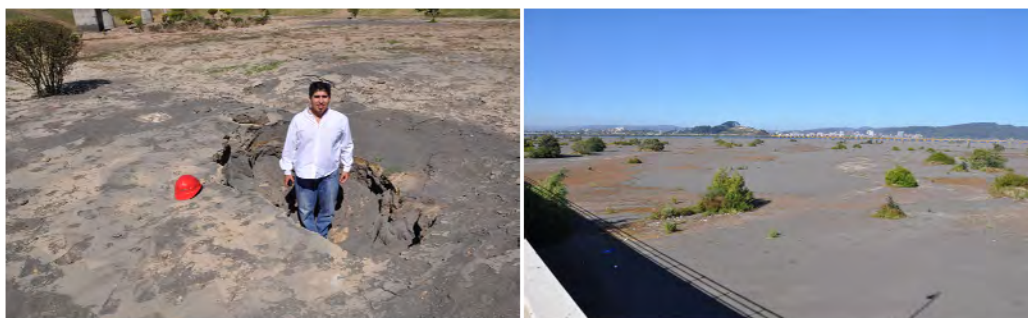
Noticeable pier settlements were observed at several locations along the length of the bridge. Vertical settlements appeared to be due to liquefaction of the soil near the pier foundations. Visual inspection of the surrounding soils indicated the presence of loose sands near the surface. Although the Bio Bio River was once navigable by ship up to the City of Nacimiento, over-logging during the twentieth century has led to heavy erosion that has choked the river with silt and rendered it impossible to ship traffic. Near Concepción the river behaves as a meandering river with fine-grained material deposited on the floodplains. The GEER team identified several sand boils near the approaches (e.g. Figure 9.12a) and along the bridge spans (in sections not covered by water). The presence of fine material is clearly shown in Figure 9.12(b).

Figure 9.12. Juan Pablo II bridge: (a) Sand ejecta near northeast approach and (S36.815619° W73.083311°; 1522 hrs on 3/15/2010) (b) Fine-grained material in the floodplains (S36.825592° 73.093264° on 3/15/2010).

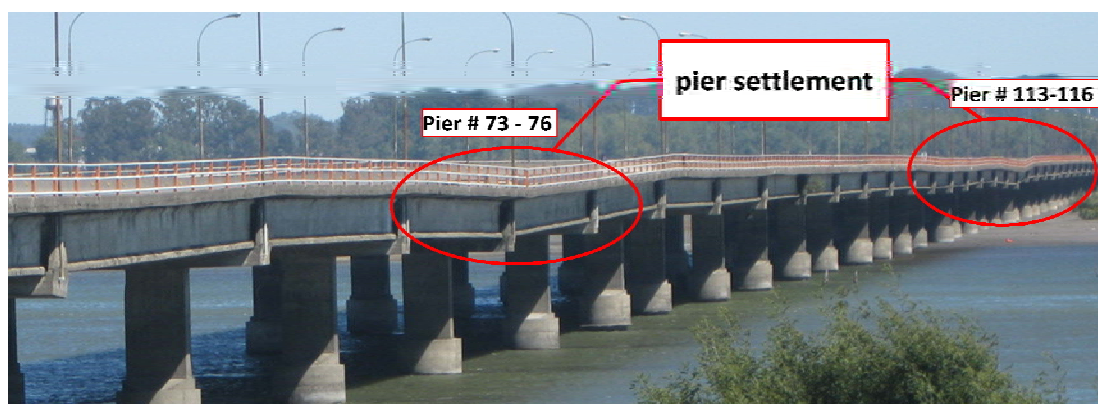
Settlements on the order of 0.50 m to 0.70 m were observed in piers #73-76 and piers #113-116 as indicated in Figure 9.13 (odd numbers for piers on the north side and even numbers for piers on the south side). The bridge deck accommodated these settlements with large vertical deformations but with relatively minor damage of the asphaltic layer. This is observed in Figure 9.14(b). Settlements of piers # 73, 75, 113 and 115 on the south side were larger than those at piers #74, 76, 114, and 116 on the north side indicating rotation of the bridge bents.

Figure 9.13. Juan Pablo II bridge – Pier settlements (S36.815122° W73.084369°; 1453 hrs on 3/15/2010)

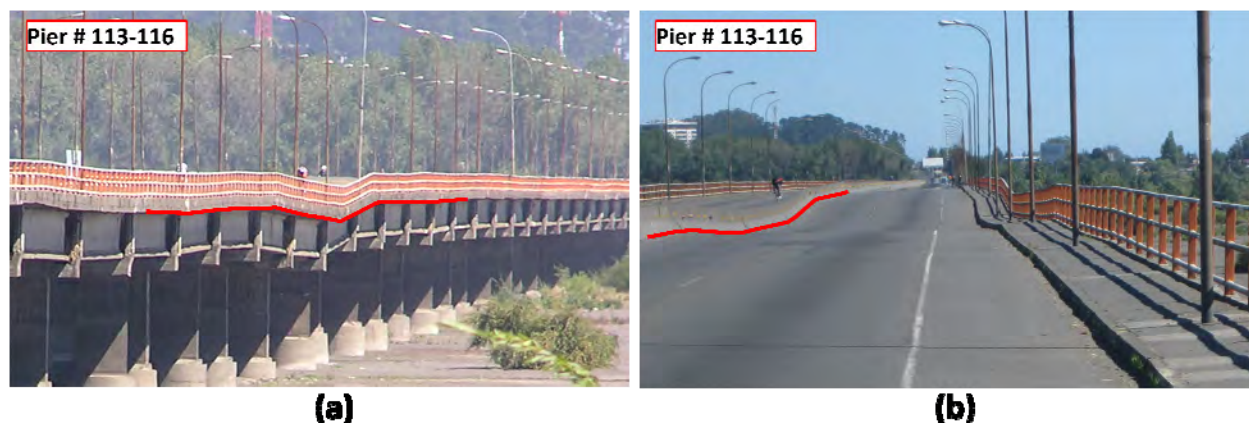
Figure 9.14. Juan Pablo II bridge (a) View of bridge bent settlement (S36.826596° W73.094345° on 3/15/2010)(b) View of bridge deck settlement (S36.826596° W73.094345° on 3/15/2010)

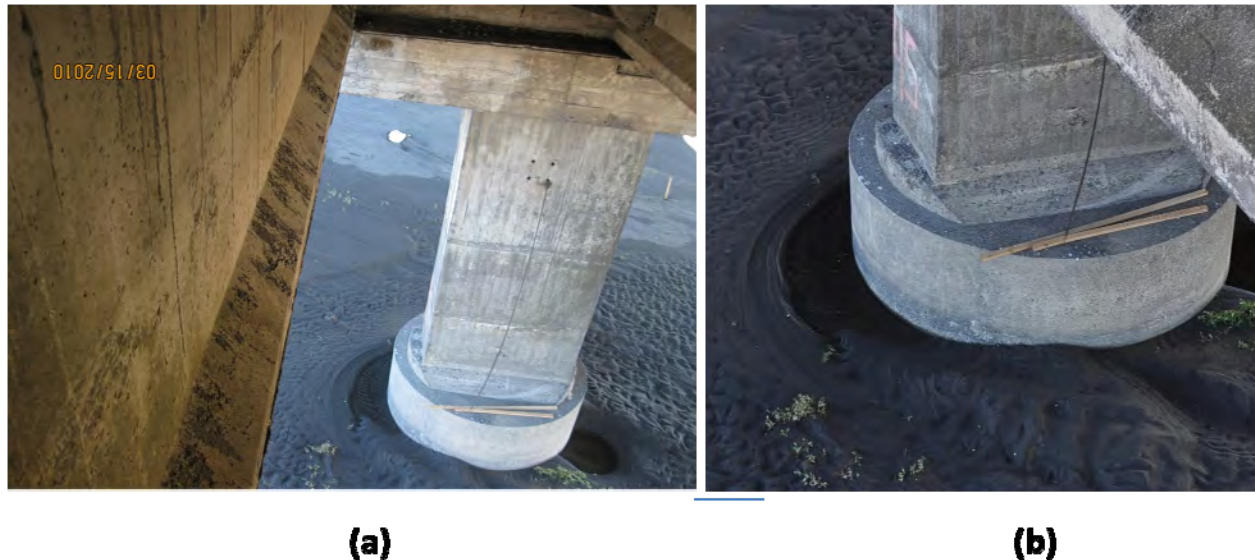
Although the GEER team had no direct access to the piers subjected to liquefaction and settlement it was possible to obtain some photos of the affected foundations. Figure 9.15(a) and (b) show the top view of a pier corresponding to pier group #113-116 and a close-up of the soil-pier interface. The figure shows the effects of liquefaction of the soil surrounding the pier with soil depressions and standing water covering an annular section around the pier. The soil in the vicinity of the pier shows evidence of water being brought to the surface and accumulation of sand probably ejected during the liquefaction event.

Figure 9.15. Juan Pablo II bridge—Evidence of liquefaction at piers subjected to settlements.(a)column and pier, (b) detail of pier and surrounding soil. (S36.826596° W73.094345° on 3/15/2010)

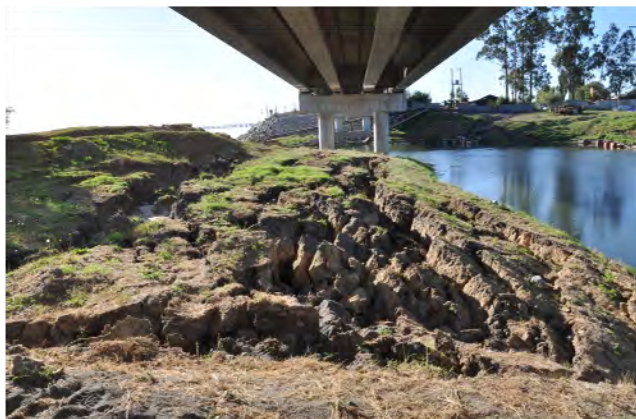
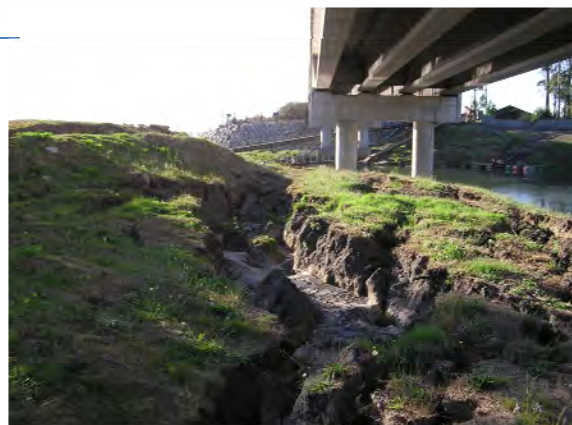
The bridge superstructure shifted transversely largely as a unit towards the east due to failure of the soil mass surrounding bents 2 and 3. Upon inspection of the ground at bents 2 and 3, significant spreading-like failure towards the water treatment plant inlet water was observed (Figure 9.17). This failure may have been attribute to either a deep seated slope instability or liquefaction-induced lateral spreading mechanism. It is noted that sand boils below the bridge were observed near bent #2 and 3 (Figure 9.18). Follow-up site investigation is being conducted by GEER to more fully understand the characteristics of

Figure 9.17. Ground failure at the La Mochita bridge, (a) looking north at bent #3 ($S36.847389^\circ$, $W73.055219^\circ$; 1831 hrs on 3/15/2010) and (b) looking north at bent #2 ($S36.847495^\circ$, $W73.055027^\circ$; 1835 hrs on 3/15/2010)

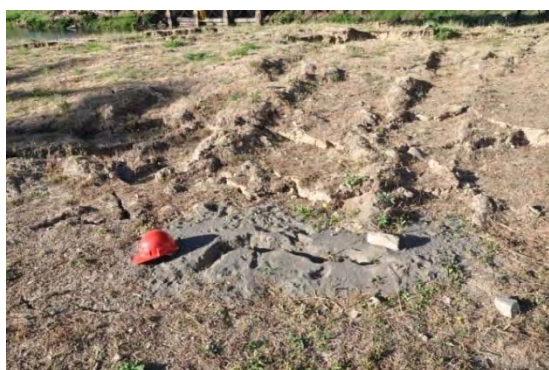
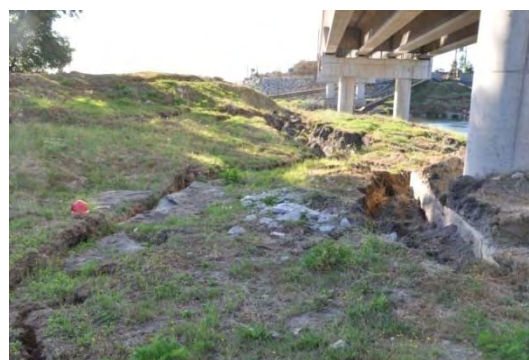
Figure 9.18. La Mochita bridge: (a) Sand boils observed below the bridge ($S36.847456^\circ$, $W73.055129^\circ$; 1830 hrs on 3/15/2010), and (b) View looking north ($S36.847453^\circ$, $W73.055225^\circ$; 1830 hrs on 3/15/2010)

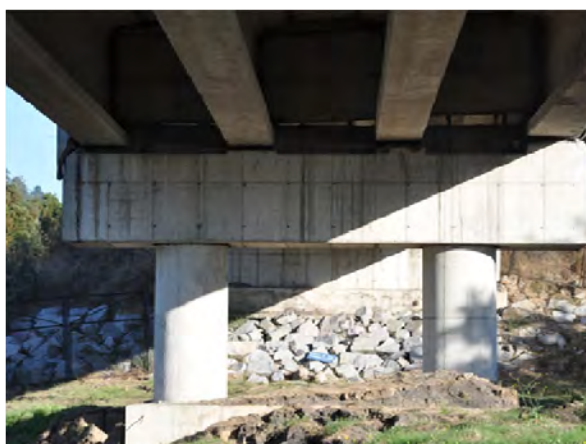
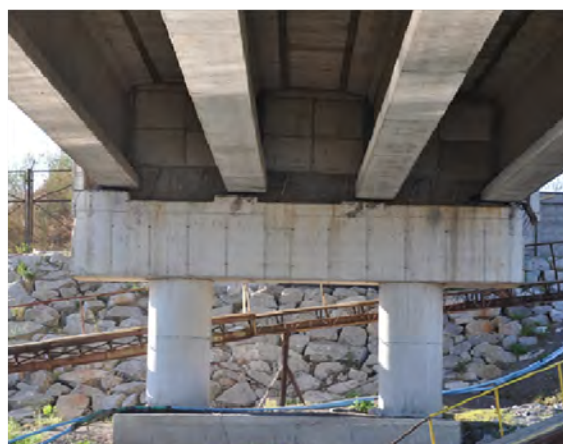
Figure 9.19. La Mochita bridge: (a) Rotation of bent #3 and surrounding ground failure at La Mochita bridge. View looking south ($S36.847302^\circ$, $W73.055151^\circ$; 1835hrs on 3/15/2010), and (b) Transverse shift of deck relative to bent #1. (the tilt of bent #1 could not be measured at the time of site visit). Ground failure surrounding bent #1 was not observed from this vantage point. View looking north ($S36.847049^\circ$, $W73.055443^\circ$; 1835 hrs on 3/15/2010).

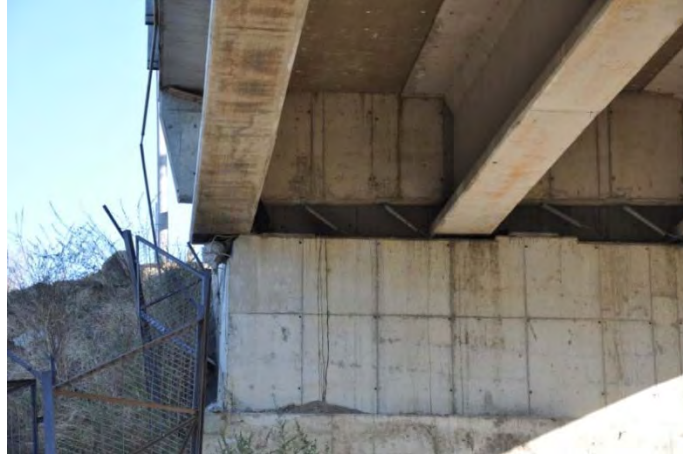
Figure 9.20. Transverse shift of deck relative to south abutment at the La Mochita bridge (S36.847547°, W73.054876°; 1834 hrs on 3/15/2010).

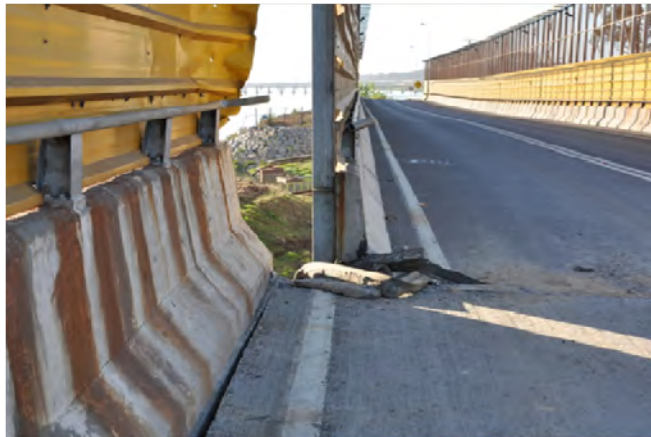
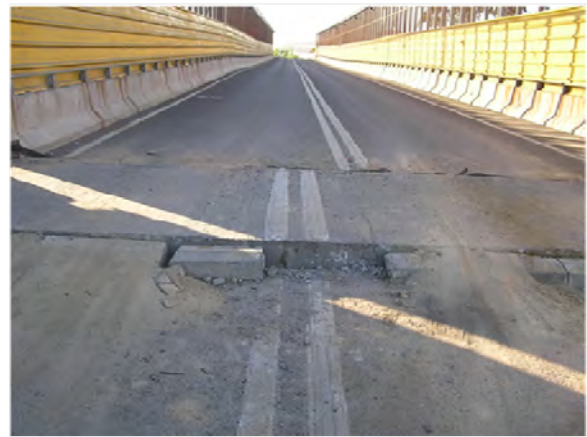
Figure 9.21. Mataquito bridge (a) Transverse gap developed between deck and south abutment. View looking north. (-36.847798°, -73.054797°; 1856 hrs on 3/15/2010), (b) Damage at the south abutment-road-deck interface due to transverse shift of the deck. View looking north. (S36.847761°, W73.054777°; 1856 hrs on 3/15/2010).

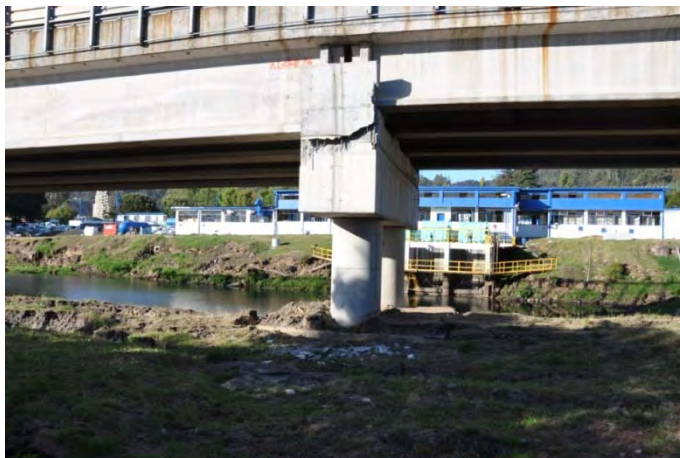
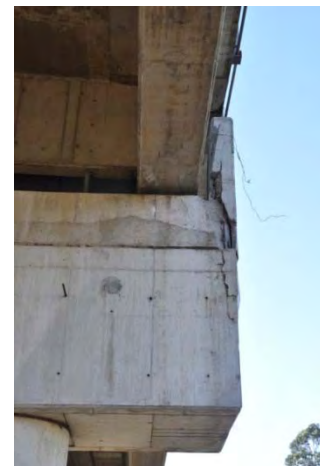
Figure 9.22. Damage to transverse shear keys at bent #3 due to movement of the La Mochita bridge (S36.847405°, W73.055084°; 1830 hrs on 3/15/2010).

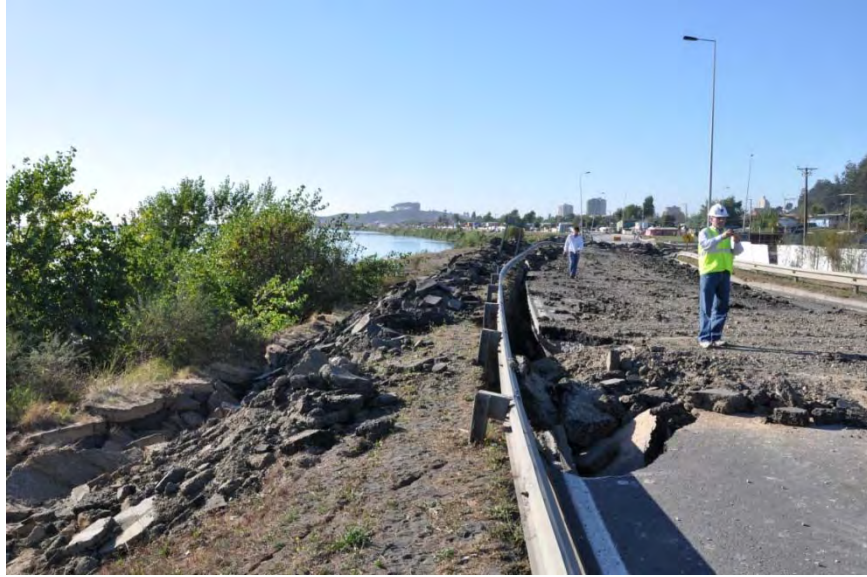
Figure 9.23. Damage to the approach road north of the La Mochita Bridge (S36.846473°, W73.055881° on 3/15/2010). View looking north. The Bio Bio river is shown on the left (west) of the view.

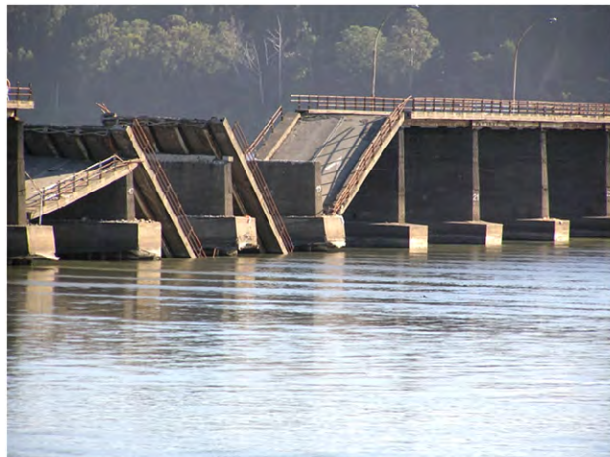
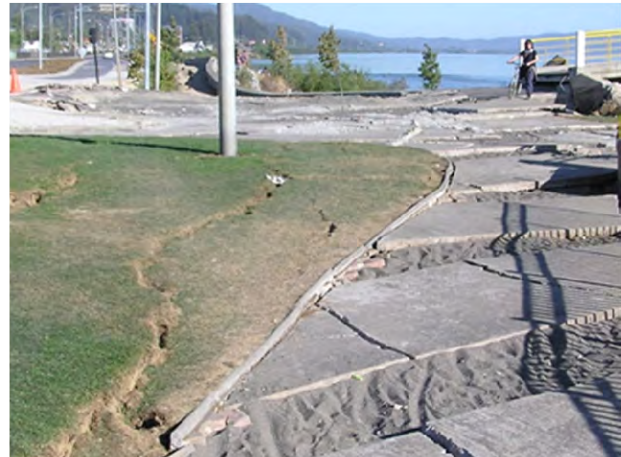
Figure 9.24. Puente Bio-Bio: (a) Collapsed slabs (S36.836789° W73.062203° on 3/15/2010), (b) Evidence of lateral spreading near East bridge approach (S36.837311° -73.061831°; 1753 hrs on 3/15/2010).

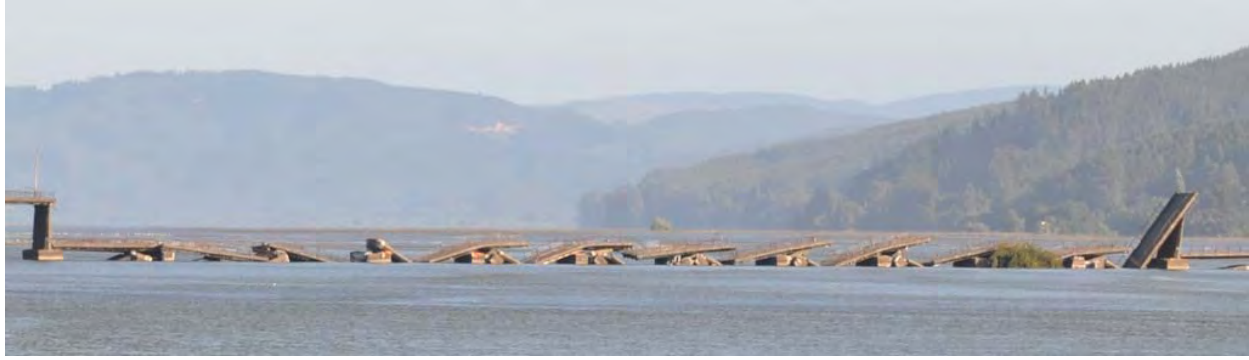
Figure 9.25. Puente Bi-Bio's collapsed slab sections and bridge bents (S36.837968° W73.062896° on 3/15/2010).
