Geo-engineering Reconnaissance of the 2010 Maule, Chile Earthquake

Report of the NSF Sponsored GEER Association Team

GEER Association Report No. GEER-022

Version 1: April 15, 2010

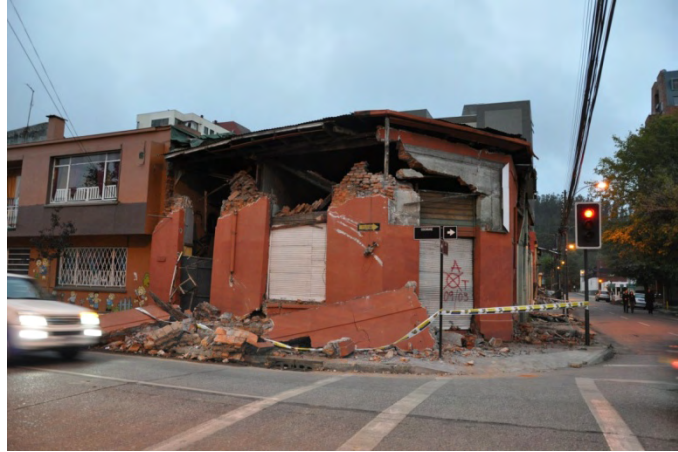
Figure 9.26. Typical construction type and observed damage within the city of Talca (S36.832375,W73.055439; 2016 hrs on 3/17/2010).

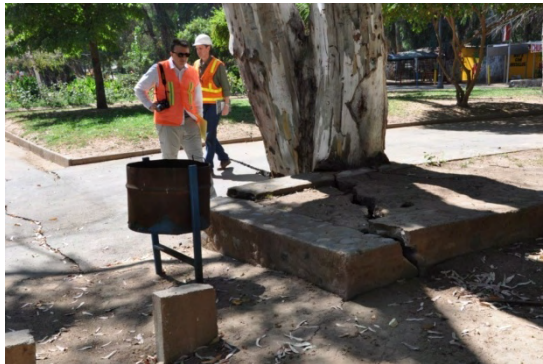
Local ground failure was observed approximately 50 m north of the Puente Rio Claro Nuevo (vehicular bridge) (Figure 9.30 and Figure 9.31). Two distinct regions were observed, a smaller lateral spread near shore (Figure 9.31), and a larger ground failure more characteristic of a soft clay failure confined within a park area (Figure 9.30). Soils near the shore area were predominantly gravely materials, likely with pockets of sand (one sand boil was observed at the near shore failure), whereas the park area was a soft clayey material. The ground failure extended approximately 90 m by 33 m north-south, however, it had no impact on the vehicular bridge, as it was open to traffic with no visible distress noted from the team's inspection on the east shore area. In contrast, the Puente Rio Claro Viejo (pedestrian bridge) suffered unseating of the longitudinally spanning girders and subsequent shear failure of the southern-most girder at a vista point near the mid-span of the bridge (Figure 9.32). From the team's limited access to the bridge it was not clear if the deck unseating was due to movement of the bent due to ground failure or excessive structural deformation at the bent.

Figure 9.30. Ground failure in a park area near the shore of the Rio Claro in Talca ($S35.419919^{\circ}$, $W71.682289^{\circ}$; 1408 hrs on 3/18/2010), views looking north and south, for left and right images, respectively.

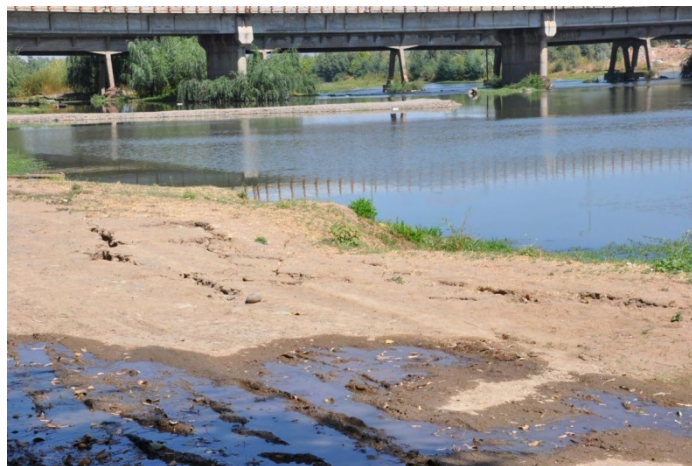
Figure 9.31. Near shore lateral spread on the western shore of the Rio Clara in Talca, view looking south. ($S35.419682^{\circ}$, $W71.682359^{\circ}$ on 3/18/2010). Both the pedestrian and vehicular crossing bridges are shown in the background.

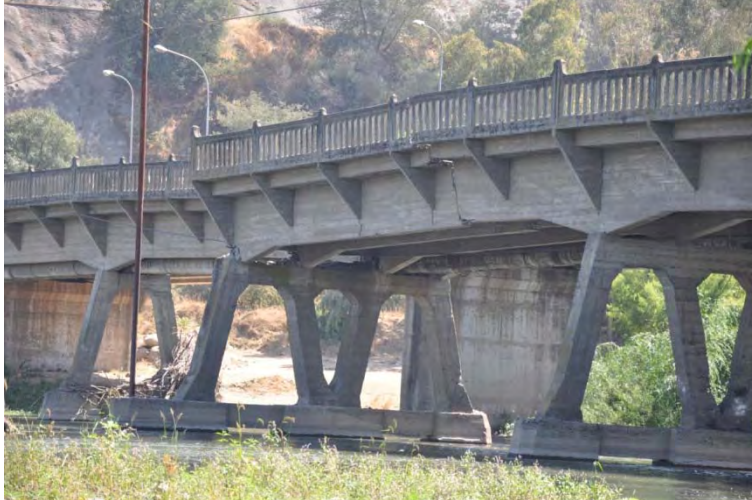
Figure 9.32. Deck unseating and shear failure of longitudinal spanning girders of the Talca pedestrian bridge at the vista area (S35.421044, W71.683197; 1354 hrs on 3/18/2010)

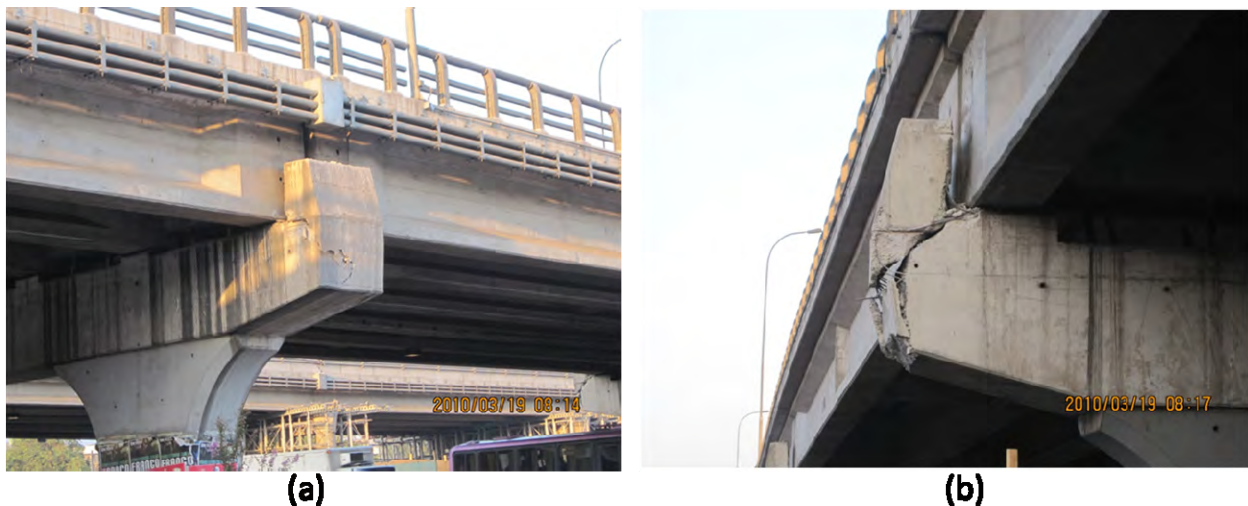
Figure 9.33. (a) Damaged shear key is an example of typical performance on bridges along this section of Vespucio Norte Expressway in Quilicura (S33.365585, W70.688657; 814 hrs on 3/19/2010), (b) Close up of damaged shear key along Vespucio Norte Expressway (S33.365893, W70.688584; 817 hrs on 3/19/2010).

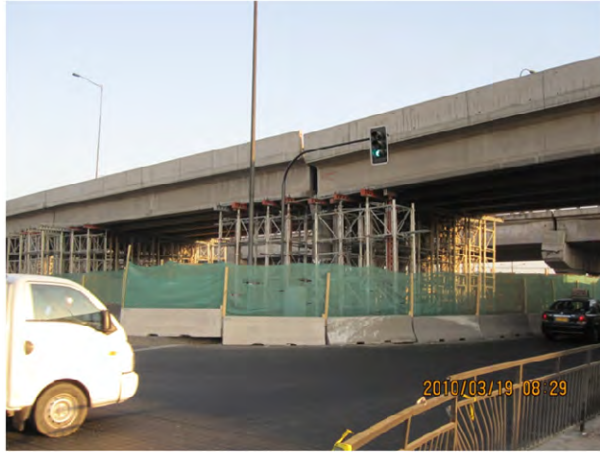
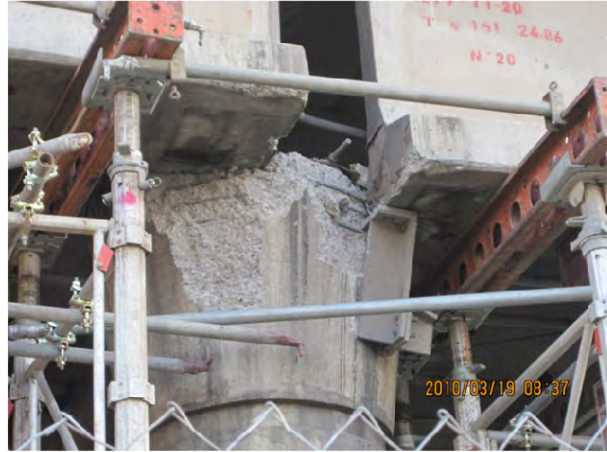
Figure 9.34 (a). Example of one of the newer under crossings that suffered damage along the Vespucio Norte Expressway. The right span became unseated due to excessive transverse movement (S33.36245, W70.688865; 829 hrs on 3/19/2010) (b) Close-up of shear key area on bent cap, with metal shear key or keeper bar hanging on right side of bent cap. Note complete unseating of I-girder on right side of bent cap (S33.366638, W70.689301; 837 hrs on 3/19/2010).

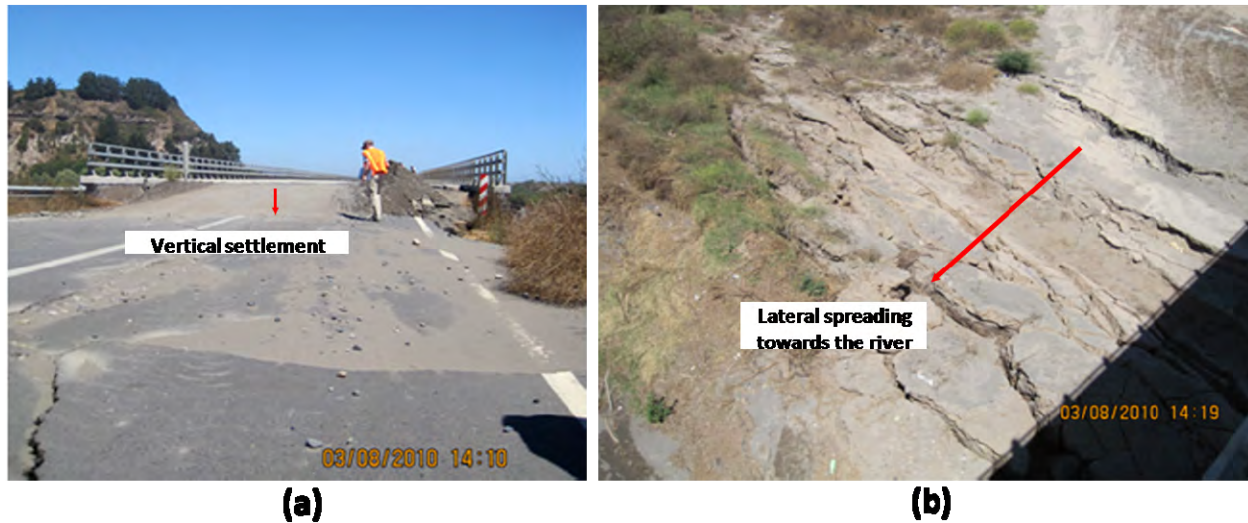
Built in 2008, the Mataquito Bridge is a two-lane 280 m-long reinforced concrete bridge, which runs in the north-south direction over the Mataquito River. Despite evidence of liquefaction at both abutments of this bridge, its overall seismic performance was good. No signs of structural damage due to lateral spreading were observed. Vertical settlement of about 50 cm was observed at the north approach fill, probably induced by liquefaction.

Figure 9.36. Mataquito bridge-(a) Settlement of approach fill at North end (b) Ground cracks at the South abutment due to lateral spreading (S35.051961, W72.163217, 1419 hrs on 3/08/2010)

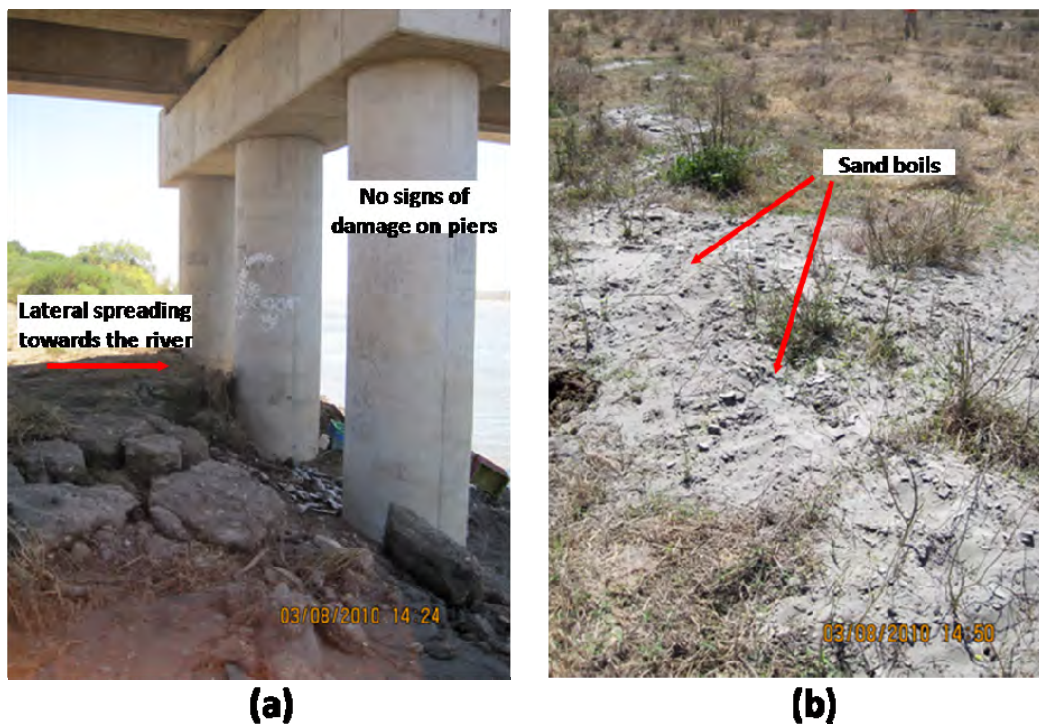
Figure 9.37. Mataquito bridge-(a) Blocks of soil crust against piers at the south end, (b) Sand boils at the north end of the bridge (S35.051961, W72.163217; 1450 hrs on 3/08/2010)

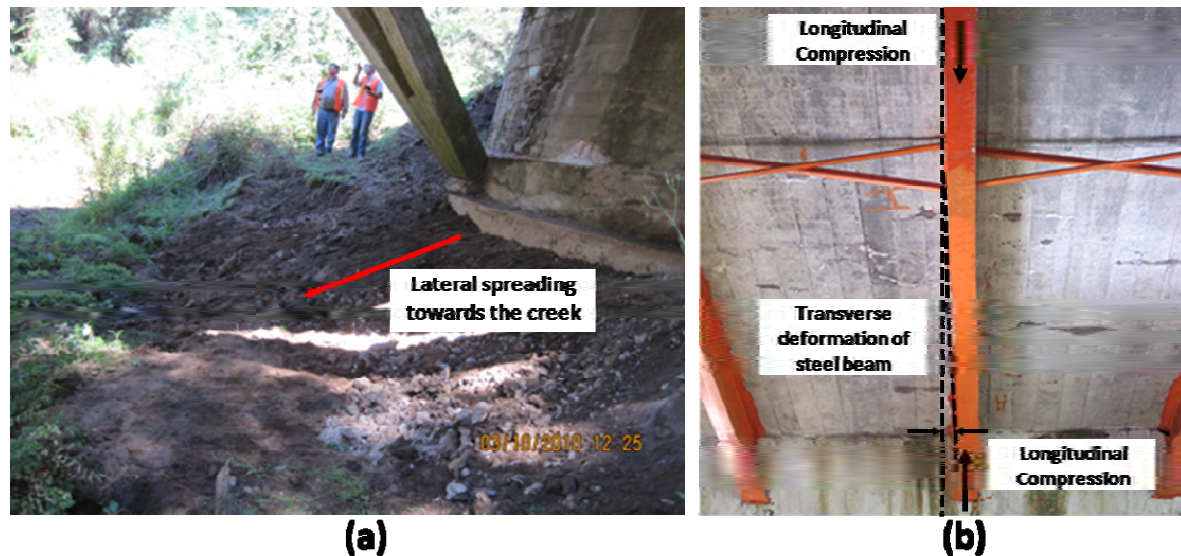
There was moderate damage of these bridges due to liquefaction and lateral spreading. These two-lane single-span old reinforced concrete bridges were close to each other. In these bridges the longitudinal movement due to lateral spreading of both abutments seemed to have compressed the bridges causing geometric distortion and moderate damage. The originally horizontal decks of the bridges ended up with a concave-down shape. Some transverse cracks were observed on the bridge deck due to this effect. Information provided by local authorities indicates that most of these bridges, if not all, have been recently surveyed as a part of a broad bridge assessment and improvement program, so there may be accurate survey points that could be used for future detailed analysis of the deformations.

Figure 9.38. Pulen Bridge-(a)Evidence of lateral spreading at the north abutment (b) Loss of longitudinal alignment of steel I-beam (S37.112036, W72.986902, 1225 hrs on 3/10/2010)

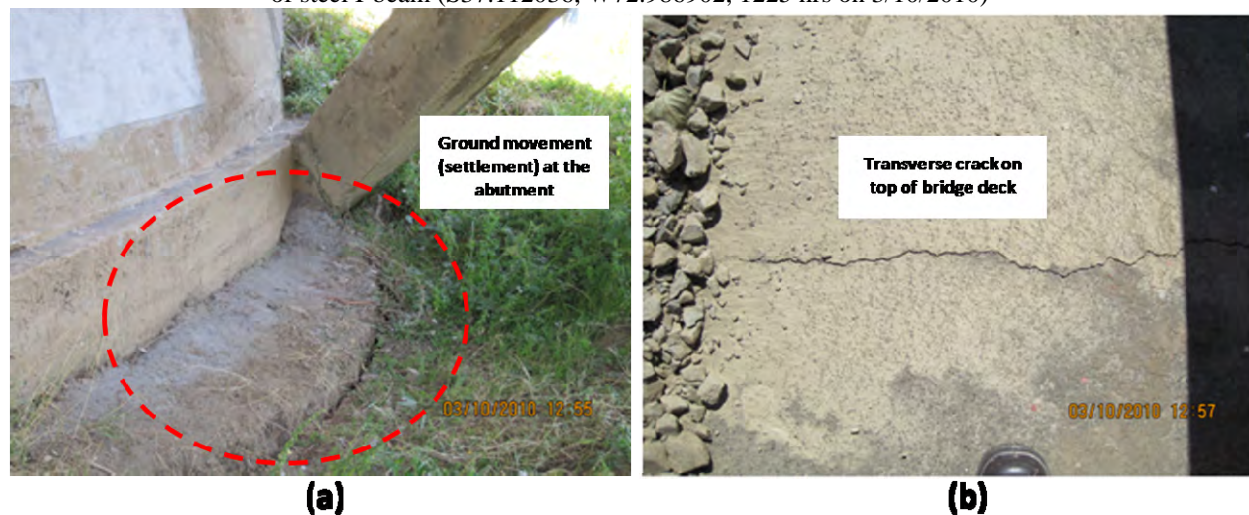
Figure 9.39. Patagual Bridge-(a) Ground movement at the abutment (b) Sidewalk crack in the transverse direction on the top of the bridge deck(S37.111325, W72.987583, 1257 hrs on 3/10/2010).

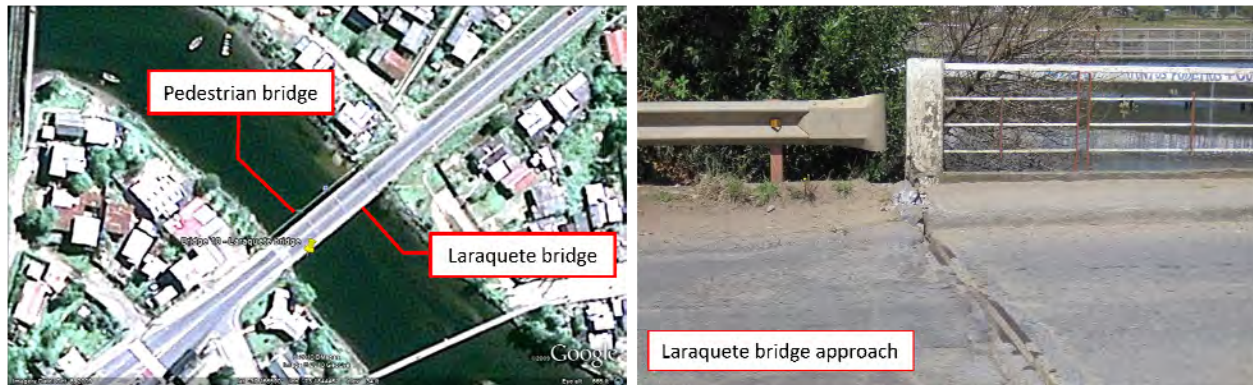
Two bridges were inspected in the Town of Laraquete, which is 50 km south of Concepción: A pedestrian two span bridge and an adjacent vehicular three span reinforced concrete bridge. The pedestrian bridge experienced damage due to foundation settlement of the middle bent with an estimated 0.50 m vertical deformation. Figure 9.41 shows the deformed bridge with noticeable inclination of the bridge deck. The adjacent reinforced concrete bridge, shown in Figure 9.40, suffered minor damage near the approaches due to pounding with the concrete structure and settlement due to poorly compacted fill. This bridge did not show evidence of foundation settlement.

Figure 9.40. Laraquete bridge (a) Aerial view ($S37.166788^{\circ}$ $W73.184486^{\circ}$), (b) Bridge approach ($S37.166804^{\circ}$ $W73.184760^{\circ}$; 1430 hrs on 3/10/2010)

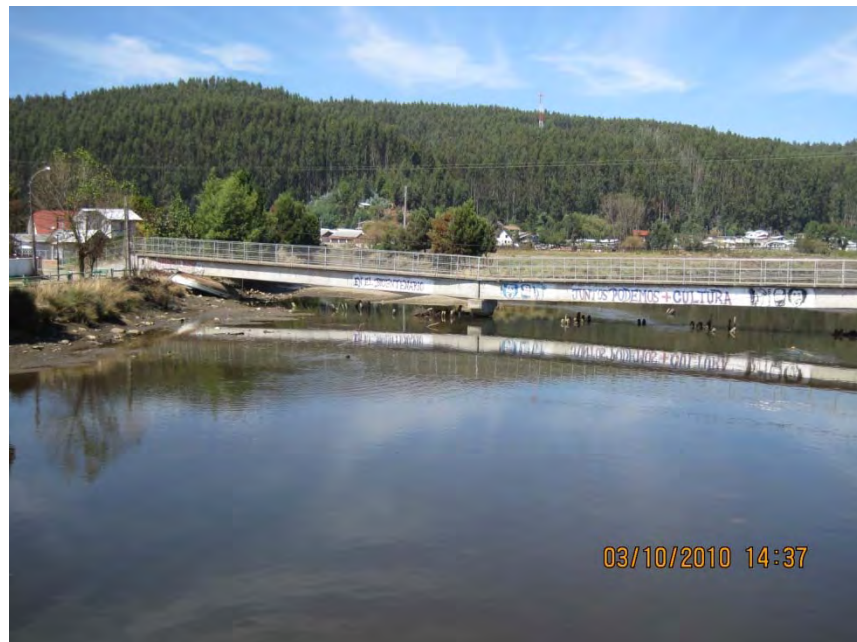
Figure 9.41. Pedestrian Laraquete Bridge showing large settlement of middle pier ($S37.166742^{\circ}$ $W73.184384^{\circ}$; 1437 hrs on 3/10/2010).

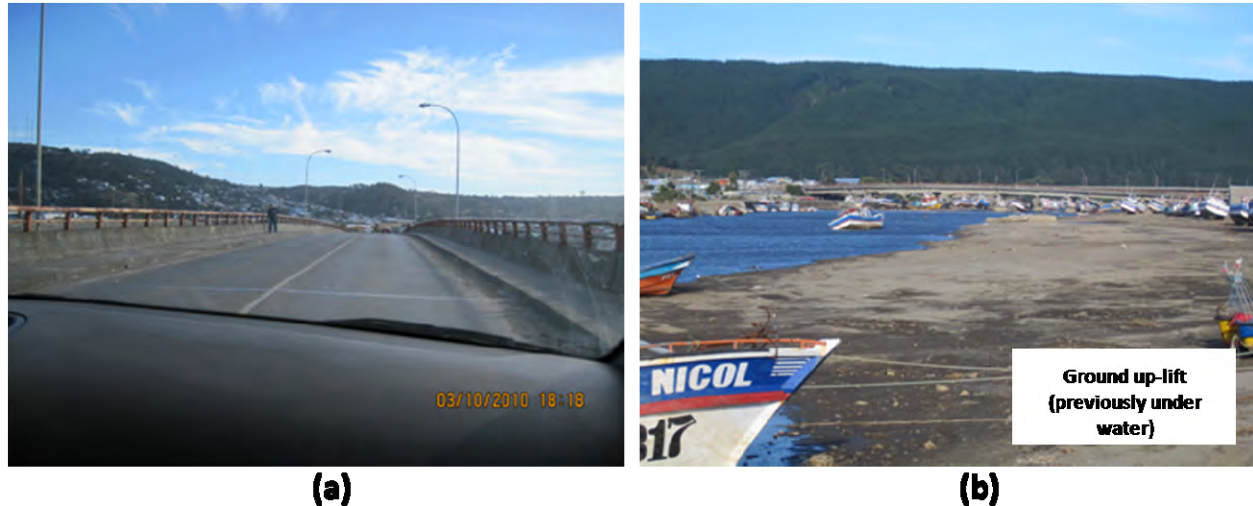
This bridge was operational by the time the GEER team got to Lebu. No major approach fill settlement could be observed. Good overall performance of the bridge in an area where evidence of ground uplift of 1.8 m to 2 m was found.

Figure 9.42. Lebu bridge: (a) Crossing Lebu bridge fully functional, and (b) Lebu bridge from the distance (S37.606344, W73.649496, 1818 hrs on 3/10/2010)

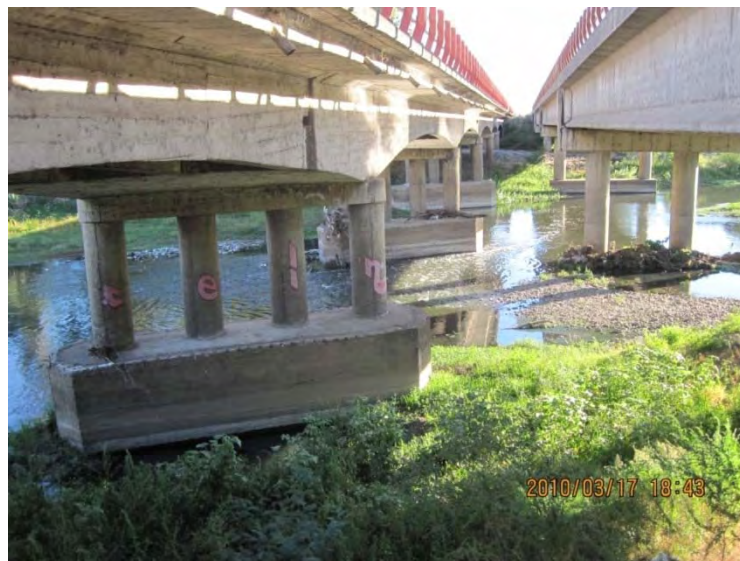
The EERI LFE Bridge Team observed this pair of bridges crossing the Rio Nebuco just South of Chillan along Route 5. The northbound bridge had a single dropped span, which had already been removed. The newer southbound bridge suffered only minor damage and was still in service handling both northbound and southbound traffic. The collapse was apparently a result of strong shaking. No apparent signs of liquefaction or lateral spreading and slope movement were observed.

Figure 9.43. This pair of bridges crosses the Rio Nebuco along Route 5 (S36.641846° W72.211264°; 1843 hrs on 3/17/2010).

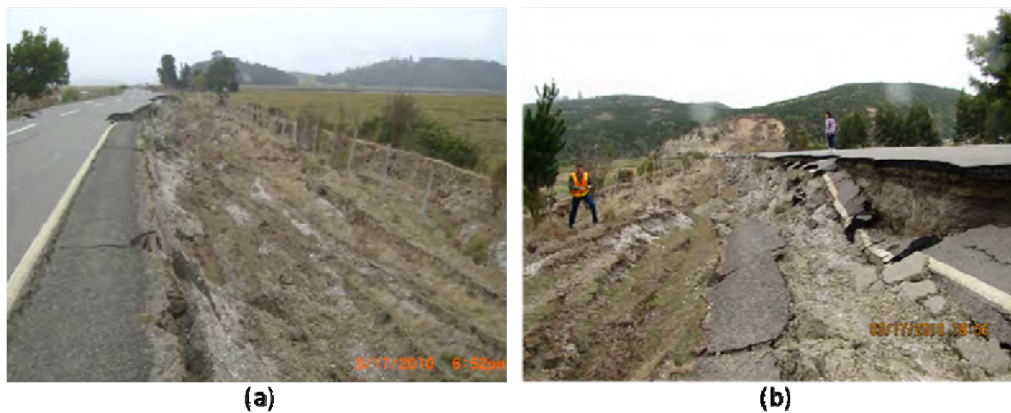
On both sides of the roadway, slumps developed along nearly the entire length of the roadway leaving vertical scarps 1.0 to 2.0 m in height as shown in Figure 9.46. The slopes on both sides of the roadway appear to have rotated downward causing an upward heave and rotation of the outer edge of the failure surface similar to a bearing capacity failure surface. In addition to the slumping along the sides of the road, the middle section of the road experienced lateral displacement towards the north as evidenced by the bow in the centerline of the road evident in Figure 9.46(a).

Figure 9.46. Photos showing scarps along both sides of the roadway due to bearing capacity failure in soil underlying the fill. Note lateral spreading in upper photo (S37.254161°, W73.437577° on 3/17/2010)

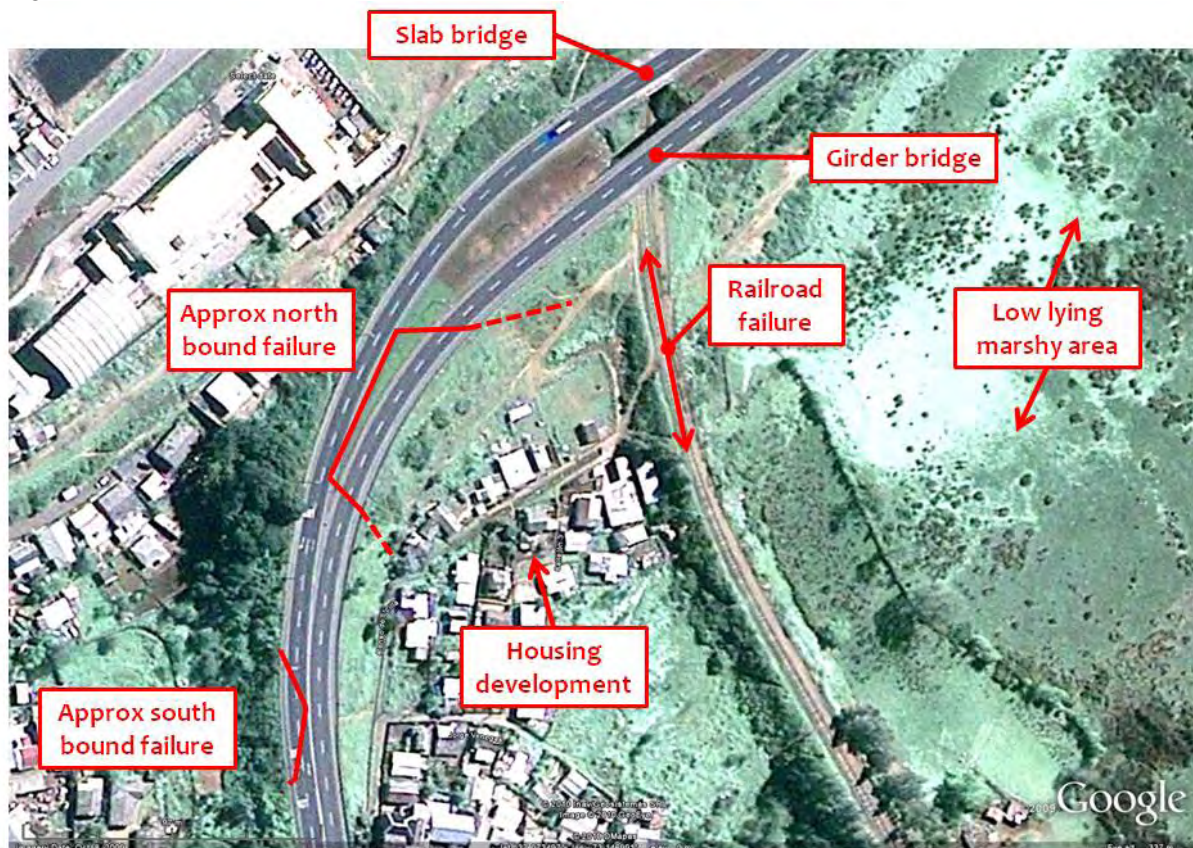
Several large ground failure areas were observed north of Lota along Route 160. Two failures resulted in damage to a roadway embankment section (denoted herein as the “south bound failure” and “north bound failure”; Figure 9.49), while a third failure resulted in damage to an elevated railroad section (denoted as “railroad failure”; Figure 9.47 and Figure 9.50). Minor side road spreading-like failures were also noted near the approach abutments to two short span overpass bridges, north of the embankment failures, as well as just north of the short span bridges. The area east of Route 160 is largely marshy with low lying organic material (Figure 9.47). South of the north bound failure and east of the south bound failure of the elevated roadway sections is a small housing development.

Figure 9.47. Plan view of approximate affected area (Google Earth image at S37.0734°, W73.1469°).

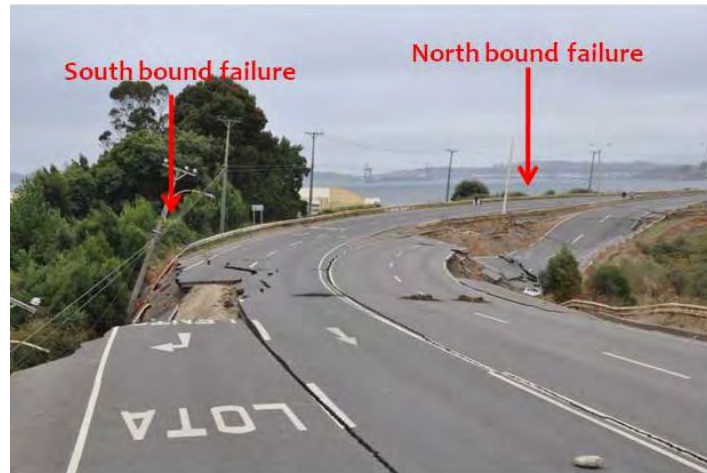
The north bound ground failure appeared to be deeply seated, perhaps due to softening of the foundation materials. It was not clear whether the south bound failure was due to a deep seated foundation failure or due to poorly compacted earth fill in the embankment section. A gray sandy fill overlaid by compacted clay fill was used in the elevated road embankment. The roadway elevation was approximately 10–15m above the valley area (10 m nearest to the overcrossing bridges, with high point above the housing development area). The bridge overcrossings, and therefore the road embankments, each of the north and south bound sections may have been constructed at different times, as evident in the differences in construction type of the bridges (Figure 9.50(a)). The neighboring elevated railroad failure is characterized by a slumping and spreading of the elevated section, which is likely due to movement of the compacted fill (Figure 9.50(b)). The railroad was approximately 5-7 m above the low lying marshy area along its failure zone.

Figure 9.48. View looking north on route 160 showing south bound and north bound failure areas (S37.0744°, W73.1480°; 1220 hrs on 3/16/2010).

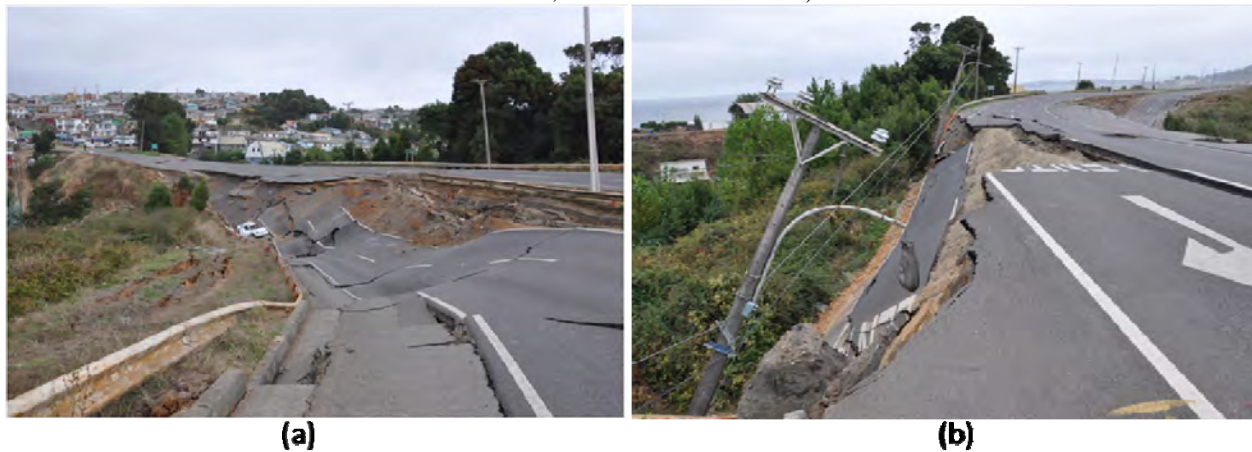
Figure 9.49. Lota (a)View looking south on route 160 showing north bound failure area (S37.0730°,W73.1475°; 1145 hrs on 3/16/2010) (b)View looking north on route 160 showing south bound failure area (S37.0746°, W73.1479°; 1215 hrs on 3/16/2010).

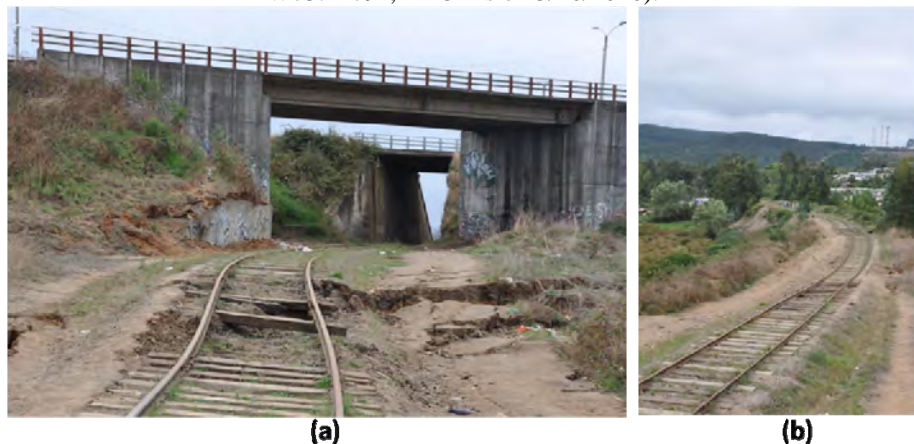
Figure 9.50. Lota (a)Slab and girder-type overpasses at northern end of road embankment failure area, showing railroad and supporting ground settlement. View looking west. (S37.0729°, W73.1469°; 1150 hrs on 3/16/2010), (b) Ground failure below elevated railroad east of road embankment failure. (image looking east; S37.0727°, W73.1471°; 1150 hrs on 3/16/2010)

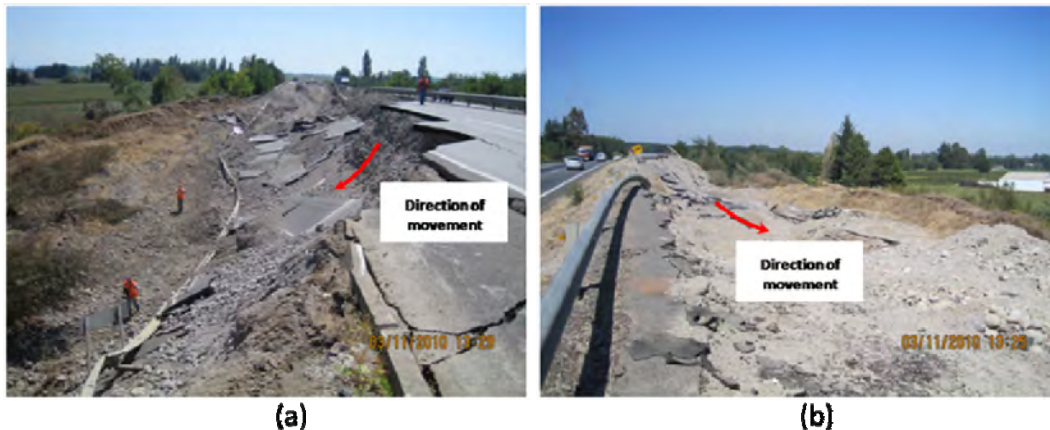
Two collapsed embankment fills were identified near Copihue and Parral. The first, shown in Figure 9.51, occurred on a straight section of Ruta 5 located ~ 8 km North of Parral (S36.0796 W71.7881). The Southbound lanes collapsed to the West and appeared to involve a shallow translational slide in near surface foundation soils as evidenced by the location of the failed soil mass including a mound of soil pushed up at West toe of the embankment (Figure 9.51a). The embankment failed along a length of approximately 150 m at a location where a low lying softer soil area was located at the toe.

Figure 9.51. This embankment fill collapsed together with an overhead near Copihue, north of Parral, closing the South bound of Route 5 (a) View from the South, (b) View from the North (S36.087891, W71.791513, 1325 hrs on 3/11/2010)

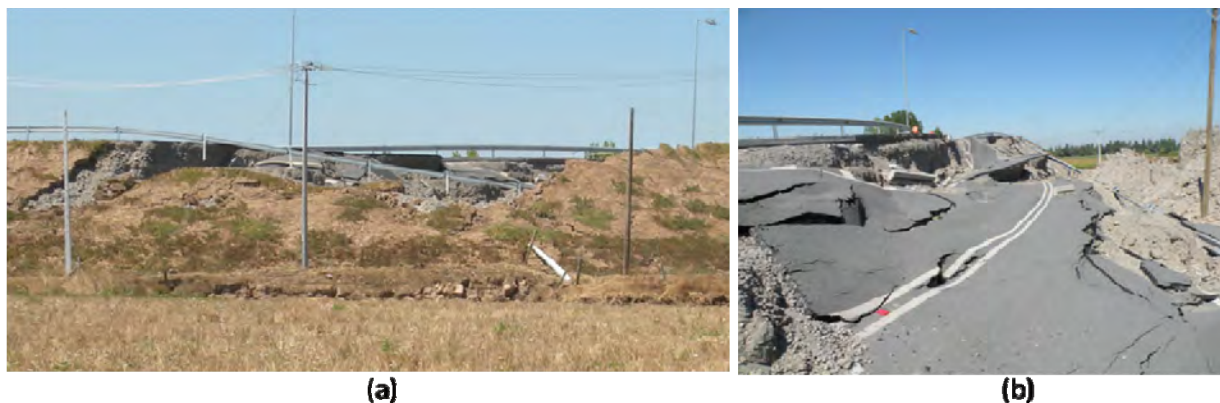
The second failure, shown in Figure 9.52, occurred on an overpass of Ruta 5 located ~ 13 km North of Parral. (S36.0347 , W71.7558). The overpass embankment was curved and the embankment failed over a length of about 80 m towards the outside of the curved section. Again, the failure appeared to involve a shallow translational slide in the near surface foundation soils as evidenced by the intact failed soil mass and the mound of soil pushed up at the toe (Figure 9.52a). Foundation soils in the region appeared to be relatively competent (unlike the above case) suggesting possible elevated pore pressures in the foundation soils played a role in the observed failure with 3-D effects leading to failure to the outside of the curved embankment section as opposed to the inside of the embankment. The outside section of the slide mass remained completely intact as evidenced in Figure 9.52b.

Figure 9.52. Curved overpass embankment failure 13 km North of Parral (a) Translational 3-D slide failure, (S36.0343 W71.7568; 1405 hrs on 3/11/2010) and (b) Failed outside of the curved embankment (S36.0347 W71.7558; 1409 hrs on 3/11/2010)

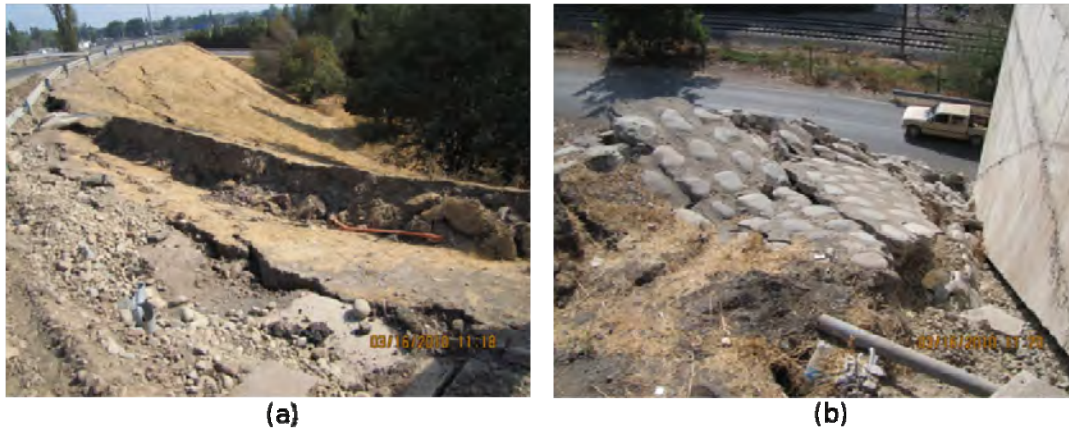
Abutment and embankment failures were common along Route 5. Figure 9.53 and Figure 9.54 show typical highway failures due to poor compaction of the embankment fill and abutments near Paine 62 km South of Santiago. The same scenario repeated at multiple sites. In contrast, mechanically stabilized retaining structures performed exceptionally well. Figure 9.53 shows the failure of an overpass bridge. The figure shows cracks on the sloping ground that propagated away from the abutment, and reduced in size away from the bridge. It seems cracks succeeded the abutment failure. The structural damage of the overpass was caused by differential settlement of the supports. Figure 9.54 shows the failure of the highway shoulder and pavement due to poor compaction of the fill material.

Figure 9.53. Highway 5 crossing near Paine; (a)View of bridge approach from East ($S33.854592^{\circ}$ $W70.747687^{\circ}$; 1118 hrs on 3/16/2010); (b) View of damaged bridge abutment ($S33.854211^{\circ}$ $W70.747784^{\circ}$; 1120 hrs on 3/16/2010)

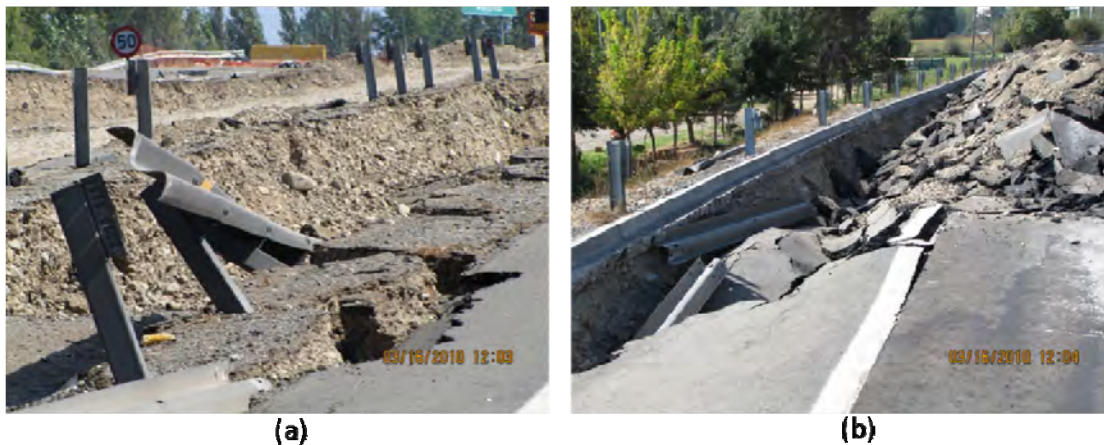
Figure 9.54. Highway 5 failure near Paine; (a)shoulder settlement due to poorly compacted soil ($S33.864897^{\circ}$ $W70.742222^{\circ}$ 1203 hrs on 3/16/2010), and (b) road failure due to poorly compacted soil ($S33.864897^{\circ}$ $W70.742222^{\circ}$; 1204 hrs on 03/16/2010)

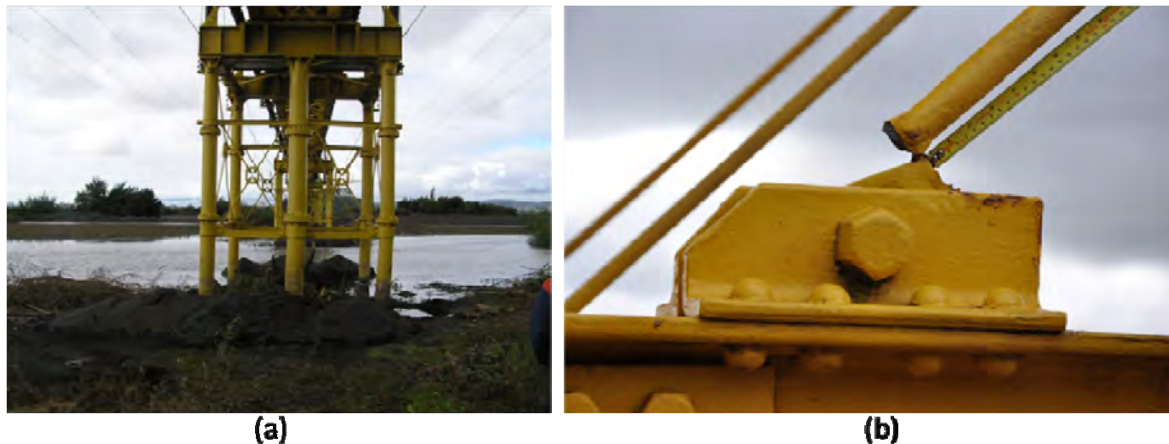
The Bio Bio river railroad bridge is one of the oldest crossings of the Bio Bio river. Originally built in 1889 m, it was completely retrofitted in 2005. This railroad structure is composed of parallel top and bottom chords separated by diagonal and vertical members in a Warren truss arrangement. Three hundred and seventy pillars support the structure covering a length of 1889 m. The bridge was damaged during the 2010 Chile earthquake due to strong shaking and possibly lateral spreading of the river banks. Of the 370 pillars of the bridge, 19 were damage during the earthquake and several portions of the rail were bended or miss-aligned (Figure 9.56) .Visual inspection of pillars near the West abutment seems to indicate several piles moved in the lateral direction and rotated (Figure 9.55). The rail lines were moved out of alignment as shown in Figure 9.53.

Figure 9.55. Bio Bio Railroad crossing (a) Pillars move and rotated during earthquake (b) Detail of broken crossbar, (S36.836075° W73.086969°; 1717 hrs on 3/17/2010)

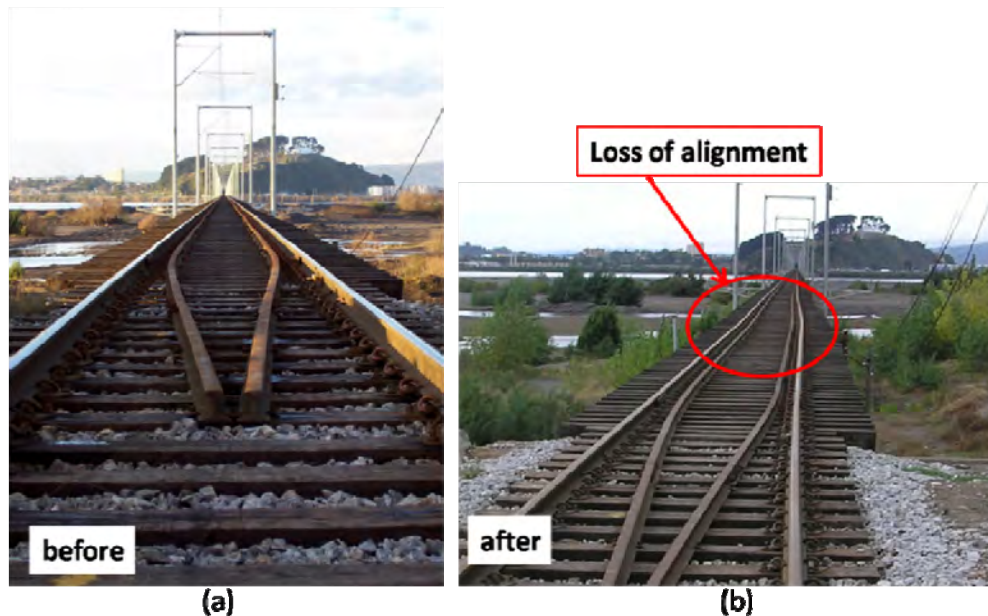
Figure 9.56. Bio Bio Railroad crossing (a) rails aligned before earthquake, (b) rails bended after earthquake (S36.836097° W73.087094° on 3/17/2010)

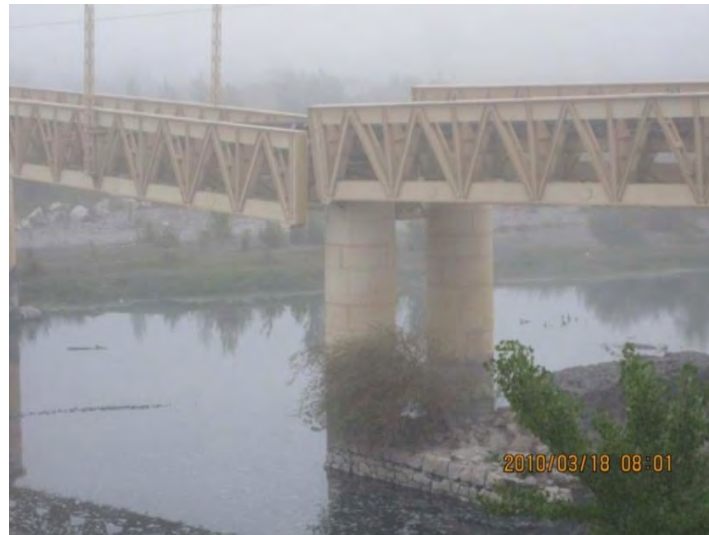
The EERI Bridge team observed the unseated railroad bridge span shown in Figure 9.57 approximately 330 km south of Santiago. This appeared to be the result of strong shaking, as no signs of liquefaction were observed. The Route 5 highway bridge was undamaged. An adjacent highway bridge was out, but demolished prior to the earthquake (S36.004136, W71.726193). Approximately 217 km south of Santiago, a railroad bridge crossing the Rio Claro was apparently undamaged, though the approach fills settled over 0.5 m, resulting in separation of the tracks from the support.

Figure 9.57. Unseated railway bridge span near Longavi from excessive transverse movement (S36.004136, W71.726193, 0801 hrs on 3/18/2010)

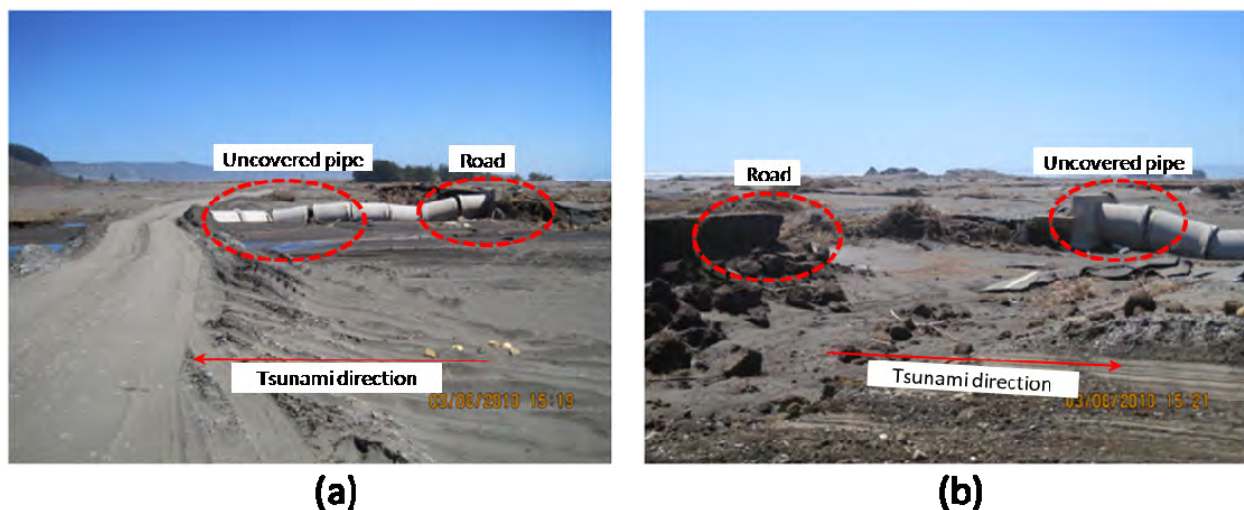
In this area, the tsunami caused most of the damage, washing off the road and uncovering a concrete pipe (Figure 9.55). Considering the extent of the damage in this zone, the pipe did not distort very much. This part of the road, however, was totally destroyed.

Figure 9.58. Failed culvert pipe: (a) View from the north, and (b) View from the south (S35.115611, W72.203245, 1519 hrs on 3/8/2010)

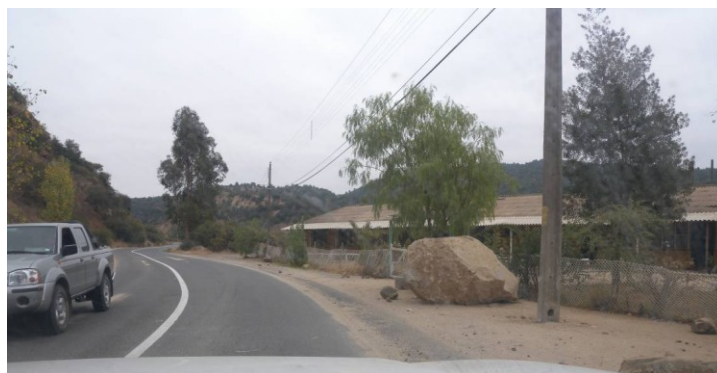
Rapel Dam (34.041445°S, 71.588856°W) - Figure 10.1 shows a rock fall from a road cut in granitic jointed rock mass on the main road approaching the Rapel Dam. Fortuitously, there was no damage to the buildings, because the road acted as a buffer. Rock falls also occurred from steep unscaled slopes immediately below Rapel Dam on both abutments. While not causing any damage of consequence, the fallen rock did represent a removal nuisance (Figure 10.2). A shallow disaggregated slide in road cut in the weathered rock mass also covered a portion of the roadway along the immediate upstream section of the right abutment of the reservoir (Figure 10.3). This type of limited raveling failure is characteristic of failures observed sporadically throughout the region, as shown below.

Figure 10.1. Rock fall from a road cut at the approach to Rapel Dam (34.0365°S, 74.586983°W).

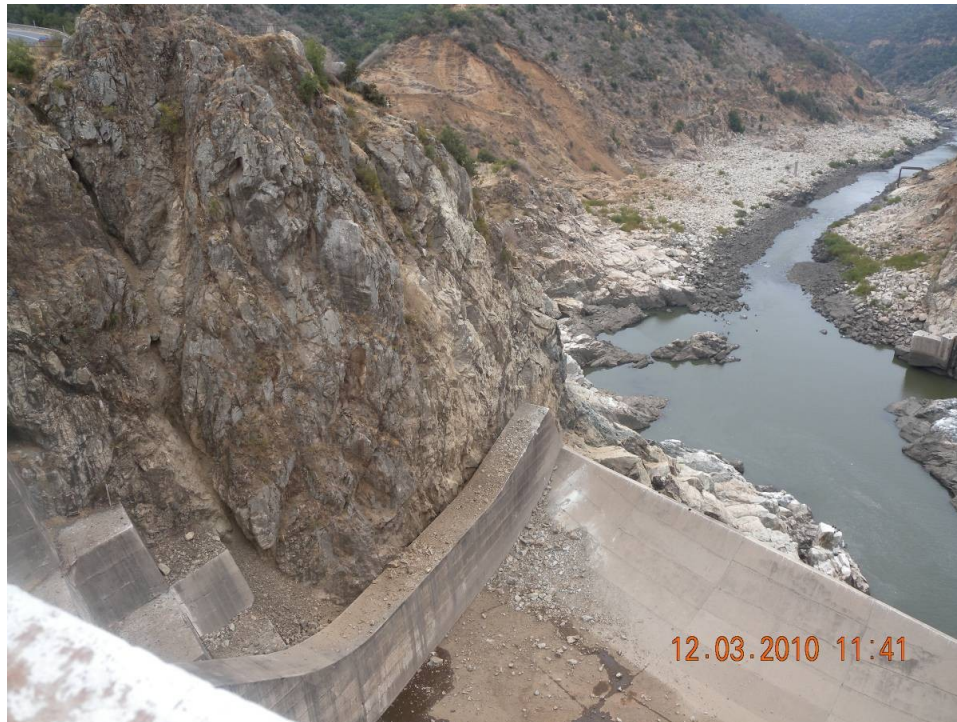
Figure 10.2. Rock fall from the downstream left abutment of Rapel Dam (34.04167°S, 71.59263°W).

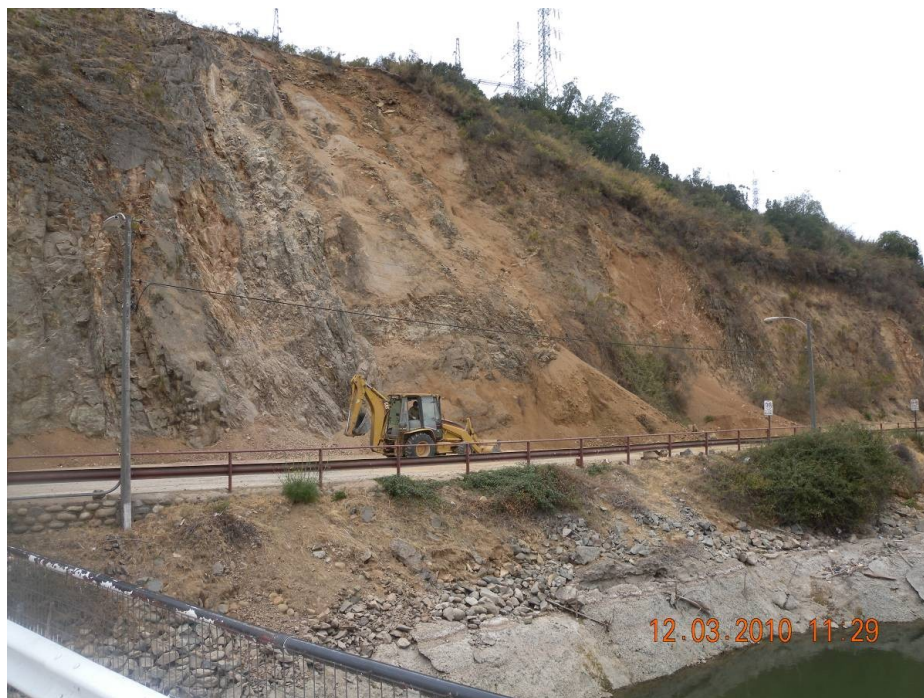
Figure 10.3. Shallow raveling failure of a road cut in weathered and heavily jointed granitic rock at Rapel Dam (34.0407421°S, 71.587153°W).

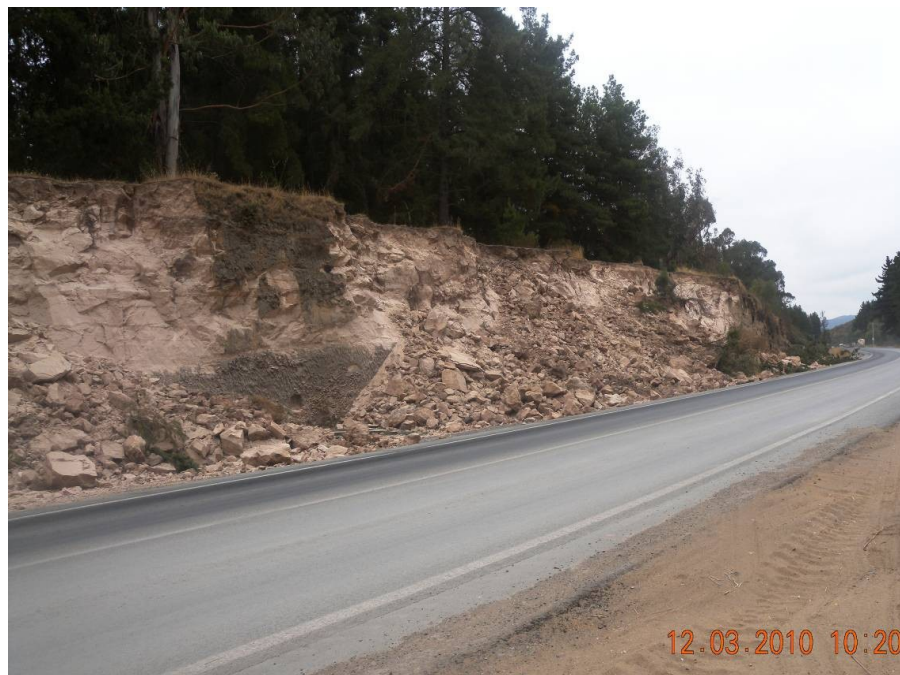
Road Cut Failures – Sporadic failures in road cuts were noted throughout the region and their size and characteristics typically reflected the height of the cut and the competency of the source material. More competent rock types exhibited larger size boulders within the failed mass while less competent source materials exhibited more disaggregated masses of smaller boulders and particles. Figure 10.4 shows a relatively extensive failure in a cut in jointed welded tuff north of El Manzano along the western edge of Lago Rapel. Figure 10.5 is a shallow failure in an approximately 15 m (45 ft) high cut in highly weathered rock on the road from Nacimiento to Santa Juana. The volume of the material was just enough to overtop the barrier, but not enough to damage it or to impede traffic. Figure 10.6 is a cut in Holocene fluvial sand deposits just North of Pulen bridge (Bridge Case No. 9) that simply sloughed along most of its face. The failure was shallow and had no effect on traffic. Similar shallow slides were observed on numerous highway overpass fills which typically appeared to be densely compacted sand with very few fines. Finally, Figure 10.7 is a bench failure in a high, ~ 30 m, benched road cut in residual soil/heavily weathered rock. The failure appears to have occurred along a daylighting joint surface that was unrecognized when the uppermost bench was cut. An immediately adjacent, identically benched slope showed no signs of failure; hence, joint orientation most likely controlled the location and mode of failure.

Figure 10.4. Road cut failure in jointed welded tuff north of El Manzano. The height of the cut is about 6 m (20 feet). Picture looking NE (34.144076°S, 71.38000°W).

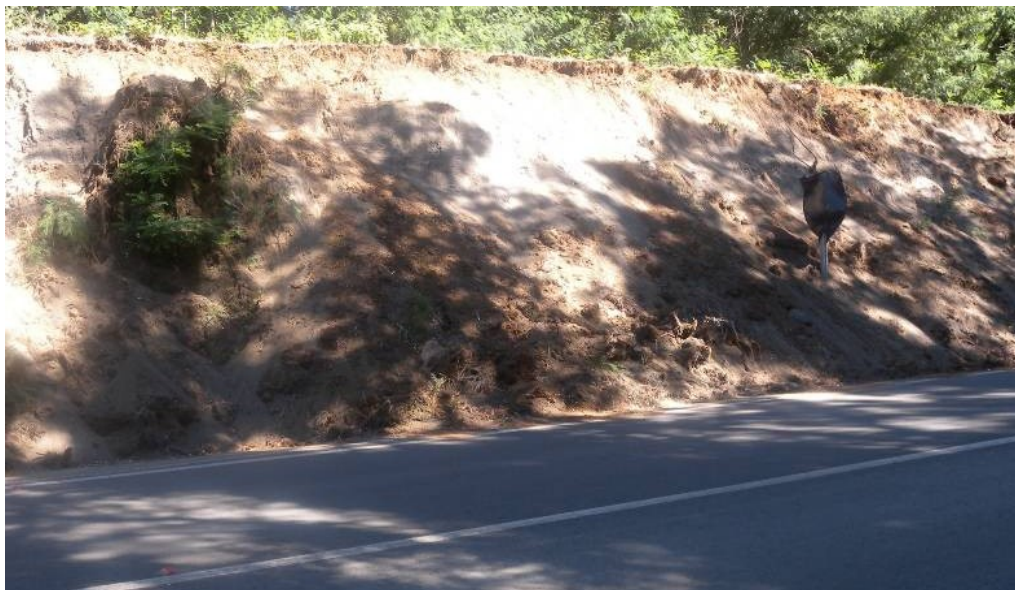
Figure 10.6. Sloughing of unconsolidated fluvial sand in a road cut North of Santa Juana (37.1111°S, 72.9876°W).

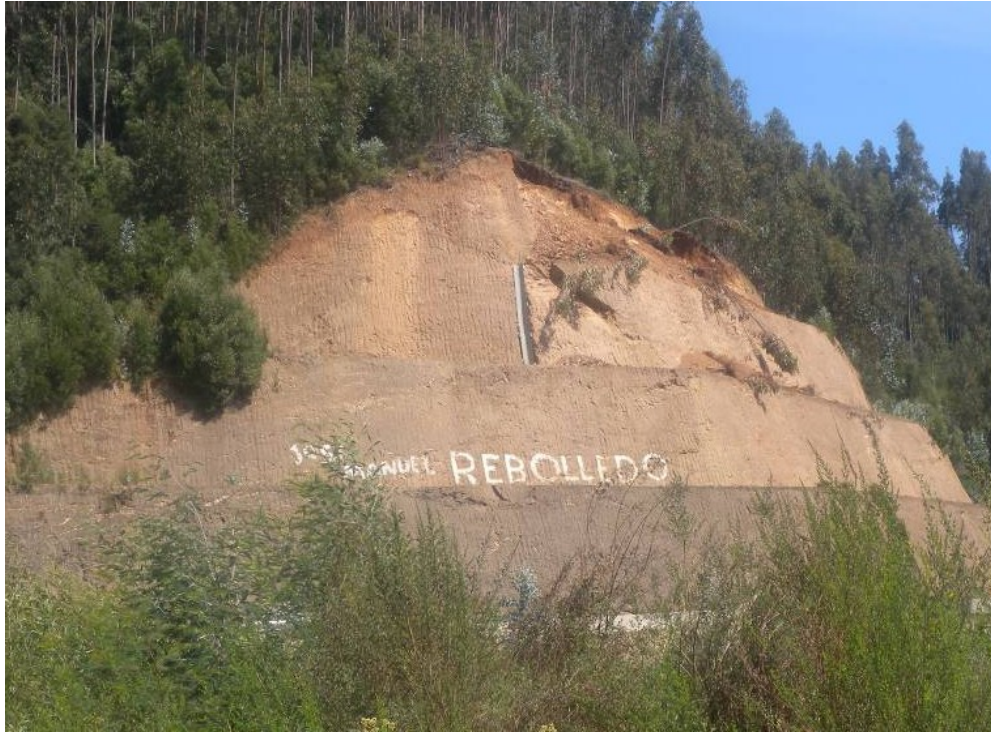
Figure 10.7. Bench failure along a daylighting joint in a road cut in deeply weathered rock south of Lota (37.1213°S, 73.1550°W).
