Geo-engineering Reconnaissance of the 2010 Maule, Chile Earthquake

Report of the NSF Sponsored GEER Association Team

GEER Association Report No. GEER-022

Version 1: April 15, 2010

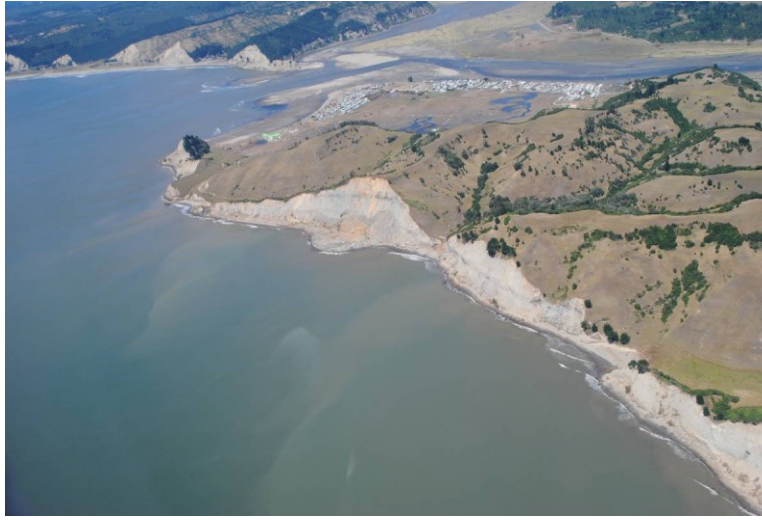
The character of the coastline changes to the north of Arauco, with softer sediments exposed in the terrace and beach bluff slopes. The slopes tend to be more gentle and more densely vegetated. Similarly slope failures are less frequent although when they occurred they had greater impact as road alignments take advantage of the less rugged coastal zone. A series of slides occurred at the seaward ends of low ridges in soft sandstones west of Arauco, with two of the slides closing the coastal road. The aerial view of the general setting is shown in Figure 10.10 with the town of Tubul in the distance and Arauco off the picture to the distant left (SE). A view of a slide that closed the road just West of Arauco is shown in Figure 10.11.

Figure 10.10. Aerial view of the coastal bluffs West of Arauco (37.2205°S, 73.443°W).

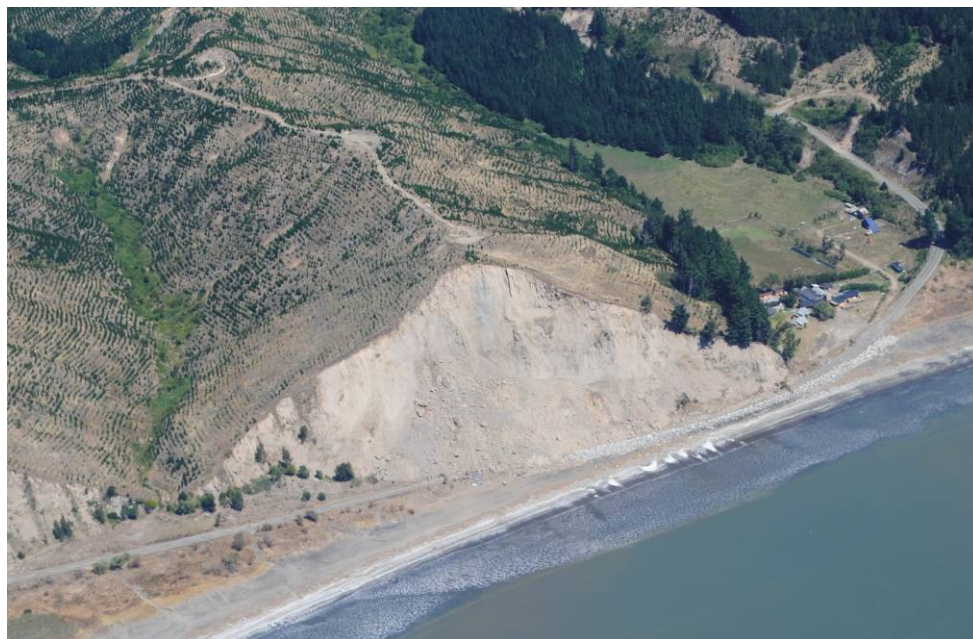
Figure 10.11. Shallow failure along a truncated ridge forcing road closure West of Arauco (37.2437°S, 73.413°W) .

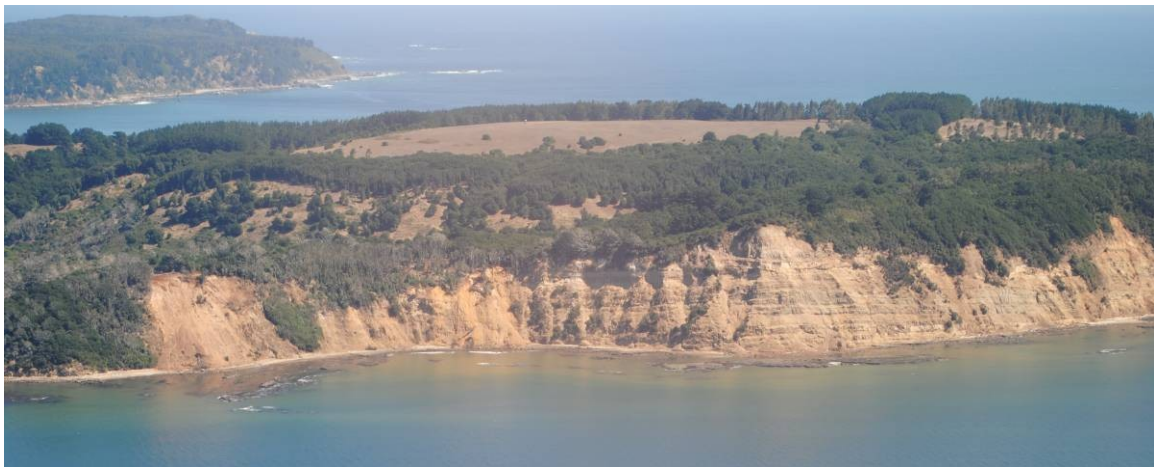
Concepcion Area – Very similar types of highly localized landslides occurred on bluffs in Tertiary sedimentary rocks in the region around Concepcion. Figure 10.12 shows steep bluffs on the eastern shore of Isla Quiriquina which experienced shallow raveling which mostly denuded the slopes. However, several larger failures occurred in this area as well. Figure 10.13 shows a large complex of shallow coalescing slides located on the western shore of Pta Tumbes just north of Talcahuano. While this landslide complex in Tertiary sedimentary rocks was one of the most extensive failures noted along the entire coastline, pre-existing photography suggests that this was a previously disturbed area used as a quarry with a history of prior sliding. This conclusion is supported by the fact that very few other slides are found in the vicinity. However, a well documented large failure of a road cut occurred across the bay just north of Tome (Figure 10.14). The road cut in interbedded sandstone and shale is about a year old and the estimated volume of the slide is 3200 cubic meters (Jose Miguel, personal communication).

Figure 10.12. Shallow failures and raveling in Tertiary sedimentary rocks on Isla Quiriquina (36.627°S, 73.05°W).

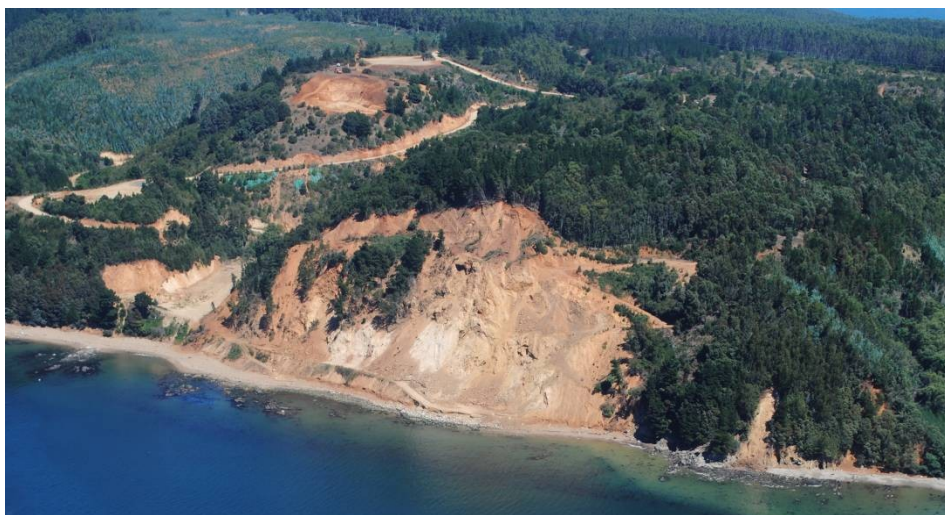
Figure 10.13. Disaggregated landslide complex, Punta Tumbes looking West (36.66°S, 73.098°W).

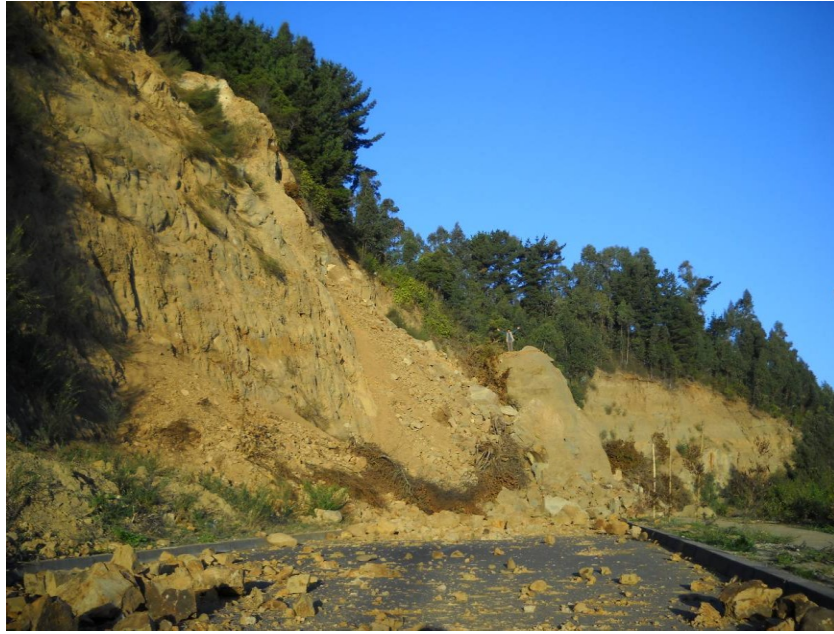
Figure 10.14. Landslide in a road cut in Cocholgue, north of Tome (36.595 S, 72.974 W). Photo and details courtesy of J.M. Lopez.

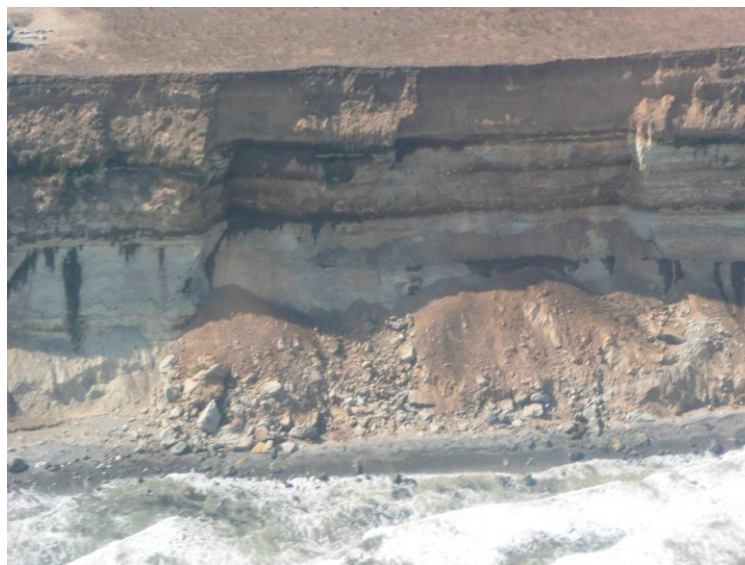
Navidad to San Antonio – Long stretches of the coastline north of Concepcion are fronted by broad beaches that are punctuated by occasional headlands with only occasional small slope failures. To the north of Navidad the coastline is defined by a relatively flat terrace capped by unconsolidated shallow marine and fluvial deposits. The terrace has an elevation of 80 to 100 m and drops abruptly to a narrow rocky beach. Numerous shallow failures by toppling and slumping of relatively thin slabs of bedrock and overlying sediments occurred in this region as illustrated in Figure 10.15.

Figure 10.15. Typical shallow failure of steep coastal bluffs, Reserva Nacional El Yali (33.841°S, 71.817°W) .

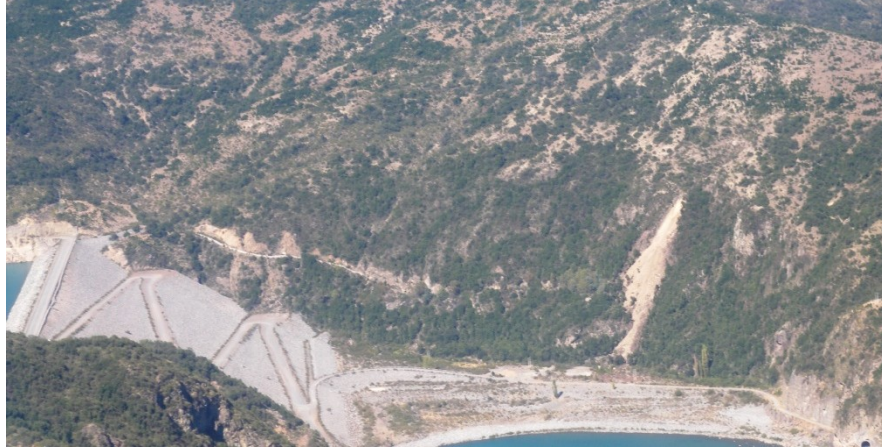
Interior Region – Widely scattered occasional disaggregated slides in natural slopes seemed to occur without any particular association with lithology or damage to nearby infrastructure as already shown at Rapel Dam. Figure 10.16 is an example of a typical small failure from a steep slope which occurred just below the Colbun Dam which suffered no damage.

Figure 10.16. Typical shallow disaggregated slide, Colbun Dam (35.668°S, 71.351°W) .

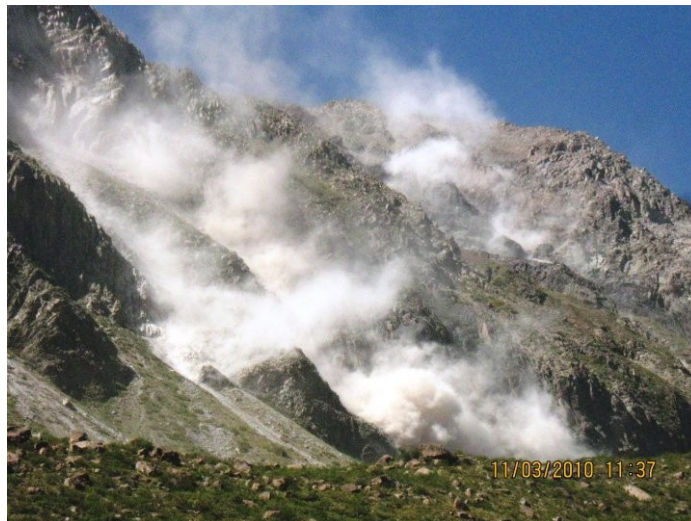
Given the paucity of sliding and rock falls in the main event, or at least lack of any significant damage due to them, it is interesting that rock falls and shallow raveling type failure was captured on camera in the foothills of the Andes during the M 6.9 event on March 11 (Figure 10.17). The site is east of San Fernando, in the direction of the Tiguiririca volcano, roughly 160 km east south east from the epicenter of the event, in steep terrain in highly fractured volcanic rock of the Coya-Machali Formation. Hence, rock falls presumably occurred in the main event but were not observed due to darkness and were apparently not considered significant enough to be reported as they did not cause damage of any consequence.

Figure 10.17. Rock falls and shallow debris slides following the M 6.9 event on March 11, 2010 (approx. 34.8°S, 70.5°W). Note, the time in the picture is 20 minutes off. Picture courtesy of J.M. Lopez.

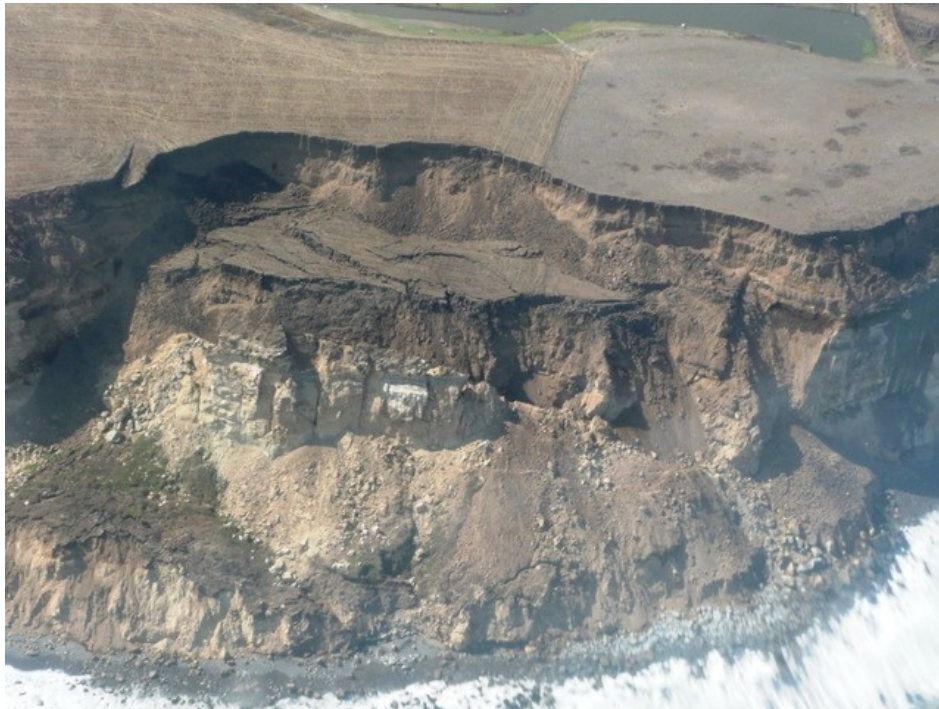
In general, deep-seated block or rotational slides were notable by their general absence. The one observed large failure, a deep-seated block slump, occurred in the coastal terrace in the El Yali National Park (Figure 10.18). The failure is clearly joint controlled, however, the exact reason for the size of this slump in an area otherwise characterized by relatively minor toppling or slumping (see Figure 10.15) is not readily apparent without further investigation.

Figure 10.18. Deep-seated bedrock slump in Tertiary sedimentary bedrock capped by marine terrace sediments (33.846°S, 71.821°W).

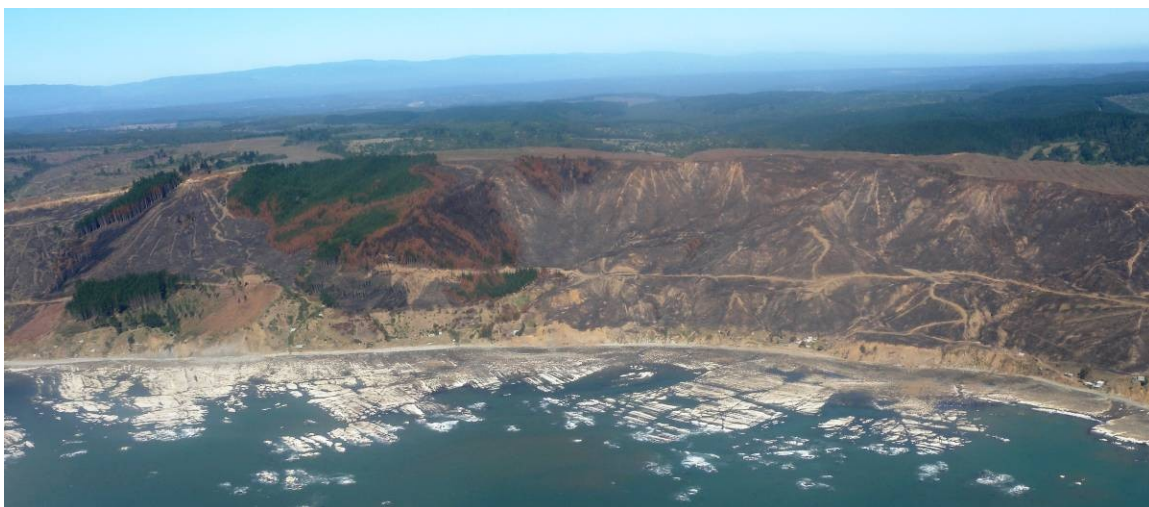
The general paucity of landsliding is best illustrated by the fact that even clearly identifiable areas of prior extensive landslide activity had little or no evidence of seismically triggered slides. For example, Figure 10.19 shows an old landslide complex along the coastal ridge just north of Lebu. The only evidence of sliding is seen at the lowermost portions of the slopes which form the back of the beach.

Overall the most likely explanation is that the earthquake occurred during the dry season and groundwater levels were low and the slopes were quite dry, as evidence of past debris flows and other rainfall triggered slides was abundant throughout the region. In addition, apparently the intensity of shaking was focused in relatively small zones within the whole region and in those locations the landslide activity was greater as well.

Figure 10.19. Old landslide complex north of Lebu showing no evidence of seismically-induced slope movement (37.561°S, 71.64°W).

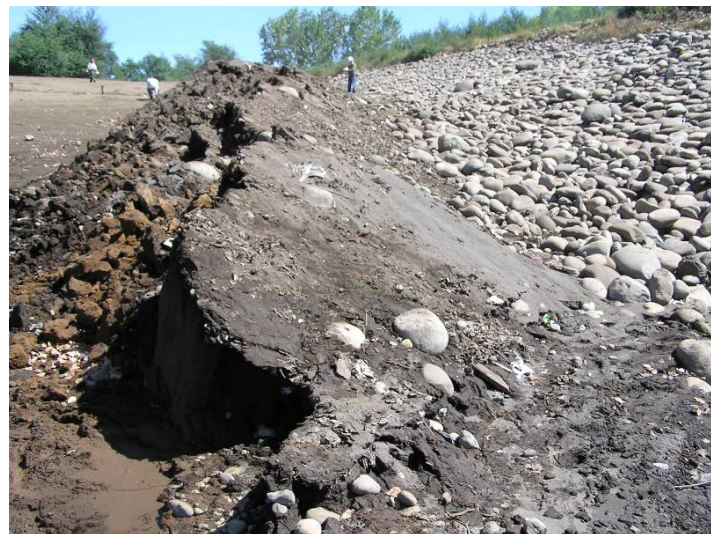
Figure 11.1c View of toe bulge area near left abutment of main dam, showing fine sand at the ground surface; due to the foot traffic it was not possible to see evidence that would allow one to classify these features as sand ejecta from soil liquefaction.

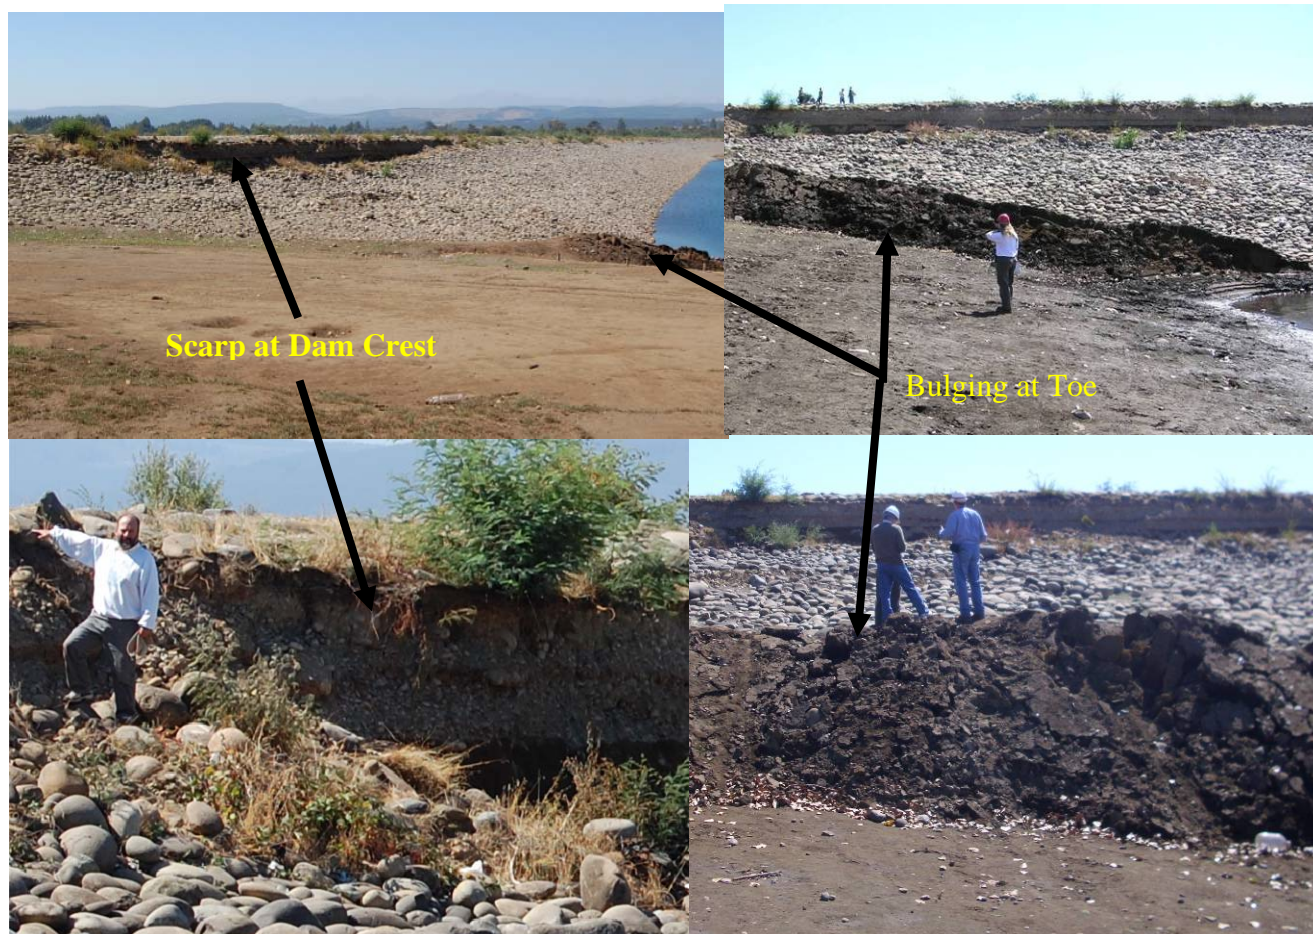
Figure 11.2. March 10, 2010. Slump of the upstream face of Coihueco Dam near the left abutment (S36.637166°, W71.797530°)

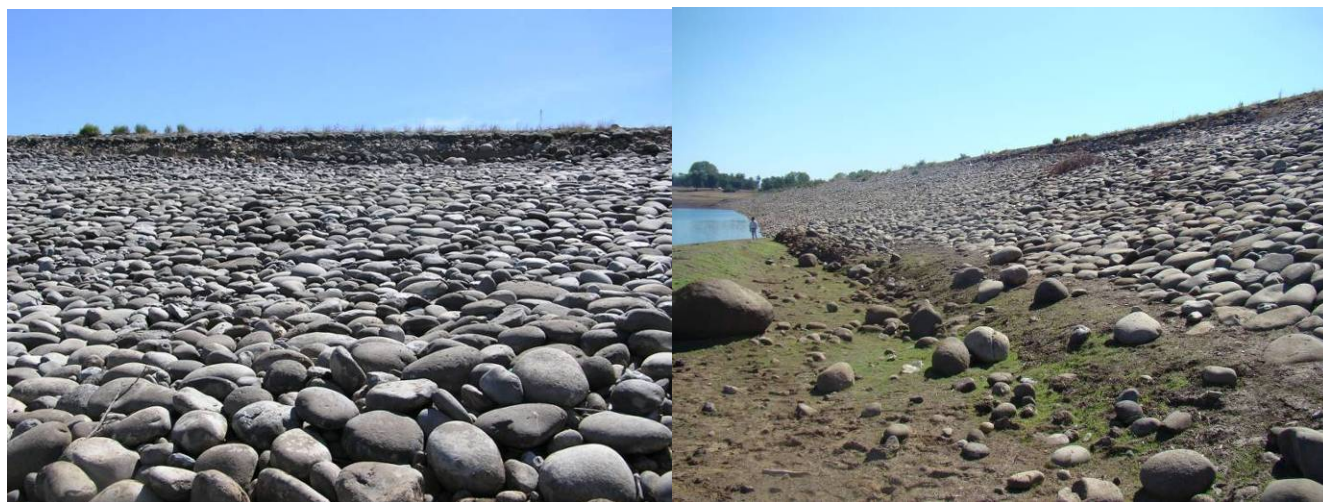
Figure 11.3. March 10, 2010. Slumping at Coihueco Dam Crest and Bulging at Dam Toe. (S36.636508°, W71.792505°)

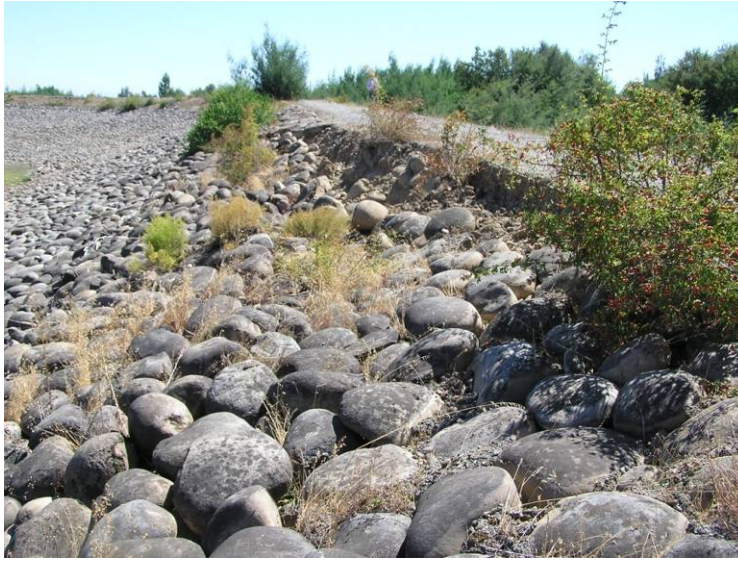
Figure 11.4. March 10, 2010. Small Area of Upstream Crest Slumping on Coihueuco Dam (S36.636902°, W71.788897°)

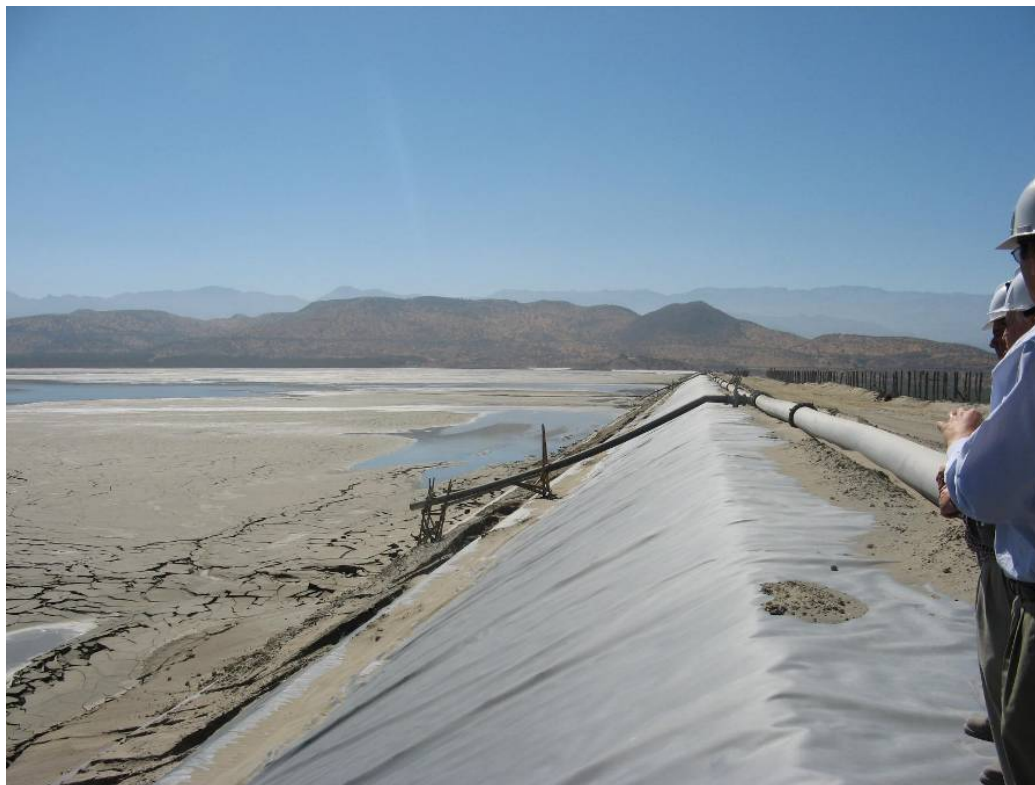
Figure 11.10. March 9, 2010 View along the Upstream Face of the Ovejeria Tailings Dam. There is no damage to the liner and no signs of slumping of the sand beneath the liner
(S33.052911°, W70.807067°)

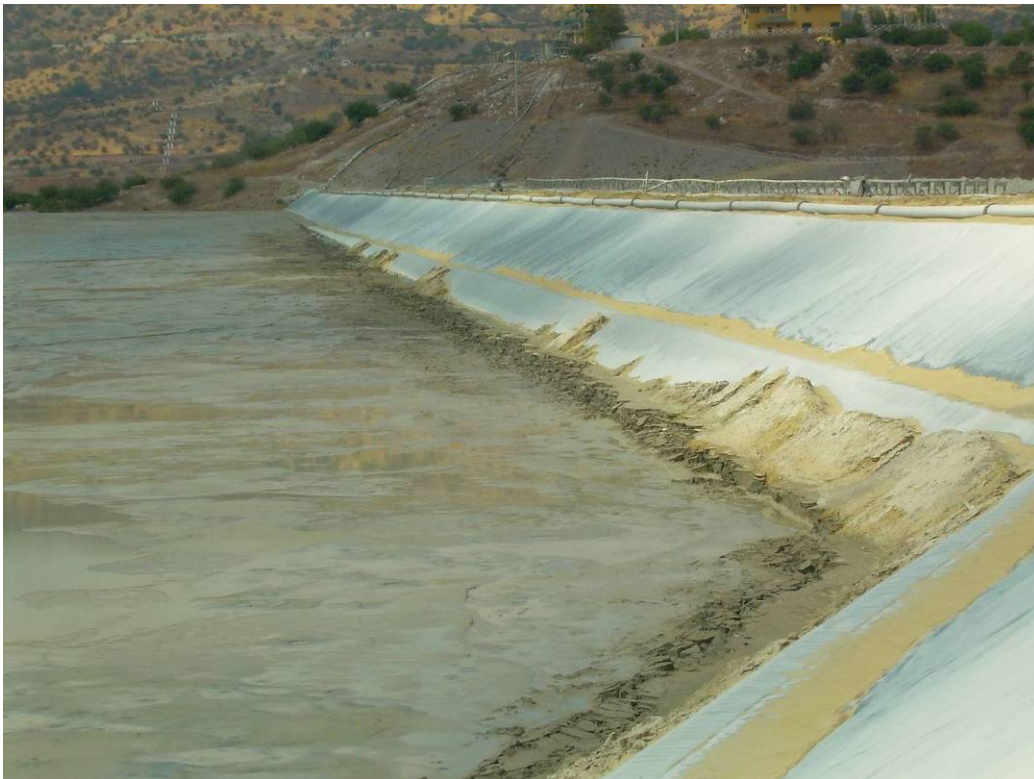
Both the on-ground inspection and the helicopter reconnaissance identified no problems with the tailings sand dam. There were many expressions of high pore pressure (sand boils) in the tailings upstream of the dam and the maximum settlement of the tailings near the dam was about 0.5 m, representing a strain of about 1%. The liner on the upstream showed no signs of dam. Several large valves rest directly on the liner, and there was not stretching or tearing of the liner at these valves. No cracks were observed on the crest or on the downstream face.

Figure 11.12. March 10, 2010. Upstream face of the Ovejeria Tailings Dam showing approximately 0.5 m of the tailings adjacent to the dam. (S33.052081, W70.792067)

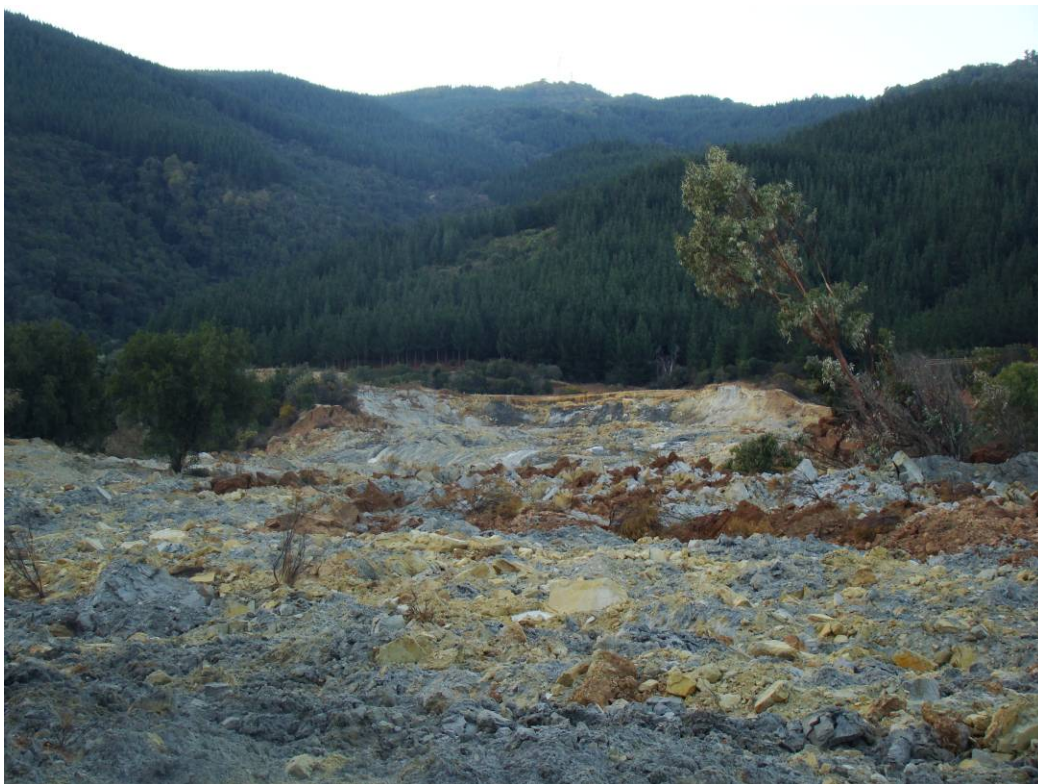
Las Palmas mine was operated from the early 1980's until 1997. The mine was closed and the tailings area partially covered with a thin (+/- 6") layer of gravelly material. Drilling of the tailings is reported to have been carried out in January and February 2010 to assess reprocessing of tailings for additional gold recovery. The profile seen at the upper failure scarp shows the gravelly cover layer and unsaturated tailings. Variable oxidation of the tailings has occurred with colours varying from tan to rusty in oxidized tailings to grey in unoxidized tailings. Clear evidence of liquefaction of the tailings with sand boils and ejecta along cracks indicating some portion of the tailings was saturated. Tailings flowed almost 0.5 kilometers.

Figure 11.26. March 11, 2010. View Along Flowpath of Tailings (35.18468°
S, 71.759410° W)

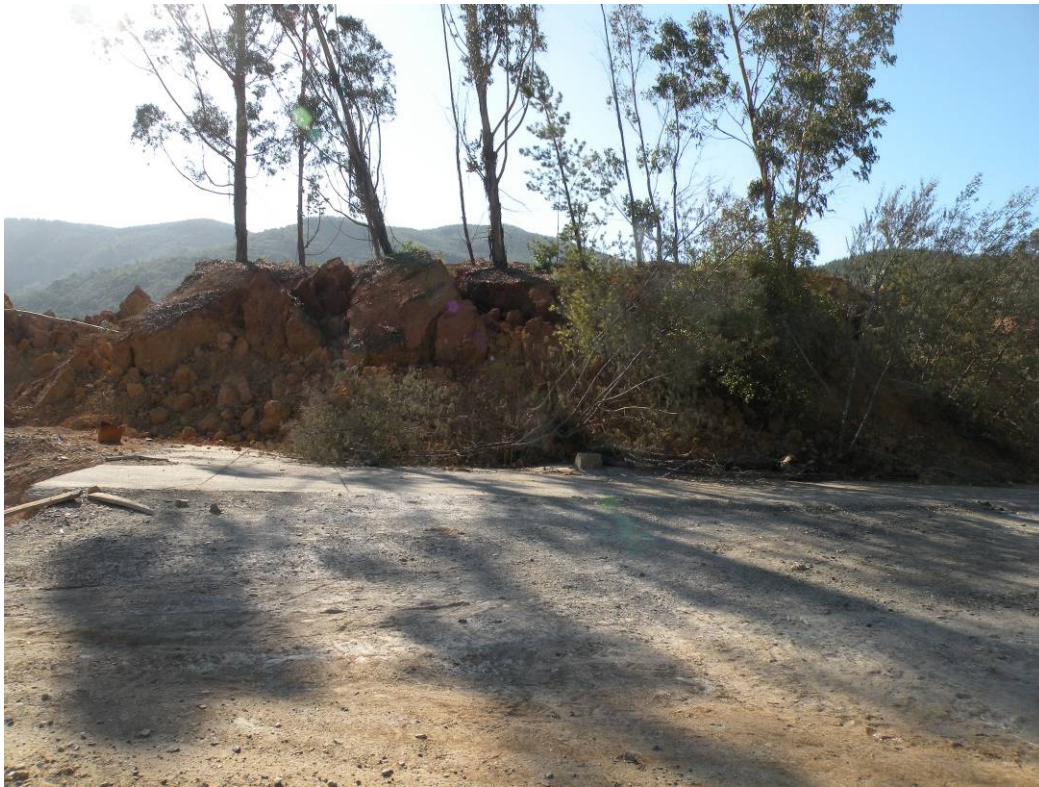
Figure 11.27. March 11, 2010. Side View of Tailings Flow
(35.186864° , 71.757873°W)

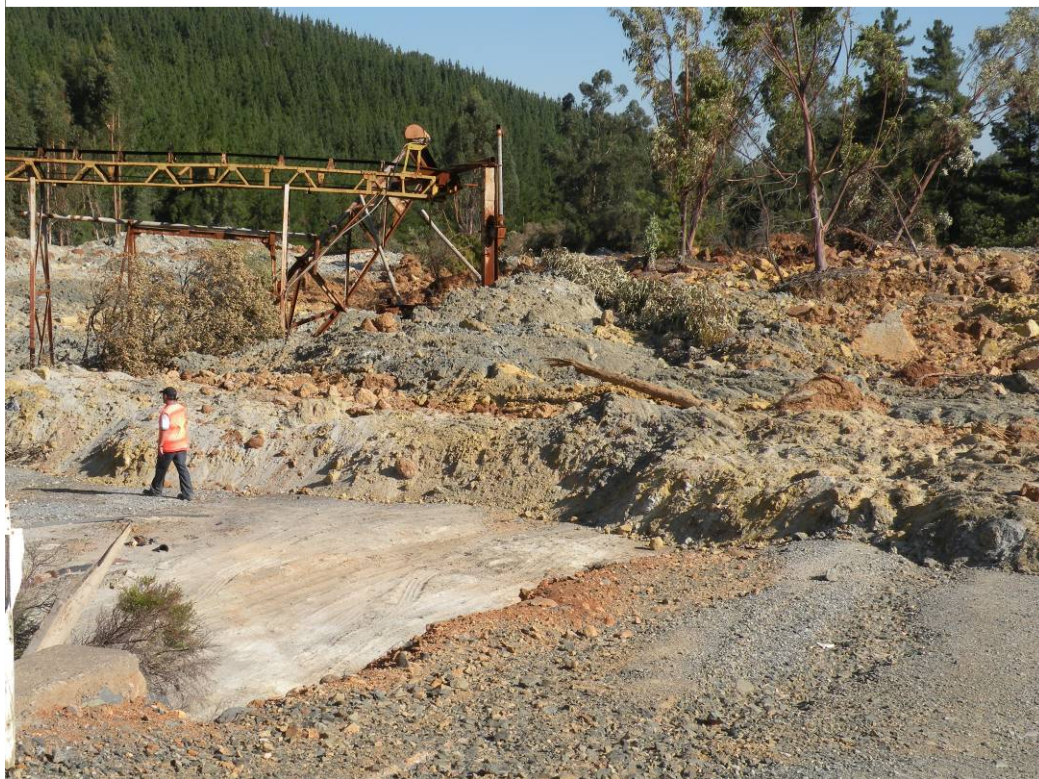
Figure 11.28. March 11, 2010. Side View of Tailings Flow
(35.187204° S, 71.757997° W)

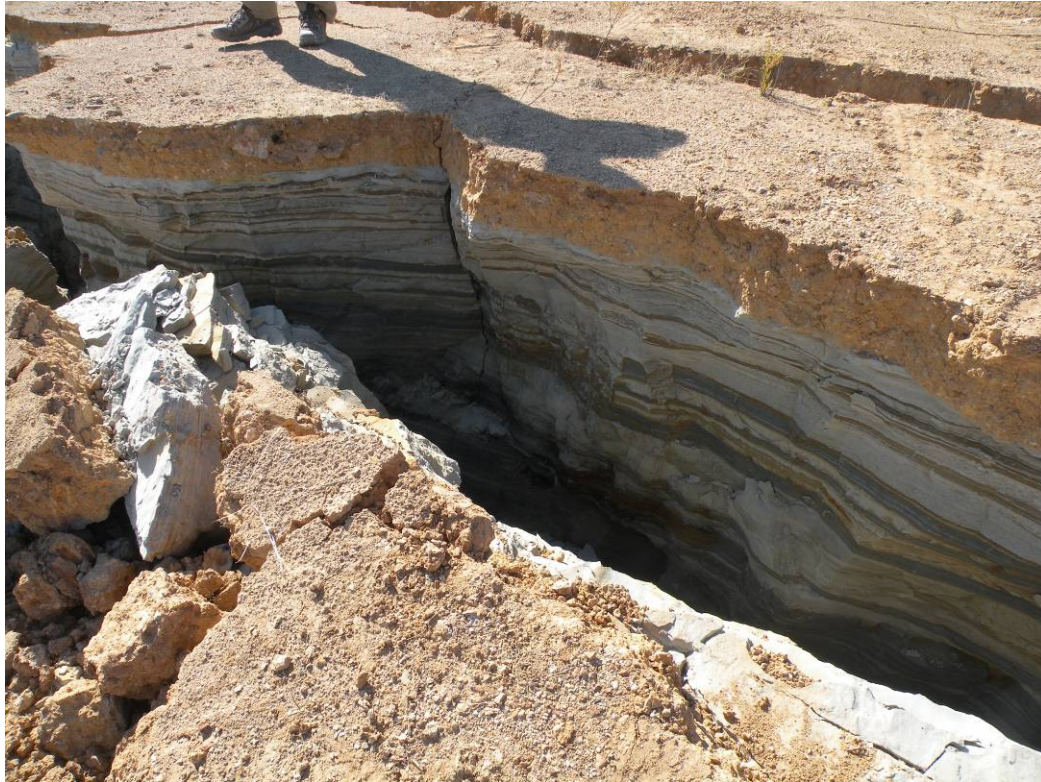
Figure 11.29. March 11, 2010. Gravelly Cover Layer Over Oxidized and Unsaturated Tailings (35.184679° S, 71.759410° W)

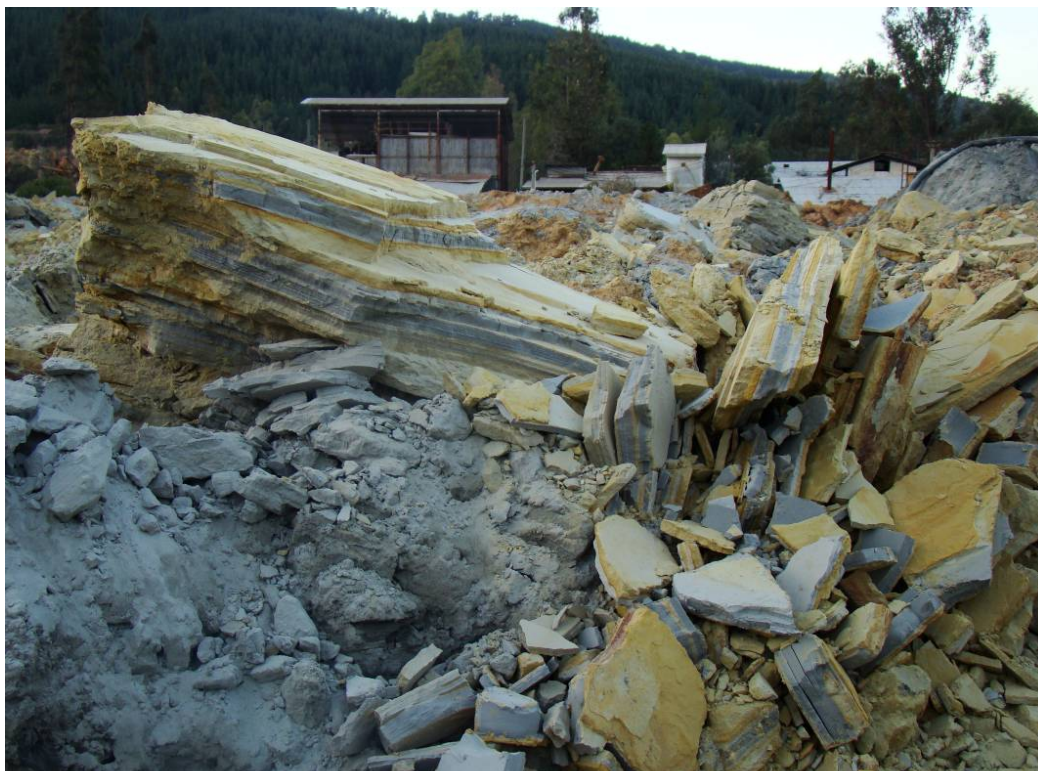
Figure 11.30. March 11, 2010. Variably Oxidized Tailings – Unsaturated Conditions in Upper Portion of Tailings Impoundment (S35.18728°, W71.75781°)

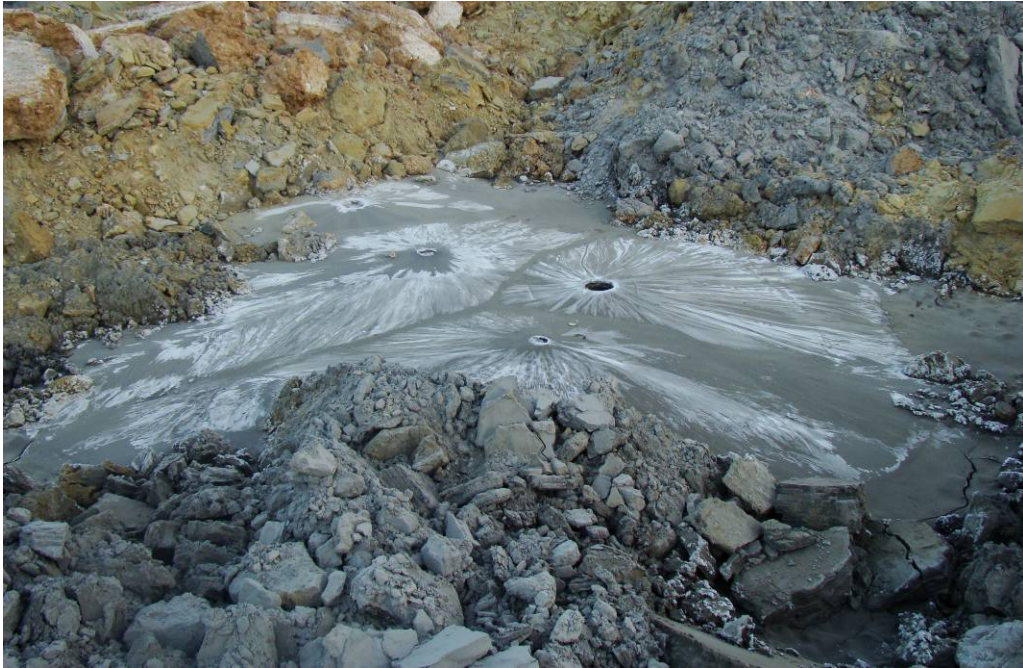
Figure 11.31. March 11, 2010. Sand Boil in Tailings (S35.18872°, W71.75764°)

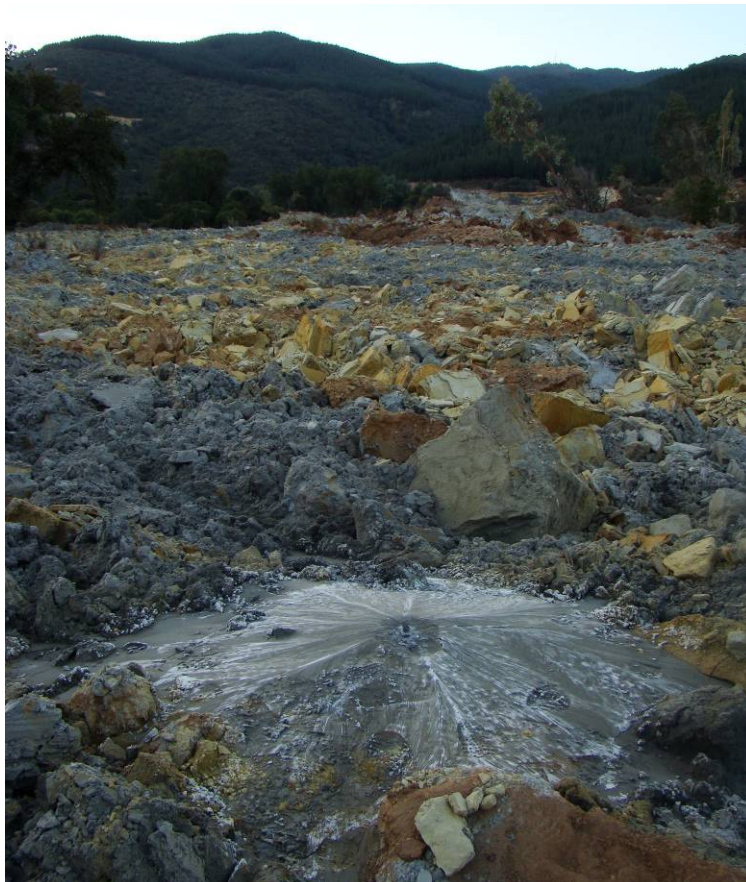
Figure 11.32. March 11, 2010. Sand Boil In Tailings along Flow Path (S35.18872°, W71.75777°)

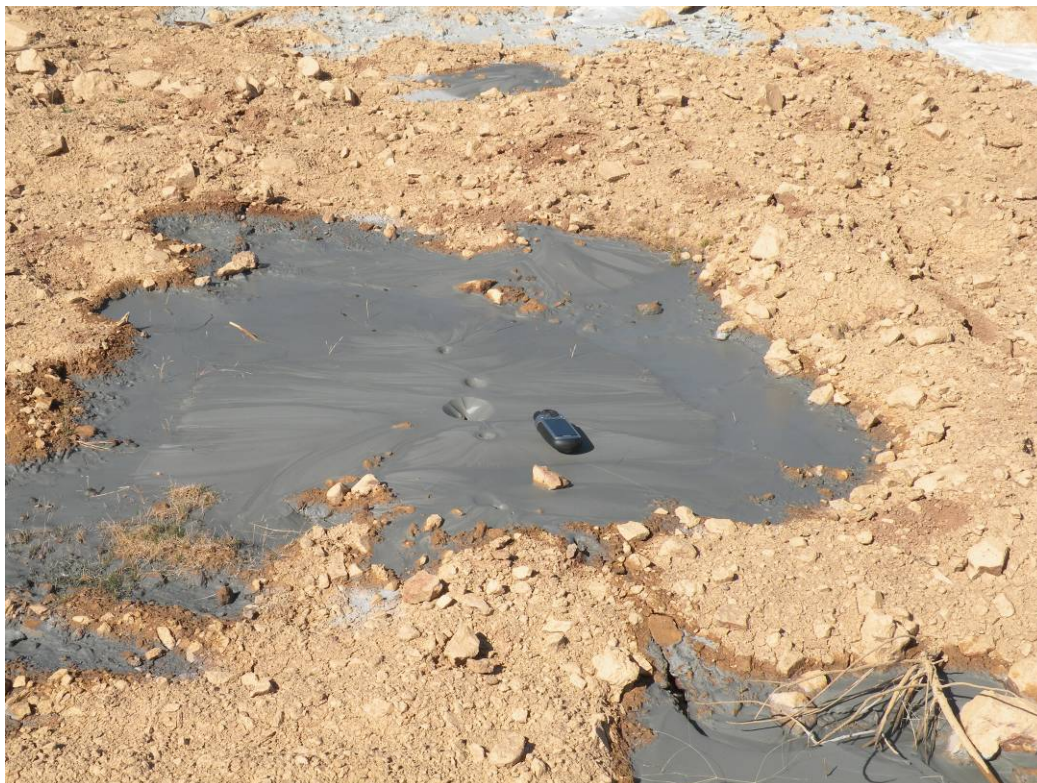
Figure 11.33. March 11, 2010. Tailings Sand Boil Due to March 11, 2010 M6.9 Earthquake near Rancagua ($S35.184146^{\circ}$, $W71.761118^{\circ}$)

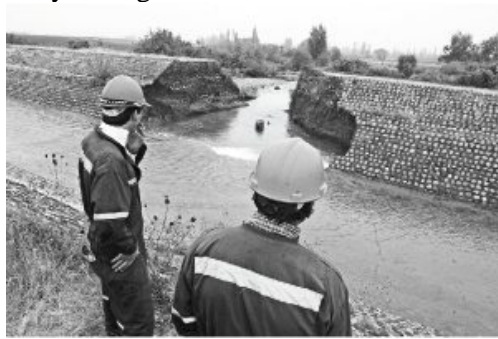
An earth levee that is located west of Colbun failed at 6:50 pm on March 13, 2010 (Figure 11.35), two days after the $M_w=6.9$ aftershock (epicenter at $S34.259^\circ$, $W71.929^\circ$) that occurred on March 11, 2010 at 11:40 am. The levee was inspected after the $M_w=8.8$ main shock of February 27, 2010, and no evidence of distress was noted. Additionally, a rapid inspection of the levee after the significant aftershocks on March 13, 2010 did not identify evidence of distress. The levee breach reportedly released a discharge of 80 cm, which is reported to have flooded a few neighboring homes in this agricultural area of Chile, but none of the homes were significantly damaged.

Figure 11.35. Earthen levee breach west of Colbun ($S35.698672^\circ$, $W71.487294^\circ$; photograph taken by Mr. Juan Carlos Romo of the El Mercurio on March 12, 2010; <http://diario.elmercurio.cl>).

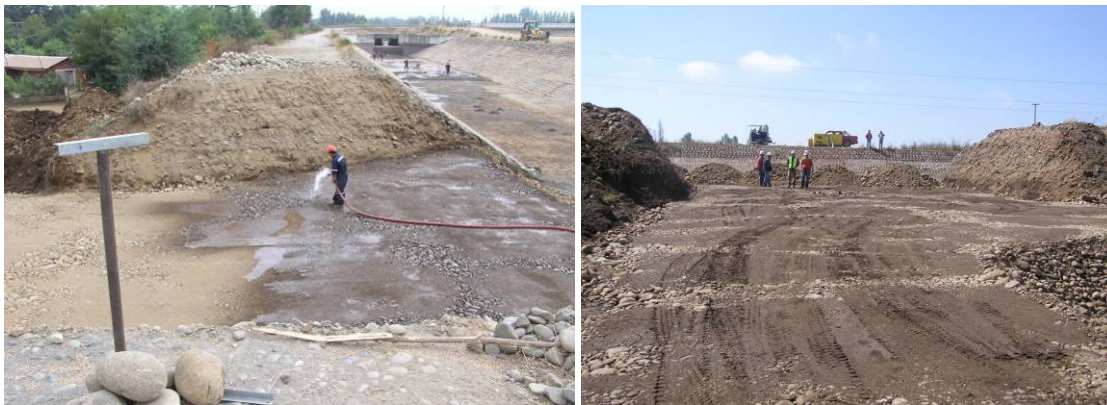
The levee breach site was visited by GEER team members on March 18, 2010. At that time the levee was being reconstructed as shown in Figure 11.36. A sample of the levee fill material was taken and is in the process of being classified. The levee fill material appears to be a silty sandy gravel material with a significant amount of cobbles. The levee is approximately 7 m high with a crest width of 6 m. Its side are sloped at about 1.5H:1V with cobble facing on its water side. The width of the zone being rebuilt was 15 m. The levee was reported to have been built 25 years ago. Whereas at other locations the existing material was excavated to build the levee, it is reported that no or little excavation occurred at this location because the natural ground surface elevation was already low at this location.

Figure 11.36. Site of earthen levee breach during reconstruction on March 18, 2010 ($S35.698672^\circ$, $W71.487294^\circ$).

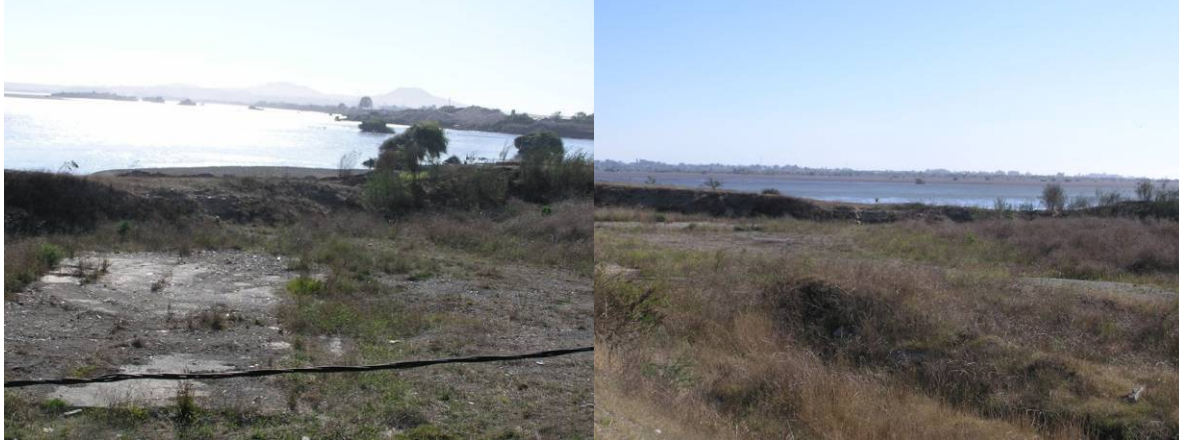
A liquefaction-induced levee slump occurred along the River Bio Bio north of the Juan Pablo II bridge's NE abutment (Figure 11.37). The water level was well below the top elevation of the slumped crest of the levee so there was no breach at this location. Details of the levee construction are not known.

Figure 11.37. View obliquely down on the slumped levee from the NE approach of the Juan Pablo II bridge with evidence of sand ejecta in the foreground, and ground level view looking back at slumped level crest (S36.814555°, W73.084624°); 1700 hrs on 3/15/10).

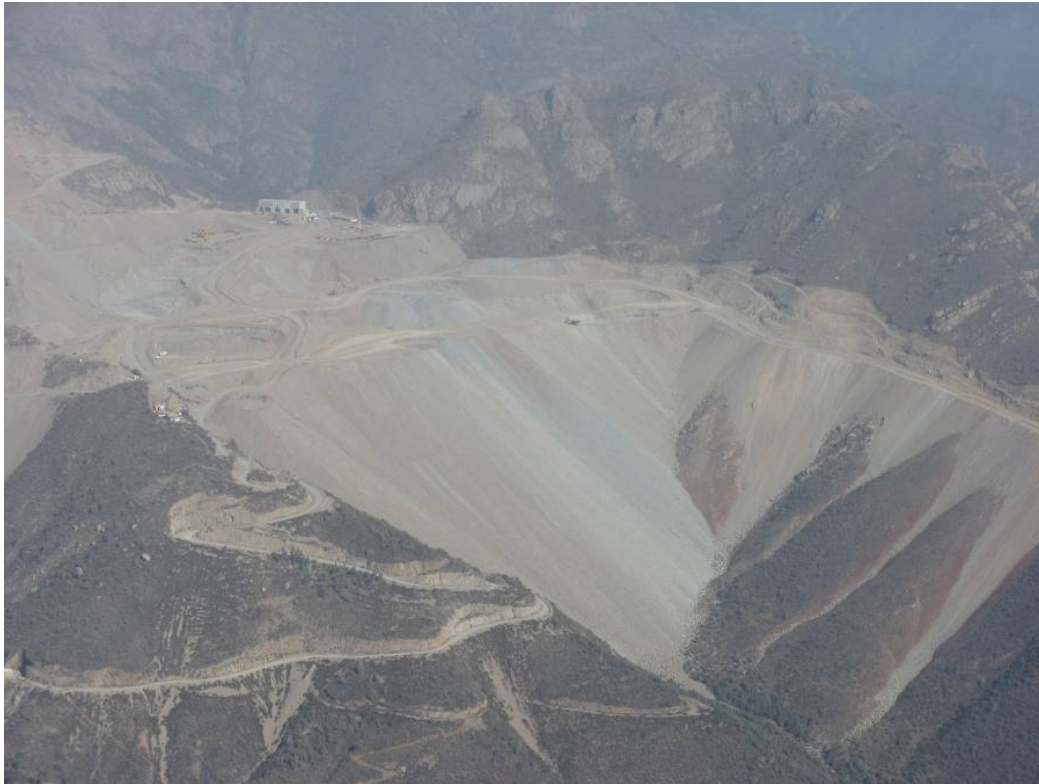
Overflight by helicopter made. No evidence of movement of these high rock dumps.

Figure 11.38. March 10, 2010. Soldado Waste Dump
(S32.654695°, W71.121352°)

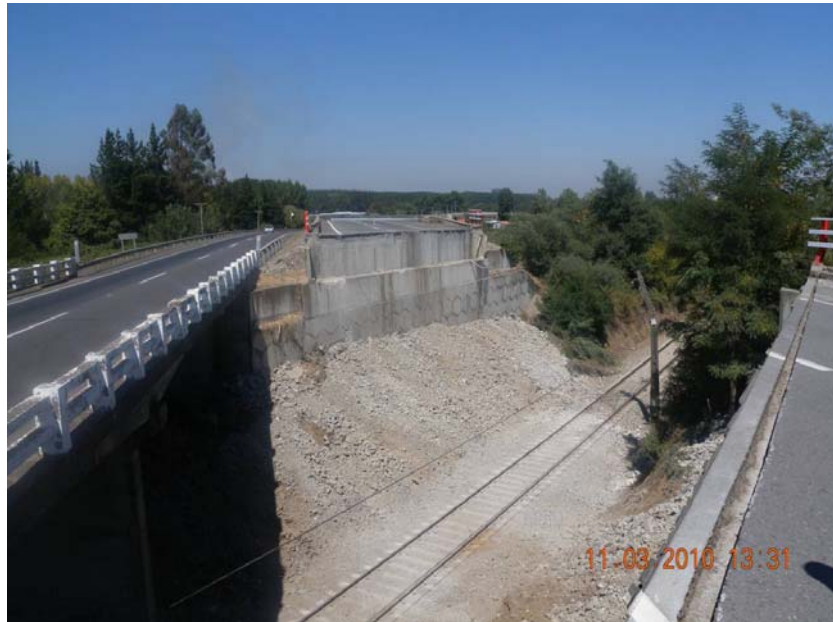
Figure 12.2. Reinforced Earth bridge abutments at a collapsed rail crossing on Route 5 north of Parral (36.0803°S, 71.788°W)

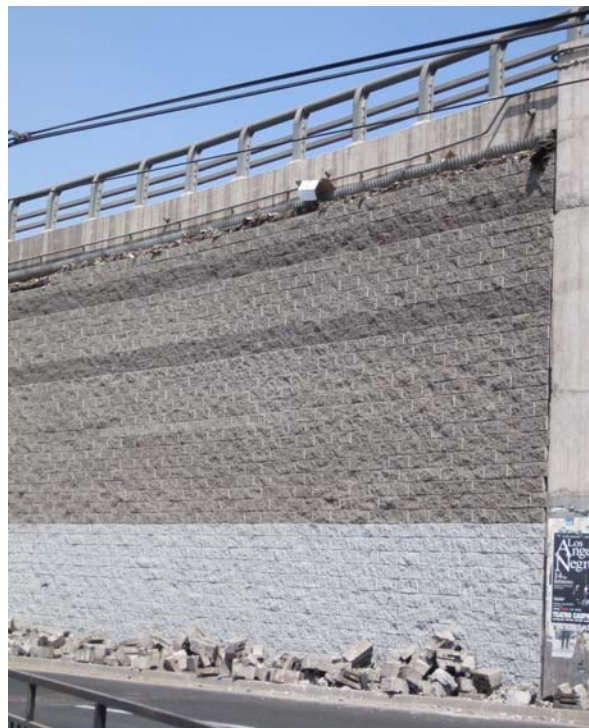
Similarly, block faced mechanically stabilized wall performed very well. Figure 12.3 shows a block faced mechanically stabilized bridge approach which lost the top most row of blocks but otherwise remained intact.

Figure 12.3. Block faced mechanically stabilized embankment, Intersection of Americo Vespucio Norte and Lo Echevers. (33°22'34.54"S, 70°44'52.83"W)

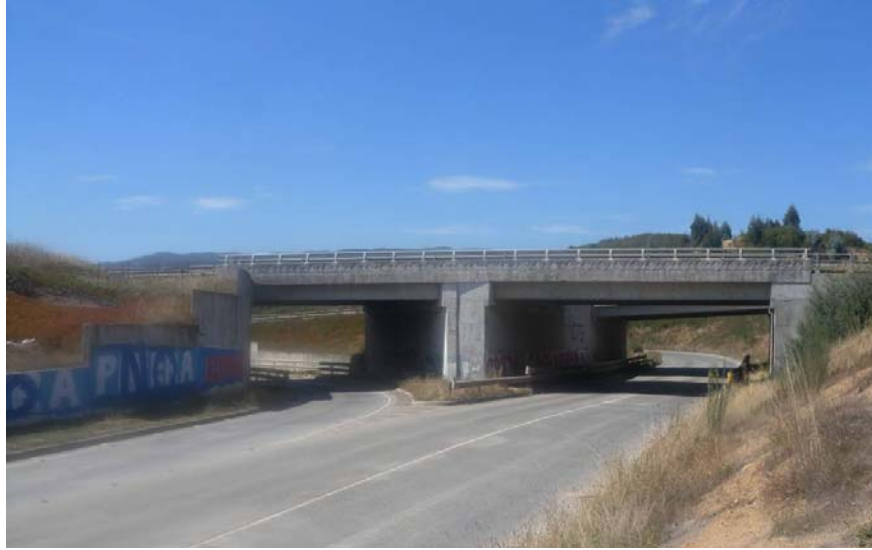
Conventional, Concrete Gravity and Cantilever Structures – Conventional concrete gravity and retaining structures similarly performed very well in many different settings. Figure 12.5 shows an overpass structure on the coastal highway just south of Coronel, about 140 km south of the epicenter in an area which experienced significant shaking. The structure experienced no distress and the bridge structures were fully functional after the event.

Figure 12.5. Multiple retaining structures for highway overpass structures south end of Coronel (37.0455°S, 73.1421°W)
