Geo-engineering Reconnaissance of the 2010 Maule, Chile Earthquake

Report of the NSF Sponsored GEER Association Team

GEER Association Report No. GEER-022

Version 1: April 15, 2010

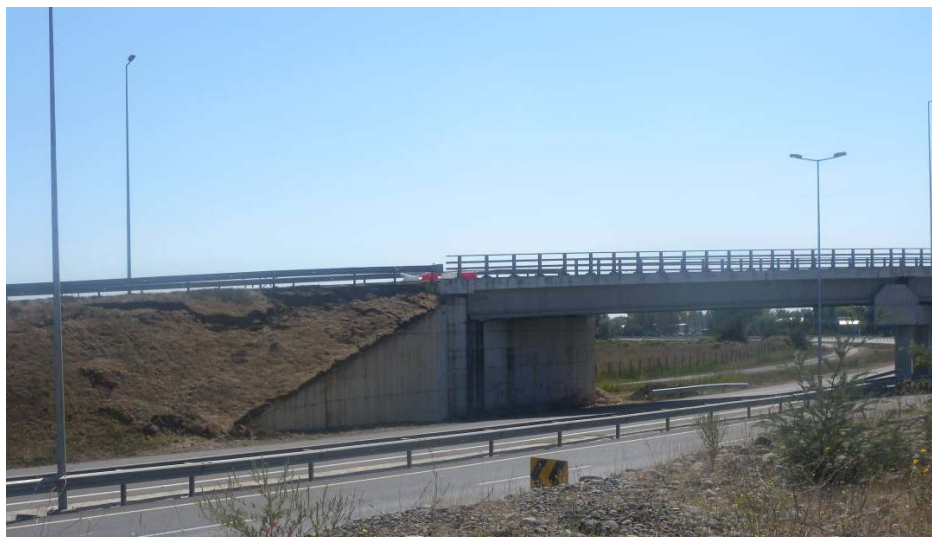
Most importantly, there were numerous bridge approach embankments that were shaken with sufficient intensity to experience surficial slumping, yet the abutment forming retaining walls performed very well and showed no evidence of damage. The bridge decks on the other hand were often offset and the concrete seats were spalled or completely fractured. Figure 12.5 shows one such bridge approach embankment and abutment wall on Route 5 north of Chillan. The bridge deck had temporary scaffolding supporting it at the other abutment as it was close to sliding off.

Figure 12.6. Surficial sloughing on a bridge approach embankment, with the abotment showing no evidence of damage, Route 5, north of Chillan.

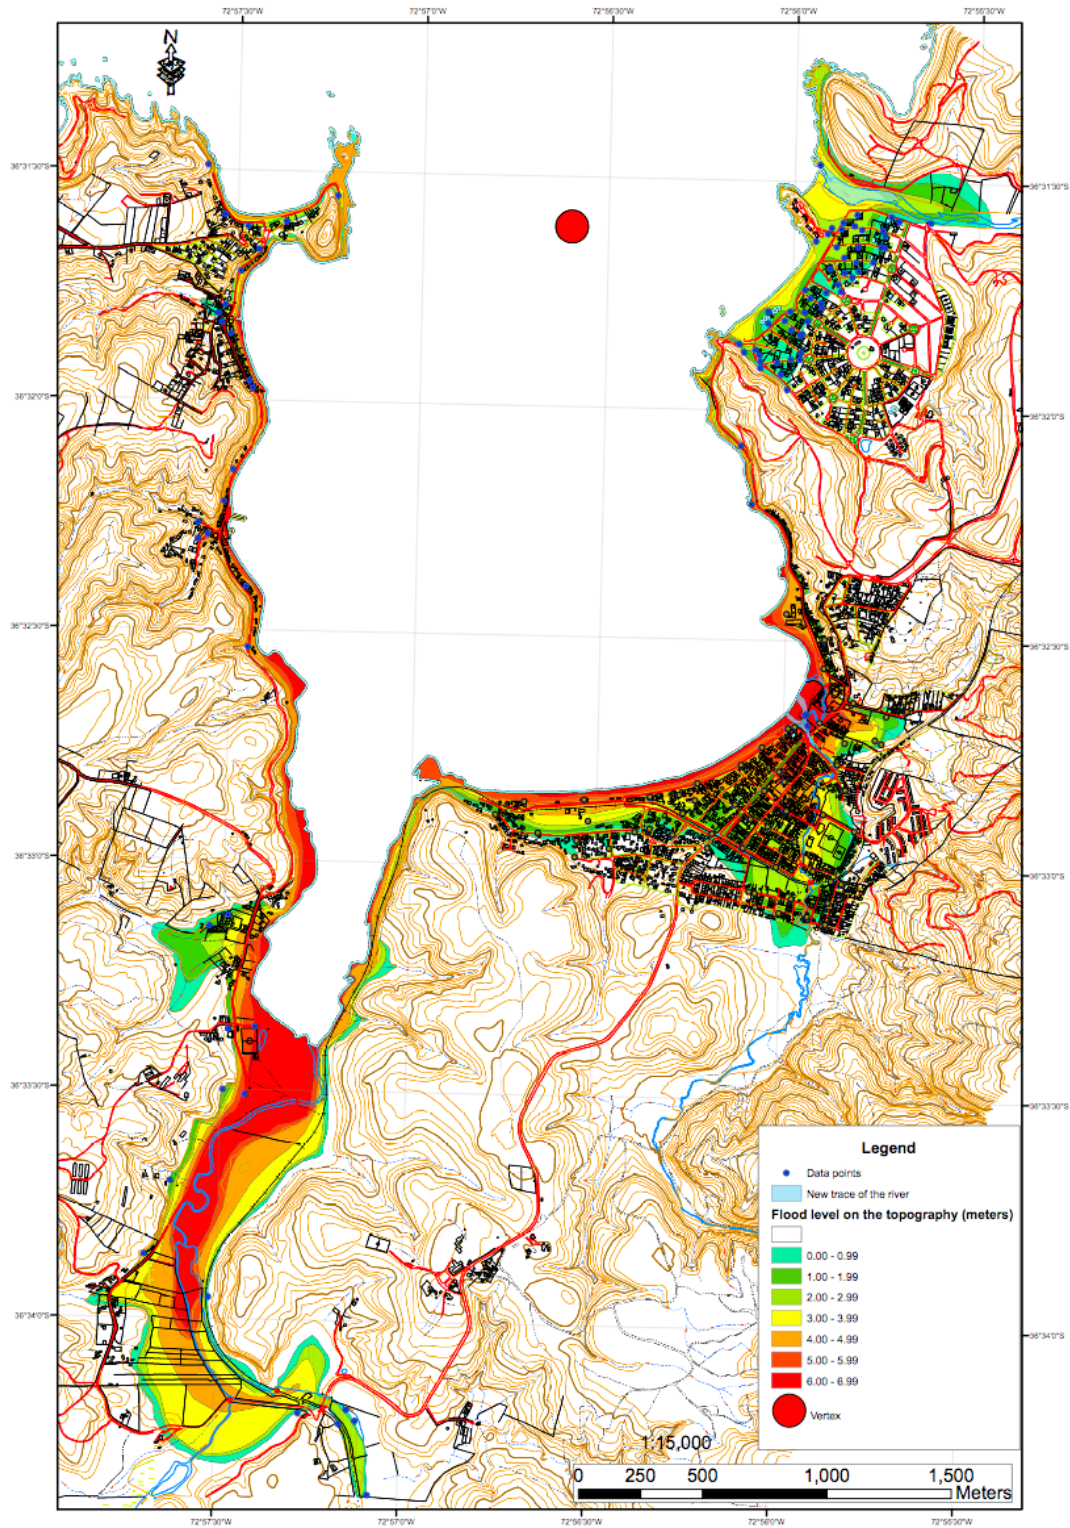
Figure 13.2 Inundation extent and depth for Dichato region based on ground observations by Zoa et al.

Sea water surged 2.2 km into the agricultural valley southwest of Dichato as previously shown in Figure 13.2. Several large fishing boats and other vessels remain beached in these fields and farmlands, which are now brown and dead due to salt poisoning.

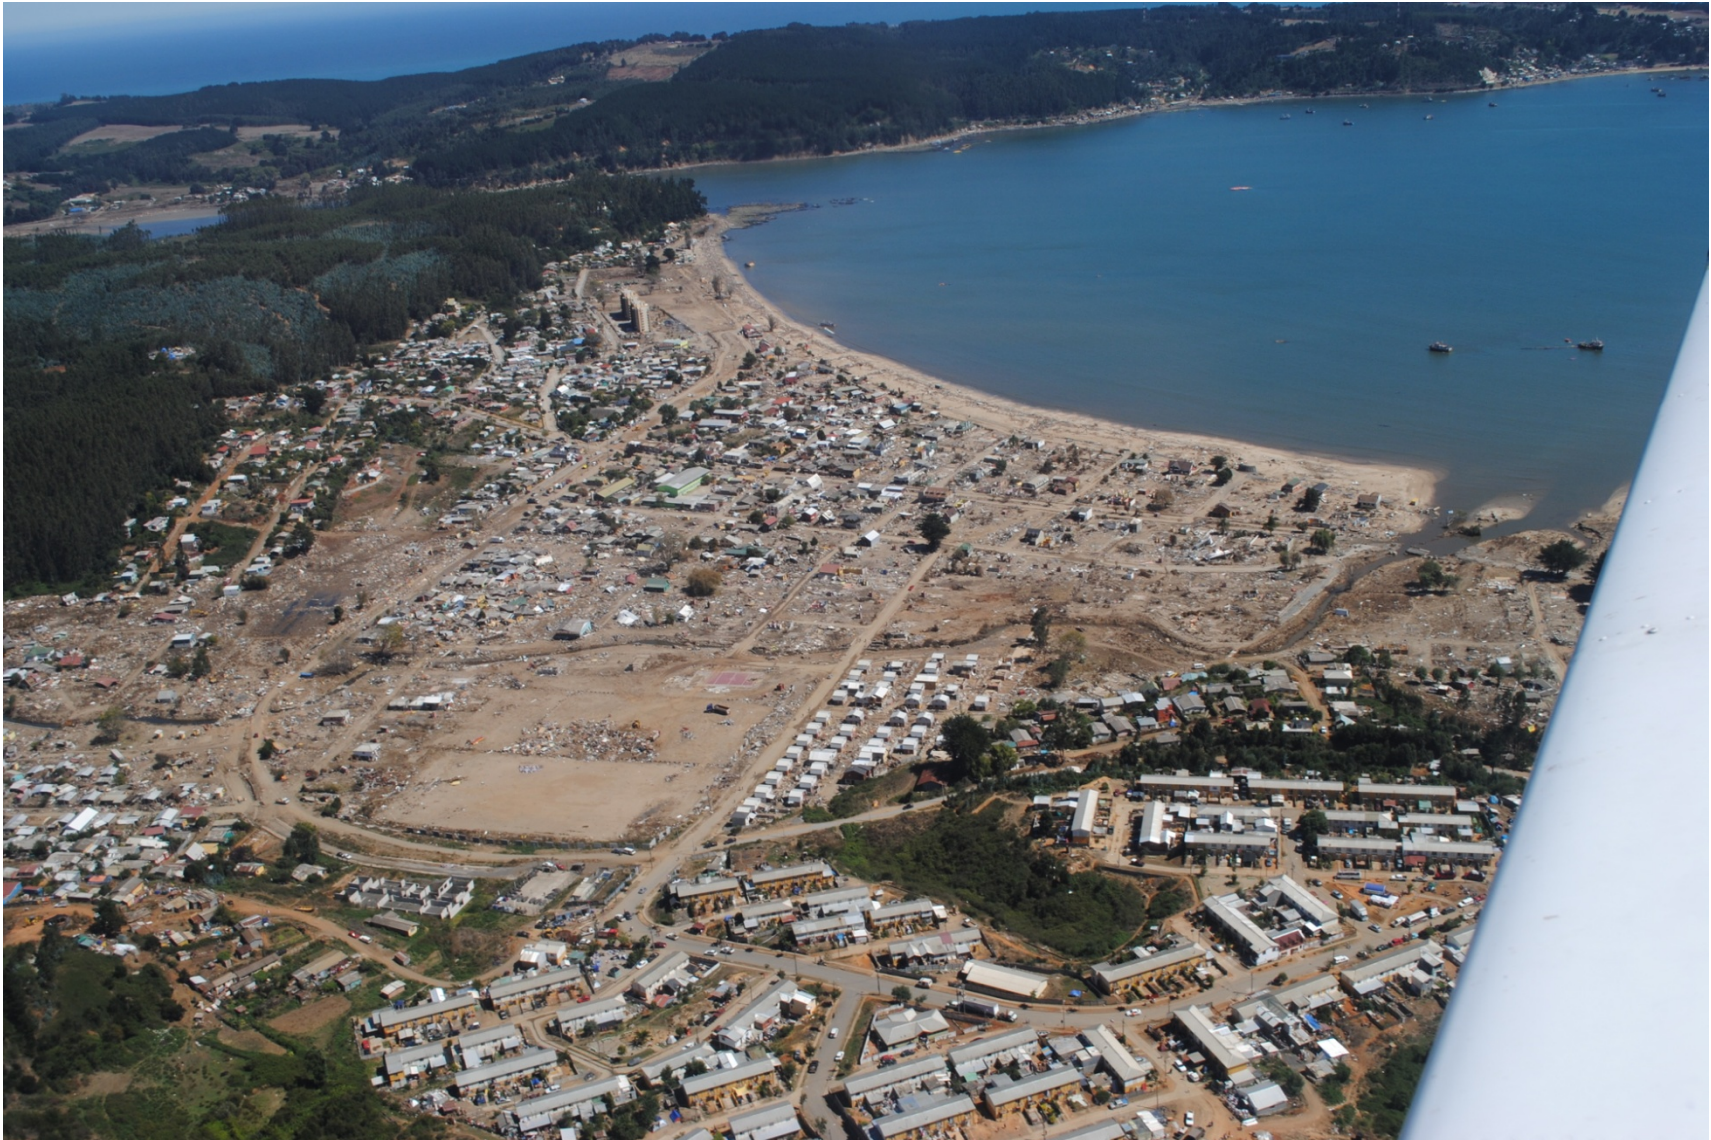
Figure 13.3 Aerial reconnaissance photograph of portion of Dichato and Coliumo Bay (S 36.5488° W72.9314°)

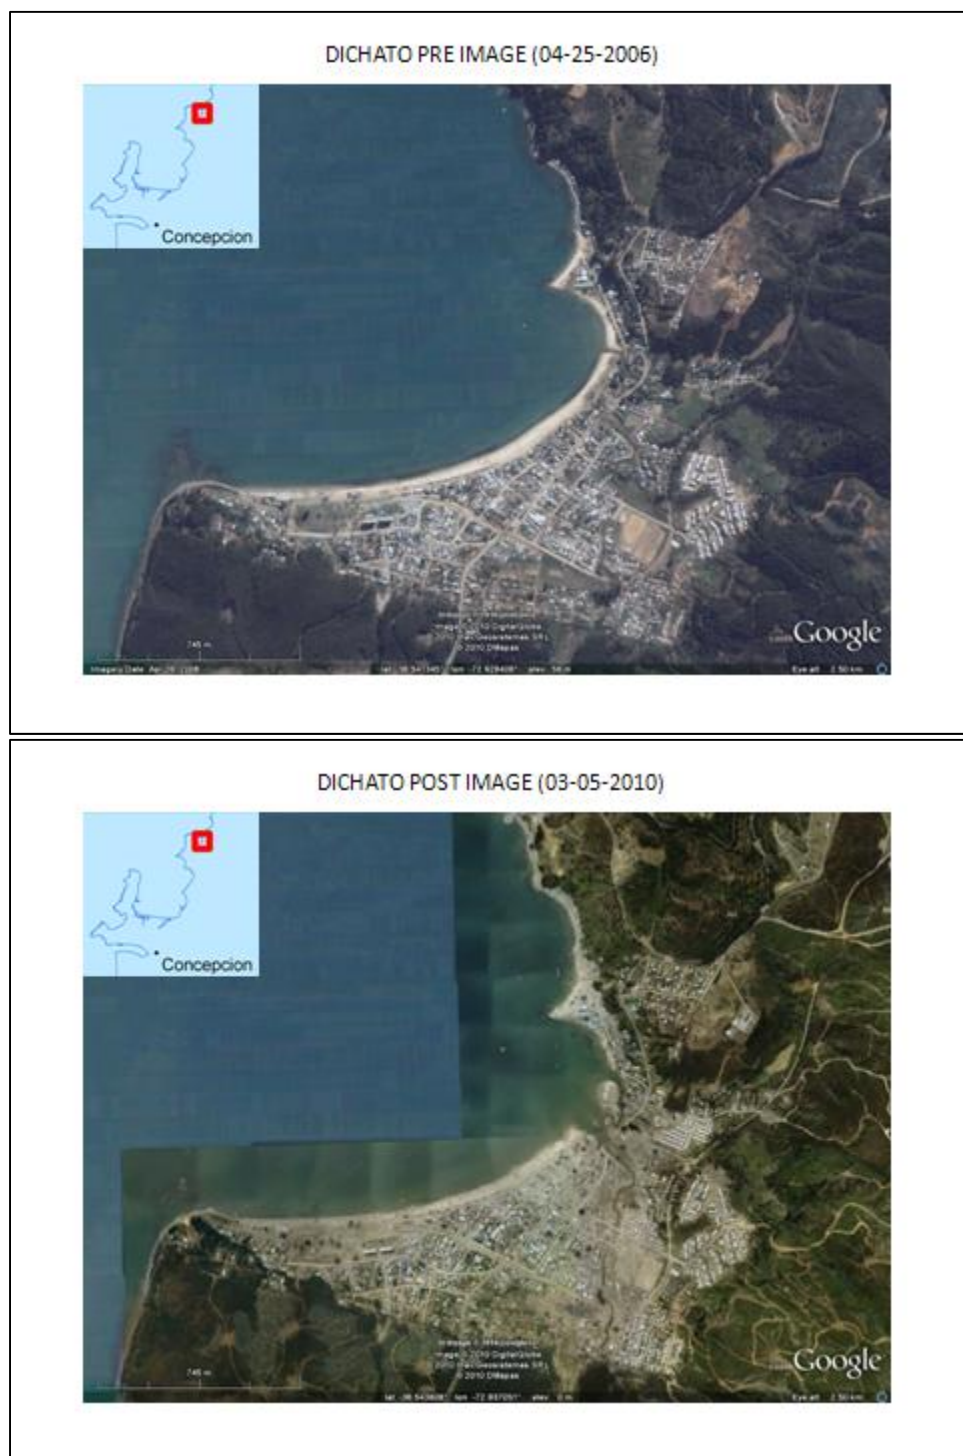
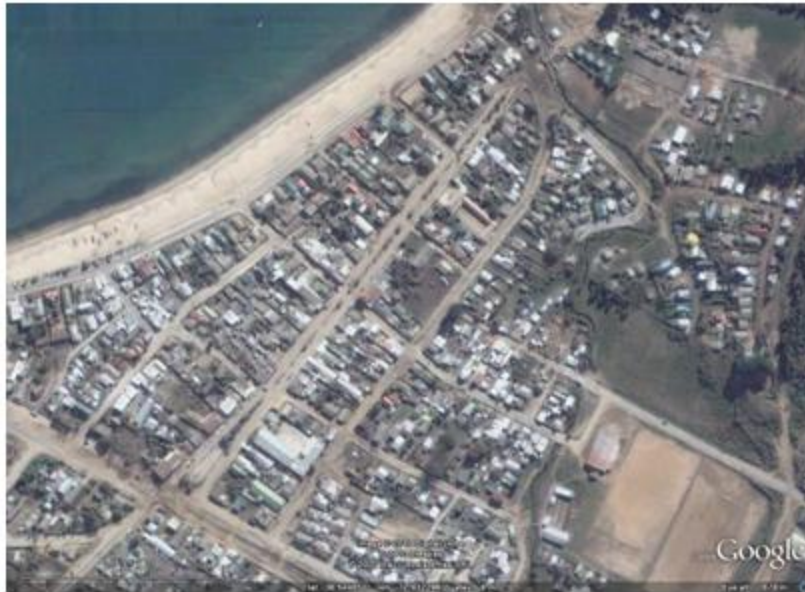
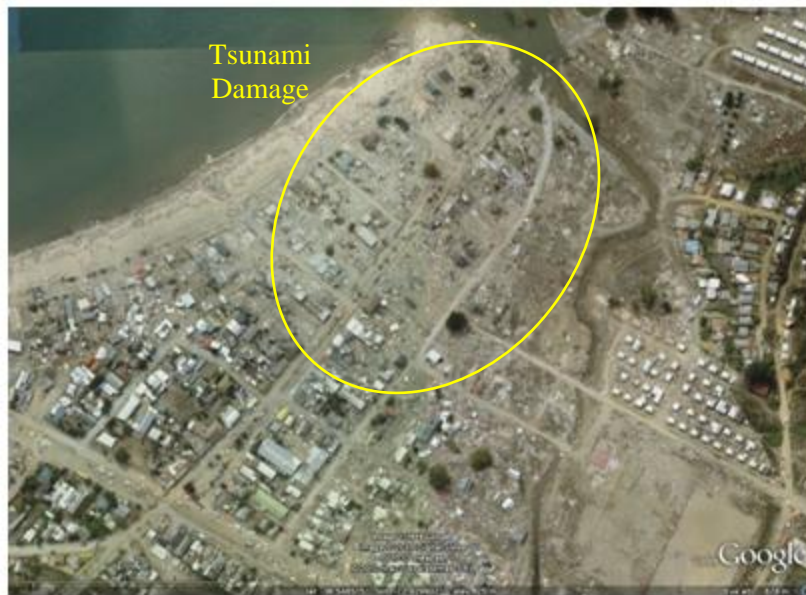
Figure 13.6 Pre/Post Imagery of Dichato ($S36.546^{\circ}$, $W72.933^{\circ}$)

Although the motion of the water was primarily north-south, fishermen on the west side of the bay observed east-west surges during the morning of the 27th February. Large waves that struck the west side of the bay seemed to have been reflected off the eastern shore. Pre and post event image pairs showing tsunami damage are given in Figures 13.6 and 13.7.

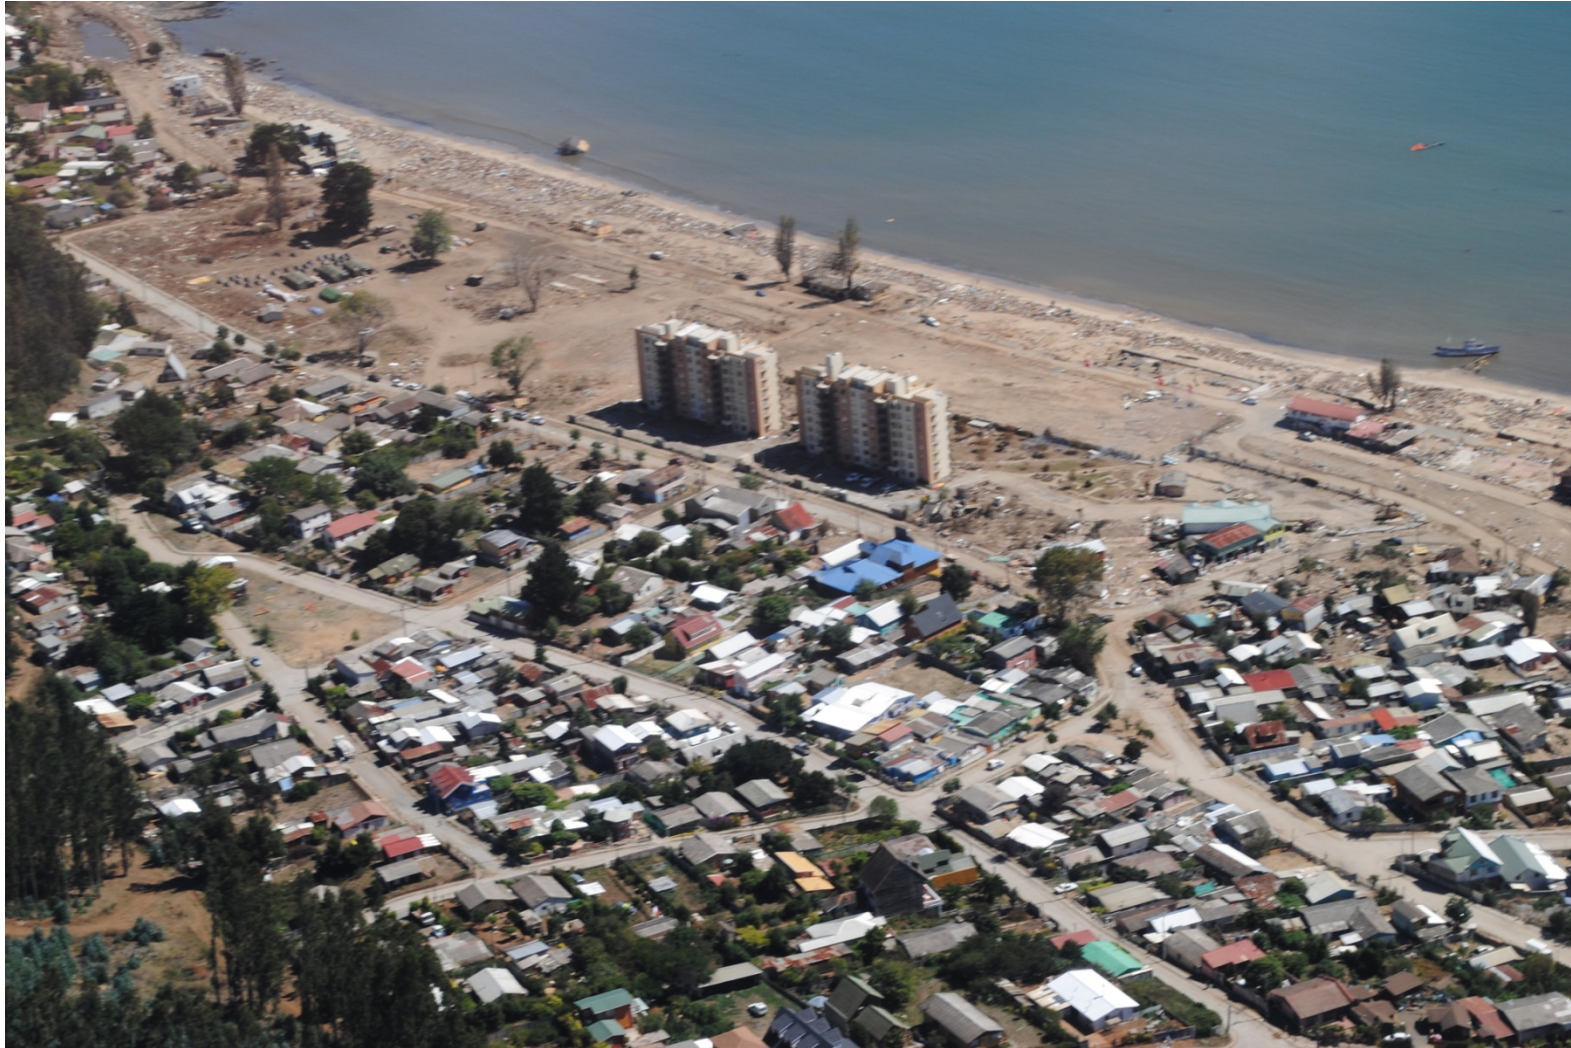
Figure 13.8 Pre/Post Imagery of Dichato (S36.548°, W72.942°)

On the west side of Dichato there are two 10 story apartment buildings. These buildings incurred no obvious structural damage as shown in the pre and post images in Figure 13.8 and the aerial reconnaissance photo in Figure 13.9. They withstood the earthquake and at least one 3 m wave. Although the first floor apartments and the basement show significant flooding damage, the upper floor apartments were intact and were available to be reoccupied after the residents cleaned up broken items inside them. Behind the 10-story apartment buildings are about a dozen homes and shops which are constructed of lightweight materials, such as wood and corrugated metal. Little damage occurred to these structures suggesting that they may have been sheltered from a direct impact from the tsunami by the 10-story apartment buildings located between them and the bay. A pre and post image pair for the area further to the East of the apartment buildings shows significant damage to smaller structures much further inland (Figure 13.10).

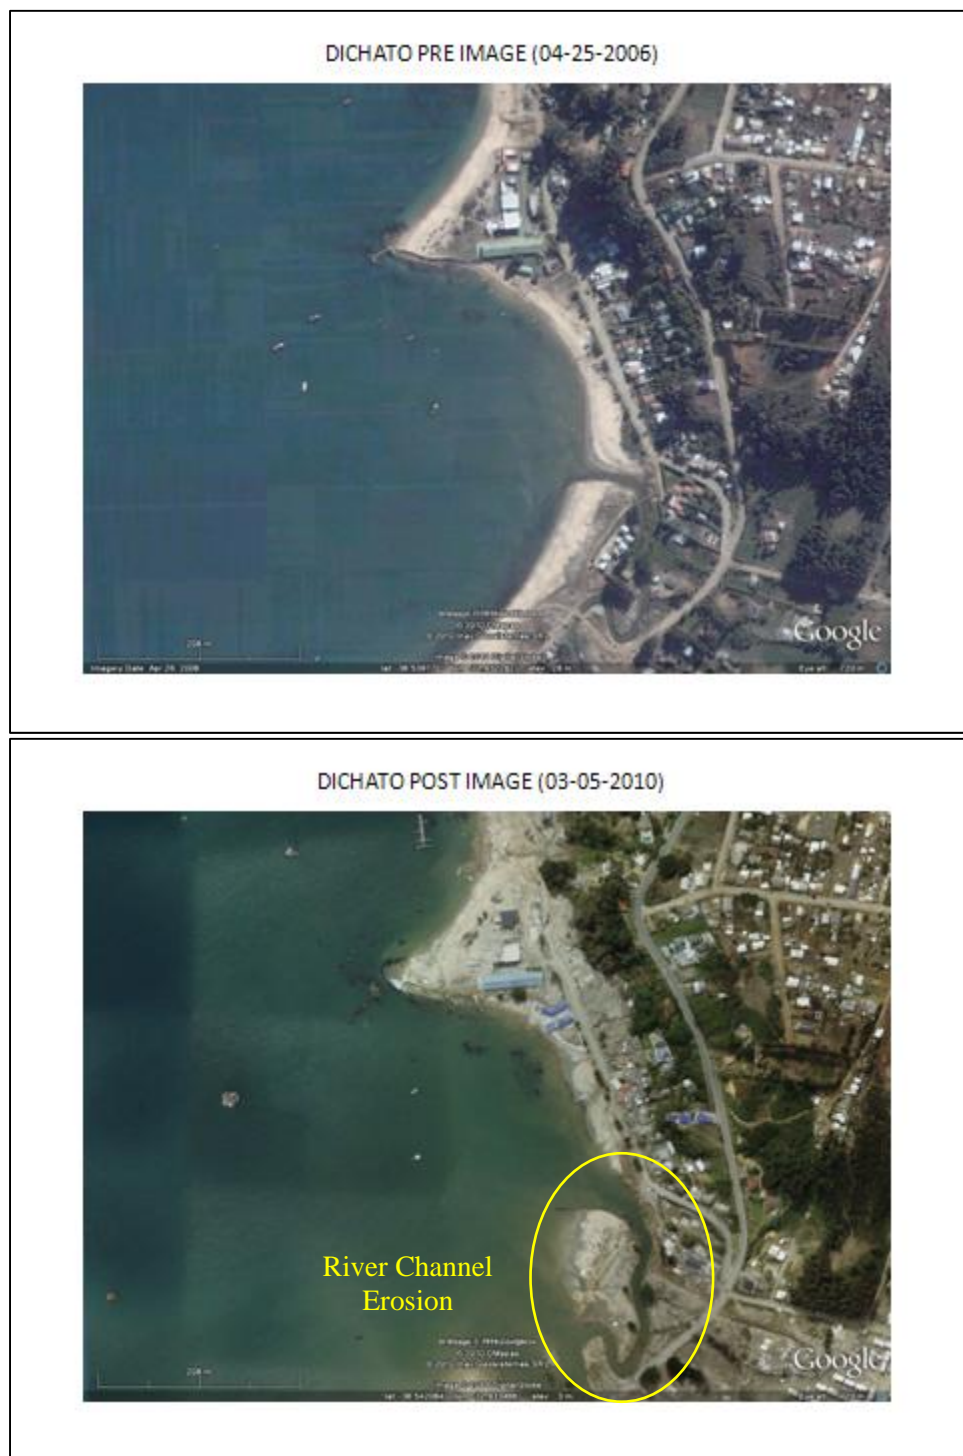
Figure 13.11 Pre/Post Imagery of Dichato ($S36.541^{\circ}$, $W72.933^{\circ}$)

The course of the Rio Dichato has been altered as shown in Figure 13.11. Prior to the earthquake, the river meandered through a neighborhood with gardens abutting the river, before exiting to the bay at the east end of town. The tsunami's greatest water depth -- and presumably the most destructive erosional power -- was in the area of this meander. The tsunami removed the soft sediments that formed a barrier between the river and the bay and the meander has been eliminated. Now, the mouth of the river is about 100 meters southwest of its former location. A delta is forming where a neighborhood used to be. The area of the former river bed is now a low-lying mudflat, which floods at high tide.

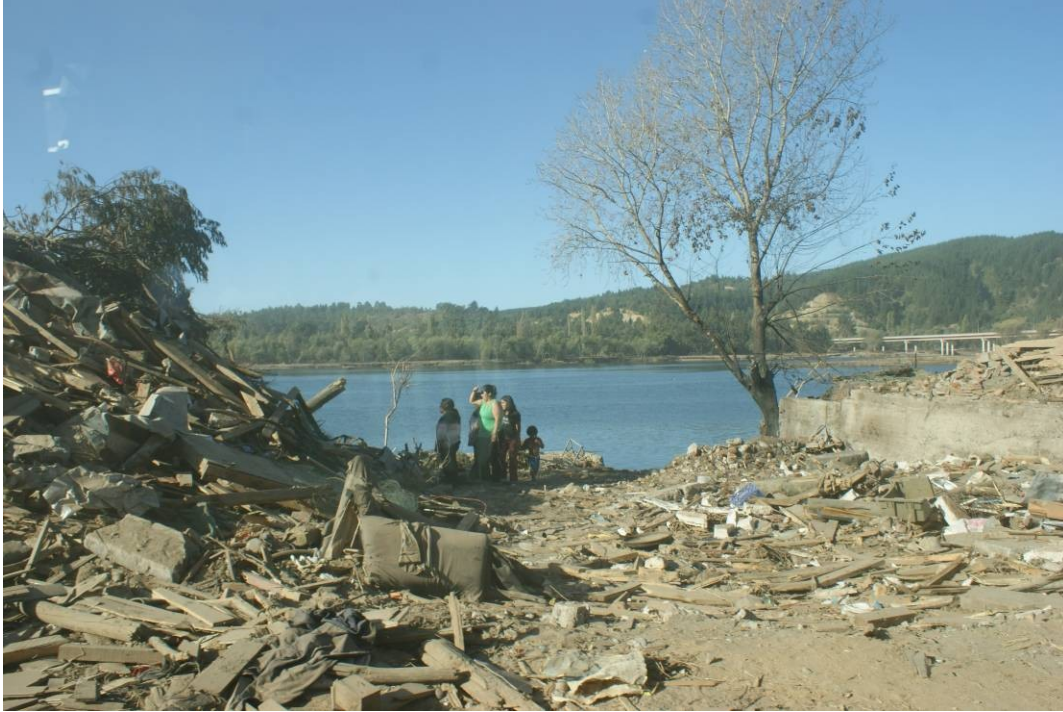
Figure 14.2. Constitucion, March 14, 2010. Debris removal and road clearing still underway in the tsunami inundation zone along the Maule River.

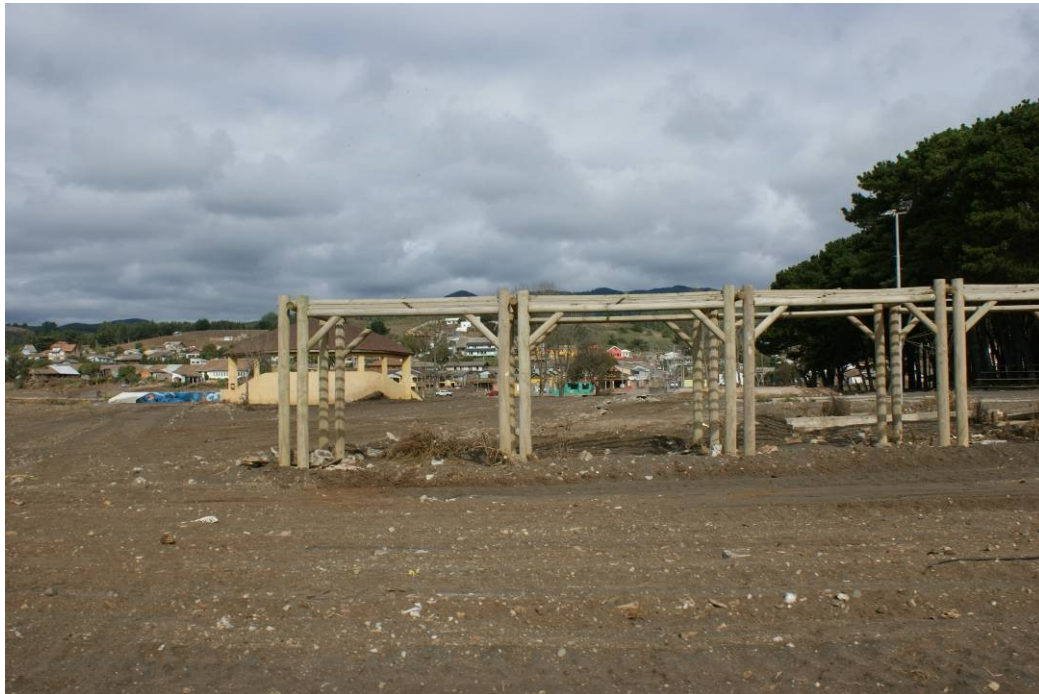
Figure 14.5. Curanipe, March 17. According to locals, hundreds were at a campground in this grove of trees. Many ran to the beach to avoid falling trees and were swept away by the tsunami.

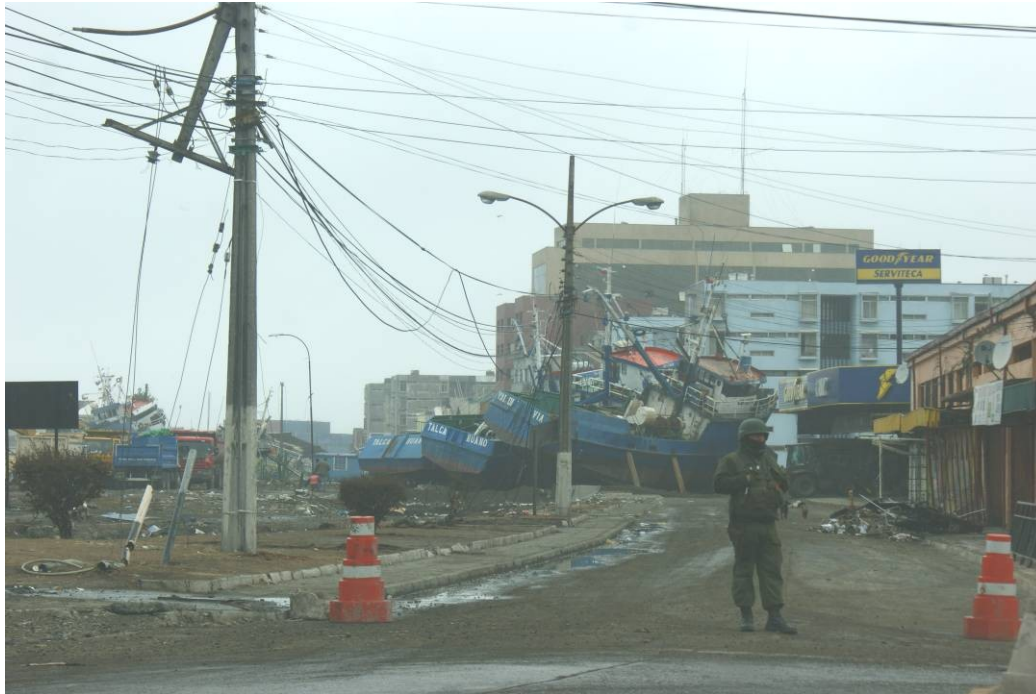
Figure 14.6. Talcahuano, March 16. Tsunami damage near Navy facilities and bayside port of Talcahuano.

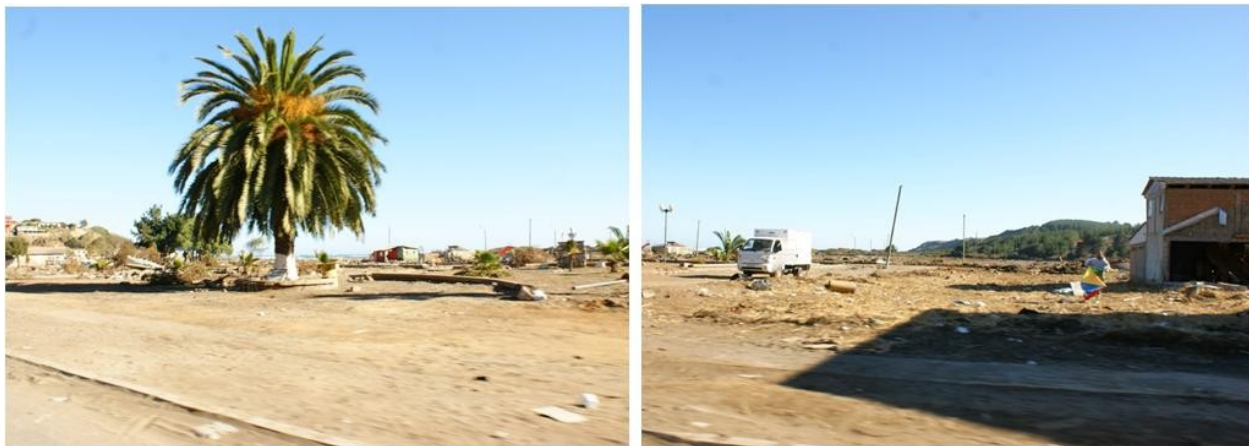
Local policeman say that there were many cabanas, campgrounds, and discos along the estuary, and about 500 people were in this low-lying area when the earthquake hit (see Figures 14.7a and 14.7b). There was a lot of moonlight and many people were out dancing. There was no tsunami alarm. But, many of the local people, firemen and police shouted to get out knowing that a tsunami might strike after the earthquake shaking stopped. Some saw the ocean receding and knew it was a forewarning of tsunami. Vacationers jumped into their cars and drove inland and up into the hills above the town. The tsunami was up to 2 meters deep in the estuary valley area and penetrated nearly 1 kilometer up the river, pushing fishing boats upstream under the coast highway bridge.

Figure 14.7a and 14.7b Bucalemu, March 15. Much of the tsunami debris and damaged structures had already been removed from the low-lying area along the estuary that had campgrounds, hotels, restaurants, and discos. As many as 500 people were in this area when the earthquake struck.

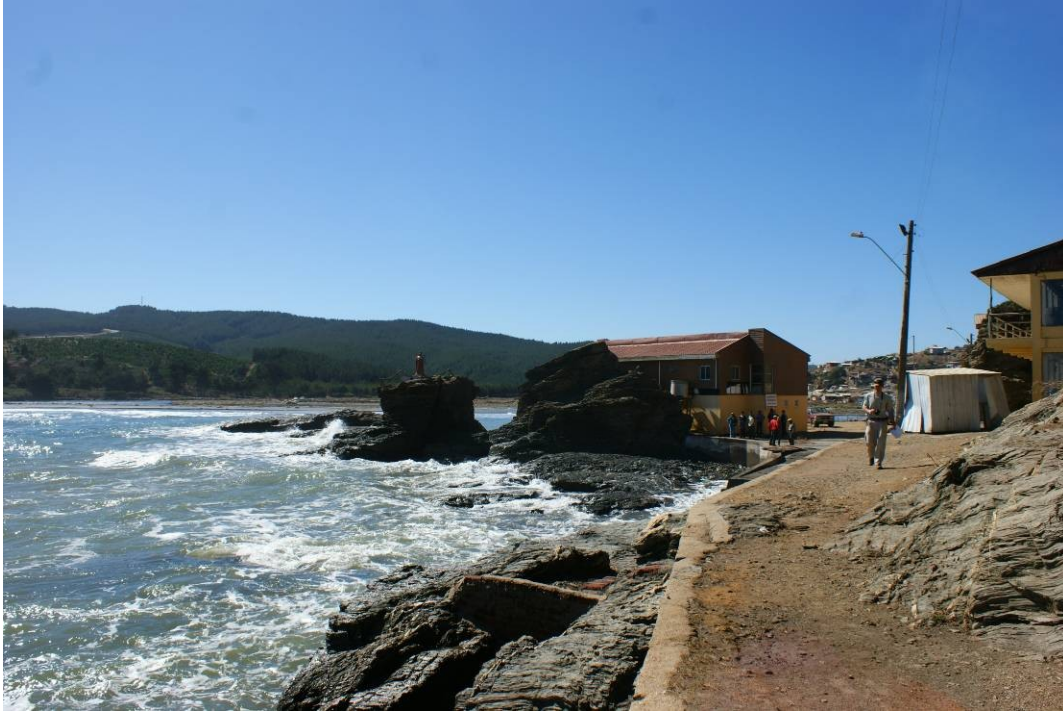
Prior to the earthquake, the town had been embarking in a fairly significant capital improvement project that included expansion of the lagoon and construction of a boardwalk along the shore (see Figures 14.8 and 14.9). Local residents say that the lagoon used to be only 10 meters wide and did not have a permanent opening to the sea and the rough waves like it does now. They say the beach extended about 20 meters beyond the arched, orange bridge out next to the pub building at the rocky point. Now the waves are crashing up against the pub building (see Figure 14.10). The cement boat launch ramp next to the pub building is now under water and the beach that local fisherman used to pull their boats up onto is gone.

Figure 14.10. Bucalemu, March 15. Waves crashing up against the pub building. The cement boat launch ramp and former beach are now submerged after the tsunami.

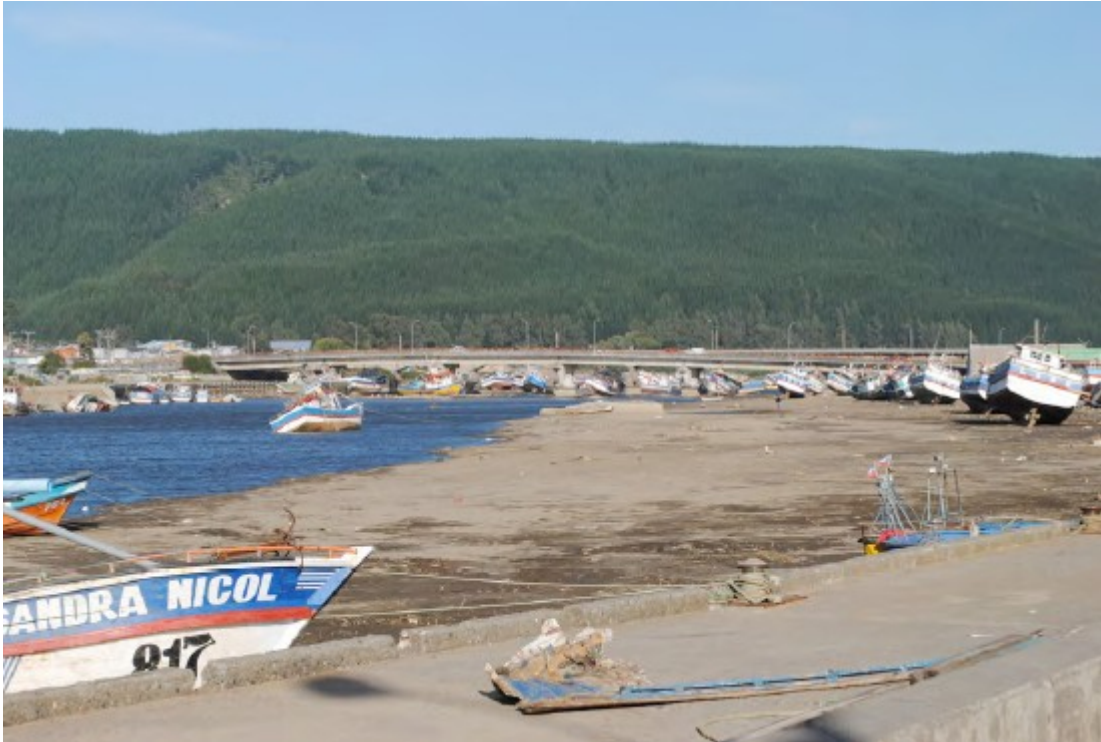
Coseismic uplift has stranded boats in Lebu's harbor (see Figure 14.11). The lighthouse northwest of the Lebu Harbor inlet is on an island that was uplifted enough to almost form a peninsula. Lebu will likely have significant land use planning issues as part of the rebuilding that may include relocation and construction of the harbor and appropriation of rights to the newly-created land. This area was also uplifted in the 1960 earthquake, so there are historic decisions and ongoing risk management issues to be studied as well.

Figure 14.11. Lebu, March 2010. Boats stranded in Lebu's Harbor.

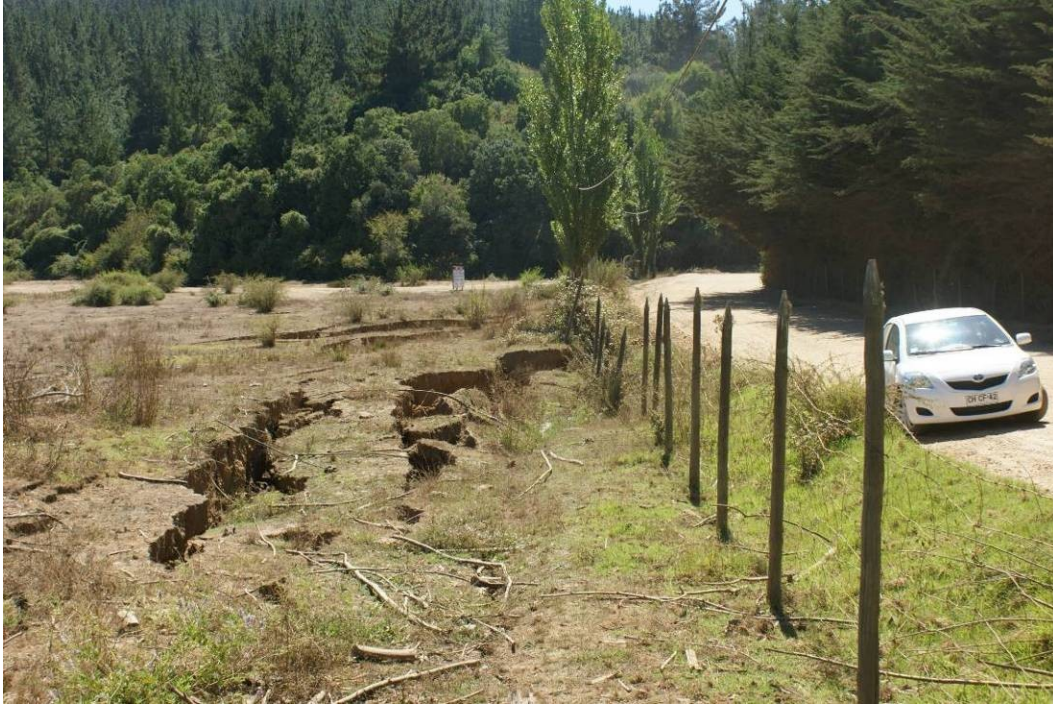
Lateral spreading along the banks of Lago Vichuquen ($S34.796068^\circ$, $W72.078810^\circ$), near the Laguna Torca National Reserve, severely impacted the road bed, underground utilities, and lakeside properties (see Figures 14.12, 14.13, and 14.14). Much of the ground underlying a small lakeside cabana hotel has been affected. Over 50 feet of shoreline was submerged and there was evidence for submarine landsliding as well. Sections of lawn, trees, and boat docks were all submerged. The shore side piers of several cabanas were also submerged and there was evidence of structural damage as well. The future viability of this property is definitely in question since there is not adequate land area between the cabanas and the road to setback and reconstruct. Ground deformation was observed in another location along the lake road but did not appear to be a consistent feature along the shoreline. Other boat docks along the shoreline did not appear damaged or submerged, but further study is needed.

Figure 14.12. Lago Vichuquen, March 15. Lateral spreading on the inland side of the lakefront road.

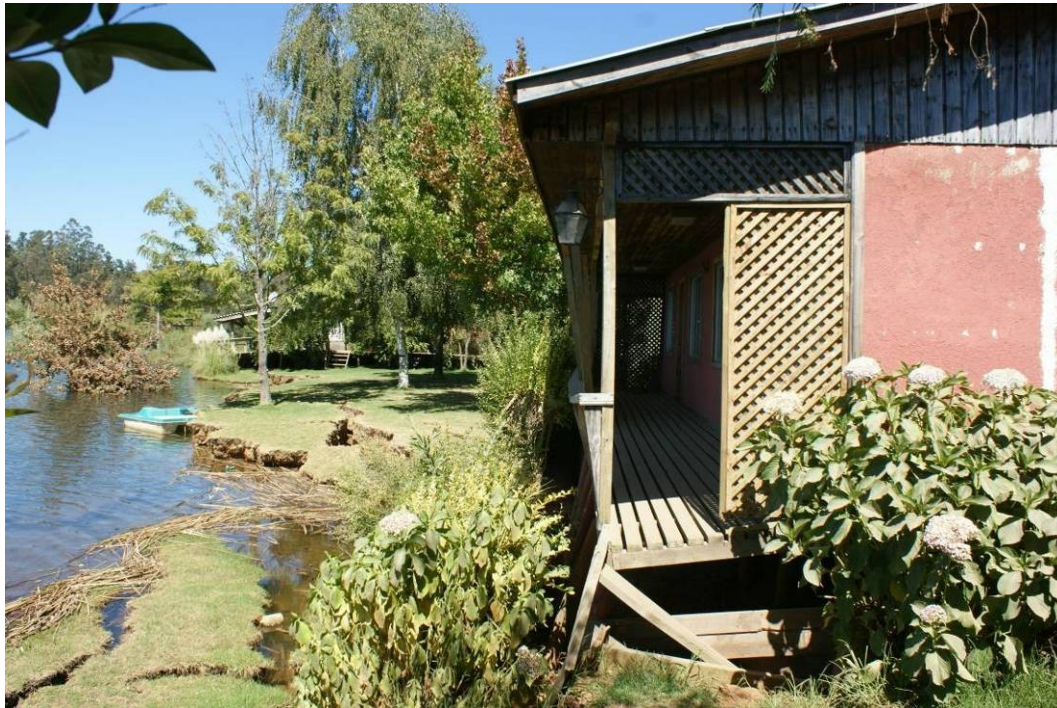
Figure 14.13. Lago Vichuquen, March 15. Lateral spreading has affected much of the ground underlying a small lakeside cabana hotel. Some shore side piers of the cabanas were submerged and there was evidence of structural damage as well.

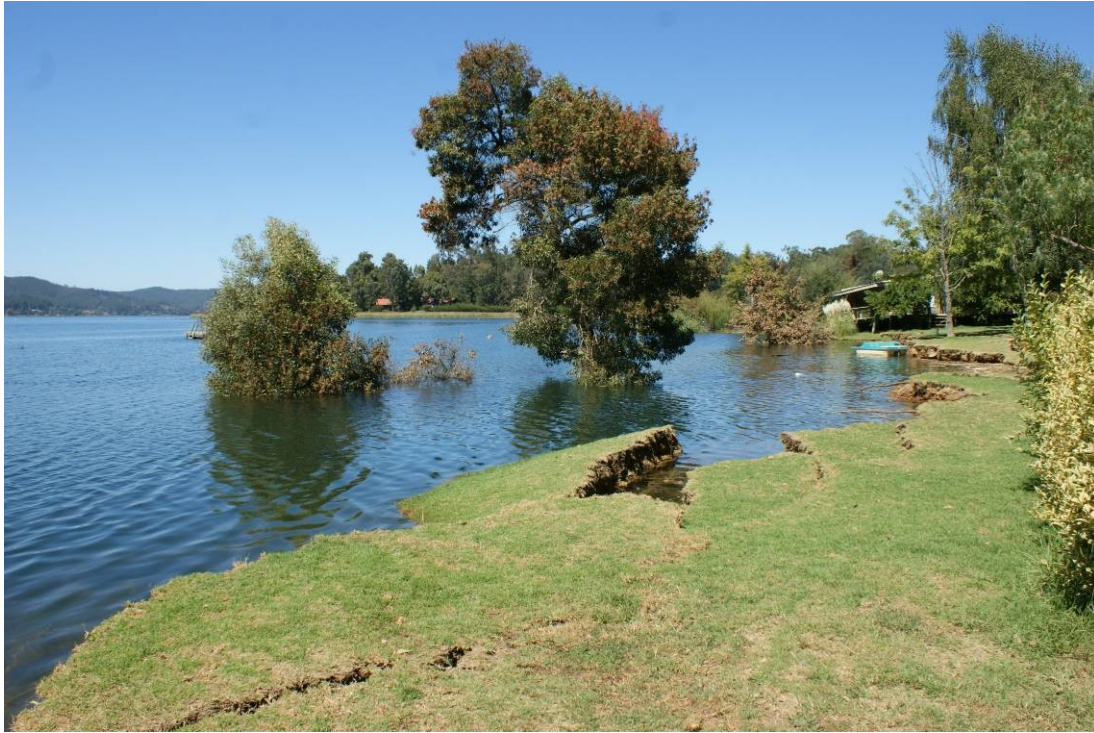
Figure 14.14. Lago Vichuquen, March 15. The lawn, trees, and boat docks are all submerged and there was evidence for submarine landsliding as well.

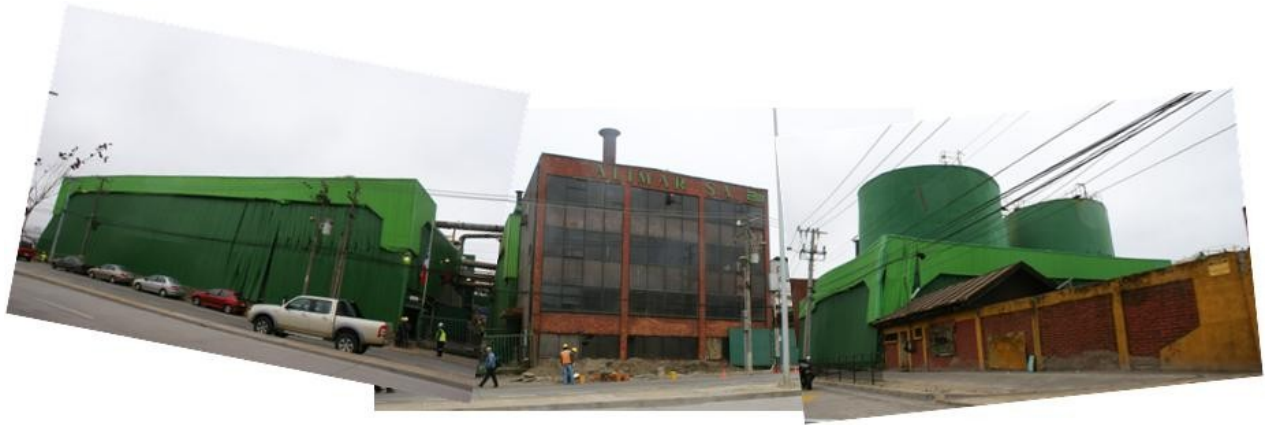
Several port side properties at Port San Vicente in Talcahuano were also significantly damaged by lateral spreading and ground deformation (S36.72593°, W73.12872°). Two fish processing plants, Alimentos Marinos and Concession Maritima, were both severely damaged and not in operation on March 15 (see Figures 14.15 and 14.16).

Figure 14.15. Port San Vicente, Talcahuano, March 16. The damaged Alimentos Marinos fish processing plant will likely not be rebuilt at this port.

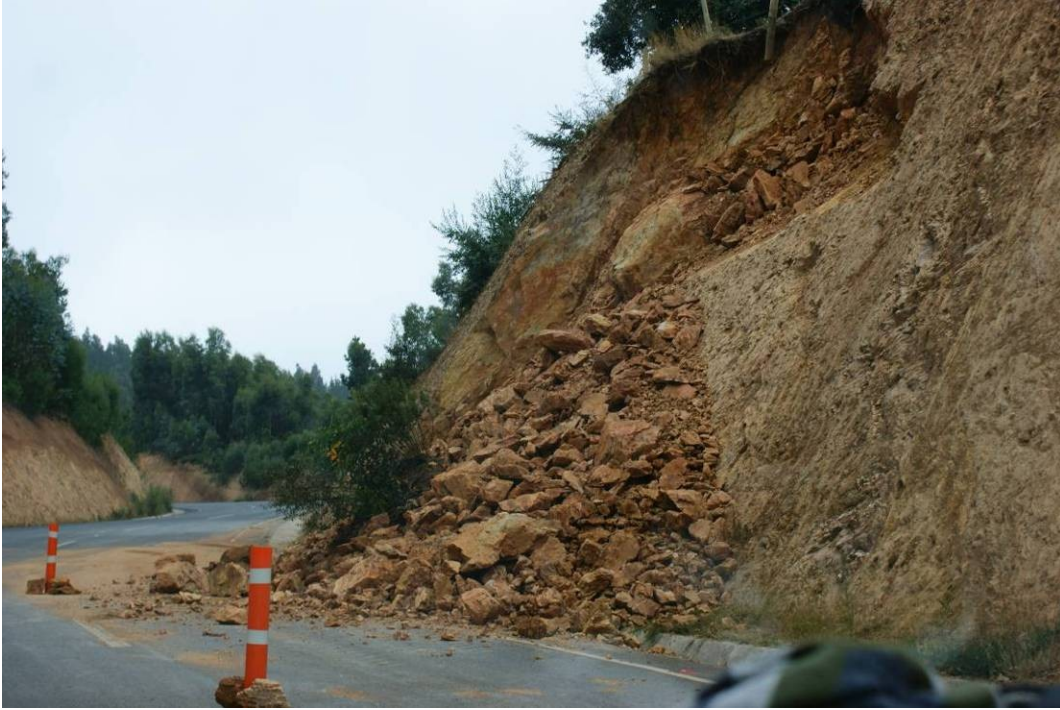
The February 27 earthquake occurred at the end of the dry, summer period and ground water tables were low. Slope instability may significantly increase into the rainy season, with more significant episodes of landsliding possible as future earthquake sequences occur. Access across the coast ranges to coastal areas could be significantly affected by rain-induced slope failures.

Figure 14.18. Failures on the road cuts along one of two main highways leading to the Port of Coronel and surrounding coastal cities.

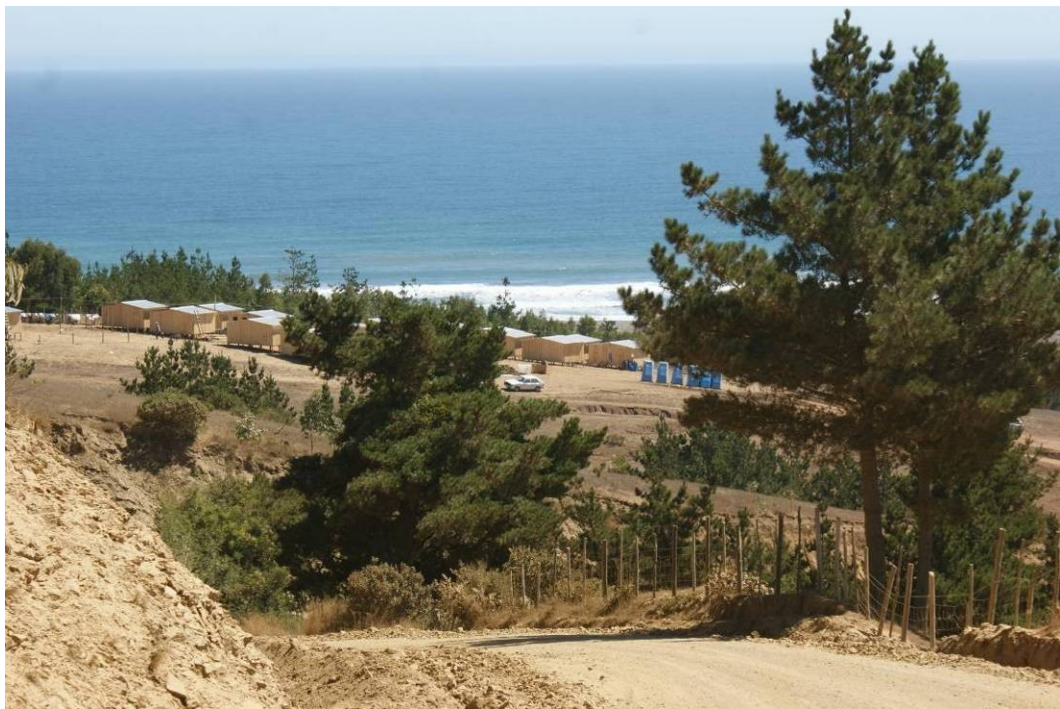
Also, many temporary settlements were observed in hillsides and on coastal bluffs (see Figure 14.19). The site selection of both informal and formal (organized) encampments is likely being driven by tsunami-hazard related concerns. Formal encampments established by the government and non-governmental organizations seem to have included some site preparations. However, informal settlements did not. These encampments may be vulnerable to landsliding in future aftershocks or with increased rainfall and soil moisture conditions. Local architects report that there is a history of temporary encampments becoming permanent, low-cost housing.

Figure 14.19. Temporary housing settlement being established in the hills above the coast near the town of Lipimavidia.

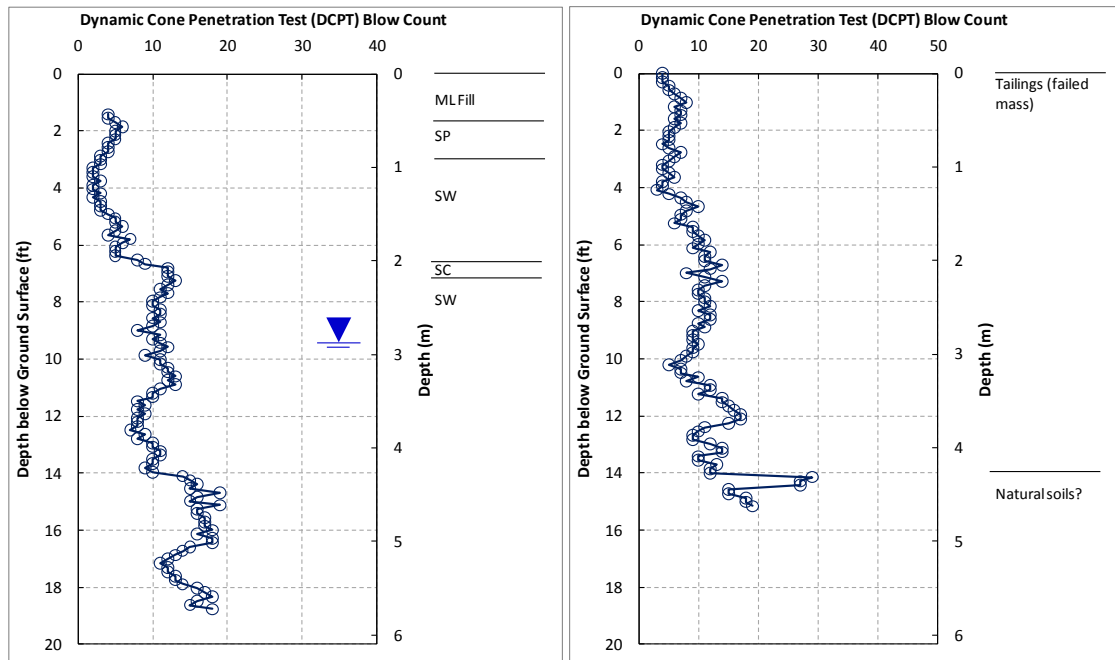
Figure 15.6 provides sample DCPT/hand auger results for one sounding performed at West Bio Bio Bridge (Juan Pablo II) and one sounding performed at Las Palmas tailings facility (through the failed mass). In addition, the DCPT provided a viable wave source at shallow depths for the SASW testing described subsequently (see Figure 15.7)

Figure 15.6. DCPT/hand auger results for one sounding performed at West Bio Bio Bridge (Juan Pablo II) (at left) and one sounding performed at Las Palmas tailings facility (at right, through the failed mass).

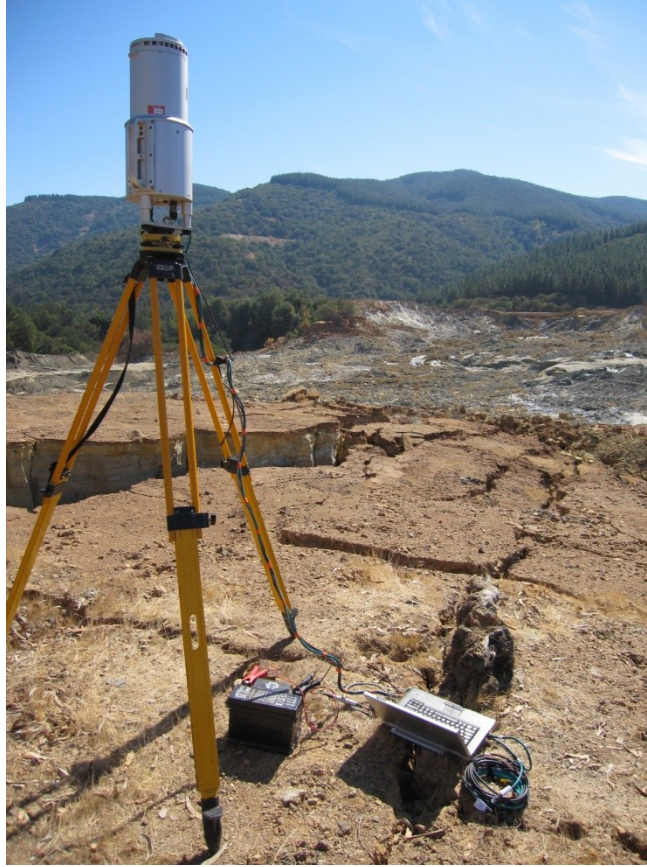
Figure 15.10. Terrestrial laser scanning with a Riegl z420 LIDAR unit at the Las Palmas Mine tailings dam failure. The system uses a PC for data acquisition and a car battery to power the laser.
