Geo-engineering Reconnaissance of the 2010 Maule, Chile Earthquake

Report of the NSF Sponsored GEER Association Team

GEER Association Report No. GEER-022

Version 1: April 15, 2010

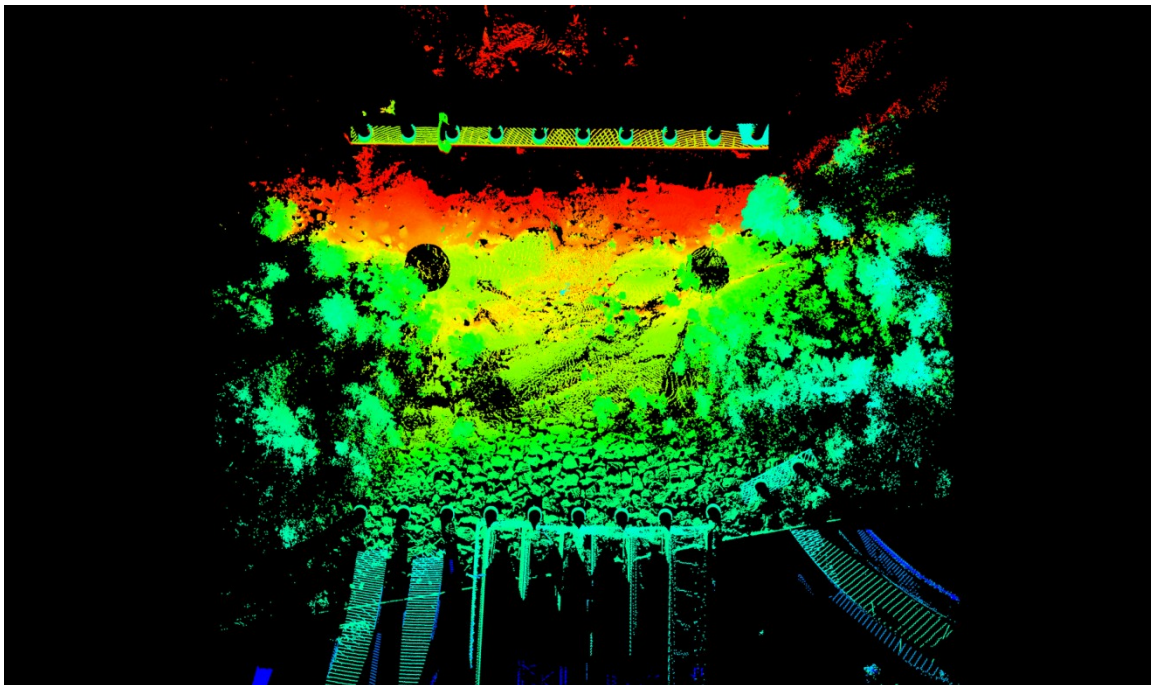
individual scans, and rescanned at ultra-high resolution to determine the reflector center. A least square best fit model was used to translate and rotate the individual scans to merge them together. For several sites (Curanilue Hospital, Las Palmas Tailings Pond, and the Parallel bridge), it was impossible to place reflectors. For these sites, a best fit translation and rotation registration process, using millions of points, aligns the overlapping data within a pair of point cloud data-scans. For example, at the Llaracon bridge approach deck failure (Figure 15.11), we digitally removed the bridge deck to digitally view the lateral spread in plan view. As shown in Figure 15.12, the approach deck collapse is at the bottom of the image (also seen in the photograph in Figure 15.11). The cylindrical cross section of the bridge piers that displaced riverward can be seen just above (west) of the bridge collapse. The first river-crossing pier is at the top of image, and can also be seen in Figure 15.11.

Figure 15.12. Plan view, with the Llaracon bridge deck digitally removed, of the approach deck collapse and lateral spread towards the Bio Bio River. The cylindrical cross section of the bridge piers can be seen just west of the bridge collapse (bottom of image, also seen in Figure 15.11) and the first river-crossing pier (top of image, also seen in Figure 15.11).
