Case Study: Oso, Washington, Landslide of March 22, 2014—Material Properties and Failure Mechanism

Timothy D. Stark, F.ASCE¹; Ahmed K. Baghdady, S.M.ASCE²; Oldrich Hungr, M.ASCE³; and Jordan Aaron, S.M.ASCE⁴

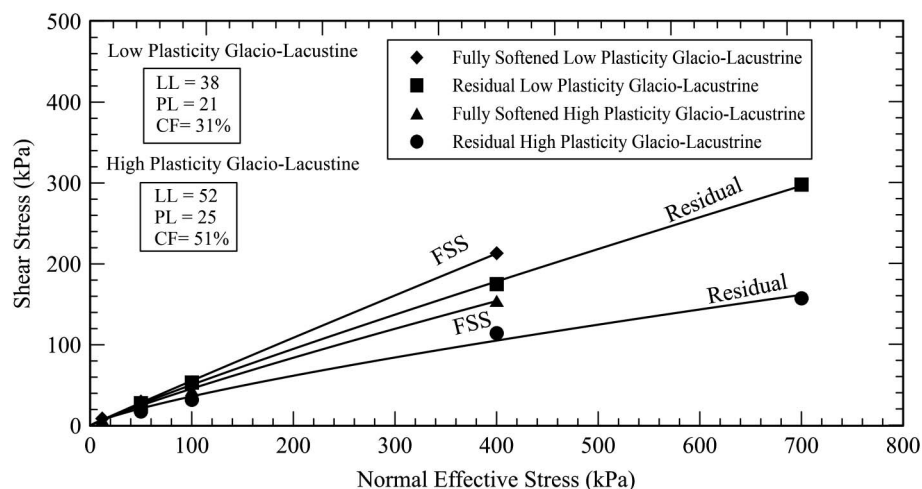
Fully softened (FSS) and residual shear strengths of the advanced glaciolacustrine clay deposit were measured using a torsional ring shear device in accordance with ASTM D7608 (ASTM 2010b) and ASTM D6467 (ASTM 2013), respectively. As expected, the shear strength envelopes are stress dependent (Stark and Hussain 2013) so the friction angles in Table 1 represent the secant friction angles for the normal effective stresses used in the testing. The FSS and residual stress-dependent strength envelopes shown in Fig. 3 were used directly in the 2D limit equilibrium stability analyses discussed subsequently. The fully softened and residual friction angles in Table 1 are in agreement with empirical correlations in Stark and Hussain (2013) and Gamez and Stark (2014) for the measured liquid limit and clay-size fraction values in Table 1.

Fig. 3. Fully softened and residual strength envelopes for advanced glaciolacustrine clay deposits
