COMPARING LIQUEFACTION PHENOMENA OBSERVED DURING THE 2010 MAULE, CHILE EARTHQUAKE AND 2011 GREAT EAST JAPAN EARTHQUAKE

Ramón VERDUGO¹

¹ Principal, CMGI Ltda. Santiago, Chile
rverdugo@cmgi.cl

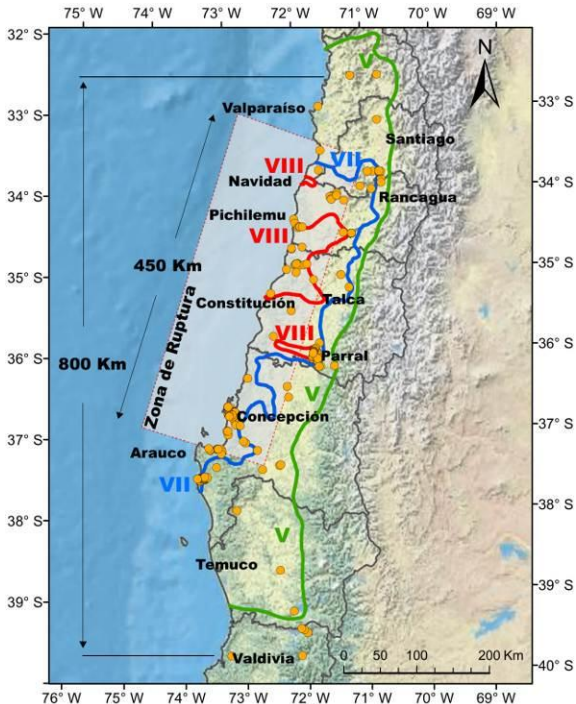
Combining the damage reported in the extensive work performed by Astroza and collaborators (Ruiz and Astroza, 2012), with the infrastructure damage reported by the Ministry of Public Work, a map of intensity was elaborated, which is presented in Fig. 8. It is observed some irregularities in the isoseismals that reflect local site effects. The higher intensity (greater than VIII) are concentrated in three areas: the town of Navidad, the coastal area from Pichilemu to Constitución, entering the central valley in the towns of Santa Cruz and Talca, and the central depression in the towns of Cauquenes and Parral.

Fig. 8.- Intensity map, 2010 Chile Earthquake

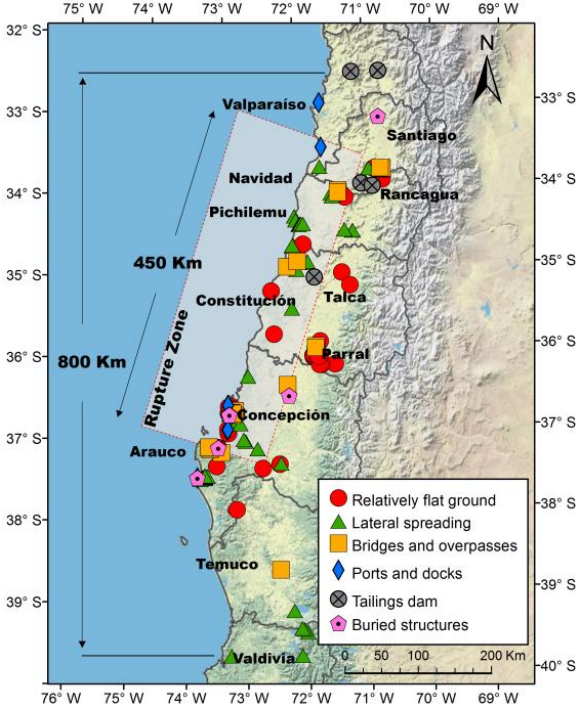
Regarding the occurrence of liquefaction, field observations have highlighted that the Maule 2010 Chile earthquake triggered liquefaction in more than 100 sites (Fig. 9). The northernmost site with evidence of liquefaction, corresponds to the limited slope instability experienced by the downstream slope of the tailings dam Veta del Agua, located approximately 13 km north-east of La Calera. While southernmost liquefaction occurred in Calafquén and Panguipulli lakes, located around 250 km to the south of the rupture zone. Consequently, the area with evidence of liquefaction covers a north-south distance of about 800 km, which corresponds to an area of almost twice the rupture zone.

It is observed that liquefaction sites cover an extensive area to the south of the rupture zone, which is much reduced to the north of the rupture zone. This fact could be explained by the limited existence of saturated sandy soils deposits to the north of Santiago, while saturated sandy soils are more common to the south of Concepción, especially on the banks of rivers and lakes. The areas that showed more sites affected by liquefaction are in Concepción, Retiro – Parral and Paine (south of Santiago).

Fig. 9.- Sites where liquefied was observed during 2010 Chile Earthquake

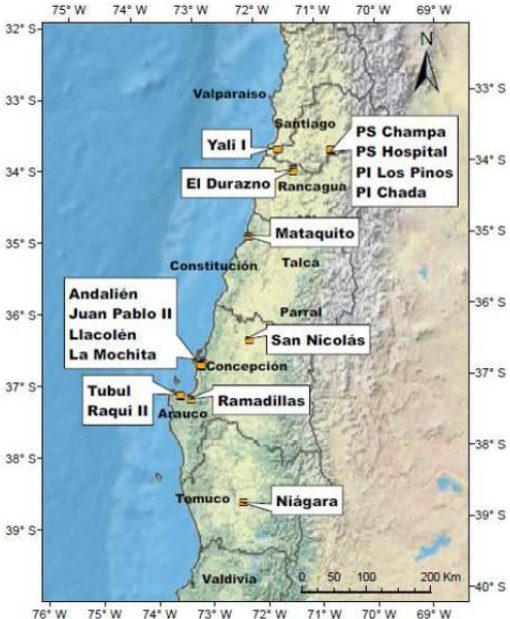
According to all the information that has been collected and analyzed, 12 bridges and 4 overpasses were damaged by ground failure associated with liquefaction of ground foundations or accesses. Bridges affected by liquefaction of soil foundation were Andalién, Juan Pablo II, La Mochita, Niagara, Ramadillas, Raqui II, San Nicolás, Tubul and Yali I. Bridges with ground failure at the accesses were Alhue, El Durazno and Llacolén. Additionally, there were signs of liquefaction (settlements and sand boils) of the natural soil at Mataquito Bridge, which was not affected because the liquefiable soil was not used to support the structure. On the other hand, overpasses affected by the phenomenon of liquefaction were: Chada, Champa, Hospital and Los Pinos.

The location of these bridges and overpasses is shown in Fig. 15. It can be observed that there are two areas where there is a concentration of liquefaction phenomena. Failure of bridges is more concentrated in the Concepción area, whereas failure of overpasses is clearly observed to be concentrated to the south of Paine area, as shown in Fig. 16, where three additional sites liquefied.

Fig. 15.- Bridges and overpasses affected by liquefaction

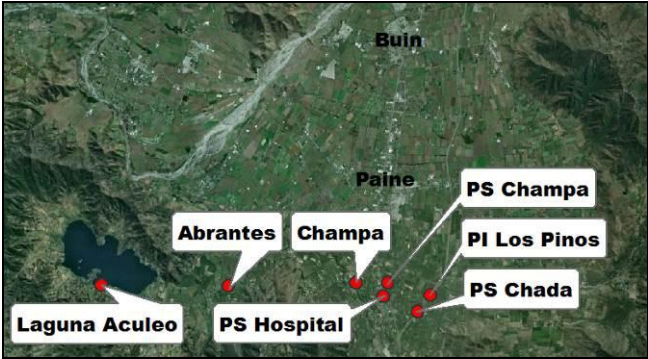
Fig. 16.- Concentration of liquefaction in Paine area
