Description and analysis of geotechnical aspects associated to the large 2010 Chile earthquake

Descripción y análisis de aspectos geotécnicos asociados al gran terremoto de Chile del 2010

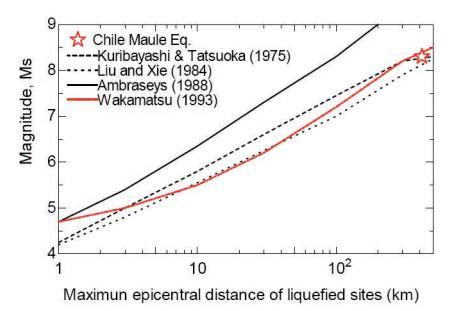
Figure 2: Relationship between seismic magnitude Ms and epicentral distance for the farthest liquefaction sites

Soil liquefaction occurred in several places mainly because of the large earthquake magnitude. However, fortunately liquefaction was not so widespread since the ground water table was relatively low at the end of summer, except for sites close to water bodies or sites around or close to wetlands. The farthest epicentral distance of a liquefaction site was at Veta del Agua tailing dam, 350 km North. This distance is plotted against the surface magnitude 8.3 as a star in Figure 2, where it is possible to observe that the star is matches to the trend proposed by other authors (except Ambraseys 1988), based on experiences from past earthquakes.

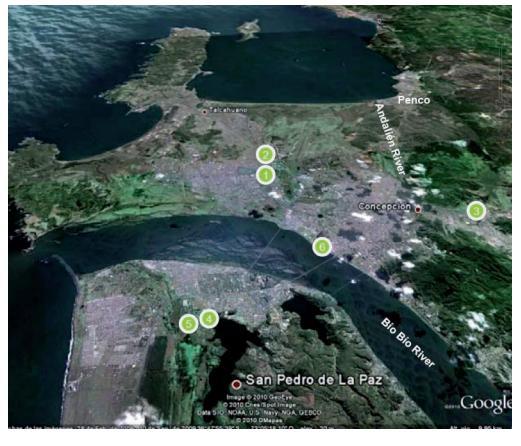
Figure 3: Sites considered in this study

The reconnaissance survey detected liquefaction at fill or replaced backfill in and around Concepción only, with the exception of Las Palmas tailing dam. In the Concepción area, subsoil liquefaction caused settlement of buildings and houses as well as uplift of underground tanks. The sites to be considered in this study are shown in Figure 3.

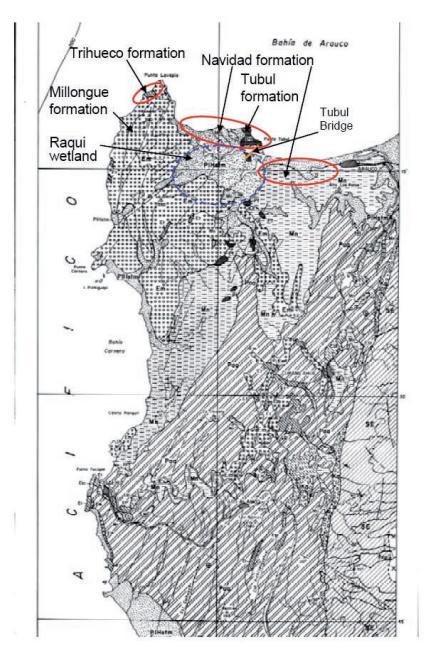
Figure 12: Geologic map of the Arauco Peninsula, showing in red ellipses landslide areas (Ferraris and Bonilla, 1980)

During a heavy rain season it is not a surprise that dangerous landslides can occur in the Bío Bío Region. Notwithstanding the strong ground shaking induced by the earthquake, the dry condition of the ground seems to have reduced the number and extension of landslides. Although, several landslides were found in hills around Concepción, the volume of ground mobilised was not so significant because failures were relatively shallow. Different was the case of cliffs 100 m high in average found in the Arauco Peninsula, were large amount of ground slid. Figure 12 shows a geologic map of the Arauco Peninsula, highlighting the areas were landslides were observed. The material of these cliffs corresponds to different geological formations, but they are composed mainly of marine sandstones and siltstones. Figure 13a shows a landslide of the Navidad formation just at the entrance of the Raqui wetland (seen behind). The ground on the shore is made up of marine terrace sediments and in the wetland this material becomes a very soft organic peat. Figure 13b shows a landslide in the Tubul formation with a view behind of part of the Raqui wetland and the town of Tubul. In both landslides the failure surface is very steep with the material falling over the beach. It is important to know that, for this earthquake, the Arauco Peninsula is located approximately in the further South part of the Nazca plate section which dips under the South America plate. In other words, the further South aftershocks recorded were around this peninsula (Barrientos 2010). Moreover, large tectonic movements have been measured by GPS instruments and by visual

observations. For example, in Concepción (50 km north from Arauco city) horizontal displacements between 3 and 4 m and uplifts in Punta Lavapié of around 2 m have been estimated (Barrientos 2010). It is believed that landslides were triggered not only by the strong cyclic motion but also by the lateral (towards the trench) and vertical (uplift) displacements of the earth crust. Further research is needed to understand the effect of coupling of this complex shaken plus pushing and uplifting on seismic slope stability.
