Seismic Performance of Earth Structures during the February 2010 Maule, Chile, Earthquake: Dams, Levees, Tailings Dams, and Retaining Walls

Ramon Verdugo,^{a)} Nicholas Sitar,^{b)} M.EERI, J. David Frost,^{c)} M.EERI, Jonathan D. Bray,^{d)} M.EERI, Gabriel Candia,^{e)} M.EERI, Terry Eldridge,^{f)} Youssef Hashash,^{g)} M.EERI, Scott M. Olson,^{h)} M.EERI, and Alfredo Urzuaⁱ⁾

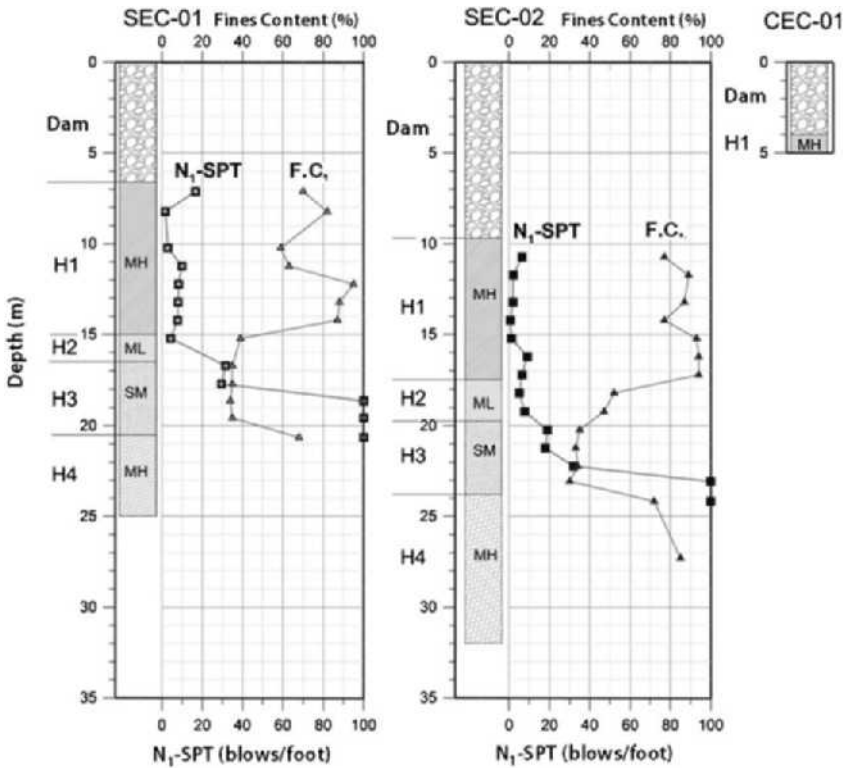
Figure 9. Soil profile at Coihueco Dam.

To assist in investigating the cause of the observed failure, a limited geotechnical exploration was performed, consisting of two boreholes, SEC-01 and SEC-02, of 25 m and 32 m depth, respectively, and one test pit of 5 m depth (CEC-01). The location of the borehole and test pit logs are illustrated in Figure 8 relative to the dam cross section, and the stratigraphic profile with measured standard penetration test (SPT) blow counts (N-values) and fines contents (F.C., percent passing #200 sieve) are shown in Figure 9. The Atterberg Limits

are plotted in Figure 10. The MH soil likely contains allophane, which is commonly present in southern regions of Chile. The foundation materials encountered in the exploration consist of the following:

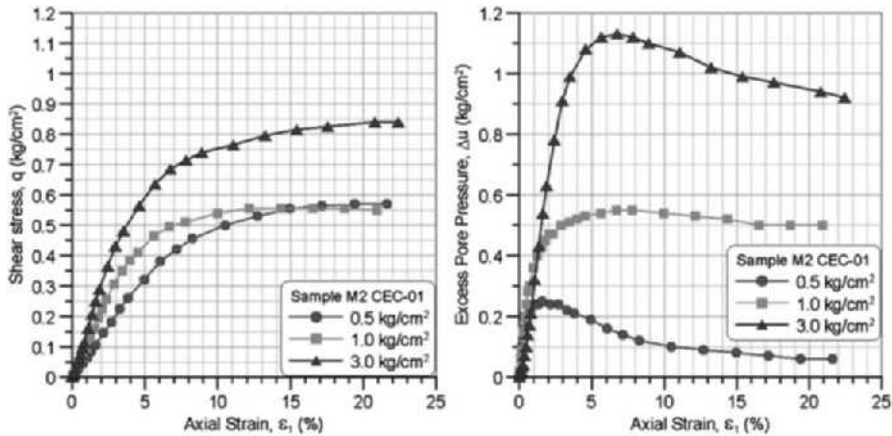
Figure 11. Triaxial test results, sample M2 CEC01. Coihueco Dam.

Isotropically consolidated, undrained triaxial tests with porewater pressure measurements (CIU) were performed on “undisturbed” samples retrieved with Shelby tubes. The stress-strain and pore water pressure responses for two samples are presented in Figures 11 and 12, corresponding to materials from pit CEC-01 (depth 4.6–5.0 m) and borehole

SEC-02 (depth 15.6–16.0 m), respectively. The results of the CIU triaxial tests show a dilation even under a confining pressure of 3 kg/cm² (300 kPa), suggesting that the silty soil is slightly overconsolidated for the range of confining pressure used. Considering the low hydraulic conductivity of this silty soil, its undrained response and thus use of undrained strength (S_u) is appropriate for seismic stability analysis. Measured undrained strengths

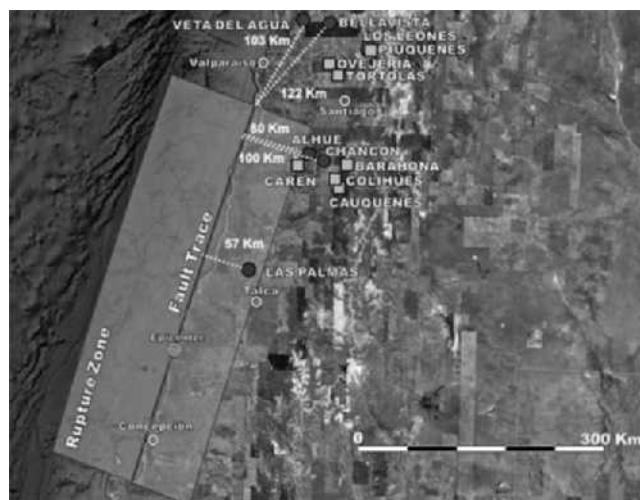
The tailings dams farthest from the epicenter that experienced seismic distress were Veta del Agua Dike No. 5 and Bellavista Dike No. 1. However, the distance of these structures to the fault rupture was only 100 km and 120 km, respectively. The other tailings dams that suffered failures have fault rupture distances of 57 km (Las Palmas Dam), 80 km (Alhué Dam), and 100 km (Chancón Dam). Figure 18 compares these distances to the relationship suggested by Conlin (1987) that relates potential for tailings dam failure to earthquake magnitude and epicentral distance.

Figure 17. Large tailings dams with stable response (square) and tailings dams that experienced seismic failures during 2010 Maule Earthquake (circles).

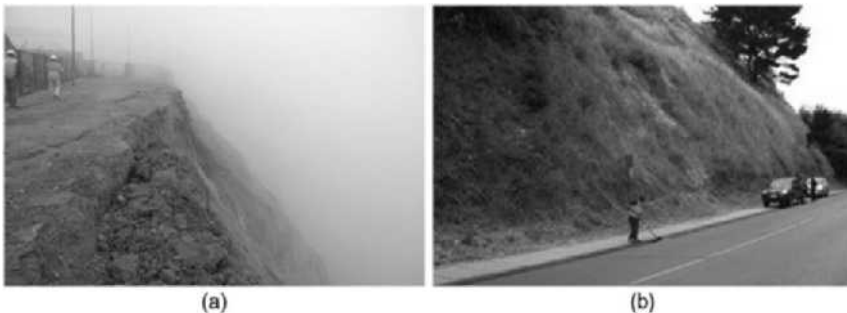
in other areas where no failures were observed. The particular condition that affected the area of Arauco, where these massive seismic slope failures occurred, is the significant tectonic uplift that reached nearly 3 m near the coast. It is hypothesized that the superposition of the inertial forces of the earthquake plus the distortion generated by the crustal deformation could be responsible for the observed slope failures. It is interesting to remark that many steep slopes in other areas such as those shown in Figure 23 did not fail, and only limited surficial displacements were observed.

Figure 23. Steep slopes without evidence of major seismic displacements. (a) Near Barahona tailings dam. (b) City of Constitución.

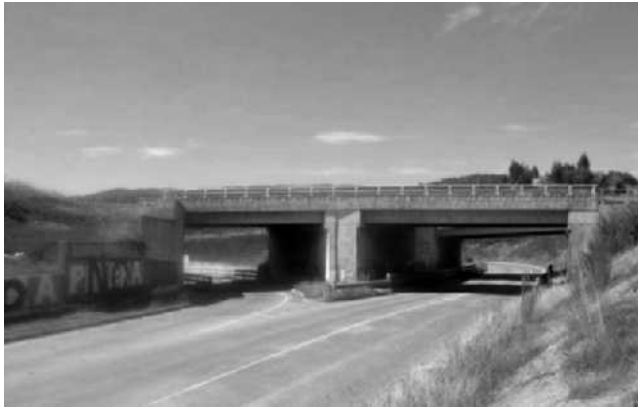
Conventional concrete gravity and cantilever retaining structures similarly performed very well in many different settings. Figure 26 shows an overpass structure on the coastal highway just south of Coronel, about 140 km south of the epicenter in an area that experienced significant shaking. The structure experienced no distress and the bridges were fully functional after the event.

Figure 26. Multiple retaining structures for highway overpass structures south of Coronel.
