# Geo-engineering Reconnaissance of the 2010 Maule, Chile Earthquake

Report of the NSF Sponsored GEER Association Team

# GEER Association Report No. GEER-022

Version 2: May 25, 2010

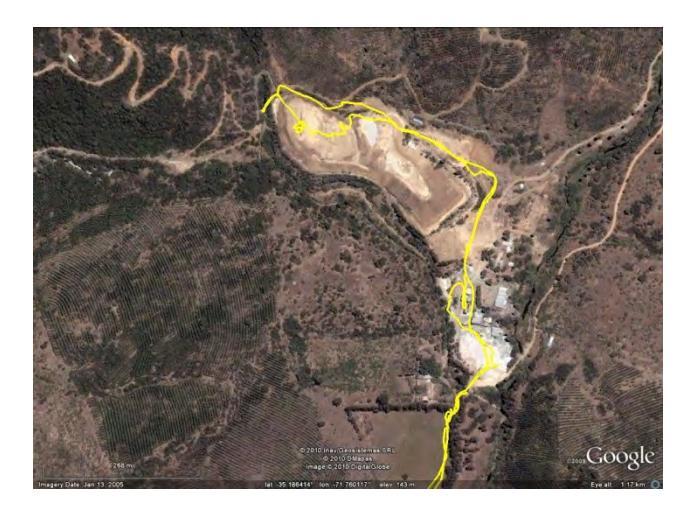
Figure 3.17. Google Earth based pre-event image of Las Palmas Tailings Dam that failed.

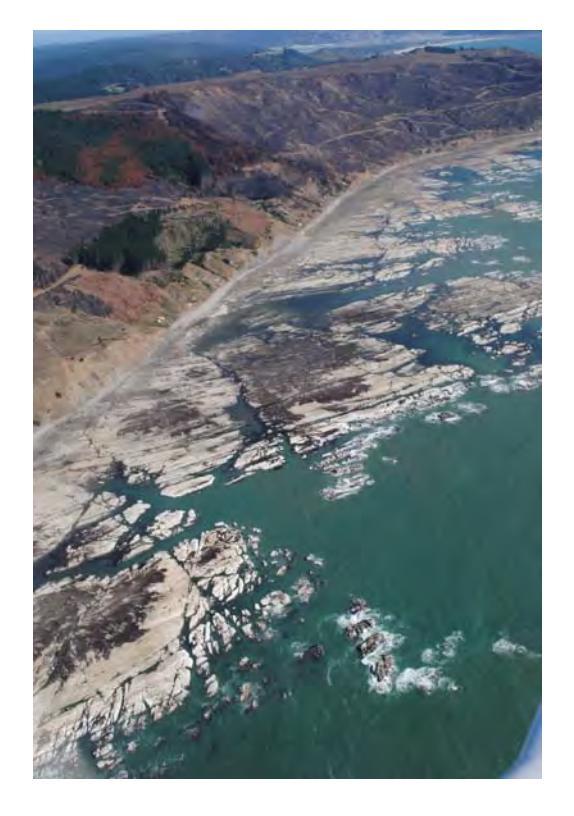
Aerial reconnaissance on March 9 included observation of the Arauco Peninsula and the town of Lebu on the southwestern side of the peninsula, and demonstrated the presence of uplifted (formerly active) wavecut bedrock platforms (Figure 4.5). From the air, these platforms appear white where covered by bleached intertidal marine organisms, and brown where covered by kelp. It is notable that kelp debris on these platforms was preserved, rather than being removed by tsunami waves. A lighthouse northwest of the Lebu Harbor inlet is on an island that was uplifted enough to nearly form a peninsula (Figure 4.6); the lighthouse appeared to be undamaged by subsequent tsunami waves.

Figure 4.5. Oblique aerial photograph looking south along the western coastline of the Arauco Peninsula, showing uplifted (formerly) modern wave-cut platform and exposed tidal zone. (\$37.540303° W73.623628°; 1701 hrs on 03/09/2010).

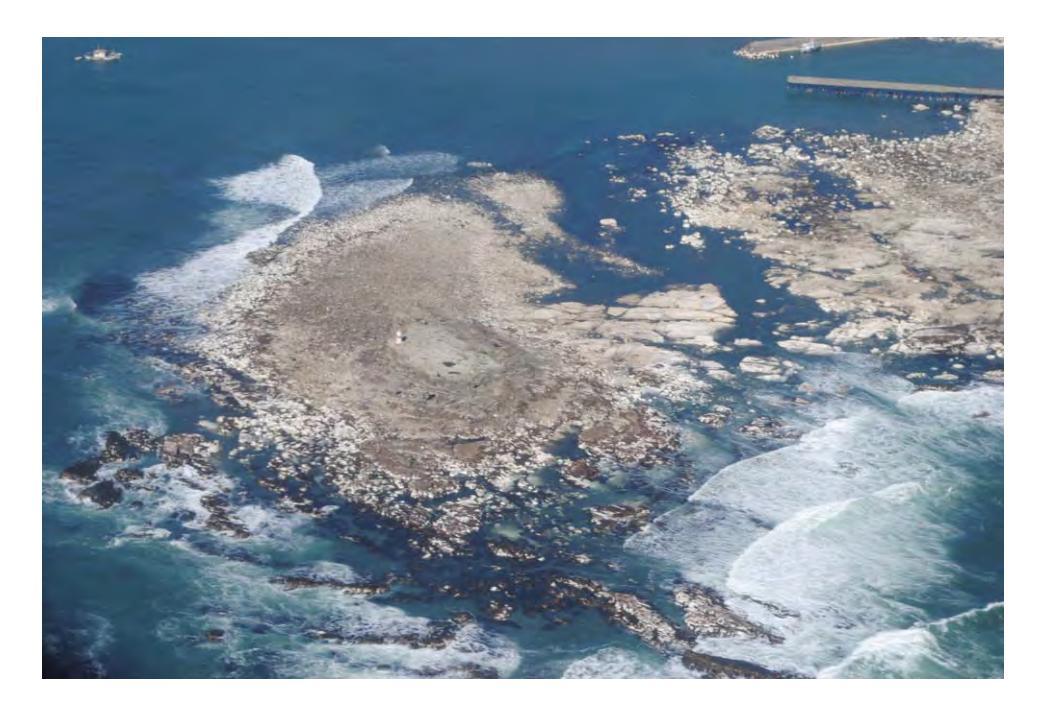
Figure 4.6. Uplifted island with lighthouse, north of Lebu Harbor inlet. Areas with whitish colors were uplifted during earthquake. (S37.591897° W73.668353°; 1714 hrs on 03/09/2010).

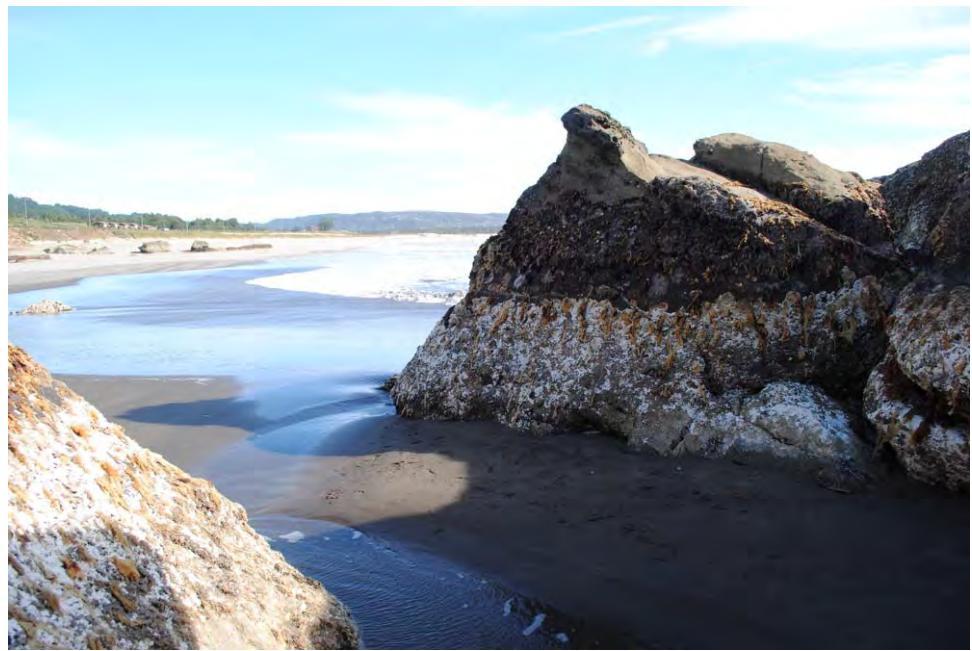
Ground reconnaissance near the town of Lebu documents approximately 1.5 to 2.0 m of uplift of the coastline. Figures 4.7 and 4.8 show uplifted tidal organisms attached to sandstone bedrock. Local fishermen contacted at this site indicated that sea level went down (i.e., the coast was uplifted) approximately 1.8 m as a result of the February 27 earthquake. Evidence of coastal uplift is also present on the eastern side of the Lebu harbor inlet, where fishing boats were stranded above the high-tide elevation and a wooden jetty now is above tidal level (Figure 4.9). The area east of the jetty is now emergent as a result of earthquake-related uplift (Figure 4.10). Local fishermen in this area noted that the "water level went down" about 1.5 to 2.0 m as a result of the earthquake, suggesting uplift of about 1.5 to 2.0 m. Measurement of the former high-tide level on the harbor wall indicates an uplift of about 1.8 m (Figure 4.10). Almost all of the boats in the Lebu Harbor, including a large ferry, were grounded as result of the uplift. North of the Lebu Harbor inlet, the former wave-cut platform is now emergent and about 2 m above high tide (Figure 4.11). Several observations indicate that seawater drained from this platform without high flow velocities expected during tsunami surge, including the presence of attached kelp draped on the wave-cut platform, scattered buoyant trash, and several species of mobile tidal organisms (e.g., crabs, starfish) preserved in a "life assemblage". These relationships, as well as a lack of damage to waterfront residences adjacent to the Lebu harbor, indicate that tsunami waves did not inundate areas outside of the harbor channel and that the uplift raised the wave-cut platform above the inundation level. The measurements of uplift of about 1.5 to 2.0 m are consistent with (but lower than) measurements provided by Tassara (2010).

Figure 4.7. Uplifted tidal organisms northeast of Lebu Harbor, looking west; distinct bands of white organic material and brown kelp are at comparable elevations (respectively) throughout this area. Top of kelp band about 2 m above tidal level when photo was taken (5:34 pm local time, 1.5 hr prior to daily high tide). (S37.580447° W73.642911°; 1734 hrs on 03/10/2010).

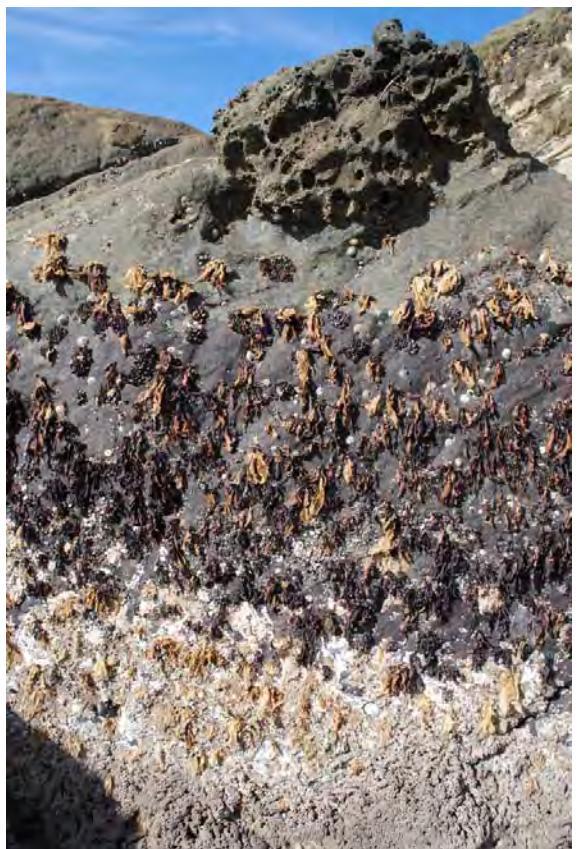
Figure 4.8. Close-up photograph of uplifted intertidal organisms, northeast of Lebu Harbor. (S37.580447° W73.642911°; 1743 hrs on 03/10/2010).

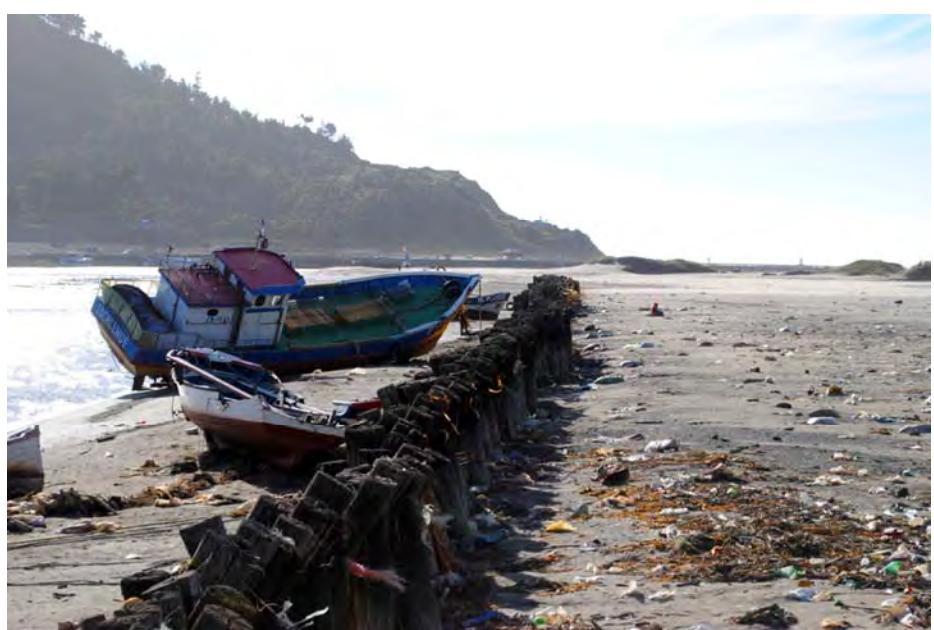
Figure 4.9. Eastern margin of Lebu Harbor, with stranded fishing boat and emergent wooden jetty; area to right was former tidal flat adjacent to harbor channel. Present high tide water level to left of boats. (S37.600789° W73.656317°; 1800 hrs on 03/10/2010).

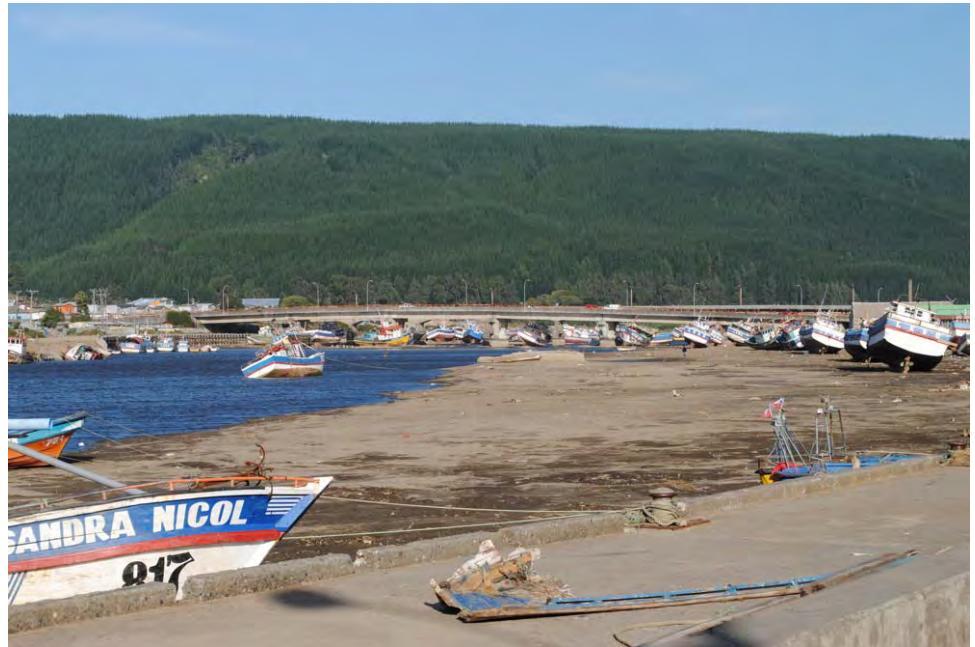
Figure 4.10. Fishing boats in Lebu harbor, stranded along uplifted western margin of harbor channel. Former high tide mark on harbor quay wall was indicated by local fishermen; measurement from high tide level on March 10 indicates uplift of 1.8 m ± 0.2 m of the harbor quay wall. (S37.603694° W73.654372°; 1832 hrs on 03/10/2010).

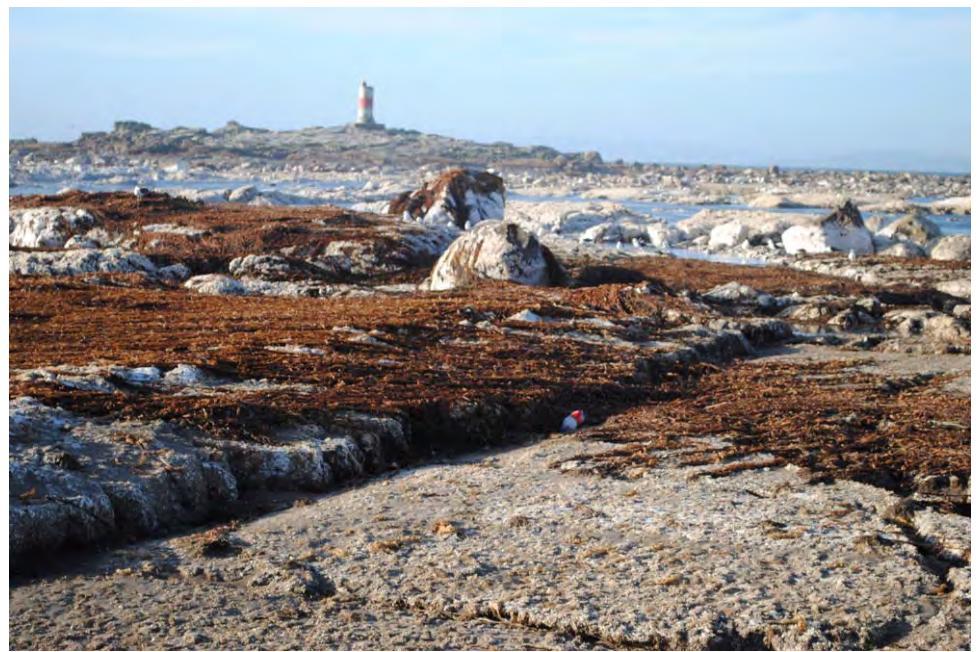
Figure 4.11. Wave-cut platform north of Lebu Harbor inlet, as also shown on Figure 4-6. Kelp draped on the platform, presence of "life assemblage" of mobile tidal organisms (e.g., crabs, starfish), and buoyant trash on the platform all suggest that seawater drained from the platform without high flow velocities expected during a tsunami surge. (S37.593958° W73.668225°; 1910 hrs on 03/10/2010).

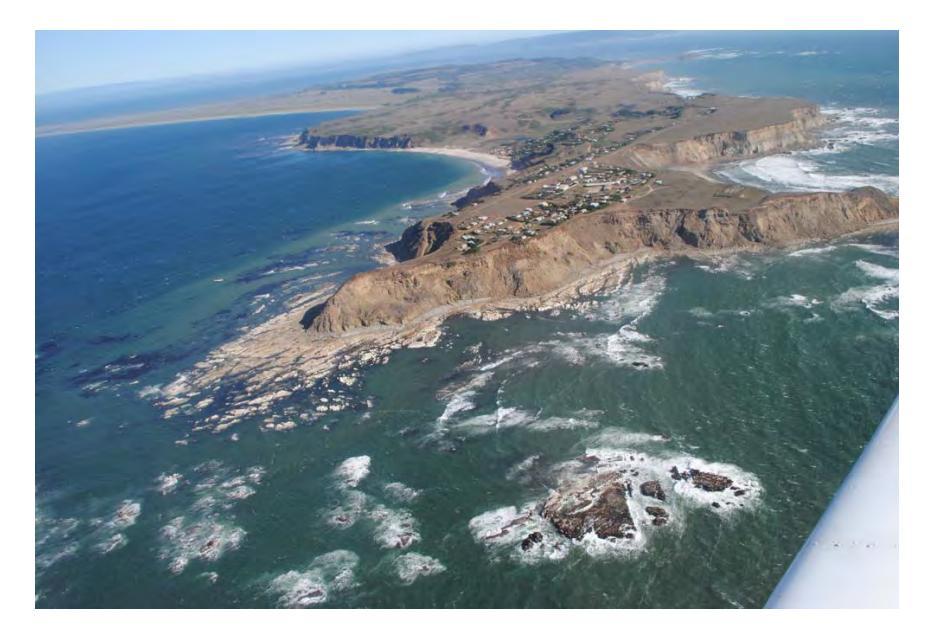
Figure 4.12. Northern end of Isla Santa Maria, looking south toward wave-cut platforms on uplifted coastline and islands. (S37.593958° W73.668225°; 1910 hrs on 03/9/2010).

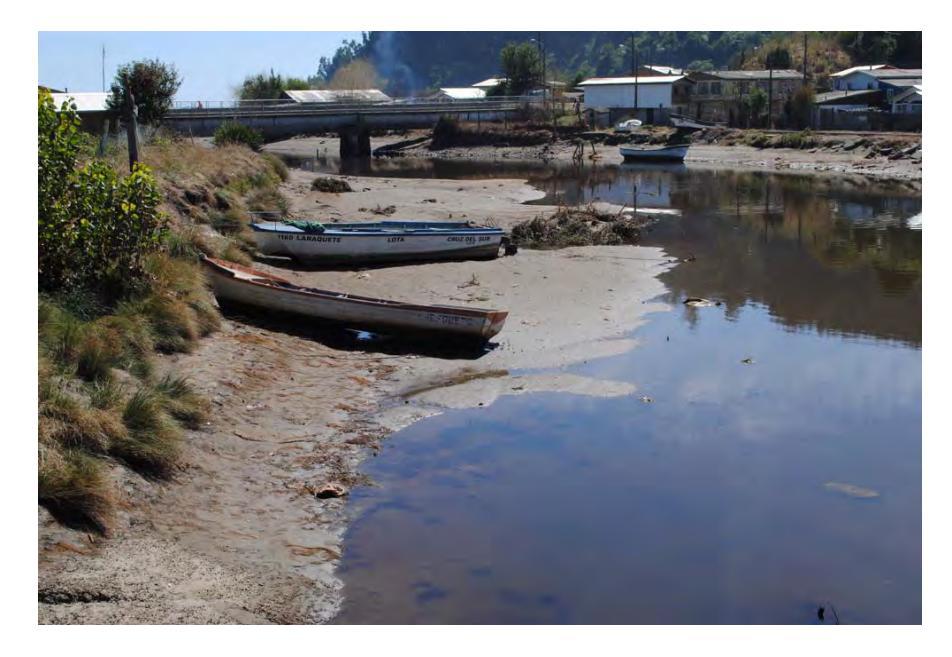
Figure 4.13. Ground view looking north in village of Laraquete, from the highway bridge toward the estuary outlet. Fishing boats stranded on left bank; tsunami high water mark approximately at the bank crest. Light, wooden-frame residences on both banks were unaffected by tsunami waves confined within existing tidal channel. Local witness indicated that the sea level went down about 0.5 m after the earthquake, and that the estuary bottom had not been exposed before (i.e., uplift of about 0.5 m). (S37.166661° W73.184481°; 1238 hrs on 03/10/2010)

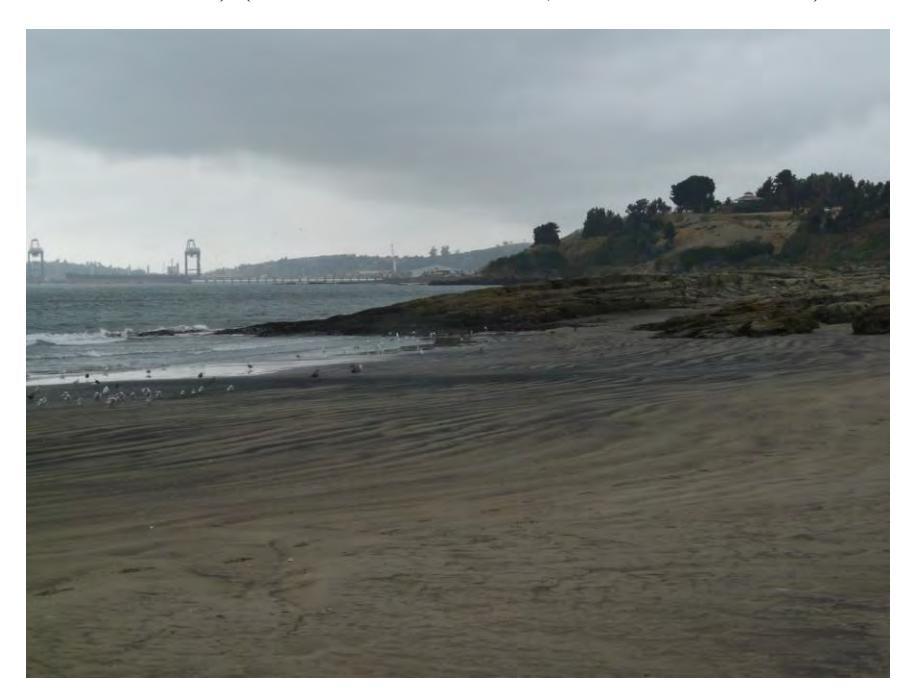
Figure 4.14. Raised mussel colonies inhabiting rocky intertidal habitats at Playa Blanca in Lota suggest the earthquake uplifted this area by about 0.9 m. A local witness attests to uplift at this site saying the shoreline has shifted westward by 15 to 25 m. (S37.058390° W73.142323°; 1701 hrs on 03/16/2010).

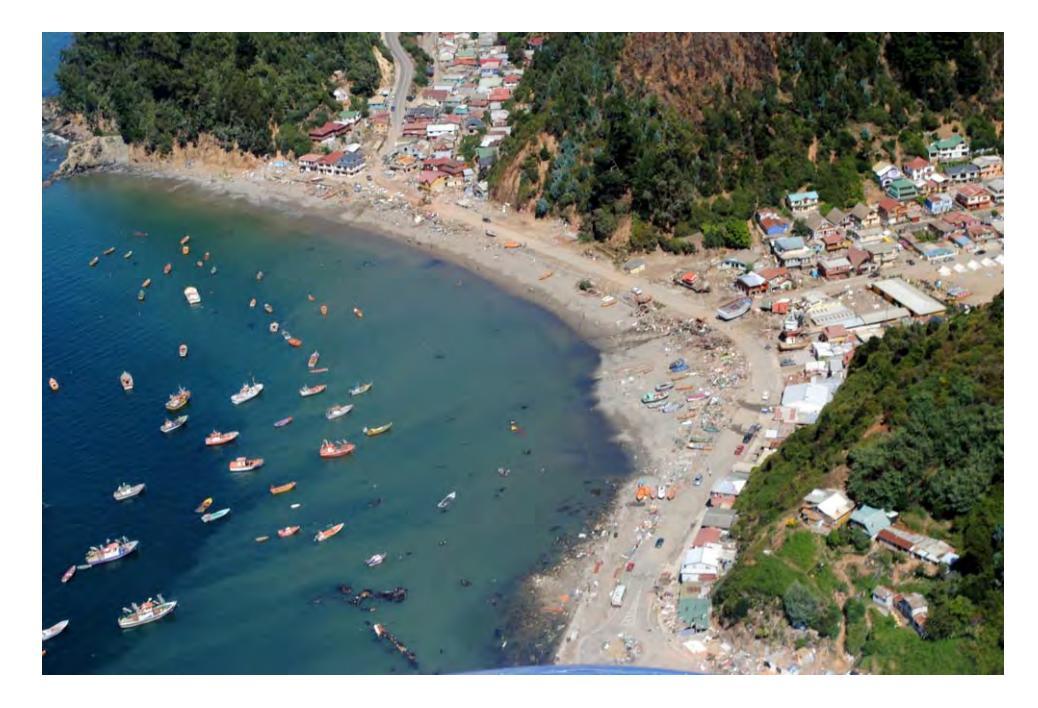
Figure 4.15. Aerial view of village on the eastern shoreline of Punta Tumbes, on western side of Bahia Talcahuano; substantial tsunami damage from runup into urbanized valleys. (S36.639522° W73.093267°; 1312 hrs on 03/09/2010)

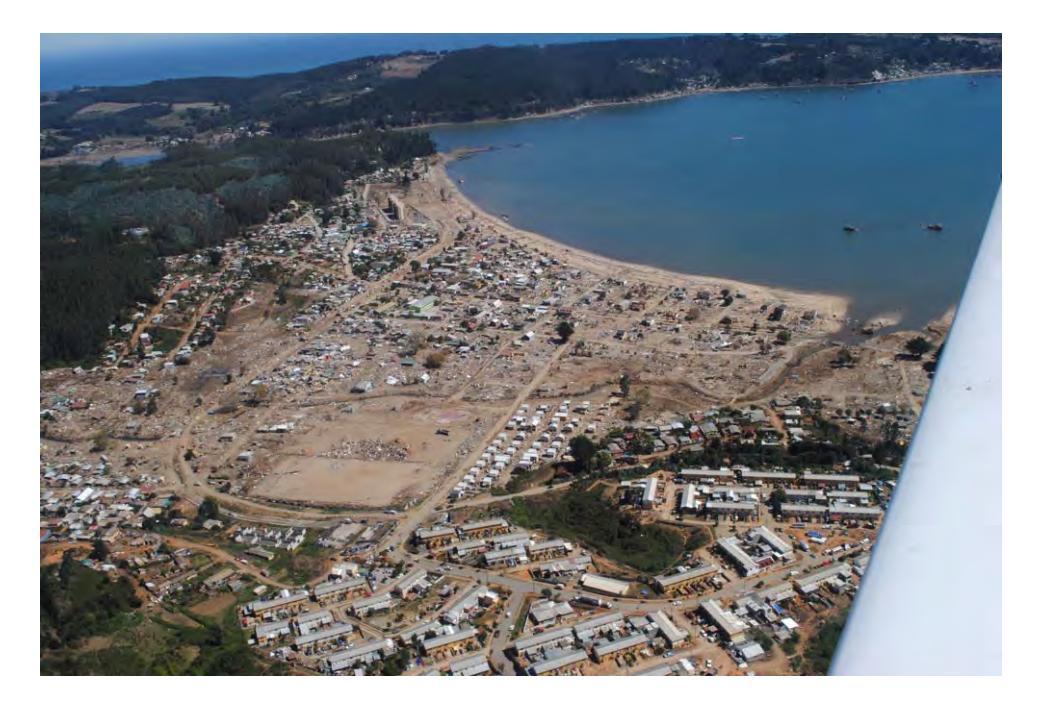
Figure 4.16. Aerial view looking west of town of Dichato, showing tsunami damage focused on north-facing shoreline in Bahia Talcahuano. (S36.548022° W72.922225°; 1301 hrs on 03/09/2010)

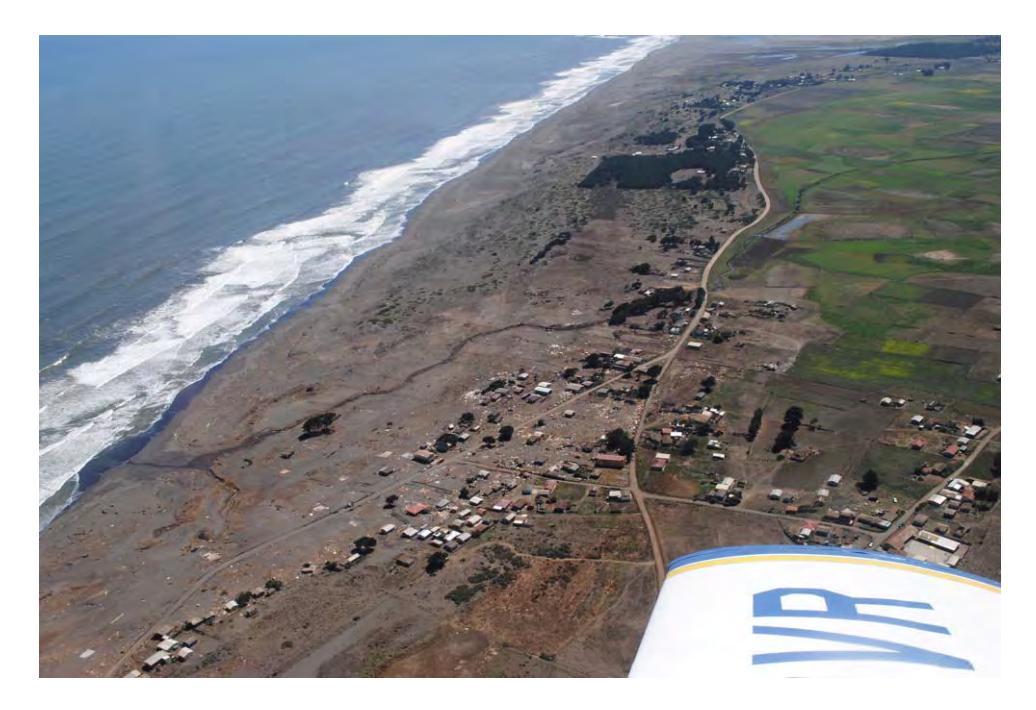
Figure 4.17. Aerial view looking north at village of Vegas de Itata, showing substantial tsunami damage. No evidence was observed of substantial uplift of this area. (S36.429192° W72.871433°; 1255 hrs on 03/09/2010)

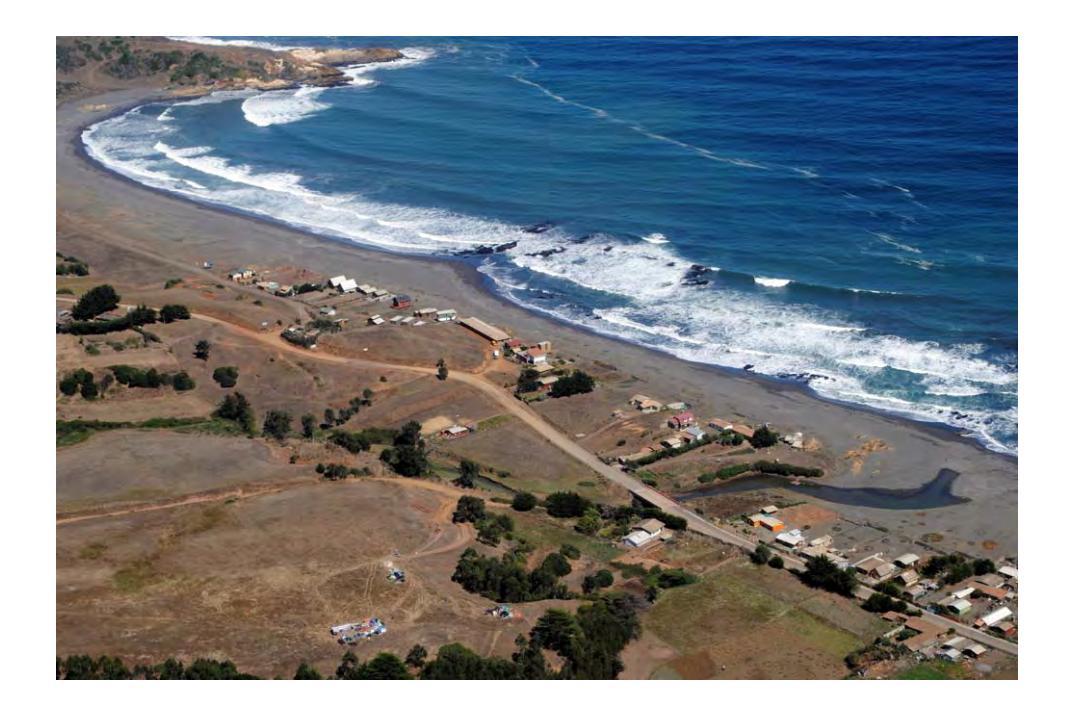
Figure 4.18. Aerial view looking southwest of shoreline at latitude of town of Cobquecura, near the Feb 27 epicenter. The tsunami extended up the tributary valley but apparently did not produce damage of residential structures close to the west-facing shore. (S36.172950° W72.808775°; 1242 hrs on 03/09/2010)

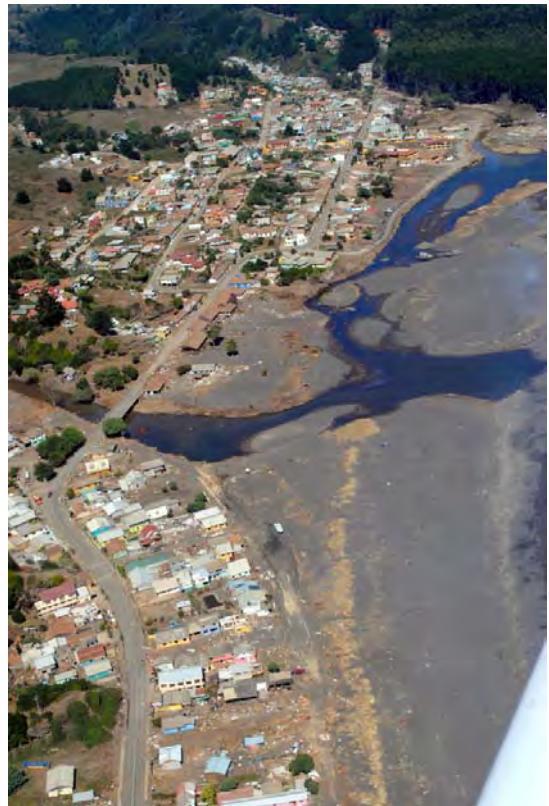
Figure 4.19. Aerial view looking south at village of Curanipe, including evidence of tsunami damage (i.e., red truck beneath bridge). Field observations of wave-cut platforms in this area indicate earthquake-related uplift of approximately 2 m. (S35.843297° W72.631214°; 1225 hrs on 03/09/2010)

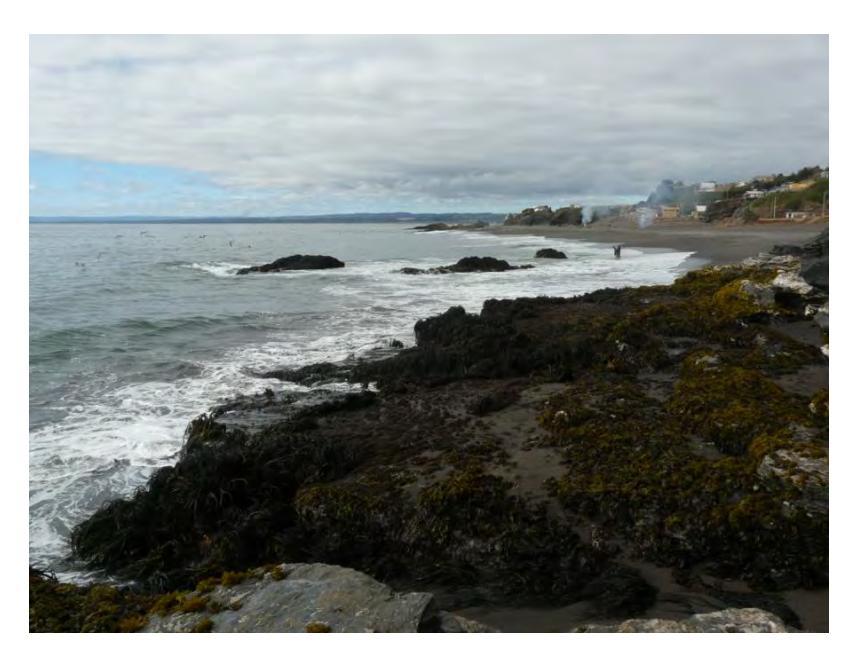
Figure 4.20. Intertidal mussels and algae exposed on rocky reefs south of Pelluhue suggest as much as 2.0 m of uplift. (S35.821915° W72.602106°, 1706 hrs on 03/17/2010).

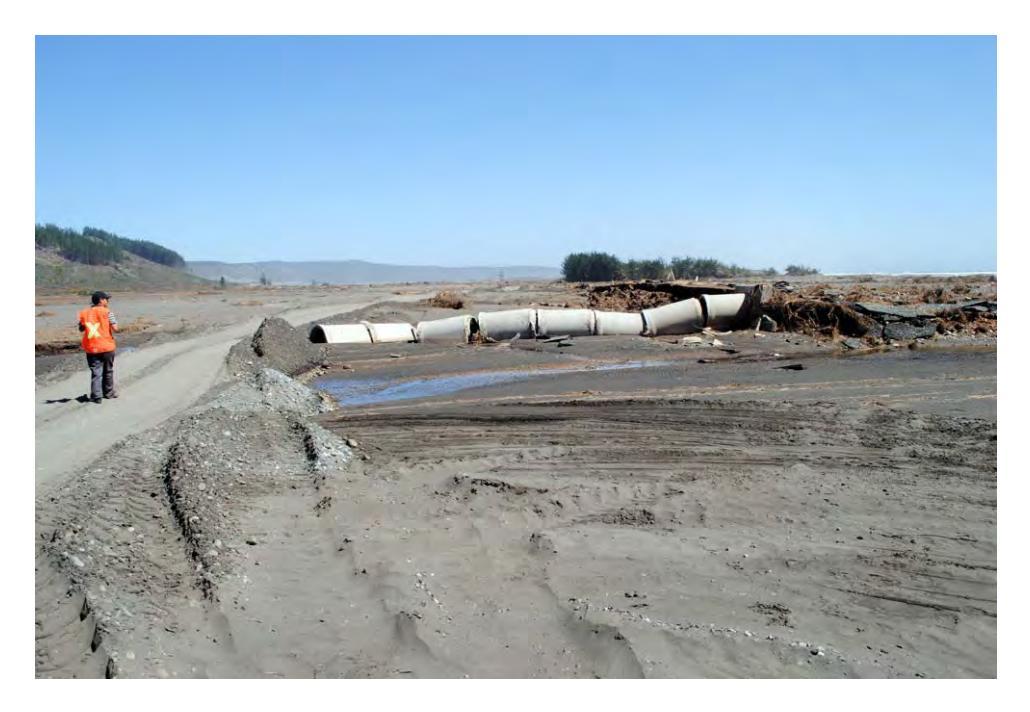
Figure 4.21. Ground photograph of area inundated and scoured by tsunami between Rio Mataquito and the town of Putú. Sections of concrete pipe were exposed and highway asphalt was eroded by tsunami flow, suggesting very high velocities; the extensive inundation in this area suggests possible land subsidence. (S35.115414° W72.203106°; 1500 hrs on 03/08/2010)

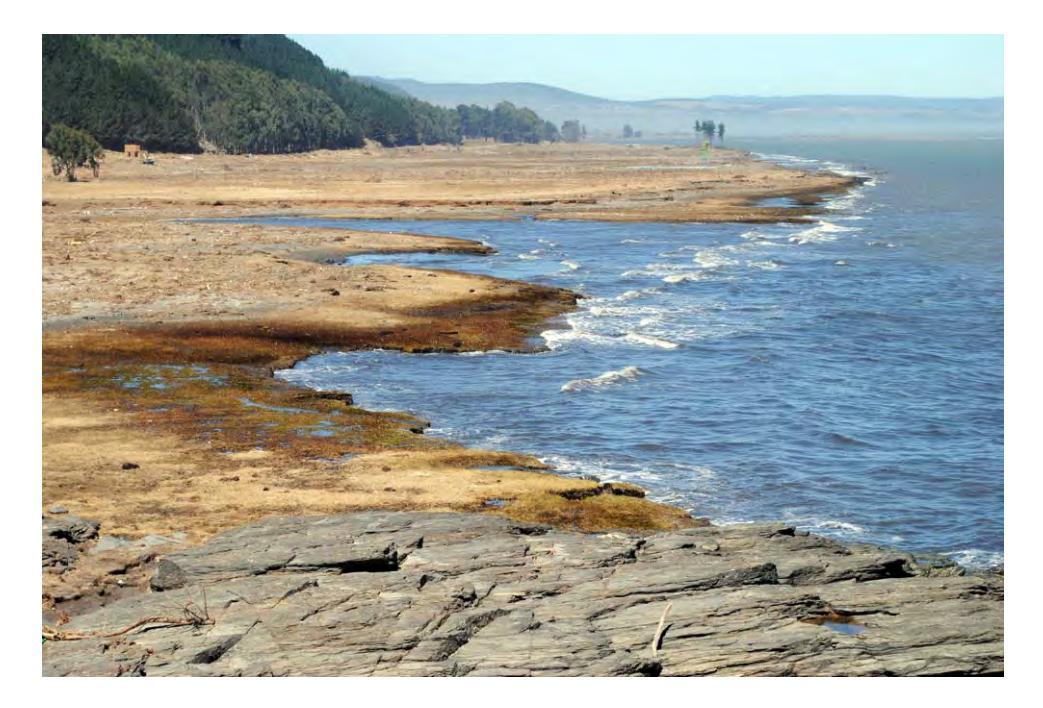
The barrier spit at the mouth of Rio Mataquito was breached by the tsunami and suffered extensive erosion and possibly coseismic subsidence. Field observations show that ocean waves now break over the remains of the sand barrier. Evidence of ocean flooding along the shoreline during higher tides, formerly the bank of the Rio Mataquito, suggests the area may have subsided during the earthquake. Near the village of Iloca, which was strongly affected by tsunami inundation, waves now regularly wash the lower part of pasture fields that were not inundated prior to the earthquake (Figure 4.22). These relationships suggest the occurrence of local coastal subsidence during the earthquake.

Figure 4.22. Ground photograph looking south from near Iloca, along the present coastline. Inundated grassy area in middle ground suggests substantial subsidence to as far north as the town of Iloca. The amount of subsidence at this location was not determined. (S34.982047° W72.181792°; 1354 hrs on 03/08/2010)

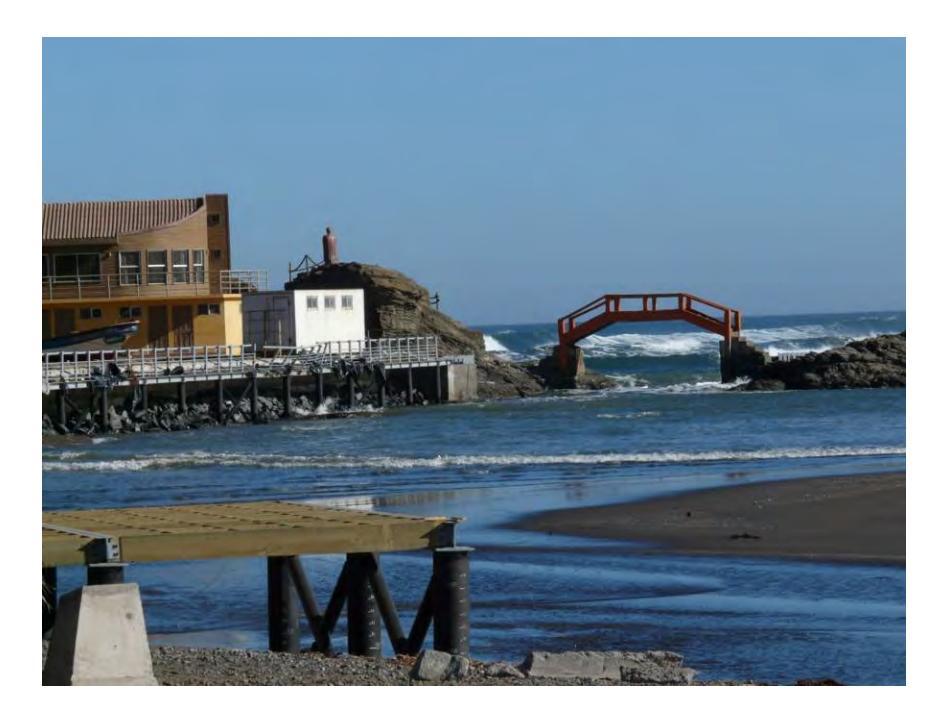
Evidence for coseismic subsidence at Bucalemu includes a dramatic eastward (landward) shift in the shoreline, extensive erosion of the beach, and a previously protected lagoon that is now inundated by ocean waves. Pre-earthquake images of Bucalemu show a 25-m-wide sandy beach that is now submerged (Figures 4.23 and 4.24). Field observation suggests that the present shoreline is located about 150 m east of the pre-earthquake shoreline (Figure 4.25). These changes may be related to both tsunami scour and tectonic subsidence. The field observations favor the interpretation that the beach at Bucalemu was lowered about 0.5 m during the earthquake.

Figure 4.24. Erosion by tsunami waves and, possibly, an undetermined amount of coseismic subsidence has shifted the shoreline approximately 150 m eastward into an area formerly occupied by a shallow lagoon. (S34.641883° W72.042919°, 1012 hrs on 03/15/2010).

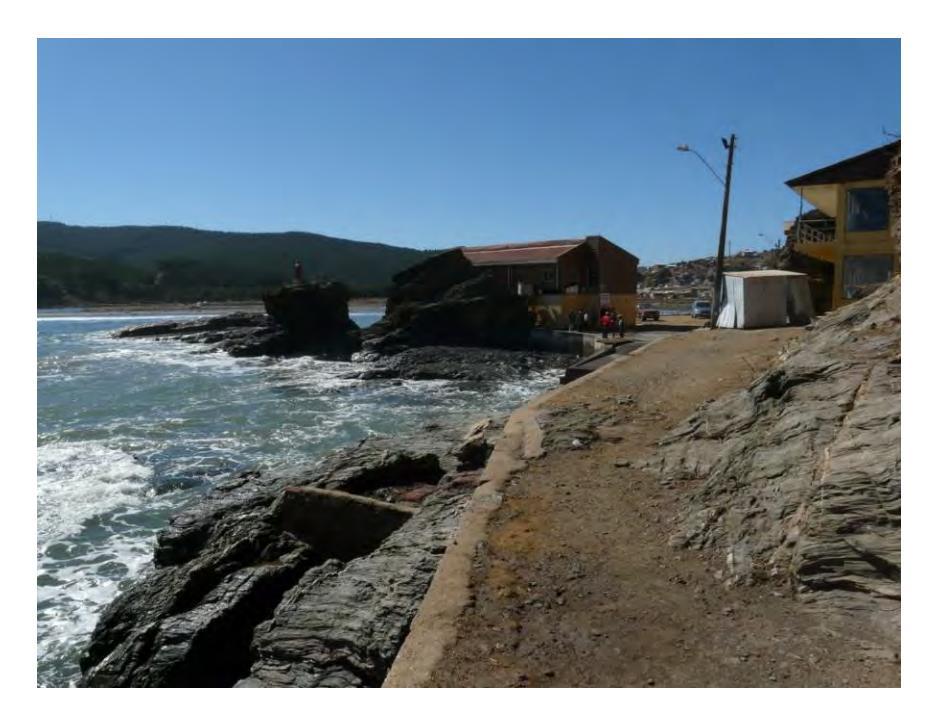
Figure 4.25. The shoreline at Bucalemu has shifted over 25 m east as a result of tsunami erosion and, possibly, coseismic subsidence. Pre-earthquake imagery shows a 25-m-wide sandy beach west of the boat ramp and sea wall that is now under attack by ocean waves. Where waves now crash on rocks in this photo taken two weeks after the earthquake, once was a wide sandy beach before tsunami flooding. (S34.639916° W72.044664°, 1142 hrs on 03/15/2010).

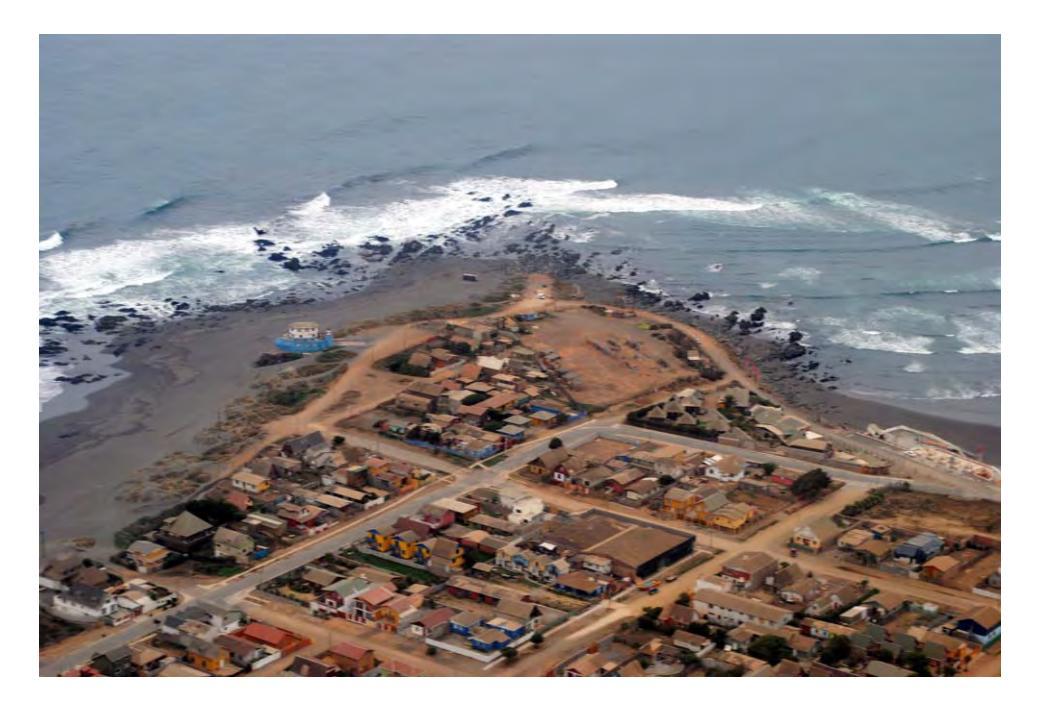
Figure 4.26. Aerial view looking northwest of shoreline in town of Pichilemu, showing bedrock underlying low-elevation marine terrace. The town of Pichilemu sustained local tsunami damage at elevations lower than this marine terrace or areas not protected by beach dunes. (S34.389619° W72.016661°; 1552 hrs on 03/12/2010)

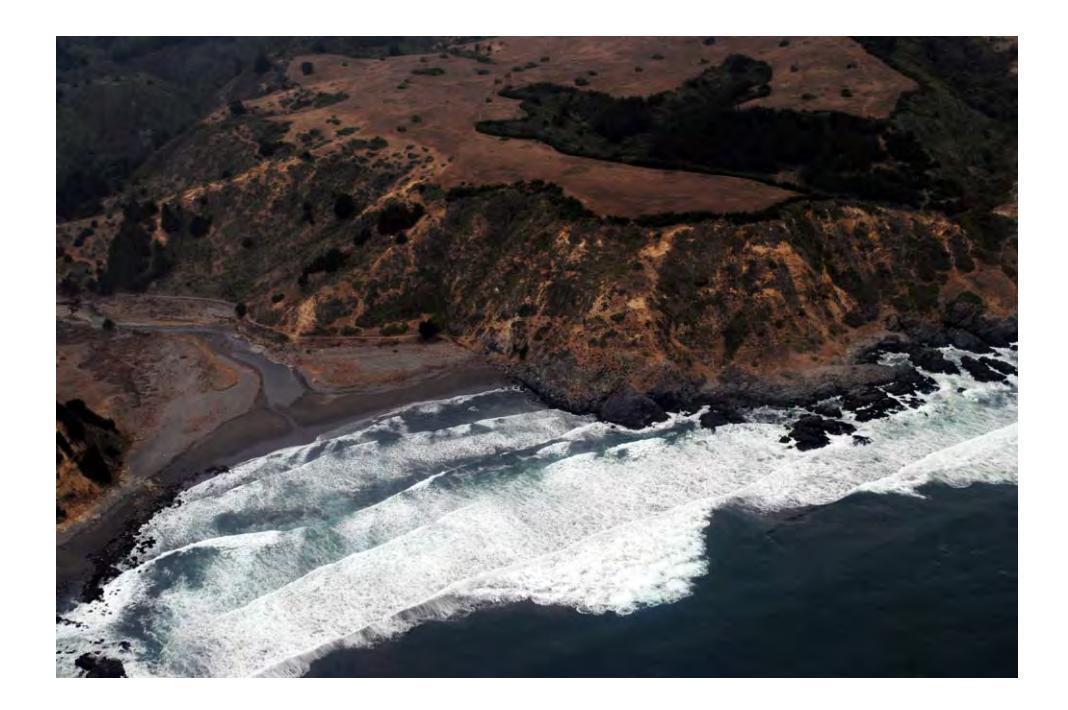
Figure 4.28. Aerial view looking southeast at shoreline on remote coastline between Pichilemu and Navidad, showing low-elevation marine terrace on far right, and thick marine deposits underlying high marine terrace in background. No evidence of earthquake-related uplift or subsidence was observed in this area. (S34.233969° W71.992883°; 1457 hrs on 03/12/2010)

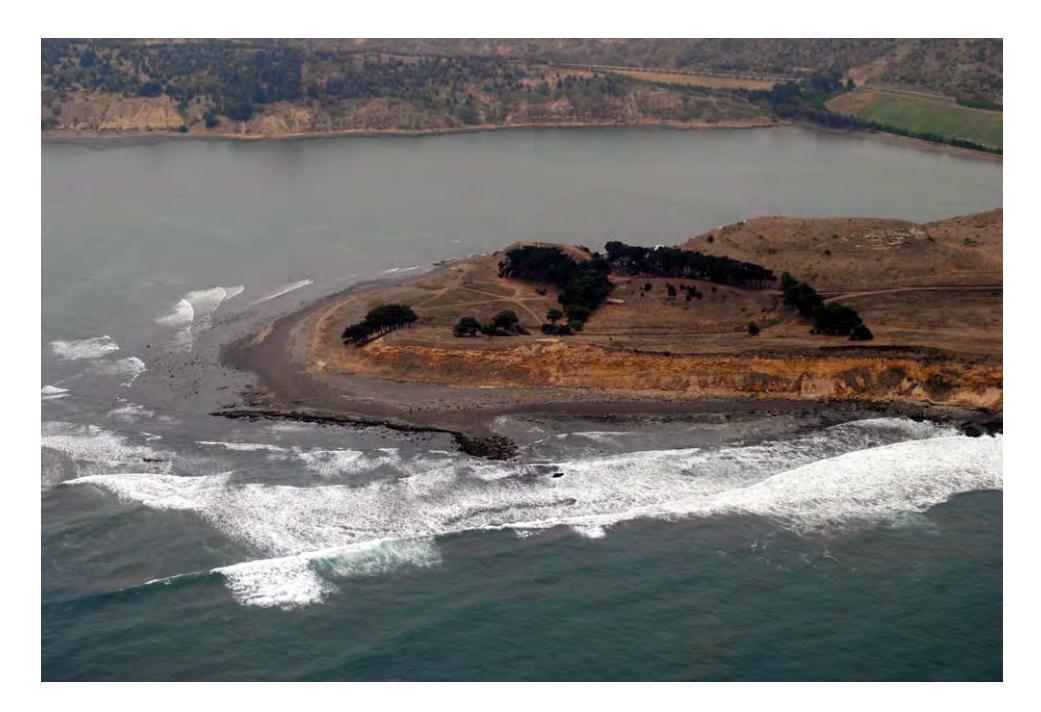
Figure 4.29. Aerial view looking east at shoreline at mouth of Rio Rapel near town of Navidad, showing low-elevation bedrock marine terrace in center, and thick marine deposits underlying high marine terrace. No evidence of earthquake-related uplift or subsidence was observed in this area. (S34.898536° W71.844794°; 1511 hrs on 03/12/2010)

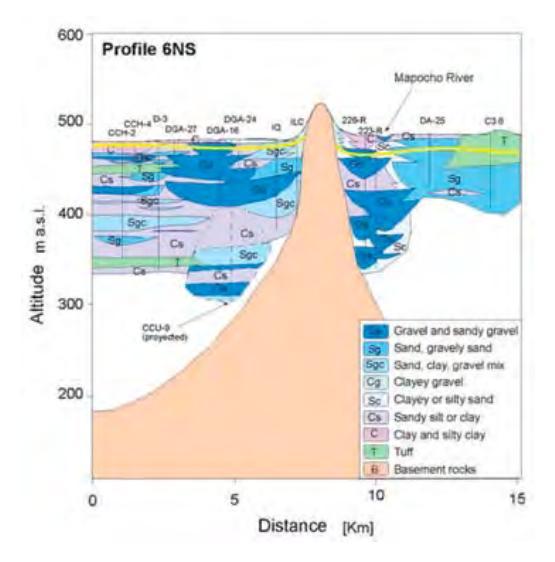
Figure 5.4 depicts the locations of the bridge sites on the geological map by Iriarte-Diaz (2003), along with typical N-S cross section of the valley geology. The depth to bedrock-basement at the bridge sites as approximately interpreted from the cross-section does not show clear correlation with the damage states.

Figure 5.4. Location of the four bridge sites on the map of geological cross-sections in the North-Western part of Santiago de Chile; and Geological cross-section along profile 6NS (Iriarte-Diaz, 2003). Site DA008 (minor damage) is located on clay/silty clay, DA008a (collapsed) on clay/silty sand, and sites RL001 (minor damage) and DA009 (damaged) on sandy silt or silt.

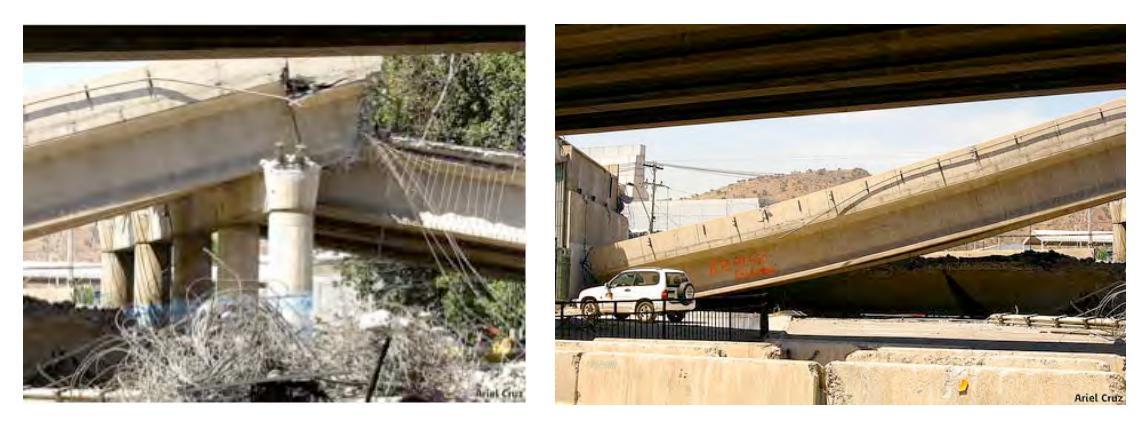
Site DA008a (S33.3759° W70.7476°) – Paso Superior Lo Echevers

The bridge suffered collapse of the east direction deck of the highway (see Figure 5.6). According to the local geology map, the soil profile at the site is clayey/silty sand.

Figure 5.6. Paso Superior Lo Echevers (S33.3759° W70.7476°). Collapse of the eastbound deck of the Americo Vespucio Norte ring road (Source: http://www.flickr.com/photos/consulta\_recorridos/).

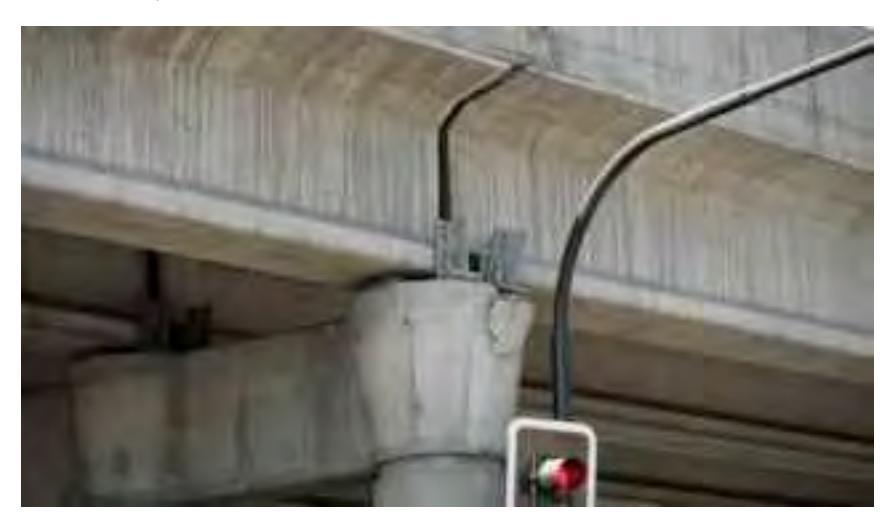
Site RL001 (S33.3865° W70.7601°) - Paso Lo Boza

The bridge suffered minor damage, primarily shear key failure and subsequent displacement of the deck in the transverse direction (see Figure 5.7). According to the local geology map, the soil profile at the site is sandy silt.

Figure 5.7. Paso Lo Boza (S33.3865° W70.7601°). Minor structural damage of shear keys (Source: Dr. Roberto Leon, personal communication).

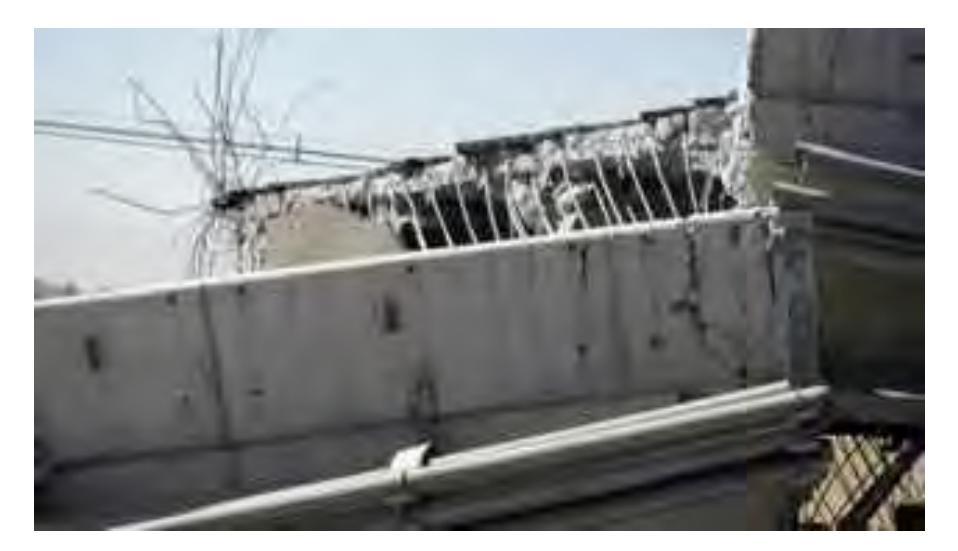
Site DA009 (S33.3945° W70.7700°)- Paso Miraflores

The bridge suffered collapse of the east direction deck of the highway (see Figure 5.8). According to the local geology map, the soil profile at the site is sandy silt.

Figure 5.8. Paso Miraflores (S33.3945° W70.7700°). Deck collapse detail (Source: Dr. Roberto Leon, personal communication).

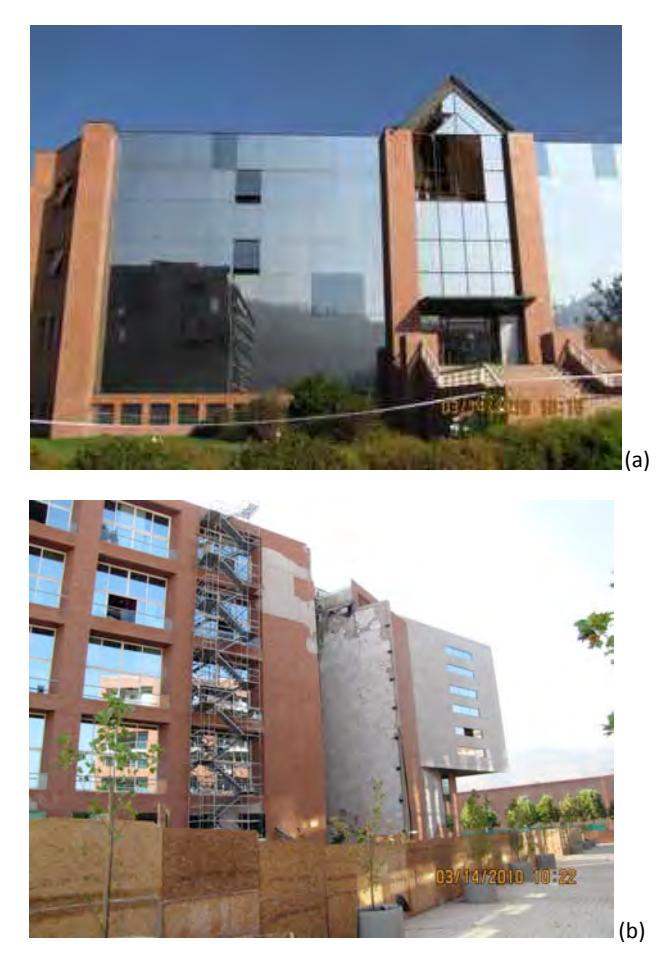
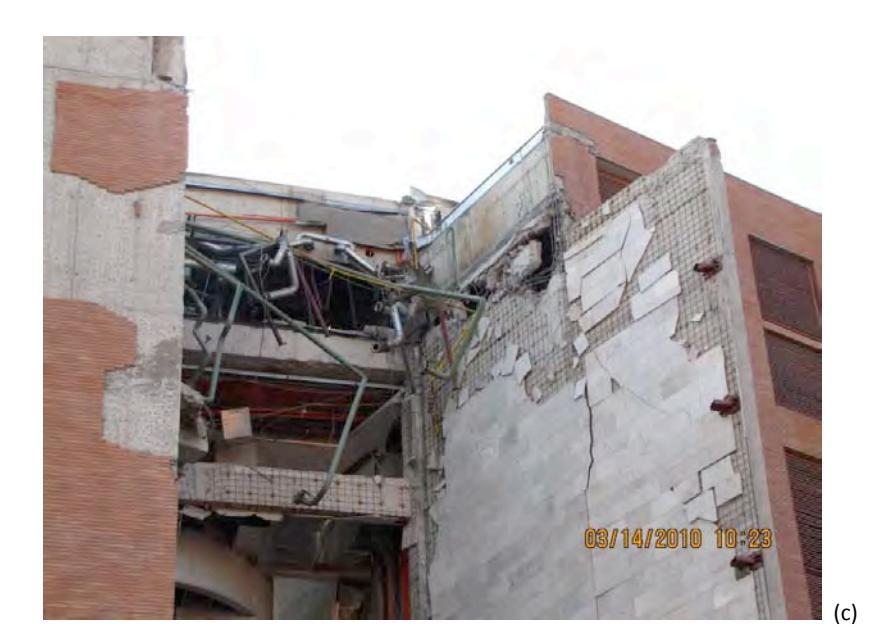
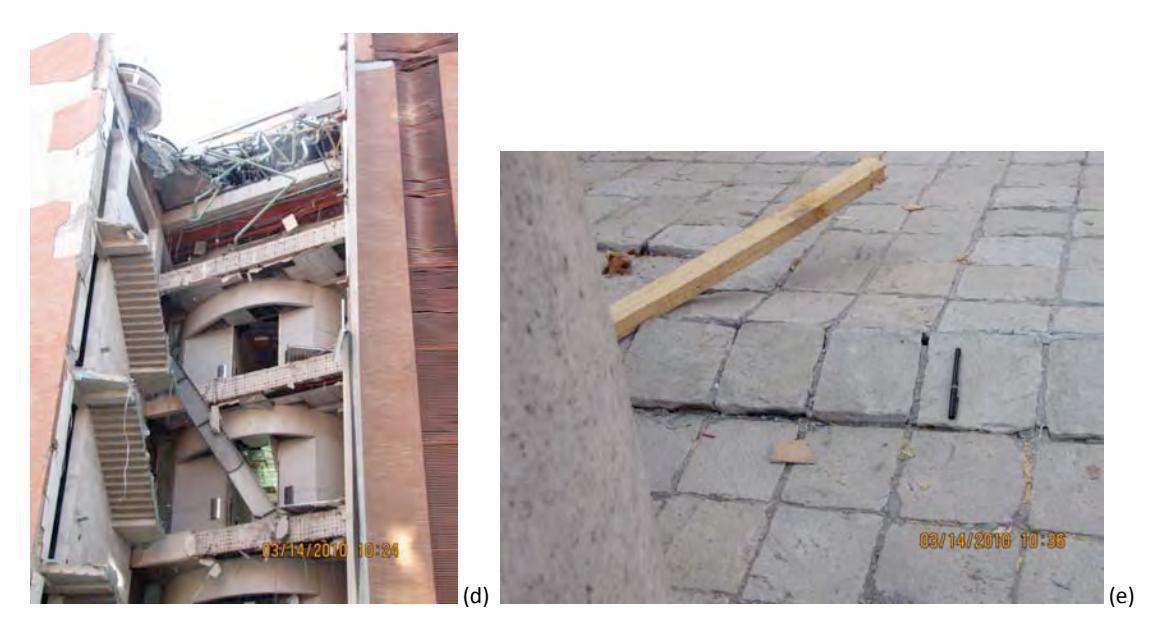
Figure 5.11. Site DA003 (S33.387985° W70.618815°, 1015 hrs on 03/14/2010) 6-story commercial building. Damage of non-structural elements (glass windows, red brick façade) (Figures 11a,b) and emergency staircase (Figures 11c,d). Evidence of ground deformation (Figure 11e).

Overall, the business park was severely damaged, with 7 buildings that failed and were closed to the public. No total collapse was documented and no casualties were reported at the site, while the only evidence of soil deformation is shown in Figure 11e. The damaged structures ranged from a 5- to 12-stories, which to first approximation corresponds to 0.5-1.2 sec resonant periods (0.8-2 Hz).
