# Geo-engineering Reconnaissance of the 2010 Maule, Chile Earthquake

Report of the NSF Sponsored GEER Association Team

# GEER Association Report No. GEER-022

Version 2: May 25, 2010

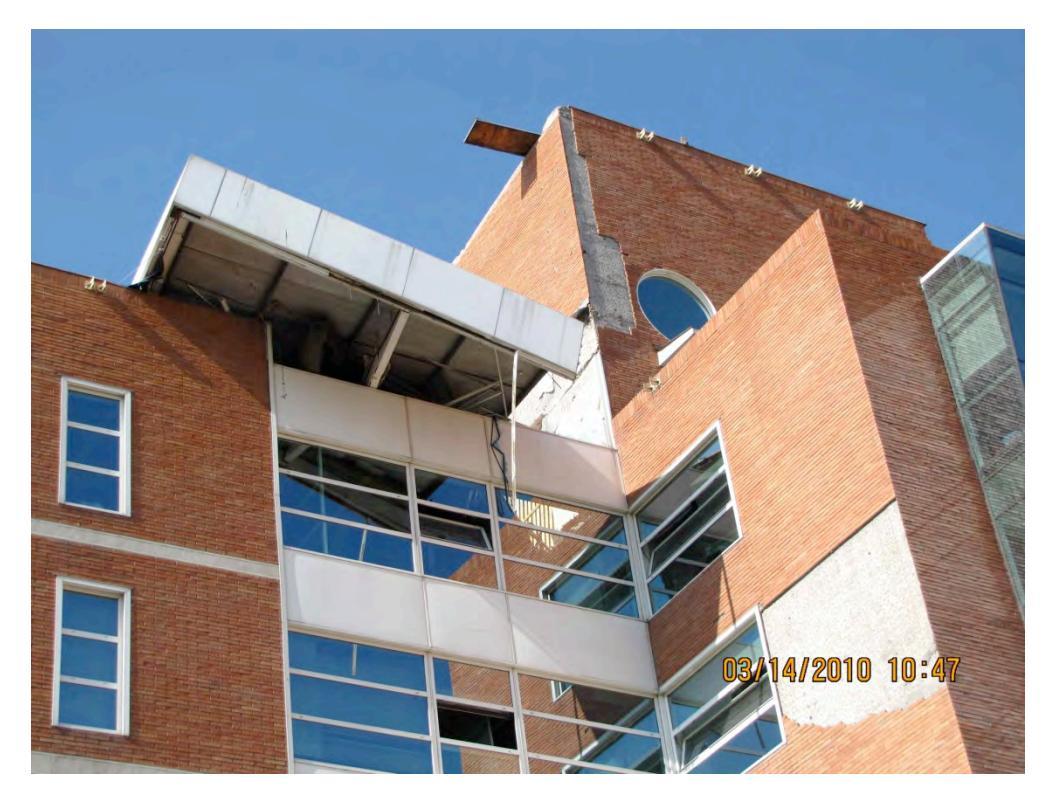
Figure 5.12. Site DA004 (S33.387652° W70.617122°, 1047 hrs on 03/14/2010) Identical 7-story buildings connected; damage was observed in only one of the two.

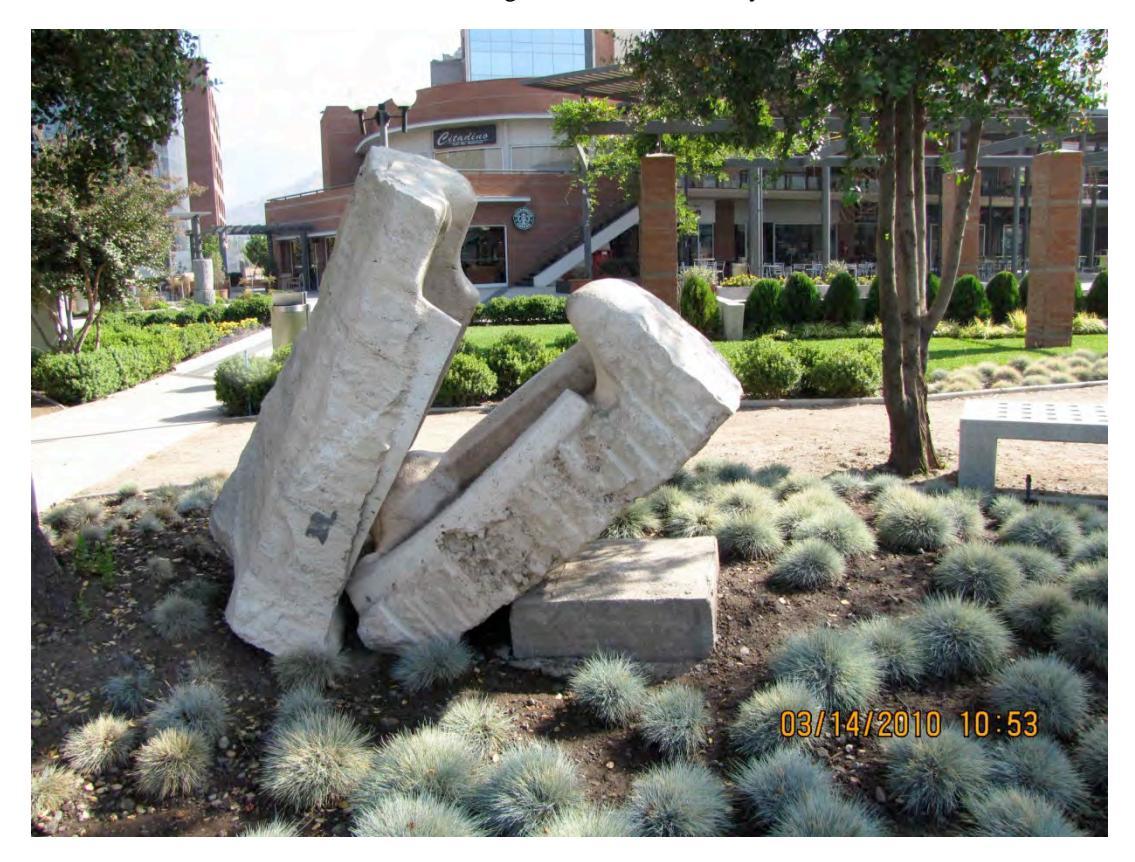
Figure 5.13. Site DA005 (S33.387652° W70.617123°, 1053 hrs on 03/14/2010) Overtopped art.

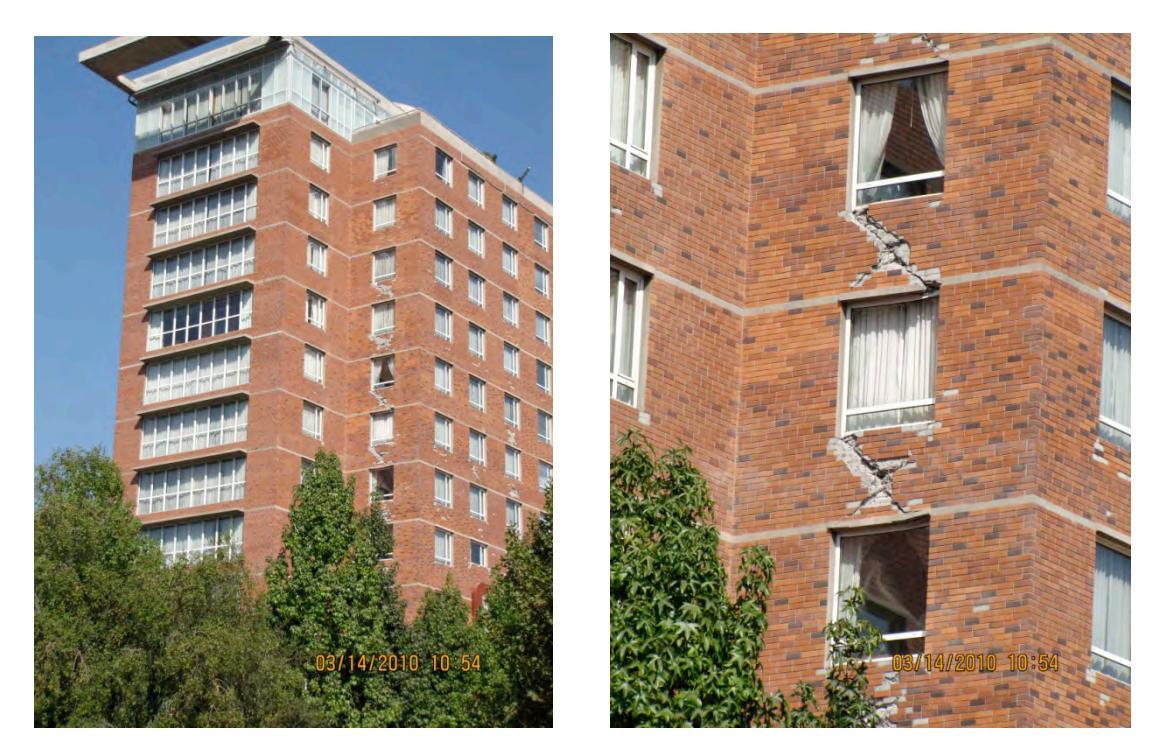
Figure 5.14. Site DA005 (S33.387652° W70.617123°, 1054 hrs on 03/14/2010) 12-story building with severe structural damage.

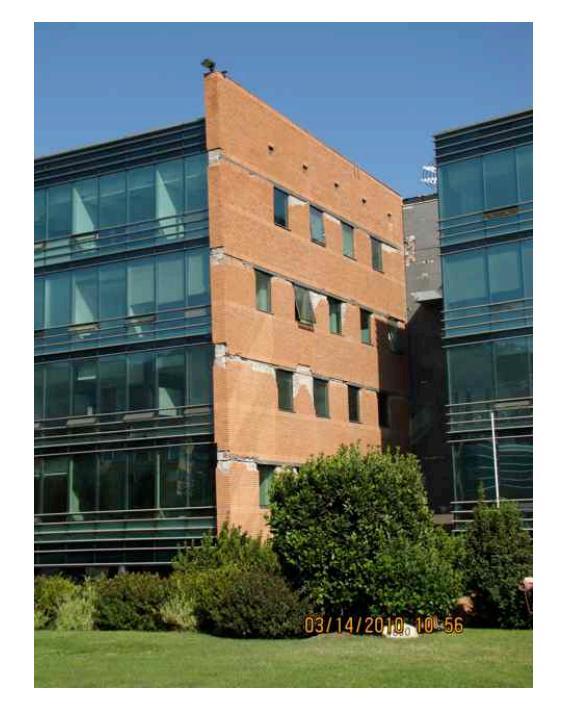
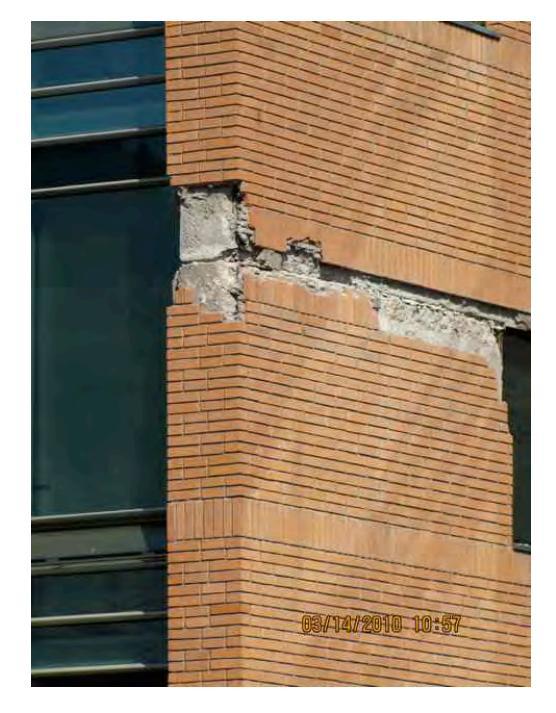
Figure 5.15. Site DA006 (S33.389586° W70.618349°, 1056 hrs on 03/14/2010) 5-story building, structural damage.

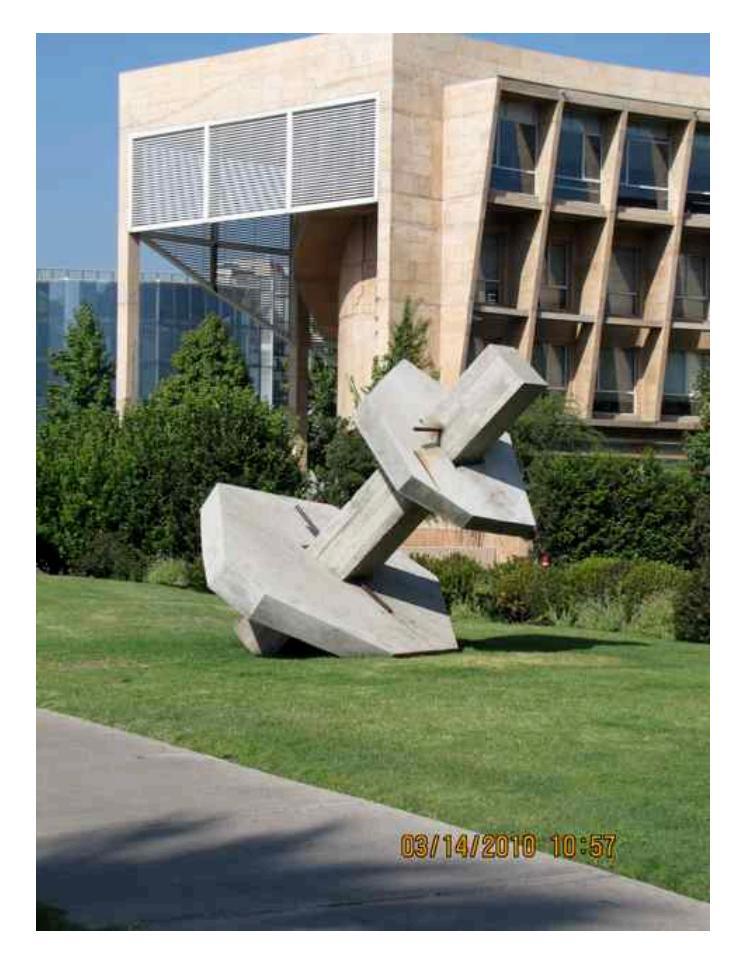
Figure 5.16. Site DA007 (S33.391163° W70.619502°, 1057 hrs on 03/14/2010) Minor external damage – non-structural. Overtopped art.

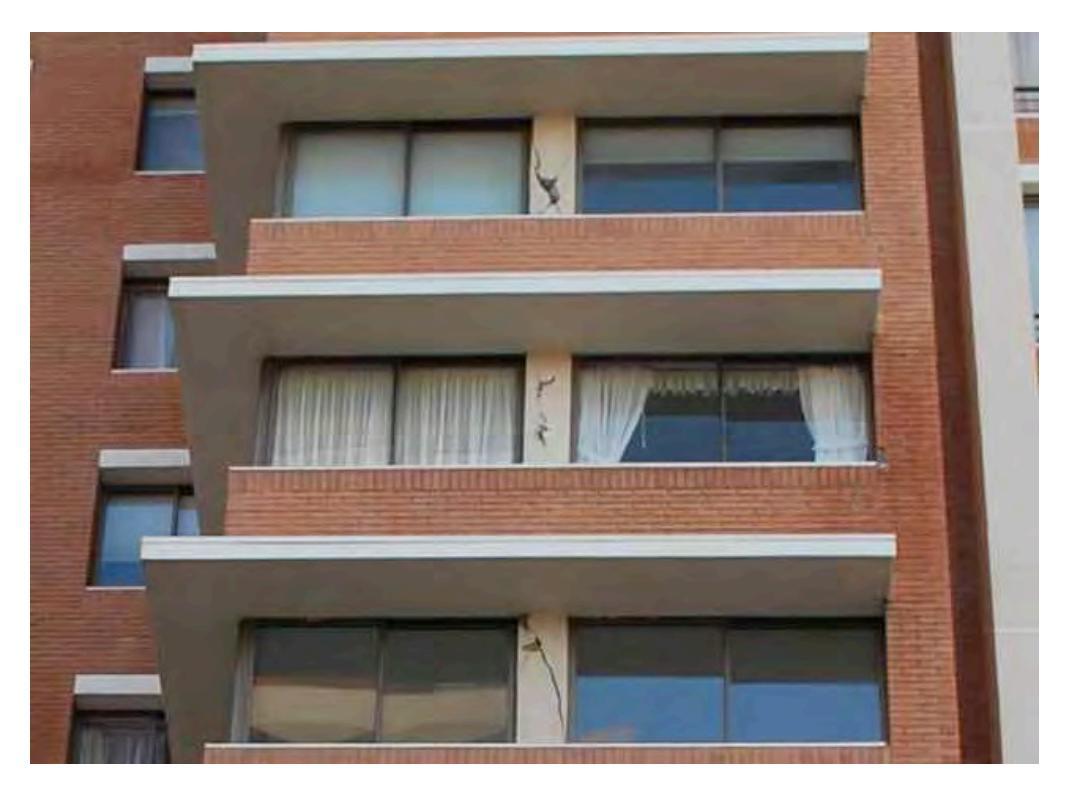
Figure 5.25. Site DA020 (S 33.018678° W 71.556288°, 1953 hrs on 03/14/2010). Diagonal cracks of columns in all the floors of 19-story building.

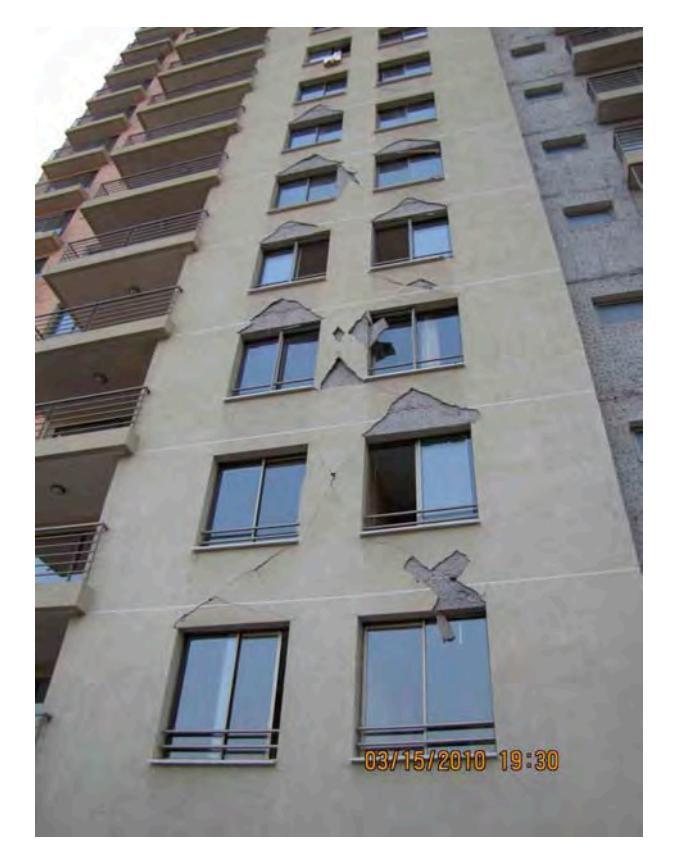
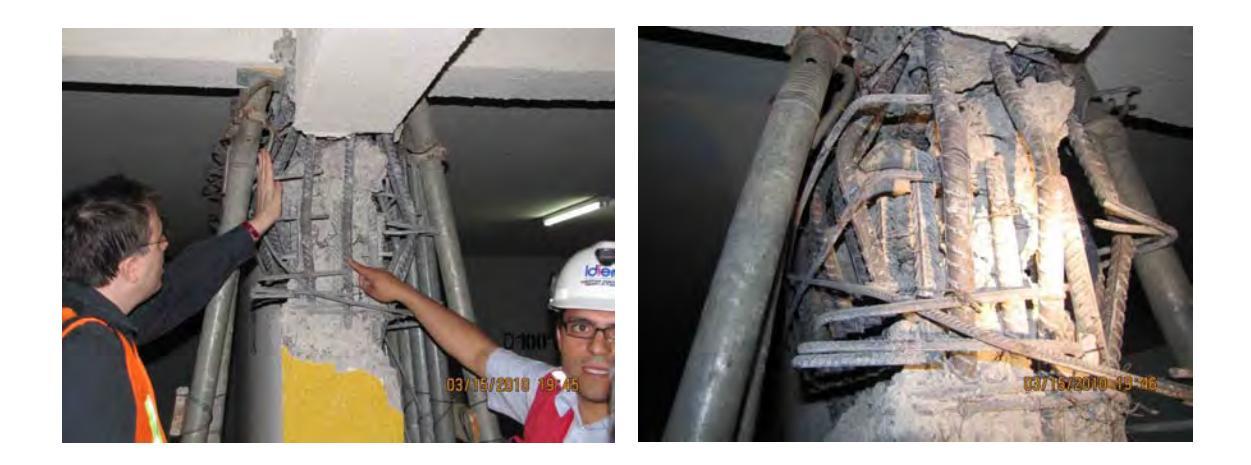
Figure 5.26. Site DA027 (S 33.020074° W 71.544055°, 1945 hrs on 03/15/2010). Heavily damaged 20story building, lack of confinement at beam-column joints.

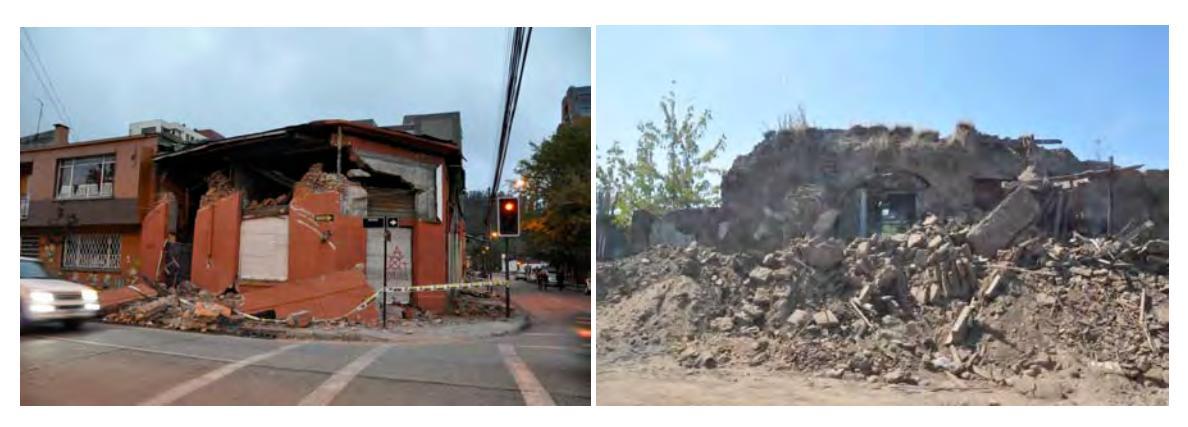
Figure 5.28. Adobe and unreinforced concrete damage concentrated adjacent to the Maule river across Talca (pictures shot from passenger seat while driving).

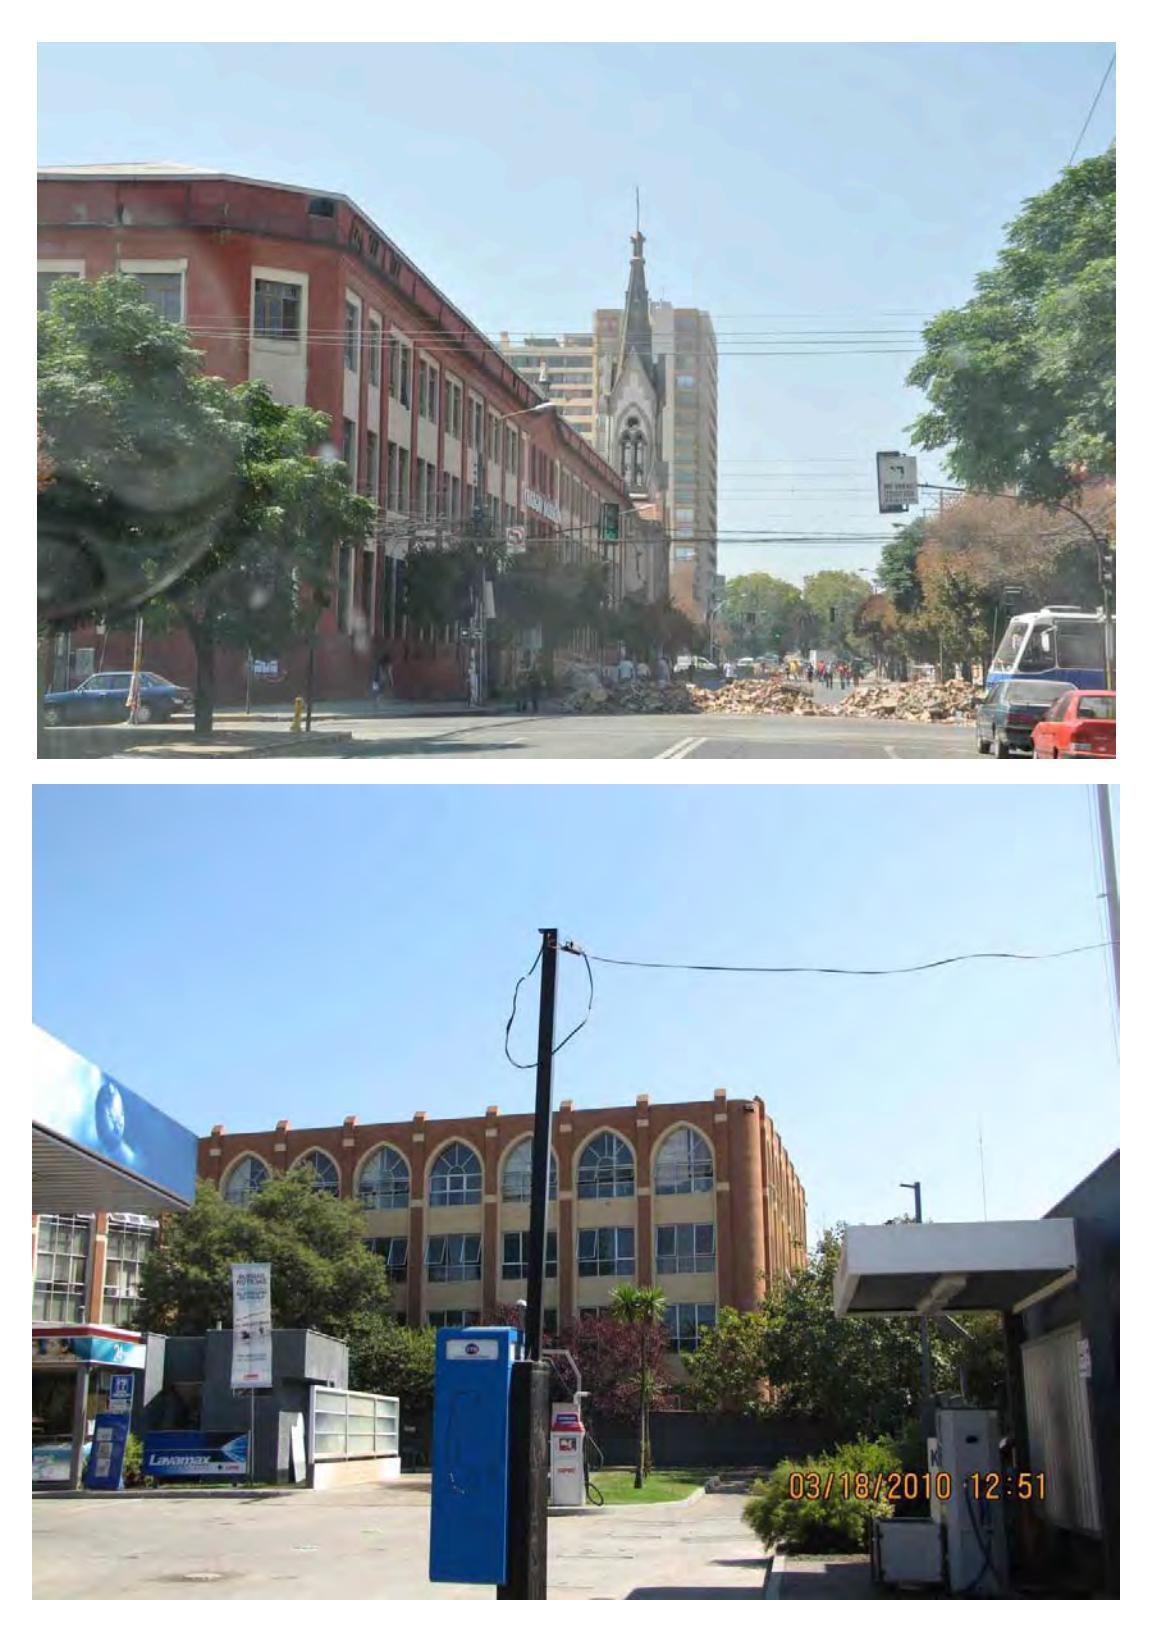
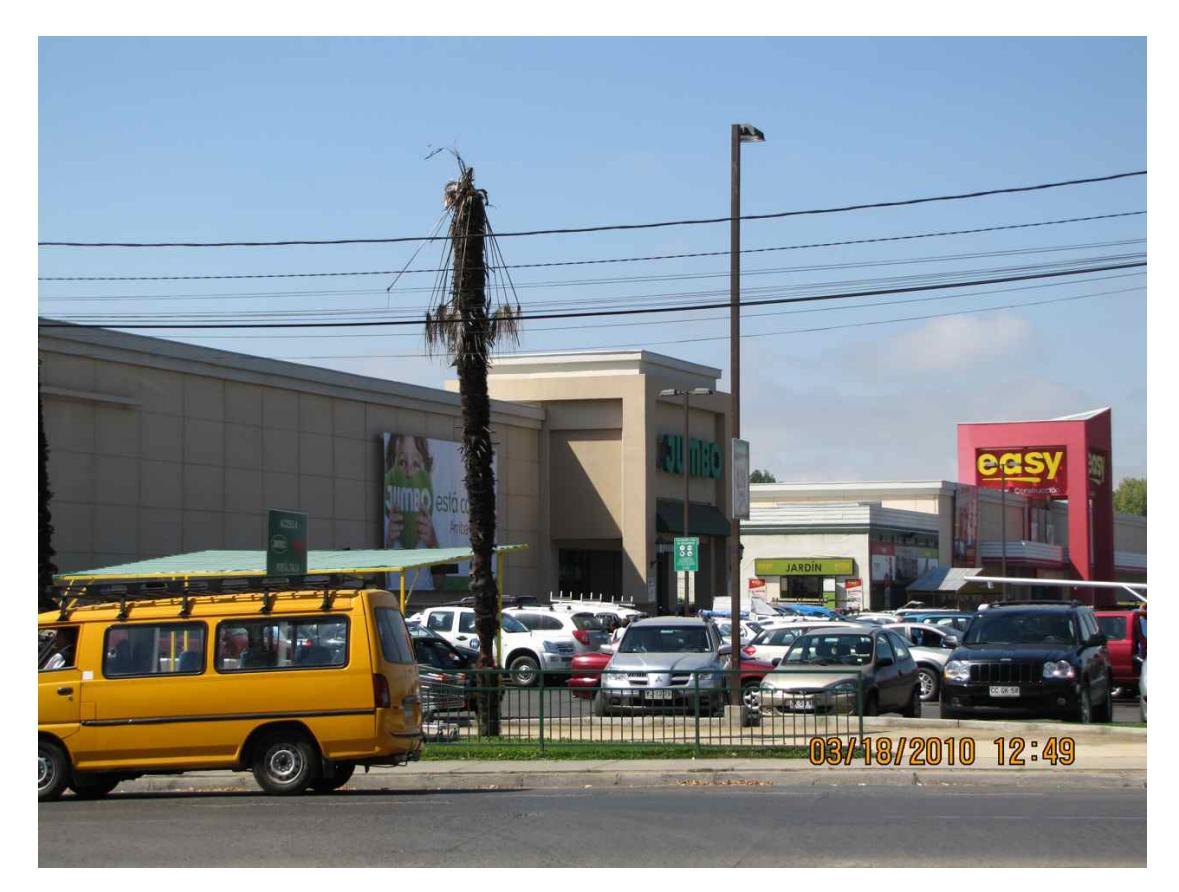
Figure 5.29. Modern (engineered) structures adjacent to the river that showed no or minor damage (S 35.437897° W 71.660151°, 1249 hrs on 03/18/2010).

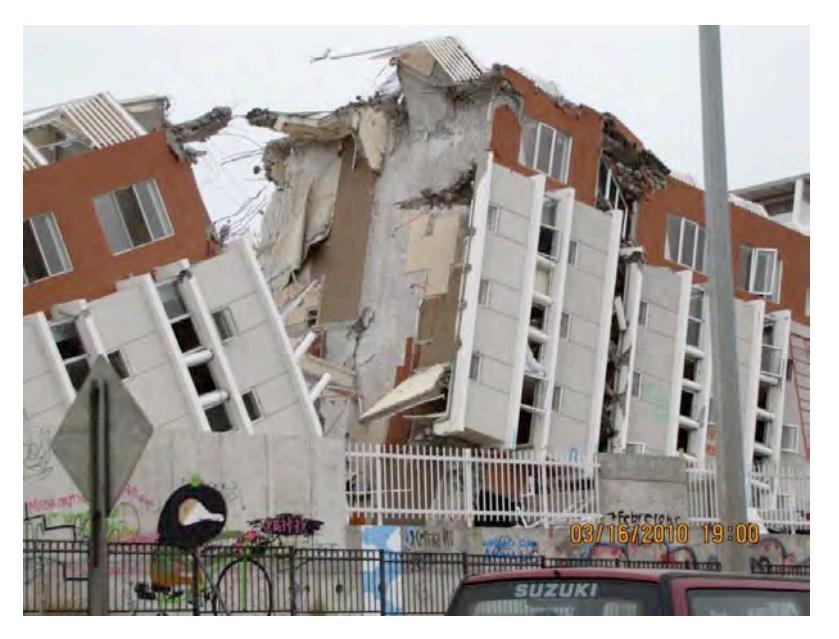
Two adjacent 20-story structures were inspected during reconnaissance close to the Llacolen bridge in downtown Concepción (see location in Figure 5.32), one fully collapsed during the 2010 event and the other suffered minor damage and is currently being repaired. The collapsed building was designed using Site Type II (Chilean design code) and the one that did not collapse using Site Type III, which implies different design spectra. While there is no evidence that the soil conditions are indeed different at the locations of the two structures (distance between approximately 20m), the difference in design spectra likely played an important role in the failure of the building. The locations of the two buildings are depicted in Figure 5.33 below.

Figure 5.34. Collapsed structure (S 36.828067° W73.061639°, 1900 hrs on 03/16/2010) designed using Soil Type II conditions.

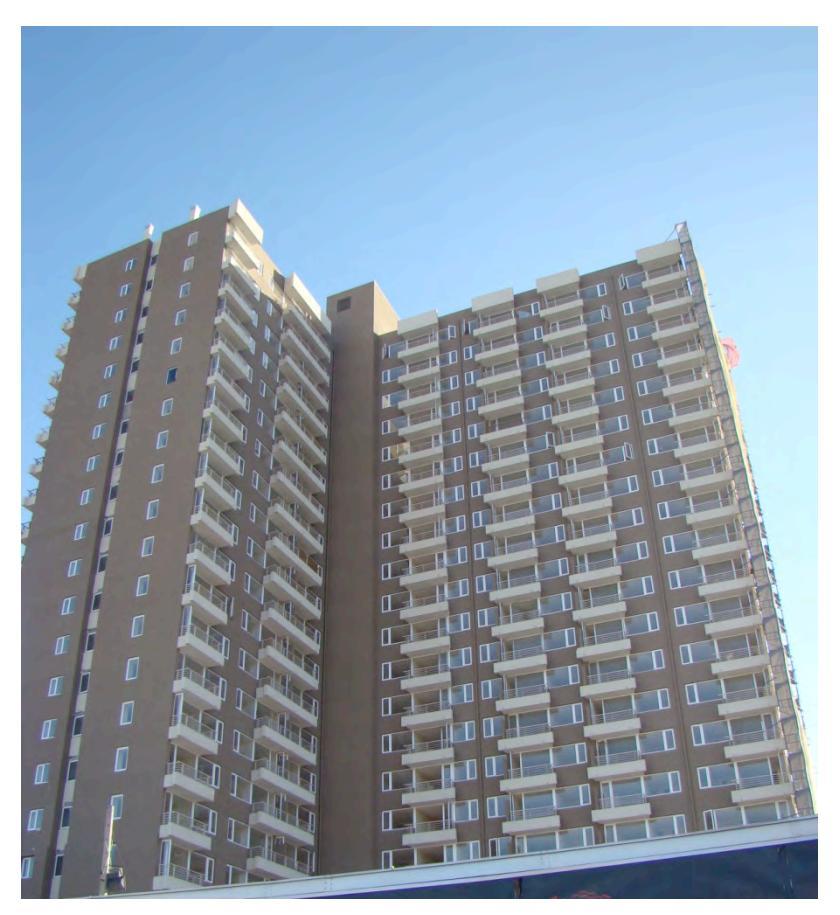
Figure 5.35. 20-story structure adjacent to collapsed (S 36.828083° W 73.060600°, 1910 hrs on 03/16/2010) designed using Soil Type III conditions, and suffering only minor damage.

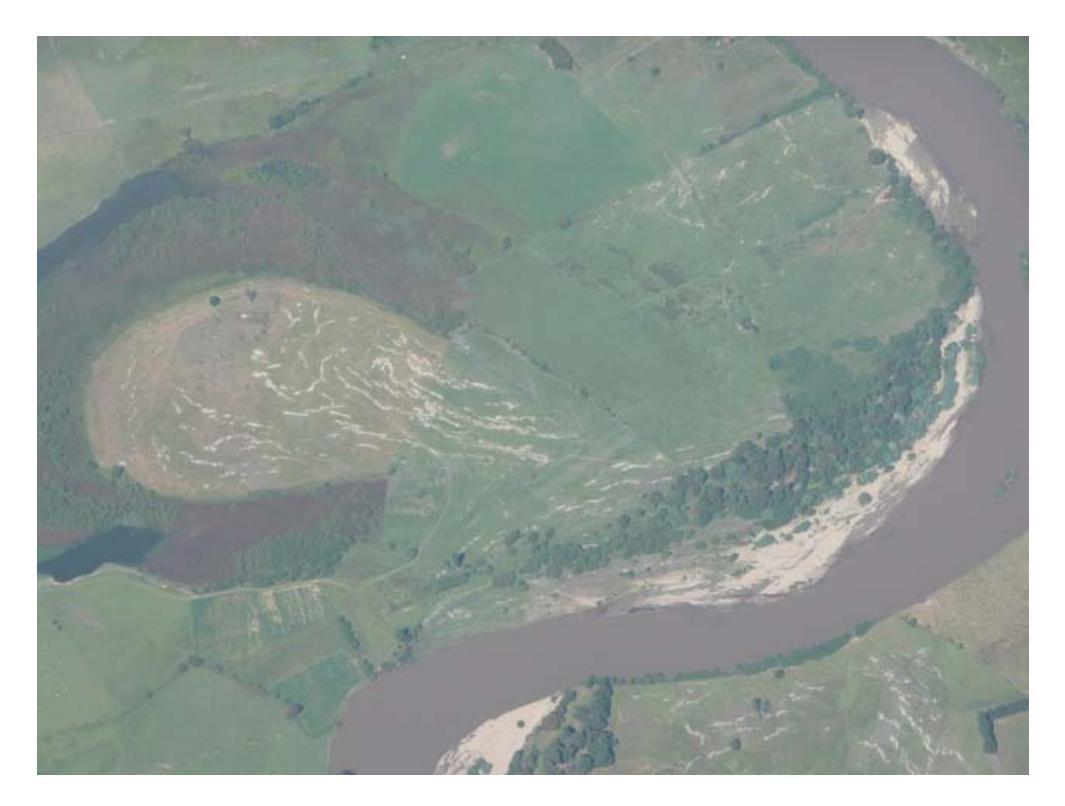
Figure 6.4. Liquefaction ejected and lateral spreading features observed along Carampangue River towards the southern extents of damage (~S37.2780°, ~W73.2541°, 17:00, 3/6/2010).

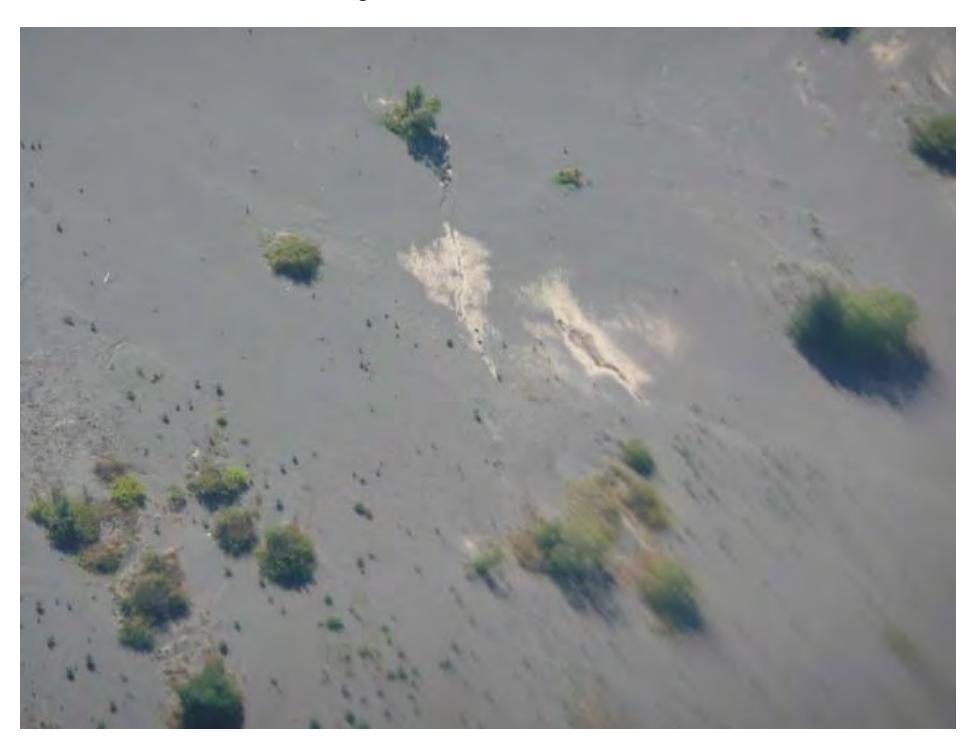
Figure 6.5. Lower elevation view of fissures and liquefaction ejecta. This was taken along the lower Rio Bio Bio near Concepcion (~S36.8239°, ~W73.0944°, 15:00, 3/6/2010). The dark surface sediment is from the Rio Laja that intersects the Bio Bio approximately 20-30 km upstream from this point. The light ejected sediment is supplied by the main stem of the Rio Bio Bio upstream of the Rio Laja.

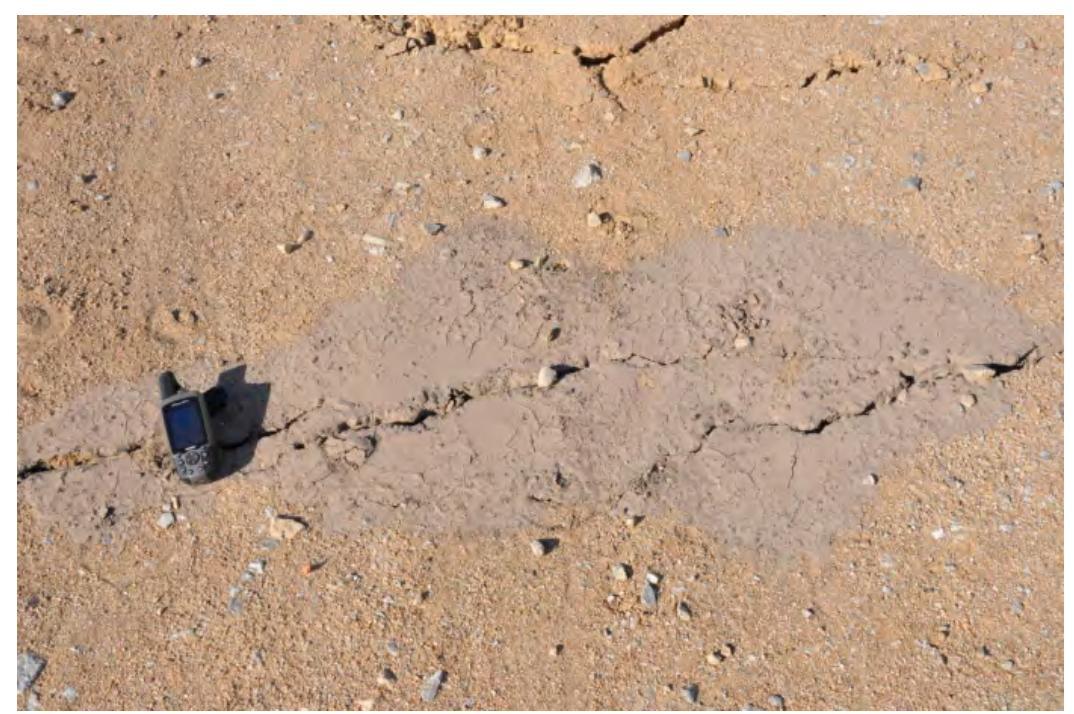
Figure 6.7. Liquefaction boils in undeveloped land area along west shore of Tres Pasquales lagoon in Concepcion (S36.8155°, W73.0460°; 3/14/2010)

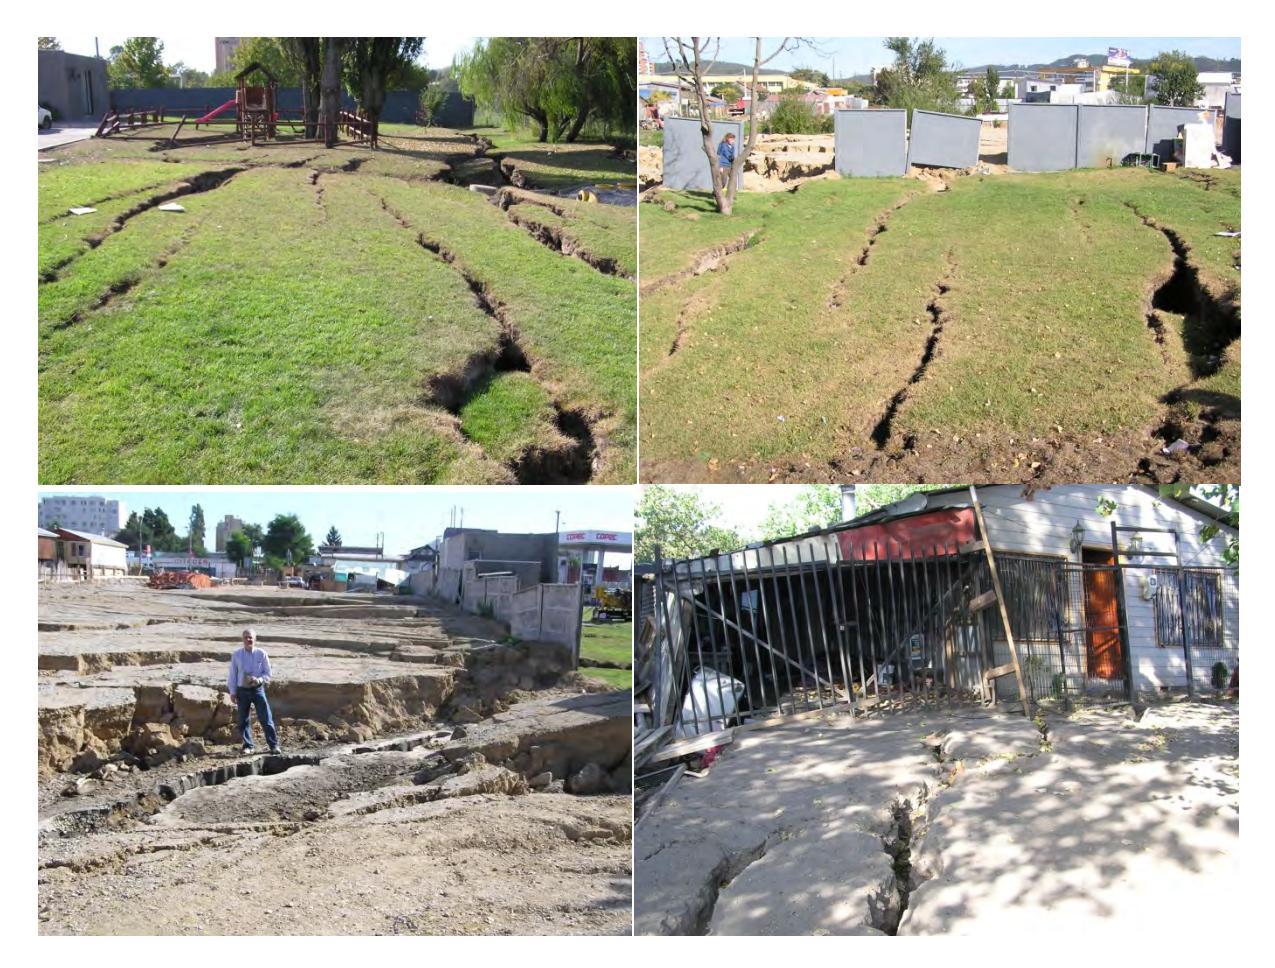
A large liquefaction-induced lateral spread was observed along the southwestern edge of the shoreline of the Tres Pascuales lagoon in Concepcion, just south of Universidad San Sebastian (S36.8152°, W73.0459°). The spread extended approximately 85 m west of the lagoon and along shore for about 100 m. Evidence of liquefaction boils was noted within the undeveloped land area (Figure 6.7). The lateral spreading occurred in a small park along the lake shown in Figure 6.8a, and continued through an open space to the south of the park (Figure 6.8b) into an area further south that was undergoing construction (Figure 6.8c). The lateral spread continued southward where the extension of the ground pulled apart modest homes in a poor neighborhood (Figure 6.8d). Severe separation and distortion of fences between properties within the spread zone were observed, and both underground and above ground structures were observed to be impacted. It was believed that an underground tank uplifted at the affected gas station (S36.8156°, W73.0464°) at the west end of the extent of ground failure as shown in Figure 6.9.

Figure 6.8. Effects of the lateral spread in Concepcion at the southwest edge of Laguna Las Tres Pascualas (S36.8153°, W73.0458°; 1700 hrs on 3/14/2010).

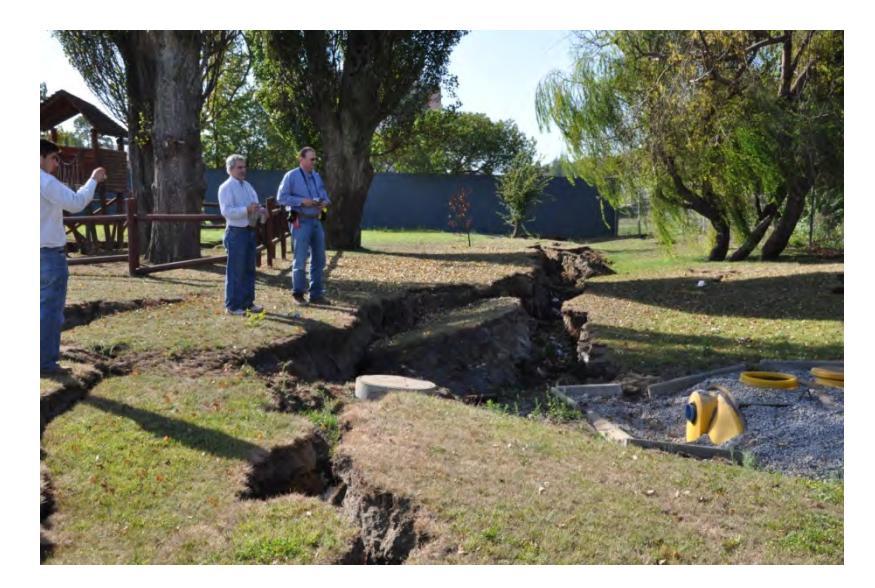
Figure 6.9. Tank uplift in park along west shore of Tres Pasquales lagoon in Concepcion (S36.8152°, W73.0460°; 3/14/2010)

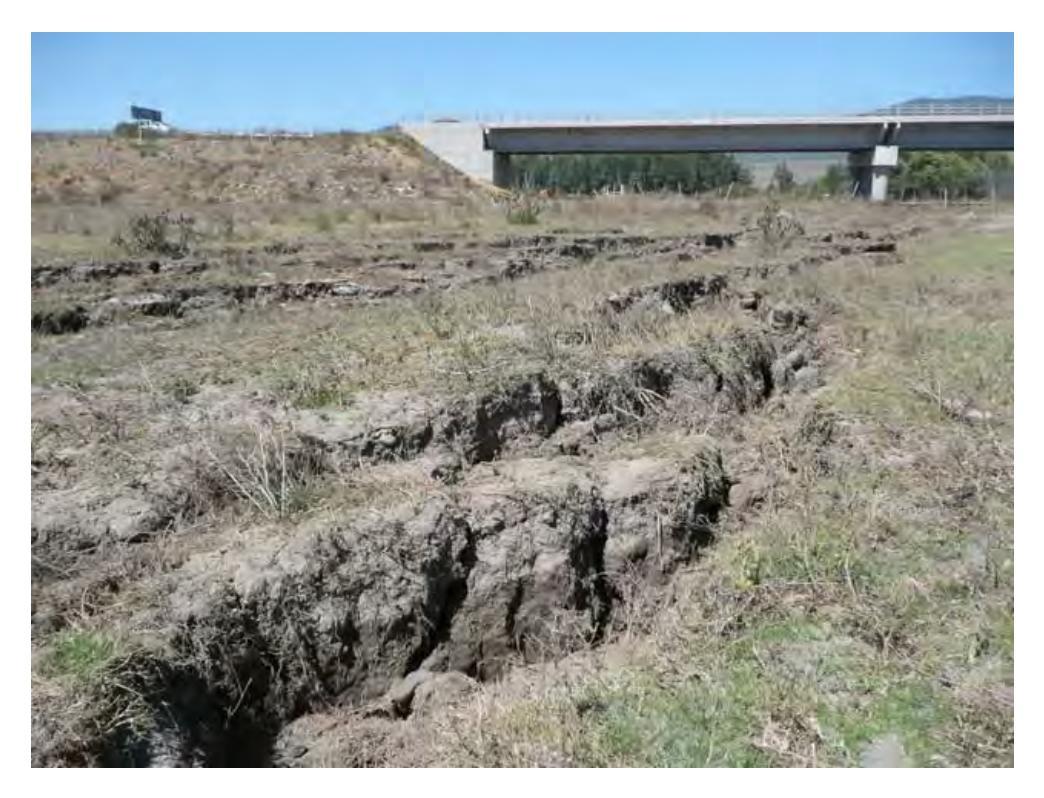
Figure 6.11. Ground based image of the previous photo (S3505078°, W72.16240°, 11:00, 3/8/2010).

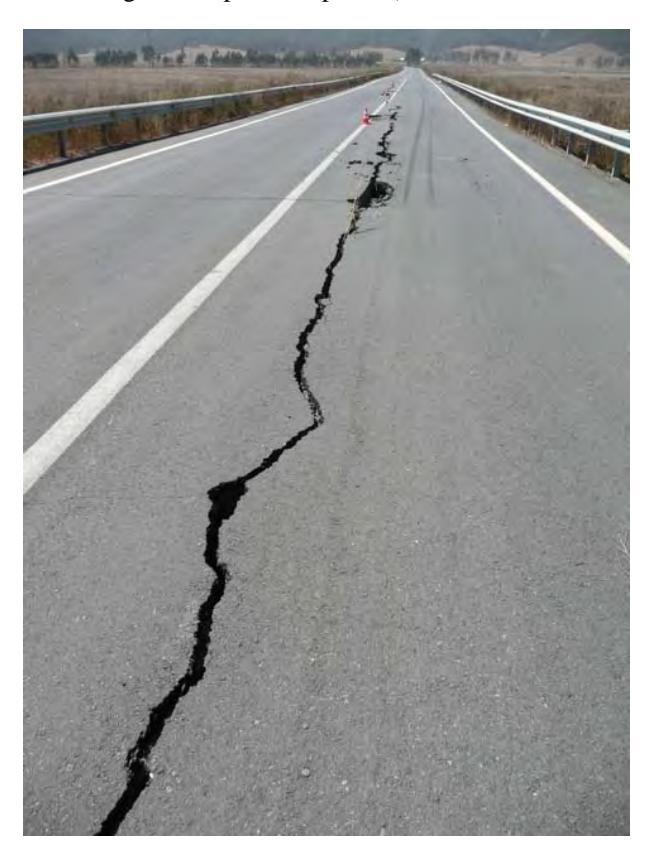
Figure 6.12. Impact of liquefaction and lateral spreading on the north approach fill of Mataquito Bridge (S3505078°, W72.16240°, 11:00, 3/8./2010).

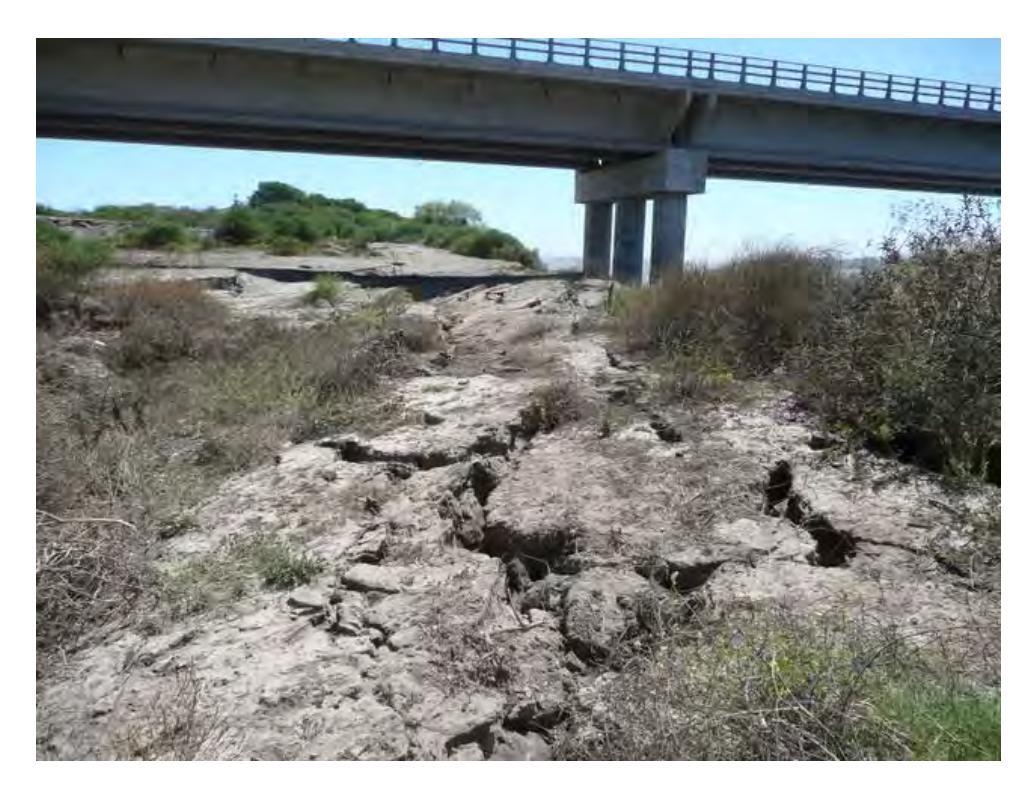
Figure 6.13. Lateral spreading at the south landing of the Mataquito bridge along the coastal highway (\$3505078°, W72.16240°, 11:00, 3/8/2010).

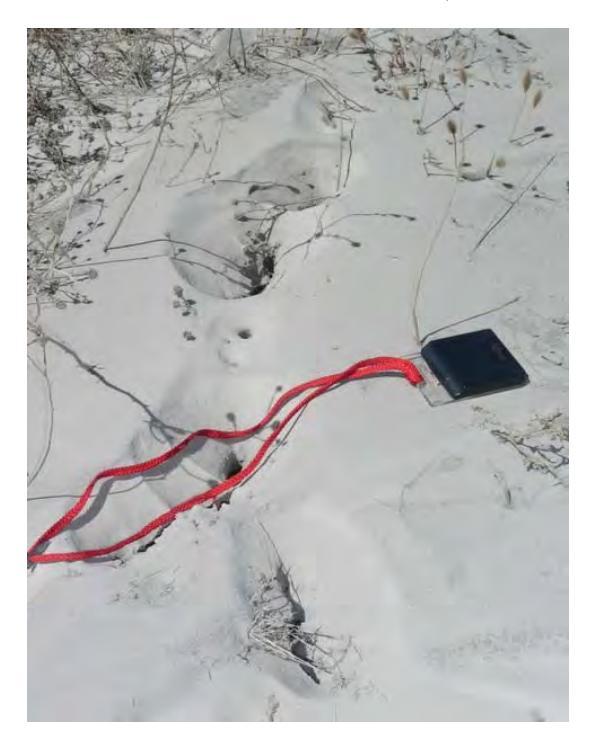
Figure 6.14. Typical liquefaction ejecta found at Mataquito bridge (S3505078°, W72.16240°, 11:00, 3/8/2010). The ejecta consisted of medium to fine sand with some fines.

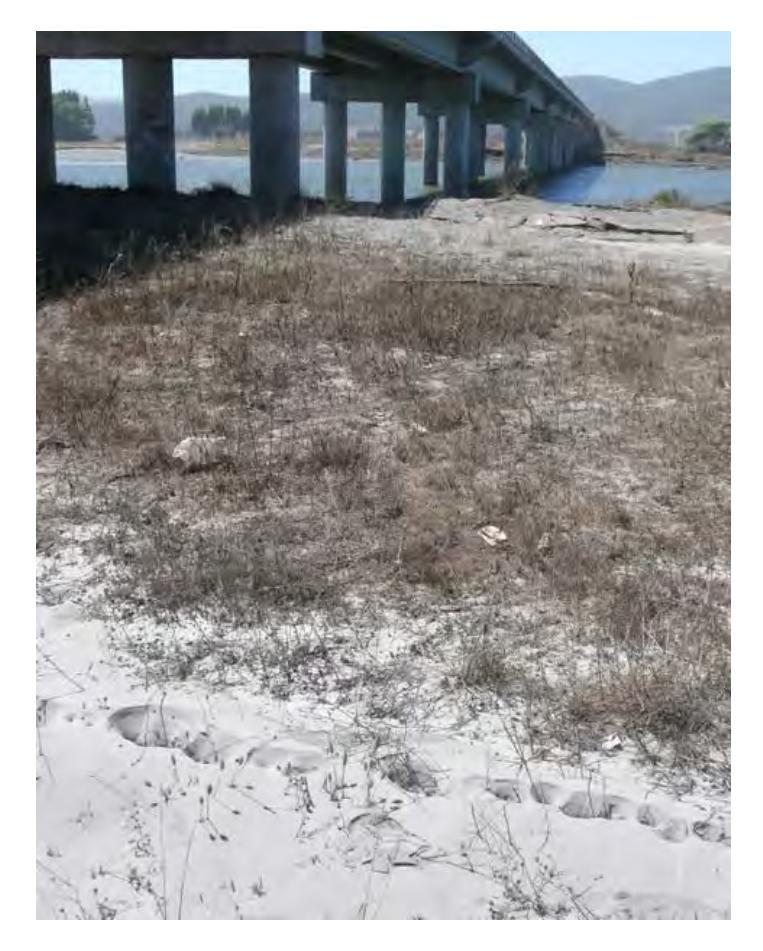
Figure 6.15. Ejecta in the foreground and lateral spreading cracks in the back ground along the south landing of the Mataquito bridge (S3505078°, W72.16240°, 11:00, 3/8/2010).

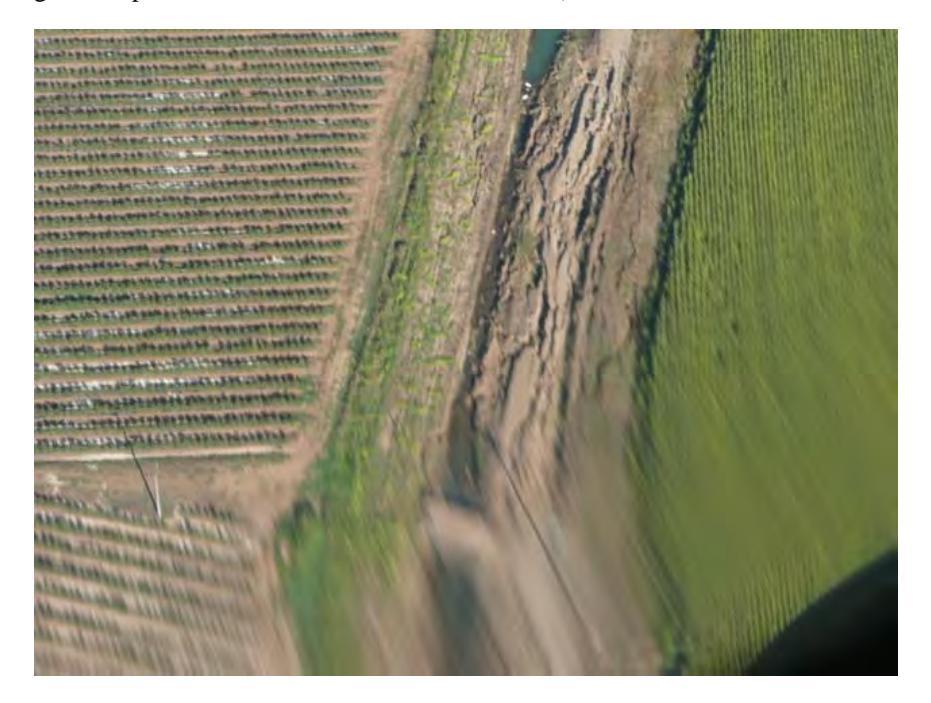
The Pan American highway crosses many rivers, water ways, canals, and ditches in the central region of Chile; this being an agricultural region with east-west trending water ways at 30-50 km spacing and the highway trending north-south. Most bridges at river crossings along the highway performed reasonably well, similar to what was described in the previous section. Surface evidence of liquefaction was observed and deformations had some impact on the approach fills. The most frequent damage along the Pan American was observed to correlate with relatively un-engineered water crossings such as canals and ditches. Systematic failures of the road foundation was seen where culverts, box sections, and other minor water conduits intersected the highway (e.g. Figures 6.16 and 6.17).

Figure 6.17. Lateral deformations in an agricultural ditch along the Pan American highway. Along the highway these non-engineered features performed very poorly in comparison with the engineered water crossings that fared much better (~S34.7794°, ~W71.1599°, 17:30, 3/6/2010).

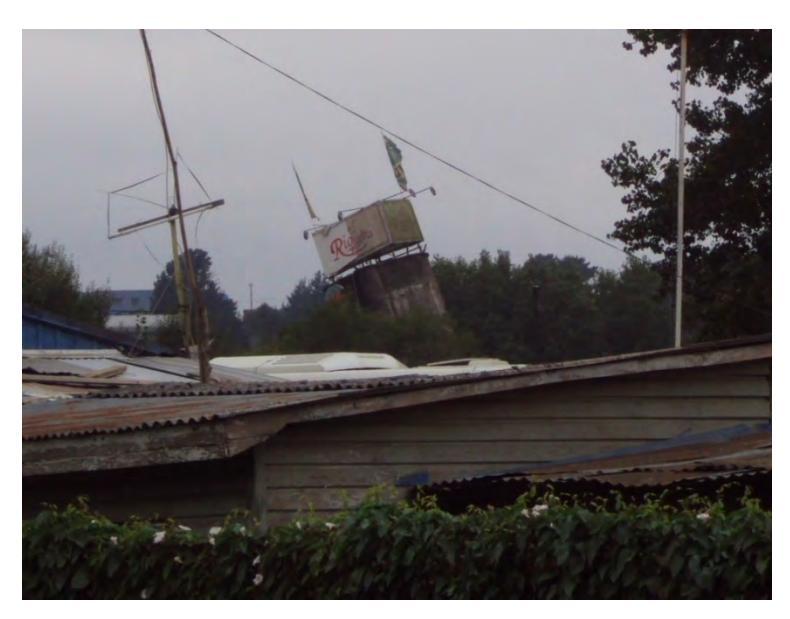
Many silos and tanks were observed to have suffered damage due to the earthquake. Whereas some of these tanks and silos failed due to the strong ground shaking with high long period motion content, there were several documented to have failed due to liquefied foundation conditions. Figure 6.18 shows an example of this near Arauco. Other liquefaction effects include tanks that became buoyant when the higher unit weight soil fluidized. This was observed in San Fernando (Figure 6.19), Chillan, Aruaco and Lebu, for example.

Figure 6.18. Leaning tank due to liquefaction of the foundation soil, near Arauco (S37.2458°, W73.3197°).

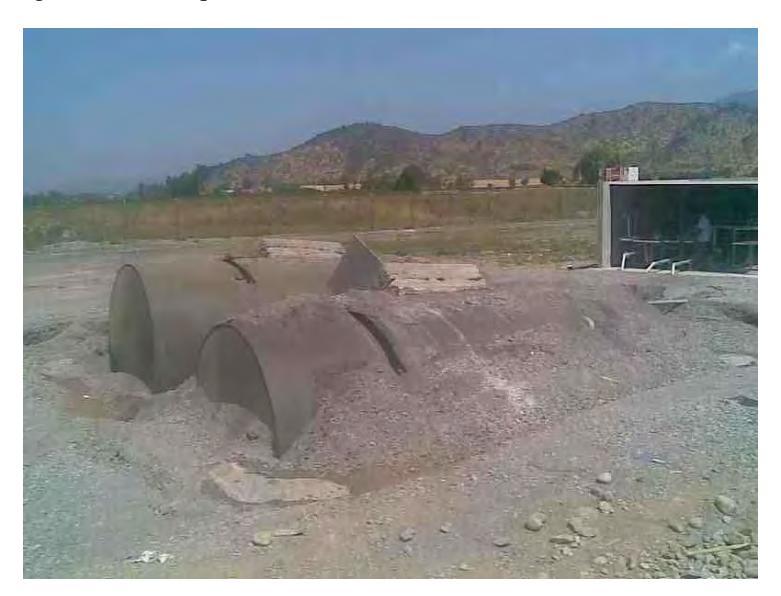
Figure 6.19. Tanks buoyed above the ground surface when the higher unit weight soil fluidized due to excess pore pressure generation. This occurred near San Fernando (~S34.5898°, ~W70.9890°)

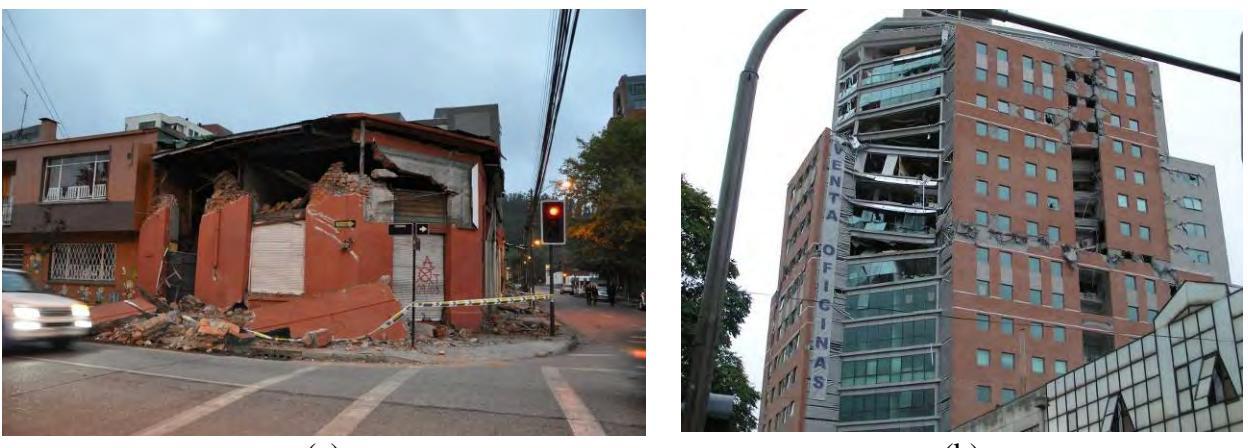
Several urbanized areas were strongly shaken by the February 27, 2010  $M_w$ =8.8 Chile earthquake. Most buildings within the affected areas performed well, especially modern buildings. However, many older buildings performed poorly particularly in areas with a large concentration of unreinforced masonry and low-rise adobe construction, such as in the cities of Curico and Talca. In contrast to other regions affected by the earthquake where shaking has been initially reported to have strongest energy content within the 0.8-2.0 second range, regions such as Curico may have observed high acceleration levels within the low period range (e.g., in the period range of 0.1-0.2 s, spectral demands greater than 1.4 g were measured at one station in Curico).<sup>1</sup> Within the city center of Curico, where many historic adobe structures are located, nearly 90% of the structures were destroyed. Similarly, in the city of Talca, 67km WSW of Curico, nearly every home in the city's center was severely damaged and most historic structures were flattened, whereas taller, well-designed structures appeared to perform relatively well with the exception of damage to nonstructural elements (Figure 7.1a). Nonetheless, given the widespread construction type and earthquake characteristics across the broad extent of this event, there certainly were a number of cases in which modern buildings performed poorly, such as the high-rise office building located in downtown Concepción that is shown in Figure 7.1b.

Figure 7.1. (a) Typical construction type and observed damage within the city of Talca (S36.8323°,W73.0554°; 1230 hrs on 3/18/2010) and (b) Significant structural damage, including partial collapse of a floor, of a modern high-rise building in downtown Concepción (S36.8296° W73.0550°; 2000 hrs on 03/17/2010).
