# Geo-engineering Reconnaissance of the 2010 Maule, Chile Earthquake

Report of the NSF Sponsored GEER Association Team

# GEER Association Report No. GEER-022

Version 2: May 25, 2010

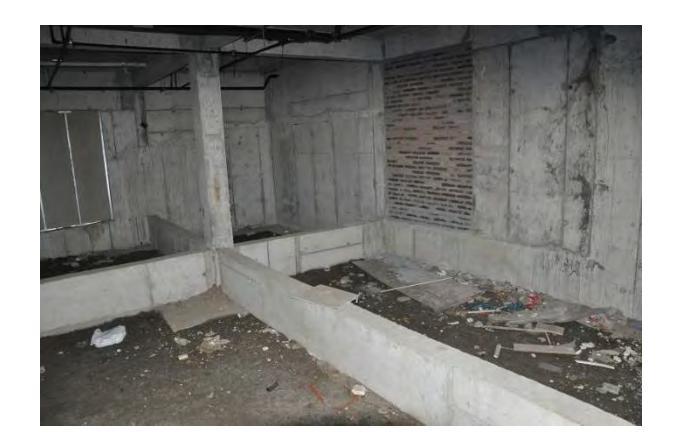
The ten wings of the hospital are of common concrete construction. Lateral loading is predominantly resisted by structural concrete pier shear walls linked via deep spandrel beams. For the taller structures (wings 1A, 1B, 1C) where one axis of the building is much shorter than the other, structural shear walls are used in isolation along the (sparser window) transverse axis. Interior concrete columns are used to carry gravity loads with a slab-girder style diaphragm. The diaphragm appeared to be conventional cast-in-place construction. Infill masonry walls are used at ground floor locations at select lower floors and the foundation is a likely common to that observed in the two-story wings, namely shallow spread and strip-type construction with interconnecting grade-beams (Figure 7.6).

Figure 7.6. General configuration of the foundation, perimeter structural shear walls and interior gravity columns (view at ground floor of wing 2I looking east) (\$37.47366°, \$W73.34761°; 1625 hrs on 3/16/2010)

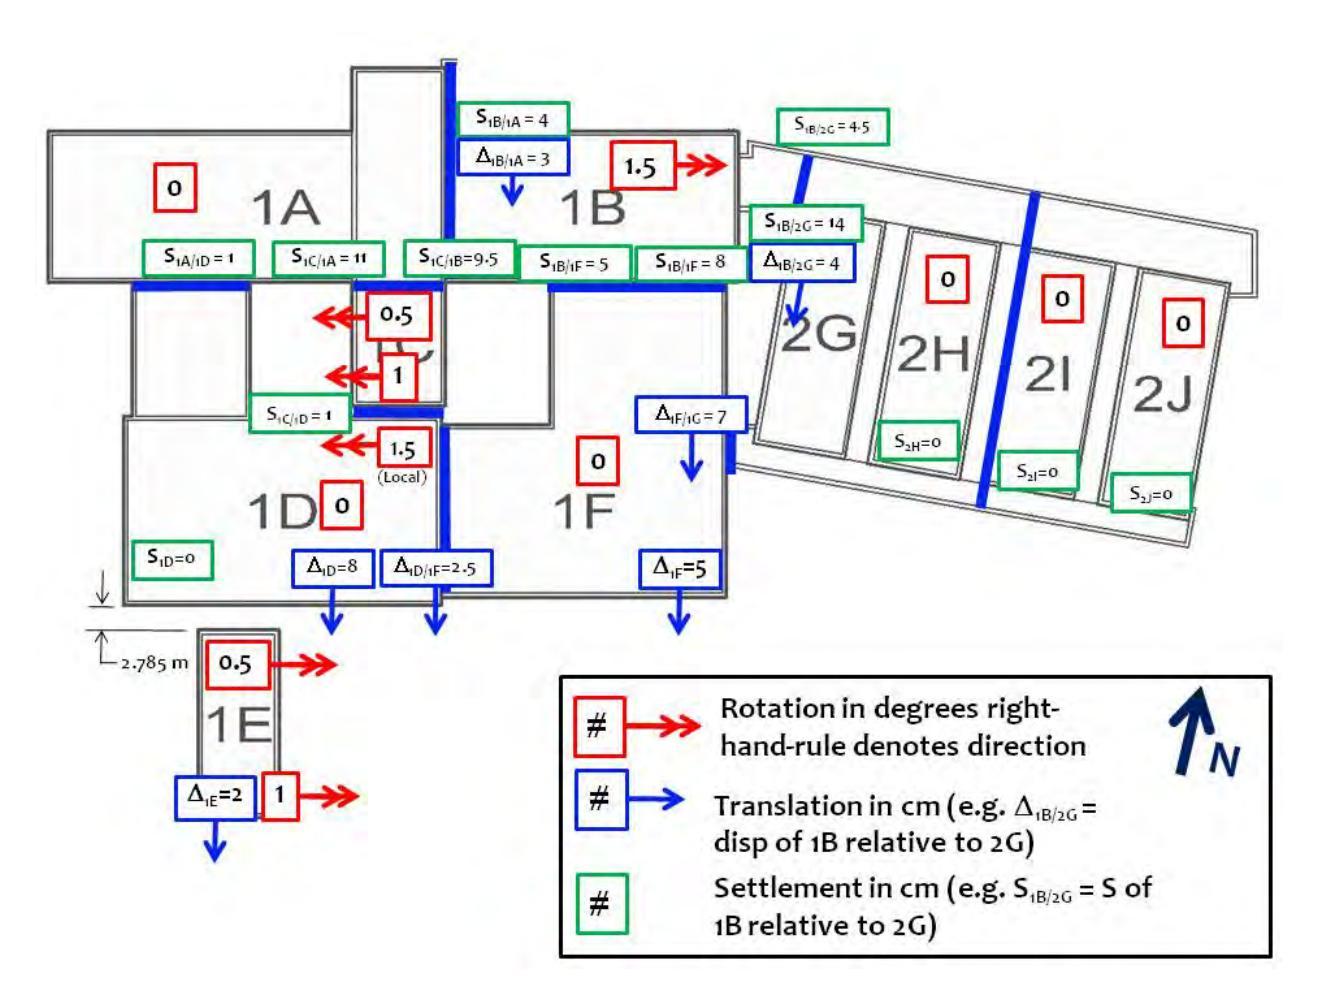
Measurements of relative building movement and tilt are provided on Figure 7.8. Wing 1C is the tallest wing and it contains the primary elevator shaft. It displaced downward the most relative to the other wings of the hospital. Wing 1C displaced downward around 11 cm relative to 1A. Wing 1C displaced downward about 9.5 cm relative to the southwest corner of Wing 1B, and Wing 1C displaced downward 1 cm relative to Wing 1D. The northeast side of Wing 1D was pulled down locally with respect to Wing 1C and a tilt of 1.5° downward toward Wing 1C was measured on the ground floor of Wing 1D in this area. As no tilt was measured in Wings 1A and 1D, the non-uniform downward displacement of Wing 1C indicated that it tilted somewhat back towards Wing 1A.

Figure 7.8. Measurements of relative building movement (Bray, Hutchinson, Arduino, and Maureira).

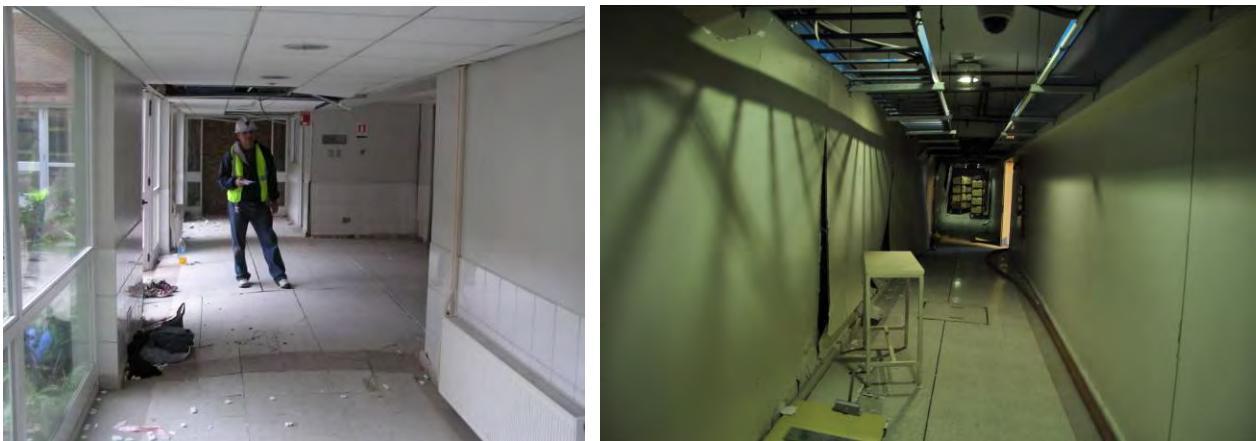
There was also evidence of internal distortion of these structures and their foundations. Bulging of the ground slab in front of the elevator shaft in Wing 1C is shown in Figure. 7.9a. The slab raised up about 19 cm relative the undeformed slab in the foreground of the picture. There was also evidence of floor bulging up or distorting in other wings of the hospital, such as the extensive warping of the slab-on-grade in Wing 1B as shown in Figure 7.9b.

Figure 7.9. Distortion of the slab-on-grade: (a) floor bulging in front of elevator shaft inWing 1C (S37.47345°, W73.34835°), and (b) floor distortion in eastern hallway of Wing 1B (S37.4733°, W73.3478°).

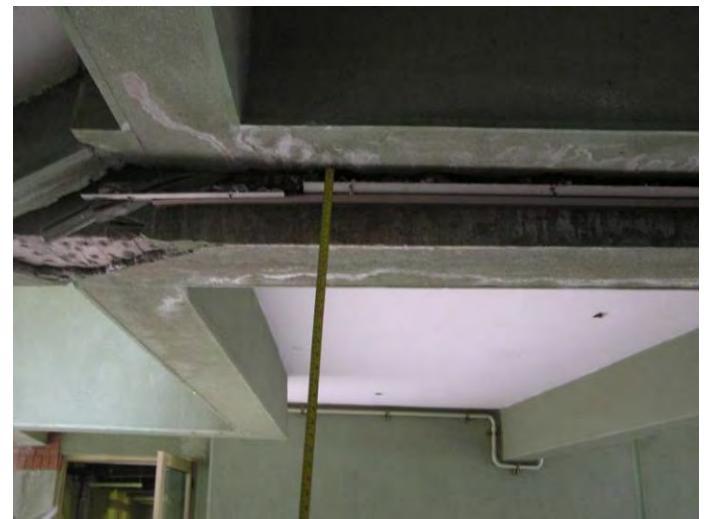
Relative movement between Wings 1B and 2G was apparent at the connection of these two wings as shown in Figure 7.10. At the northeast corner of the Wing 1B extension adjacent to the northwest corner of Wing 2G, Wing 1B displaced 4.5 cm downward and 4 cm southward relative to Wing 2G. The downward movement of Wing 1B relative to Wing 2G at the location of the photograph shown in Figure 7.10 was 14 cm. The measured relative offset between these two wings, however, was non-uniform, which suggested that Wing 1B tilted with respect to Wing 2G, which appeared not to tilt. The tilt of Wing 1B was reliably measured to be  $1.5^{\circ}$  with its top displacing to the south relative to its base. The southeast corner of Wing 1B displaced downward 8 cm relative to Wing 1F.The northwest corner of Wing 1B displaced downward 8 cm relative to Wing 1B also displaced laterally to the south about 4 cm relative to Wing 2G.

Figure 7.10. Relative movement between Wing 1B (in the background) and Wing 2G (in the foreground) (\$37.47335°, W73.34786°; 03/16/10).

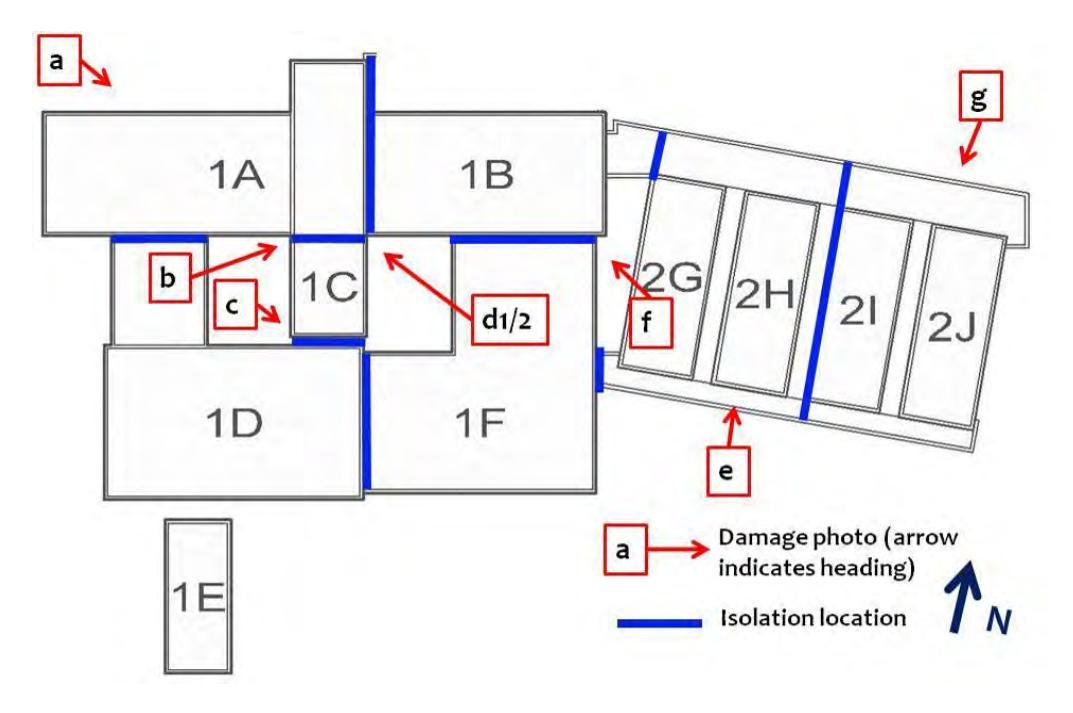
Structural and nonstructural damage was observed throughout the hospital; however, the extent of structural damage was minimal due to the isolation gap provided between the wings. The most pronounced damage was associated with closure of the seismic gap and resulting contact between wings, and in particular, Wing 1C and its neighboring structures (1A, 1B, and 1F). Select locations of shear wall damage were noted; however the extent of this was minimal. Figure 7.11 provides a map of the more pronounced structural damage observed, with photographic documentation associated with the map provided in Figure 7.12.

Figure 7.11. Damage map denoting select locations of observed perimeter damage; refer to Figure 7.12 for photographs and description of observation associated with letter annotations in this figure.

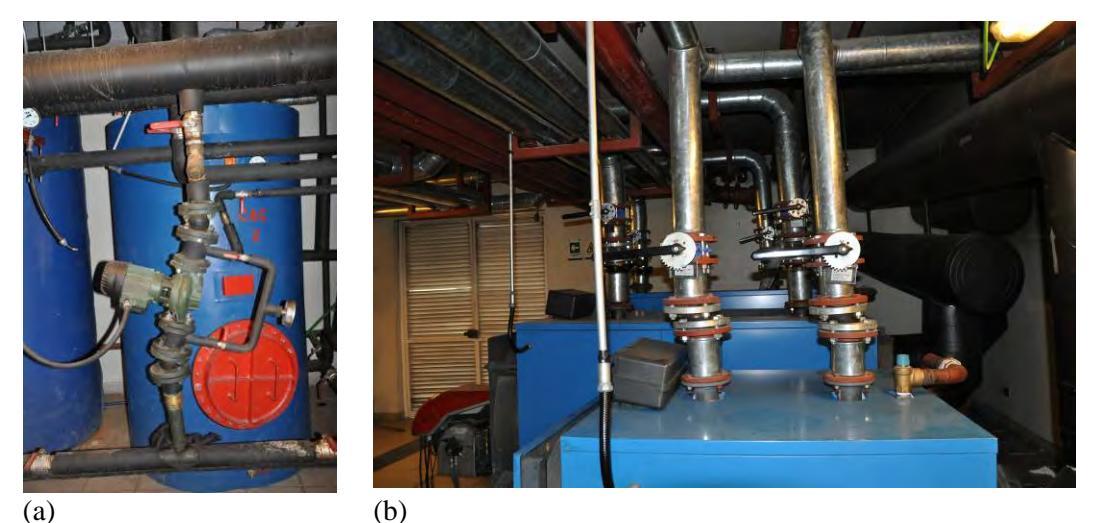
Nonstructural damage was largely confined to partition walls and ceiling systems. Due to the isolation of the various wings, the building services were designed with significant flexibility in mechanical, electrical and plumbing systems crossing the various wings. Engineers on site at the time of the team's visit noted no disruption to the mechanical, electrical, and plumbing systems within the wings. An example of the flexibility of the design connections and resulting good performance is shown in Figure 7.13. Detailed review of the immediate post-event nonstructural damage was conducted by Professor Eduardo Miranda of Stanford University and interested readers should consult his findings.

Figure 7.13. Generally good performance of building services equipment in the hospital building (note the blue tank in the background of the image of part (a) was unanchored and slide laterally, resulting in the lateral shift of the lower pipe run in the foreground). All connections were intact and operational for these service equipment. (images taken in wing 1F, approximately S37.473577°, W73.348042°; 1345 hrs on 3/16/2010).

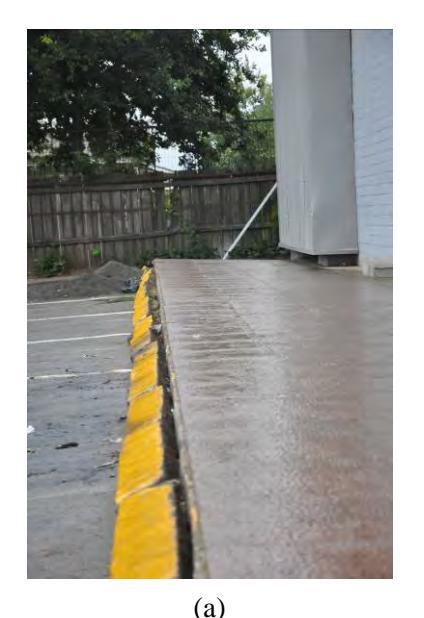
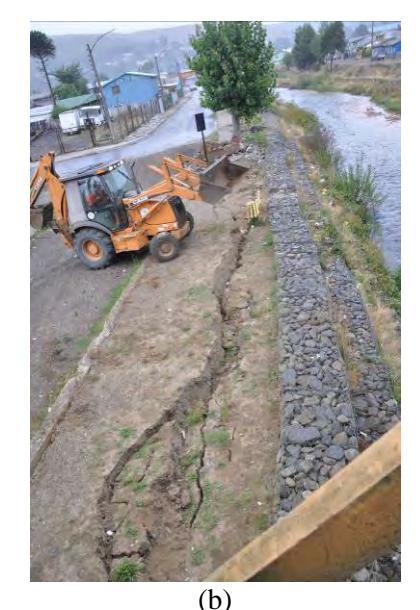
Slight evidence of liquefaction was observed to the north of the hospital in the parking lot area of a market (Figure 7.14a). Minor pavement distress and minor uplift of manholes in this area were observed. However, the pervasive liquefaction that was observed at the hospital was not observed here or at other locations in the city. Lastly, ground failure was observed near the river that is located south of the hospital (Figure 7.14b); however, the street that ran along the north side of the river showed no damage to its north, which indicates that the ground failure near the river was localized and did not extend to the hospital grounds.

Figure 7.14. (a) Curled sidewalk north across the street from the hospital (S37.4727°,W73.3477°) and (b) ground failure near the river south of the hospital (S37.4742°, W73.3471°; at 1930 and 1830 hrs, respectively, on 3/16/2010).

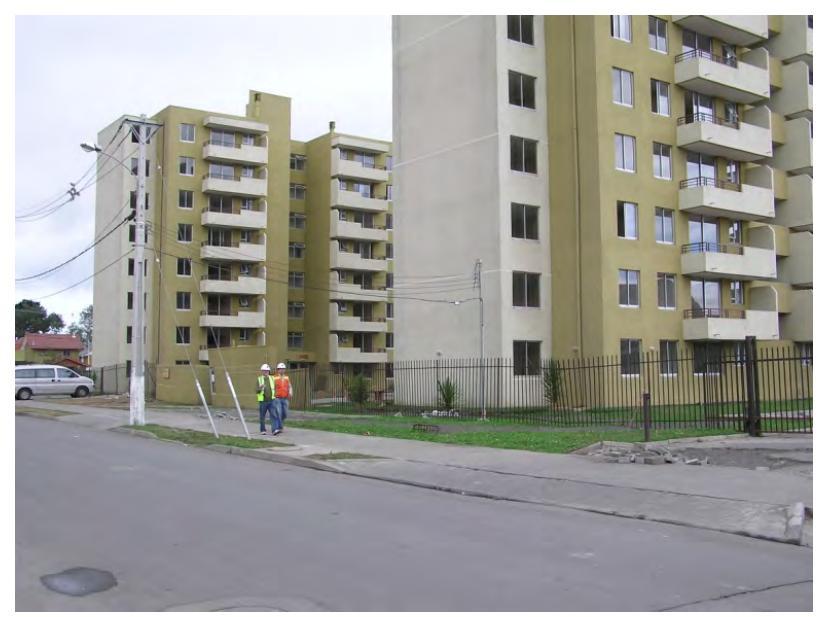
Figure 7.16. Southern most buildings at the four 8-story condominium building site (S36.791026°; W73.081235°; 1300 hrs on 03/17/10).

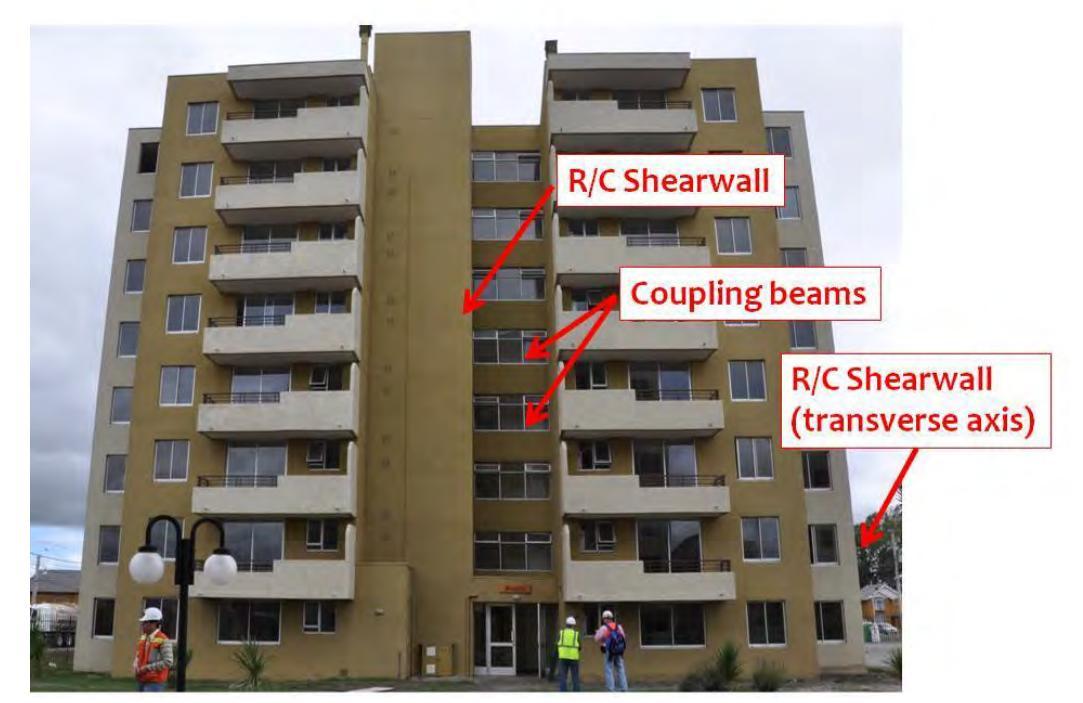
Figure 7.18. Elevation of the Riesco building depicting the general components of the structural system of the building (image taken at S36.790929°, W73.081296°; 1400 hrs on 3/17/2010).

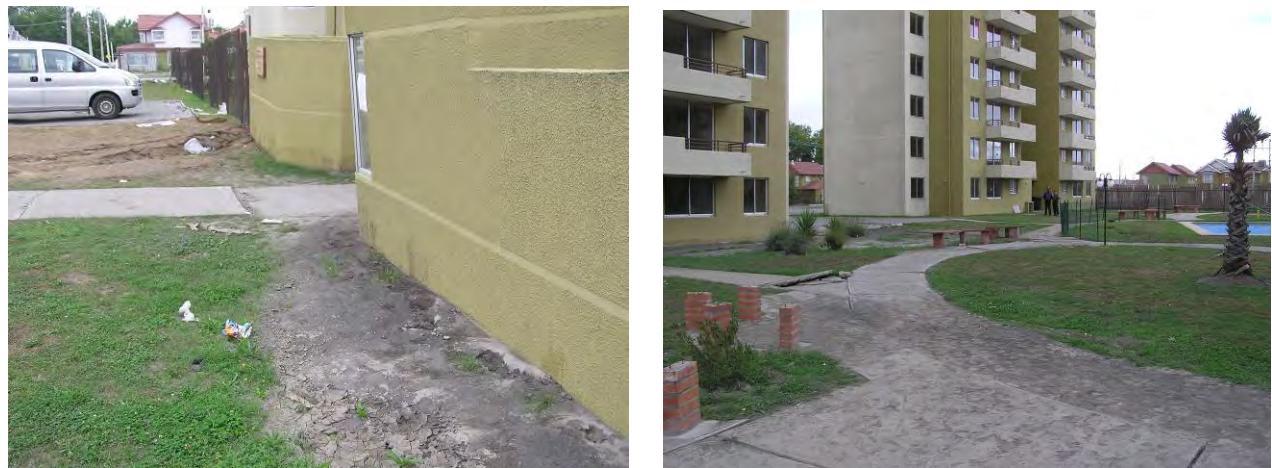
As shown in Figure 7.19, evidence of liquefaction of the gray sandy fill was present throughout the site. Sediment ejecta, ground cracking, ground settlement, and other evidence of liquefaction could be seen throughout the site. In the left photograph of Figure 7.19, sediment ejecta, ground settlement, ground cracks, and tilt of the guard room at the condominium entrance are seen. In the right photograph of Figure 7.19, similar evidence of liquefaction is seen inside the fenced area of the property.

Figure 7.19. Sediment ejecta, ground cracks, and other evidence of liquefaction of the sandy fill were found throughout the condominium site; however, street curbs around the property did not show evidence of liquefaction (\$36.79107°, W73.08149°; 1300 hrs on 03/17/10).

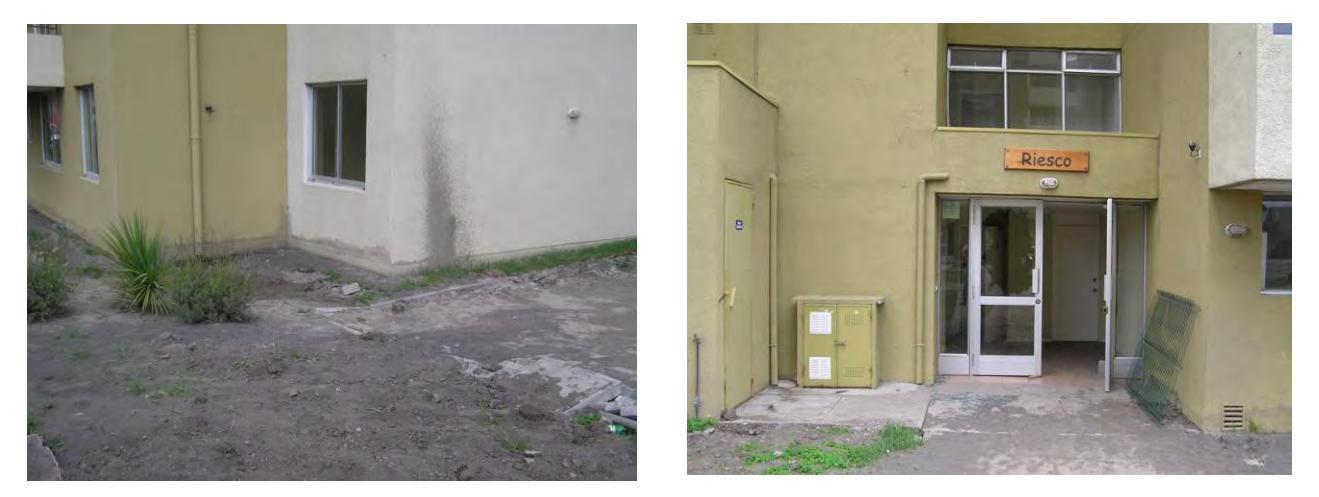
Clear evidence of sediment ejecta is seen in the left photograph of Figure 7.20. Large amounts of sand and water stains were observed in this area, which is at the northeast corner of the Riesco Building (i.e., the southwest existing building). The maximum vertical displacement of a building at this site was measured at this location. The base of the northeast corner of the northern extension of the Riesco Building (i.e., the northwest existing building), which did not appear to undergo seismically induced permanent ground movement during the earthquake. The southern end of the Riesco Building, however, appeared to settle only 10 cm, and in this area, the ground surrounding the building actually settled an additional 9 to 14 cm more than the building's foundation. The top of the Riesco Building's northern end tilted 1° to the east and 1° to the north as a result of the differential ground movement across the building. The differential foundation movement produced tiling and warping of the interior on floor slab, which appeared to be on grade, and this produced damage of the living spaces as shown in Figure 7.21. A map depicting the measured foundation movement can be seen in Figure 7.22.

Figure 7.20. Riesco building that underwent most significant liquefaction-induced movement. Left photo shows evidence of large sediment ejecta at its northeast corner (S36.79077°, W73.08124°; 1330 hrs on 03/17/10). Right photo shows entrance to the building in the middle of its east facing side (S36.79089°, W73.08131°; 1310 hrs on 03/17/10).

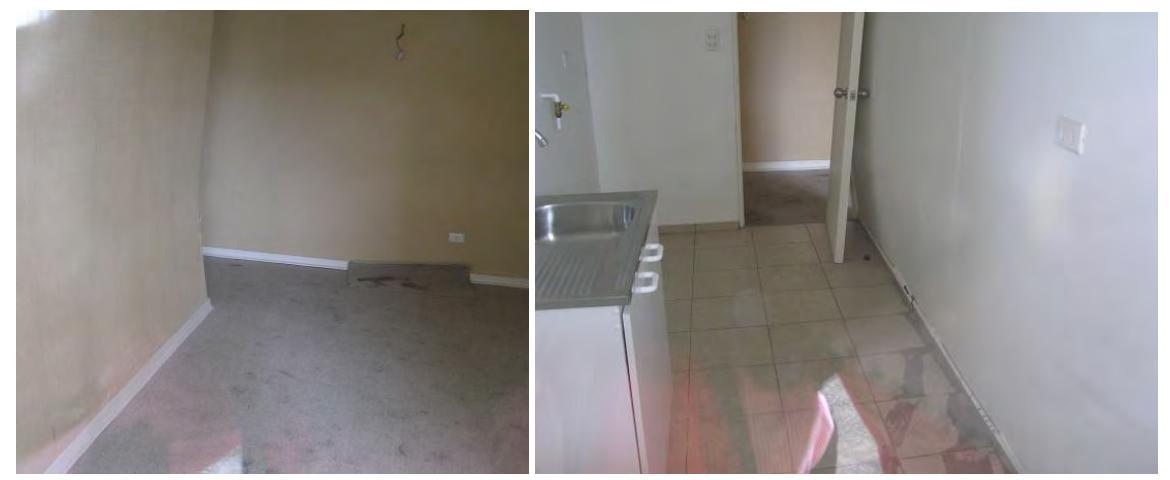
Figure 7.21. Evidence of interior damage to Riesco Building due to differential foundation movement (S36.79085°, W73.08128°; 1320 hrs on 03/17/10).

Structural damage to the Riesco building appeared to be largely a result of damage induced by differential settlement of its foundation. In particular, damage was precipitated by the significant liquefaction-induced settlement of the northern end of the building. As a result of the uneven foundation settlement and rotation about the transverse axis of the building of its northern half, excessive internal deformations were imposed on the coupling beams. All coupling beams up the height of the building were heavily loaded and observed shear failure at their interface with the full height shear wall at the elevator core (Figure 7.23 and 7.24). Shear walls in the transverse direction of the Riesco building appeared to be undamaged.

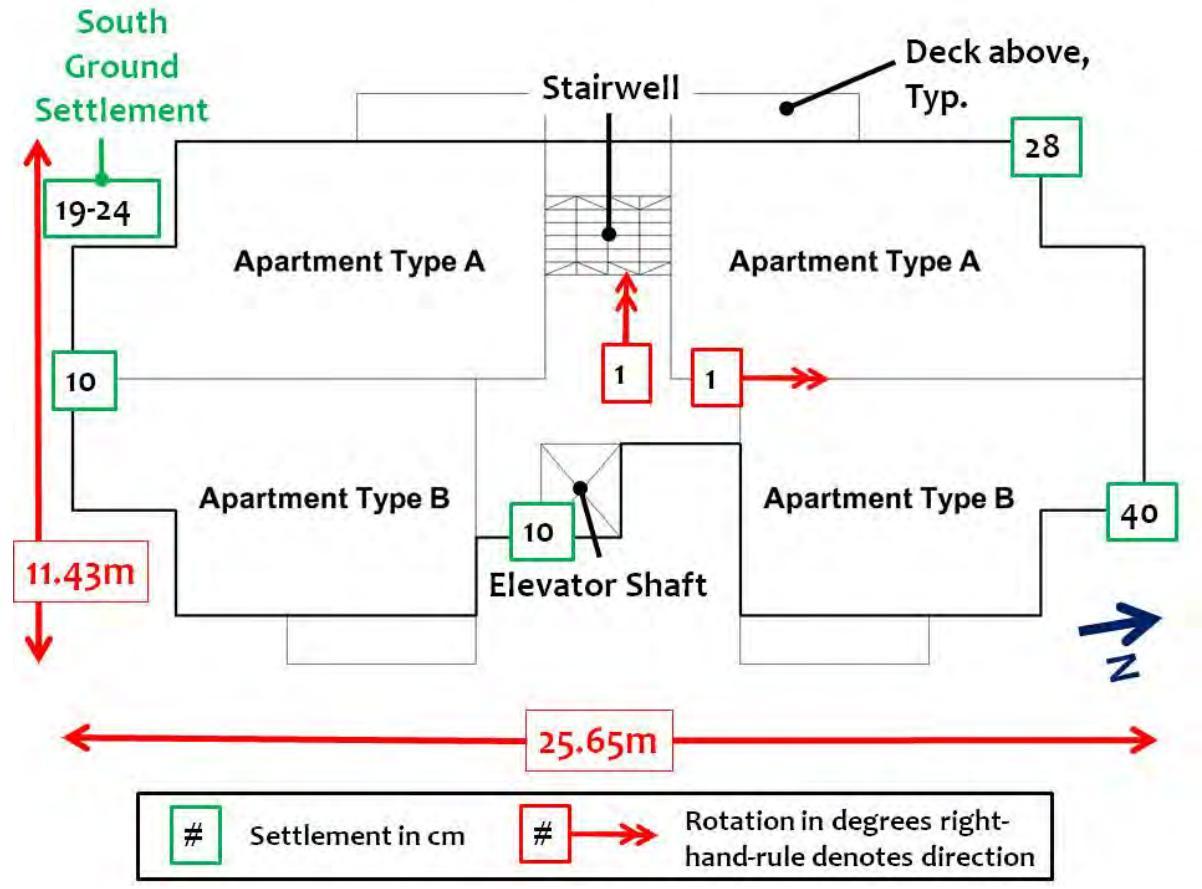
Figure 7.22. Schematic plan view of the Riesco building depicting measured movement of foundation. (note that rotation about the transverse axis of the building is believed to largely hinge about the shear wall-coupling beam interface as shown in Figure 7.23 (Bray, Hutchinson, Arduino, and Maureira).

In summary, the Riesco Building settled 40 cm at its northeast corner and only 10 cm at its south end. This led to a tilt of the top of the building toward the north and toward the east of 1 degree, respectively. The northern axis tilt appeared to hinge about the ends of the coupling beams to the structural shear walls along the longitudinal axis of the building. The differential ground settlement contributed to structural damage. In contrast the Bulnes Building did not appear to settle. The Errázuriz and Montt buildings appeared to settle at most 10 cm, and this settlement was fairly uniform around the perimeter of the buildings. The ground in the open space between buildings settled a non-uniform amount ranging from 0 cm in the area around the Bulnes Building, but more commonly 10 to 20 cm in the areas closer to the other three buildings (e.g., Figure 7.27). The street that surrounded the property did not appear to settle and there was no evidence of ground failure in adjacent properties which contained relatively light oneand two-story homes. However, there was evidence of ground failure which collapsed a sidewalk within the neighborhood of the condominiums adjacent to a culvert approximately 120 m north of the site, in addition to a ground failure at a roads edge exiting the neighborhood at 700 m north of the site was observed (Figure 7.28). Neither failure was related to that at the condominium site.

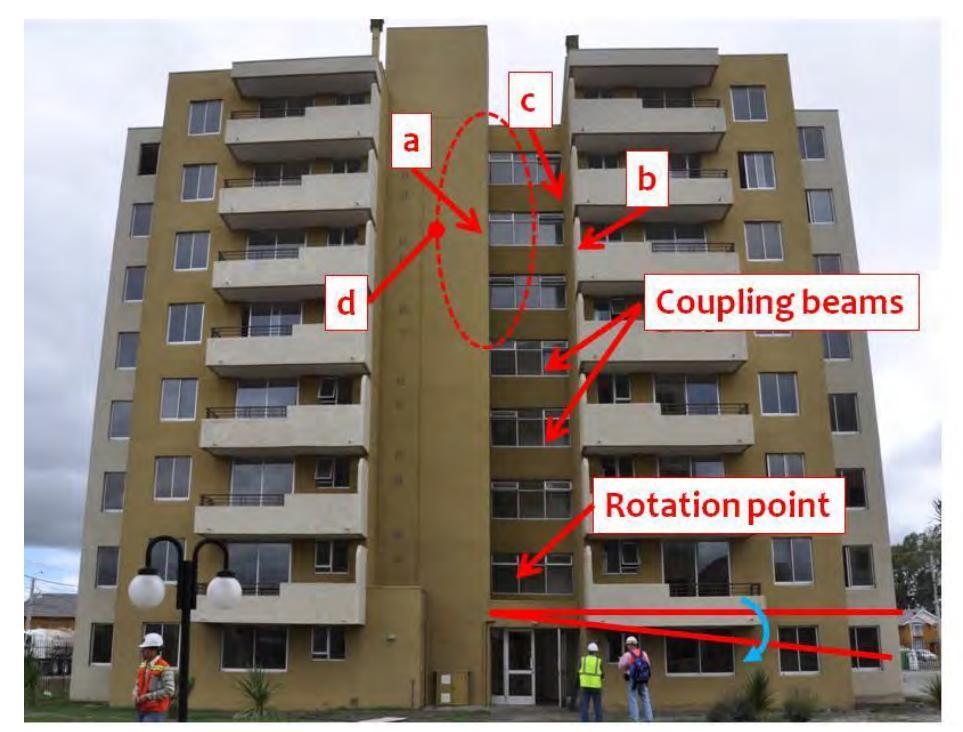
Figure 7.23. Elevation of the Riesco building depicting the movement characteristics (about transverse axis only) and resulting damage map – refer to Figure 7.24 for images of a-d (image taken at S36.790929°, W73.081296°; 1400 hrs on 3/17/2010).

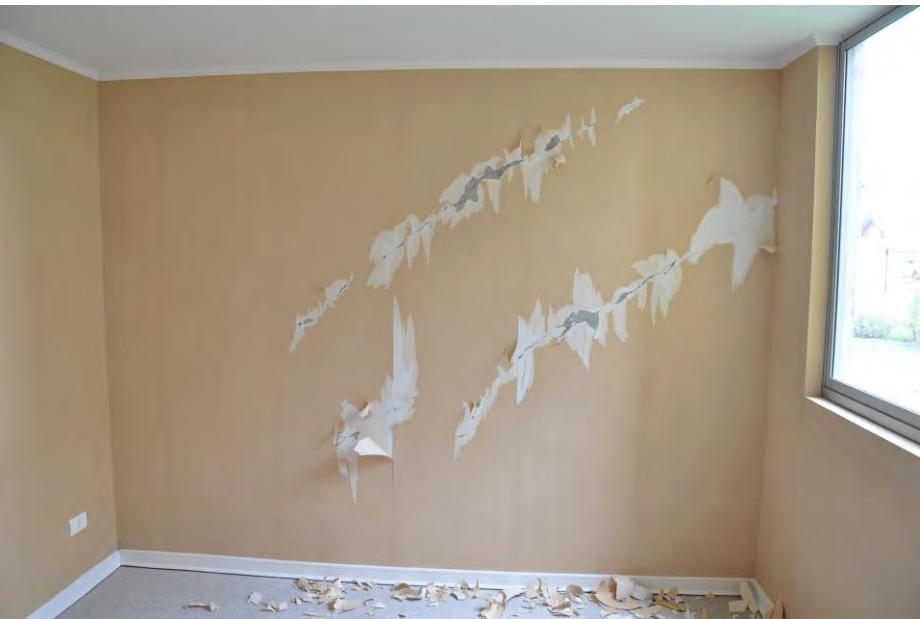
In contrast transverse shear walls in the other three buildings, which did not significantly rotate, suffered damage to the first floor structural shear walls in the form of large shear cracks (Figure 7.25). Nonstructural damage to these buildings included primarily cracked and fallen glass and partition wall damage buckling and cracking (e.g., see Figure 7.26).

Figure 7.25 Damage to ground floor shear walls of the Montt building (S36.790737°, W73.080901°; 1545 hrs on 3/17/2010)

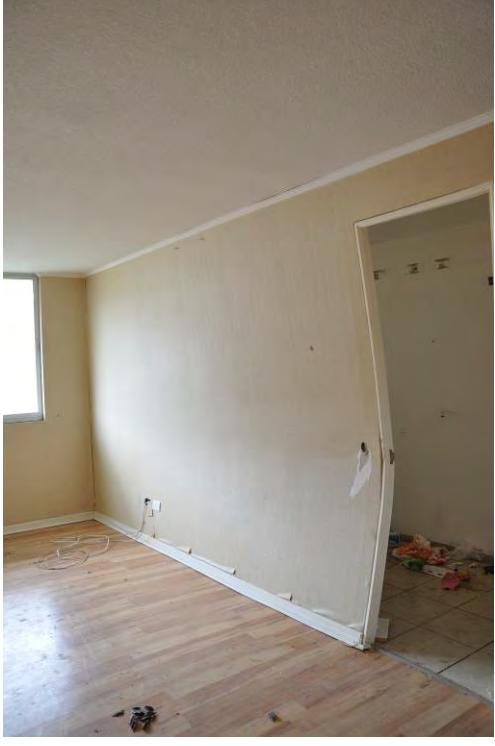
Figure 7.26.Typical nonstructural damage to nonstructural components in the buildings. Interior partition wall due to bulging of the ground slab (ground floor Errázuriz building, S36.791063°, W73.081043°; 1415 and 1430 hrs, respectively, on 3/17/2010)

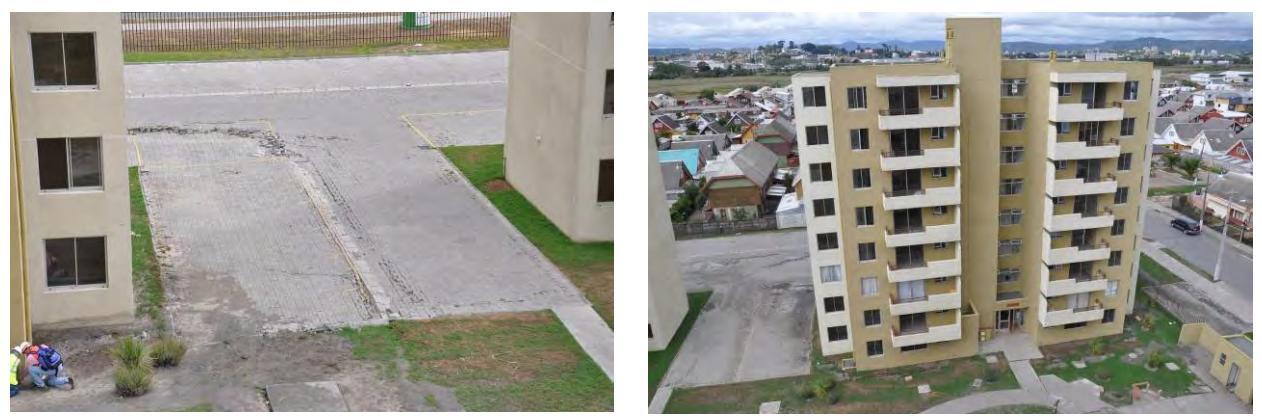
Figure 7.27. Ground settlement and ejecta pattern (a) between the Riesco and Bulnes building (taken from the Errazuriz building; S36.7909°, W73.0810°; 1400 hrs on 3/17/2010) and (b) surrounding the Errazuriz building (taken from the Riesco building; S36.7909°, W73.0814°; 1430 hrs on 3/17/2010).

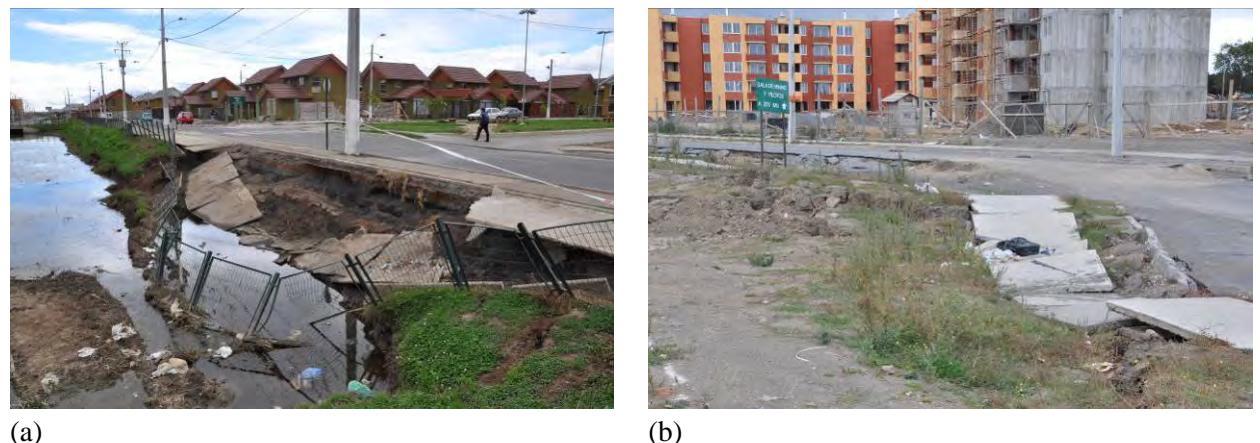
Figure 7.28. Neighboring ground failures at (a) sidewalk adjacent to a culvert about 120 m north of condominiums (S36.7898°, W73.0813°; 1300 hrs on 3/17/2010) and (b) roadside at 700m north of condominiums (S36.7847°, W73.0796°; 1630 hrs on 3/17/2010).

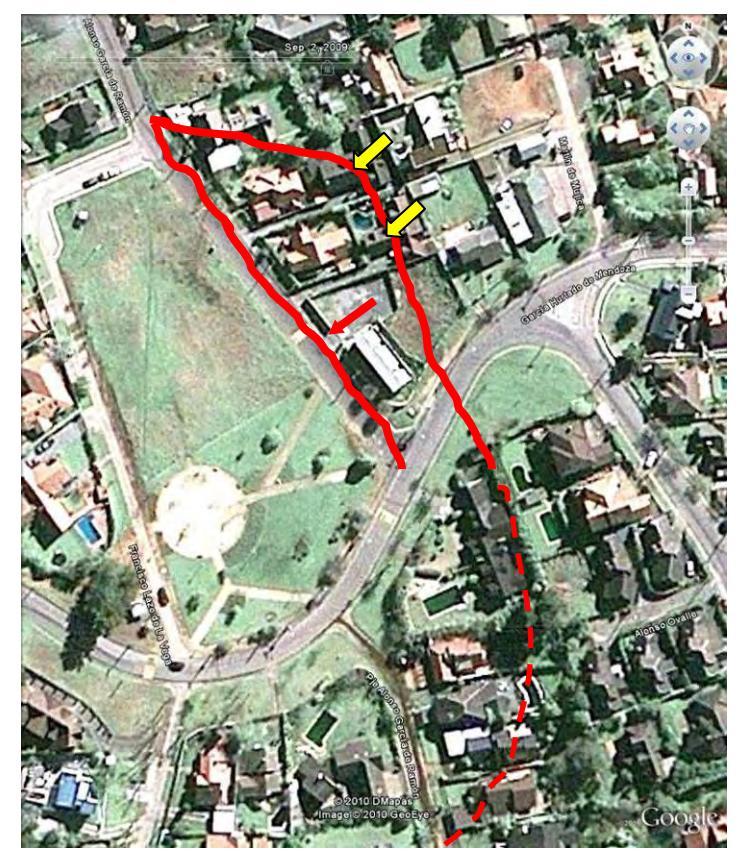
Several up-scale homes in the northern part of Concepción were damaged by a translational ground movement. The area is 2 km southeast of the Carriel Sur International Airport in Concepción near the intersection of Alonso García de Ramón Road and García Hurtado de Mendoza Road (S36.791841°, W73.056996°). A September 2, 2009 GoogleEarth image of the area is shown in Figure 7.29. Shallow groundwater was observed at the site near the toe of the slide. At the back of the slide there were manholes that suggested that there was a drain line that may have supplied water to the affected zone. There was no obvious change in topography at the location of the head scarp of the slide. Photographs of the toe of the slide, and of the extension zone at the head scarp of the slide are shown in Figures 7.30 and 7.31, respectively. Additional perspectives of the slide are shown in Figure 7.32.

Figure 7.29. Affected area with approximate limits of the translational earth movement; the toe of the slide is along the eastern side of Alonso García de Ramón Road and the head scarp runs through the houses and the open field behind the rectangular apartment complex. (S36.791841°, W73.056996°). The yellow arrows denote the location of two severely damaged home which are shown in Figure 7.31.

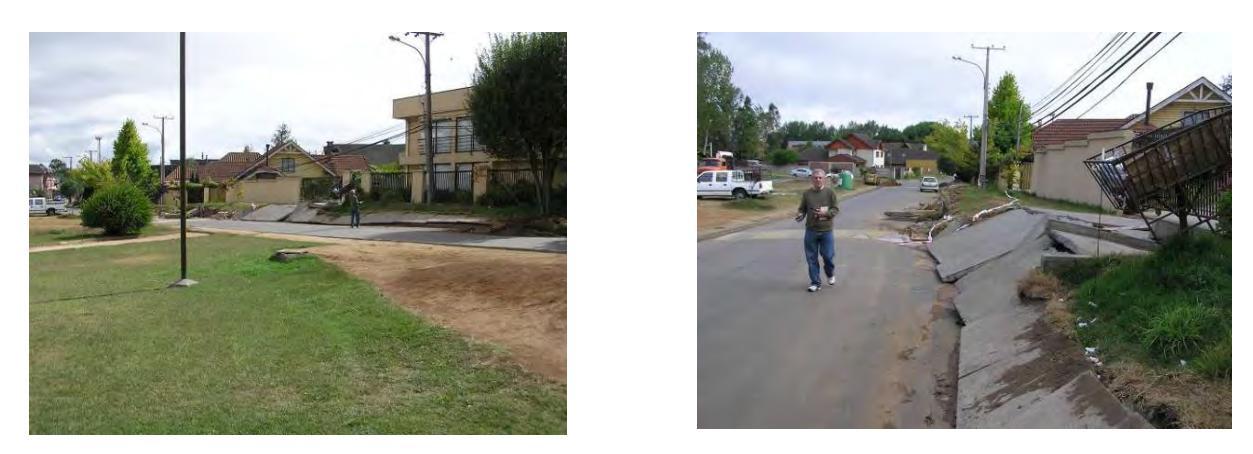
The slide appeared to be relatively shallow with its toe compressing ground directly along Alonso García de Ramón Road in a zone that was about 8 m wide, its head scarp causing a series of parallel extension cracks over a zone that was about 11 m wide, and its body between the toe and head scarp showing little evidence of internal ground distortion within it. Careful measurements across the head scarp extension zone at the location of the right photograph in Figure 7.32 showed that a zone that was 9.05 m wide initially (as evidenced by regular-sized pavement sections) extended about 1.7 m, so that it was now 10.73 m wide. At the toe of the slide, at the location of the person standing in the right photograph of Figure 7.30, the ground shortened about 1 m and pushed up about 1 m due to compression across a zone that was initially 8.5 m wide.

Figure 7.30. View to the north showing toe of slide in left photo, and view to the northwest of toe of slide along Alonso García de Ramón Road (right photo taken near its intersection with García Hurtado de Mendoza Road; S36.79146°, W73.05754°; 1200 hrs on 3/17/10).

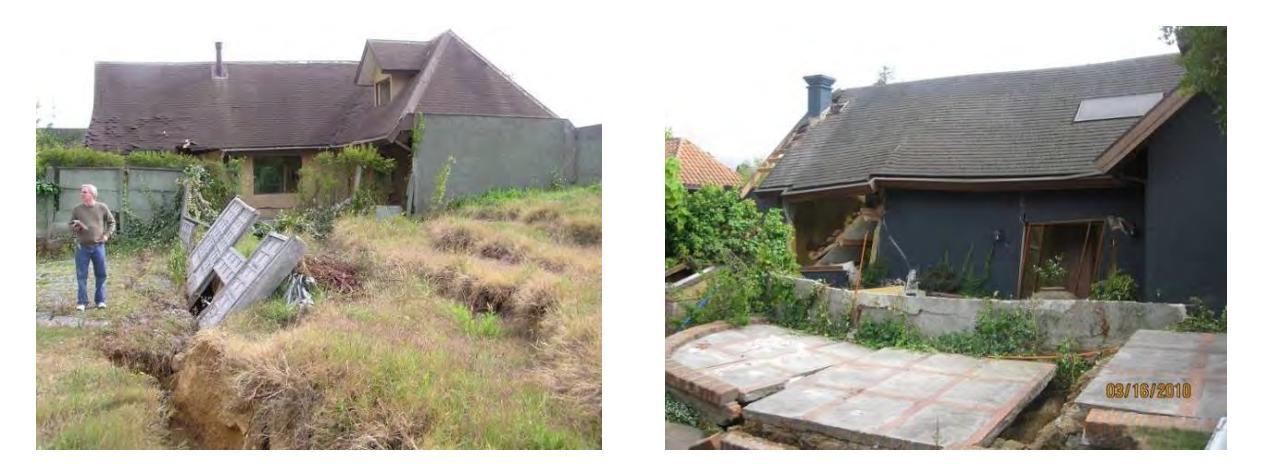
Figure 7.31. View of extension zone in open field behind apartment building (left photo(S36.79126°, W 73.05714°; 1120 hrs on 03/17/10), and view of damage to a home due to ground extension across its foundation (right photo, S36.79108°, W73.05728°; 1200 hrs on 3/17/2010).

The two homes identified in Figure 7.29 and shown in Figure 7.31 were the most heavily damaged structures in the area. Both of these structures were located across the head scarp of the landslide where the extension of the ground was most severe. Most damage to surrounding homes was cosmetic or limited to ground or hardscape dislocations, whereas these homes were severely damaged. Parents of the son residing in the home shown in Figure 7.34 informed the GEER team that the home was a total loss and will need to be demolished and reconstructed.

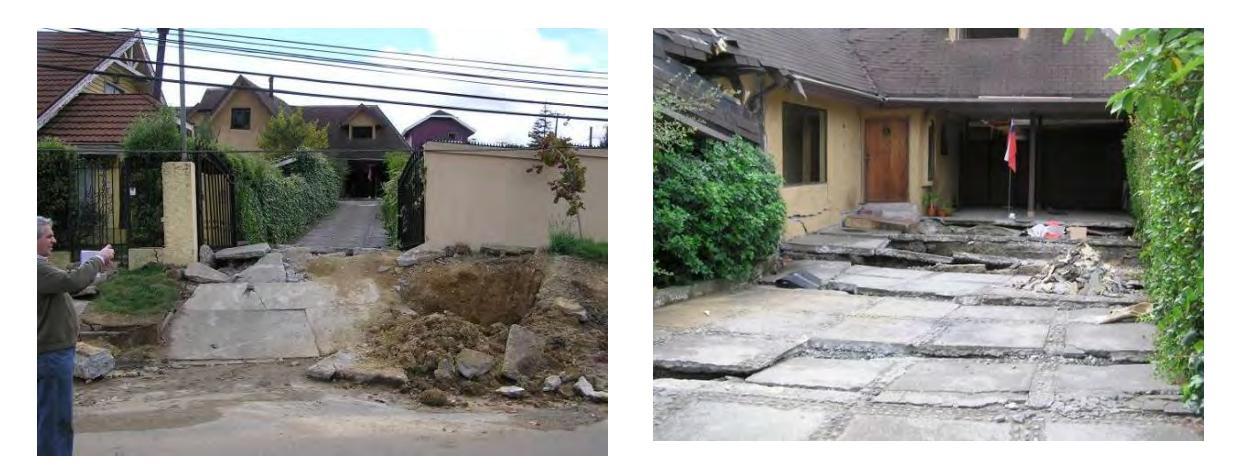
Figure 7.32. View of toe of translation slide in foreground of left photo (also note that the driveway behind the toe is not damaged(S 36.79134°, W 73.05762°; 1150 hrs on 03/17/10), and view of the head scarp of the translation slide at back of driveway in the right photo (S36.79126°, W73.05719°; 1130 hrs on 03/17/10).

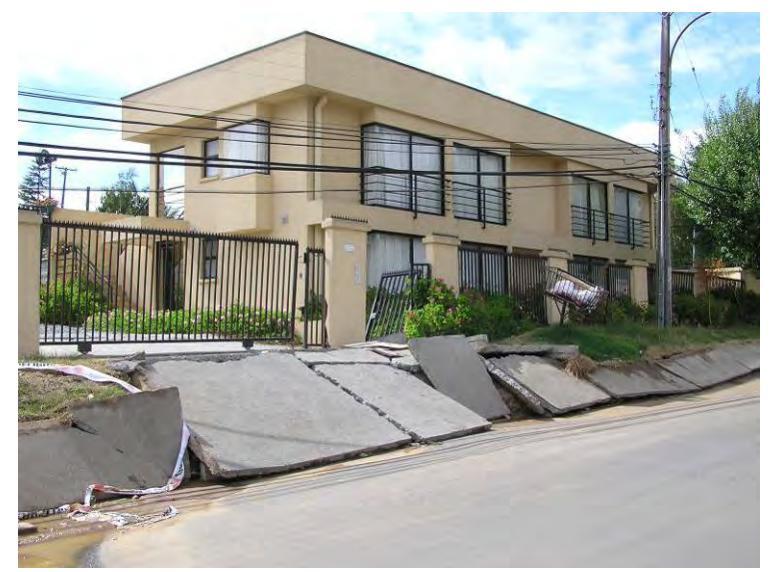
Figure 7.33. Apartment building underwent translation and tilt, but suffered no significant structural damage. (S 36.79167°, W 73.05721°; 1200 hrs on 03/17/10).

Interestingly, the 2-story apartment building shown in Figure 7.33, which is located near the intersection of Alonso García de Ramón and García Hurtado de Mendoza roads, showed no evidence of significant structural damage. Although the building translated to the southwest as a result of the translational earth movement, it did not appear to undergo internal distortion. However, its top tilted  $1^{\circ}$  to the northwest and  $1^{\circ}$  to the northwest, indicating that it had displaced and tilted in a rigid body manner.

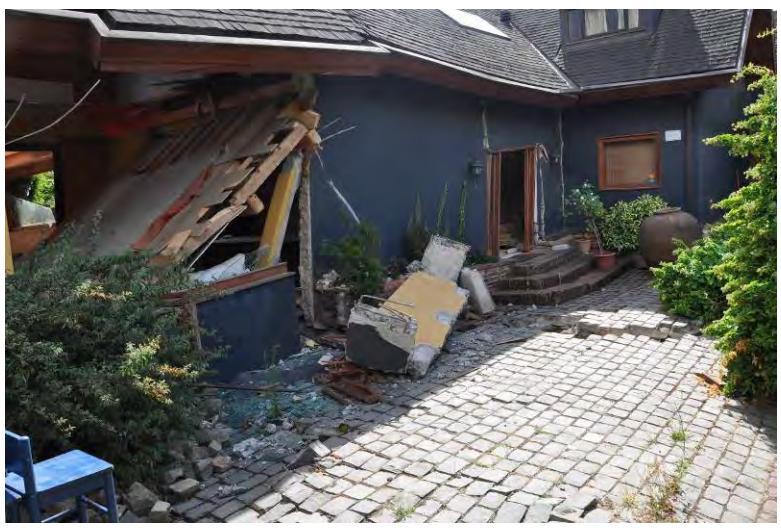
Figure 7.34. Single family residence severely damaged at backside of scarp (S36.79108°, W73.05728°; 1200 hrs on 3/17/2010).

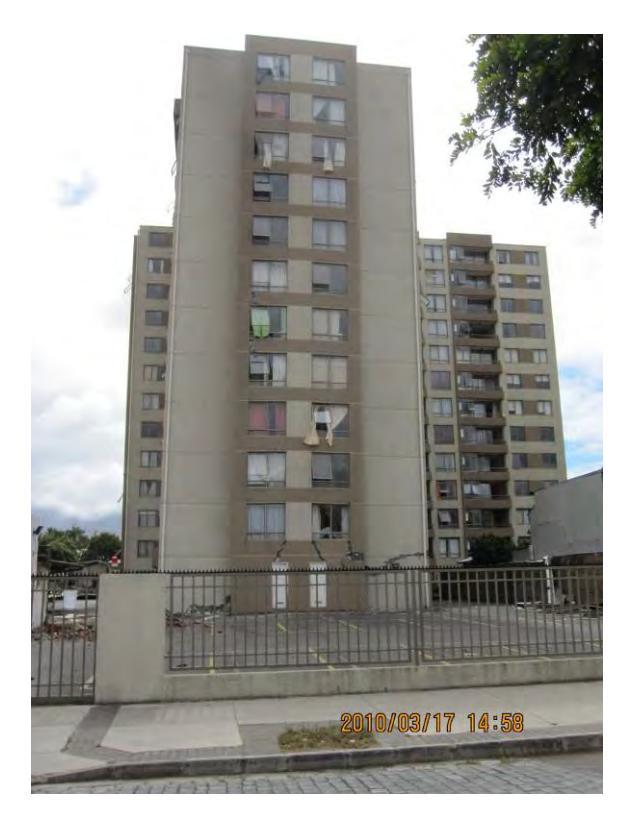
The EERI Reconnaissance Team observed damage of the south wing of a 13-story building located at 1343 Salas (S36.82044, W73.06164). The apartment building consisted of 2 rectangular wings in an offset T-shape (denoted as north and south wing in Figure 7.35). The north wings longitudinal axis runs approximately east-west, while the south wings longitudinal axis runs approximately north-south. The response of the two wings was extremely different. The north wing suffered only moderate damage, while the damage to the south wing was significant, including a residual tilt to the east of the entire wing. Residual tilt is believed to largely be attributed to cumulative structural damage. Failure was observed in the walls of the south wing, manifested as local shear as well as horizontal cracking (Figure 7.36).

Figure 7.36. Elevation view of 1343 Salas, looking north. North wing in is the background, while the south wing is in the foreground. Note shear and horizontal cracks in the wall on first floor of south wing. (S36.8205°, W73.0619°; 1458 hrs on 03/17/10).

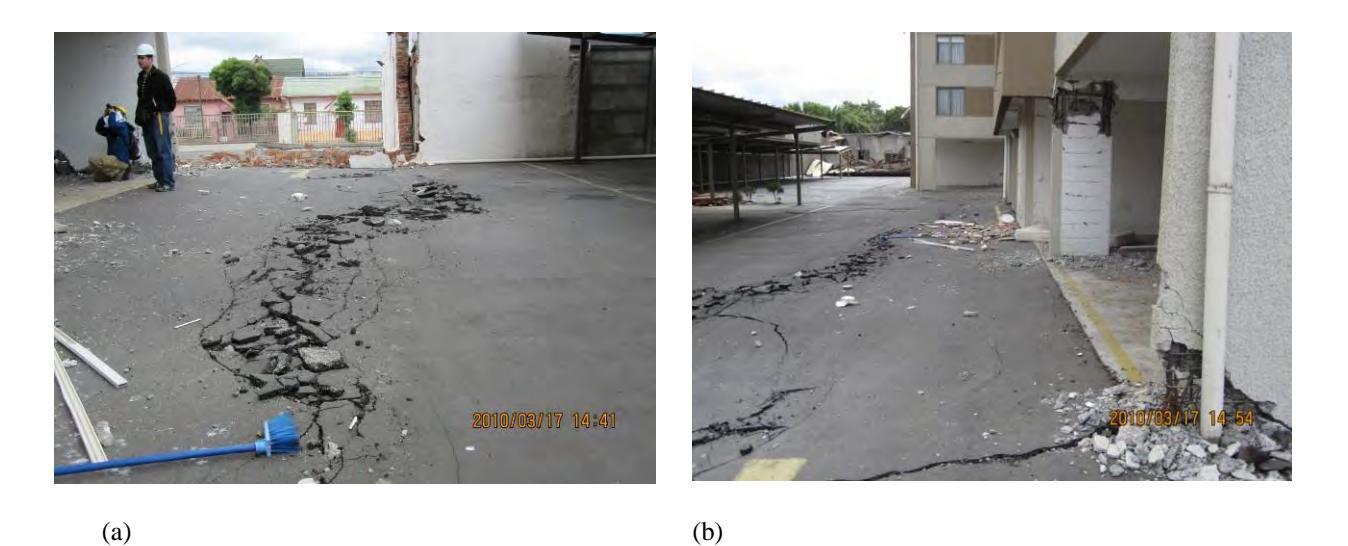
Although minor settlement was observed around both wings, pavement buckling was observed on the west, south, and east sides of the south wing (Figure 7.37), leading the EERI team to suspect that the south end foundation of the south wing underwent rocking during the shaking (Figures 7.37 and 7.38). The foundation below the north end (east-west running walls) of the south wing did not manifest pavement buckling. This may be due to restraint provided at the north end of the south wing foundation from the north wing. Minor pounding between the north and south wings was evident in the upper stories of the east side (Figure 7.39). It should be noted that the cracking pattern observed at the south end of the south wing was not pure shear as would be observed in well designed Chilean construction practice, but rather tension-type failure manifesting nearly horizontal crack patterns (Figure 7.37). For more information on the structural performance, refer to the EERI Reconnaissance Report.

Figure 7.37. Pavement buckling on the west side of the south wing (a) looking south and (b) looking north (note the utility settlement off to the left of the photograph and the diminishing intensity of damage to the structure, with greatest damage at south end – foreground of photograph) (S36.8205°, W73.0619°; 03/17/10).

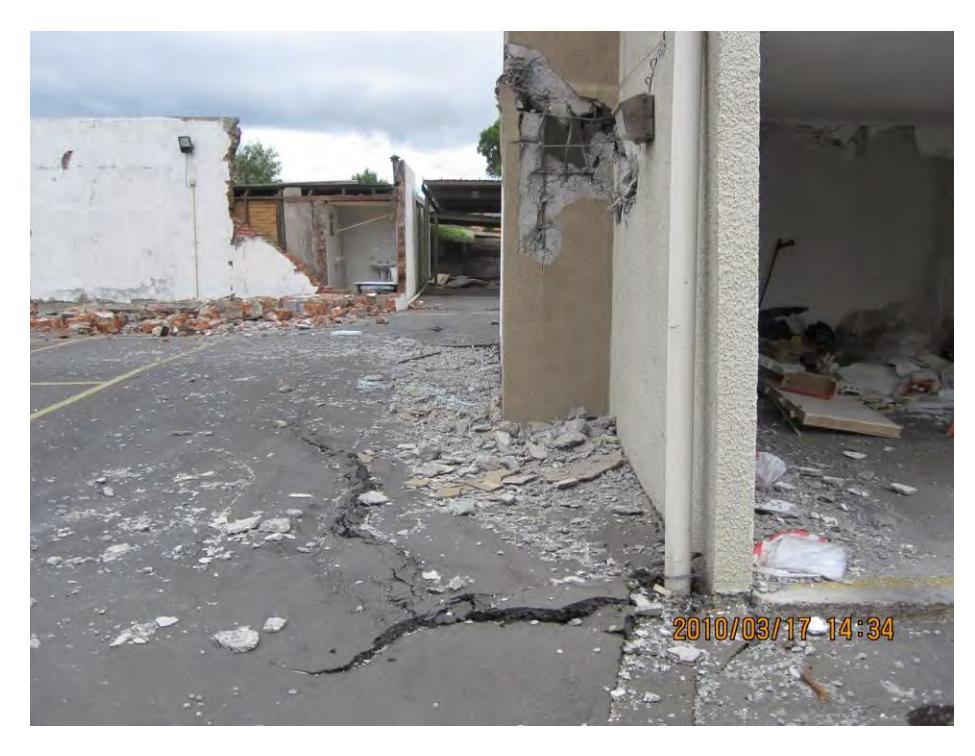
Figure 7.38. Pavement buckling on south side of south wing, view looking west (S36.8205°, W73.0619°; 03/17/10).
