# Geo-engineering Reconnaissance of the 2010 Maule, Chile Earthquake

Report of the NSF Sponsored GEER Association Team

# GEER Association Report No. GEER-022

Version 2: May 25, 2010

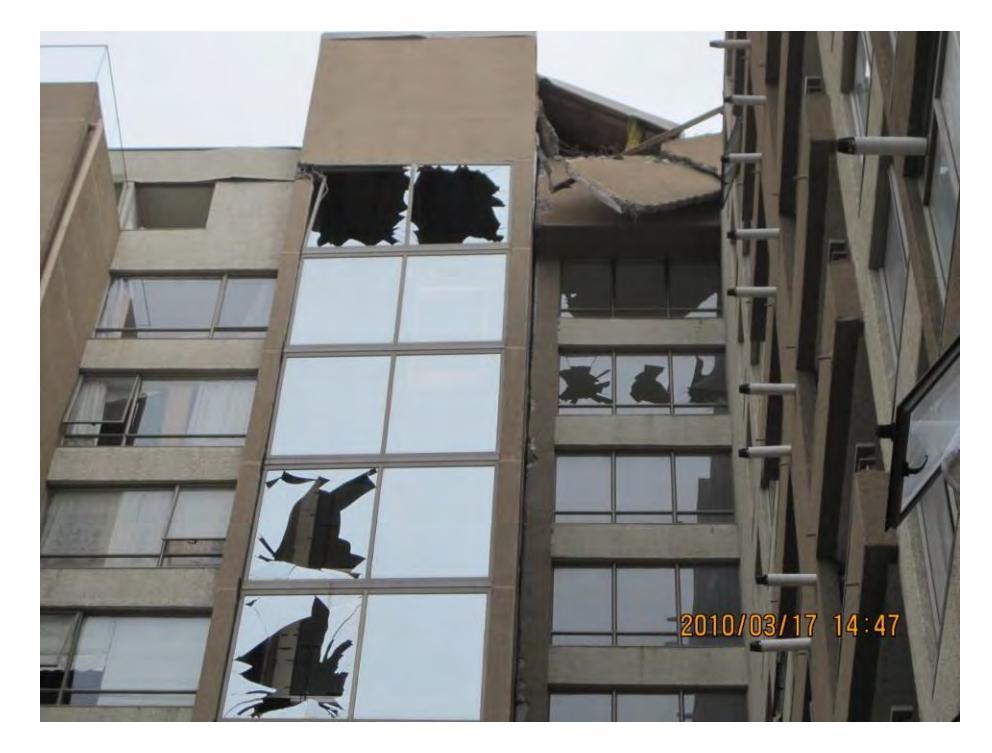
Figure 7.39. Interface between the north and south wings at the upper floors (north wing on right of photograph) showing evidence of minor pounding (view of east side, looking west) (\$36.8205°, W73.0619°; 03/17/10).

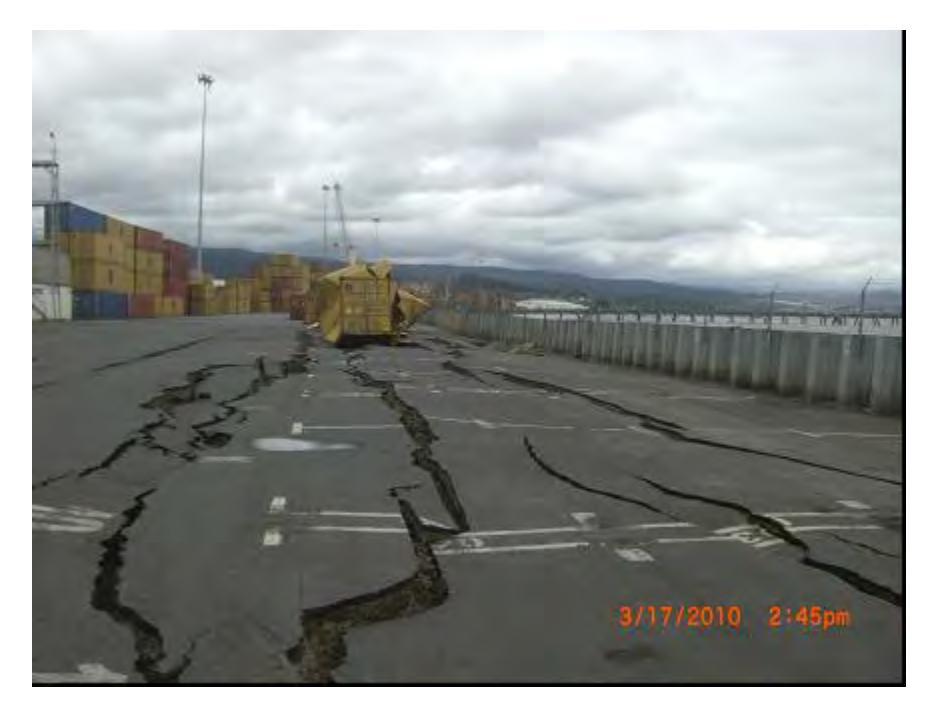
During the earthquake, about 10% of the cargo containers, which were typically stacked four high, fell over according to port personnel. In one case, the top two containers were ejected in front of the sheet pile wall, passing through the barbwire fence above the wall. The wrecked containers were subsequently recovered from the beach and brought back to the dock using a crane (Figs. 8.2, 8.3).

In addition, the port experienced significant lateral spreading as shown in Figs. 8.2, 8.3 which caused cracking to the pavement as shown in Figs. 8.2 and 8.3. Black sand ejecta obtained from cracks in the lateral spread was similar to that of the sand on the beach. The sand had a  $D_{50}$  size of 0.5 mm and a fines content of 2%. The sand classified as SP material based on the Unified Soil Classification System (USCS). Based on Google Earth<sup>TM</sup>, the slope of the beach at the port varies from 4 to 6 percent. Evidence of lateral spreading was greatest in the northern part of the port where the surface was paved with asphalt with a 0.2 m thick layer of compacted gravel fill. Movement was, naturally, less obvious in the southern part of the port where the surface was paved.

Figure 8.2. Photograph of lateral spread displacements at the Port of Coronel (S37.028680°, W73.150054°; 1445 hrs, 03/17/2010).

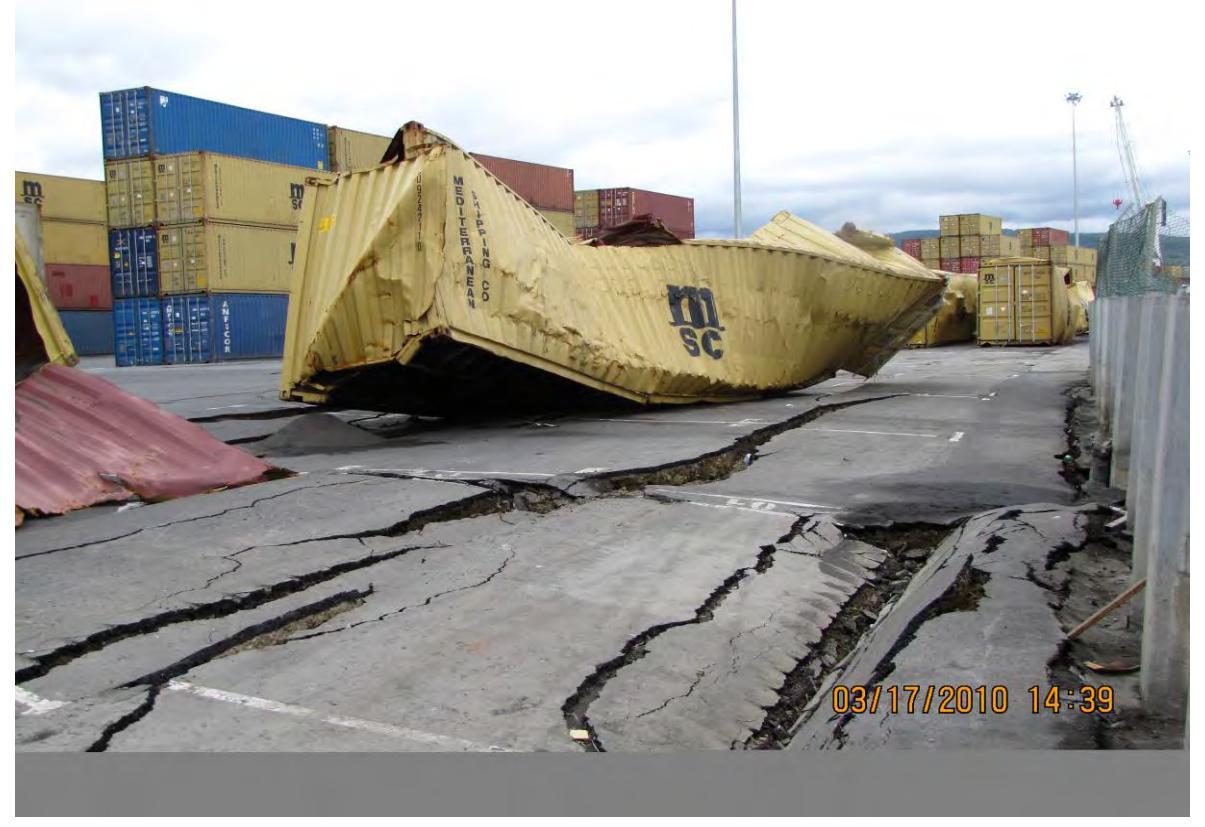
Figure 8.3. Photograph of lateral spread displacements at the Port of Coronel. The wrecked container was part of a stack and was ejected in front of the sheet pile wall, passing through the barbwire fence above the wall. It was subsequently recovered from the beach and brought back to the dock using a crane (S37.028680°, W73.150054°; 1440 hrs, 03/17/2010).

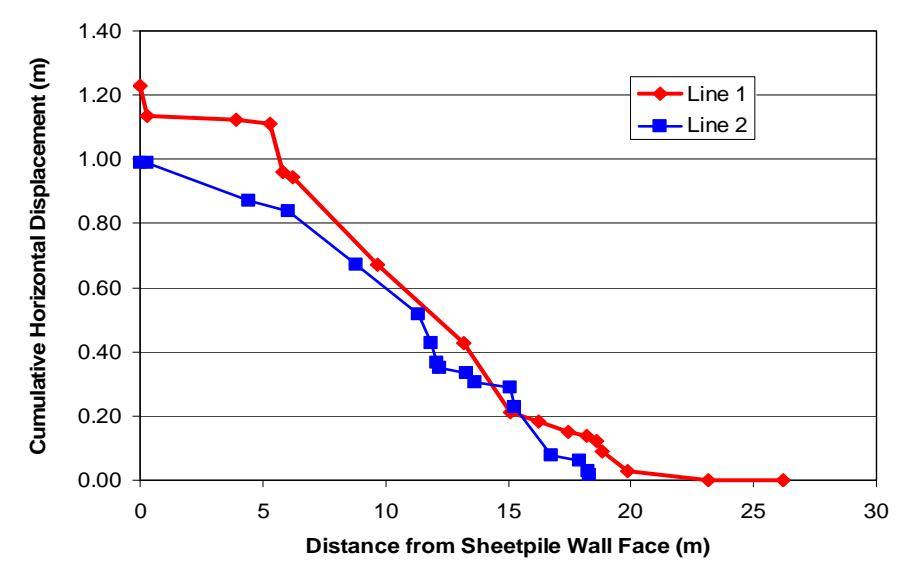
Measurements were made of the cumulative horizontal displacement behind the sheet pile wall by summing the crack widths in the pavement along two lines. The locations of the survey lines are shown in Fig. 8.1 and plots of the displacement vs. distance for each line are provided in Fig. 8.4. Maximum movement at the wall was between approximately 1 and 1.20 m and relatively little movement occurred beyond a distance of 25 m behind the wall.

Figure 8.4. Cumulative horizontal displacement vs. distance from the sheet pile face resulting from lateral spreading at the port of Coronel, Chile. (Rollins, Mylonakis, and Assimaki).

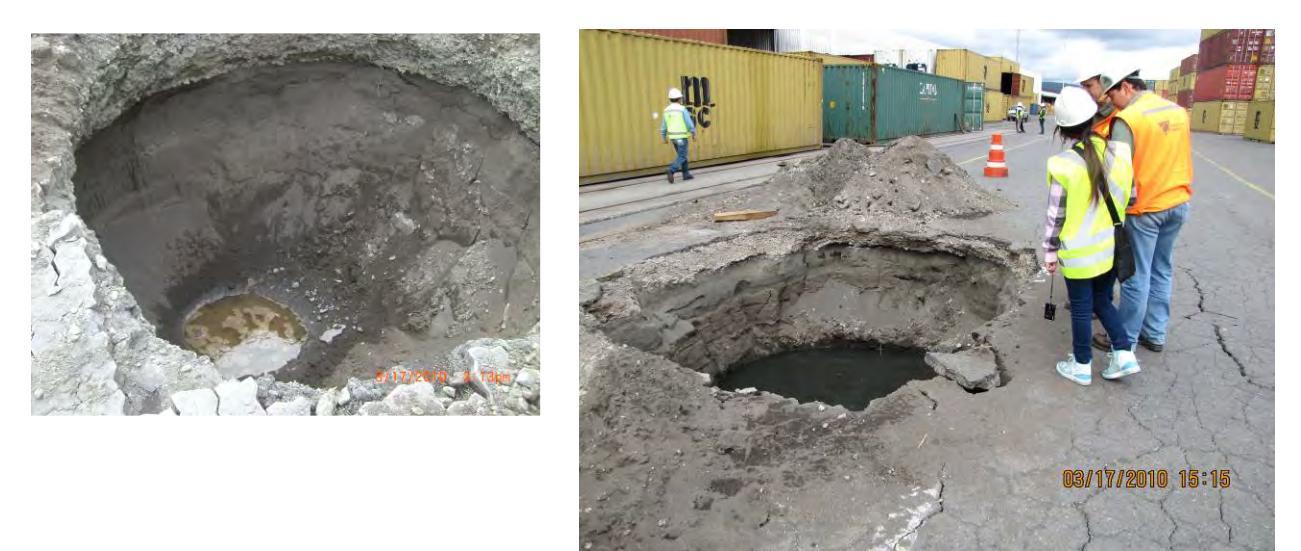
At least four large sinkholes developed at the port sometime after the earthquake. The sinkholes were typically about 3.5 m in diameter and extended to a depth of 2.2 to 2.4m as shown in Fig. 8.5. These dimensions are approximate, as some of the sinkholes were excavated after the earthquake. At the bottom of one hole a crack or gap in an underground pipeline could be observed as shown in the right photo of Fig. 8.5. Sand could flow into this gap eventually producing a cave-in at the ground surface. A major pipeline runs parallel to shore in the North-South direction. Secondary pipelines run perpendicular to the sheet-pile wall at a number of locations as highlighted in the photo in Fig. 8.6. These pipelines would be subjected to longitudinal strain due to lateral spreading which could cause distress to the pipes.

Figure 8.5. Development of sinkholes (2.2 m deep, 3.5 m diameter) as a result of crack (gap) in pipe (S37.0339°, W73.1467°; 1513 hrs, 03/17/2010).

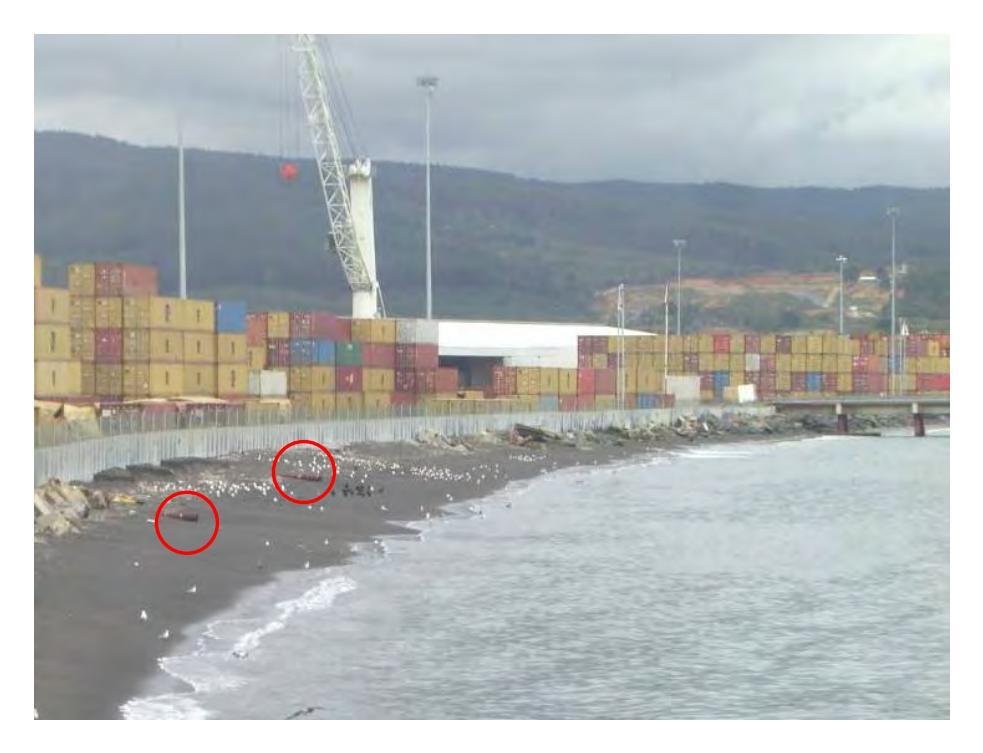
Figure 8.6. Pipelines running transverse to sheet-pile wall which were subjected to longitudinal strain due to lateral spreading (S37.028680°, W73.150054°; 1520 hrs, 03/17/2010).

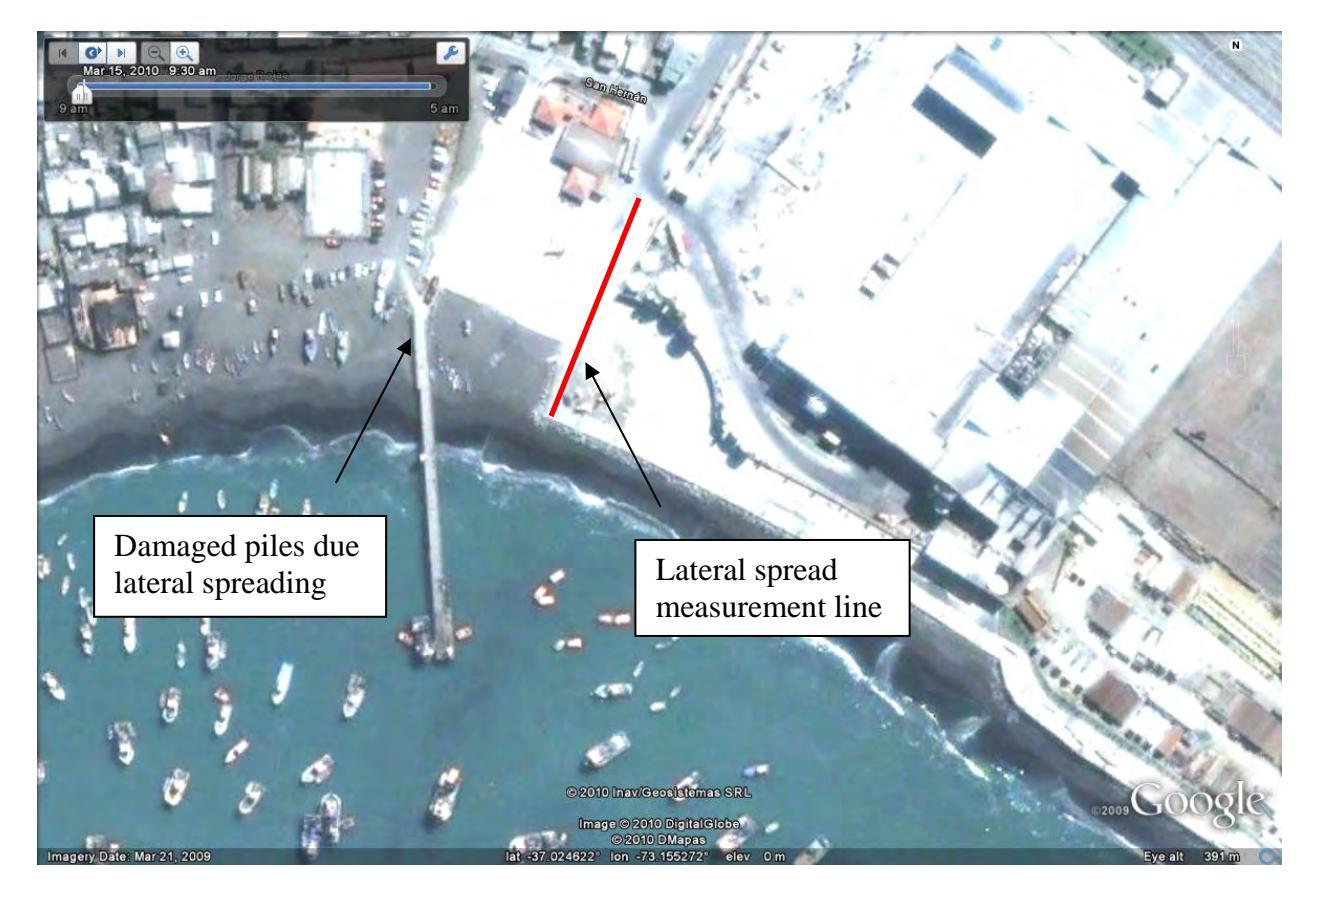
Figure 8.9. Location of lateral spread measurement line and damaged pile cap with battered piles supporting pier at fishermen port north of the main Port at Coronel (S37.024622°, W73.155272°).

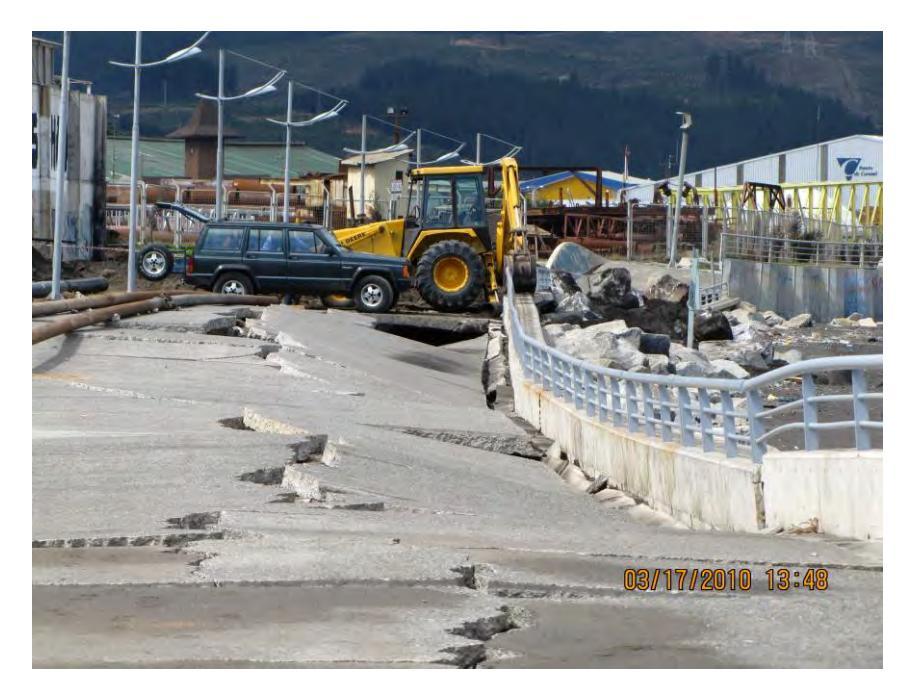
Figure 8.10. Photograph of lateral spreading which destroyed pavement and cracked walls at the fishermen's Port of Coronel (\$37.0247°, \$W73.1550°; 1348 hrs, 03/17/2010).

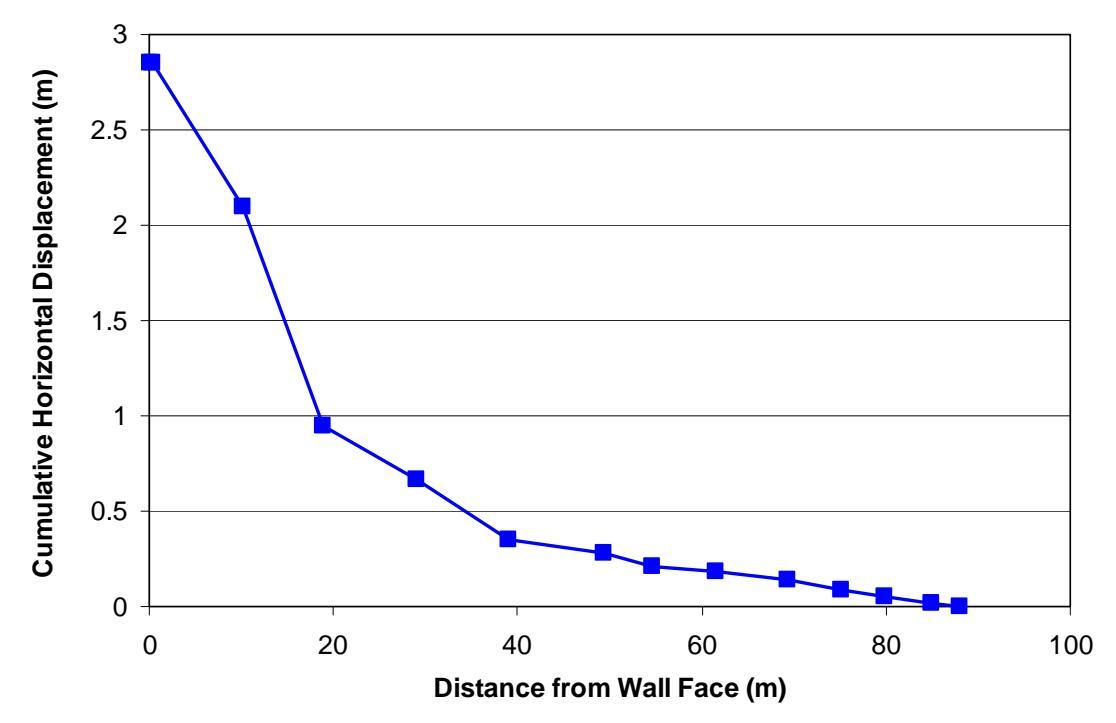
In a small fishing port located about 600 m north of the main port (37.024°, 73.156°), liquefactioninduced lateral spreading also produced significant damage to paved areas and a small pier extending 80 m into the ocean. An aerial view of the pier and the line along which displacement measurements were made is provided Fig. 8.9. A photograph of the damage to the pavement and adjacent wall produced by lateral spreading is shown in Fig. 8.10. Horizontal ground displacements were measured relative to a concrete wall on the beach as shown in Fig. 8.9 by summing crack widths in the concrete pavement. Maximum displacements reached nearly 3 m and movement extended about 90 m behind the wall (Fig. 8.11). Ground slope above water level at this location ranged from 3.5 to 5%.

Figure 8.11. Cumulative horizontal displacement vs. distance from wall face due to lateral spreading at Pier on small fishermen's port at north end of Port of Coronel. (Rollins, Mylonakis, and Assimaki).

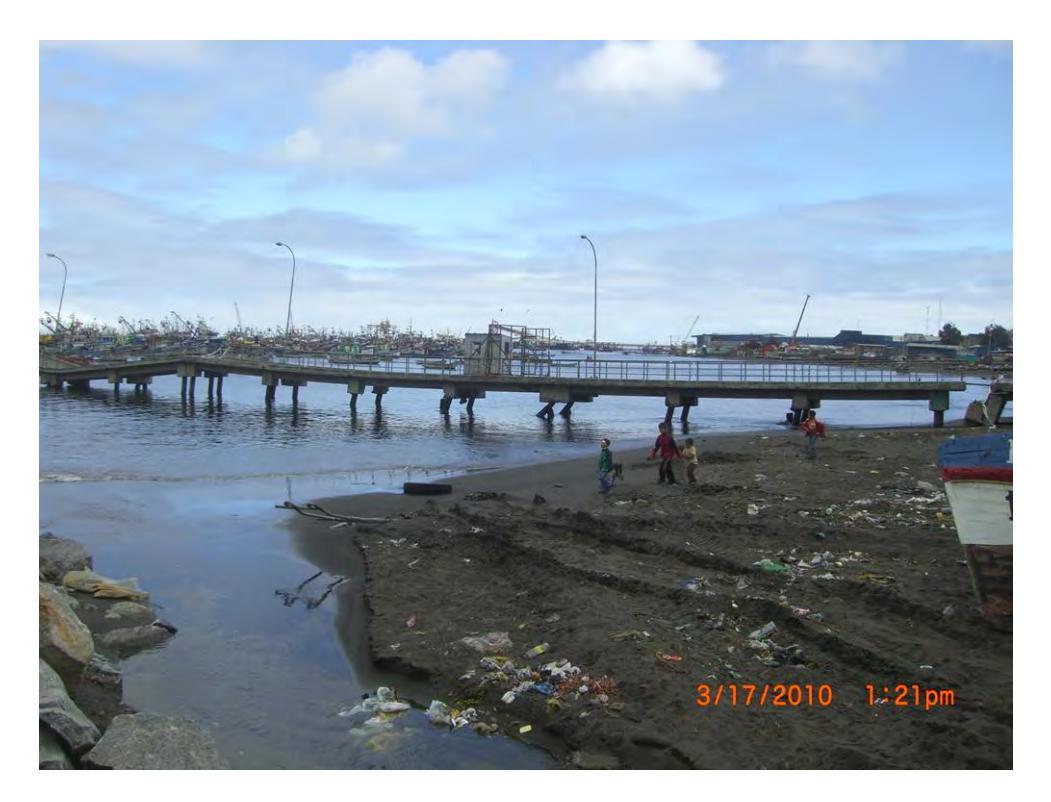
Damage to the pier, which was subjected to the 3 m measured previously, is shown in Fig. 8.12. The pier was pulled apart in the landward side with gaps of 0.5 and 1.1 m between two segments; however, at the seaward end, the pier appears to be in compression as no gaps were present and the pier appears to have moved upward relative to the rest of the pier. The pier was supported by a combination of battered piles and vertical piles. Battered piles were used on alternating supports along the pier. A photo of a pile cap supported by battered piles is provided in Fig. 8.13. Based on field measurements, the batter was approximately forward 20° for the seaward pile and backward 20° for the landward pile. A sketch of the pile cap before and after the earthquake is provided in Fig. 8.14. When subjected to the large lateral spread movements induced by earthquake, the leading row pile remained embedded in the cap, while the trailing row pile pulled out of the pile cap. Relative to the pile cap, the trailing row pile moved down 0.8 m and horizontally 0.3 m so that it was within 10 cm of impacting the leading row pile.

Figure 8.12. Damage to pile supported pier at small fishermen's Port of Coronel due to lateral spreading (\$37.024319°, W73.156210°; 1321 hrs, 03/17/2010).

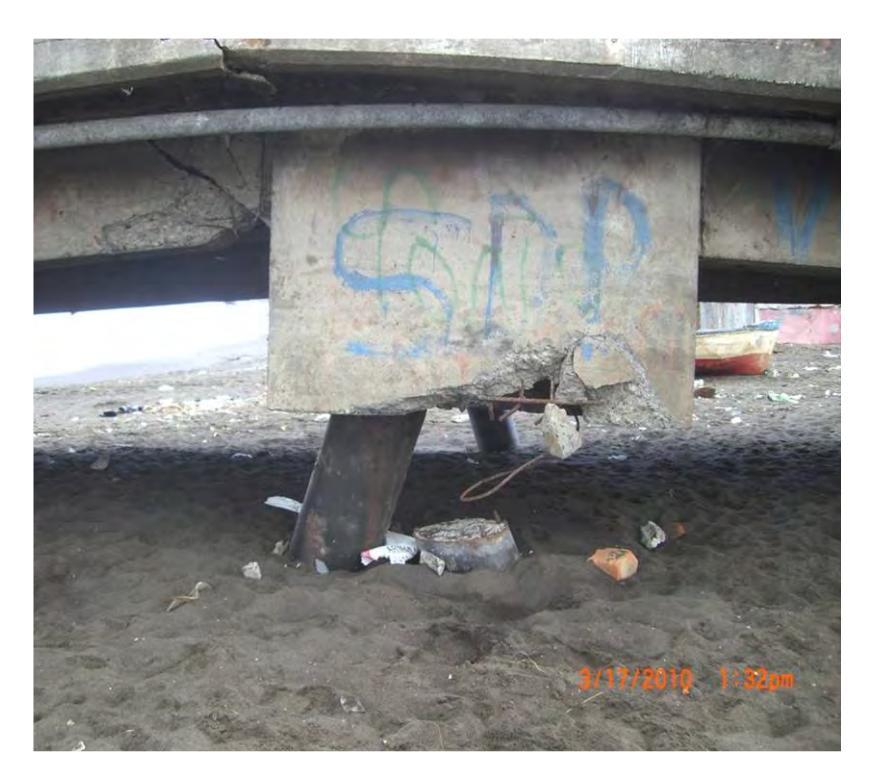
Figure 8.13. Photograph of pile cap with battered piles supporting pier at small fishermen's Port of Coronel showing pull out of trailing row piles (S37.024319°, W73.156210°; 1322 hrs, 03/17/2010).

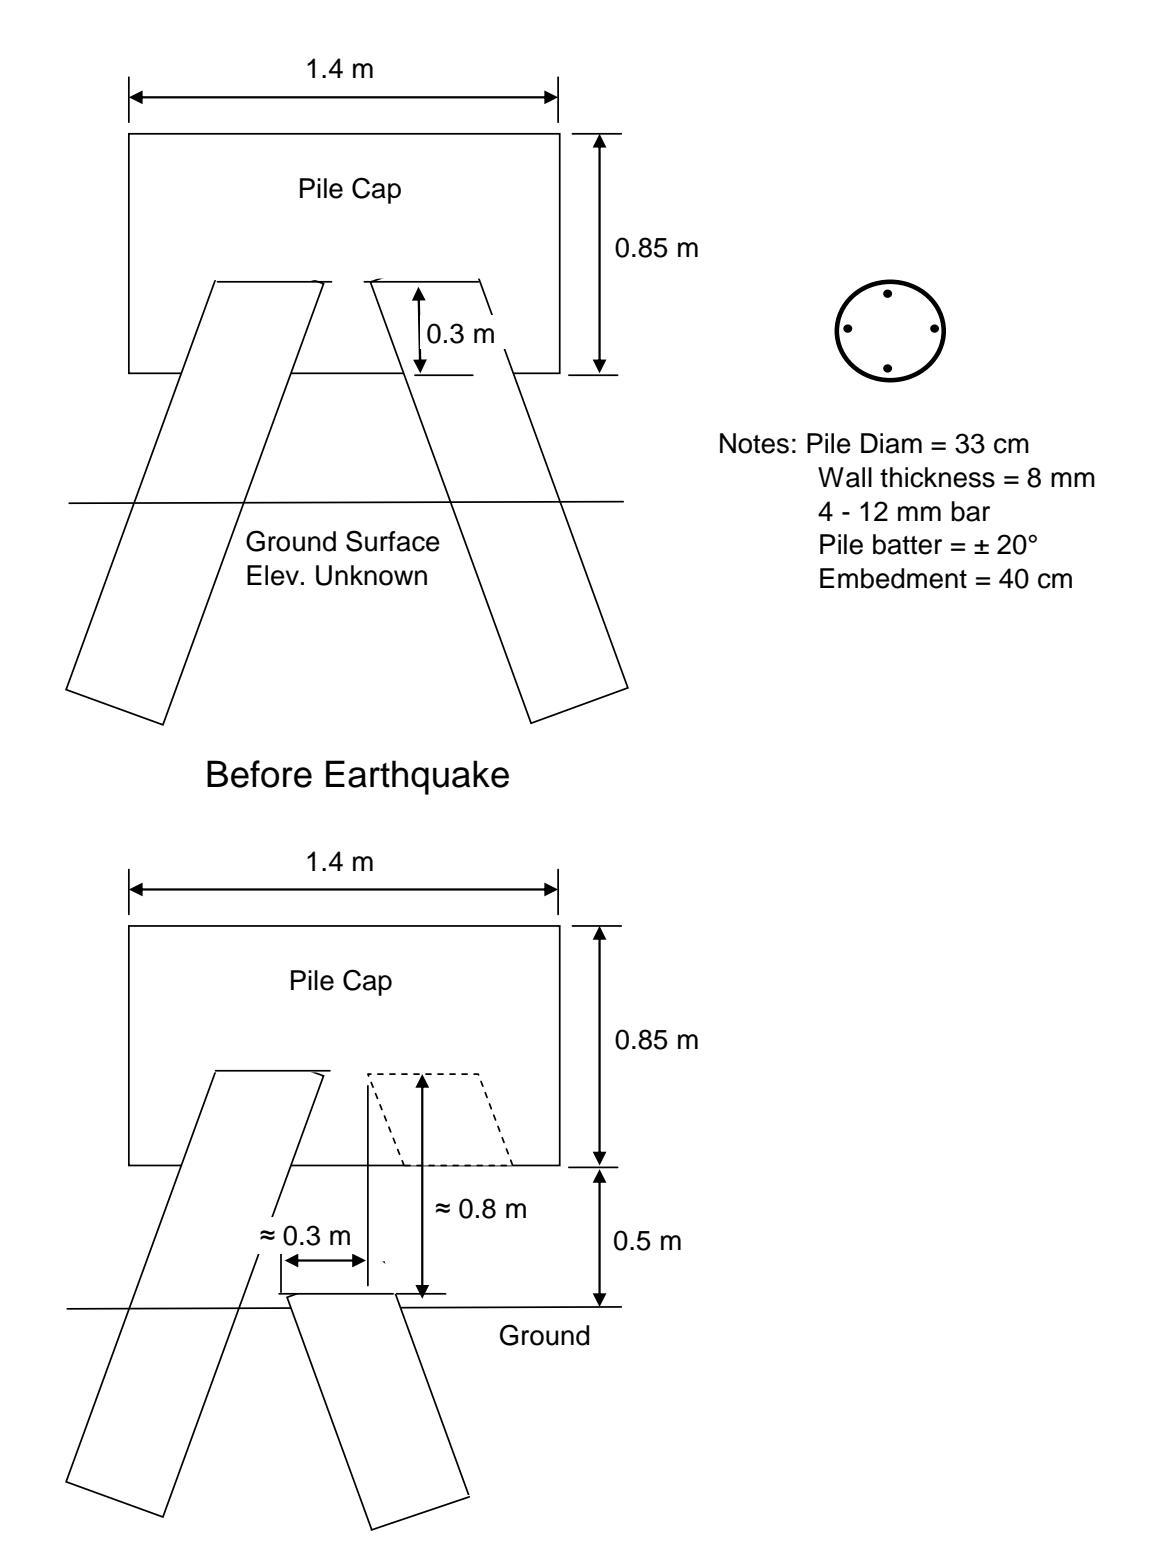
Figure 8.14. Measurements of pile cap with battered piles supporting pier at small fishermen's Port of Coronel before and after lateral spreading. (Rollins, Mylonakis, and Assimaki).

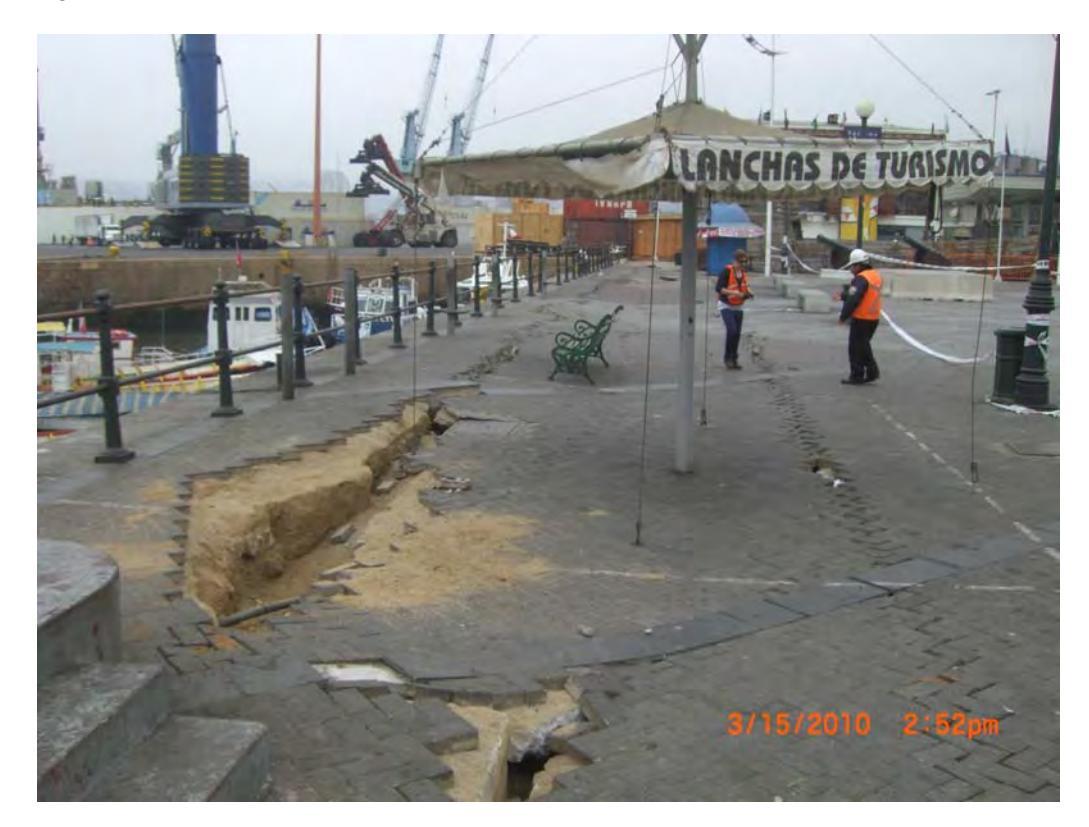
The public dock consists of a concrete-block gravity wall about 1m thick which extends about 5.5 m above water level. No sand boils were observed at the site, so it is not possible to determine if the movement was a result of liquefaction or simply lateral pressure on the wall. Outward movement of the wall led to settlement of about 20cm in a section behind the wall as shown in the figure. A plot of cumulative horizontal displacement vs. distance behind the wall is provided in Fig. 8.17.

Figure 8.16. Photograph of lateral movement and vertical displacement of ground behind public dock at port of Valparaiso (S33.0375°, W71.6274°; 1452 hrs, 03/15/2010).

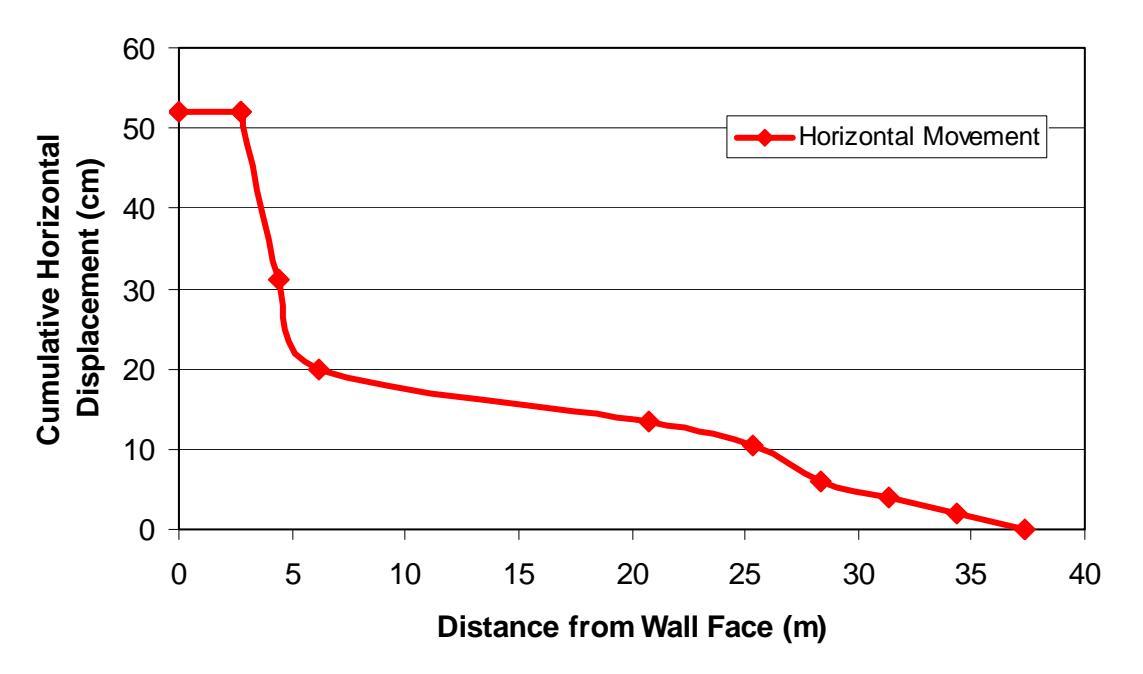
Figure 8.17. Plot of cumulative horizontal displacement vs. distance from free-face. (Rollins, Assimaki and Mylonakis).

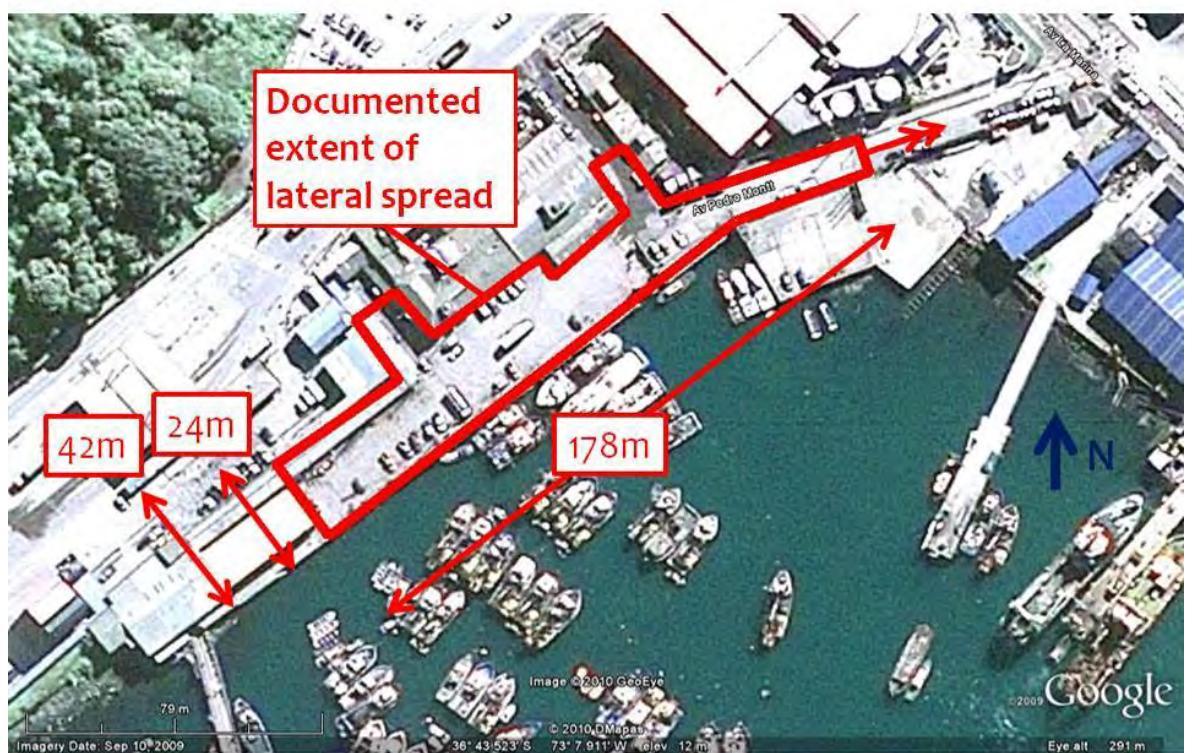
Figure 8.21. Lateral spread at fishing wharf area (S36.7252°, W73.1320°) denoted by red boundary. Note that spread likely continued to the East of the area documented.

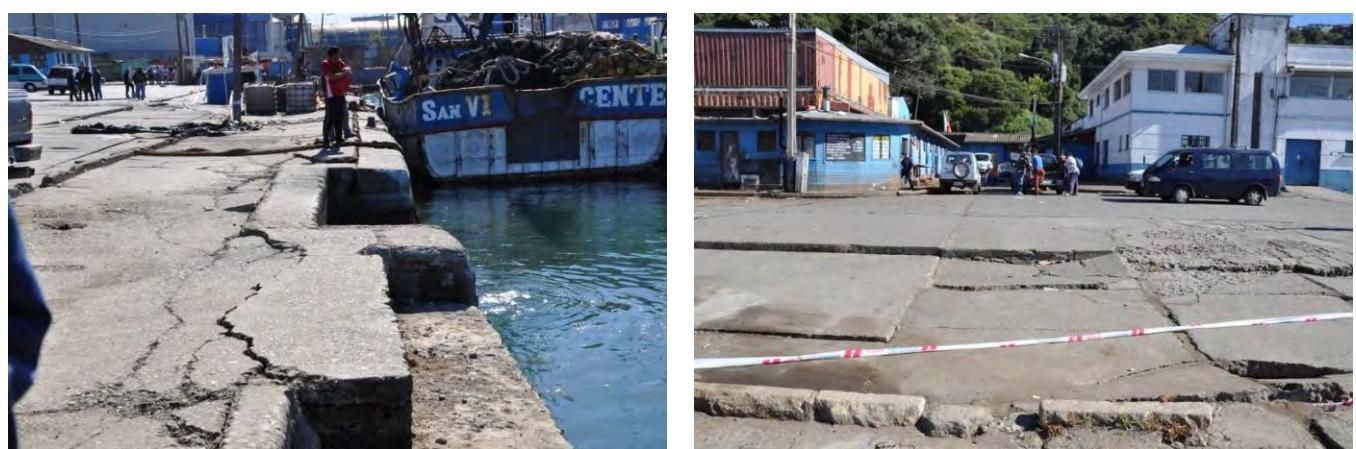
Figure 8.22. Photographs of lateral spread at fishing wharf (1110 hrs, 03/15/2010).

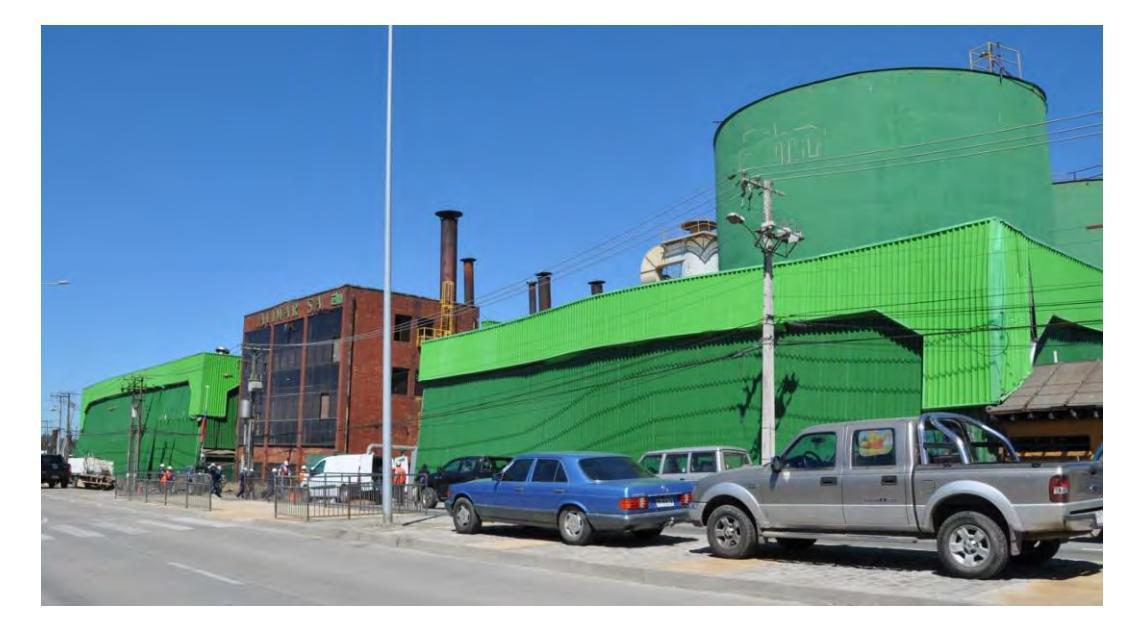
Figure 8.23. Damage to fish packaging facility (S36.7260°, W73.1288°; 1356 hrs, 03/15/2010).

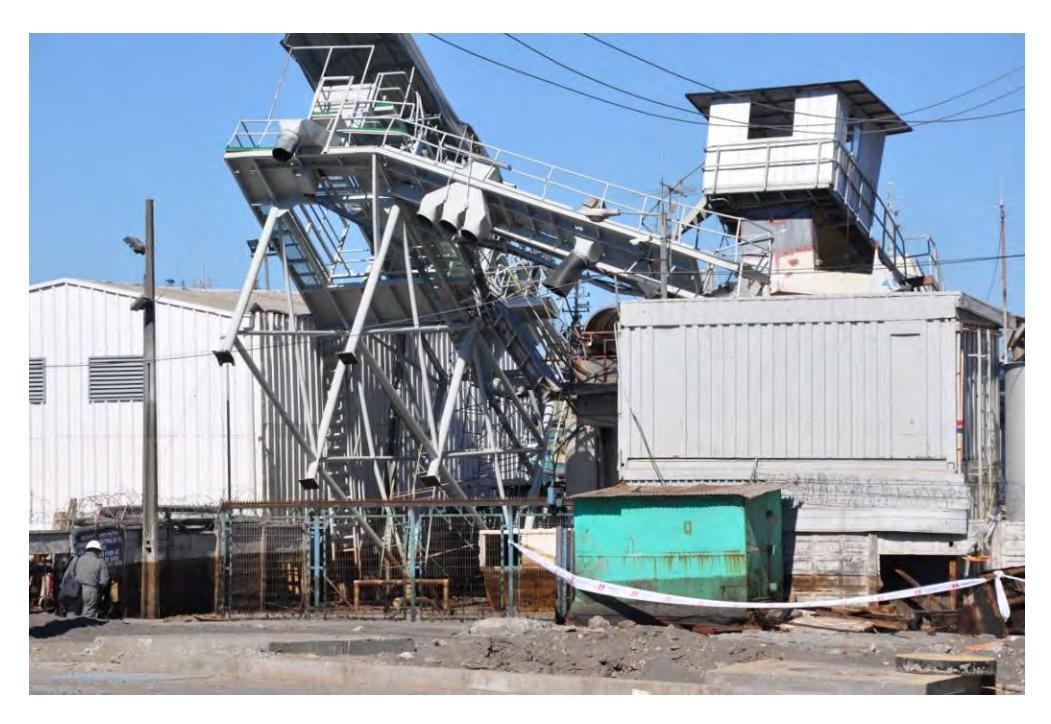
Figure 8.27. Damage to structures neighboring the fish packaging facility (S36.7267°, W73.1282°; 1200 hrs, 03/15/2010). Note the scum level at the base of the structure of approximately 1-2 m evidence of the water rise.

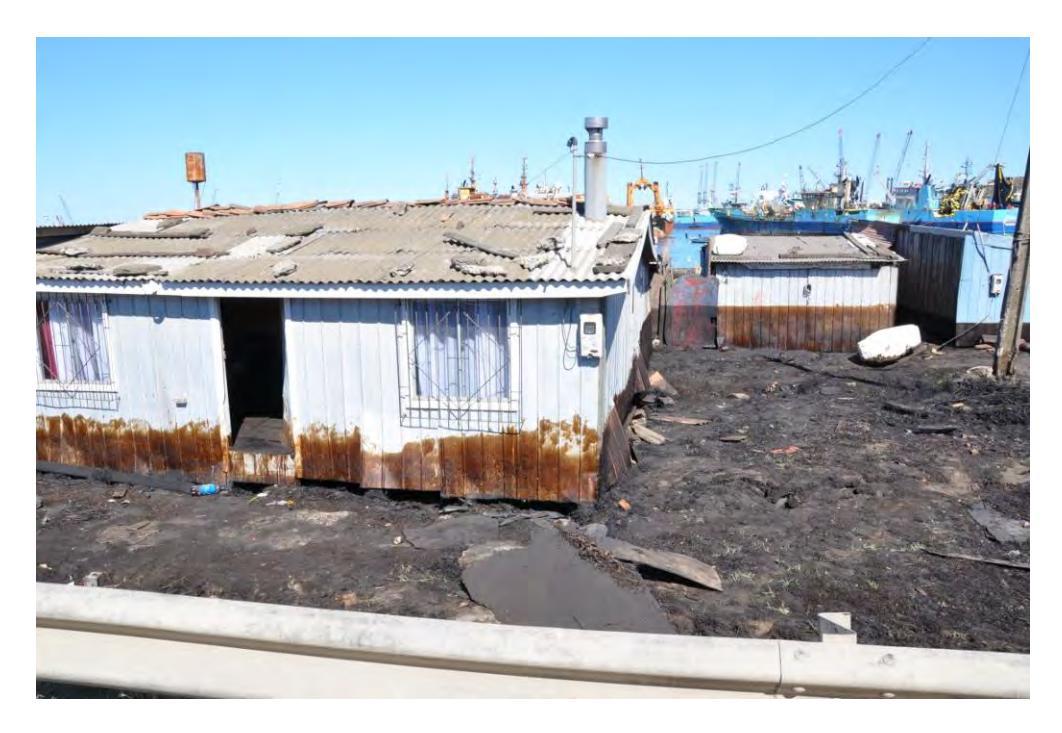
Figure 8.28. Evidence of water level rise at port area – neighboring fish packaging facility (\$36.7267°, \$W73.1282°; 1200 hrs, 03/15/2010).

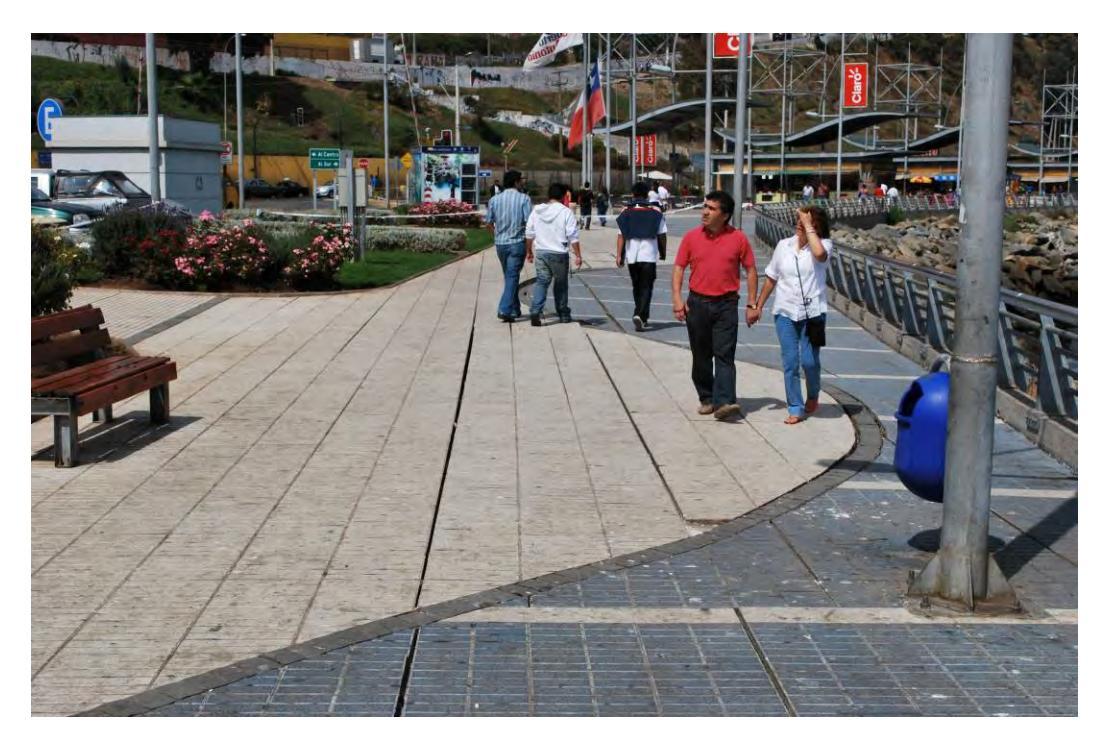
Surprisingly, despite the magnitude of the Feb 27, 2010 event, little damage was observed in the port. Indeed, with the exception on several minor cracks measuring no more than 5cm on the asphalt pavement behind the quay wall (Figs. 8.31, 8.32) and some rock falls (Fig 8.33), most of the port appears to be undamaged. No surface evidence of soil liquefaction was observed. The satisfactory performance is attributed to the reconstruction of 1992-1997.

Figure 8.32. Cracks on brick pavement behind quay wall in San Antonio Port (S33.5830°, W71.6138°; 1432 hrs, 03/14/2010).

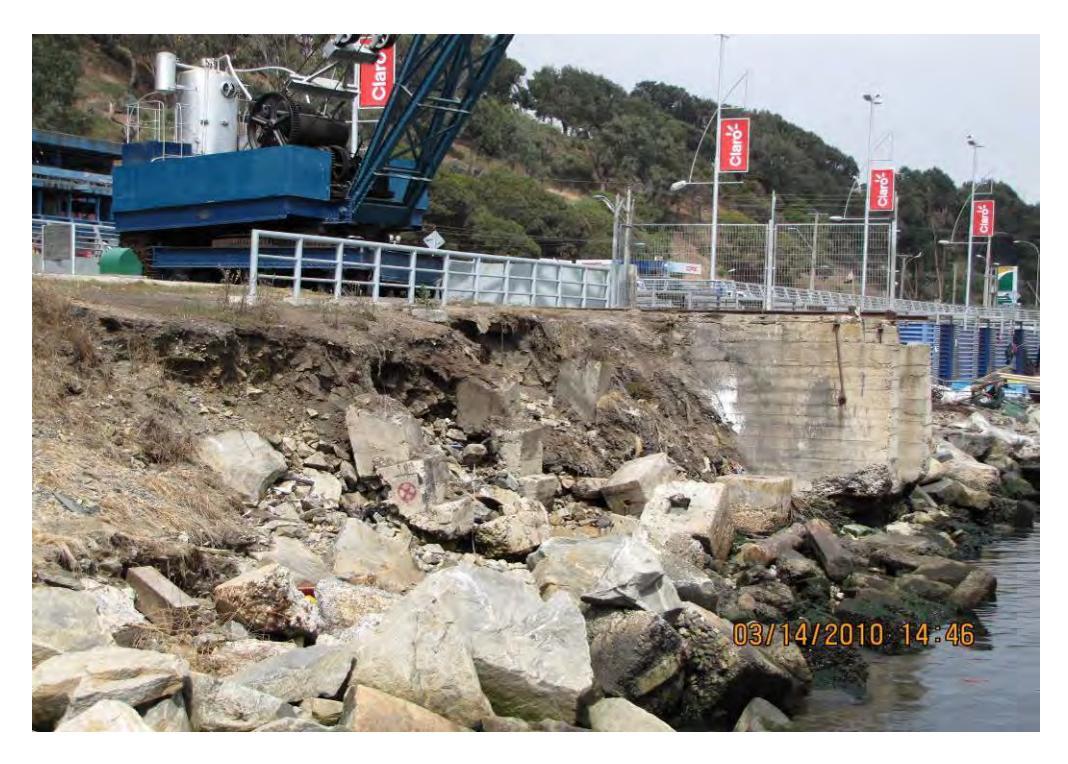
Figure 8.33. Rockfalls in San Antonio Port (S33.587°, W71.613°; 1446 hrs, 03/14/2010).

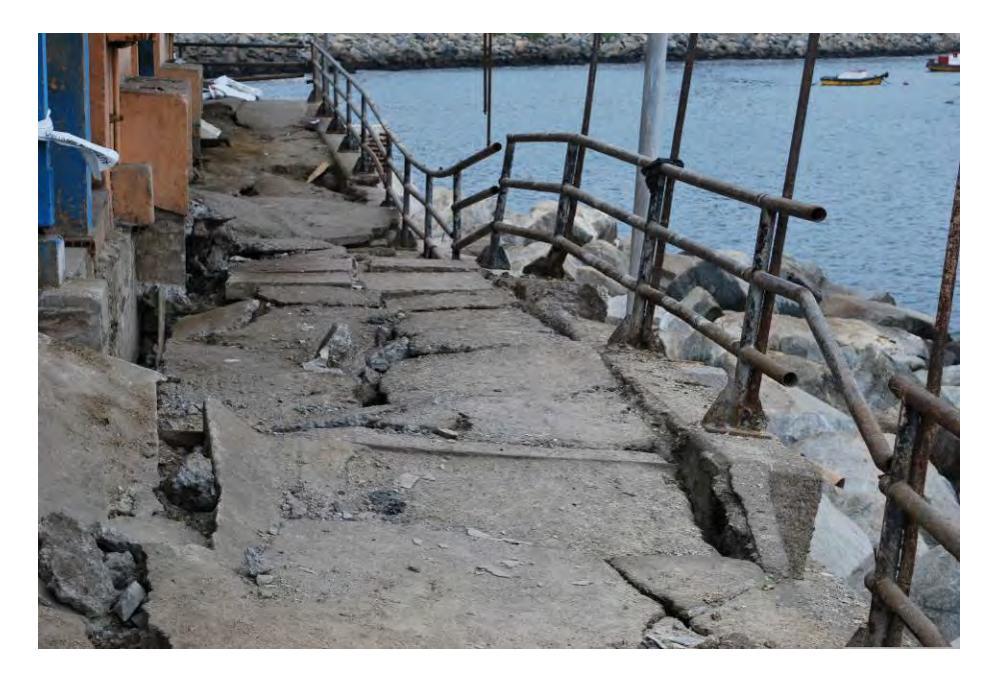
Notable exceptions are an old dock (apparently not part of the reconstruction) which suffered very severe damage (Fig. 8.34) and a wharf structure supported on combinations of vertical and raked steel piles. Displacements in excess of 1m were observed (Fig. 8.35) leading to failure of the connections at the pile heads (Fig. 8.36). The settlement of the piles – a consequence of liquefaction - is also evident the figure.

Figure 8.34. Severely damaged old dock in San Antonio Port (S33.5817°, W71.6154°; 1448 hrs, 03/14/2010).

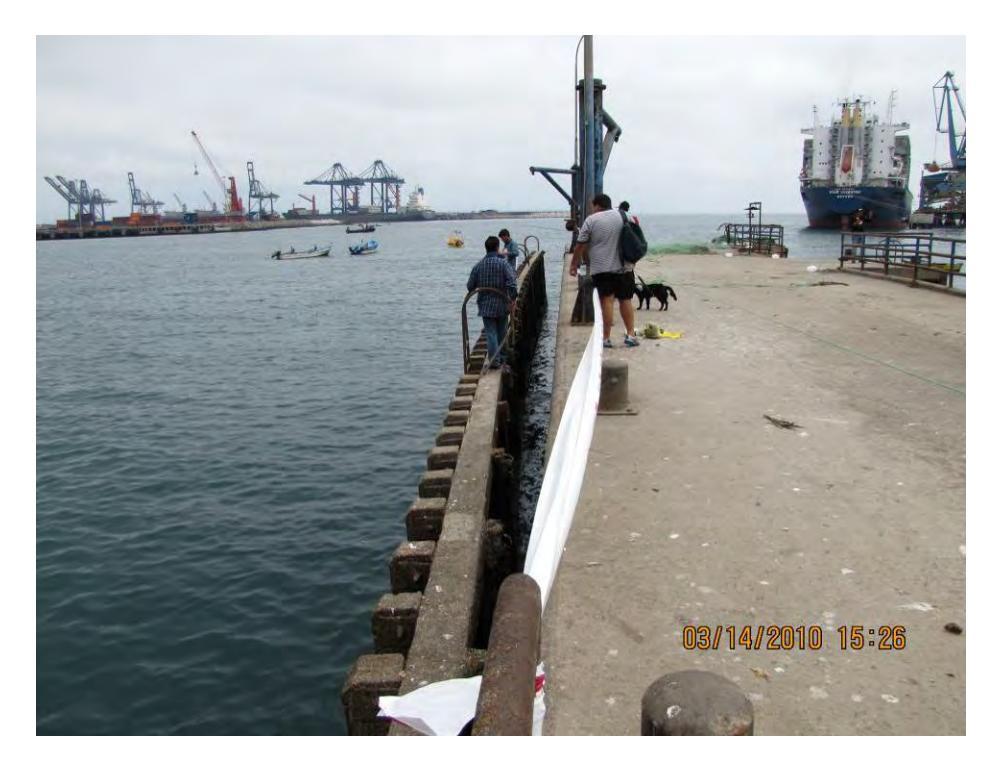
Figure 8.35. Separation from lateral pile screen of wharf structure in San Antonio Port (S33.5817°, W71.6154°; 1526 hrs, 03/14/2010).

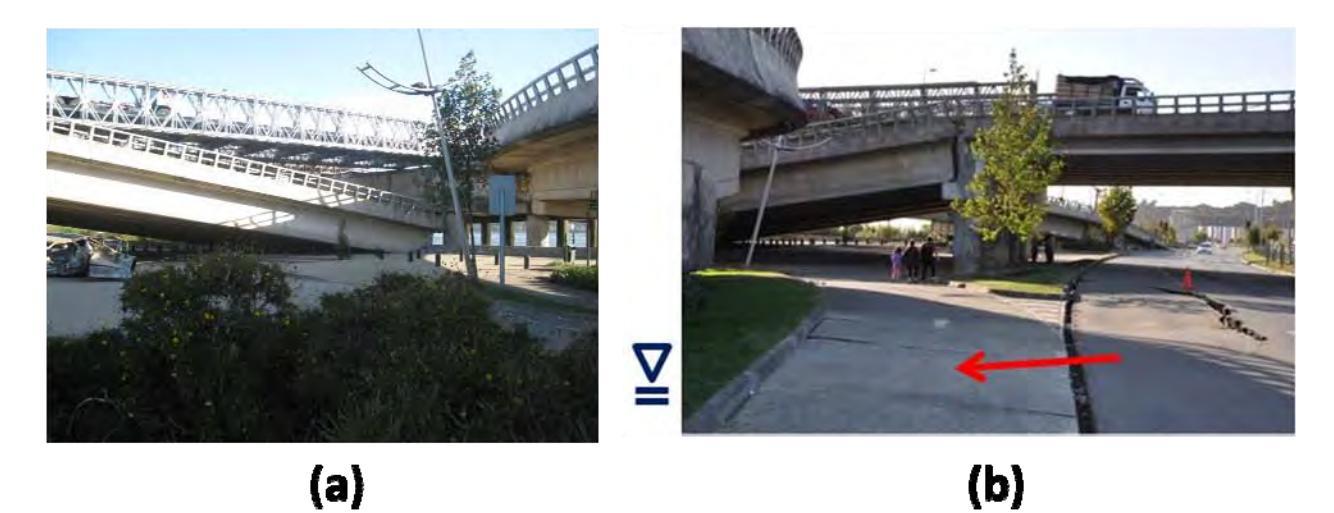
The Llacolén Bridge in Concepción was constructed in 2000 and spans 2,160 m across the Bio Bio river supporting four lanes of vehicular as well as pedestrian access to downtown Concepción (Figure 9.1). During the earthquake the north approach (S36.830108°; W73.067991°) suffered deck unseating and lateral spreading shore (Figure 9.2). Ground damage at this approach was observed to extend inland into the southbound traffic lane of Calle Nueva road and south below the bridge's exit ramp continuing along a pedestrian walkway (Figure 9.4). Calle Nueva parallels the coastline and runs under the approach to the bridge. The lateral spreading ground resulted in unseating of the west and east bound traffic support deck (Figure 9.5). Flexural cracks on the river-side face of the 1.5 m diameter support columns were observed near the ground surface typically tightly spaced at approximately 0.10-0.20 m on center (Figure 9.6). The distribution of flexural cracking was more severe for those columns supporting the unseated deck, however, all columns at the north shoreline support observed flexural cracking at their construction joint (between 2-2.5m above ground surface). Ground settlement of 0.25-0.30 m was also noted to surround each of the exit ramp bents (Figure 9.7).

Figure 9.5. Deck unseating at Llacolén bridge in Concepción. (note the temporary deck supporting approach traffic). View South (S36.829707°, W73.068220°, 1809 hrs on 3/14/2010) and (b) view north (S36.830380°, W73.067541°, 1911 hrs on 3/14/2010).
