# Geo-engineering Reconnaissance of the 2010 Maule, Chile Earthquake

Report of the NSF Sponsored GEER Association Team

# GEER Association Report No. GEER-022

Version 2: May 25, 2010

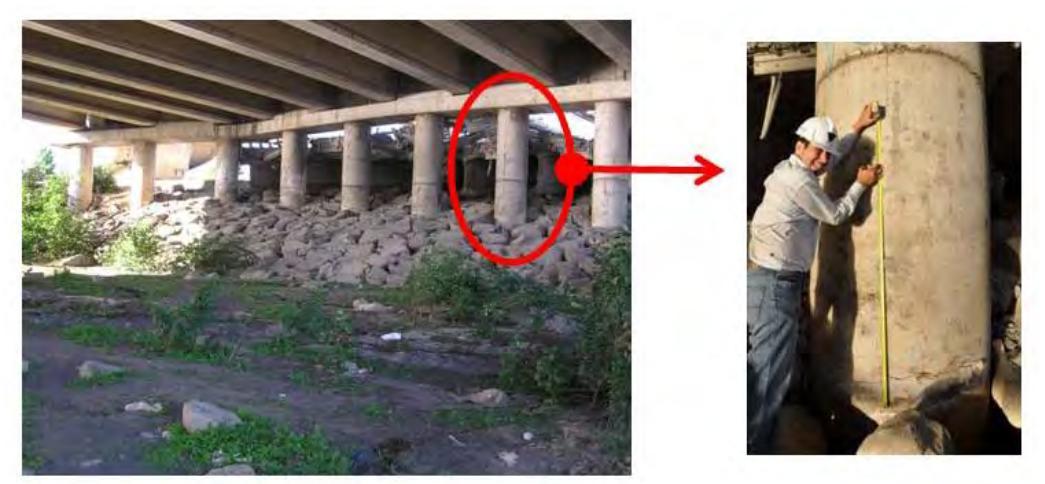
Figure 9.6. Substructure of the north approach at the damaged Llacolén bridge in Concepción showing the unseated deck in the foreground. Flexural cracking of the column supports was observed at ground level and extending to the construction joint (2-2.5m above groun

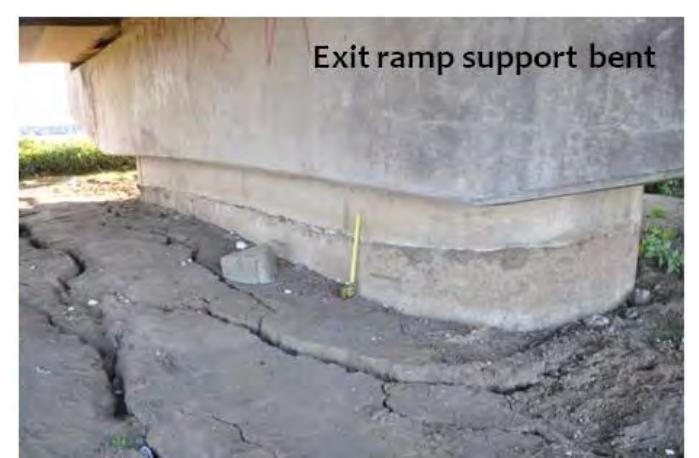
The Llacolén Bridge in Concepción was constructed in 2000 and spans 2,160 m across the Bio Bio river supporting four lanes of vehicular as well as pedestrian access to downtown Concepción (Figure 9.1). During the earthquake the north approach (S36.830108°; W73.067991°) suffered deck unseating and lateral spreading shore (Figure 9.2). Ground damage at this approach was observed to extend inland into the southbound traffic lane of Calle Nueva road and south below the bridge's exit ramp continuing along a pedestrian walkway (Figure 9.4). Calle Nueva parallels the coastline and runs under the approach to the bridge. The lateral spreading ground resulted in unseating of the west and east bound traffic support deck (Figure 9.5). Flexural cracks on the river-side face of the 1.5 m diameter support columns were observed near the ground surface typically tightly spaced at approximately 0.10-0.20 m on center (Figure 9.6). The distribution of flexural cracking was more severe for those columns supporting the unseated deck, however, all columns at the north shoreline support observed flexural cracking at their construction joint (between 2-2.5m above ground surface). Ground settlement of 0.25-0.30 m was also noted to surround each of the exit ramp bents (Figure 9.7).

Figure 9.7. Ground settlement surrounding an exit ramp support bent at the Llacolén bridge in Concepción (S36.830380°, W73.067541°, 1901 hrs. on 3/14/2010).

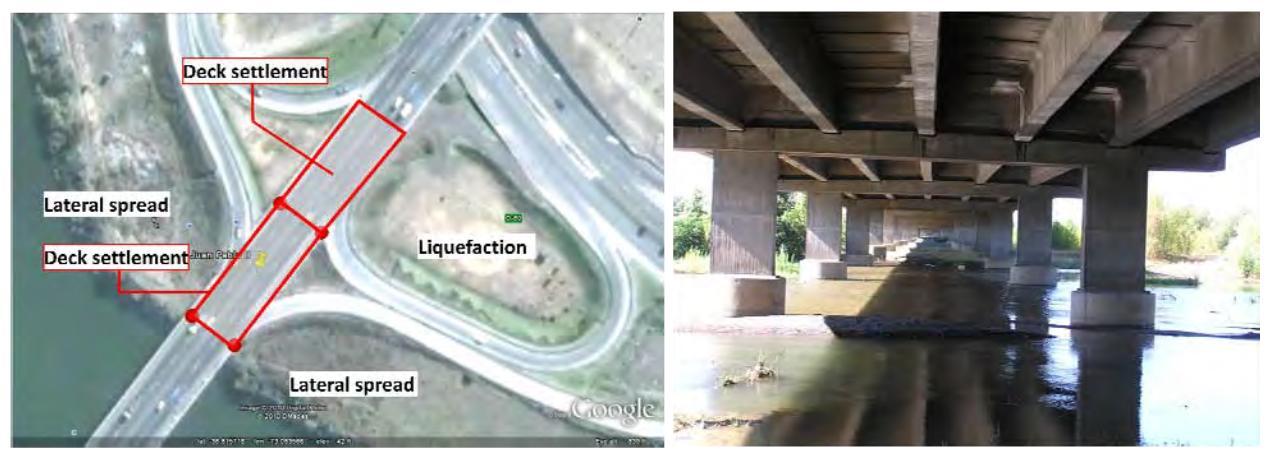
During the 2010 Chile earthquake, the bridge suffered severe damage and was closed to the public. Evidence of liquefaction and lateral spreading was observed in the north-east approach with significant effects on the bridge. A Google Earth view of in Figure 9.9a and Figure 9.9b. As shown in the northeast approach with schematics of the observed ground failure and structural effects is shown Figure 9.11, liquefaction of the soil and lateral spreading in the embankment contributed to settlements and lateral displacement of the bridge deck. Visual inspection of the surrounding soils indicated the presence of fine loose sands. Several sand ejecta features were observed near the structure on the south and north sides of the embankment as shown in Figure 9.12. Several samples of the ejected soil were taken at this site, and grain size analysis and Atterberg limit testing are being performed. The results of this testing will be included in later versions of this report.

Figure 9.9. Juan Pablo II Bridge (a) Google Earth view of northeast Approach with schematics of observed damage (S36.815864° W73.083674°) (b) Typical bridge bent configuration (S36.828181° W73.095850°; 1636 hrs on 3/15/2010).

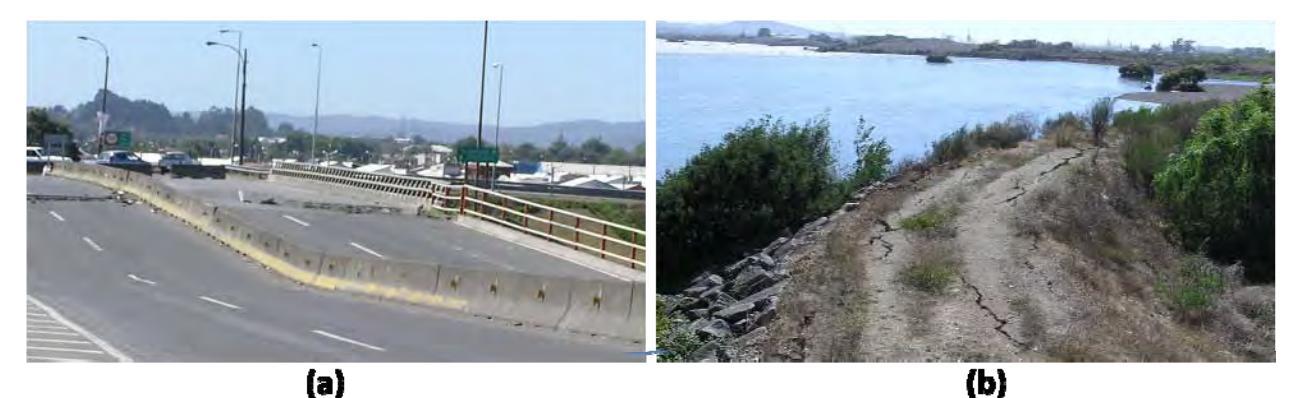
Figure 9.10. Juan Pablo II northeast approach: (a) Settlement of bridge deck near bridge approach (S36.815900° W73.084064°; 1455 hrs on 3/15/2010), (b) Lateral spreading on northeast bridge abutment.

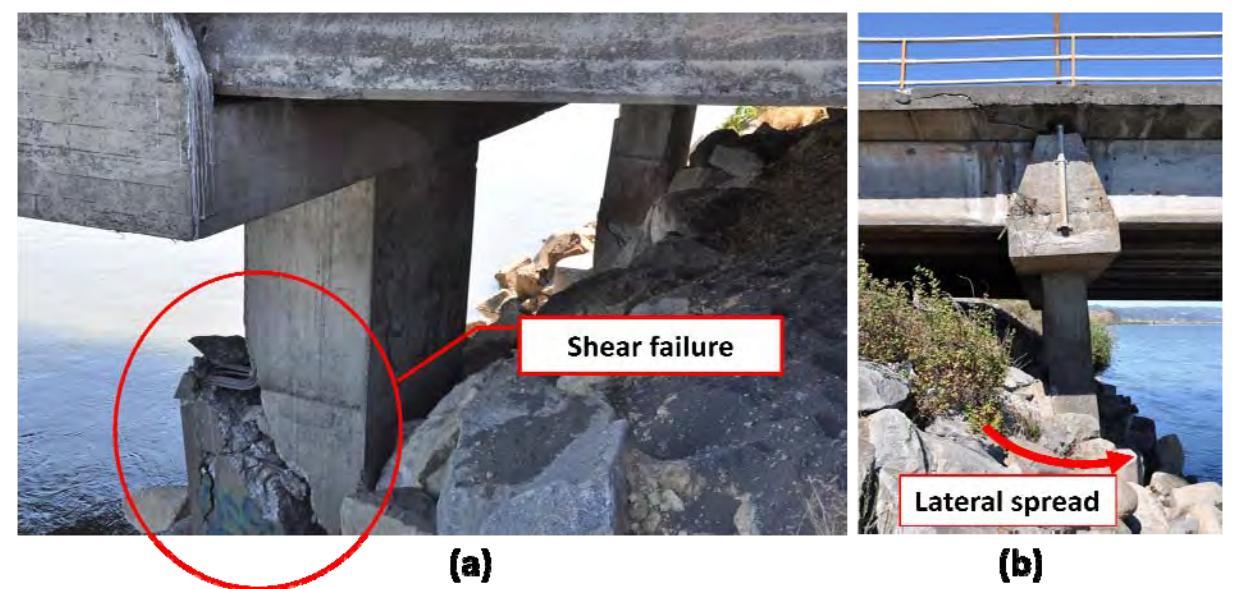
Column shear failure and significant displacements and rotation of the bridge bent were observed on the north-east approach Figure 9.11(a) shows shear failure of the column facing the bent's south side. The north column, shown in Figure 9.11(b), indicates evidence of tension cracks and rotation and also suffered shear failure. In contrast with the damage observed at the northeast approach to the bridge, the southwest approach suffered minor damage.

Figure 9.11. Juan Pablo II northeast approach: (a) Column shear failure (S36.816233 W73.084144°; 1528 hrs on 3/15/2010) (b) Rotation and lateral displacement of bridge bent (S36.816233° W73.084144°; 1530 hrs on 3/15/2010)

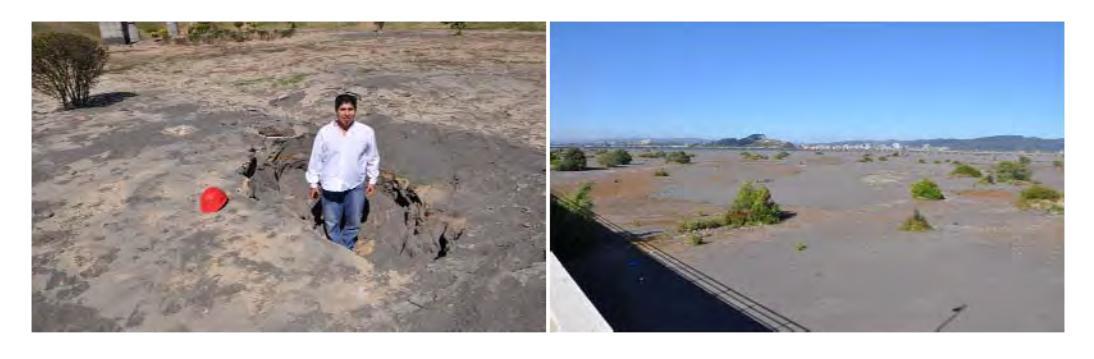
Noticeable pier settlements were observed at several locations along the length of the bridge. Vertical settlements appeared to be due to liquefaction of the soil near the pier foundations. Visual inspection of the surrounding soils indicated the presence of loose sands near the surface. Although the Bio Bio River was once navigable by ship up to the City of Nacimiento over-logging during the twentieth century has led to heavy erosion that has choked the river with silt and rendered it impossible to ship traffic. Near Concepción the river behaves as a meandering river with fine-grained material deposited on the floodplains. The GEER team identified several sand boils near the approaches (e.g. Figure 9.12a) and

along the bridge spans (in sections not covered by water). The presence of fine material is clearly shown in Figure 9.12(b).

Figure 9.12. Juan Pablo II bridge: (a) Sand ejecta near northeast approach and (S36.815619° W73.083311°; 1522 hrs on 3/15/2010) (b) Fine-grained material in the floodplains (S36.825592° W73.093264° on 3/15/2010).

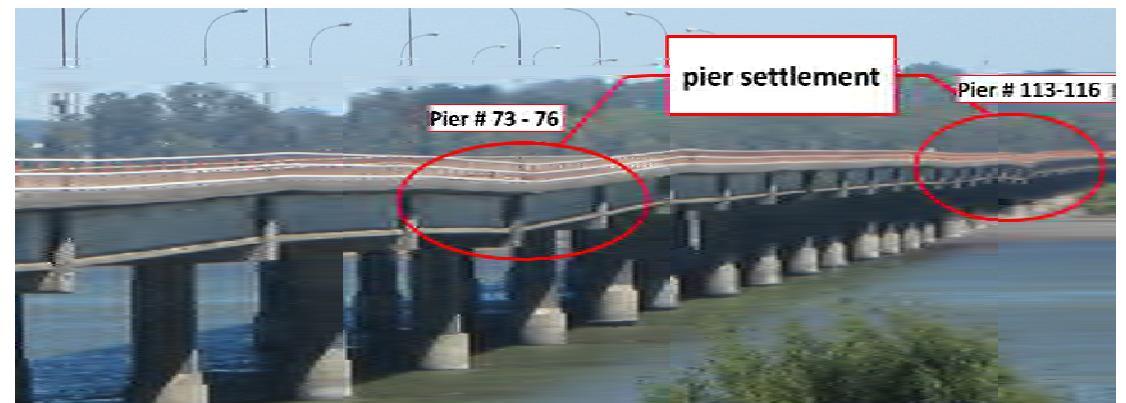
Settlements on the order of 0.50 m to 0.70 m were observed in piers #73-76 and piers #113-116 as indicated in Figure 9.13 (odd numbers for piers on the north side and even numbers for piers on the south side). The bridge deck accommodated these settlements with large vertical deformations and relatively minor damage of the asphaltic layer. This is observed in Figure 9.14(b). Settlements of piers #73, 75, 113 and 115 on the south side were larger than those of piers #74, 76, 114, and 116 on the north side indicating rotation of the bridge bents.

Figure 9.13. Juan Pablo II bridge - Pier settlements (S36.815122° W73.084369°; 1453 hrs on 3/15/2010)

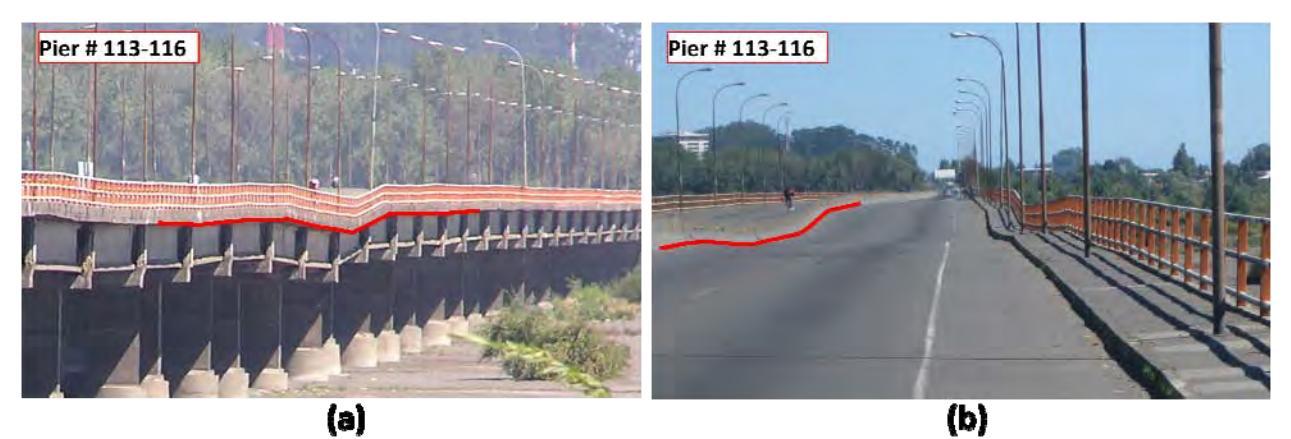
Figure 9.14. Juan Pablo II bridge (a) View of bridge bent settlement (S36.826596° W73.094345° on 3/15/2010)(b) View of bridge deck settlement (S36.826596° W73.094345° on 3/15/2010)

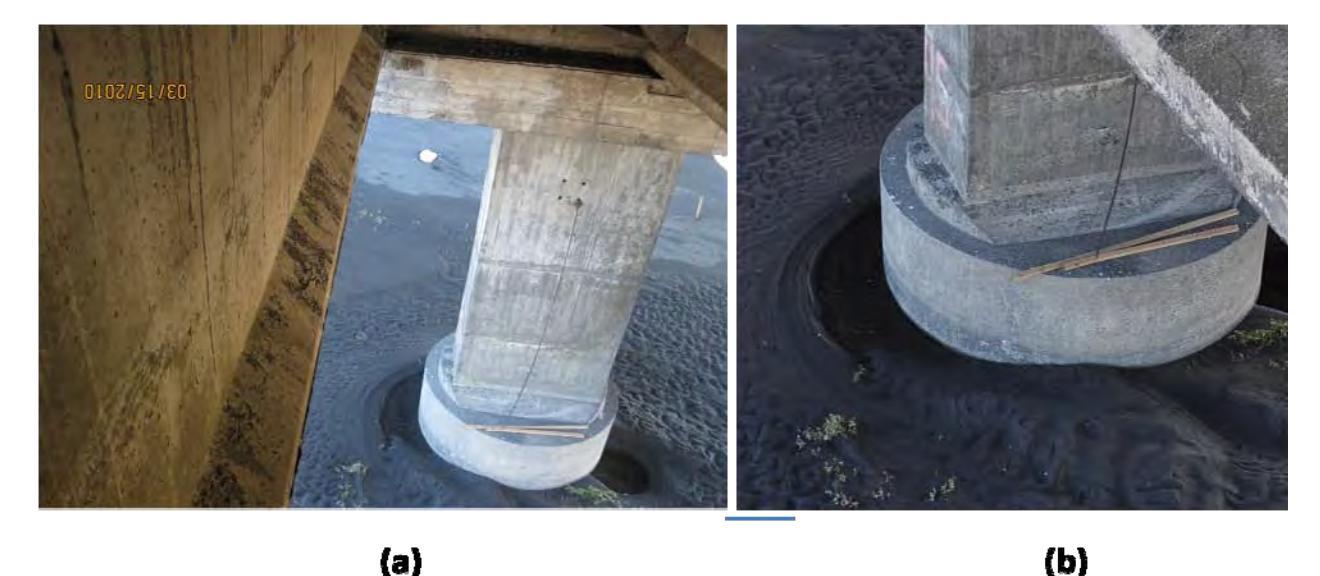
Although the GEER team had no direct access to the piers subjected to liquefaction and settlement it was possible to obtain some photos of the affected foundations. Figure 9.15(a) and (b) show a top view of a pier corresponding to pier group #113-116 and a close-up of the soil-pier interface. The figure shows the effects of liquefaction of the soil surrounding the pier with soil depressions and standing water covering an annular section around the pier. The soil in the vicinity of the pier shows evidence of water being brought to the surface and accumulation of sand probably ejected during the liquefaction event.

Figure 9.15. Juan Pablo II bridge–Evidence of liquefaction at piers subjected to settlements. (a) column and pier, (b) detail of pier and surrounding soil. (S36.826596° W73.094345° on 3/15/2010)

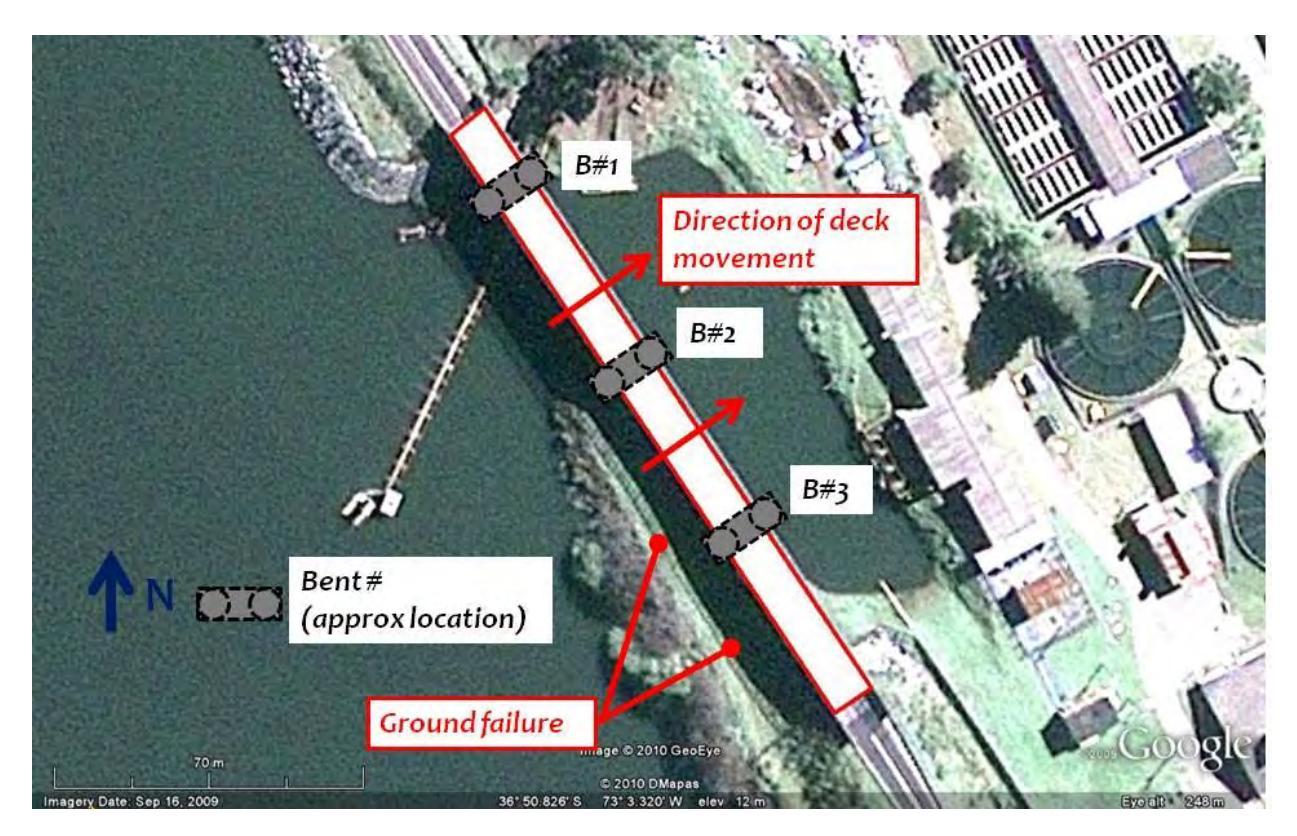
La Mochita bridge, shown in Figure 9.16 (S36.846841°; W73.055496°), is a 4-span concrete bridge supported by seat-type abutments at each end and two-column bents at the interior locations. At this site, ground failure occurred which induced transverse movement of the bridge superstructure.

Figure 9.16. Plan view of the La Mochita bridge in south Concepción describing observed damage (S36.846841° W73.055496°).

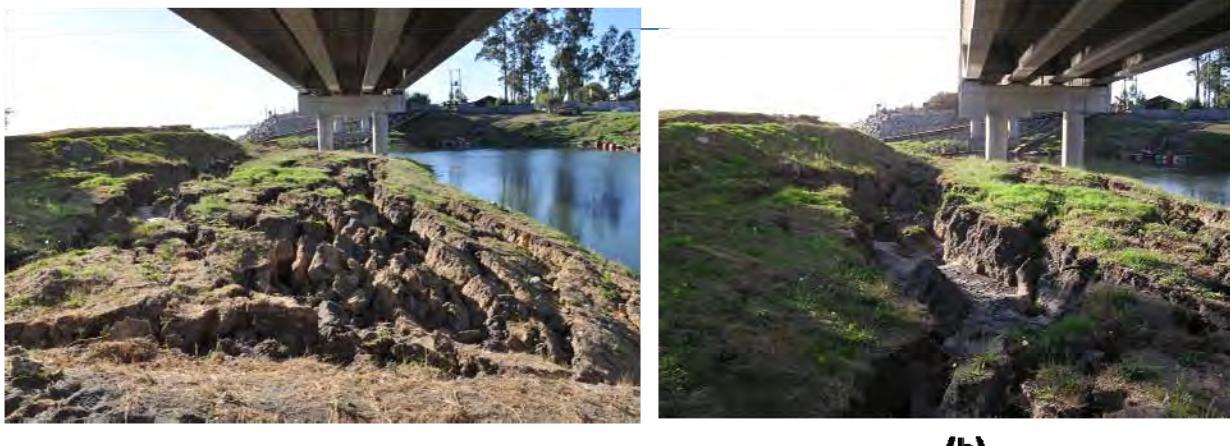
The bridge superstructure shifted transversely largely as a unit towards the east due to failure of the soil mass surrounding bents 2 and 3. Upon inspection of the ground at bents 2 and 3, significant spreadinglike failure towards the water treatment plant inlet water was observed (Figure 9.17). This failure may have been attribute to either a deep seated slope instability or liquefaction-induced lateral spreading mechanism. Sand boils below the bridge were observed near bent #2 and 3 (Figure 9.18). Follow-up site investigation is being conducted by GEER to more fully understand the characteristics of soils at the site and understand the underlying ground failure mechanism. Measurements taken by the team on March 15, 2010 indicated that the north end of the bridge deck shifted 0.5 m to the east relative to the approach fill, while the south end of the bridge shifted 0.9 m towards the east relative to the approach fill on that side. Bents 2 and 3 subassemblies (columns, bent cap and pile cap) were observed to rotate about the longitudinal axis of the bridge towards the east in consistent fashion with the deck movement. Rotations of bents 2 and 3 were measured as 2 and 4 degrees, respectively (Figure 9.19a). Bent 1 could not be accessed at the time of the teams visit, however, views from the land mass at bent 2 indicate that the deck moved independently of bent 1 (Figure 9.19b). In addition, ground failure was not immediately visible from this vantage point, or above the north shore of the bridge. Movement of the abutments was observed to be minimal, with the resulting damage to the superstructure largely attributed to the rotation of the bents (Figure 9.21). It is noted that movement of the bridge resulted in damage on both east and west end transverse shear keys of the interior bents (Figure 9.22). In addition, the approach road from the north observed significant ground movement and distress leading to the bridge (Figure 9.23).

Figure 9.17. Ground failure at the La Mochita bridge, (a) looking north at bent #3 (\$36.847389°, W73.055219°; 1831 hrs on 3/15/2010) and (b) looking north at bent #2 (\$36.847495°, W73.055027°; 1835 hrs on 3/15/2010)

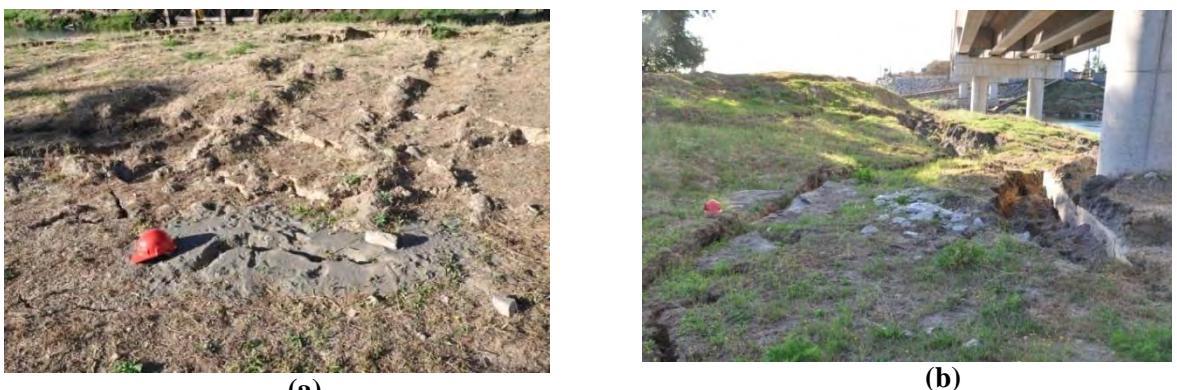
Figure 9.18. La Mochita bridge: (a) Sand boils observed below the bridge (S36.847456°, W73.055129°; 1830 hrs on 3/15/2010), and (b)View looking north (\$36.847453° W73.055225°; 1830 hrs on 3/15/2010)

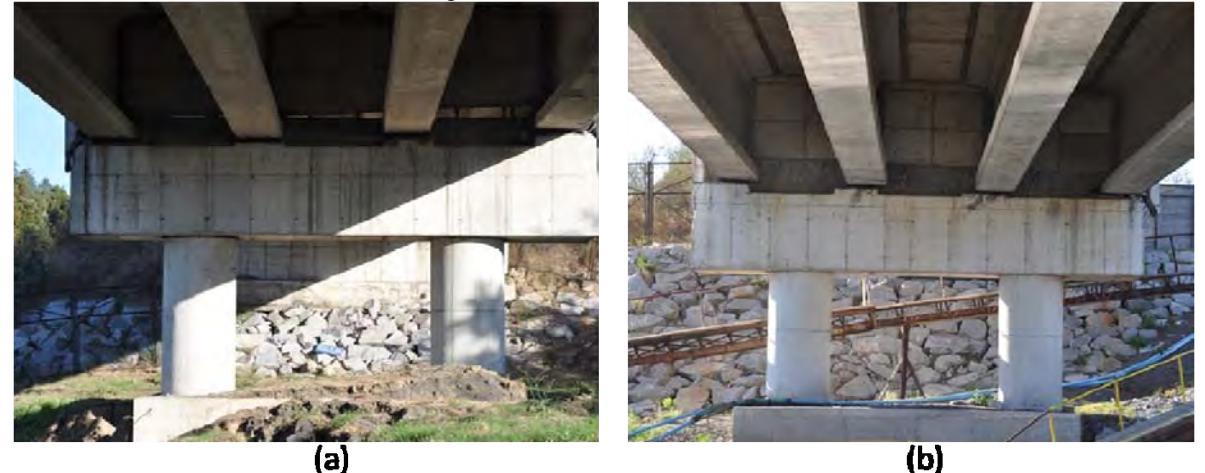
Figure 9.19. La Mochita bridge: (a) Rotation of bent #3 and surrounding ground failure at La Mochita bridge. View looking south (S36.847302°, W73.055151°; 1835hrs on 3/15/2010), and (b) Transverse shift of deck relative to bent #1. (the tilt of bent #1 could not be measured at the time of site visit). Ground failure surrounding bent #1 was not observed from this vantage point. View looking north (S36.847049°, W73.055443°; 1835 hrs on 3/15/2010).

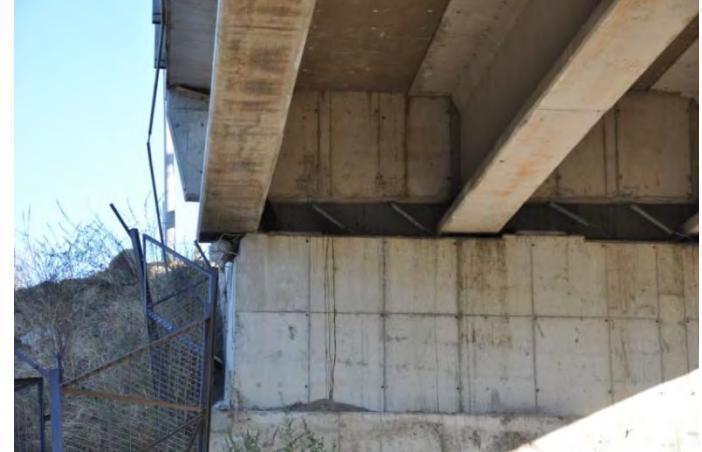
Figure 9.20. Transverse shift of deck relative to south abutment at the La Mochita bridge (S36.847547°, W73.054876°; 1834 hrs on 3/15/2010).

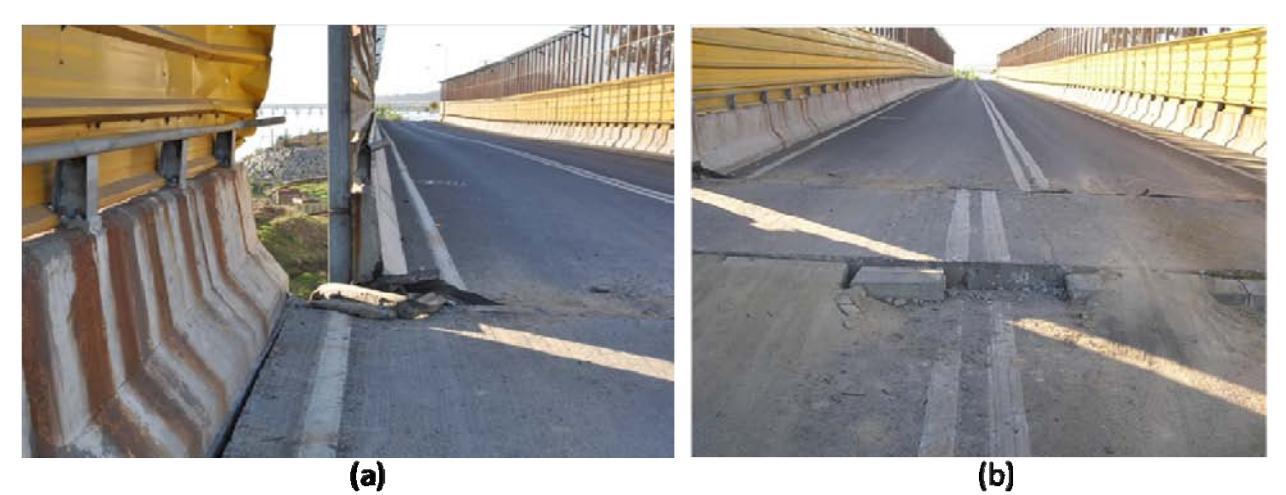
Figure 9.21. La Mochita bridge (a)Transverse gap developed between deck and south abutment. View looking north. (-36.847798°, -73.054797°; 1856 hrs on 3/15/2010), (b) Damage at the south abutment-road-deck interface due to transverse shift of the deck. View looking north. (S36.847761°, W73.054777°; 1856 hrs on 3/15/2010).

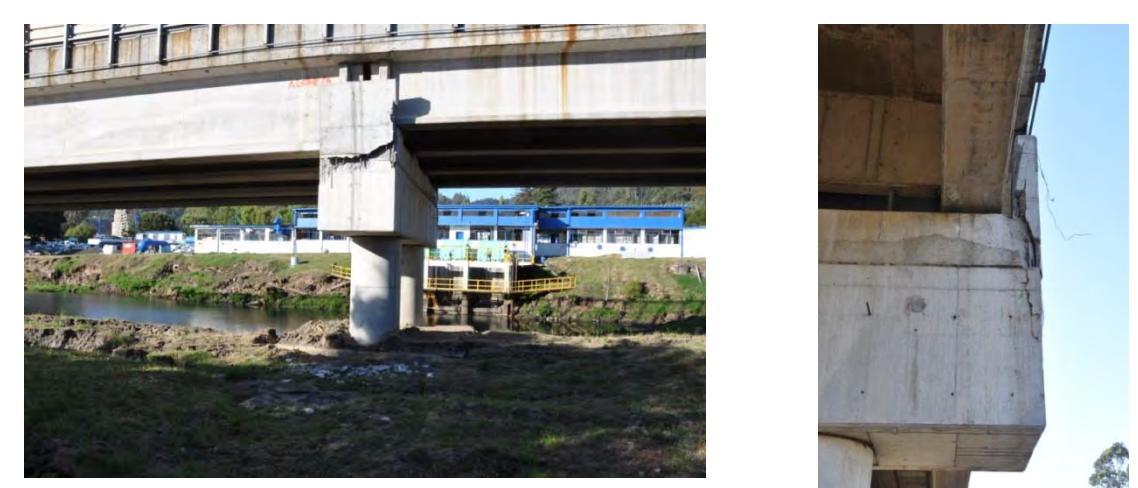
Figure 9.22. Damage to transverse shear keys at bent #3 due to movement of the La Mochita bridge (S36.847405°, W73.055084°; 1830 hrs on 3/15/2010).

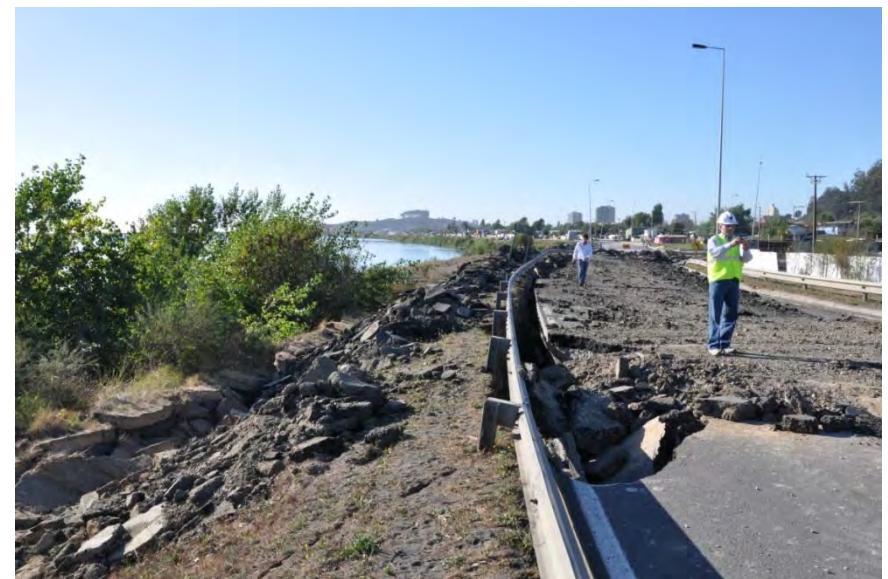
Figure 9.23. Damage to the approach road north of the La Mochita Bridge (S36.846473°, W73.055881° on 3/15/2010). View looking north. The Bio Bio river is shown on the left (west) of the view.

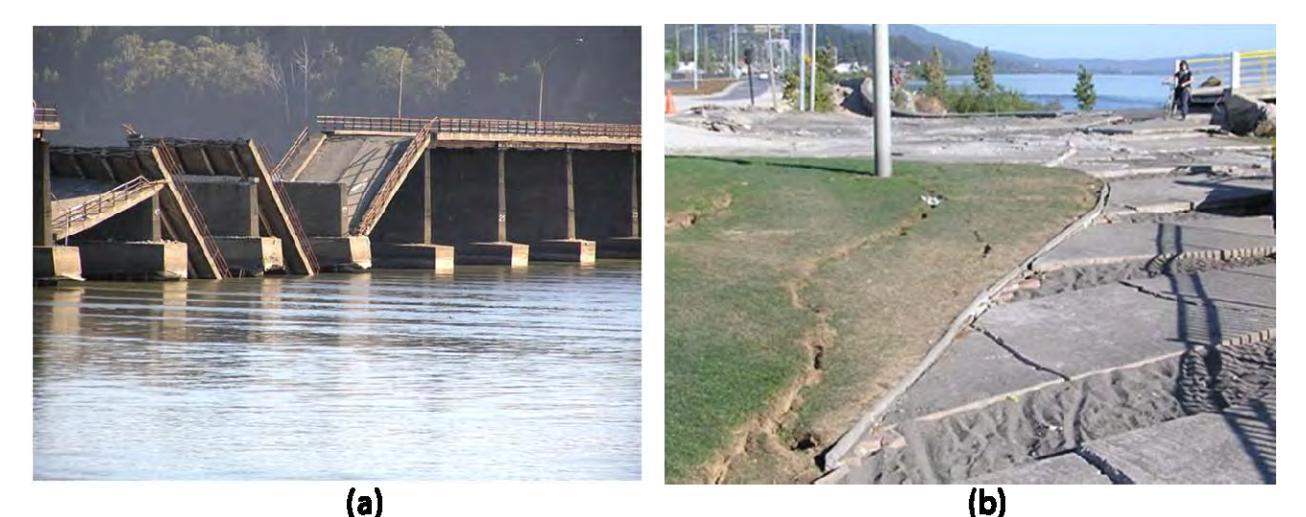
The Bio-Bio bridge, also known as Puente Viejo (Old Bridge), was built in the 1930s and inaugurated in 1937. The bridge connected the cities of Concepción and San Pedro de la Paz and had a length of 1,419 m. For many years it was the only vehicular bridge connecting the two cities. Due to its precarious structural condition the bridge was closed in May 2002 and used only for pedestrian transit. During the 2010 Chile earthquake the bridge suffered severe damaged with many slab sections collapsing (Figure 9.24a). Several bridge bents also collapsed during the seismic event (Figure 9.25). Evidence of liquefaction was observed at the East bridge abutment with visible lateral deformations and vertical settlements.

Figure 9.24. Puente Bio-Bio: (a) Collapsed slabs (S36.836789° W73.062203° on 3/15/2010), (b) Evidence of lateral spreading near East bridge approach (S36.837311° -73.061831°; 1753 hrs on 3/15/2010).

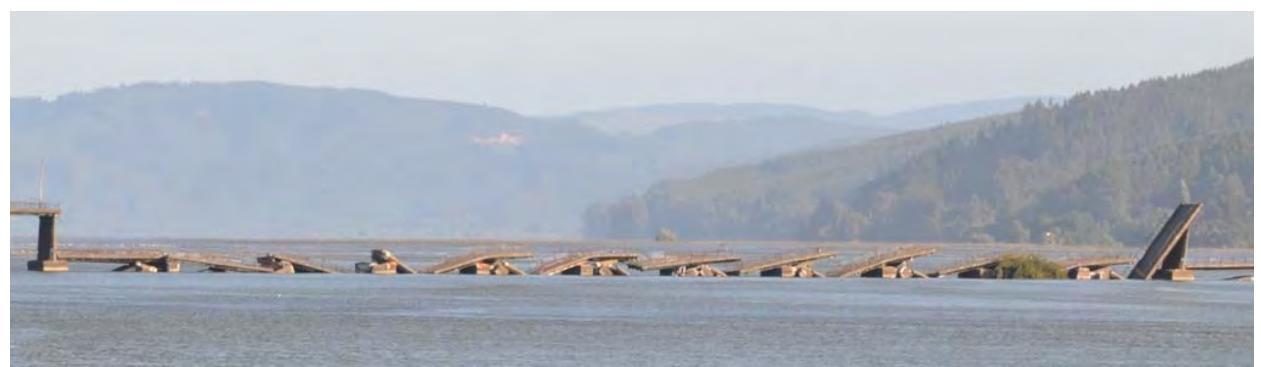
Figure 9.25. Puente Bi-Bio's collapsed slab sections and bridge bents (S36.837968° W73.062896° on 3/15/2010).

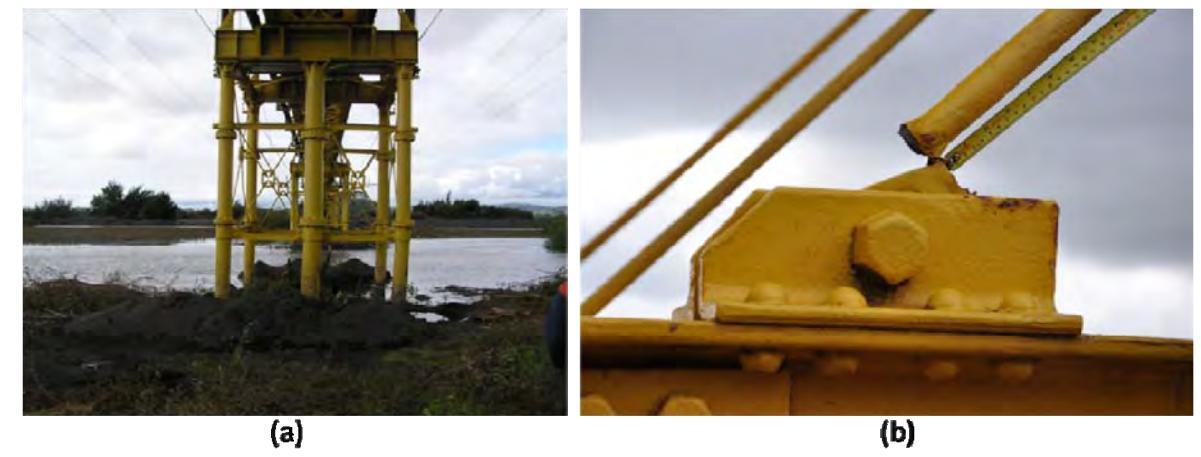
The Bio Bio river railroad bridge is one of the oldest crossings of the Bio Bio river. Originally built in 1889 m, it was completely retrofitted in 2005. This railroad structure is composed of parallel top and bottom chords separated by diagonal and vertical members in a Warren truss arrangement. Three hundred and seventy pillars support the structure covering a length of 1889 m. The bridge was damaged during the 2010 Chile earthquake due to strong shaking and possibly lateral spreading of the river banks. Of the 370 pillars of the bridge, 19 were damage during the earthquake and several portions of the rail were bent or miss-aligned (Figure 9.27).Visual inspection of pillars near the West abutment seems to indicate several piles moved in the lateral direction and rotated (Figure 9.26). The rail lines were moved out of alignment as shown in Figure 9.27b.

Figure 9.26. Bio Bio Railroad crossing (a) Pillars move and rotated during earthquake (b) Detail of broken crossbar, (\$36.836075° W73.086969°; 1717 hrs on 3/17/2010)

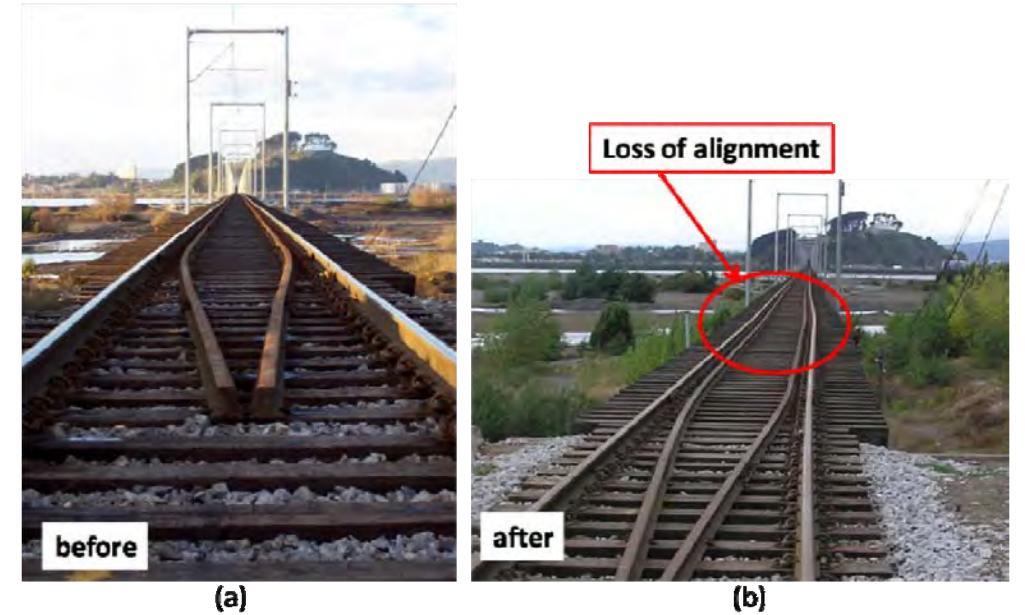
Figure 9.27. Bio Bio Railroad crossing (a) rails aligned before earthquake, (b) rails bended after earthquake (S36.836097° W73.087094° on 3/17/2010)

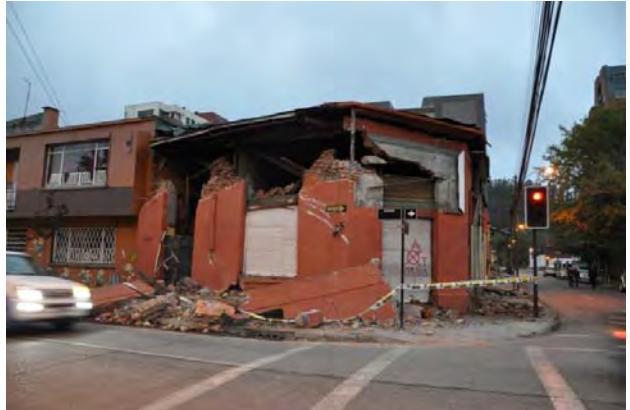
The City of Talca suffered significant damage due to earthquake shaking. The damage was predominantly associated with low-rise adobe and unreinforced masonry construction (Figure 9.28). Taller, well-designed structures performed relatively well, with the exception of damage to exterior cladding and contents in the upper floors (RMS, 2010). The GEER team did not conduct an extensive survey of building damage within the city; rather the team focused on regions near the Rio Claro, which runs along the west edge of the city, extending north-south parallel with Route 5 (Figure 9.29). In addition, the team inspected areas along a branch of the river running east-west towards the southern edge of the city.

Figure 9.28. Typical construction type and observed damage within the city of Talca (\$36.832375, \$W73.055439; 2016 hrs on 3/17/2010).

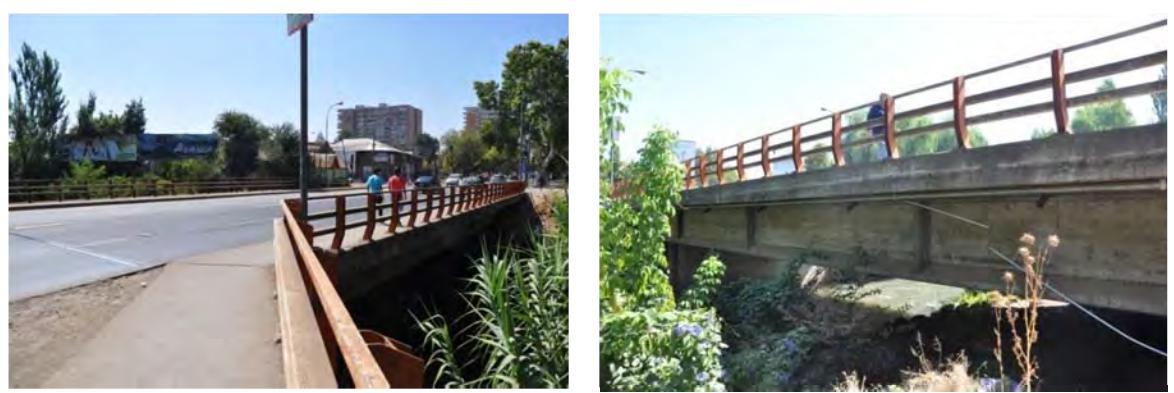
Figure 9.30. (a) Typical short span bridge construction on the branch of the Rio Claro, city of Talca (S35.428011° W71.670269°; 1302 hrs on 3/18/2010). (b) Bridges were observed to remain undamaged (S35.428086° W71.669894°; 1303 hrs on 3/18/2010).

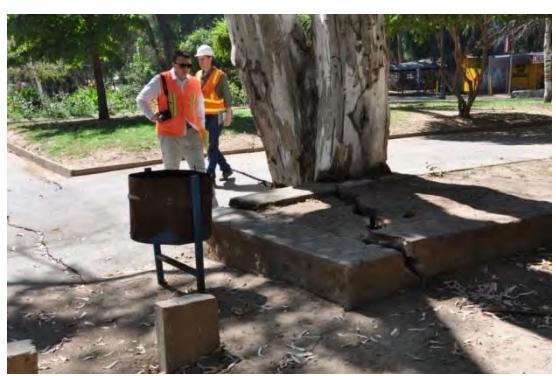
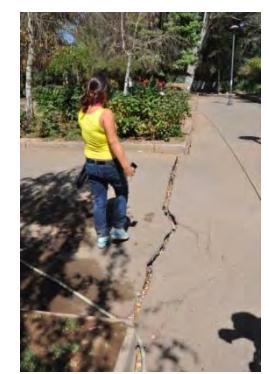
Local ground failure was observed approximately 50 m north of the Puente Rio Claro Nuevo (vehicular bridge) (Figure 9.32 and Figure 9.33). Two distinct regions were observed, a smaller lateral spread near shore (Figure 9.33), and a larger ground failure more characteristic of a soft clay failure confined within a park area (Figure 9.32). Soils near the shore area were predominantly gravely materials, likely with pockets of sand (one sand boil was observed at the near shore failure), whereas the park area indicated the presence of a soft clayey material. The ground failure extended approximately 90 m by 33 m north-south, however, it had no impact on the vehicular bridge, as it was open to traffic with no visible distress noted from the team's inspection on the east shore area. In contrast, the Puente Rio Claro Viejo (pedestrian bridge) suffered unseating of the longitudinally spanning girders and subsequent shear failure of the

Figure 9.32. Ground failure in a park area near the shore of the Rio Claro in Talca (S35.419919°, W71.682289°; 1408 hrs on 3/18/2010), views looking north and south, for left and right images, respectively.

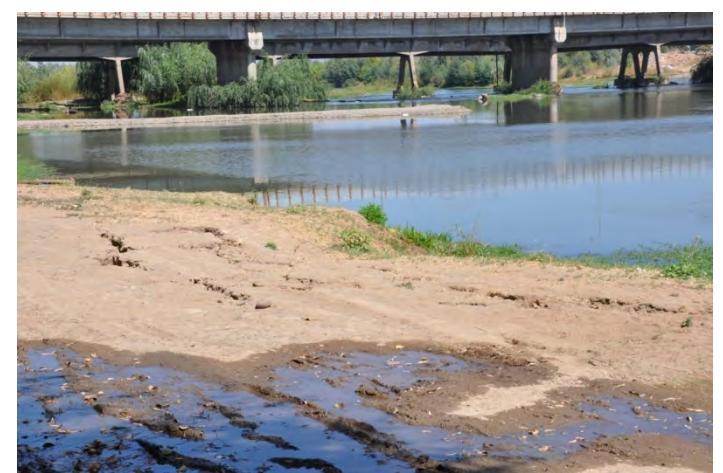
Figure 9.33. Near shore lateral spread on the western shore of the Rio Claro in Talca, view looking south. (S35.419682°, W71.682359° on 3/18/2010). Both the pedestrian and vehicular crossing bridges are shown in the background.

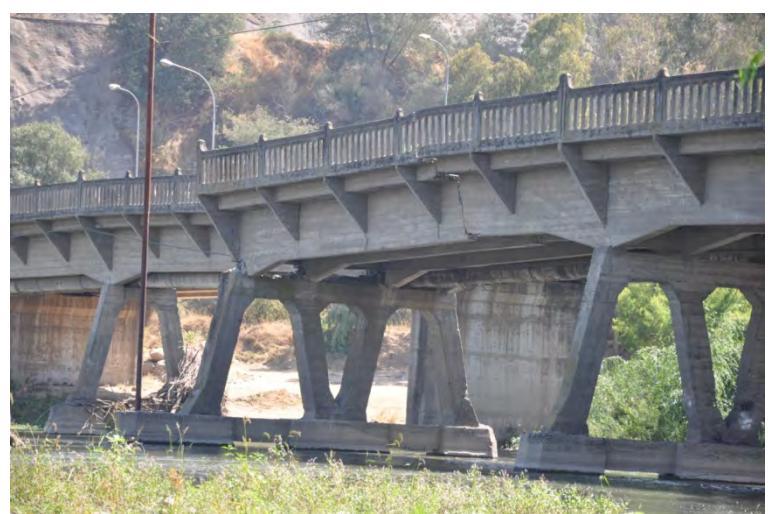
southern-most girder at a vista point near the mid-span of the bridge (Figure 9.34). From the team's limited access to the bridge it was not clear if the deck unseating was due to movement of the bent due to ground failure or excessive structural deformation at the bent.

Figure 9.34. Deck unseating and shear failure of longitudinal spanning girders of the Talca pedestrian bridge at the vista area (S35.421044, W71.683197; 1354 hrs on 3/18/2010)

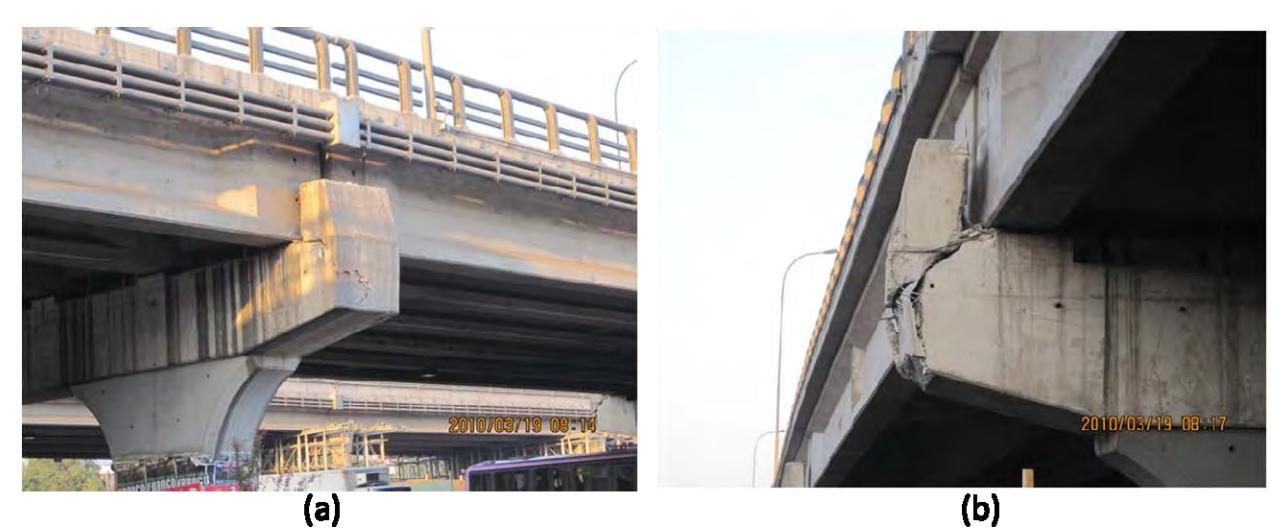
Several transportation structures along the Autopista Vespucio Norte Express (i.e., Vespucio Norte Expressway) were damaged in the Quilicura area of North West Santiago (Figure 9.35). There was at least one collapse and several spans were unseated requiring temporary support (Figure 9.36). Both older and newer structures were damaged, and the damage appeared to be the result of strong shaking. Since the damage appeared localized only as the Vespucio Norte Expressway came through the Quilicura area, it is suspected that local site effects, resulting from either soil conditions or subsurface topography contributed to the strong shaking. Retaining walls and mechanically stabilized embankment (MSE) walls appeared to perform well in the area (Figure 9.37). No other signs of geotechnical conditions influencing the performance, such as liquefaction or slope movements, were observed.

Figure 9.35. (a) Damaged shear key is an example of typical performance on bridges along this section of Vespucio Norte Expressway in Quilicura (S33.365585, W70.688657; 814 hrs on 3/19/2010), (b) Close up of damaged shear key along Vespucio Norte Expressway (S33.365893, W70.688584; 817 hrs on 3/19/2010).

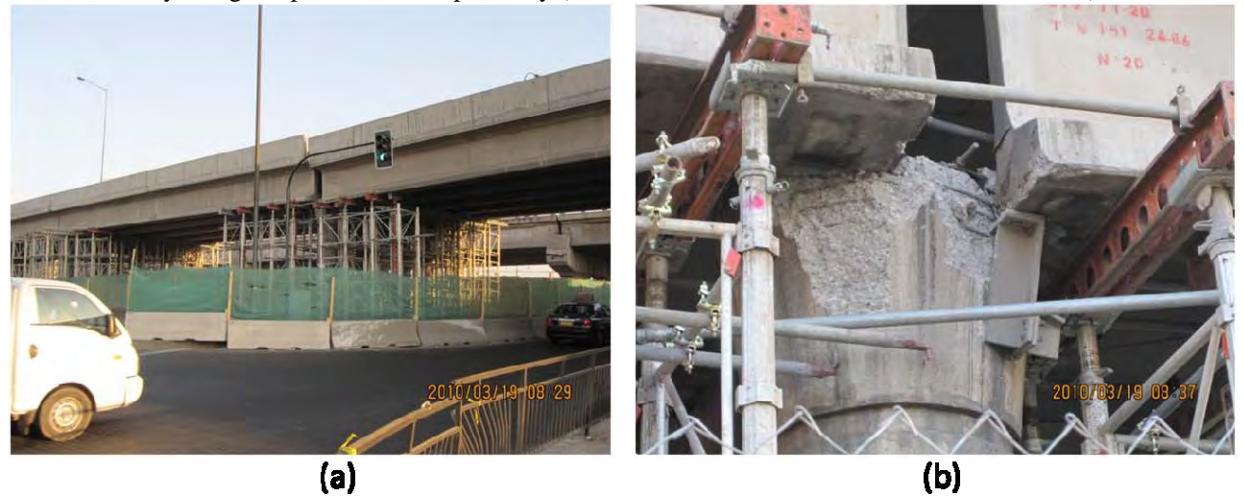
Figure 9.36 (a). Example of one of the newer under crossings that suffered damage along the Vespucio Norte Expressway. The right span became unseated due to excessive transverse movement (S33.36245, W70.688865; 829 hrs on 3/19/2010) (b) Close-up of shear key area on bent cap, with metal shear key or keeper bar hanging on right side of bent cap. Note complete unseating of I-girder on right side of bent cap (S33.366638, W70.689301; 837 hrs on 3/19/2010).

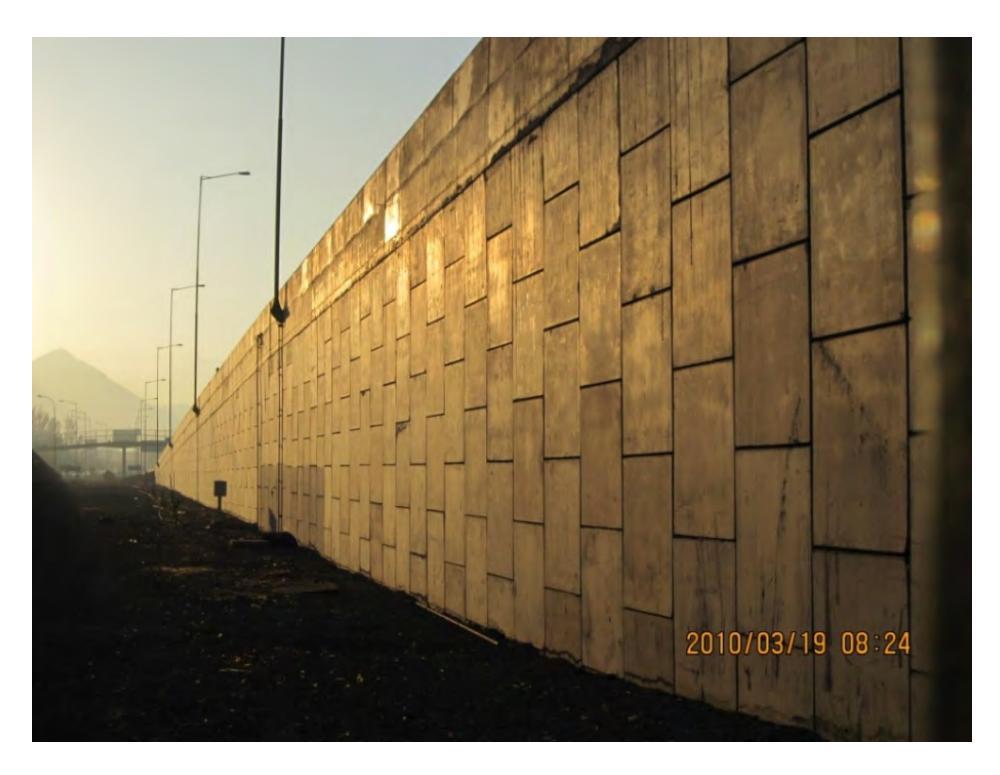
Figure 9.37. Retaining walls and mechanically-stabilized-embankment (MSE) walls appeared to perform well in the Quilicura area of Santiago (S33.366137, W70.688913; 824 hrs on 3/19/2010)

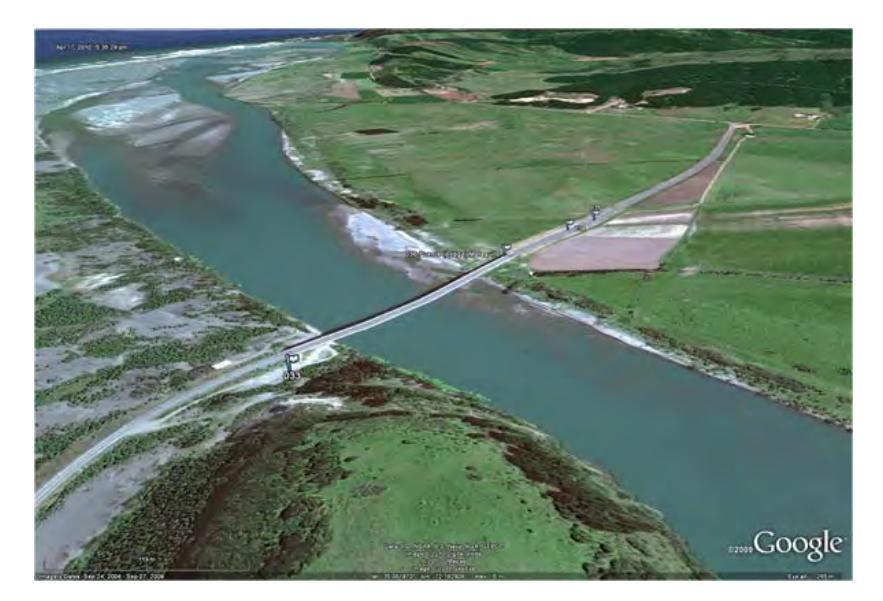
Figure 9.38 Puente Mataquito, looking north, S35.050712°, W72.162258°, April 16, 2010

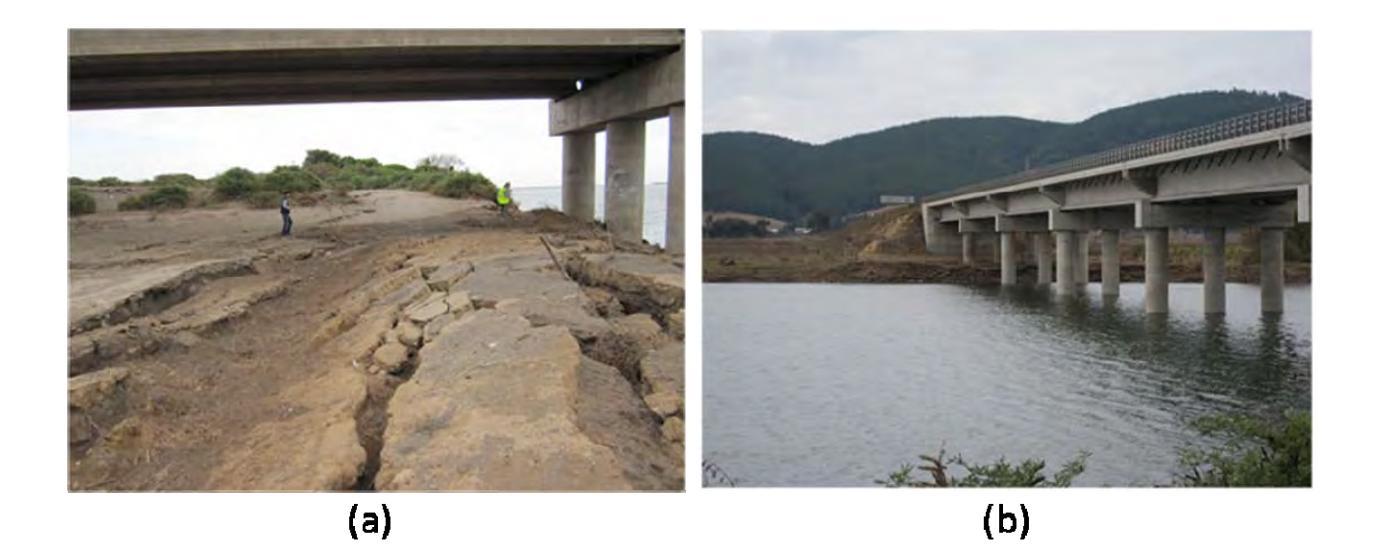
This bridge crosses the Mataquito river close to the Pacific Ocean. During the 2007 Maule earthquake extensive liquefaction and lateral spreading occurred at the north and south abutments and in the adjacent fields. Figure 9.39 through Figure 9.43 show photos of the bridge and the damage. The lateral spreading on the south abutment appeared to be more confined due to the topography of the area. In contrast, on the north side, and due to the large extent of the fields that are around the bridge, extensive lateral spreading was observed going back almost 270 m from the river edge. The lateral spreading from the edge of the abutment wall to the first row of piers was about 54 cm and the total lateral spreading from the edge of the abutment wall to the river's edge was about 180 cm (over a distance of about 65 m). The approach embankment is about 7.6 m high, and settled about 70 cm relative to the bridge deck. The approach embankment experienced outward transverse movement of about 60 cm from the center line as manifested by cracking of the asphalt along a distance of about 200m. This appears due to liquefaction and failure of the underlying soil and is evidenced by compression ridged in the field at the toe of the embankments. Despite evidence of liquefaction at both abutments of this bridge, its overall seismic performance was good.

Figure 9.39 (a) Lateral spreading on the south end of the bridge, Puente Mataquito, S35.050712°,W72.162258°, April 16, 2010. (b)Lateral spreading on the north end of the bridge, Puente Mataquito, S35.050712°,W72.162258°, April 16, 2010.
