# Geo-engineering Reconnaissance of the 2010 Maule, Chile Earthquake

Report of the NSF Sponsored GEER Association Team

# GEER Association Report No. GEER-022

Version 2: May 25, 2010

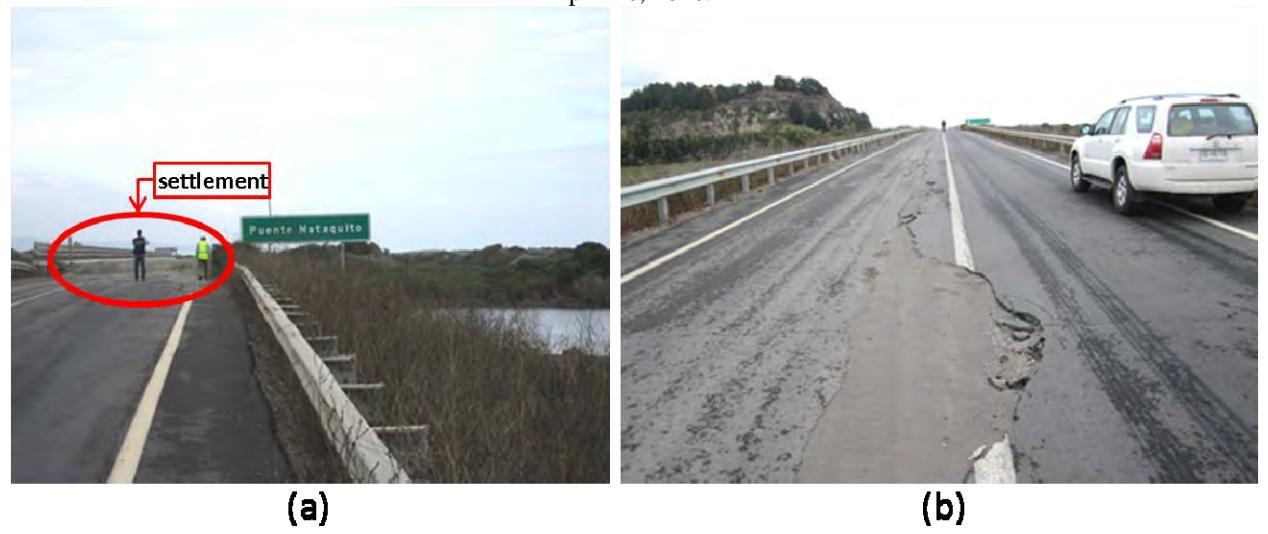
Figure 9.40. (a) Settlement of the north abutment of the bridge, 70 cm offset at the bridge deck, Puente Mataquito, S35.050712°,W72.162258°, April 16, 2010. (b) Cracking and transverse movement (60 cm on each side) of embankment due to liquefaction of underlying soi

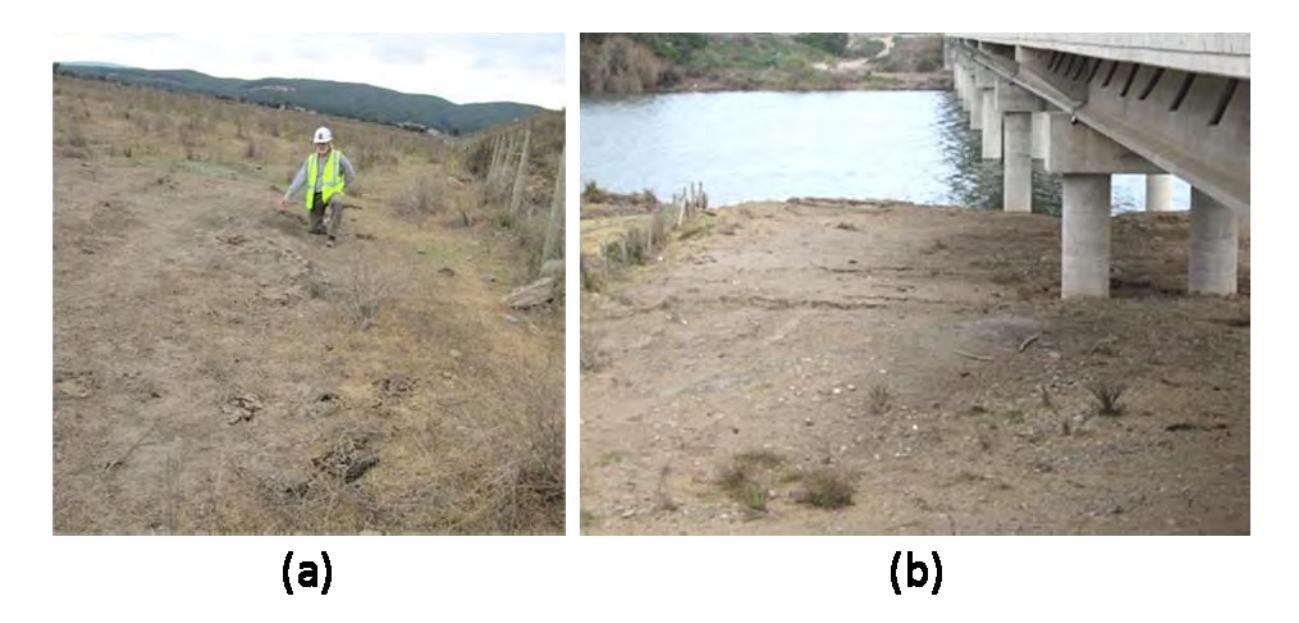
Figure 9.41 (a) Compression ridges at toe of embankment, due to liquefaction of underlying soil and settlement of embankment, north abutment of the bridge, Puente Mataquito, S35.050712°,W72.162258°, April 16, 2010. (b) Lateral Spreading towards the river, north abutment of the bridge, Puente Mataquito, S35.050712°,W72.162258°, April 16, 2010.

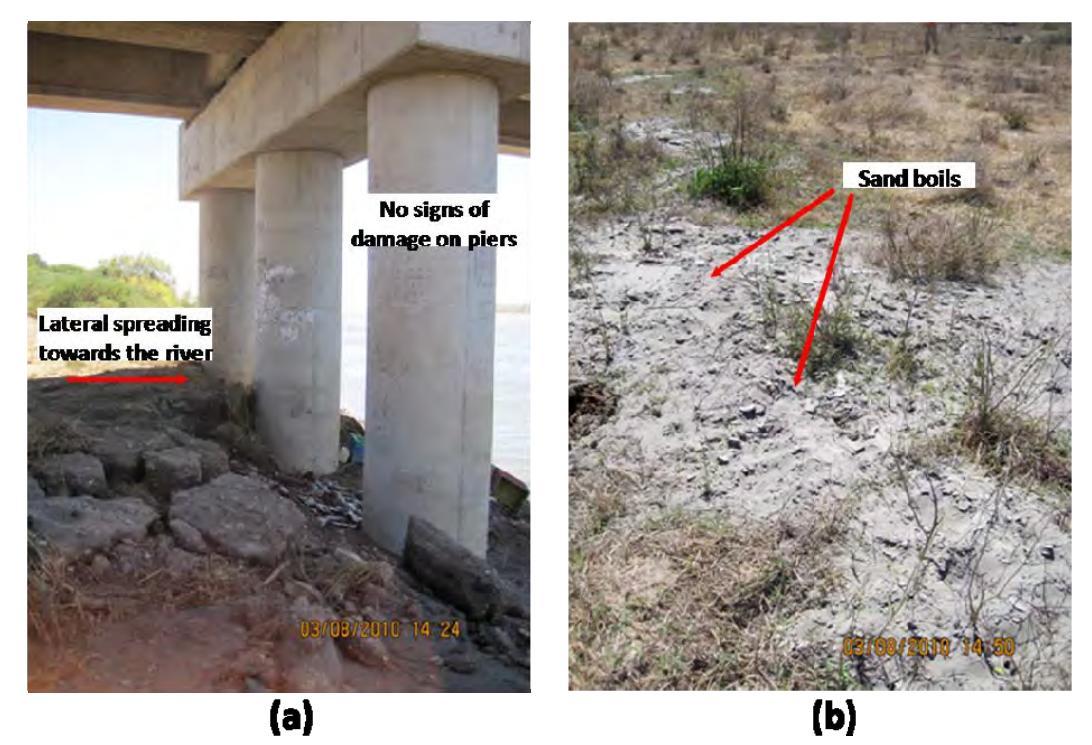
Figure 9.42. Mataquito bridge-(a) Blocks of soil crust against piers at the south end, (b) Sand boils at the north end of the bridge (S35.051961, W72.163217; 1450 hrs on 3/08/2010)

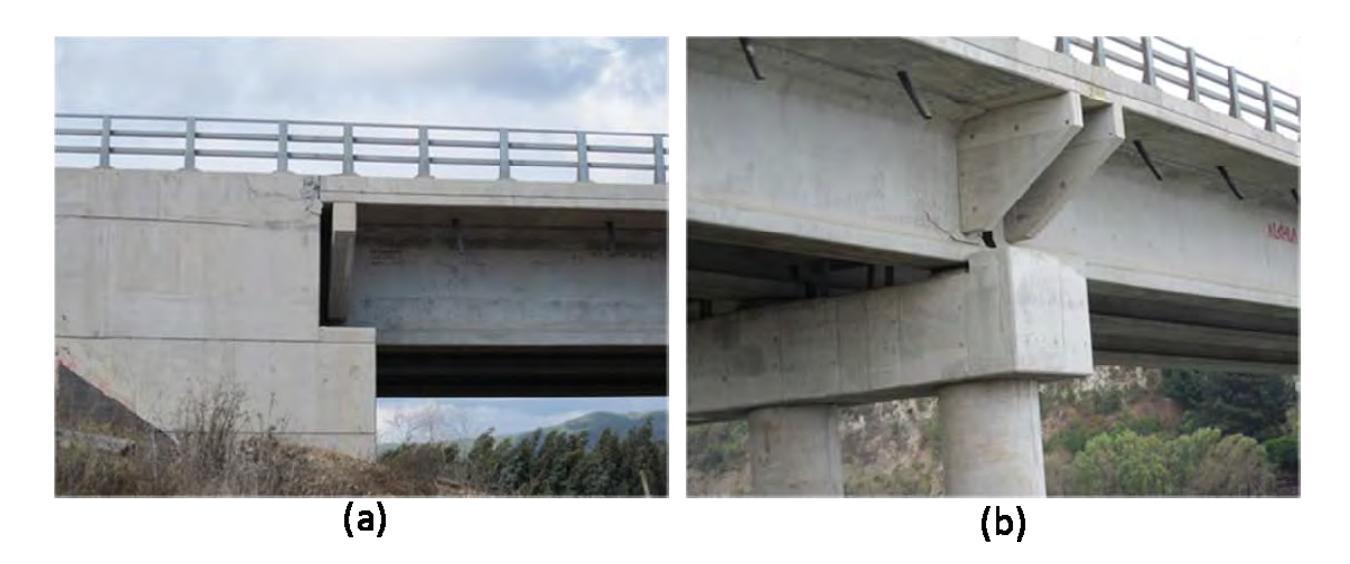
Figure 9.43 (a) North abutment shoved into bridge deck due to lateral spreading, Puente Mataquito, S35.050712°,W72.162258°, April 16, 2010, (b) Shearing of bridge girder, North abutment of bridge, Puente Mataquito, S35.050712°,W72.162258°, April 16, 2010.

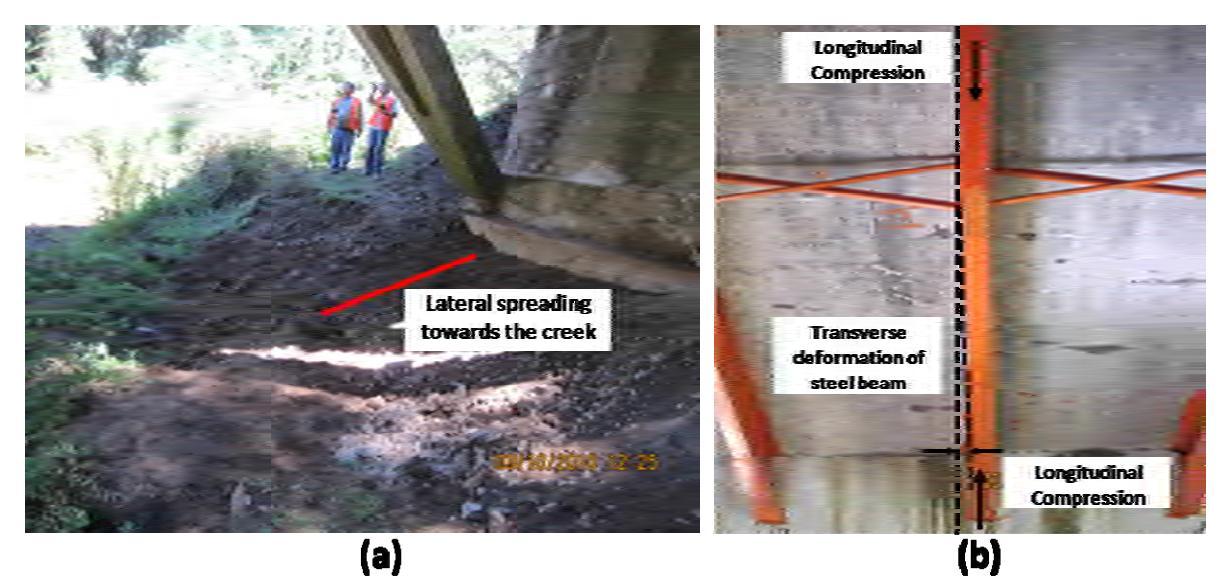
There was moderate damage of these bridges due to liquefaction and lateral spreading. These two-lane single-span old reinforced concrete bridges were close to each other. In these bridges the longitudinal movement due to lateral spreading of both abutments seemed to have compressed the bridges causing geometric distortion and moderate damage. The originally horizontal decks of the bridges ended up with a concave-down shape. Some transverse cracks were observed on the bridge deck due to this effect. Information provided by local authorities indicates that most of these bridges, if not all, have been recently surveyed as a part of a broad bridge assessment and improvement program, so there may be accurate survey points that could be used for future detailed analysis of the deformations.

Figure 9.44. Pulen Bridge-(a)Evidence of lateral spreading at the north abutment (b) Loss of longitudinal alignment of steel I-beam (S37.112036, W72.986902, 1225 hrs on 3/10/2010)

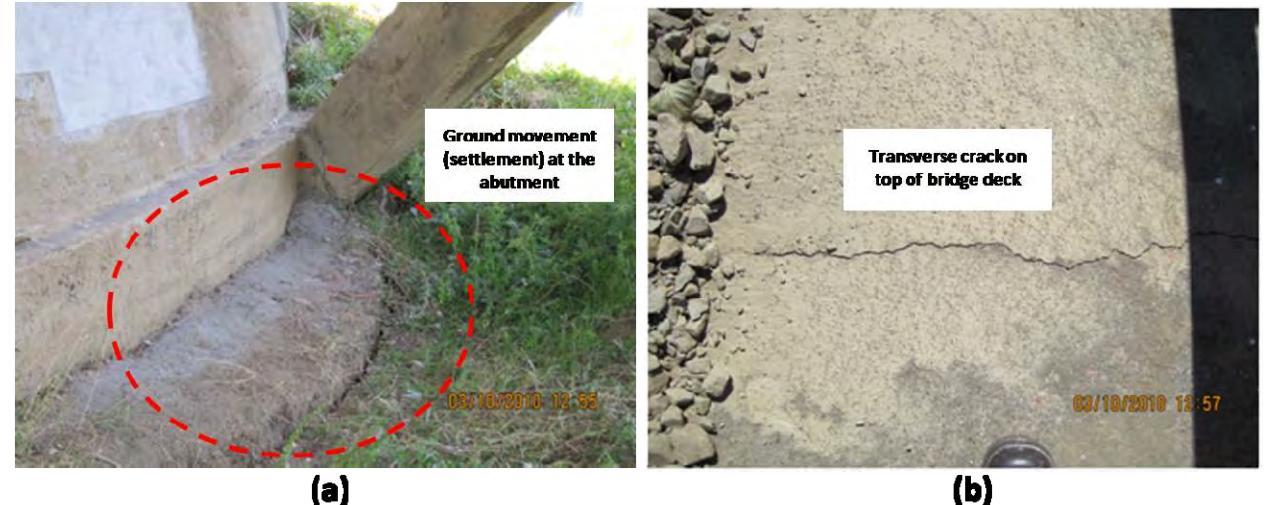
Figure 9.45. Patagual Bridge-(a) Ground movement at the abutment (b) Sidewalk crack in the transverse direction on the top of the bridge deck(S37.111325, W72.987583, 1257 hrs on 3/10/2010).

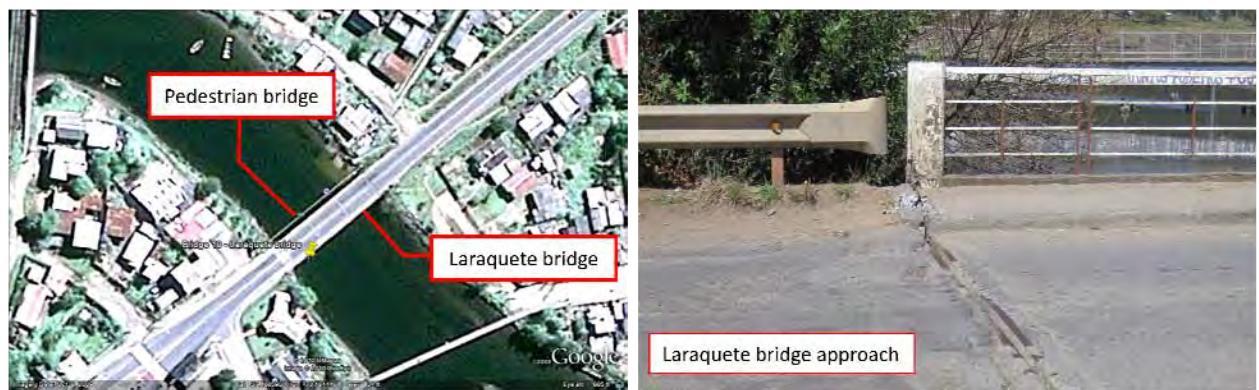
Two bridges were inspected in the Town of Laraquete, which is 50 km south of Concepción: A pedestrian two span bridge and an adjacent vehicular three span reinforced concrete bridge. The pedestrian bridge experienced damage due to foundation settlement of the middle bent with an estimated 0.50 m vertical deformation. Figure 9.47 shows the deformed bridge with noticeable inclination of the bridge deck. The adjacent reinforced concrete bridge, shown in Figure 9.46, suffered minor damage near the approaches due to pounding with the concrete structure and settlement due to poorly compacted fill. This bridge did not show evidence of foundation settlement.

Figure 9.46. Laraquete bridge (a) Aerial view (S37.166788° W73.184486°), (b)Bridge approach (S37.166804° W73.184760°; 1430 hrs on 3/10/2010)

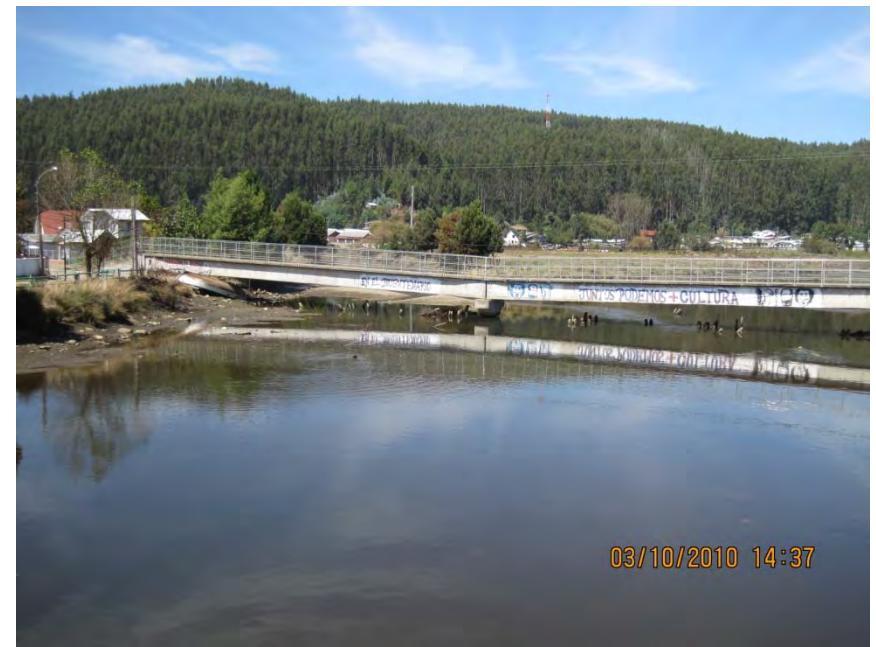
Figure 9.47. Pedestrian Laraquete Bridge showing large settlement of middle pier (S37.166742° W73.184384°; 1437 hrs on 3/10/2010).

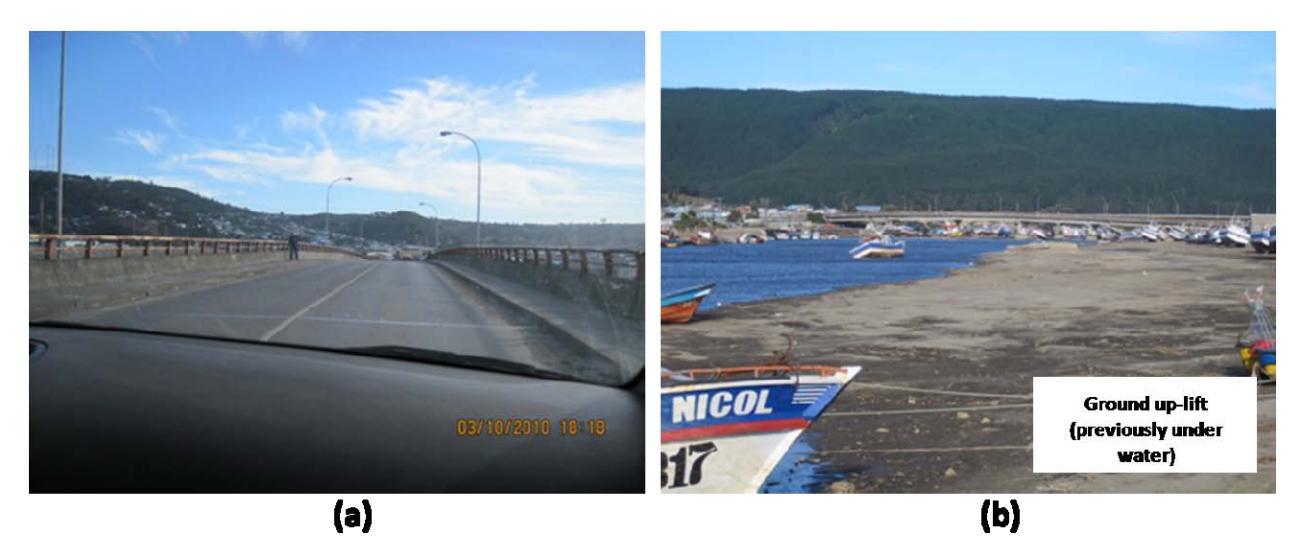
This bridge was operational by the time the GEER team got to Lebu. No major approach fill settlement could be observed. Good overall performance of the bridge in an area where evidence of ground uplift of 1.8 m to 2 m was found.

Figure 9.48. Lebu bridge: (a) Crossing Lebu bridge fully functional, and (b) Lebu bridge from the distance (S37.606344, W73.649496, 1818 hrs on 3/10/2010)

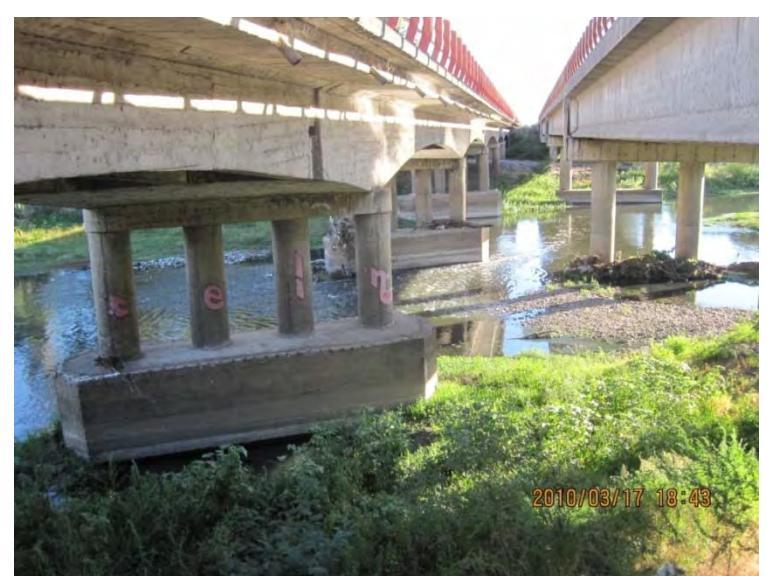
The EERI LFE Bridge Team observed this pair of bridges crossing the Rio Nebuco just South of Chillan along Route 5. The northbound bridge had a single dropped span, which had already been removed. The newer southbound bridge suffered only minor damage and was still in service handling both northbound and southbound traffic. The collapse was apparently a result of strong shaking. No apparent signs of liquefaction or lateral spreading and slope movement were observed.

Figure 9.49. This pair of bridges crosses the Rio Nebuco along Route 5 (S36.641846° W72.211264°; 1843 hrs on 3/17/2010).

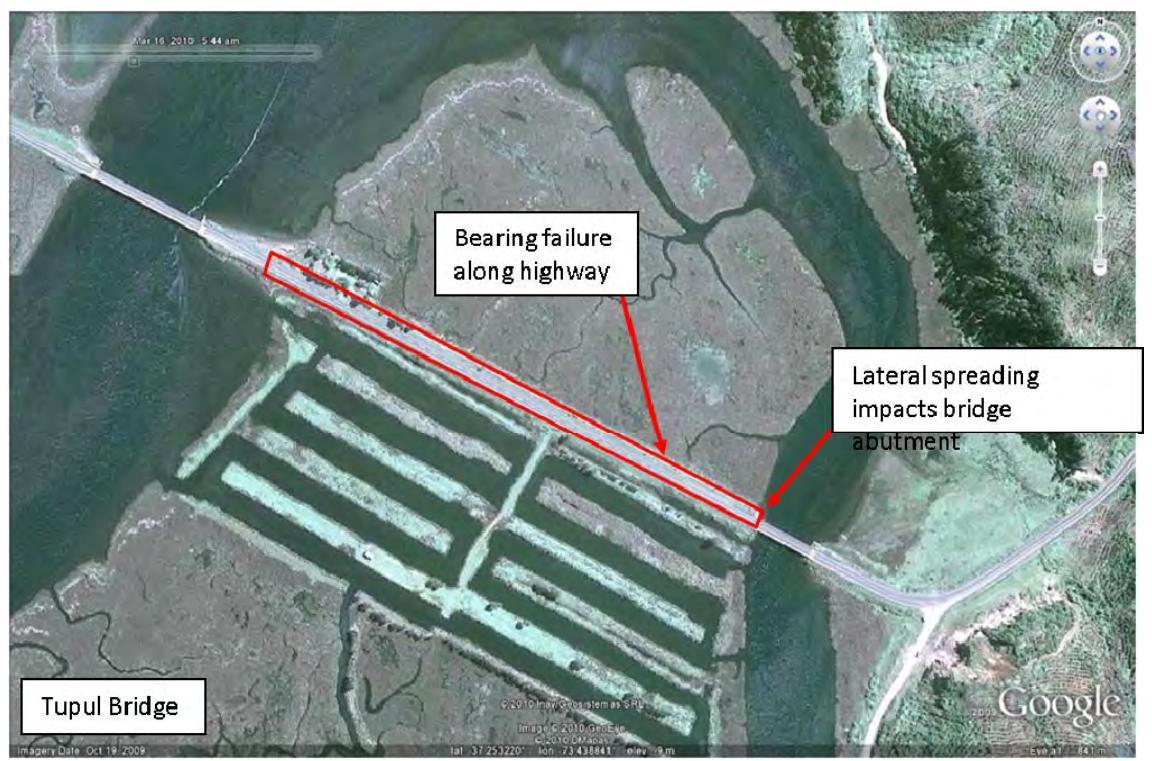
A roadway and bridge near the small town of Tubul were damaged due to ground failure. The layout of the bridge and roadway is shown in Figure 9.50. The roadway is about 0.33 km long and single span bridges cross the river on the east and west ends. Damage to the roadway and the bridge on the east end closed the road to traffic following the earthquake. The two lane roadway, with an embankment height of about 2 m, traverses a swampy, low-lying area adjacent to a small river which flows northward into the Pacific Ocean. Therefore, soils in this area are likely to be soft and saturated. The eastern bridge, which is about 50 m long, is supported by steel beams, which rest on a seat type abutment.

Figure 9.50. Damage to roadway and bridge due to ground failure near town of Tubul, Chile (S37.254345°, W73.437021°).

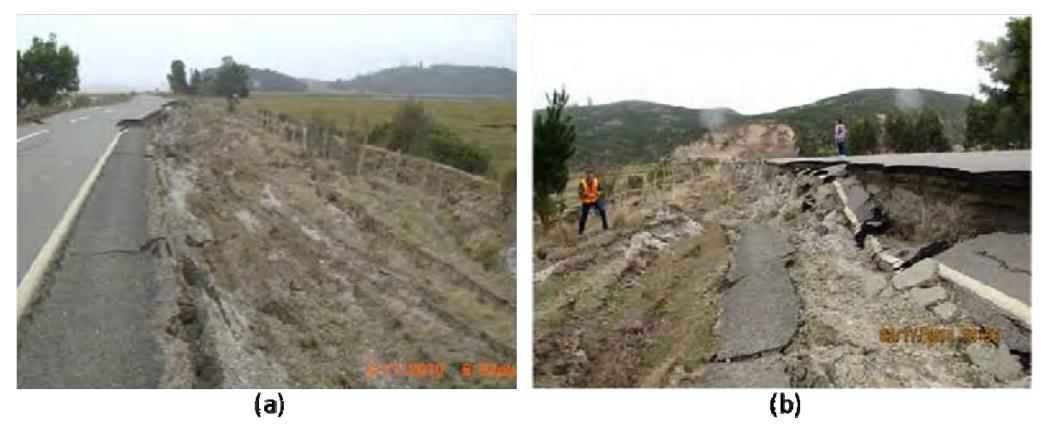
On both sides of the roadway, slumps developed along nearly the entire length of the roadway leaving vertical scarps 1.0 to 2.0 m in height as shown in Figure 9.52. The slopes on both sides of the roadway appear to have rotated downward causing an upward heave and rotation of the outer edge of the failure surface similar to a bearing capacity failure surface. In addition to the slumping along the sides of the road, the middle section of the road experienced lateral displacement towards the north as evidenced by the bow in the centerline of the road evident in Figure 9.52(a).

Figure 9.52. Photos showing scarps along both sides of the roadway due to bearing capacity failure in soil underlying the fill. Note lateral spreading in upper photo (S37.254161°, W73.437577° on 3/17/2010)

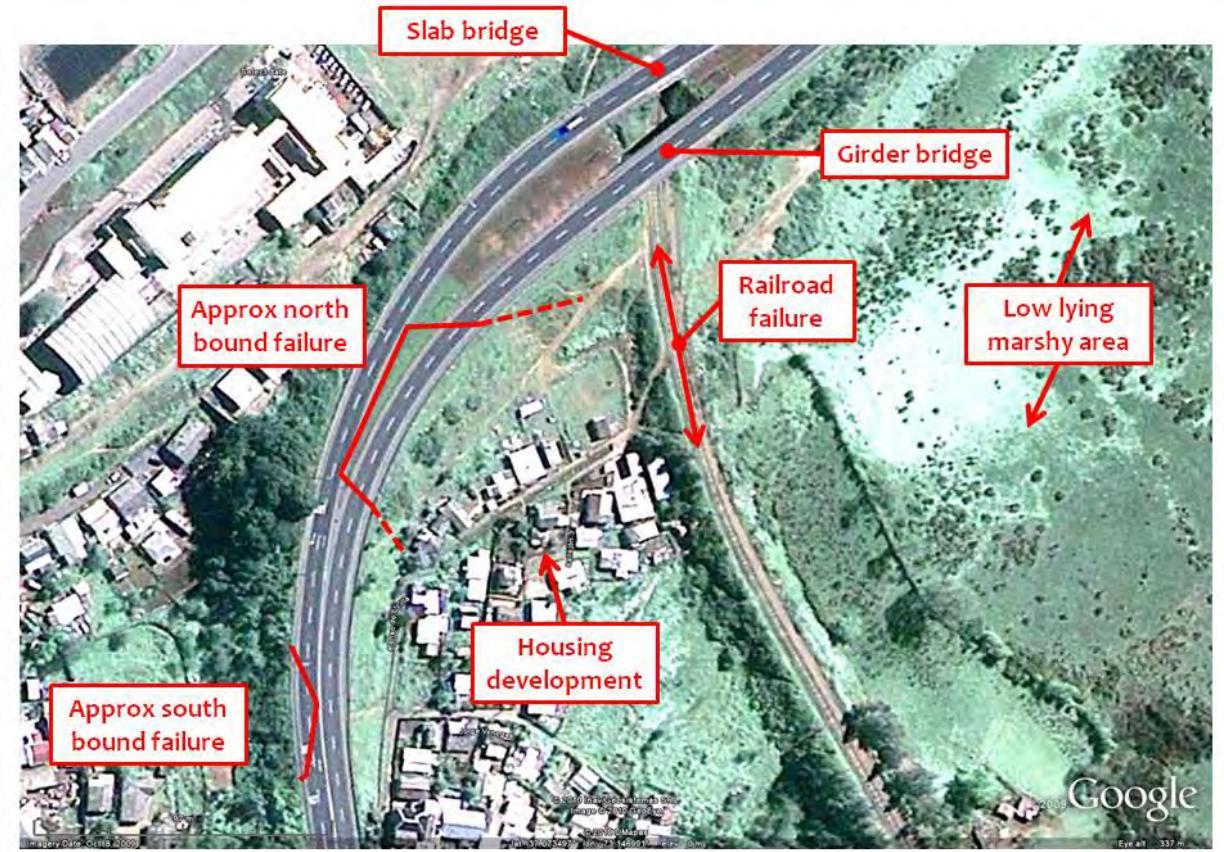
Several large ground failure areas were observed north of Lota along Route 160. Two failures resulted in damage to a roadway embankment section (denoted herein as the "south bound failure" and "north bound failure"; Figure 9.55, 9.56 and 9.57), while a third failure resulted in damage to an elevated railroad section (denoted as "railroad failure"; Figure 9.53 and Figure 9.56). Minor side road spreading-like failures were also noted near the approach abutments to two short span overpass bridges, north of the embankment failures, as well as just north of the short span bridges. The area east of Route 160 is largely marshy with low lying organic material (Figure 9.53). South of the north bound failure and east of the south bound failure of the elevated roadway sections is a small housing development.

Figure 9.53. Plan view of approximate affected area (Google Earth image at S37.0734°, W73.1469°).

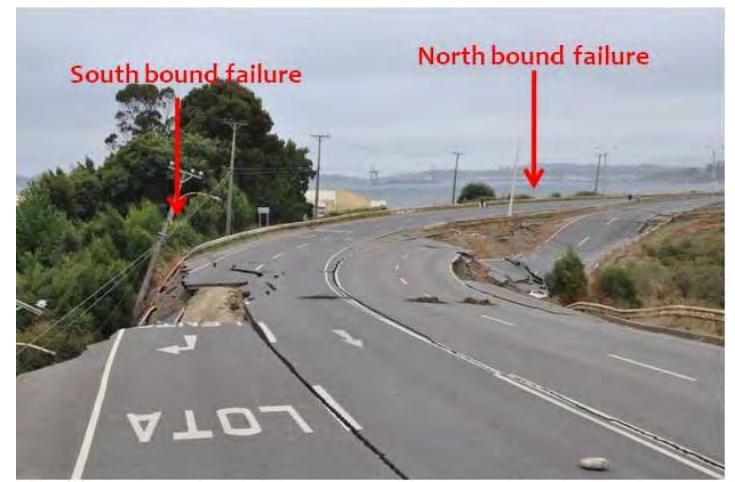
Figure 9.54. View looking north on route 160 showing south bound and north bound failure areas (S37.0744°, W73.1480°; 1220 hrs on 3/16/2010).

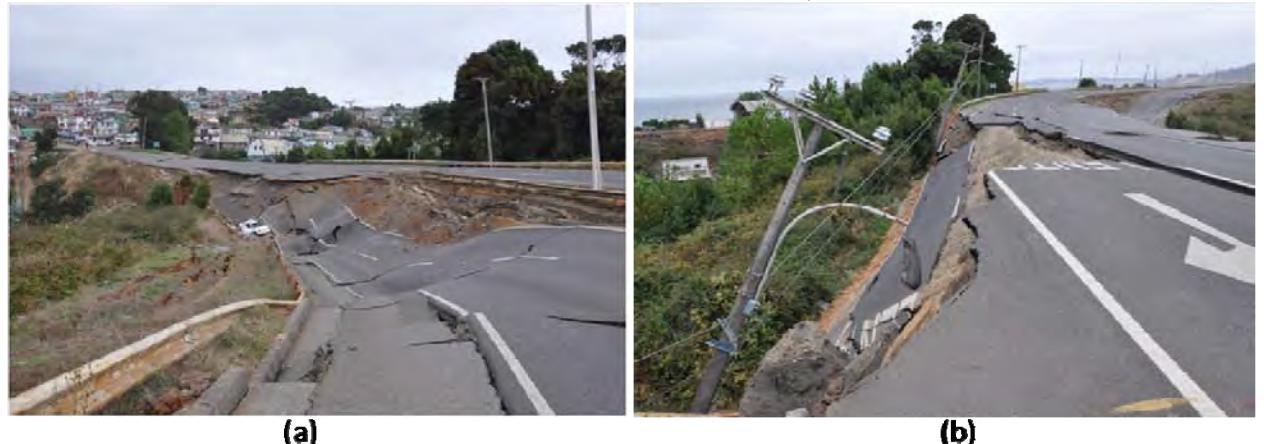
The north bound ground failure appeared to be deeply seated, perhaps due to softening of the foundation materials. It was not clear whether the south bound failure was due to a deep seated foundation failure or due to poorly compacted earth fill in the embankment section. A gray sandy fill overlaid by compacted clay fill was used in the elevated road embankment. The roadway elevation was approximately 10–15m above the valley area (10 m nearest to the overcrossing bridges, with high point above the housing development area). The bridge overcrossings, and therefore the road embankments, of the north and south bound sections may have been constructed at different times, as evident in the differences in construction type of the bridges (Figure 9.56(a)). The neighboring elevated railroad failure is characterized by a slumping and spreading of the elevated section, which is likely due to movement of the compacted fill (Figure 9.56(b)). The railroad was approximately 5-7 m above the low lying marshy area along its failure zone.

Figure 9.55. Lota (a)View looking south on route 160 showing north bound failure area (S37.0730°,W73.1475°; 1145 hrs on 3/16/2010) (b)View looking north on route 160 showing south bound failure area (S37.0746°, W73.1479°; 1215 hrs on 3/16/2010).

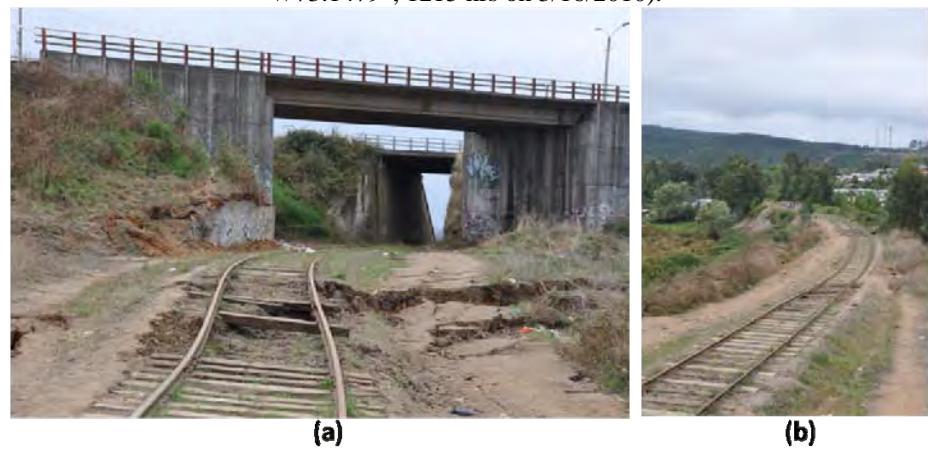
Figure 9.56. Lota (a) Slab and girder-type overpasses at northern end of road embankment failure area, showing railroad and supporting ground settlement. View looking west. (S37.0729°, W73.1469°; 1150 hrs on 3/16/2010), (b) Ground failure below elevated railroad east of road embankment failure. (image looking east; S37.0727°, W73.1471°; 1150 hrs on 3/16/2010)

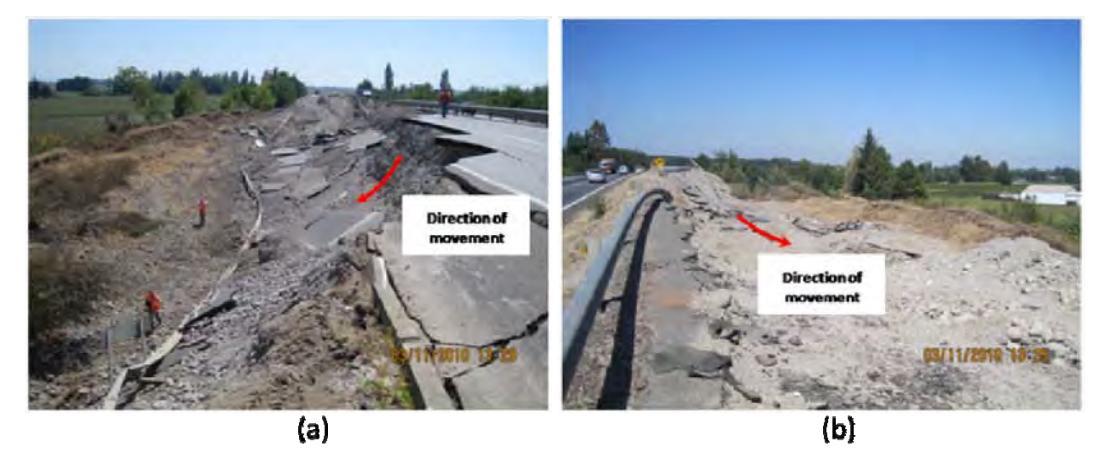
Two collapsed embankment fills were identified near Copihue and Parral. The first, shown in Figure 9.57, occurred on a straight section of Ruta 5 located ~ 8 km North of Parral (S36.0796 W71.7881). The Southbound lanes collapsed to the West and appeared to involve a shallow translational slide in near surface foundation soils as evidenced by the location of the failed soil mass including a mound of soil pushed up at West toe of the embankment (Figure 9.57a). The embankment failed along a length of approximately 150 m at a location where a low lying softer soil area was located at the toe.

Figure 9.57. This embankment fill collapsed together with an overhead near Copihue, north of Parral, closing the South bound of Route 5 (a) View from the South, (b) View from the North (S36.087891, W71.791513, 1325 hrs on 3/11/2010)

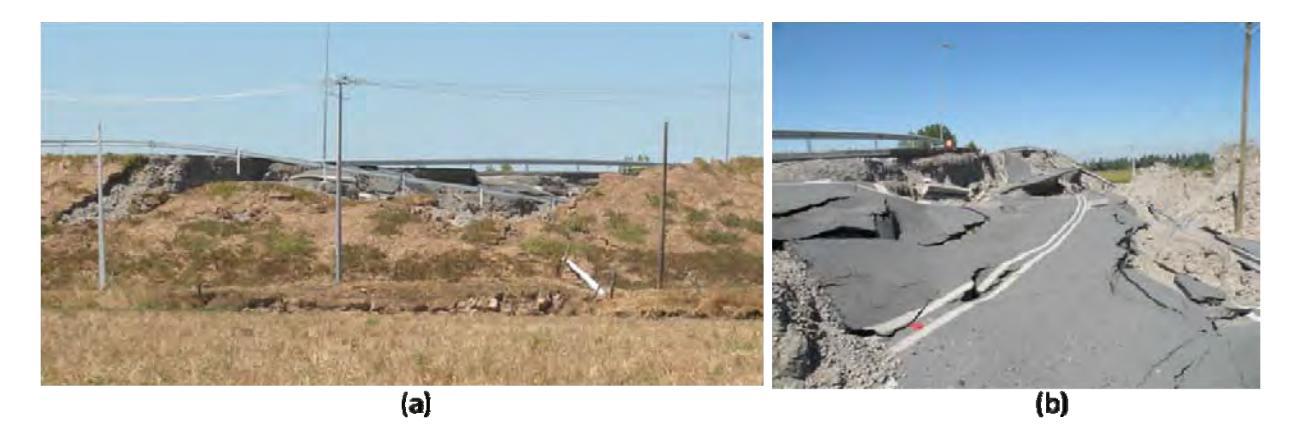
The second failure, shown in Figure 9.58, occurred on an overpass of Ruta 5 located ~ 13 km North of Parral. (S36.0347, W71.7558). The overpass embankment was curved and the embankment failed over a length of about 80 m towards the outside of the curved section. Again, the failure appeared to involve a shallow translational slide in the near surface foundation soils as evidenced by the intact failed soil mass and the mound of soil pushed up at the toe (Figure 9.58a). Foundation soils in the region appeared to be relatively competent (unlike the above case) suggesting possible elevated pore pressures in the foundation soils played a role in the observed failure with 3-D effects leading to failure to the outside of the curved embankment section as opposed to the inside of the embankment. The outside section of the slide mass remained completely intact as evidenced in Figure 9.58b.

Figure 9.58. Curved overpass embankment failure 13 km North of Parral (a) Translational 3-D slide failure, (S36.0343 W71.7568; 1405 hrs on 3/11/2010) and (b) Failed outside of the curved embankment (S36.0347 W71.7558; 1409 hrs on 3/11/2010)

A large embankment failure occurred on an overpass of Route 5, approximately 13 km North of Parral (S36.0347, W71.7558). The overpass embankment was curved and the embankment failed over a length of about 80 m towards the outside of the curved section. The failure appeared to involve a shallow translational slide in the near surface foundation soils as evidenced by the intact failed soil mass and the mound of soil pushed up at the toe (Figure 9.52a). Foundation soils in the region appeared to be relatively competent suggesting possible elevated pore pressures in the foundation soils played a role in the observed failure with 3-D effects leading to failure to the outside of the curved embankment section as opposed to the inside of the embankment. The outside section of the slide mass remained largely intact. We performed two DCPT soundings and hand augers at the site, along with LIDAR scanning. Both soundings and hand augers refused at shallow depth because of the high gravel content of the soils below the ground water table.

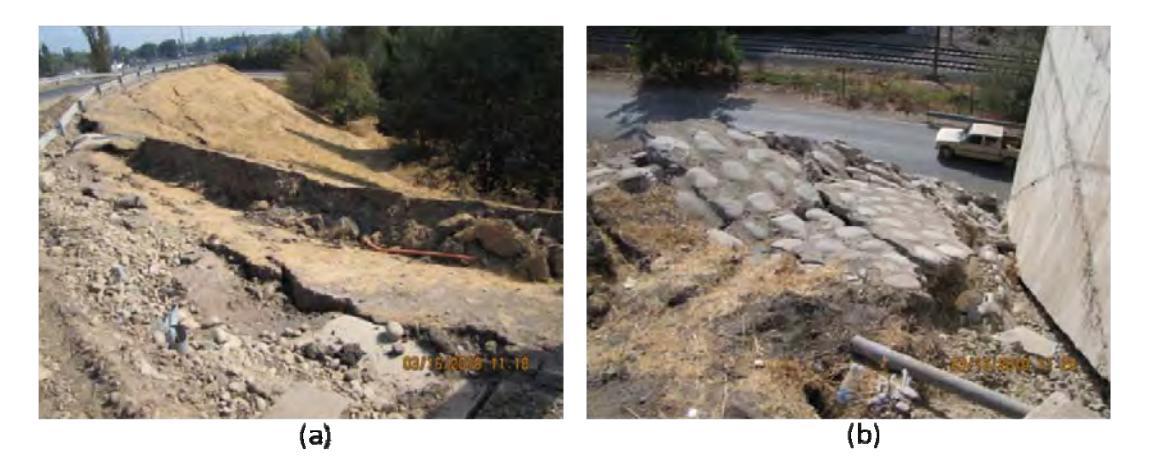
Abutment and embankment failures were common along Route 5. Figure 9.59 and Figure 9.60 show typical highway failures due to poor compaction of the embankment fill and abutments near Paine 62 km South of Santiago. The same scenario repeated at multiple sites. In contrast, mechanically stabilized retaining structures performed exceptionally well. Figure 9.59 shows the failure of an overpass bridge. The figure shows cracks on the sloping ground that propagated away from the abutment, and reduced in size away from the bridge. It seems cracks succeeded the abutment failure. The structural damage of the overpass was caused by differential settlement of the supports. Figure 9.60 shows the failure of the highway shoulder and pavement due to poor compaction of the fill material.

Figure 9.59. Highway 5 crossing near Paine; (a)View of bridge approach from East (S33.854592° W70.747687°; 1118 hrs on 3/16/2010); (b) View of damaged bridge abutment (S33.854211° W70.747784°; 1120 hrs on 3/16/2010)

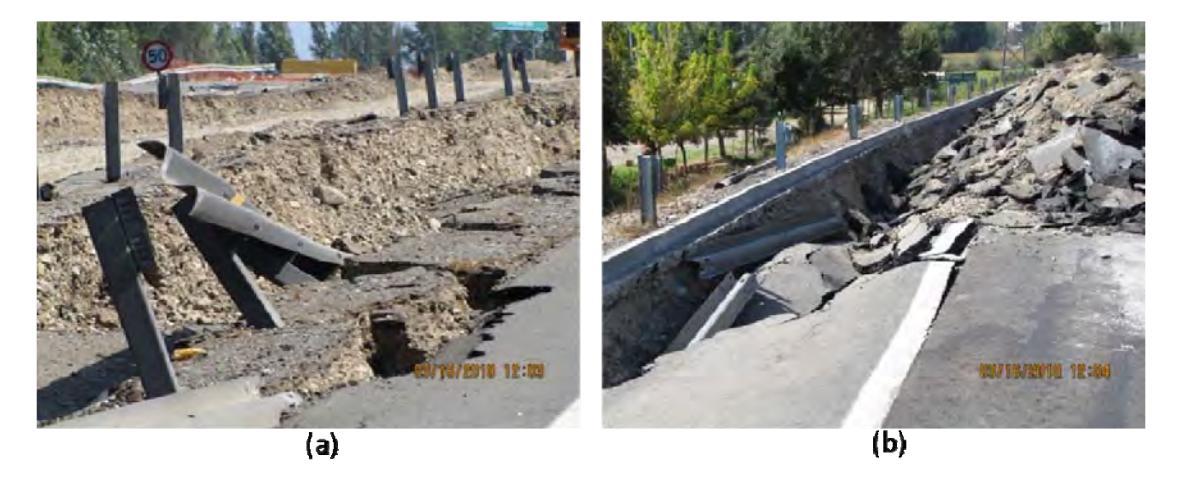
Figure 9.60. Highway 5 failure near Paine; (a)shoulder settlement due to poorly compacted soil (S33.864897° W70.742222° 1203 hrs on 3/16/2010), and (b) road failure due to poorly compacted soil (S33.864897° W70.742222°; 1204 hrs on 03/16/2010)

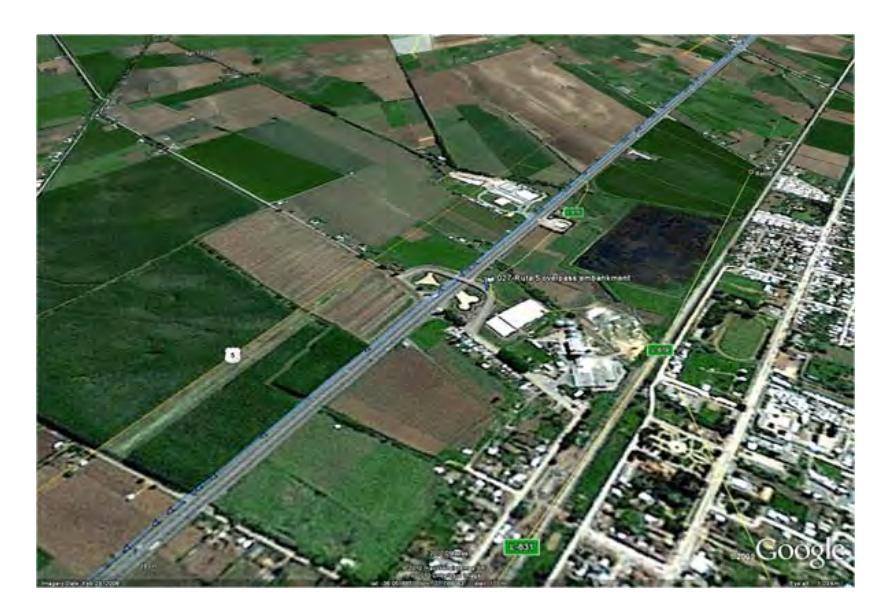
Team D performed SASW measurement s on a damaged overpass embankment on the right side of the north bound lane of Route 5 Sur. The damage of the embankment appears to be due to shaking and bulging of the embankment material. The underlying soils appear to be intact with no evidence of loss of loss of strength. The embankment bulged laterally and settled. The overpass embankment to the left of the north bound lane does not show signs of damage.

Figure 9.61 Ruta 5 Sur overpass embankment, looking north, to Retiro at Tucapel Mill (\$36.051209°, W71.768005°).

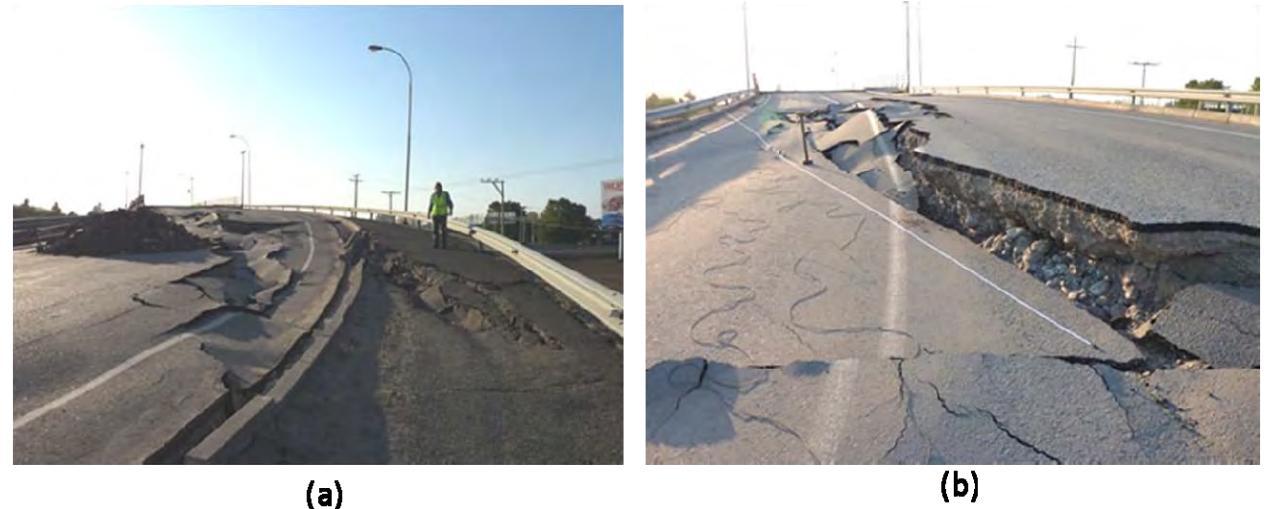
Figure 9.62 (a) Damage to overpadd embankment, Ruta 5 Sur overpass embankment, to Retiro at Tucapel Mill, April 15, 2010 (S36.051209°,W71.768005°), (b) SASW line, Ruta 5 Sur overpass embankment, to Retiro at Tucapel Mill, April 15, 2010 (S36.051209°,W71.768005°).

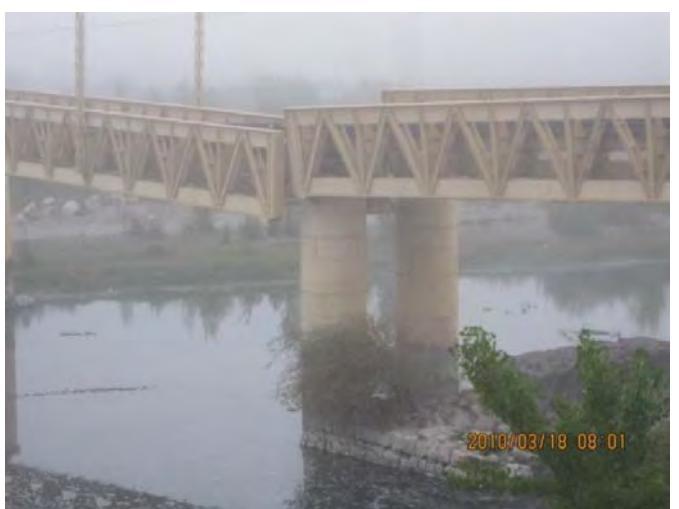
The EERI Bridge team observed the unseated railroad bridge span shown in Figure 9.63 approximately 330 km south of Santiago. This appeared to be the result of strong shaking, as no signs of liquefaction were observed. The Route 5 highway bridge was undamaged. An adjacent highway bridge was out, but demolished prior to the earthquake (S36.004136, W71.726193). Approximately 217 km south of Santiago, a railroad bridge crossing the Rio Claro was apparently undamaged, though the approach fills settled over 0.5 m, resulting in separation of the tracks from the support.

Figure 9.63. Unseated railway bridge span near Longavi from excessive transverse movement (S36.004136, W71.726193, 0801 hrs on 3/18/2010)

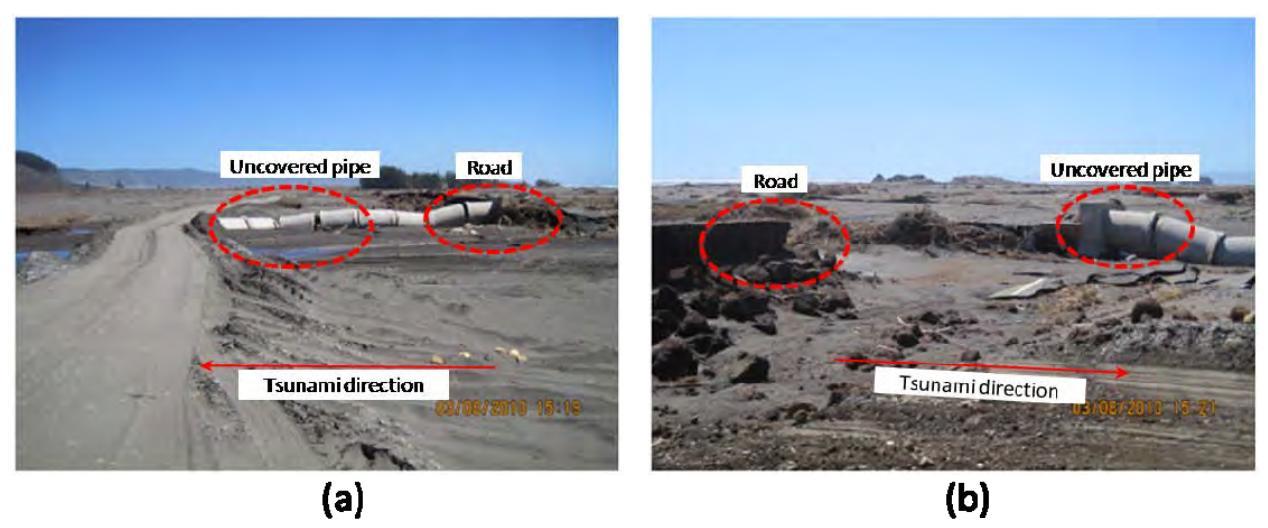
In this area, the tsunami caused most of the damage, washing off the road and uncovering a concrete pipe (Figure 9.64). Considering the extent of the damage in this zone, the pipe did not distort very much. This part of the road, however, was totally destroyed. This may be due to the orientation of the pipe relative to the receding tsunami water.

Figure 9.64. Failed culvert pipe: (a) View from the north, and (b) View from the south (S35.115611, W72.203245, 1519 hrs on 3/8/2010)

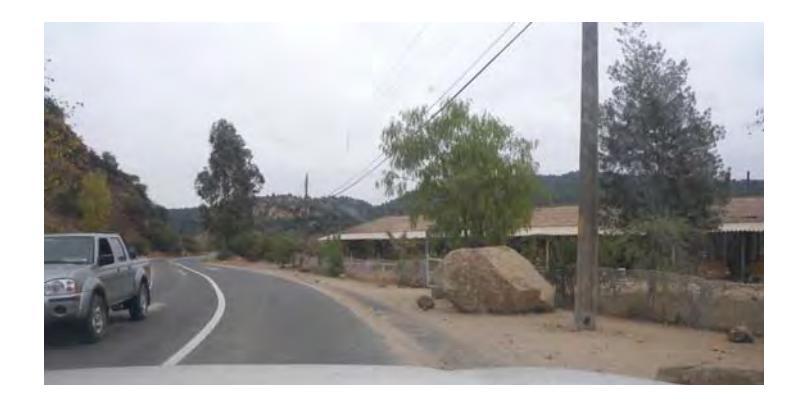
**Rapel Dam (34.041445°S, 71.588856°W) -** Figure 10.1 shows a rock fall from a road cut in granitic jointed rock mass on the main road approaching the Rapel Dam. Fortuitously, there was no damage to the buildings, because the road acted as a buffer. Rock falls also occurred from steep unscaled slopes immediately below Rapel Dam on both abutments. While not causing any damage of consequence, the fallen rock did represent a removal nuisance (Figure 10.2). A shallow disaggregated slide in road cut in the weathered rock mass also covered a portion of the roadway along the immediate upstream section of the right abutment of the reservoir (Figure 10.3). This type of limited raveling failure is characteristic of failures observed sporadically throughout the region, as shown below.

Figure 10.1. Rock fall from a road cut at the approach to Rapel Dam (34.0365°S, 74.586983°W).

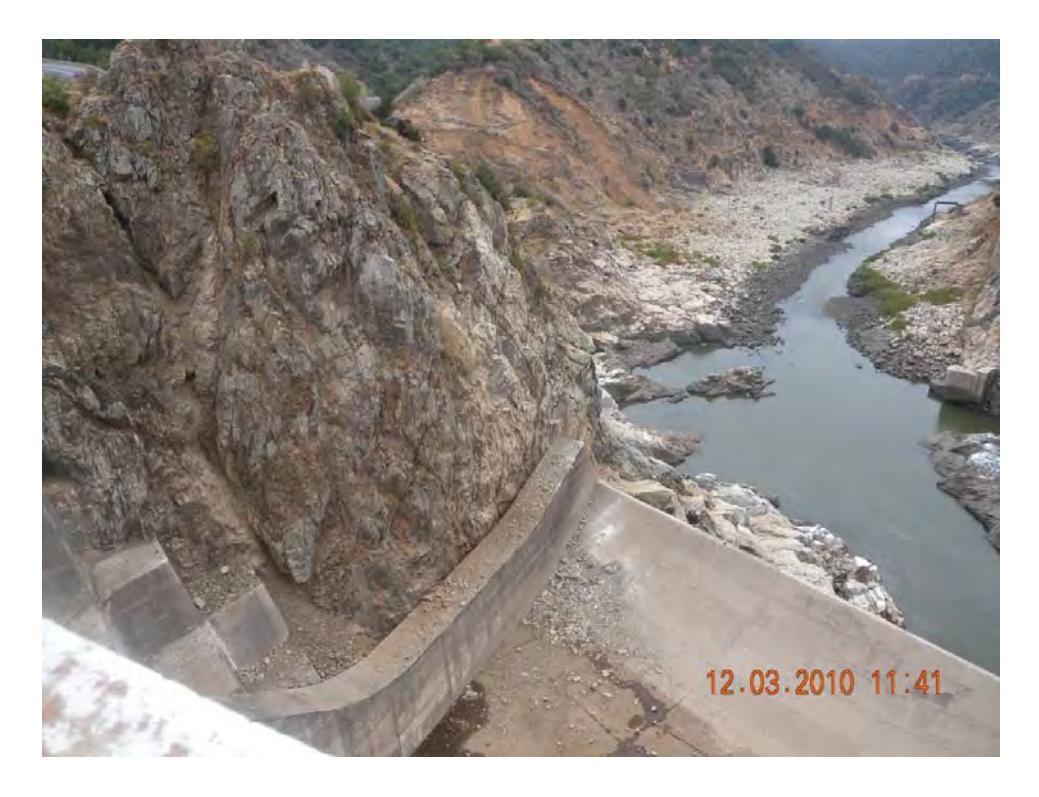
Figure 10.2. Rock fall from the downstream left abutment of Rapel Dam (34.04167°S, 71.59263°W).

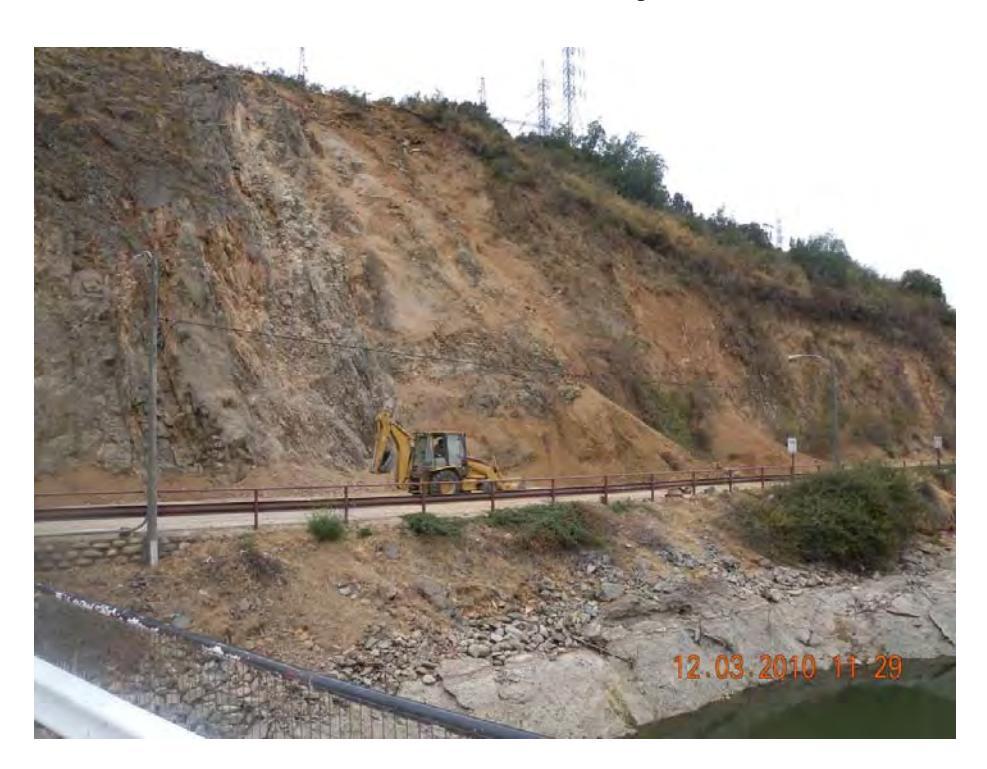
Figure 10.3. Shallow raveling failure of a road cut in weathered and heavily jointed granitic rock at Rapel Dam (34.0407421°S, 71.587153°W).

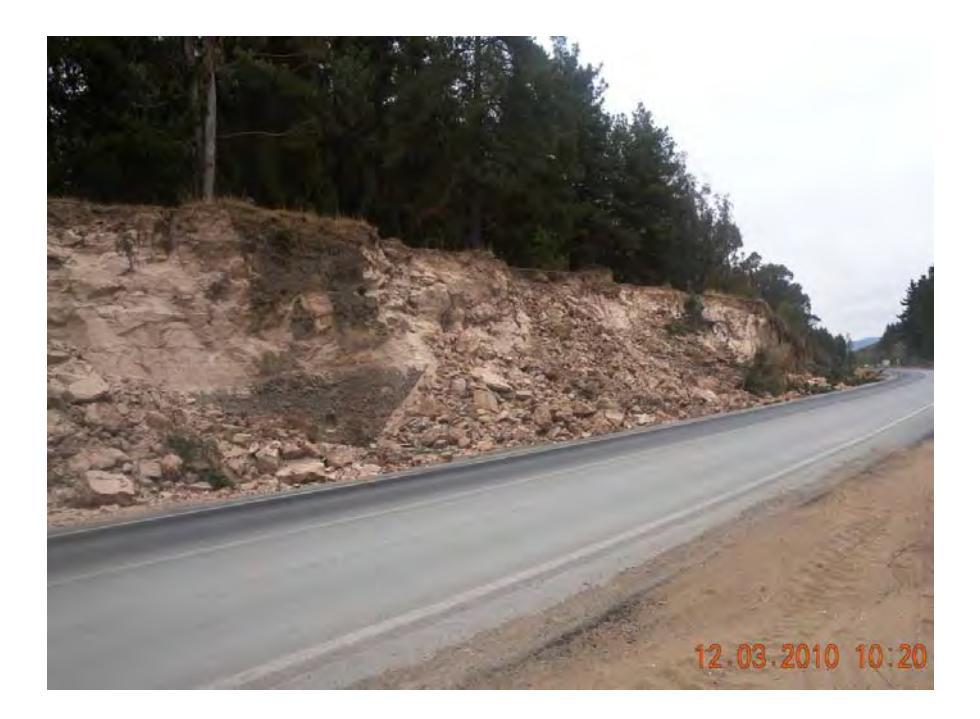
Road Cut Failures – Sporadic failures in road cuts were noted throughout the region and their size and characteristics typically reflected the height of the cut and the competency of the source material. More competent rock types exhibited larger size boulders within the failed mass while less competent source materials exhibited more disaggregated masses of smaller boulders and particles. Figure 10.4 shows a relatively extensive failure in a cut in jointed welded tuff north of El Manzano along the western edge of Lago Rapel. Figure 10.5 is a shallow failure in an approximately 15 m (45 ft) high cut in highly weathered rock on the road from Nacimiento to Santa Juana. The volume of the material was just enough to overtop the barrier, but not enough to damage it or to impede traffic. Figure 10.6 is a cut in Holocene fluvial sand deposits just North of Pulen bridge (Bridge Case No. 9) that simply sloughed along most of its face. The failure was shallow and had no effect on traffic. Similar shallow slides were observed on numerous highway overpass fills which typically appeared to be densely compacted sand with very few fines. Finally, Figure 10.7 is a bench failure in a high,  $\sim 30$  m, benched road cut in residual soil/heavily weathered rock. The failure appears to have occurred along a daylighting joint surface that was unrecognized when the uppermost bench was cut. An immediately adjacent, identically benched slope showed no signs of failure; hence, joint orientation most likely controlled the location and mode of failure.

Figure 10.4. Road cut failure in jointed welded tuff north of El Manzano. The height of the cut is about 6 m (20 feet). Picture looking NE (34.144076°S, 71.38000°W).
