# Geo-engineering Reconnaissance of the 2010 Maule, Chile Earthquake

Report of the NSF Sponsored GEER Association Team

# GEER Association Report No. GEER-022

Version 2: May 25, 2010

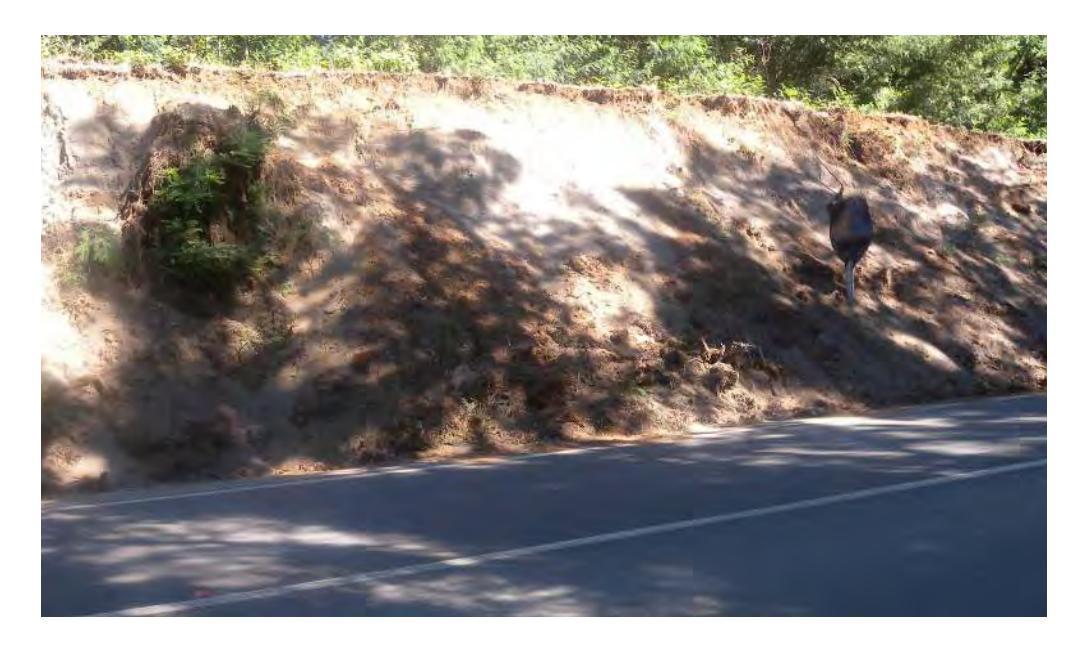
Figure 10.6. Sloughing of unconsolidated fluvial sand in a road cut North of Santa Juana (37.1111°S, 72.9876°W).

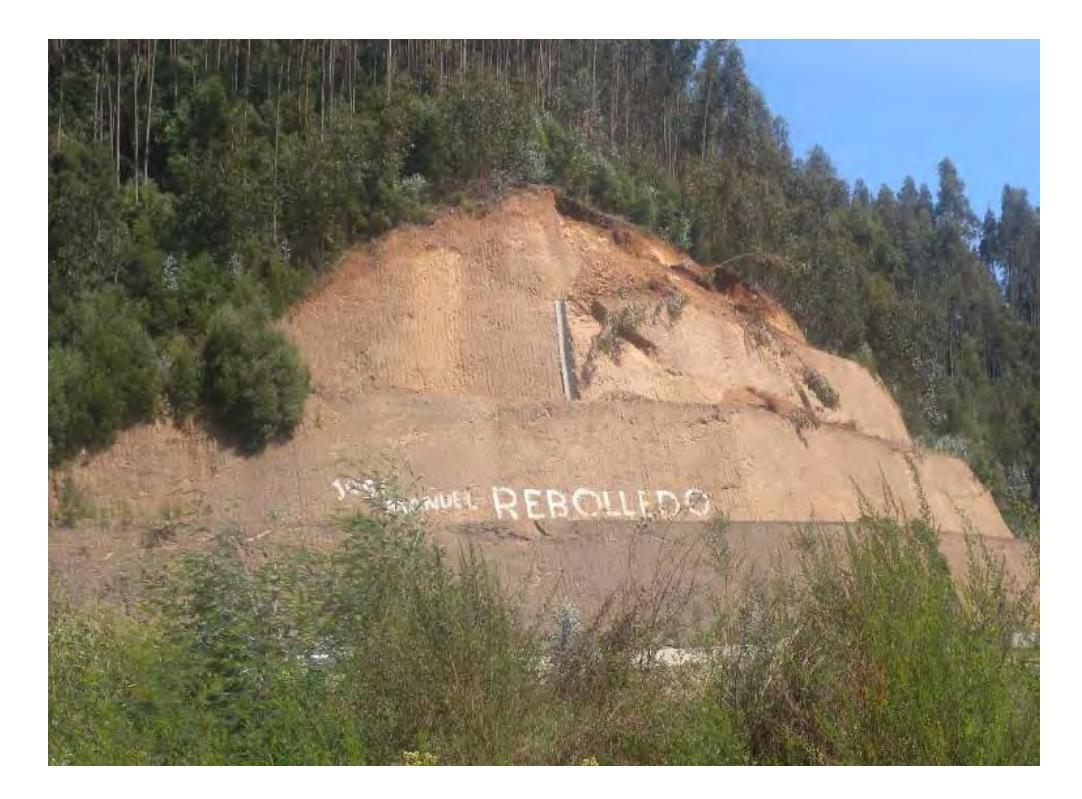
Figure 10.7. Bench failure along a daylighting joint in a road cut in deeply weathered rock south of Lota (37.1213°S, 73.1550°W).

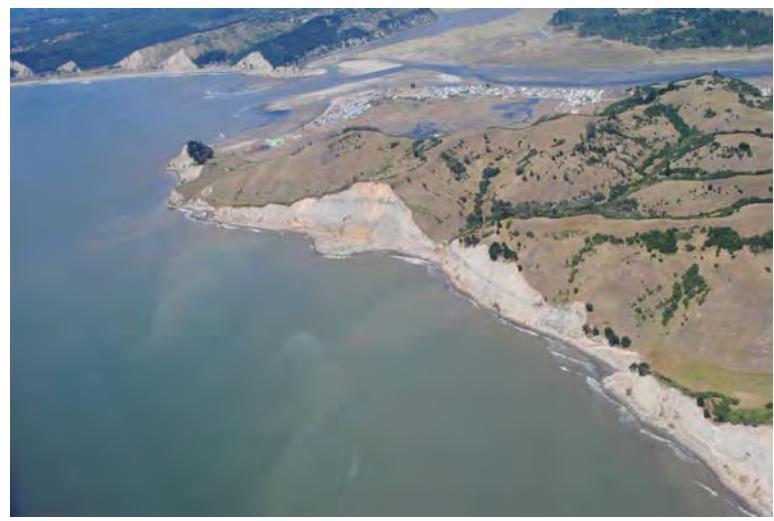
The character of the coastline changes to the north of Arauco, with softer sediments exposed in the terrace and beach bluff slopes. The slopes tend to be more gentle and more densely vegetated. Similarly slope failures are less frequent although when they occurred they had greater impact as road alignments take advantage of the less rugged coastal zone. A series of slides occurred at the seaward ends of low ridges in soft sandstones west of Arauco, with two of the slides closing the coastal road. The aerial view of the general setting is shown in Figure 10.10 with the town of Tubul in the distance and Arauco off the picture to the distant left (SE). A view of a slide that closed the road just West of Arauco is shown in Figure 10.11.

Figure 10.10. Aerial view of the coastal bluffs West of Arauco (37.2205°S, 73.443°W).

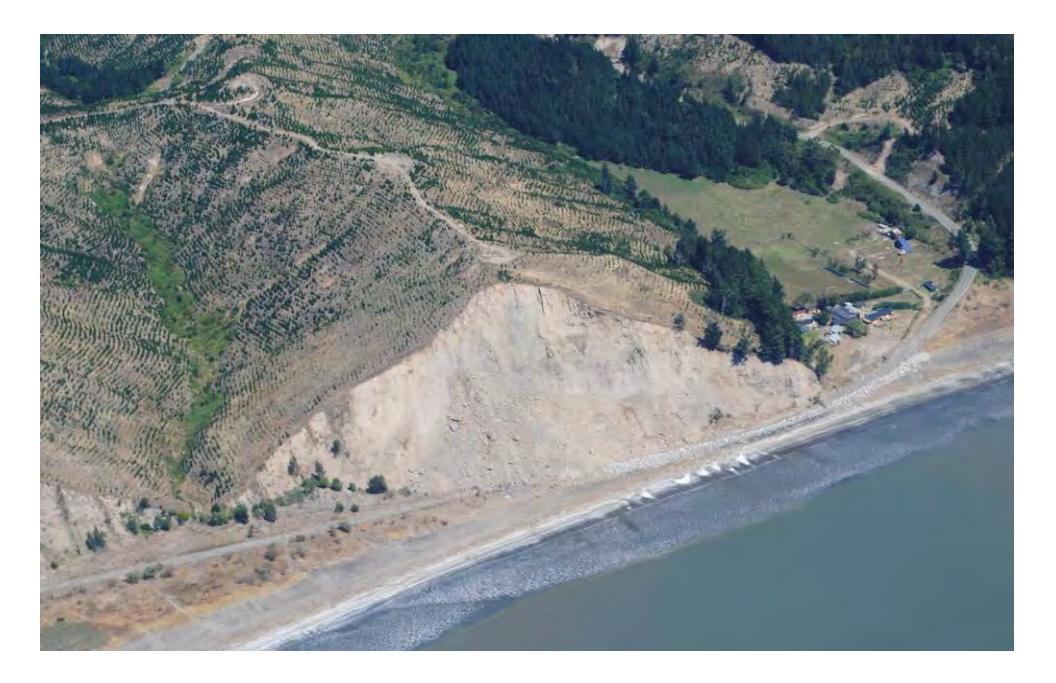
Figure 10.11. Shallow failure along a truncated ridge forcing road closure West of Arauco (37.2437°S, 73.413°W).

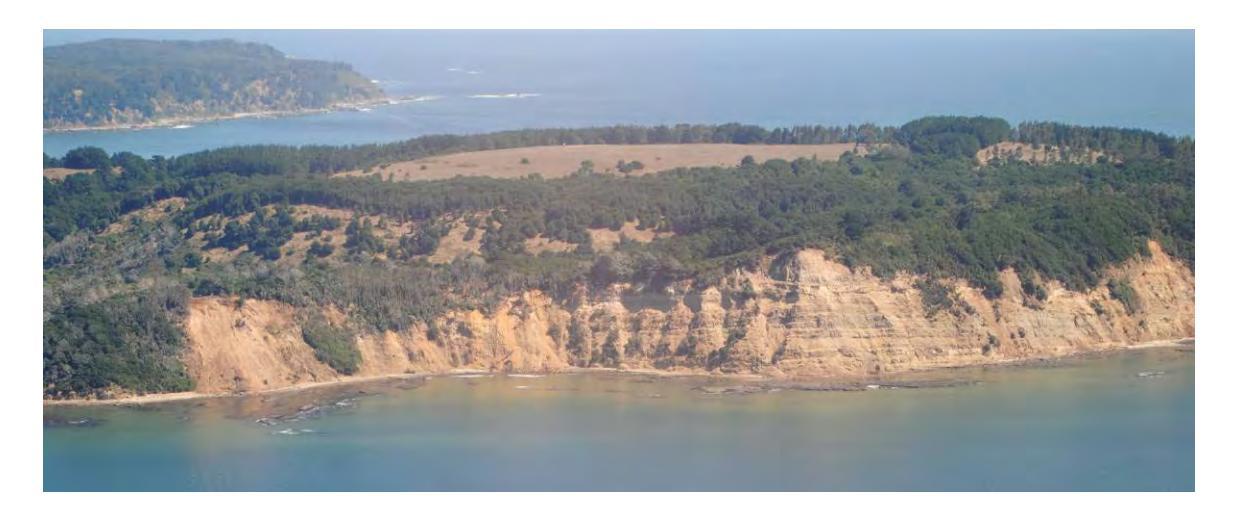
**Concepcion Area** – Very similar types of highly localized landslides occurred on bluffs in Tertiary sedimentary rocks in the region around Concepcion. Figure 10.12 shows steep bluffs on the eastern shore of Isla Quiriquina which experienced shallow raveling which mostly denuded the slopes. However, several larger failures occurred in this area as well. Figure 10.13 shows a large complex of shallow coalescing slides located on the western shore of Pta Tumbes just north of Talcahuano. While this landslide complex in Teritiary sedimentary rocks was one of the most extensive failures noted along the entire coastline, pre-existing photography suggests that this was a previously disturbed area used as a quarry with a history of prior sliding. This conclusion is supported by the fact that very few other slides are found in the vicinity. However, a well documented large failure of a road cut occurred across the bay just north of Tome (Figure 10.14). The road cut in interbedded sandstone and shale is about a year old and the estimated volume of the slide is 3200 cubic meters (Jose Miguel, personal communication).

Figure 10.12. Shallow failures and raveling in Tertiary sedimentary rocks on Isla Quiriquina (36.627°S, 73.05°W).

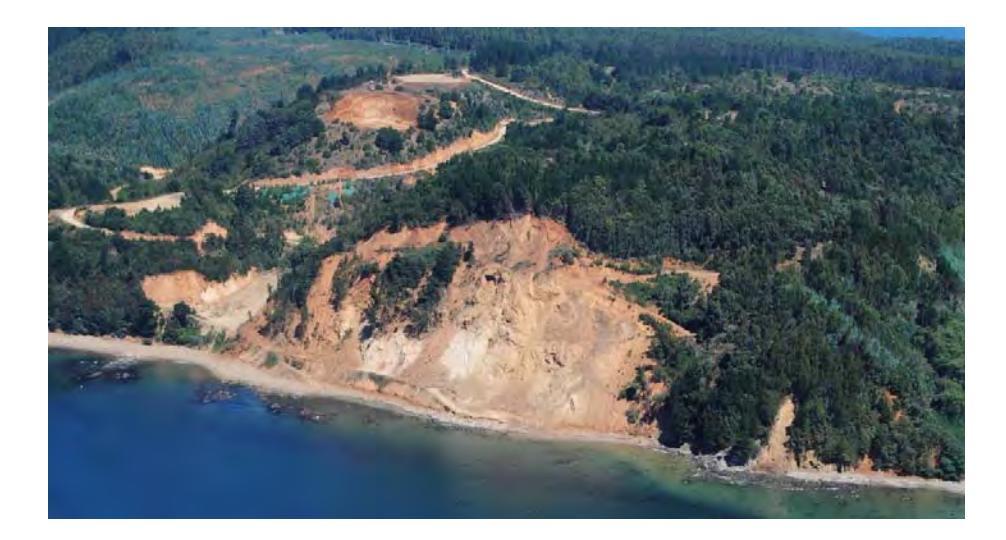
Figure 10.13. Disagregated landslide complex, Punta Tumbes looking West (36.66°S, 73.098°W).

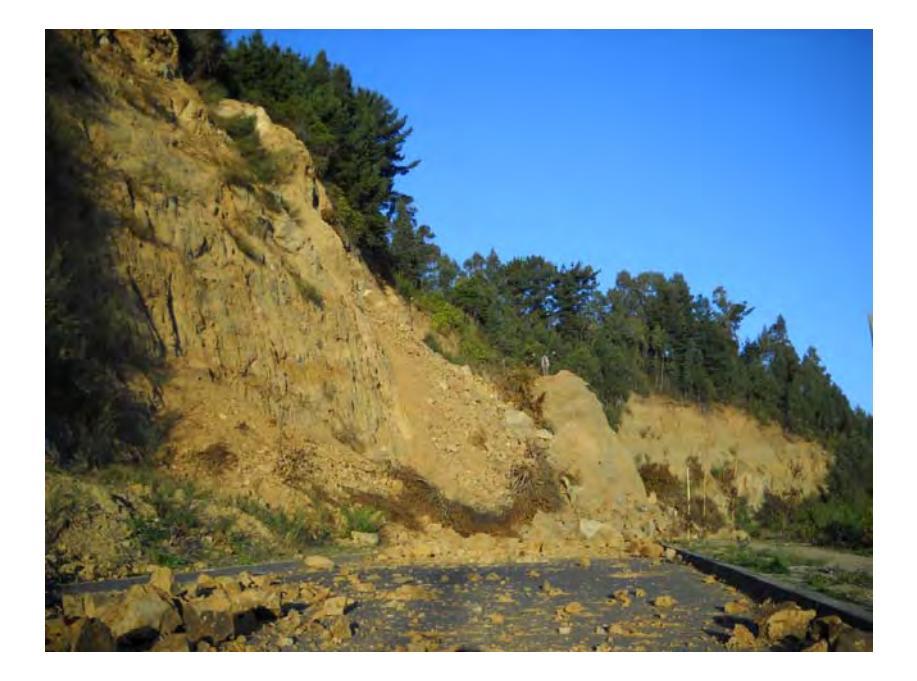
Figure 10.14. Landslide in a road cut in Cocholgue, north of Tome (36.595 S, 72.974 W). Photo and details courtesy of J.M. Lopez.

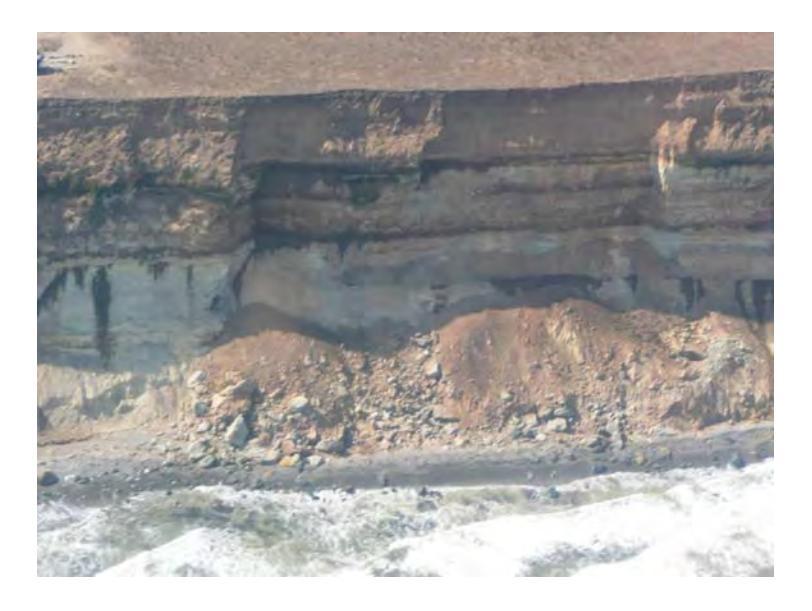
**Navidad to San Antonio** – Long stretches of the coastline north of Concepcion are fronted by bread beaches that are punctuated by occasional headlands with only occasional small slope failures. To the north of Navidad the coastline is defined by a relatively flat terrace capped by unconsolidated shallow marine and fluvial deposits. The terrace has an elevation of 80 to 100 m and drops abruptly to a narrow rocky beach. Numerous shallow failures by toppling and slumping of relatively thin slabs of bedrock and overlying sediments occurred in this region as illustrated in Figure 10.15.

Figure 10.15. Typical shallow failure of steep coastal bluffs, Reserva Nacional El Yali (33.841°S, 71.817°W).

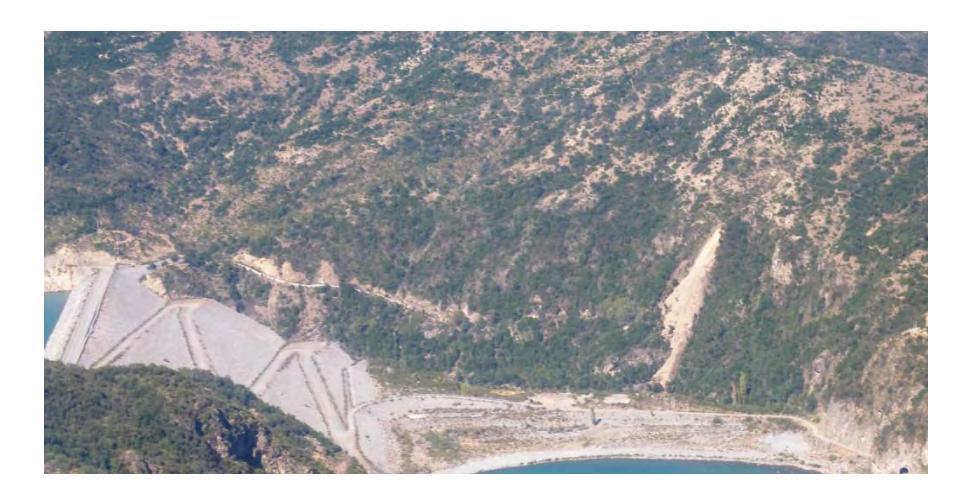
**Interior Region** – Widely scattered occasional disaggregated slides in natural slopes seemed to occur without any particular association with lithology or damage to nearby infrastructure as already shown at Rapel Dam. Figure 10.16 is an example of a typical small failure from a steep slope which occurred just below the Colbun Dam which suffered no damage.

Figure 10.16. Typical shallow disaggregated slide, Colbun Dam (35.668°S, 71.351°W) .

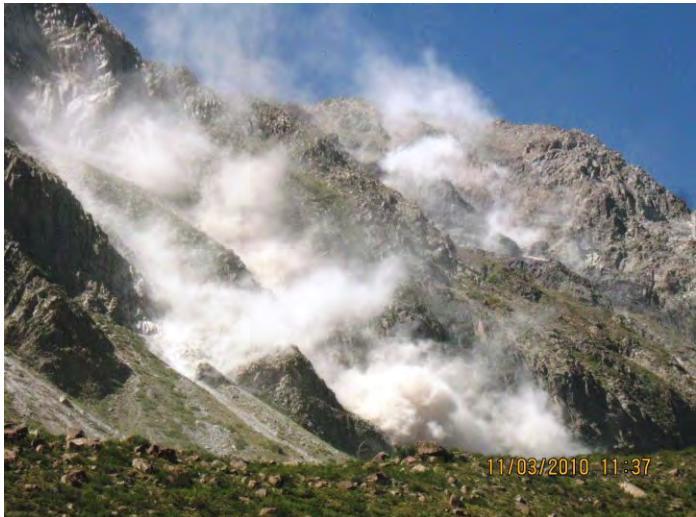
Given the paucity of sliding and rock falls in the main event, or at least lack of any significant damage due to them, it is interesting that rock falls and shallow raveling type failure was captured on camera in the foothills of the Andes during the M 6.9 event on March 11 (Figure 10.17). The site is east of San Fernando, in the direction of the Tiguiririca volcano, roughly 160 km east south east from the epicenter of the event, in steep terrain in highly fractured volcanic rock of the Coya-Machali Formation. Hence, rock falls presumably occurred in the main event but were not observed due to darkness and were apparently not considered significant enough to be reported as they did not cause damage of any consequence.

Figure 10.17. Rock falls and shallow debris slides following the M 6.9 event on March 11, 2010 (approx. 34.8°S, 70.5°W). Note, the time in the picture is 20 minutes off. Picture courtesy of Cristian Avila.

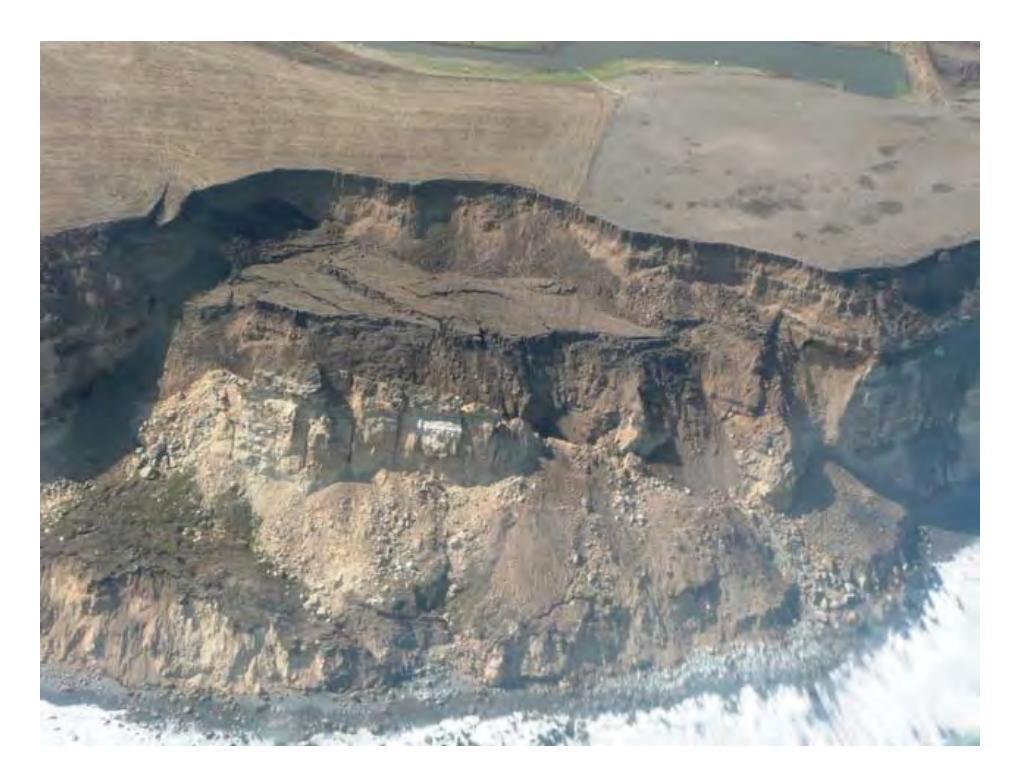
In general, deep-seated block or rotational slides were notable by their general absence. The one observed large failure, a deep-seated block slump, occurred in the coastal terrace in the El Yali National Park (Figure 10.18). The failure is clearly joint controlled, however, the exact reason for the size of this slump in an area otherwise characterized by relatively minor toppling or slumping (see Figure 10.15) is not readily apparent without further investigation.

Figure 10.18. Deep-seated bedrock slump in Tertiary sedimentary bedrock capped by marine terrace sediments (33.846°S, 71.821°W).

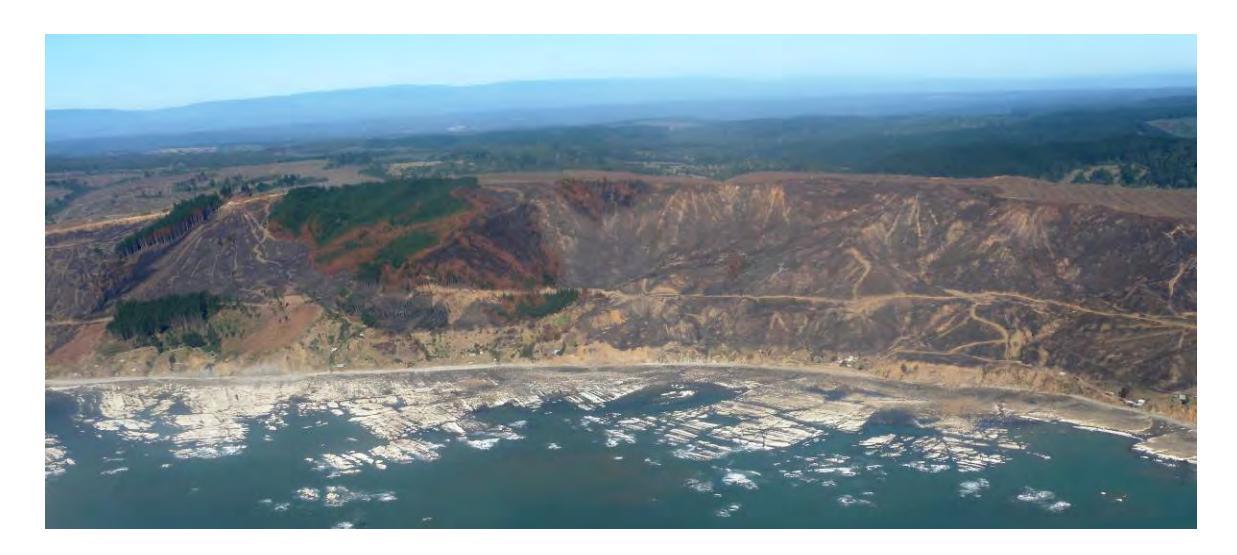
he general paucity of landsliding is best illustrated by the fact that even clearly identifiable areas of prior extensive landslide activity had little or no evidence of seismically triggered slides. For example, Figure 10.19 shows an old landslide complex along the coastal ridge just north of Lebu. The only evidence of sliding is seen at the lowermost portions of the slopes which form the back of the beach.

Figure 10.19. Old landslide complex north of Lebu showing no evidence of seismically-induced slope movement (37.561°S, 71.64°W).

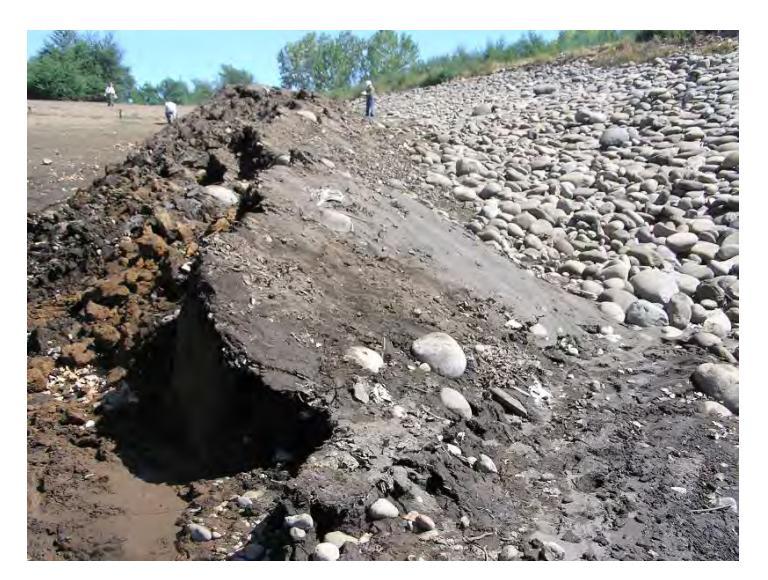
**Figure 11.1c** View of toe bulge area near left abutment of main dam, showing fine sand at the ground surface; due to the foot traffic it was not possible to see evidence that would allow one to classify these features as sand ejecta from soil liquefaction.

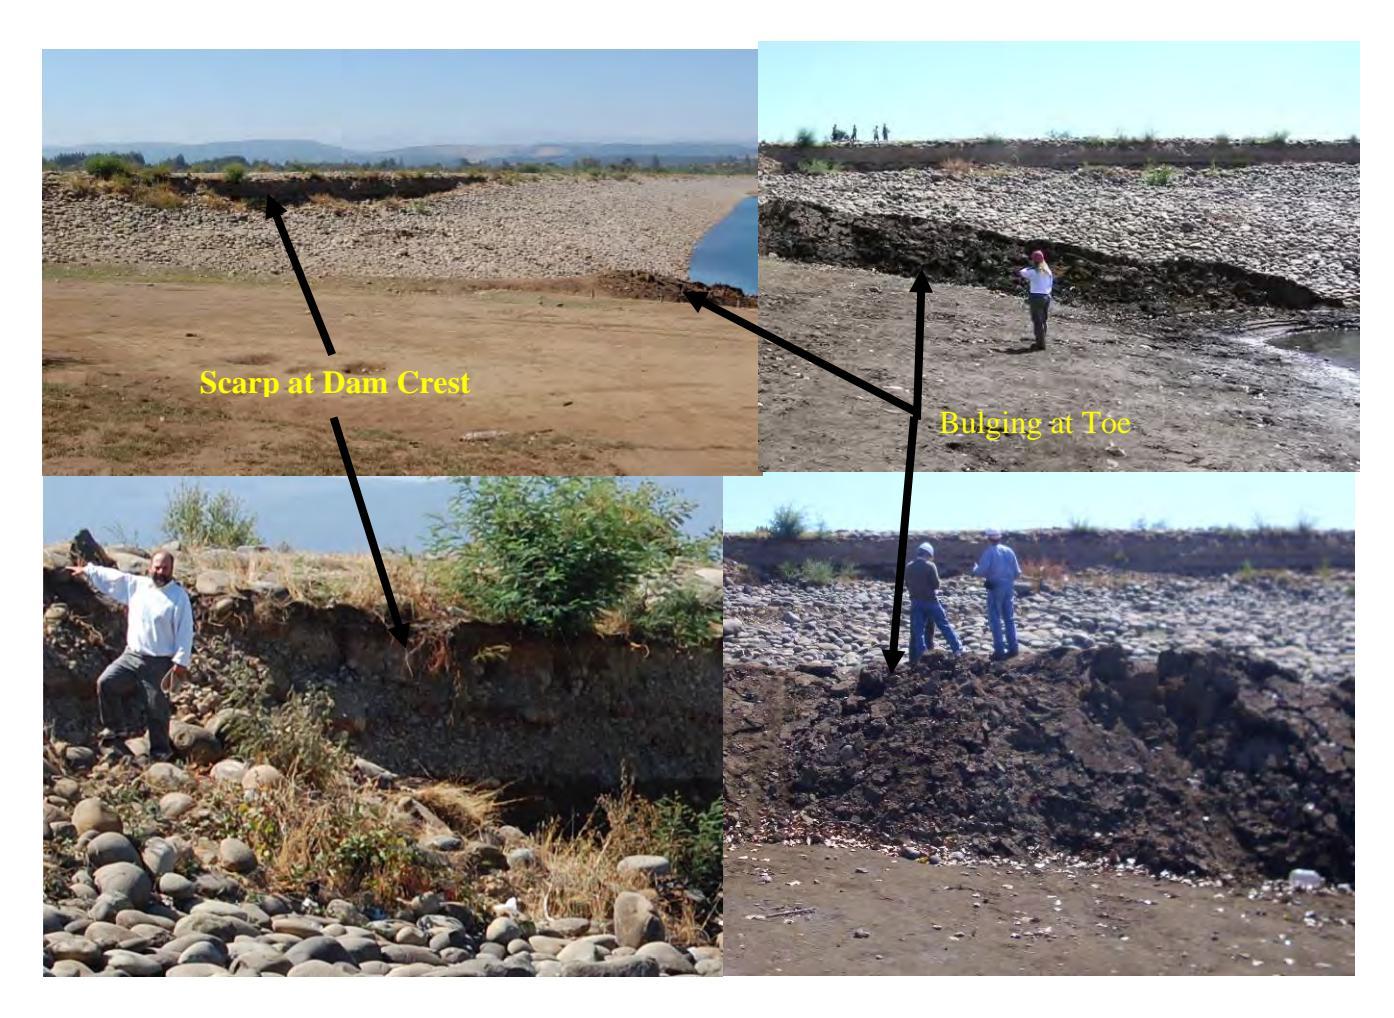
Figure 11.2. March 10, 2010. Slump of the upstream face of Coihueco Dam near the left abutment (S36.637166°, W71.797530°)

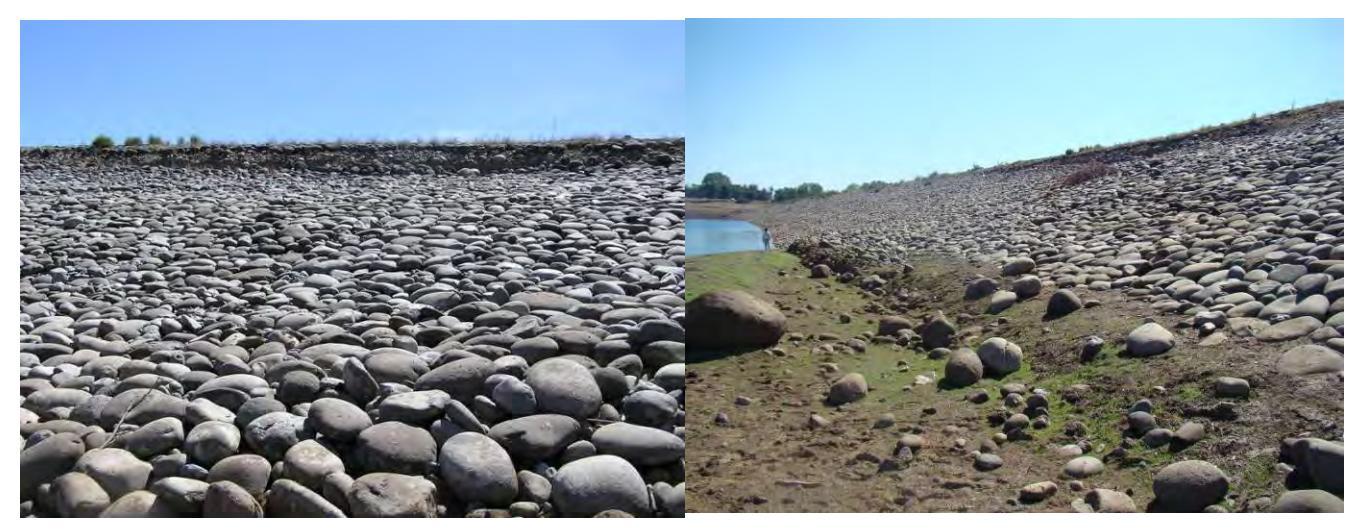
Figure 11.3. March 10, 2010. Slumping at Coiheuco Dam Crest and Bulging at Dam Toe. (S36.636508°, W71.792505°)

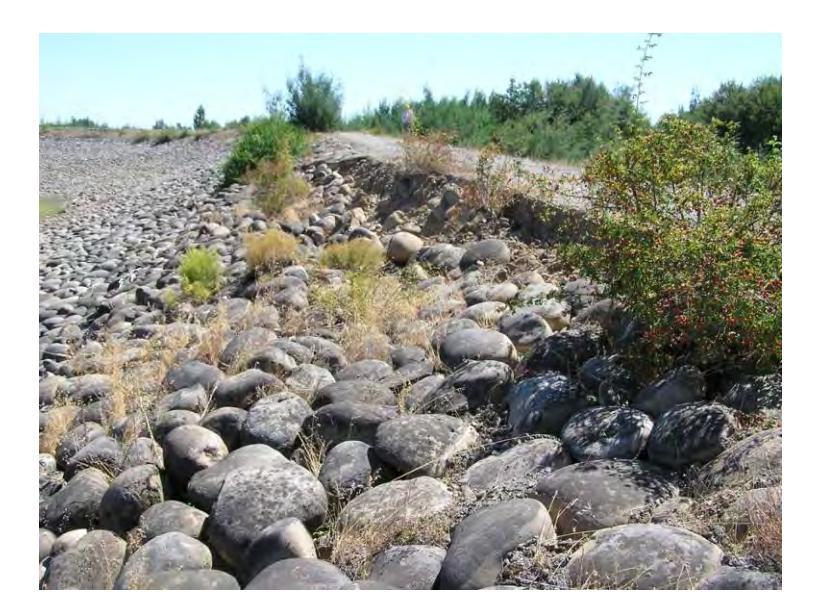
Figure 11.4. March 10, 2010. Small Area of Upstream Crest Slumping on Coiheuco Dam (S36.636902°, W71.788897°)

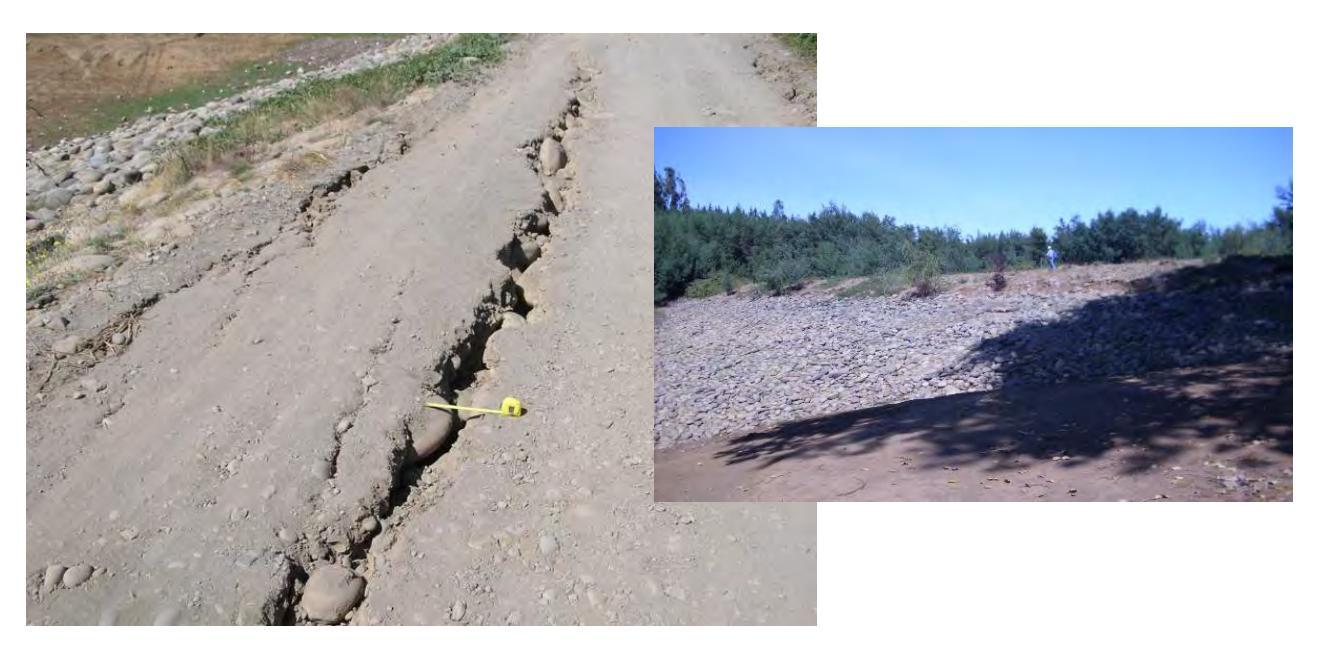
The dam was built during the period from 1964 to 1970 and has a maximum height of 31 m and a crest length of 1040 m. A Google Earth image of the dam taken before the earthquake with the reservoir full is shown in Figure 11.1a. The typical section used for the dam is shown in Figure 11.1b. It was not clear if soil liquefaction occurred at this site as potential evidence of liquefaction was destroyed by the time the GEER team arrived. Several slumps occurred in the upstream shell. A scarp is visible at the upstream crest and toe bulging occurs along the upstream toe. The left (west) abutment slump is most significant with clear toe bulging (Figure 11.2). A second slump occurs to the east with lesser amounts of toe bulging (Figure 11.3). There is another small area of crest movement further to the east (Figure 11.4). A small dam on the west side of the impoundment, to the south of the main dam, shows cracking along the crest (Figure 11.5).

Figure 11.5. March 10, 2010. Cracking of Crest of Small Dam South of Main Coihueco Dam (S36.645411°, W71.800212°).

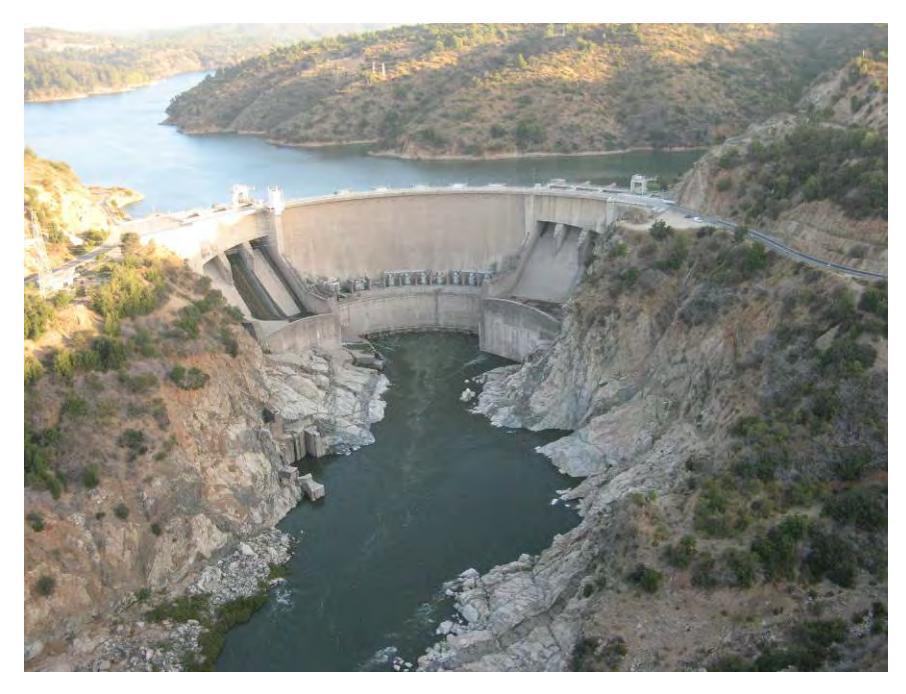
Observations of the Rapel Concrete Dam were made from helicopter on March 10, 2010. The dam was functioning and no signs of damage were observed. A leak upstream of one of the gates is reported to pre-date the February 27, 2010 earthquake.

Figure 11.6. March 10, 2010. Rapel Concrete Dam Downstream Face (\$34.038754°, W71.590223°)

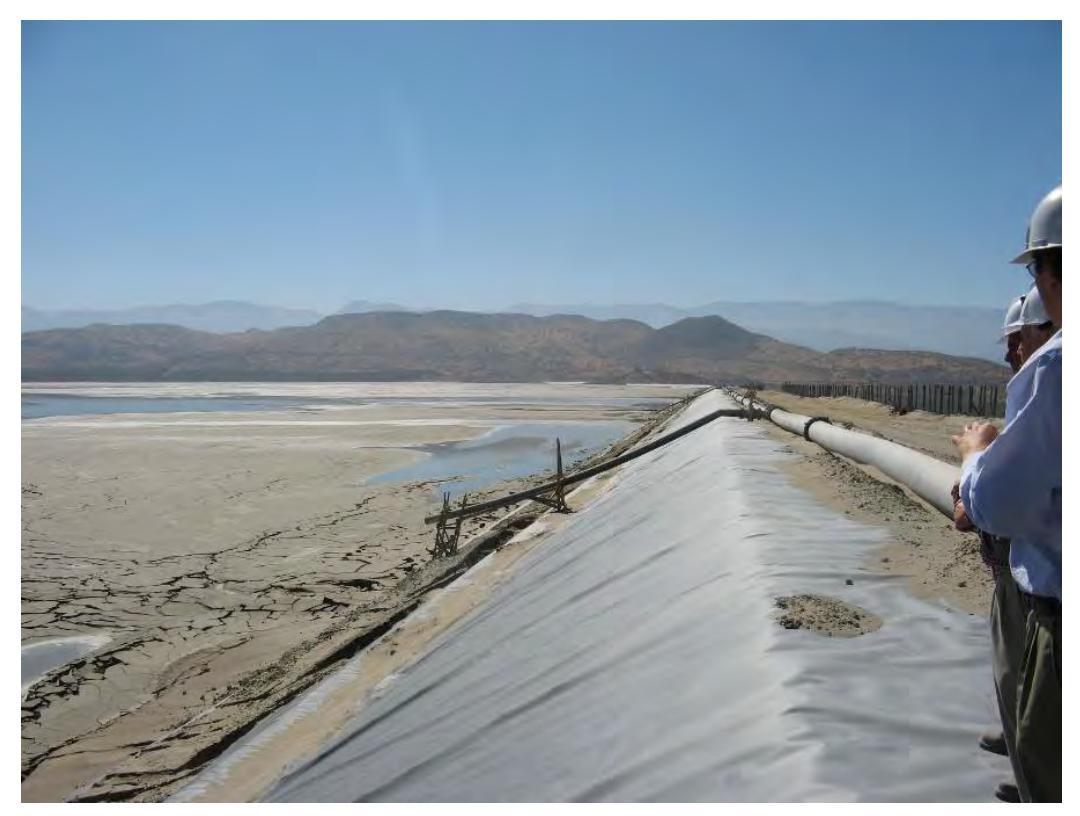
Figure 11.10. March 9, 2010 View along the Upstream Face of the Ovejeria Tailings Dam. There is no damage to the liner and no signs of slumping of the sand beneath the liner (\$33.052911°, W70.807067°)

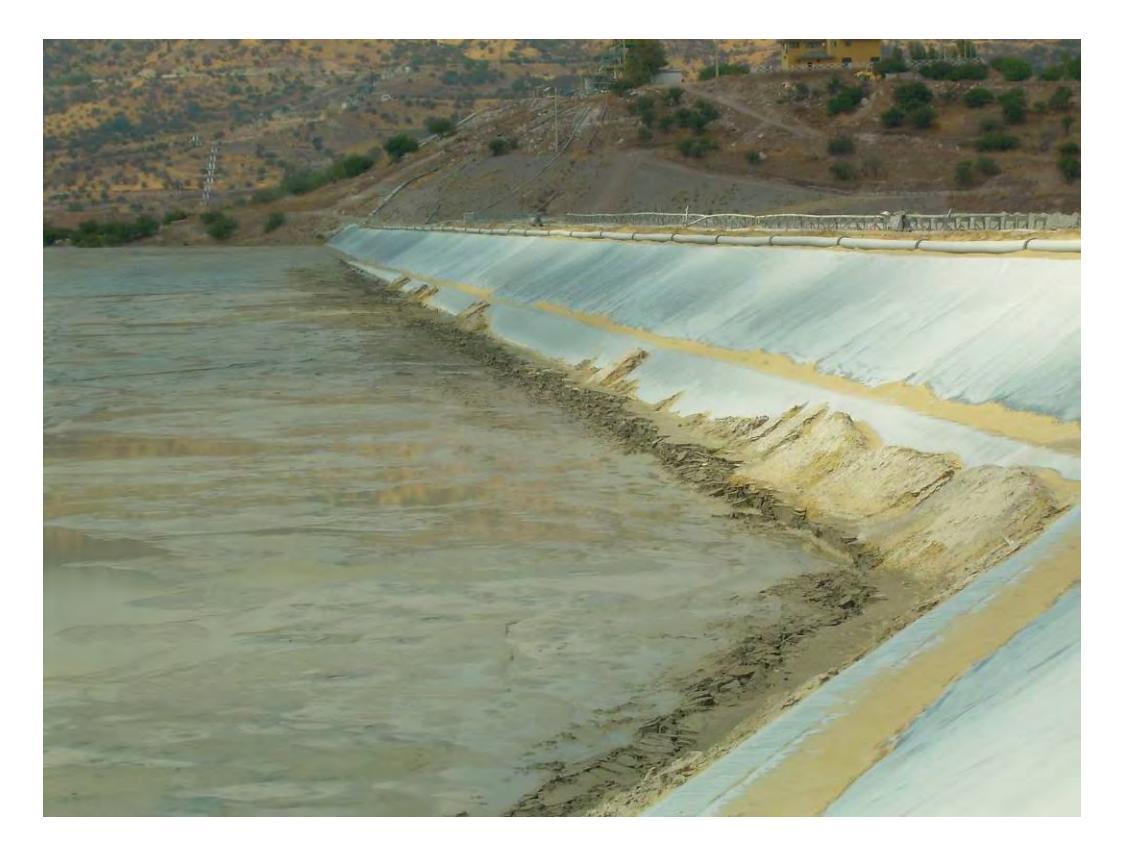
Both the on-ground inspection and the helicopter reconnaissance identified no problems with the tailings sand dam. There were many expressions of high pore pressure (sand boils) in the tailings upstream of the dam and the maximum settlement of the tailings near the dam was about 0.5 m, representing a strain of about 1%. The liner on the upstream showed no signs of dam. Several large valves rest directly on the liner, and there was not stretching or tearing of the liner at these valves. No cracks were observed on the crest or on the downstream face.

Figure 11.12. March 10, 2010. Upstream face of the Ovejeria Tailings Dam showing approximately 0.5 m of the tailings adjacent to the dam. (S33.052081, W70.792067)

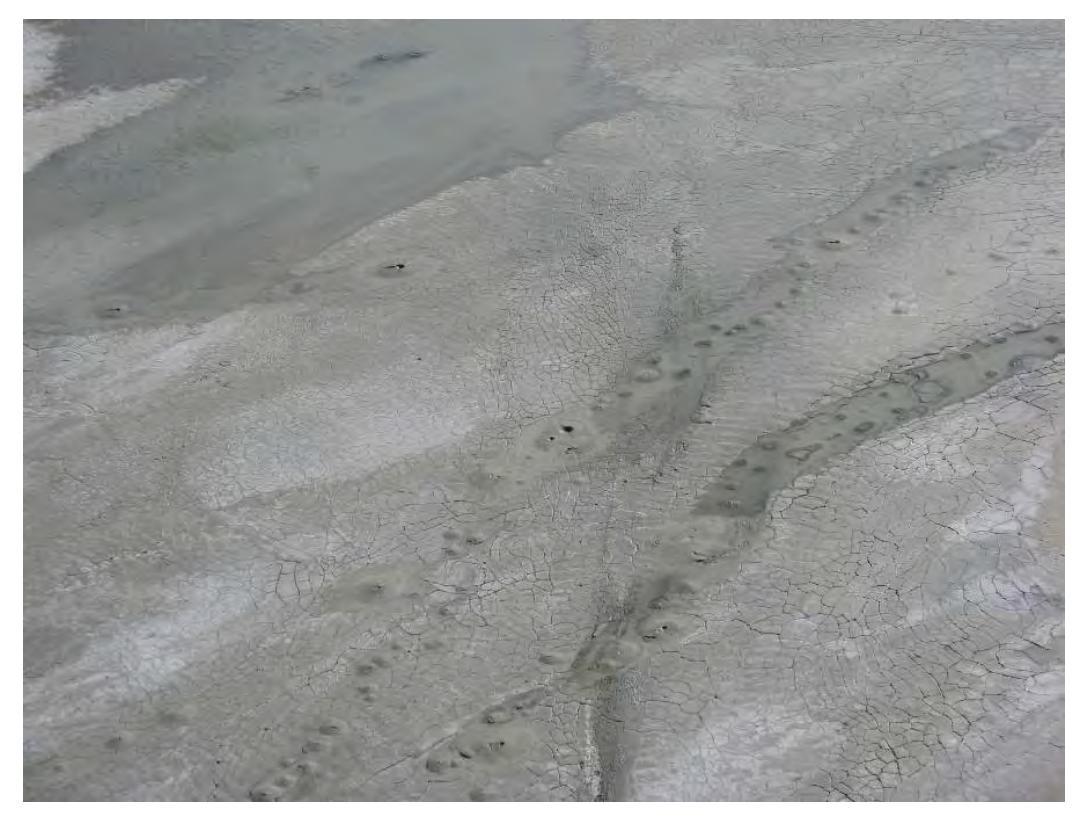
The Caren Tailings Dam is a zoned earthfill embankment using a sloping upstream core. The dam is raised using the downstream method. Dam raise construction was in progress at the time of the February 27, 2010 earthquake. Foundation preparation was complete for the downstream raise and compacted rockfill had been placed to about original ground level. The dam was visited on March 10, 2010. The March 11, 2010 M6.9 aftershock also affected this dam, but the site was not visited by GEER personnel following this second event. Minor (mm width) transverse cracking observed near each abutment, Figure 11.19. Evidence of settlement or movement of the downstream face not observed. Tailings upstream of the dam liquefied. Sand boils were observed in many areas of the tailings beach, Figure 11.17.

Figure 11.17. March 10, 2010 Sand Boils in Tailings Upstream of Caren Dam (S34.111476°, W71.141992°)

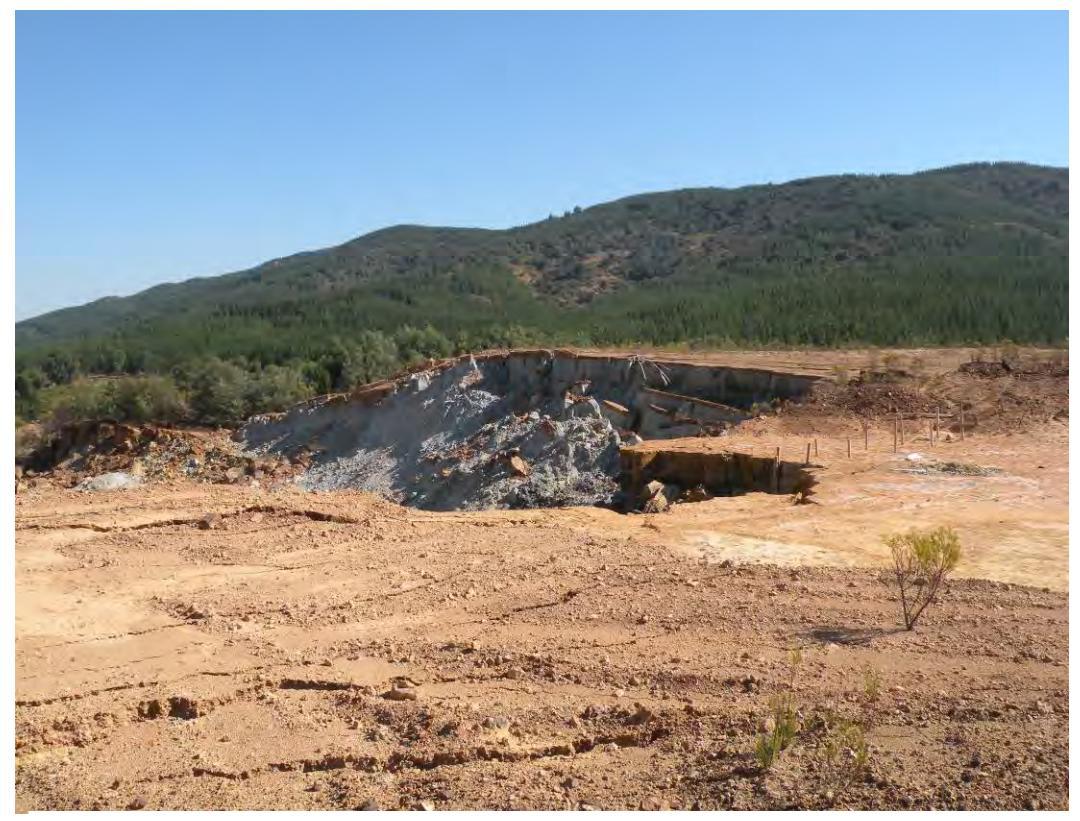
Las Palmas mine was operated from the early 1980's until 1997. The mine was closed and the tailings area partially covered with a thin (+/- 6") layer of gravelly material. Drilling of the tailings is reported to have been carried out in January and February 2010 to assess reprocessing of tailings for additional gold recovery. The profile seen at the upper failure scarp shows the gravelly cover layer and unsaturated tailings. Variable oxidation of the tailings has occurred with colours varying from tan to rusty in oxidized tailings to grey in unoxidized tailings. Clear evidence of liquefaction of the tailings with sand boils and ejecta along cracks indicating some portion of the tailings was saturated . Tailings flowed almost 0.5 kilometers.

Figure 11.23. March 11, 2010. Upper Scarp of Failed Tailings Impoundment Looking Southwest (35.184679° S, 71.759410° W)

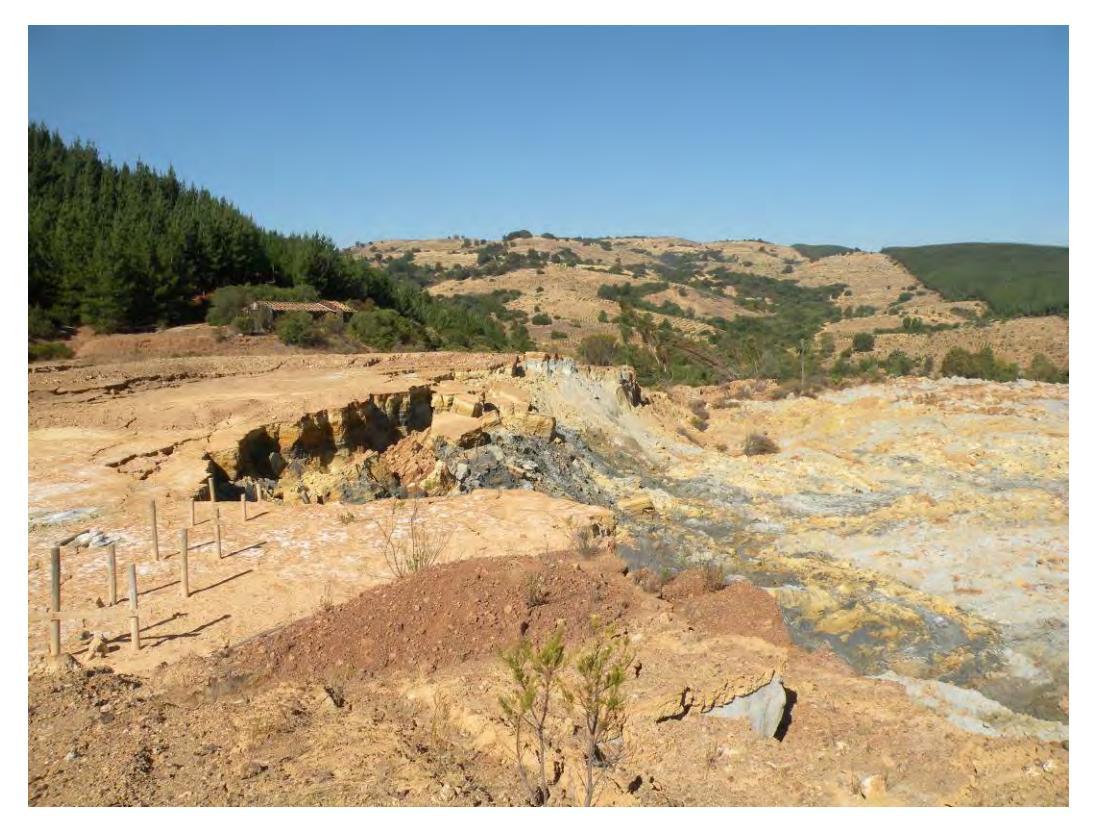
Figure 11.24. Upper Scarp of Failed Tailings Impoundment Looking Northeast (35.184679° S, 71.759410° W)

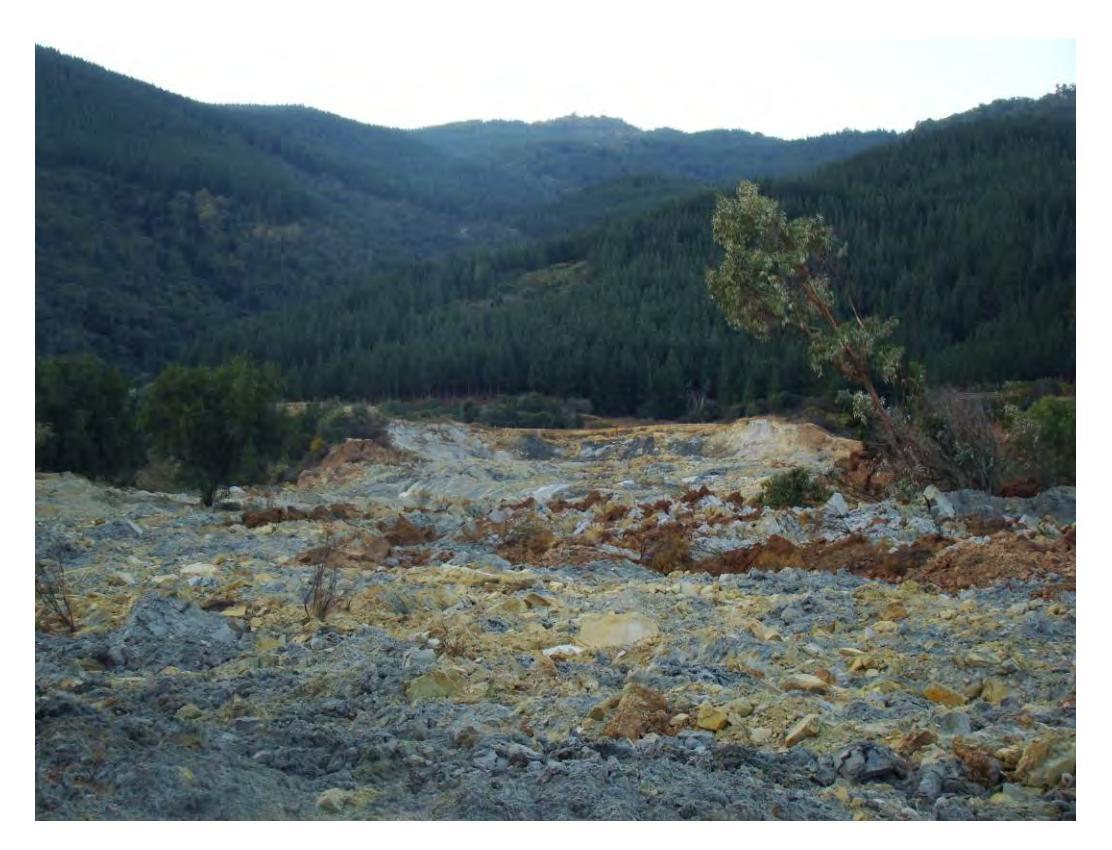
Figure 11.26. March 11, 2010. View Along Flowpath of Tailings  $~(35.18468^{\circ}$  S, 71.759410° W)

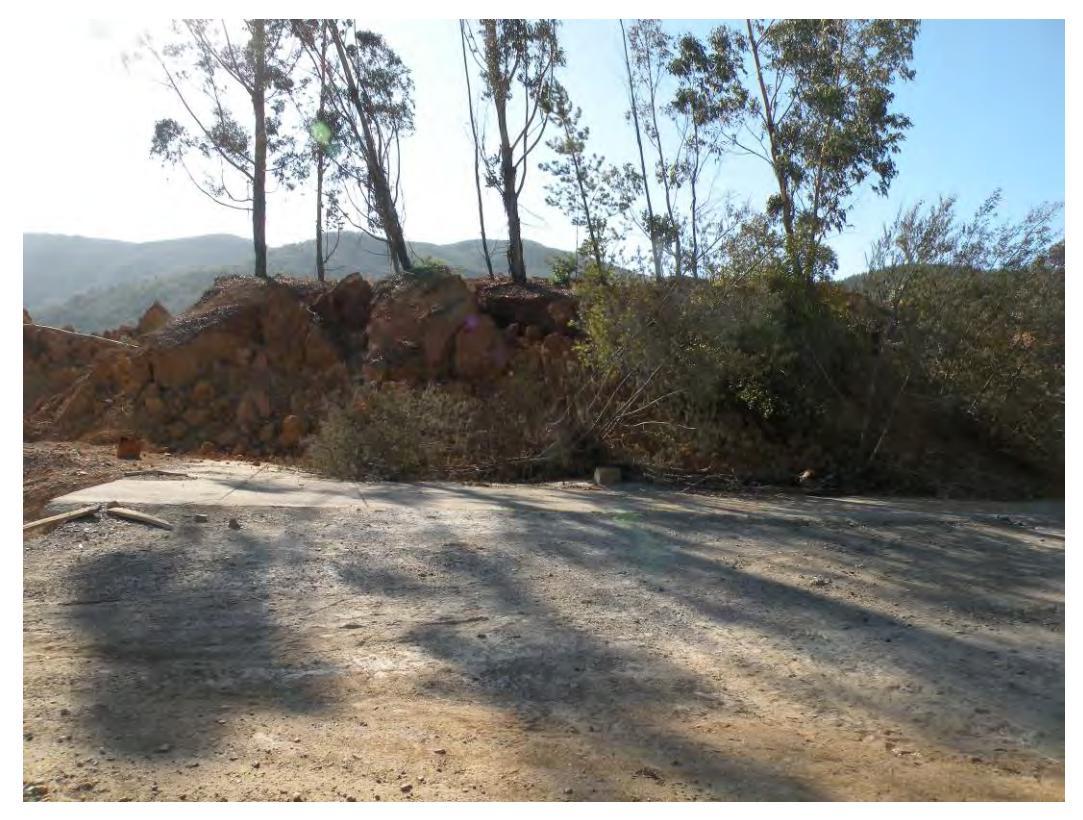
Figure 11.27. March 11, 2010. Side View of Tailings Flow (35.186864°, 71.757873°W)

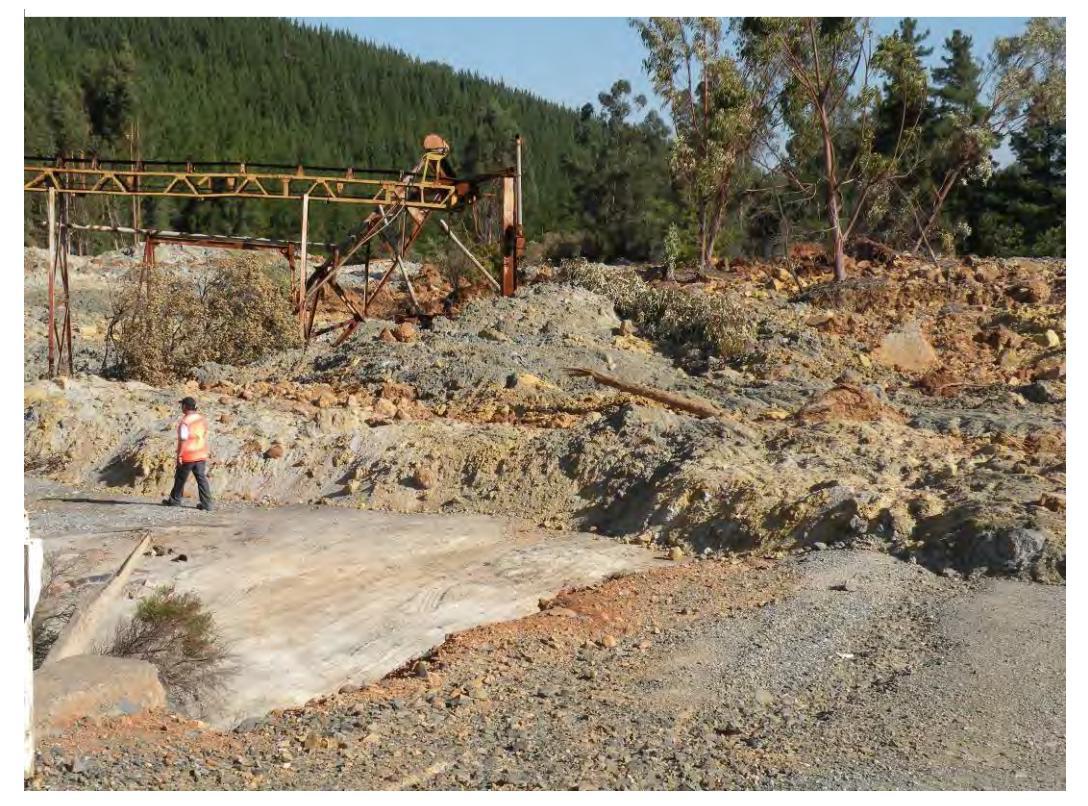
Figure 11.28. March 11, 2010. Side View of Tailings Flow (35.187204° S, 71.757997° W)
