# Geo-engineering Reconnaissance of the 2010 Maule, Chile Earthquake

Report of the NSF Sponsored GEER Association Team

# GEER Association Report No. GEER-022

Version 2: May 25, 2010

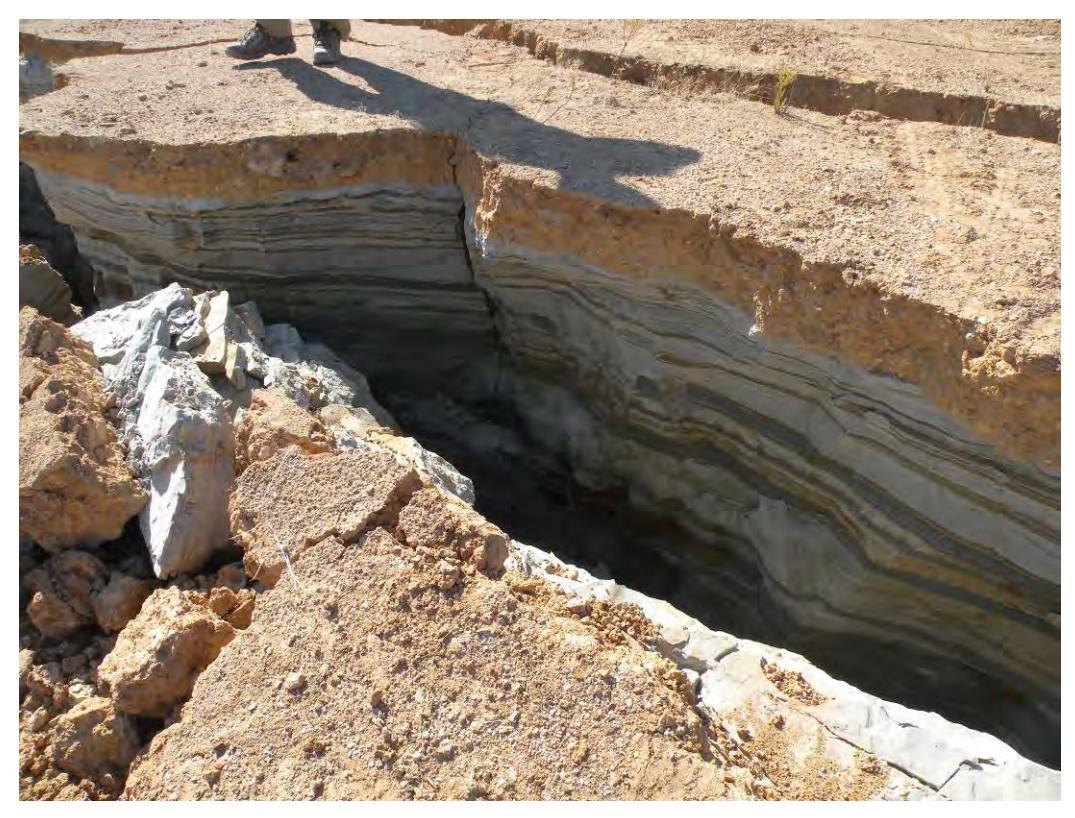
Figure 11.29. March 11, 2010. Gravelly Cover Layer Over Oxidized and Unsaturated Tailings (35.184679° S, 71.759410° W)

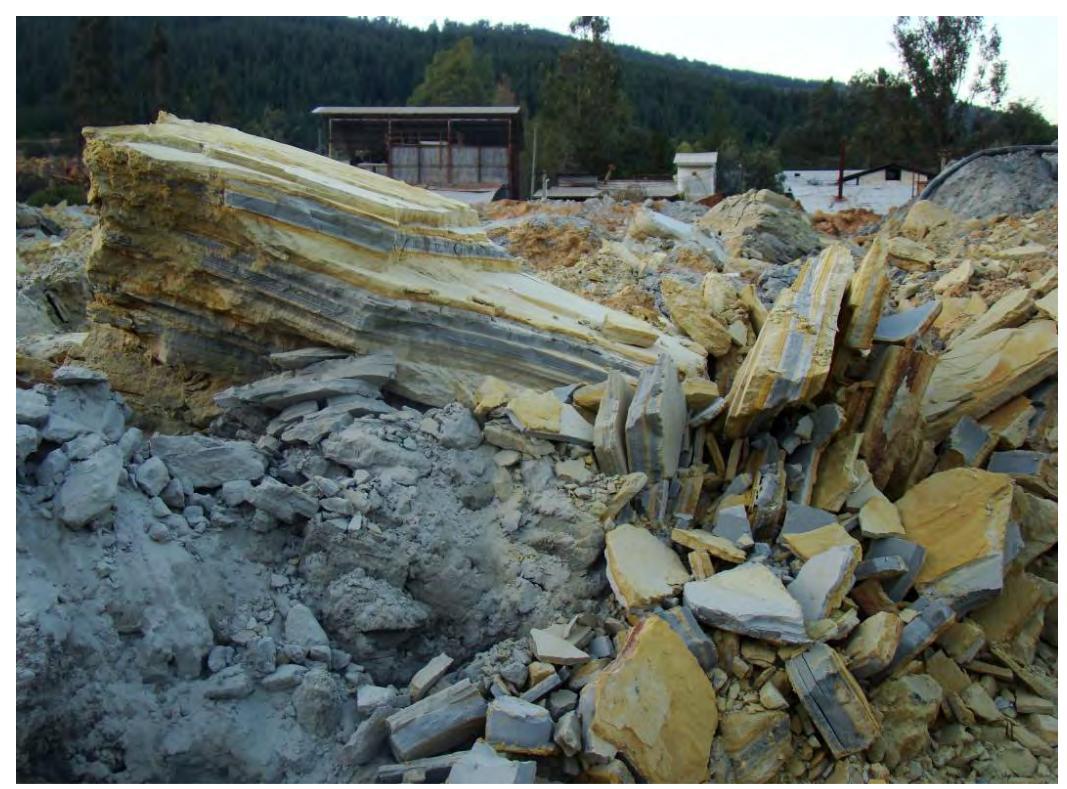
Figure 11.30. March 11, 2010. Variably Oxidized Tailings – Unsaturated Conditions in Upper Portion of Tailings Impoundment (S35.18728°, W71.75781°)

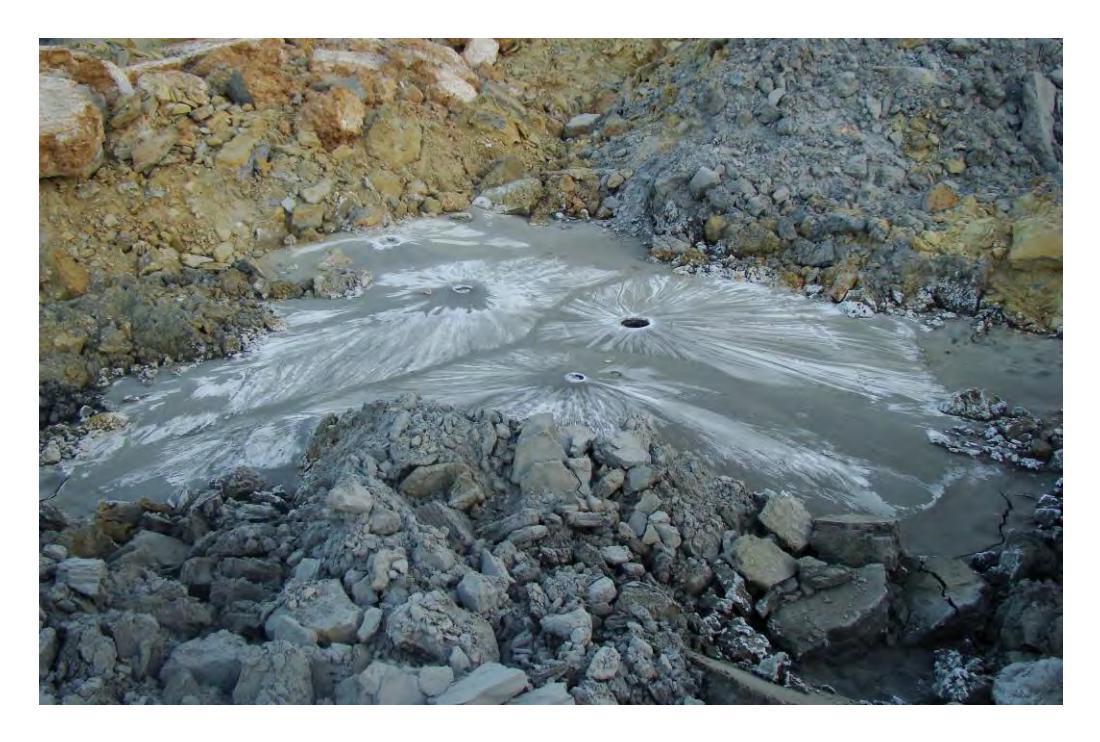
Figure 11.31. March 11, 2010. Sand Boil in Tailings (S35.18872°, W71.75764°)

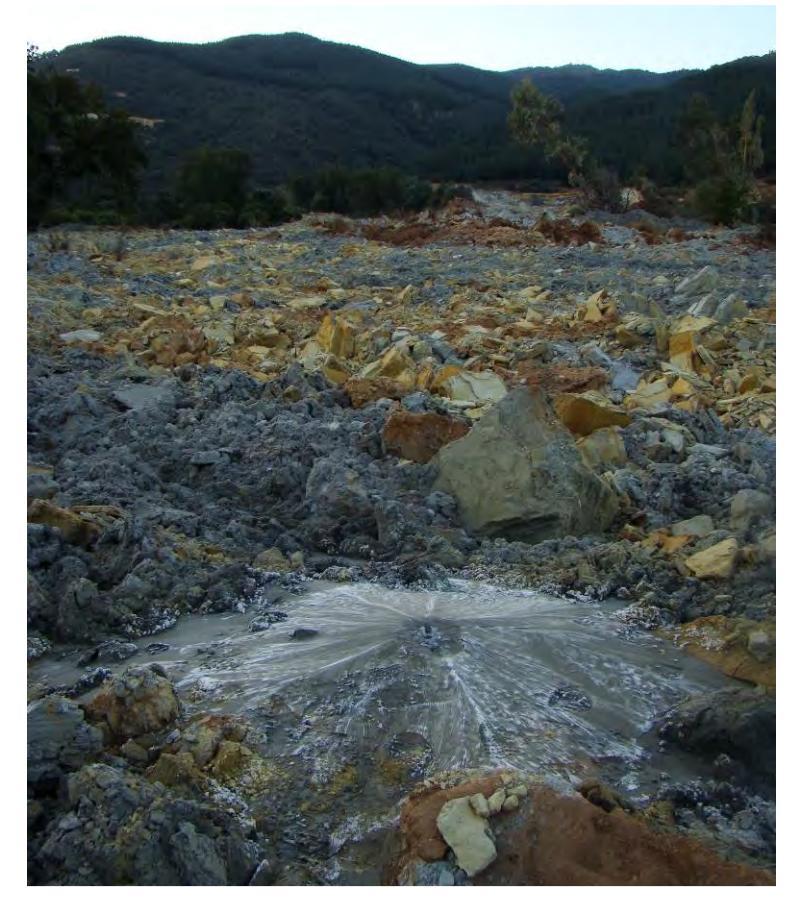
Figure 11.32. March 11, 2010. Sand Boil In Tailings along Flow Path (S35.18872°, W71.75777°)

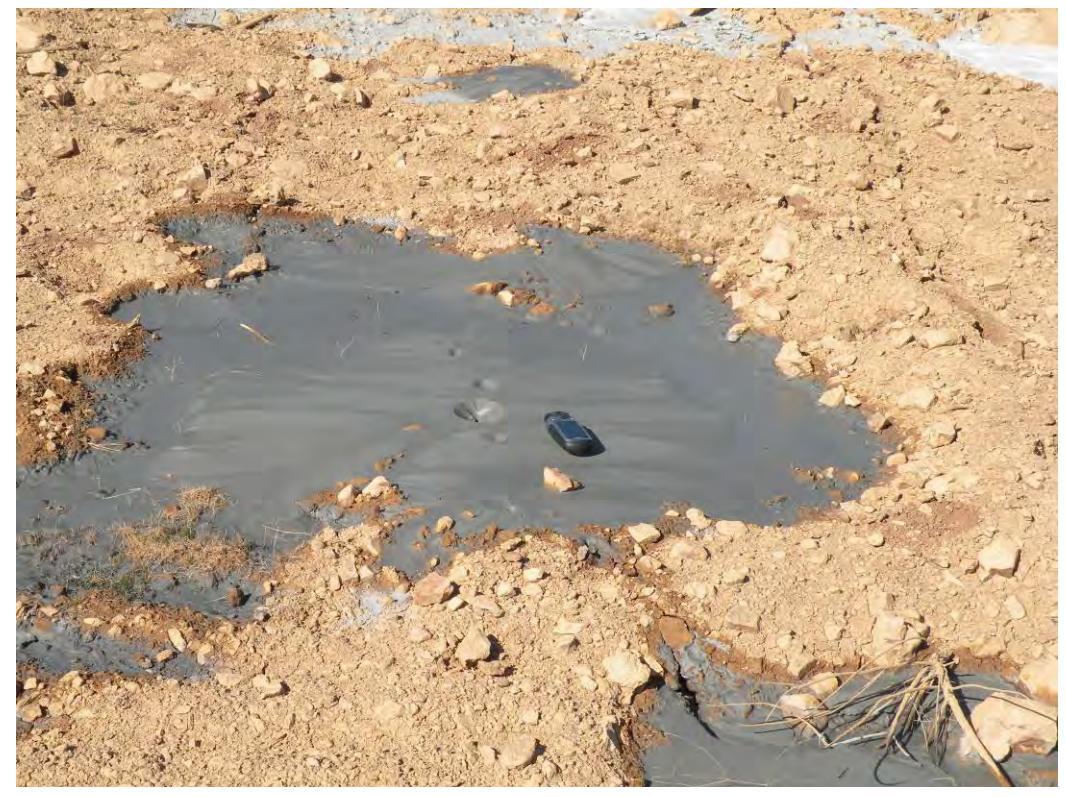
Figure 11.33. March 11, 2010. Tailings Sand Boil Due to March 11, 2010 M6.9 Earthquake near Rancagua (S35.184146°, W71.761118°)

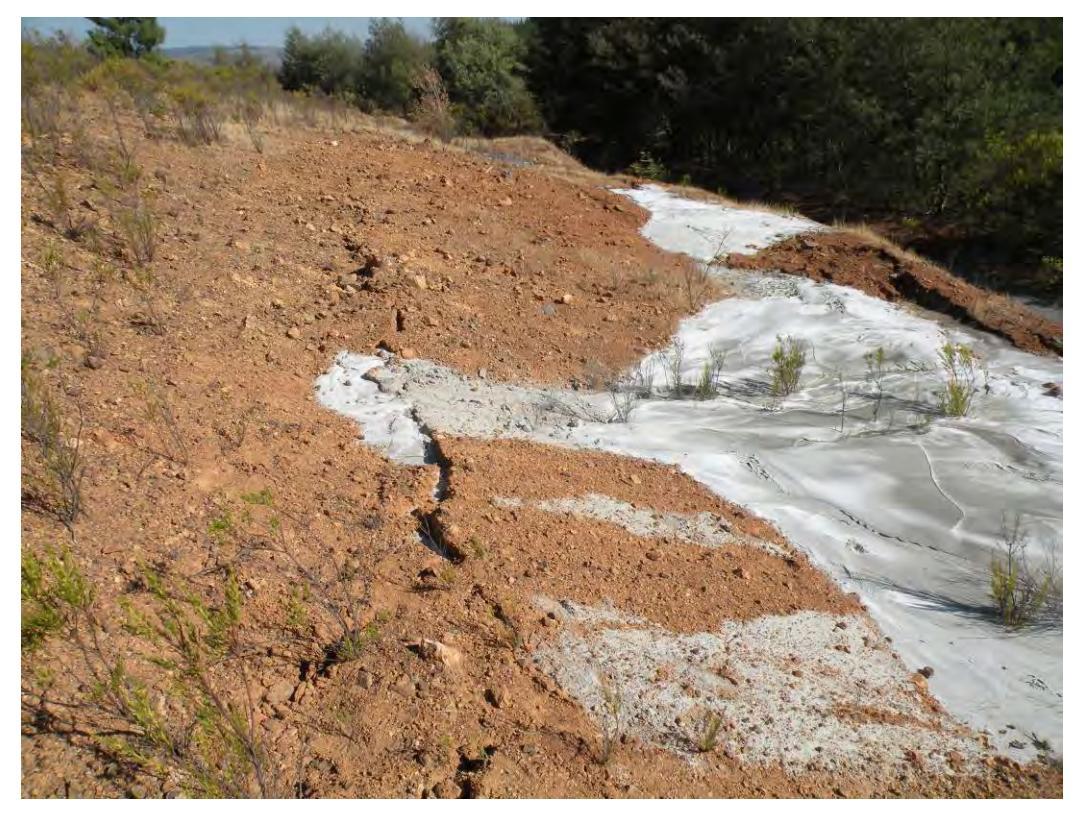
Figure 11.34. March 11, 2010. Ejecta of Tailings from Cracks Indicating Liquefaction of Tailings (S35.183986°, W71.761844°)

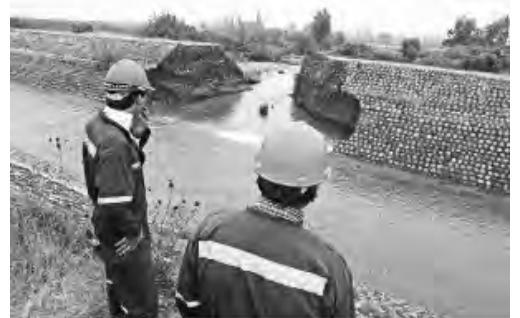
An earth levee that is located west of Colbun failed at 6:50 pm on March 13, 2010 (Figure 11.35), two days after the  $M_w$ =6.9 aftershock (epicenter at S34.259°, W71.929°) that occurred on March 11, 2010 at 11:40 am. The levee was inspected after the  $M_w$ =8.8 main shock of February 27, 2010, and no evidence of distress was noted. Additionally, a rapid inspection of the levee after the significant aftershocks on March 13, 2010 did not identify evidence of distress. The levee breach reportedly released a discharge of 80 cm, which is reported to have flooded a few neighboring homes in this agricultural area of Chile, but none of the homes were significantly damaged.

Figure 11.35. Earthen levee breach west of Colbun (S35.698672°, W71.487294°; photograph taken by Mr. Juan Carlos Romo of the El Mercurio on March 12, 2010; <u>http://diario.elmercurio.cl</u>).

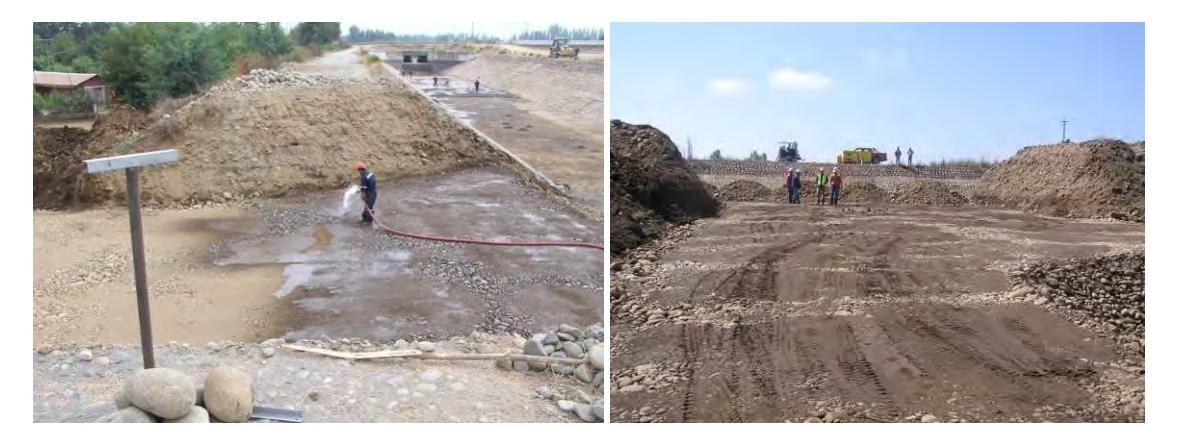
The levee breach site was visited by GEER team members on March 18, 2010. At that time the levee was being reconstructed as shown in Figure. 11.36. A sample of the levee fill material was taken and is in the process of being classified. The levee fill material appears to be a silty sandy gravel material with a significant amount of cobbles. The levee is approximately 7 m high with a crest width of 6 m. Its side are sloped at about 1.5H:1V with cobble facing on its water side. The width of the zone being rebuilt was 15 m. The levee was reported to have been built 25 years ago. Whereas at other locations the existing material was excavated to build the levee, it is reported that no or little excavation occurred at this location because the natural ground surface elevation was already low at this location.

Figure 11.36. Site of earthen levee breach during reconstruction on March 18, 2010 (S35.698672°, W71.487294°).

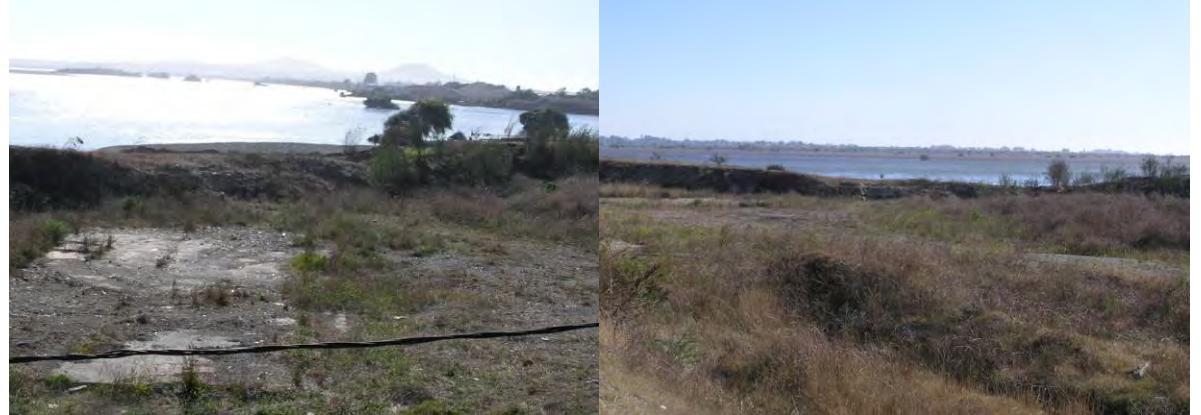
A liquefaction-induced levee slump occurred along the River Bio Bio north of the Juan Pablo II bridge's NE abutment (Figure 11.37). The water level was well below the top elevation of the slumped crest of the levee so there was no breach at this location. Details of the levee construction are not known.

Figure 11.37. View obliquely down on the slumped levee from the NE approach of the Juan Pablo II bridge with evidence of sand ejecta in the foreground, and ground level view looking back at slumped level crest (S36.814555°, W73.084624°); 1700 hrs on 3/15/10).

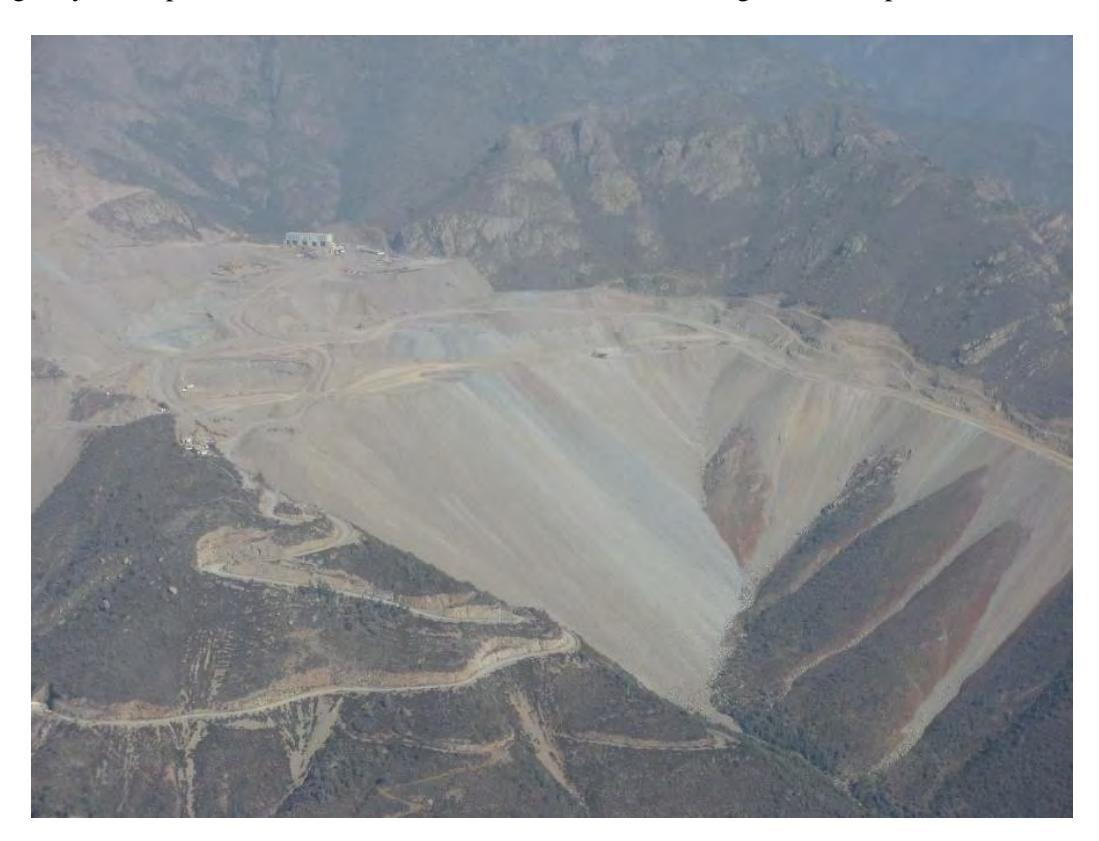
Overflight by helicopter made. No evidence of movement of these high rock dumps.

Figure 11.38. March 10, 2010. Soldado Waste Dump (S32.654695°, W71.121352°)

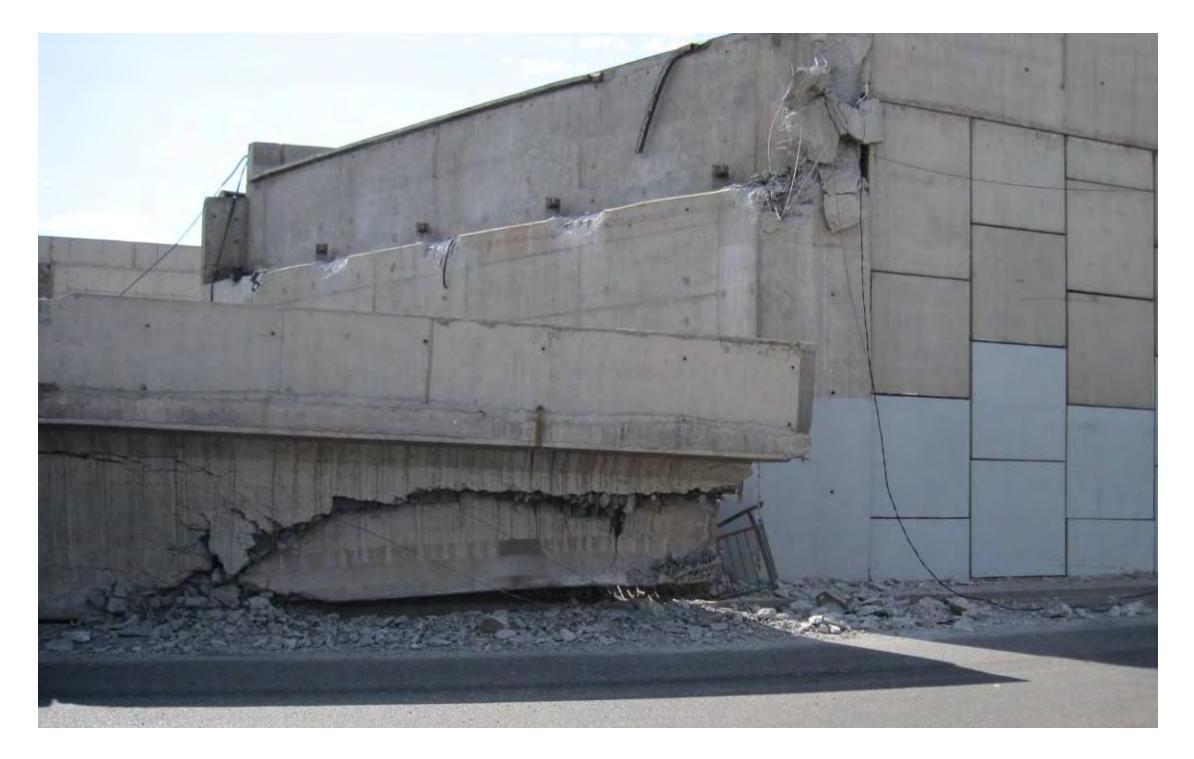
Figure 12.1. Intersection of Americo Vespucio Norte and Independencia. Abutment of a collapsed bridge. (33°21'57.83"S, 70°41'17.71"W)

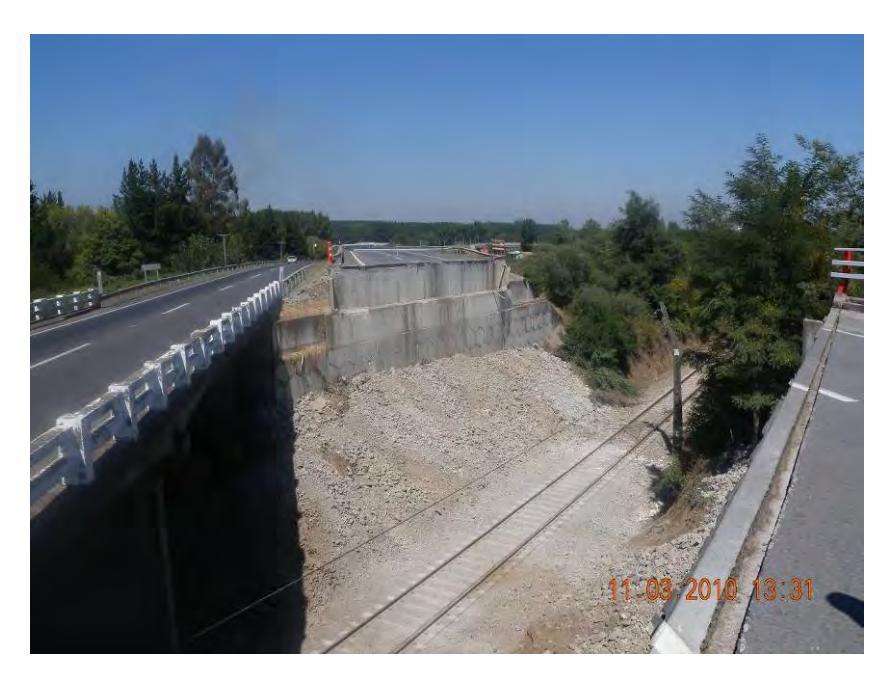
Figure 12.2. Reinforced Earth bridge abutments at a collapsed rail crossing on Route 5 north of Parral (36.0803°S, 71.788°W)

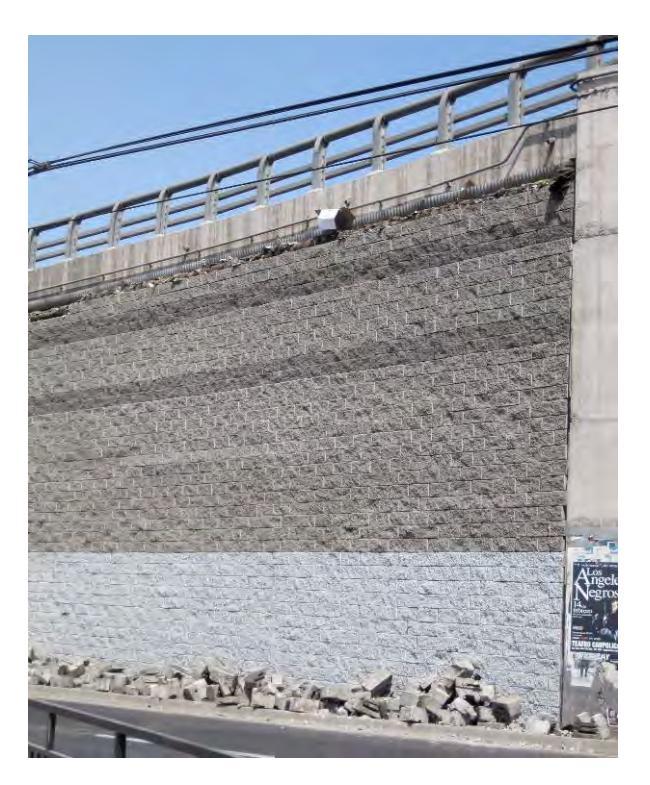
Similarly, block faced mechanically stabilized wall performed very well. Figure 12.3 shows a block faced mechanically stabilized bridge approach which lost the top most row of blocks but otherwise remained intact.

Figure 12.3. Block faced mechanically stabilized embakment, Intersection of Americo Vespucio Norte and Lo Echevers. (33°22'34.54"S, 70°44'52.83"W)

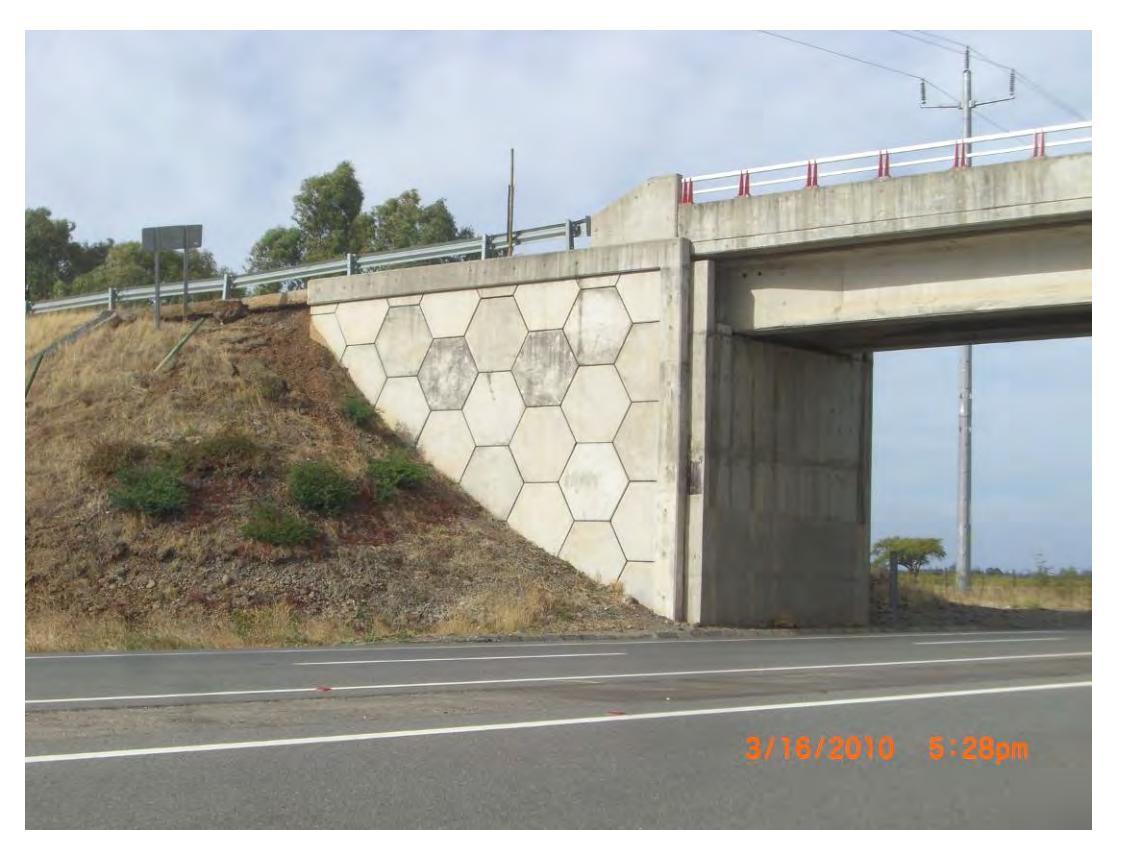
Figure 12.4 shows a photograph of yet another typical MSE retaining structure. This wall, located west of Chillan, was approximately 6 m high and exhibited no damage despite surficial slope instability in the adjacent approach fill slope.

Figure 12.4 Undamaged MSE wingwall on overpass structure over highway 152 west of Chillan despite sliding of adjacent fill slope (S36.6588, W72.2776).

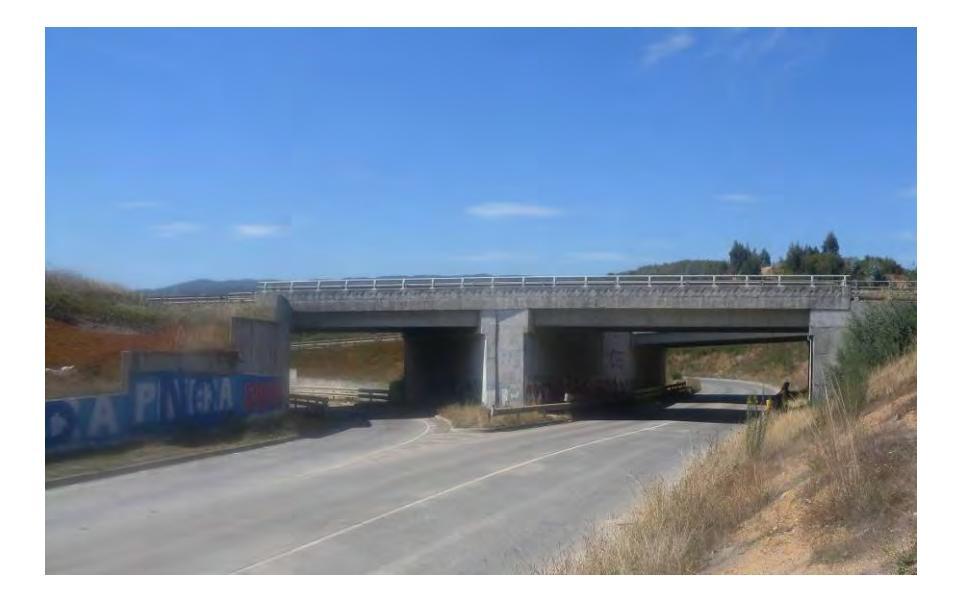
**Conventional, Concrete Gravity and Cantilever Structures** – Conventional concrete gravity and retaining structures similarly performed very well in many different settings. Figure 12.5 shows an overpass structure on the coastal highway just south of Coronel, about 140 km south of the epicenter in an area which experienced significant shaking. The structure experienced no distress and the bridge structures were fully functional after the event.

Figure 12.5. Multiple retaining structures for highway overpass structures south end of Coronel (37.0455°S, 73.1421°W)

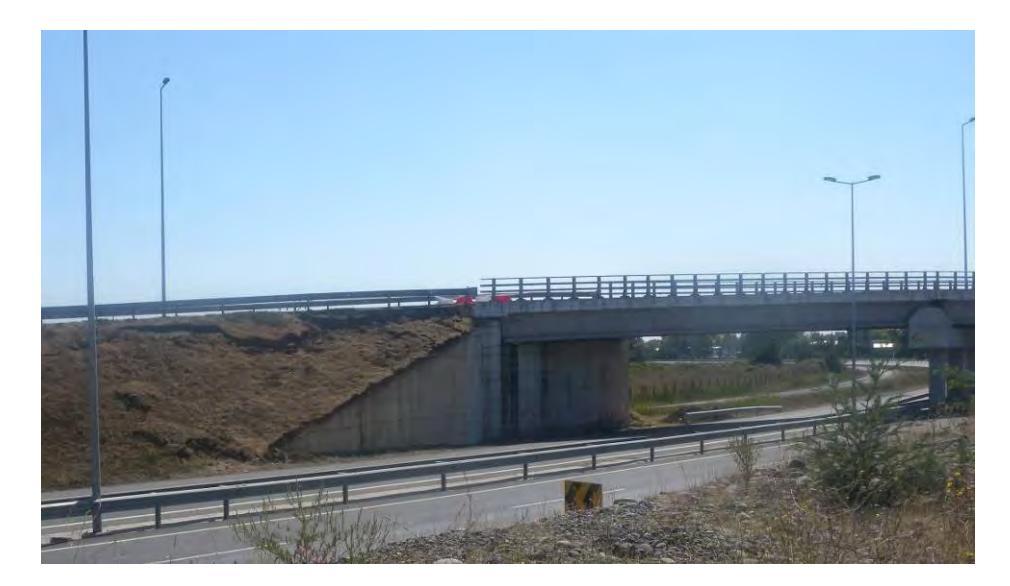
Most importantly, there were numerous bridge approach embankments that were shaken with sufficient intensity to experience surficial slumping, yet the abutment forming retaining walls performed very well and showed no evidence of damage. The bridge decks on the other hand were often offset and the concrete seats were spalled or completely fractured. Figure 12.5 shows one such bridge approach embankment and abutment wall on Route 5 north of Chillan. The bridge deck had temporary scaffolding supporting it at the other abutment as it was close to sliding off.

Figure 12.6. Surficial sloughing on a bridge approach embankment, with the abotment showing no evidence of damage, Route 5, north of Chillan.

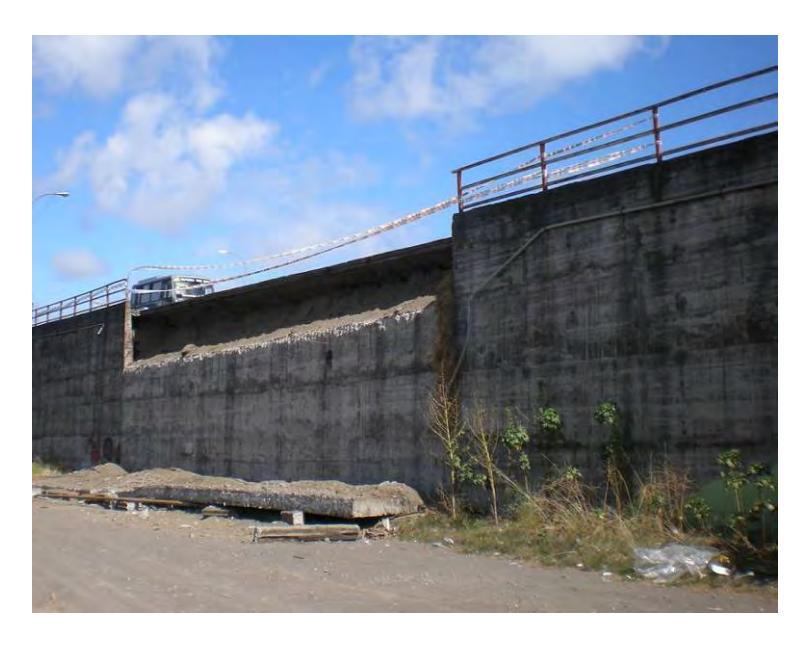
A rare failure of the uppermost section of a reinforced concrete retaining structure was observed in San Pedro, about 110 km south of the epicenter. The wall (Figure 12.7) was located within 3 km of the south approach to the Llacolen Bridge (the middle bridge across the River Bio Bio connecting Concepcion and San Pedro). The 16-inch thick wall was reinforced vertically with No. 3 or No. 4 bars on 12 inch centers (Figure 12.8). Failure occurred at the uppermost joint as the top wall toppled to the east apparently due to inertial forces. The granular backfill is clearly self supporting (Figure 12.9). Figures 12.9 and 12.10 show water seepage behind the intact portion of the wall and corrosion of the horizontal reinforcing along the joint.

Figure 12.7. Failed reinforced concrete retaining structure in San Pedro.

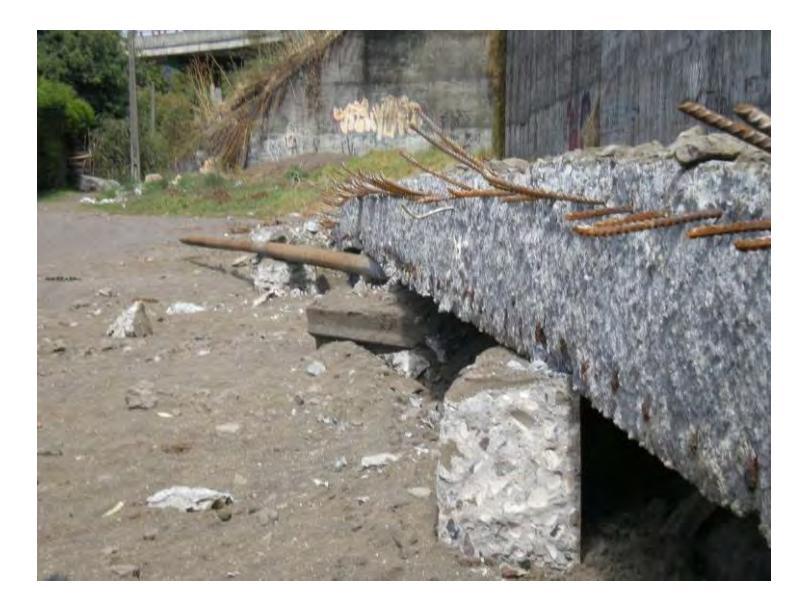
Figure 12.8. Toppled portion of 16-inch thick wall showing bent compression bars and snapped tension bars.

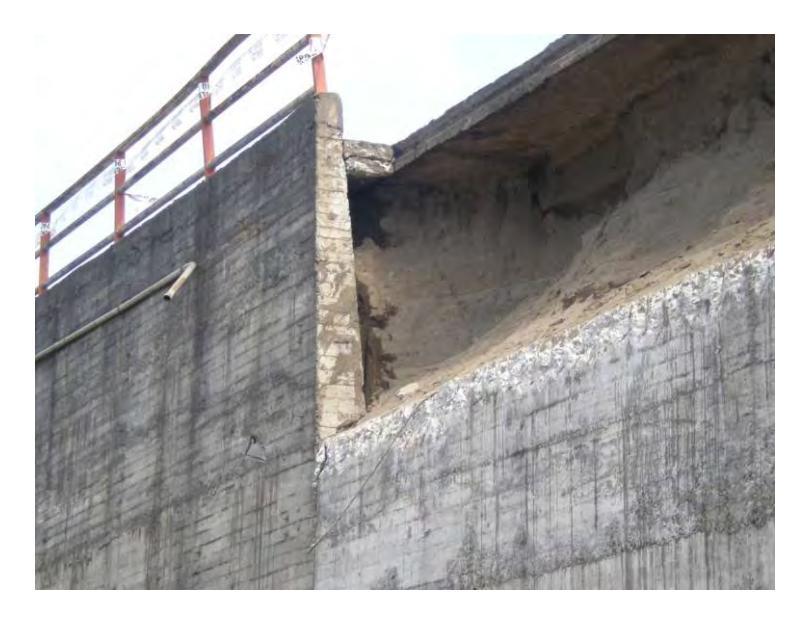
Figure 12.9. Granular fill soils and water seepage evident behind failed portion of wall.

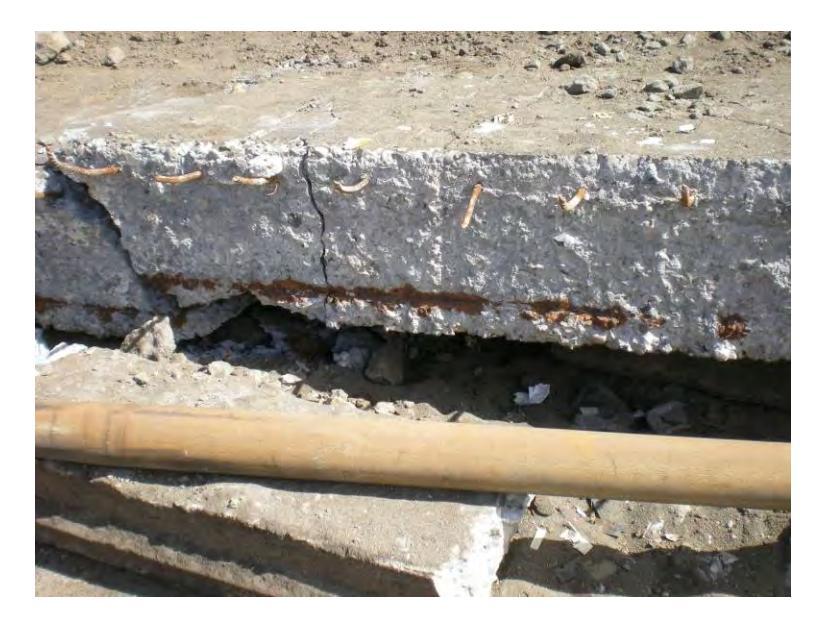
Figure 12.10. Corrosion of horizontal reinforcing steel where water entered the joint.

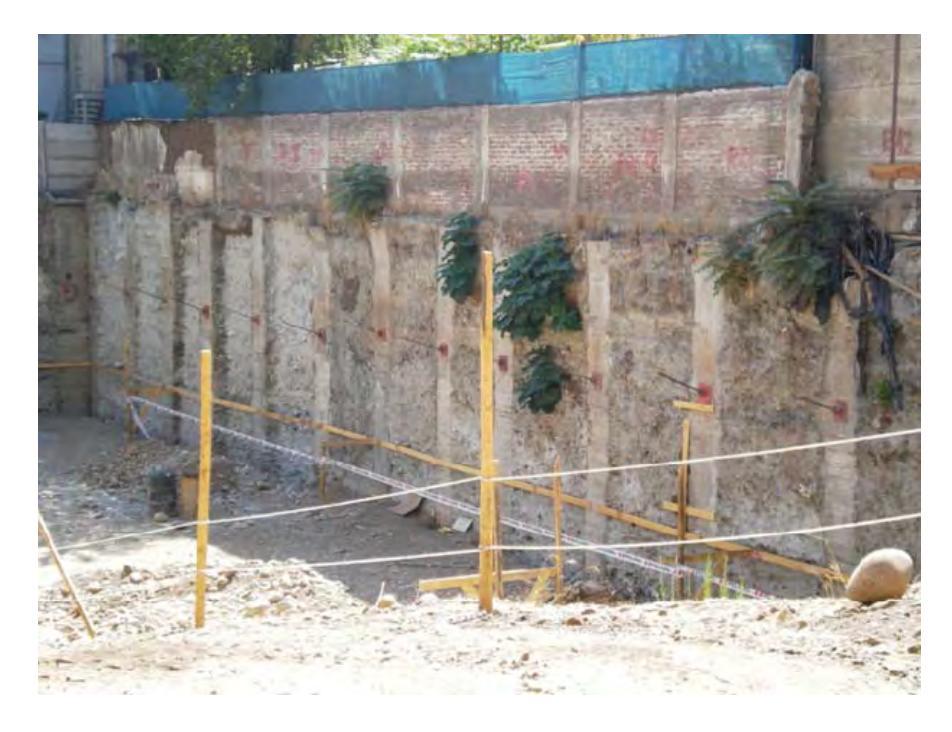
**Temporary Retaining Structures** – Temporary retaining structures were not widely observed; however, those observed performed well. Figure 12.11 shows a temporary shoring system in Santiago that appears to have been constructed some months before the earthquake given the vegetative growth on the wall face. The vertical members and single row of tieback anchors appeared undamaged while the exposed gravels between the vertical members did experience some raveling.

Figure 12.11. Undamaged temporary retaining structure in Santiago.

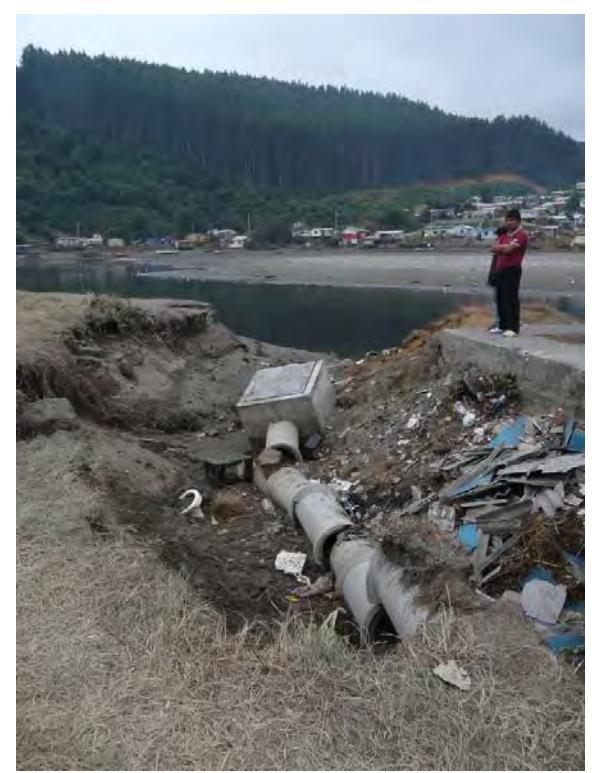
In Laraquete, sand blanketing the road along the beach and accounts from local residents indicate the tsunami reached the first row of houses. Considerable flooding of the beach and along the river channel is evident by deep scouring that damaged the outfall of a storm sewer near the river bank (Figure 13.1). At one beach front house a car was pushed tens of meters landward and water marks on the foundation indicate a minimum flow depth of 0.55 m (Figure 13.2).

Figure 13.1. Tsunami scoured out the foundation of this storm sewer outfall at Laraquete (\$37.165352° W73.188051, 1907 hrs on 03/16/2010).

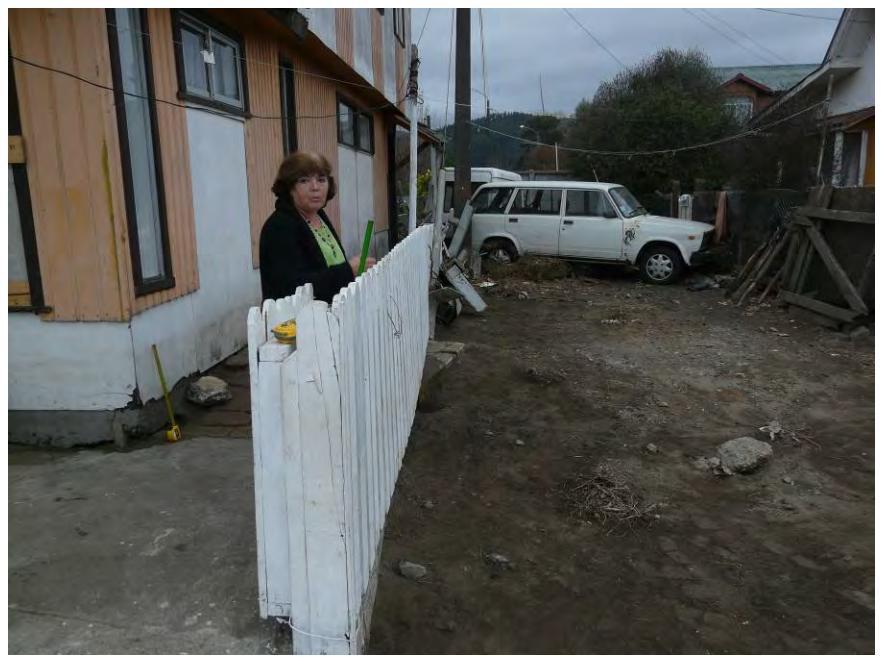
Figure 13.2. Beach-front homes in Laraquete were inundated by the tsunami. At this woman's home, tsunami flow depths reached at least 0.55 m, which transported the white car from the street to the backyard. The tape measure left of the woman indicates the flow depth measured from a water stain on the building (S37.165650° W73.188136, 1915 hrs on 03/16/2010).

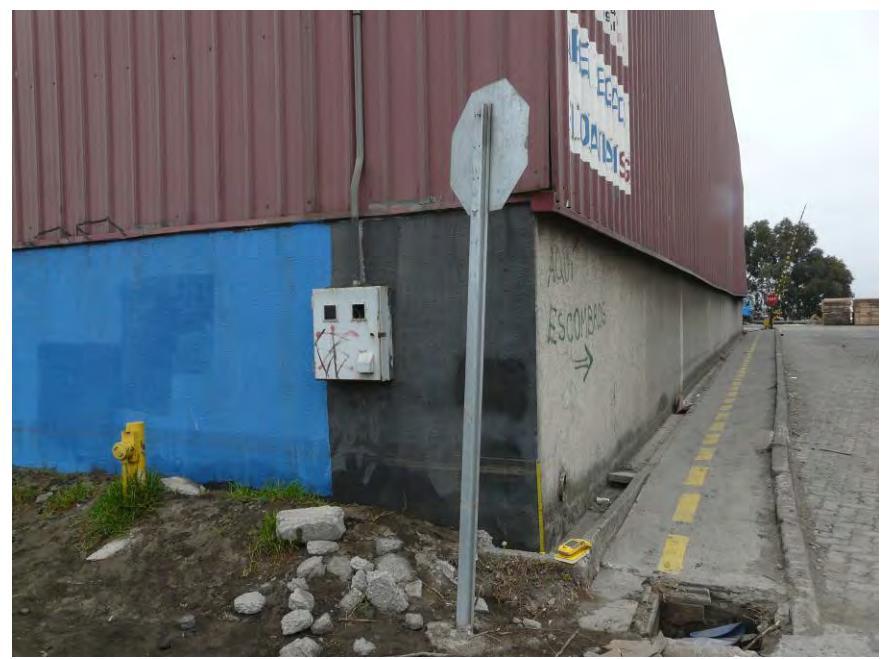
Minimum tsunami flow depths were measured at four sites in Talcahuano. At the storage warehouse, water lines left by flooding indicate 0.65 m flow depths along Perez Gacitua Street near Rio Andalien (Figure 13.3). West of the warehouse, high water marks showed sustained flow depths of about 0.63 m (Figure 13.4). To the north, sites closer to the bay experienced greater flow depths. At one building along Avenue Manuel Rodriquez the tsunami left marks 1.6 m high above ground (Figure 13.5). Port facilities along the shore of Bahia San Vicente experienced heavy damage caused by ground failure due to liquefaction and tsunami inundation. Near a fish processing plant at the port in west Talcahuano, lateral spreading dropped the waterfront down making it more susceptible to moderate tsunami flooding. Here the tsunami left a 1-m-high, indelible dark tarry stain along waterfront buildings that had slid toward the bay (Figure 13.6). At adjacent areas unaffected by lateral spreading and settlement, including a vast fuel tank farm, little or no flooding occurred. In light of the relatively modest tsunami inundation in western Talcahuano compared to more extensive inundation and damage observed in the eastern part of the city, we propose that Punta Pardo and the massive Tumbes Peninsula may have offered some protection to the northeastern shoreline of Bahia San Vicente, especially if tsunami waves propagated from north to south.

Figure 13.3. Tsunami flow depths reached a minimum of 0.65 m at this waterfront warehouse in Talcahuano along Perez Gacitua Street (S36.728263° W73.109199°, 1136 hrs on 03/16/2010).

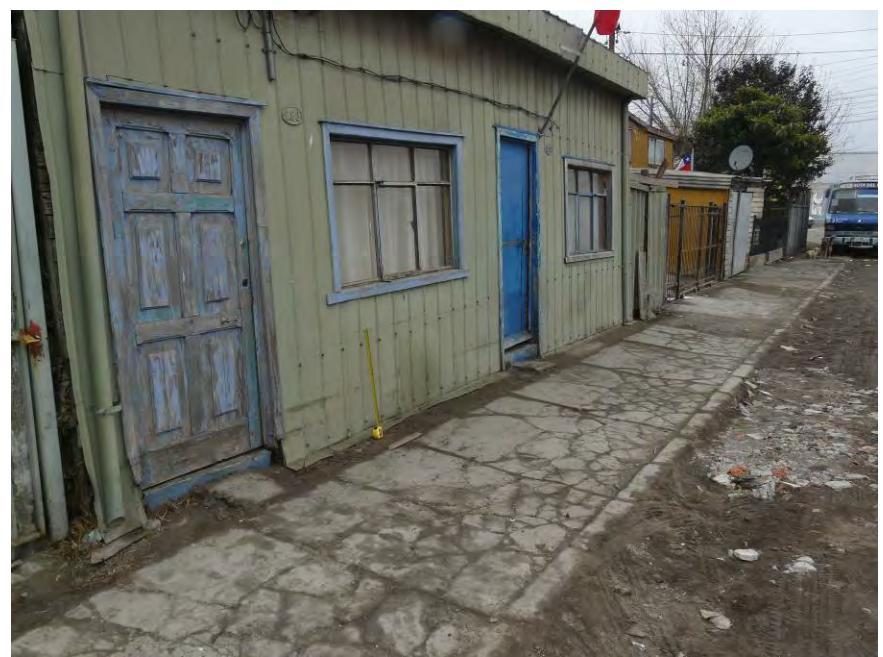
Figure 13.4. Tsunami flow depths reached a minimum of 0.63 m at this green house on El Morro Street in Talcahuano (S36.727354° W73.109530°, 1206 hrs on 03/16/2010).

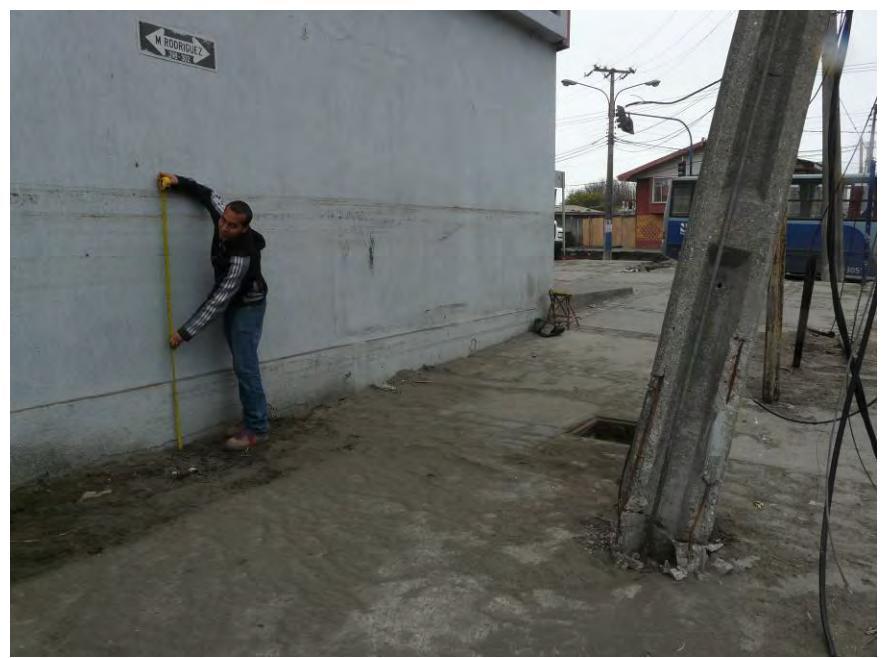
Figure 13.5. Along Avenue Manuel Rodriquez in Talcahuano, the tsunami reached minimum flow depths of 1.6 m (S36.725249° W73.106313°, 1215 hrs on 03/16/2010).

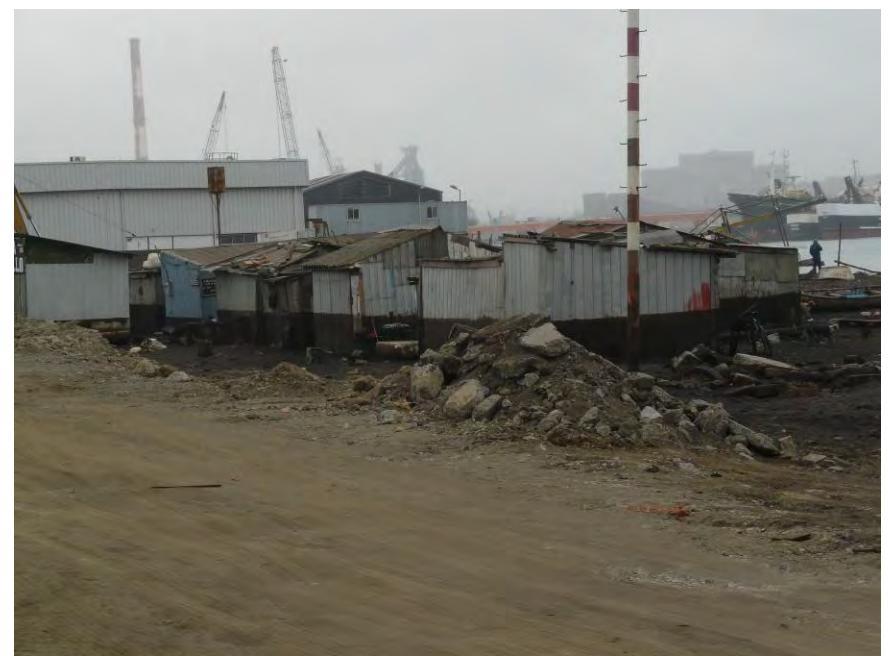
Figure 13.6. One-meter high dark stains on buildings at Talcahuano port facilities along Bahia San Vicente mark the elevation of the tsunami. Major damage of port facilities, including a fish processing plant were caused by a combination of factors, including modest tsunami inundation in areas that dropped vertically due to liquefaction-induced lateral spreading (S36.727076° W73.128058°, 1258 hrs on 03/16/2010).

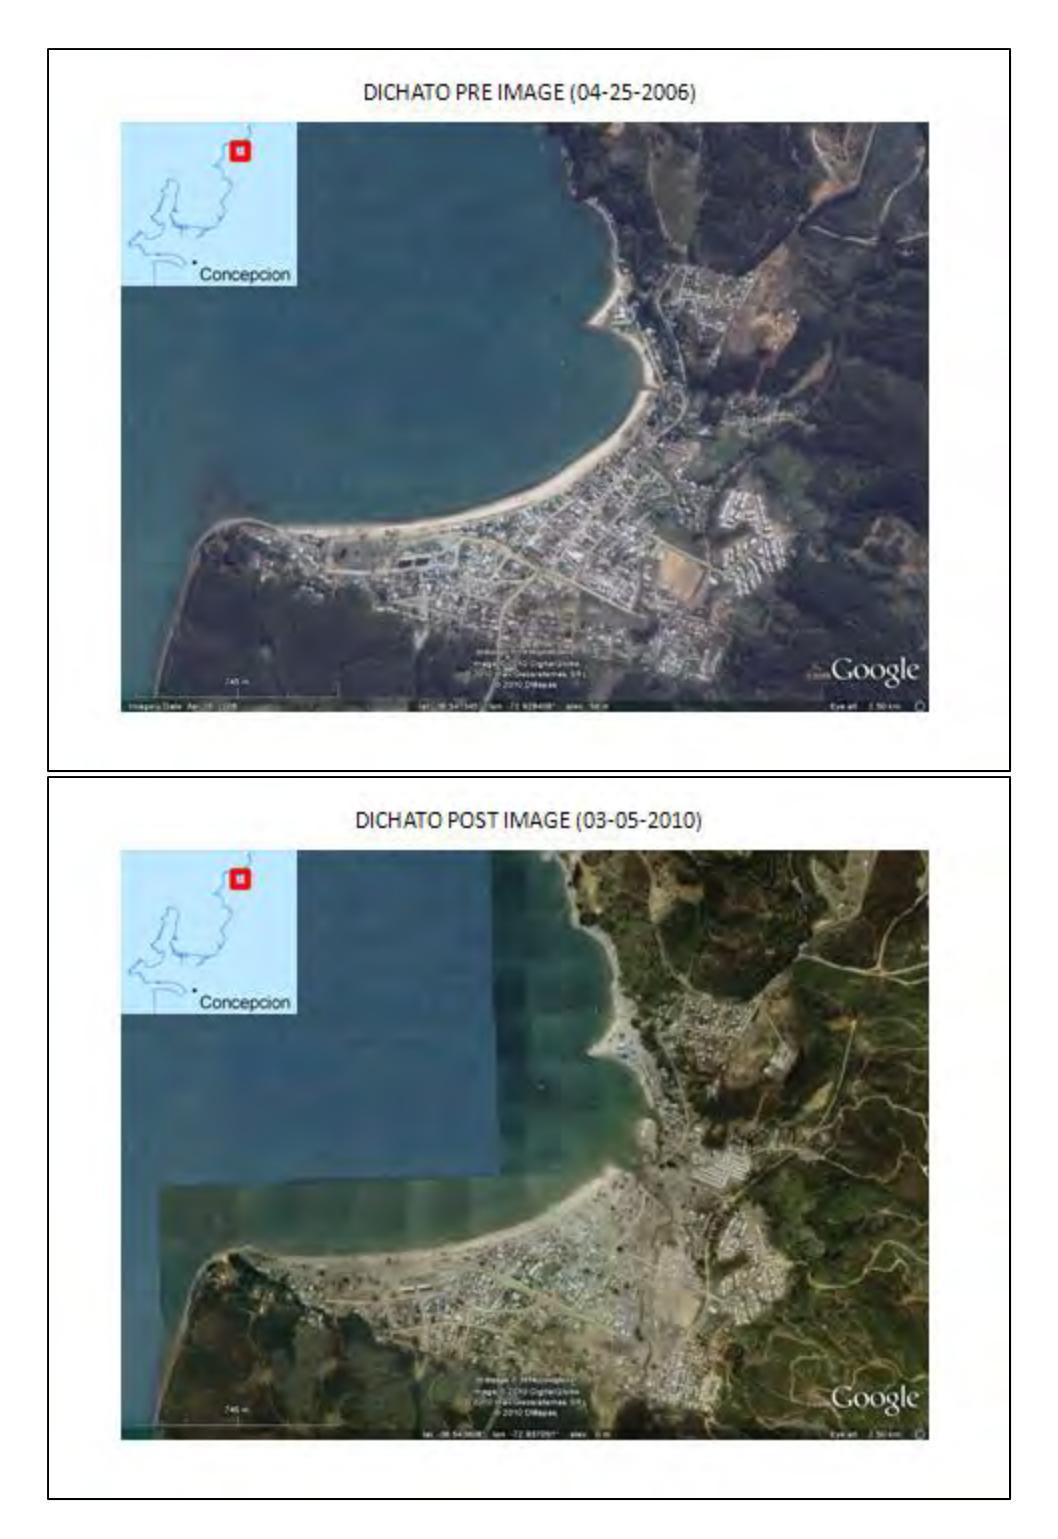
Although the motion of the water was primarily north-south, fishermen on the west side of the bay observed east-west surges during the morning of the 27<sup>th</sup> February. Large waves that struck the west side of the bay seemed to have been reflected off the eastern shore. Pre and post event image pairs showing tsunami damage are given in Figures 13.12 and 13.13.

Figure 13.12 Pre/Post Imagery of Dichato (S36.546°, W72.933°)
