# Geo-engineering Reconnaissance of the 2010 Maule, Chile Earthquake

Report of the NSF Sponsored GEER Association Team

# GEER Association Report No. GEER-022

Version 2: May 25, 2010

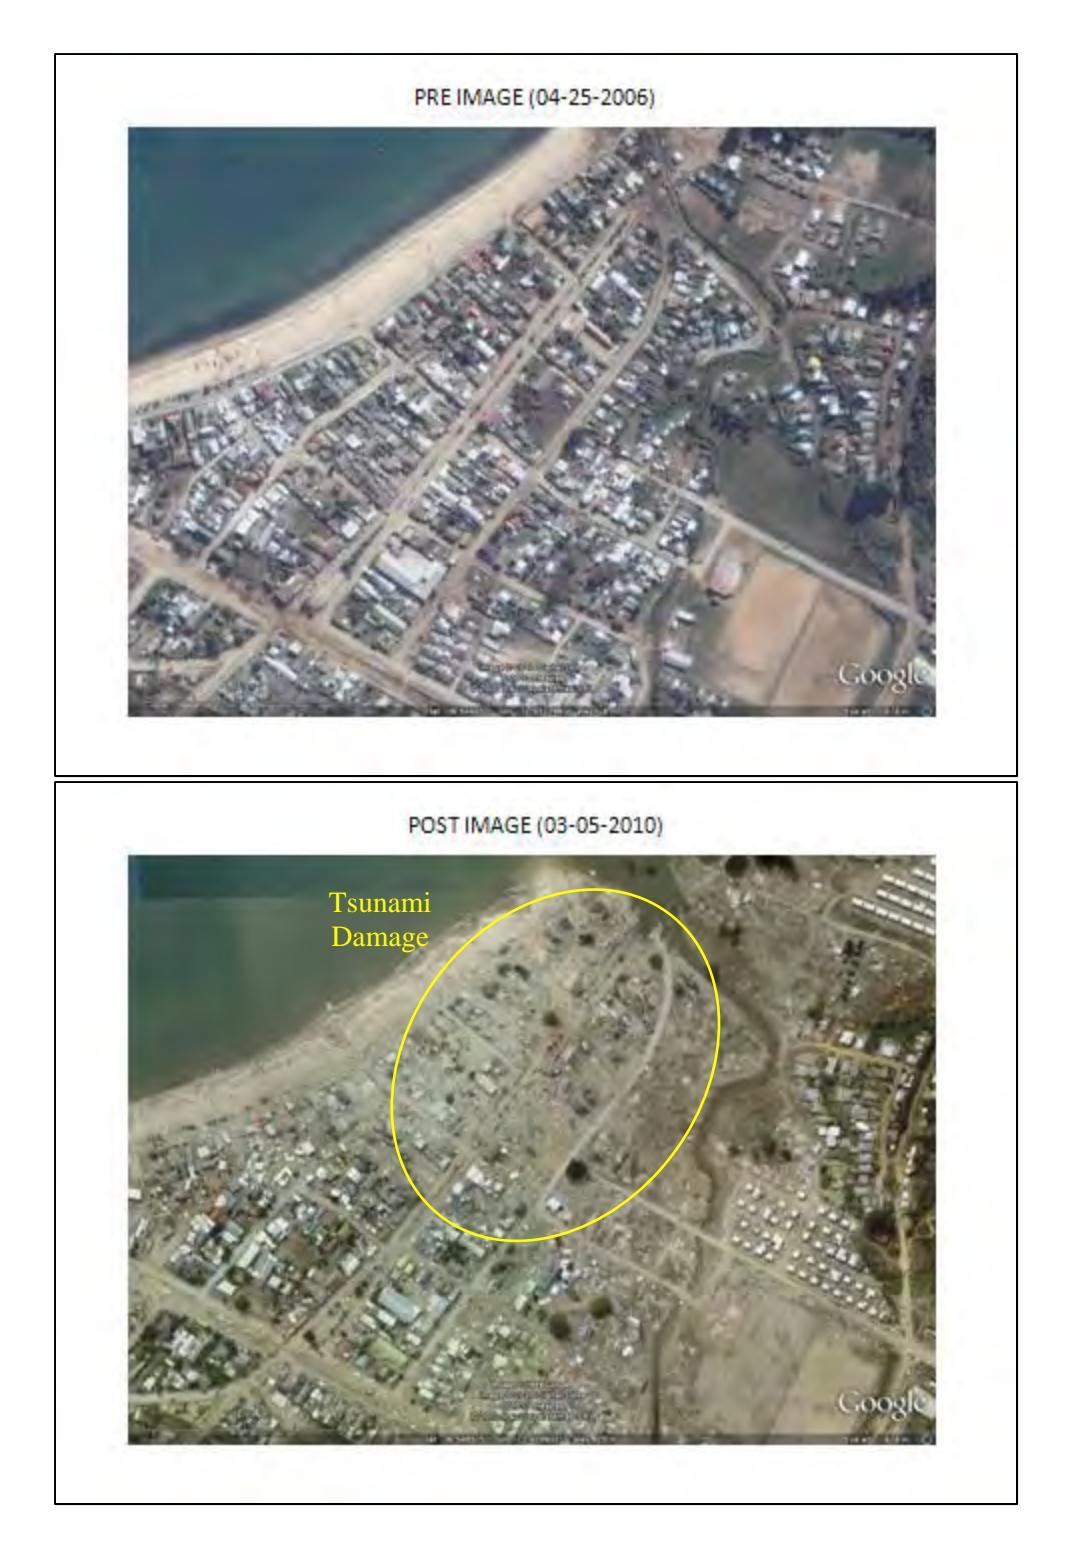
Although the motion of the water was primarily north-south, fishermen on the west side of the bay observed east-west surges during the morning of the 27<sup>th</sup> February. Large waves that struck the west side of the bay seemed to have been reflected off the eastern shore. Pre and post event image pairs showing tsunami damage are given in Figures 13.12 and 13.13.

Figure 13.13 Pre/Post Imagery of Dichato (S36.548°, W72.935°)

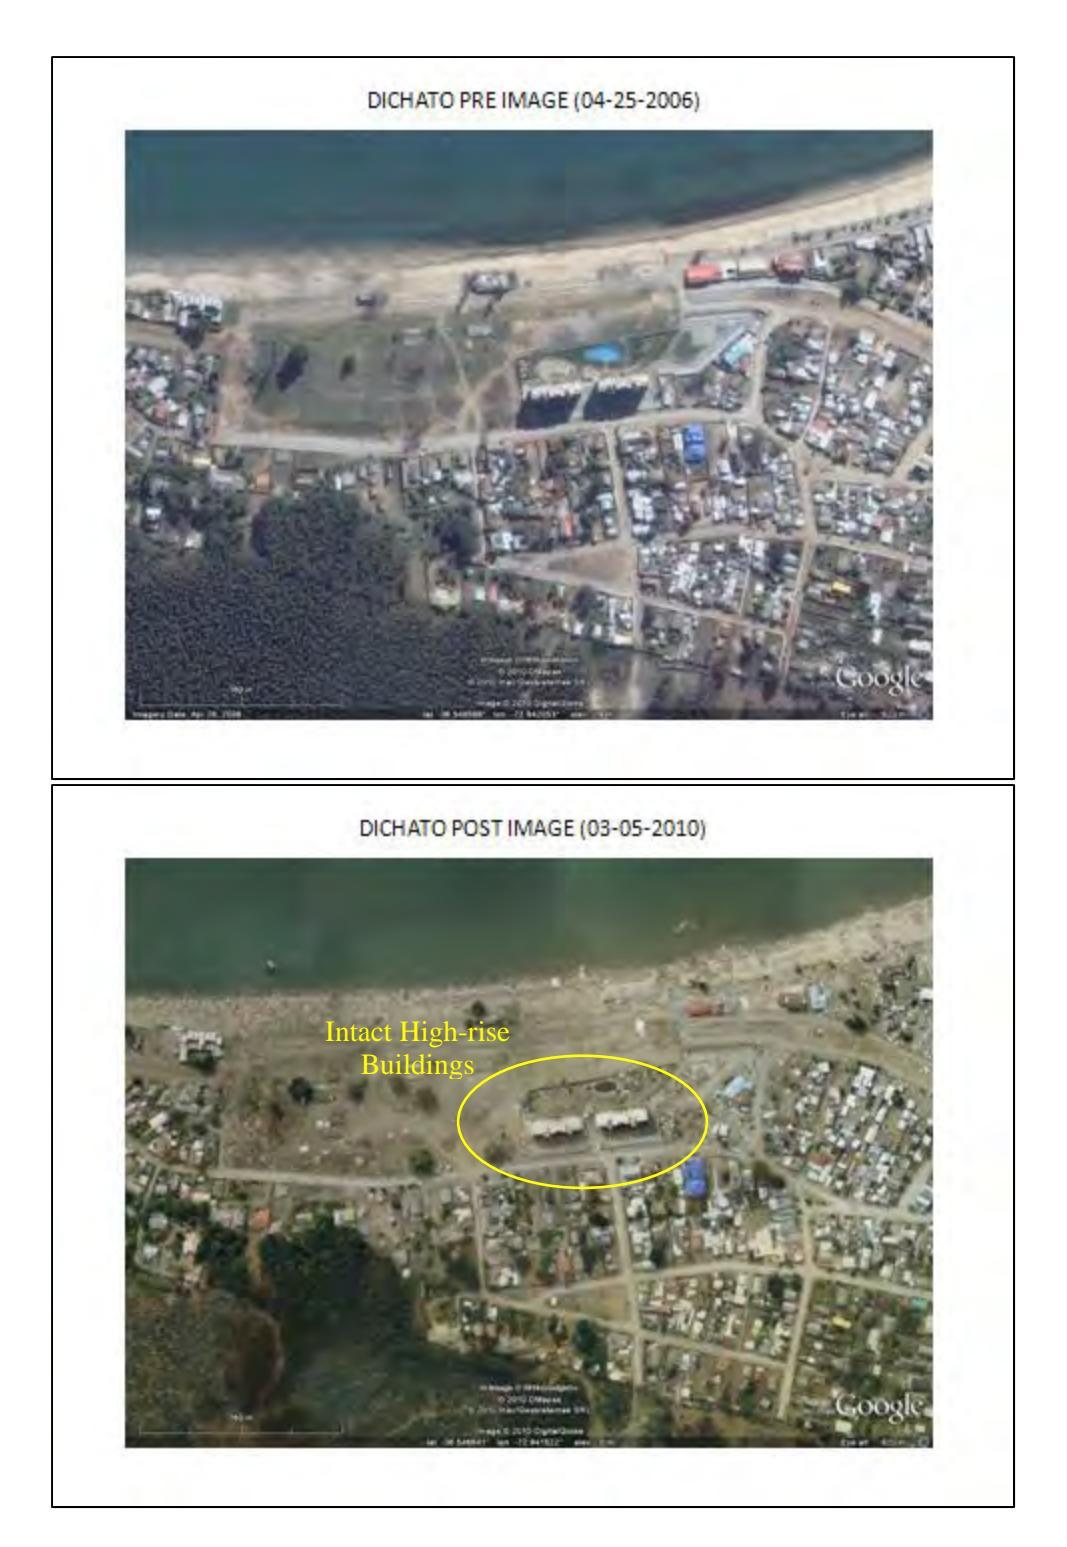
On the west side of Dichato there are two 10 story apartment buildings. These buildings incurred no obvious structural damage as shown in the pre and post images in Figure 13.14 and the aerial reconnaissance photo in Figure 13.15. They withstood the earthquake and at least one 3 m wave. Although the first floor apartments and the basement show significant flooding damage, the upper floor apartments were intact and were available to be reoccupied after the residents cleaned up broken items inside them. Behind the 10-story apartment buildings are about a dozen homes and shops which are constructed of lightweight materials, such as wood and corrugated metal. Little damage occurred to these structures suggesting that they may have been sheltered from a direct impact from the tsunami by the 10-story apartment buildings shows significant damage to smaller structures much further inland (Figure 13.16). Severe damage to homes in central Dichato illustrate the effects of the tsunami with a wave depth of about 5 meters (Figures 13.17 and 13.18).

Figure 13.14 Pre/Post Imagery of Dichato (S36.548°, W72.942°)

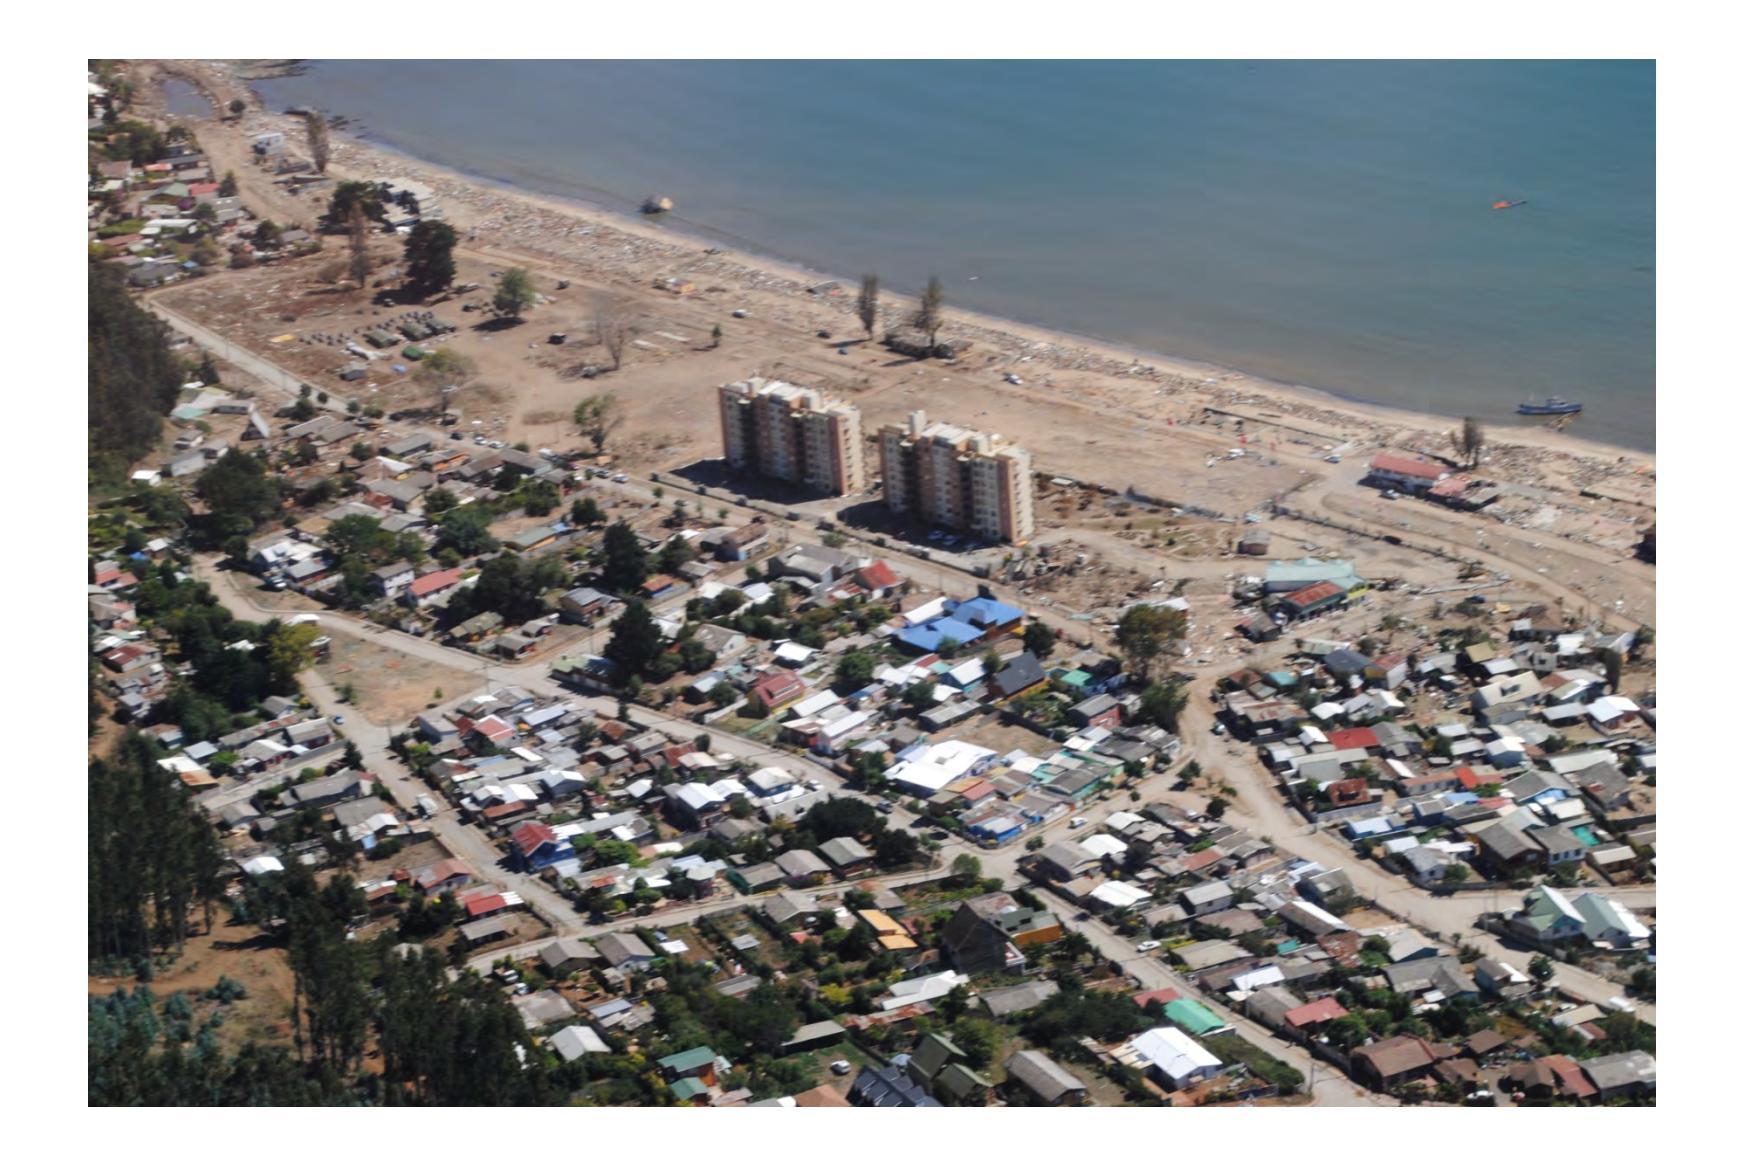
Figure 13.15. Aerial reconnaissance photograph of high-rise apartment buildings (S36.548°, W72.942°)

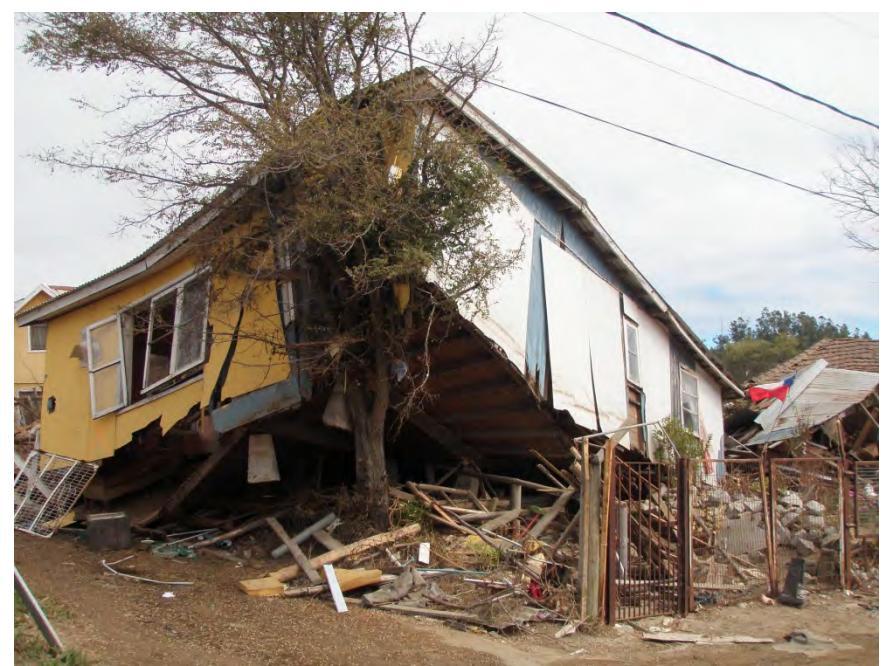
Figure 13.17 The home in this picture was lifted by the 3rd wave and dropped onto a tree (S36.547, W72.939, 2010 hrs, 3/13/10).

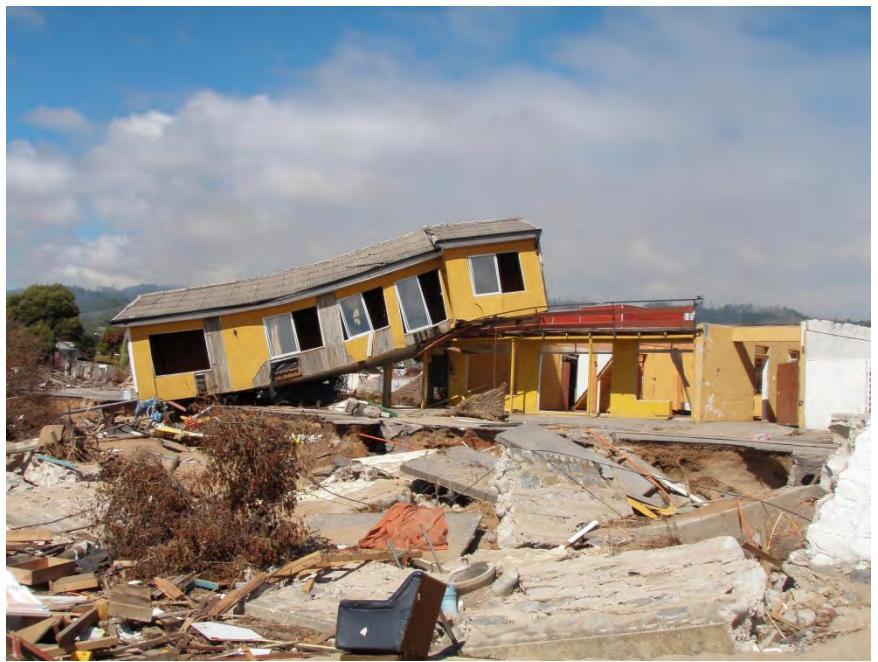
Figure 13.18 The tsunami wave removed the lightweight wooden second story of this house from its more substantial masonry and concrete block first floor (\$36.546, W72.935, 2010 hrs, 3/13/10).

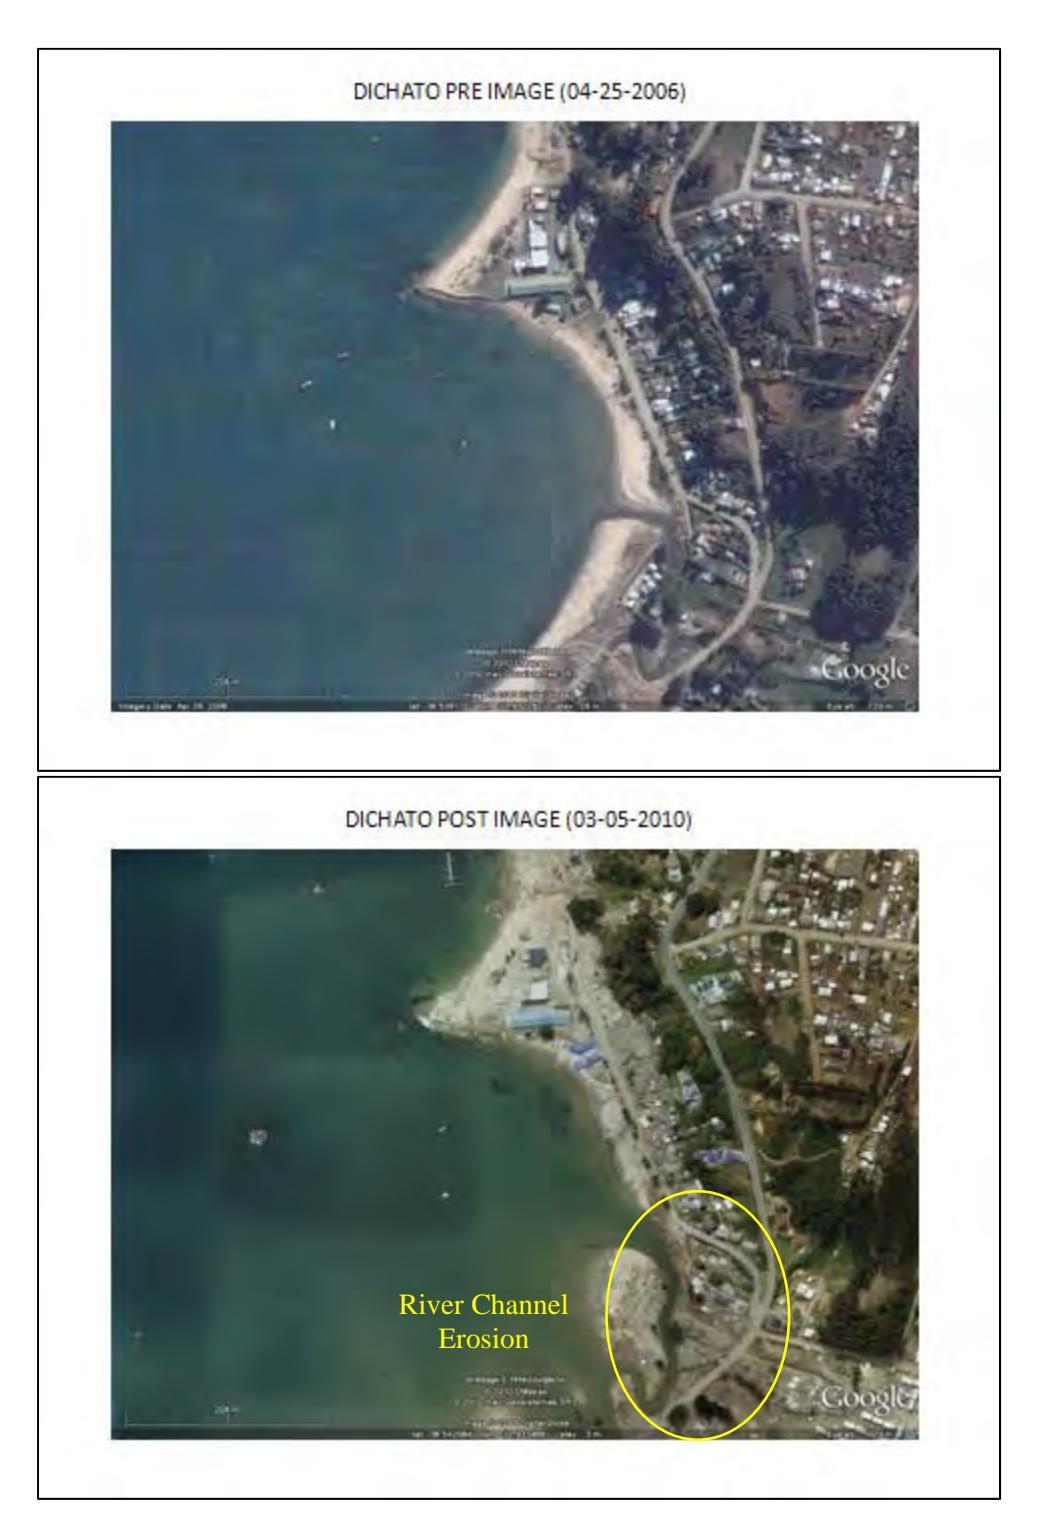
The course of the Rio Dichato has been altered as shown in Figure 13.17. Prior to the earthquake, the river meandered through a neighborhood with gardens abutting the river, before exiting to the bay at the east end of town. The tsunami's greatest water depth -- and presumably the most destructive erosional power -- was in the area of this meander. The tsunami removed the soft sediments that formed a barrier between the river and the bay and the meander has been eliminated. Now, the mouth of the river is about 100 meters southwest of its former location. A delta is forming where a neighborhood used to be. The area of the former river bed is now a low-lying mudflat, which floods at high tide.

Figure 13.17 Pre/Post Imagery of Dichato (S36.541°, W72.933°)

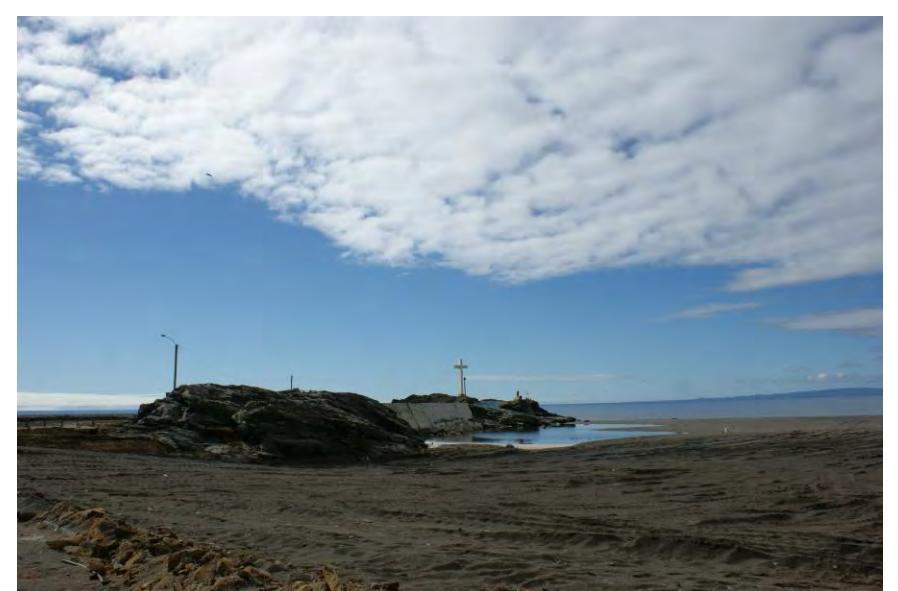
Figure 13.20. Roca San Pedro, a prominent landmark in Curanipe, was almost entirely submerged by the tsunami says one local resident. Only the cross remained above the water (S35.8436°, W72.6390°, 03/17/2010).

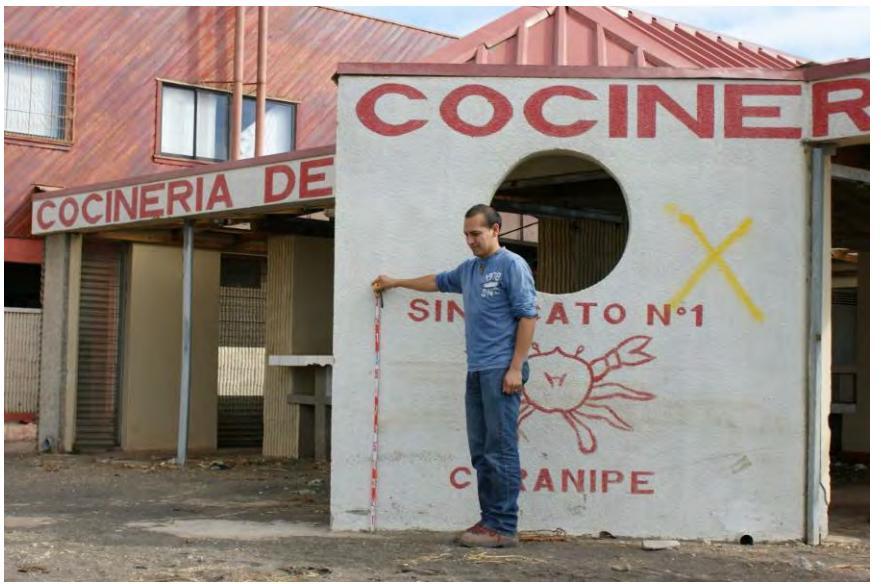
Figure 13.21. Watermarks on a restaurant in Curanipe indicate minimum tsunami flow depths of 1 m at this location (S35.8436°, W72.6365°, 03/17/2010).

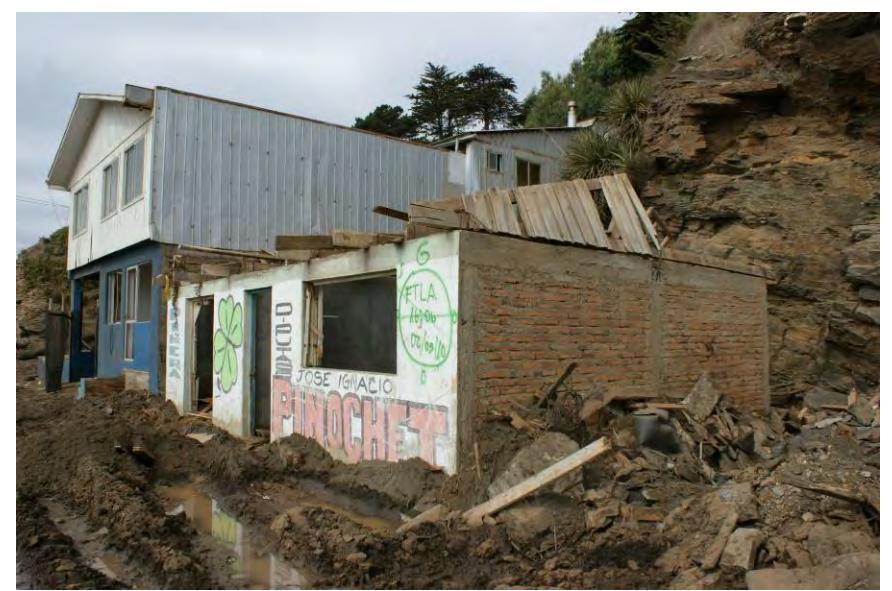
Figure 13.22. The blue and white two-story house in the beach community of El Torreon was heavily damaged by the tsunami and all but the walls of the adjacent vacation house was destroyed. The tsunami arrived at 4:05 am, about 30 minutes after the earthquake, and the water remained high for four hours when it started to retreat around 8 am (S35.8215°, W72.5990°, 03/17/2010).

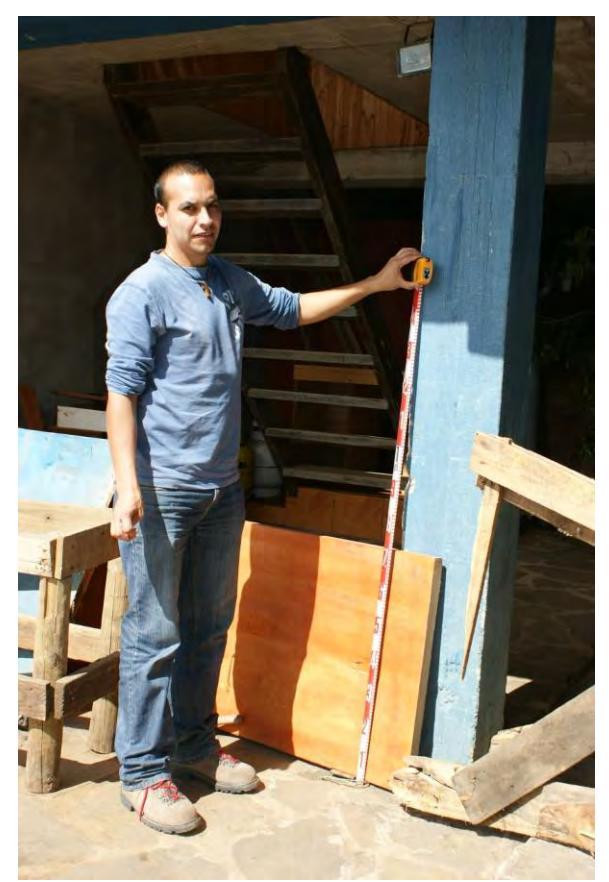
Figure 13.23. On this post inside the first floor of a beach front house in El Torreon, a small community south of Pelluhue, visible lines mark the water height 1.6 m above the ground providing a minimum estimate of the tsunami flow depth at this location (S35.8214°, W72.8215°, ~1556 hrs on 03/17/2010).

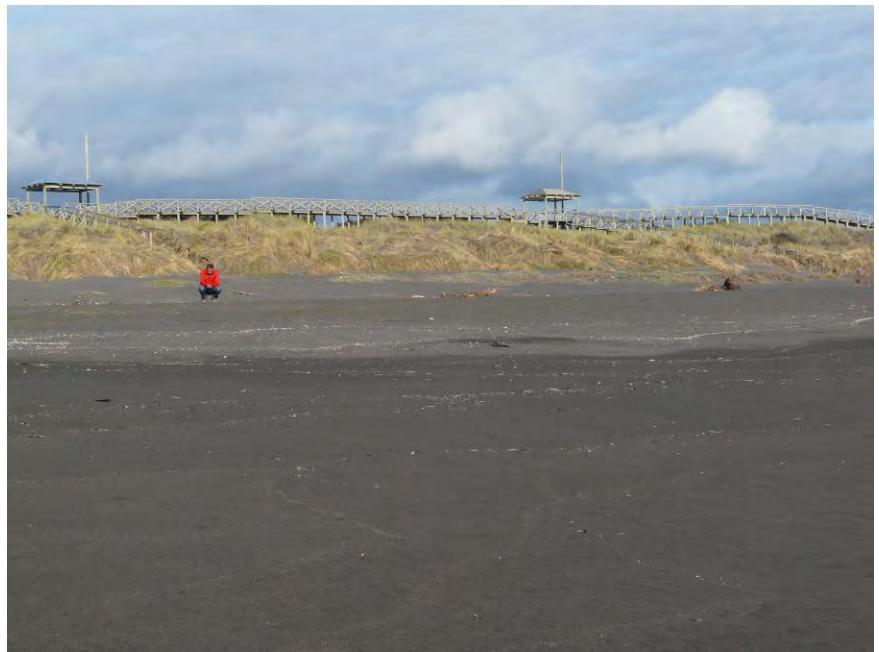
Figure 13.24. The tsunami carried wood and debris about halfway up these dunes near Chanco but left the walkway along the dune crest undamaged (S35.739239° W72.571586°, 1829 hrs on 03/17/2010).

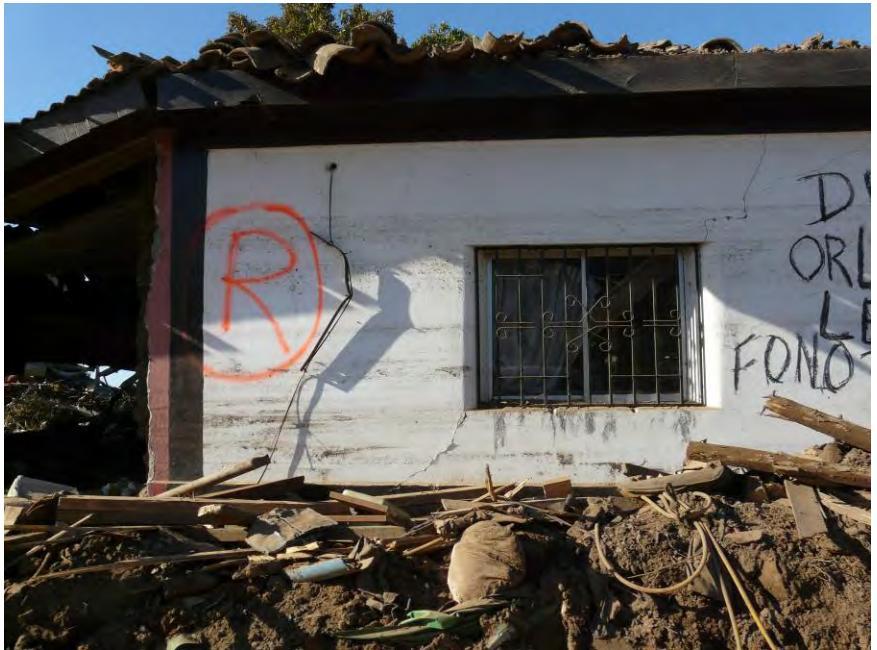
Figure 13.25. Watermarks on damaged buildings in Constitución indicate tsunami flow depths reached at least 2 m along the waterfront on Calle Blanco (S35.336 W72.403, 1757 hrs on 03/15/2010).

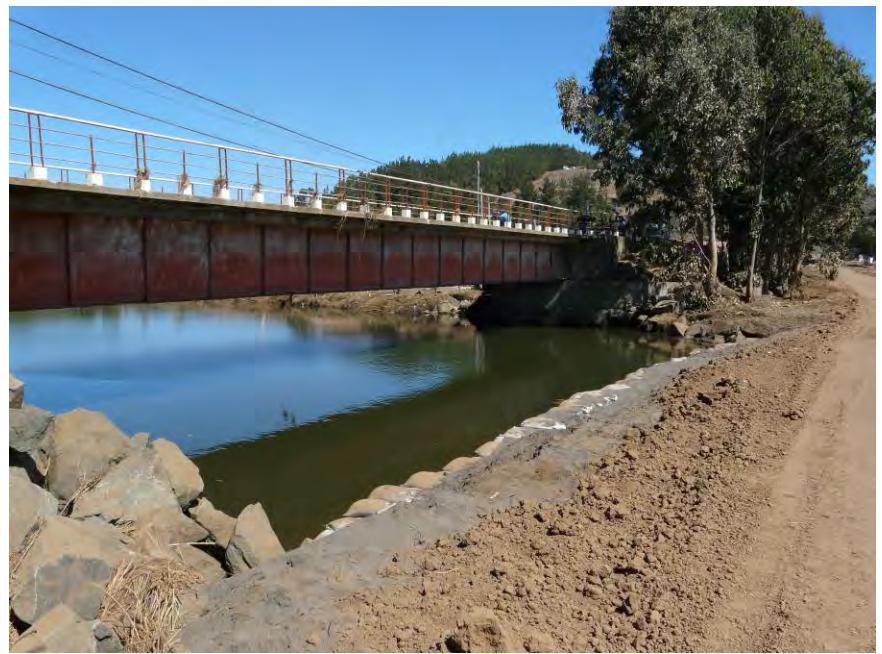
Communities between Iloca and Bucalemu may have been more severely impacted by the tsunami because this region of the coast may have dropped vertically during the earthquake (see evidence in Section 4). Evidence of high flow depths comes from debris caught in the railings of a bridge damaged by the tsunami at Pichibudi. A temporary road had been constructed over the river to detour around the bridge. Grass debris in the bridge indicates minimum flow depths of 5.2 m above the river (Figure 13.26). Local residents encountered at the bridge attest the wave topped 6.6 m and report of a bus that was carried 80 m inland.

Figure 13.26. Debris clinging to the railing of this damaged bridge in Pichibudi suggests minimum tsunami flow depths reached 5.15 m. Local residents reported flow depths of 6.65 m above the creek. Anecdotal accounts suggest the tsunami moved a bus 80 m up the creek valley. Tsunami damage along coast becomes heavier toward the south of this site in Iloca (S34.880055° W72.155819°, 1515 hrs on 03/15/2010).

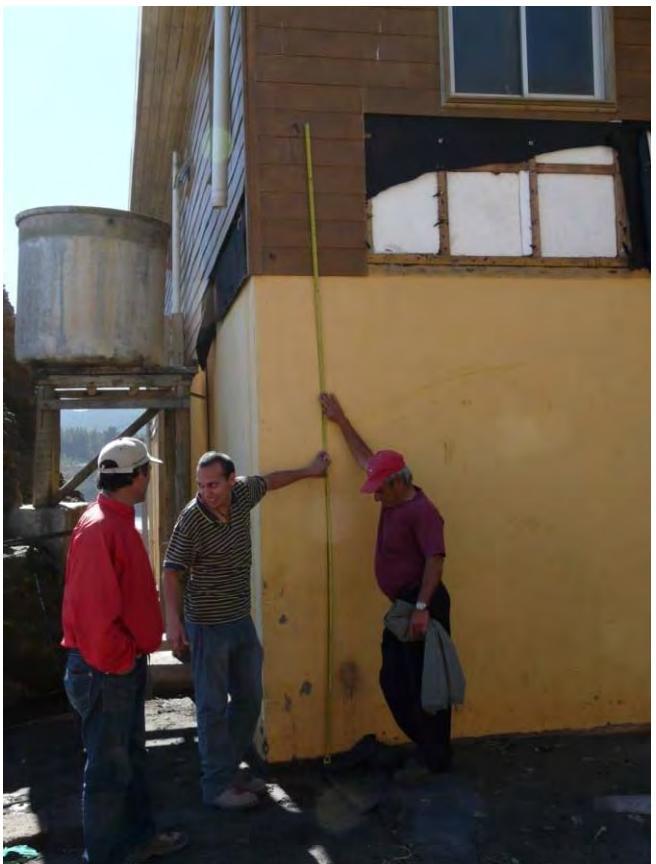
Figure 13.27. Damaged siding on this building suggests tsunami flow depths reached at least 3.5 m at the west end of Bucalemu (S34.640097° W72.044194°, 1130 hrs on 03/15/2010).

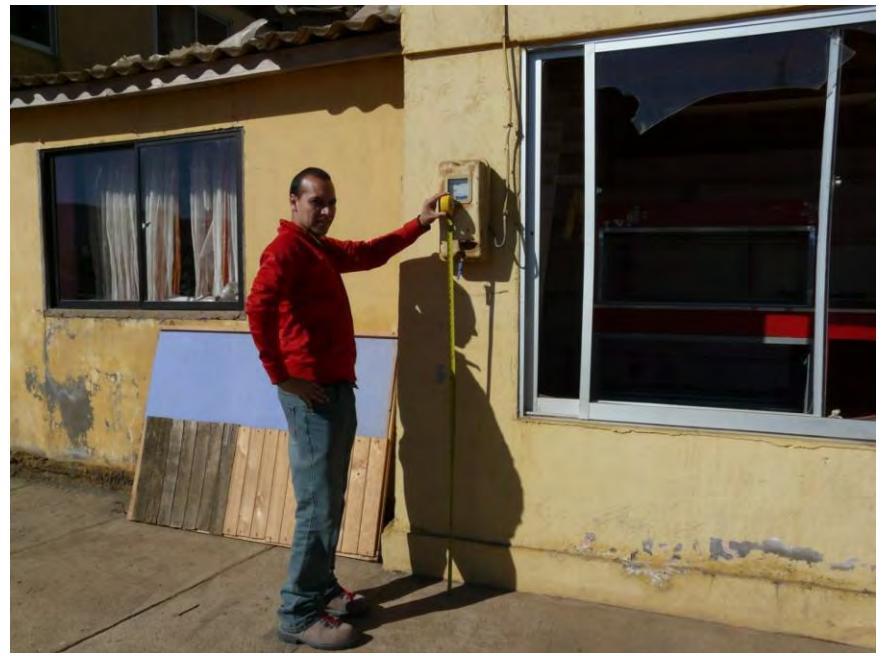
Figure 13.28. Tsunami flow depths reached a minimum of 1.5 m along the waterfront in Bucalemu (S34.641882° W72.043158°, 1051 hrs on 03/15/2010).

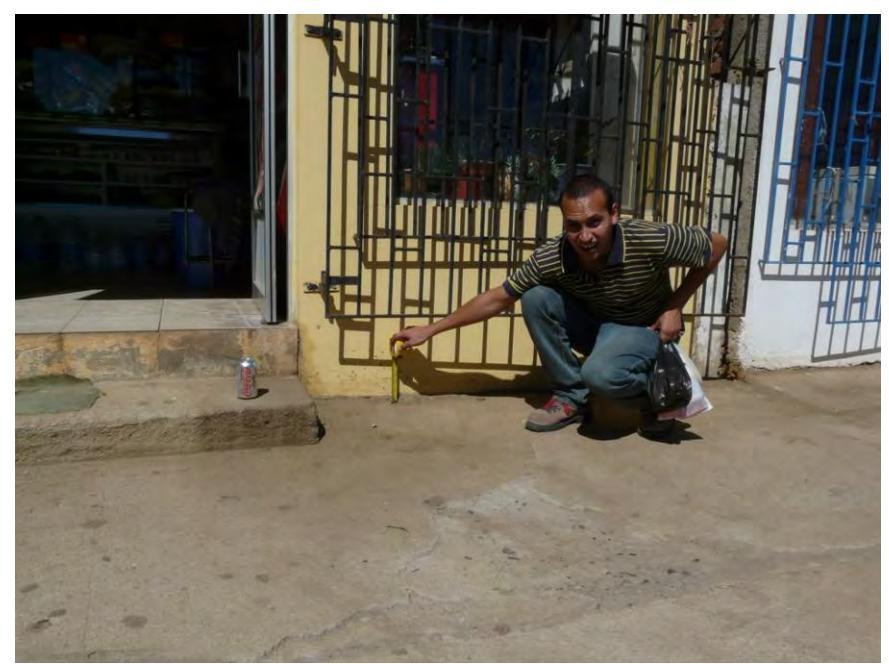
Figure 13.29. Tsunami flow depths at the east end of Bucalemu reached 0.1 m or less near the landward limit of tsunami inundation (S34.642586° W72.037371°, 1228 hrs on 03/15/2010).

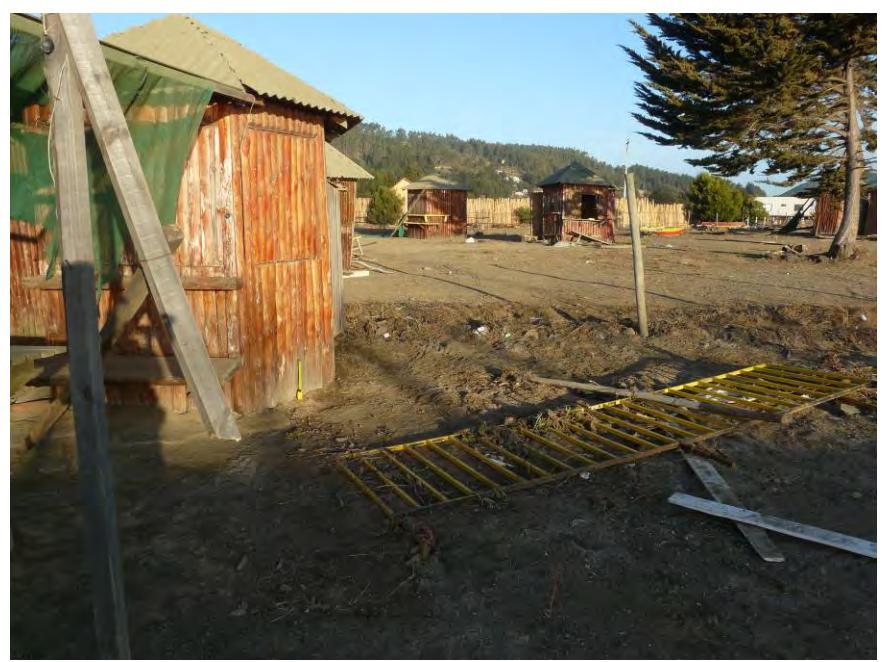
At Puente Cahuil, a bridge over Rio Est Nilahue, we investigated tsunami impacts at a campground with small wooden kiosks and a fence that appear to have been moved around by high water. Near the first intact fence and kiosk evidence of high water offers measurements of tsunami flow depth near the probable upper limit of inundation (Figure 13.30). Dead and dried vegetation strewn in wooden lattice fencing along with what appears to be a water mark on the adjacent kiosk indicate water depths of 0.3 to 0.4 m. Between this location and the river, small cabanas or kiosks appear to have been transported ~30 m landward. A yellow metal fence has been pushed over in the direction of a wave flowing inland.

Figure 13.30. At Puente Cahuil tsunami flow depths reached a minimum of 0.3 to 0.4 m and pushed kiosks at a campground several tens of meters landward (S34.479276° W72.017610°, 1922 hrs on 03/14/2010).

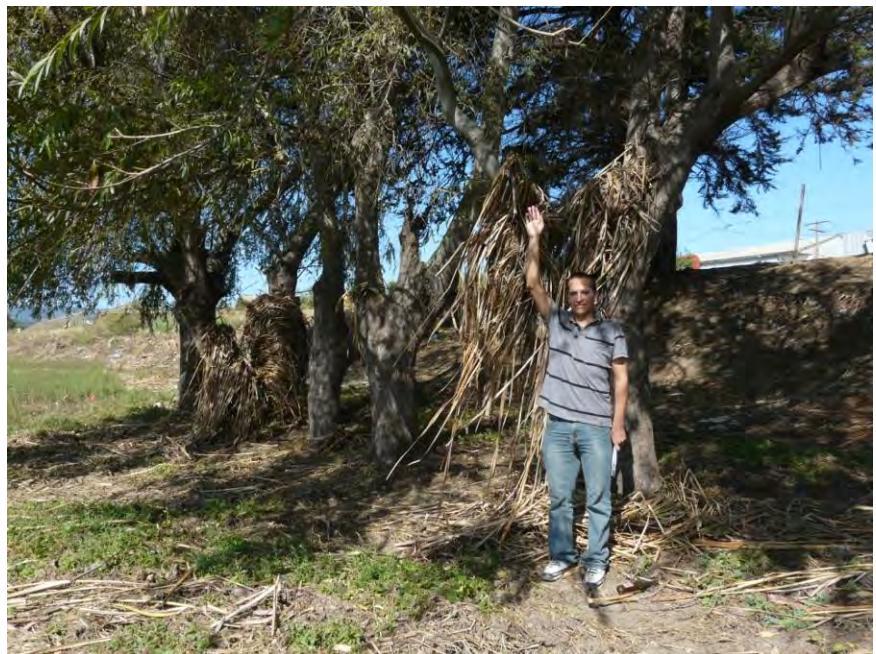
Figure 13.31. Debris suspended in trees along a lagoon north of Pichilemu indicate tsunami flow depths exceed 3 m at this site (S34.385195° W71.999901°, 1619 hrs on 03/14/2010).

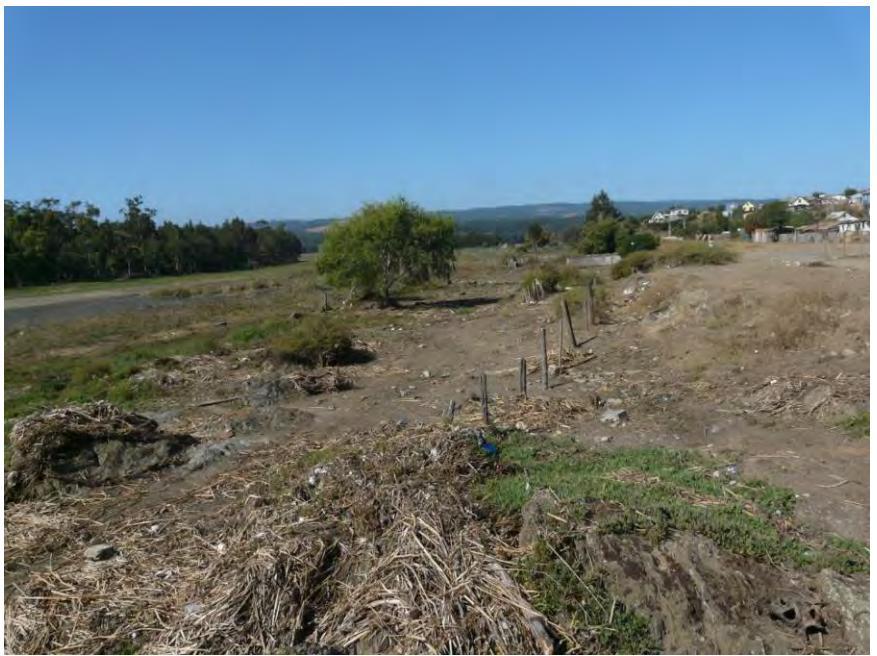
Figure 13.32. Tsunami inundation north of Pichilemu was restricted to a small coastal lagoon, leaving stems of reeds, trash and other debris near the landward limit of inundation. The "wrack line" of debris indicates the tsunami reached the fence in the distance but probably did not overtop the higher ground in the right of the photo (S34.384558° W71.996936°, 1631 hrs on 03/14/2010).

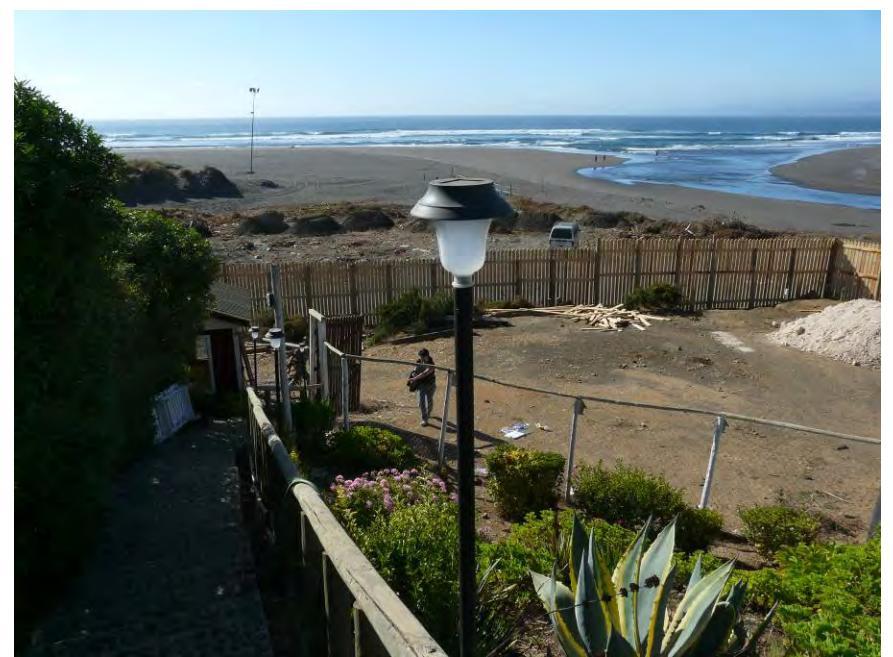
The daughter in law of the owner of Cabanas Gusman-Lyon testified that the height of the first wave reached about 1.5 m high on a chain-link fence near the beach and about the same height in a small shed a few meters away (Figure 13.33). She said the first wave arrived between 3:30 and 4 am in the morning.

Figure 13.33. Below Cabanas Gusman-Lyon, a local lodging along the water front in Pichimelu, tsunami flow depths reached about 1.5 m, destroyed a wooden fence (in this photo the fence has been replaced by a new one) and washed away cars in the parking area (S34.384288° W72.003774°, 1711 hrs on 03/14/2010).

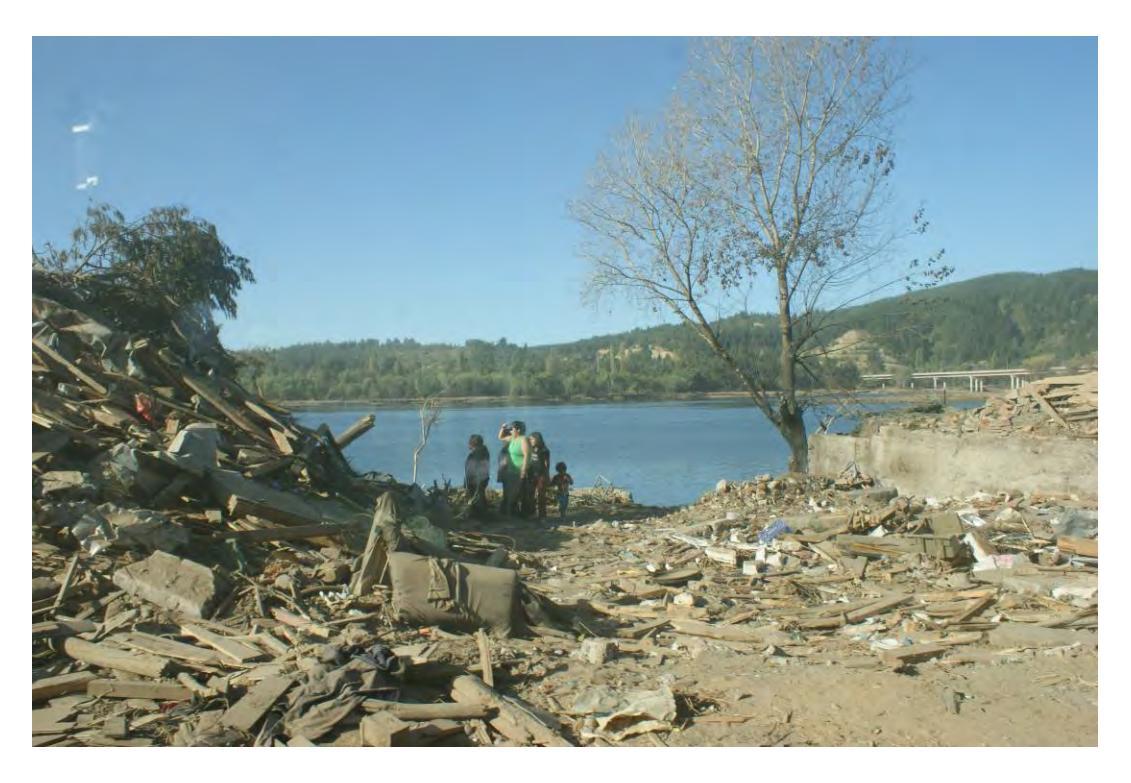
Figure 14.2. Constitucion. Debris removal and road clearing still underway in the tsunami inundation zone along the Maule River. (S35.340323°, W72.396772°; 16:54 hours on 3/15/2010).

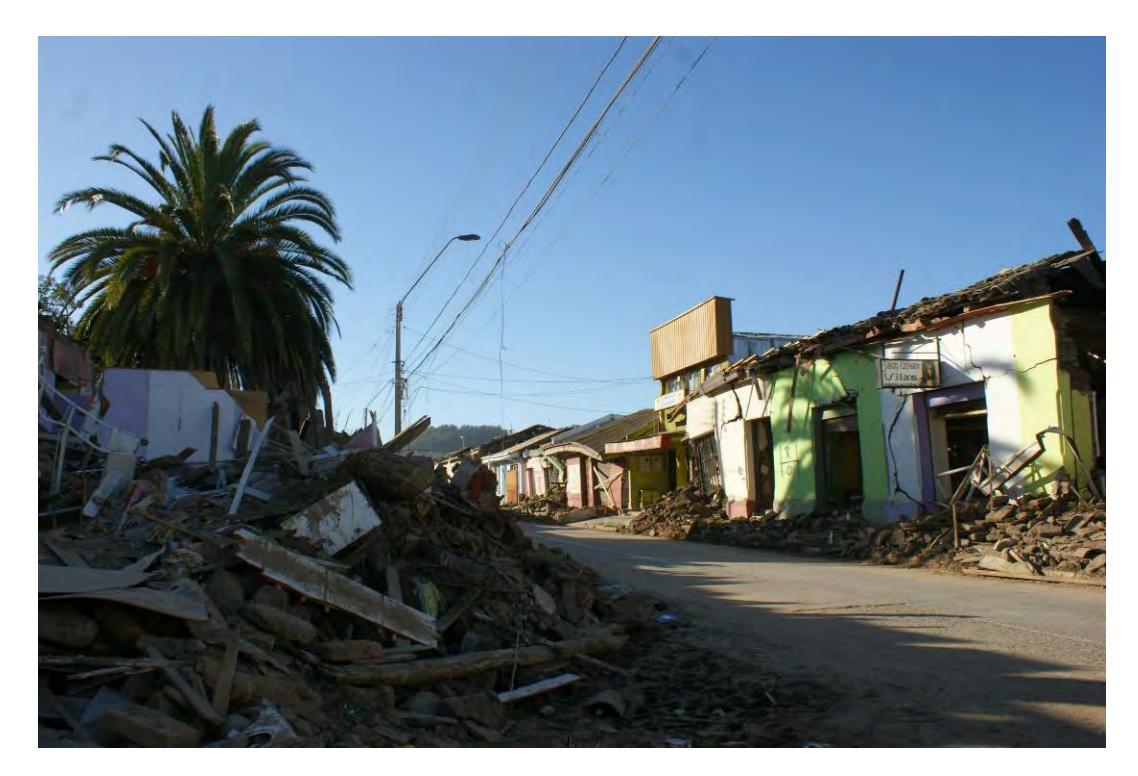
Figure 14.3. Constitucion. Tsunami damage merges with shaking related damage in the older section of the city center with its many adobe and unreinforced masonry buildings. (S35.335383°, W72.410055°; 17:25 hours on 3/15/2010).

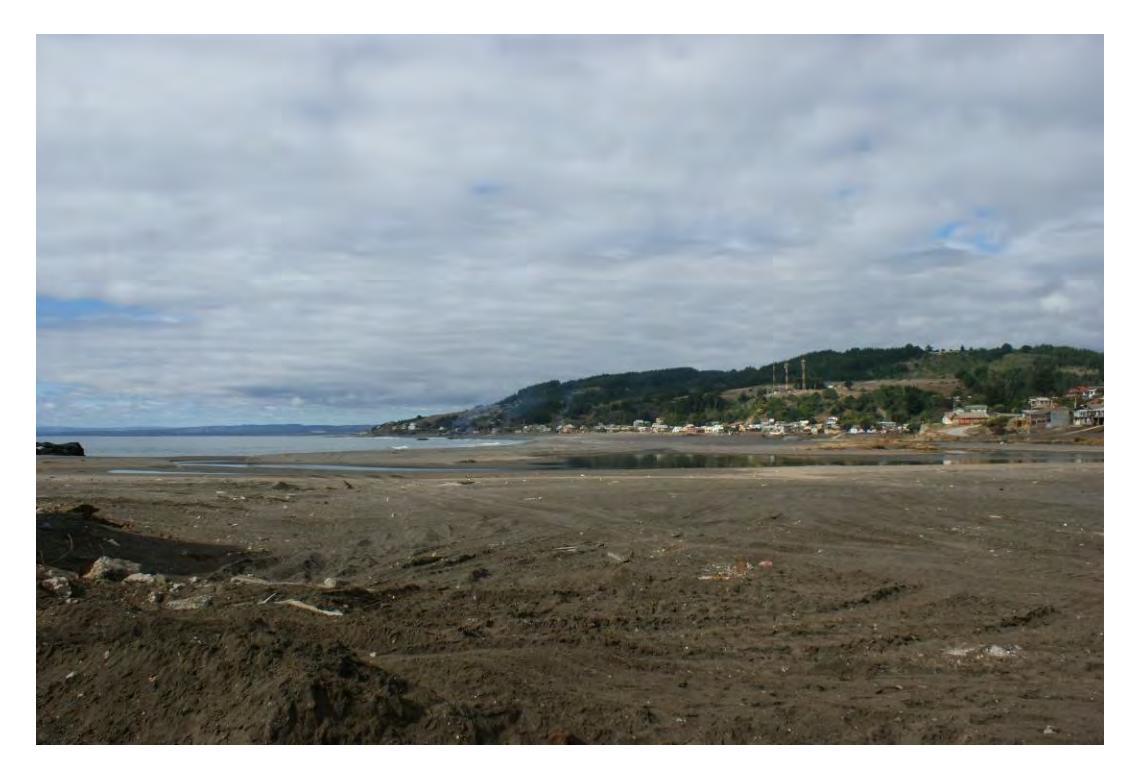
Figure 14.4. Curanipe. Main beach and much of town's debris has been completely cleared. (S35.843823°, W72.6385°; 15:58 hours on 3/17/2010)

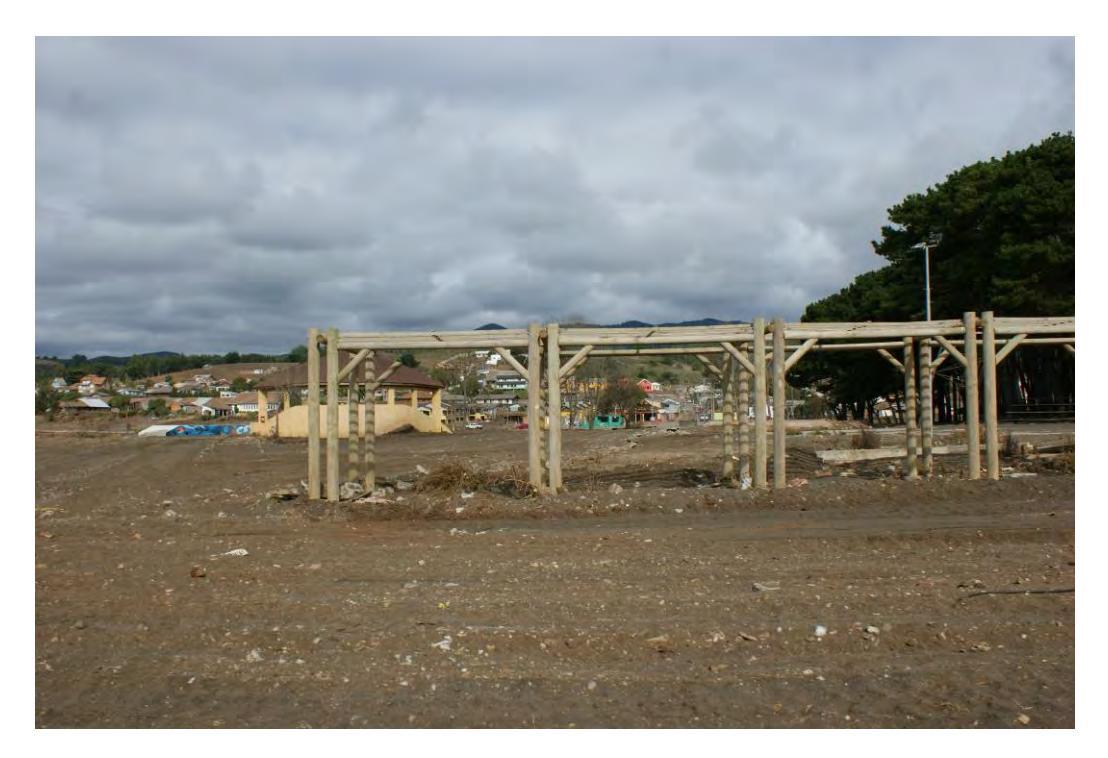
Figure 14.5. Curanipe. According to locals, hundreds were at a campground in this grove of trees. Many ran to the beach to avoid falling trees and were swept away by the tsunami. (S35.843957°, W72.69647°; 15:59 hours on 3/17/2010)

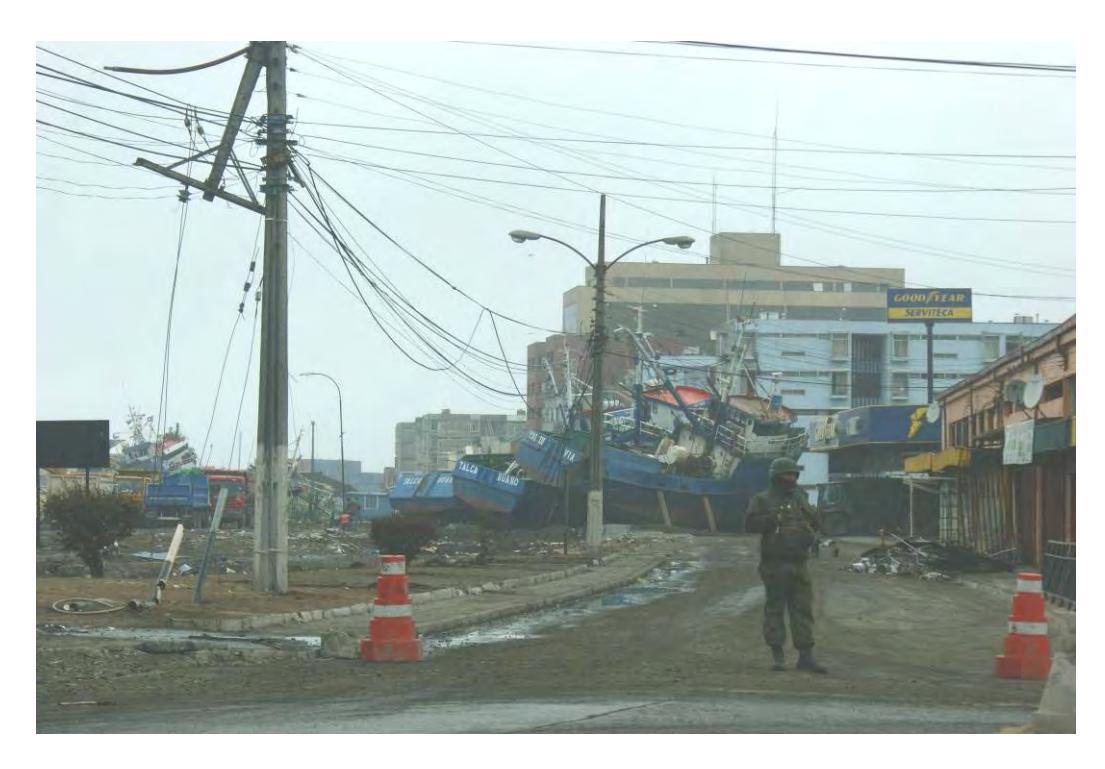
Figure 14.6. Tsunami damage near Navy facilities and bayside port of Talcahuano. (S36.711305°, W73.114808°; 12:39 hours on 3/16/2010)
