# Geo-engineering Reconnaissance of the 2010 Maule, Chile Earthquake

Report of the NSF Sponsored GEER Association Team

# GEER Association Report No. GEER-022

Version 2: May 25, 2010

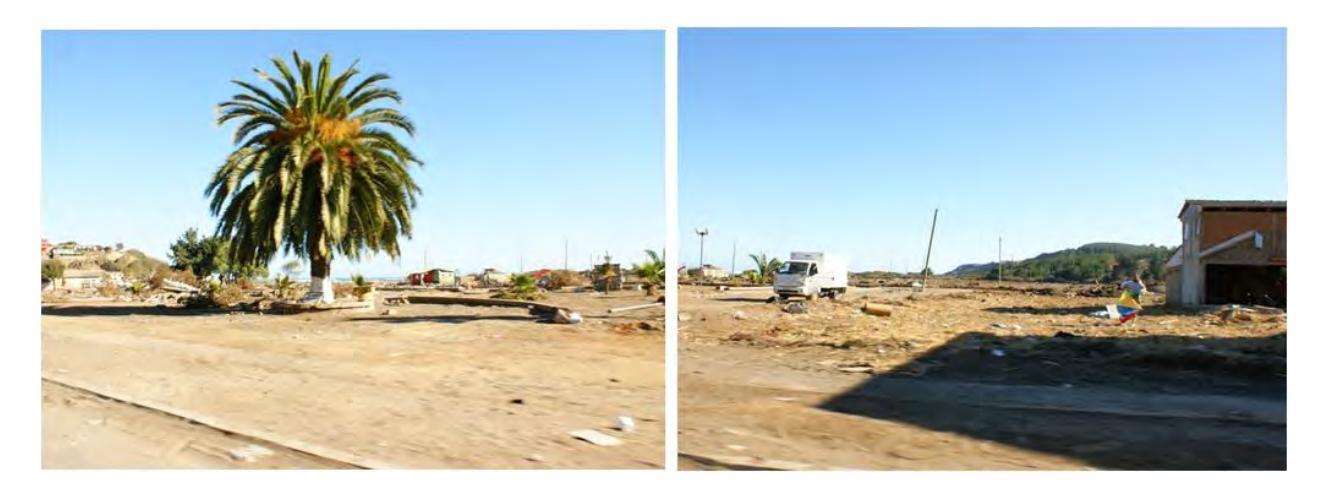
Local policeman say that there were many cabanas, campgrounds, and discos along the estuary, and about 500 people were in this low-lying area when the earthquake hit (see Figures 14.7a and 14.7b). There was a lot of moonlight and many people were out dancing. There was no tsunami alarm. But, many of the local people, firemen and police shouted to get out knowing that a tsunami might strike after the earthquake shaking stopped. Some saw the ocean receding and knew it was a forewarning of tsunami. Vacationers jumped into their cars and drove inland and up into the hills above the town. The tsunami was up to 2 meters deep in the estuary valley area and penetrated nearly 1 kilometer up the river, pushing fishing boats upstream under the coast highway bridge.

Figure 14.7a and 14.7b Bucalemu. Much of the tsunami debris and damaged structures had already been removed from the low-lying area along the estuary that had campgrounds, hotels, restaurants, and discos. As many as 500 people were in this area when the earthquake struck. (S34.62552°, W72.038395°; 09:05 hours on 3/15/2010)

Bucalemu's physical geography has been dramatically altered by the earthquake and tsunami. Highdensity tourist-oriented uses that were previous adjacent to the estuary may be much more vulnerable to flooding, storm surge, and tsunami hazards. As part of the rebuilding, changes in land use, reductions in allowable densities, and condemnation or acquisition of low-lying areas both along the estuary and the adjusted shoreline, may be considered in addition to other risk reduction and community improvement measures.

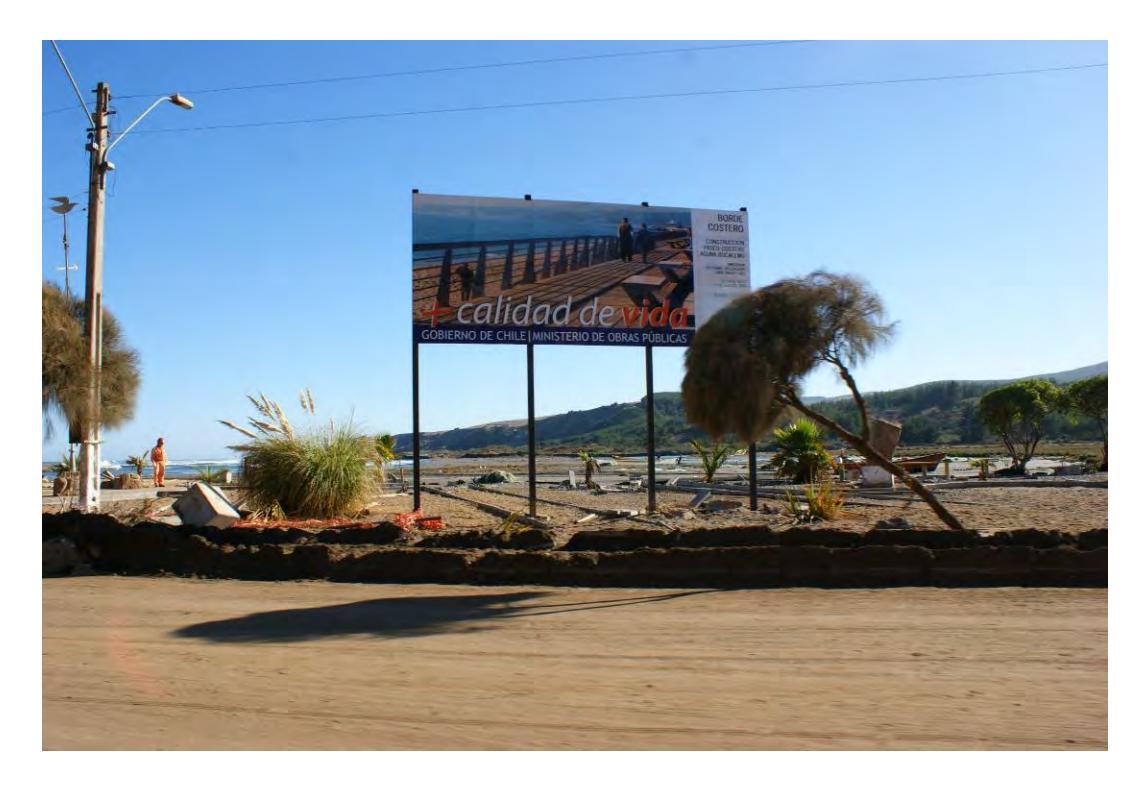
Prior to the earthquake, the town had been embarking in a fairly significant capital improvement project that included expansion of the lagoon and construction of a boardwalk along the shore (see Figures 14.8 and 14.9). Local residents say that the lagoon used to be only 10 meters wide and did not have a permanent opening to the sea and the rough waves like it does now. They say the beach extended about 20 meters beyond the arched, orange bridge out next to the pub building at the rocky point. Now the waves are crashing up against the pub building (see Figure 14.10). The cement boat launch ramp next to the pub building is now under water and the beach that local fisherman used to pull their boats up onto is gone.

Figure 14.8. Bucalemu. Prior to the earthquake, the town had been expanding the lagoon and constructing a boardwalk along the shore. (S34.642367°, W72.040965°; 09:06 hours on 3/15/2010)

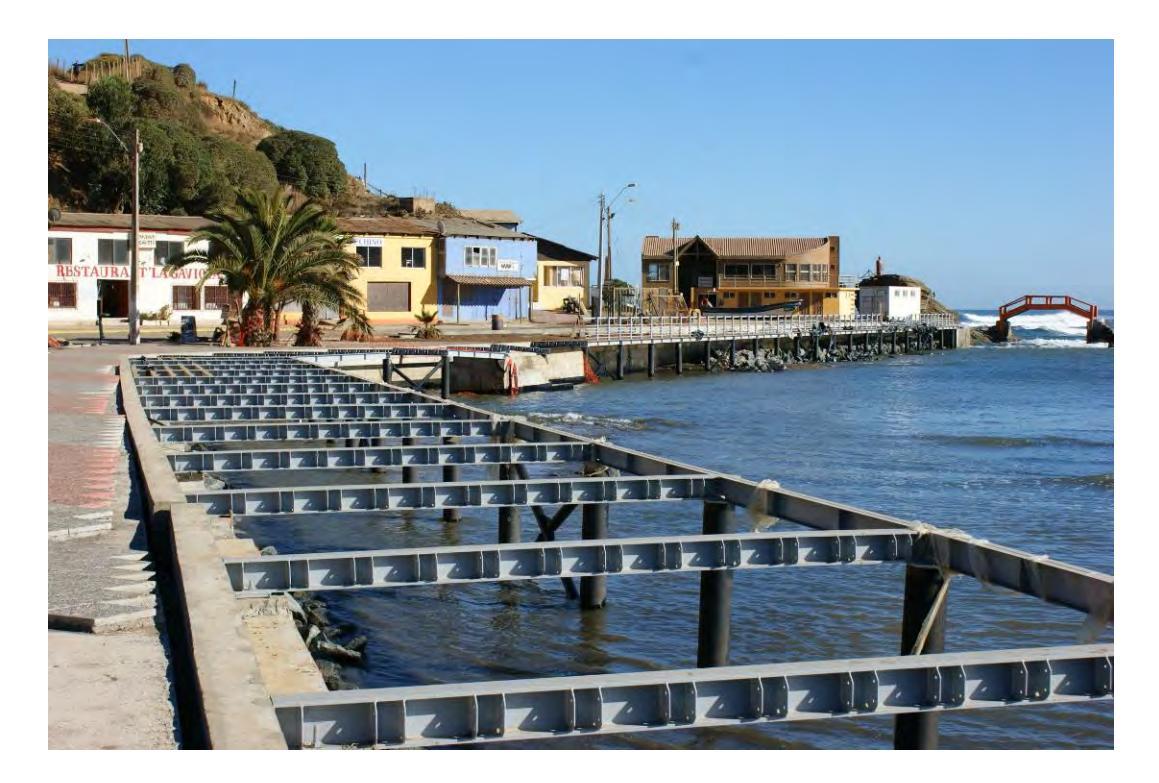
Figure 14.9. Bucalemu. Local residents say the beach extended about 20 meters beyond the arched, orange bridge out next to the pub building at the rocky point. (S34.641713°, W72.043115°; 09:09 hours on 3/15/2010)

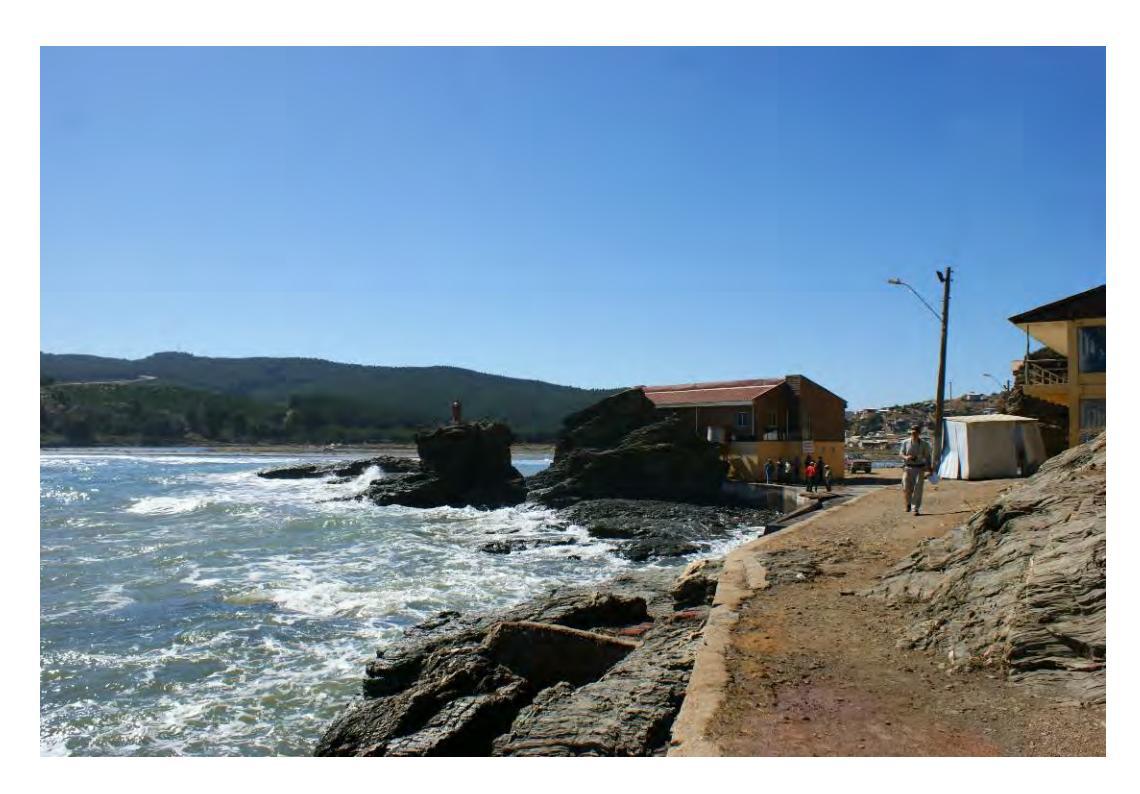
Figure 14.10. Bucalemu. Waves crashing up against the pub building. The cement boat launch ramp and former beach are now submerged after the tsunami. (S34.474325°, W72.023918°; 10:42 hours on 3/15/2010)

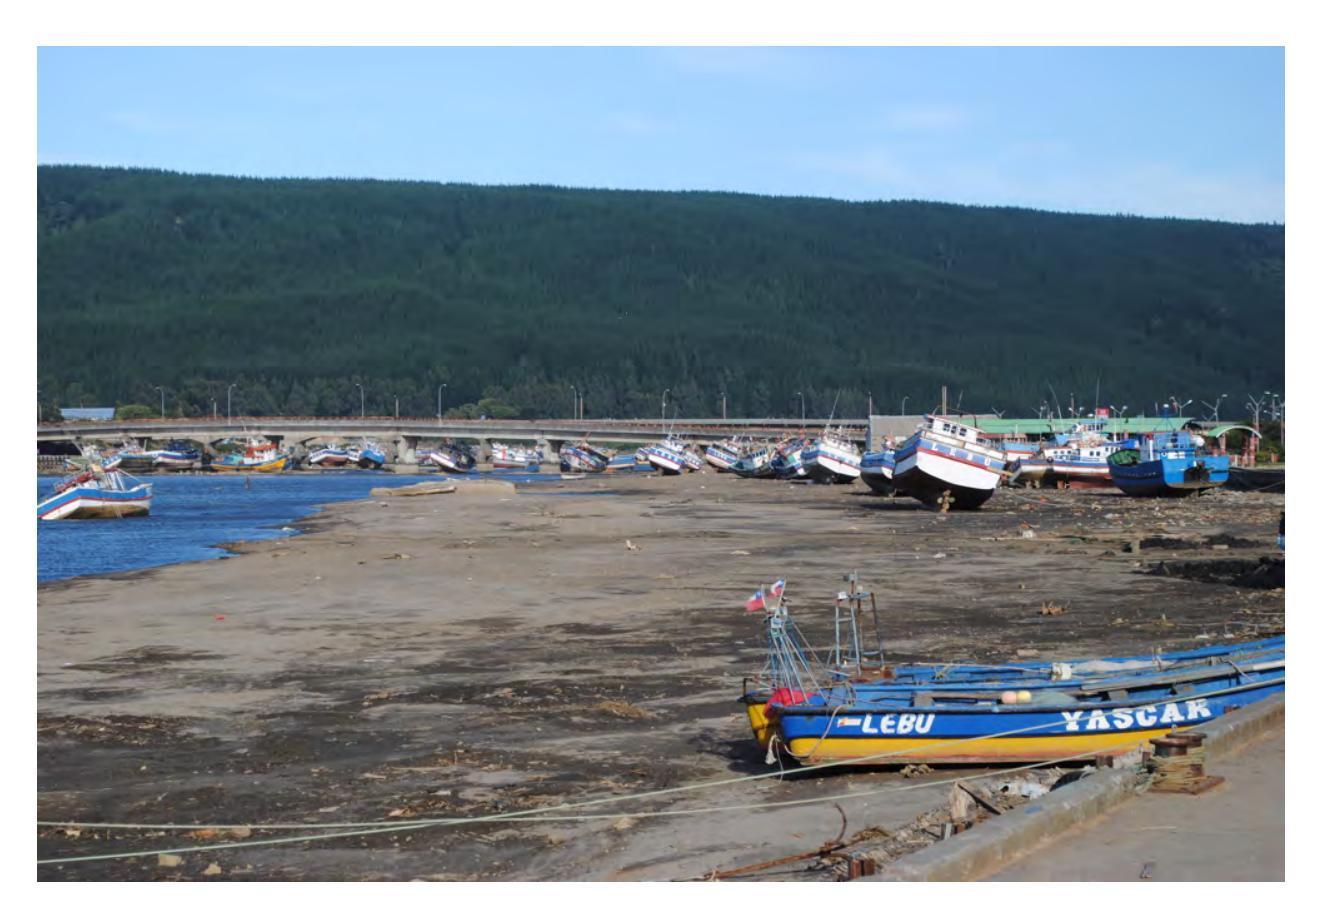
Coseismic uplift has stranded boats in Lebu's harbor (see Figure 14.11). The lighthouse northwest of the Lebu Harbor inlet is on an island that was uplifted enough to almost form a peninsula. Lebu will likely have significant land use planning issues as part of the rebuilding that may include relocation and construction of the harbor and appropriation of rights to the newly-created land. This area was also uplifted in the 1960 earthquake, so there are historic decisions and ongoing risk management issues to be studied as well.

Figure 14.11. Boats stranded in Lebu's Harbor. (S37.603694° W73.654372°; 1800 hrs on 03/10/2010).

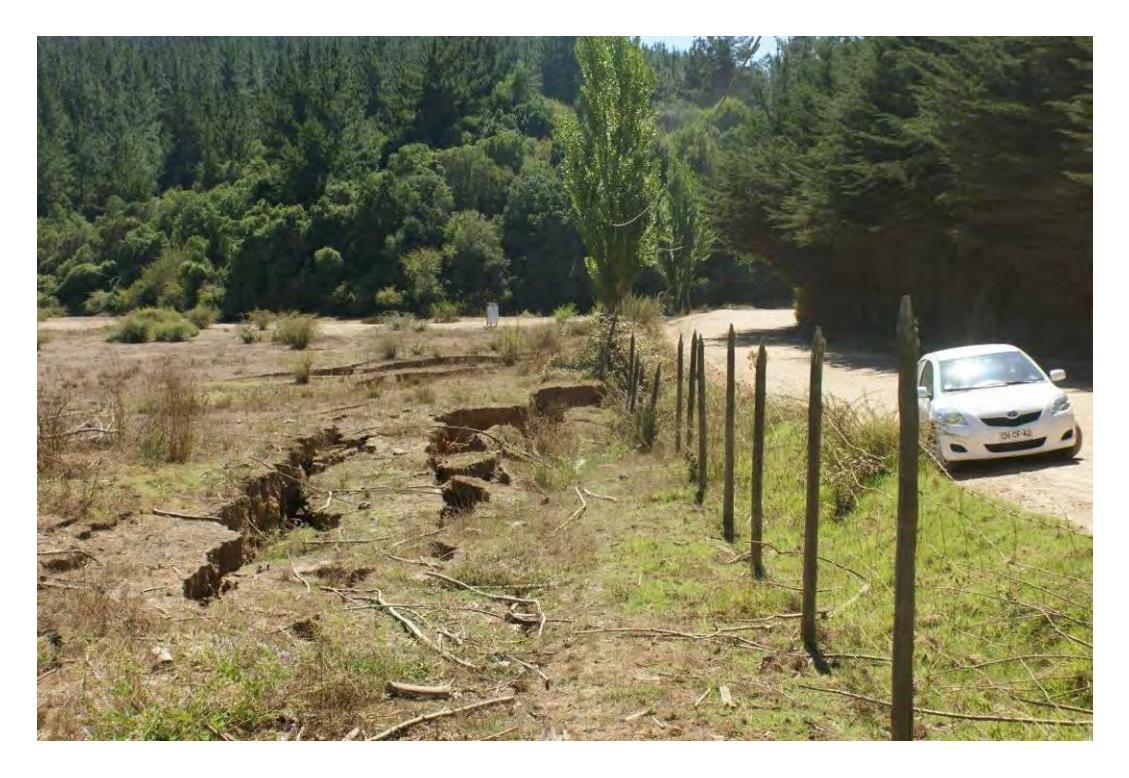
Lateral spreading along the banks of Lago Vichuquen (S34.796068°, W72.078810°), near the Laguna Torca National Reserve, severely impacted the road bed, underground utilities, and lakeside properties (see Figures 14.12, 14.13, and 14.14). Much of the ground underlying a small lakeside cabana hotel has been affected. Over 50 feet of shoreline was submerged and there was evidence for submarine landsliding as well. Sections of lawn, trees, and boat docks were all submerged. The shore side piers of several cabanas were also submerged and there was evidence of structural damage as well. The future viability of this property is definitely in question since there is not adequate land area between the cabanas and the road to setback and reconstruct. Ground deformation was observed in another location along the lake road but did not appear to be a consistent feature along the shoreline. Other boat docks along the shoreline did not appear damaged or submerged, but further study is needed.

Figure 14.12. Lago Vichuquen, Lateral spreading on the inland side of the lakefront road. (S34.39097°, W72.077815°; 12:46 hours on 3/15/2010)

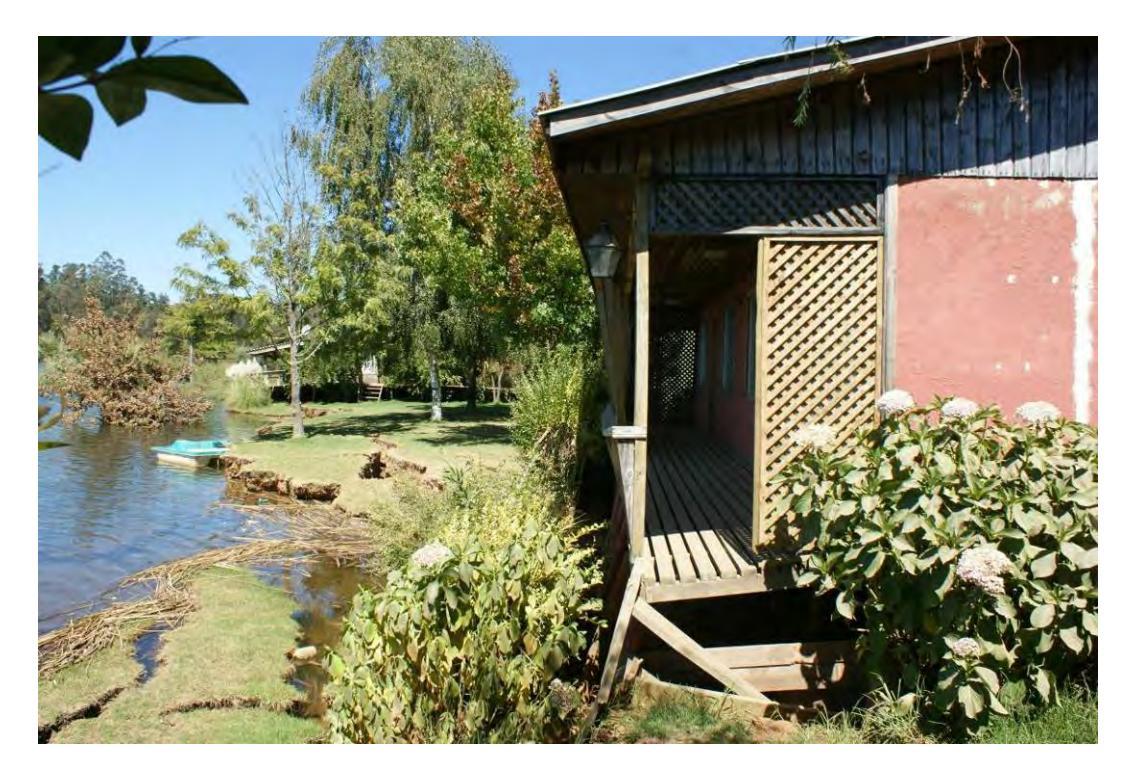
Figure 14.13. Lago Vichuquen. Lateral spreading has affected much of the ground underlying a small lakeside cabana hotel. Some shore side piers of the cabanas were submerged and there was evidence of structural damage as well. (S34.796345°, W72.07885°; 12:58 hours on 3/15/2010)

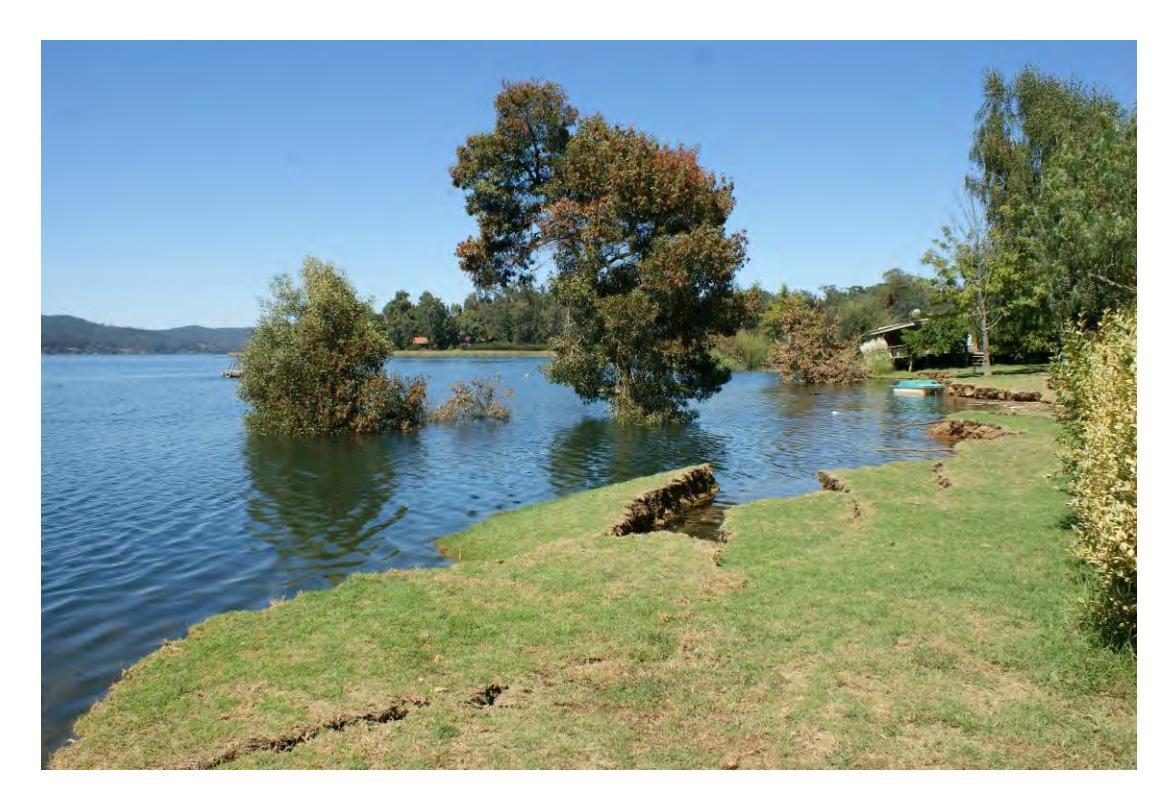
Figure 14.14. Lago Vichuquen, March 15. The lawn, trees, and boat docks are all submerged and there was evidence for submarine landsliding as well. (S34.79634°, W72.078852°; 12:52 hours on 3/15/2010)

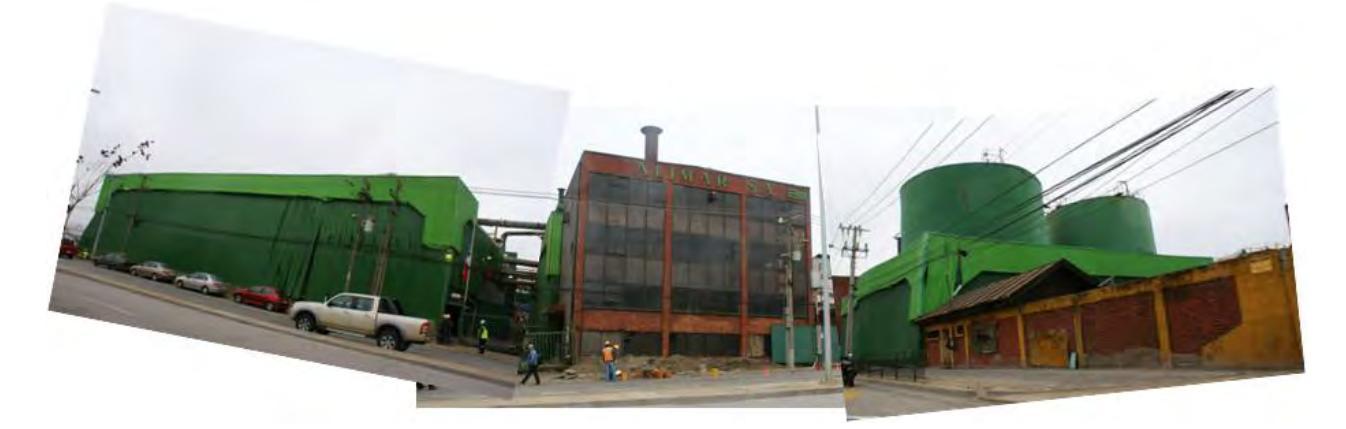
Several port side properties at Port San Vicente in Talcahuano were also significantly damaged by lateral spreading and ground deformation (S36.72593°, W73.12872°). Two fish processing plants, Alimentos Marinos and Concession Maritima, were both severely damaged and not in operation on March 15 (see Figures 14.15 and 14.16).

Port San Vicente is a major fish processing facility and the two plant closures are likely to have prolonged impacts on the region's fishing economy. On March 14, fishing boats were observed dropping their loads in the harbor since the plants were not operational. Alimentos Marinos employed 300 people directly and another 300 indirectly. Insurance adjustors were onsite on March 15 and the former plant manager said the facility will likely not be rebuilt in this location. This type of relocation could have significant local economic ripple effects. The suitability of the port side land for rebuilding is also a major question. Across the port road from the two damaged plant is a tank farm facility that had no observable damage (see Figure 14.17). Perhaps, the tank farm had better site preparations as part of its construction. Also, the port road was slightly elevated from surrounding lands and may be part of a levee system along a former shoreline. The fish processing facility may be sited on much more vulnerable bay fills than the tank farm. Additional study is needed to clarify these concerns.

Figure 14.15. Port San Vicente, Talcahuano. The damaged Alimentos Marinos fish processing plant will likely not be rebuilt at this port. (S36.725983°, W73.128817°; 11:45 hours on 3/16/2010)

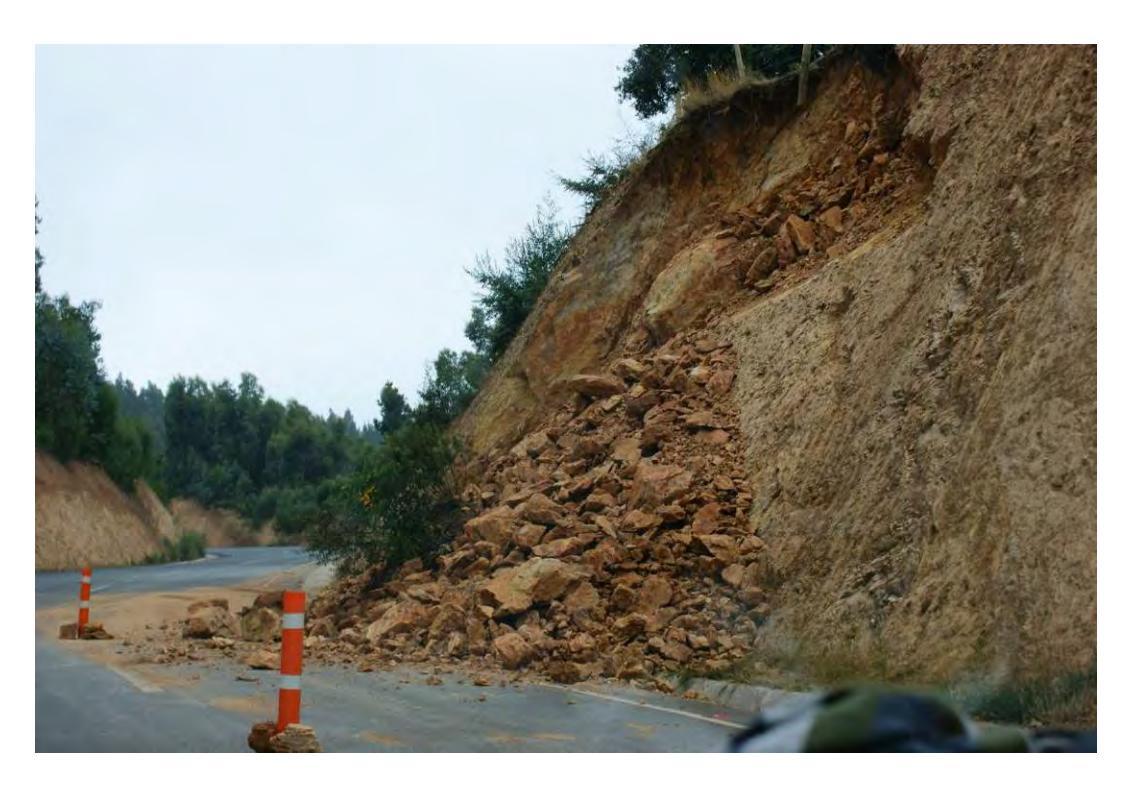
Earthquake-induced landsliding was not prevalent in this earthquake. Section 12 documents the landsliding observations made as part of the GEER reconnaissance. Rockfalls and slides were observed in highway road cuts traversing the coast ranges (see Figure 14.8). Slumping was also observed along coastal bluffs and river banks. While, there do not appear to be any large-scale landslides that would have significant long-term rebuilding issues, landsliding may have some important near- to medium-term implications for recovery.

Figure 14.18. Lota Alto, Bio Bio region. Failures on the road cuts along one of two main highways leading to the Port of Coronel and surrounding coastal cities. (S37.047677°, W73.061597°; 15:30 hours on 3/16/2010)

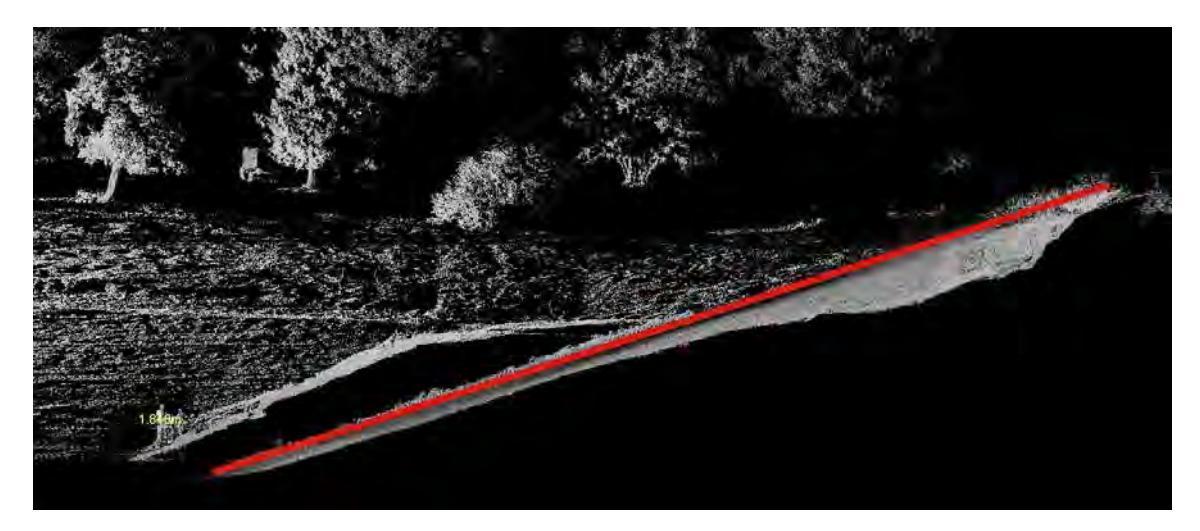
The Coiheuco Dam was visited by three GEER teams. The first visit was on March 10, 2010, the second visit was on March 14, and the third visit was on March 28. The dam was built during the period from 1964 to 1970 and has a maximum height of 31 m and a crest length of 1040 m. A Google Earth image of the dam is shown in Section 11. It was not clear if soil liquefaction occurred at this site as potential evidence of liquefaction was not apparent to the GEER teams. Several slumps occurred in the upstream shell. The upstream-left (west) abutment slump was most damaged with a well defined head scarp and toe bulging (LIDAR image Figure 15.15 and 15.16). A second slump to the east had lesser amounts of toe bulging. Team C performed LIDAR scans on the west slump. In Figure 15.15 a well defined head-scarp can be seen at the crest of the dam and, following the fall-line from the scarp (RED line), a bulge of compressed material can be seen at the lower portion of the slope defining the toe of the slump. Figure 15.16, a cross section cutting through the slump is presented along with lidar data for the adjacent unfailed upstream shell (accentuated with a RED line). There is a volumetric balance between evacuated material from the head scarp and the volume at the toe bulge at the base of the slope. The hinge point of the material and accretion appears to be approximately half way down the slope. Team C conducted one DCPT sounding near the waterline (after the reservoir was drawn down). The sounding and profile is illustrated in Figure 15.17. As illustrated in the figure, the soils were fine-grained – primarily volcanic silty clays derived from the Chillan volcano located approximately 30 km to the west of the dam site. Dynamic penetration in this material ranged from about 3 to 12 blows in the upper 3 m, then increased approximately linearly with depth. In addition, Team C members handdug a shallow trench in the upstream slope after removing the riprap from the slope surface. The near-surface soil in the upstream shell consisted of gravelly sand and sandy gravel (see Figure 15.7). The large grain size of the materials precluded the use of DCPT here.

Figure 15.16. Cross section view through the slump at the Coihueco Dam, and adjacent un-failed upstream shell, accented with a Red Line (36.63782°S, 71.79700°W; 27 March 2010; 13:00).

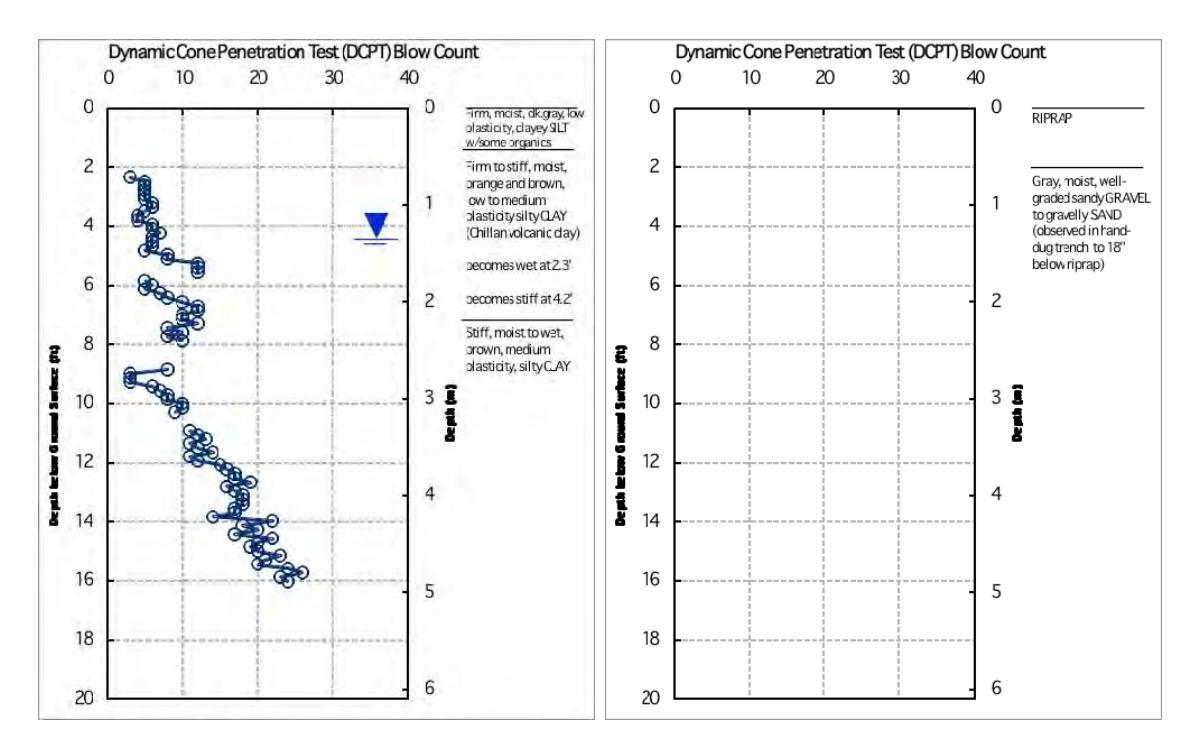
Figure 15.17. DCPT and hand auger logs from sounding performed at toe of upstream slide at Coihueco Dam (36.63782°S, 71.79700°W; 27 March 2010; 13:00) and log from hand-dug trench in upstream slope (36.63737°S, 71.79674°W; 27 March 2010; 16:00).

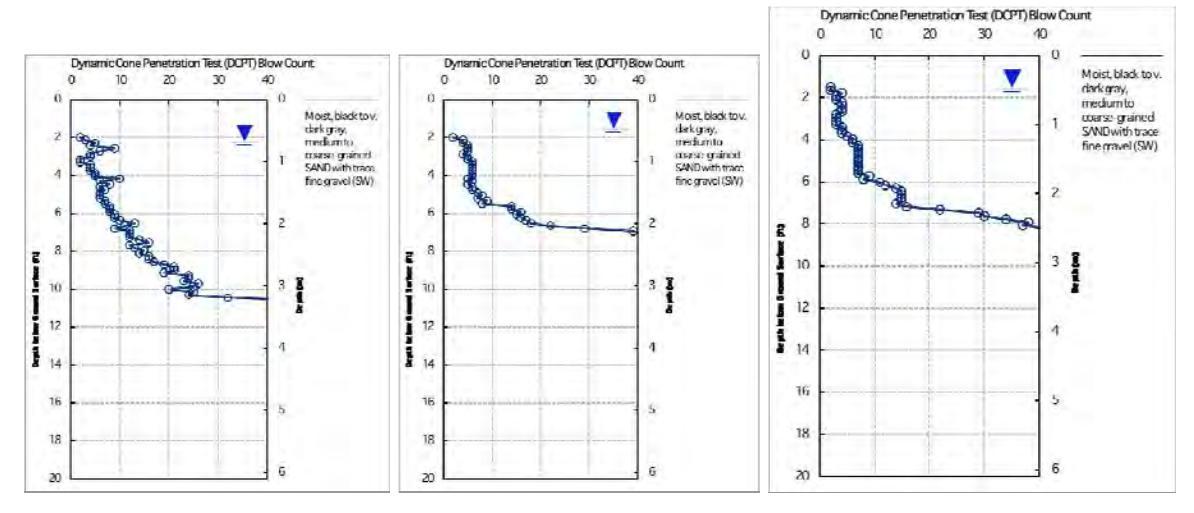
We performed three DCPT soundings and hand augers at this bridge, LIDAR sans, and an SASW profile. The soils at the bridge were relatively uniform, consisting of very dark gray to black, medium to coarse-grained sand with trace fine gravel. At depths of about 2.2 to 3 m (at nearly the same elevation), the sands became dense and penetration refused. The soils above about 2 m were loose, exhibiting DCPT blowcounts generally less than 10.

Figure 15.19. DCPT and hand auger logs from soundings performed at middle Bio Bio Bridge (Llacolen Bridge). The DCPTs and hand augers were performed at (36.83029°S, 73.06860°W; 24 March 2010; 11:30), (36.83038°S, 73.06878°W; 24 March 2010; 12:30), and (36.83007°S, 73.06908°W; 24 March 2010; 13:30).

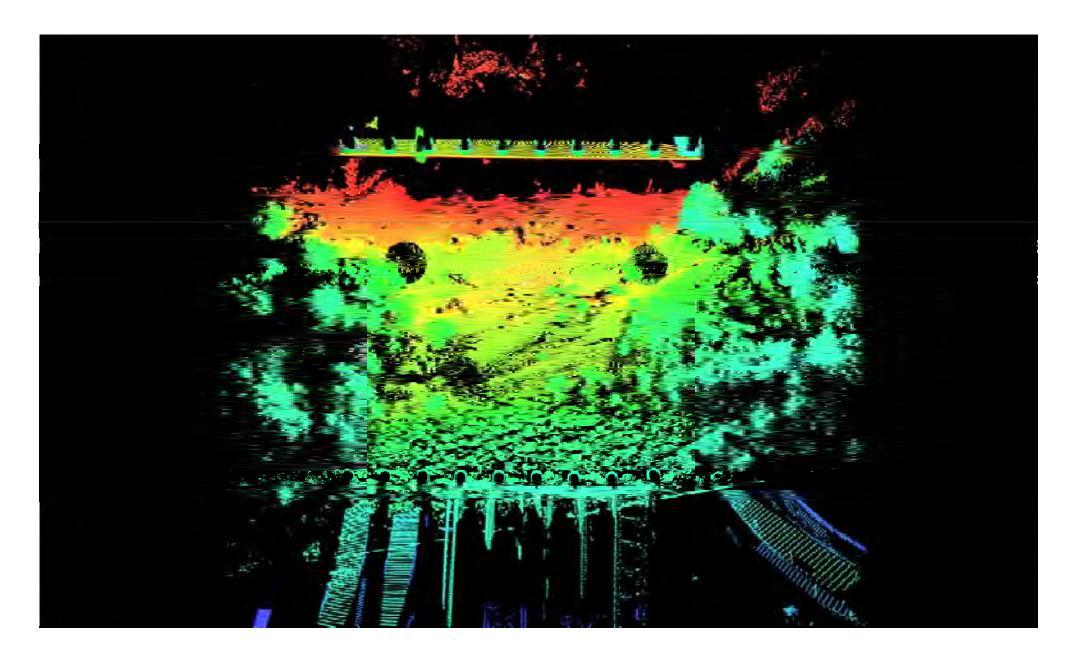
The north approach of the Llacolen Bridge suffered deck unseating due to lateral spreading of the bridge piers. The Llacolen Bridge in Concepcion was constructed in 2000 and spans 2,160 m of the Bio Bio river. The bridge supports four lanes of vehicular traffic pedestrian walkways. The lateral spreading unseated the traffic support deck. Ground settlement of 0.25-0.30 m was also noted to surround each of the exit ramp bents.

Figure 15.20. Plan view of the LIDAR scans at the Llacolen approach with the bridge deck digitally removed. The unseated approach deck is at the bottom-middle of the image adjacent to and against the circular columns. Outward tilting of the riverward (upper) columns is evident, as are fissures in the soil due to lateral spreading.

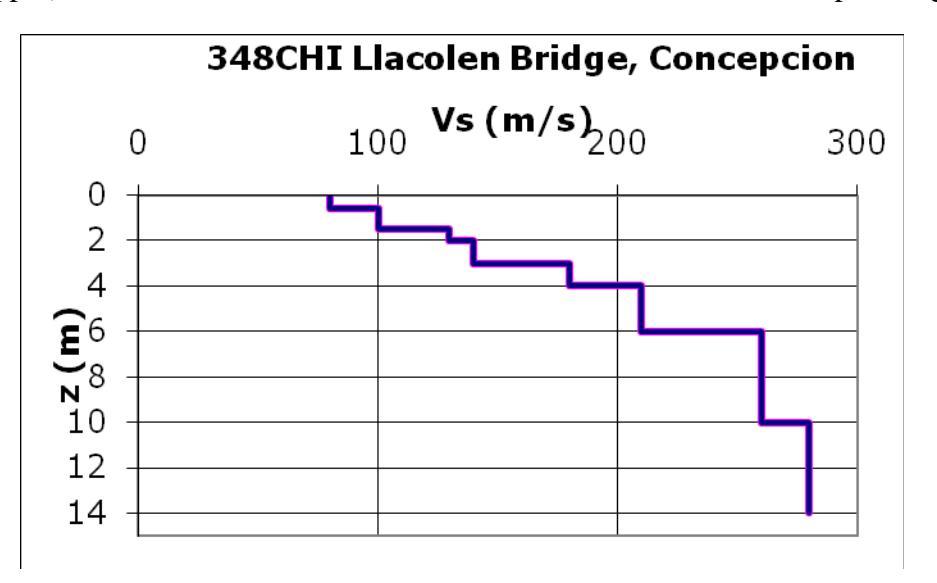
Figure 15.21 Shear Wave velocity log using the SASW method for the Llacolen Bridge approach embankment.

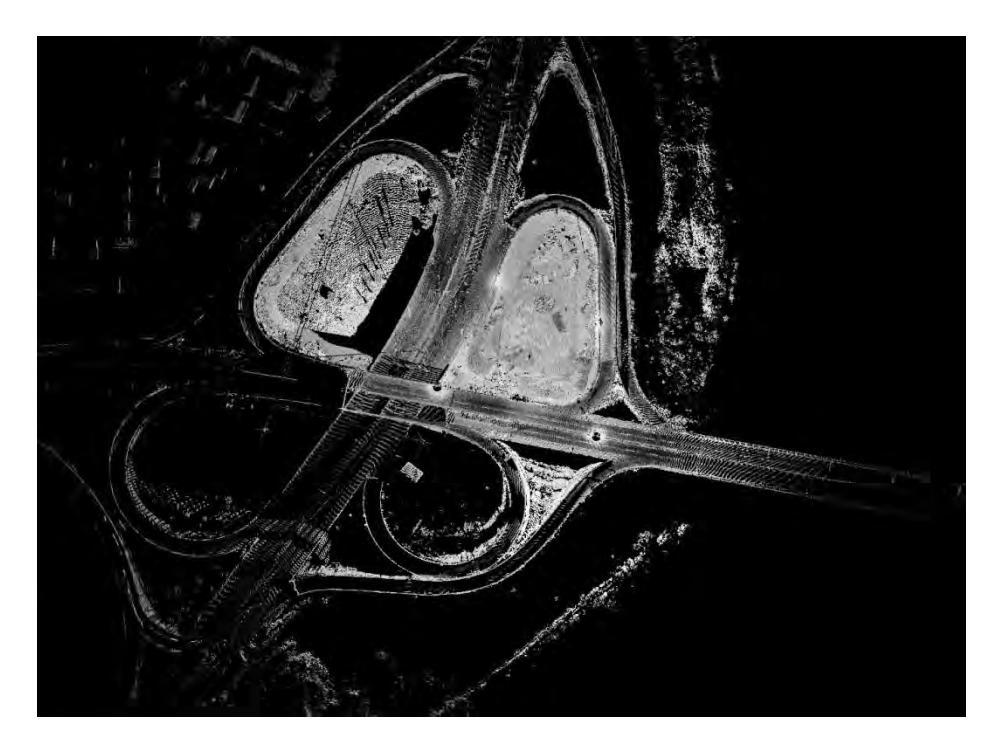
The Juan Pablo II Bridge is the longest vehicular bridge in Chile with a length of 2310 m and suffered lateral spreading on the North-East approach and liquefaction-induced settlements along the length of the bridge The Juan Pablo II Bridge connects Concepcion and San Pedro de la Paz. The bridge, designed by E.W.H Gifford & Partners and opened to the public in 1974, has 70 33m spans, each composed of 7 reinforced concrete girders and a concrete slab. The segments sit on reinforced concrete bents with drilled pier supports. Severe liquefaction and lateral spreading at the north-east approach embankment settled the bridge piers, dropping and laterally displacing the bridge deck. The team performed two DCPT soundings and hand augers at this bridge, as well as LIDAR scans and one SASW shear wave velocity profile near the settled pier at the approach embankment. Both DCPT soundings were performed to depths of about 6 m, and we terminated the soundings only because we ran out of DCPT rods. The soils below about 0.5 m consisted of loose to medium dense, poorly and well-graded sands, similar to those observed at the Llacolen Bridge.

Figure 15.22 . Plan view of the LIDAR scans at the Jan Pablo II bridge approach clover leaf ovals (south is up). Bridge damage was located on the west (right) riverward side of the interchange with the riverfront highway (S36.815864°; W73.083674°).

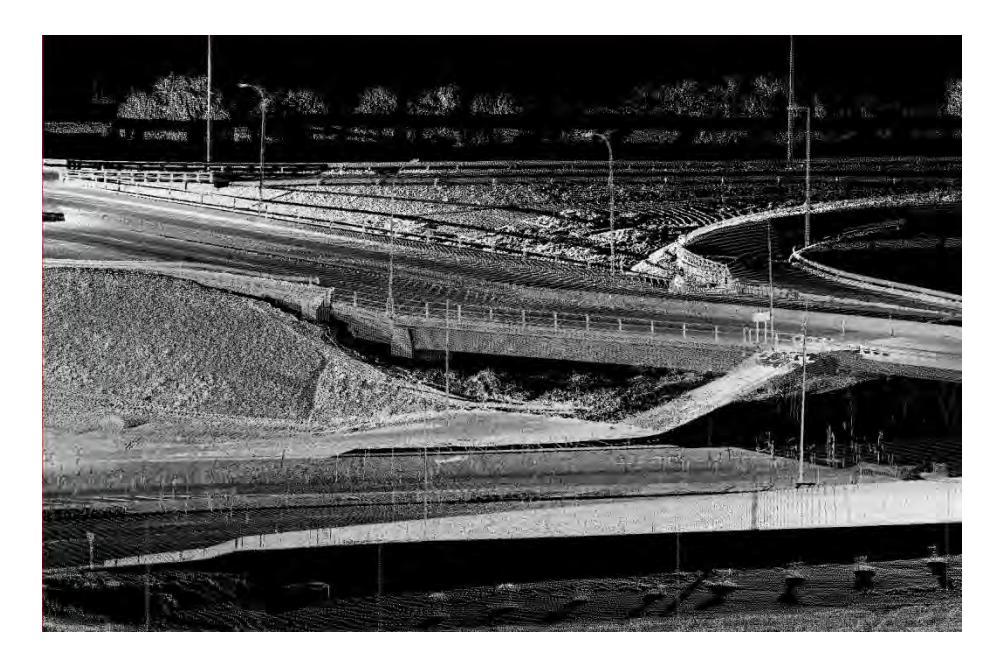
Figure 15.23. Settled bridge pier at the approach embankment of the Juan Pablo II Bridge (S36.815864°; W73.083674°).

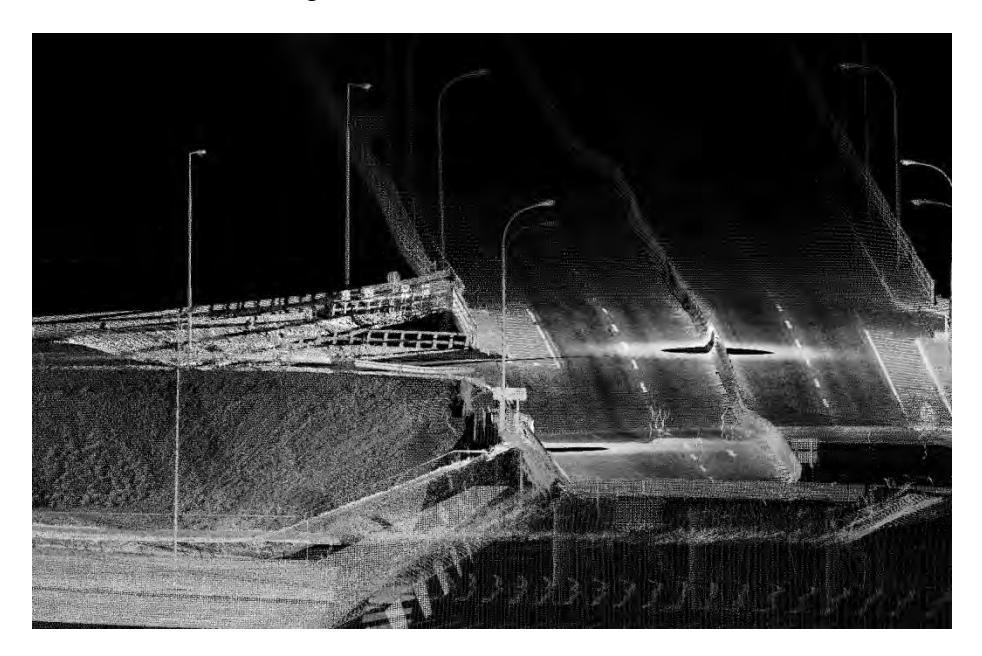
Figure 15.24. Distorted bridge centerline guard wall and settle deck above the north east approach embankment.

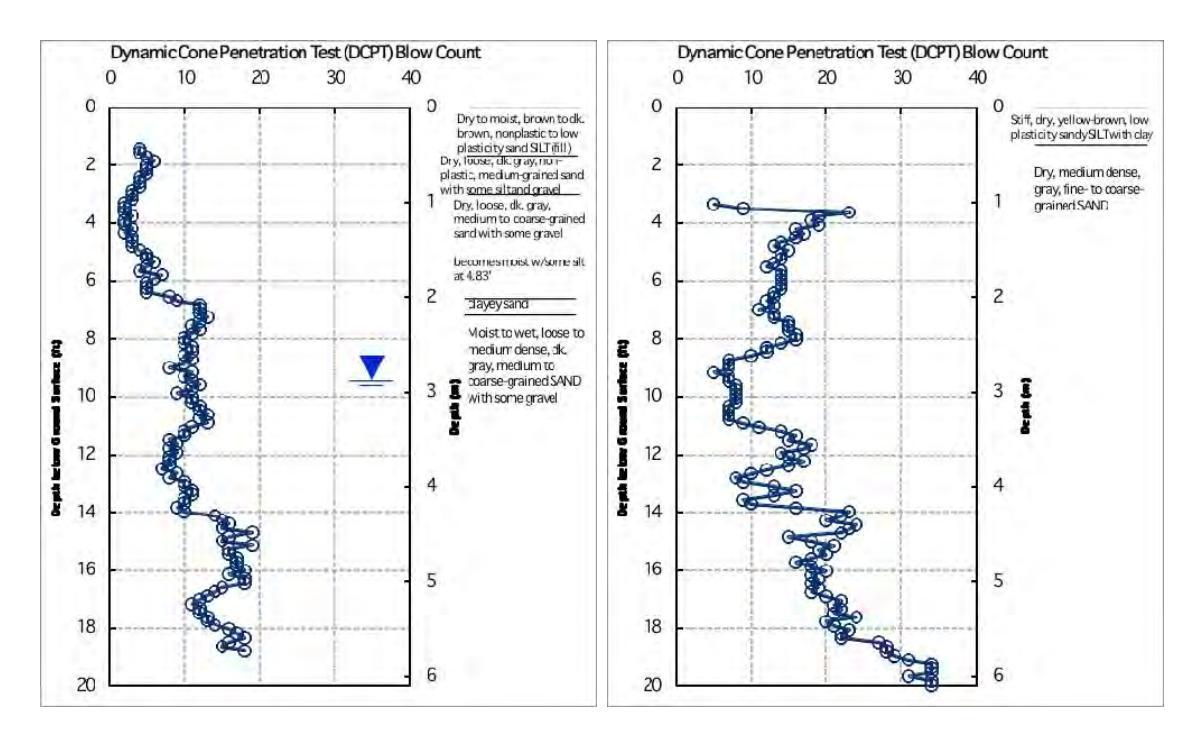
Figure 15.25. DCPT and hand auger logs from soundings performed at Juan Pablo II Bridge. The DCPTs and hand augers were performed at (36.81565°S, 73.08342°W; 25 March 2010; 11:00) and (36.81573°S, 73.08297°W; 25 March 2010; 14:00).

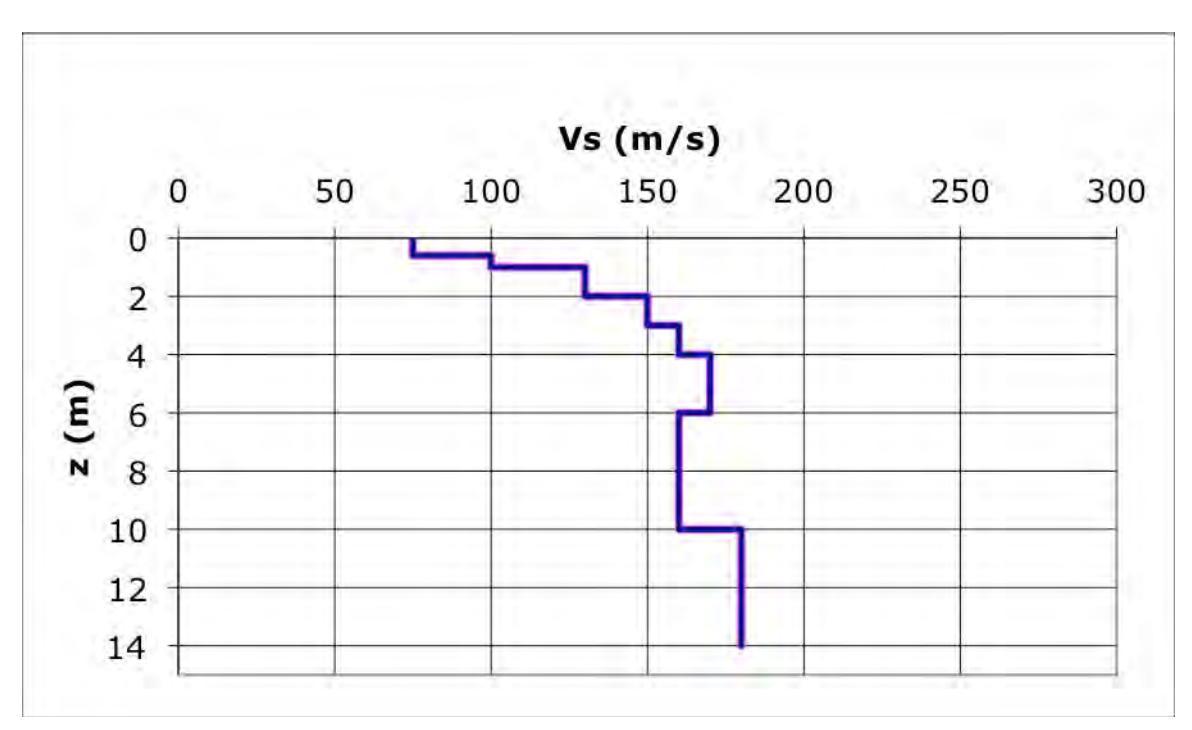
Figure 15.26. Shear Wave velocity log using the SASW method for the southwest oval soil near the settled approach embankment of the Juan Pablo II Bridge.

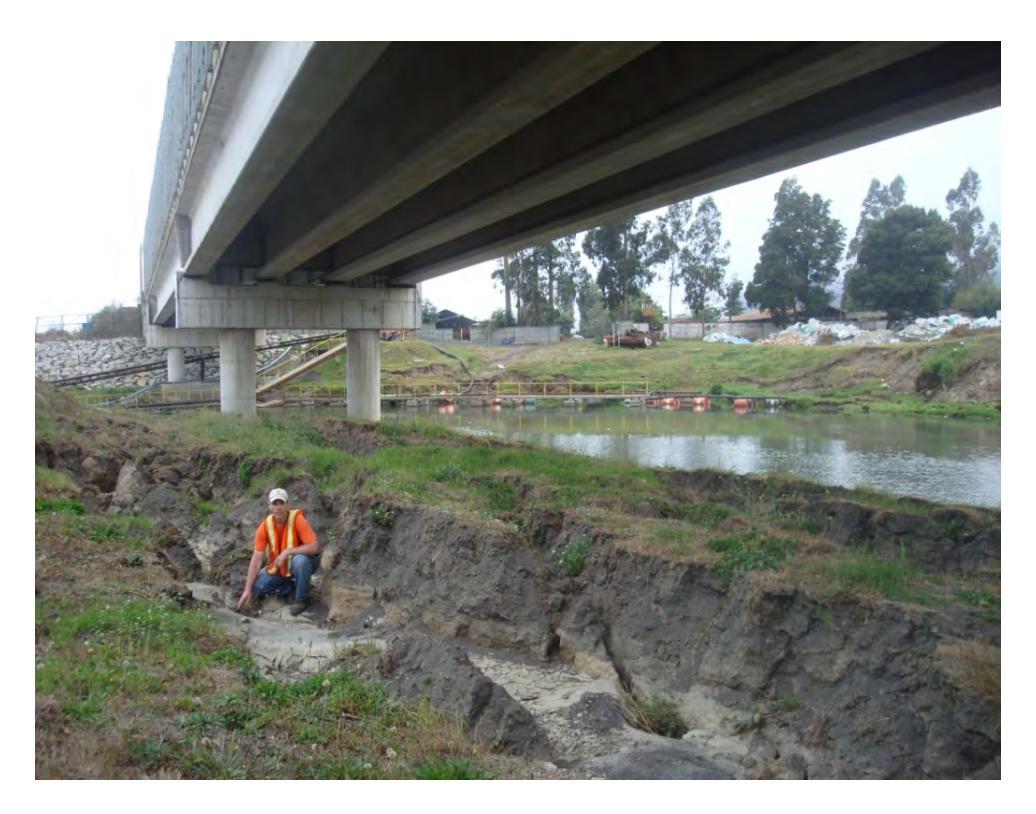
La Mochita is a 4-span concrete bridge supported by seat-type abutments at each end and two-column bents at the interior locations. At this site, ground failure induced transverse movement of the bridge superstructure. The bridge, constructed in 2005 spans a small inlet of water that fronts a water treatment facility along the east bank of the Bio-Bio river. The bridge superstructure shifted transversely as a unit towards the east due to failure of soil surrounding bents 2 and 3. A lateral spread failure moved soil towards the inlet. This failure is attributed to liquefaction-induced lateral spreading. Measurements taken by the team on March 15, 2010 indicated that the north end of the bridge deck shifted 0.5 m to the east relative to the approach fill, while the south end of the bridge shifted 0.9 m towards the east relative to the approach fill on that side. As a result of our schedule, we were unable to perform any DCPTs at this site, though we did take LIDAR scans. Team C members were able to perform a visual reconnaissance of the site and drill a single hand-auger hole from the base of a large crack below the bridge. As illustrated in Figure 15.27, the major damage at the site resulted from liquefactioninduced lateral spreading in a direction transverse to the longitudinal axis of the bridge. The large cracks at the site were filled with sand boils, which are visible in the photograph (Figure 15.27). The soils in the hand-augered borehole consisted of moist to wet, very dark gray to black, medium- to coarse-grained sand with trace fine gravel, consistent with the soils encountered at the other Bio Bio River bridges in Concepcion.

Figure 15.27. Liquefaction-induced lateral spread at Concepcion bridge parallel to the Bio Bio River. (36.84722°S, 73.05530°W; 27 March 2010; 09:25)

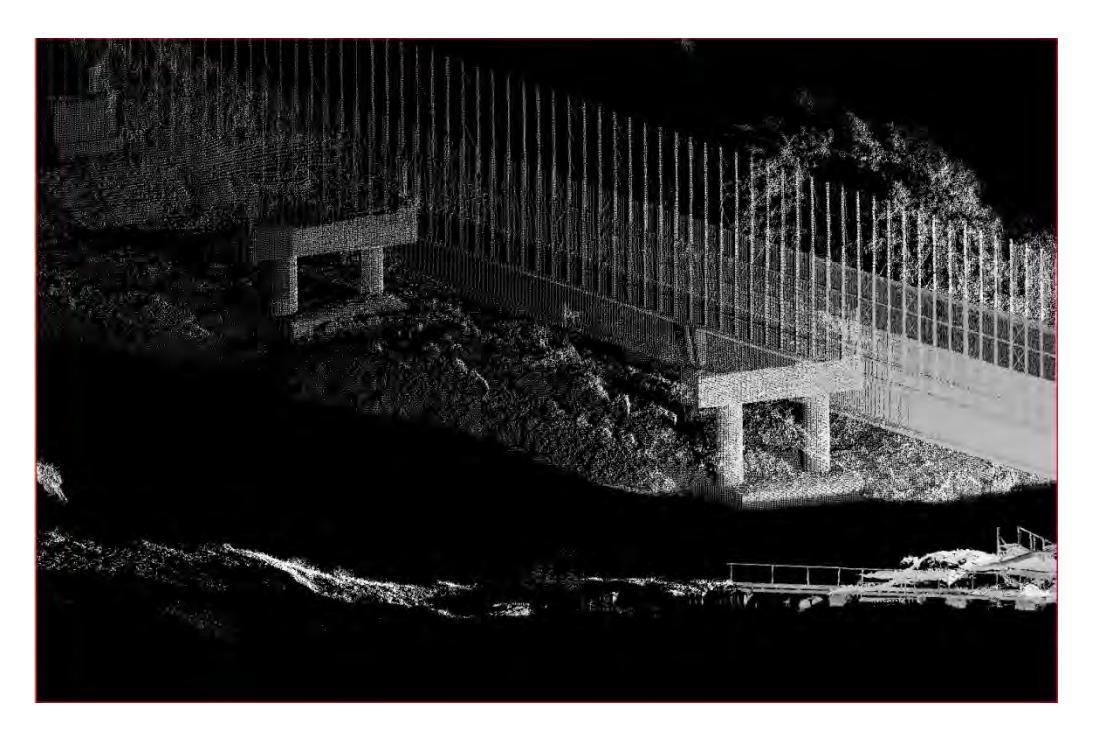
Figure 15.29. Oblique LIDAR image of Bents 2 and 3 seated in the liquefied soil mass that moved latrally to the bottom left corner.

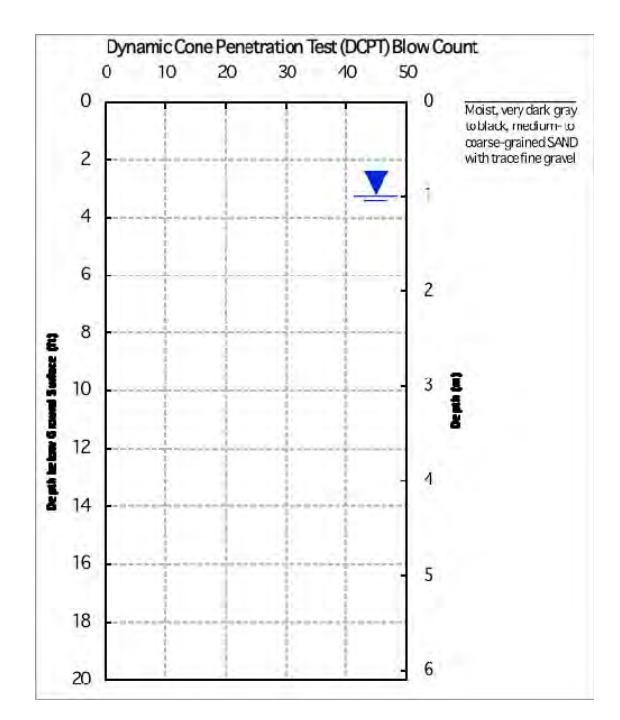
Figure 15.30. Hand-auger log from Concepcion bridge parallel to the Bio Bio River. (36.84722°S, 73.05530°W; 27 March 2010; 09:45)
