# Geo-engineering Reconnaissance of the 2010 Maule, Chile Earthquake

Report of the NSF Sponsored GEER Association Team

# GEER Association Report No. GEER-022

Version 2: May 25, 2010

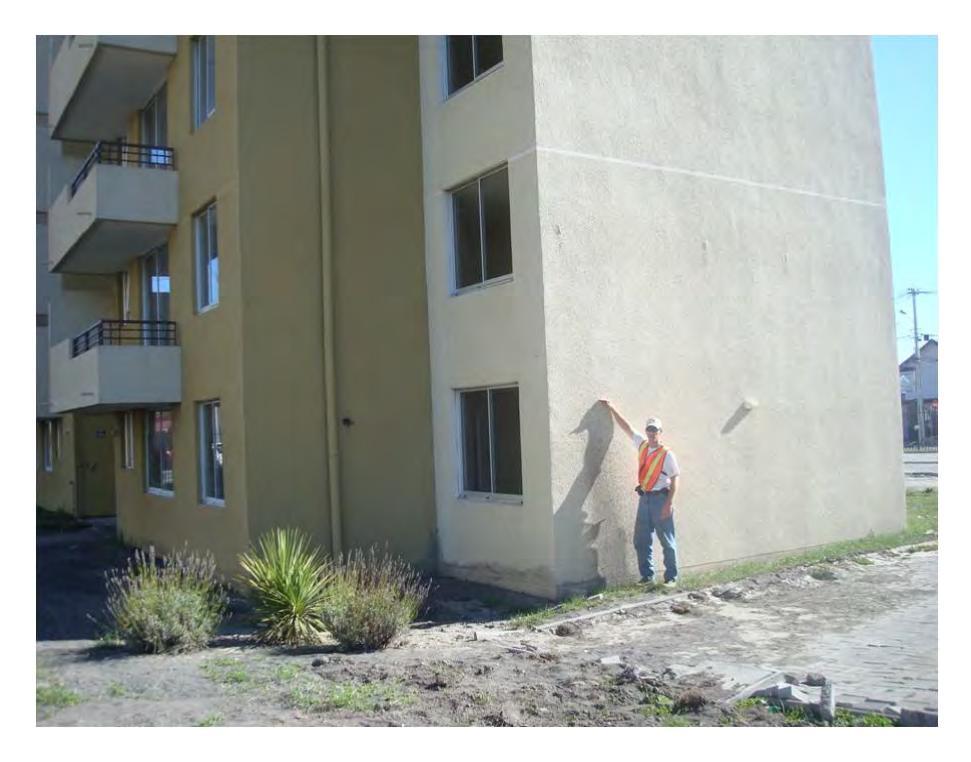
The ground surrounding the Errzuriz Building (i.e., the southeast building) and Montt Building (i.e., the northeast building) settled vertically 5 to 10 cm. Structural damage to the Riesco building appeared due to differential settlement of the foundation. The street that surrounded the property did not appear to settle and there was no evidence of ground failure in adjacent properties that have one and two-story homes.

Team C performed two DCPT soundings and hand augers at the site, as well as SASW and LIDAR scans. Both soundings encountered a 1 to 1.5-m thick layer of loose to medium dense, nonplastic, sandy silt to silty sand below a shallow watertable. The color and grain size of this layer was visually consistent with the ejecta observed at the ground surface near the southwest apartment building. This layer became relatively dense below a depth of 3 to 3.5 m, also consistent with the damage (without collapse) of the SW apartment building.

Figure 15.31. Height of ejecta sprayed onto wall of Riesco southwestern 8-story apartment building in Concepcion. Gray soil in foreground of photo also is sandy silt to silty sand ejecta, (36.79076°S, 73.08155°W; 25 March 2010; 16:50)

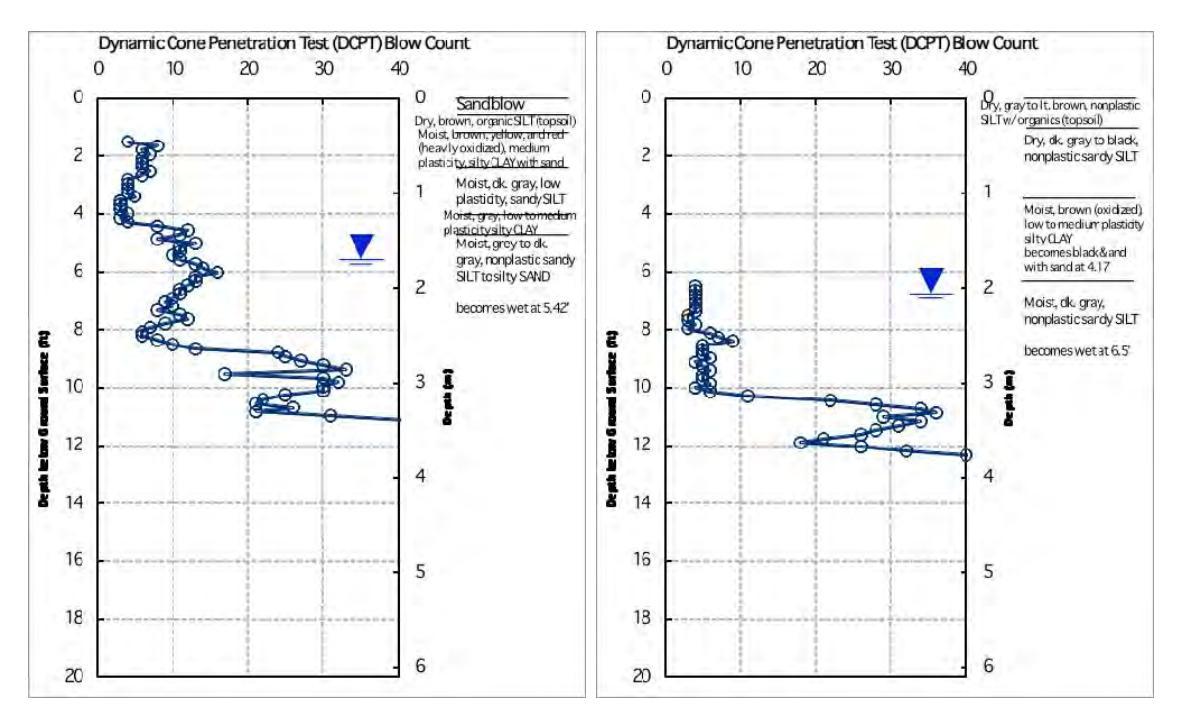
Figure 15.32. DCPT and hand auger logs from soundings performed at four 8-story apartment complex in Concepcion. The DCPTs and hand augers were performed at

(36.79076°S, 73.08155°W; 25 March 2010; 17:00) and (36.79098°S, 73.08167°W; 25 March 2010; 19:00).

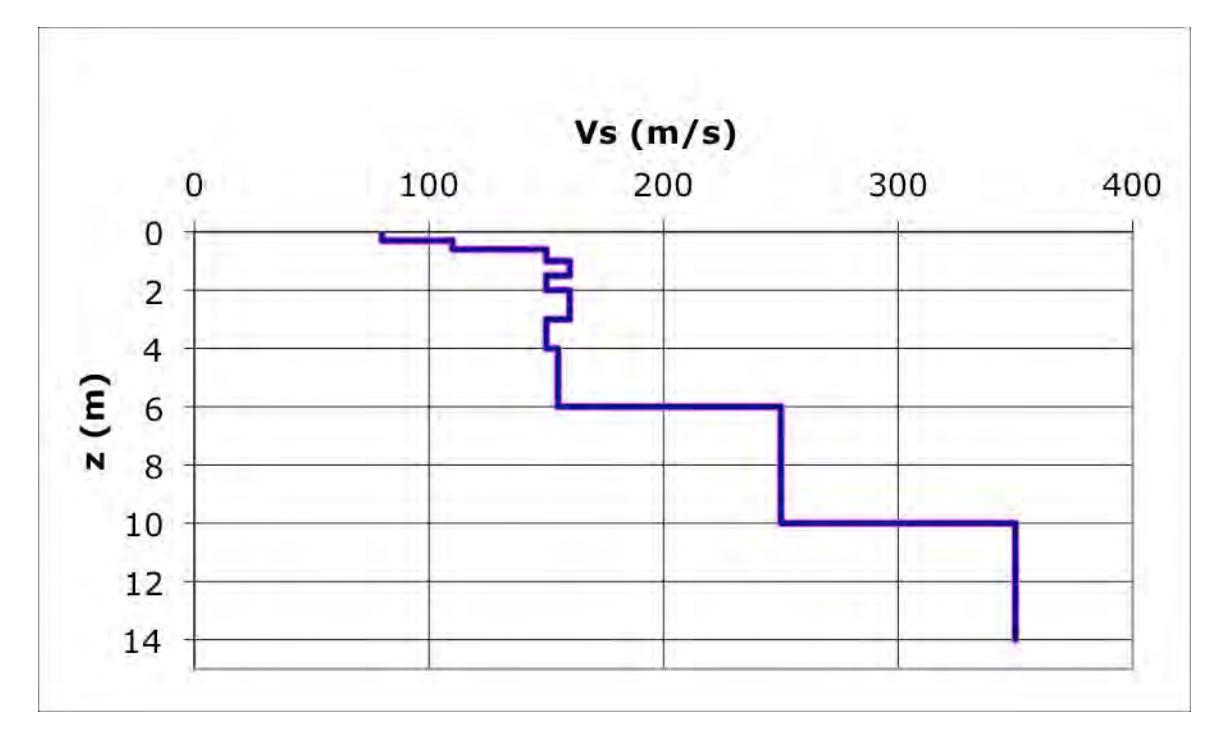
Figure 15.33.Shear wave velocity profile for the four 8-story buildings by the SASW method

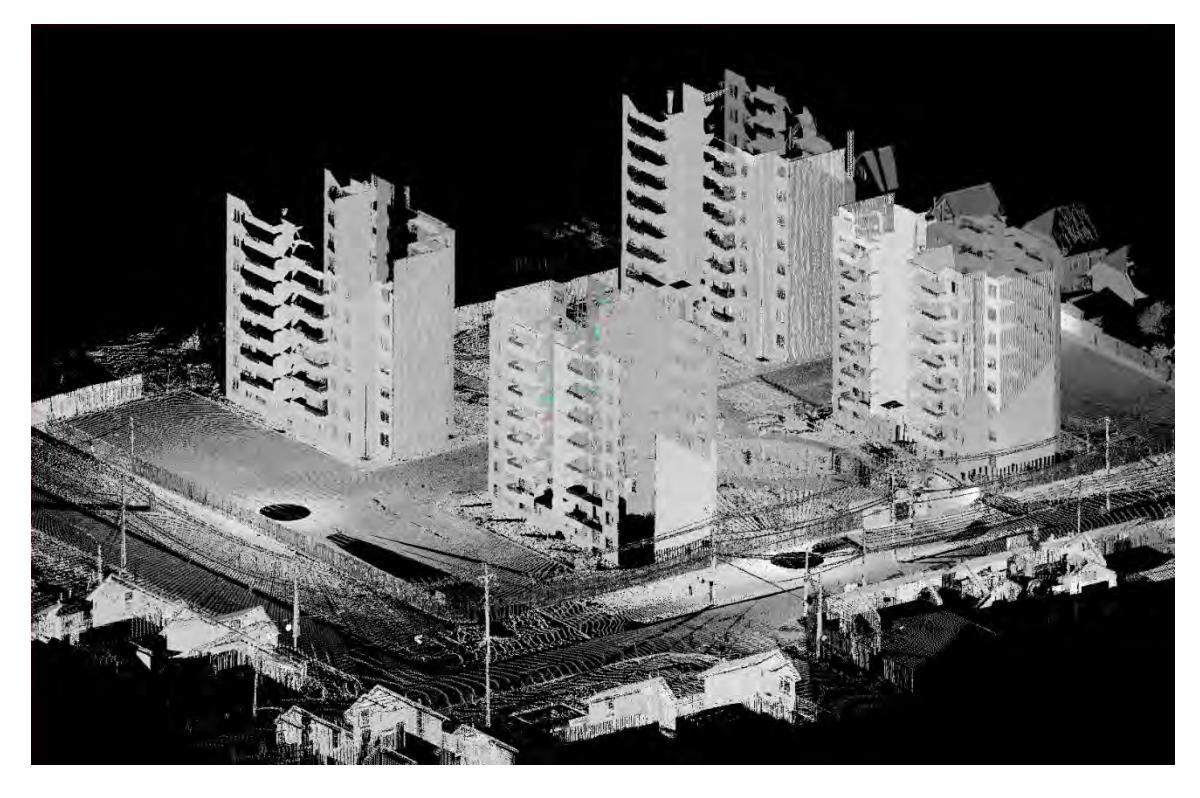
Figure 15.34. Oblique view of the 4- eight story buildings. The Riesco (southwestern) building is in front, the Errzuriz (southeast building) is to the left, the Montt is to the right (northeast) and Bulnes is in the background (northwest).

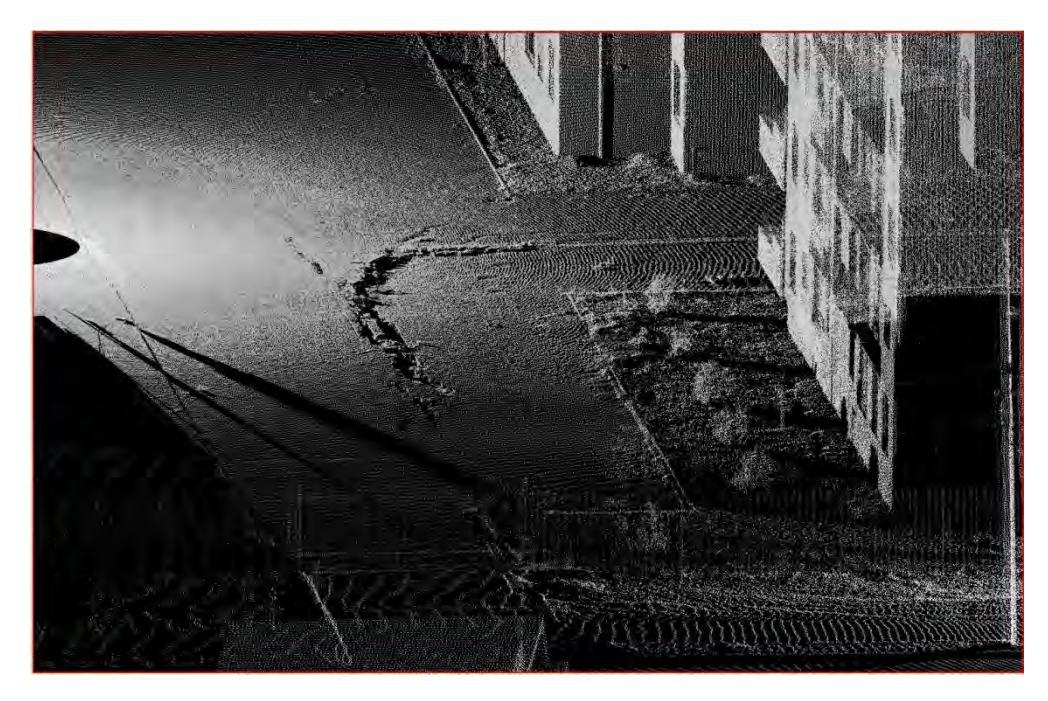
Figure 15.35. Detailed LIDAR imagery of settlement of soil around the Riesco Building (Southwest).

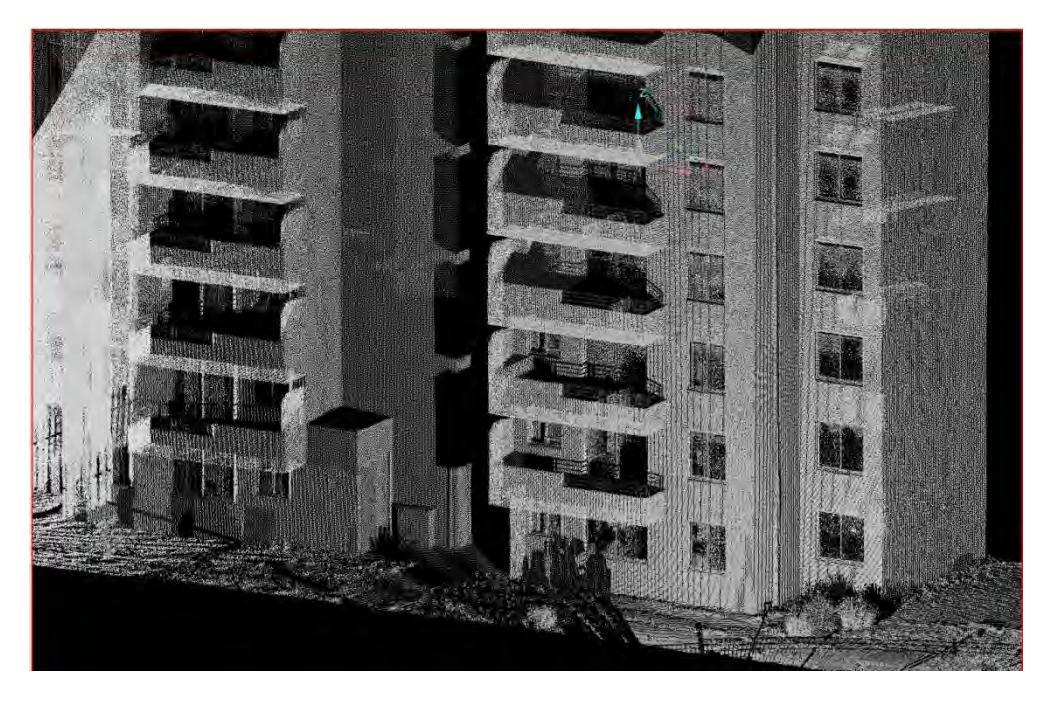
Figure 15.36. Oblique detailed LIDAR imagery of the Riesco Building (Southwest).

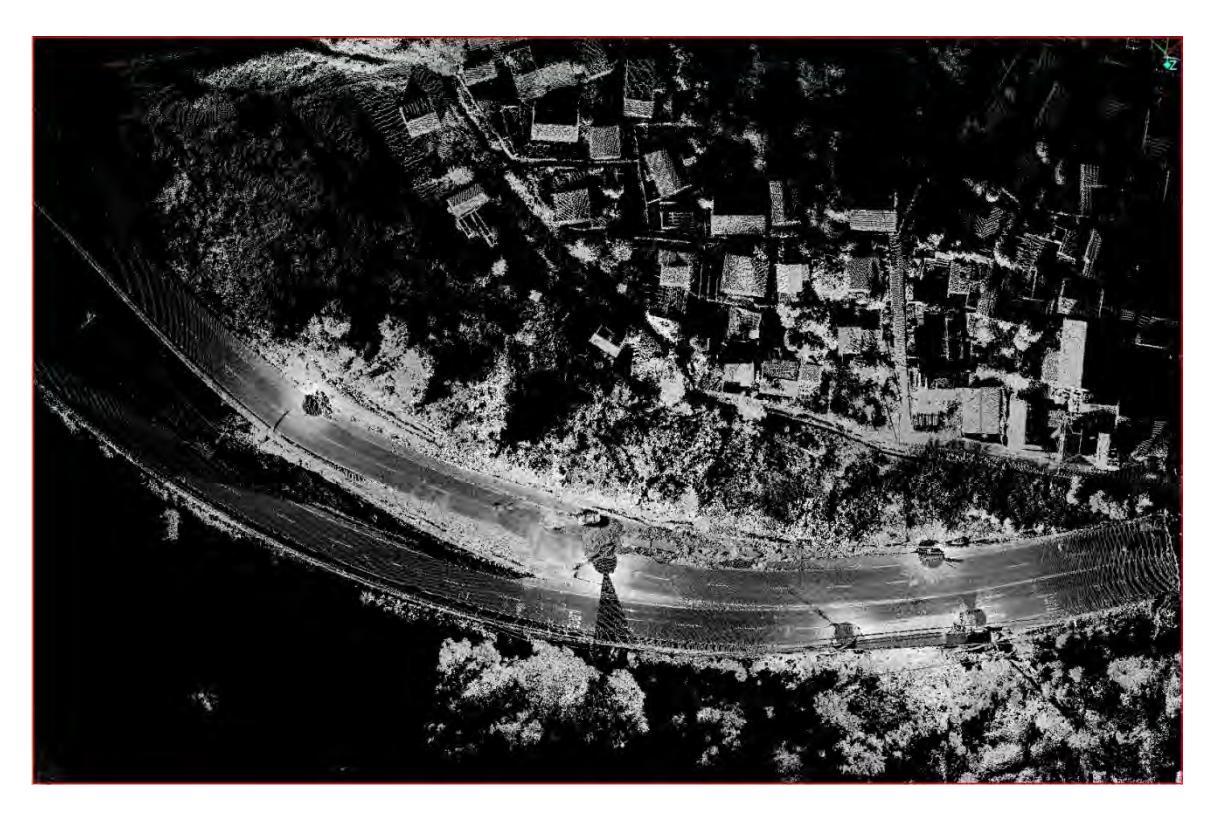
east of the south bound failure of the elevated roadway sections is a small housing development. The north and south bound failures appear to be due to oversteepened embankments, and possibly poorly compacted earth fill. A gray sandy fill overlaid by compacted clay fill was used in the elevated road embankment. The roadway elevation was approximately 10–15m above the valley area At this site, Team C collected LIDAR data to archive the embankment damage.

Figure 15.38. Plan view of route 160 embankment failures and neighboring community. One embankment failure is above the fork in the highway, and the second failure is on the lower right side of the merged highways.

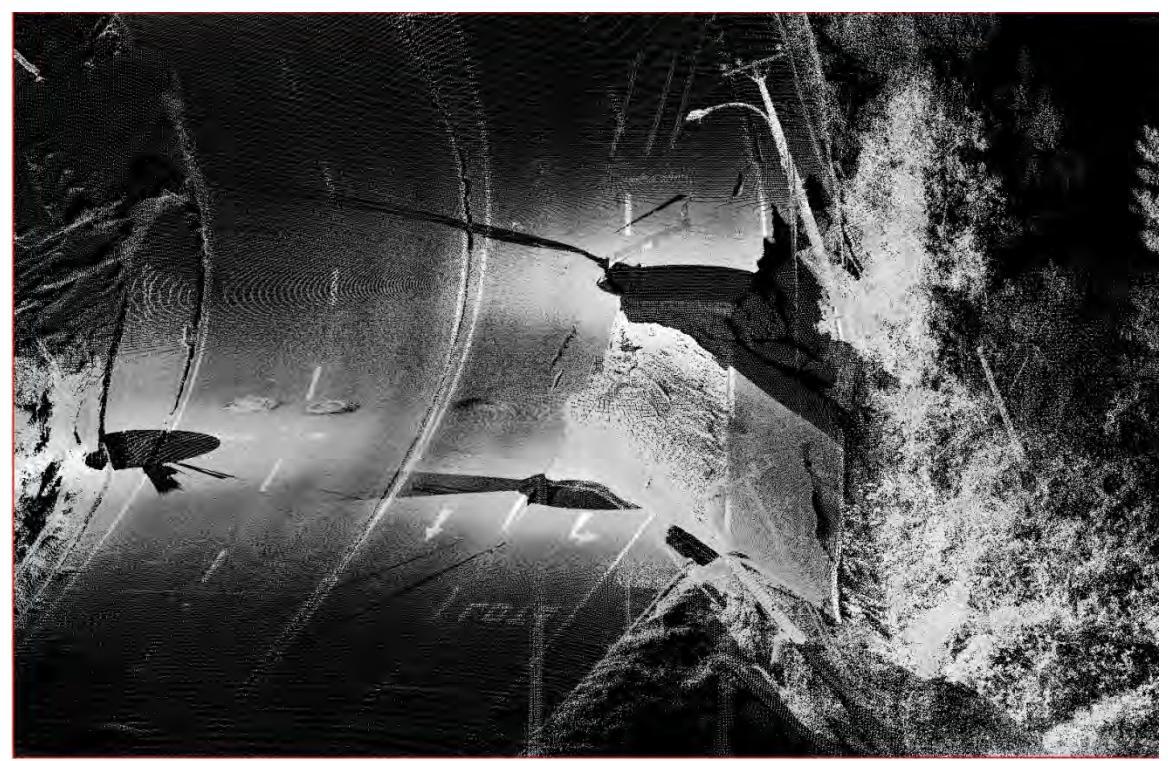
Figure 15.40. Oblique view of route 160 embankment failure along the west side of the merged highways.

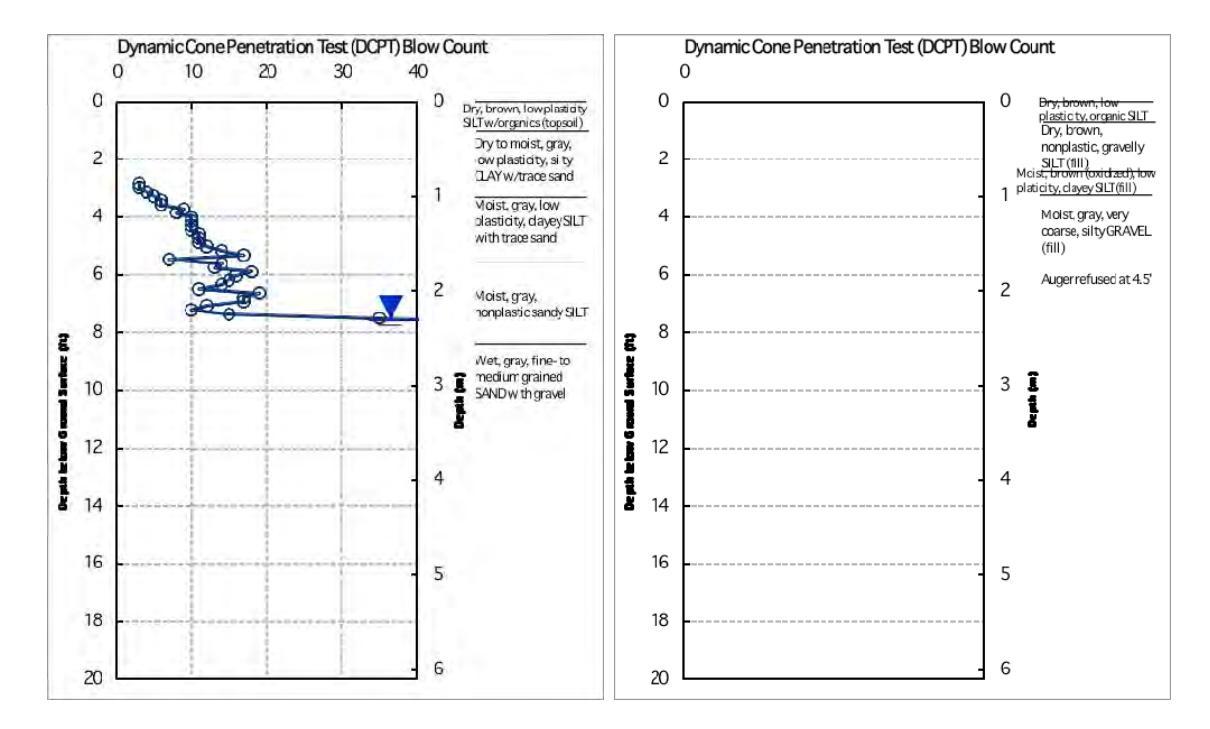
Figure 15.41. DCPT and hand auger logs from soundings performed at Hospital Curanilahue. The DCPT and hand augers were performed at (37.47384°S, 73.34892°W; 26 March 2010; 09:00) and (37.47352°S, 73.34824°W; 26 March 2010; 11:00).

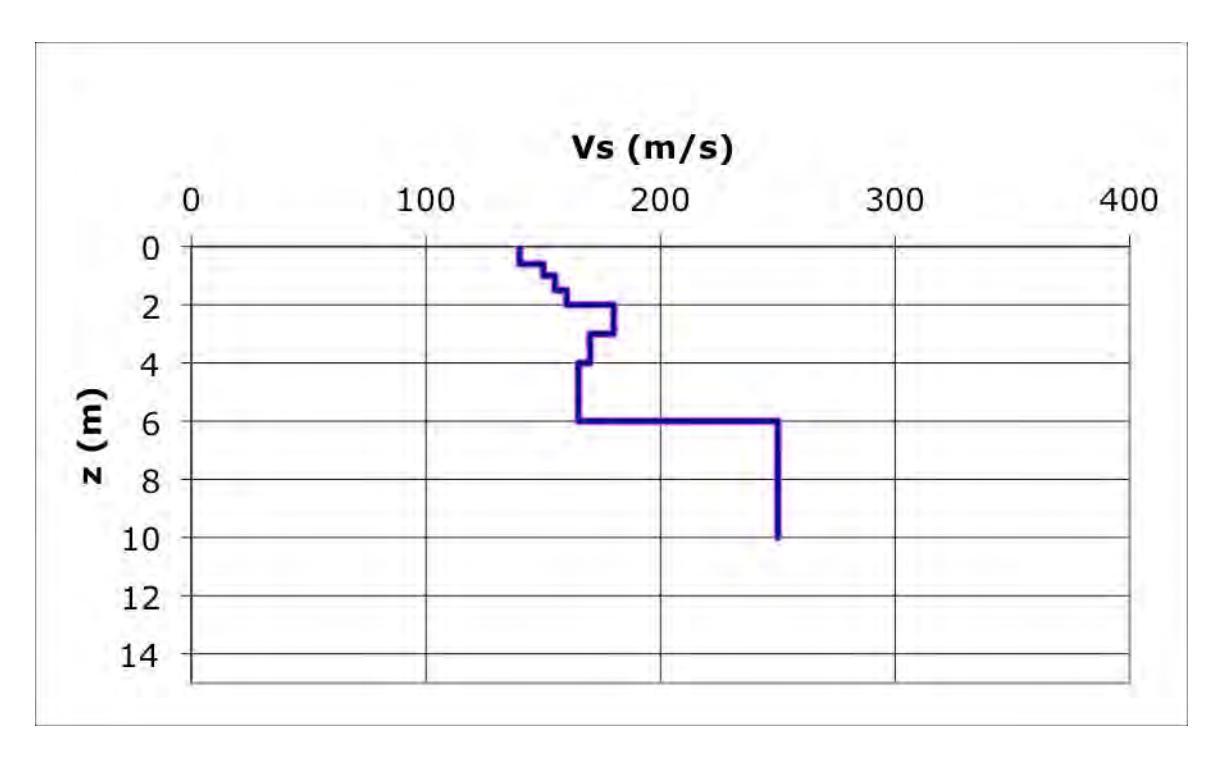
Figure 15.42. Shear wave velocity profile for the Provincial Hospital of Curanilahue by the SASW method

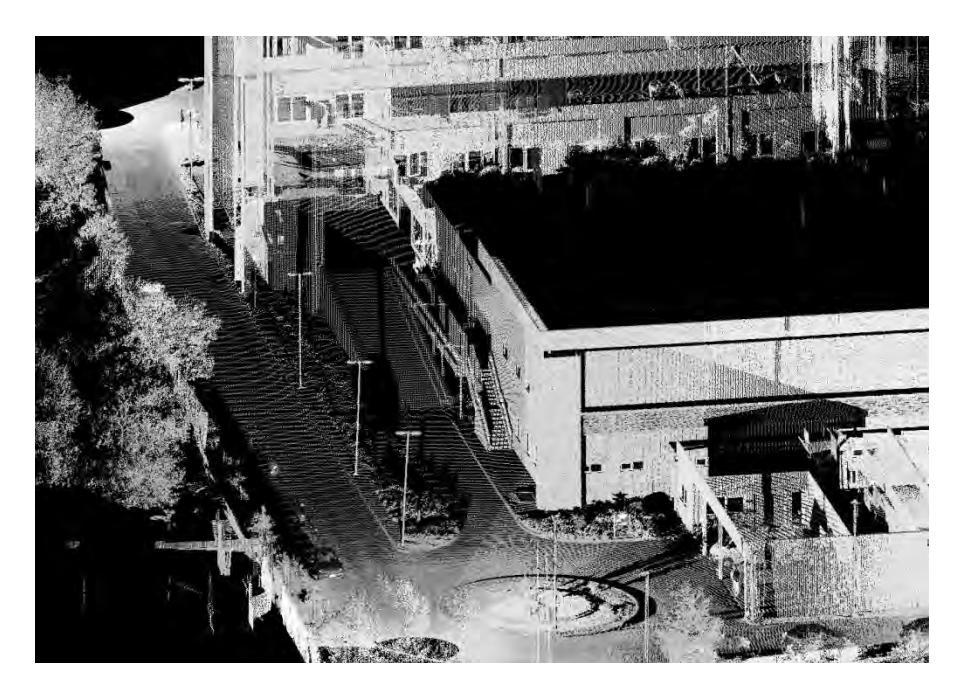
Figure 15.44. Oblique view of the north east side of Provincial Hospital of Curanilahue, 37.47352°S, 73.34824°W. The SASW test was performed along the three light posts above the circle.

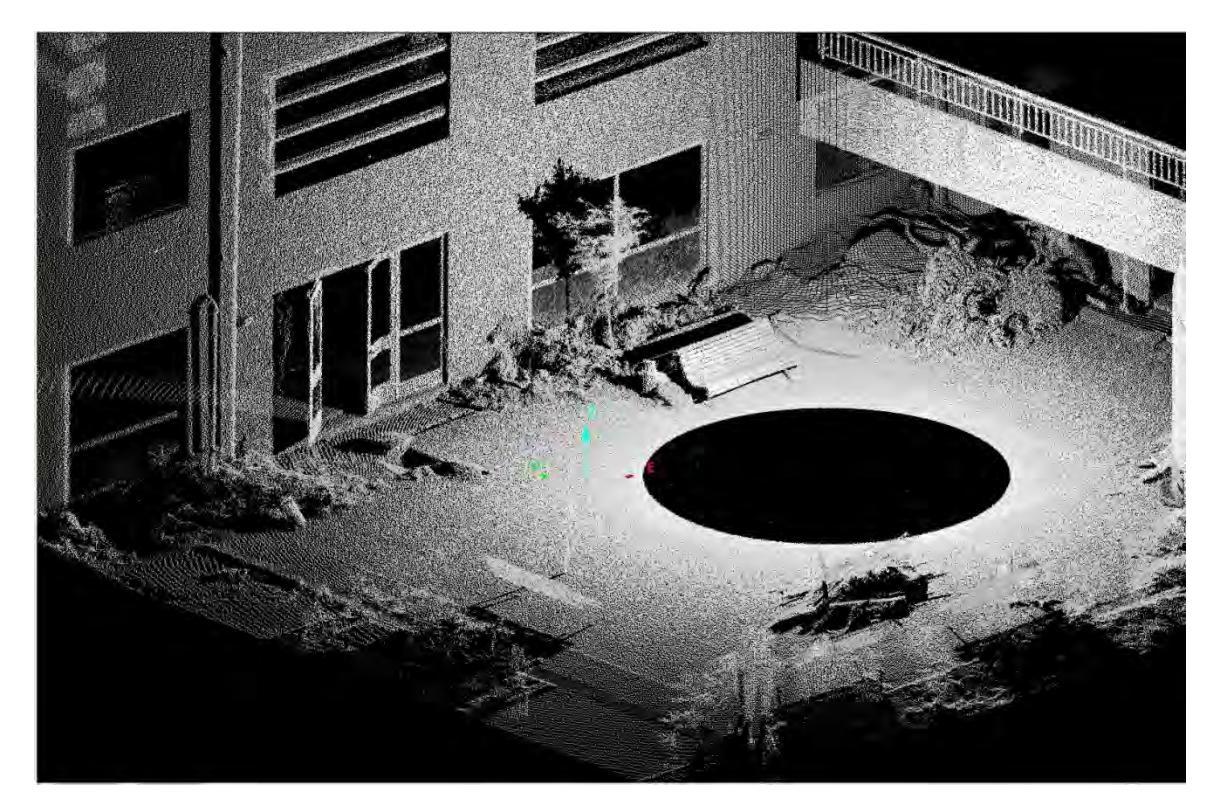
Liquefaction-induced ground deformations affected the seismic performance of the new hospital facility built in the City of Curanilahue, which is about 80 km southwest of Concepción. The hospital facility was opened in 2008. The new hospital facility has 10 structurally isolated wings with heights ranging from one to six stories, with the taller ones being amongst the tallest buildings in the city. We performed one DCPT and two hand augers at the hospital, as well as SASW and LIDAR scans. In the only DCPT sounding that we could perform outside the hospital structure, we encountered medium dense sandy SILT near the level of the ground water table. We attempted three hand augers inside the structure (in a courtyard) and two hand augers outside the structure (in a planting area near the parking lot), but refused in gravelly fill at shallow depth.

Figure 15.45. Oblique view of the east courtyard of the Provincial Hospital of Curanilahue, 37.47352°S, 73.34824°W. Liquefaction induced structural settlement is clearly evident along the courtyard perimeter.

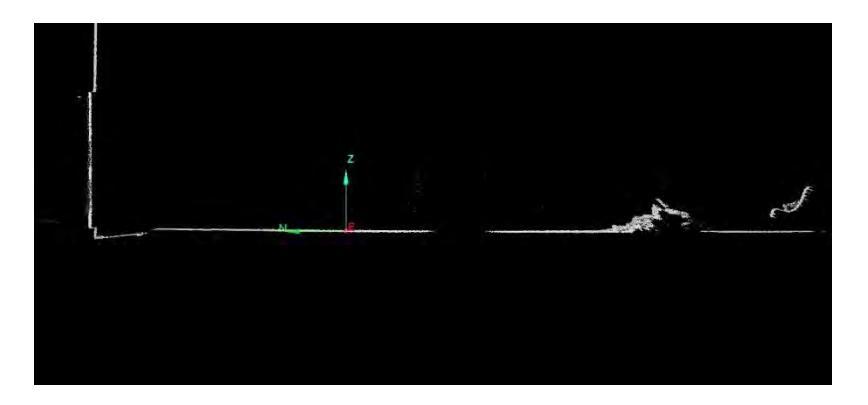
Figure 15.46. Cross section through the east courtyard of the Provincial Hospital of Curanilahue, 37.47352°S, 73.34824°W. Liquefaction induced structural settlement of 165mm measured in the LIDAR data is clearly evident along the courtyard perimeter.

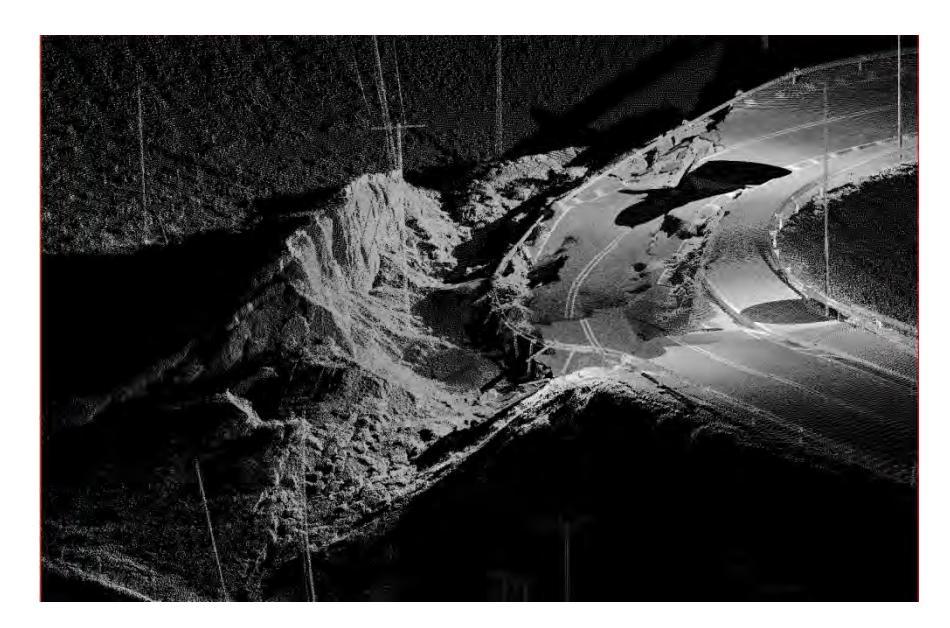
A large embankment failure occurred on an overpass of Route 5, approximately 13 km North of Parral (S36.0347, W71.7558). The overpass embankment was curved and the embankment failed over a length of about 80 m towards the outside of the curved section. The failure appeared to involve a shallow translational slide in the near surface foundation soils as evidenced by the intact failed soil mass and the mound of soil pushed up at the toe (Figure 9.52a). Foundation soils in the region appeared to be relatively competent suggesting possible elevated pore pressures in the foundation soils played a role in the observed failure with 3-D effects leading to failure to the outside of the curved embankment section as opposed to the inside of the embankment. The outside section of the slide mass remained largely intact. We performed two DCPT soundings and hand augers at the site, along with LIDAR scanning. Both soundings and hand augers refused at shallow depth because of the high gravel content of the soils below the ground water table.

Figure 15.48. Closeup of the Route 5 overpass embankment failure from the southeast side. The embankment along the outside curve can be seen to have slid out laterally 16m into the field.

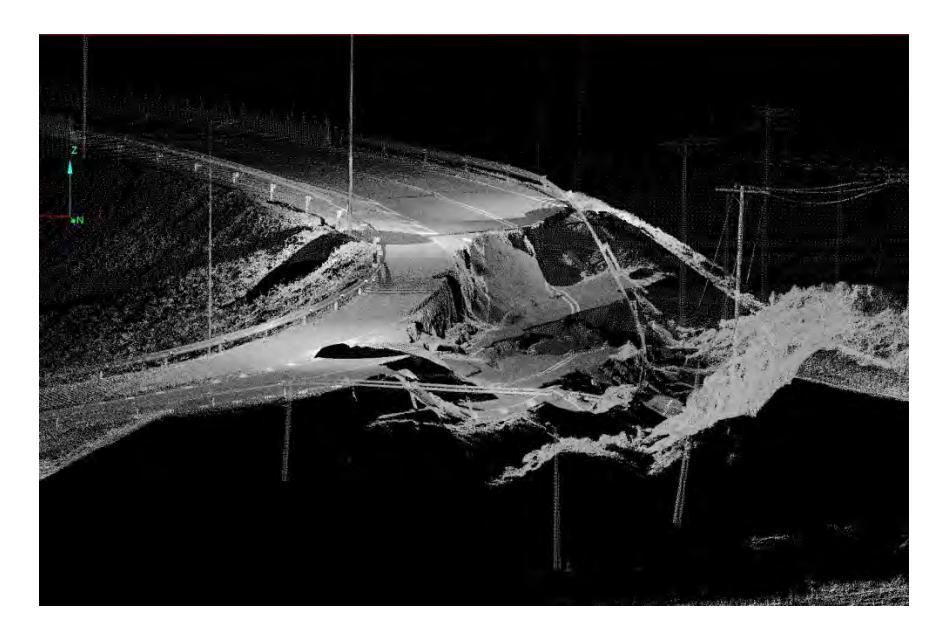
Figure 15.49. Oblique view of the Route 5 overpass embankment failure from the northwest side. Much of the roadbed slumped into the graben left behind as the outside slid out laterally to the southwest.

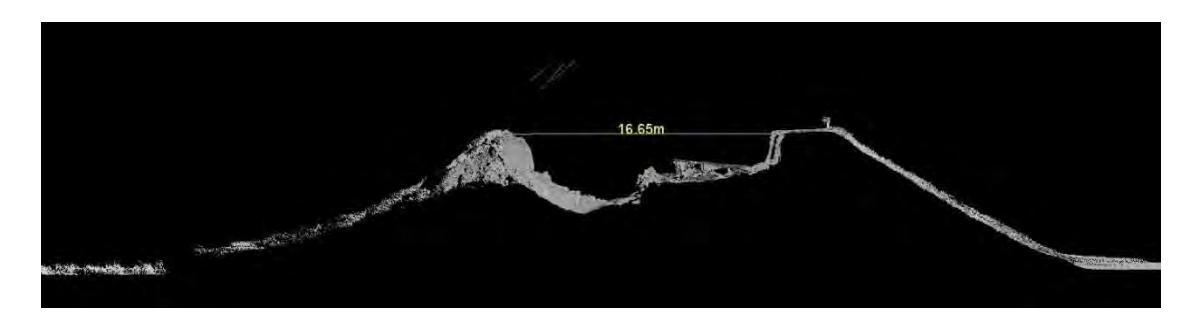
Figure 15.50. Cross-section view of the Route 5 overpass embankment failure from the east. The outside curve slid out laterally opening a large 16 meter graben.

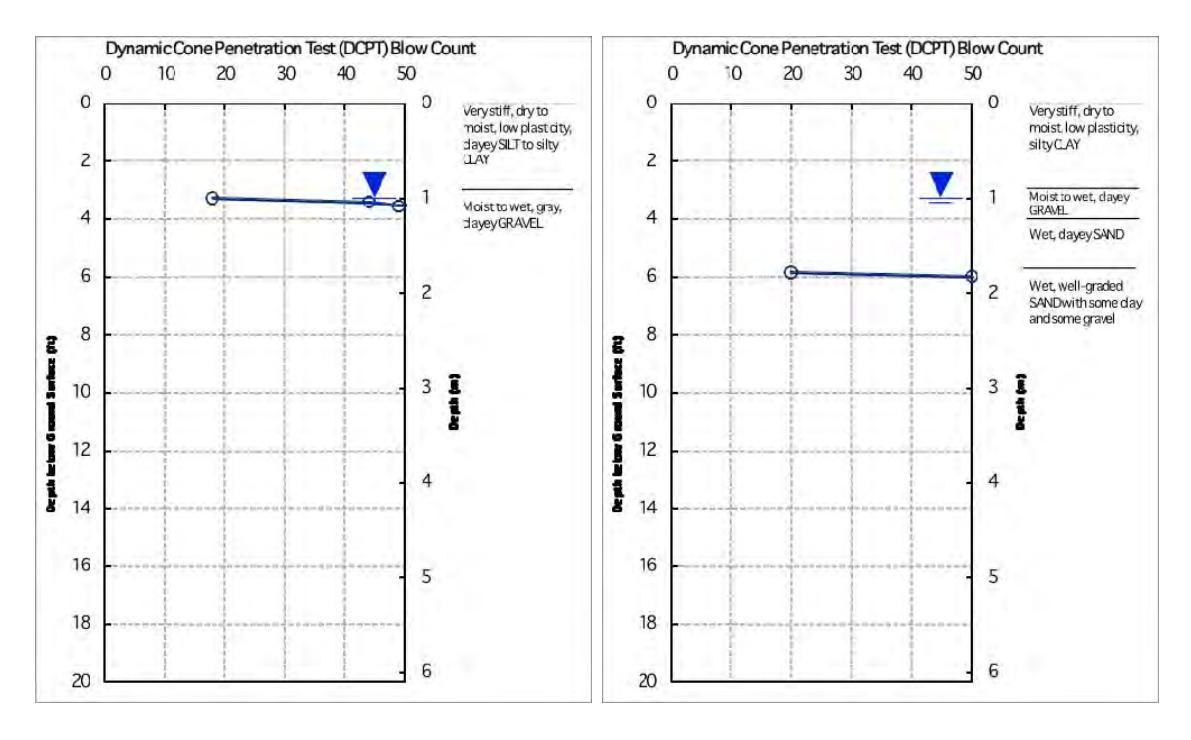
Figure 15.51. DCPT and hand auger logs from soundings performed at Ruta 5 Overpass Embankment. The DCPTs and hand augers were performed at (36.03459°S, 71.75611°W; 27 March 2010; 18:30) and (36.03488°S, 71.75610°W; 27 March 2010; 19:30).

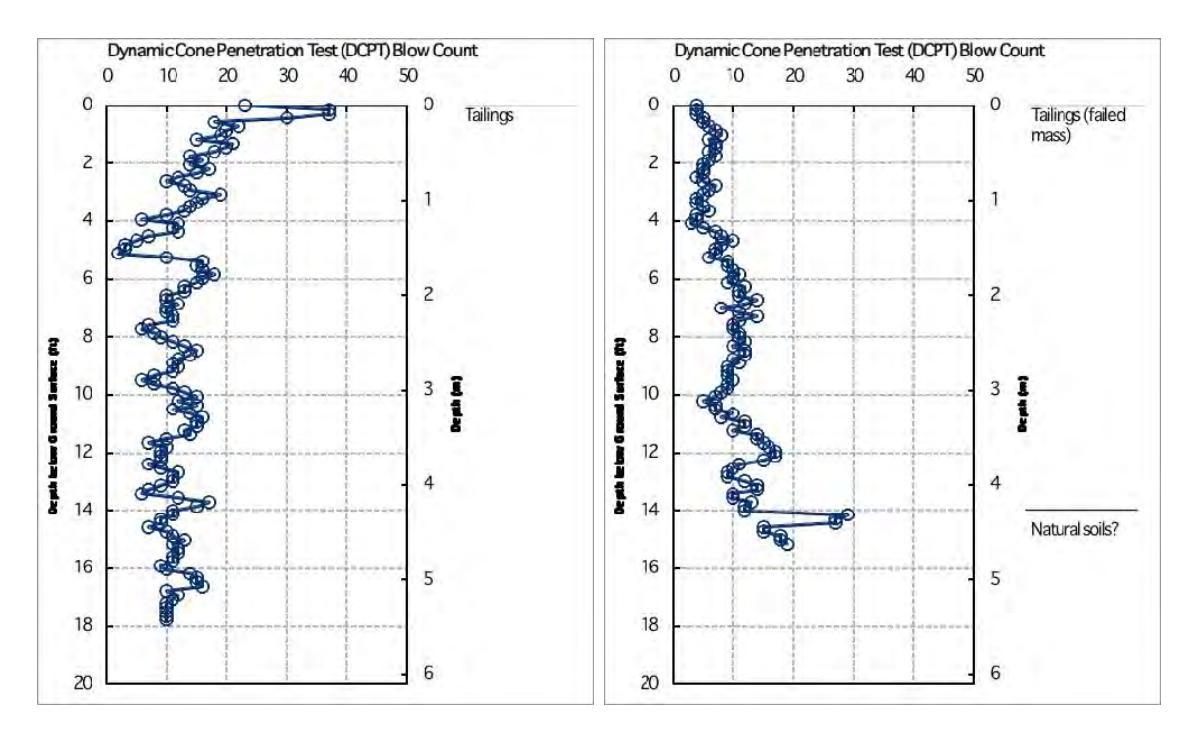
Figure 15.52. DCPT logs from soundings performed at <u>Las Palmas Mine, Talca</u>. The DCPTs were performed at (35.183884°S, 71.76110°W; 28 March 2010; 12:00) and (35.18629°S, 71.75771°W; 28 March 2010; 14:00).

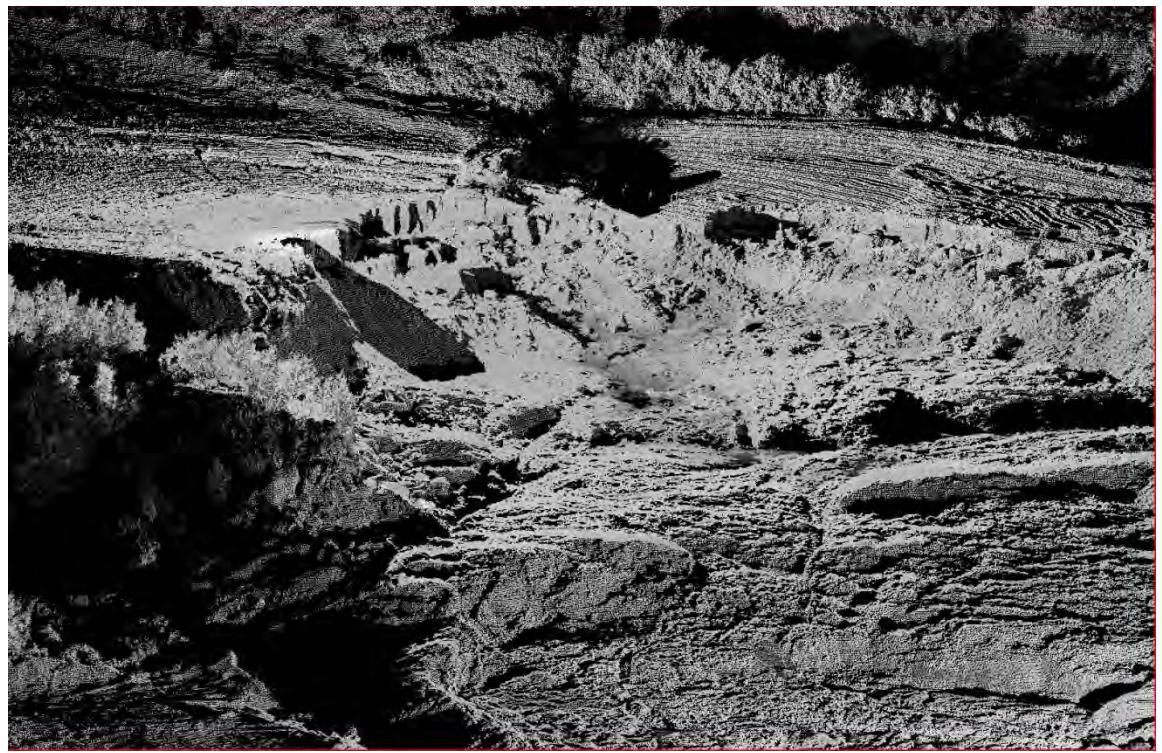
Figure 15.55 Detailed LIDAR view of the head scarp of the Las Palmas Tailings Pond (35.184679° S, 71.759410° W).

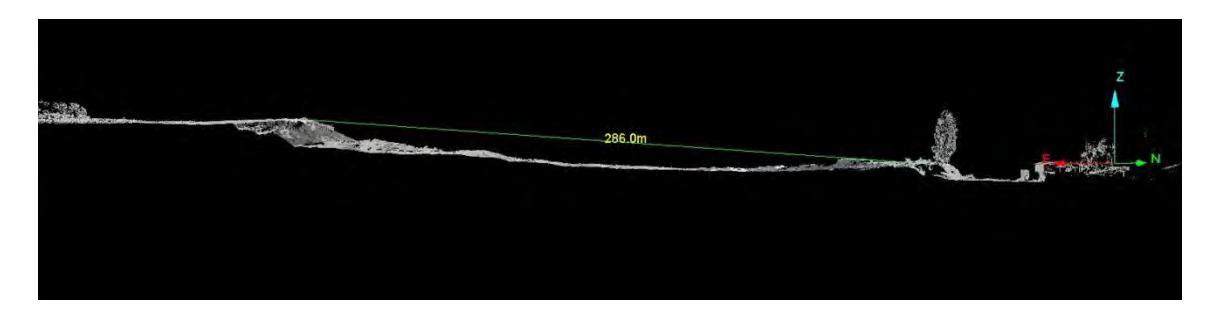
Figure 15.56 Cross-section LIDAR view of the Las Palmas Tailings Pond Failure, Talca (35.184679° S, 71.759410° W). The distance from the tailings pond head scarp to the toe of the slide is between 280 and 320m.

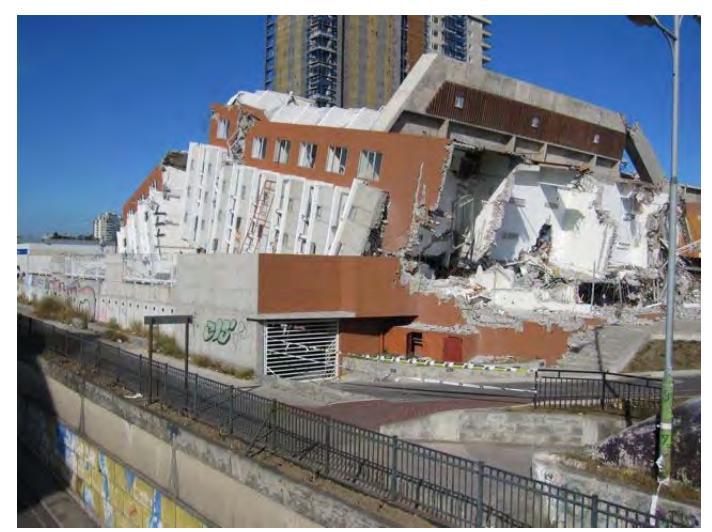
Two adjacent structures, one 20-stories and intact, and another 14 stories and collapsed were inspected during reconnaissance close to the Llacolen bridge in downtown Concepción. The collapsed building was designed using Site Type II (Chilean design code) and the one that did not collapse using Site Type III, which implies different design spectra. While there is no evidence that the soil conditions are indeed different at the locations of the two structures (distance between approximately 20m) of the building. We collected an SASW profile at the site and based on the partial profile estimate that the site would classify as a NEHRP – D site.

Figure 15.57. Collapsed 14 story building, Concepcion (36.82779S, 73.060777W)

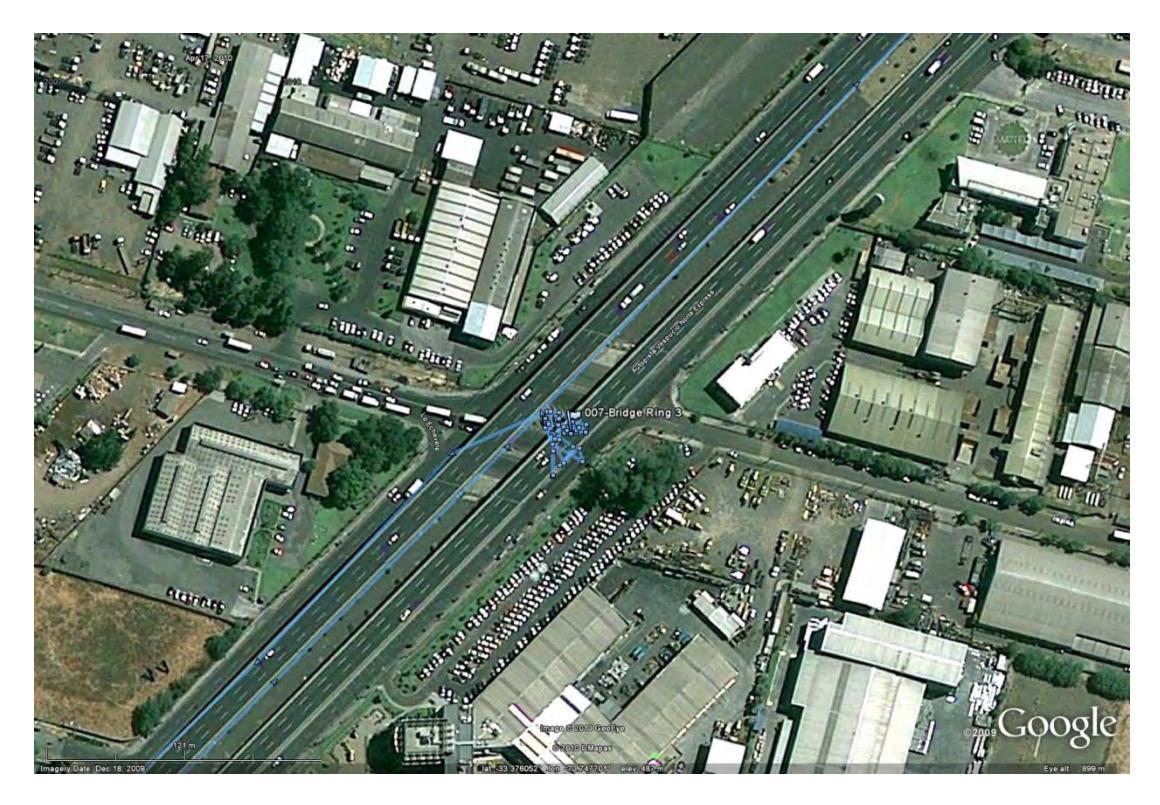
Figure 15.59 Bridge Ring 3 "Lo Echevers" Bridge, Santiago, 33.376159°S, 70.747742°W

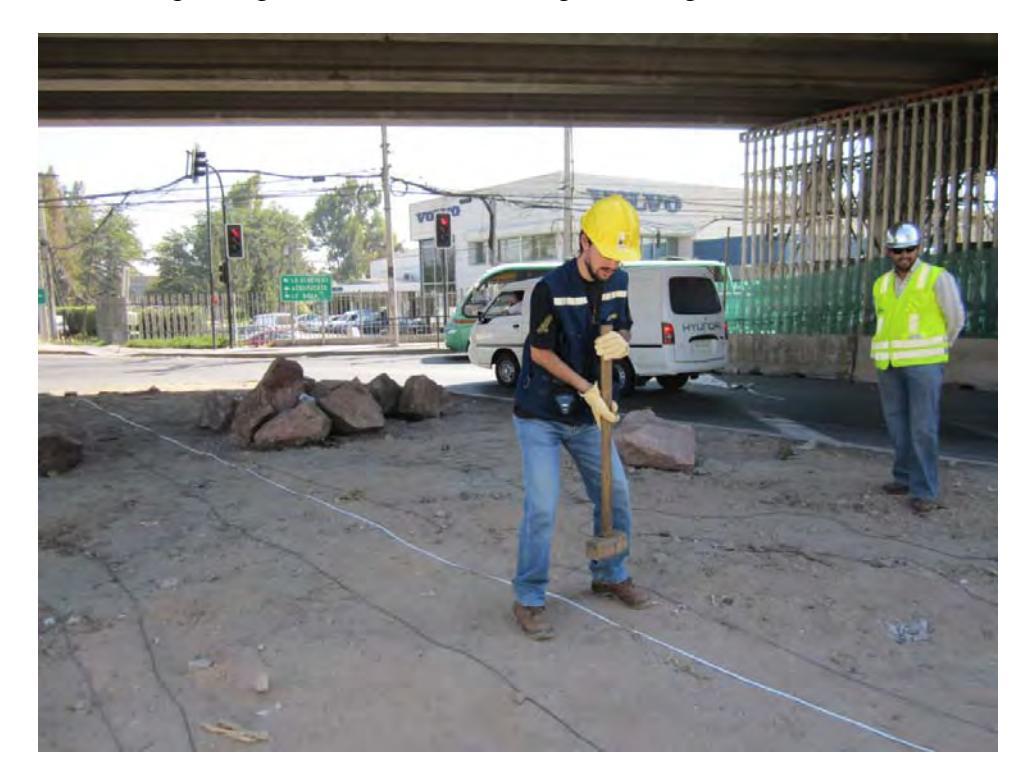
Figure 15.60 SASW line and test, Bridge Ring 3 "Lo Echevers" Bridge, Santiago, 33.376159°S, 70.747742°W, April 13, 2010

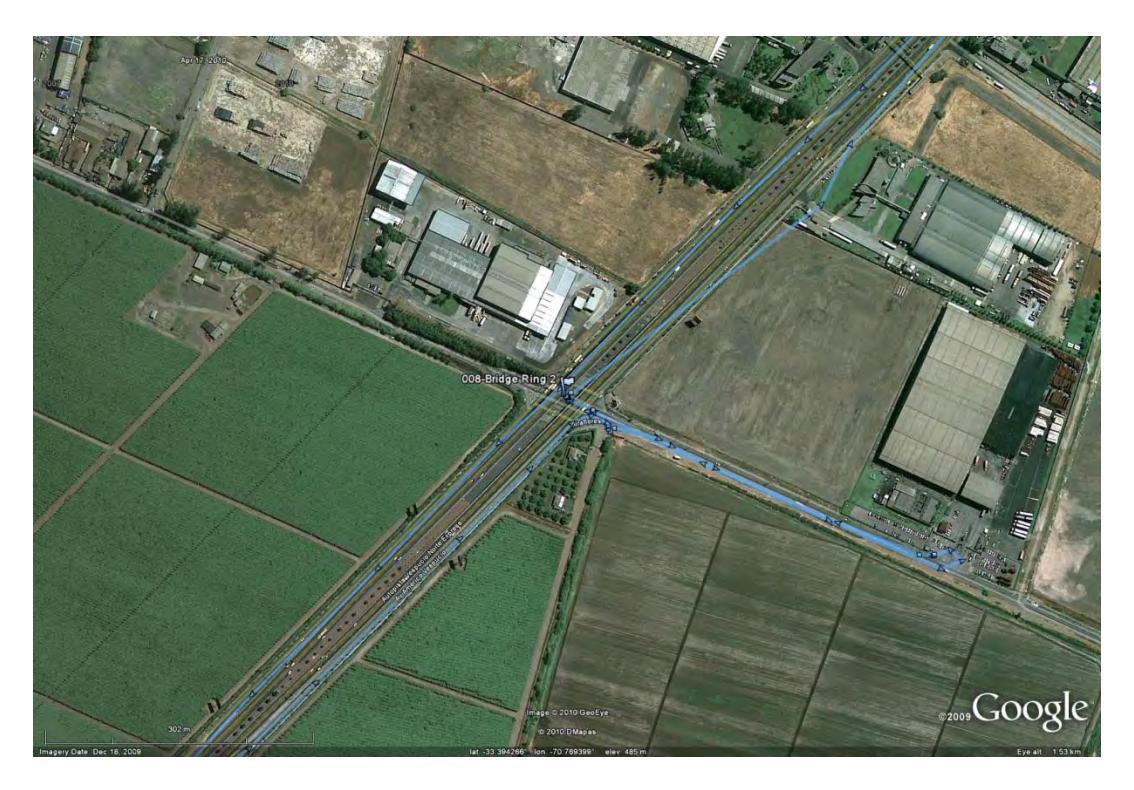
Figure 15.61 Bridge Ring 2, "Mira Flores" Bridge, Santiago, -33.394269°S,-70.769402°W

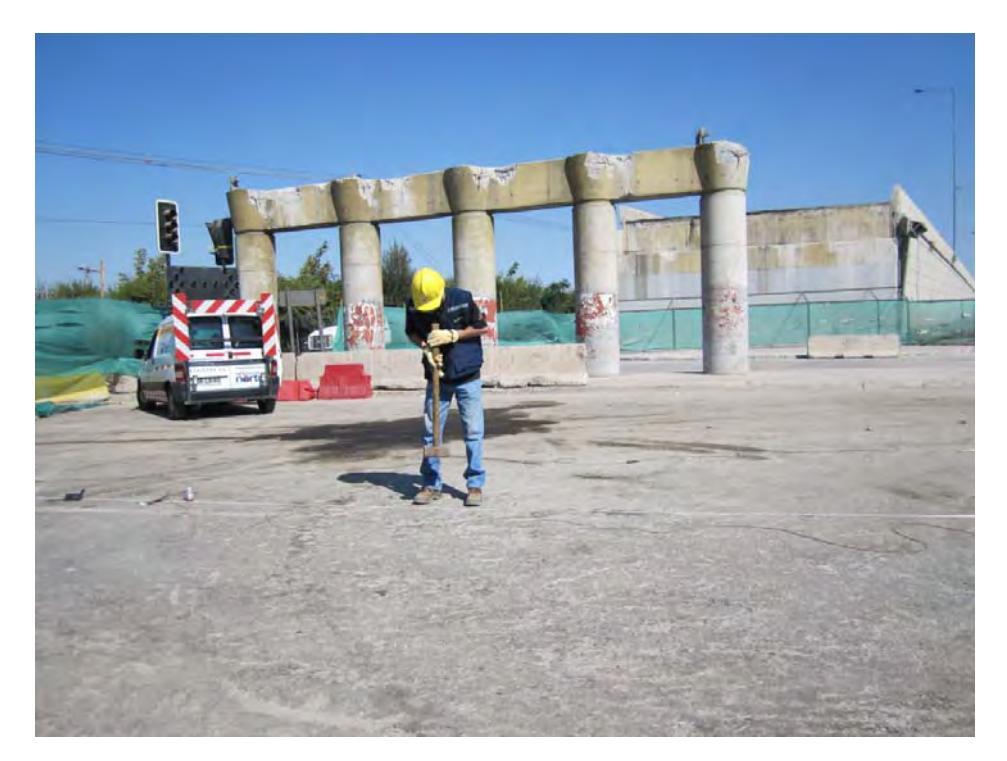
Figure 15.62 SASW Line and Test, Bridge Ring 2, "Mira Flores" Bridge, Santiago, -33.394269°,-70.769402°, April 13, 2010.

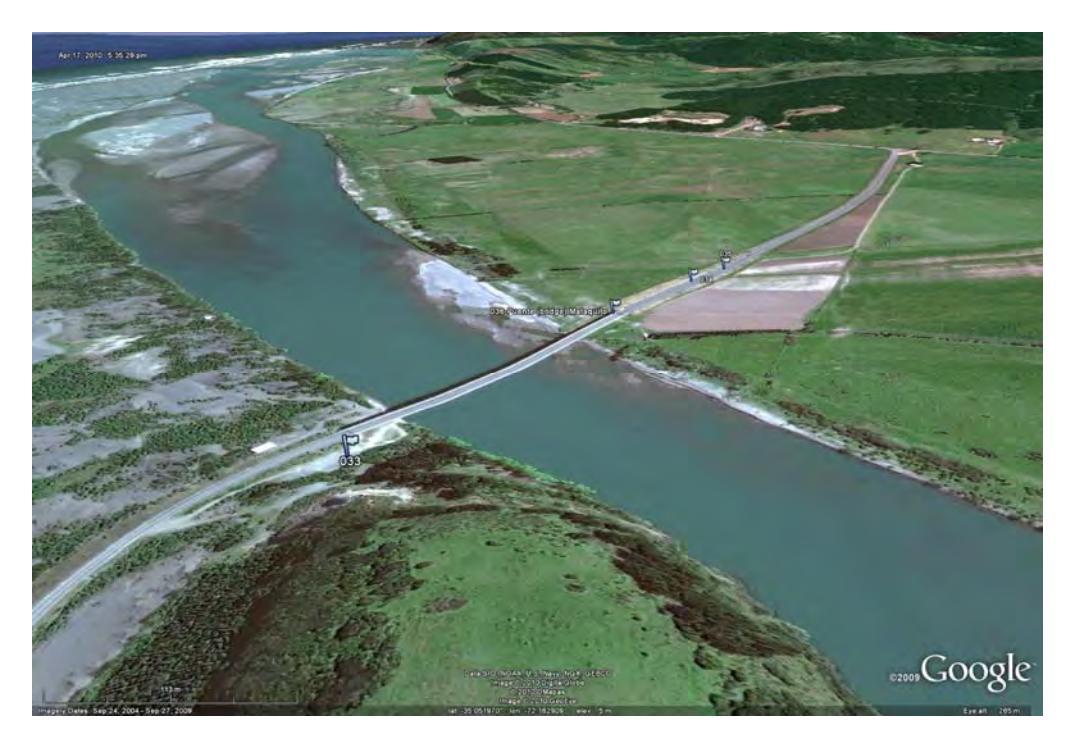
This bridge crossed the Mataquito River close to the Pacific Ocean. Extensive liquefaction and lateral spreading occurred at the north and south abutments and in the adjacent fields. Figure 15.63 through 15.72 show photos of the bridge and the damage. The lateral spreading on the south abutment appears to be more confined due to the topography of the area.

Figure 15.63 Puente Mataquito, looking north, 35.050712°S,72.162258°W, April 16, 2010.

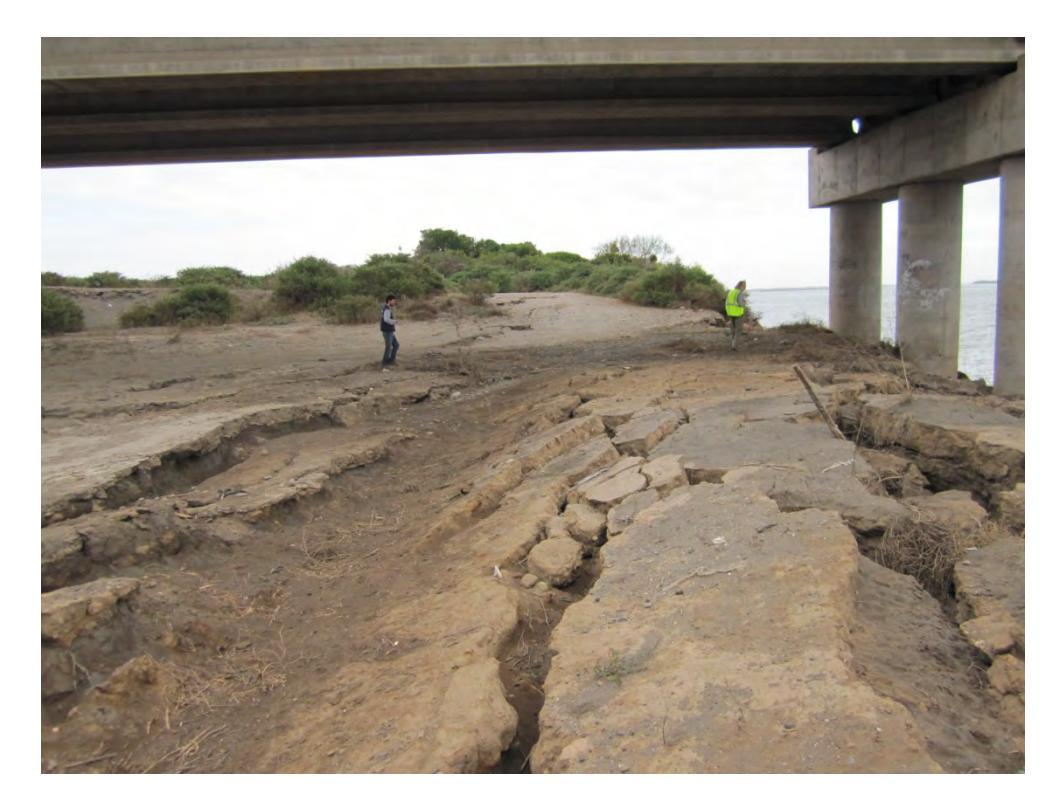
Figure 15.64 Lateral spreading on the south end of the bridge, Puente Mataquito, 35.050712°S,72.162258°W, April 16, 2010.
