# Geo-engineering Reconnaissance of the 2010 Maule, Chile Earthquake

Report of the NSF Sponsored GEER Association Team

# GEER Association Report No. GEER-022

Version 2: May 25, 2010

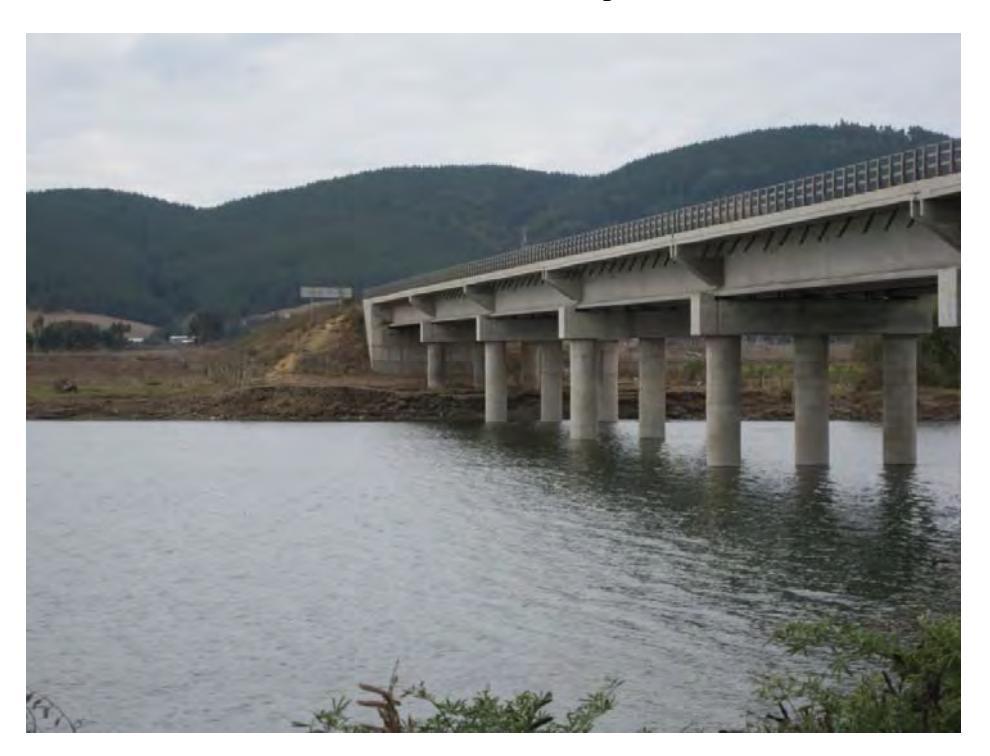
However, on the north side, and due to the large extent of the fields are around the bridge, extensive lateral spreading was observed going back almost 270 m from the river edge. The lateral spreading from the edge of the abutment wall to the first row of piers is about 54 cm and the total lateral spreading from the edge of the abutment wall to the river's edge is about 180cm (over a distance of about 65m). The approach embankment is about 7.6m high, and settled about 70cm relative to the bridge deck. The approach embankment experienced outward transverse movement of about 60cm from the center line as manifested by cracking of the asphalt along a distance of about 200m. This appears due to liquefaction and failure of the underlying soil and is evidenced by compression ridged in the field at the toe of the embankments.

Figure 15.65 Lateral spreading on the north end of the bridge, Puente Mataquito, 35.050712°S,72.162258°W April 16, 2010.

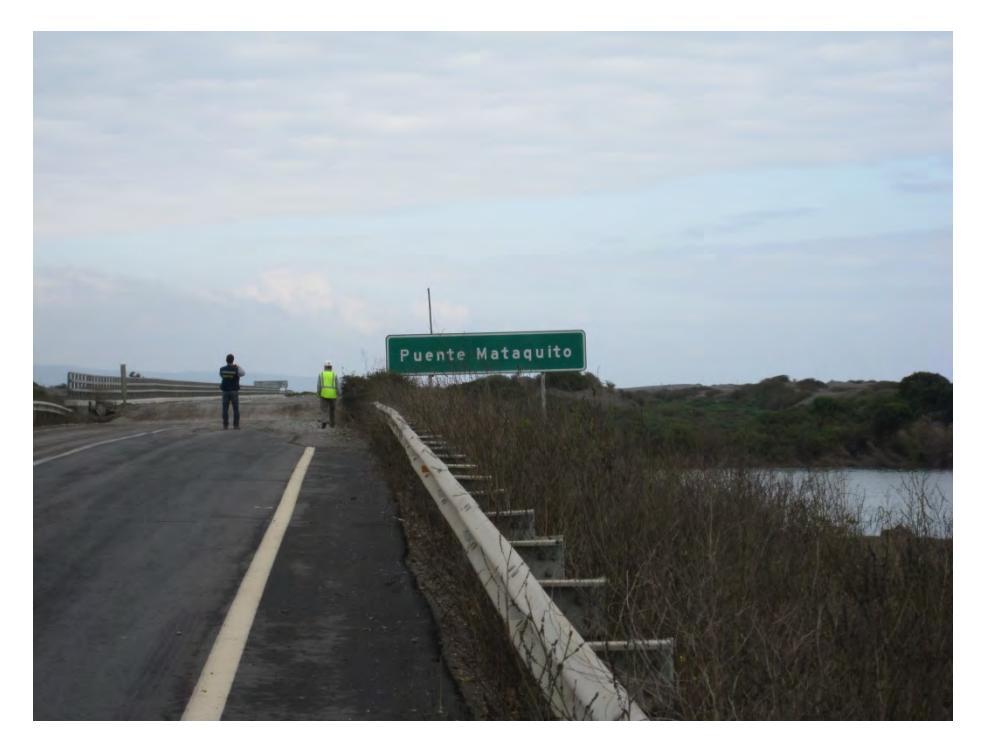
Figure 15.66 Settlement of the north abutment of the bridge, 70 cm offset at the bridge deck, Puente Mataquito, 35.050712°S, 72.162258°W, April 16, 2010.

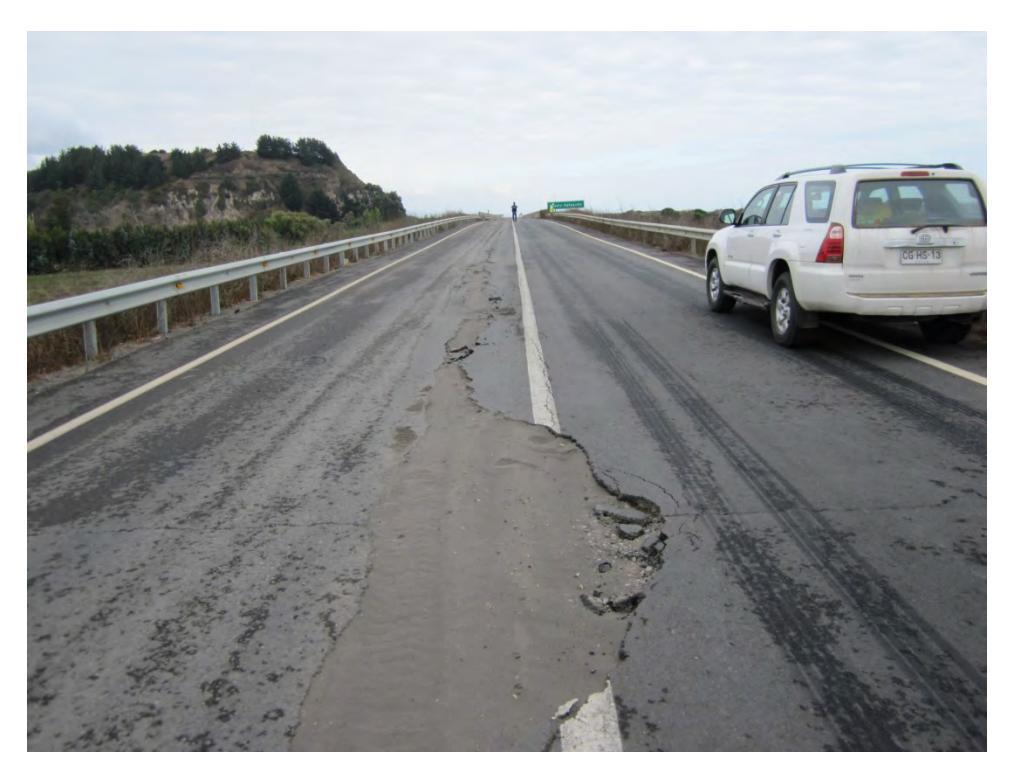
Figure 15.67 Cracking and transverse movement (60 cm on each side) of embankment due to liquefaction of underlying soil, north abutment of the bridge, Puente Mataquito, 35.050712°S,72.162258°W, April 16, 2010.

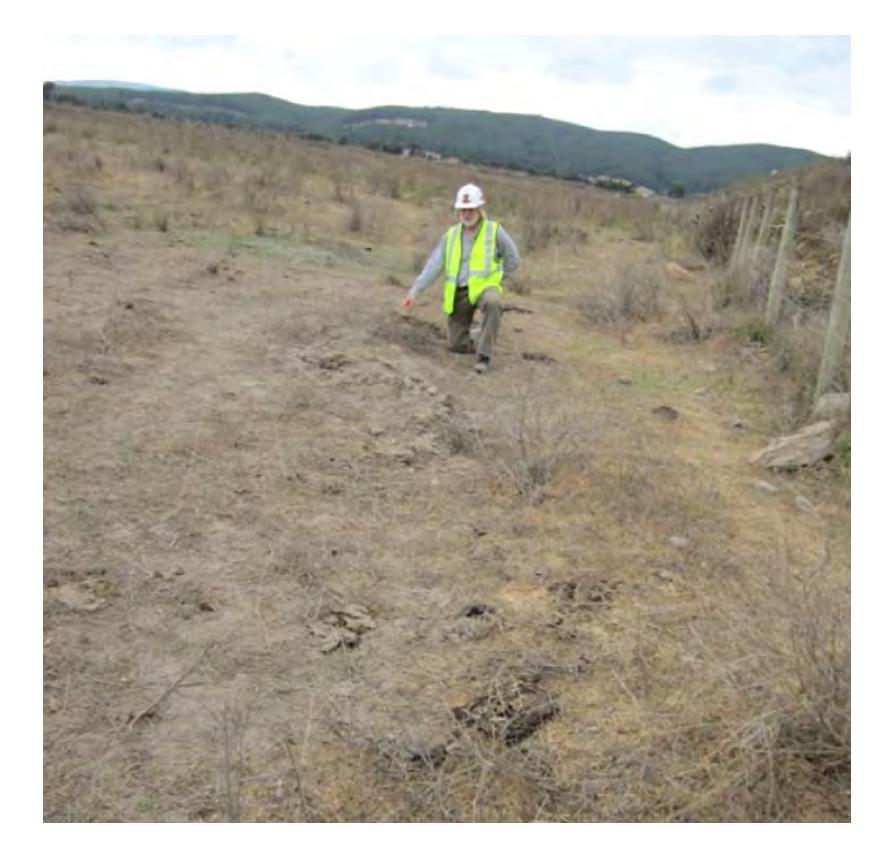
Figure 15.68 Compression ridges at toe of embankment, due to liquefaction of underlying soil and settlement of embankment, north abutment of the bridge, Puente Mataquito, 35.050712°S, 72.162258°W, April 16, 2010.

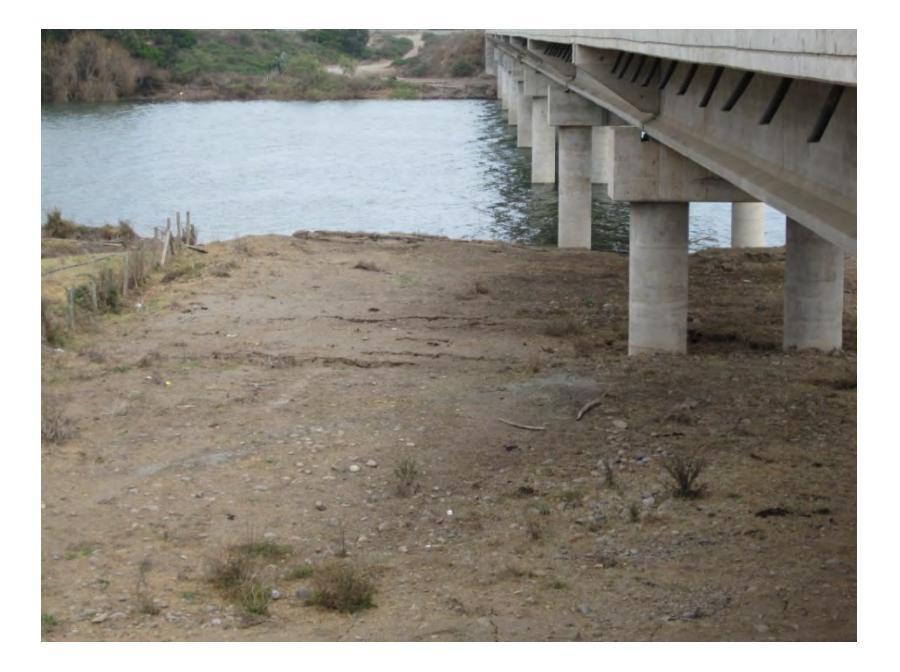
Figure 15.69 Lateral Spreading towards the river, north abutment of the bridge, Puente Mataquito, 35.050712°S, 72.162258°W, April 16, 2010.

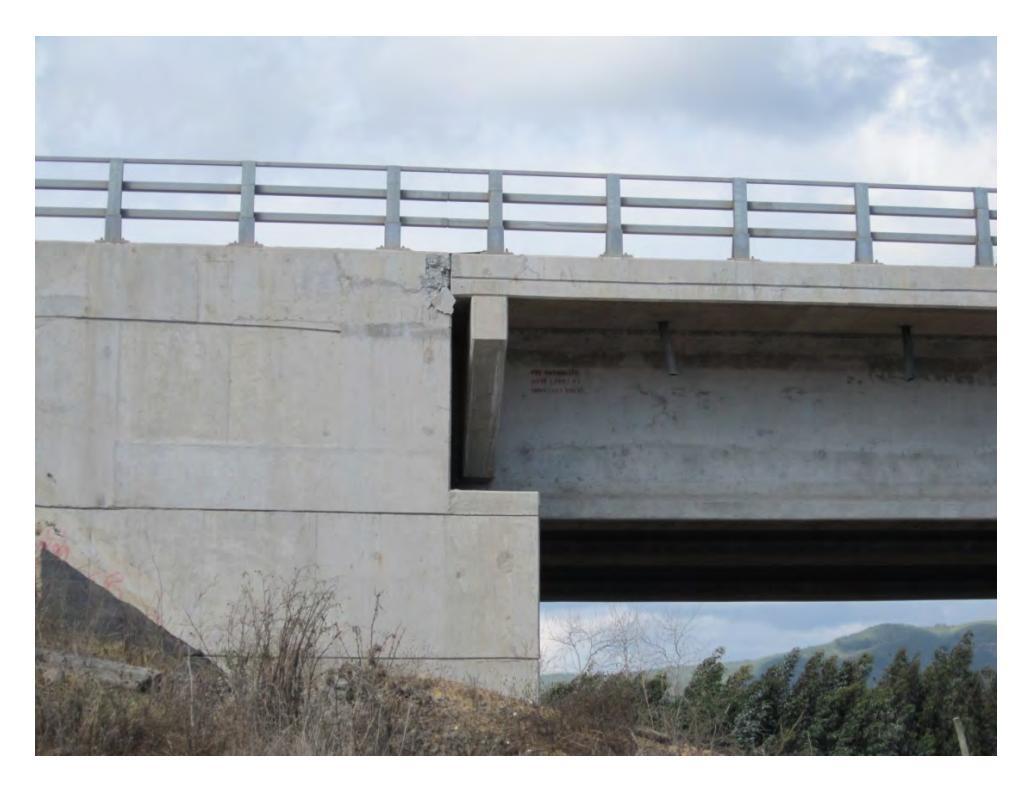
Figure 15.70 North abutment shoved into bridge deck due to lateral spreading, Puente Mataquito, 35.050712°S, 72.162258°W, April 16, 2010.

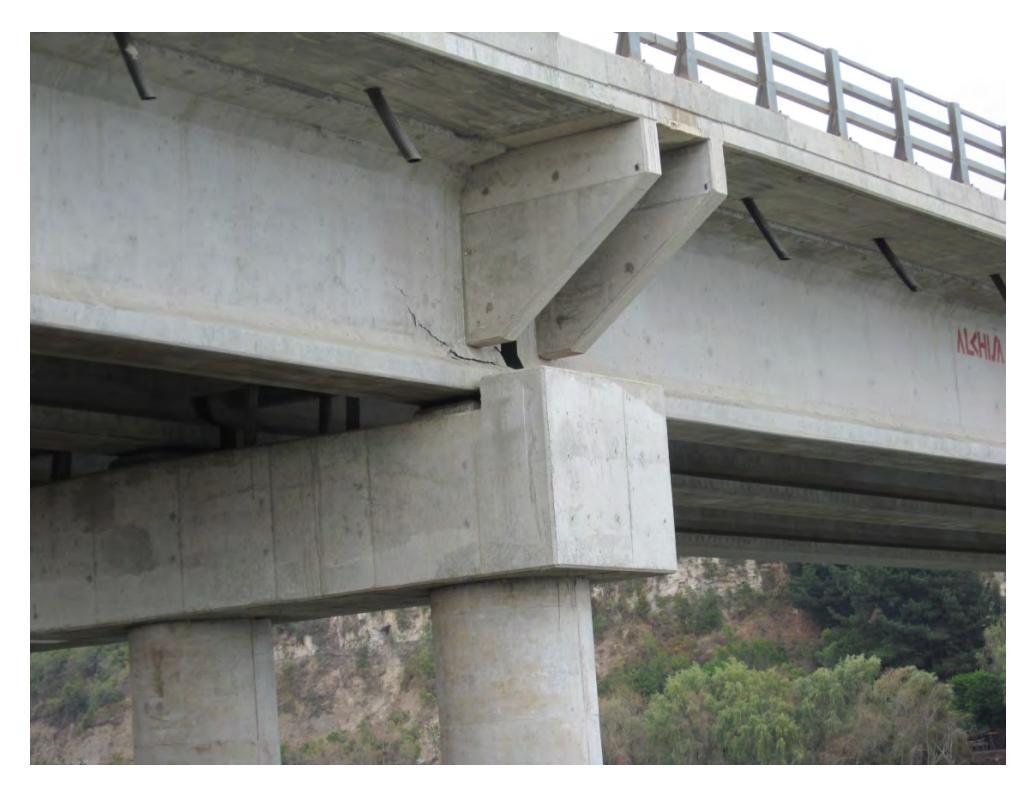
Figure 15.71 Shearing of bridge girder, North abutment of bridge, Puente Mataquito, 35.050712°S, 72.162258°W , April 16, 2010.

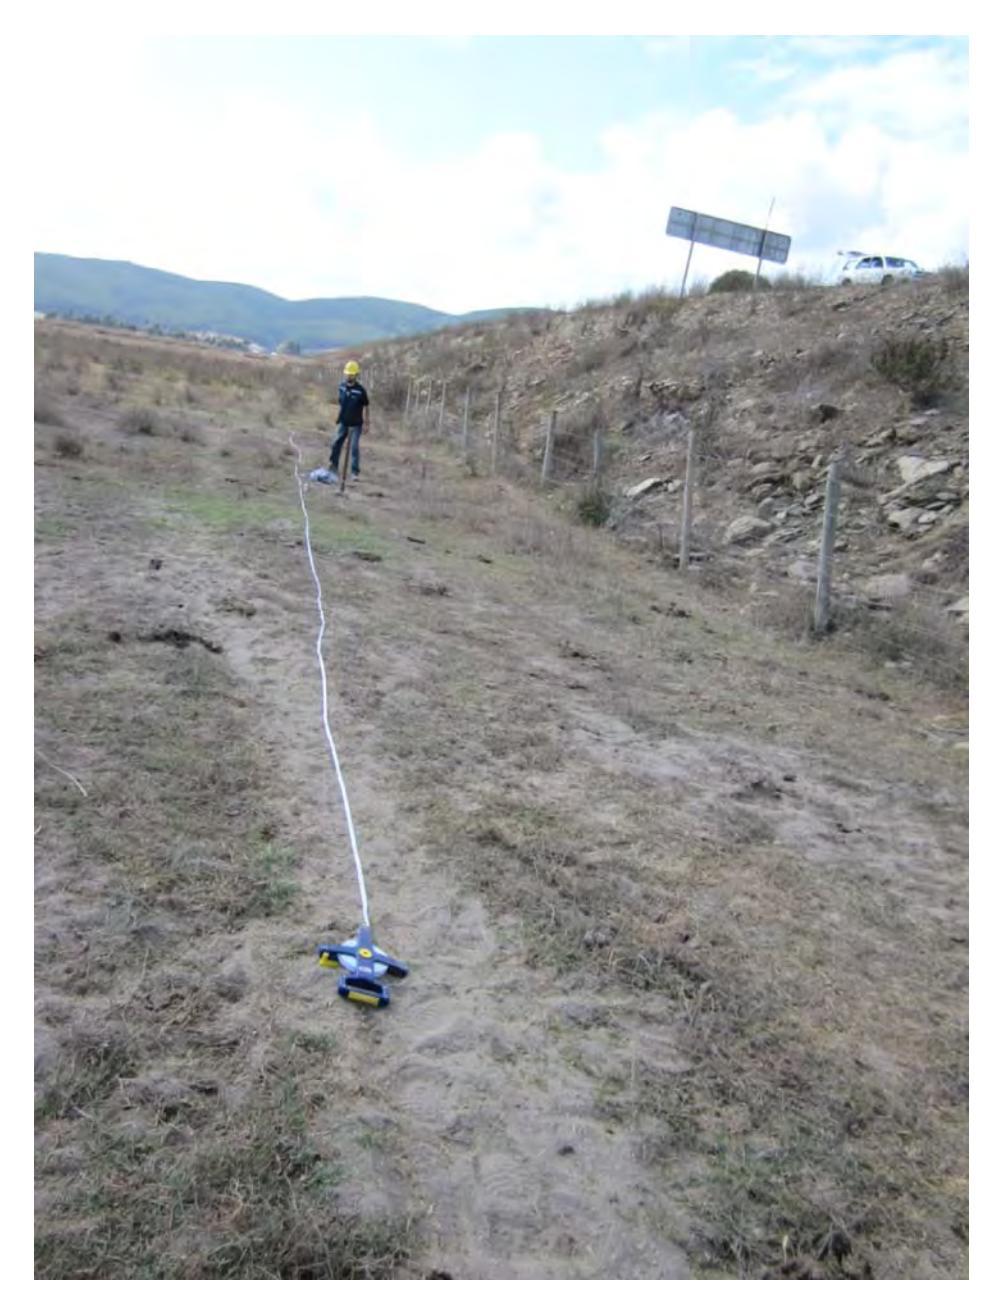
Figure 15.72 SASW line, parallel to northern approach embankment, Puente Mataquito, 35.050712°S,72.162258°W, April 16, 2010.

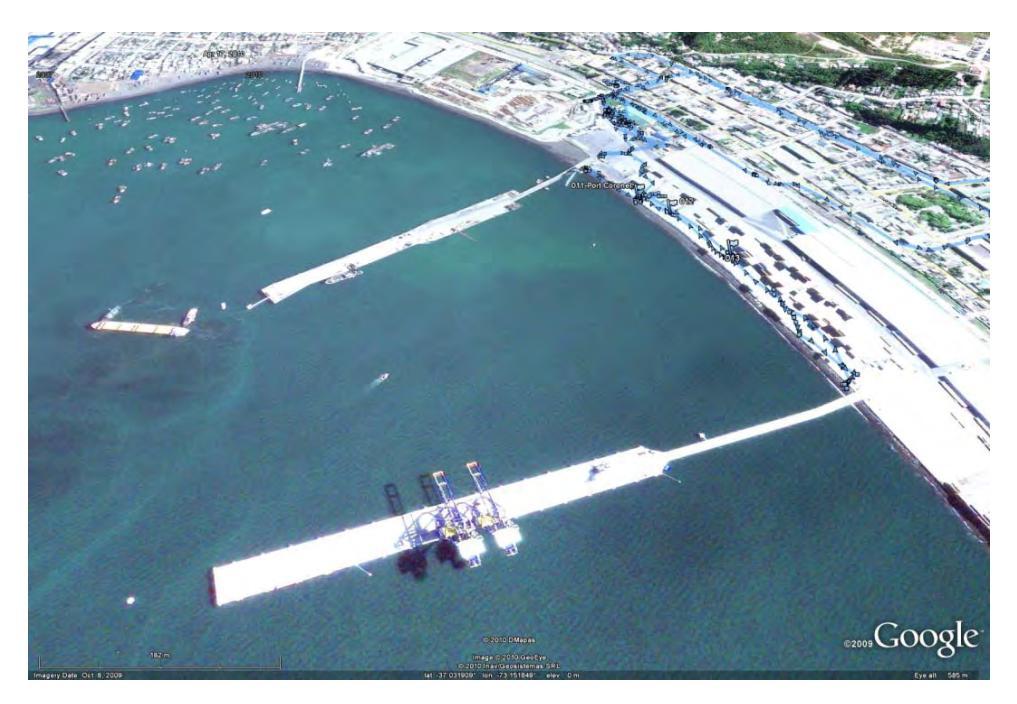
The sheet pile wall was embedded about 4-6m below the ground surface and protruded about 15-2m above the ground surface. At waypoint 11 (see Figure 15.73) we measured outward movement of about 110cm, while port official report their survey gives about 150cm, but the measurement extended all the way back to the ware houses. At waypoint 12 we measured lateral displacements of about 40 cm, and at waypoint 13 we measured outward movement of 10cm.

Figure 15.73 Port Coronel, area marked by GPS tracks along the coast experienced lateral spreading (37.028874°S, 73.149768°W).

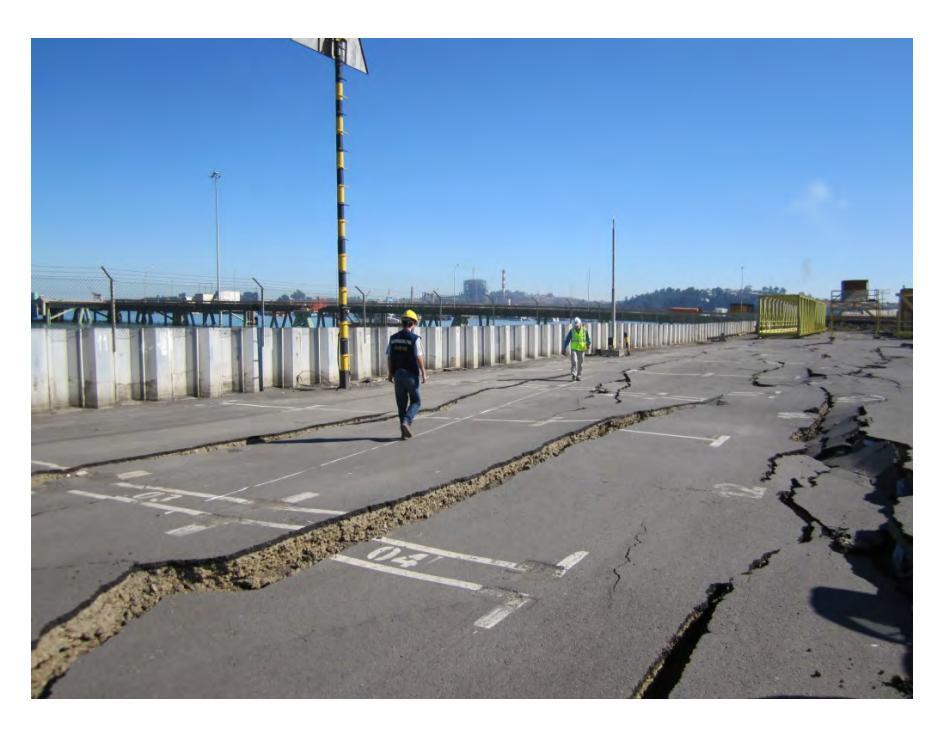
Team D made SASW measurements in the Port of Coronel where lateral spreading was experience. Figure 15.73 through 17.78 show the corresponding photos. SASW measurements were made along two lines parallel to the sheet pile wall. The first line is about 7 from the sheet pile wall in an area that experienced large lateral deformations while the second line was made 27m from the sheet pile wall in area that experienced limited deformations.

Figure 15.74 SASW line 1, and lateral spreading looking north, Port Coronel, April 14, 2010 (37.028874°S, 73.149768°W).

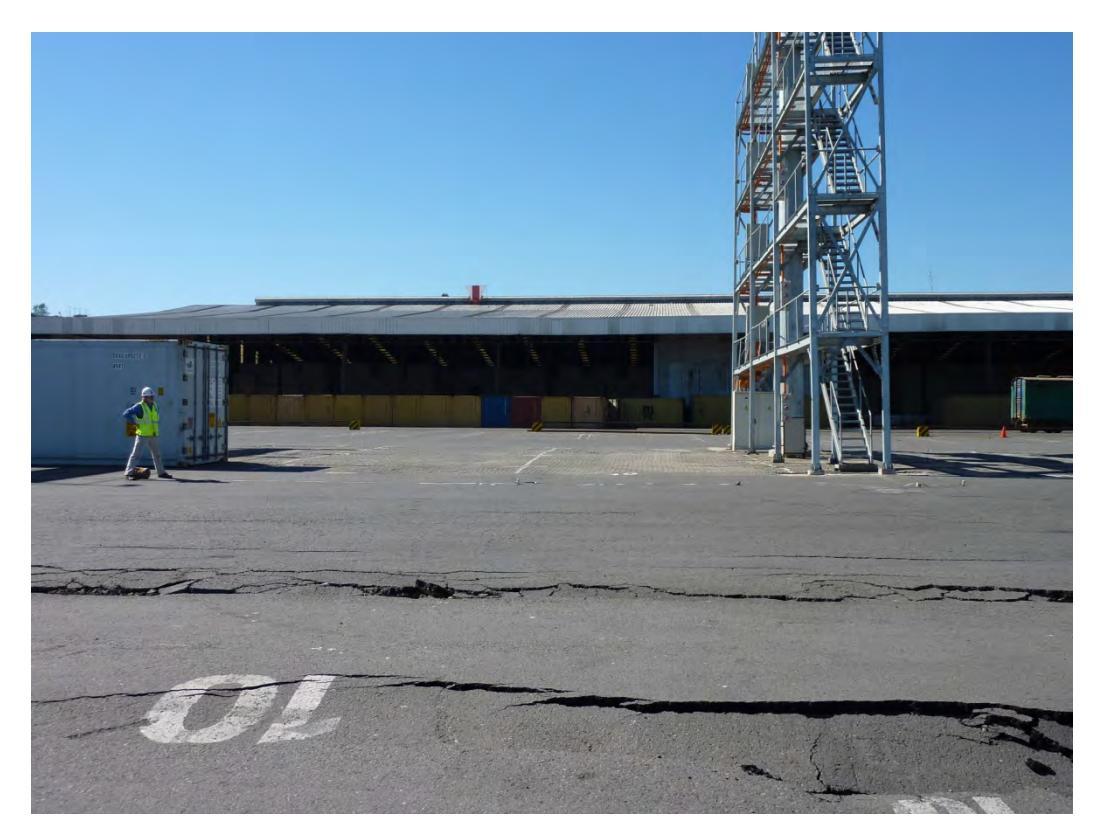
Figure 15.75 SASW line 2, and lateral spreading looking north, Port Coronel, April 14, 2010 (37.028874°S, 73.149768°W).

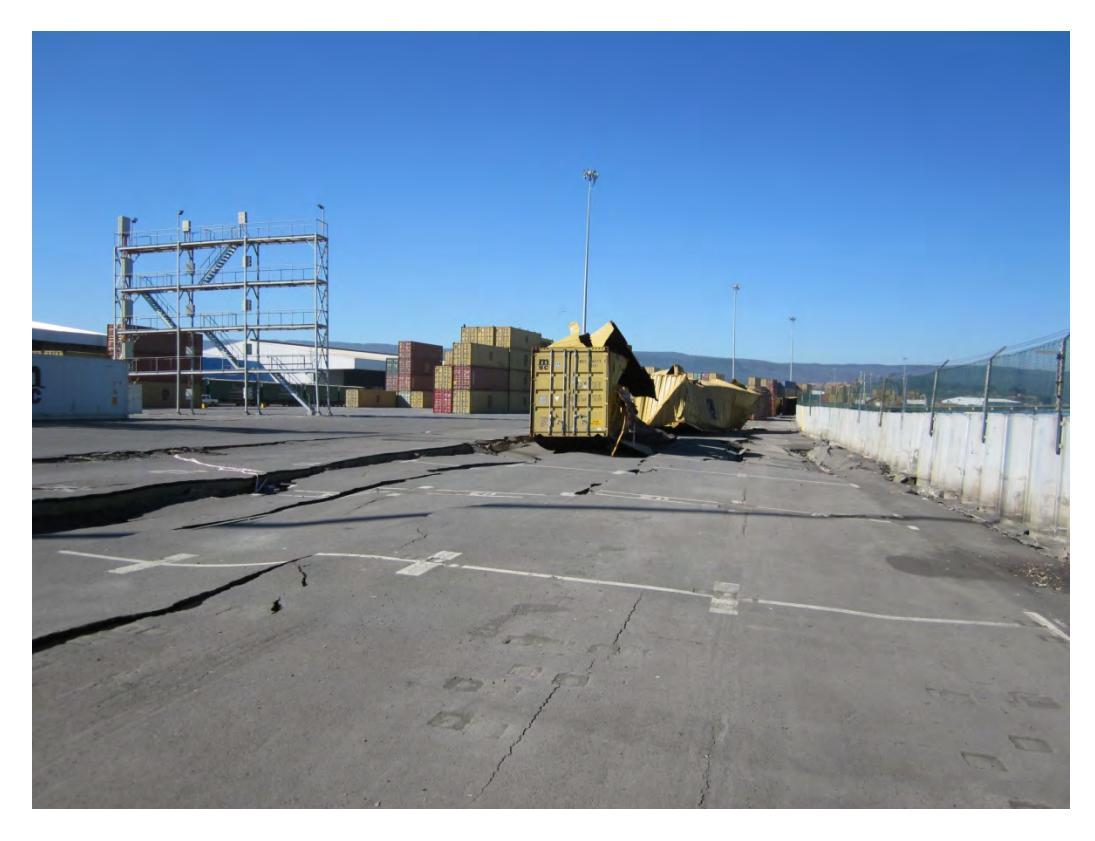
Figure 15.76 Lateral spreading looking south, Port Coronel, April 14, 2010 (37.028874°S, 73.149768°W).

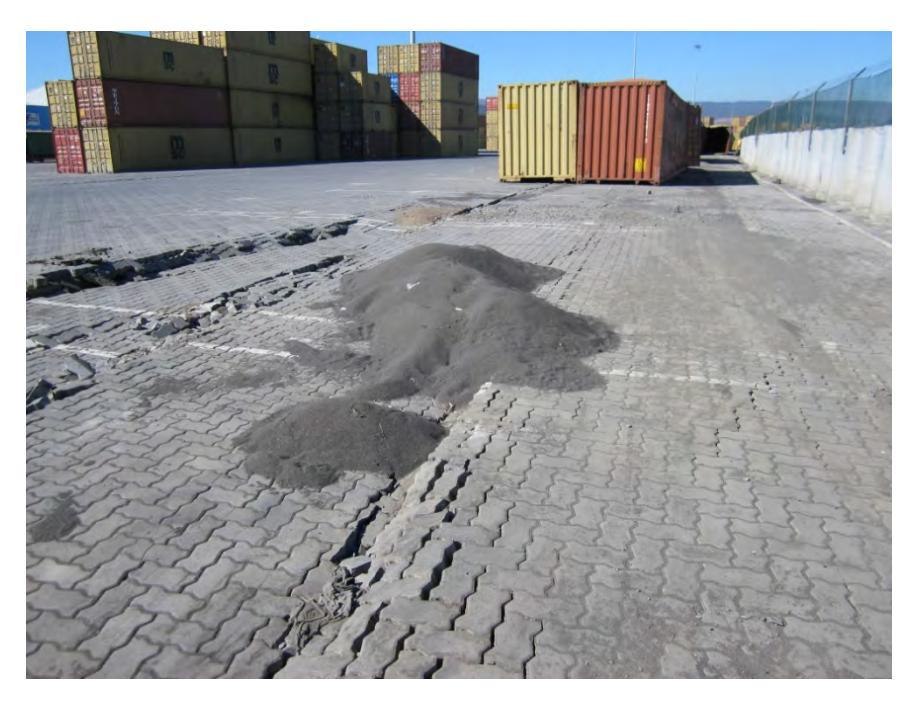
Figure 1 Sand Ejecta, Lateral Spreading, Port Coronel, April 14, 2010 (37.028874°S, 73.149768°W).

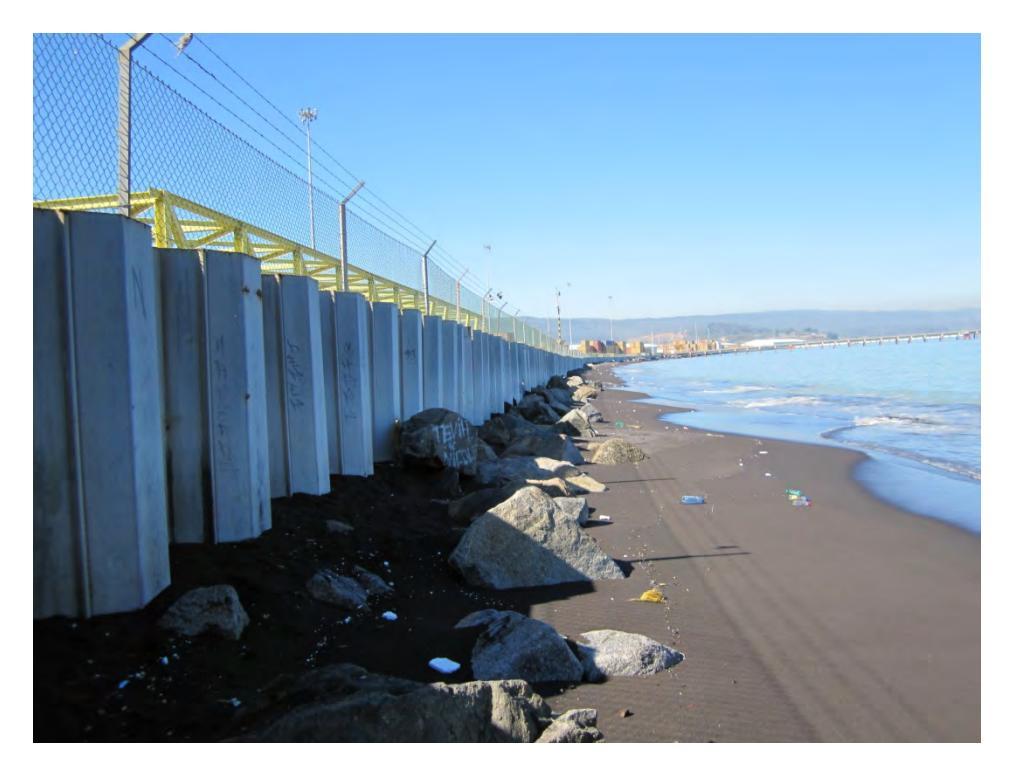
Figure 15.78 Seaside view of the sheet pile wall that experienced lateral spreading, Port Coronel, April 14, 2010 (37.028874°S, 73.149768°W).

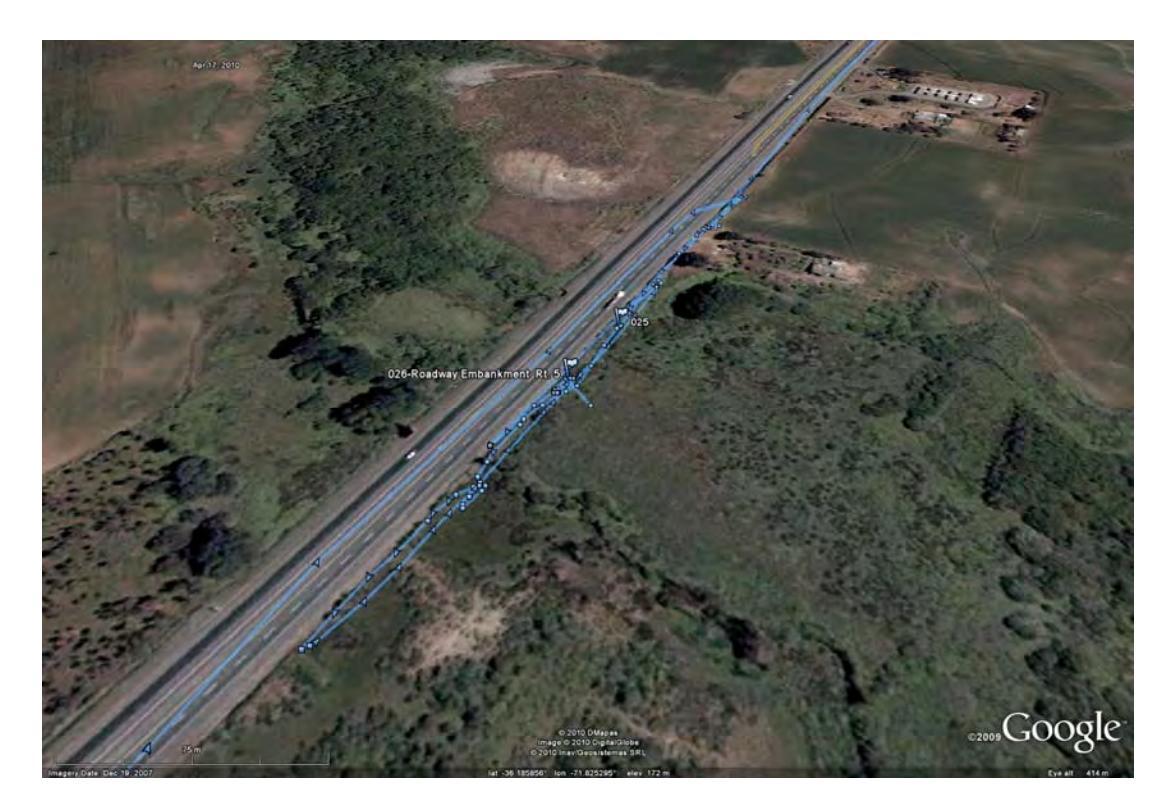
Team D performed SASW test along a repaired roadway embankment as illustrated in Figure 15.79 through 15.81. The failed section was bounded by two streams Figure 15.79 and it is likely that the failure of the embankment was due to loss of strength in the underlying soils (liquefaction) during shaking.

Figure 15.79 Roadway Embankment ~5km south of Parral, north is up, Ruta 5 Sur (36.185671°S,71.825415°W)

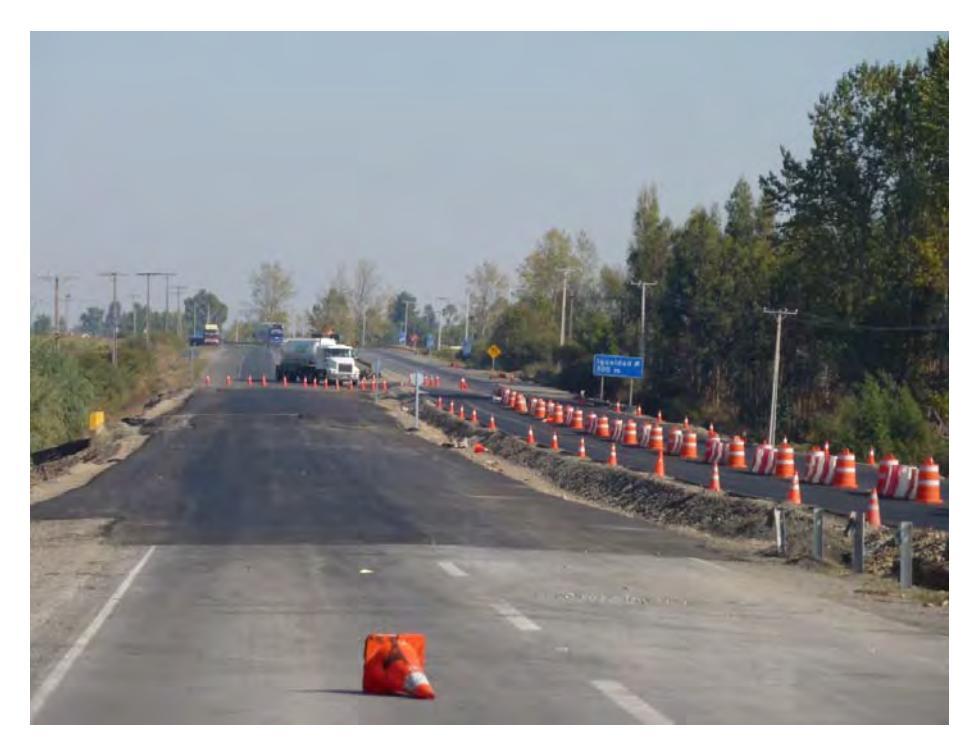
Figure 15.80 North bound lane looking south, Repaired Roadway Embankment ~5km south of Parral, Ruta 5 Sur, April 15, 2010 (36.185671°S, 71.825415°W)

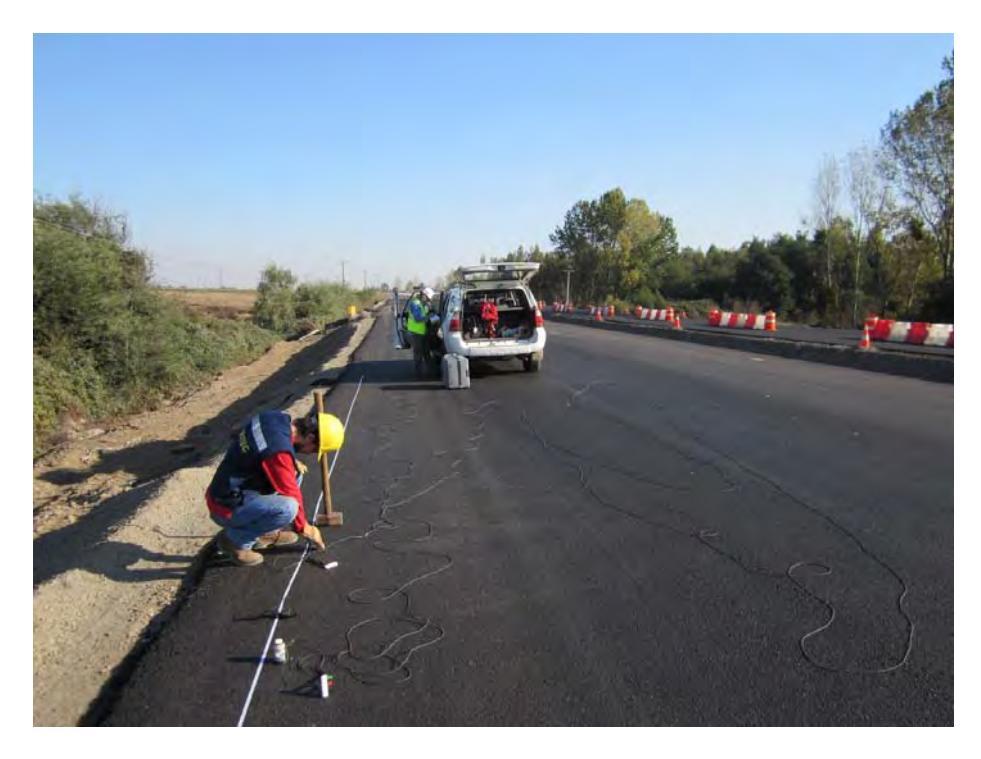
Figure 15.81 SASW line, North bound lane looking south, Roadway Embankment ~5km south of Parral, Ruta 5 Sur, April 15, 2010 (-36.185671°S,-71.825415°W).

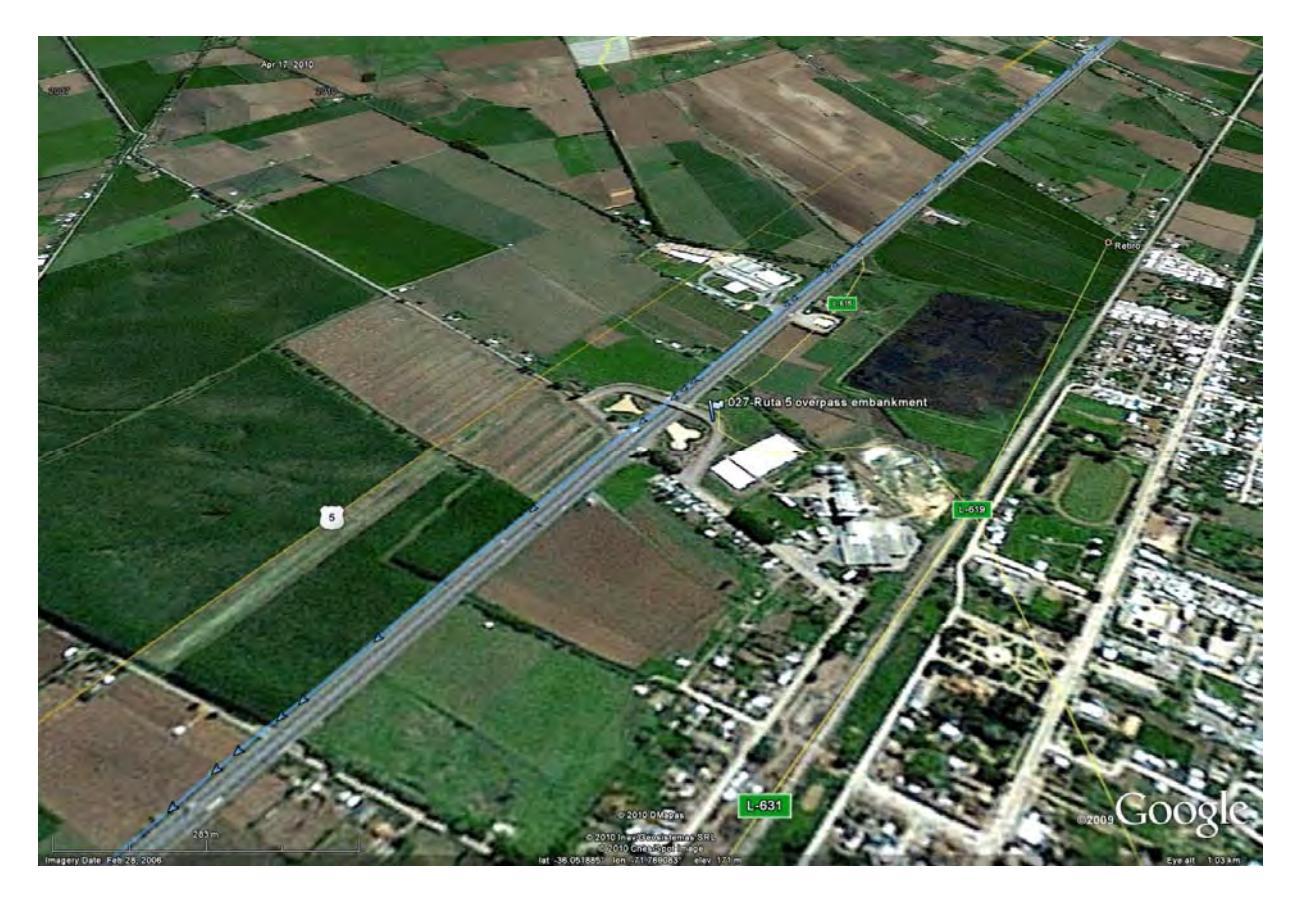
Team D performed SASW measurements on a damaged overpass embankment on the right side of the north bound lane of Ruta 5 sur (Figure 15.82 through 15.84). The damage of the embankment appears to be due to shaking and bulging of the embankment material. The underlying soil appeared to be intact with no evidence of loss of loss of strength. The embankment bulged laterally and settled. The overpass embankment to the left of the north bound lane does not show signs of damage.

Figure 15.82 Ruta 5 Sur overpass embankment, looking north, to Retiro at Tucapel Mill (36.051209°S, 71.768005°W).

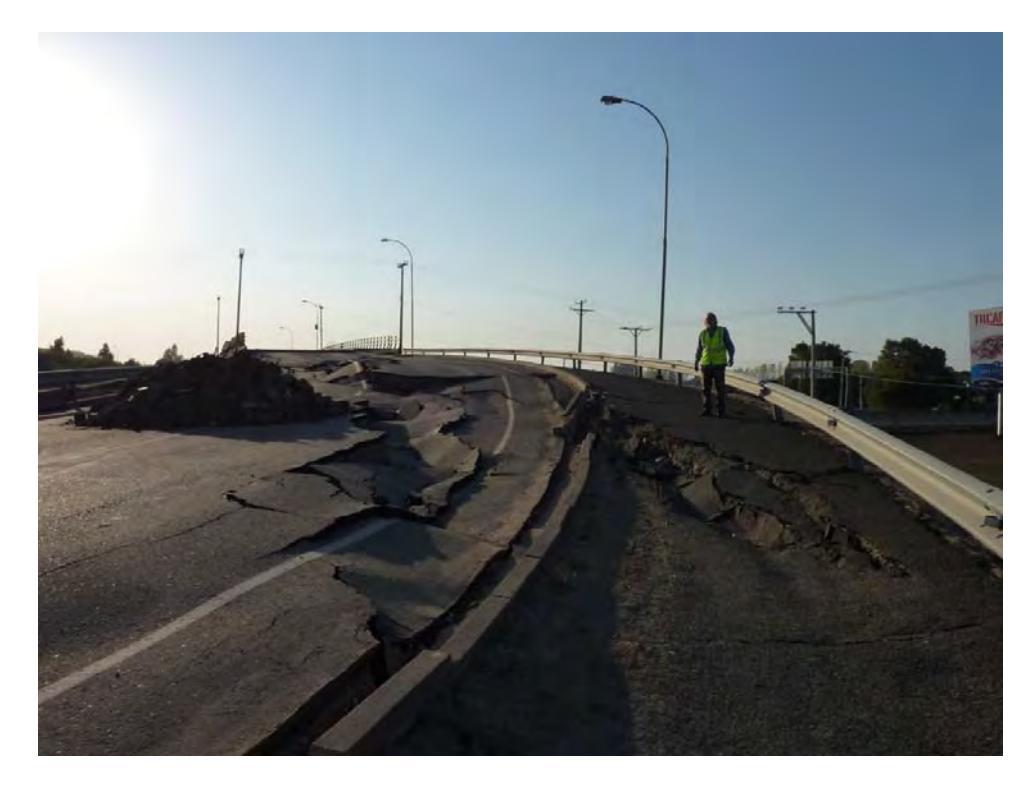
Figure 15.83 Damage to over padded embankment, Ruta 5 Sur overpass embankment, to Retiro at Tucapel Mill, April 15, 2010 (36.051209°S, 71.768005°W).

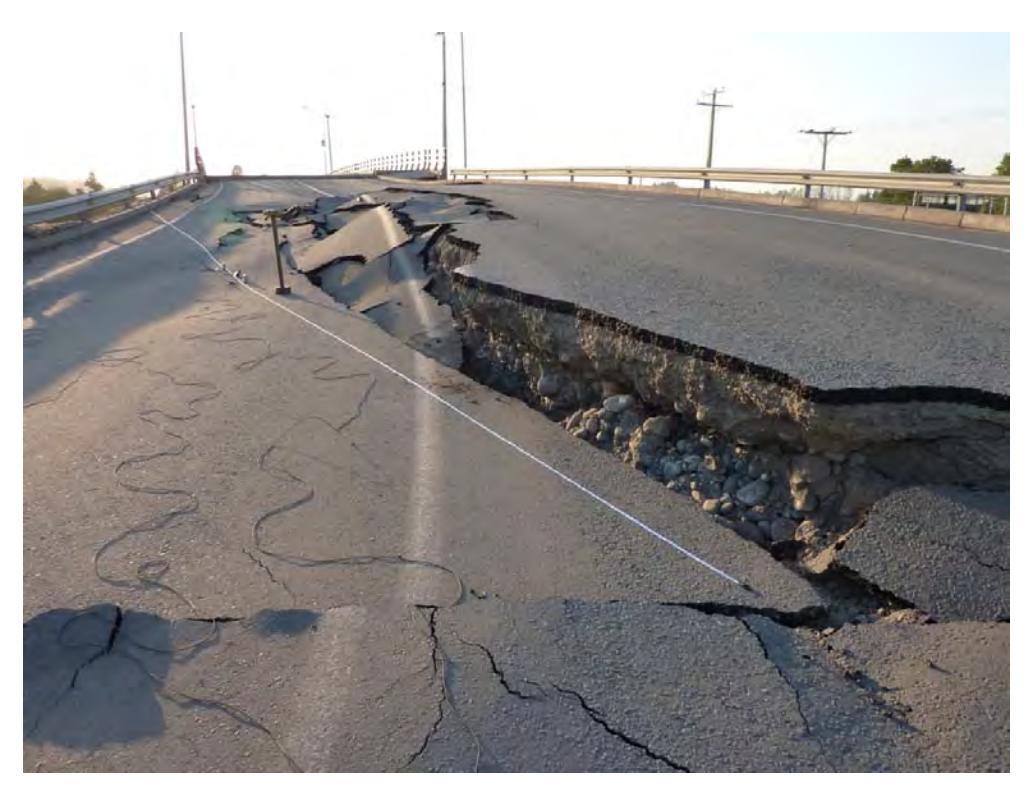
Figure 15.84 SASW line, Ruta 5 Sur overpass embankment, to Retiro at Tucapel Mill, April 15, 2010 (36.051209°S, 71.768005°W).
