Techniques for the Seismic Rehabilitation of Existing Buildings

FEMA 547/2006 Edition

FEMA 547 – October 2006

Rutherford & Chekene (R & C) Consulting Engineers (Subconsultant) under contract with National Institute of Standards and Technology (NIST).

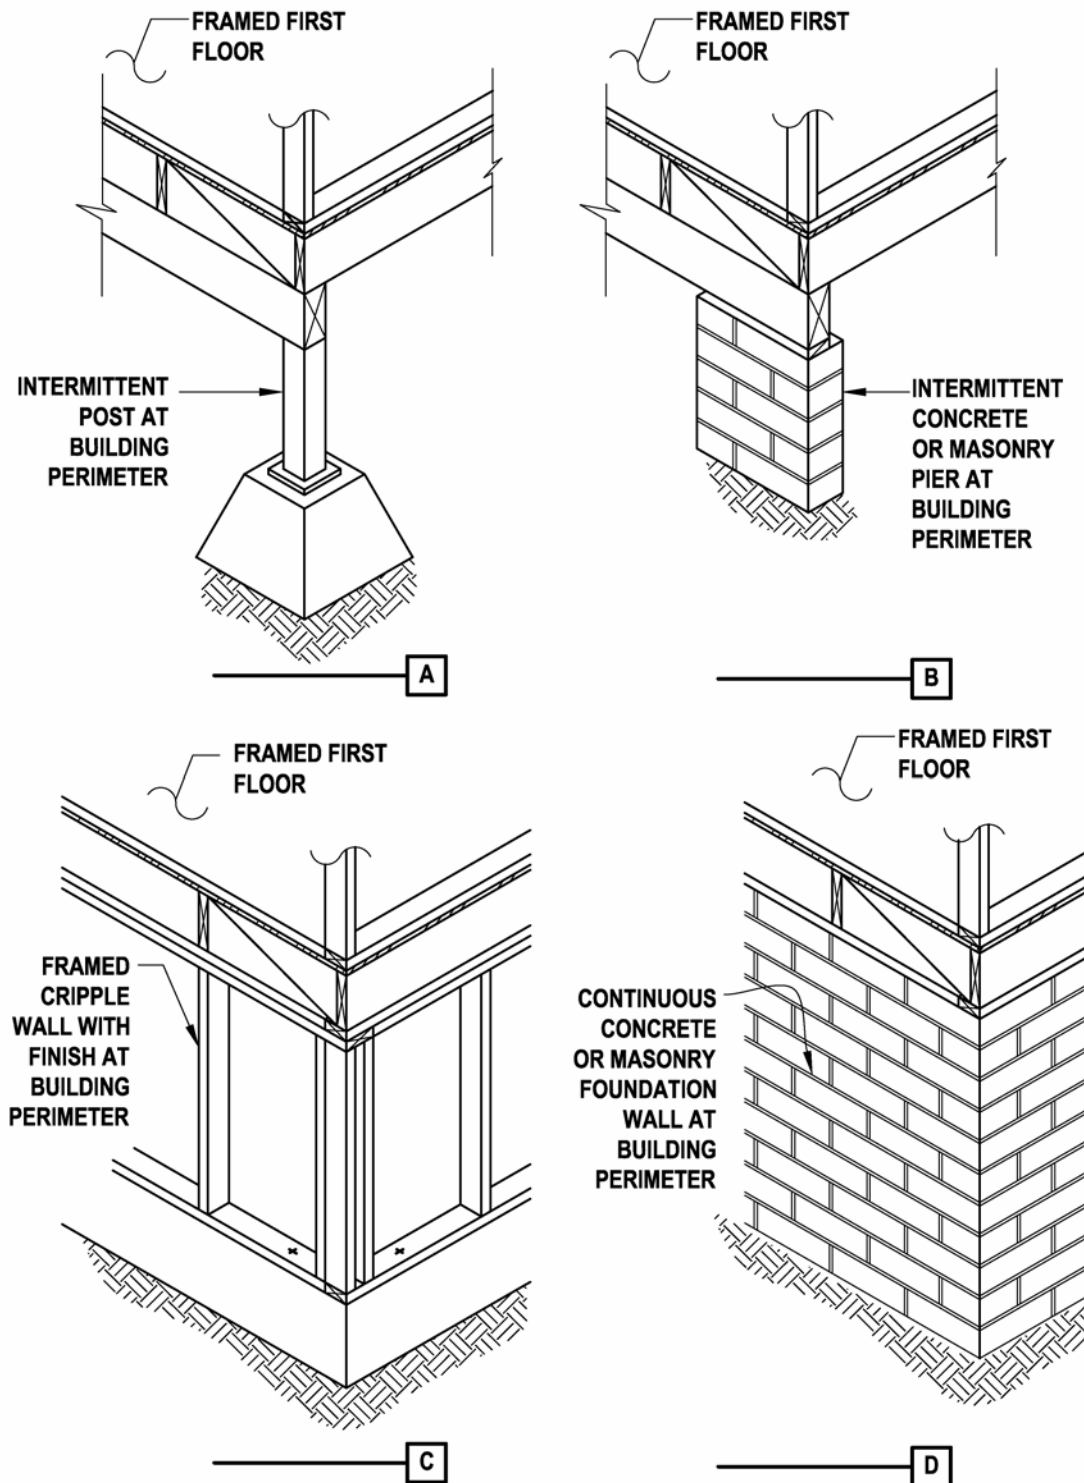
Figure 5.1-2: Systems Between First Framed Floor and Grade – Level Lot Sites

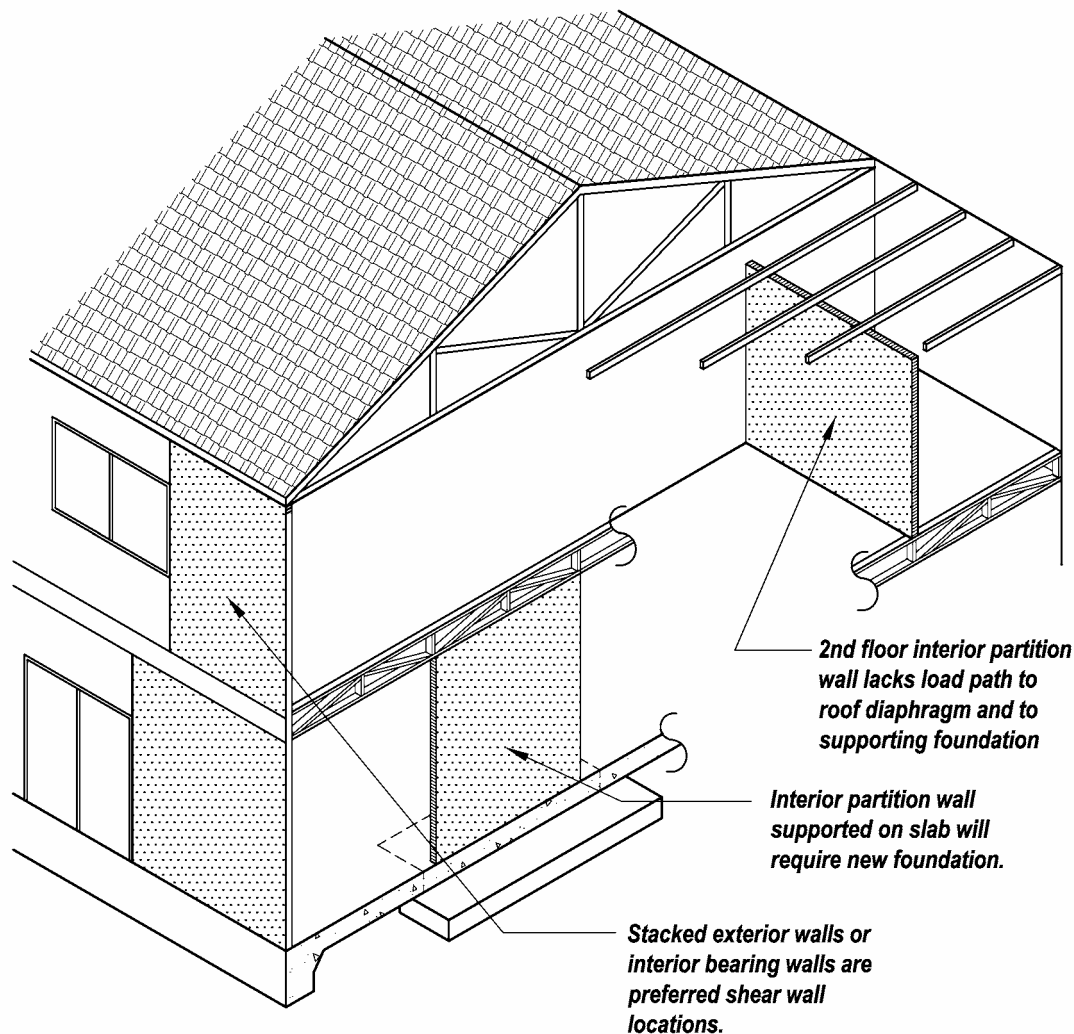
Figure 5.4.1-2: Preferred and Less Preferred Shear Wall Locations

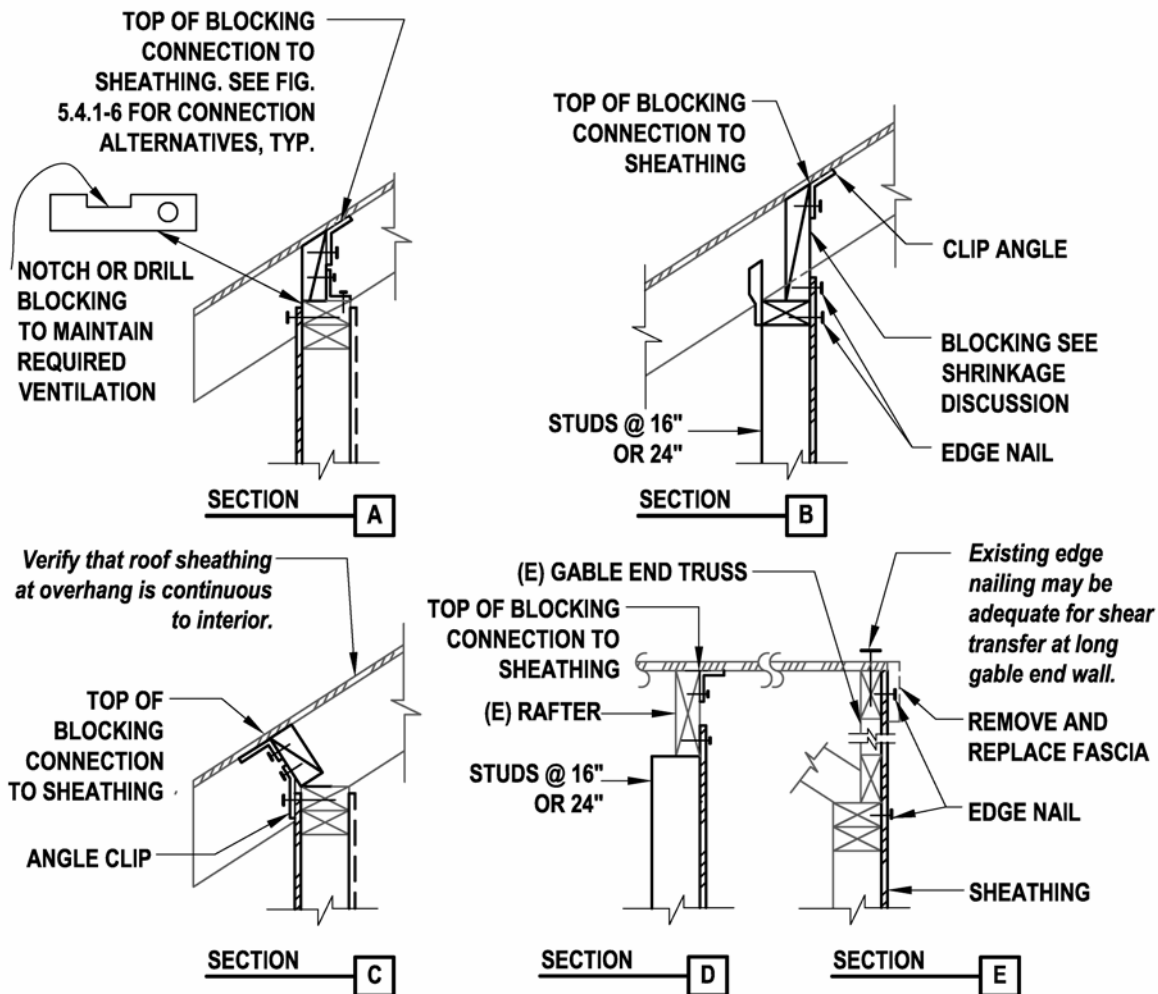
Figure 5.4.1-5: Load Path from Roof Diaphragm to Top of Shear Wall

Figure 5.4.1-5 shows a series of top of shear wall details where the shear is being transferred from a roof diaphragm into the top of the wall. Since most diaphragms in residential construction are not blocked, the unit capacity of the new shear wall is likely to be higher than the unit

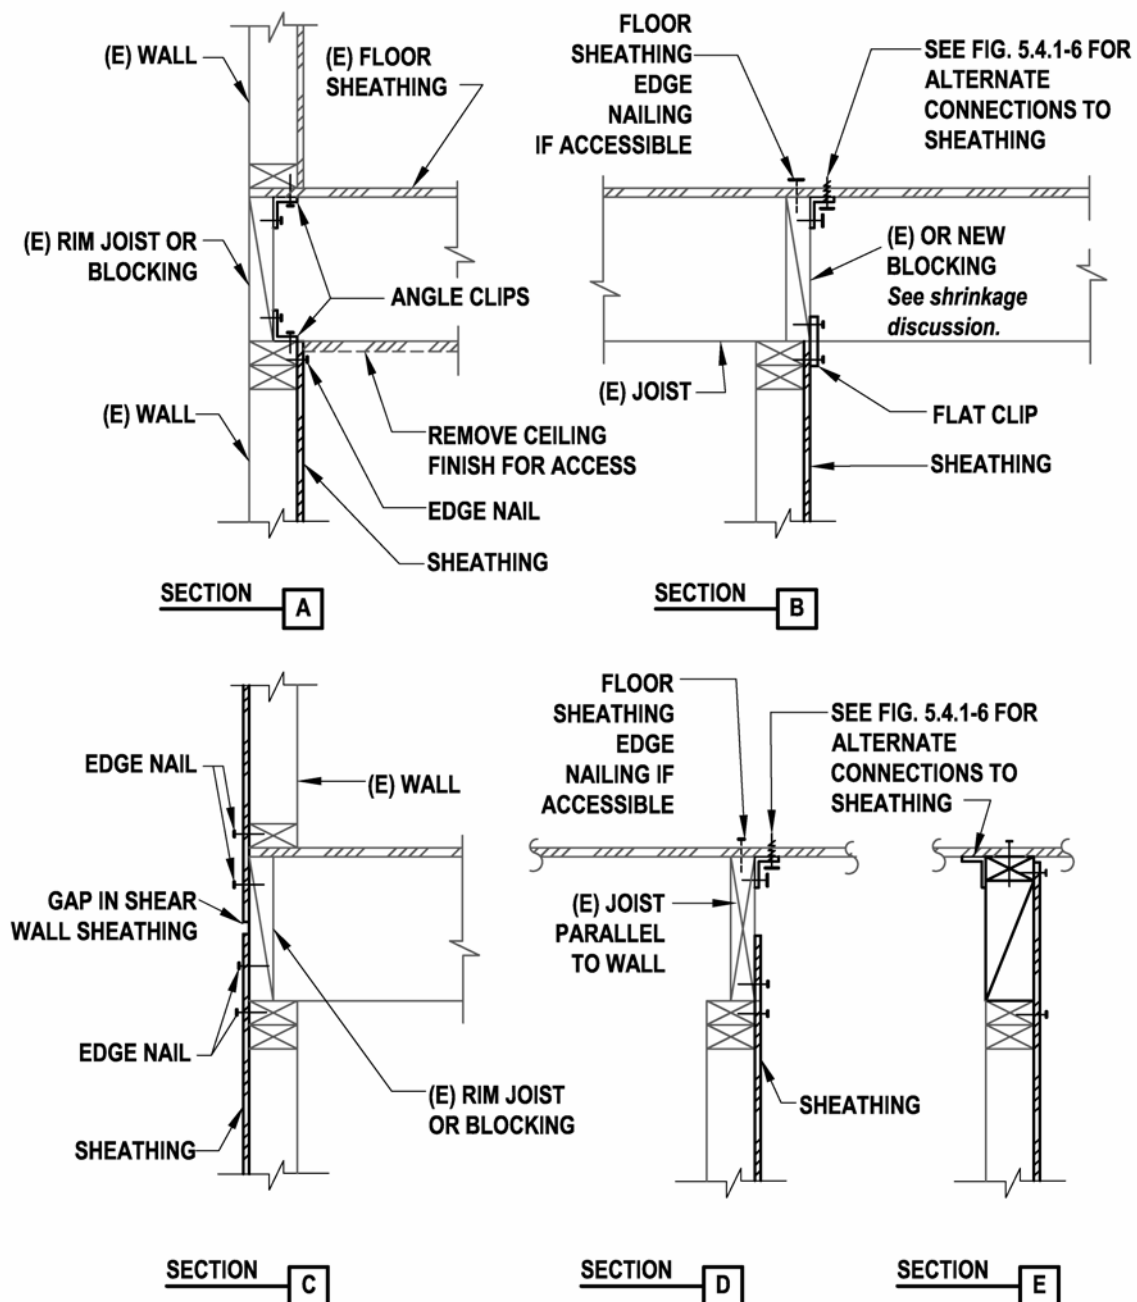
Figure 5.4.1-7: Load Path From Floor Diaphragm to Lower Story Shear Wall

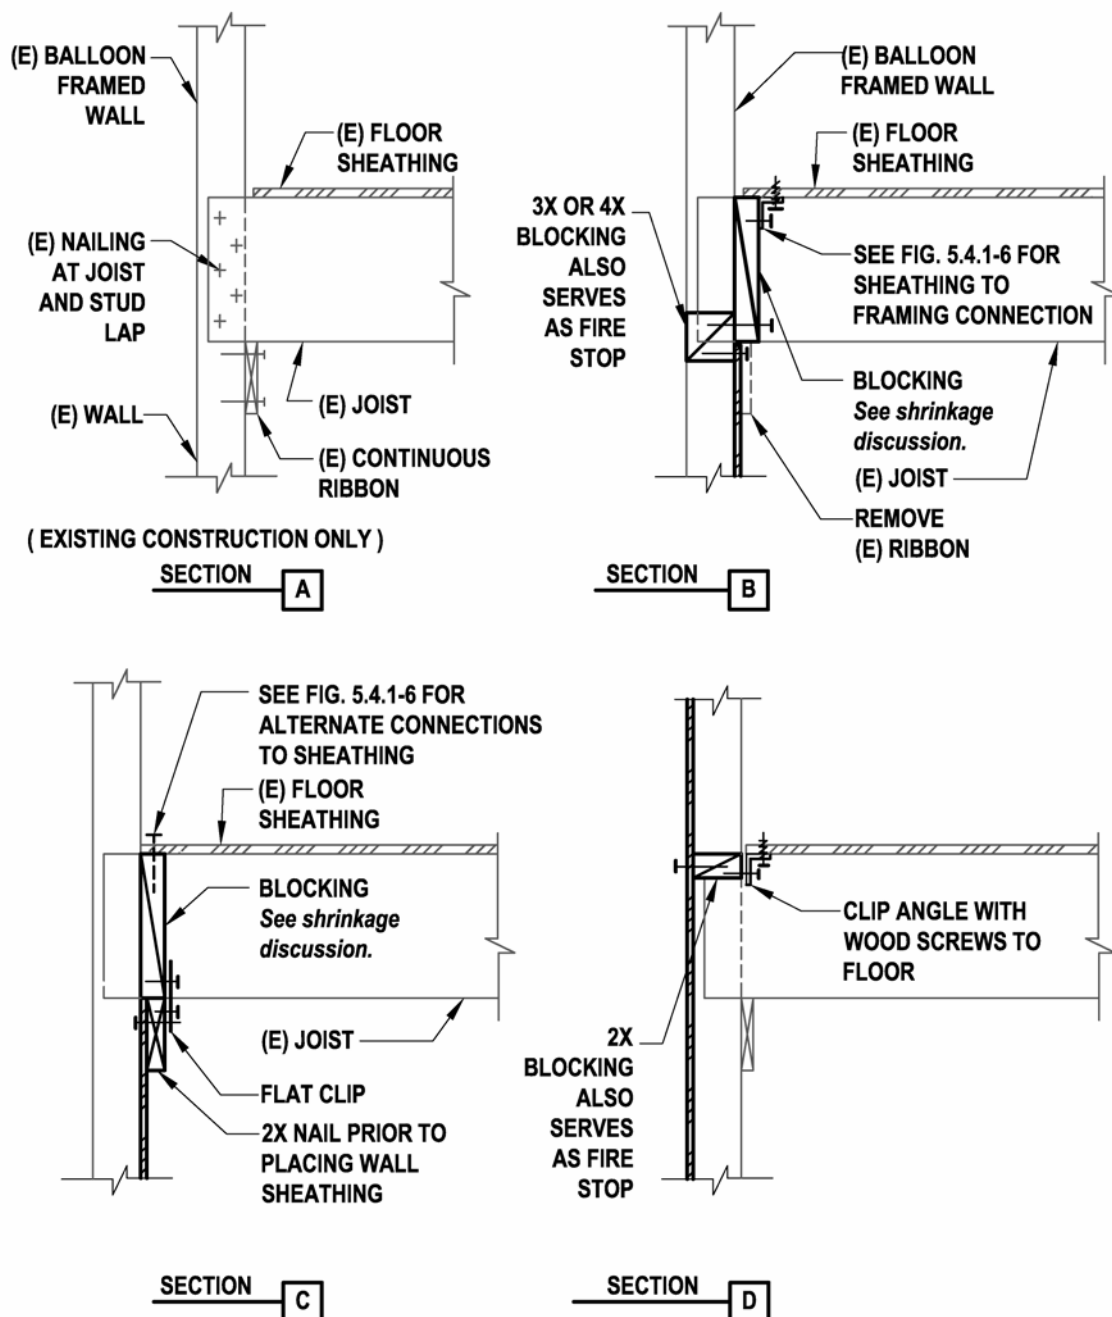
**Figure 5.4.1-8: Load Path From Floor Diaphragm to Lower Story Shear Wall
– Balloon Framing**

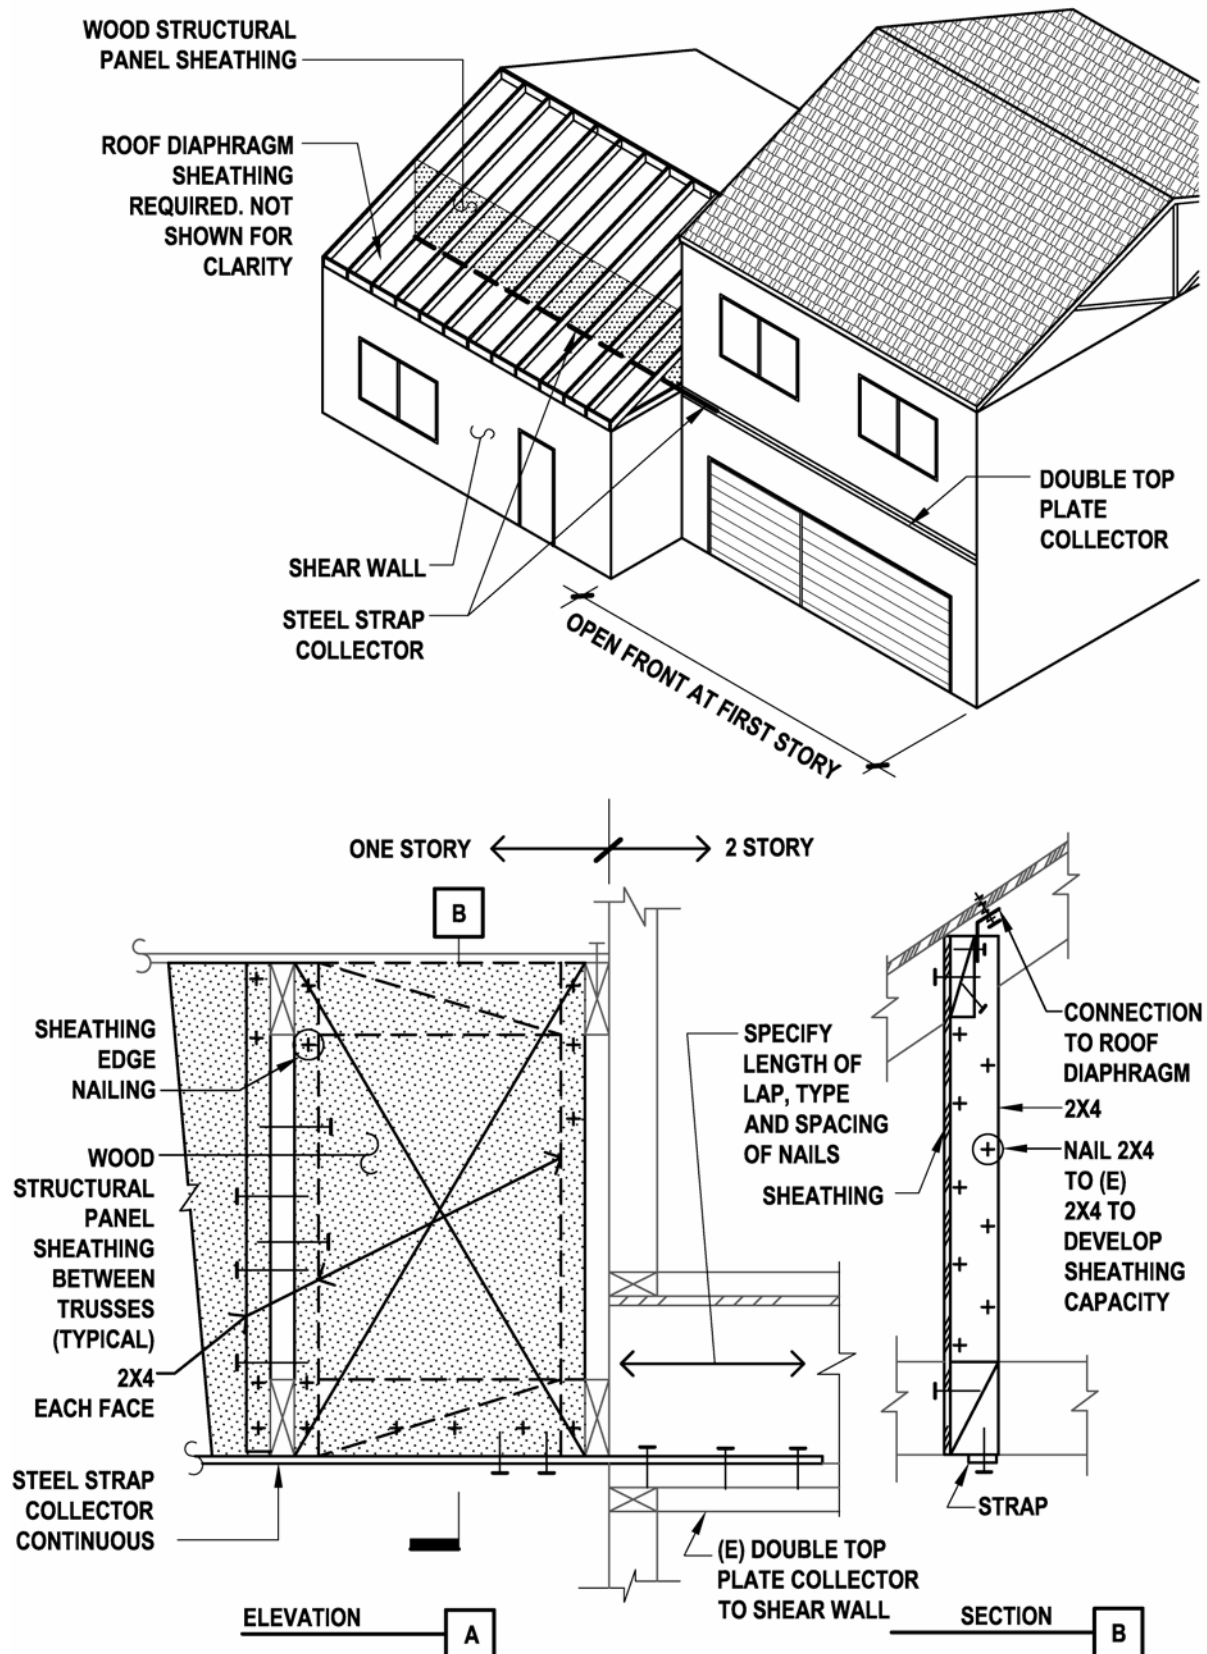
Figure 5.4.2-1: Collector from Garage Open Front to Adjacent Dwelling

Figure 5.4.2-1 shows one of several possible methods of providing a collector. In the illustrated approach, a steel strap ties the top plates from the garage open-front to wood structural panel sheathed infill panels between the roof trusses in the one-story portion of the building. The infill panels transfer the load from the truss bottom chord up to the roof diaphragm, where loads can be carried to the shear walls. In Figure 5.4.2-1, a vertical eccentricity exists between the collector

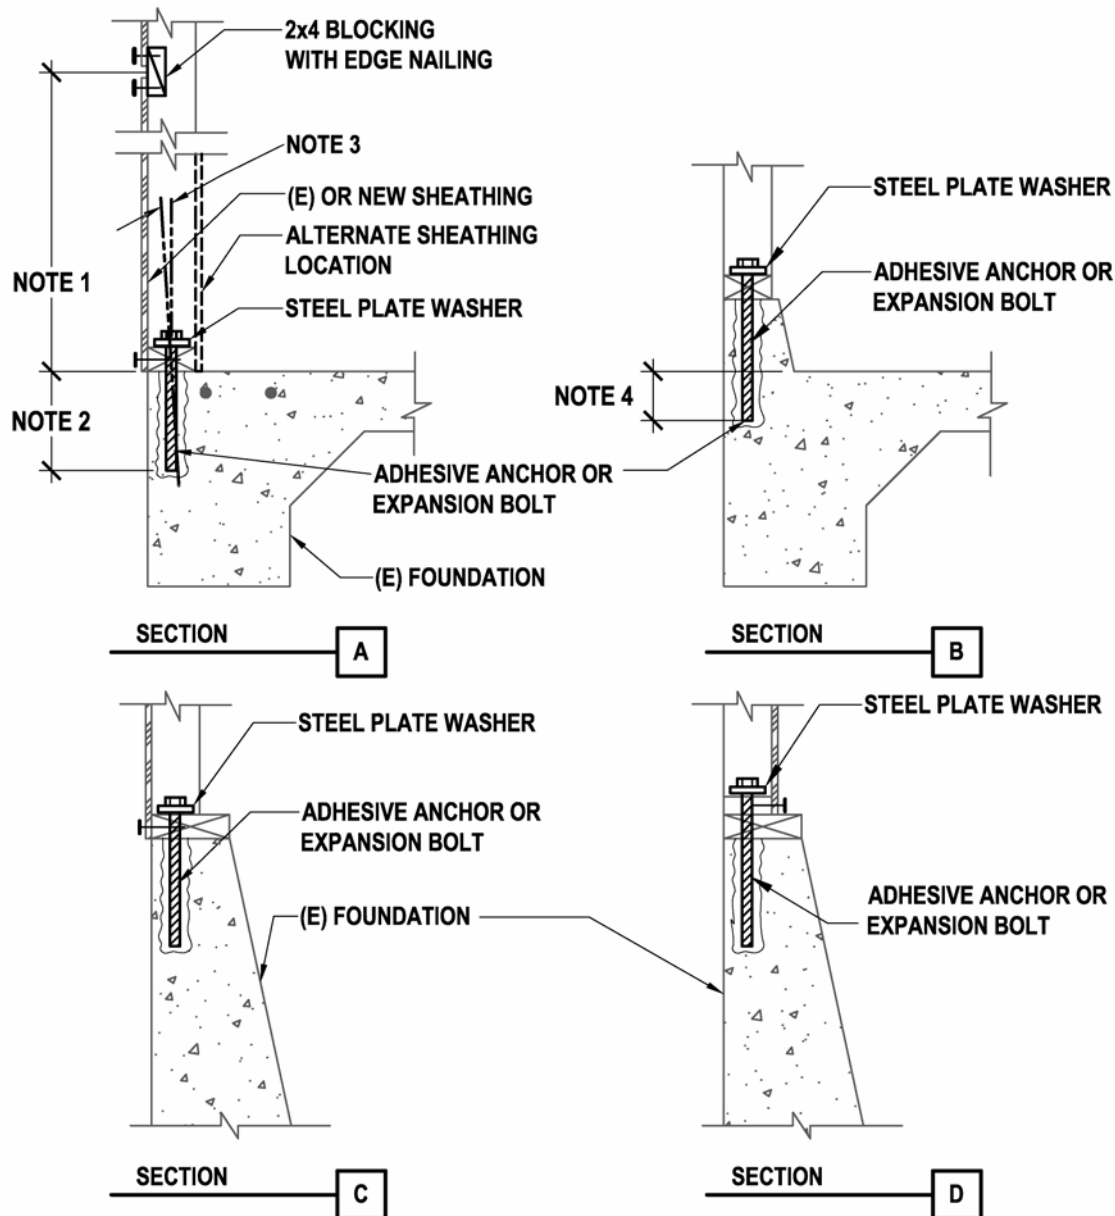
Figure 5.4.3-2: Added Anchor Bolt at Existing Partially Grouted Concrete Masonry Foundation

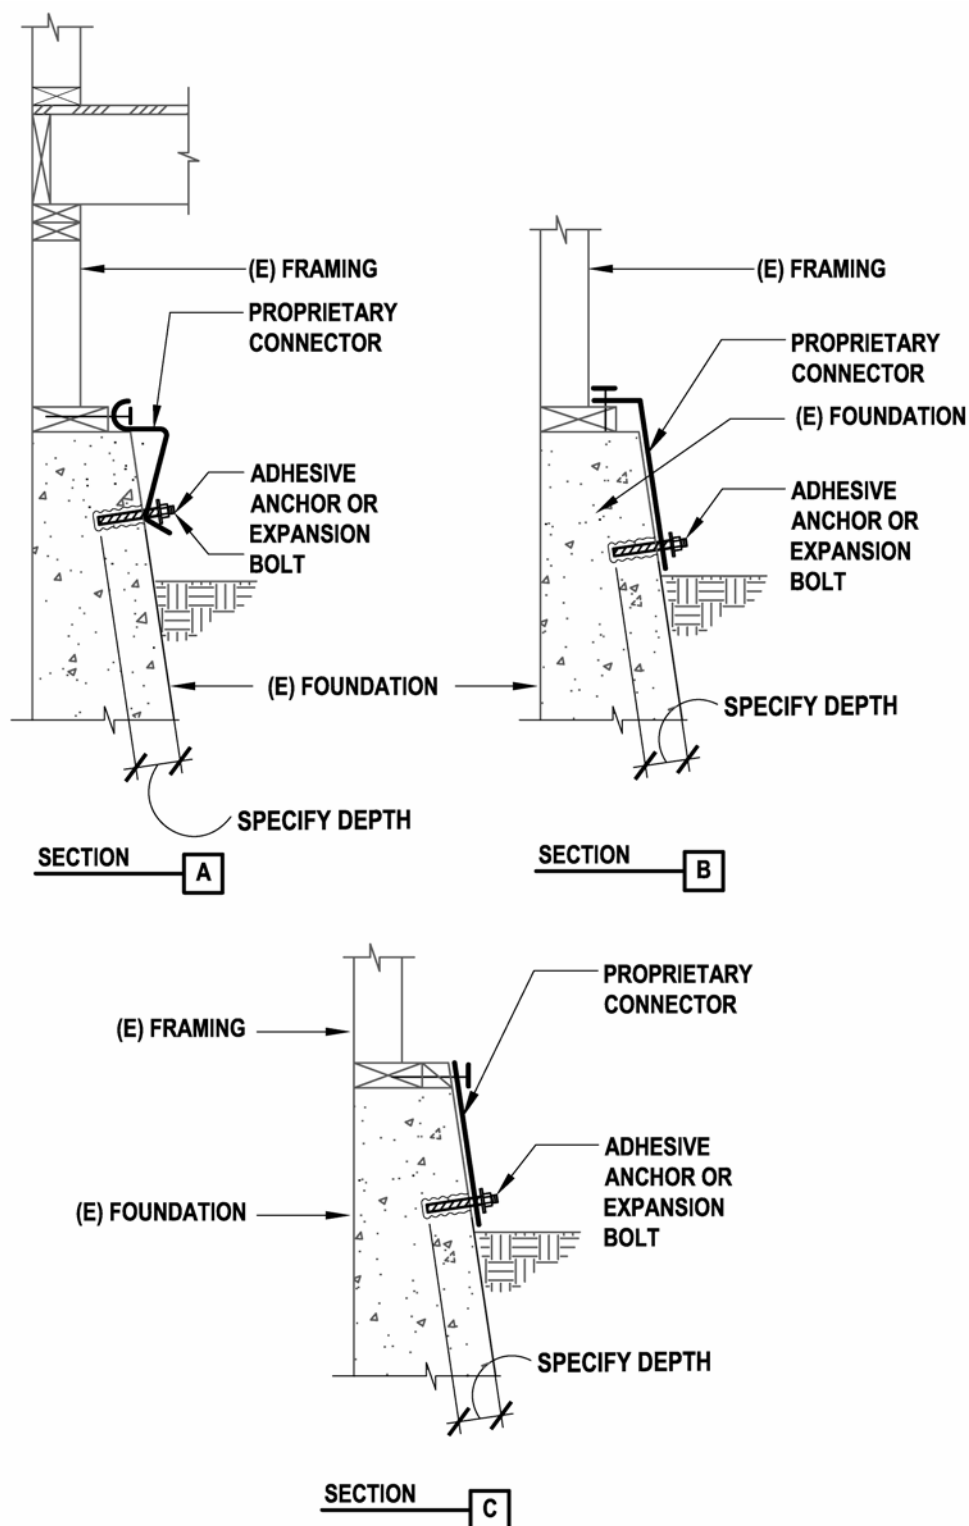
Figure 5.4.3-3: Anchorage to Existing Foundation Using Proprietary Connectors

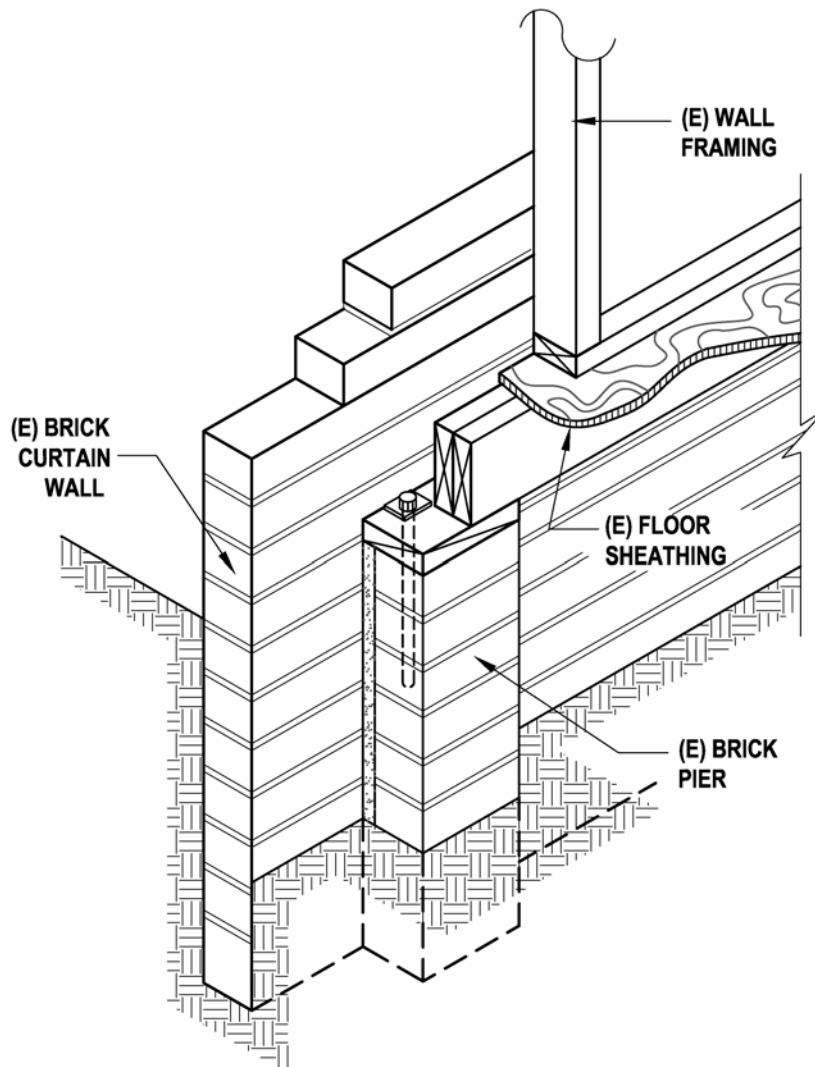
Figure 5.4.3-4: Pier and Curtain Wall Foundation System with Inadequate Load Path Between Shear Walls and Foundation

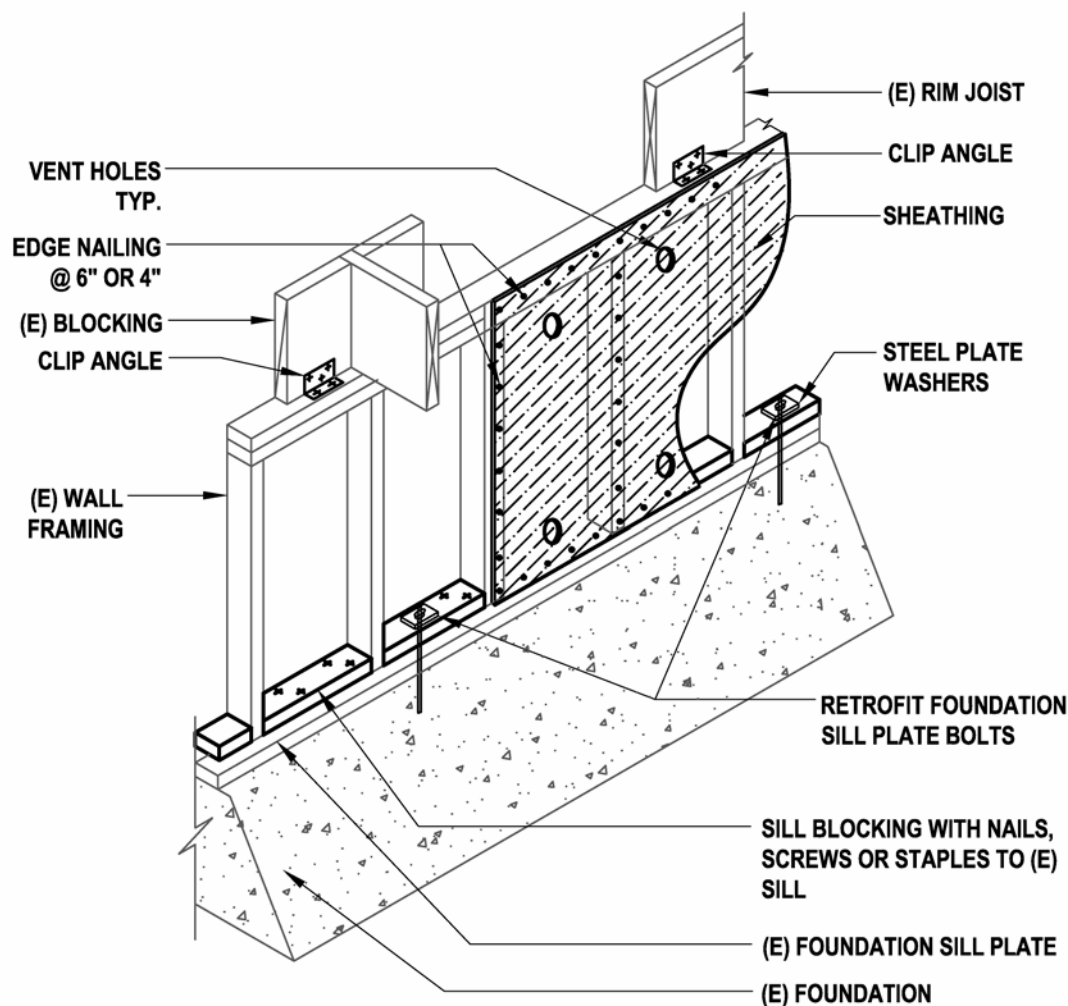
Figure 5.4.4-1: Cripple Wall Enhancement

Where cripple walls are 14 inches tall or less, wood structural panel sheathing may no longer provide reliable bracing of the studs, and splitting of the studs becomes a more significant concern. For this configuration, use of solid blocking between studs is recommended in lieu of sheathing.

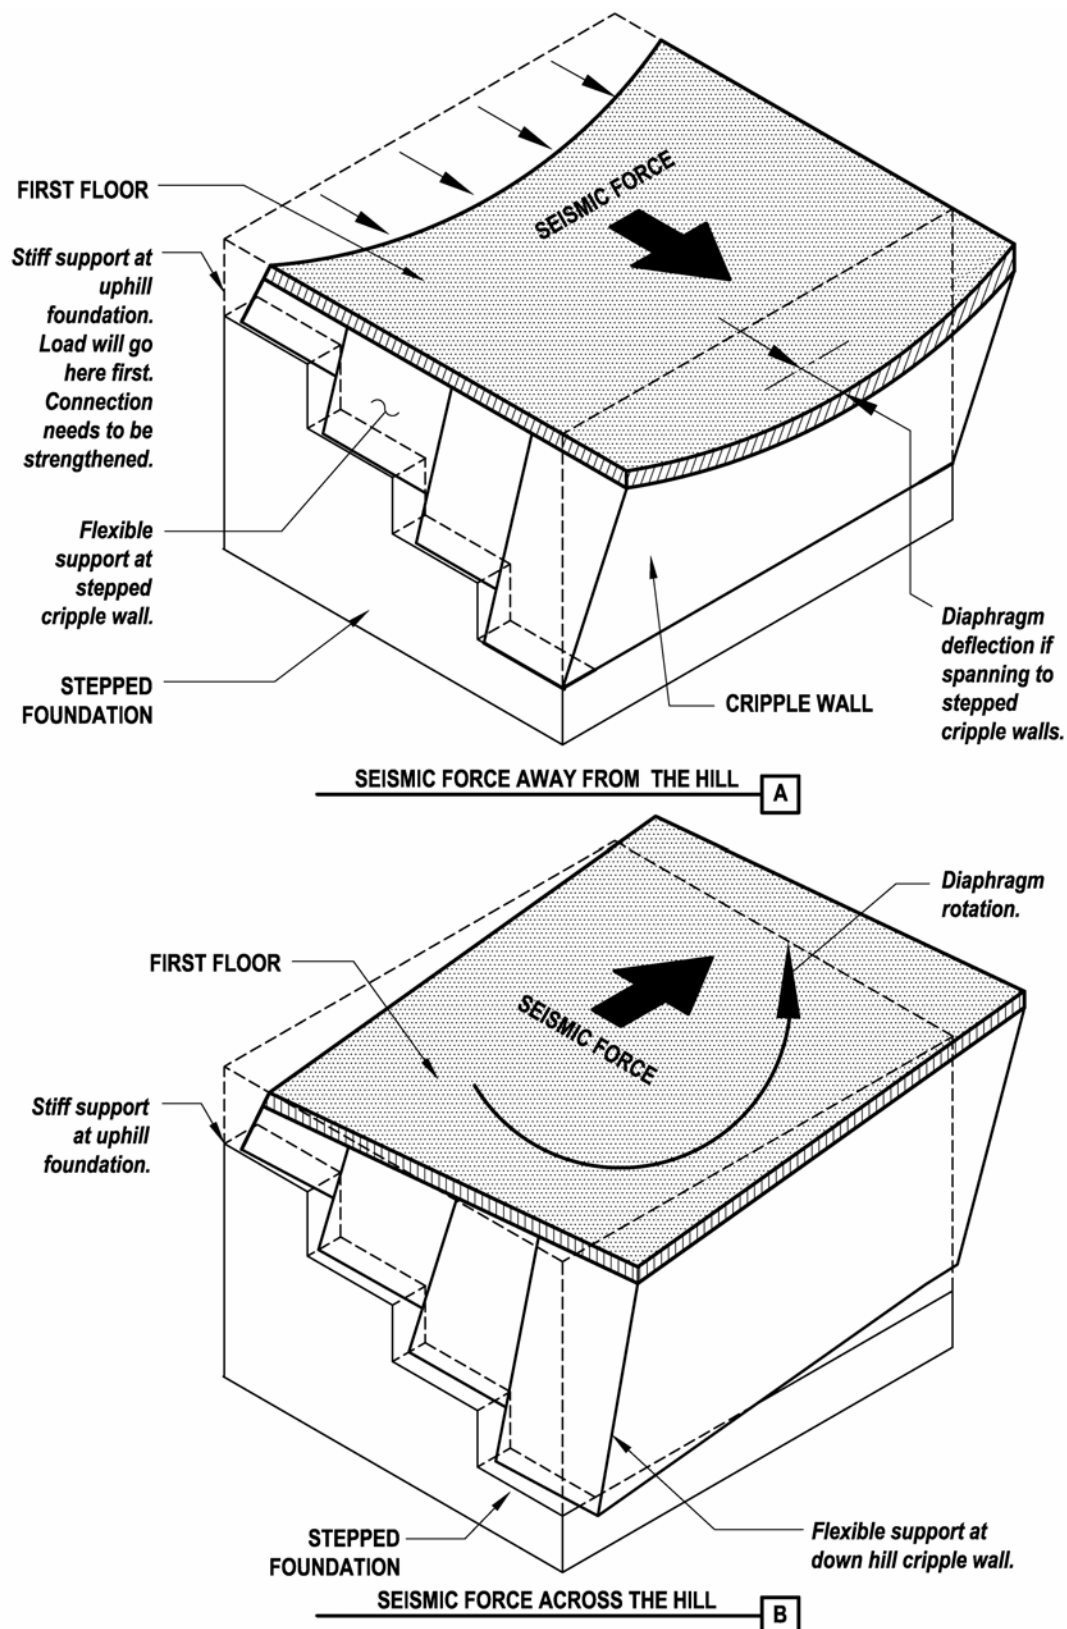
Figure 5.4.5-1: Hillside Home Response to Seismic Forces
Adapted from Von Winterfeldt, Roselund and Kitsuse (2000)

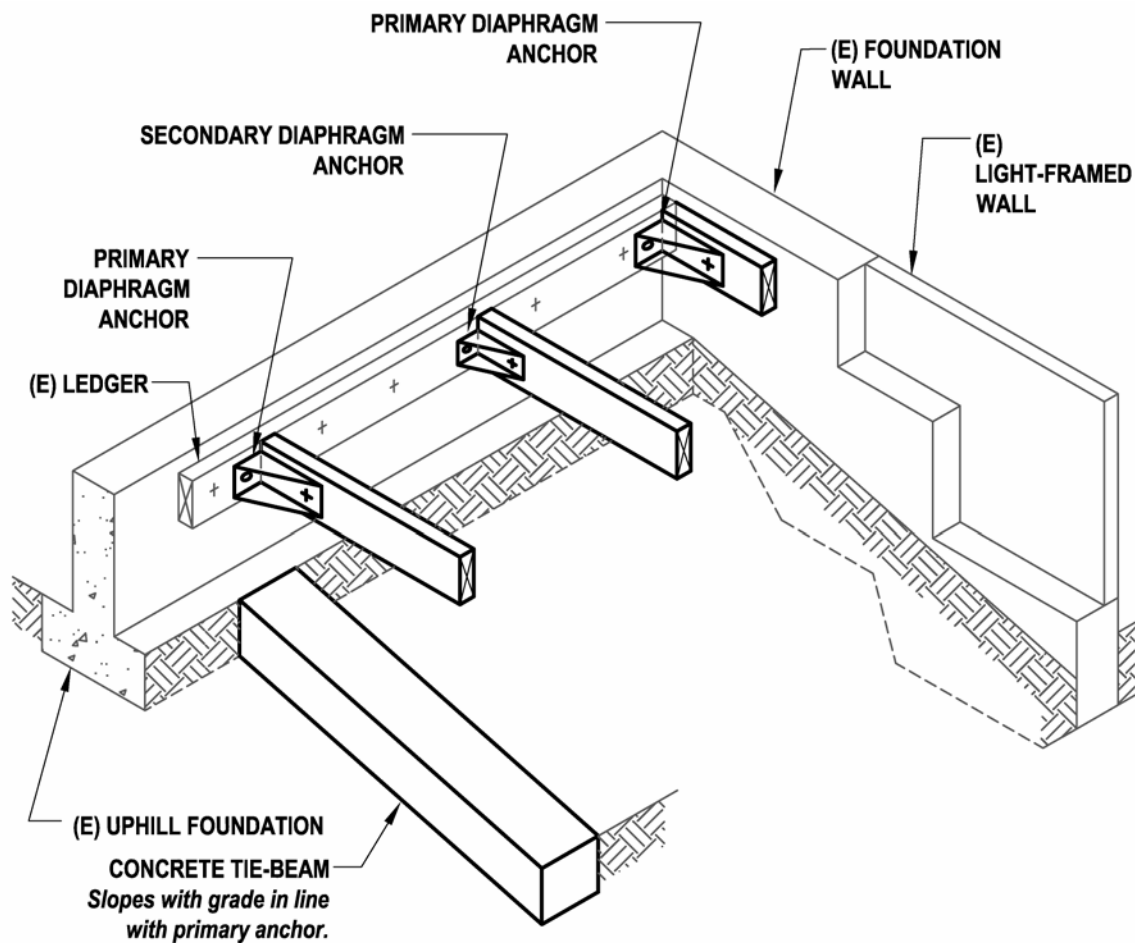
Note. Diaphragm anchor prevents existing ledger from pulling off at uphill foundation.

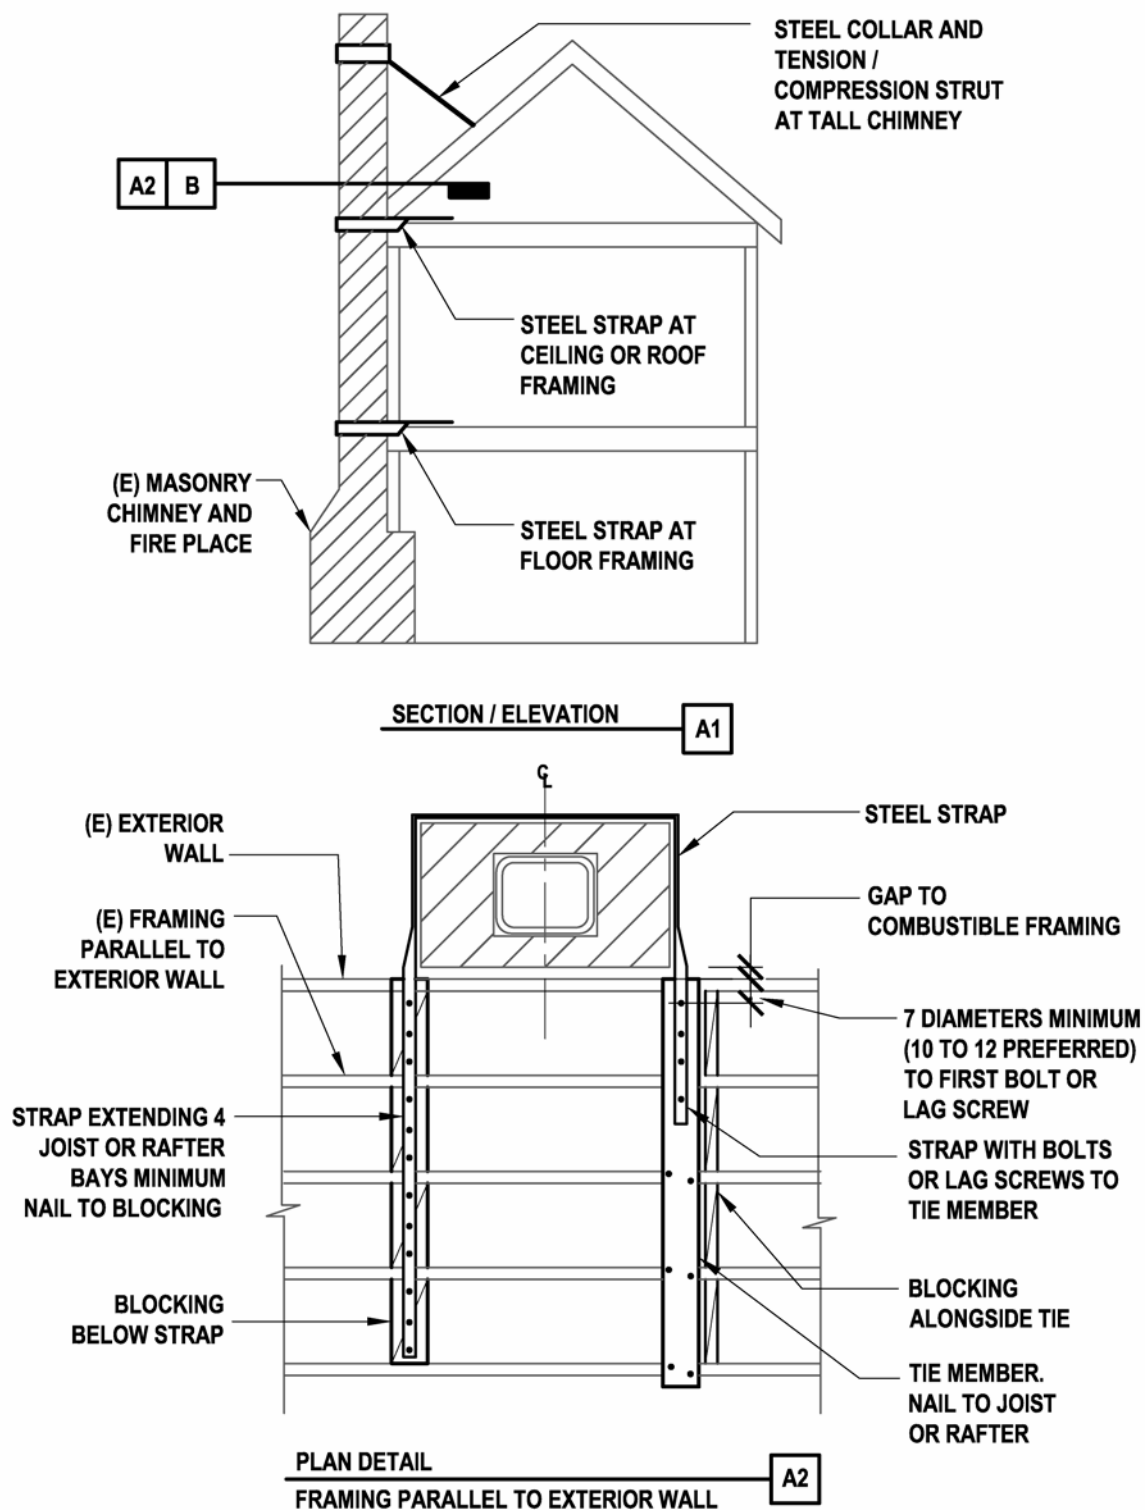
Figure 5.4.6-2A: Bracing of Masonry Chimney

Anchorage of a strap or other tie to an existing masonry chimney should be avoided where possible and otherwise approached with caution. Expansion anchors cause splitting tensile stresses that can result in cracking of the masonry. Adhesive anchors change properties under elevated temperatures that might be experienced during use of the chimney.

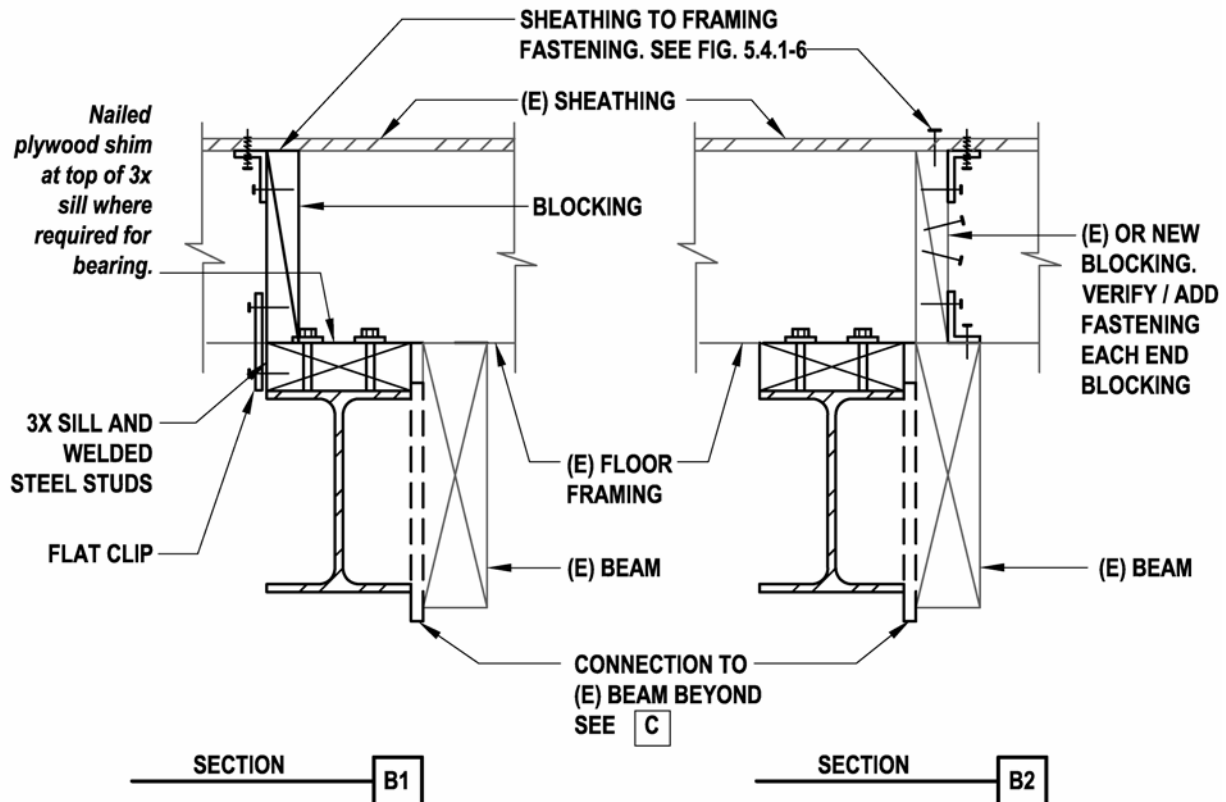
Figure 6.4.1-1B: Shear Transfer Between Moment Frame Beam and Diaphragm

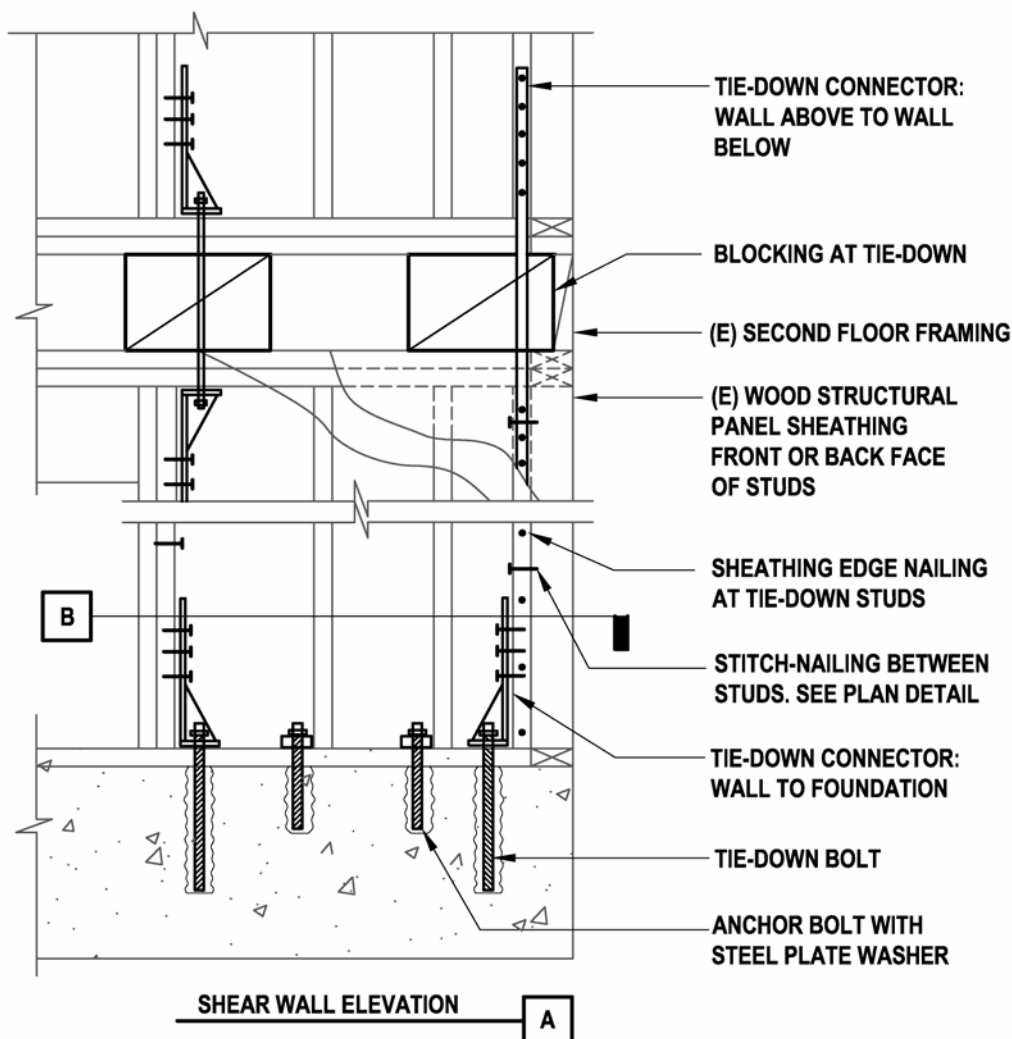
Figure 6.4.4-1A: Shear Wall Elevation with Enhanced Overturning Detailing

Figure 6.4.4-1A illustrates a shear wall elevation with commonly used tie-down connectors for a slab-on-grade condition. Figure 6.4.4-1B illustrates fastening to develop a load path between the tie-down connector and the shear wall sheathing edge nailing. For sheathing and framing conditions other than those shown, similar fastening must be provided to complete the load path.

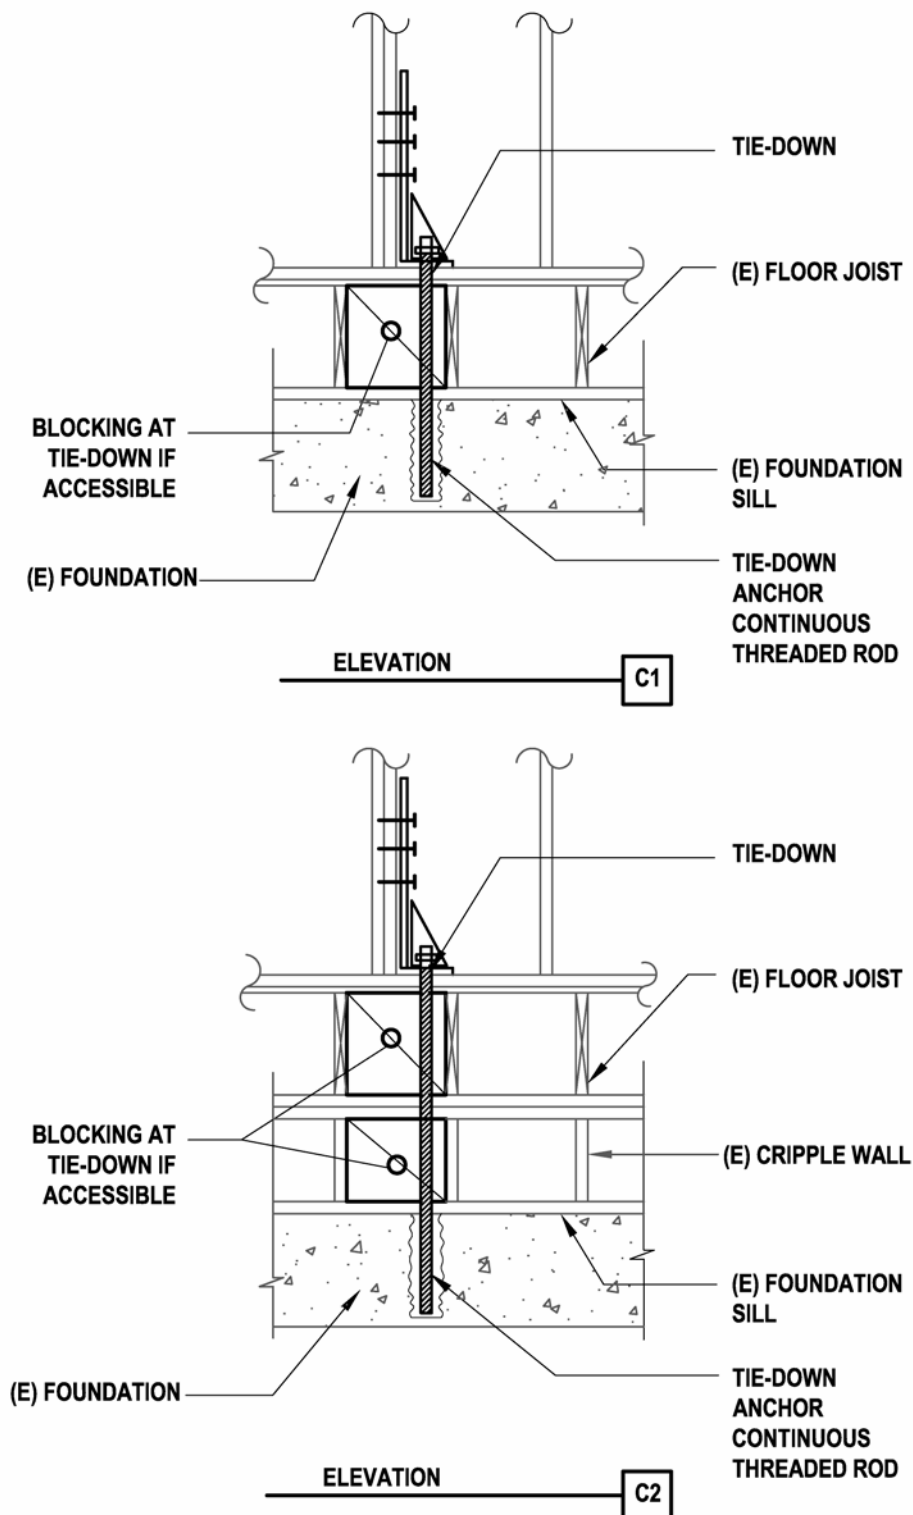
Figure 6.4.4-1C: Tie-down Details at Alternate Base Conditions
