Techniques for the Seismic Rehabilitation of Existing Buildings

FEMA 547/2006 Edition

FEMA 547 – October 2006

Rutherford & Chekene (R & C) Consulting Engineers (Subconsultant) under contract with National Institute of Standards and Technology (NIST).

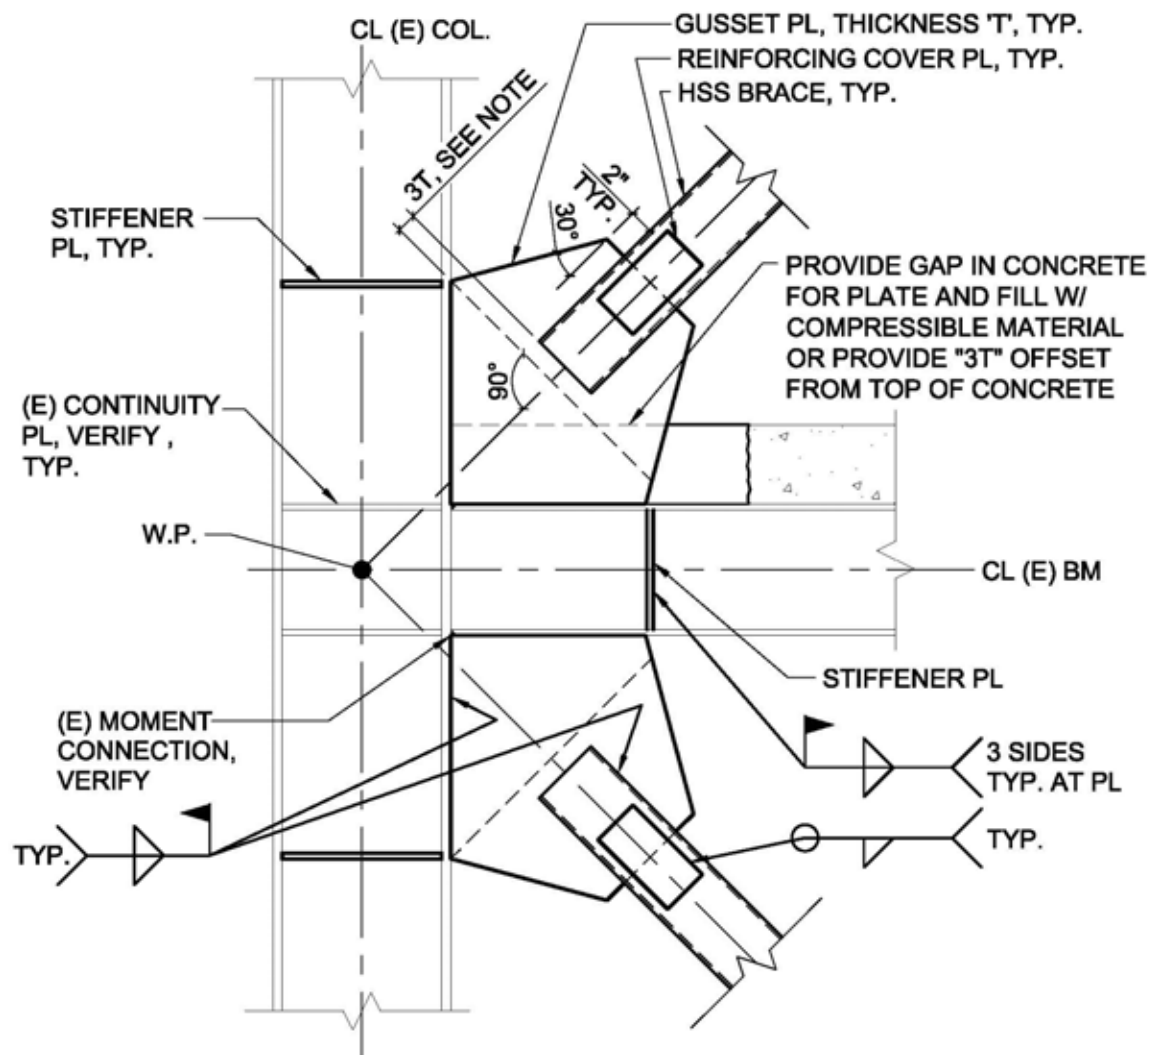
Figure 8.4.1-1: HSS Brace at Existing Beam-Column Connection in SCBF

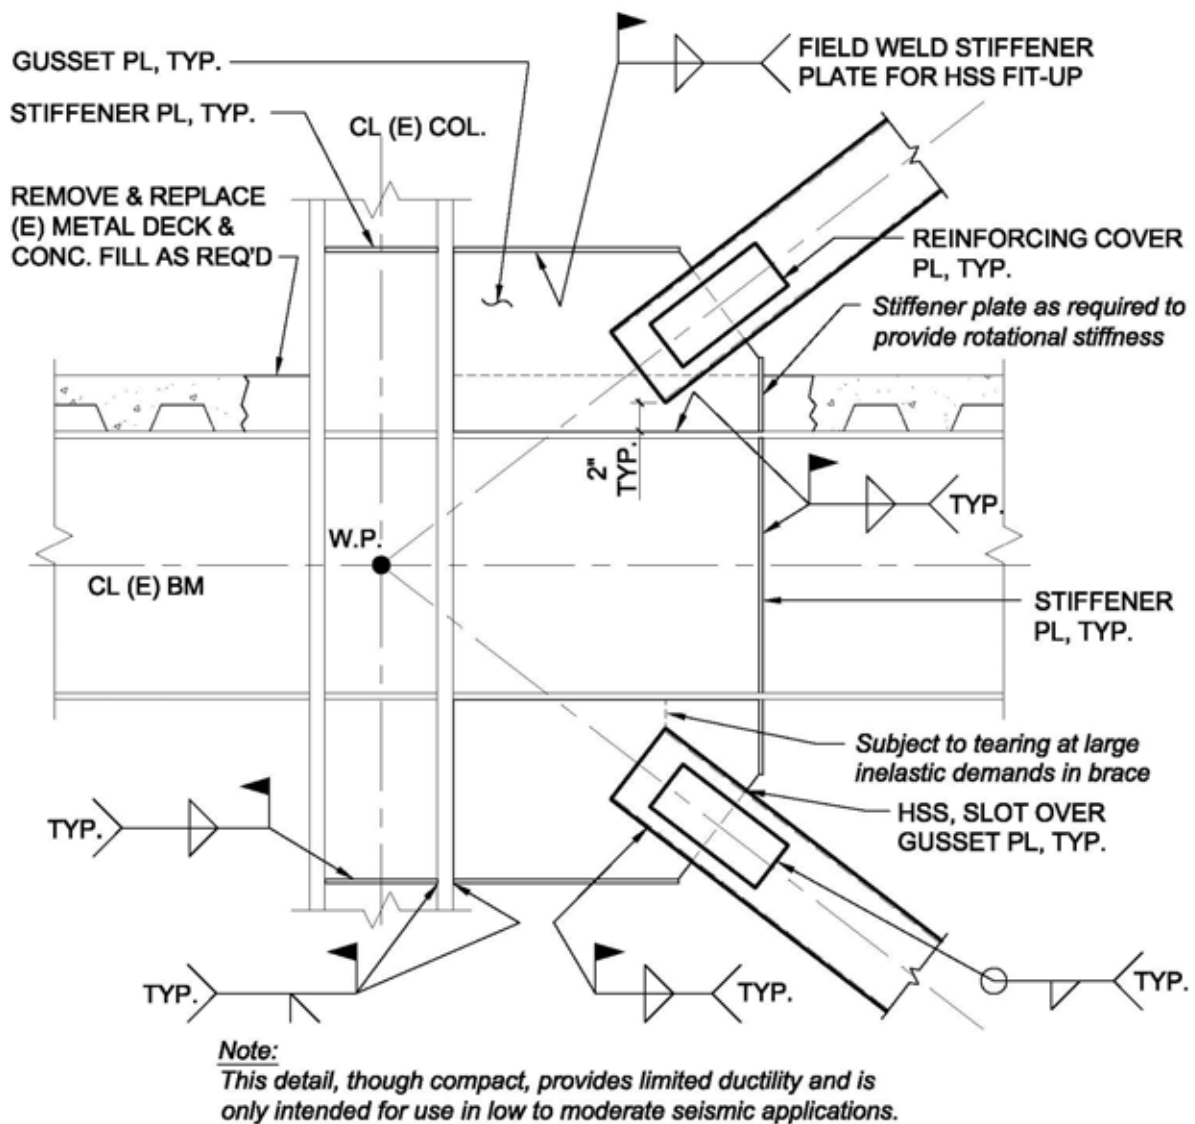
Figure 8.4.1-2: HSS Brace at Existing Beam-Column Connection in Ordinary CBF

For low to moderate seismic applications, Figure 8.4.1-2 shows a more compact connection. An example of a W-shape used as a brace and welded directly to the beam and column is shown in Figure 8.4.1-3. The two latter connections do not allow for restraint-free plastic rotations out-of-plane and should be used primarily in situations where in-plane buckling of the braces govern or

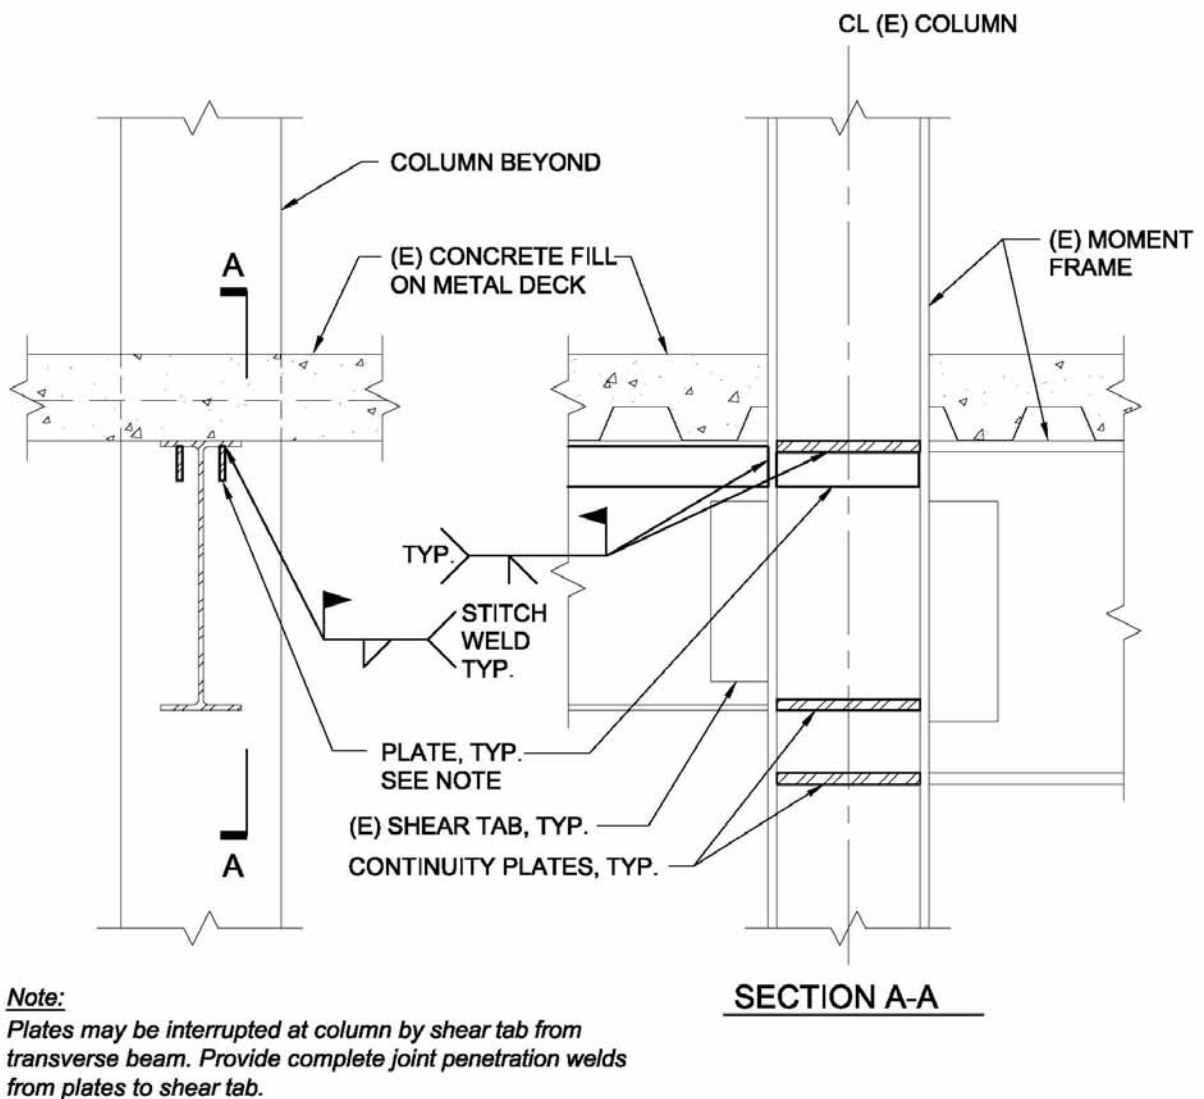
Figure 8.4.4-1: Plate Collectors at Existing Beam

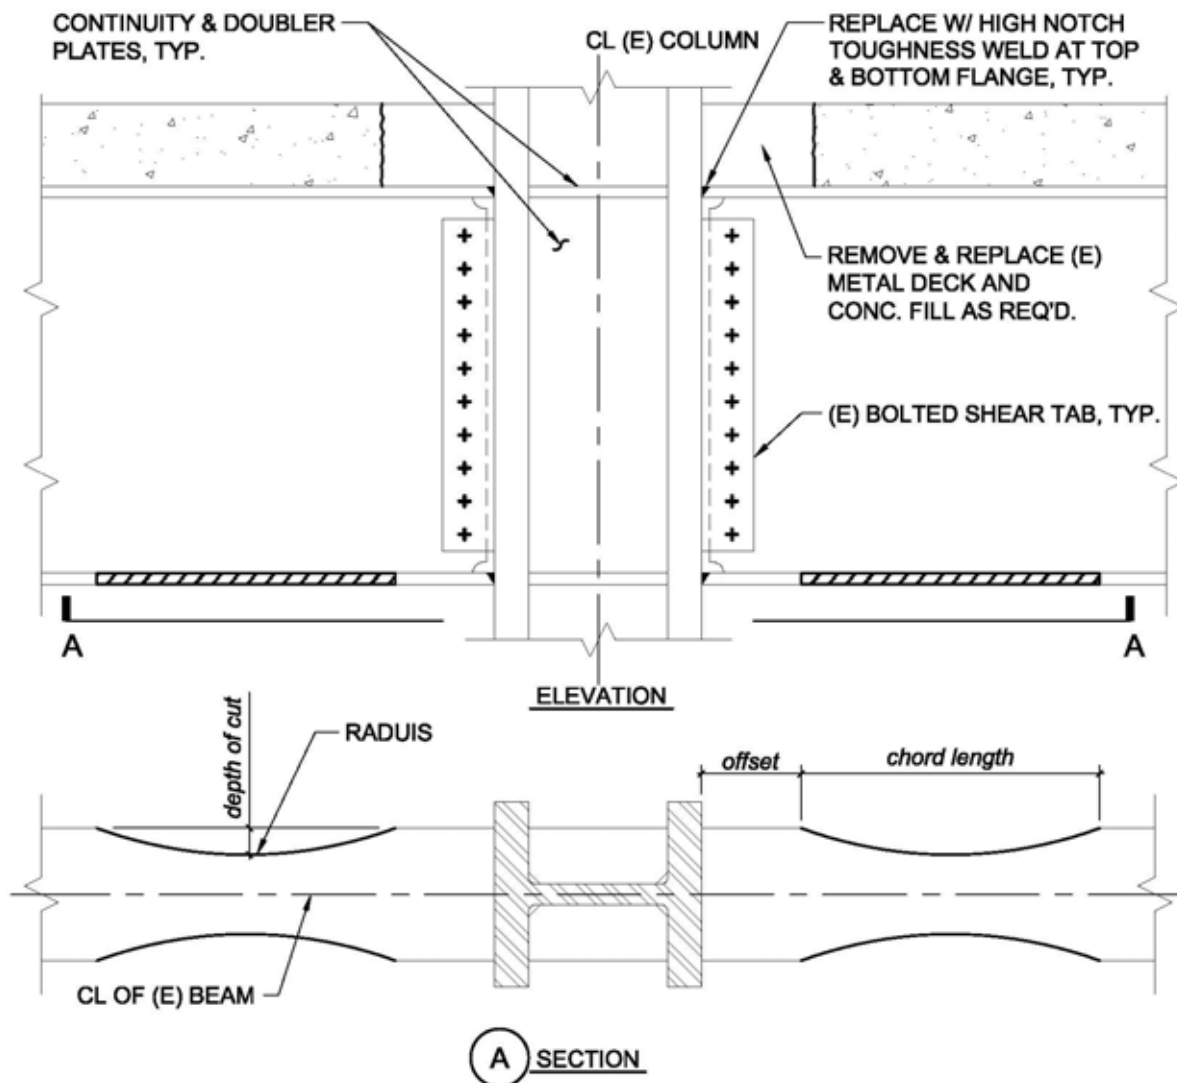
Figure 8.4.6-1: Reduced Beam Section at Bottom Flange of Existing Beam
(adapted from *AISC Design Guide 12*)

length of the cut should also be long enough to control the inelastic strains along the RBS. The radius of the cut is a function of its depth and the chord length. See *AISC Design Guide 12* for specific recommendations and guidelines for selecting these dimensions.

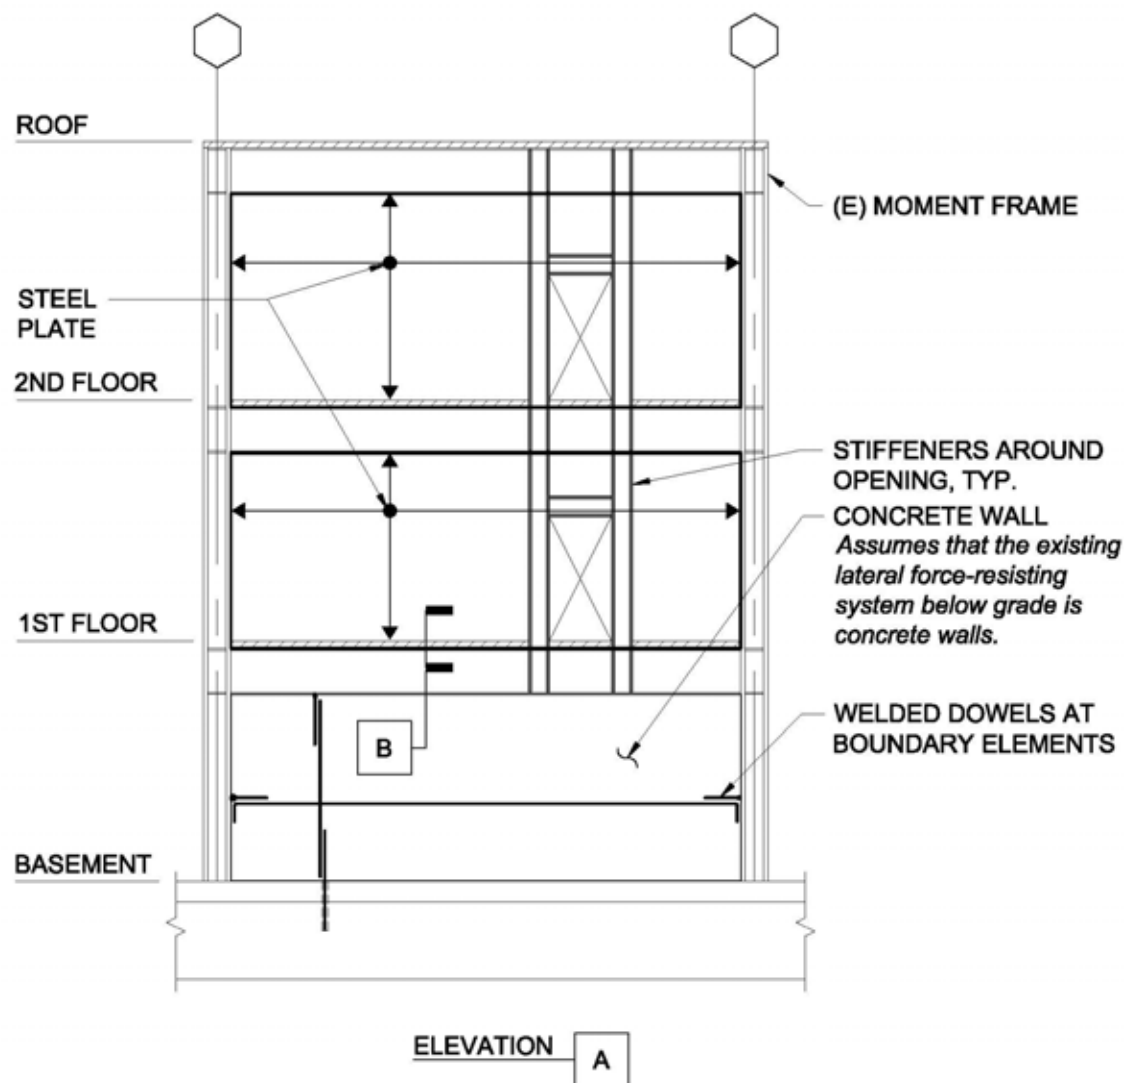
Figure 8.4.8-1A: Unstiffened Steel Plate Shear Wall

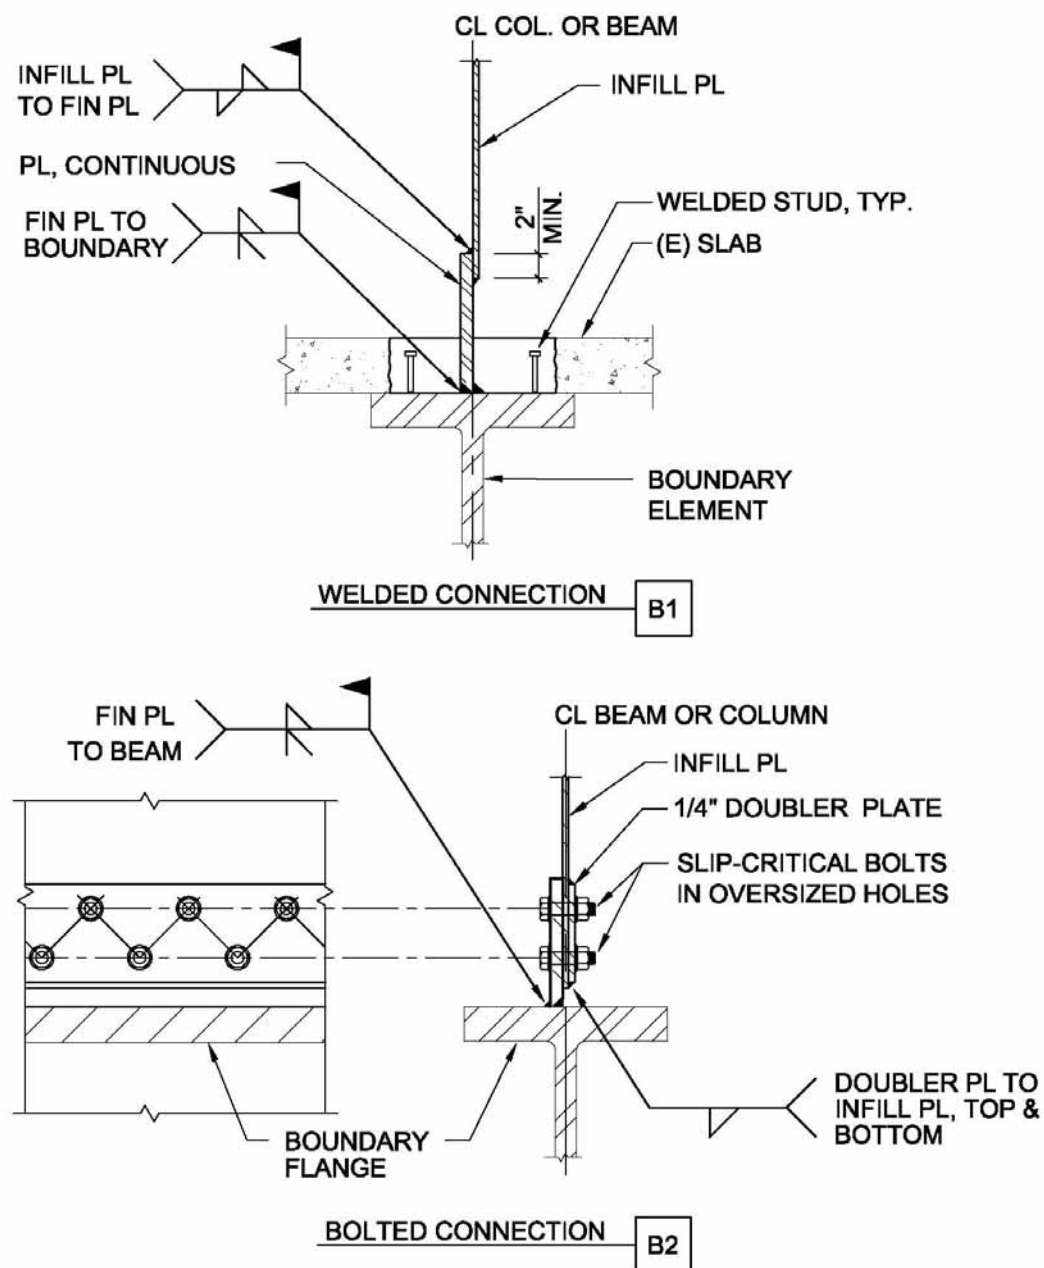
Figure 8.4.8-1B: Fin Plate Connection Options

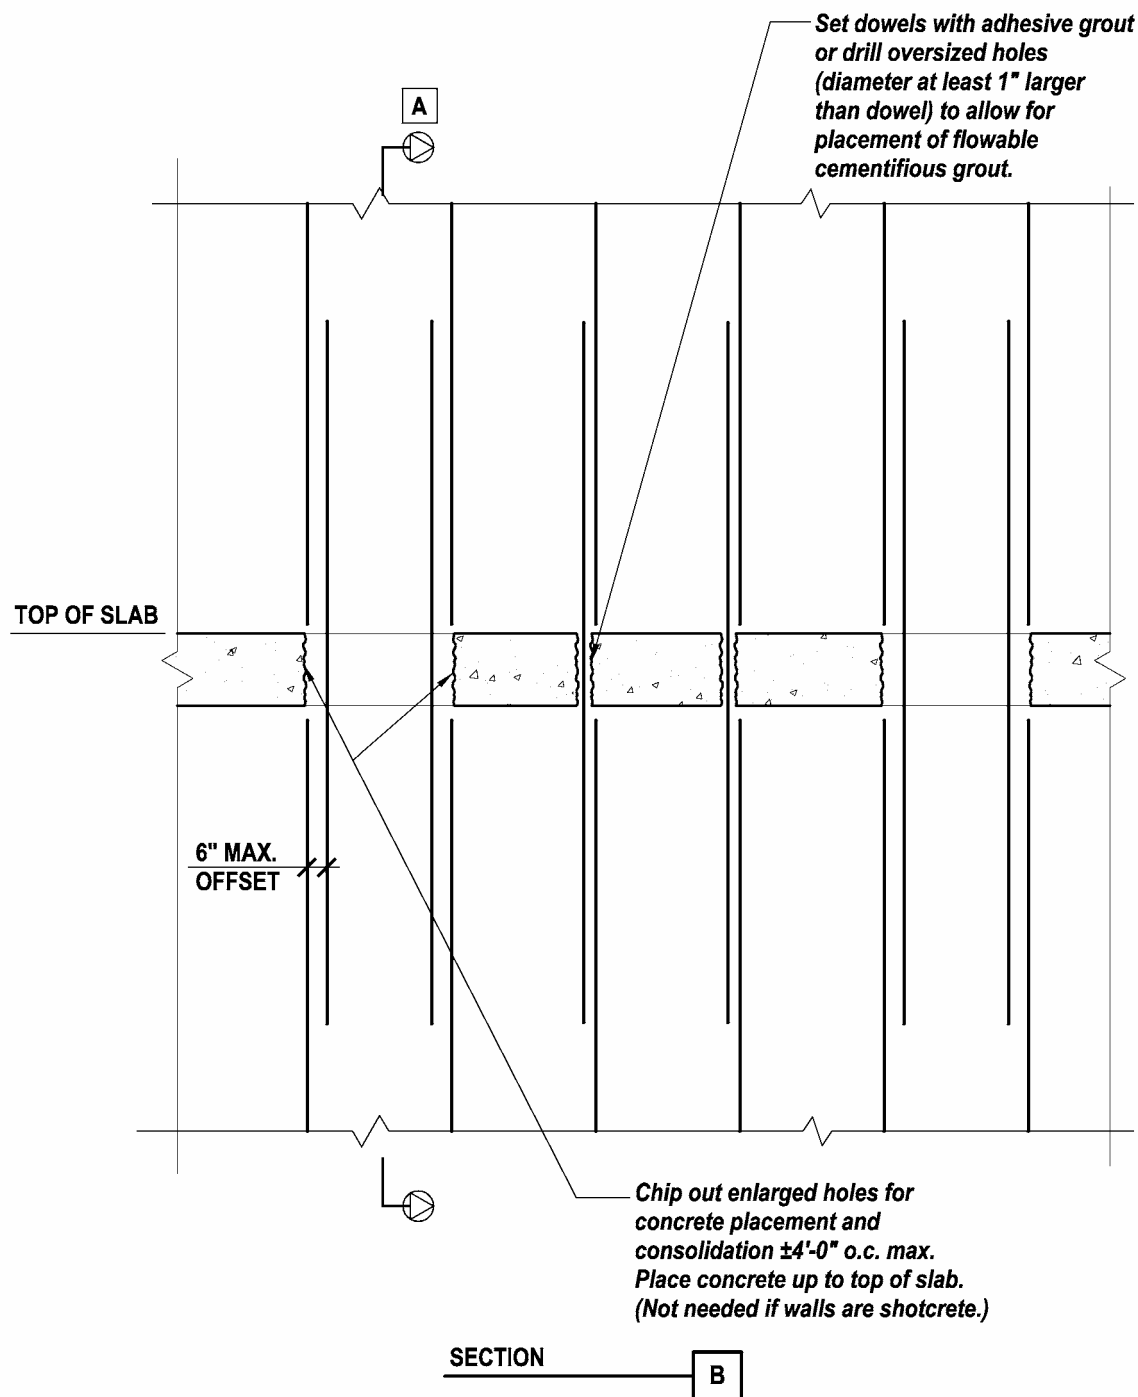
Figure 12.4.2-1B: Concrete Wall Connection to Concrete Slab – Partial Elevation View

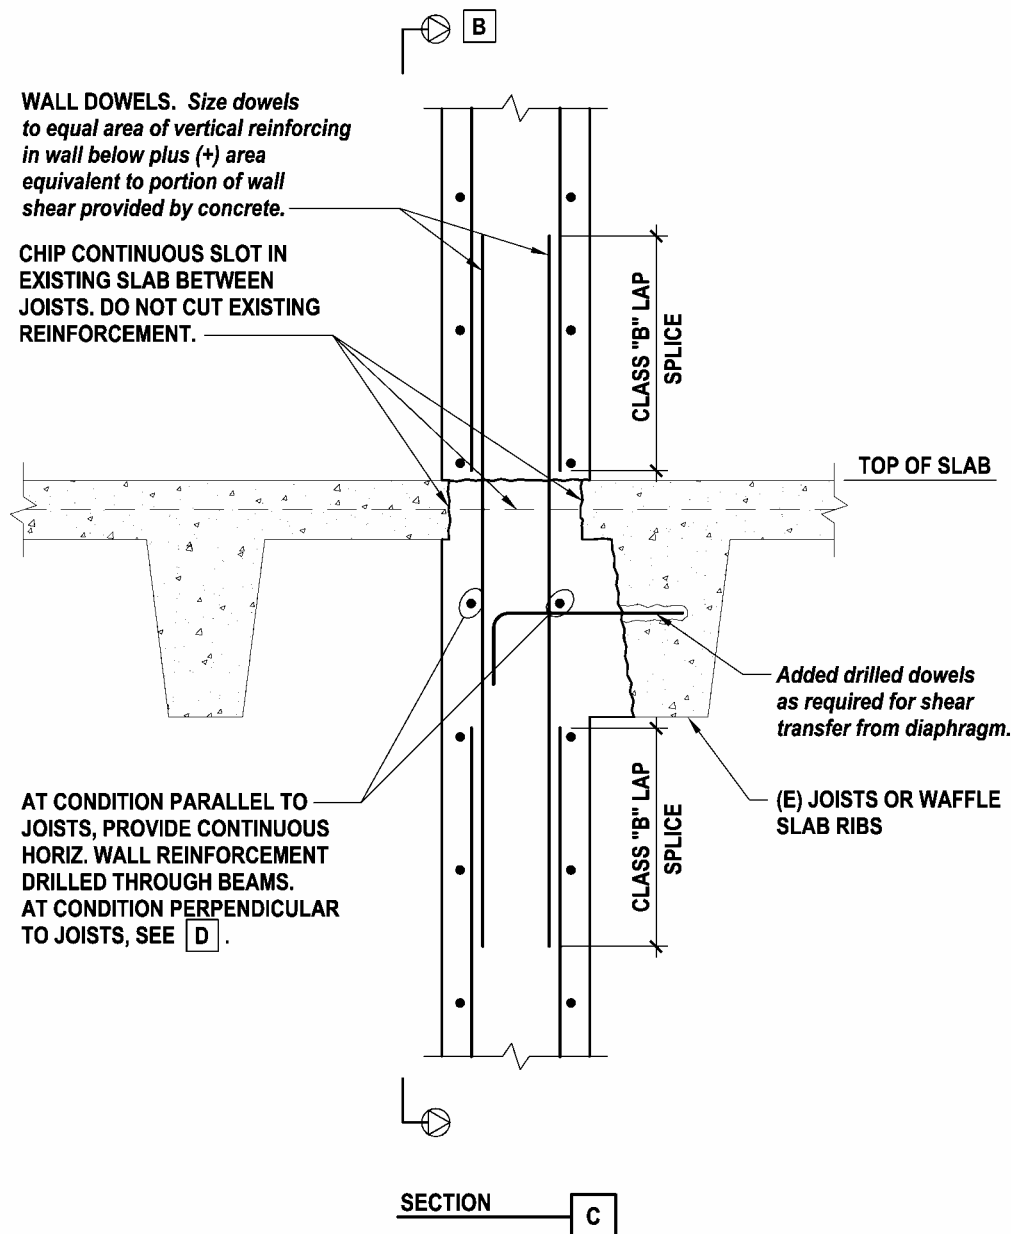
Figure 12.4.2-1C: Connection of Concrete Wall to Concrete Joists or Waffle Slab

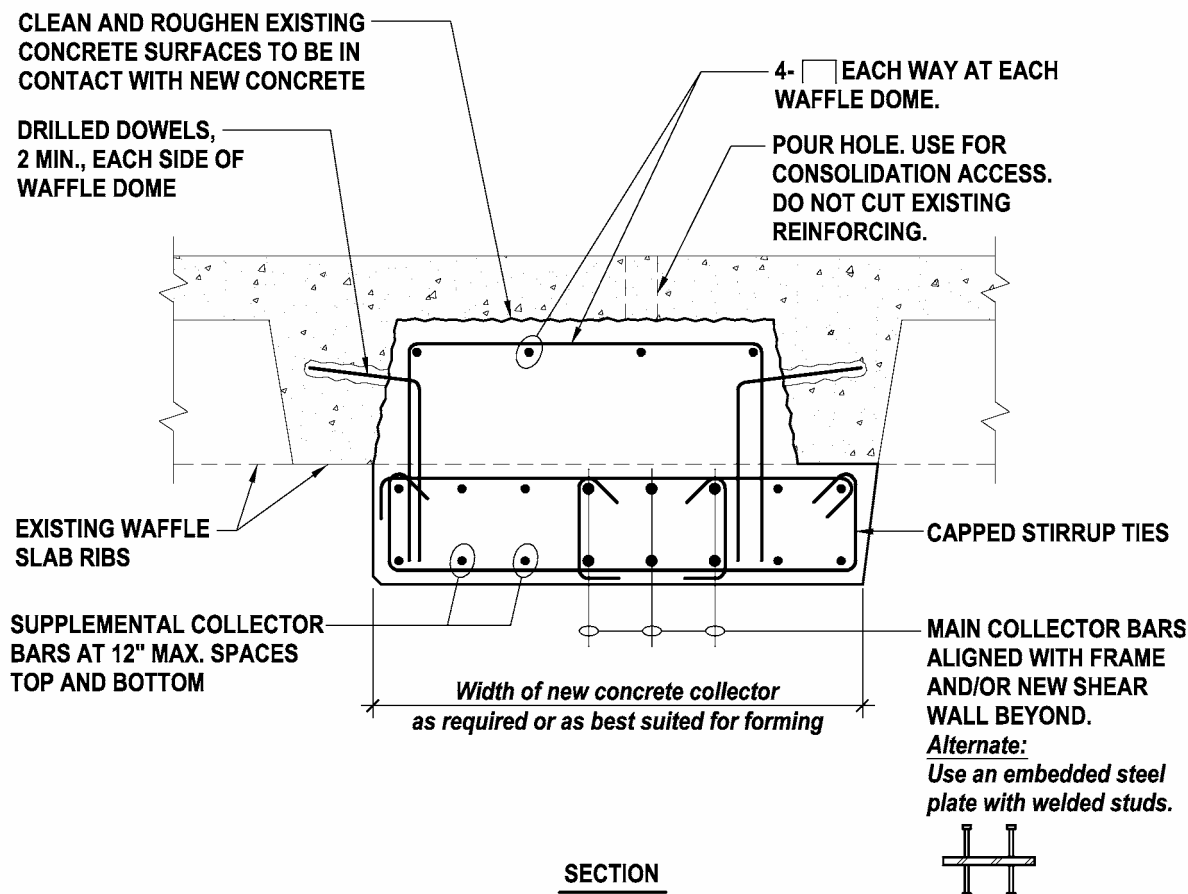
Figure 12.4.3-2: Concrete Collector at Waffle Slab

If the existing floor or roof diaphragm is a waffle or pan joist system, the continuous collector will almost always be placed below the ribs, as shown in Figure 12.4.3-2, to avoid excessive drilling and rebar splicing. In this condition, the voids between the ribs, above the dropped collector, will be filled with reinforced concrete. Advantages of this condition are that the drilled dowels can be installed into the sides of the ribs instead of the relatively thin cover slab, and making pour ports through the slab is likely to be less problematic. Also, although the new collector may weigh more in this condition, the waffle or joist ribs are much more likely to have adequate strength to support the added weight.

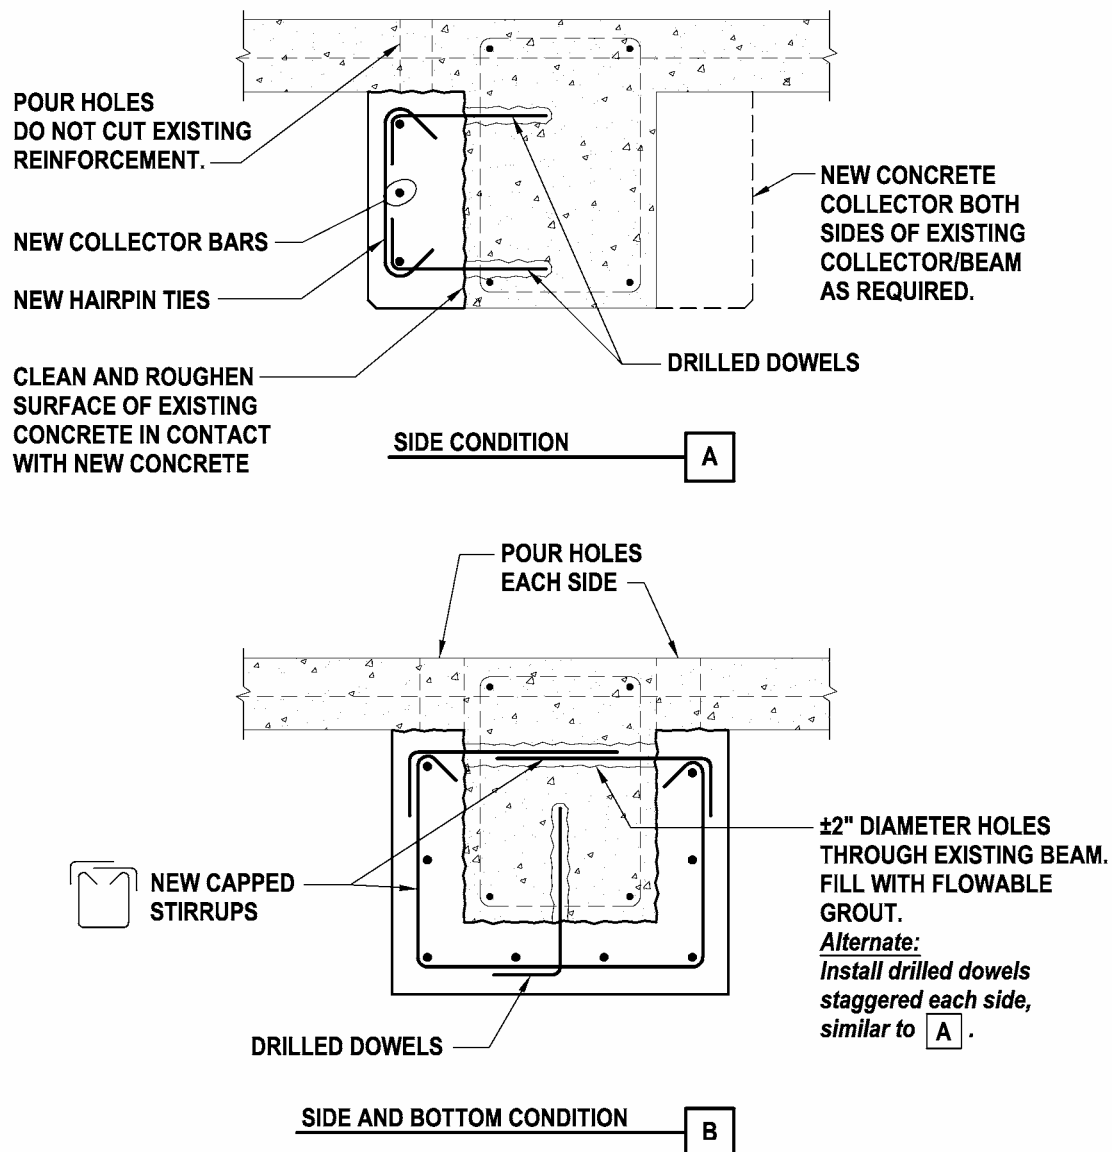
Figure 12.4.3-3: Concrete Collector at Existing Beam

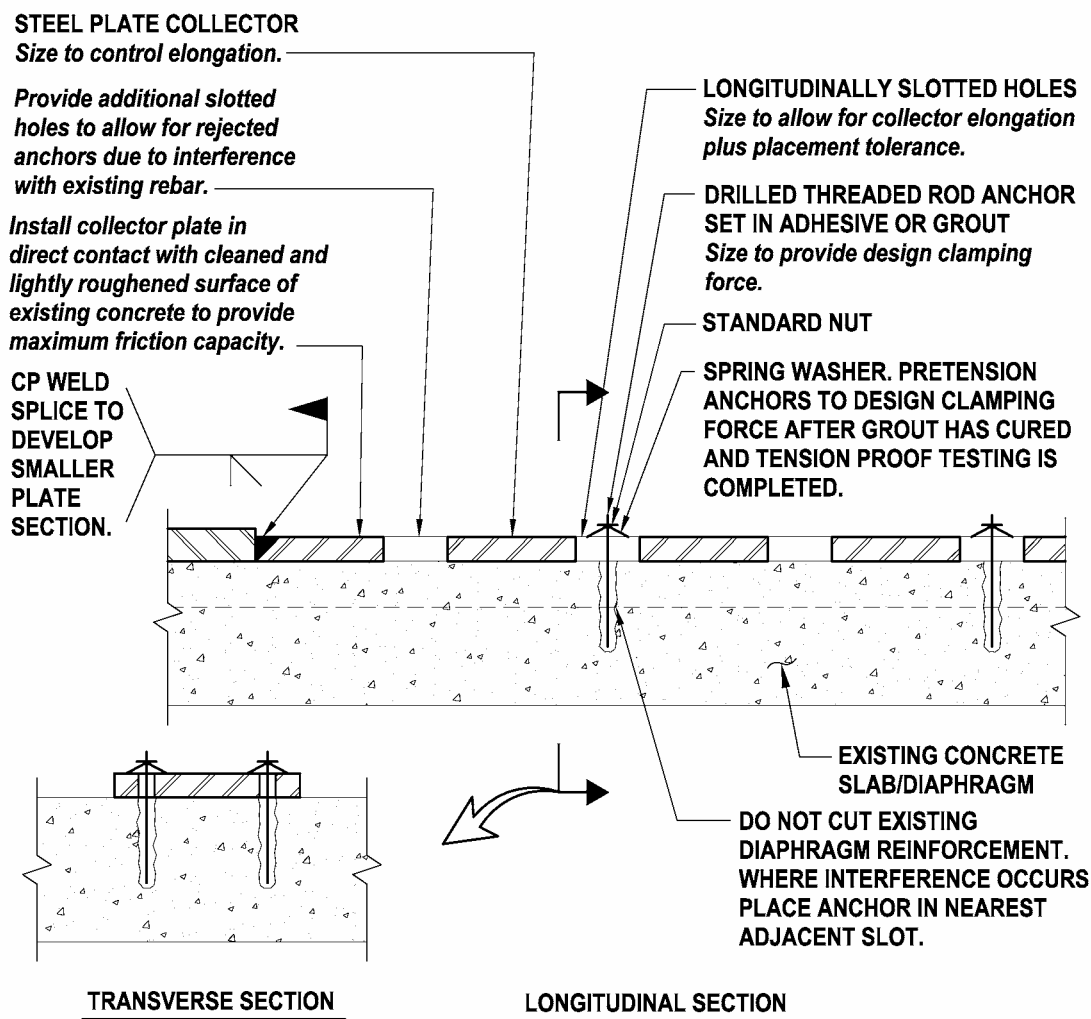
Figure 12.4.3-4: Steel Plate Collector

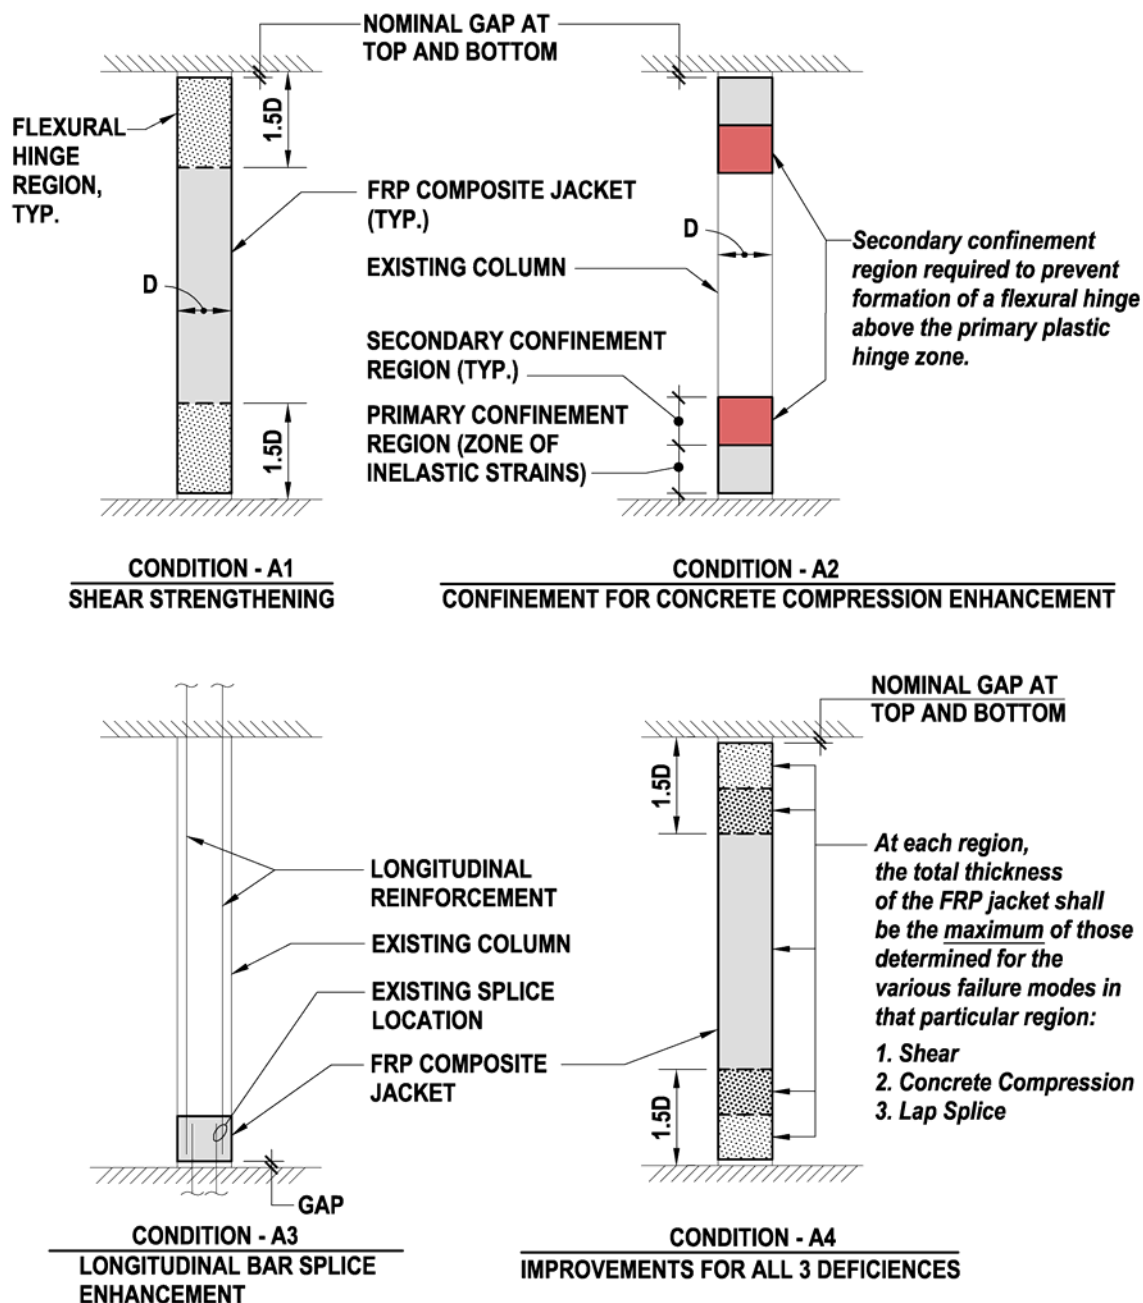
Figure 12.4.4-1A: Seismic Retrofit of Columns Using FRP Composites

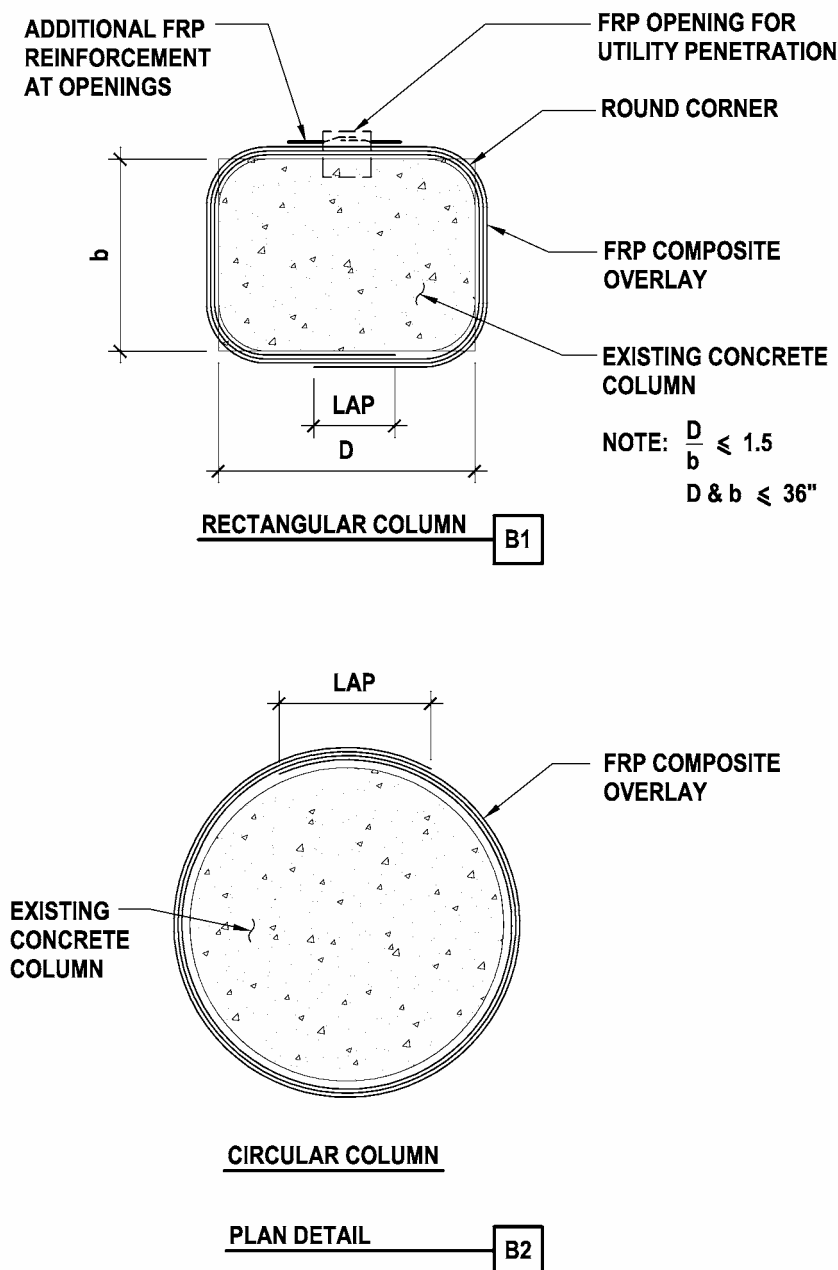
Figure 12.4.4-1B: Seismic Retrofit of Columns Using FRP Composites

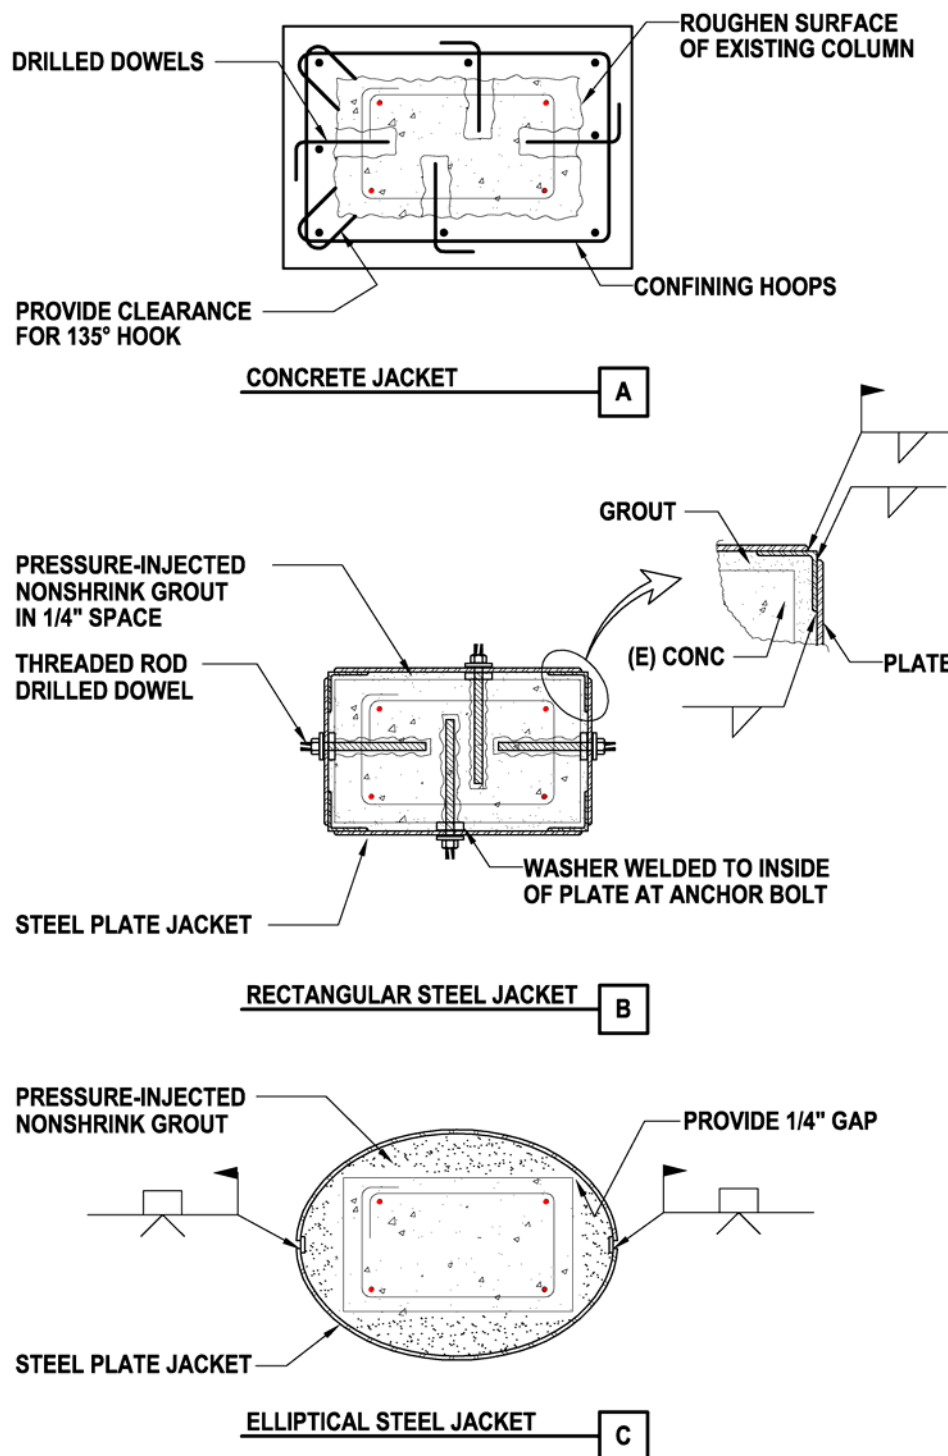
Figure 12.4.5-1: Concrete and Steel Overlays for Concrete Columns

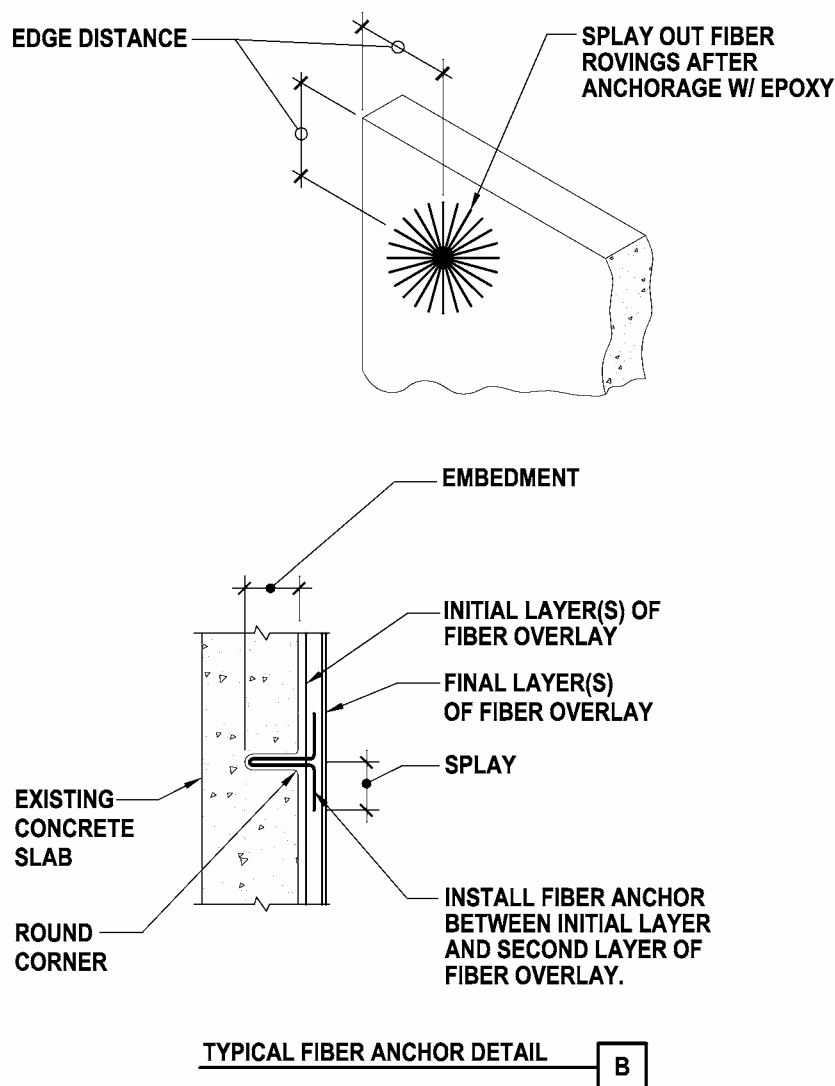
Figure 13.4.1-1B: Fiber Anchor Details

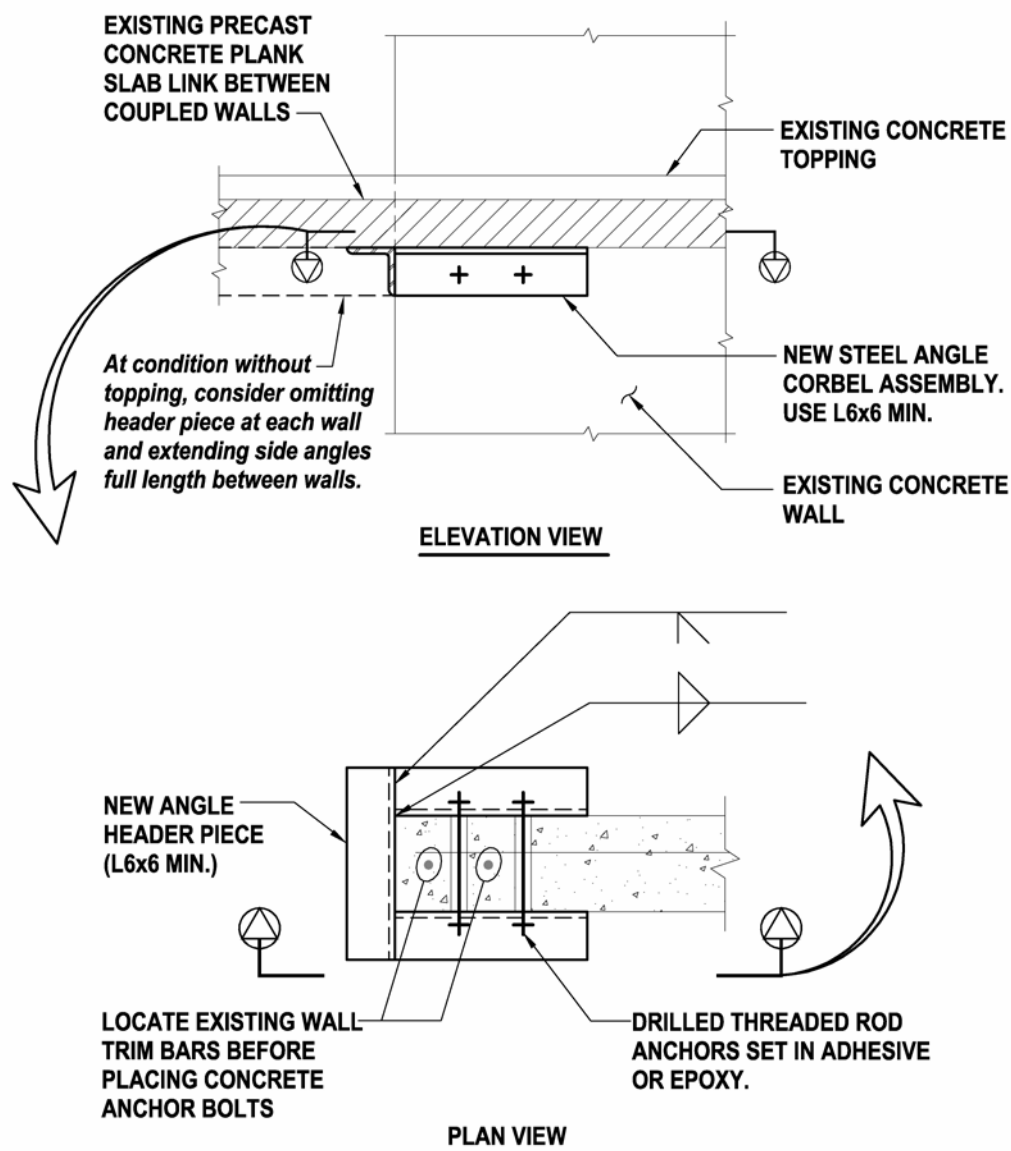
Figure 13.4.2-1: Typical Corbel at Linking Slab

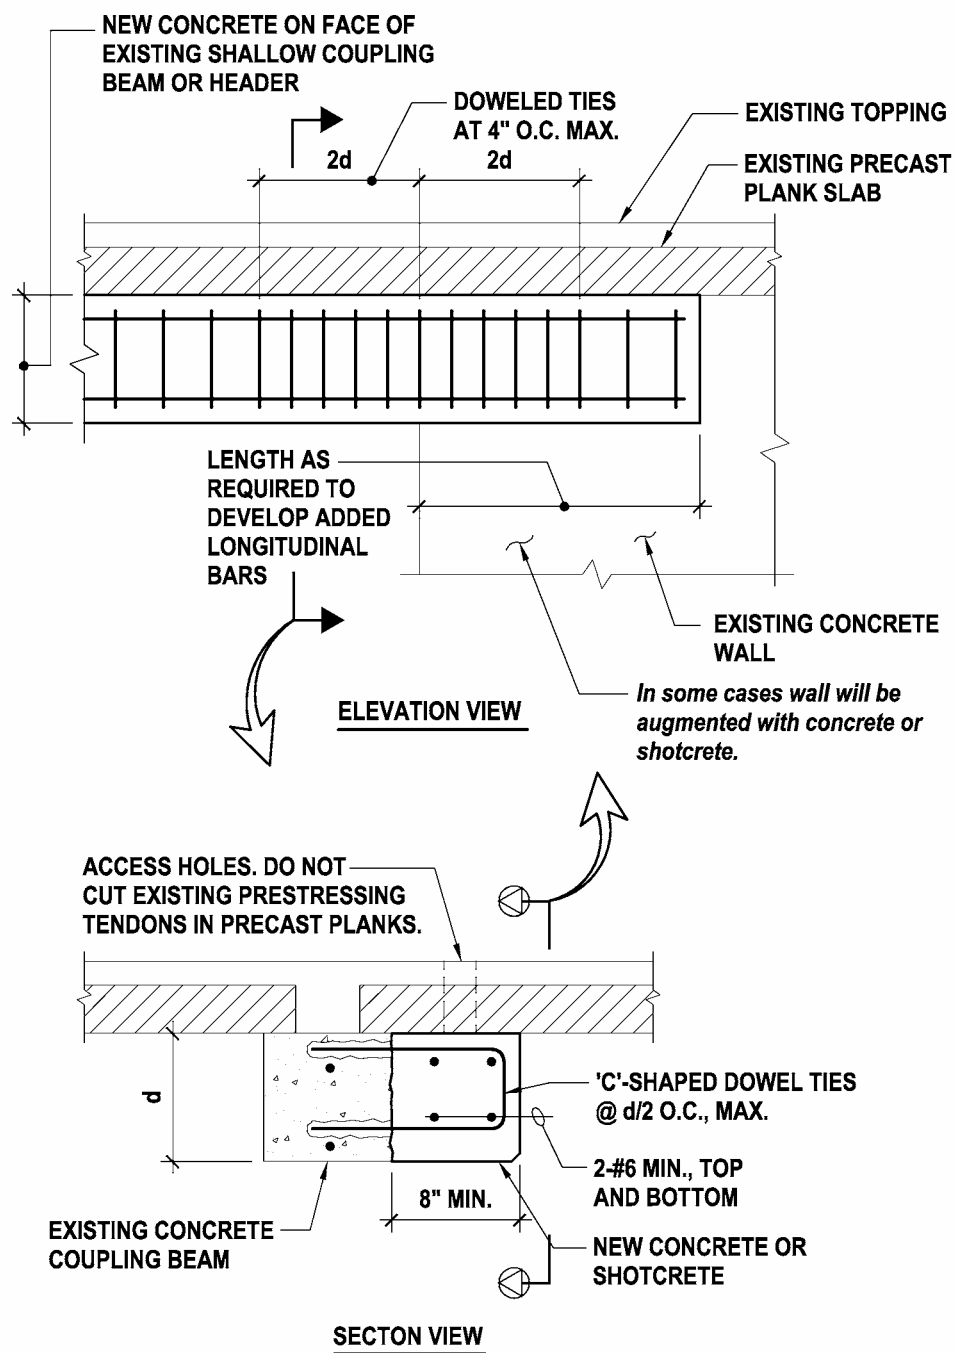
Figure 13.4.2-2: Typical Strengthening of Shallow Coupling Beam

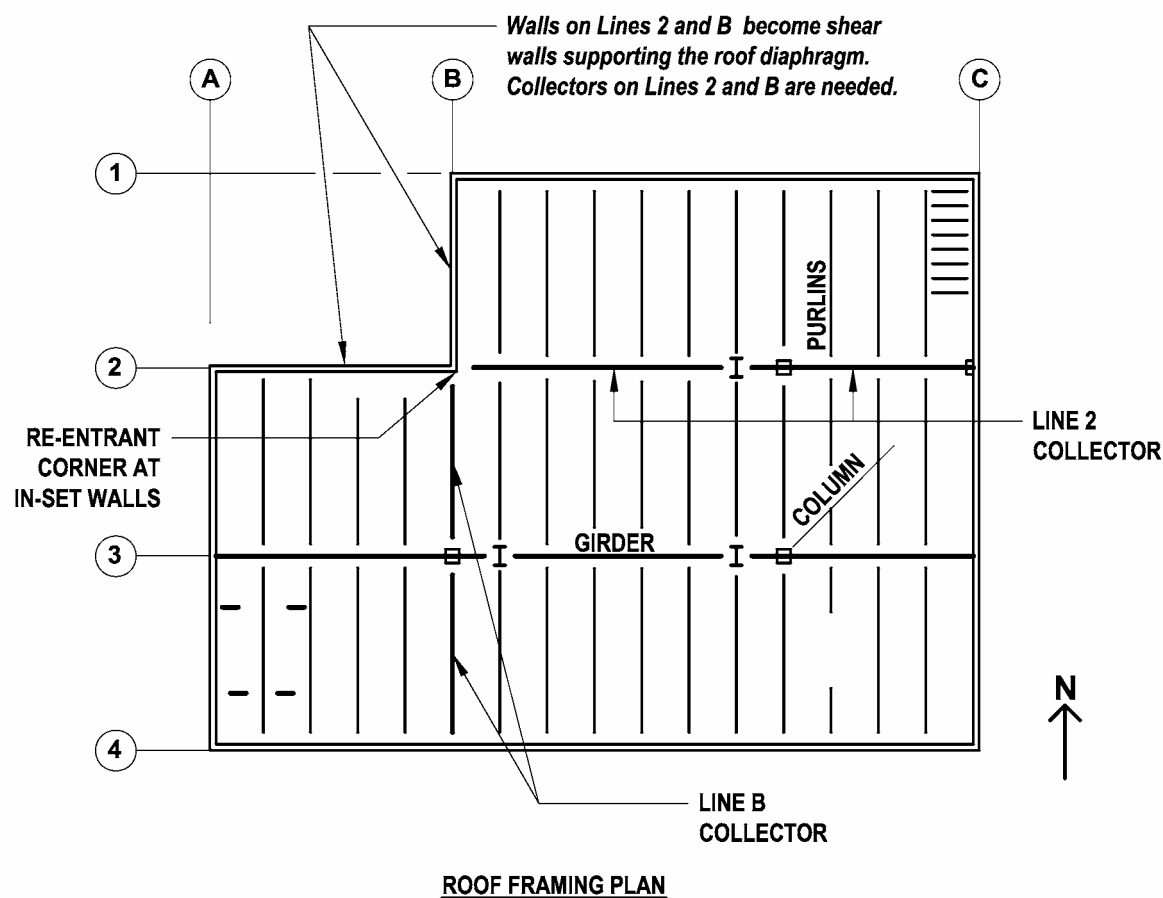
Figure 16.3-1: Plan of PC1 Building with Re-Entrant Corner at In-Set Panels
