Techniques for the Seismic Rehabilitation of Existing Buildings

FEMA 547/2006 Edition

FEMA 547 – October 2006

Rutherford & Chekene (R & C) Consulting Engineers (Subconsultant) under contract with National Institute of Standards and Technology (NIST).

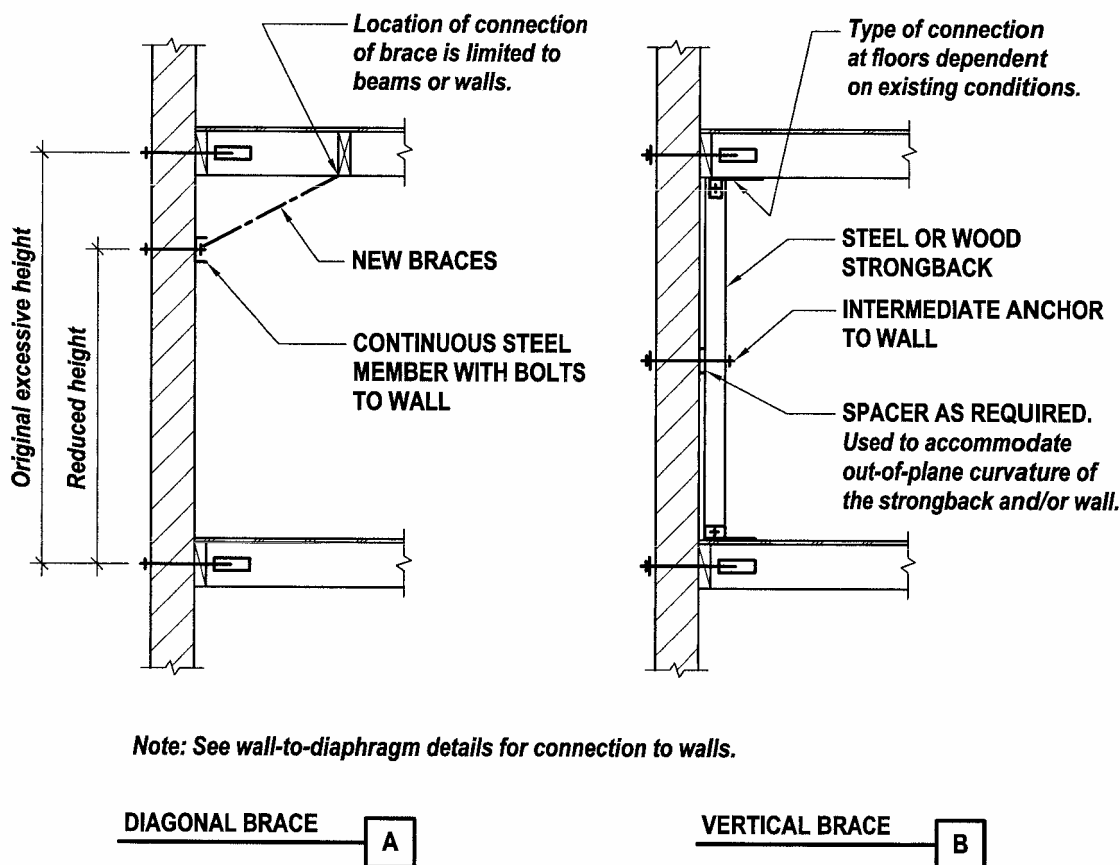
Figure 21.4.3-1: Exposed Out-of-Plane Wall Bracing

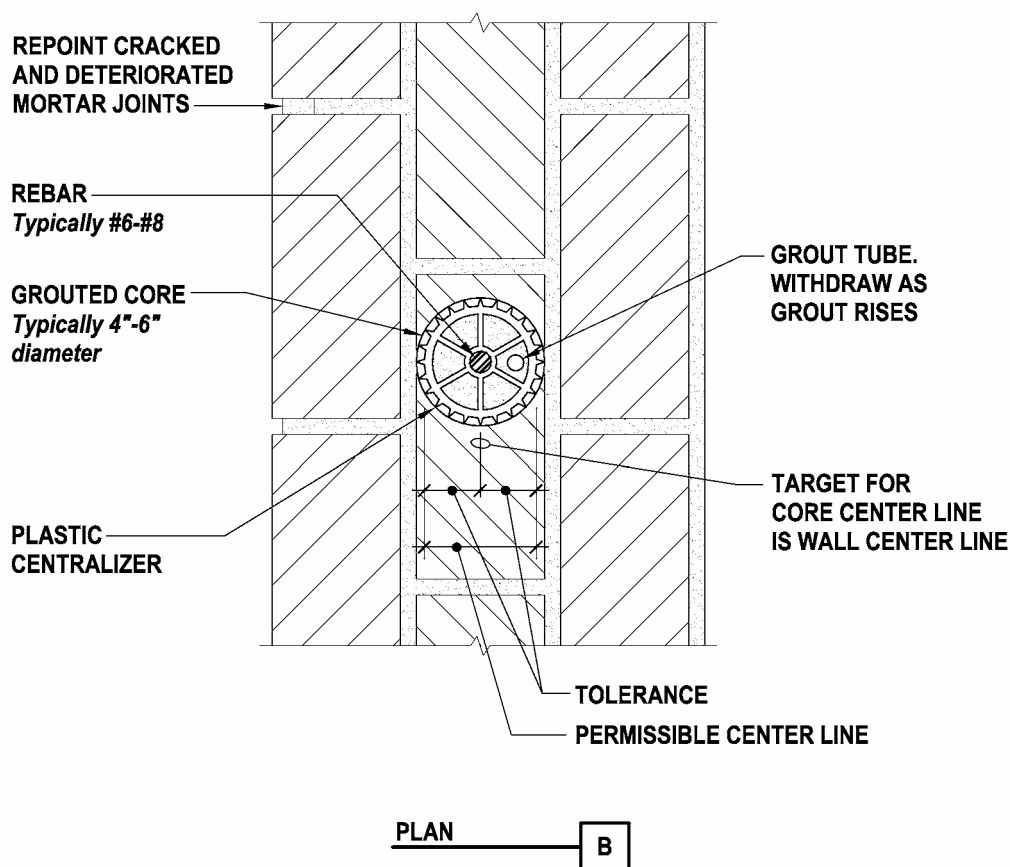
Figure 21.4.4-1B: Plan Detail of Reinforced Core in Masonry Wall

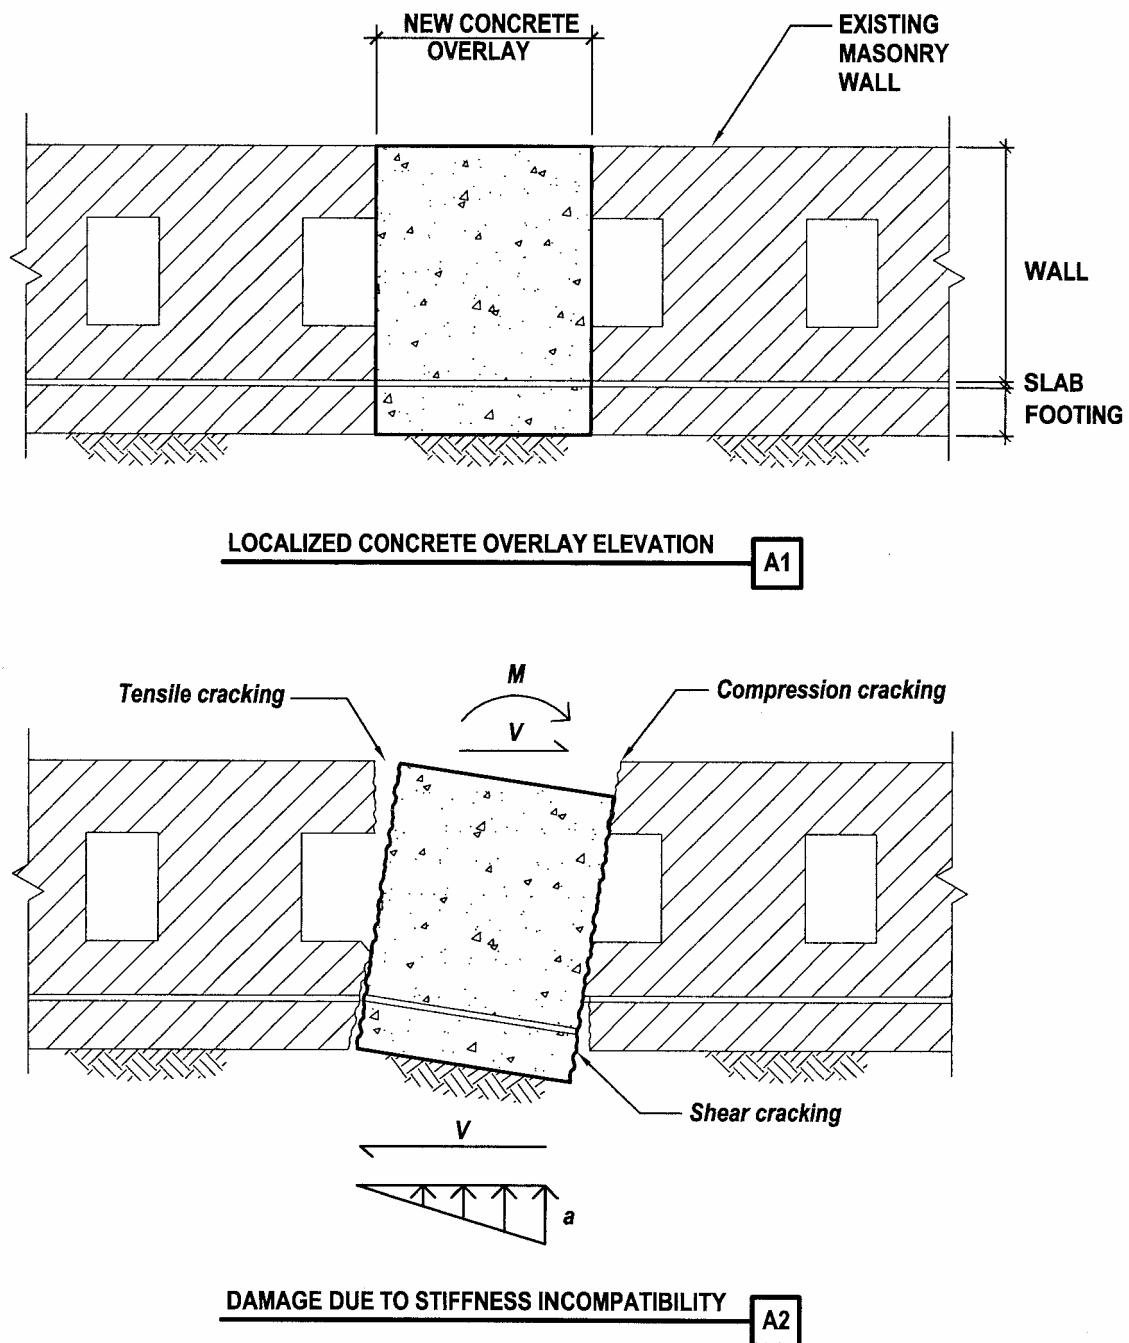
Figure 21.4.5-2A: Potential Damage at Ends of Narrow Concrete Overlay

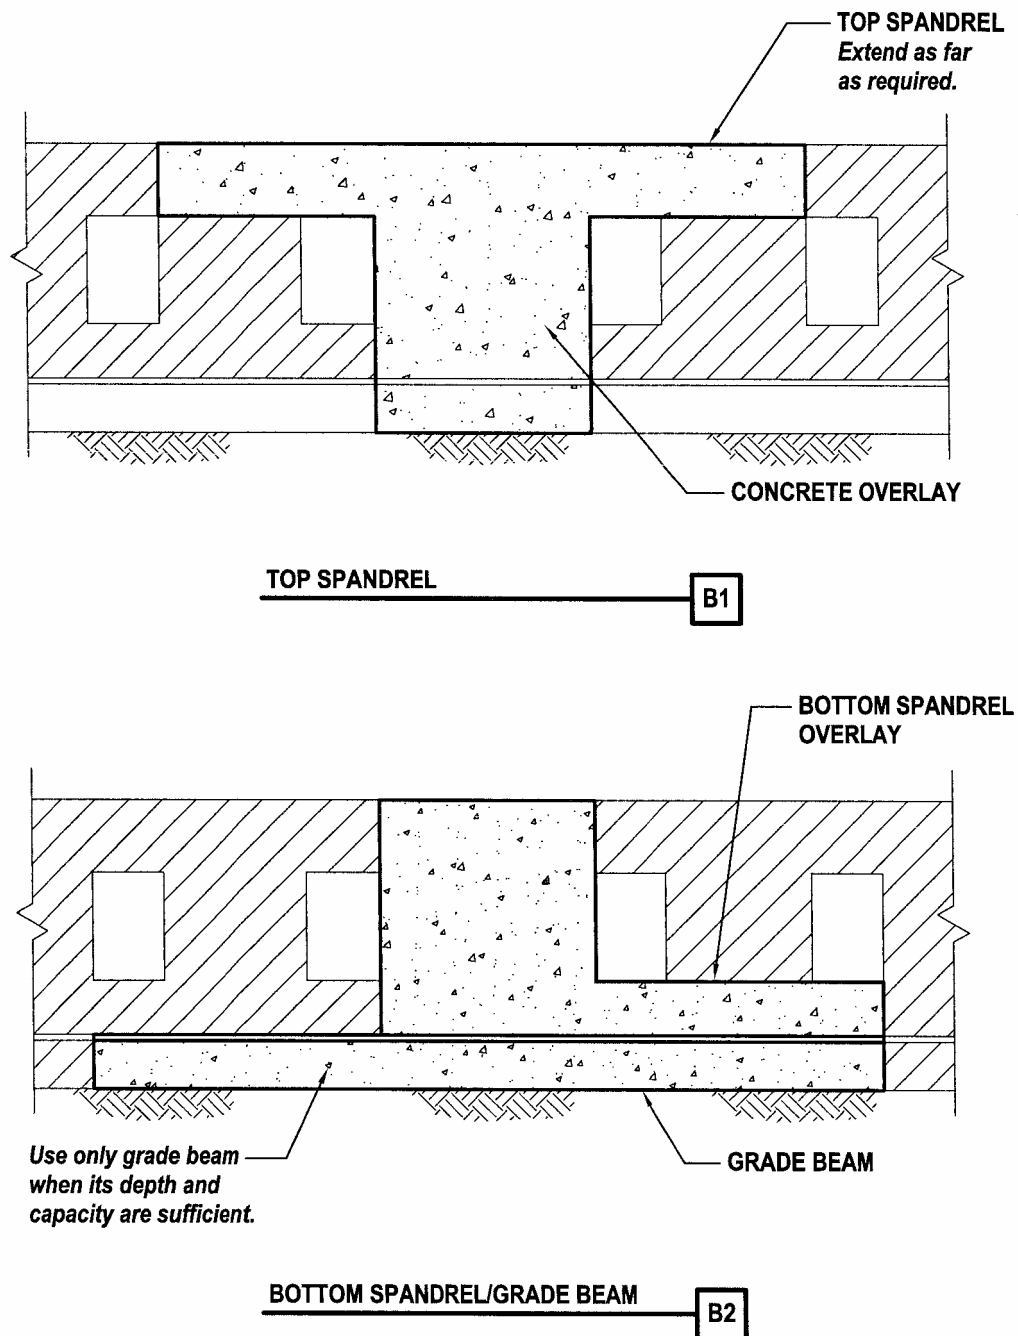
**Figure 21.4.5-2B: Alternatives to Distribute Overturning Loads
in Concrete Overlay**

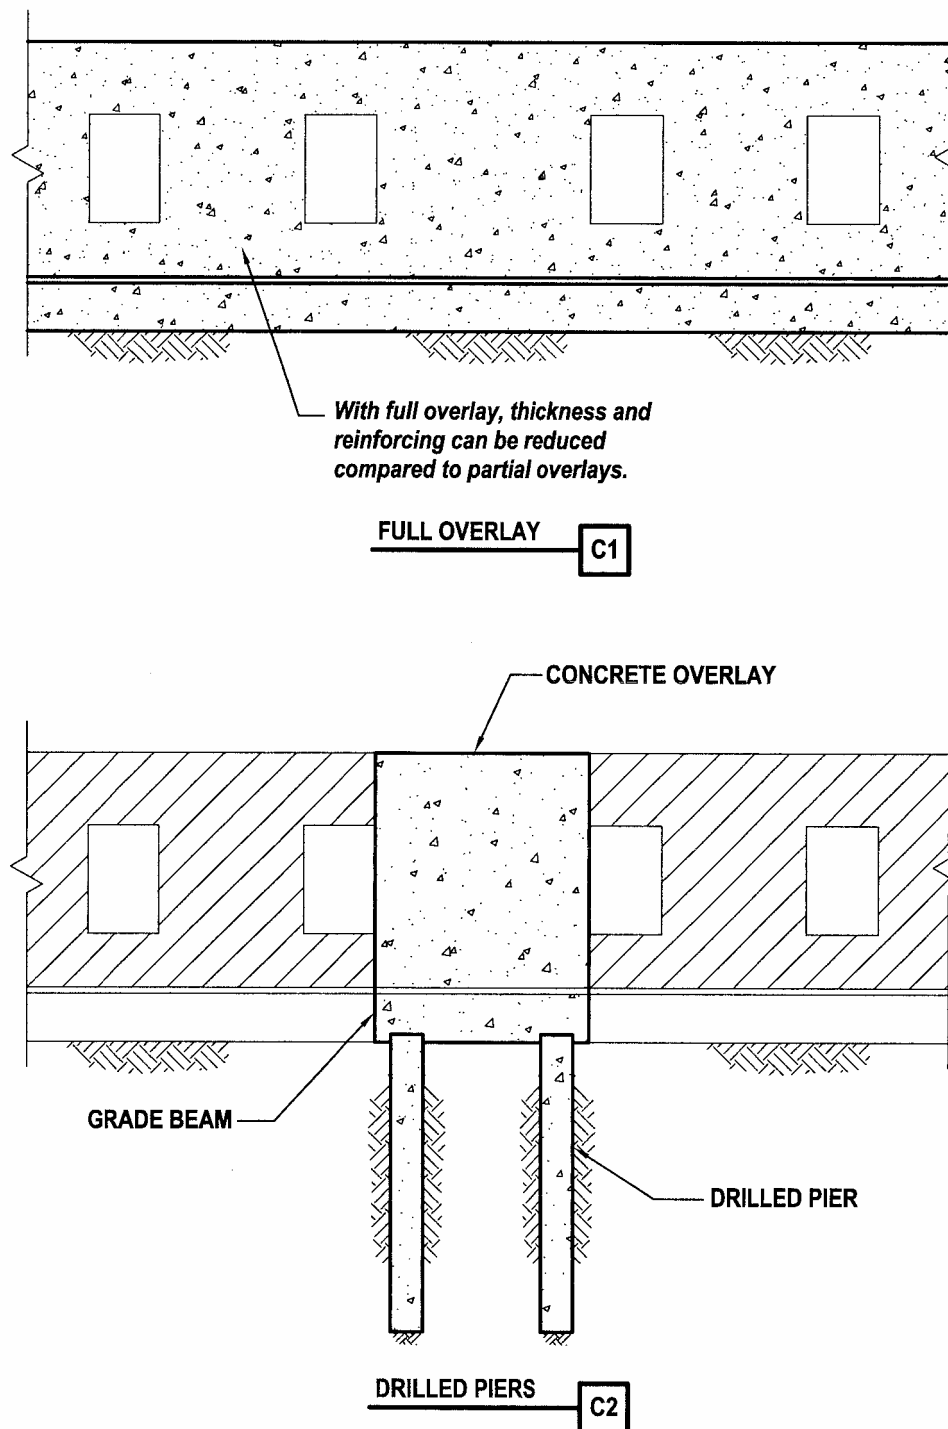
**Figure 21.4.5-2C: Alternatives to Distribute Overturning Loads
in Concrete Overlay**

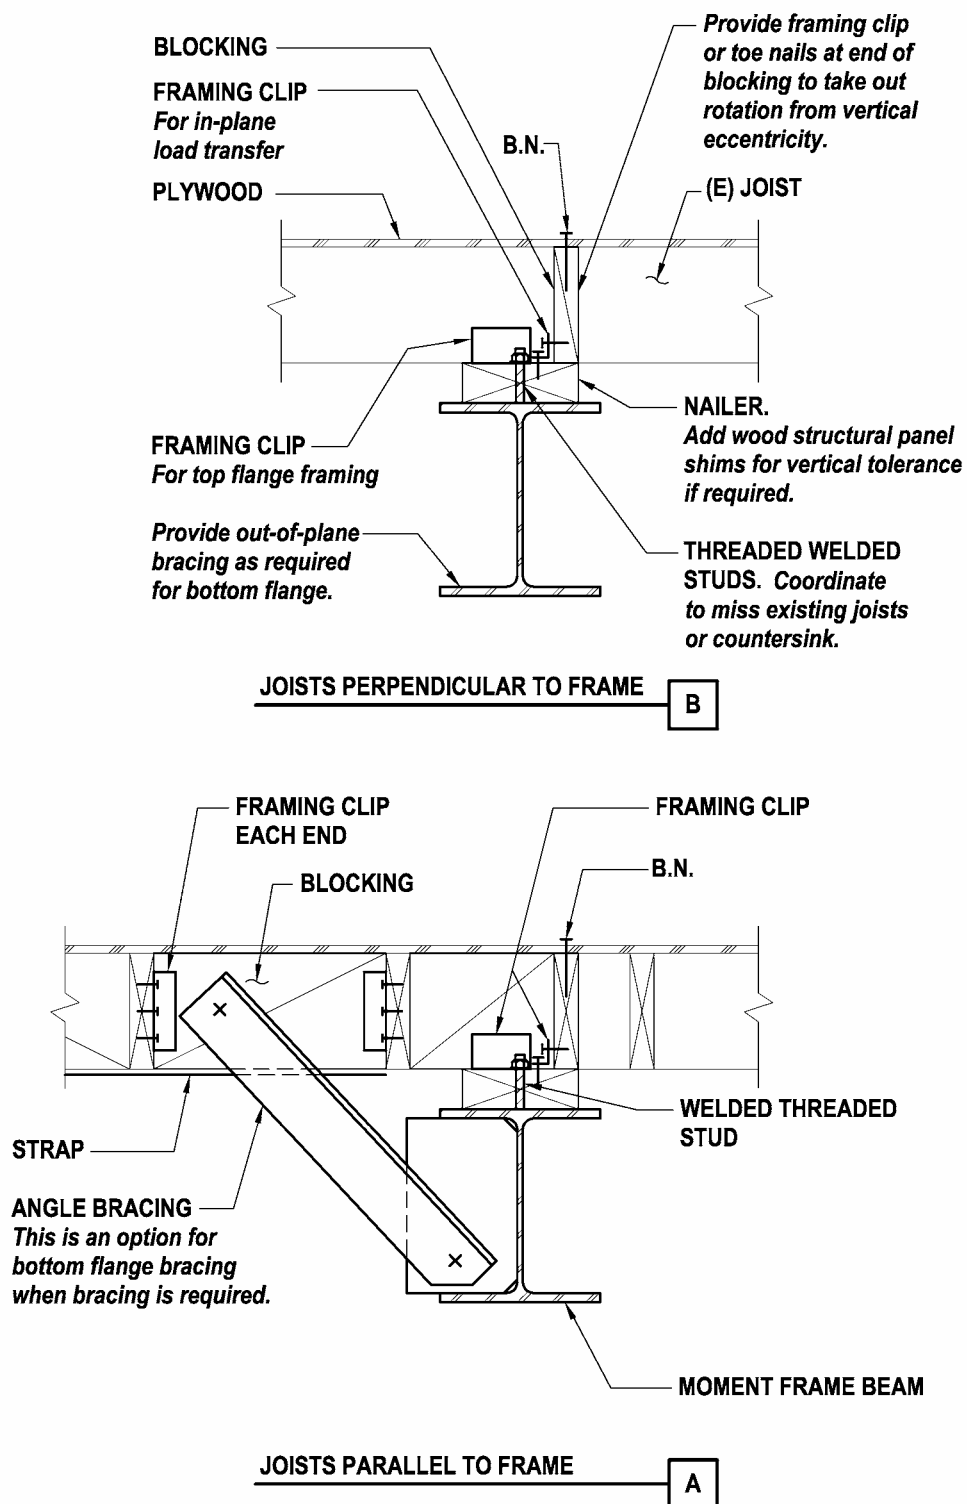
Figure 21.4.9-2: New Interior Steel Moment Frame to an Existing Wood Floor

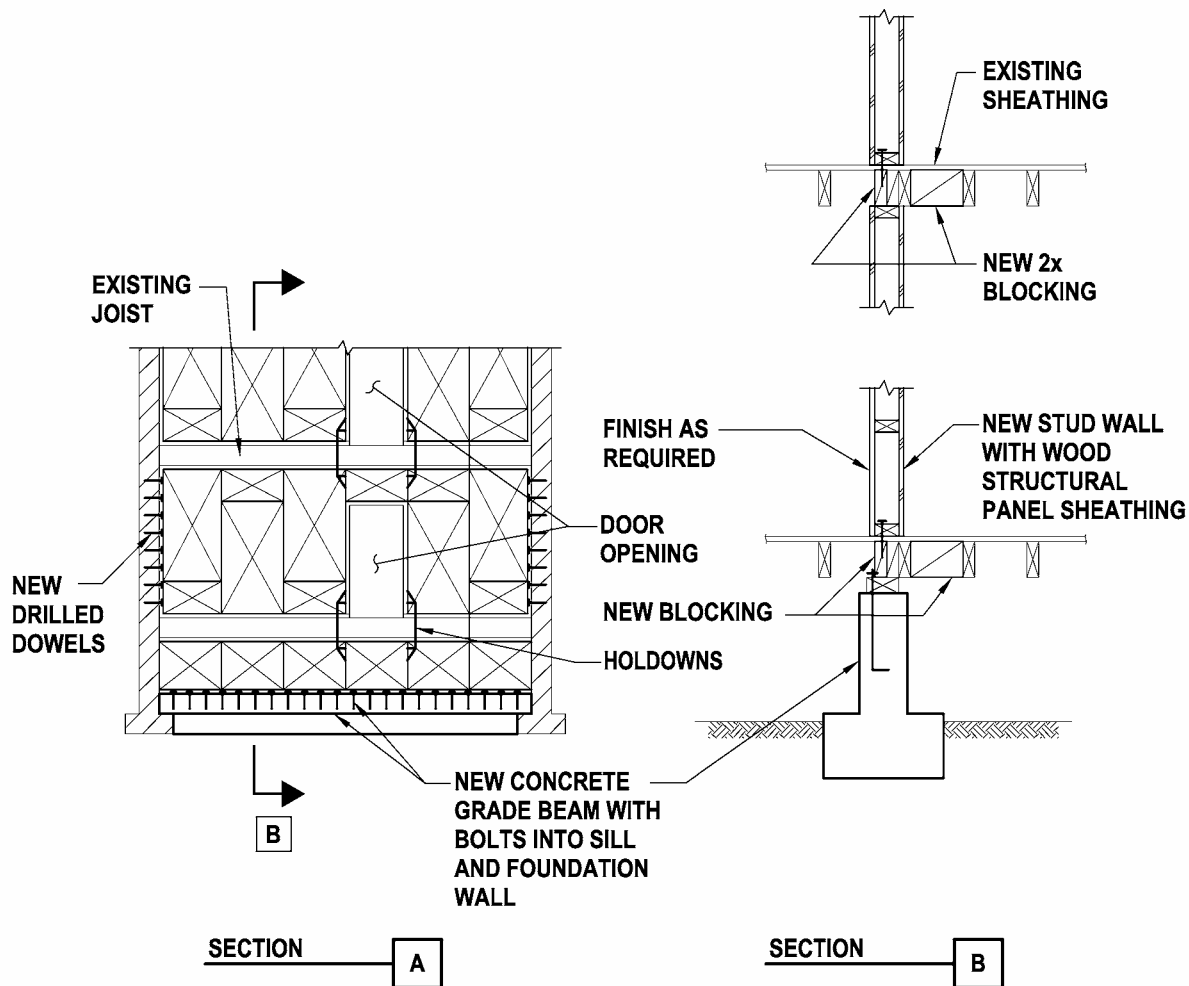
Figure 21.4.10-2: Add New Crosswalls

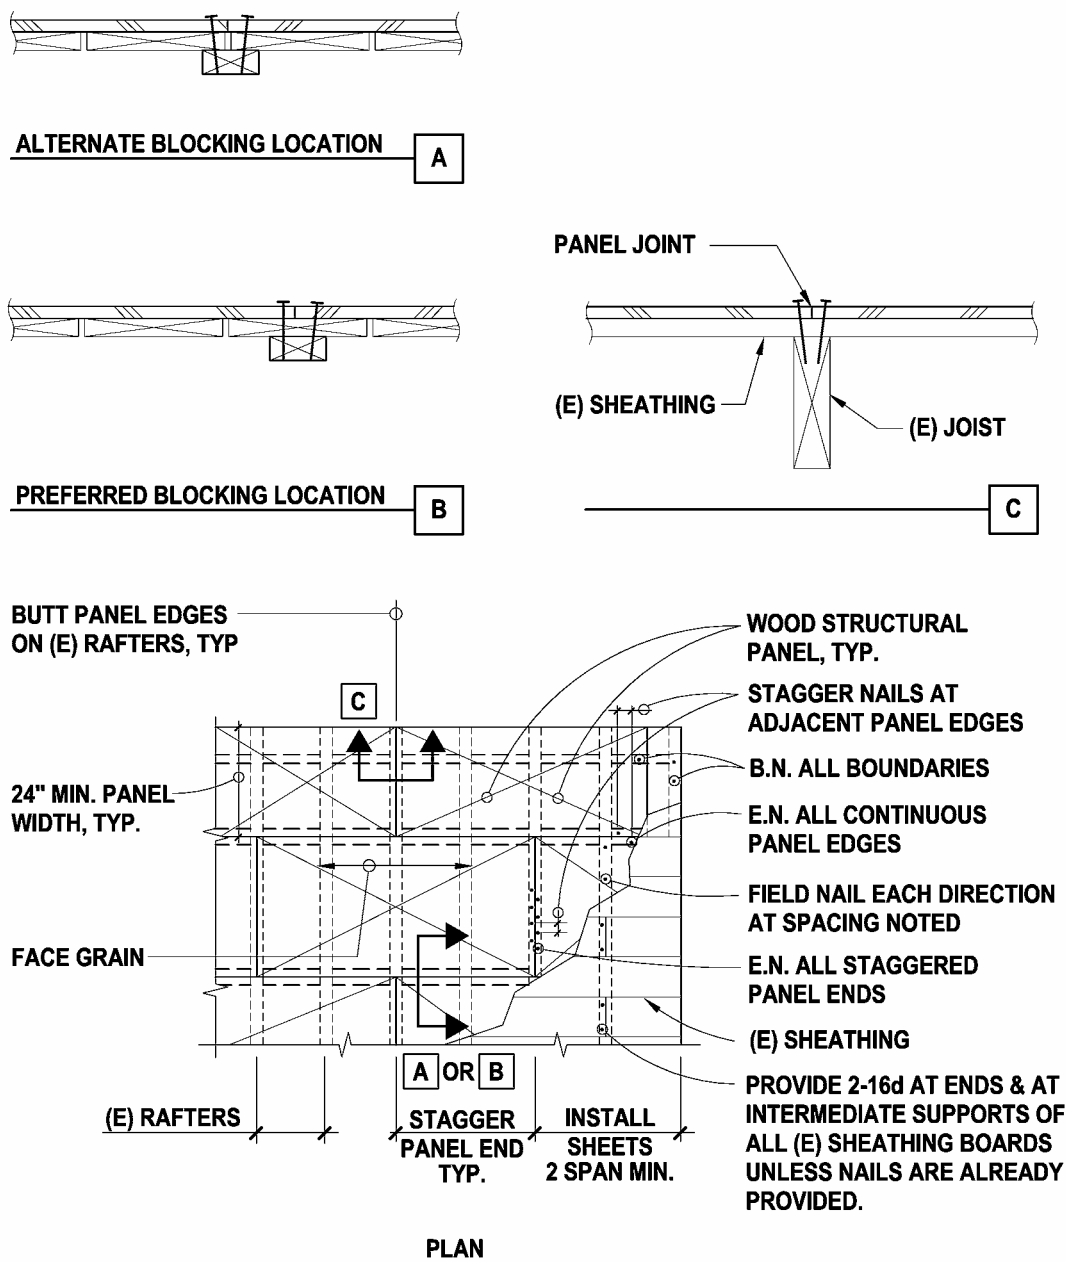
Figure 22.2.1-2: Wood Panel Overlay with Blocking Over Existing Sheathing

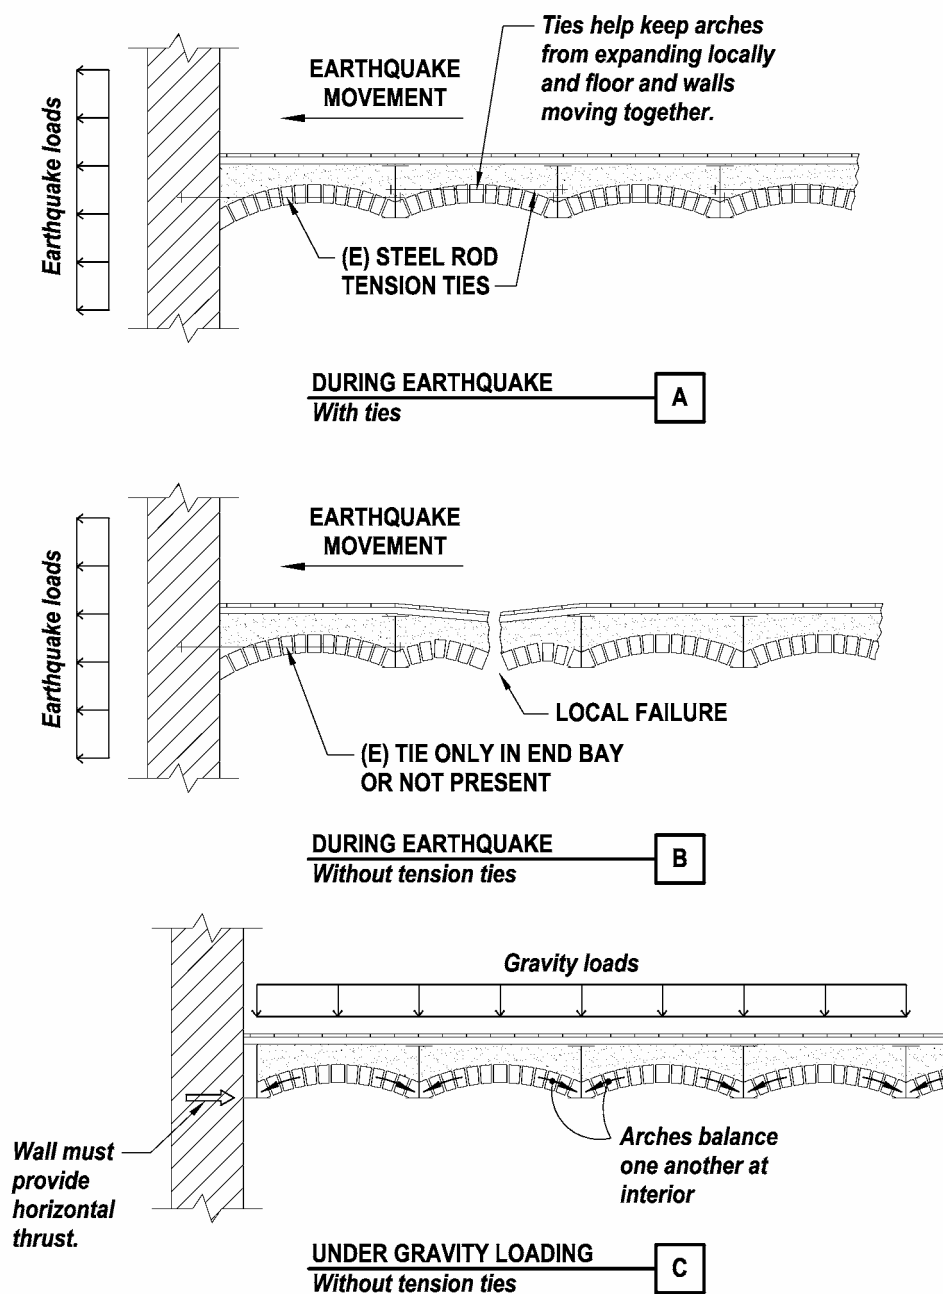
Figure 22.2.8-1: Failure Scenarios for Masonry Flat Arch Floors

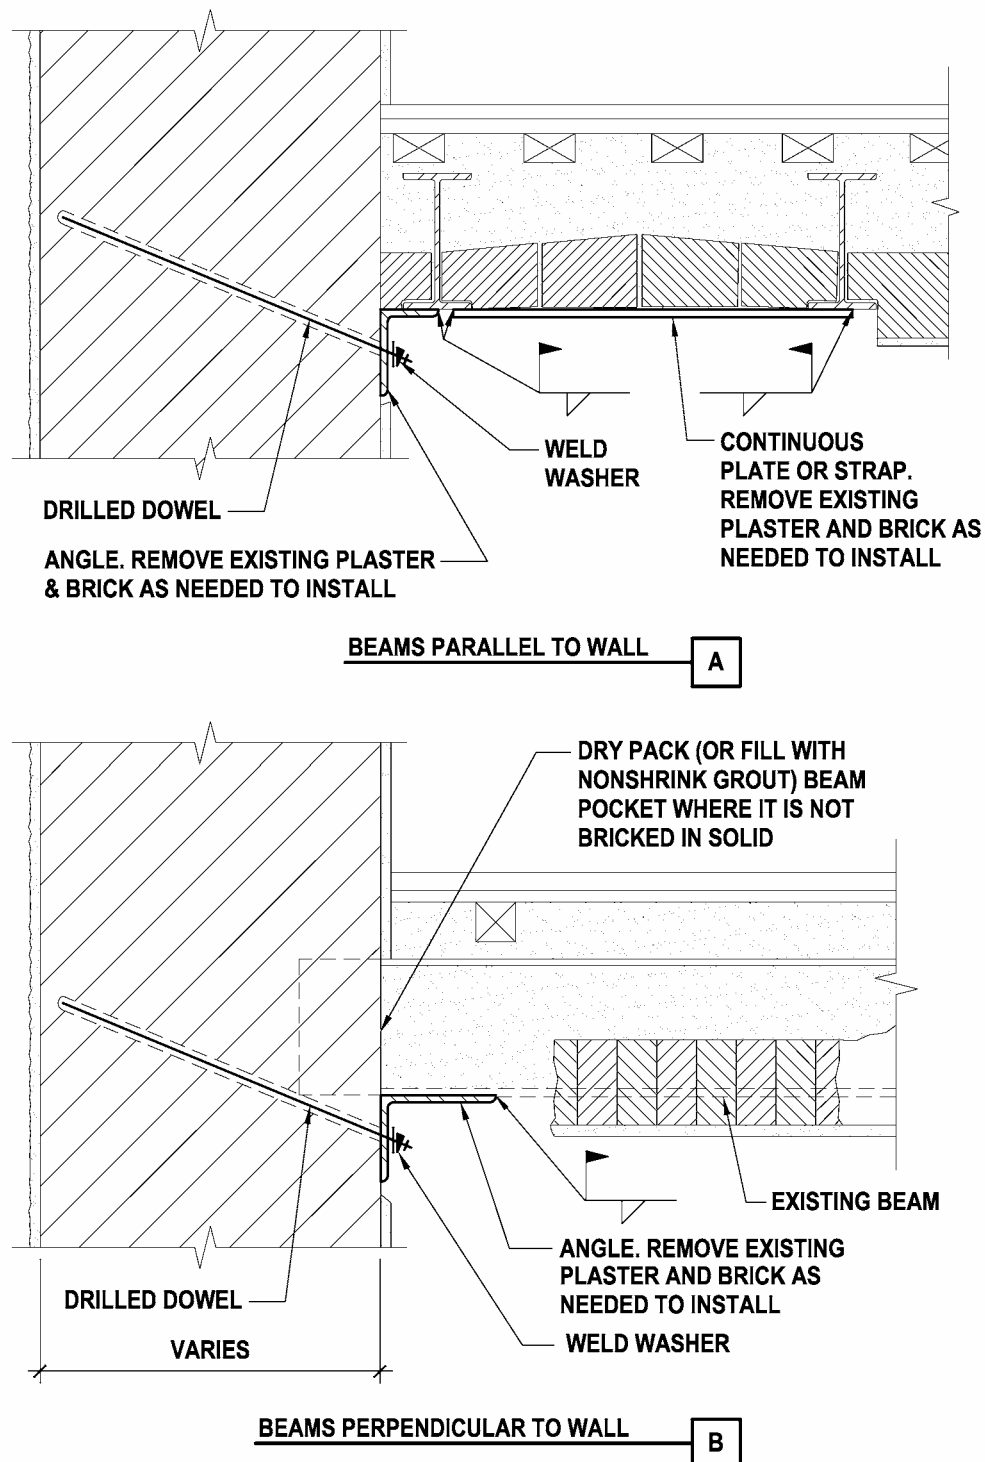
Figure 22.2.8-2: Add Wall-to-Diaphragm Ties and Chord for Masonry Flat Arch Floor - Access from Below the Floor

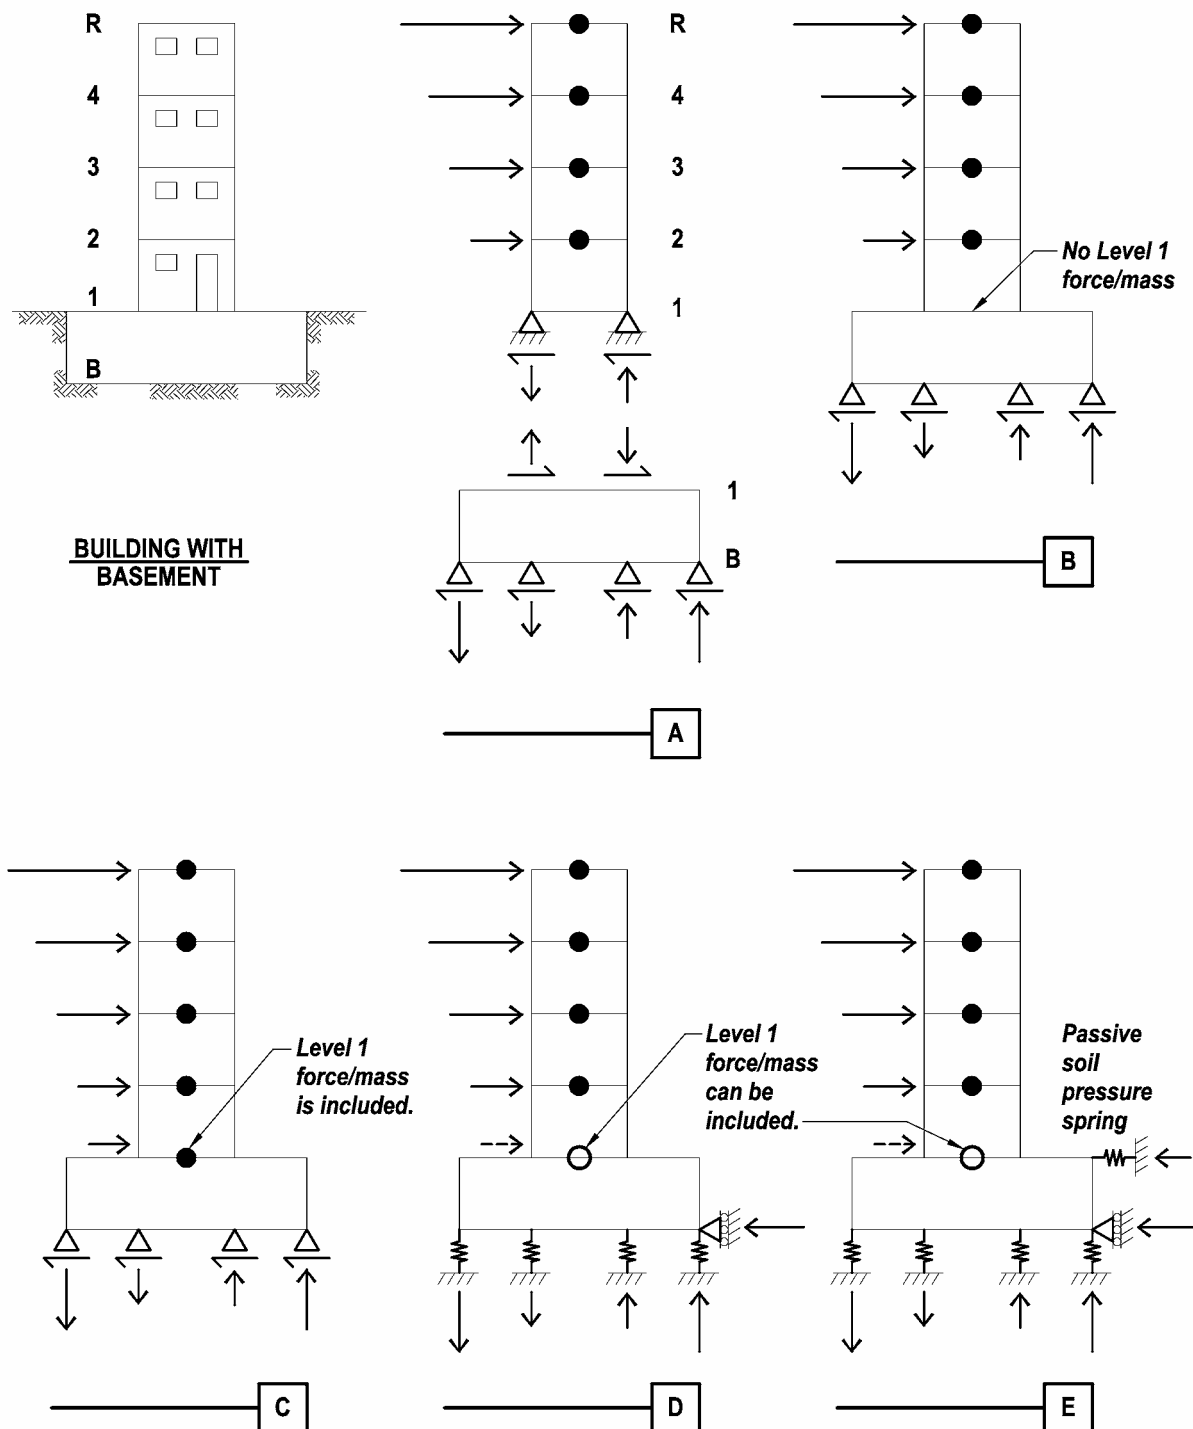
Figure 23.4-1: Modeling Approaches for Buildings with Basements

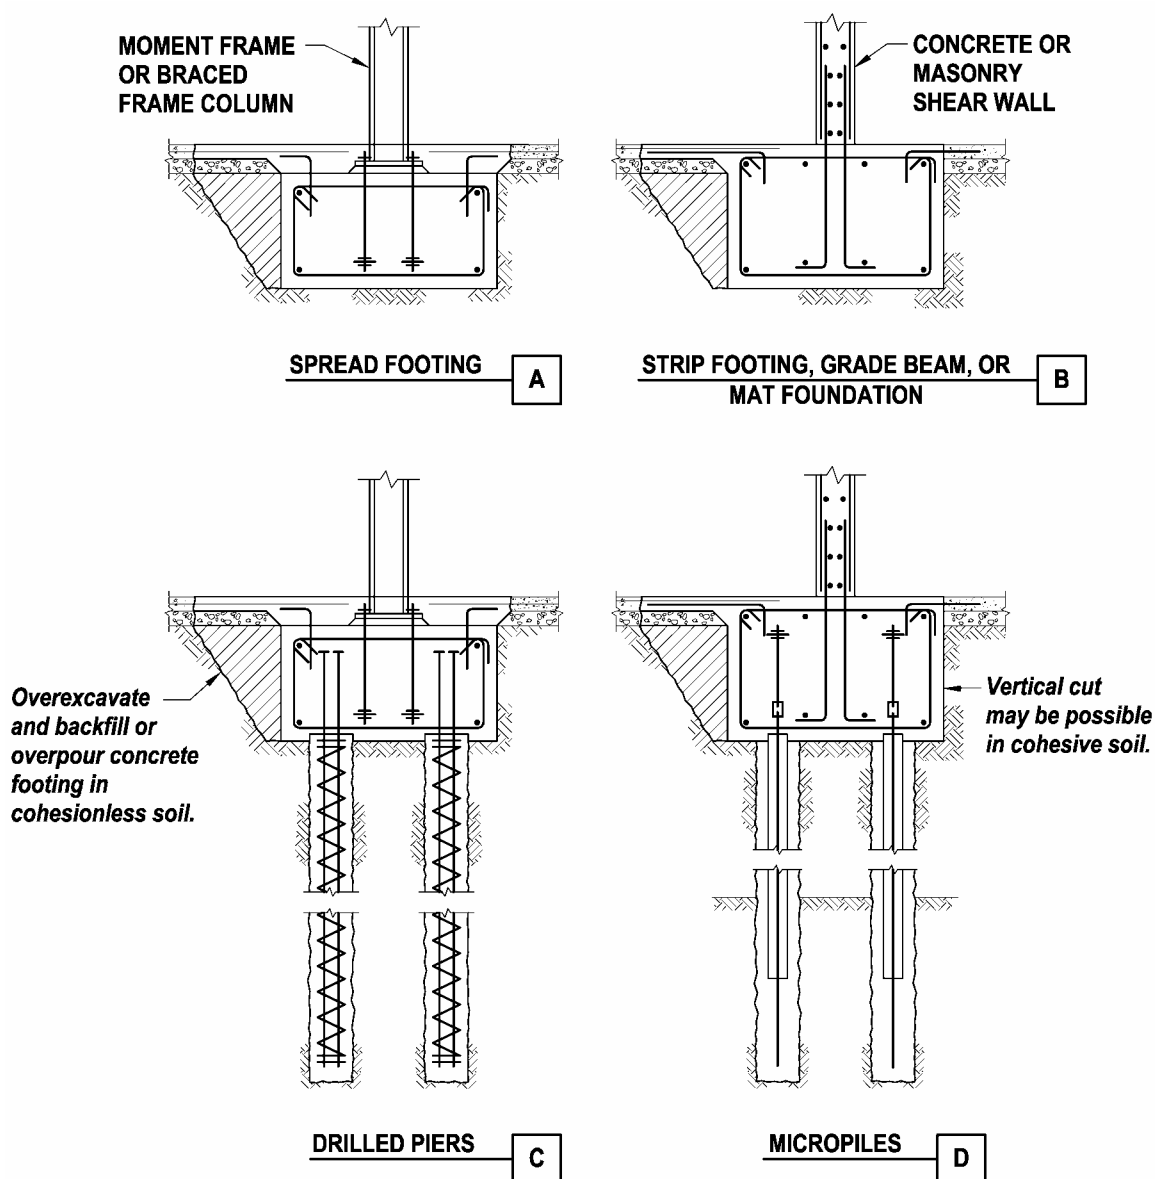
Figure 23.6.1-1: Types of New Foundations Commonly Used in Seismic Rehabilitation

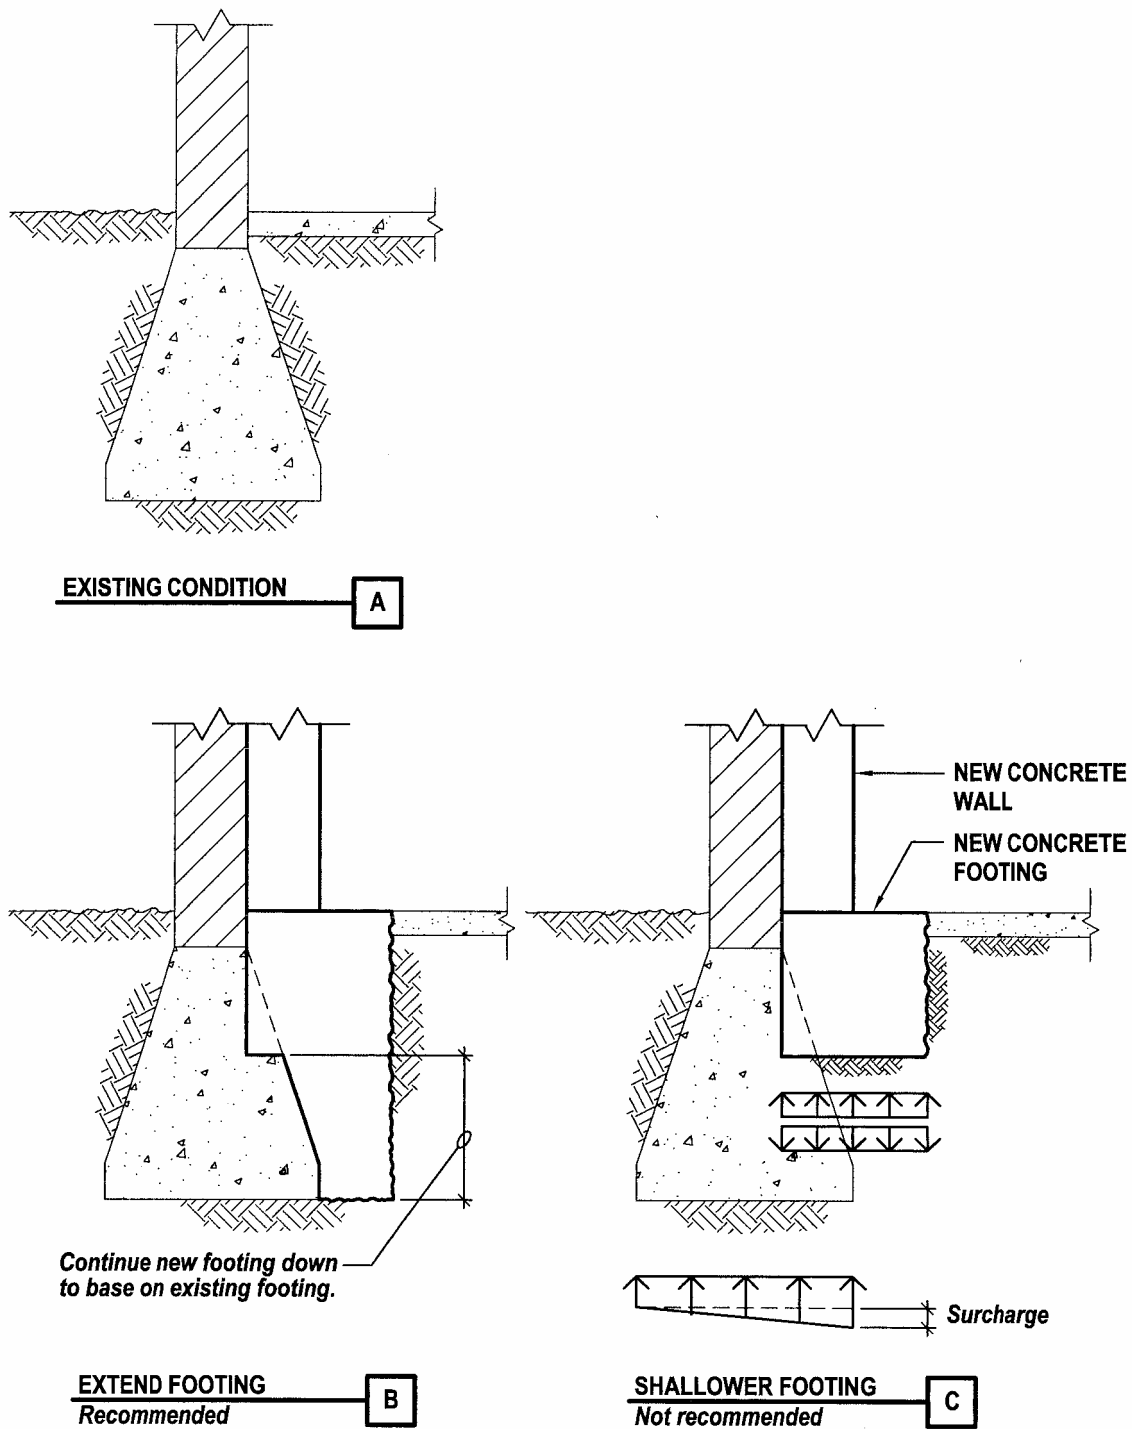
Figure 23.6.2-3: New Shallow Footing Does Not Need to be as Deep as Existing Shallow Footing

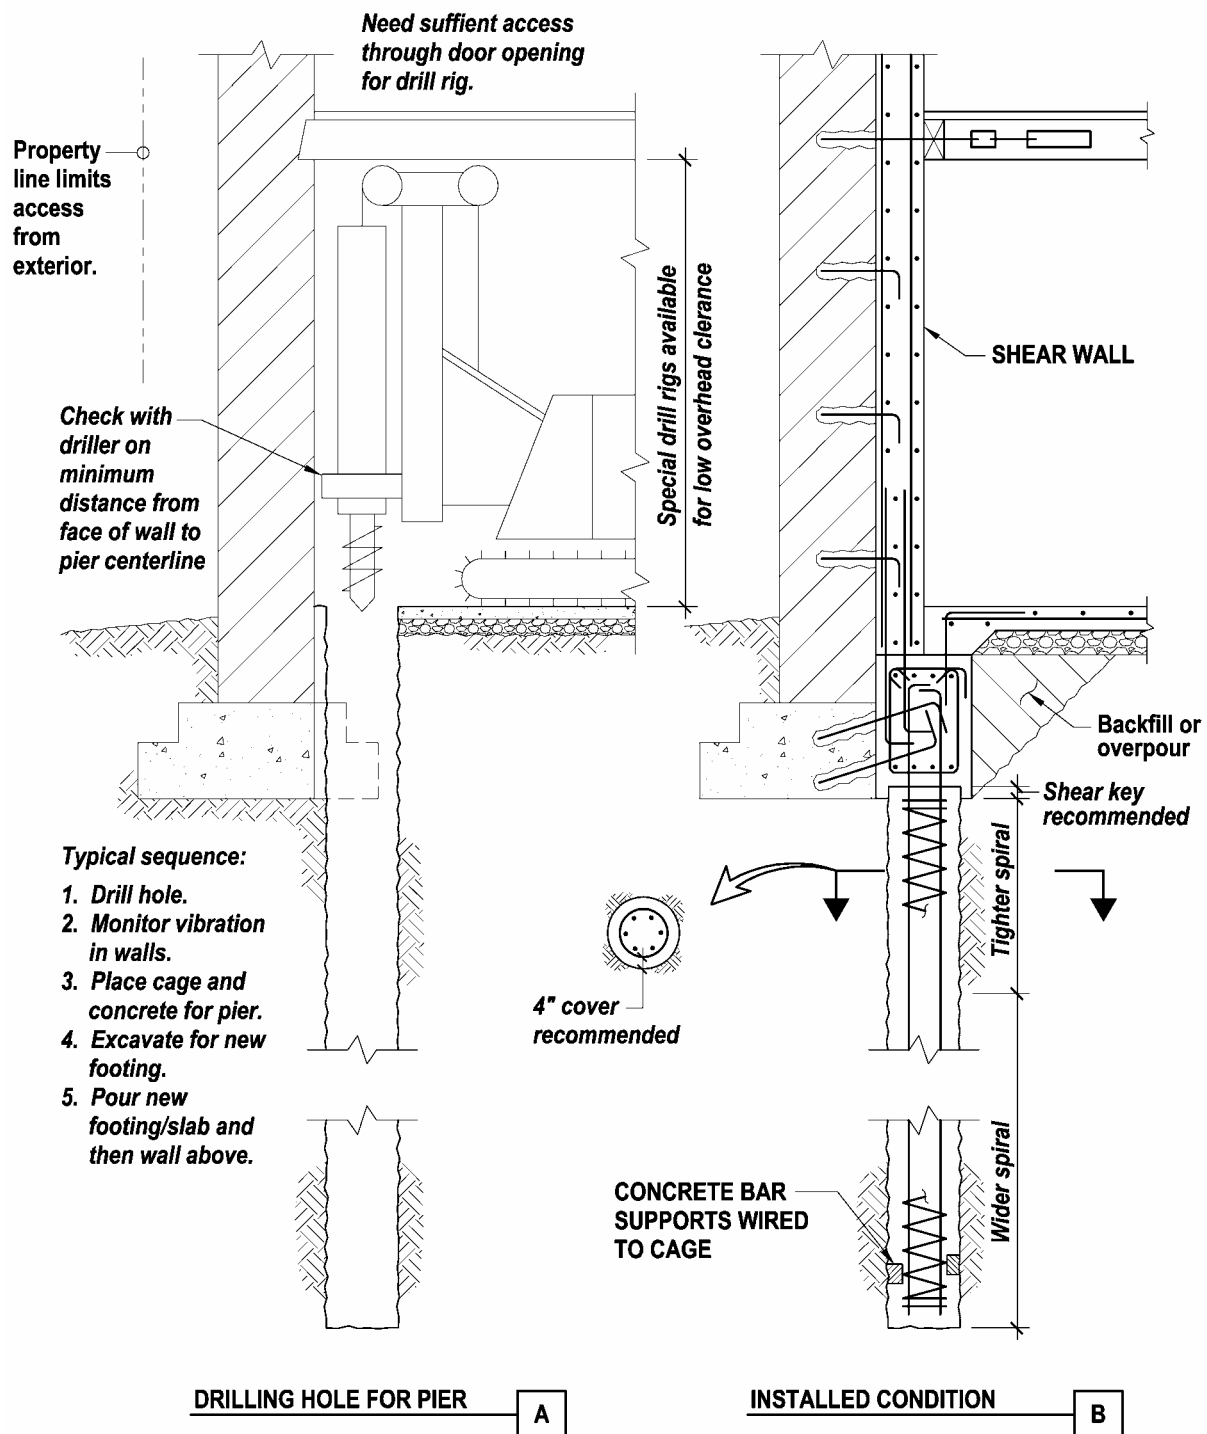
Figure 23.6.4-1: New Drilled Pier Next to Existing Strip Foundation

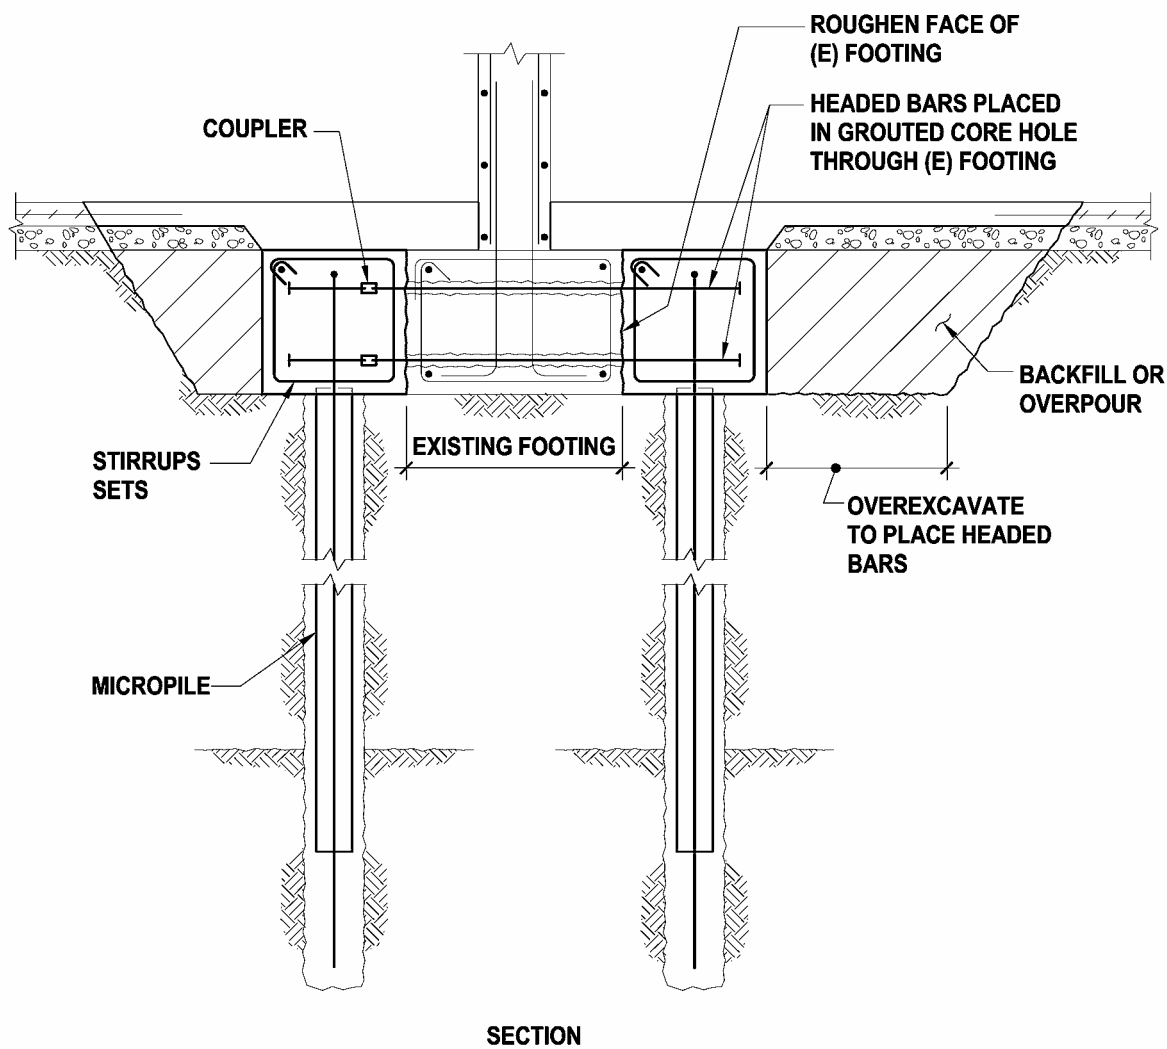
Figure 23.7.2.-1: Micropile Enhancement to Existing Strip Footing

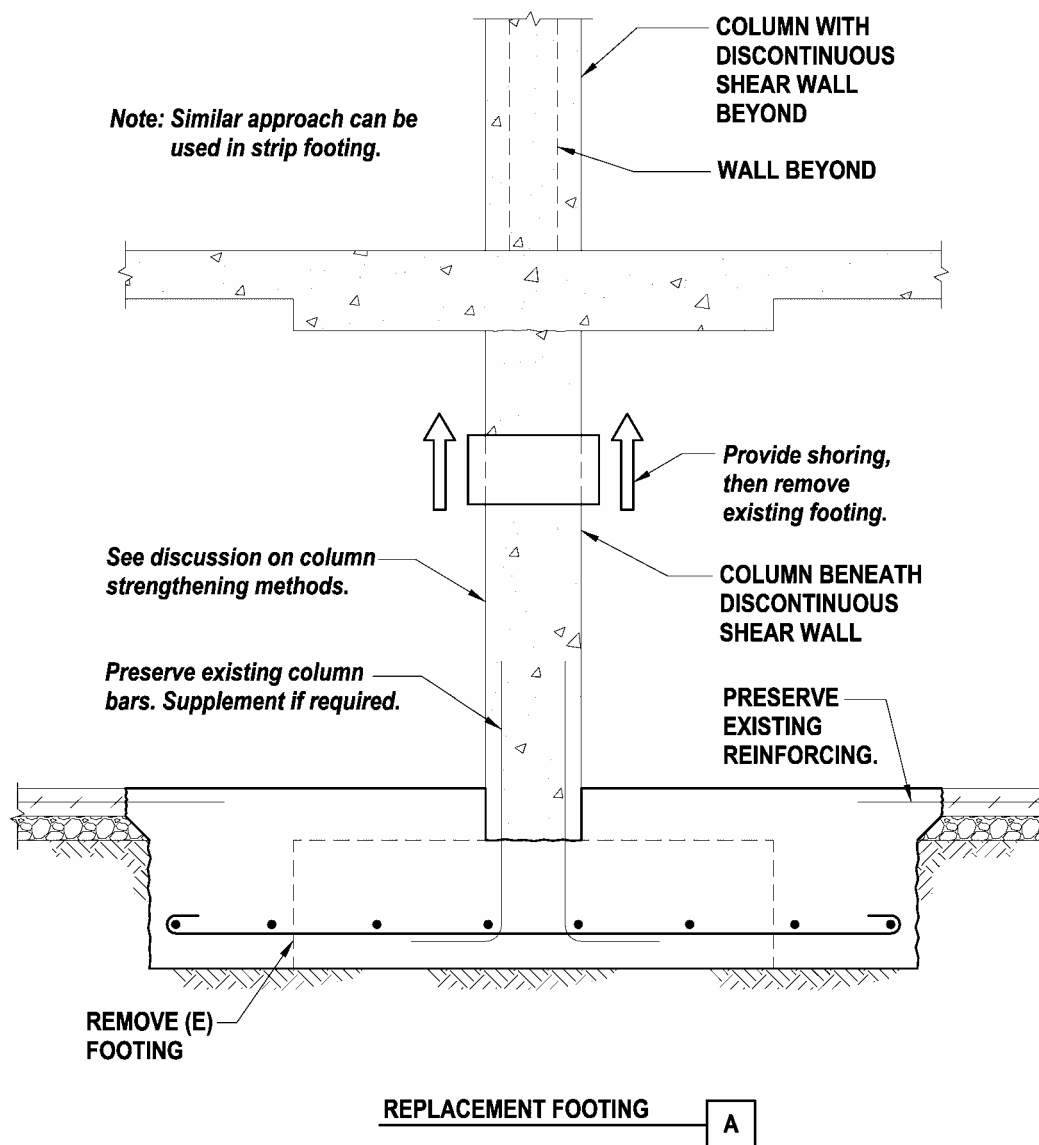
Figure 23.7.3-2: Replace Existing Spread Footing

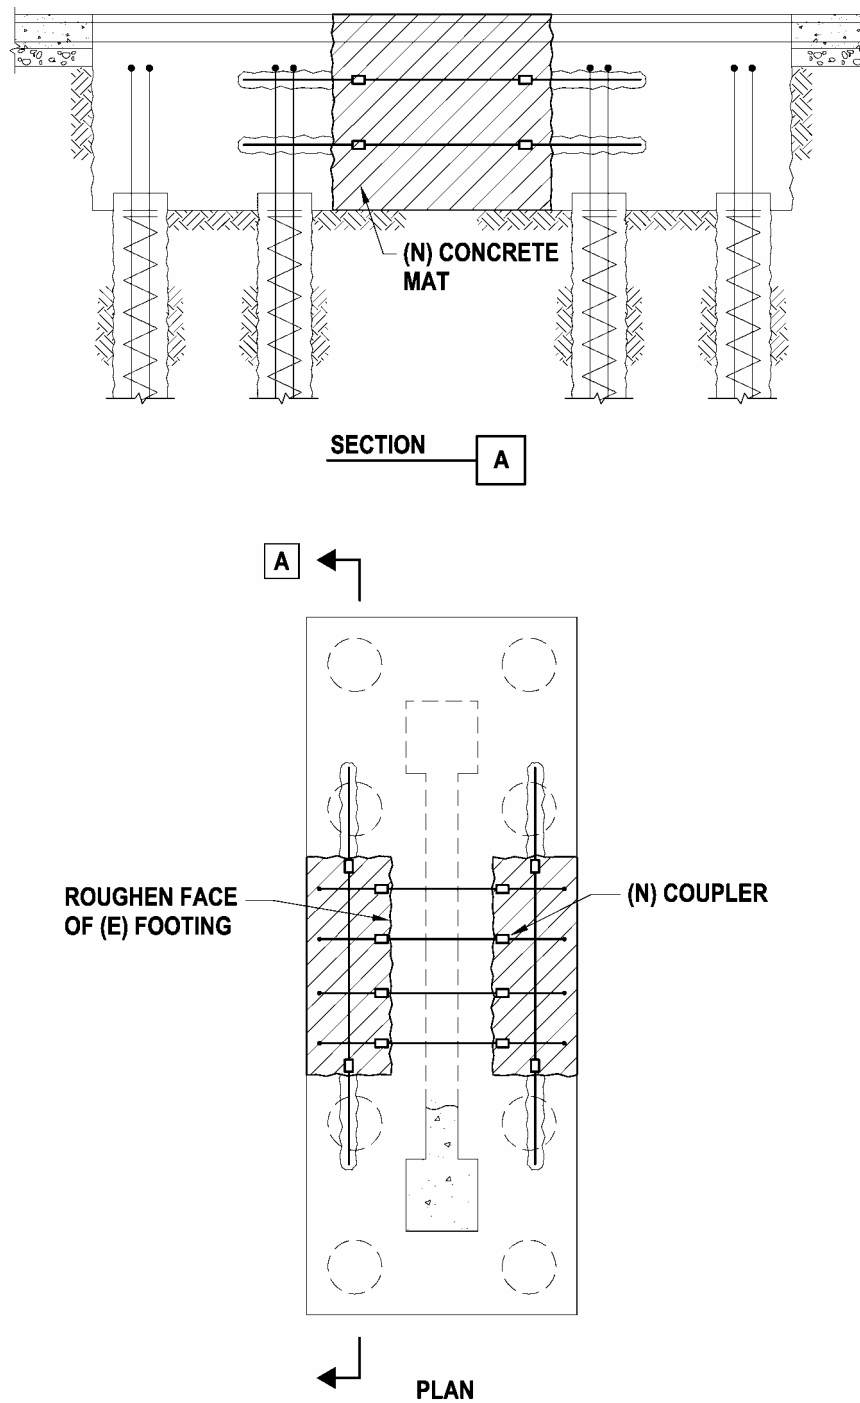
Figure 23.8.2-1: New Mat Foundation Between Existing Drilled Piers
