Techniques for the Seismic Rehabilitation of Existing Buildings

FEMA 547/2006 Edition

FEMA 547 – October 2006

Rutherford & Chekene (R & C) Consulting Engineers (Subconsultant) under contract with National Institute of Standards and Technology (NIST).

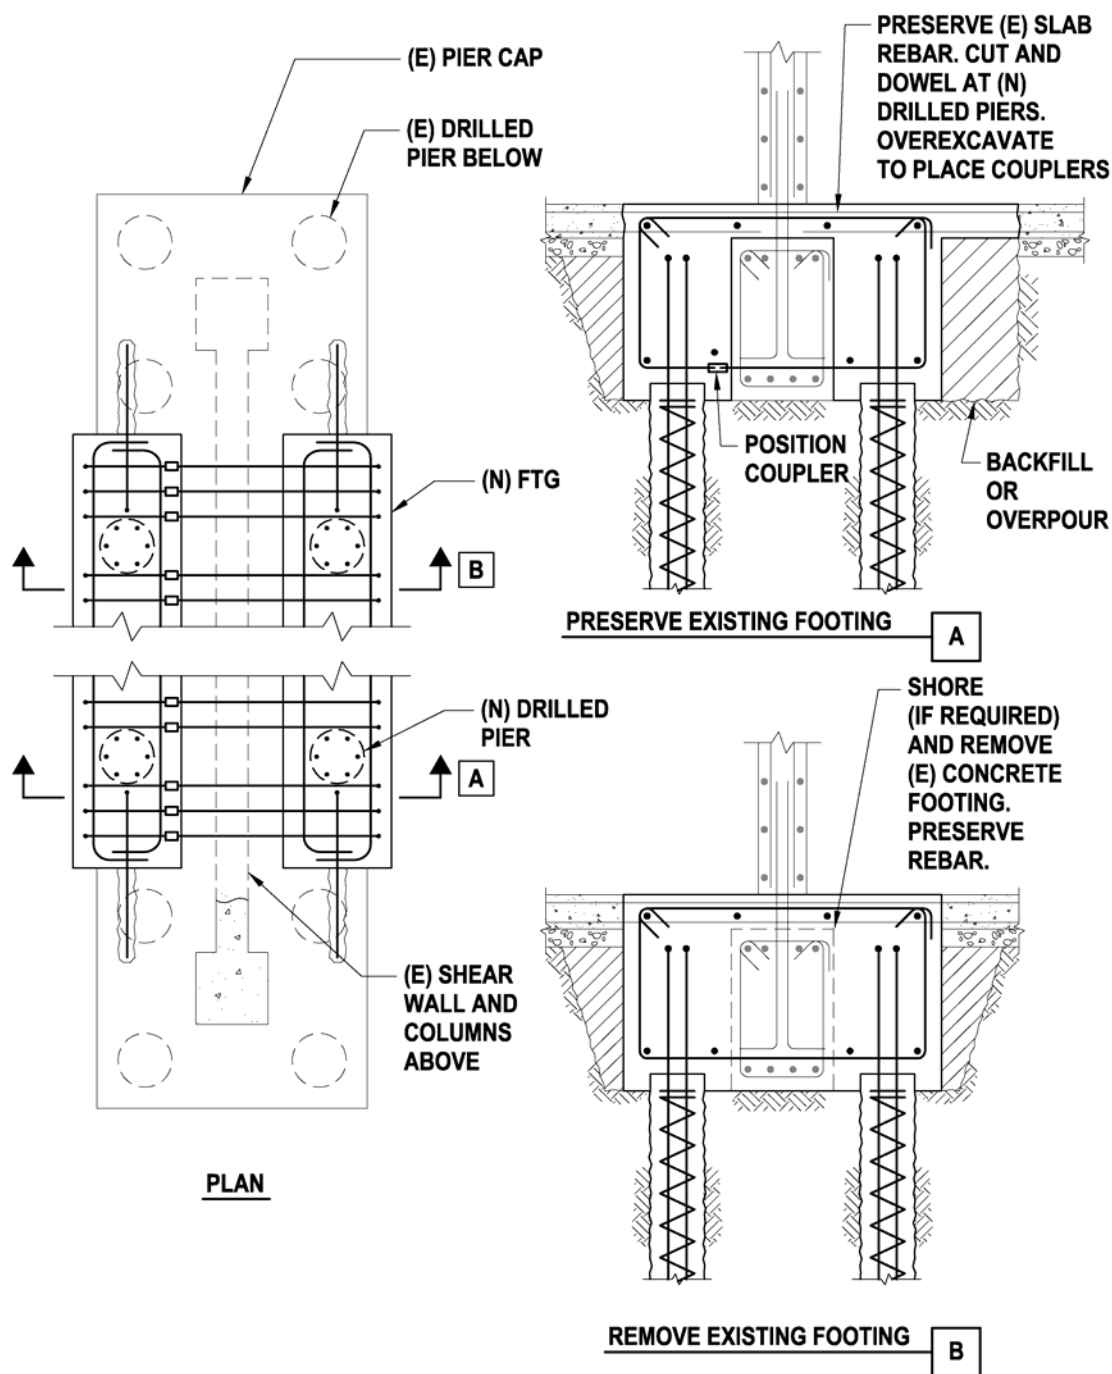
Figure 23.8.3.-1: Adding Drilled Piers to an Existing Drilled Pier Foundation

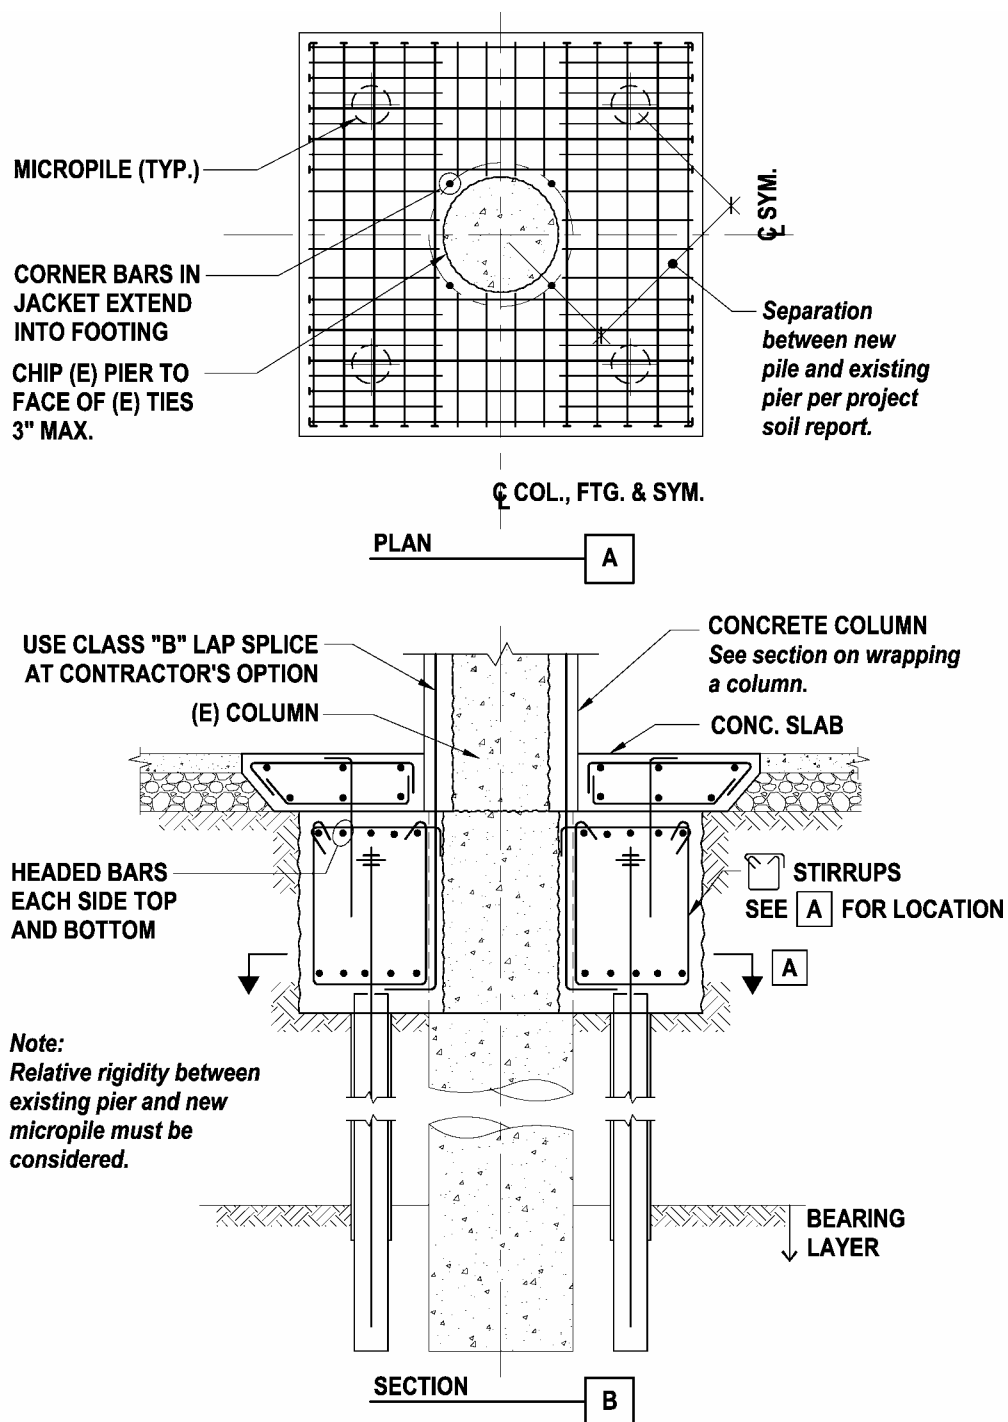
Figure 23.8.4.-1: Micropile Enhancement of an Existing Drilled Pier Footing

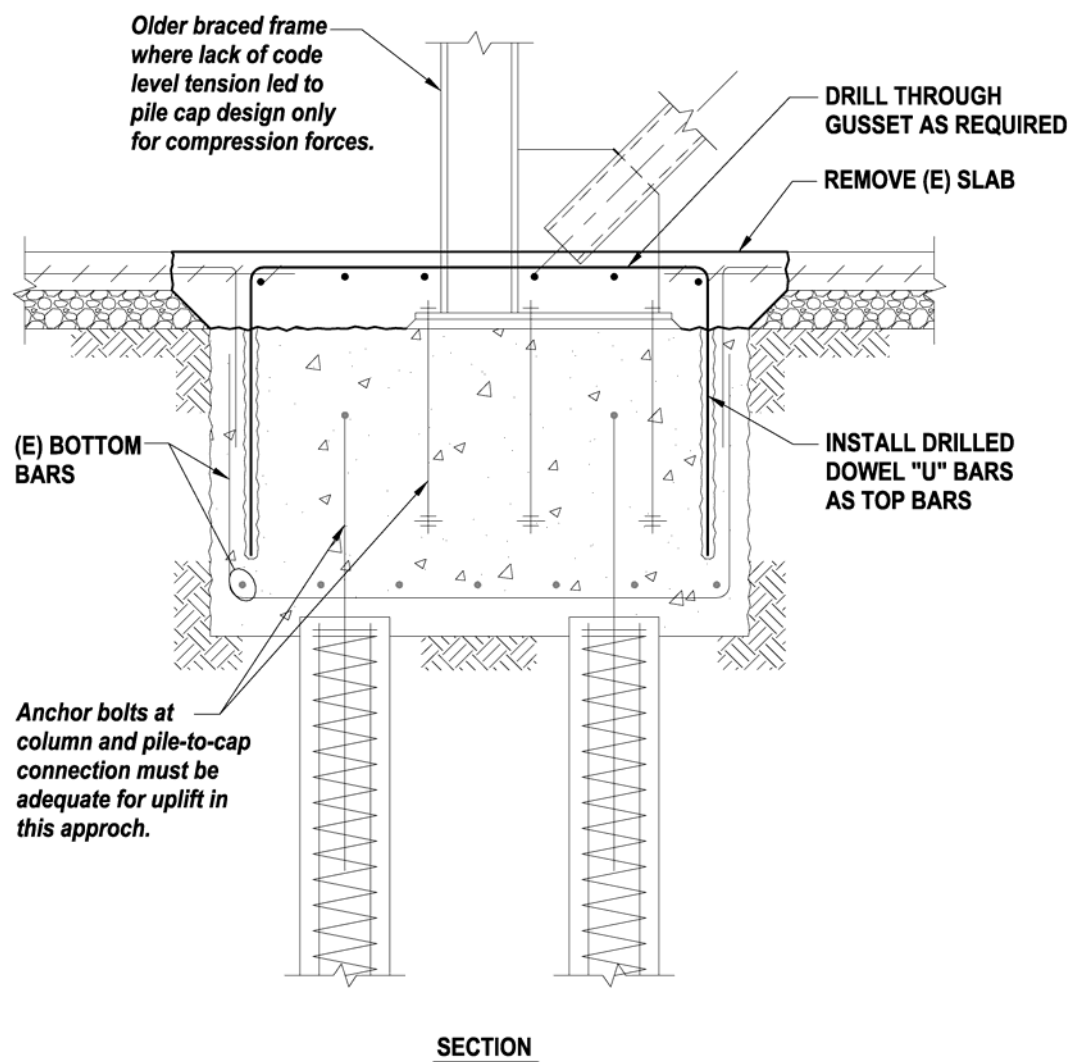
Figure 23.8.5-1: Adding Top Bars to an Existing Pile Cap

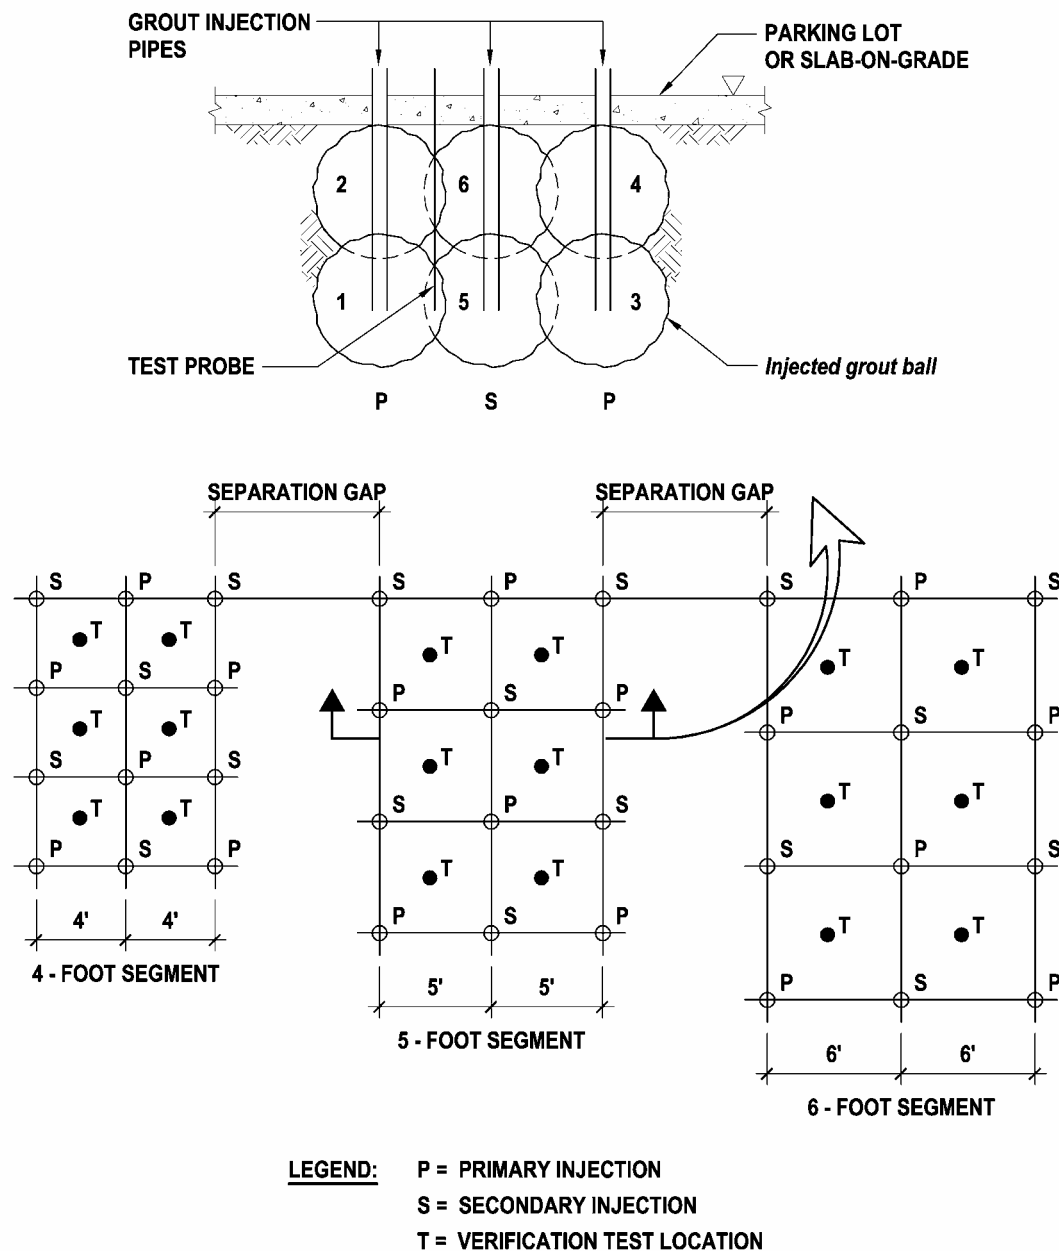
Figure 23.9.2-1: Compaction Grouting Under Existing Shallow Foundations – Pilot Test Program

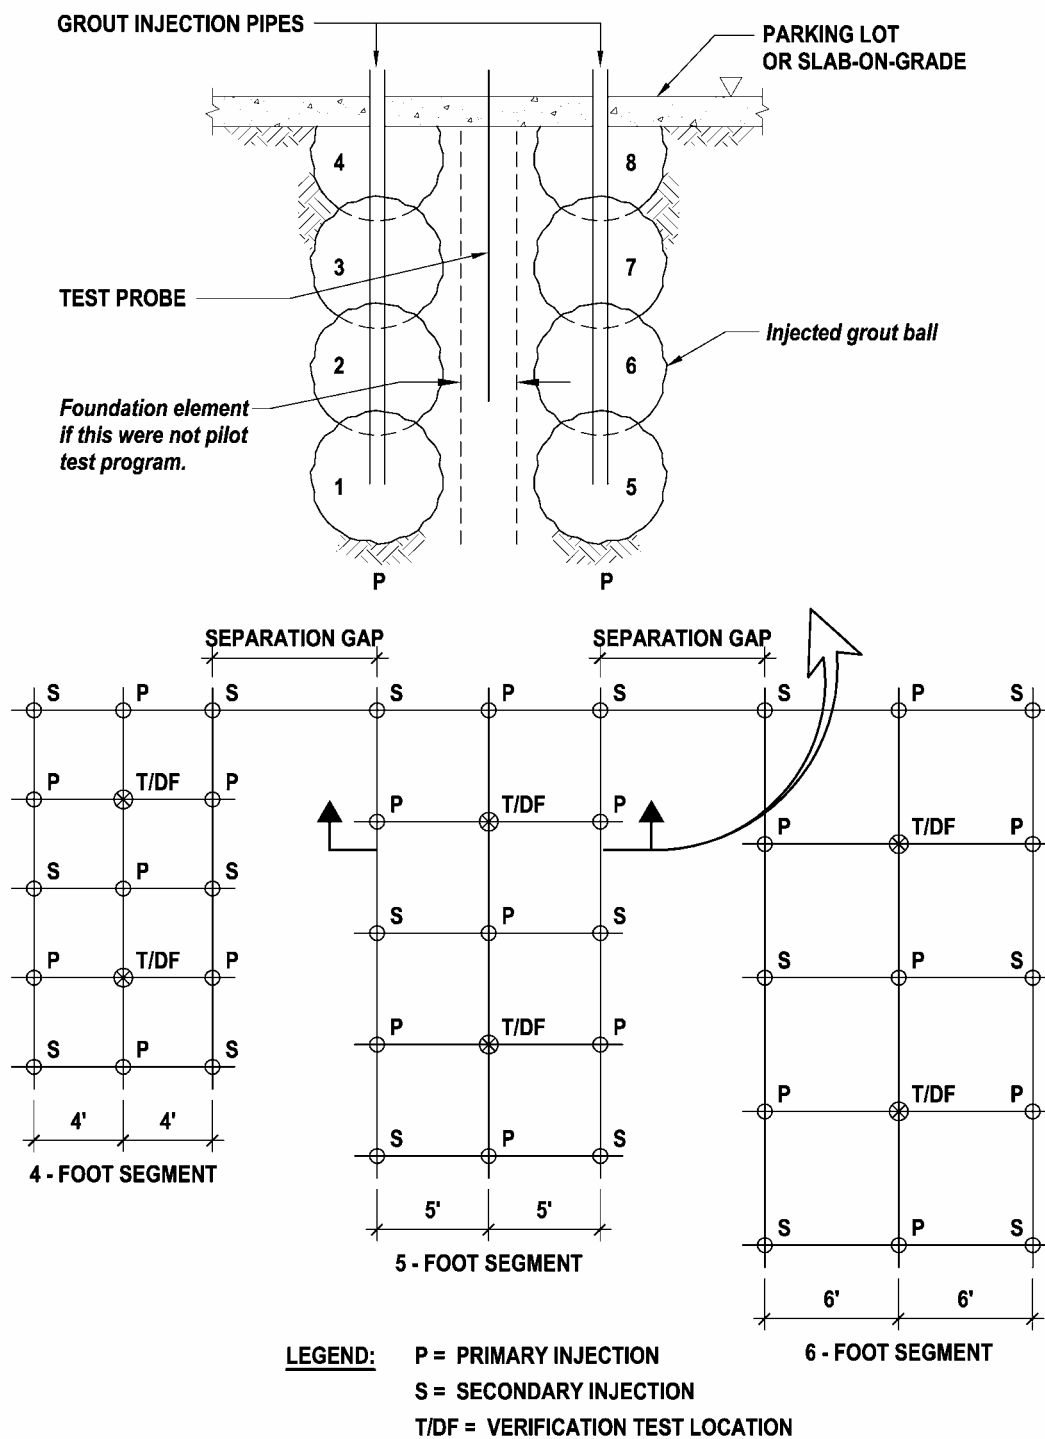
Figure 23.9.2-2: Compaction Grouting Under Existing Deep Foundations – Pilot Test Program

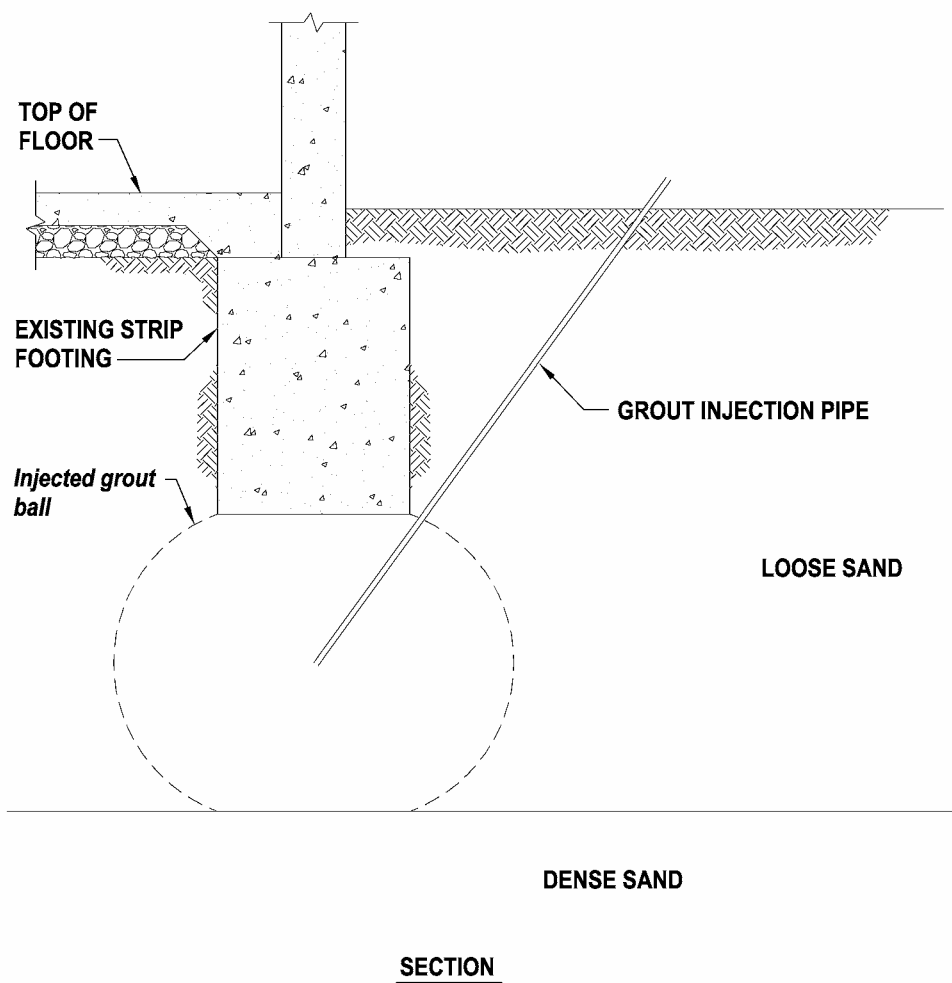
Figure 23.9.3-1: Permeation Grouting of Loose Sand Under Existing Shallow Foundation

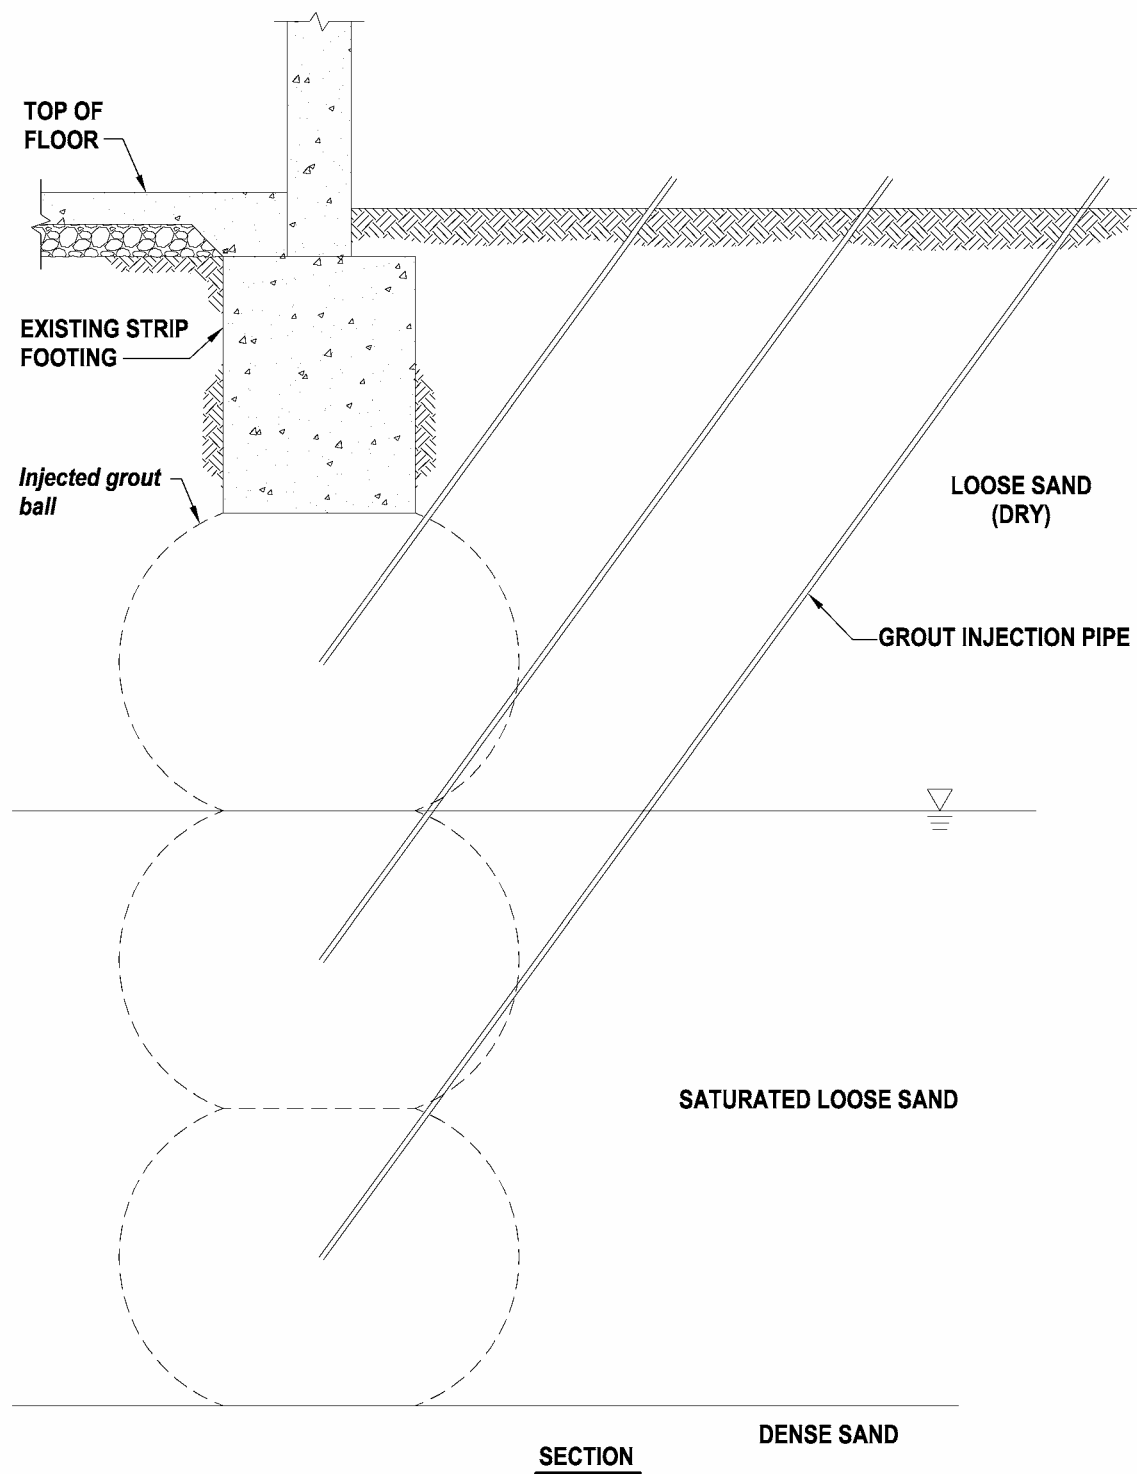
**Figure 23.9.3-2: Permeation Grouting of Liquefiable Layer
Under Existing Shallow Foundation**

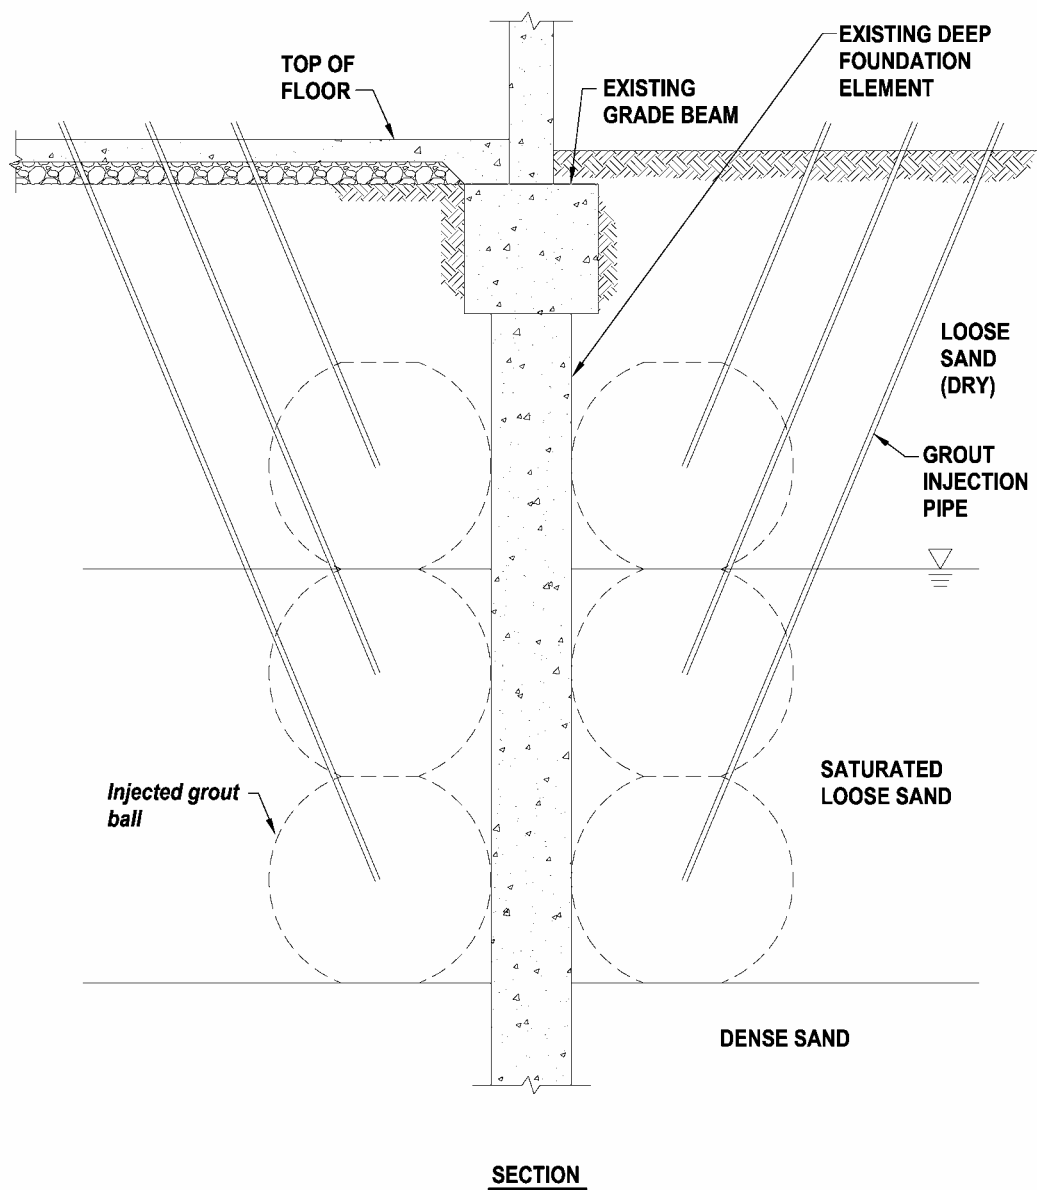
**Figure 23.9.3-3: Permeation Grouting of Liquefiable Layer
Around Existing Deep Foundation**

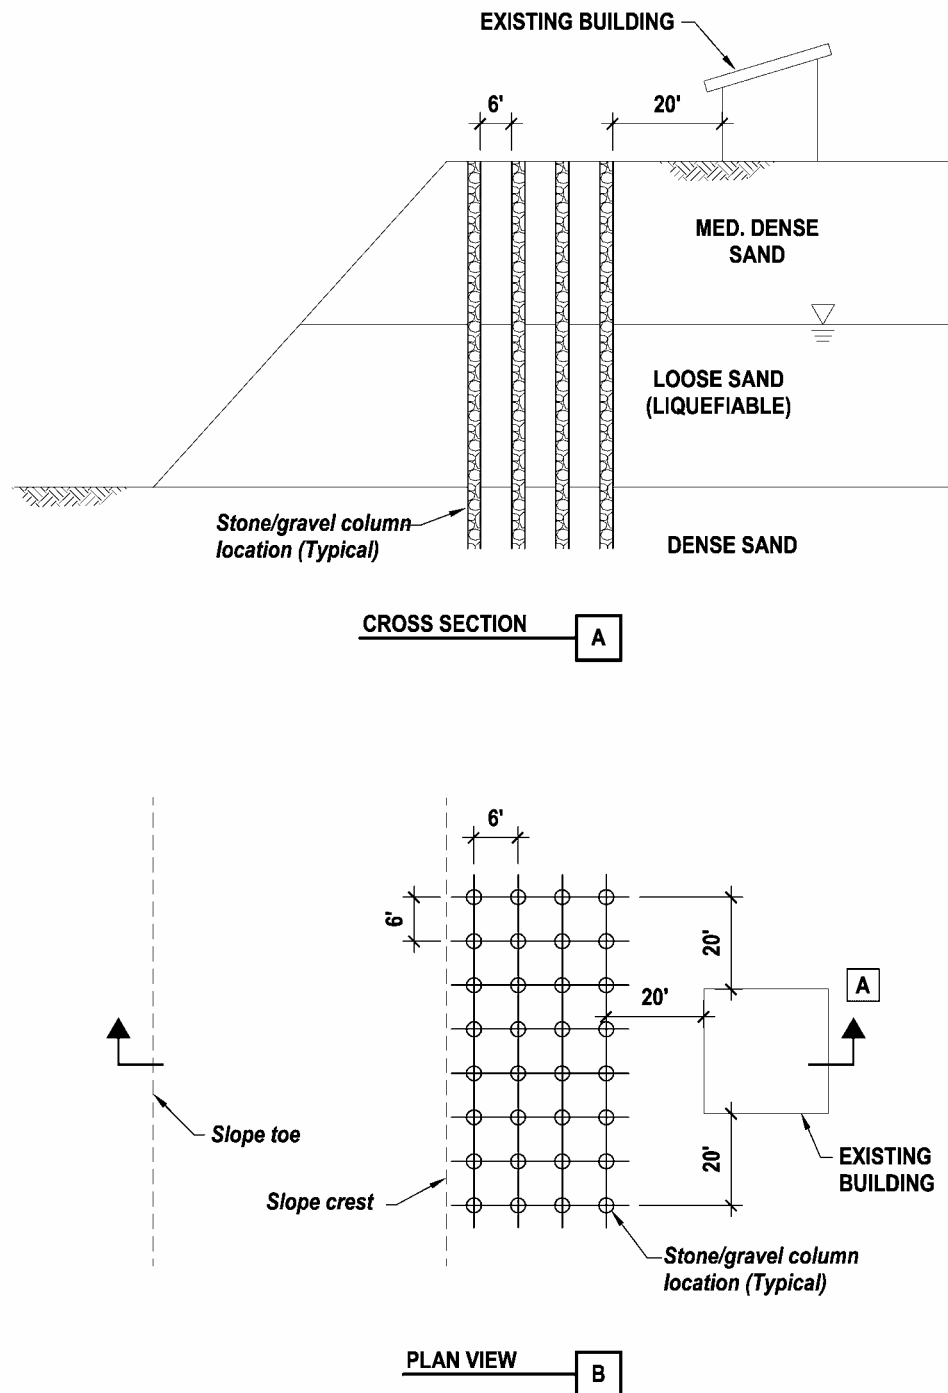
Figure 23.10.3-2: Mitigation Measure for Lateral Spreading – Stone/Gravel Column

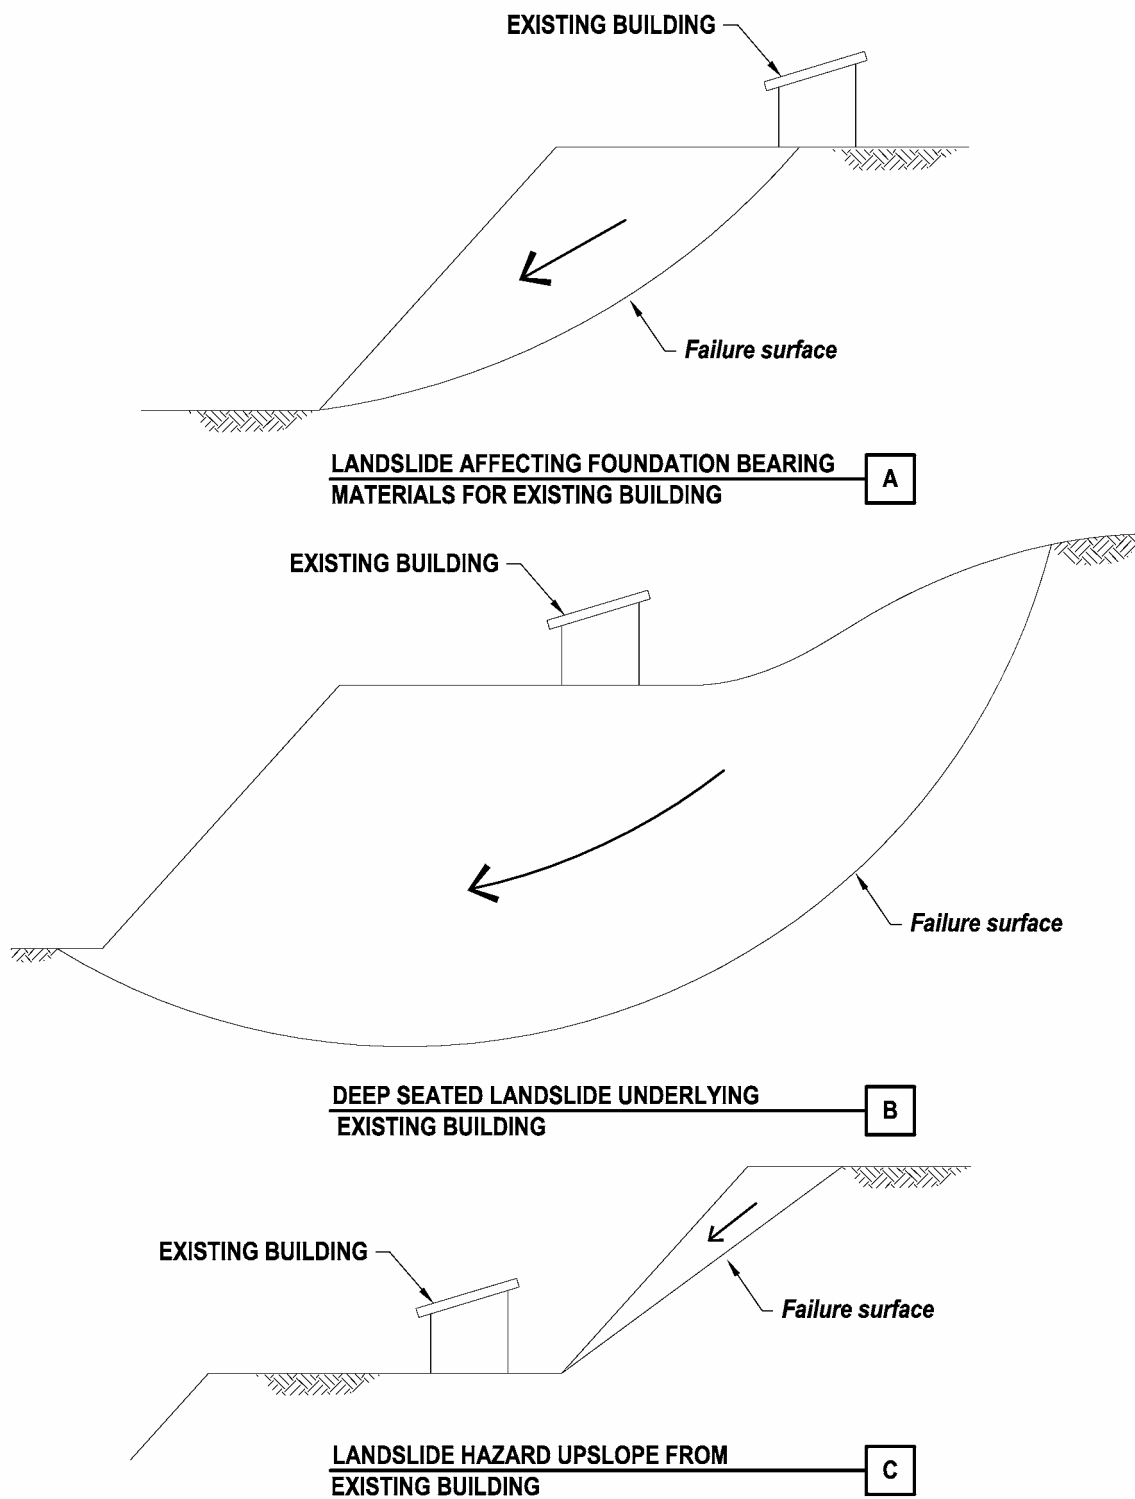
Figure 23.10.4-1: Landslide Hazards

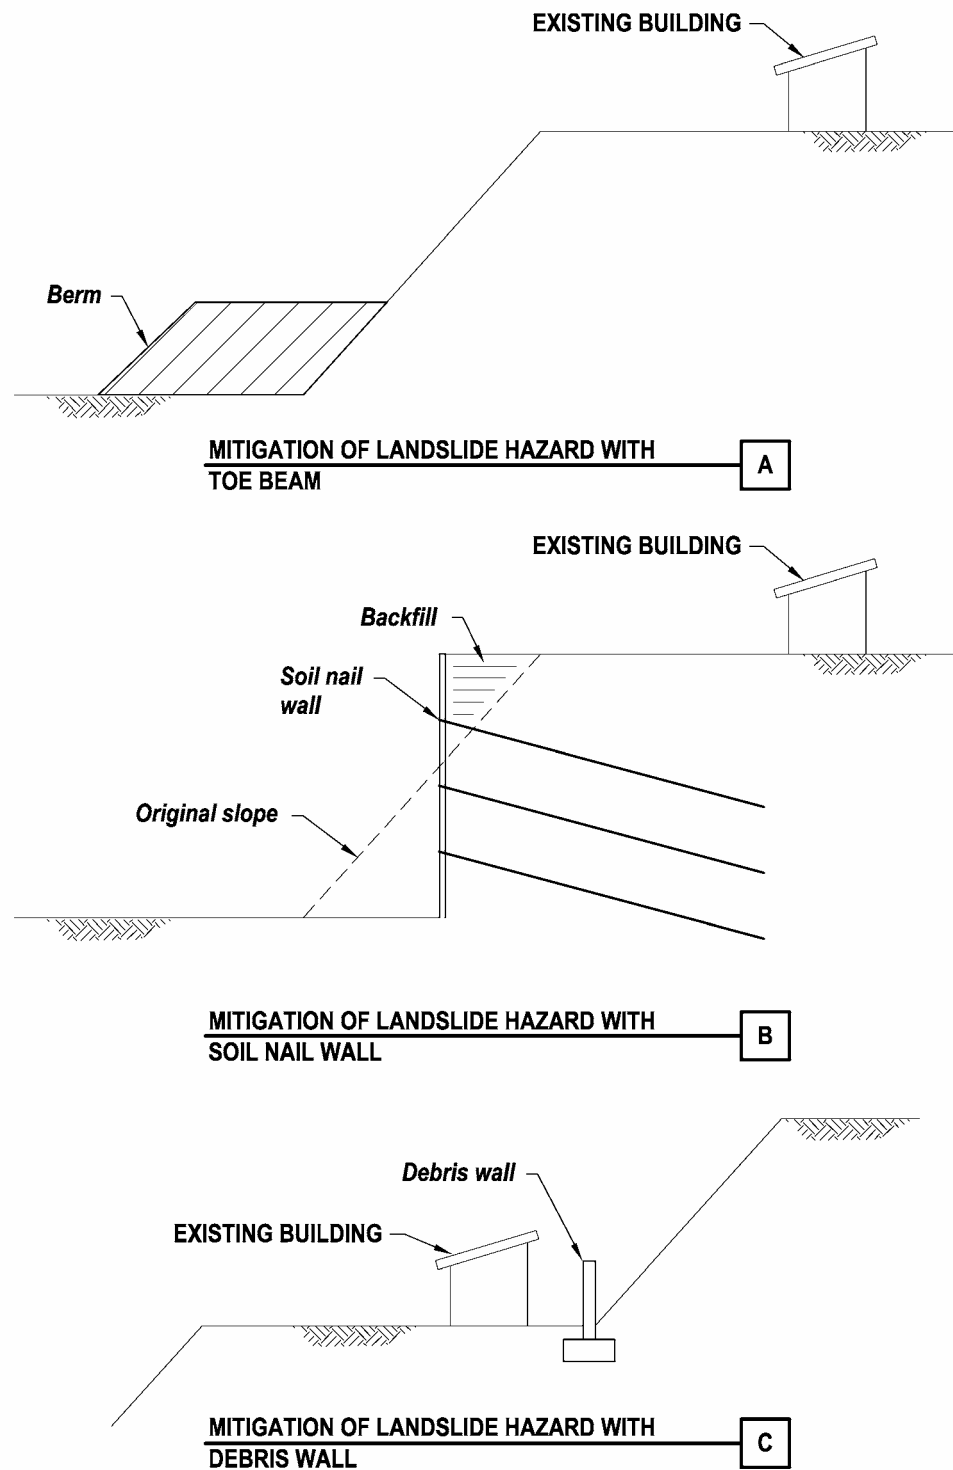
Figure 23.10.4-2: Mitigation of Landslide Hazards

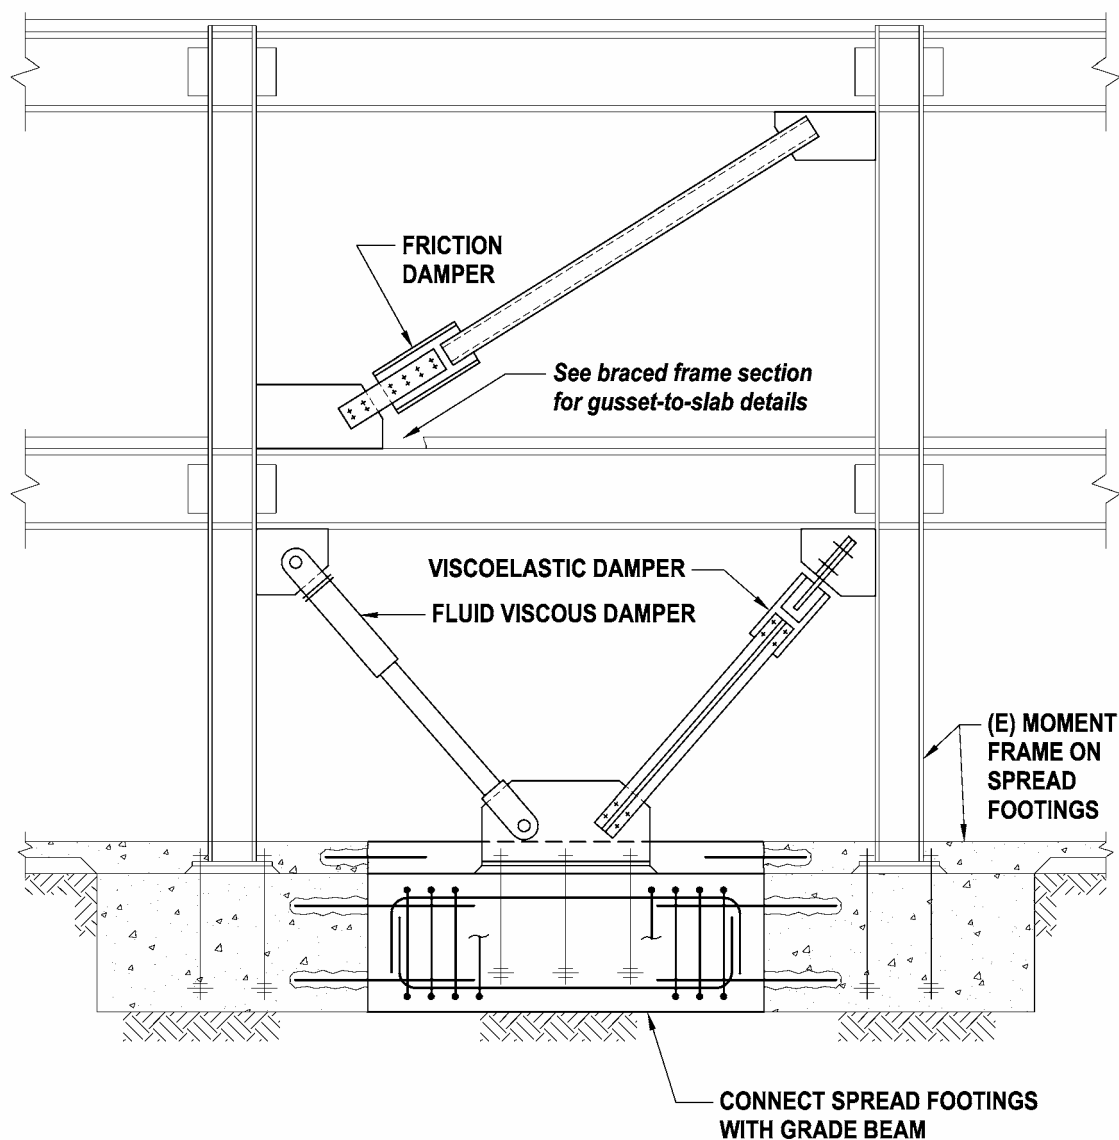
Figure 24.4-1: Damper Alternatives for Rehabilitating an Existing Moment Frame

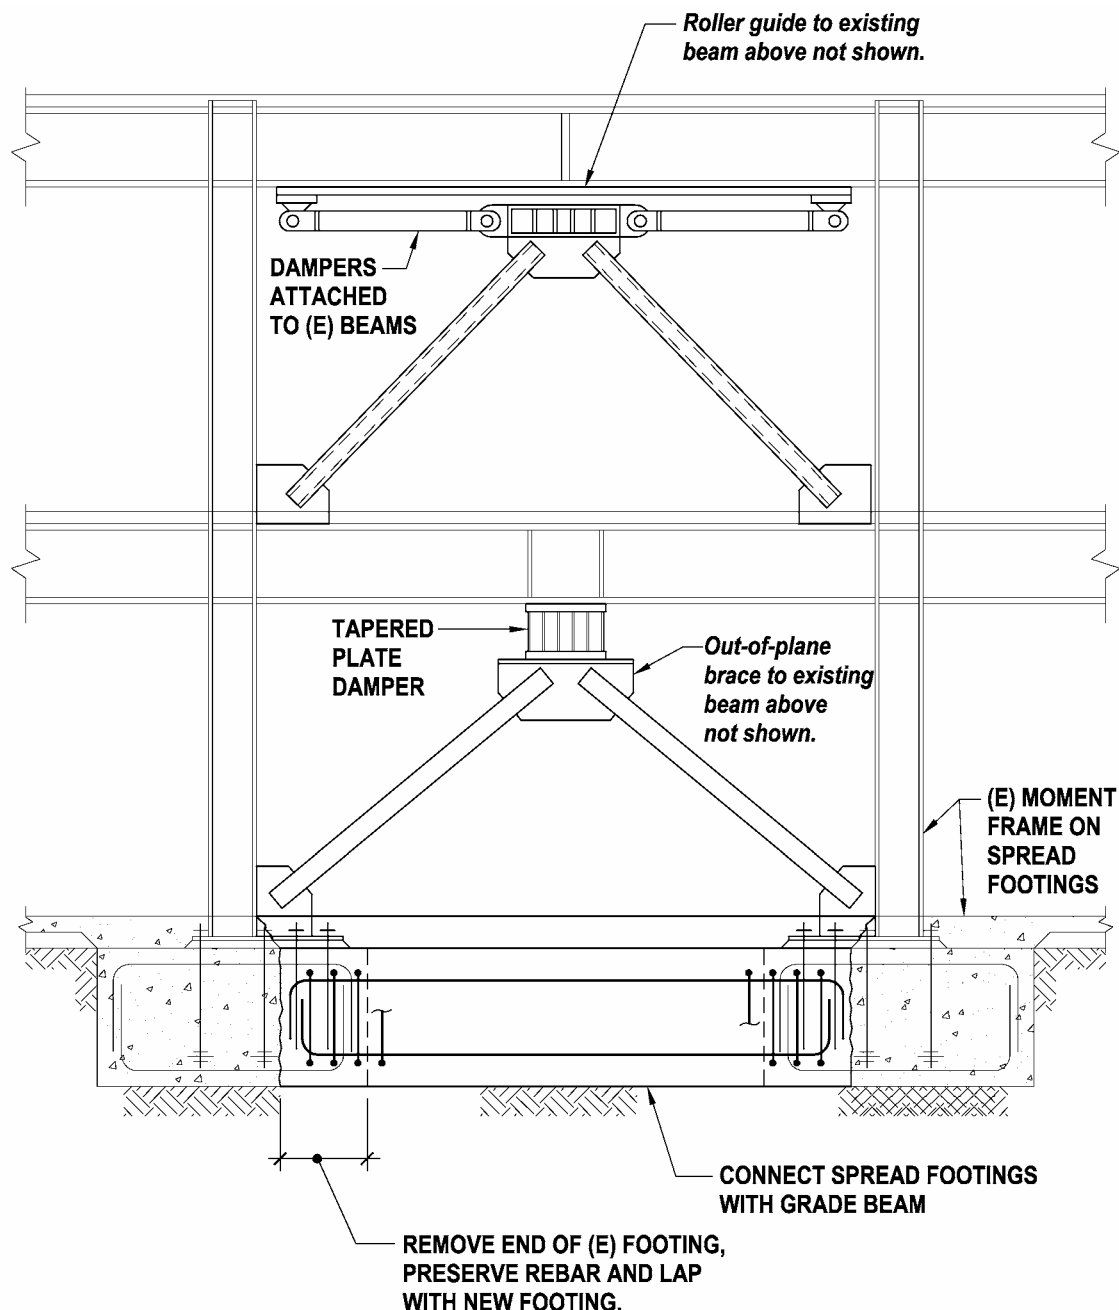
Figure 24.4-2: Additional Damper Alternatives for Rehabilitating an Existing Moment Frame
